**Appendix 4.12 F**  
**Fire Hydrant Flow Simulation Testing**

## Hydrant Testing Report

Naas, Co. Kildare

| <b>Project:</b> | Hydrant Testing & 7 Day Logging<br>Naas, Co. Kildare |

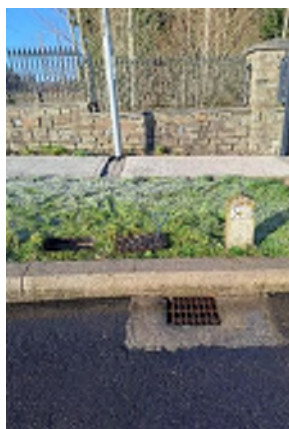
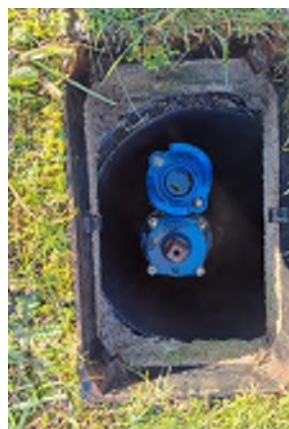
- All Hydrants are accessible and have spindles in place, except for FH2 where the Spindle is missing.
- All Hydrant Pits are in good condition, and the hydrants Frames/Covers are in poor condition.
- Hydrant outlet FH1 and FH2 connections are LUG, FH3 is an LRT connection.
- All Hydrants have marker plates to identify hydrant location/details.
- The covers to the Hydrant chambers are NOT painted canary yellow.

| FH No. | Surface | Cover / Frame | Pit | Type | Depth | Marker / Plate | Canary Yellow | Spindle | Operating | Comments |
|---|---|---|---|---|---|---|---|---|---|---|
| 1 | Grass | Poor | Good | LUG | 290 | Yes | No | Good | | No Plinth |

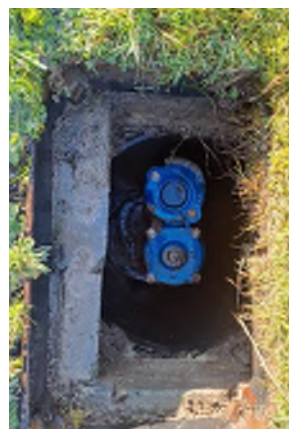
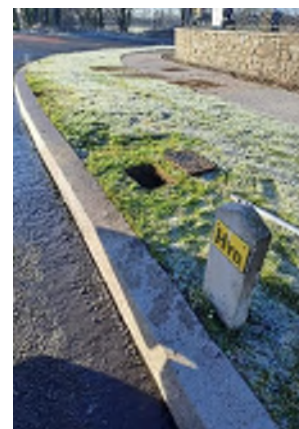
FH2

| FH No. | Surface | Cover / Frame | Pit | Type | Depth | Marker / Plate | Canary Yellow | Spindle | Operating | Comments |
|---|---|---|---|---|---|---|---|---|---|---|
| 2 | Grass | Poor | Good | LUG | 370 | Yes | No | Missing | | No Plinth |

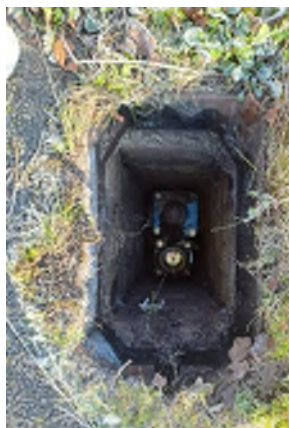
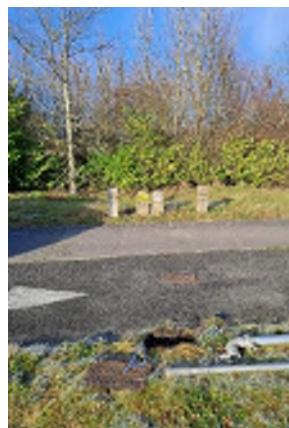
FH3

| FH No. | Surface | Cover / Frame | Pit | Type | Depth | Marker / Plate | Canary Yellow | Spindle | Operating | Comments |
|---|---|---|---|---|---|---|---|---|---|---|
| 3 | Grass | Poor | Good | LRT | 520 | Yes | No | Good | | No Plinth |
