## **Rosslare ORE Hub**

# **Soils, Geology, Hydrogeology and Contamination**

## **Appendix B: Bathymetry**

# Rosslare Europort Offshore Wind Hub Geophysical Survey Survey Report

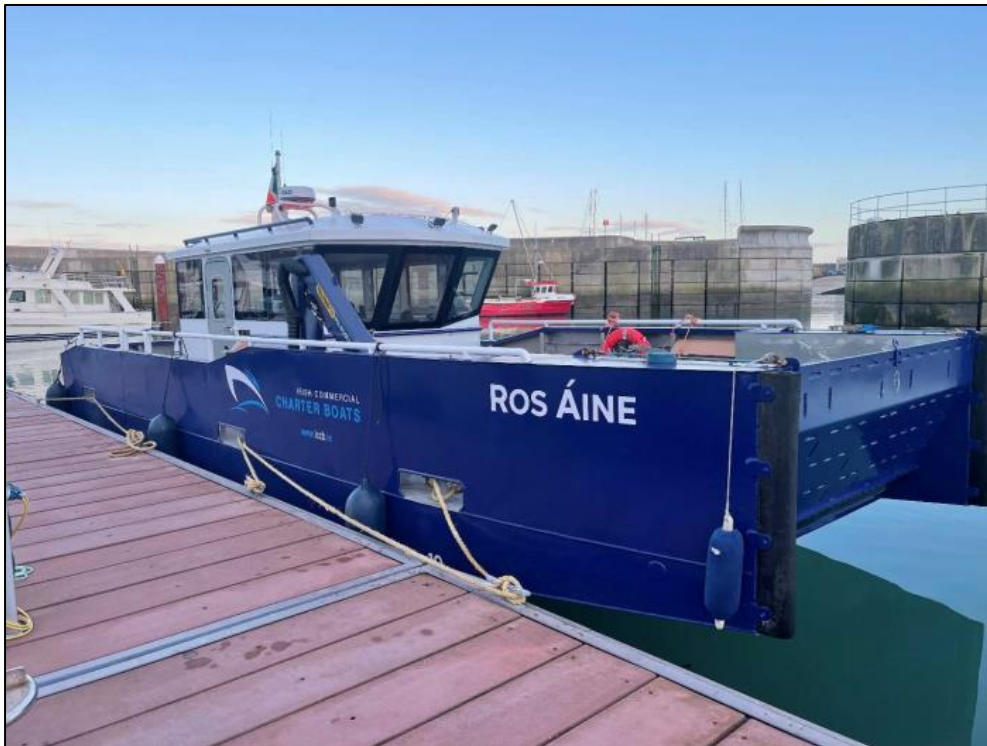
The vessel used for the geophysical survey was the Ros Aine (Figure 5). Summary specifications are listed in Table 2.

Figure 5: Ros Aine, survey vessel.

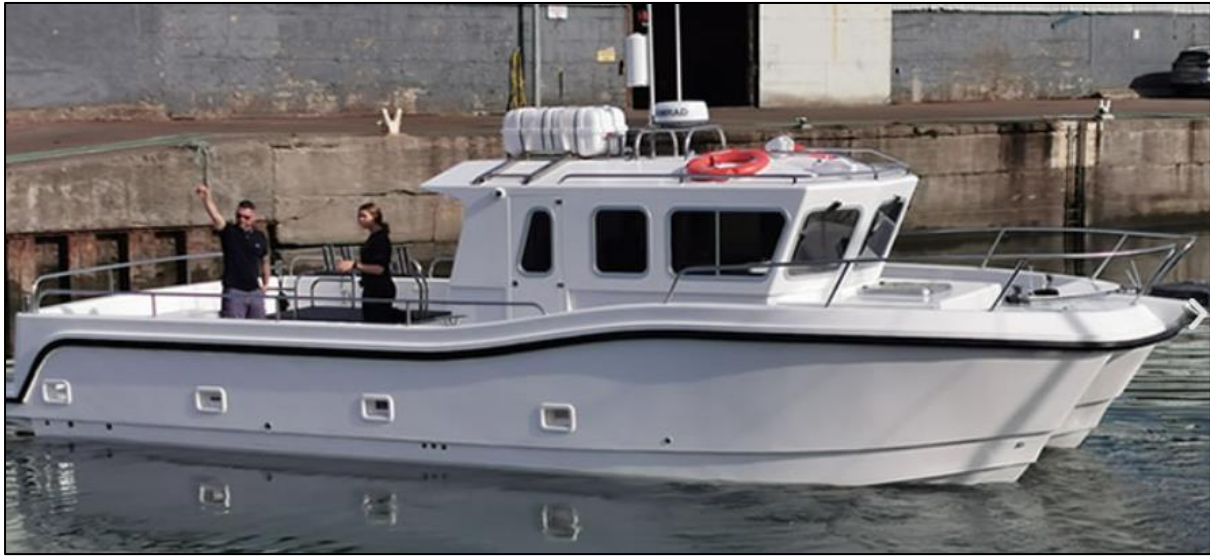
For the MF seismic survey, the Manannan vessel was used (figure 6). Summary specifications are listed in Table 3.

Figure 6: Manannan survey vessel
