Quality Audit

Ardee Main Street, Co Louth

Ardee Regeneration 2040
Louth County Council

Title: **STAGE 2 ROAD SAFETY AUDIT**
For;
Main Street Ardee

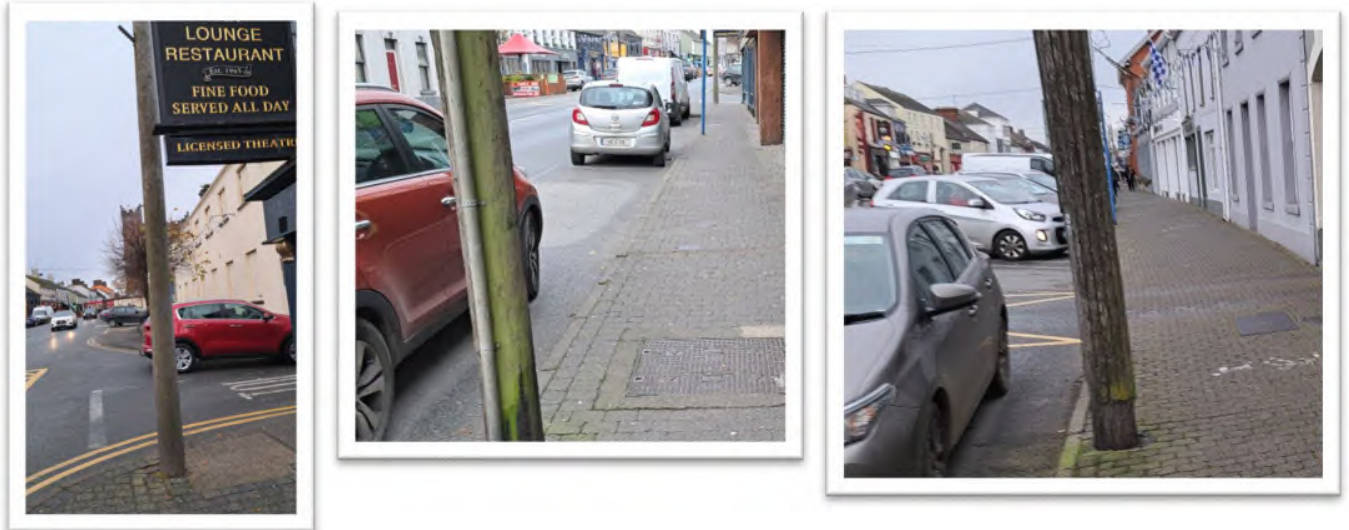
There are some substantial utility poles in the footpaths along the scheme. It is unclear if these poles are to be removed. If they are to remain they present hazards for pedestrians who may collide with them if not looking up, or if the pedestrians are visually impaired and also the poles reduce the effective width of the footpath to such an extent that some pedestrians may step onto the carriageway to avoid them thereby increasing the risk of being struck by a passing vehicle.

It is recommended that the poles be removed.

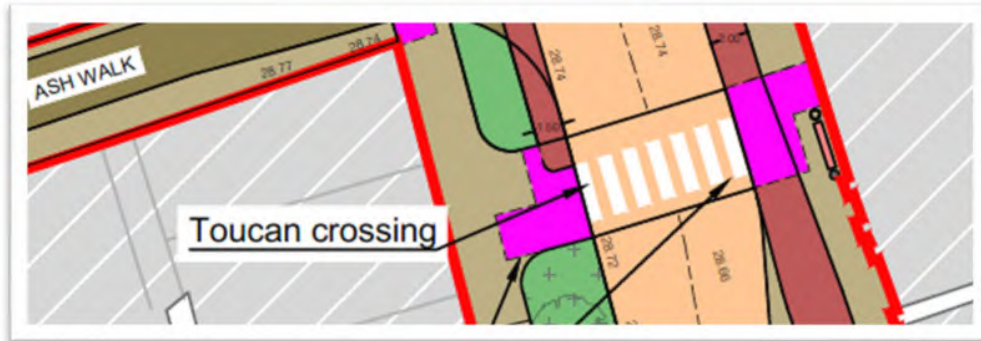
The northbound cycle track commences within the L-shaped tactile paving. This area should be shared use and access to the push buttons should be available. The Zebra type road markings should not be provided at toucan crossings as priority may be confusing. A lack of clarity could lead to collisions between vulnerable road users and passing traffic.

It is recommended that a standard layout toucan crossing be provided.

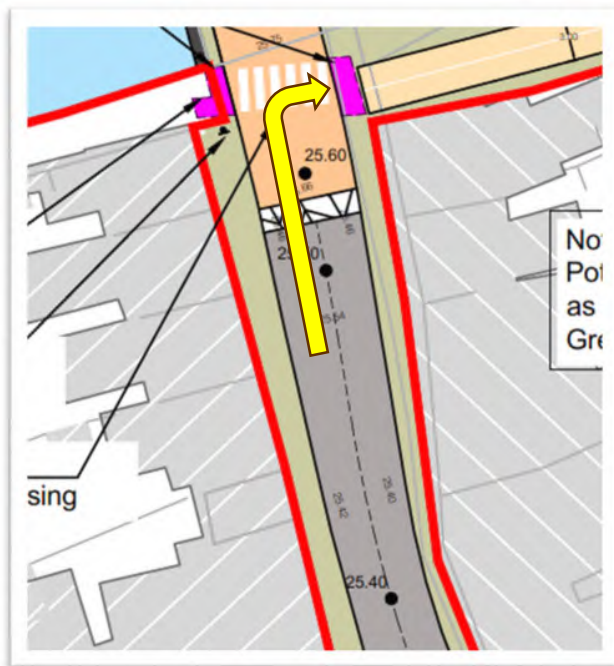
There is no provision for northbound cyclists to exit the N2 and wait to cross the signalised crossing. Cyclists will therefore continue travelling northbound on the Main Street carriageway thereby increasing the risk of collisions with general traffic. A proposal to direct cyclists via Hale Street was suggested in the Feedback Form of the Stage 1&2 Road Safety Audit. That proposal does not appear to be included in this design update.

It is recommended that a transition from on-road to off-road be provided for cyclists.

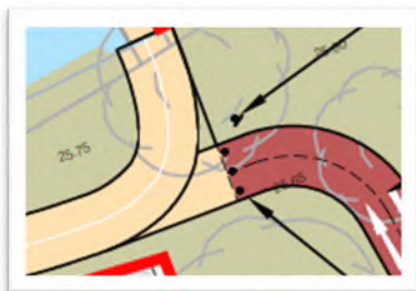
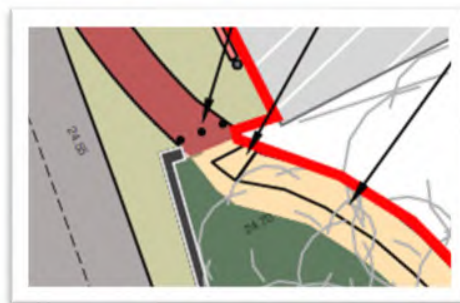
Examples only

A lack of guidance at the interface of shared use and cycle only facilities could lead to blind or partially sighted pedestrians entering a cyclists only area which would increase the likelihood of a collision with cyclists.

It is recommended that suitable tramline tactile paving be provided at the interfaces.

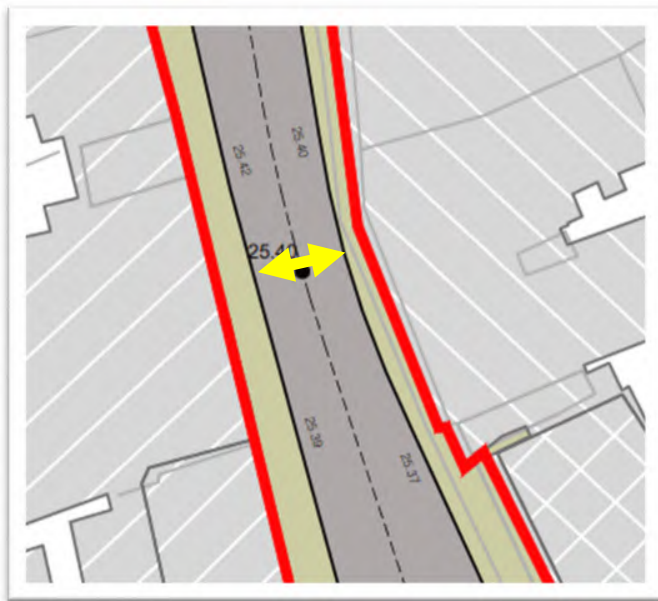
There is a pinch point in the carriageway south of the bridge. Wide vehicles currently operate an informal shuttle system to pass each other. This may not be possible with the introduction of the new crossing as vehicles may be stuck in position while queuing at the signals. This could lead to side-swipe collisions, damage to bollards and mounting of the footpath. It is noted from the site visit that queuing on the N2 is common for long periods of each day. (It was observed during the most recent site visit that flexible bollards in the footpath at this location have been struck many times and have collapsed)

It is recommended that an analysis be carried out of the likelihood of queues at the pinch point and the possible need for a longer formal shuttle system.

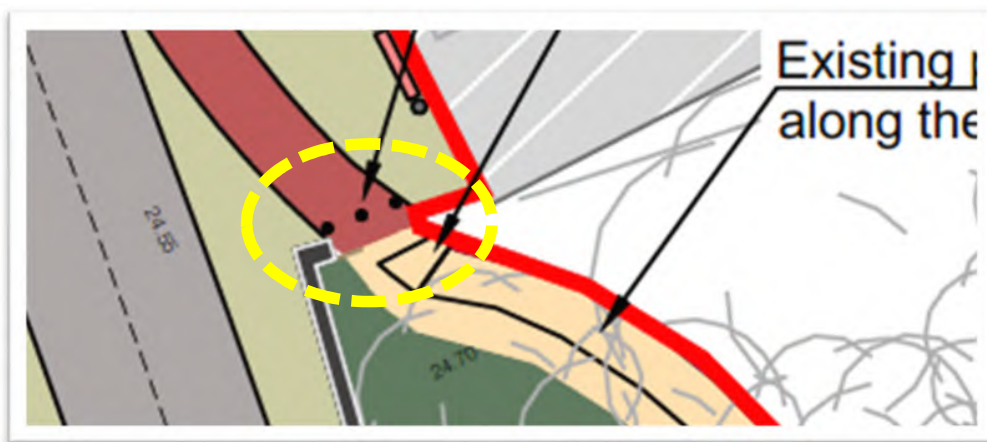
The two-way cycle track leads to a shared use area on approach to the bridge. Pedestrians have no area to join the shared use area. This could result in pedestrians crossing the road bridge which has a very narrow footpath and pedestrians would be subject to wind forces from heavy goods vehicles possibly leading to loss of balance.

It is recommended that an area be provided for pedestrians to access the pedestrian bridge.

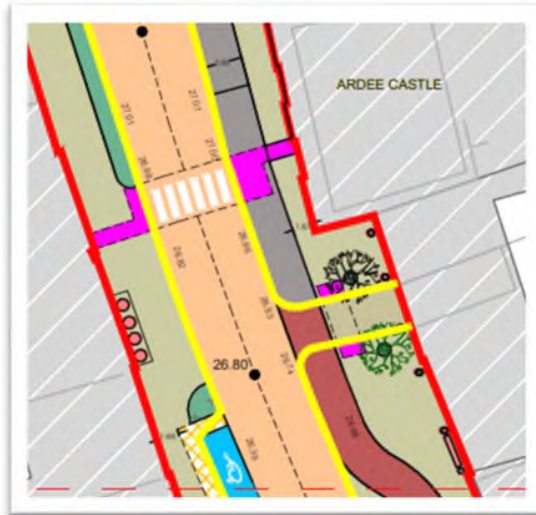
Example area only.

It is proposed to provide flush kerbs between the footpaths and cycle tracks at areas of raised tables. Given the arterial nature of the N2 and the high percentage of HGVs there will be no resistance to overrun by wide vehicles and no containment of errant vehicles. The flush kerbs will lead to higher turning speeds at side roads and private accesses which would increase injury severity if a vulnerable road user is struck. The flush kerbs also provide no warning for blind or partially sighted pedestrians that they could be entering an area trafficked by vehicles.

It is recommended that a suitable kerb upstand be provided except at pedestrian crossing areas.

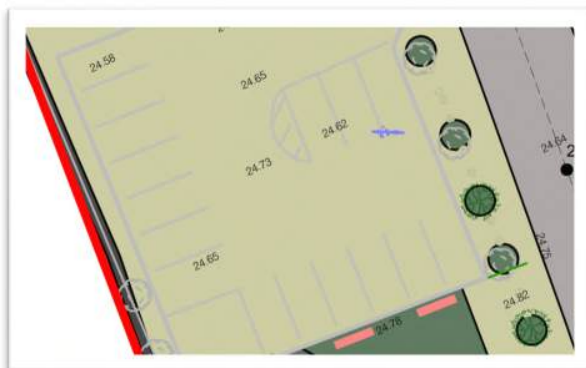
Some proposed car parking spaces appear to be difficult to enter and egress especially if the adjacent spaces are occupied. This could lead to material damage of vehicles or inaccessibility for some users with mobility impairment but not sufficient to be entitled to use the disabled spaces.

It is recommended that adequate turning space be provided for all car parking spaces.

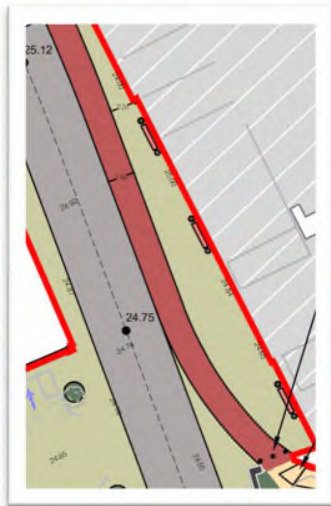
The two-way cycle track along the eastern side may not be obvious to all users that it is two-way. This could lead to lack of discipline by cyclists travelling side by side thereby increasing the risk of collisions with oncoming cyclists.

It is recommended that additional cycle road marking logos with arrow heads be provided at regular intervals. (These are provided on some drawings).

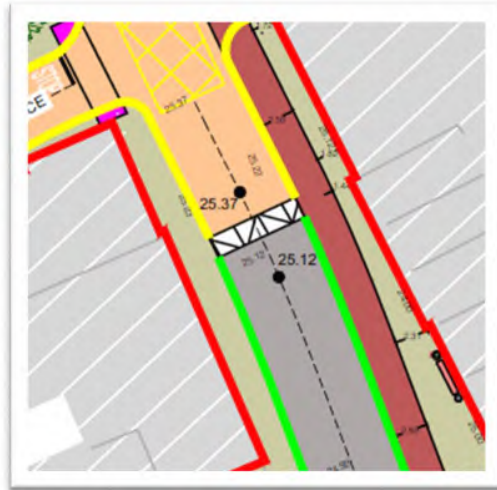
especially if affected by the wind forces associated with HGVs, resulting in collisions. This may particularly be an issue at raised tables where there are flush kerbs only to segregate cyclists from general traffic. There was a suggestion of having a 30km/hr speed limit in Ardee town centre in the feedback form of the Stage 1&2 Road Safety Audit. This does not however appear to be part of the current proposal.

It is recommended that the 30km/hr speed limit be confirmed or that a buffer zone, bollards or a suitable kerb upstand be provided.

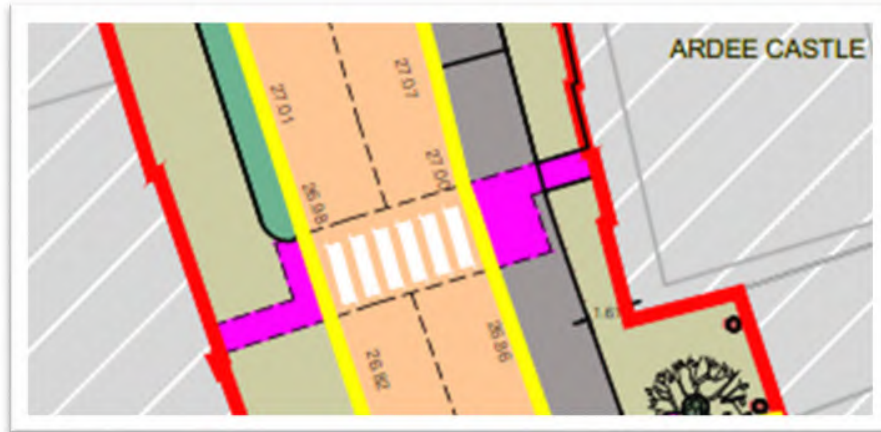
The pedestrian crossing at Ardee castle has a two-way cycle track on the eastern side. A lack of warning could lead to blind or partially sighted pedestrians not realising they are sharing space with cyclists.

It is recommended that a well-defined shared area be provided with suitable ladder and tramline tactile paving at either side. This applies to other similar crossings throughout the scheme.

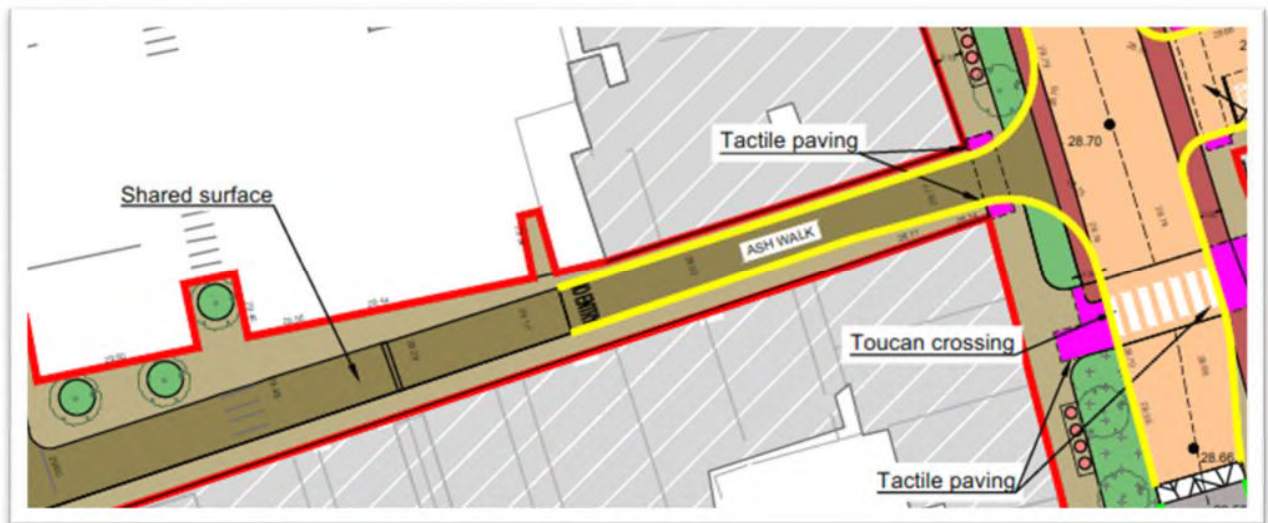
Ash Walk is shown to be a 'Shared Street' It is unclear what distinguishing features or what signage will be provided to indicate this to users, especially drivers, as they enter this area. It appears that the footpaths are to be retained beyond the initial section from the N2 which does not signify a shared street but segregated facilities for pedestrians. A lack of clarity can lead to drivers presuming priority resulting in collisions.

It is recommended suitable details be provided to denote a 'shared street' at its transition from the N2.

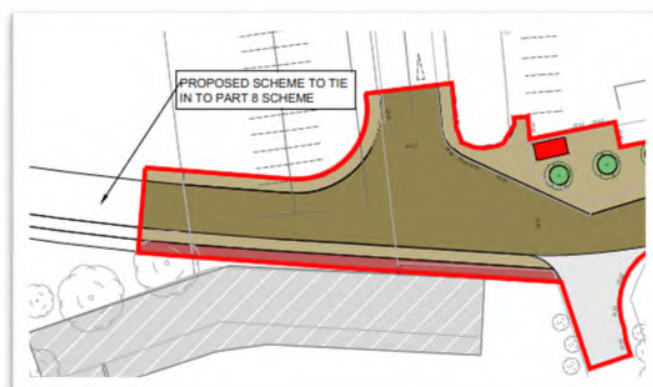
Ash Walk is shown to tie-into a Part 8 scheme at the western end. Ash Walk is shown as a 'Shared Street'. It is unclear if the Part 8 scheme is to be a shared street and if its nature and use will therefore be consistent. A change of street type could increase the risk of collisions with vulnerable road users.

It is recommended that consistency in street type be provided.

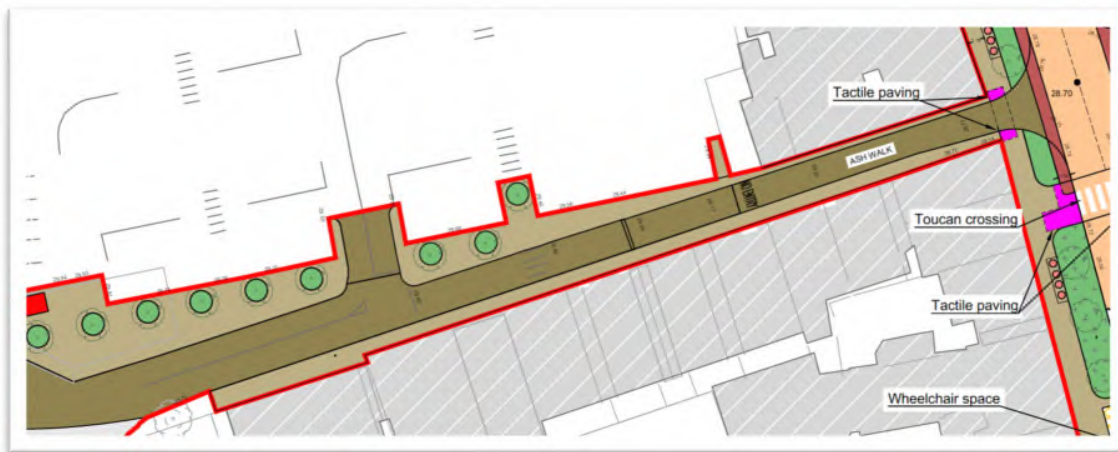
Ash Walk is relatively long and straight and one-way. This could lead to high vehicle speeds. High speeds leads to high injury severity if a vulnerable road users is struck by an errant vehicle.

It is recommended that traffic calming be provided along Ash Walk. (It is unclear if an existing raised table is to be retained)

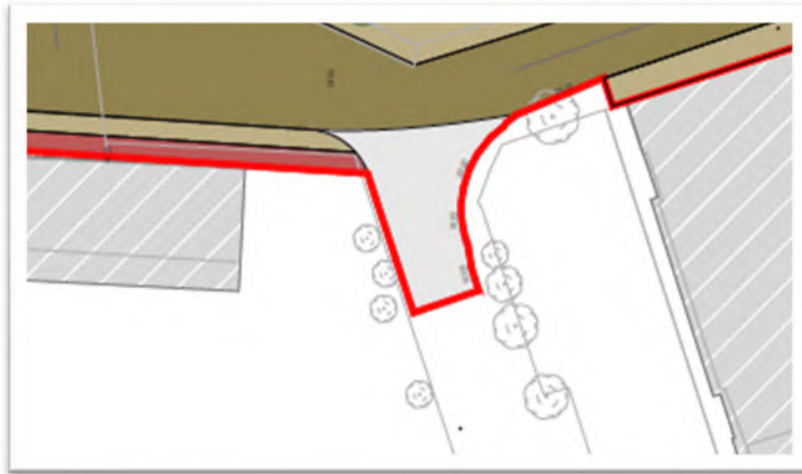
The link road to the N52 from Ash Walk is not shown to be a shared street. A change of street type could increase the risk of collisions with vulnerable road users.

It is recommended that that consistency in street type be provided or that a suitable transition be provided.

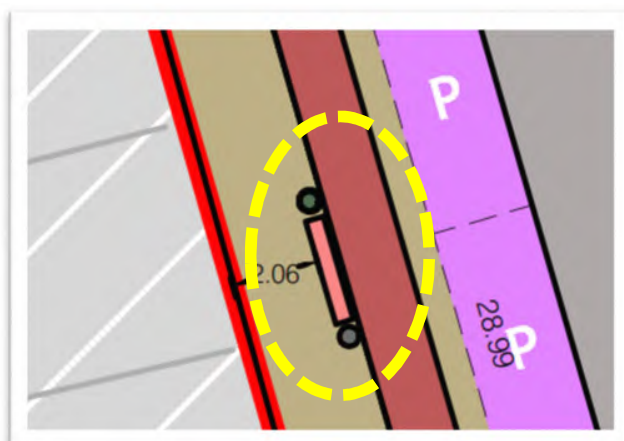
Example only

It is proposed to provide benches adjacent to the cycle track. If they are located too close to the cycle track they may be hazards for cyclists who may get their handlebars caught leading to loss of control and falls.

It is recommended adequate offset be provided at the edges of the cycle track without obstacles.

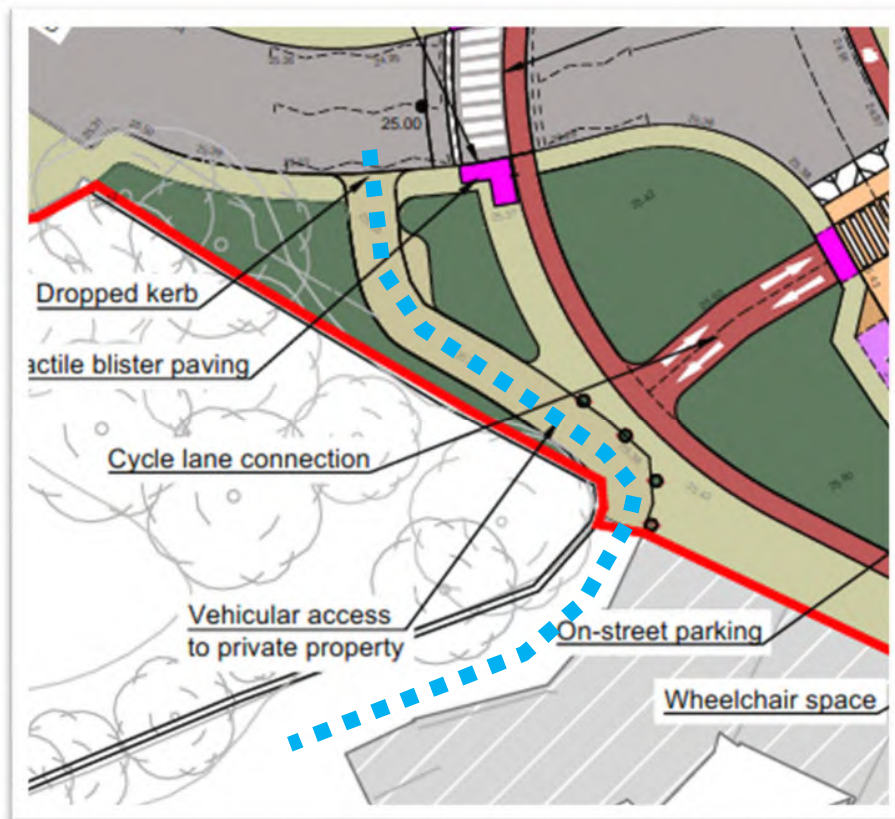
The vehicular access to the car park of the bar at the junction of Golf Links Road is for a single vehicles only. Drivers entering the route will not have inter-visibility to drivers leaving which could lead to reversing onto Golf Links Road resulting in collisions with through traffic or crossing pedestrians.

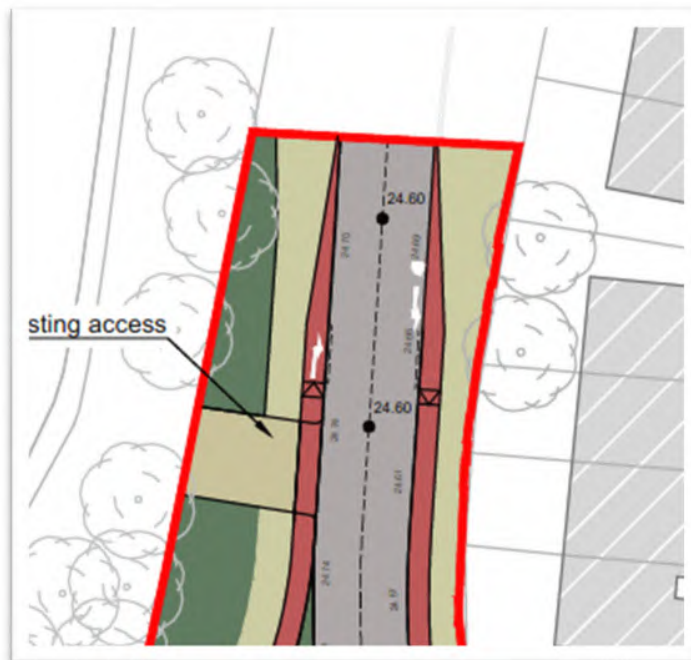
The northbound cycle track tapers gently from off-road to on-road. This could lead to cyclists entering the busy N2 without looking to see if traffic is approaching. This could lead to ‘squeezing’ and collisions especially as the N2 carriageway width has been reduced.

It is recommended that the cycle track be terminated with a jug turn type arrangement whereby cyclists will be perpendicular to traffic and will have to stop before entering the carriageway.

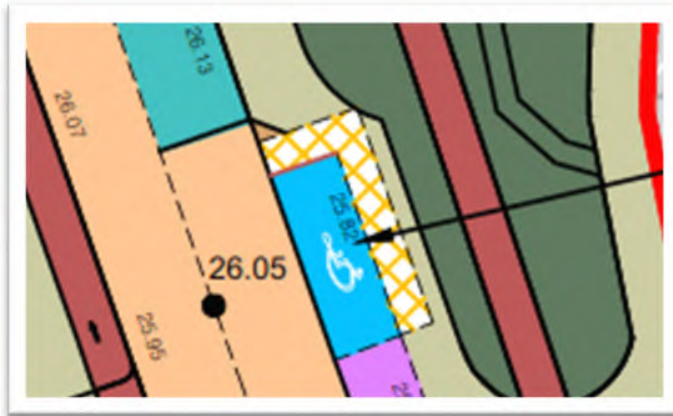
The buffer zone for the disabled parking space to the south of the southbound bus stop coincides with the footpath. It is unclear what the levels will be and if a wheelchair user will be able to use the space freely to access all areas of the car. A lack of space could lead to users entering the carriageway where they would be at greater risk of being struck by a passing vehicle.

It is recommended that the footpath be rerouted to the rear of the buffer zone.

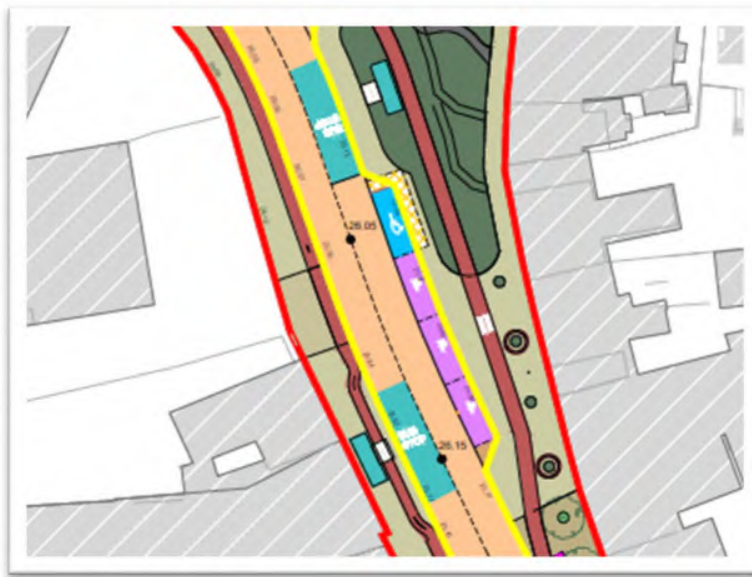
Flush kerbs are shown at the bus stops. This could lead to inaccessibility for some users resulting in loss of balance and falls.

It is recommended that kassel kerbs be provided at the bus stops with suitable transition gradients.

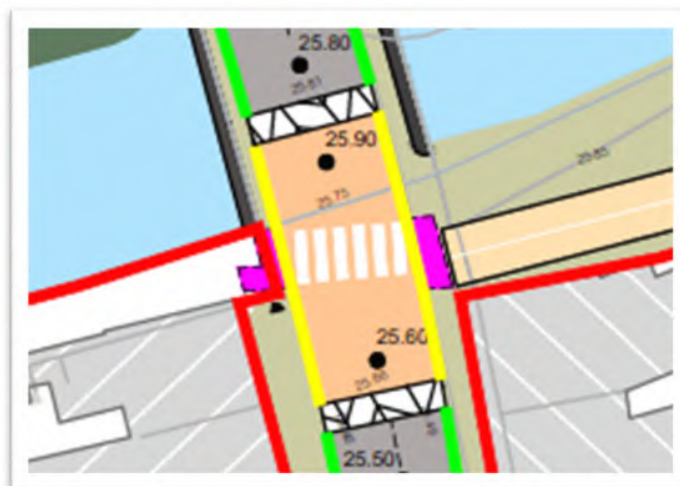
Flush kerbs are shown at the raised table partially over the river Dee bridge. A lack of kerb upstand will lead to no resistance to errant vehicle whose driver may lose concentration even at low speed resulting in a collision with the bridge parapet. This could lead to structural damage.

It is recommended that flush kerbs only be provided at the crossing point.

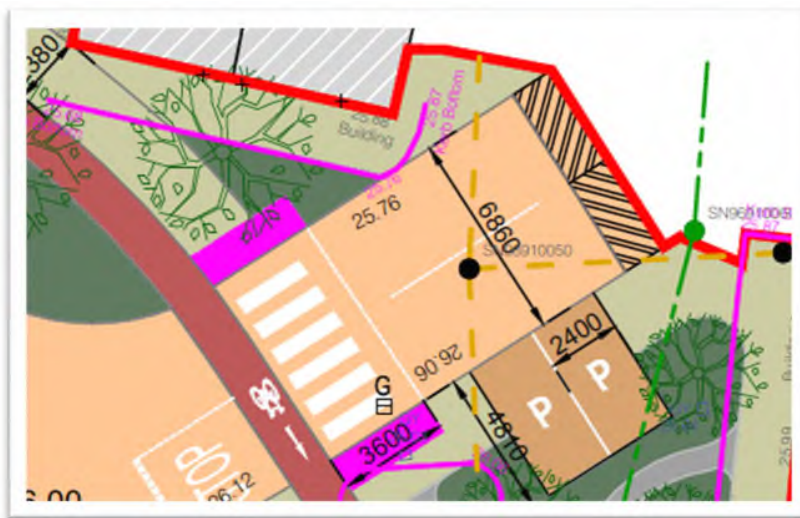
Example only

Gullies have not been provided upstream of each raised table and each pedestrian/cyclist crossing. This could lead to surface water ponding, loss of traction and loss of control in icy weather and slips and falls for vulnerable road users.

It is recommended that gullies be provided upstream of all raised area and crossing points to avoid surface water ponding.

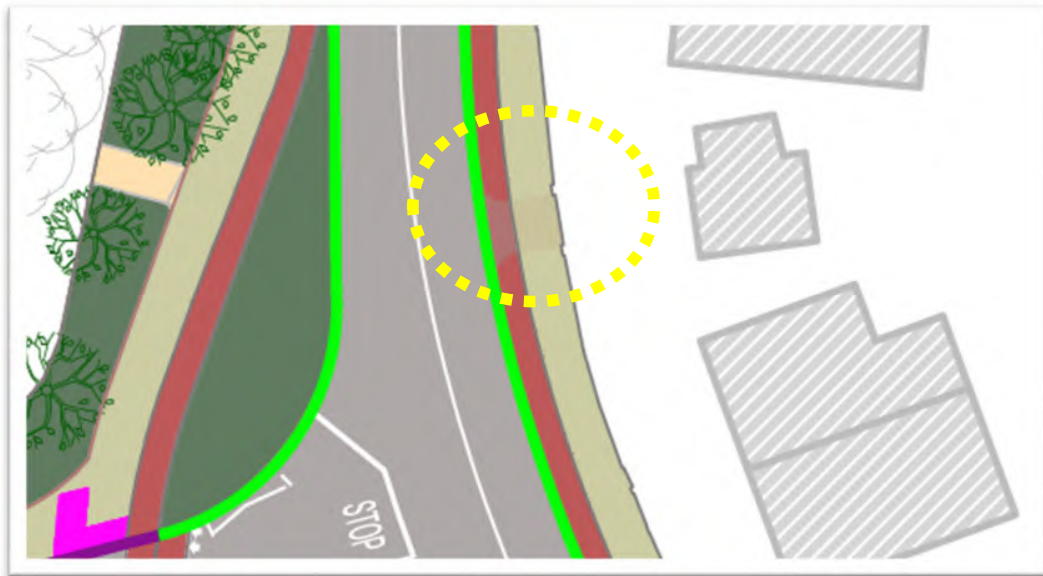
The drawing shows a 125mm high kerb at the proposed vehicular access to the private garage on the eastern side of the N2 just north of the Golf Links Road junction. A high kerb could lead to vehicles 'bouncing back' when trying to access the driveway to the garage resulting in rear-end collisions.

It is recommended that the kerb height be adjusted to facilitate vehicular access.

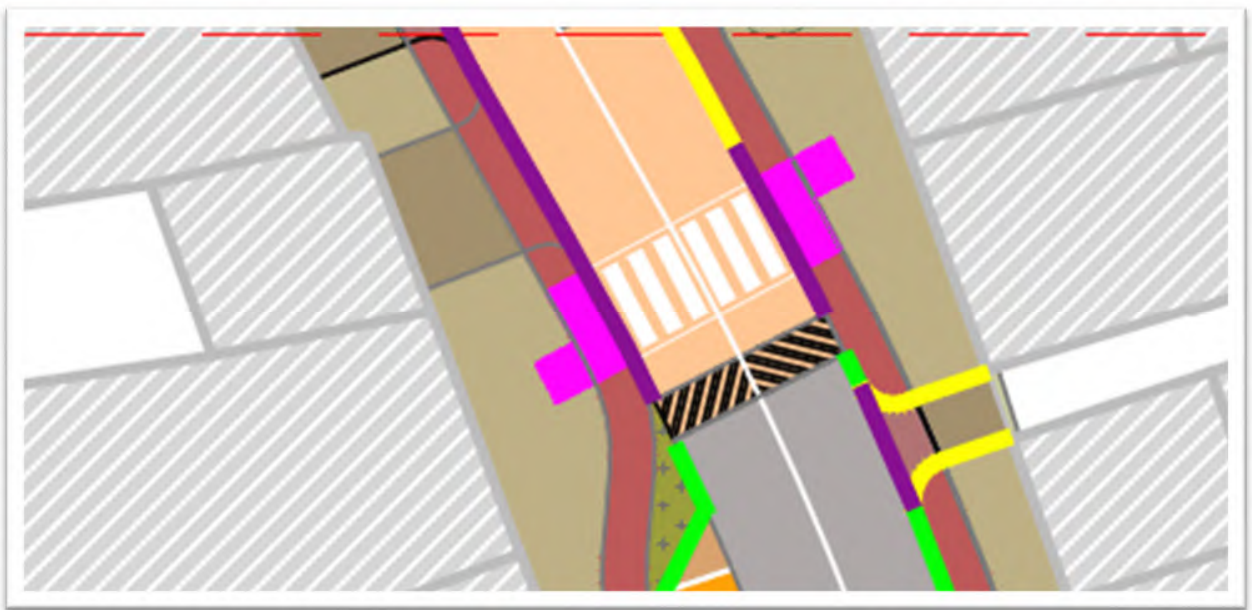
The tactile paving for the zebra crossing is within the cycle lane. It may not be clear to cyclists that pedestrians have priority as they approach the crossing. This could result in collisions between the two user groups.

It is recommended that a shared use area be developed at both sides of this zebra crossing and other similar crossings.

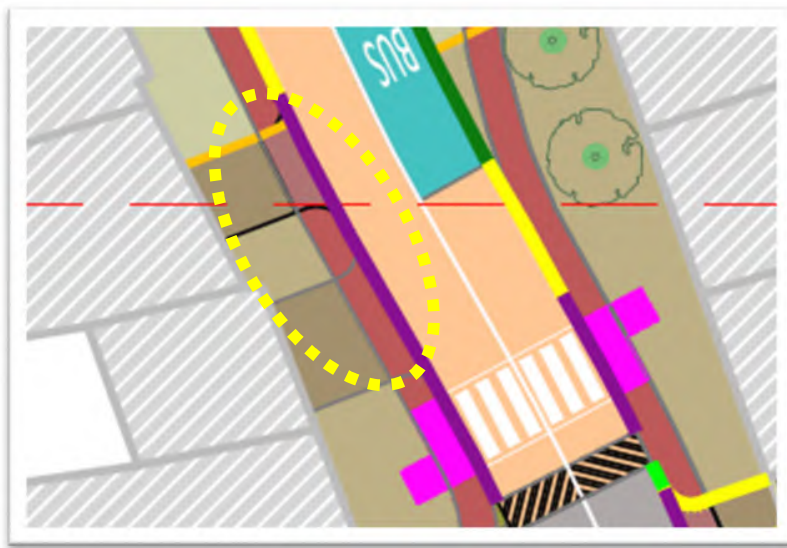
Example only

Flush kerbing is provided beyond the extents of the crossing areas at the zebra crossing. A blind or partially sighted pedestrian may inadvertently enter the carriageway if they cannot detect a level difference. This could result in collisions with passing vehicles.

It is recommended that flush kerbs only be provided at crossing points or access areas for pedestrians only.

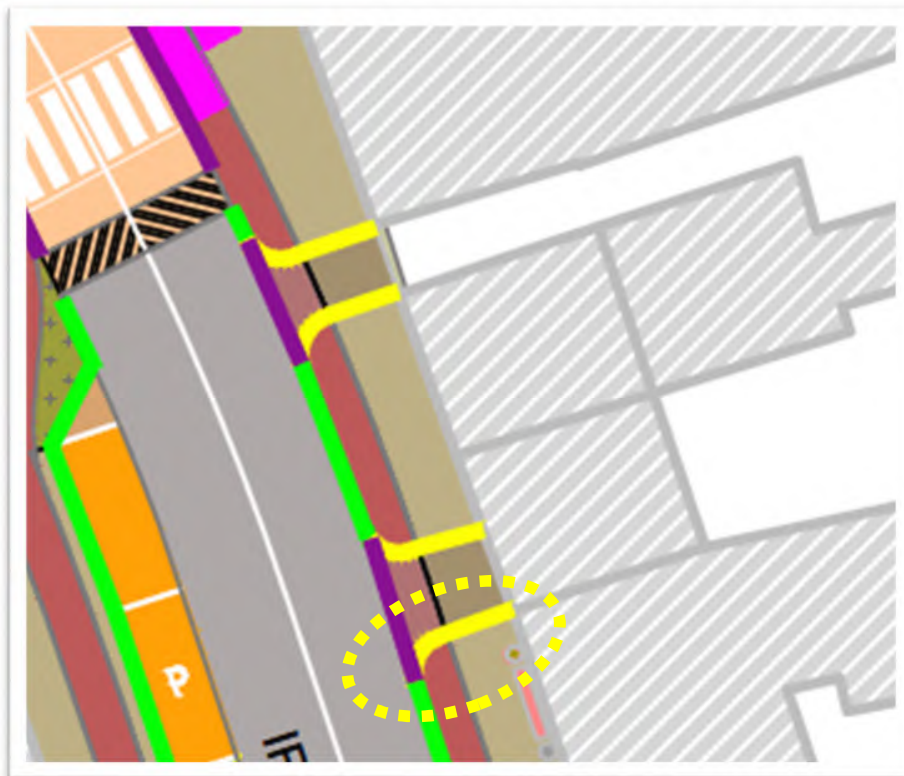
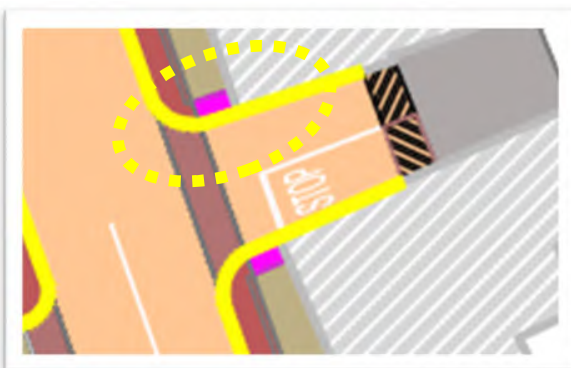
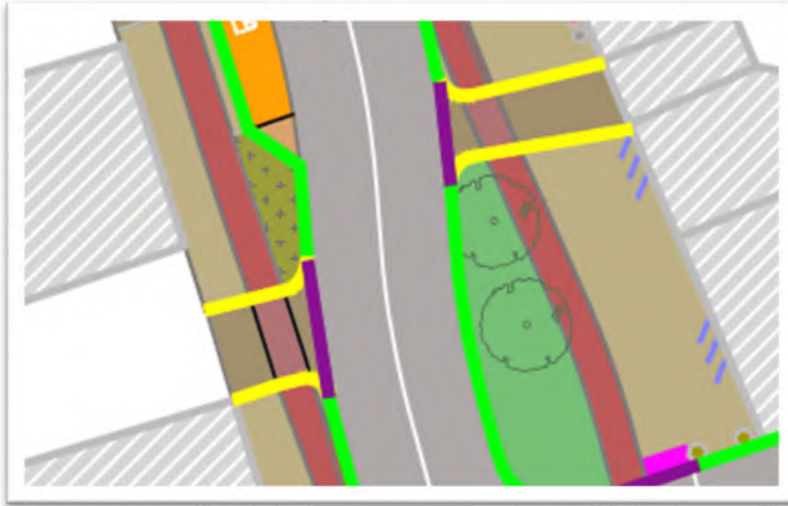
Examples only

It is proposed to provide 50mm high kerbing at some accesses across the footpath. This would be a trip hazard and would lead to inaccessibility for mobility impaired pedestrians.

It is recommended that flush kerbs be used or no kerbs and that continuous footpath and cycle track facilities be used.
