# **Volume 3: Appendices – Environmental Impact Assessment Report (EIAR)**

Ardee 2040 Regeneration Project, Co. Louth

October 2025

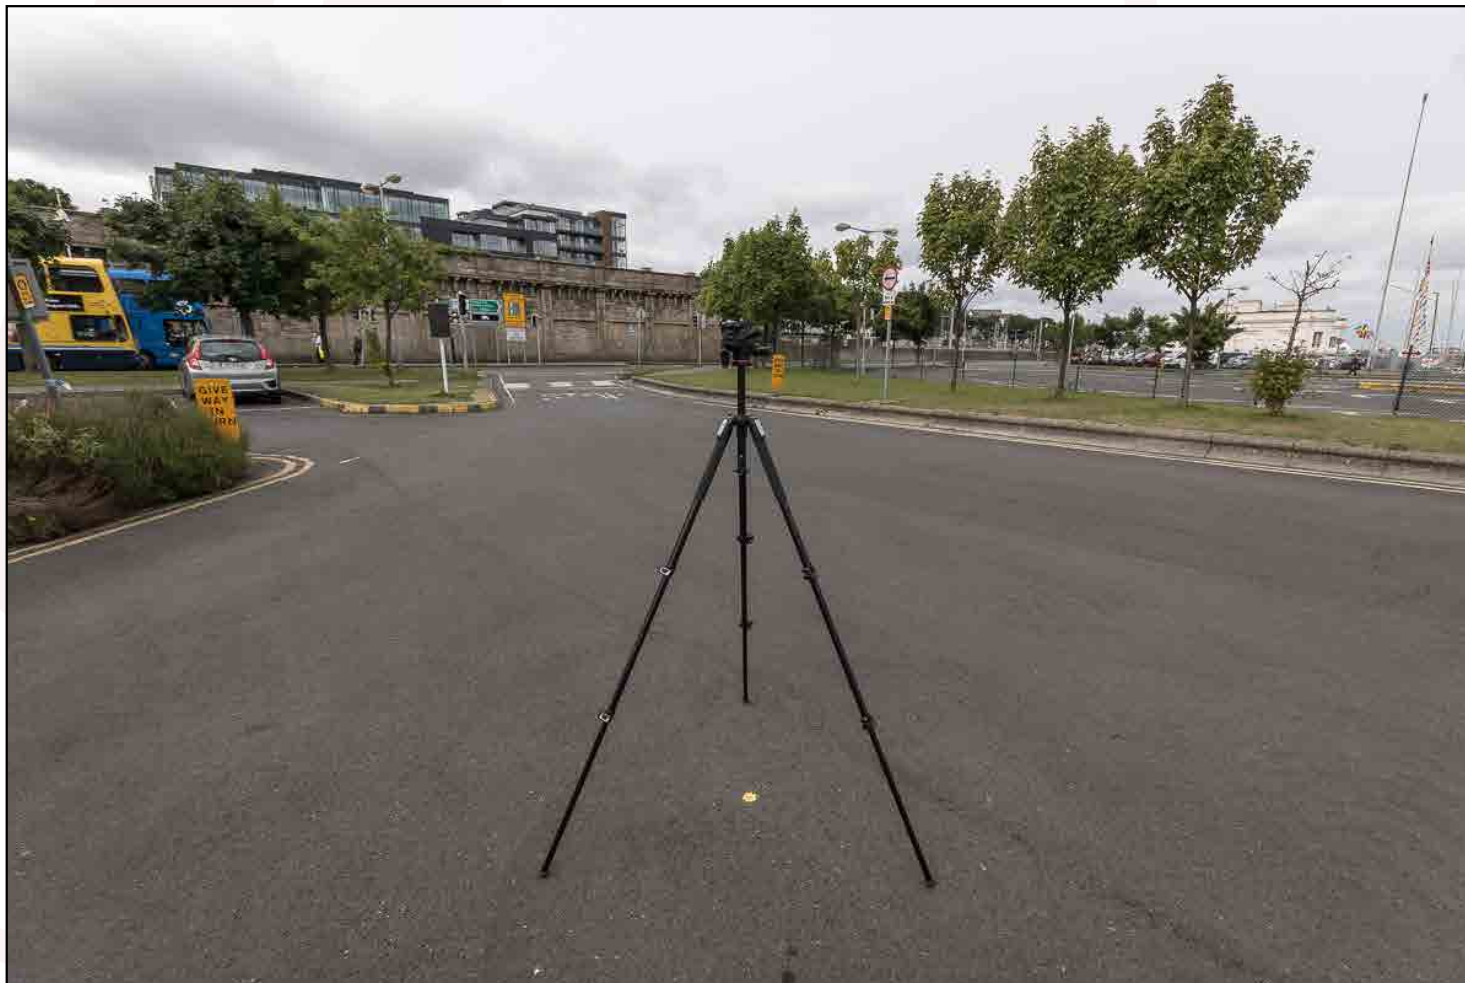
Fig.1: Camera location and height marked, recorded and photographed.

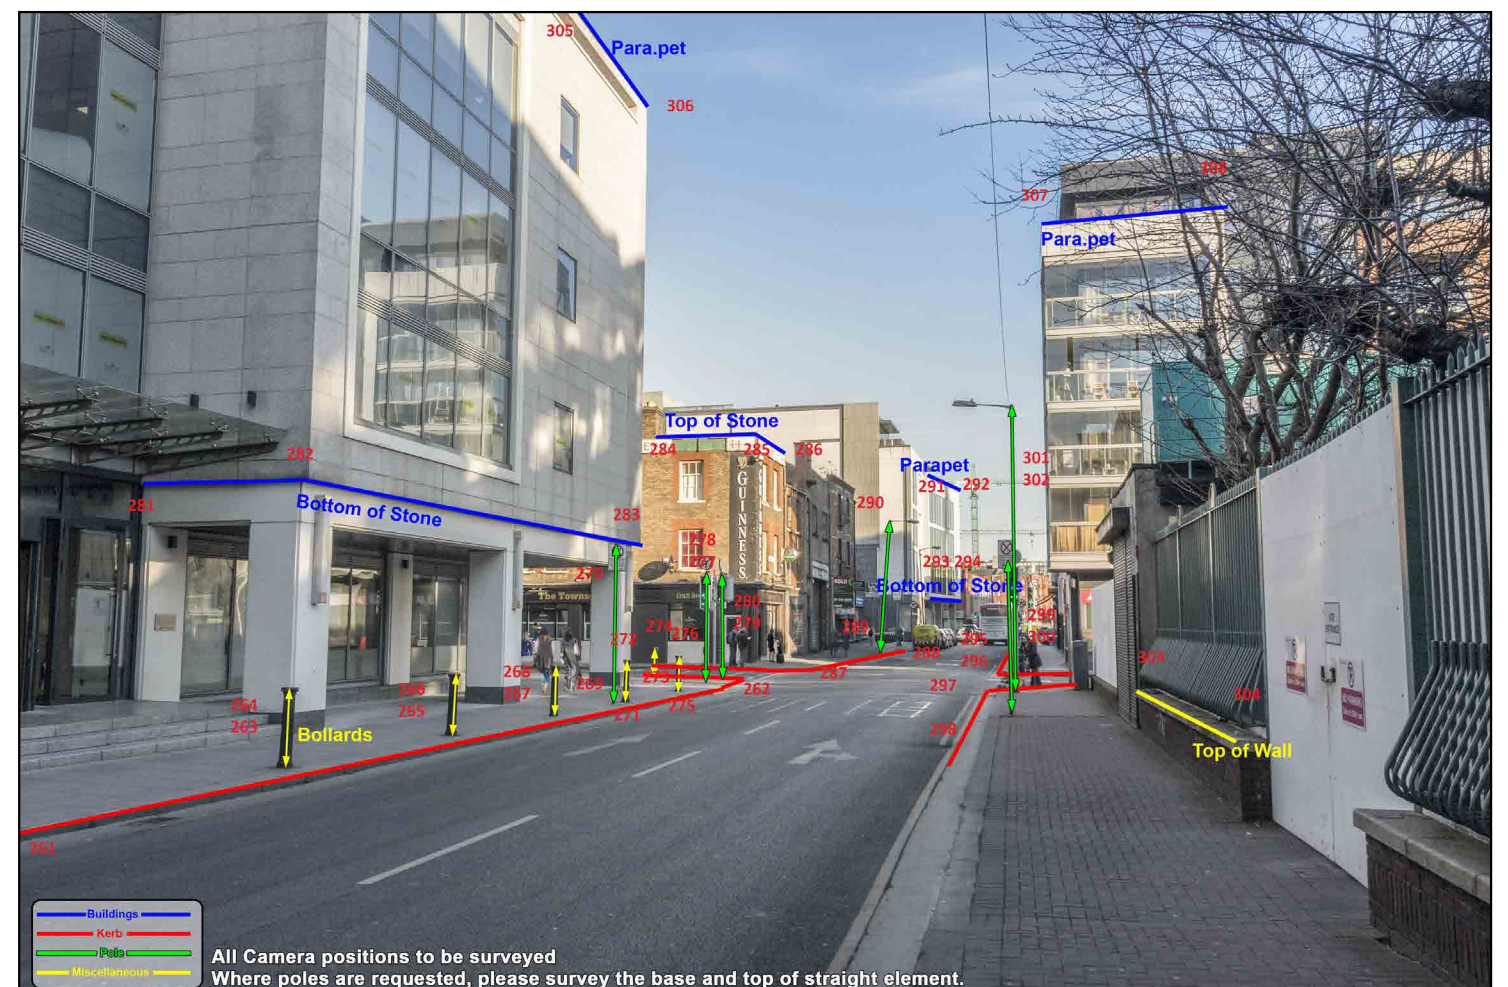
Fig.8: Fixed reference points fully surveyed and numbered.

On site, the survey team records the camera/tripod position using GPS and Total Station to an accuracy of +/-1cm Northing and Easting and to an accuracy of +/- 2cm Elevation. The 'marked up' fixed reference points identified in each photo are then surveyed to establish exact orientation of the view and to verify the photomontage process. They are clearly numbered to ensure ease of modelling. (Fig 8 below). This survey data is fed back to the production team and subsequently 3D modelled and included in the digital 3D model of the proposed development allowing for accurate positioning of the digital model within each baseline photo. (See section 3.4)

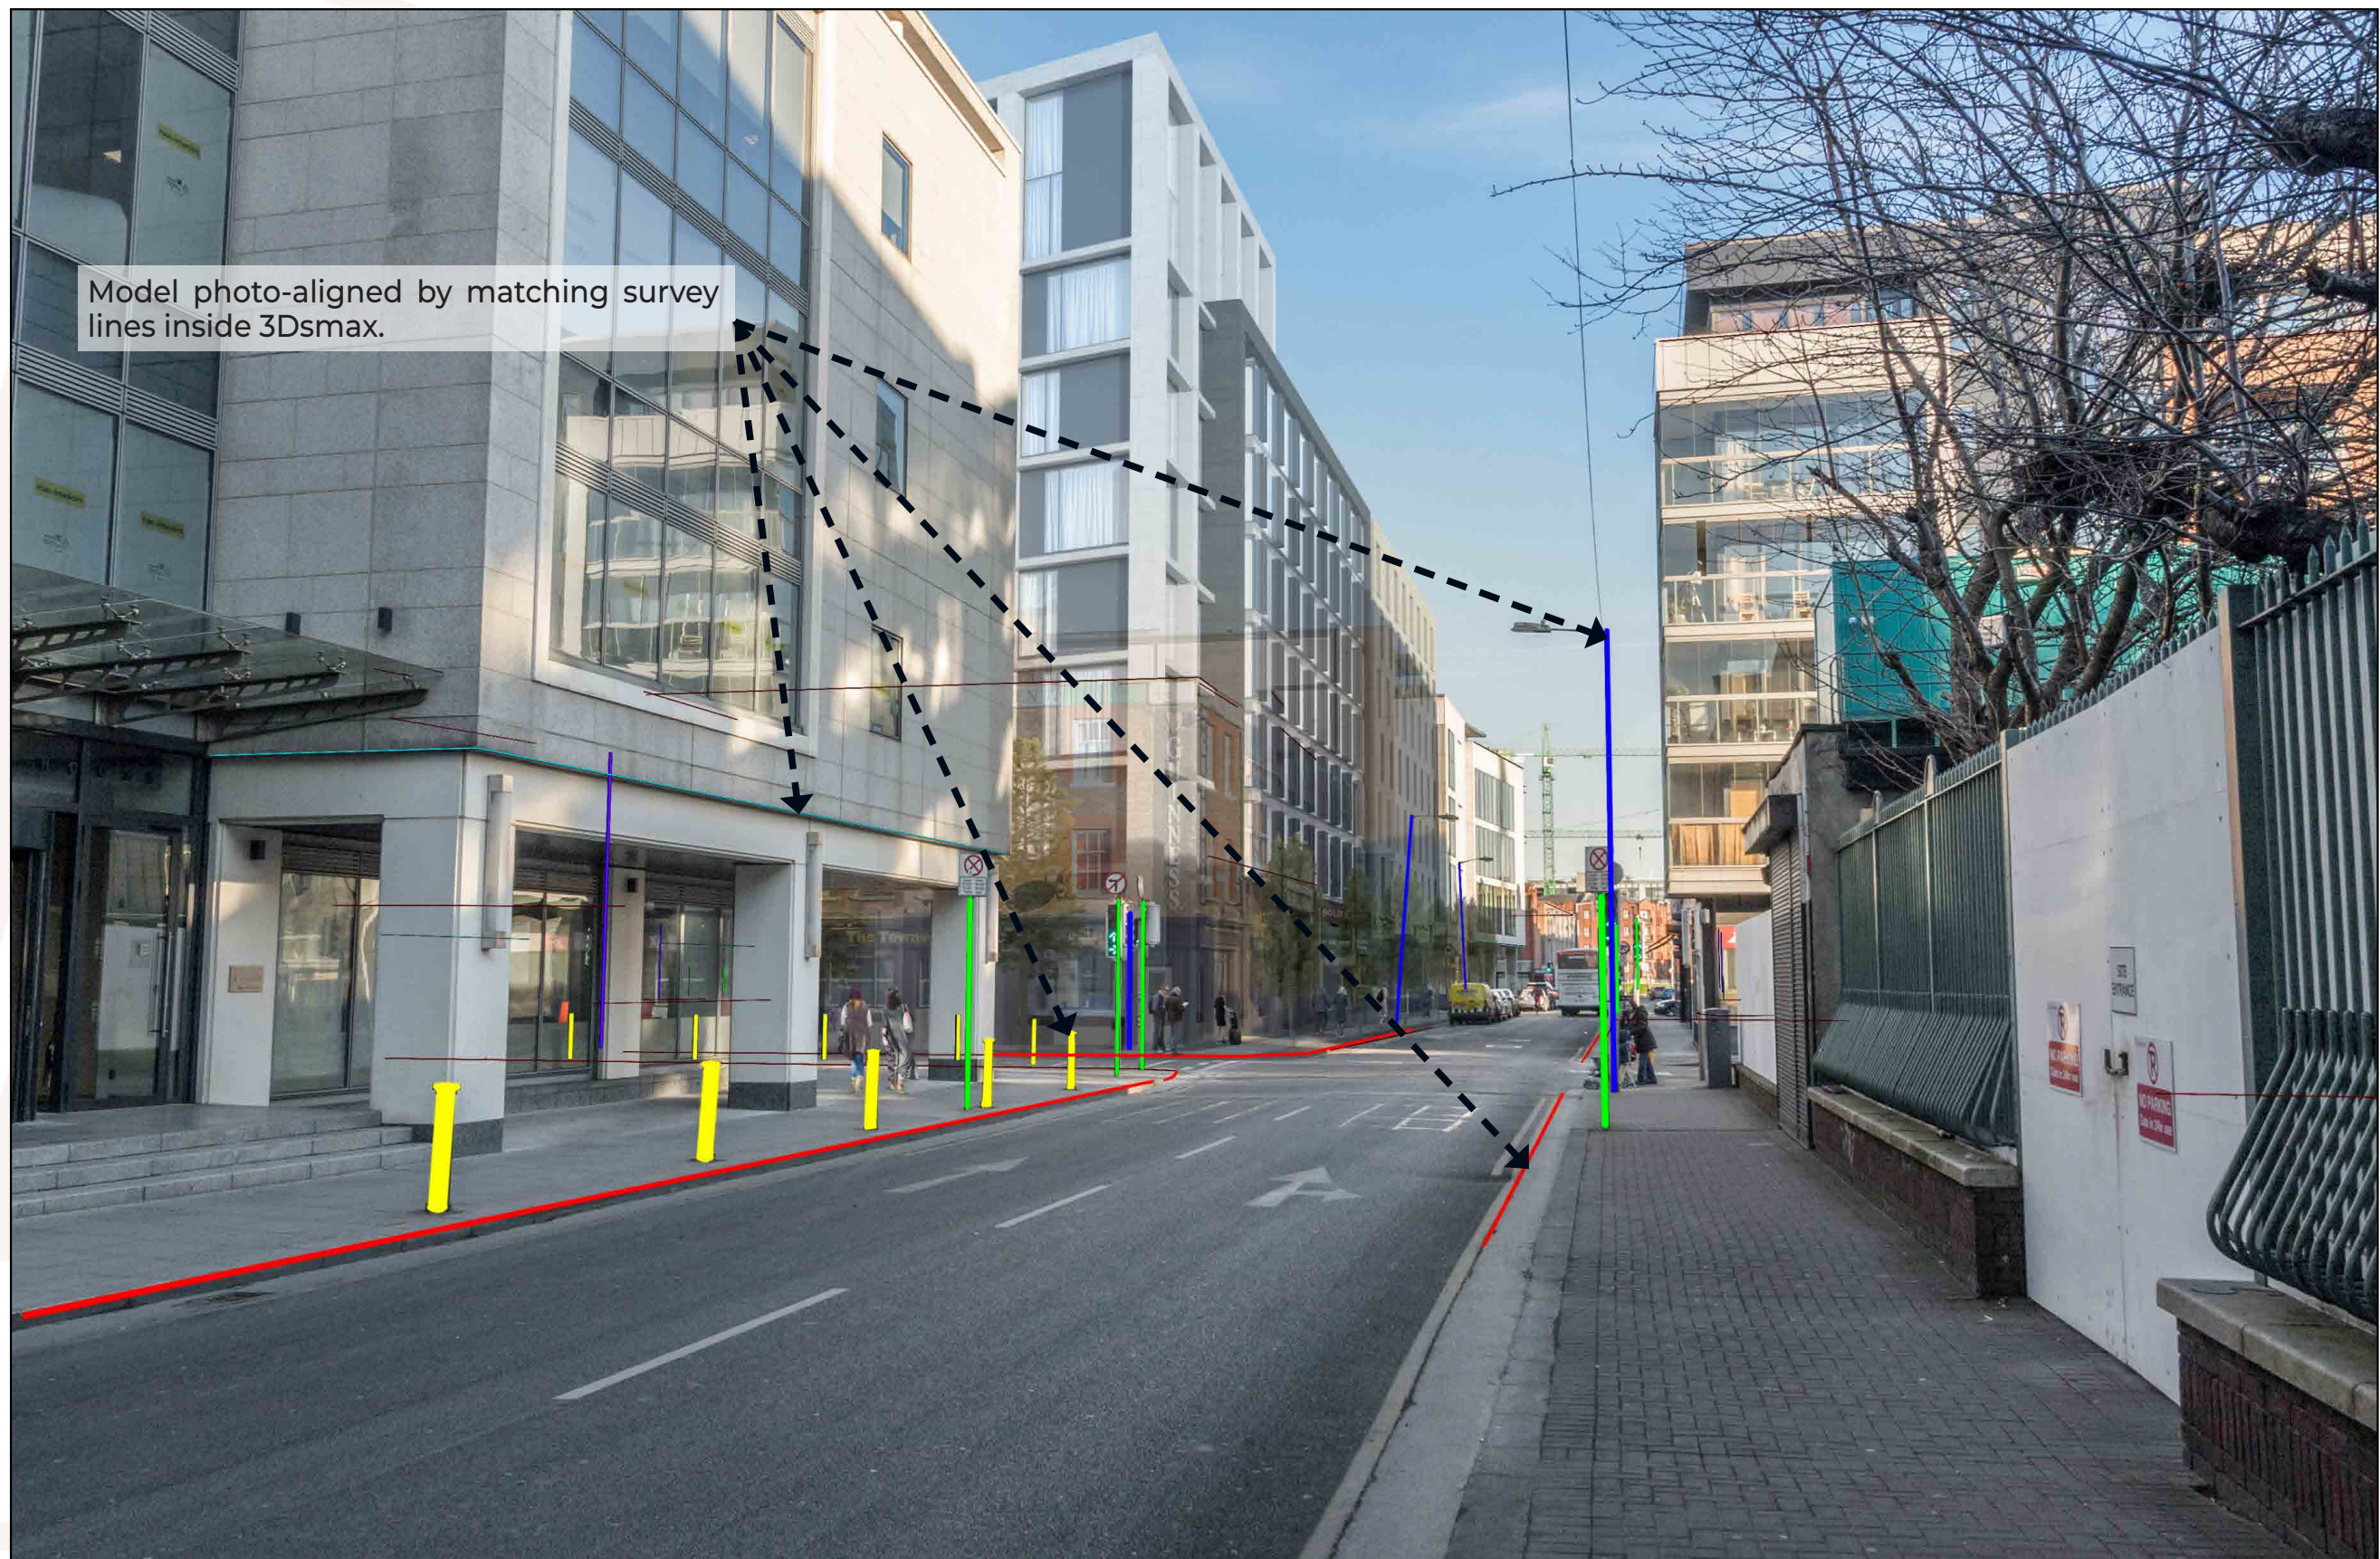
Fig.13: Fixed reference points modelled, 'rendered' and overlaid on baseline photo confirming accuracy
