The Burrow CFERM scheme

# THE BURROW COASTAL PROTECTION SCHEME

## Preliminary Risk Assessment (Desk Study) Report

IBR1296  
The Burrow Coastal  
Protection Scheme  
Preliminary Risk  
Assessment (Desk Study)  
Report  
Final  
11 September 2023

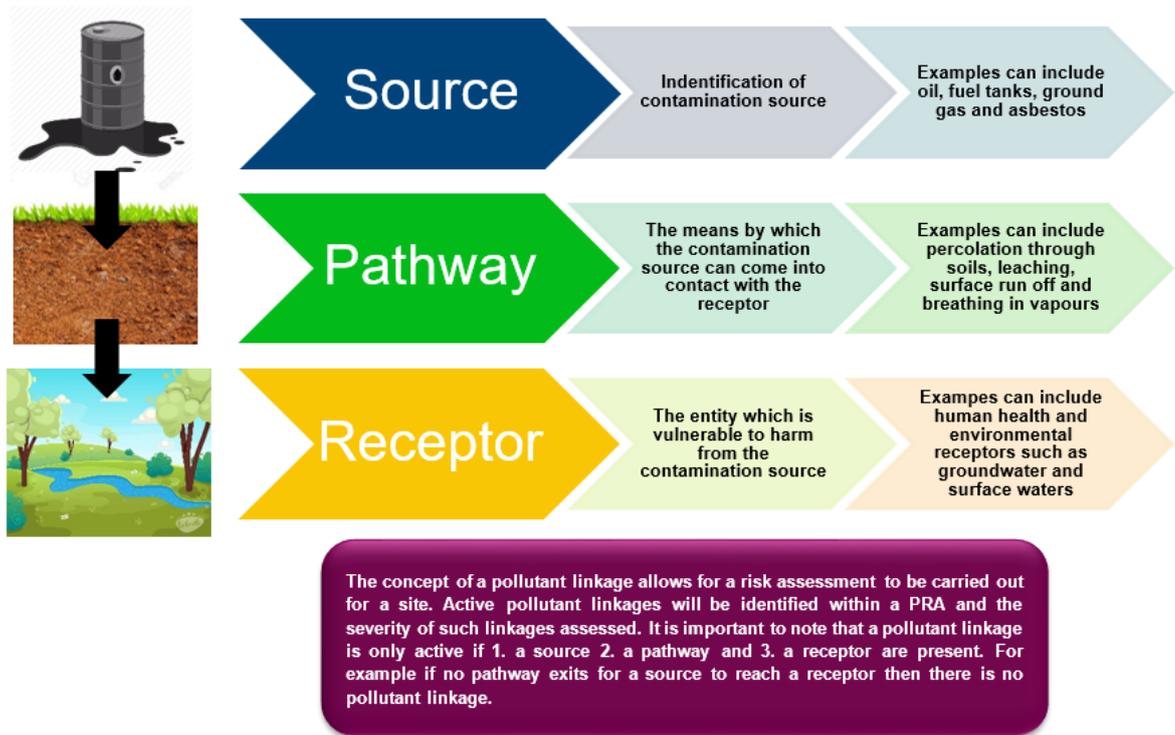
Figure 1.1 Pollutant Linkage Diagram

1. Underpinning the guidance within LCRM is a source-pathway-receptor methodology, which is used to identify Significant Pollutant Linkages (SPLs). The following definitions apply:-

2.
  - **Source:** a contaminant or pollutant that is in, on or under the land and that has the potential to cause harm or pollution;
  - **Pathway:** a route by which a receptor is or could be affected by a contaminant

- **Receptor:** something that could be adversely affected by a contaminant, for example a person, controlled waters, an organism, an ecosystem, or Part 2A receptors such as buildings, crops or animals

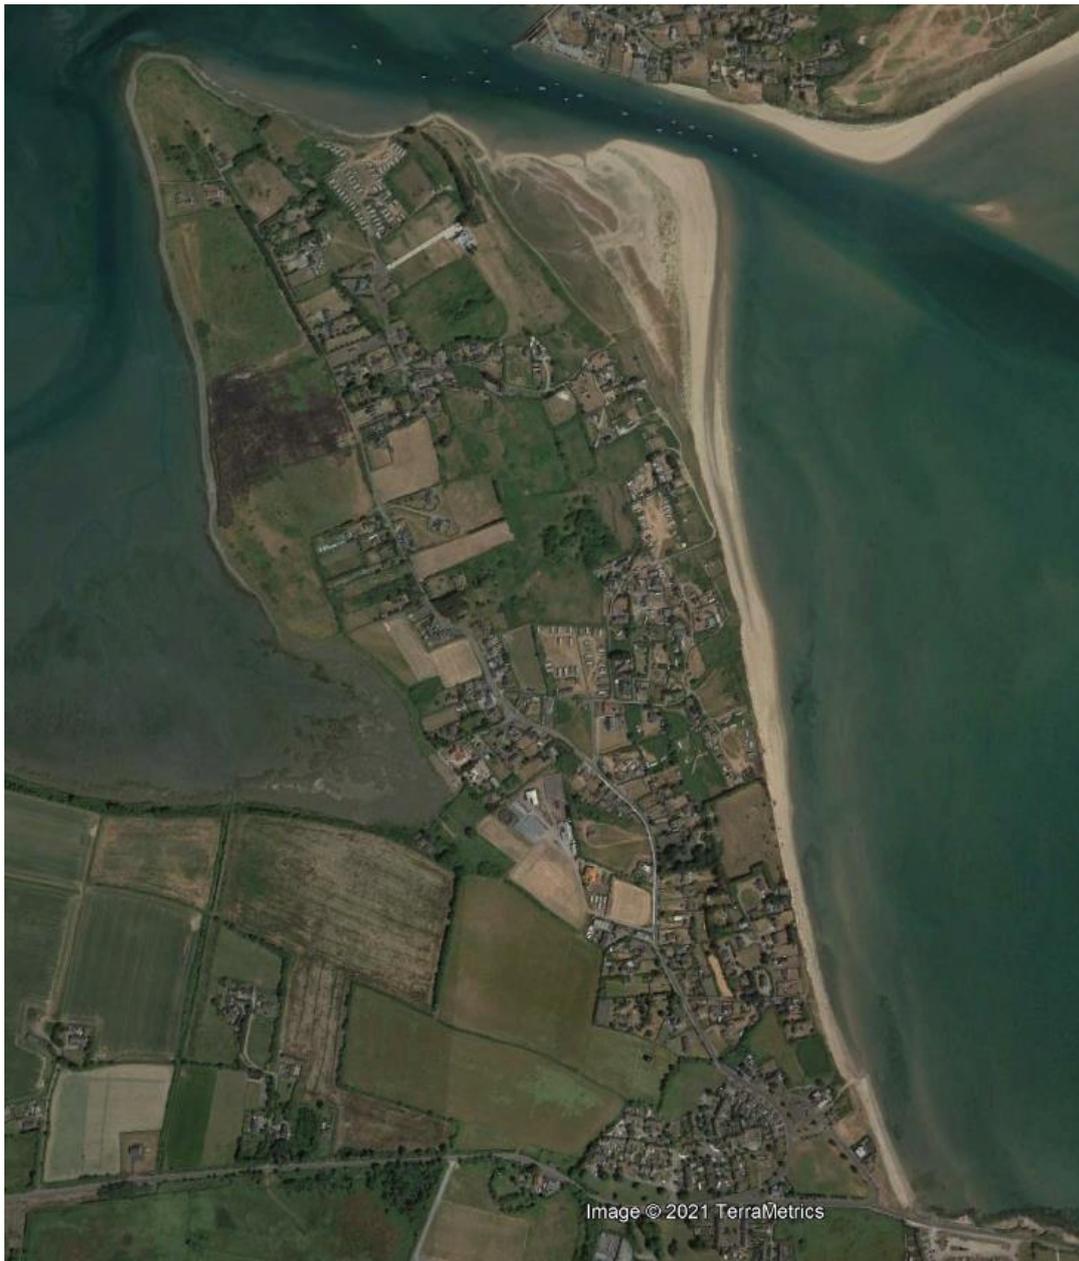
**Figure 2.2 Existing Site Layout**

The existing site layout is shown in Figure 2.2. A site walkover was completed at the site by RPS personnel on the 11<sup>th</sup> of June 2021.

The location of the coastal protection scheme encompasses a number of areas around the Burrow, these will be subject to a number of protective measures such as groynes, beach nourishment, seawalls and embankments.

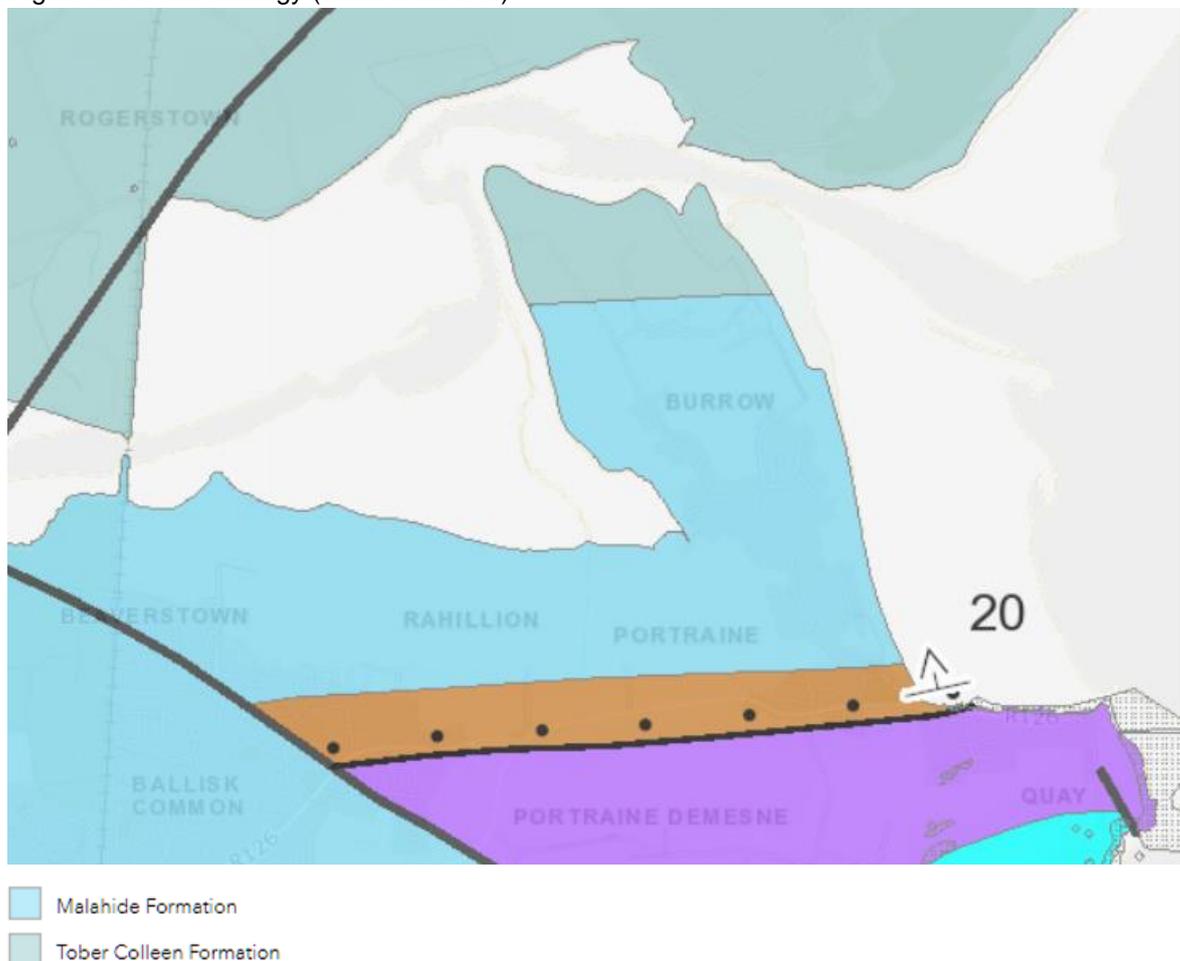
Figure 4.1 Solid Geology (taken from GSI)

The geology of The Burrow is mostly made up of Argillaceous bioclastic limestone and shale of the Malahide Formation, a portion of the northern area of the site is made up of Calcareous shale, limestone conglomerate of the Tober Colleen Formation. This is observed from the Geological Survey of Ireland (GSI), 1:100,000 mapping (Figure 4.1).

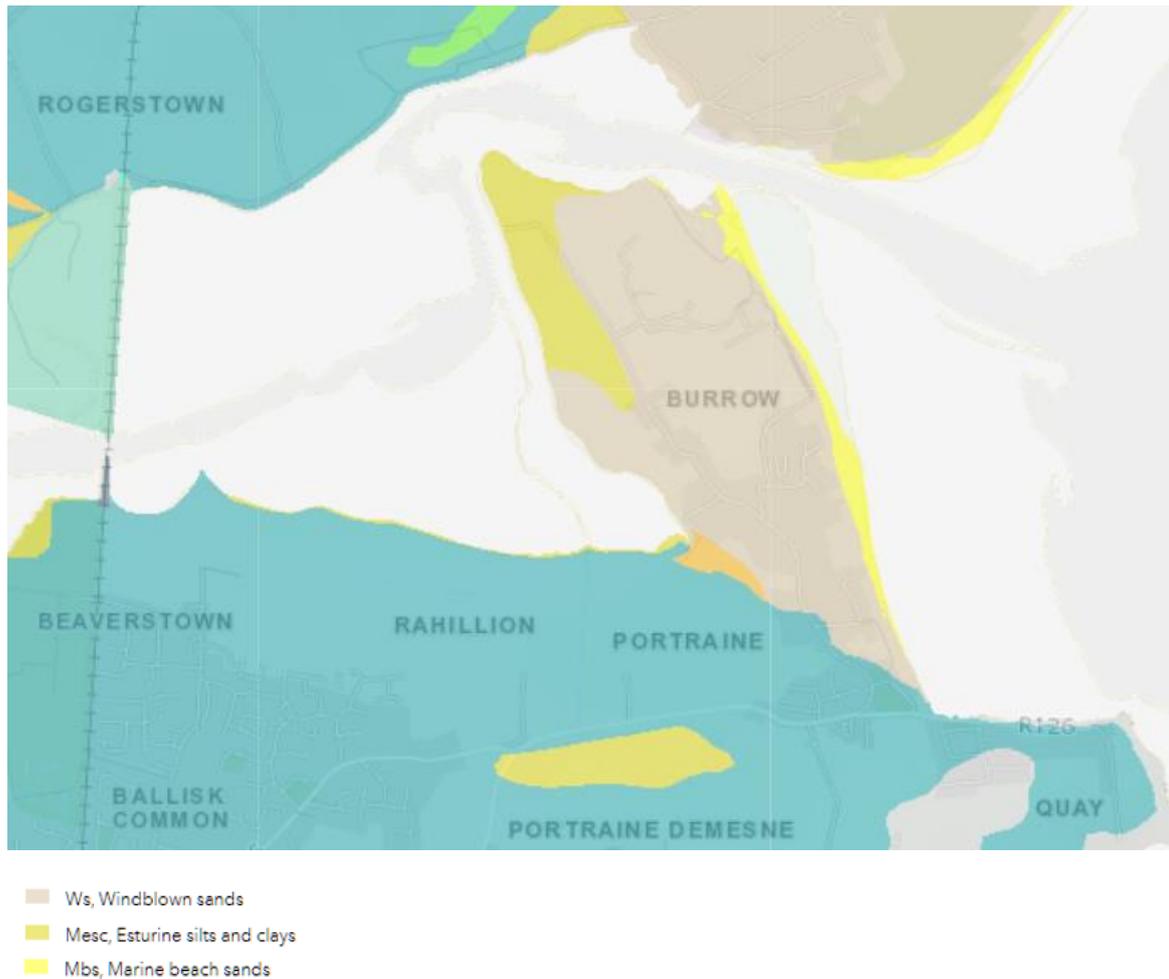
**Figure 4.2 Drift Geology (taken from GSI)**

Review of the quaternary sediments map for the area shows that the inner site is made up of marine windblown sands. The yellow shade on the eastern flank and to the north west of the site is made up of Esturine silts and clays. Quaternary sediments mapping for the study area are presented in Figure 4.2.

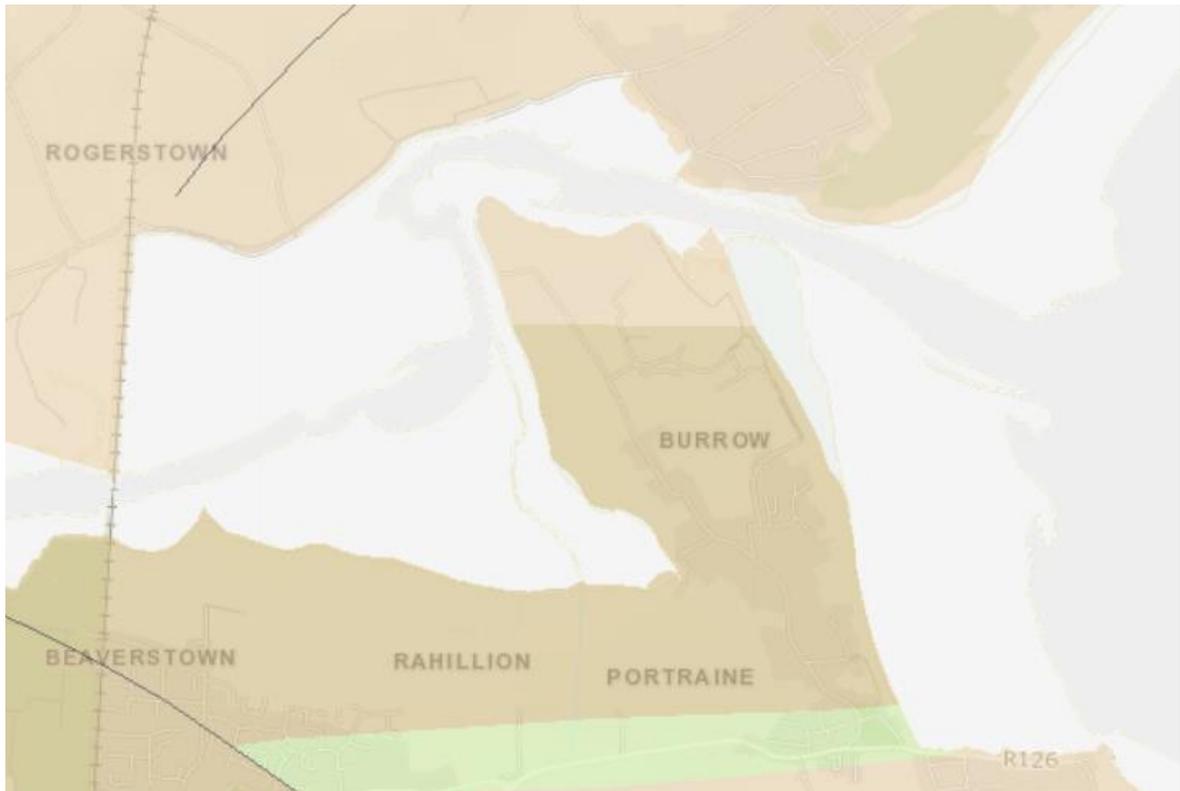
**Figure 4.3 Bedrock Aquifer (taken from GSI)**

The GSI map for bedrock aquifers (Figure 4.3), characterises mid to southern portion of the site as 'LI' being a locally important aquifer - Bedrock which is moderately productive only in Local Zones. The northern portion is characterised as 'PI' being a poor aquifer - Bedrock which is generally unproductive except for local zones.

- Rkc - Regionally Important Aquifer - Karstified (conduit)
- Rkd - Regionally Important Aquifer - Karstified (diffuse)
- RK - Regionally Important Aquifer - Karstified
- Rf - Regionally Important Aquifer - Fissured bedrock
- Lm - Locally Important Aquifer - Bedrock which is Generally Moderately Productive
- Lk - Locally Important Aquifer - Karstified
- LI - Locally Important Aquifer - Bedrock which is Moderately Productive only in Local Zones
- PI - Poor Aquifer - Bedrock which is Generally Unproductive except for Local Zones
- Pu - Poor Aquifer - Bedrock which is Generally Unproductive
- Lake

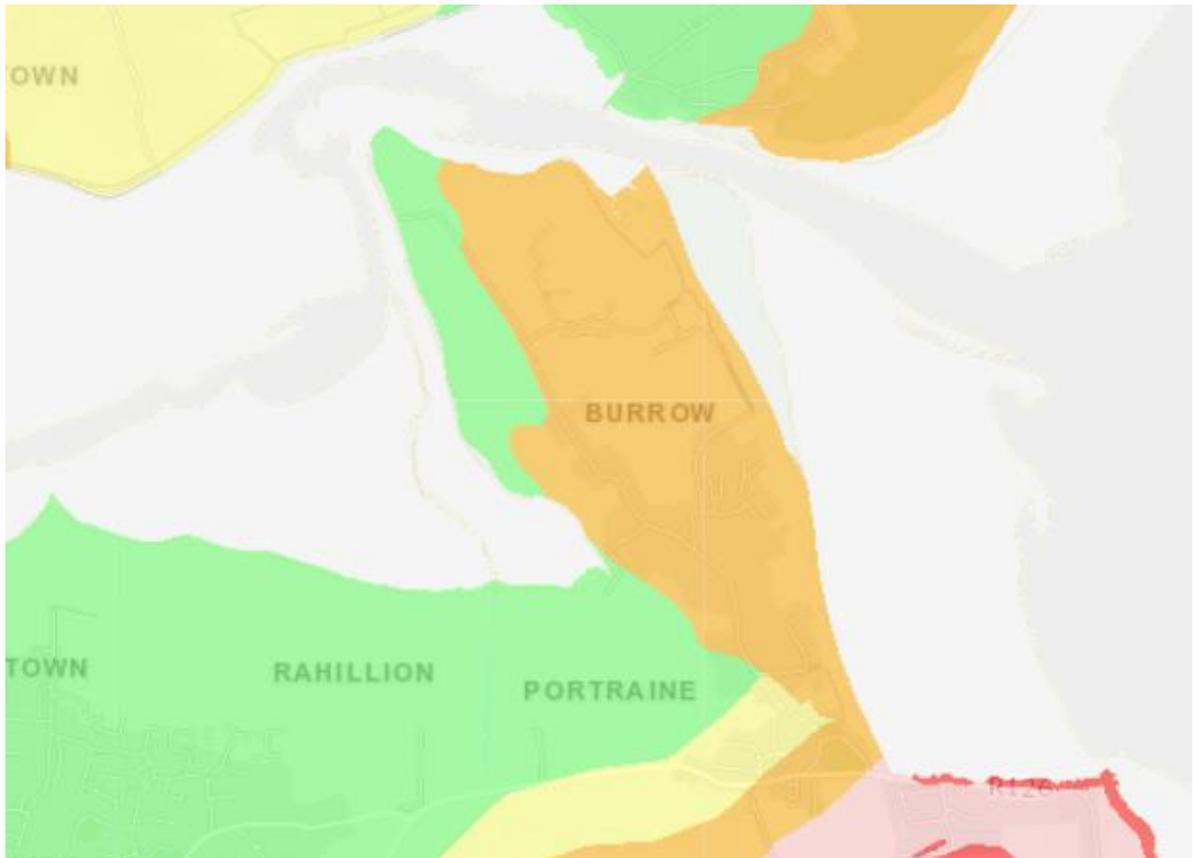
**Figure 4.4 Groundwater Vulnerability (taken from GSI)**

According to the GSI map for groundwater vulnerability (Figure 4.4), the majority of the site has a high groundwater vulnerability indicating that the natural groundwater may be easily contaminated by human activities. A small portion of the site to the west and north west is classified as being of low vulnerability.

- Rock at or near Surface or Karst
- Extreme
- High
- Moderate
- Low
- Water

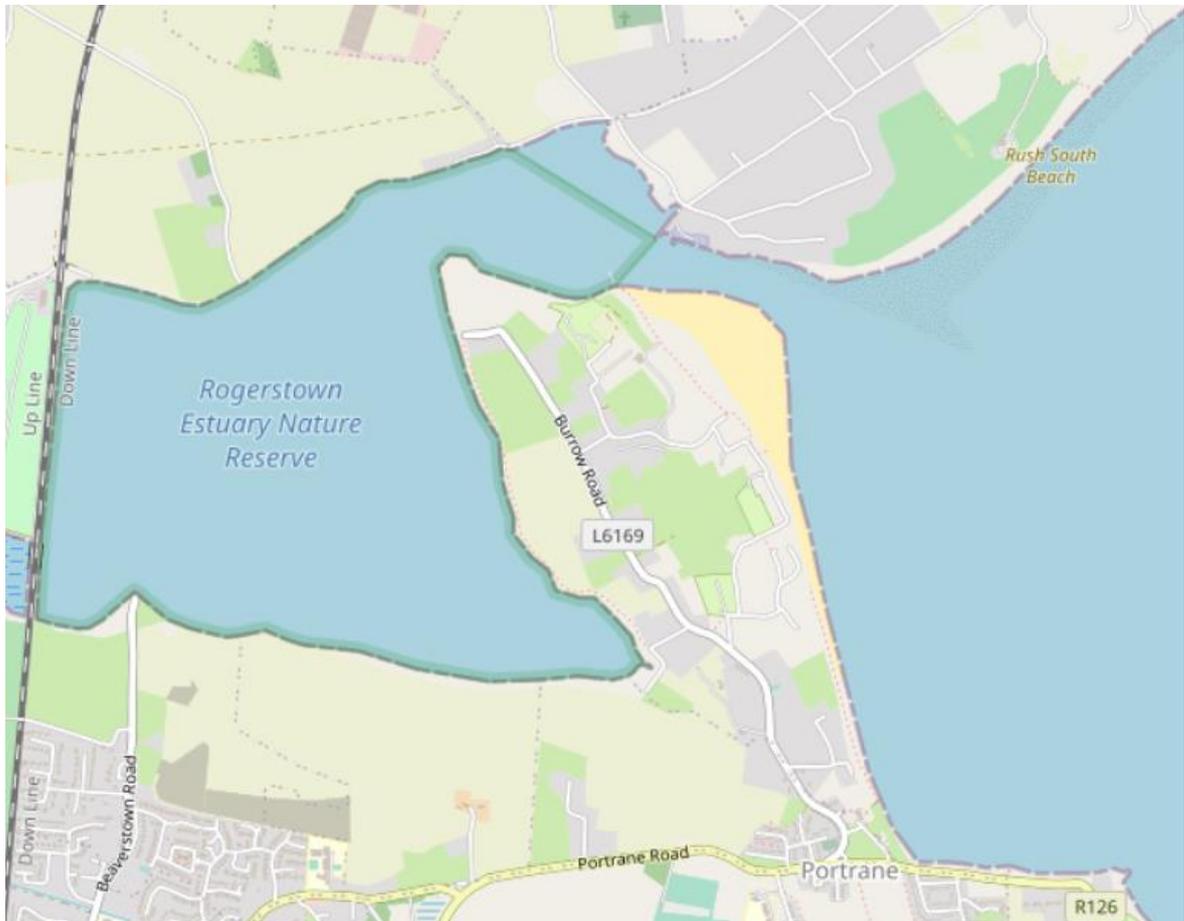
**Figure 4.5 Surface Water Features (Mapping by GSI)**

To the immediate west of the site is the Rogerstown Estuary, to the immediate east of the site is the Irish Sea. There are no known river surface waters nearby.

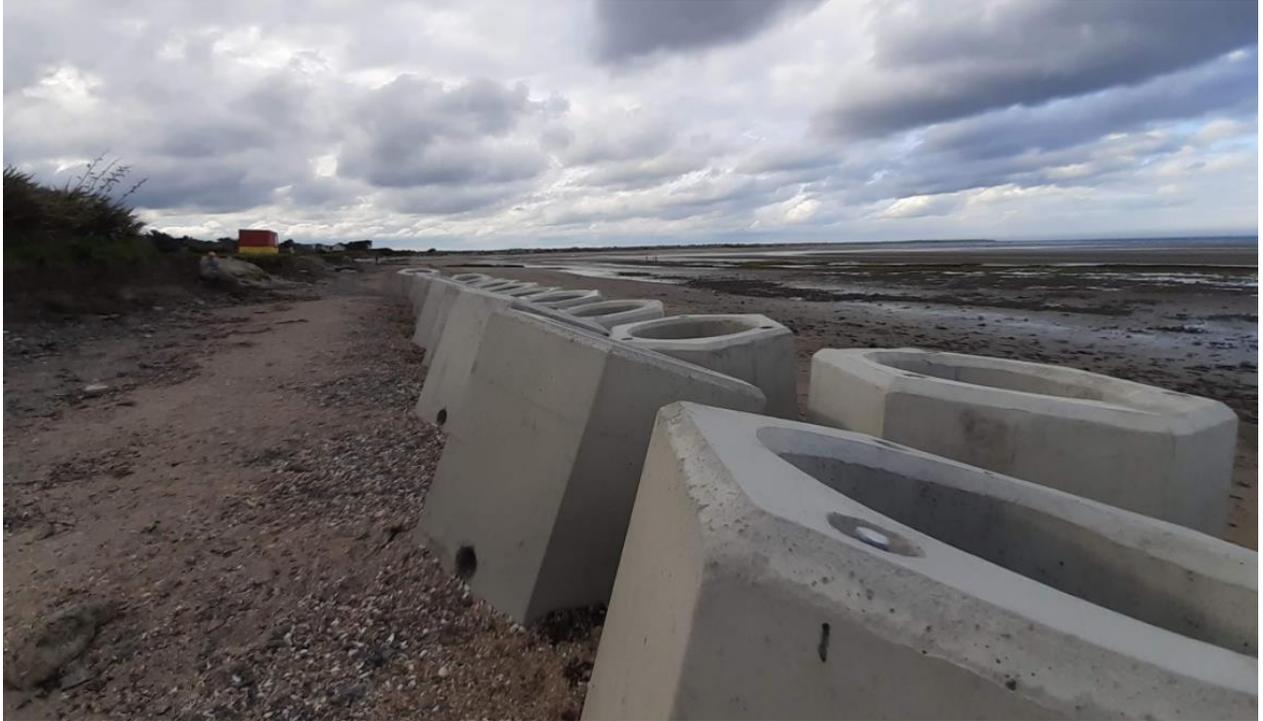
Plate 3: Photograph taken on Portrane Beach showing existing coastal defences;

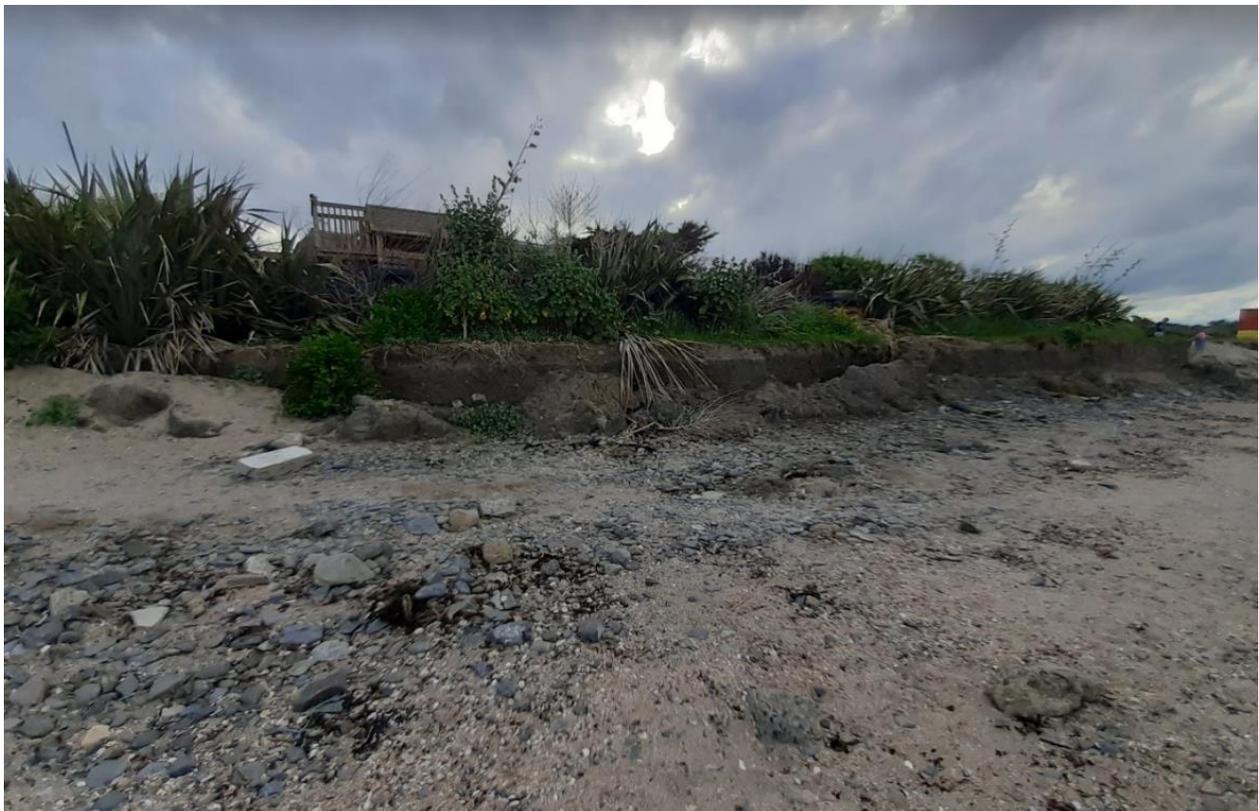
Plate 4: Photograph taken on Portrane beach showing coastal erosion at the shoreline;
