The Burrow CFERM scheme

# ROGERSTOWN OUTER ESTUARY (PORTRANE – RUSH) COASTAL DEFENCE PROJECT

Preliminary Ground Investigation Report (GIR)

RCS-RPS-00-XX-RP-C-  
GI002  
P01  
16 June 2022

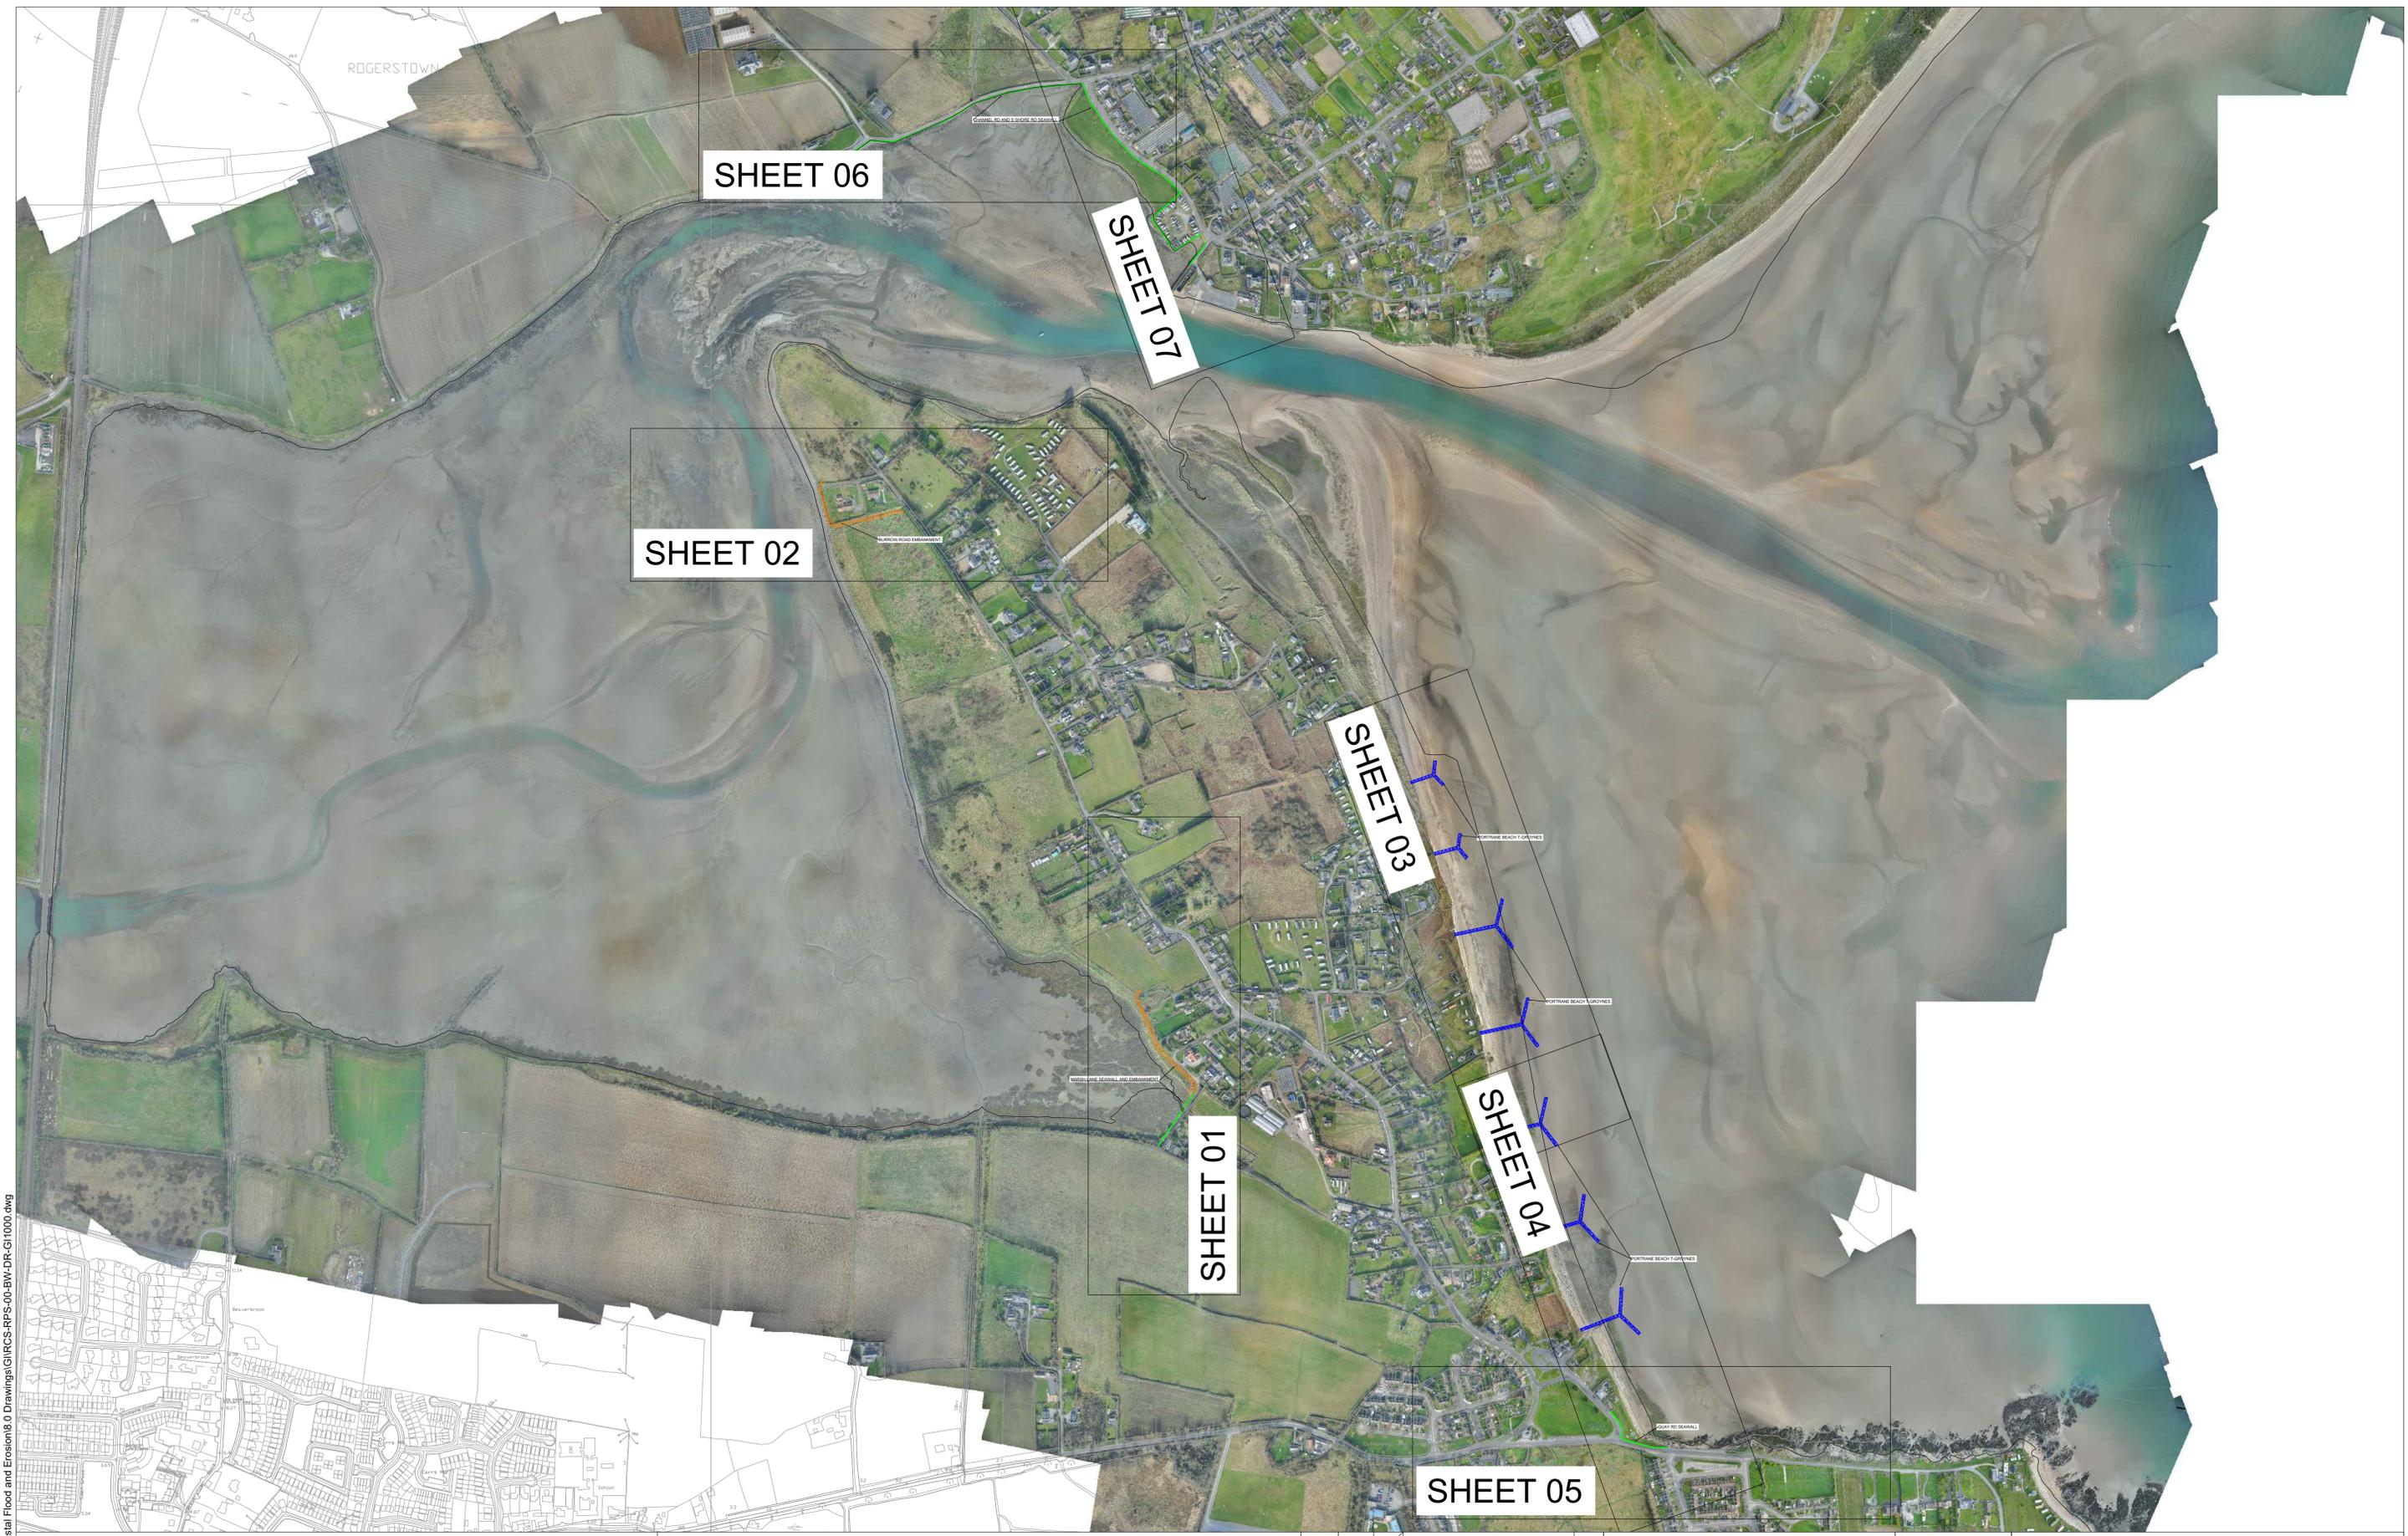
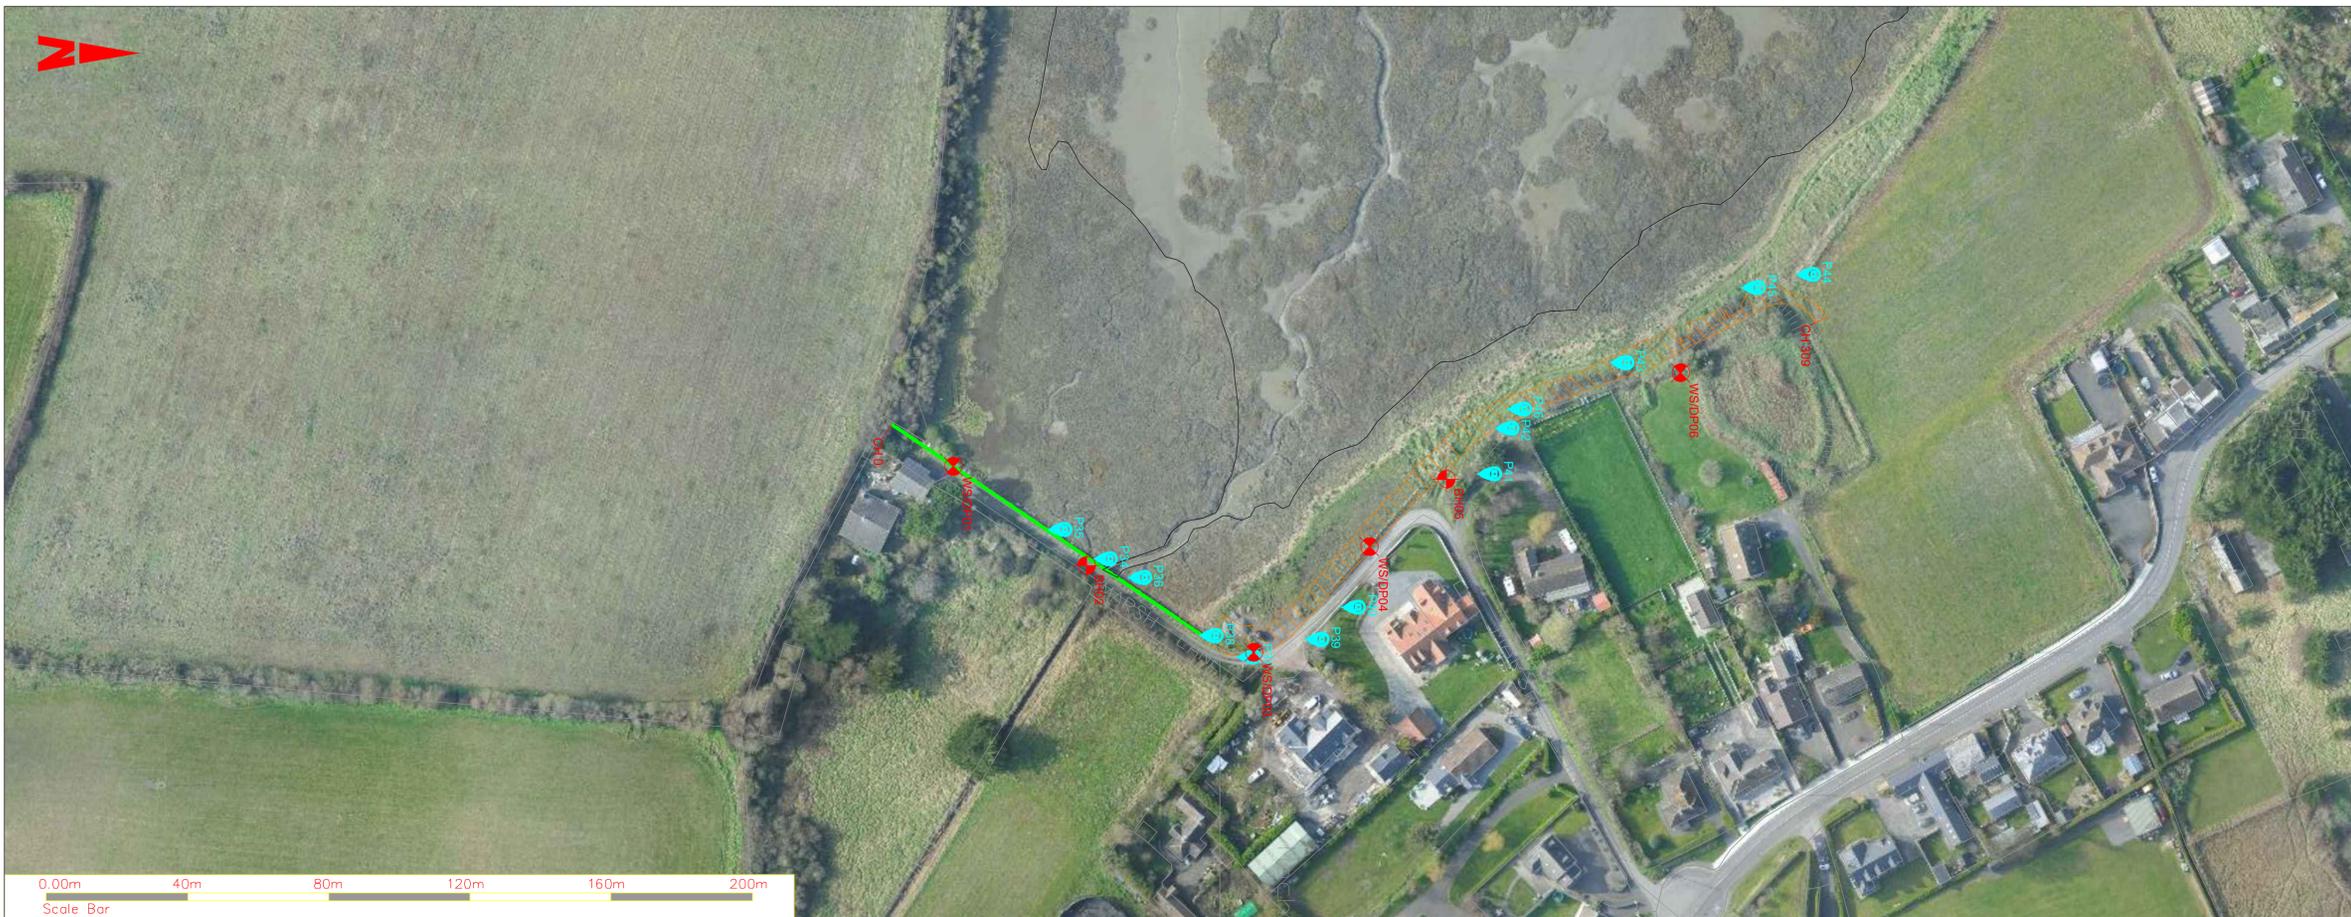
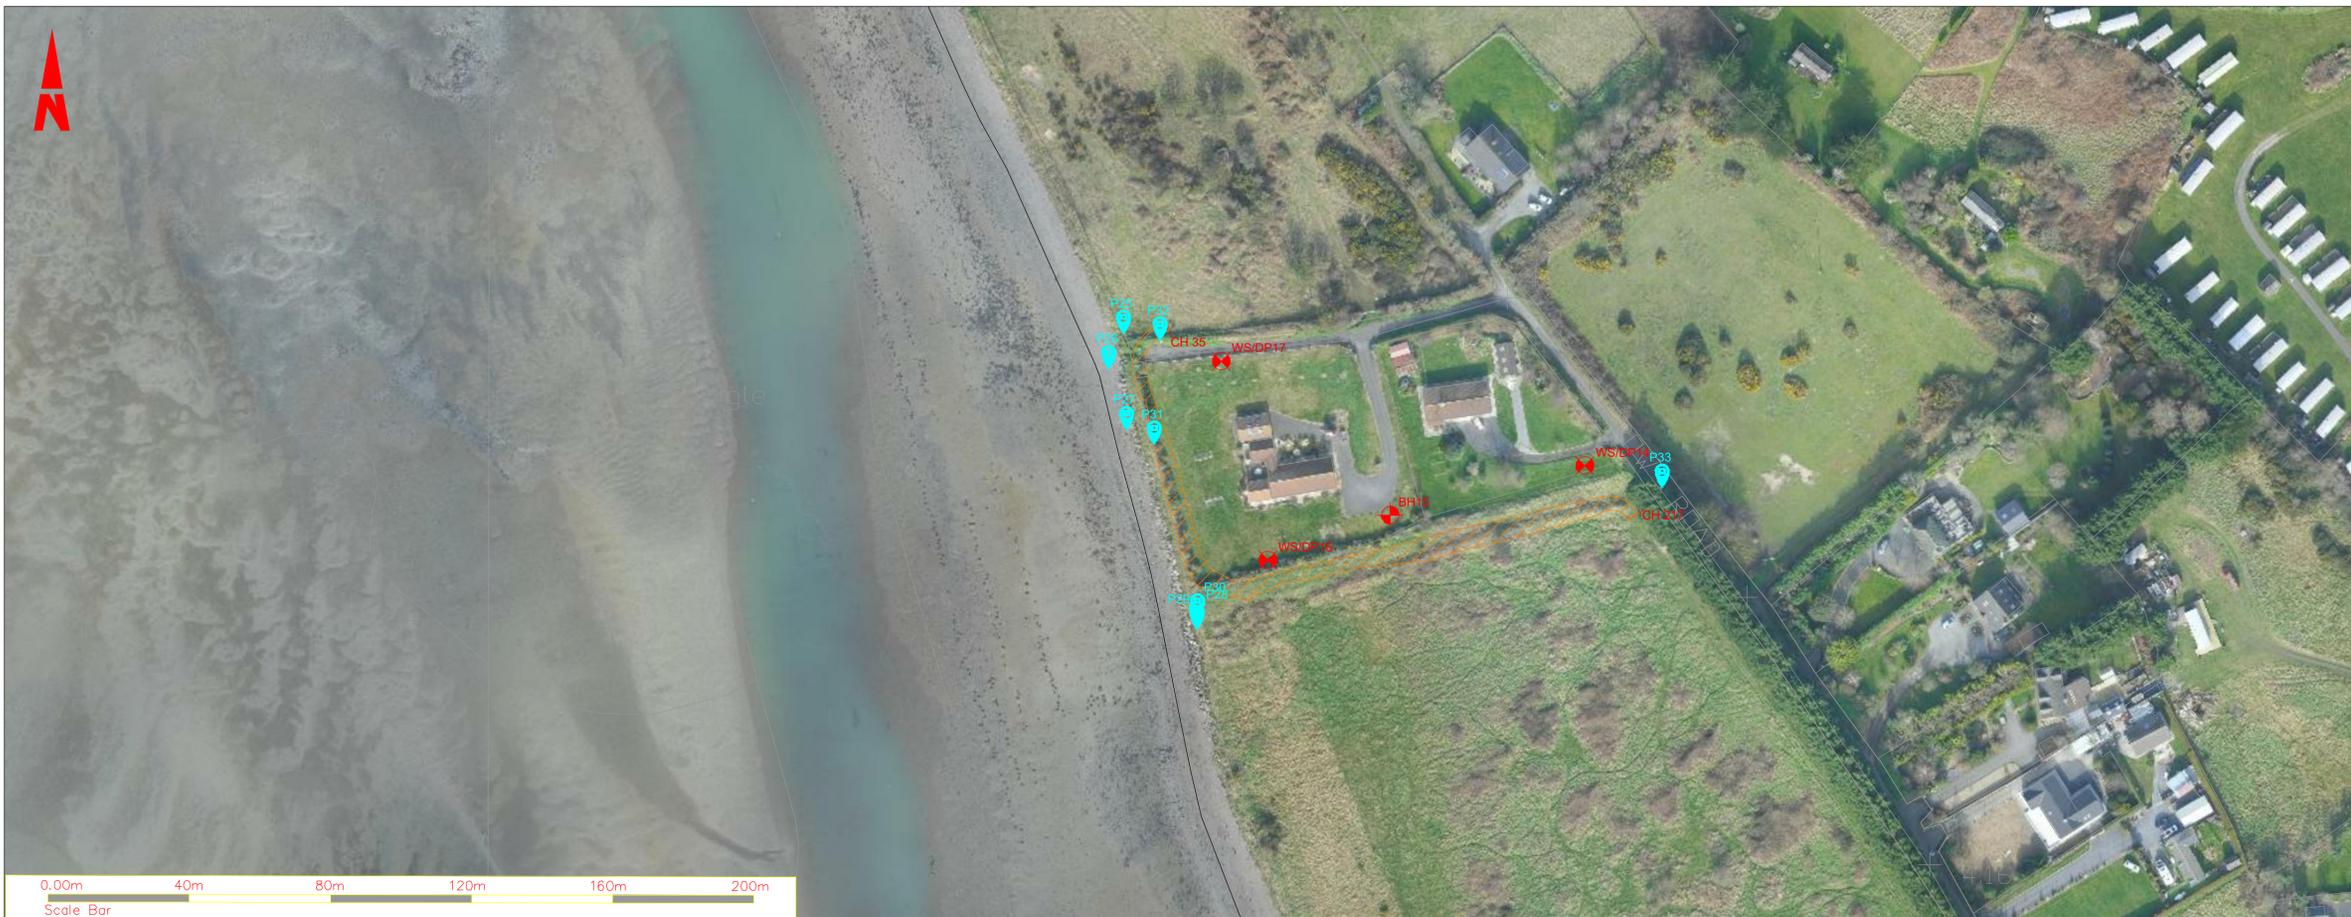
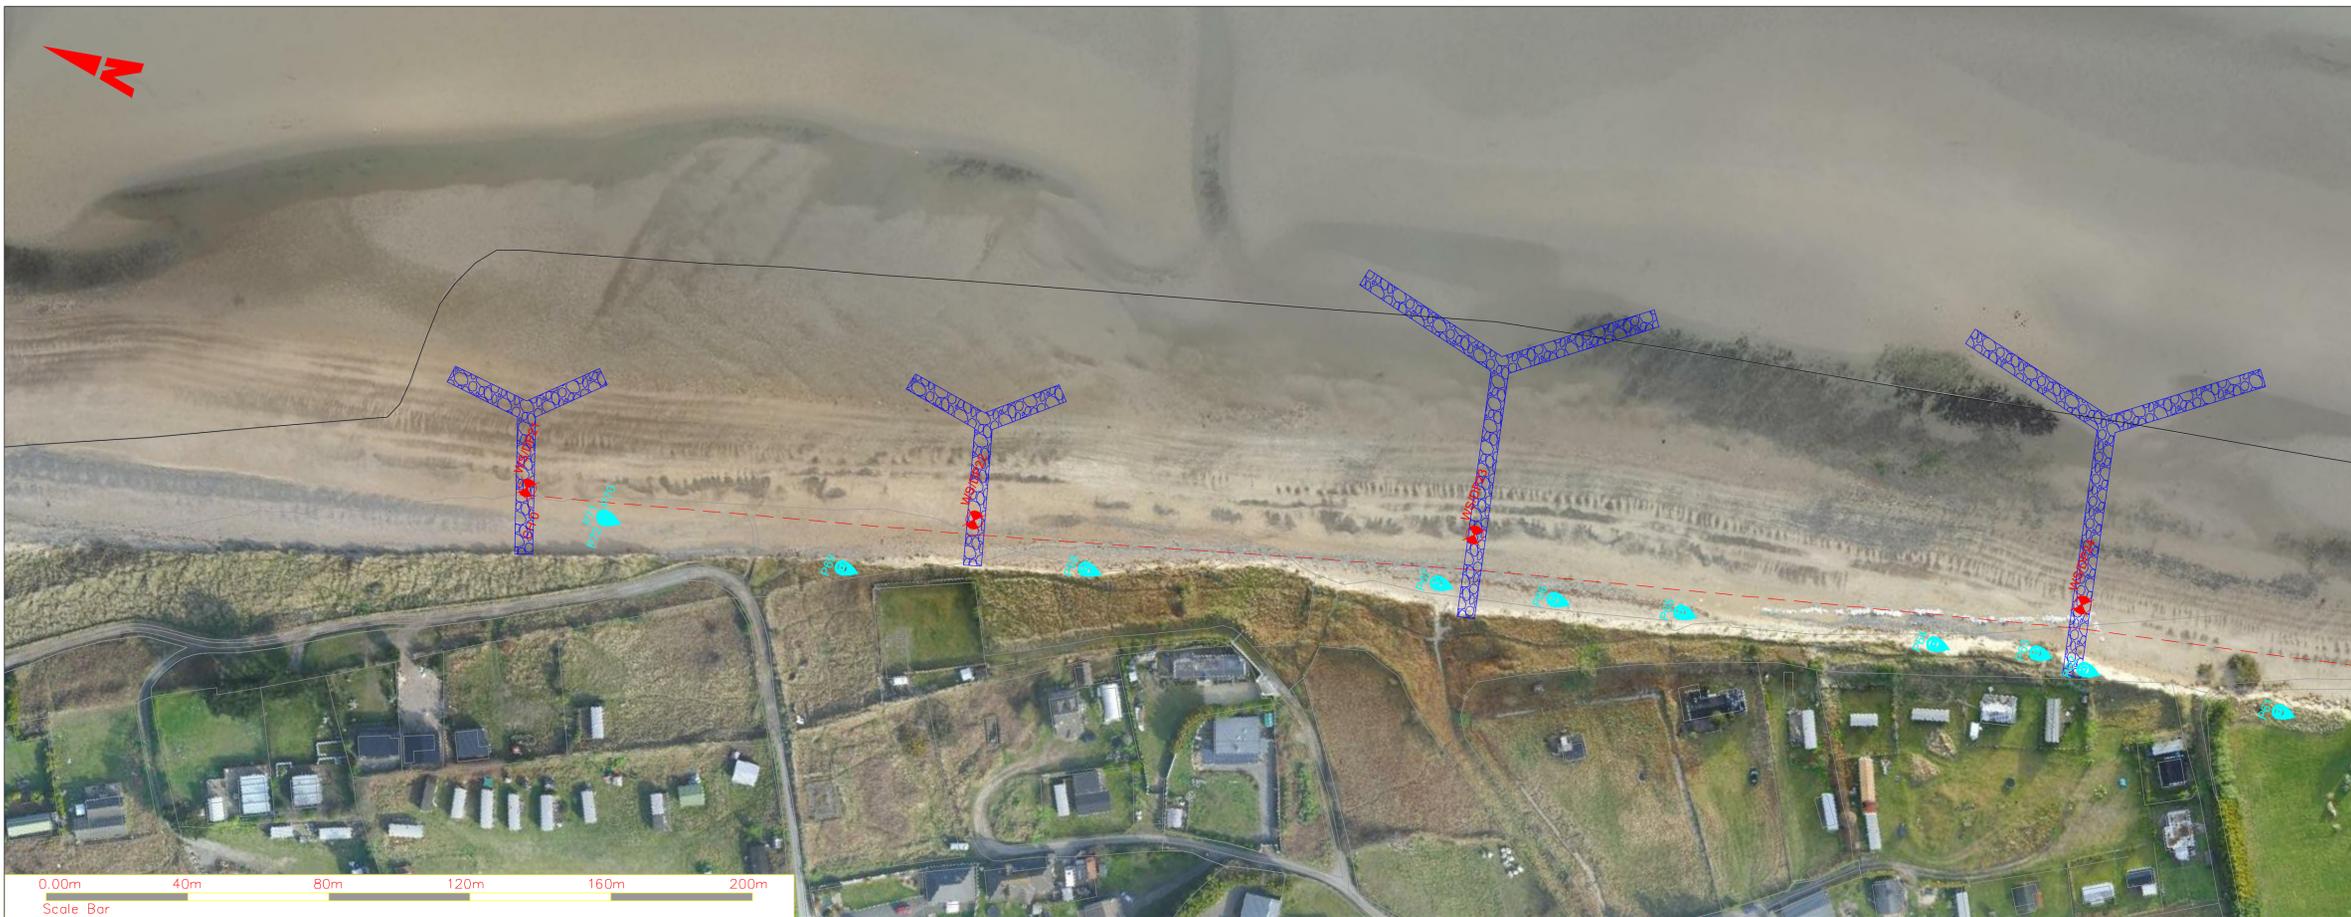
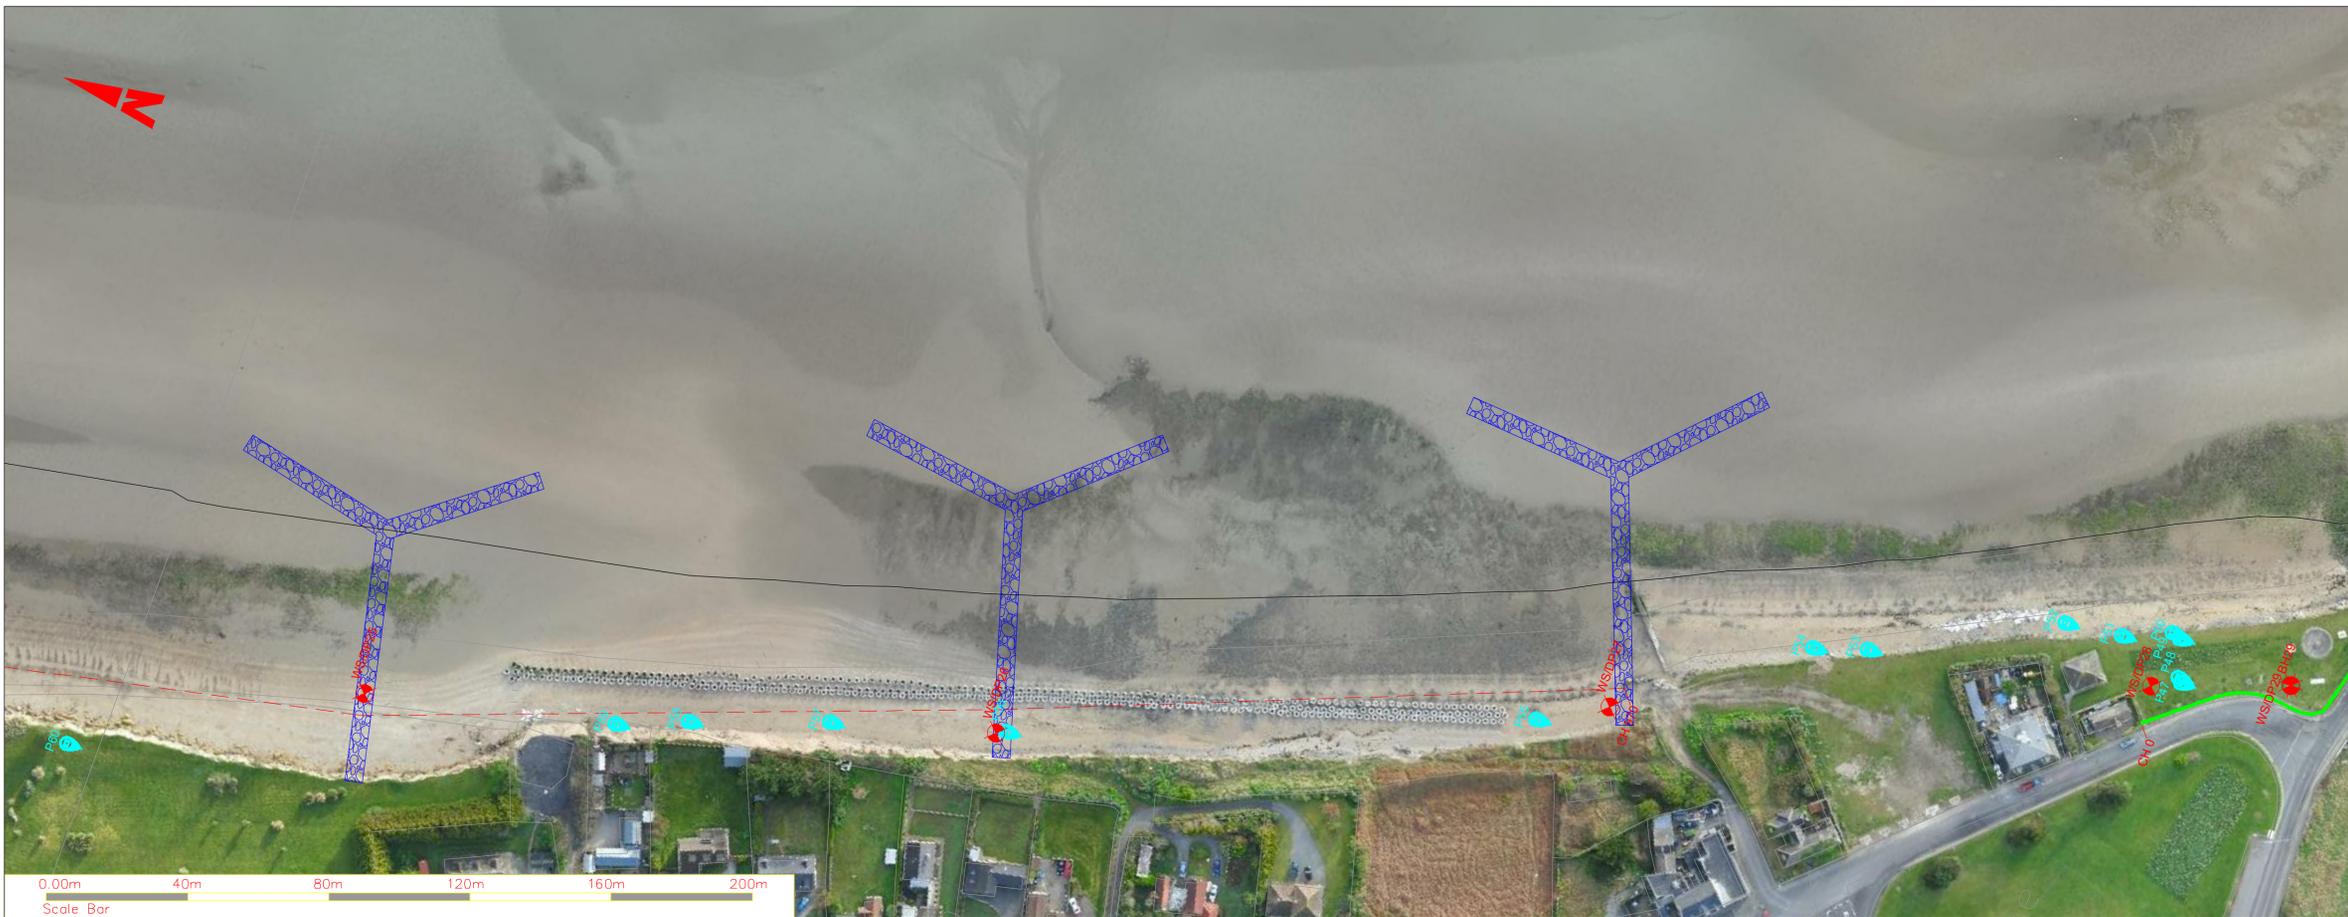
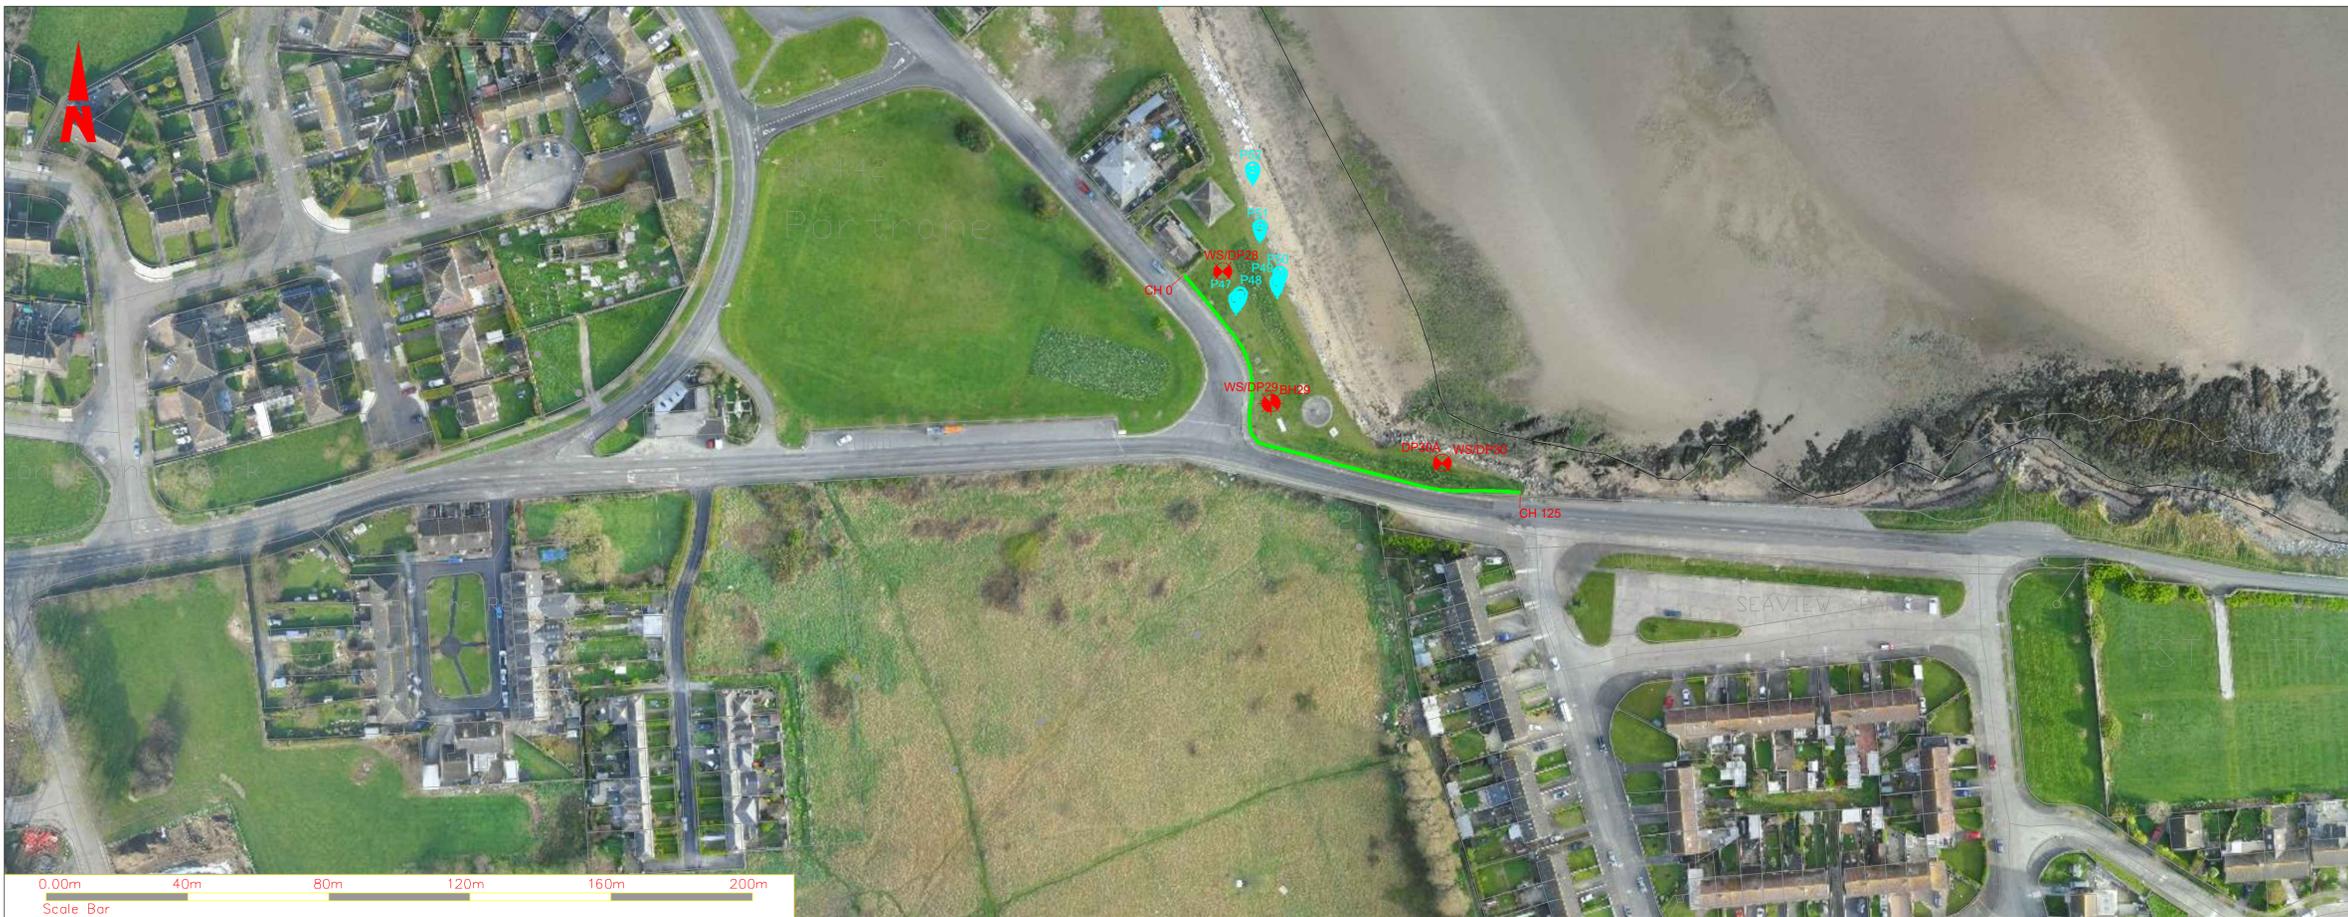
Project	ROGERSTOWN OUTER ESTUARY (PORTRANE - RUSH) COASTAL DEFENCE PROJECT		
Title	GROUND INVESTIGATION PLAN AND PROFILE		
File Identifier	RCS-RPS-00-BW-DR-G11000	Status	S4
Rev	P01

Encountered and interpreted ground conditions for each investigation location are shown graphically in the ground investigation plan and profiles included in Appendix A, and Conceptual Site Model (CSM) presented in Appendix F.

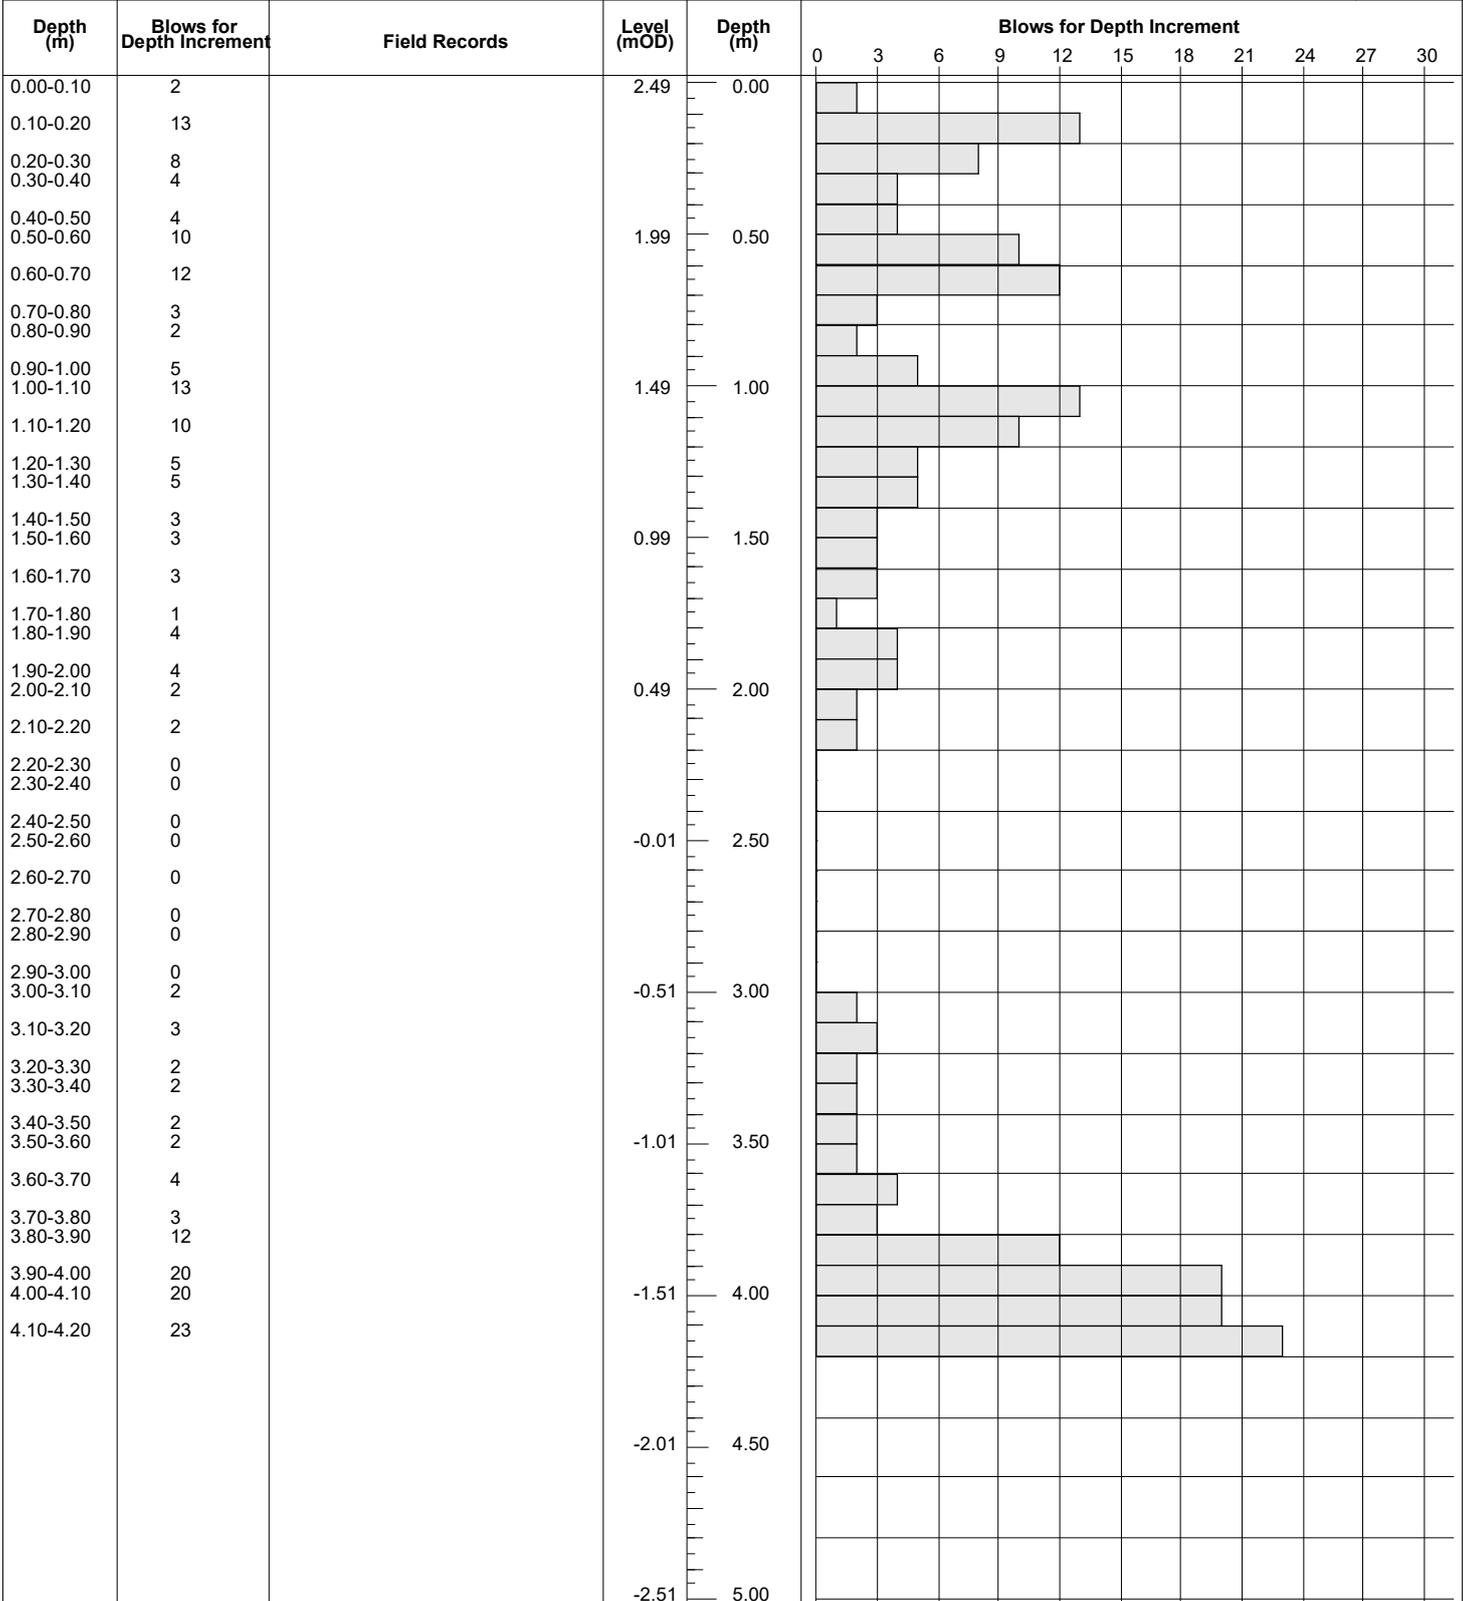
Remarks	Scale (approx)	Logged By
	1:25	RM
	Figure No. 11087-09-21.DP03

Machine : Tec 10 Method : Dynamic Probe	Cone Dimensions Diameter 43.7mm	Ground Level (mOD) 2.49	Client Fingal County Council	Job Number 11087-09-21
	Location 724745.6 E 751532 N	Dates 01/02/2022	Engineer RPS	Sheet 1/1

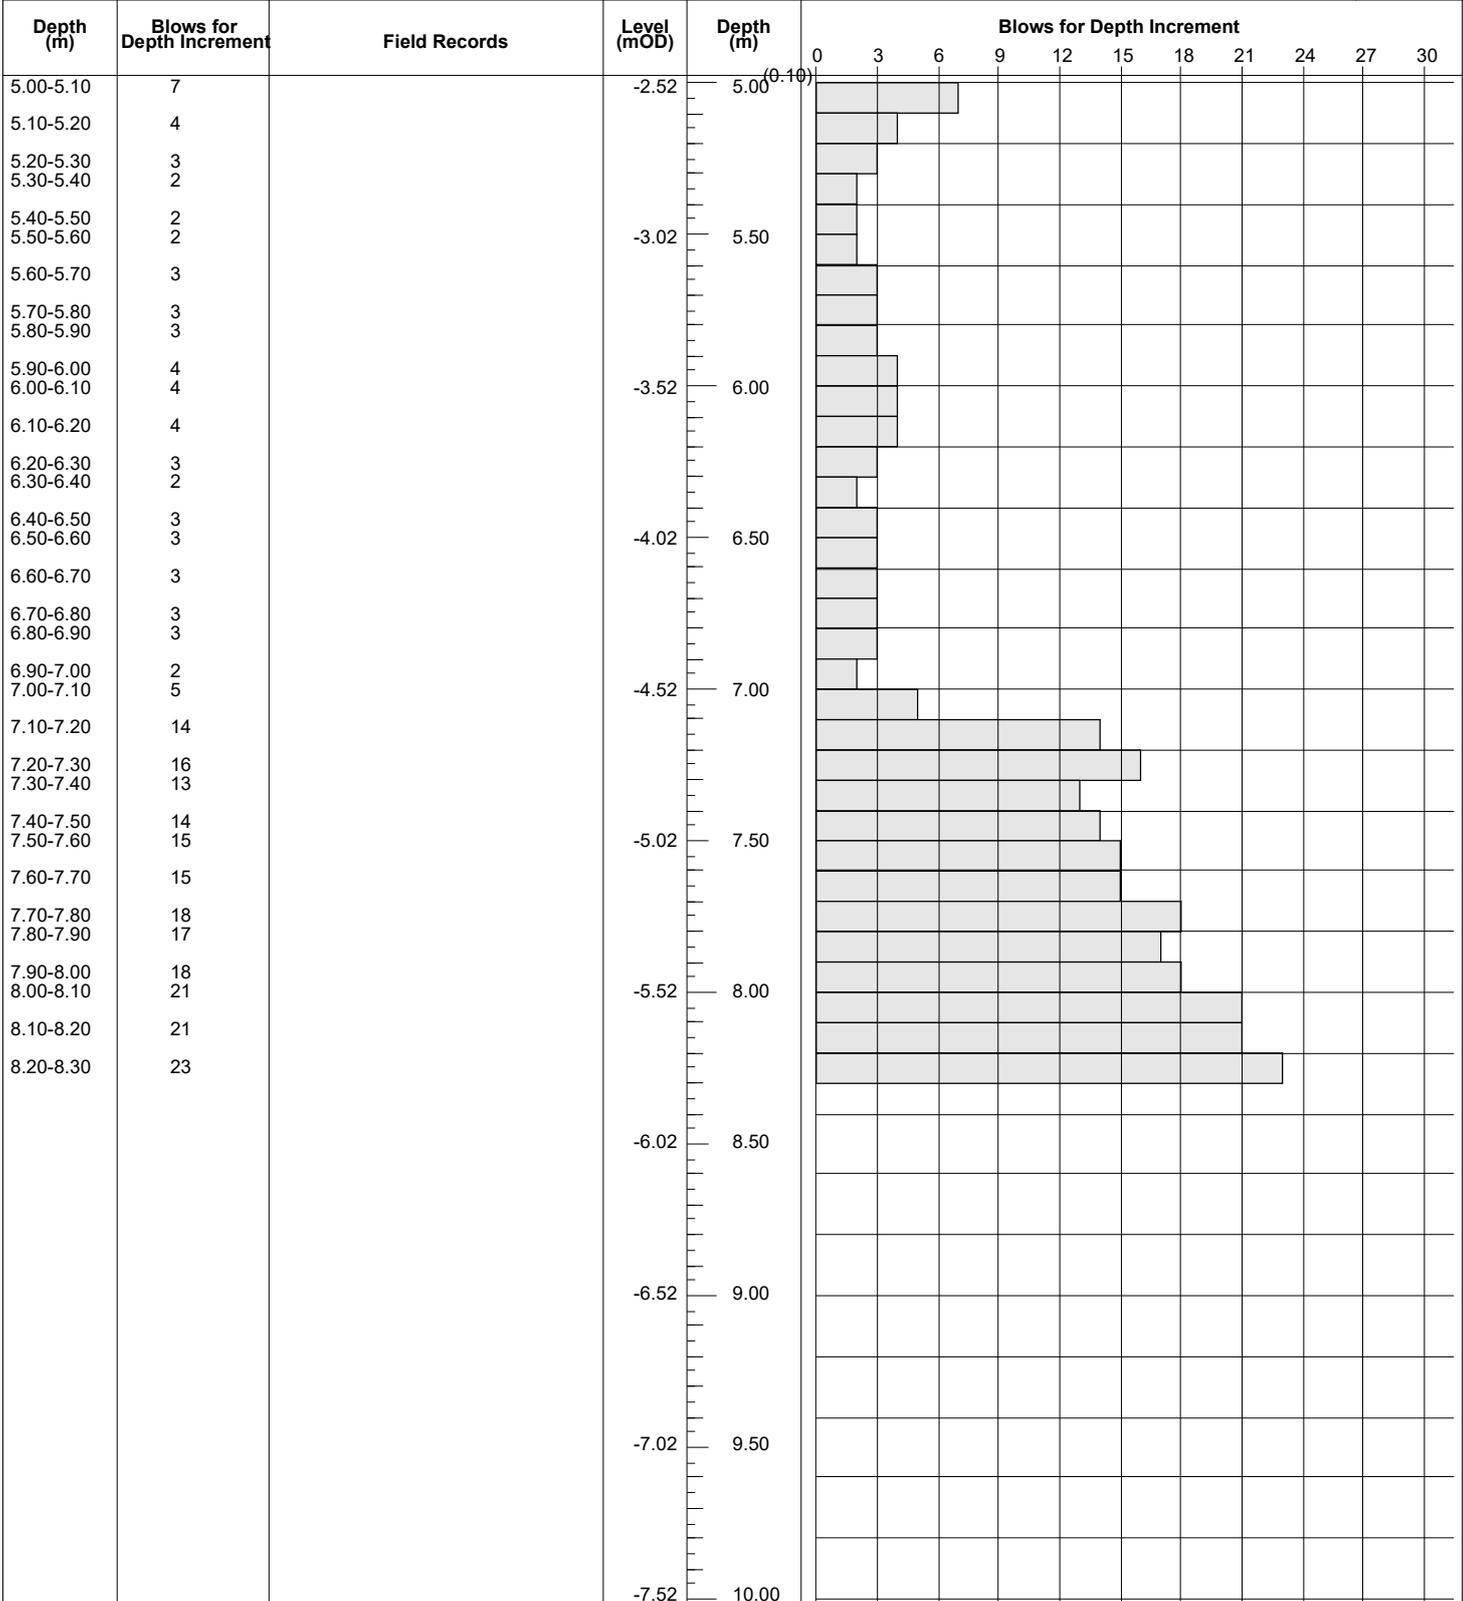
Remarks	Scale (approx)	Logged By
	1:25	RM
	Figure No. 11087-09-21.DP04

Machine : Tec 10 Method : Dynamic Probe	Cone Dimensions Diameter 43.7mm	Ground Level (mOD) 2.48	Client Fingal County Council	Job Number 11087-09-21
	Location 724715.4 E 751565.1 N	Dates 01/02/2022	Engineer RPS	Sheet 2/2

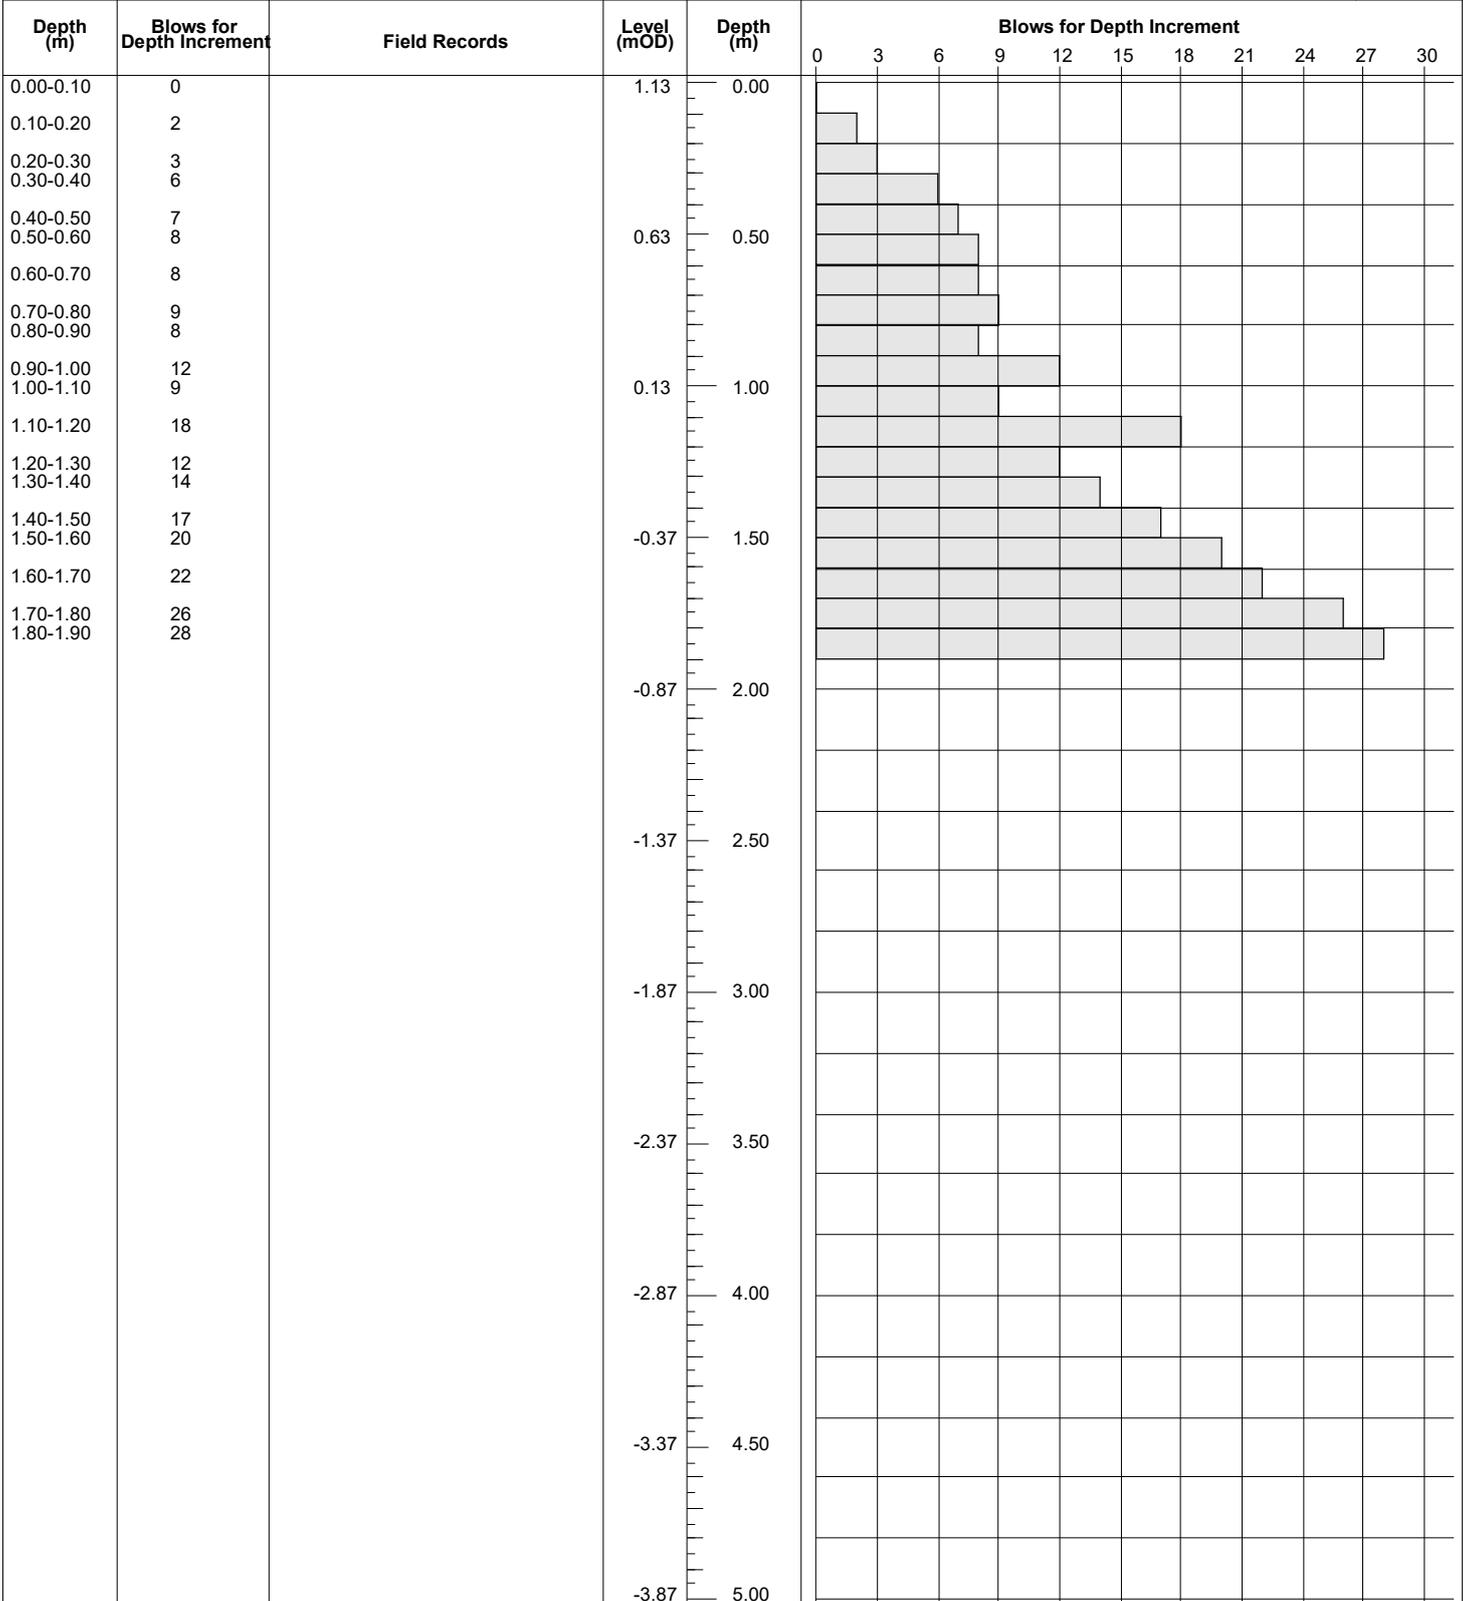
Remarks	Scale (approx)	Logged By
	1:25	RM
	Figure No. 11087-09-21.DP23

Machine : Tec 10 Method : Dynamic Probe	Cone Dimensions Diameter 43.7mm	Ground Level (mOD) 1.13	Client Fingal County Council	Job Number 11087-09-21
	Location 725206.6 E 751793.4 N	Dates 18/01/2022	Engineer RPS	Sheet 1/1
