The Burrow CFERM scheme

# ROGERSTOWN OUTER ESTUARY (PORTRANE – RUSH) COASTAL DEFENCE PROJECT

Preliminary Ground Investigation Report (GIR)

RCS-RPS-00-XX-RP-C-  
GI002  
P01  
16 June 2022

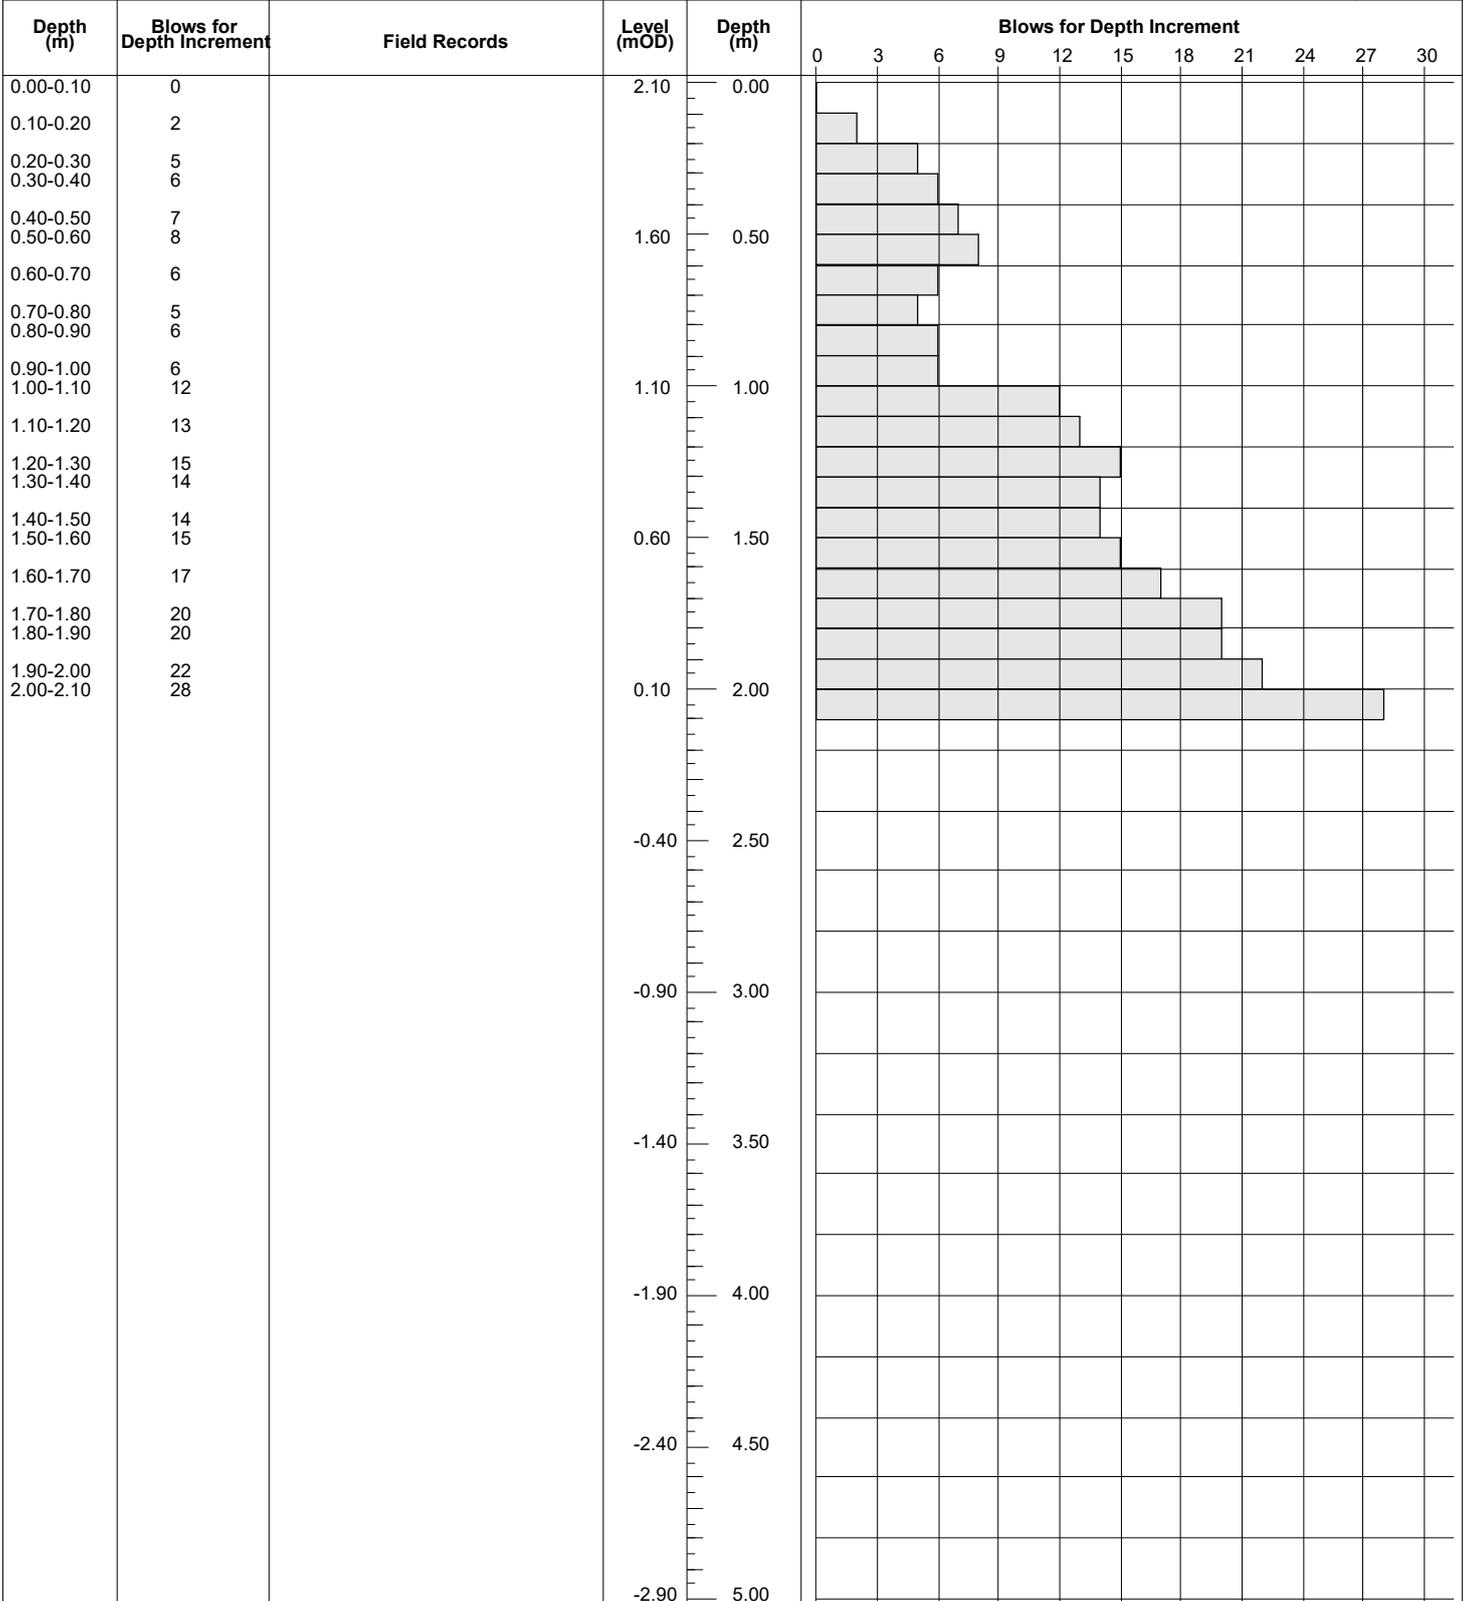
Remarks	Scale (approx)	1:25	Logged By	RM
	Figure No.	11087-09-21.DP26

Machine : Tec 10 Method : Dynamic Probe	Cone Dimensions Diameter 43.7mm	Ground Level (mOD) 2.10	Client Fingal County Council	Job Number 11087-09-21
	Location 725333.7 E 751285 N	Dates 18/01/2022	Engineer RPS	Sheet 1/1

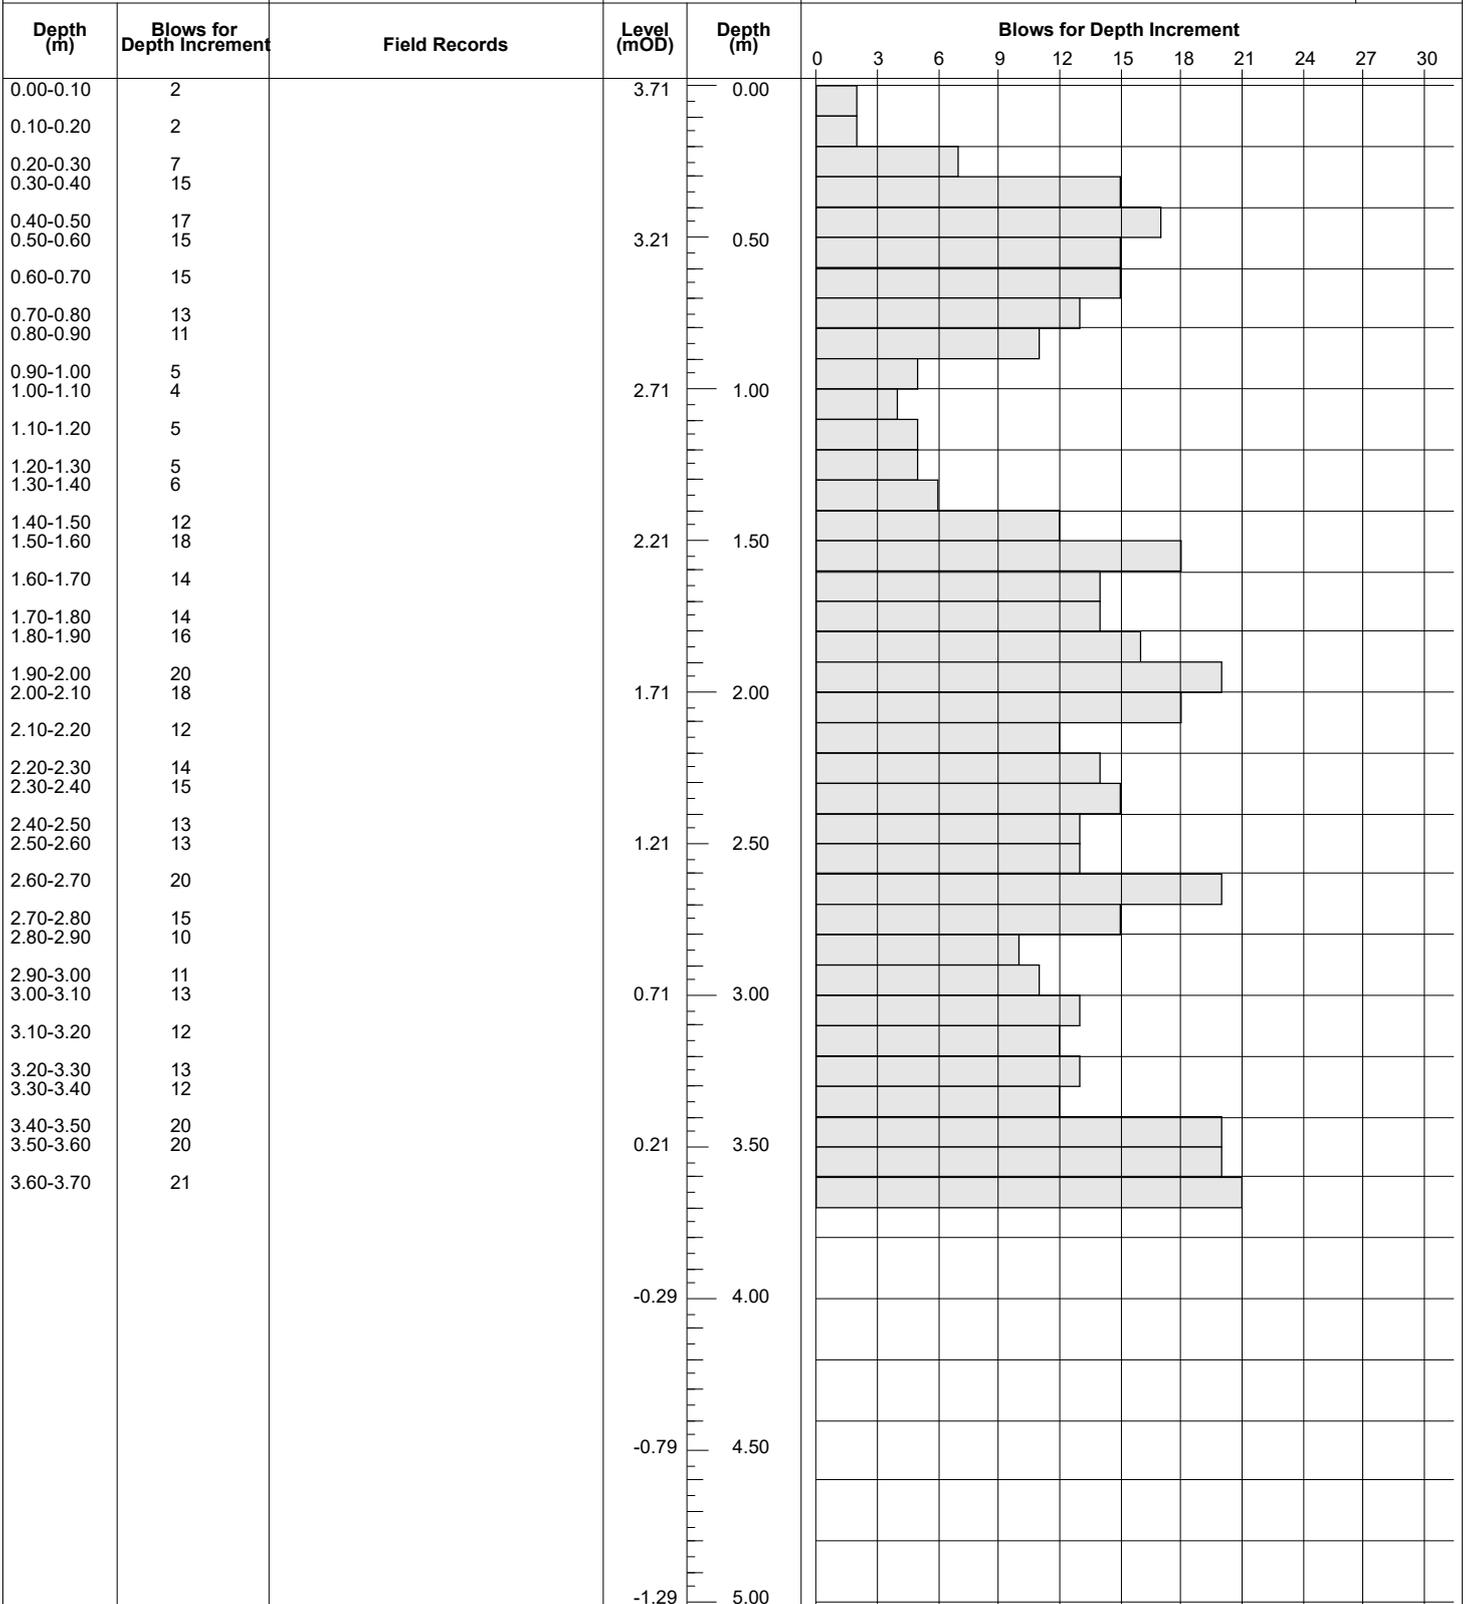
Remarks	Scale (approx)	Logged By
	1:25	RM
	Figure No. 11087-09-21.DP29

Machine : Tec 10 Method : Dynamic Probe	Cone Dimensions Diameter 43.7mm	Ground Level (mOD) 3.71	Client Fingal County Council	Job Number 11087-09-21
	Location 725471.8 E 750944.8 N	Dates 28/01/2022	Engineer RPS	Sheet 1/1

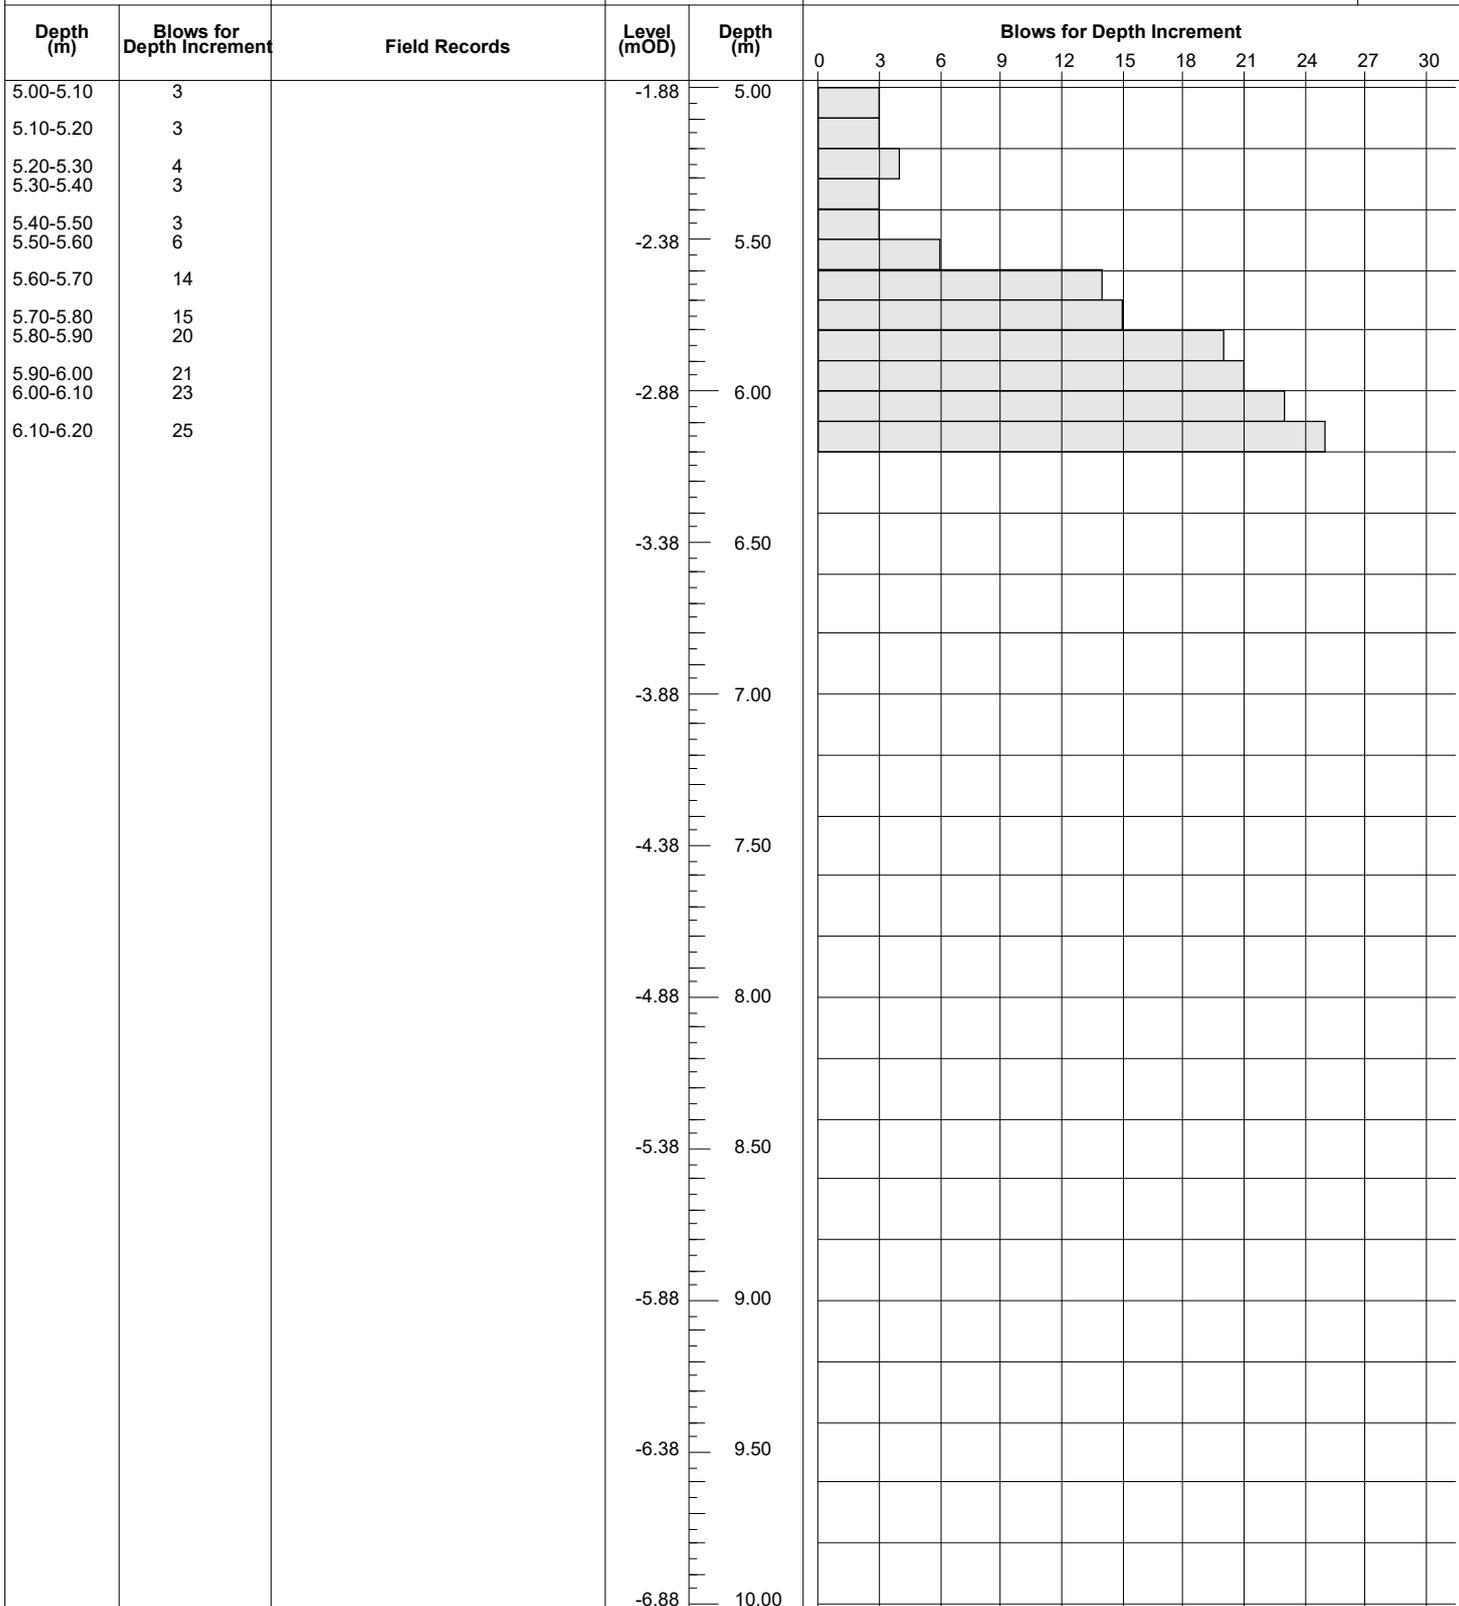
Remarks	Scale (approx)	Logged By
	1:25	RM
	Figure No. 11087-09-21.DP41

Machine : Tec 10 Method : Dynamic Probe	Cone Dimensions Diameter 43.7mm	Ground Level (mOD) 3.13	Client Fingal County Council	Job Number 11087-09-21
	Location 724575.1 E 753178.4 N	Dates 19/01/2022	Engineer RPS	Sheet 2/2

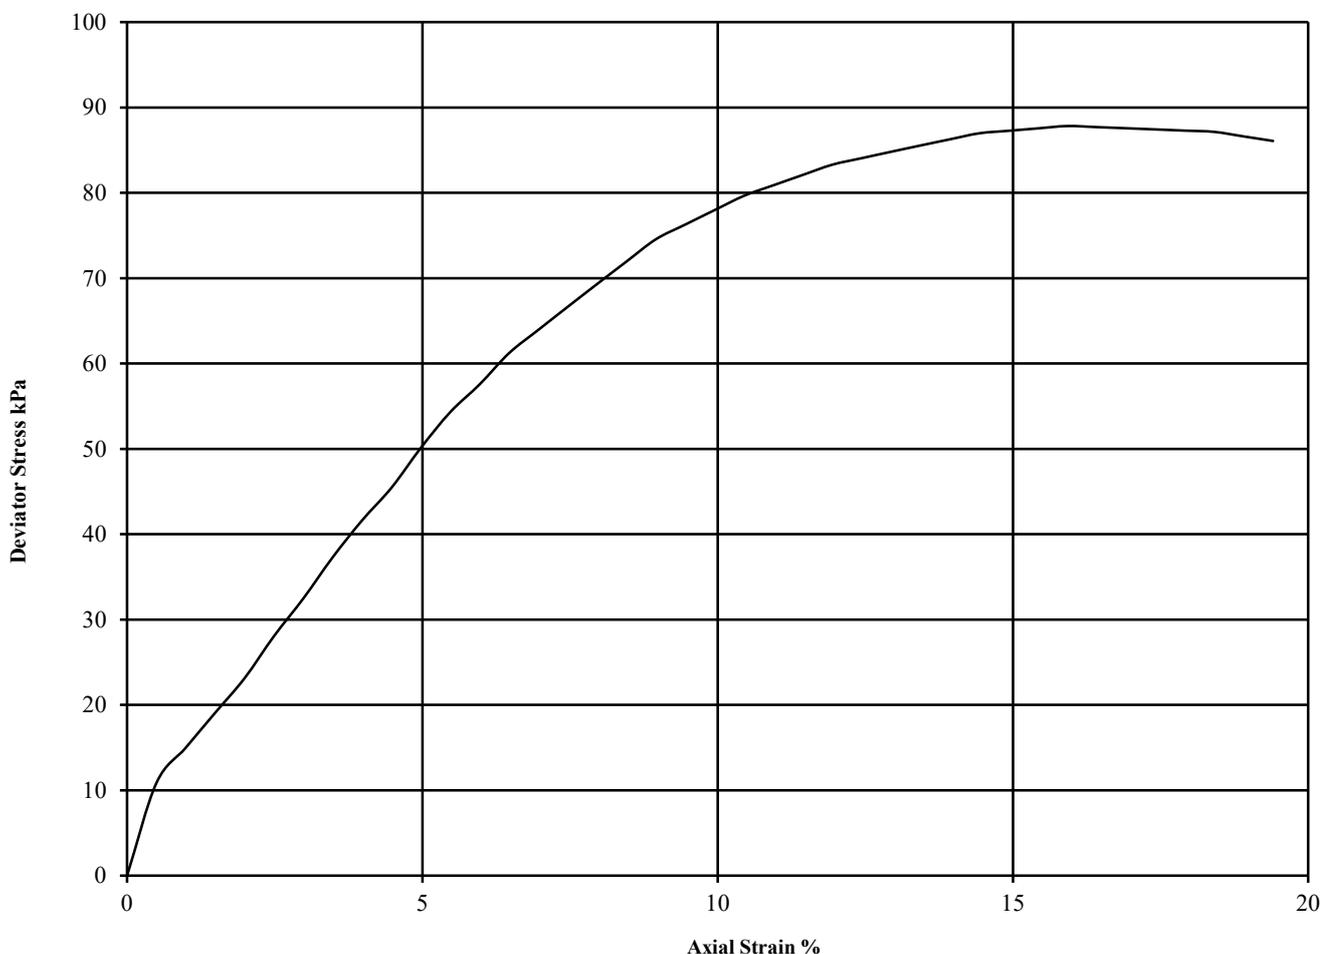
Diameter (mm):		103			Height (mm):		207		Test:	UU Single Stage		Remarks:
Specimen	Moisture Content (%)	Bulk Density (Mg/m3)	Dry Density (Mg/m3)	Cell Pressure (kPa)	Corr. Max. Deviator Stress (kPa)	$\theta_3$	$(\theta_1 - \theta_3)_f$	$\frac{1}{2}(\theta_1 - \theta_3)_f$	Shear Strength Cu (kPa)	Failure Strain (%)	Mode of Failure	Undisturbed Sample Sample taken from top of tube Rate of strain = 2 %/min Latex Membrane used 0.2 mm thick, Correction applied 0.34 See summary of soil descriptions
1	26	2.01	1.59	100	88			44	15.9	Plastic

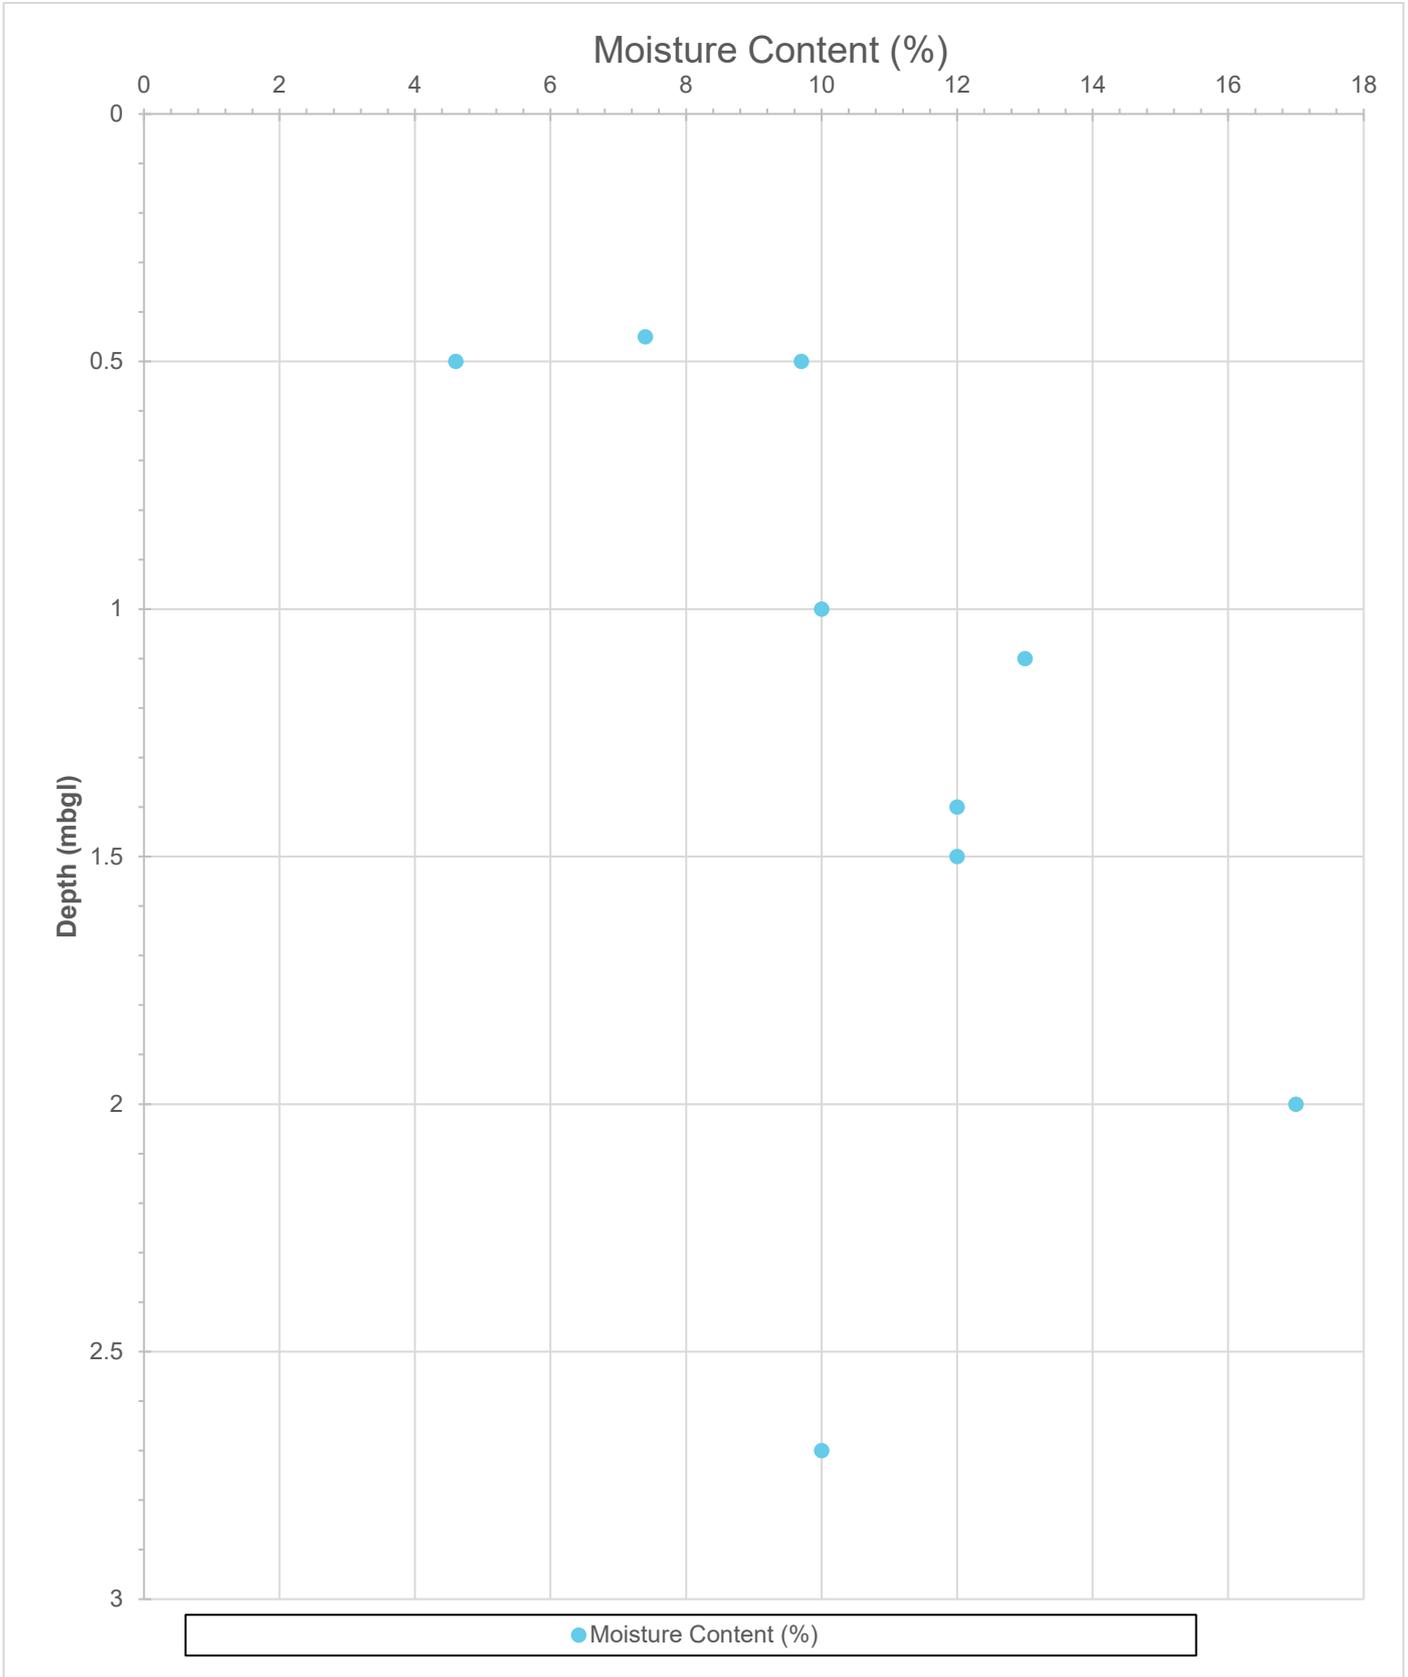
Location	Ground material	Title
	<b>ENTIRE SCHEME</b>	<b>WINDBLOWN SAND</b>	<b>MC Vs Depth</b>
Client	Project: <b>Rogerstown FRS</b>		
	Database File Identifier: <b>MGT0597</b>		
	Database status: <b>S4</b>	Database revision: <b>P01</b>	Date plot exported: <b>8/06/2022</b>

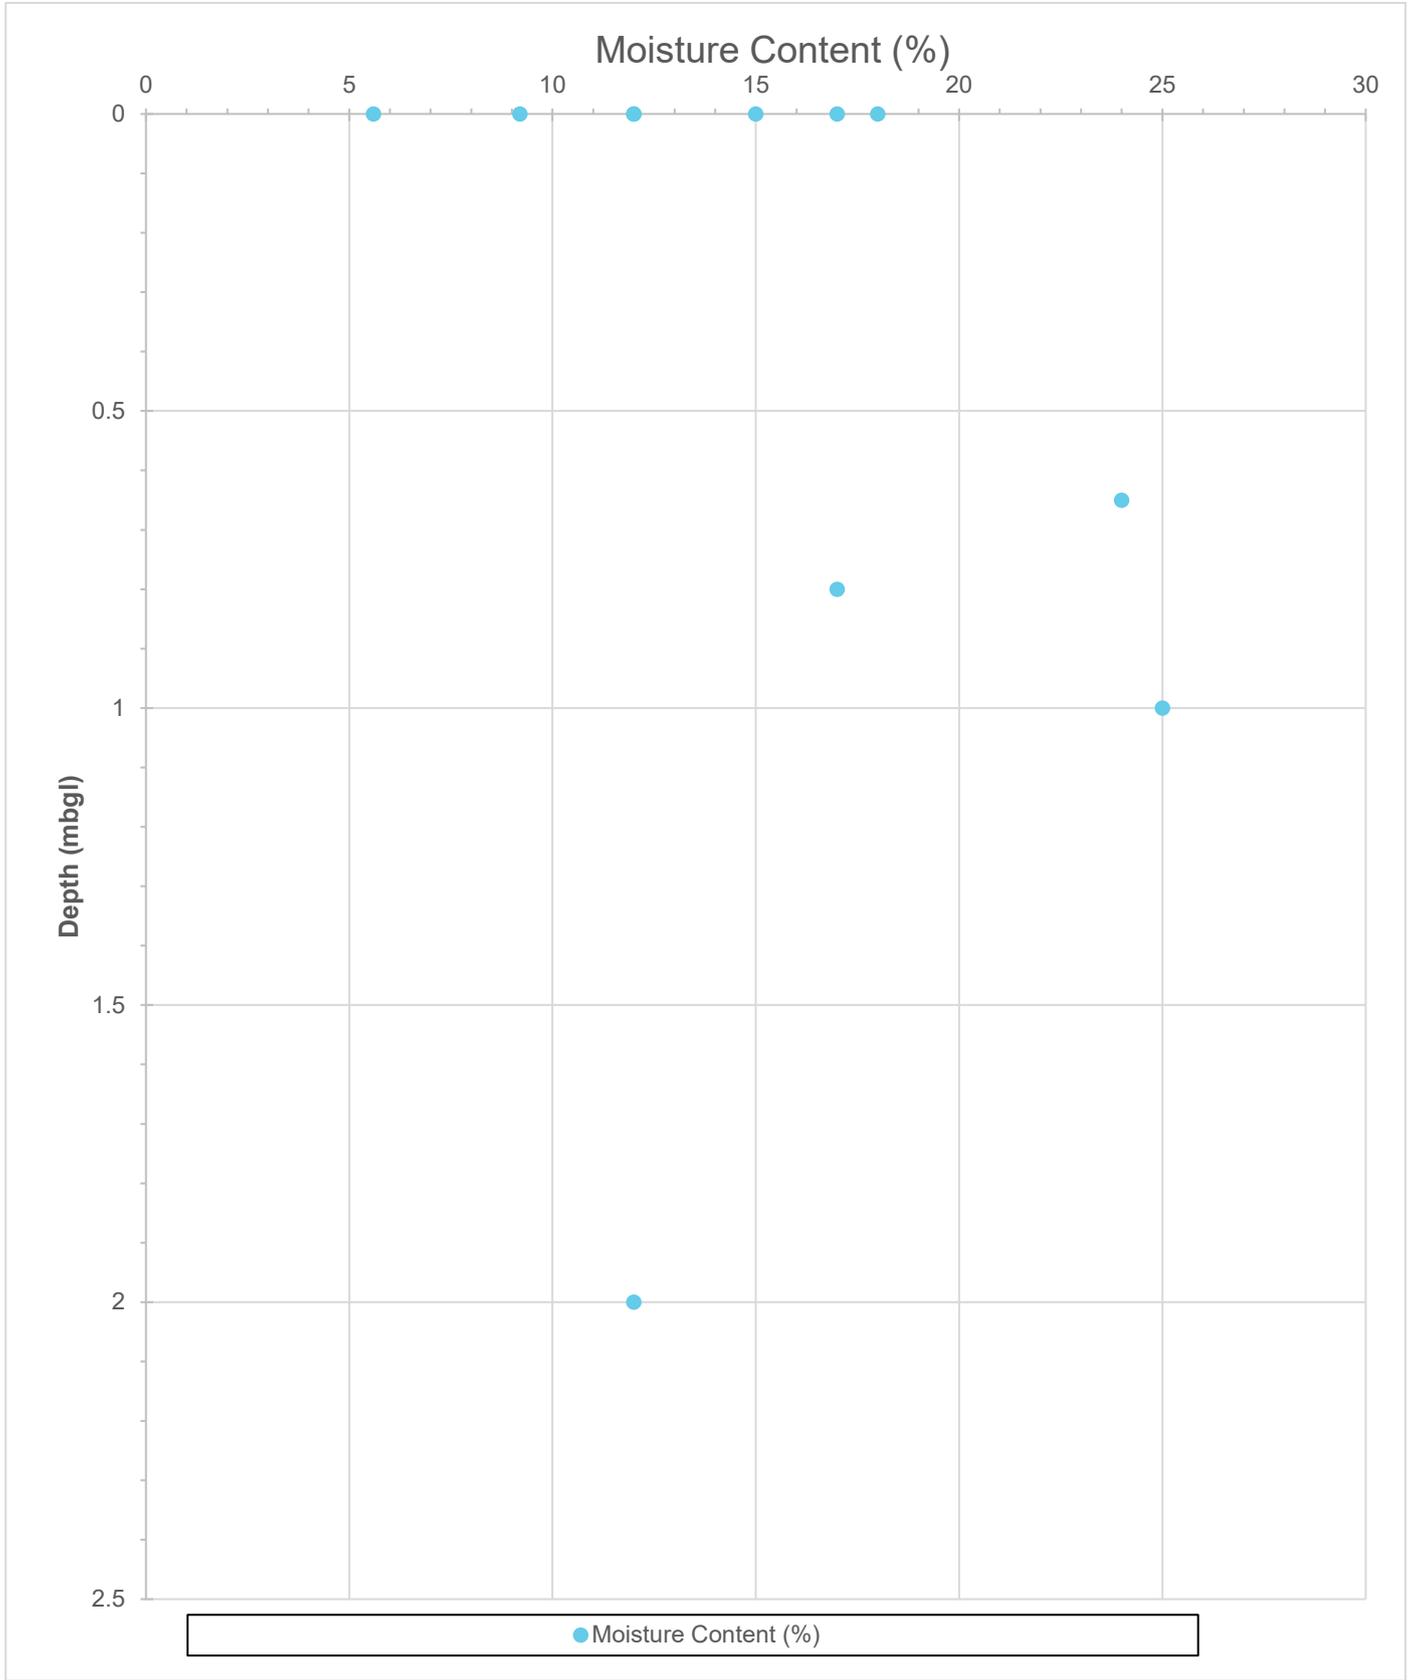
Location	Ground material	Title
	<b>ENTIRE SCHEME</b>	<b>MARINE BEACH SAND</b>	<b>MC Vs Depth</b>
Client	Project: <b>Rogerstown FRS</b>		
	Database File Identifier: <b>MGT0597</b>		
	Database status: <b>S4</b>	Database revision: <b>P01</b>	Date plot exported: <b>8/06/2022</b>

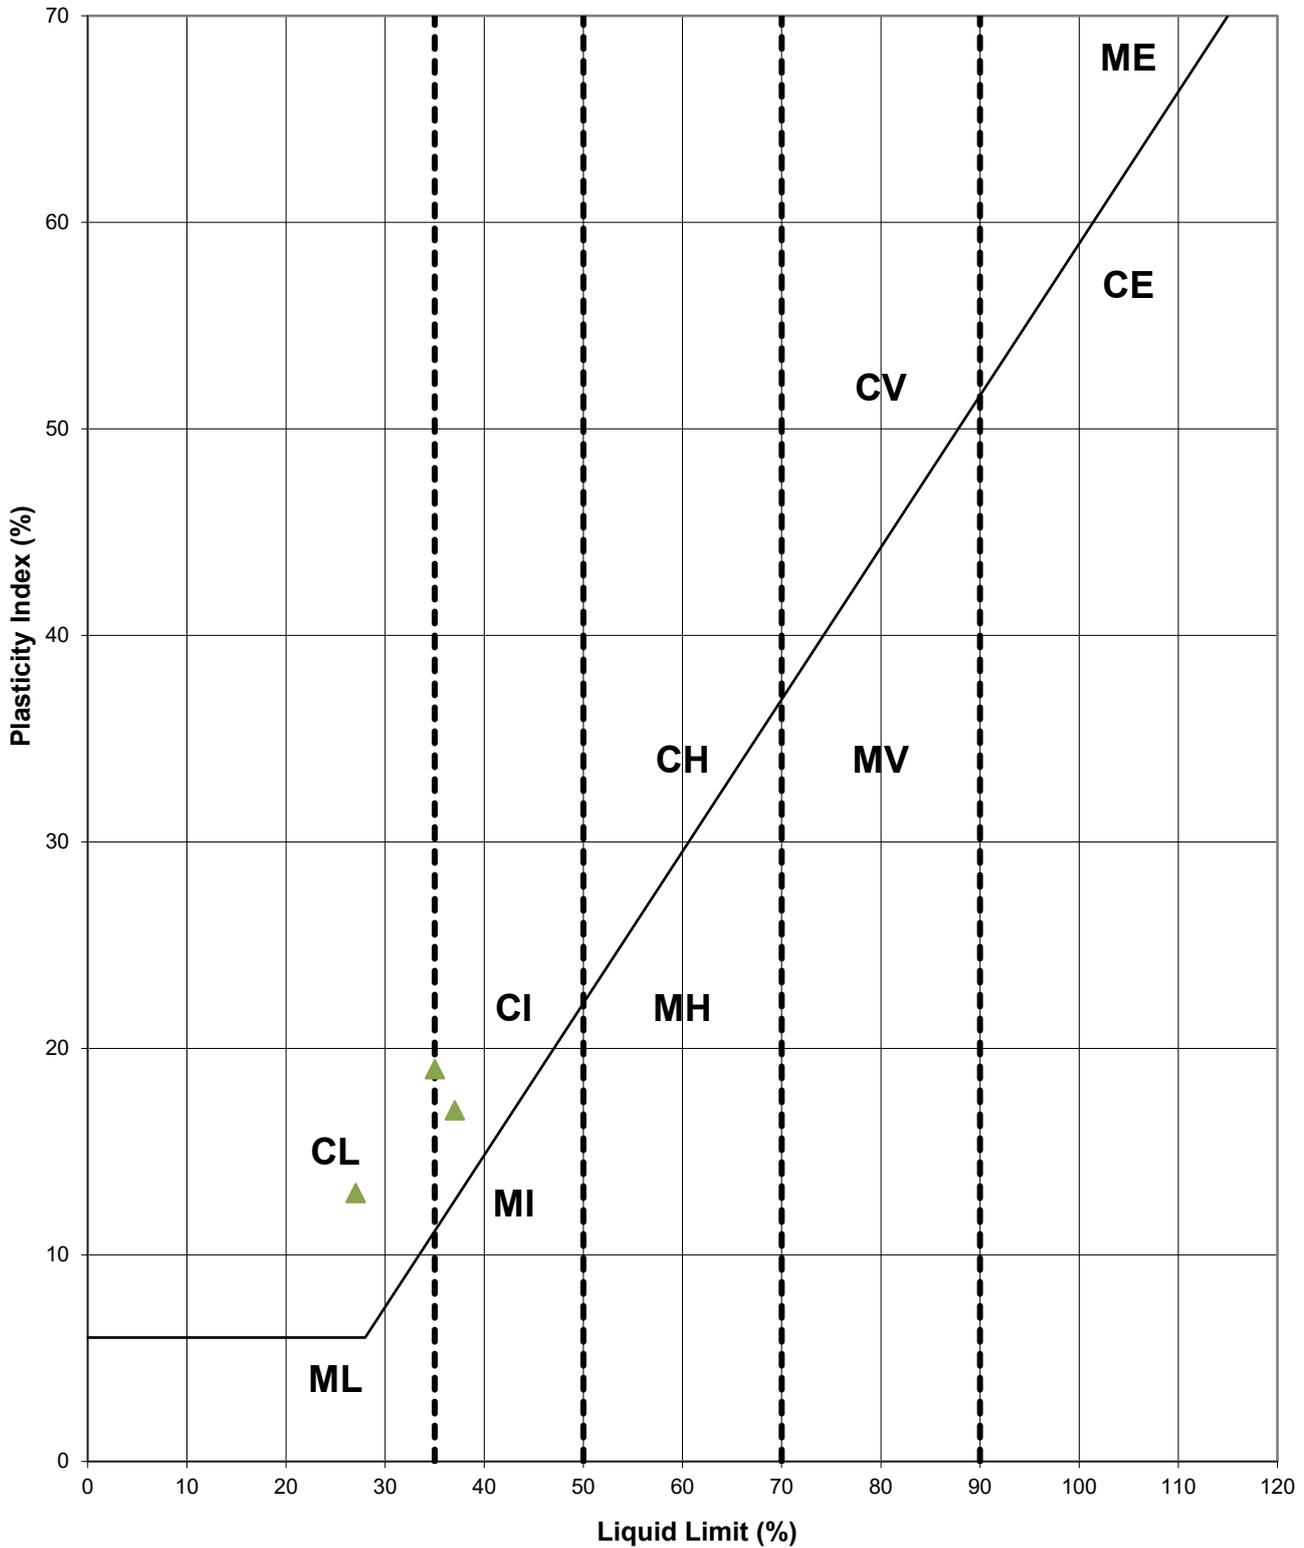
Location	Ground material	Title
<b>Entire Scheme</b>	<b>MADE GROUND</b>	<b>Atterberg Limits</b>
Client	Project: <b>Rogerstown FRS</b>	
	Database File Identifier: <b>MGT0597</b>	
	Database status: <b>S4</b>	Database revision: <b>P01</b> Date plot exported: <b>8/06/2022</b>

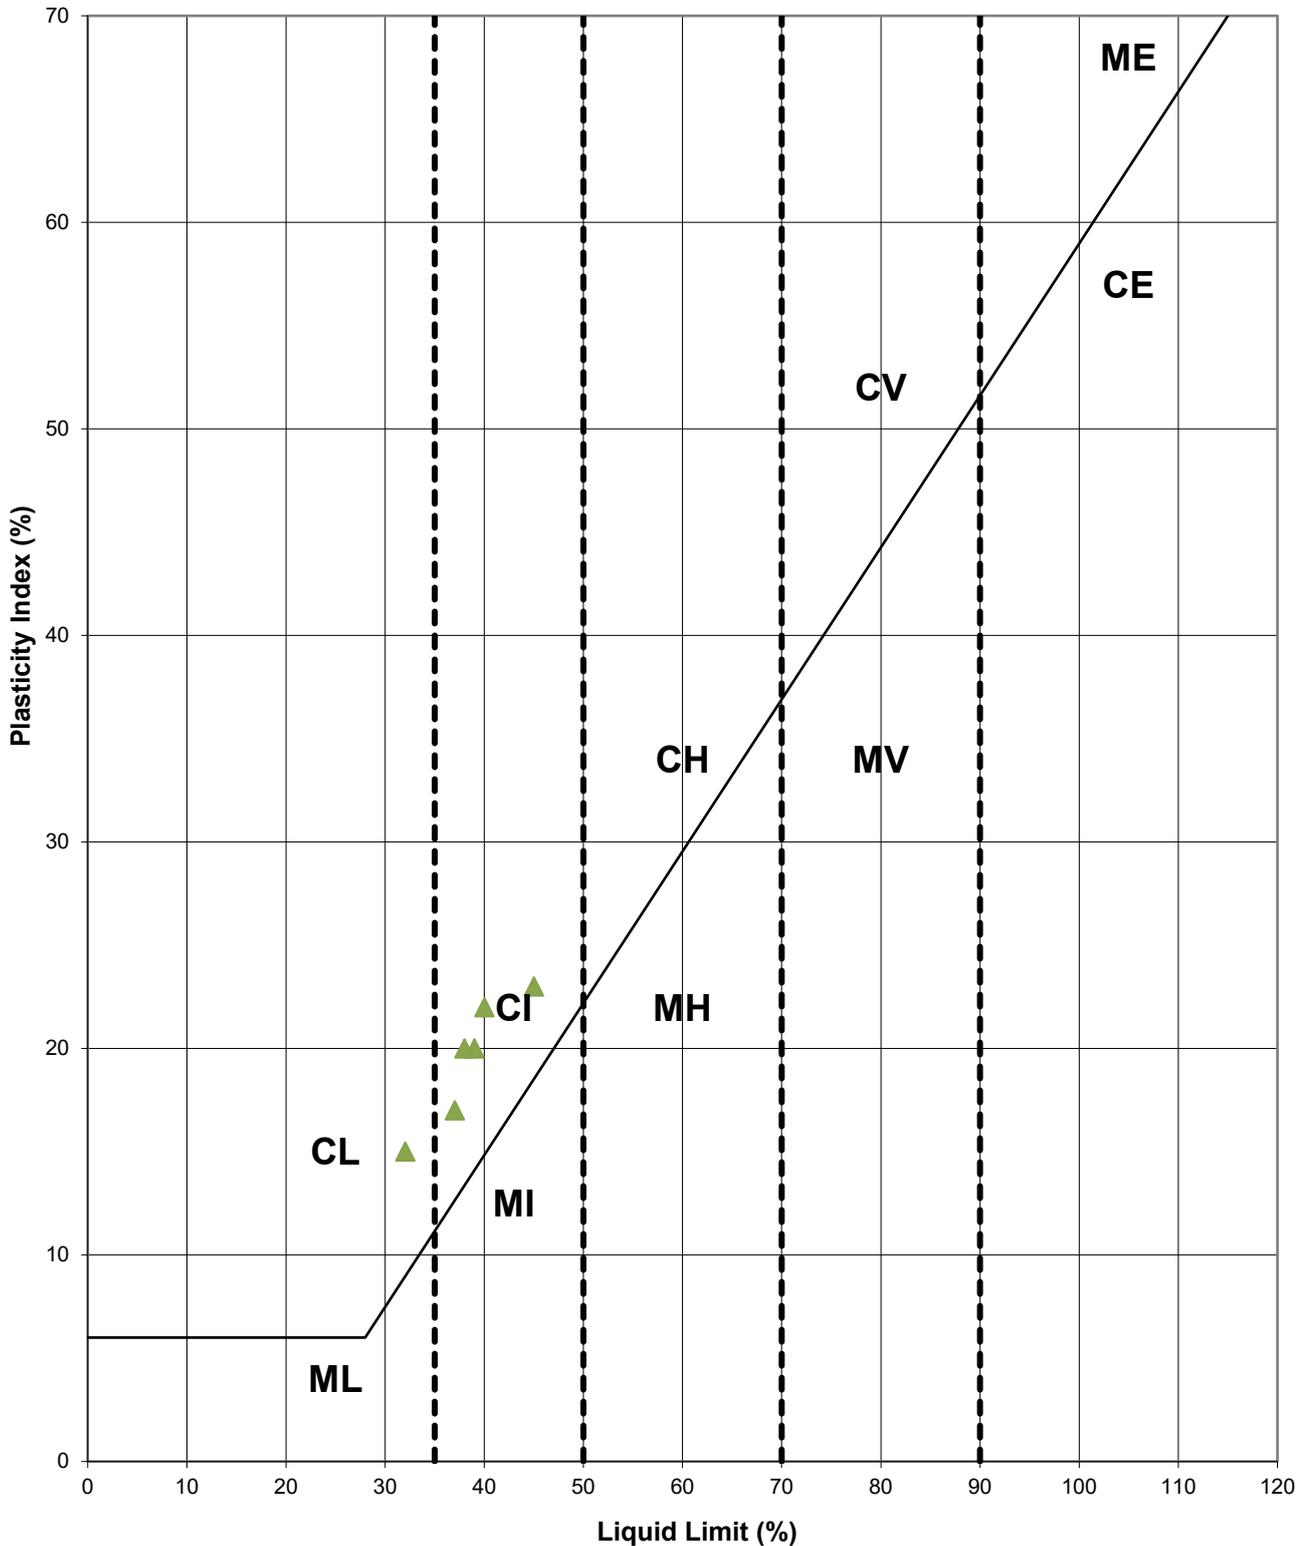
Location	Ground material	Title
	<b>Entire Scheme</b>	<b>ESTUARINE</b>	<b>Atterberg Limits</b>
Client	Project:	<b>Rogerstown FRS</b>	
	Database File Identifier:	<b>MGT0597</b>	
	Database status: <b>S4</b>	Database revision: <b>P01</b>	Date plot exported: <b>8/06/2022</b>

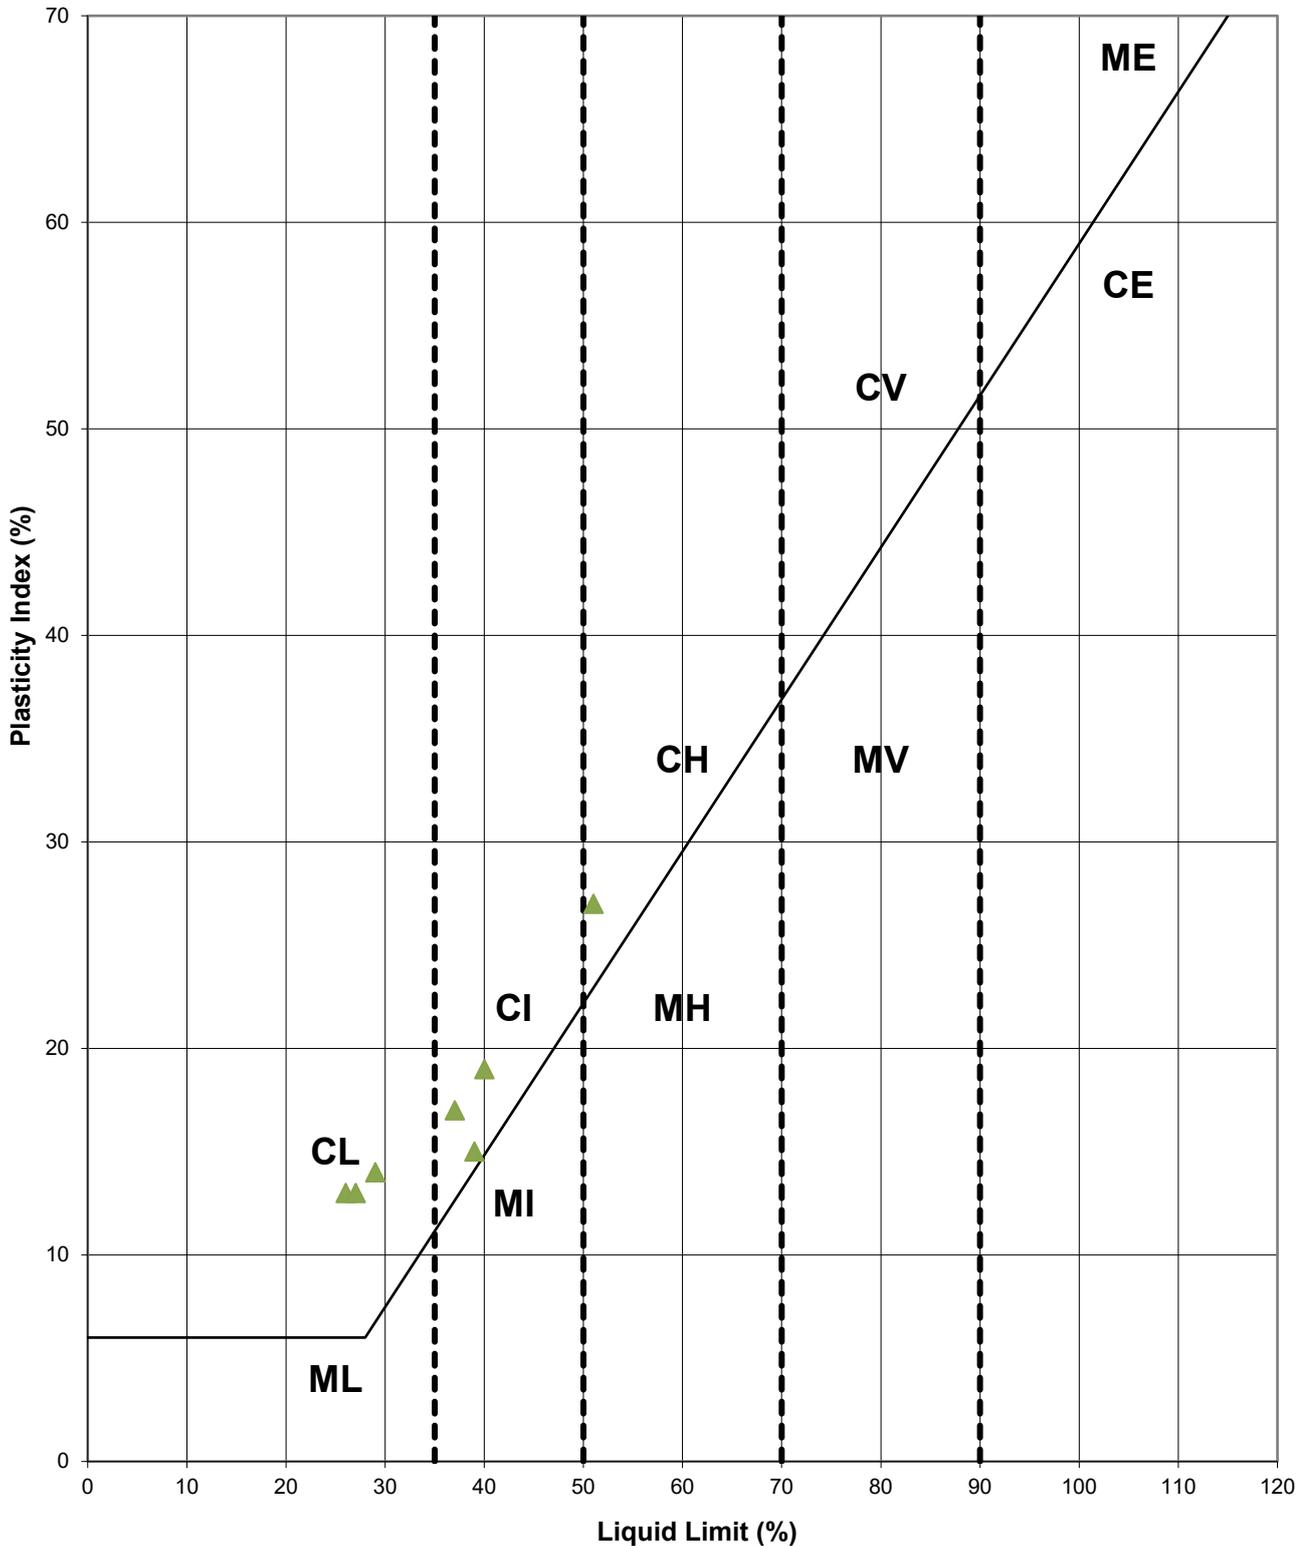
Location	Ground material	Title
<b>Entire Scheme</b>	<b>GLACIAL TILL</b>	<b>Atterberg Limits</b>
Client	Project: <b>Rogerstown FRS</b>	
	Database File Identifier: <b>MGT0597</b>	
	Database status: <b>S4</b>	Database revision: <b>P01</b> Date plot exported: <b>8/06/2022</b>

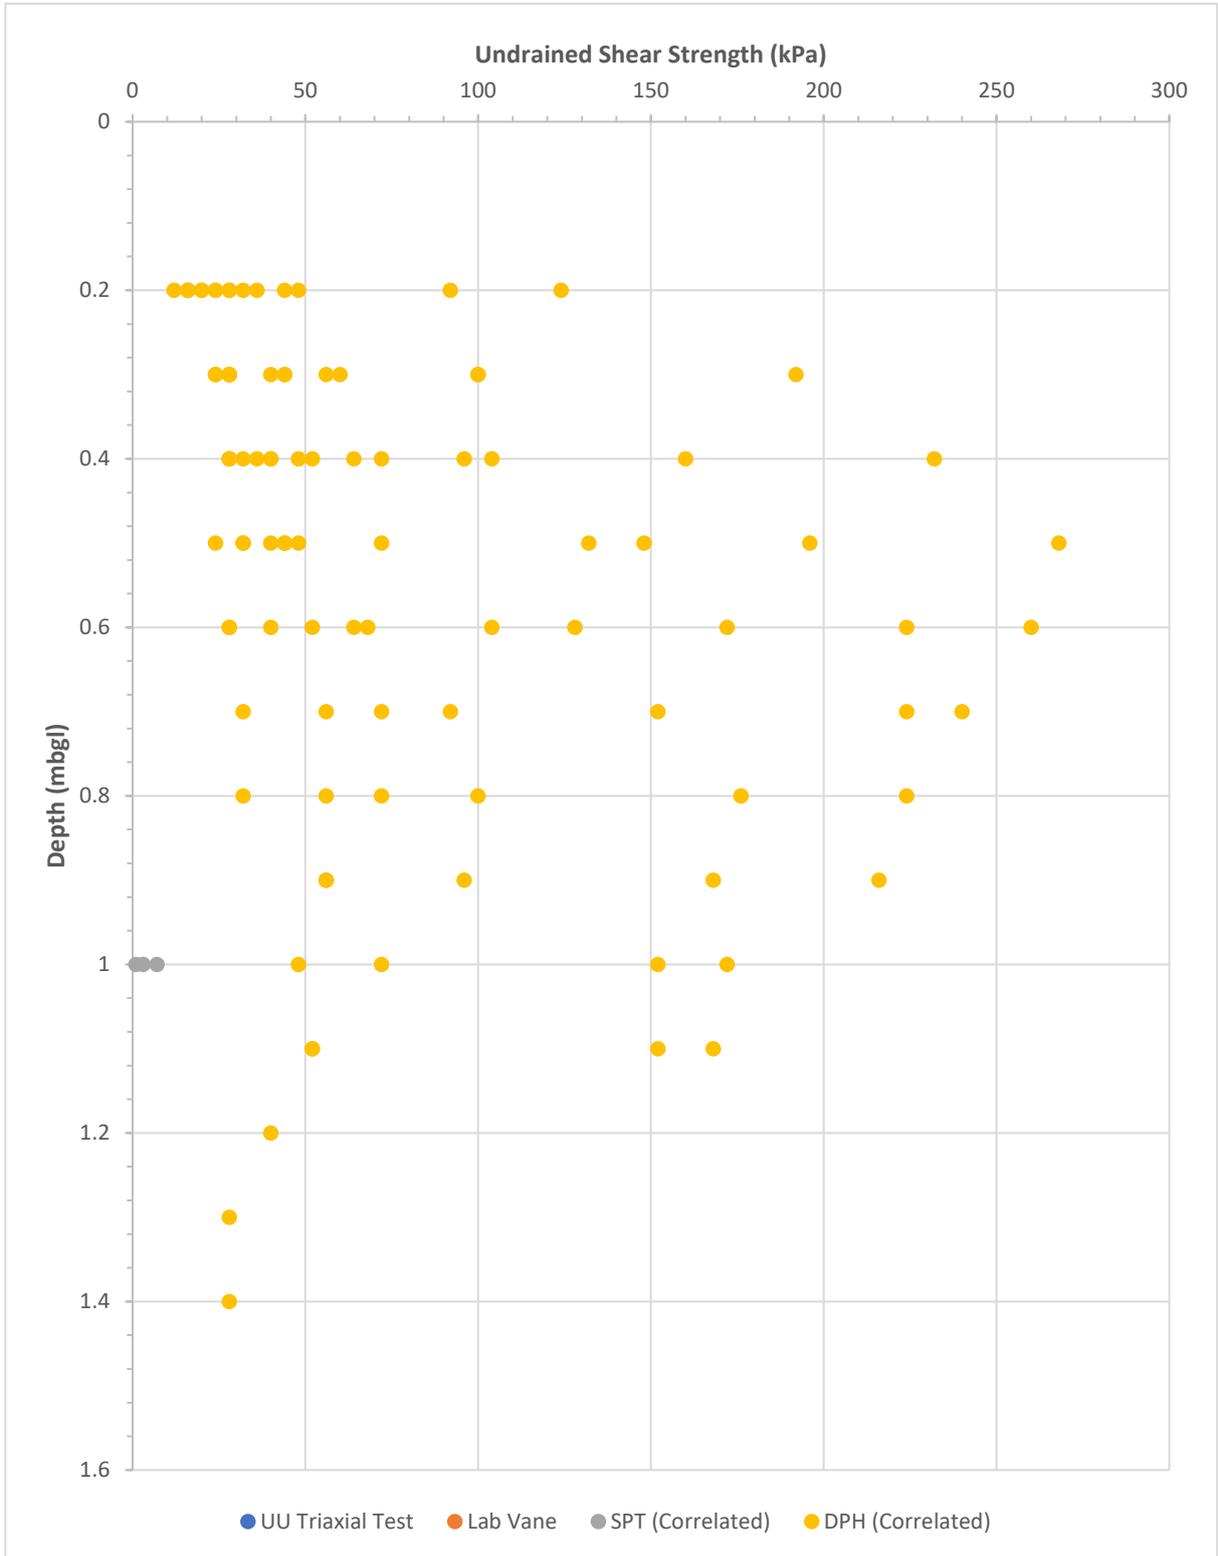
Location	Entire Scheme	Ground material	MADE GROUND	Title	Undrained Shear Strength Vs Depth
	Client	Project:	Rogerstown FRS	Database File Identifier:	MGT0597
Database status:	S4	Database revision:	P01	Date plot exported:	8/06/2022
