The Burrow CFERM scheme

# ROGERSTOWN OUTER ESTUARY (PORTRANE – RUSH) COASTAL DEFENCE PROJECT

Preliminary Ground Investigation Report (GIR)

RCS-RPS-00-XX-RP-C-  
GI002  
P01  
16 June 2022

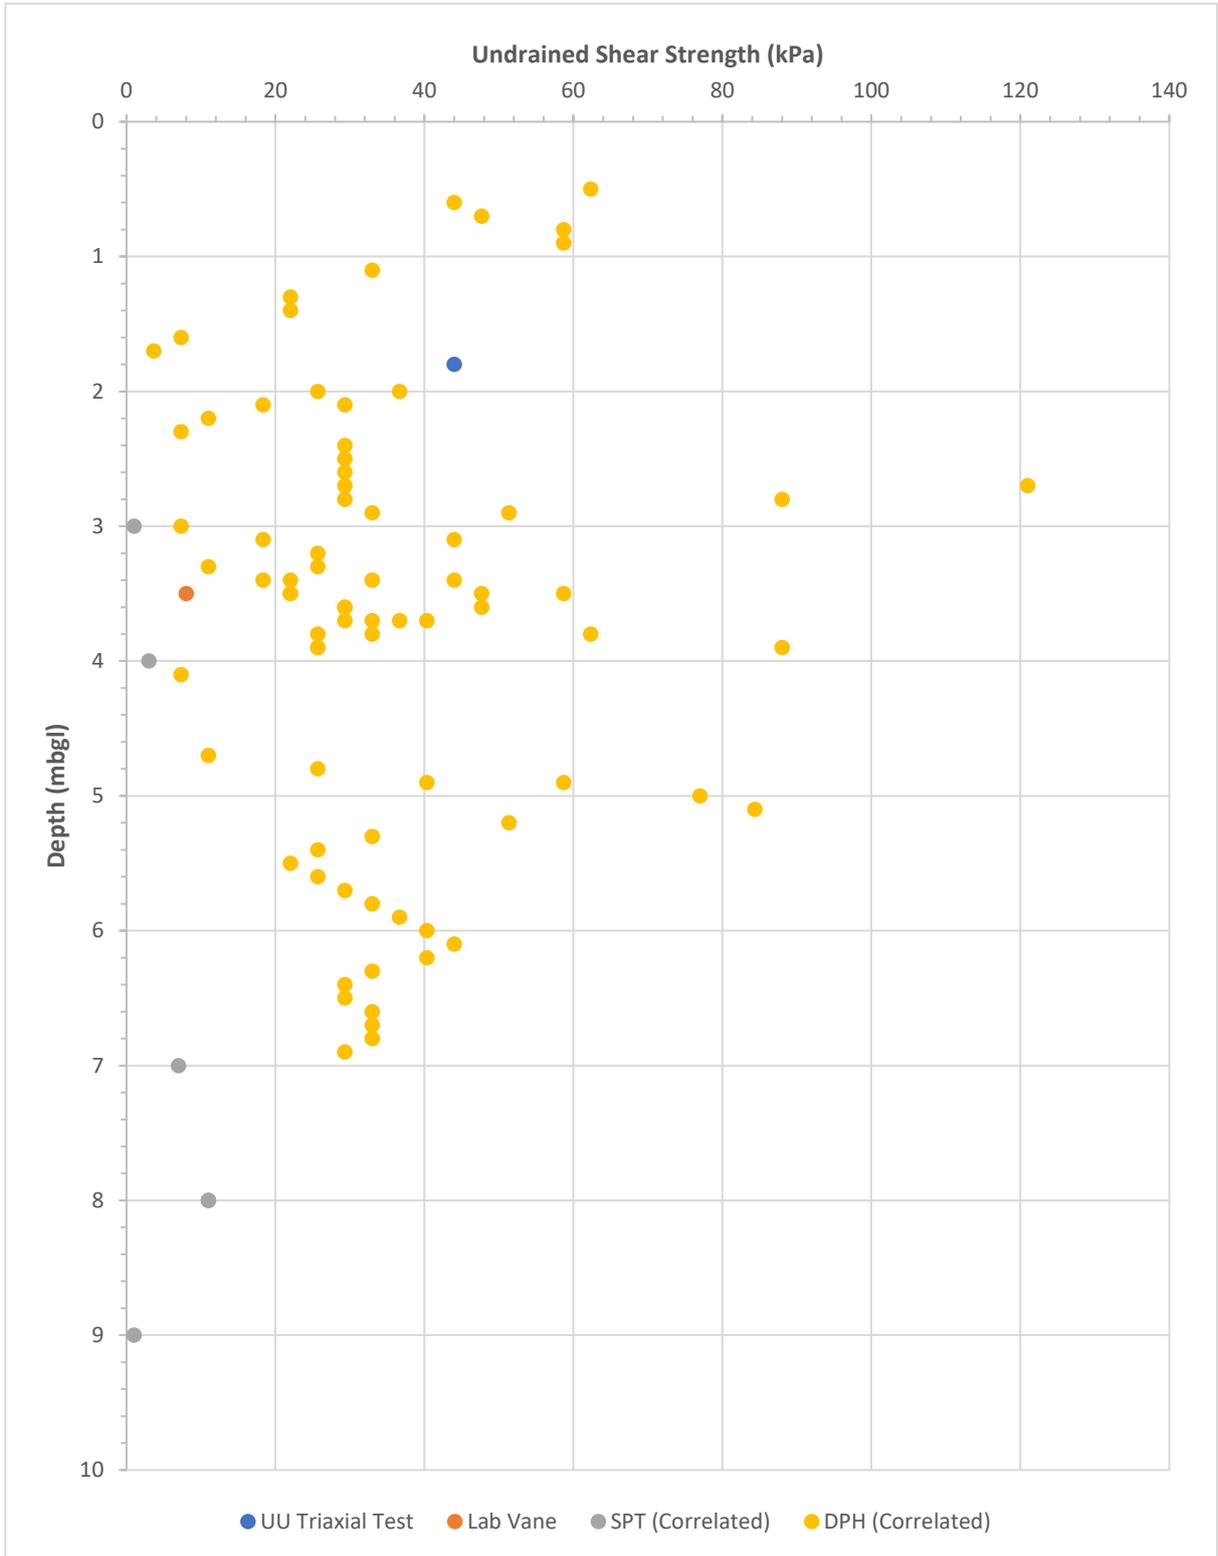
Location	Ground material	Title
Entire Scheme	ESTUARINE	Undrained Shear Strength Vs Depth
Client	Project: Rogerstown FRS	
	Database File Identifier: MGT0597	
Database status: S4	Database revision: P01	Date plot exported: 8/06/2022

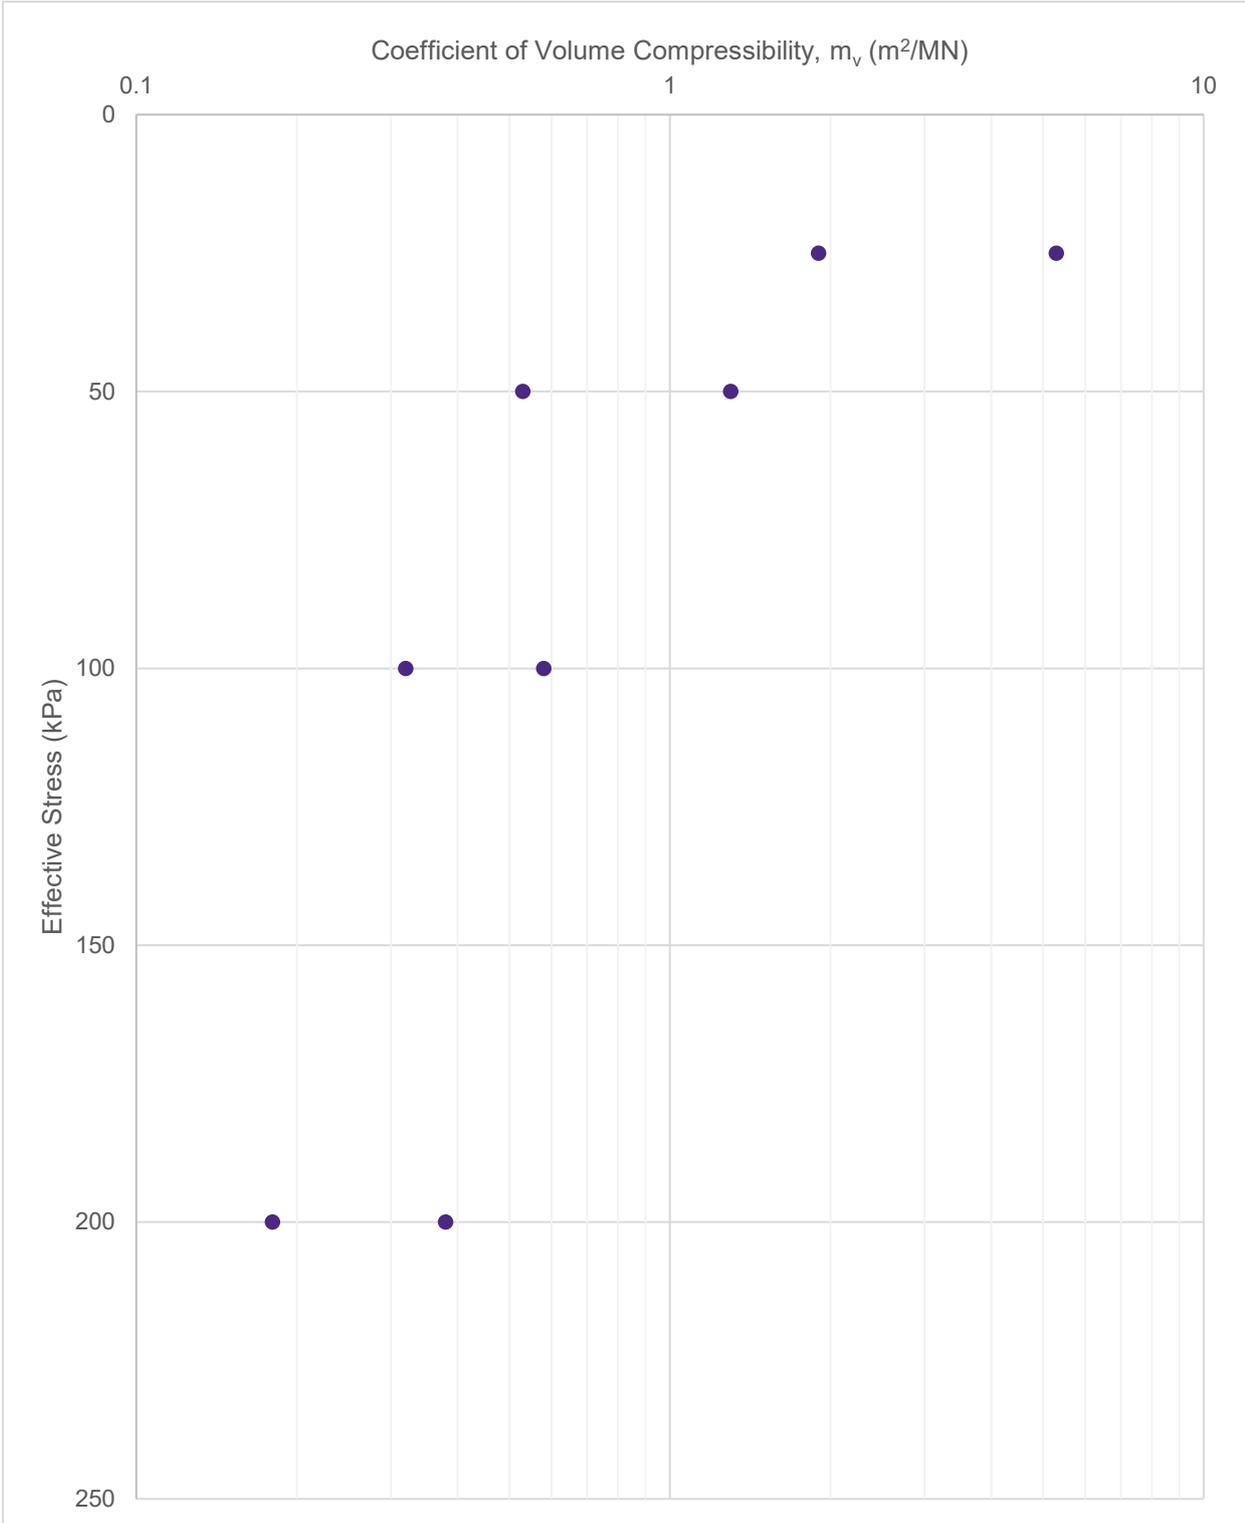
Location	Ground material	Title
	<b>Entire Scheme</b>	<b>ESTUARINE</b>	<b>Volume Compressibility Vs Effective Stress</b>
Client	Project: <b>Blaris Road Bridge</b>		
	Database File Identifier: <b>MCT0780</b>		
	Database status: <b>s4</b>	Database revision: <b>P01</b>	Date plot exported: <b>8/06/2022</b>
