Cashla Peaker Plant: Ground Conditions and Preliminary Foundation Design Commentary: Technical Note

Ground Conditions and Preliminary Foundation Design Commentary

0114485DG0033

AtkinsRéalis have been appointed by Bórd Gáis Energy (BGE) Limited (hereafter referred to as 'BGE') to prepare the planning application design and accompanying EIA/R for the Peaker Open Cycle Gas Turbine (OCGT) power plant in Pollnagroagh/Rathmorrissy, Athenry, Co. Galway.

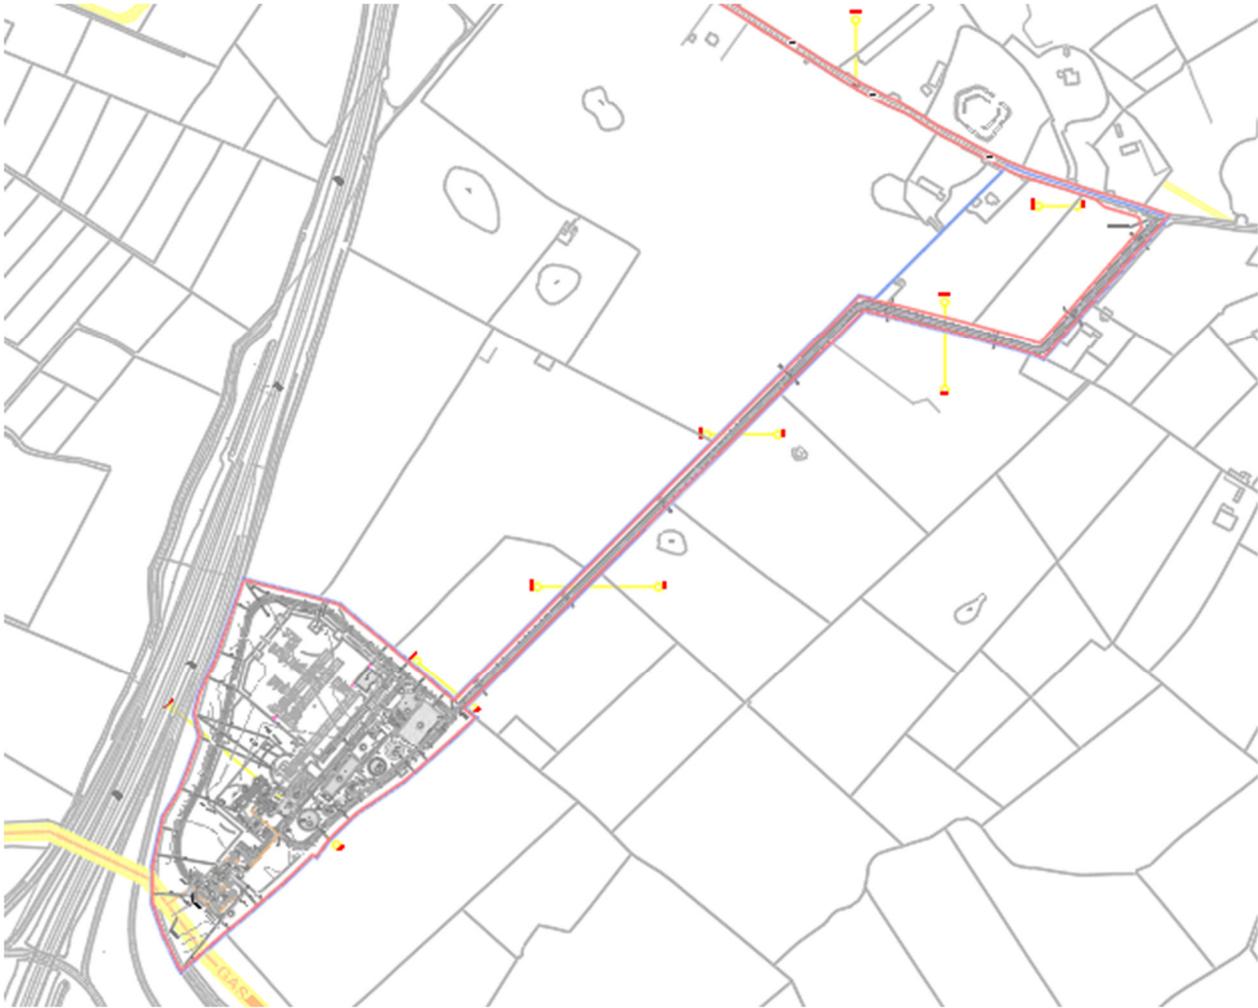
Figure 1.1 – Image of the site layout and access route

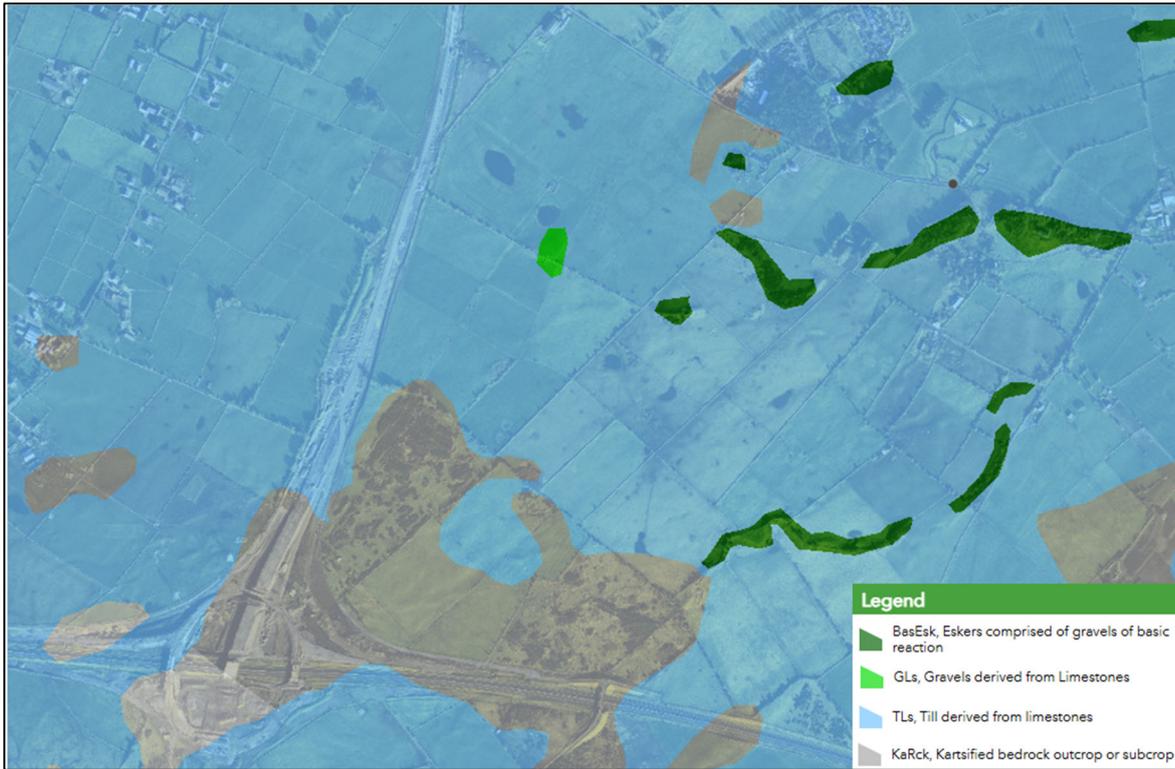
Figure 2.1 - Quaternary Sediment Map, (GSI)

According to the GSI online mapping information the bedrock is part of the western lowland karst region described as pale limestone and the Quaternary sediment consists of glacial till and gravels derived from Limestones and Eskers comprised of gravels basic reaction and Karstified bedrock outcrop or subcrop. There are bedrock outcrops and subcrop located at the Peaker Plant area and the access route (Figure 2.1 and Figure 2.2).

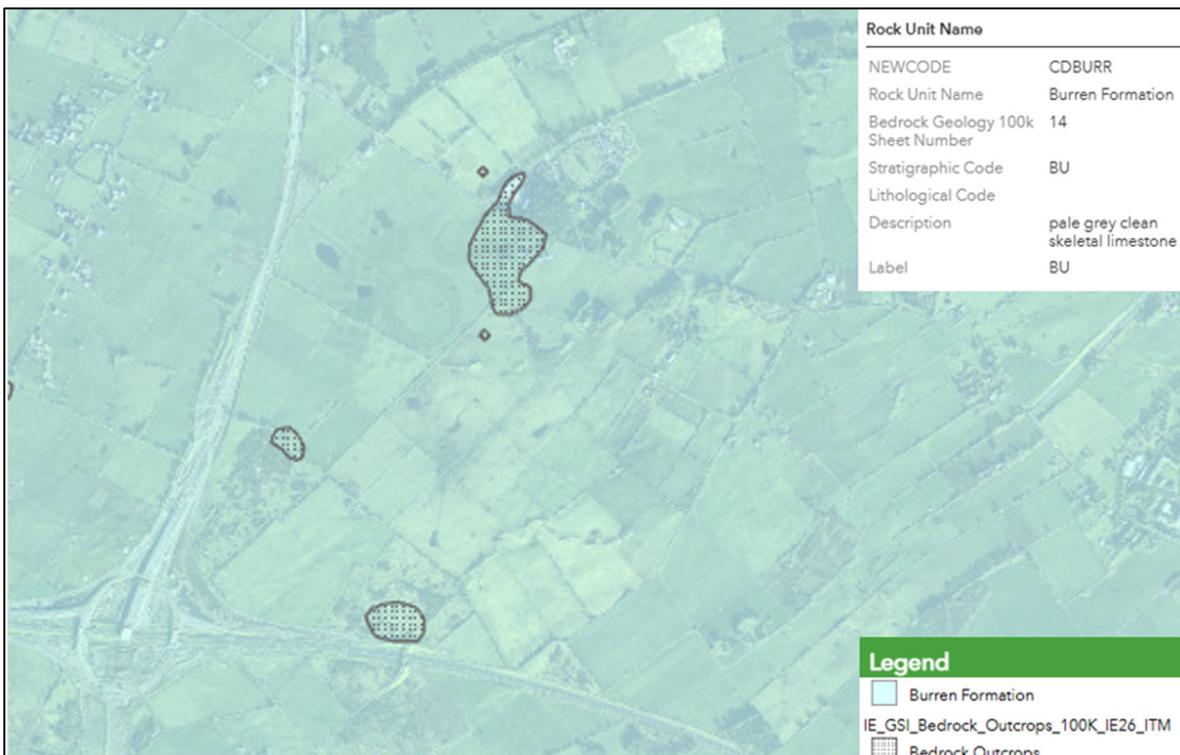
Figure 2.2 – Bedrock Geology Map, (GSI)

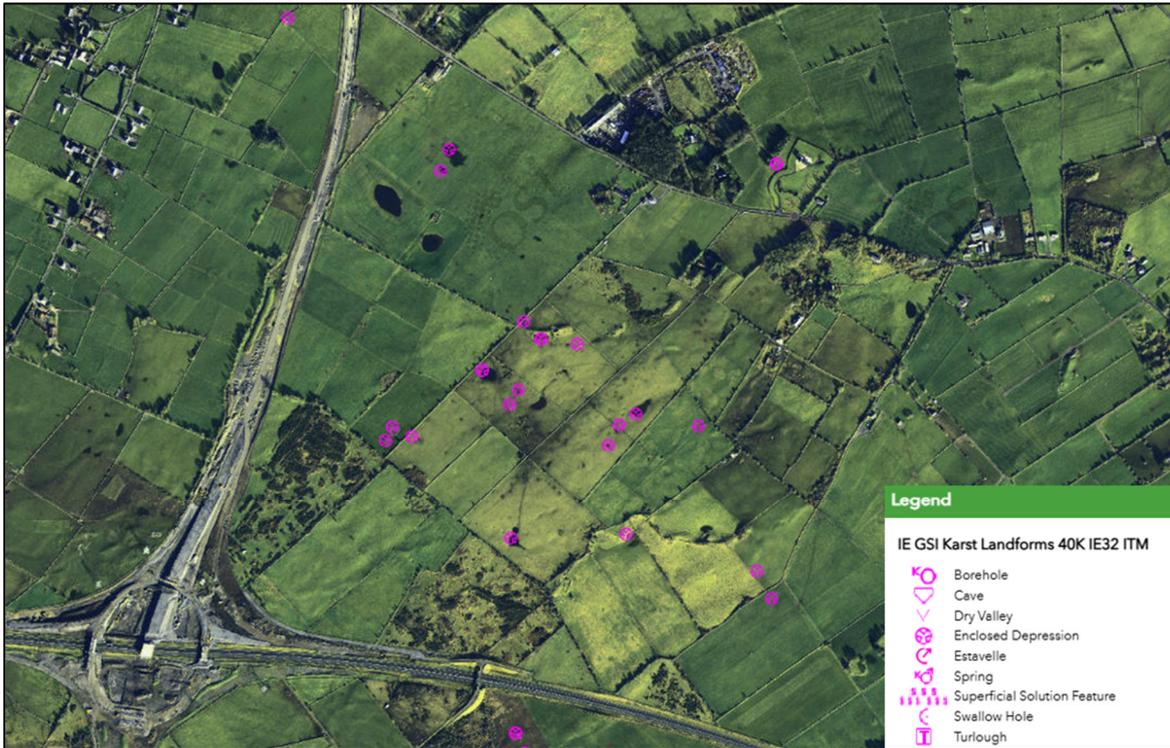
Figure 2.3 - Karst Landforms at the vicinity of the site (GSI)

Several karst features identified by GSI online mapping within the vicinity of the site. Karst features are described as enclosed depressions (Figure 2.3).

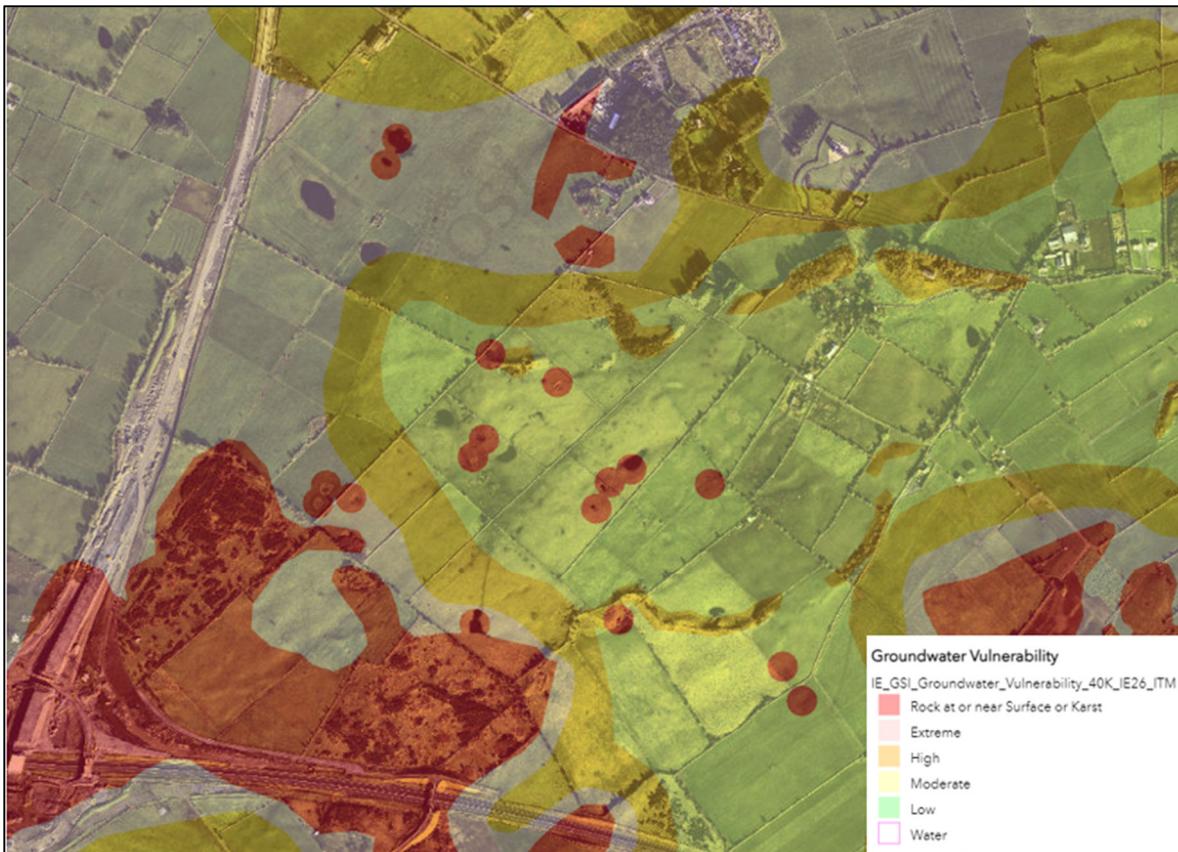
Figure 2.4 - Groundwater Vulnerability Map, (GSI)

Groundwater Vulnerability & Resources Maps indicate that the majority of the proposed site is Extreme to High vulnerability with isolated areas of moderate and the bedrock aquifer is Regionally important Aquifer- Karstified (conduit) as shown in Figure 2.4.

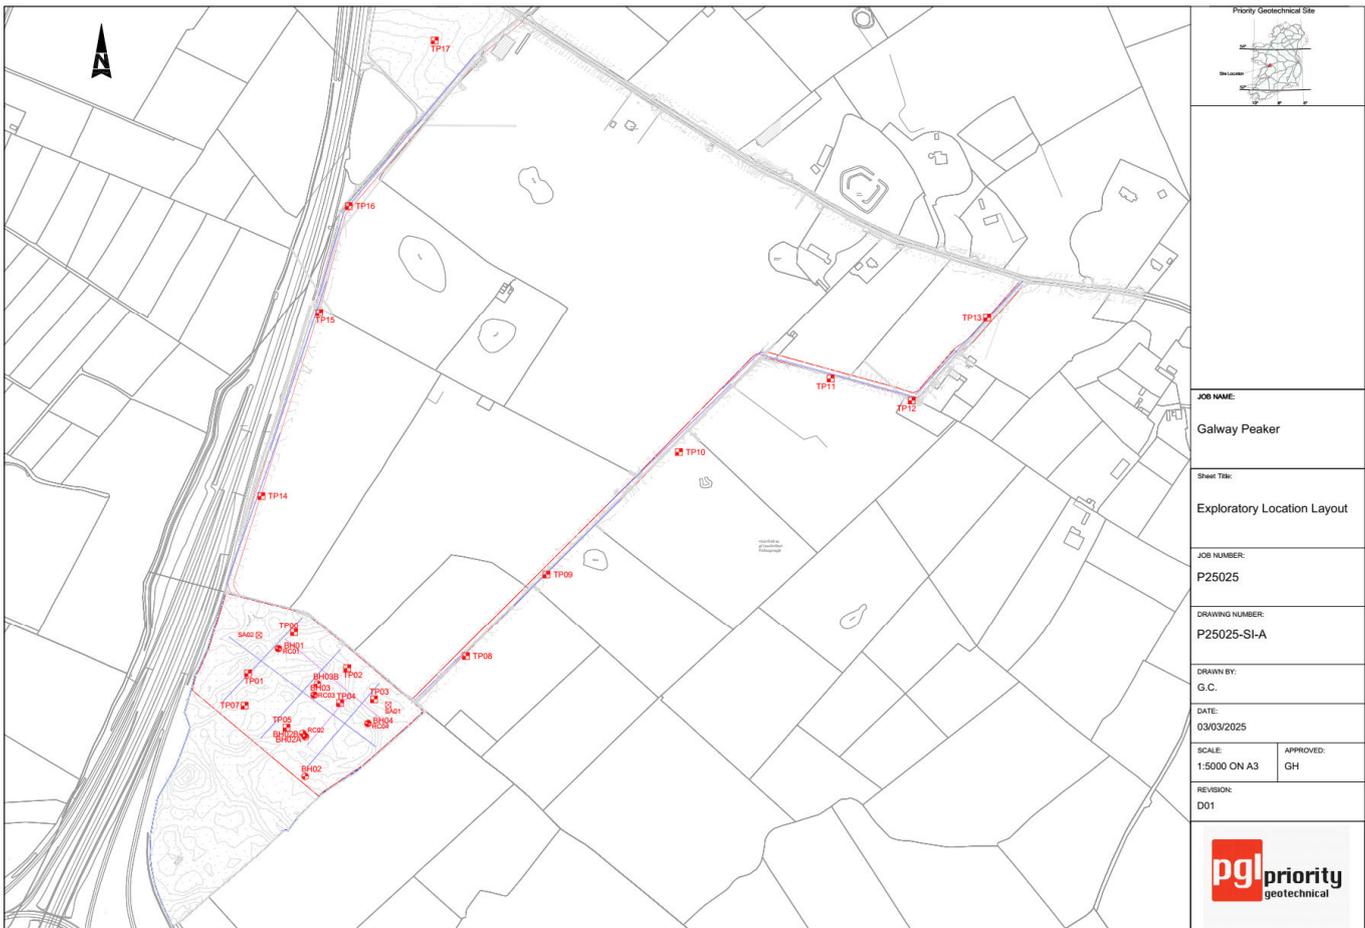
Figure 3.1 – Site Investigation Locations

The site investigation intrusive works comprised 4 no. cable percussion borehole with rotary follow on and 7 no. Trial Pits (T01 to TP07) on the peaker plant site itself. During the site works some of the cable percussion boreholes are re-located due to the presence of a high boulder and cobble content.

Trial pits from T08 to TP13 (7 in total) and from TP14 to TP17 (4 in total) were carried out to determine ground conditions along the western and eastern access route options, respectively.

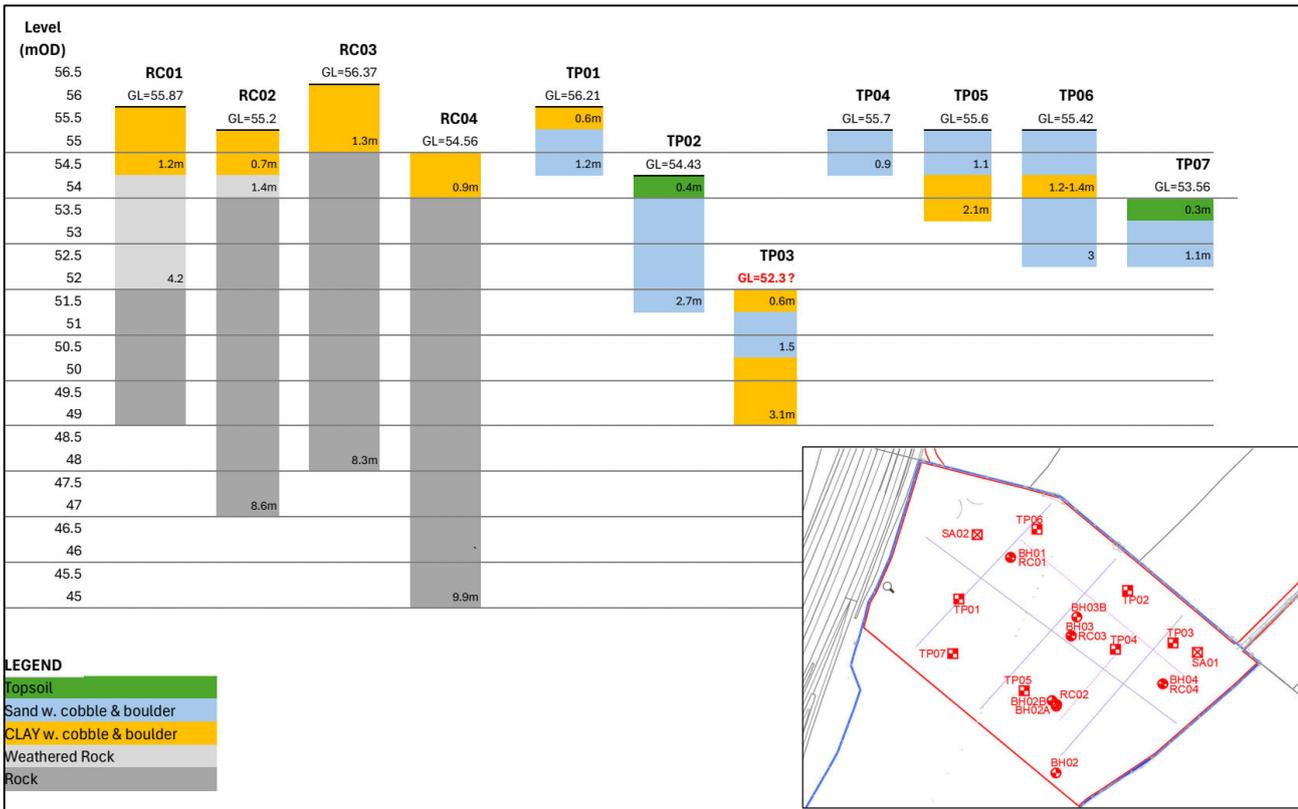
Figure 3.2 - Draft Exploratory Hole Cross Sections at Plant location

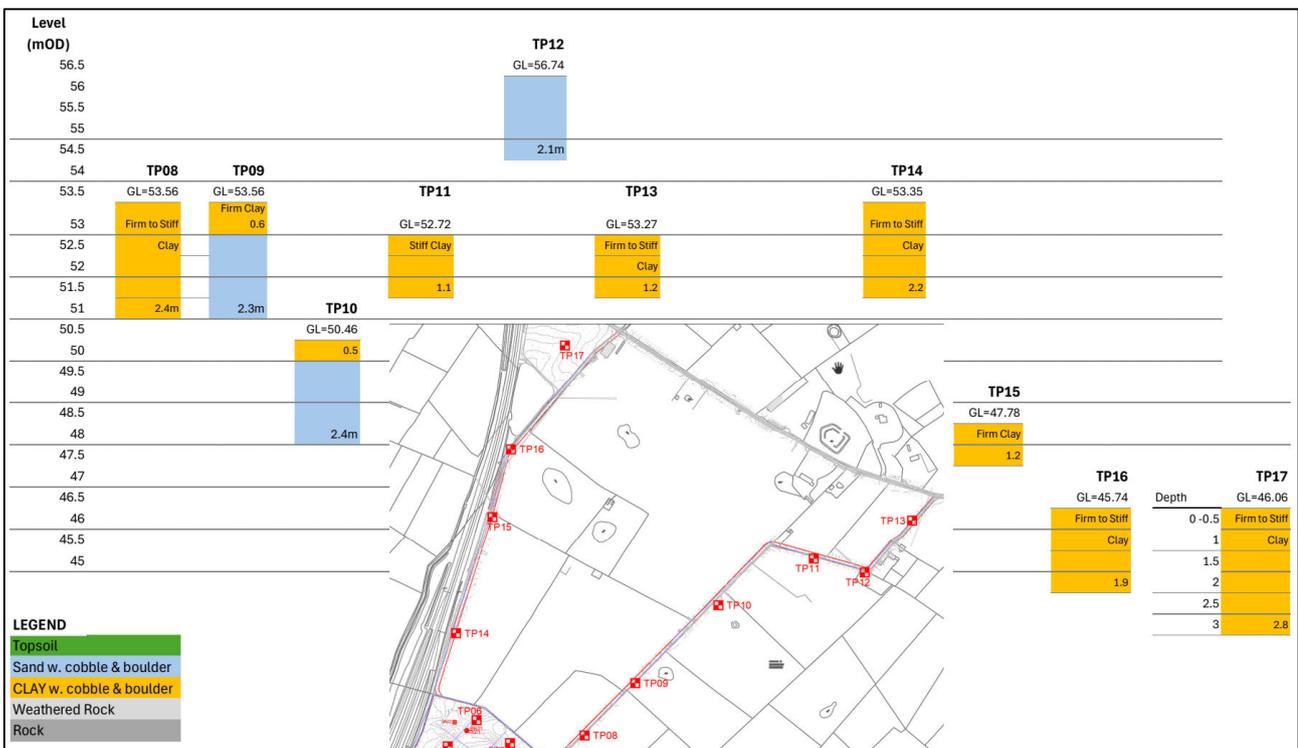
Figure 3.3 - Draft Exploratory Hole Cross Sections at Access Routes

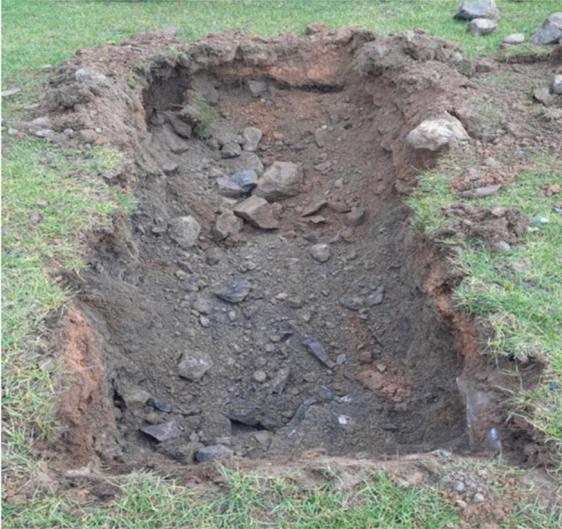
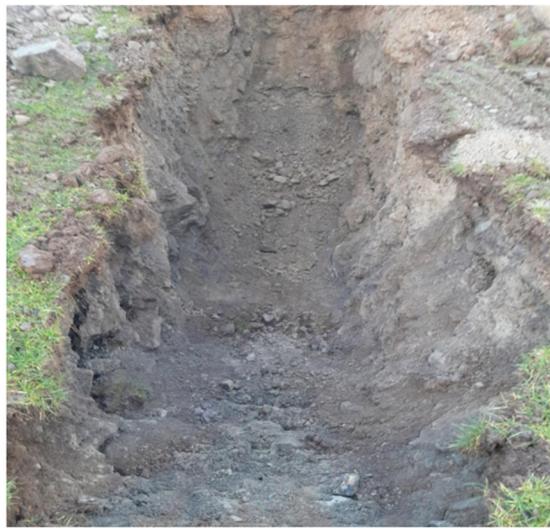
Figure 3.4 - Photos of trial pits TP01 and TP02 respectively

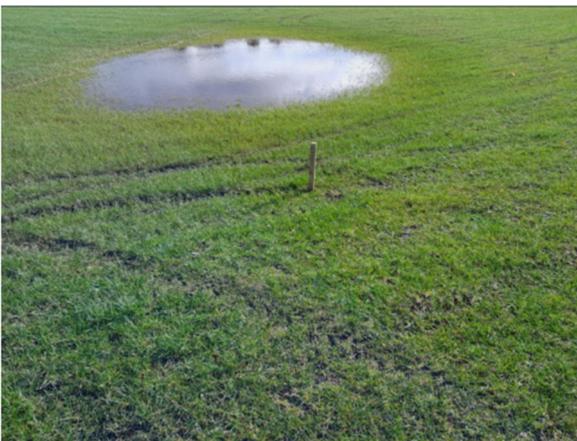
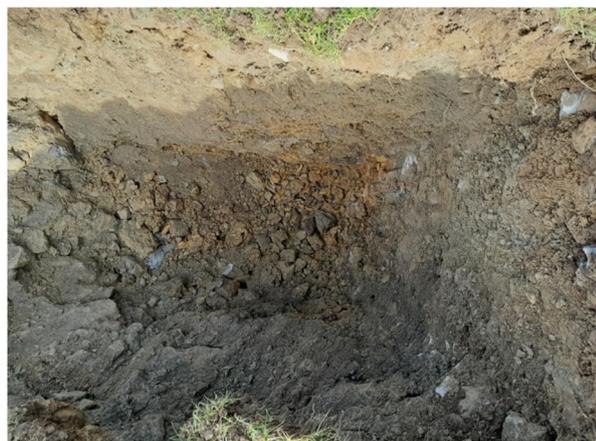
Figure 3.5 - Photos of TP03 location and pit respectively

No groundwater was encountered during the excavation of trial pits or in the cable percussion boreholes. Notably, Trial Pit TP03 was excavated in close proximity to surface water ponds observed on site, yet no groundwater ingress was recorded in the log for TP03 (refer to Figure 3.5).

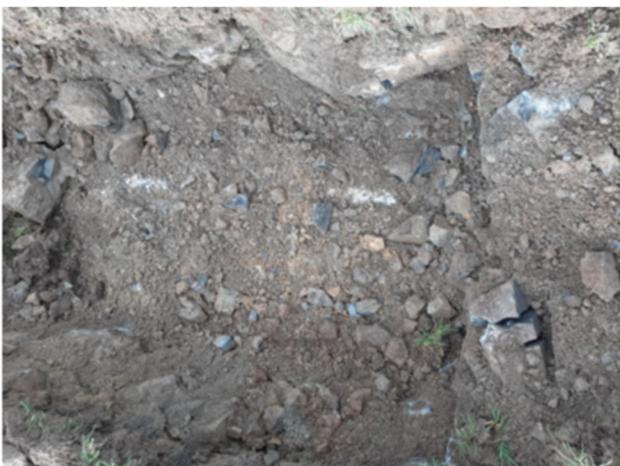
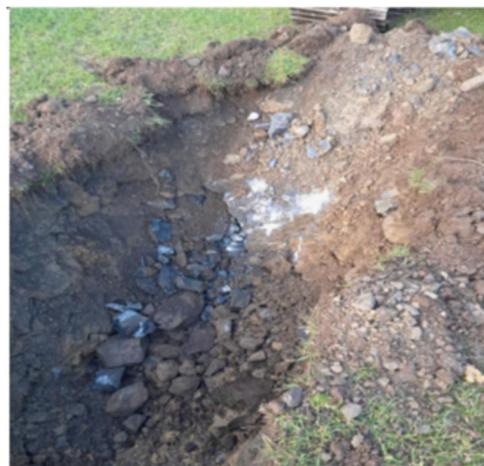
Figure 3.6 - Photos of trial pits TP04 and TP05 respectively

Clay layer was encountered below topsoil and described as sandy gravelly Firm to Stiff CLAY with low boulder content. Boulders were 200-450mm in diameter. In TP05 boulder sizes were 200-1200mm in diameter.

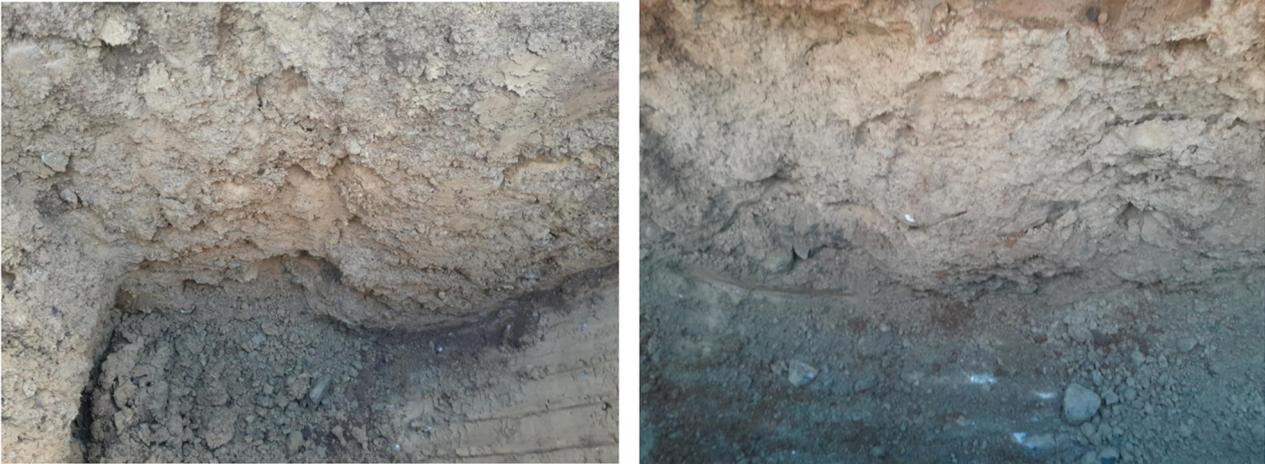
Figure 3.7 - Photos of trial pits TP08 and TP09 respectively

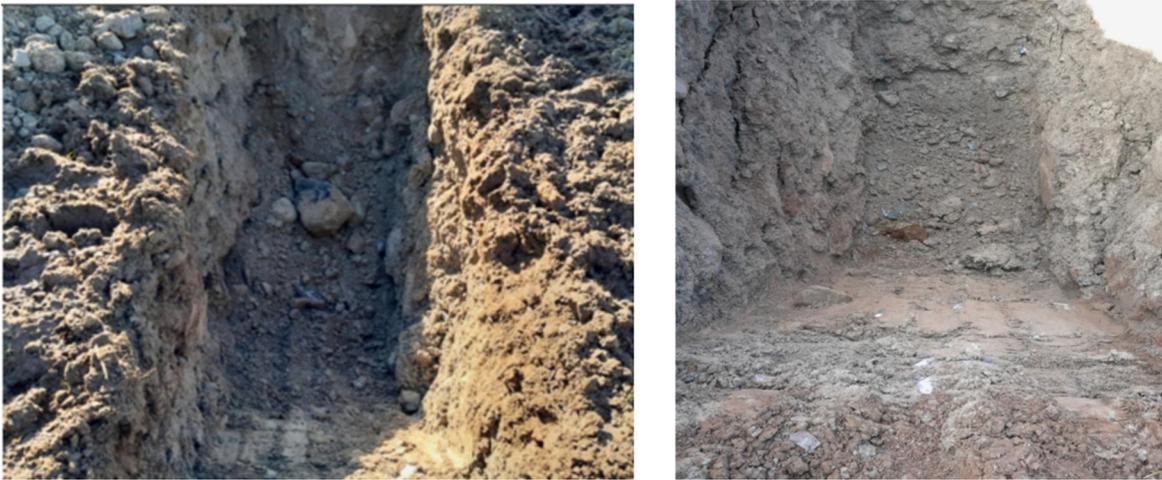
Figure 3.8 - Photos of trial pits TP13 and TP14 respectively

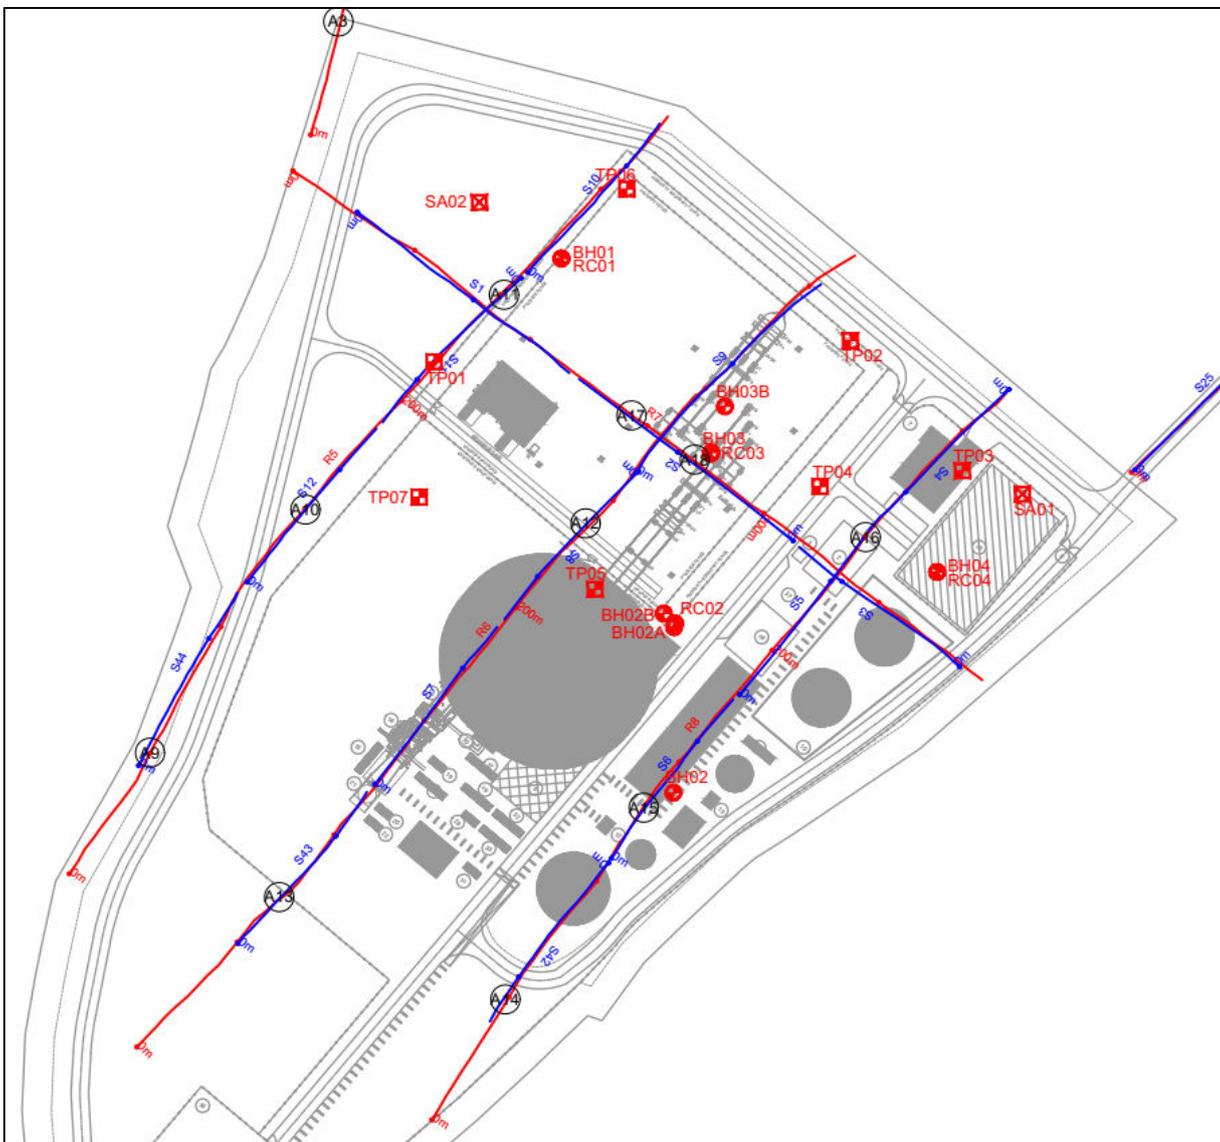
- Geophysical Interpretation: Across the survey area reveals a stratigraphic sequence consisting of Sandy gravelly Clay Overburden, underlain by a highly weathered Limestone with fresh bedrock located underneath. Numerous areas within the bedrock were flagged as suspect for karstification. Sharp lateral resistivity change have been identified and these anomalies were interpreted to represent potential karstified features. The anomalous zones were categorized in the below table according to priority levels.
- Anomalies A9 through to anomaly A18 are all pockets of high resistivity close to the surface within 15m, these areas of high resistivity were flagged as possible air or clay filled voids.

Figure 3.9 – Ground Investigation Layout Plan with the Geophysical survey section lines

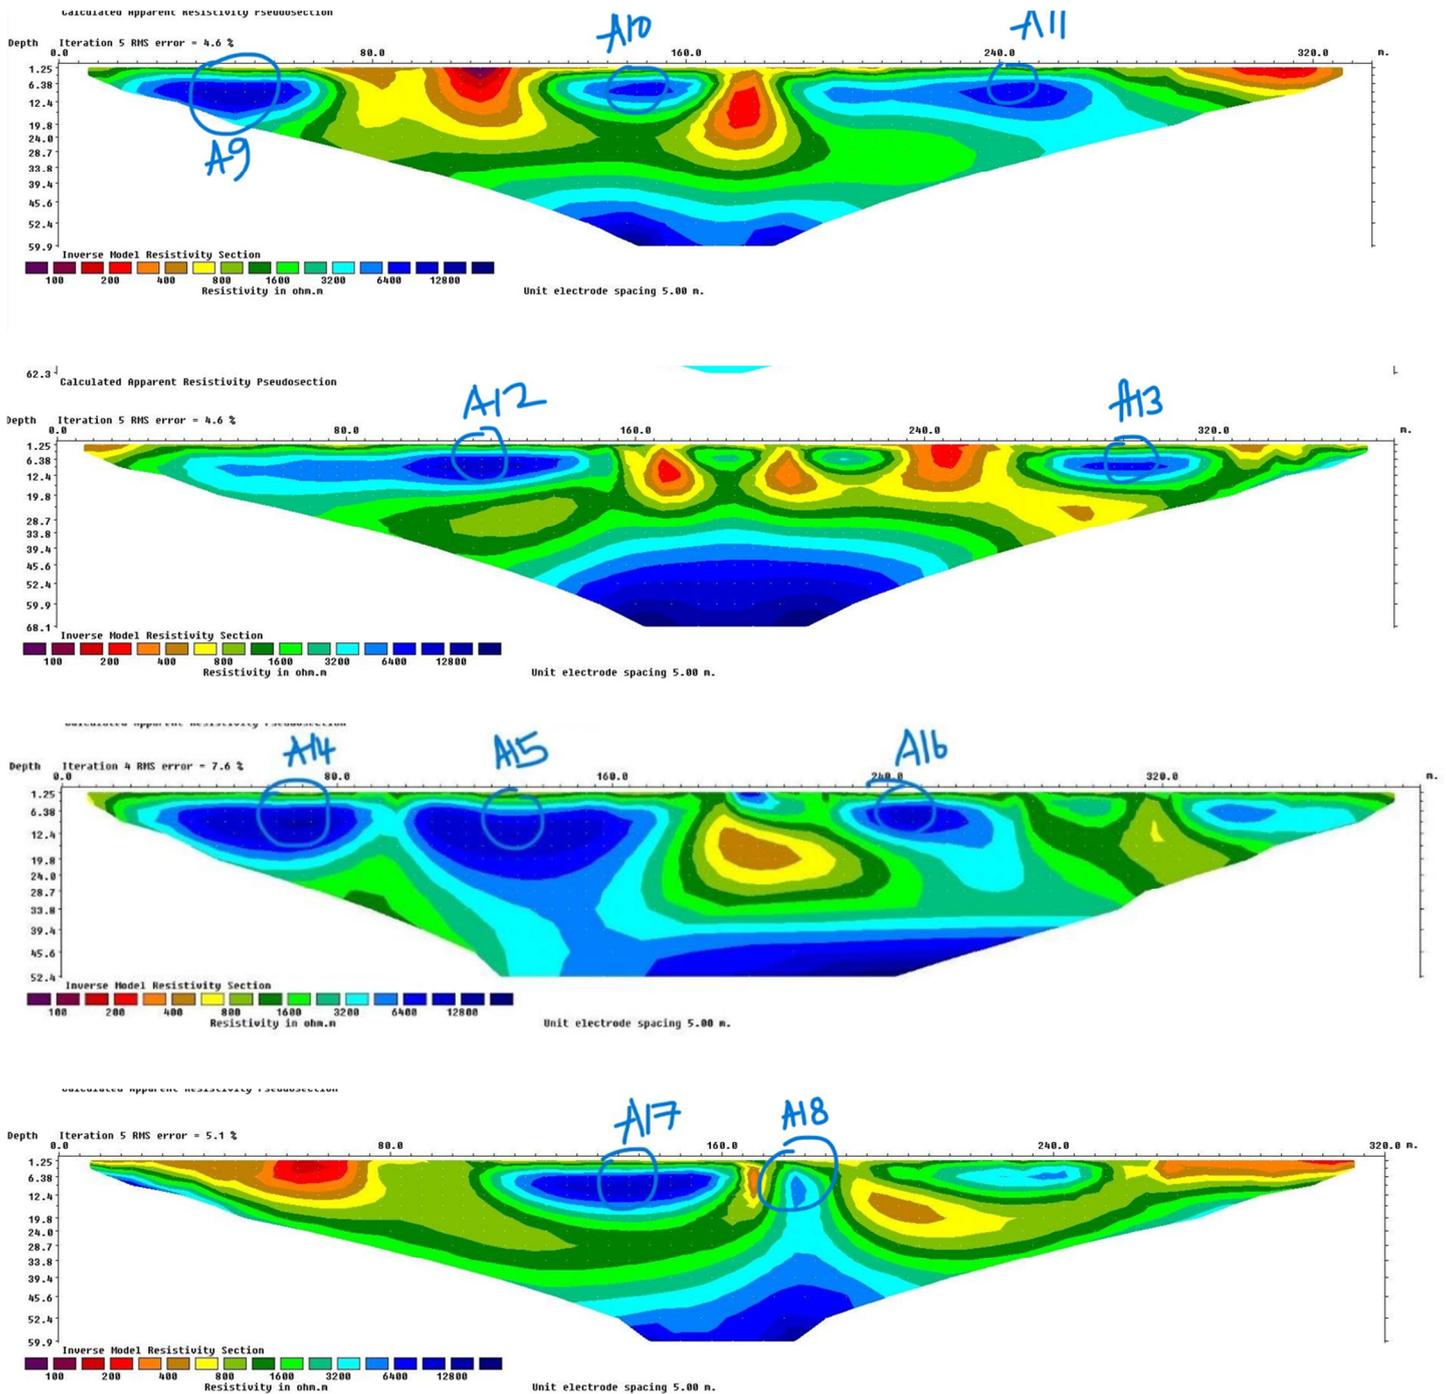
Figure 3.10 – Geophysical Profile of R5, R6, R7 and R8
