Appendix 13. Cultural Heritage

Appendix 13-6 Previous Archaeological Excavations

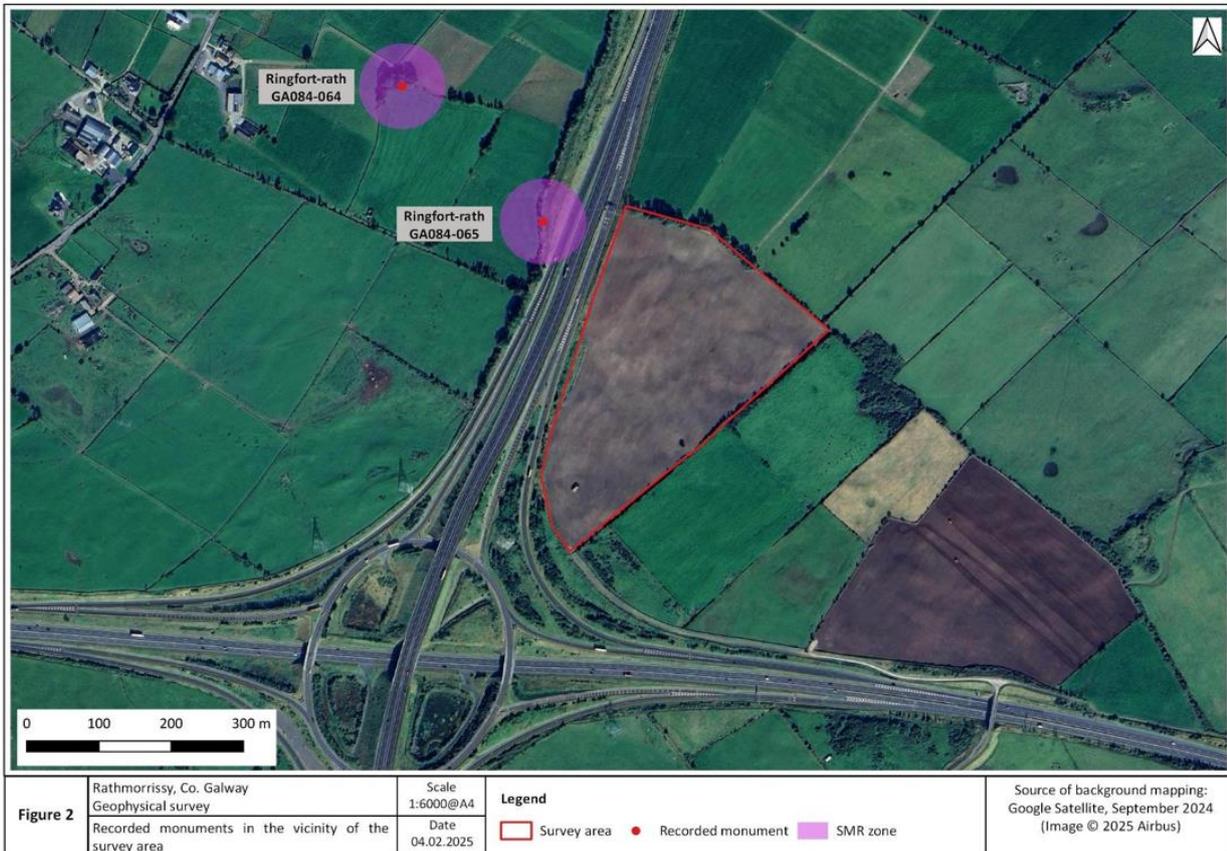
Appendix 13, Figure 13-2 - Location of Recorded Archaeological Sites in the vicinity of the survey area (as referenced within Chapter 13, Volume 2 of the EIAR)

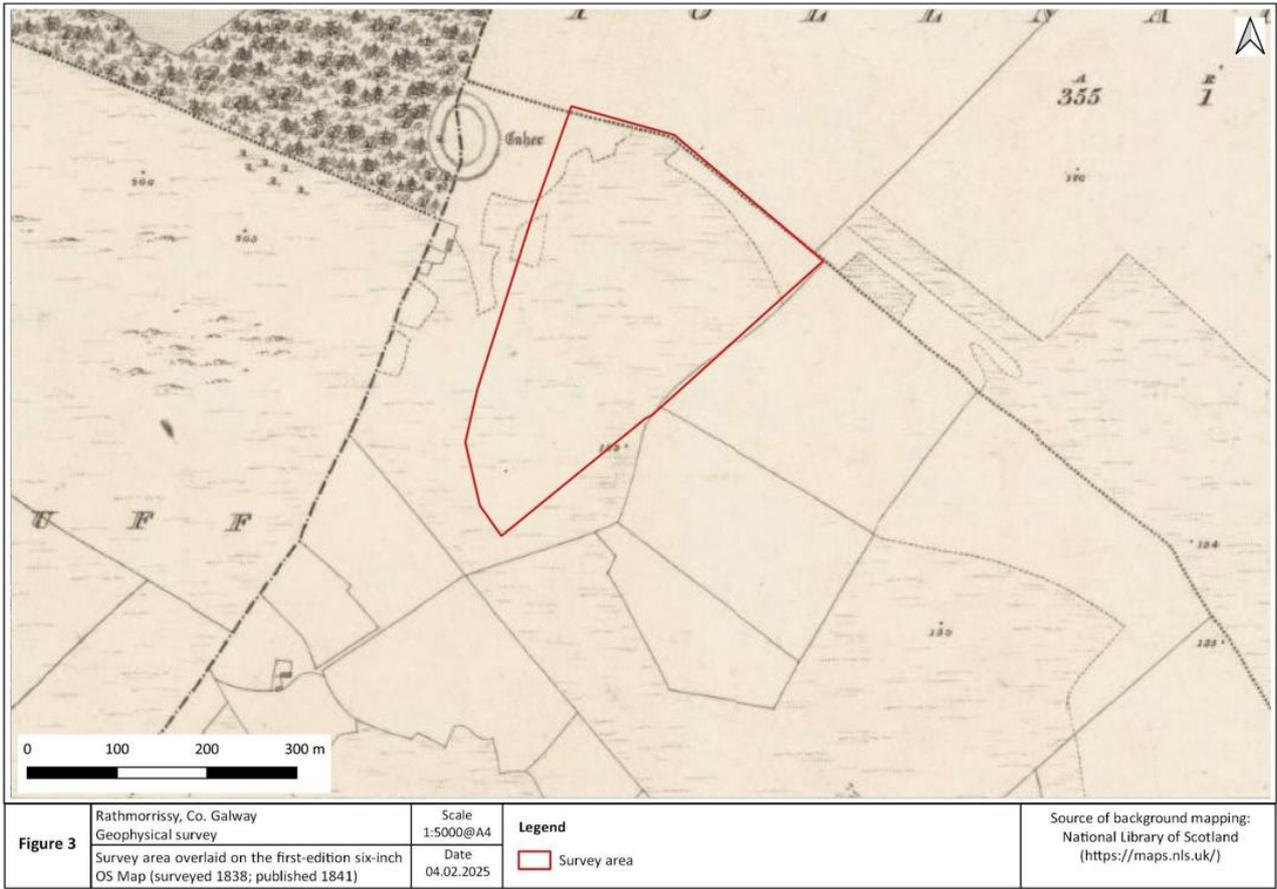
Appendix 13, Figure 13-3 - Geophysical survey area overlaid on the first-edition six-inch Ordnance Survey Map (surveyed 1838; published 1841) (as referenced within Chapter 13, Volume 2 of the EIAR)

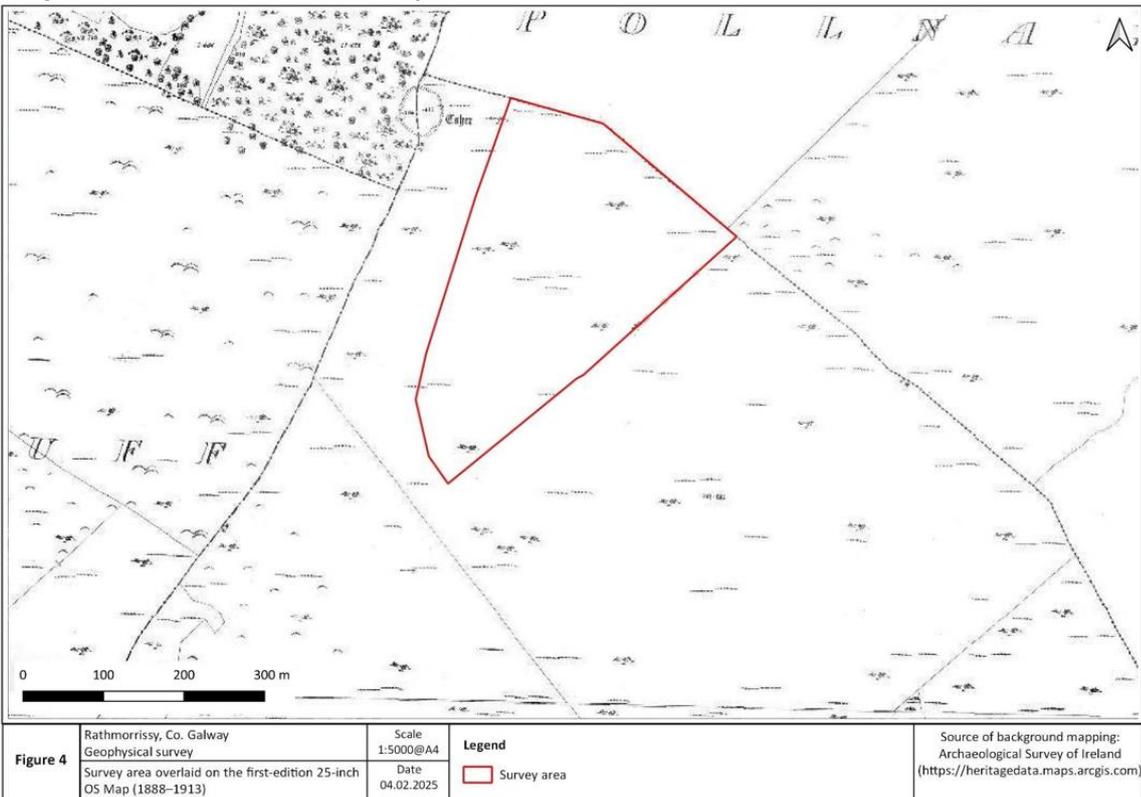
Appendix 13, Figure 13-4 - Geophysical survey area overlaid on the first-edition 25-inch Ordnance Survey Map (1888-1913) (as referenced within Chapter 13, Volume 2 of the EIAR)

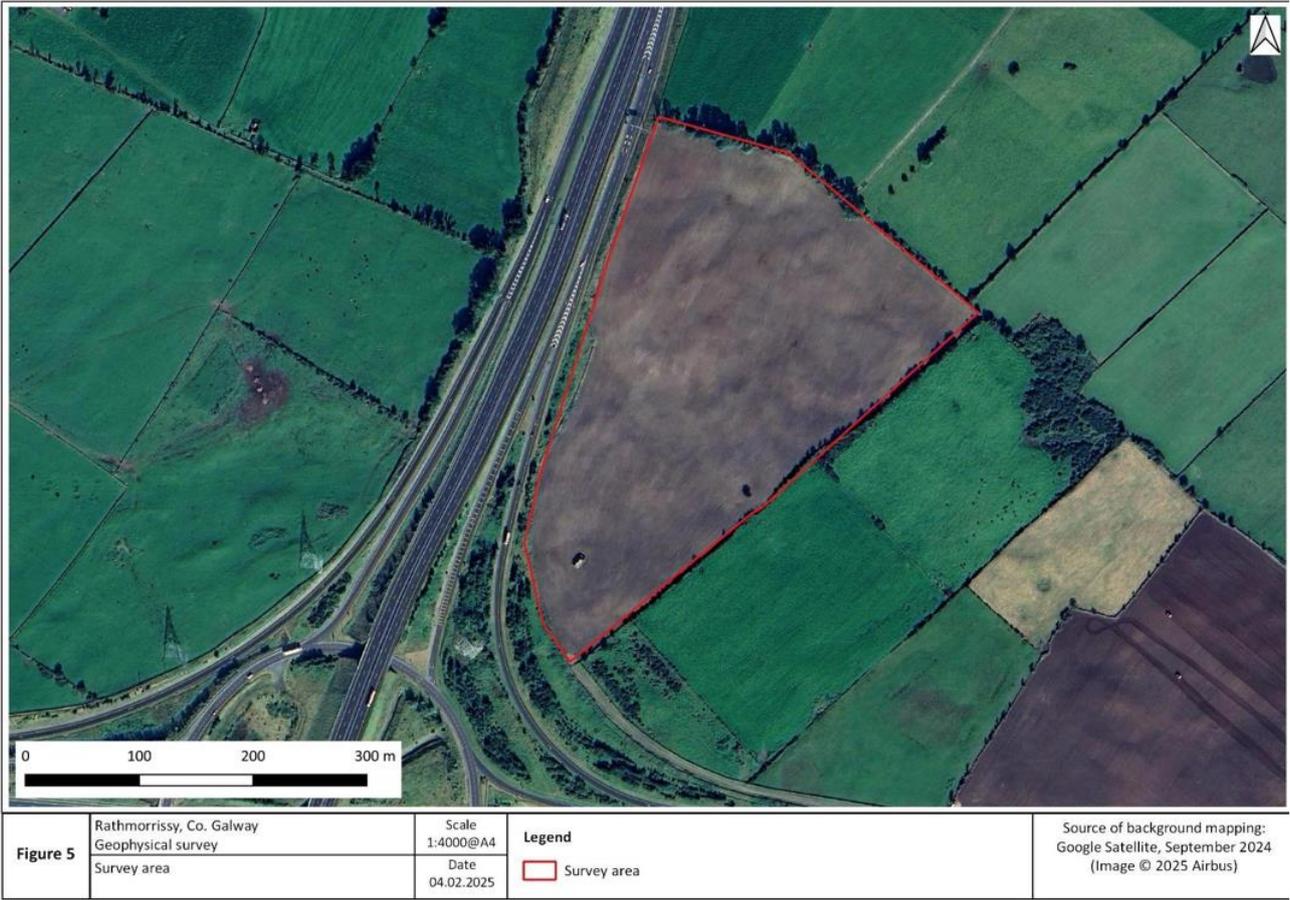
Appendix 13, Figure 13-5 – Geophysical survey area (as referenced within Chapter 13, Volume 2 of the EIAR).

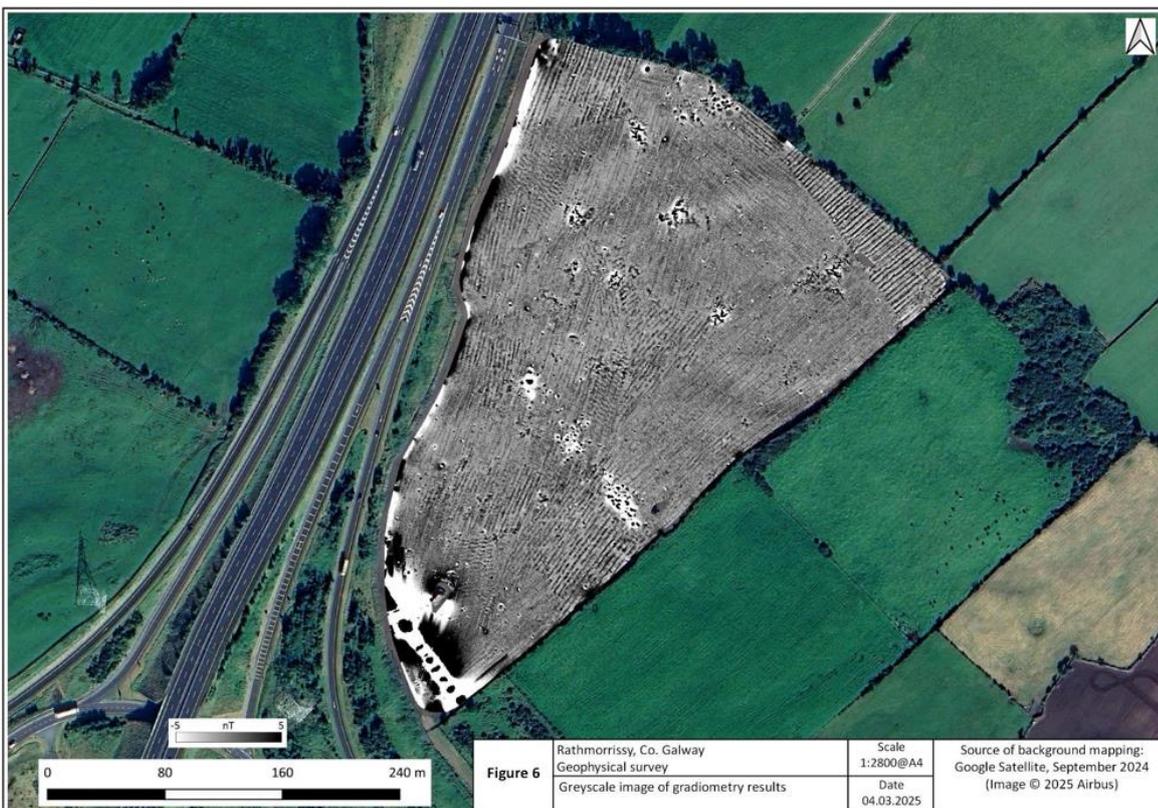
Appendix 13, Figure 13-6 - Greyscale image of gradiometry results (as referenced within Chapter 13, Volume 2 of the EIAR)

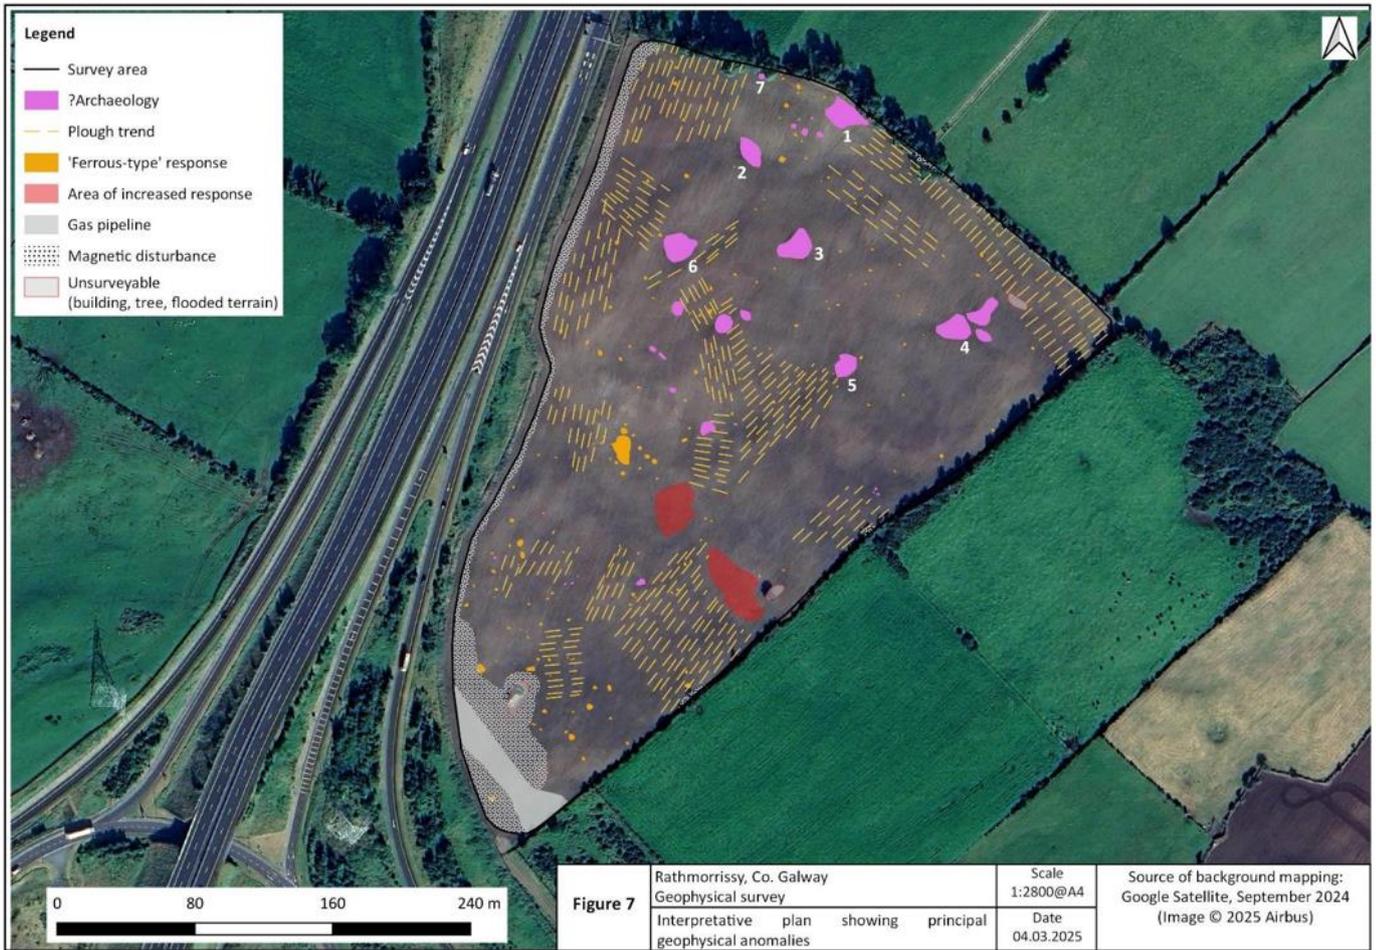
Appendix 13, Figure 13-7 - Interpretive Plan showing principal geophysical anomalies (as referenced within Chapter 13, Volume 2 of the EIAR).
