John Street Grain Store Public Realm Project, New Ross, Co. Wexford

Architectural Heritage Impact Assessment

December 2025

Dr Jason Bolton

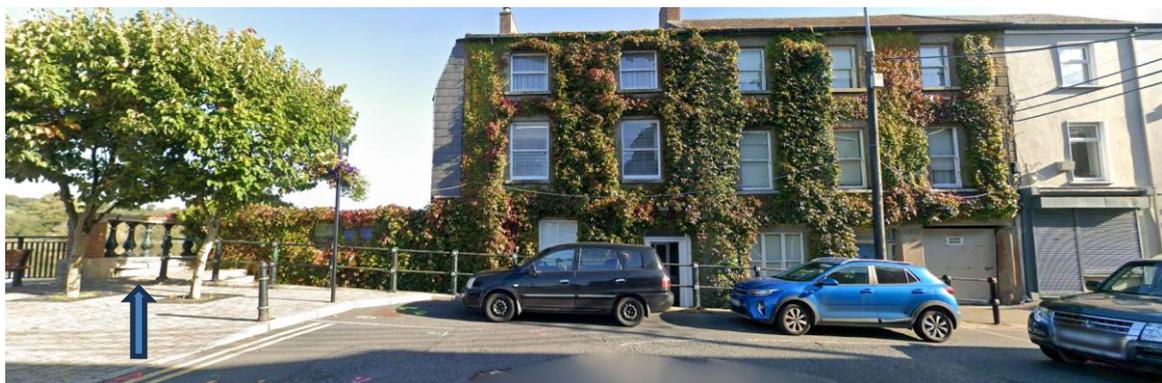
Fig.4: Left-to-right - the remains of the north side of the wing wall (arrowed) of the old New Ross bridge (demolished c.1968); the vacant lot where the hotel stood (see Figs.8-9) which will provide access in the new public realm space; and No.2 Bridge Street, forming the western surviving member of a terrace built c.1825.

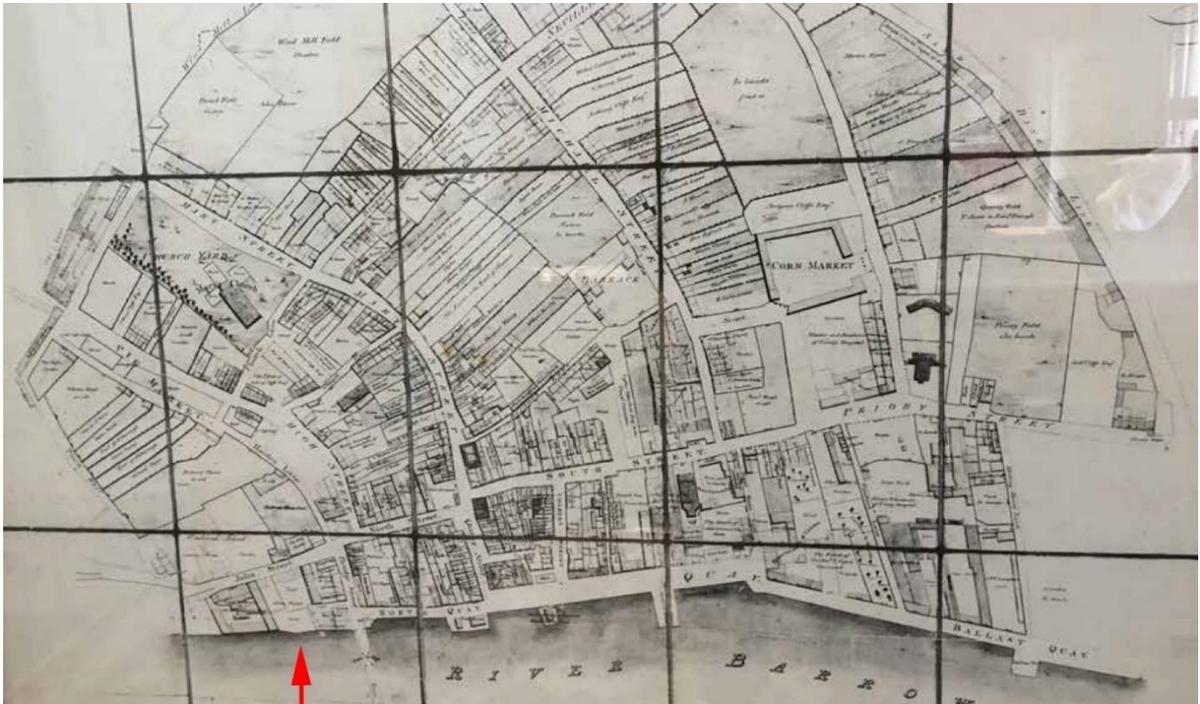
Fig.6: 1827 Tottenham Estate rent-map of New Ross showing the John Street site with buildings on John Street and Bridge Street, overlooking an open courtyard and river wall. The map shows quite a number of plots in use as gardens or waste land, with relatively dense settlement in the built-up areas.

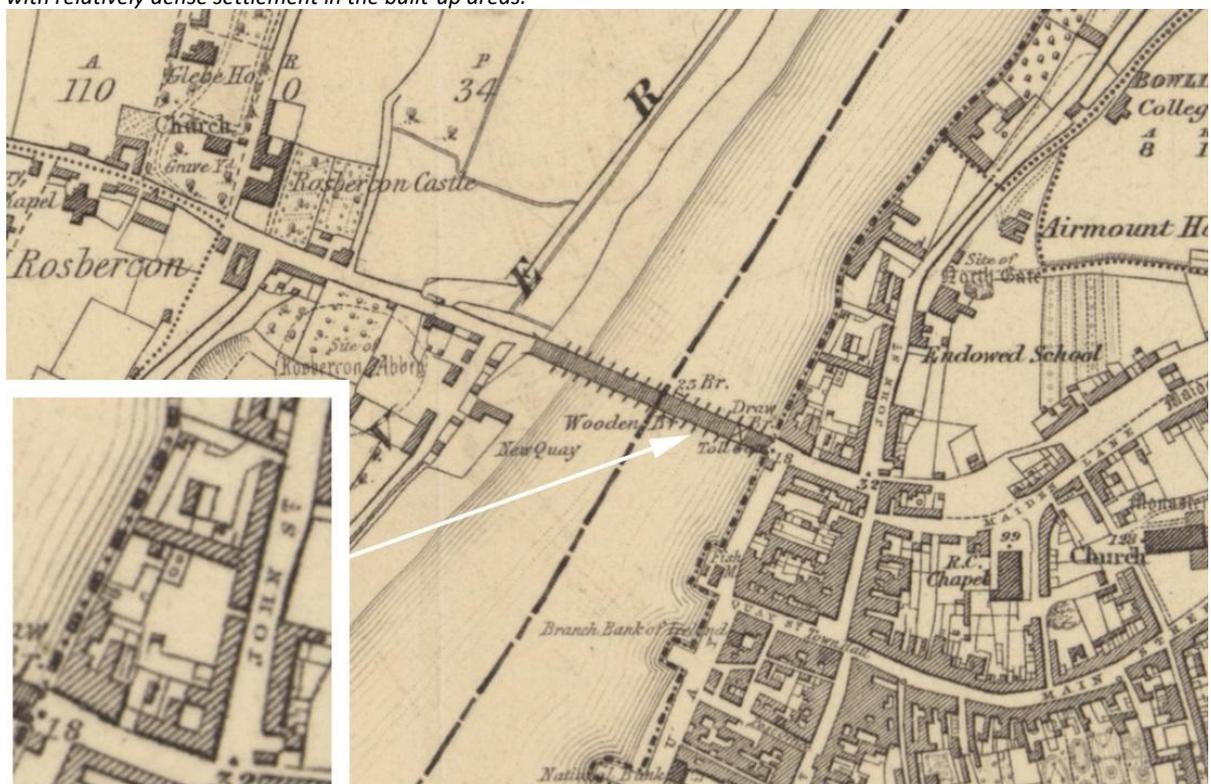
Fig.7: First edition Ordnance Survey map c.1840 showing the layout of the site, with terraced buildings with a passage on John Street, an open courtyard lined by walls and other buildings between the site and the River Barrow; and with a passageway to Bridge Street.

5.2 The Coal Yard: The Coal Yard space consists of a concreted ground surface bounded by the John Street Grain Stores and the rear of existing buildings along John Street on the east side; masonry walls on the north and west sides; open space and the rear of existing structures to the south. However, the redline boundary indicates that the **proposed improvements to the public realm in the Coal Yard are confined mainly to the western half of the yard** (see Planning-P-001 drawing), and with the exception of the new tiered staircase (see Section 5) are positioned away from the John Street Grain Store and the buildings on Bridge Street (Fig.3). The existing ground surface consists of concrete (Figs.16-17), and appears to post-date the removal of the nineteenth century lime kilns marked on nineteenth century maps (Figs.7-9) which survived until at least 1951

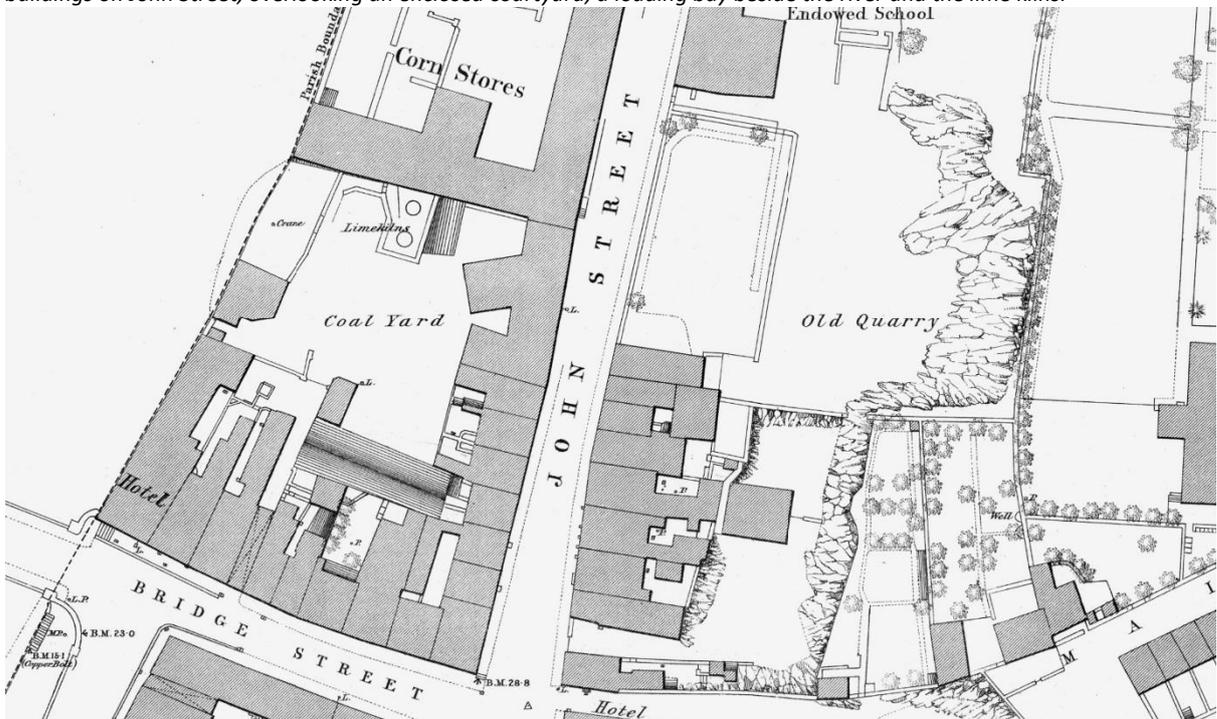
Fig.9: 1881 Ordnance Survey 25-inch map showing redevelopment with a new large grain store with off-set return to rear.

Survey map shows the site developed, with a large grain store overlooking a coal yard with lime kilns built again the north wall, and with crane in a separate enclosure beside the river, and with a passage to a watergate and a separate passage to Bridge Street (Fig.9). Historic photographs held by the National Library of Ireland (Figs.10-11) show the west (river-facing) elevation of the Grain Store appearing very similar to how it appears today.

The John Street Grain Store appears to have been built sometime c.1864-1881, replacing two earlier buildings on the site. The grain store was operated by William Howlett, a corn merchant, who also burnt lime as agricultural manure in the courtyard (Fig.9). The Grain Store formed part of a commercial property dedicated to bulk commodities, and the link to the quayside and the River Barrow (Figs.11-12) was essential for the functioning of the building. The rear elevation of the building appears little changed since the opening decade of the twentieth century, and the grain store and associated site appears to have maintained its overall character as a working element of New Ross’s industrial heritage.

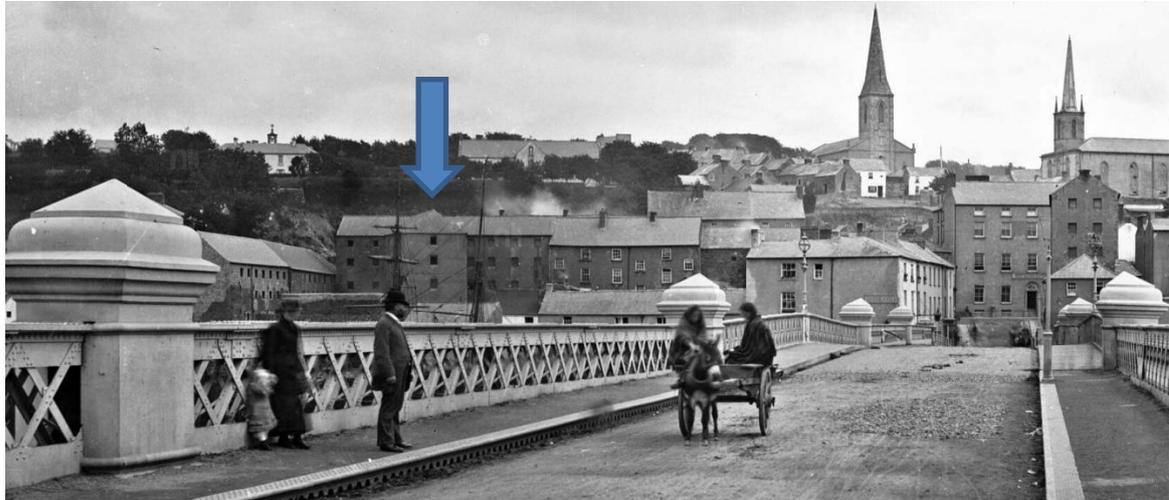
Fig.10: Photograph of New Ross by Robert French, c.1936 showing the Grain Store. Source: National Library of Ireland.

Comparison of historic photos of the site from 1906, 1936 & 1951 (Figs.10-12) show the gradual dilapidation: with the render falling off the side of the (now-lost) hotel wall, the collapse of the lime kilns, and the rough working conditions seen across the space. Note that the curving wing walls at the bridge (demolished c.1968) are in situ, as are the granite steps and the iron railings.

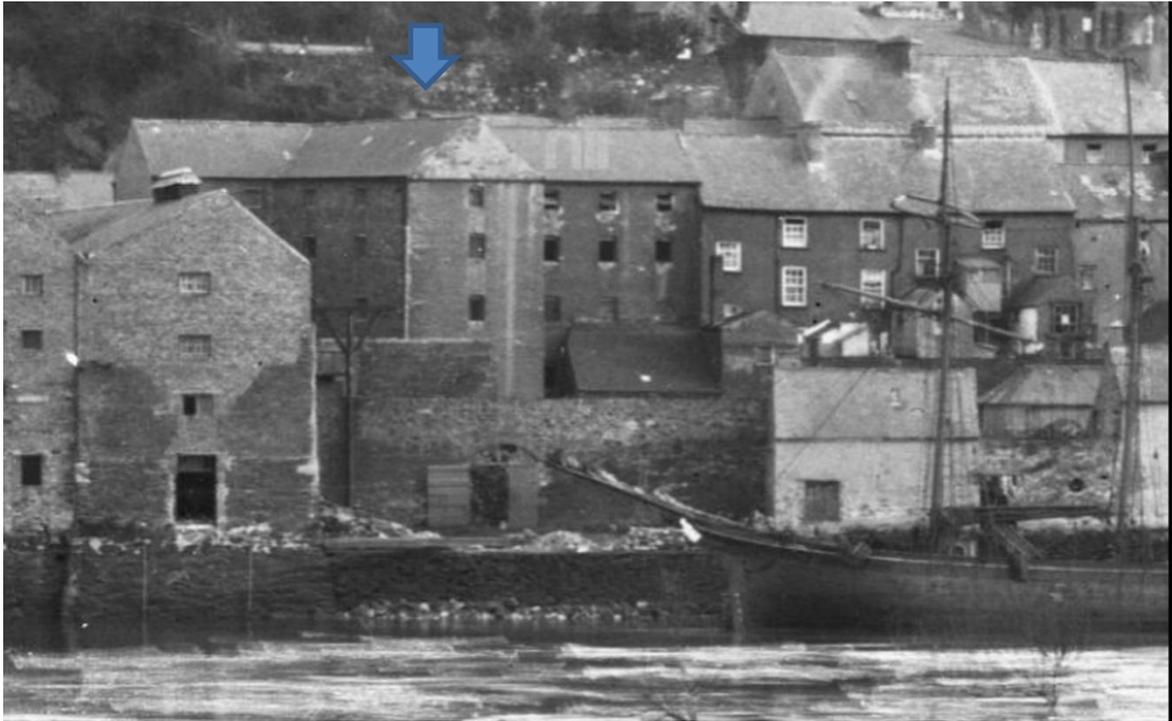
Fig.11: Photograph of the Grain Store by A.H. Poole c.1906. Source: National Library of Ireland. The photo shows the grain store, the riverside loading area separated from the coal yard by a high masonry wall with sliding timber doors, and a roofed building with a riverside window, and masonry wall with watergate to the right (south).

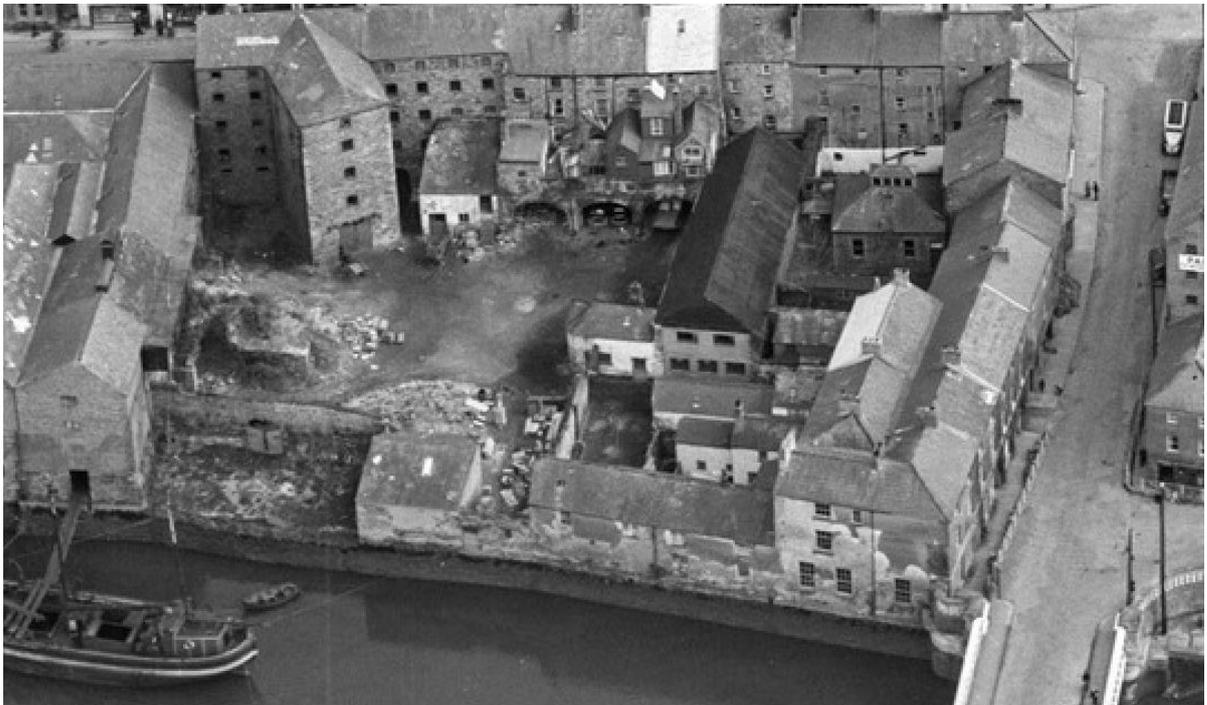
Fig.12: 1951 aerial photograph (see Fig.11) showing the three-storey hotel with outbuildings to rear which extended along the riverfront and which were later demolished. The bridge (demolished c.1968), balustraded wing walls and granite steps can be seen on Bridge Street.

(Fig.12). The rubble masonry walls of local slate and siltstone of the surrounding structures are an important contributor to the character of the Coal Yard area. The west wall (Figs.16-18) which separates the Coal Yard from the former riverside loading dock (Fig.12) has been altered with the insertion of a concrete blockwork doorway (Fig.18) into the former brick-arched opening with internal double-doors known from historic photographs.

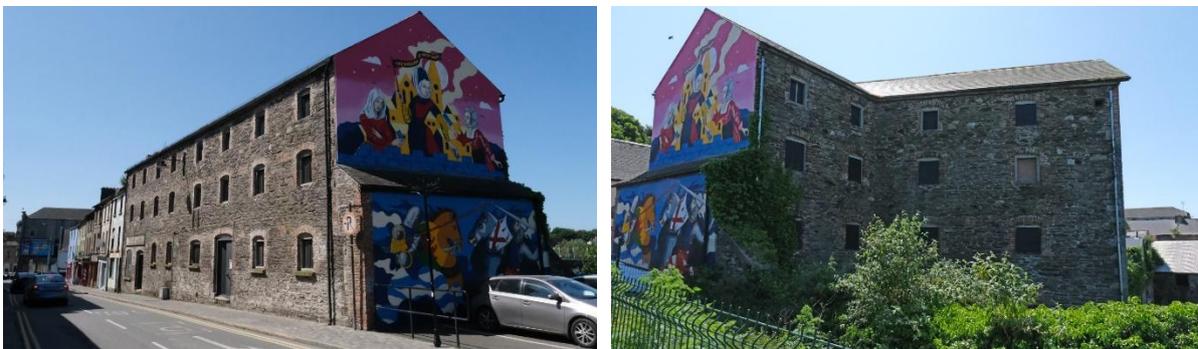
Fig.13: General view of the façade and north gable of the John Street Grain Store (left), and a view of the off-set return and the overgrown area where the proposed tiered stairs are to be constructed.

The John Street Grain Store consists of an attached pair of matching gable-ended eight-bay three-storey over basement building with an off-set four-storey return to rear. The building is built of random rubble consisting of locally obtained slates, siltstones and greywackes¹⁵. The John Street façade shows door and window openings in a hand-made clamp-fired brick, with granite used for window cills and the lower jambs and cills of the two doors. The replacement slate roof is served by cast iron rainwater goods, and the north gable has a street-level

The proposed tiered staircase, as shown on the drawings by ODKM Architects, is to rise into the corner where the John Street Grain Store (see Section 4.2) meets the car park area (Figs.13, 15).

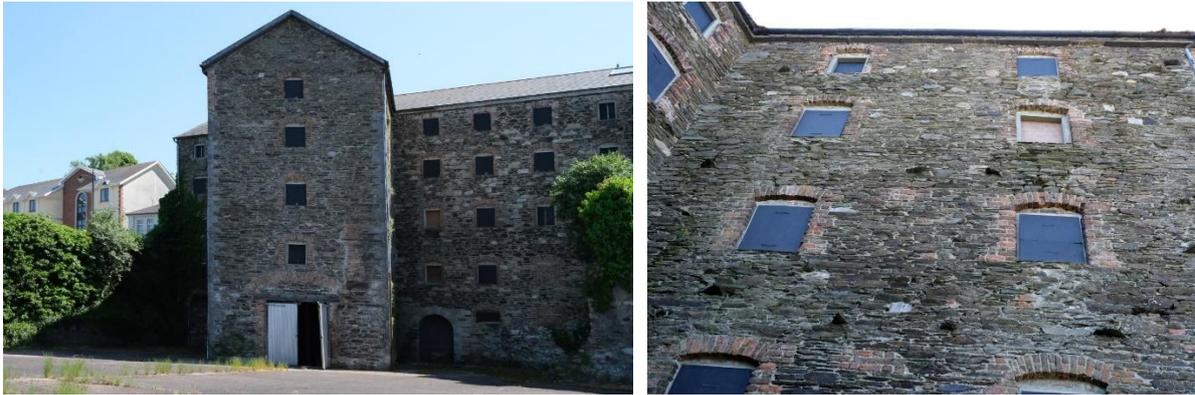
Fig.13: The rear (west) elevation of the five-storey Grain Store (three floors at John Street level & two basement levels) consists of random rubble masonry walls punctuated by camber- and segmental-headed brick windows, with granite used for the quoins of the return and for the arched doorway, with the overgrown area where the proposed tiered stairs are to be constructed in shadow (left). The north elevation of the off-set return (Fig.12) shows projecting rough corbels arranged in a diagonal pattern which routed the grain chutes.

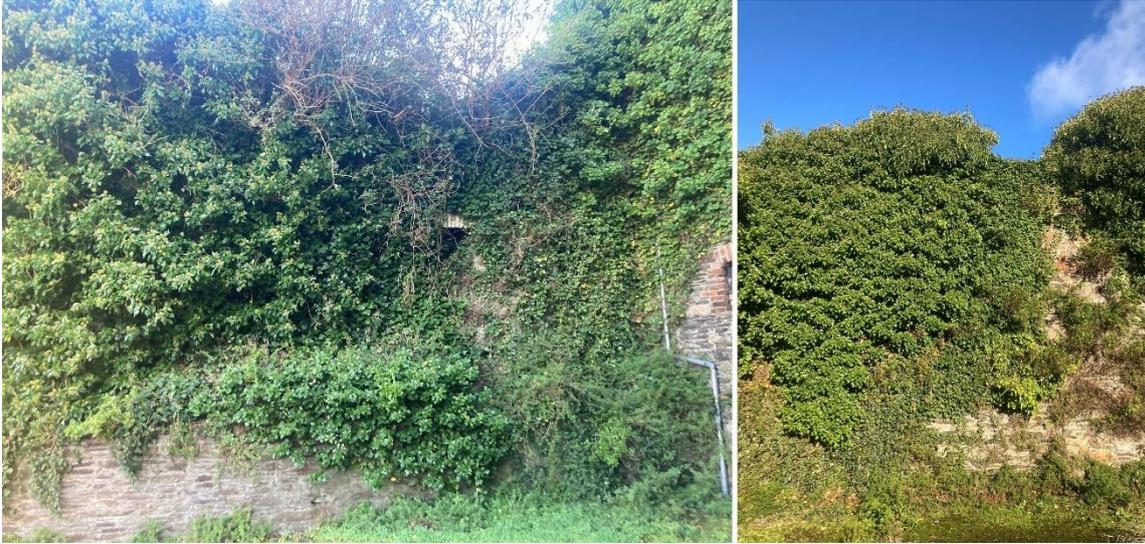
Fig.14: The north wall of the site consists of a rubble masonry wall, formerly part of a reduced building (Fig.12). The area is obscured by well-developed mature vegetation.

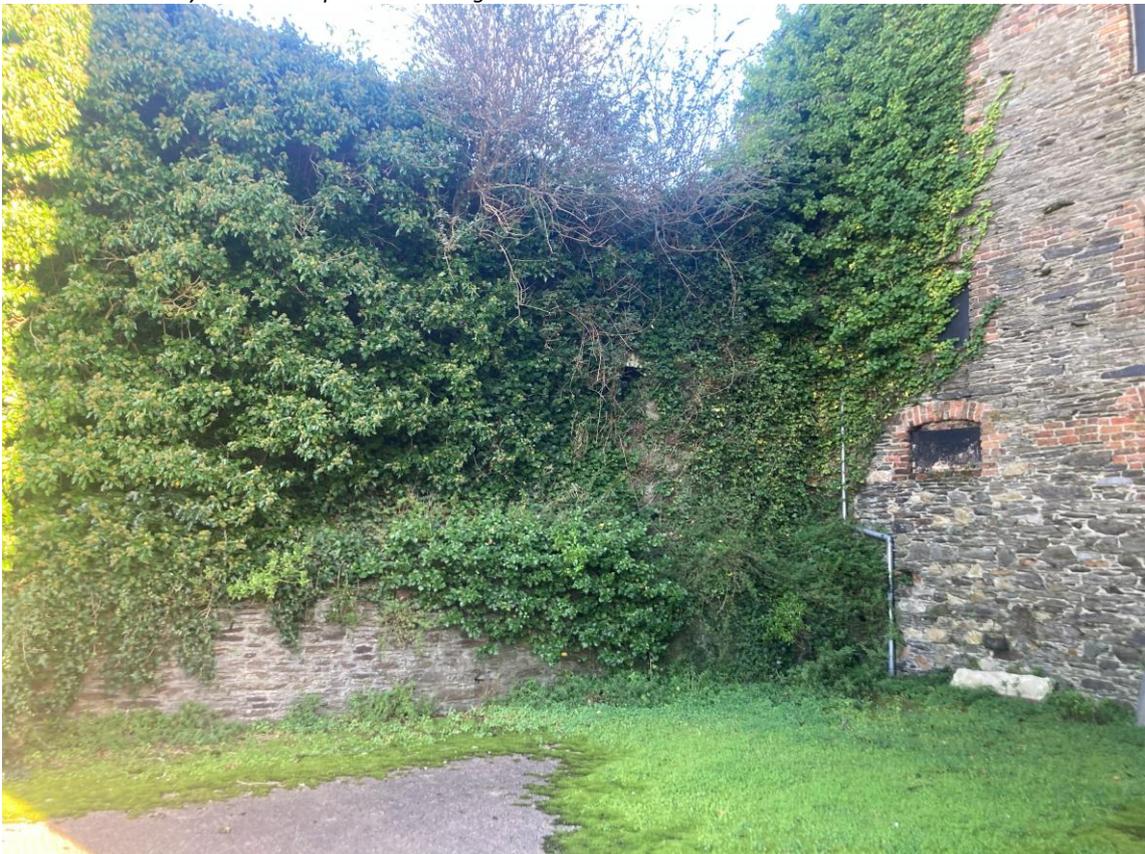
Fig.15: Proposed location of the tiered steps at the south-east corner of the site rising to John Street.

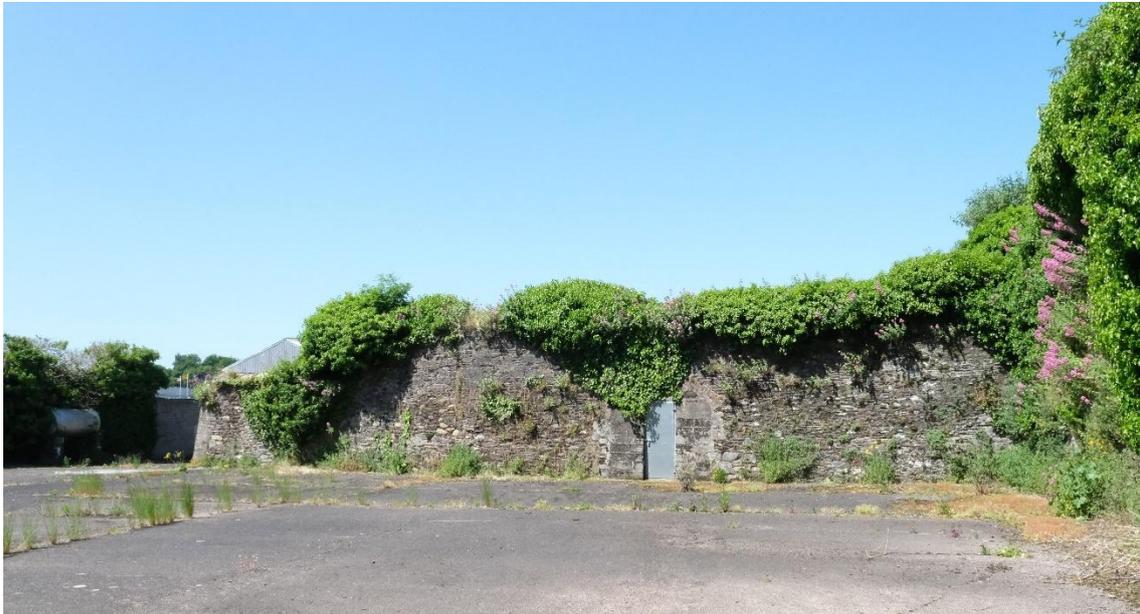
Fig.16: View looking west from the site of the proposed tiered stairs towards the masonry boundary wall enclosing the former riverside loading area (outside the redline boundary of the proposed work).

Proposed Work	Impact
Existing River Masonry Wall & Existing Stone wall separating coal yard from the former loading bay to be reduced to c.1100mm above current ground level, & existing concrete doorway to be blocked up.	<p>The proposed works have a negative impact as they remove historic fabric. The proposal to remove the concrete doorway and repair the wall with rubble masonry effectively erases a historic brick-arched opening (see Figs.18, 35), and the treatment of the crane loading bay is not addressed in the proposed works.</p> <p>Proposed Mitigation: The existing walls should be carefully recorded prior to the commencement of works, and a copy of that record together with a text interpretation of significance should be deposited in the form of a report (preservation by record) in the local studies section of Wexford Library Service and with the Irish Architectural Archive.</p> <p>A specification should be developed detailing the finish of the wall-top (to prevent water ingress to preserve the wall - either with a new stone coping, or a durable NHL haunching), the mortar to be used for repointing, for rebuilding and for any haunching²⁰).</p> <p>The stone from the upper parts of the wall should be carefully dismantled by hand and stored on pallets on site to allow sorting and re-use for repairs to all historic masonry walls within the project.</p> <p>The landscaping and treatment of the former crane loading bay (which will be visible from the plaza but outside the redline boundary) should be detailed as this area impacts the character of the former coal yard.</p> <p>Prior to the commencement of works, the quay walls (which should not be impacted by the proposed works) should be inspected from the waterside, and assessed for any necessary repairs.</p>

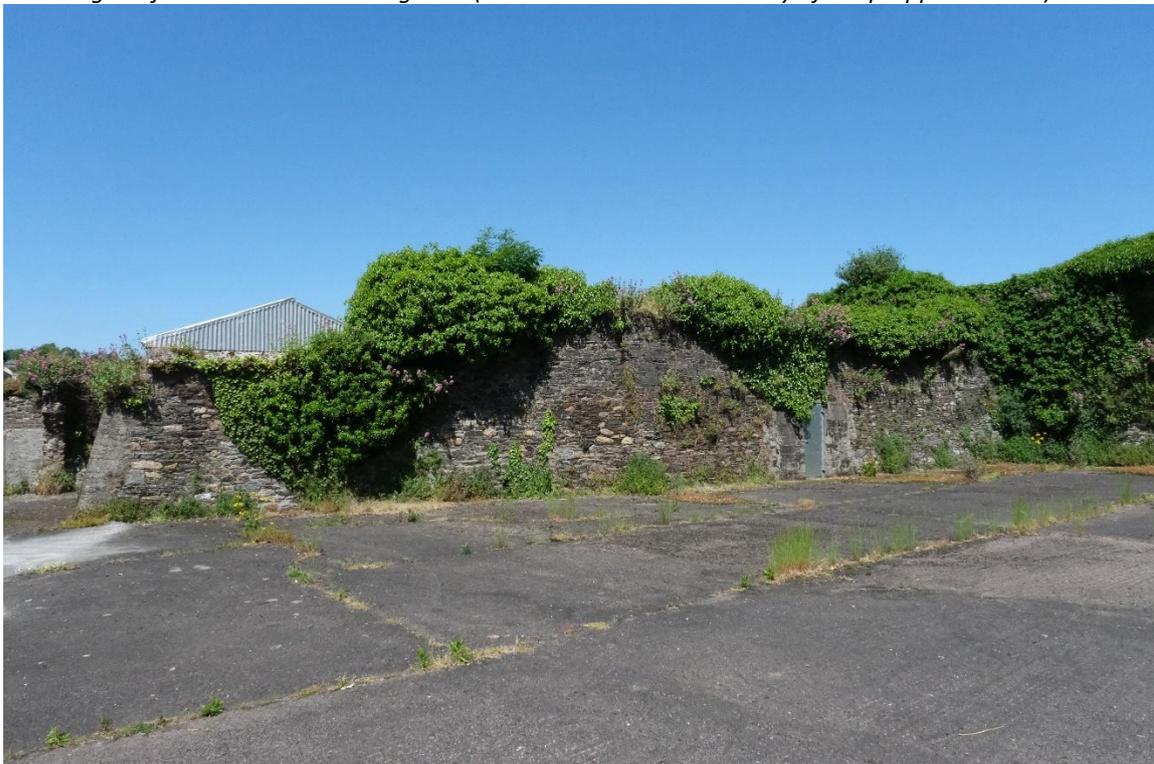
Fig.17: View looking north-west showing the concreted ground surface with the rubble masonry wall separating the coal yard space from the former loading area (see Section 2.4) which is outside the red line boundary of the proposed public realm works.

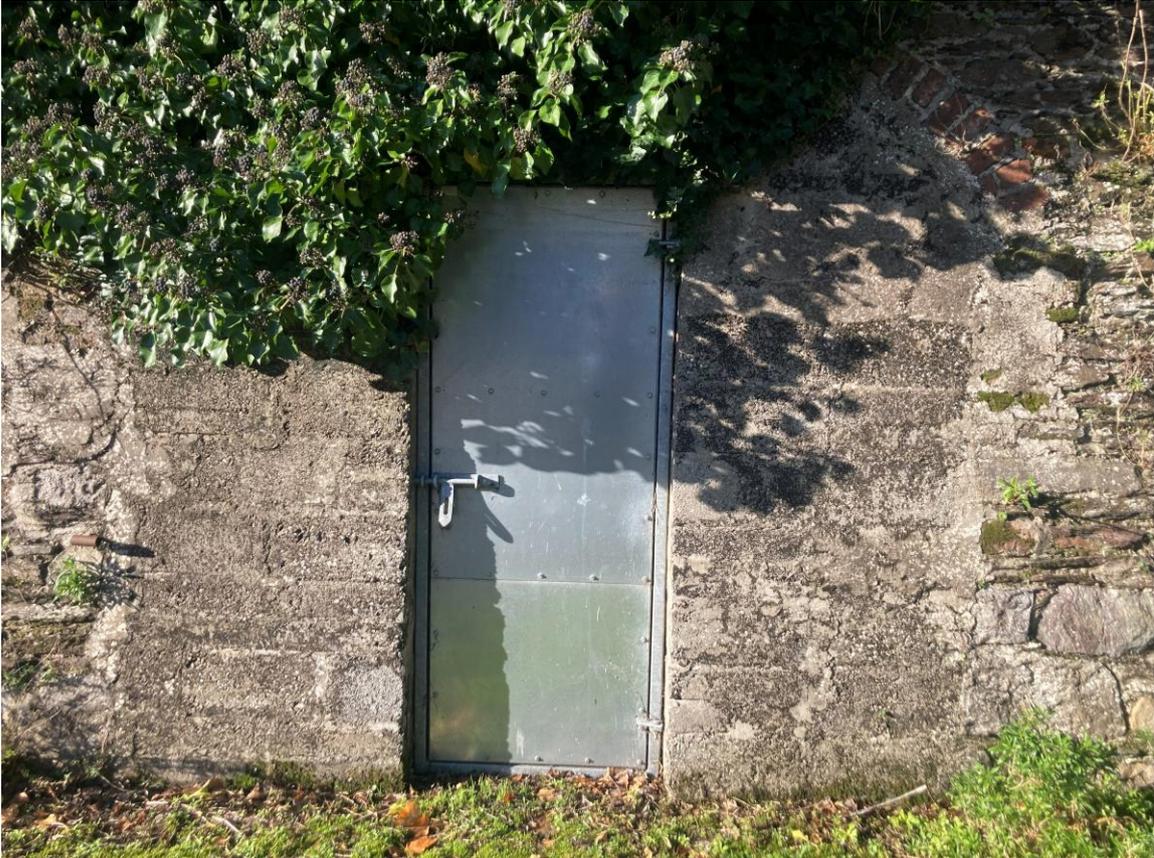
Fig.18: Detail of the concrete doorway in the western rubble masonry wall, with the brick arch surviving above.

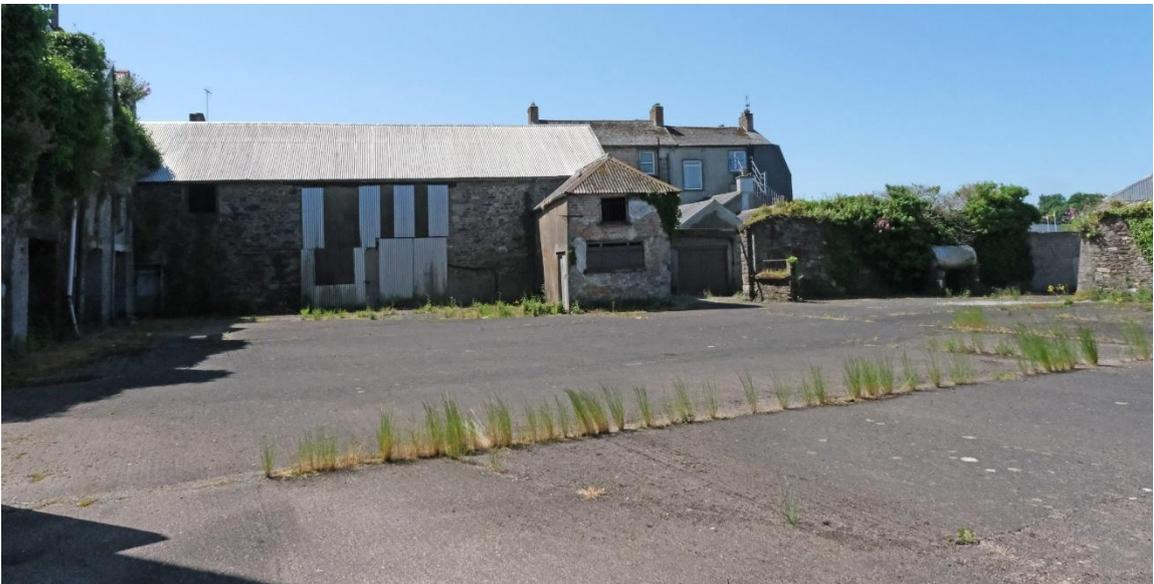
Fig.19: View looking south showing the rear of the buildings on Bridge Street and existing entrance into the Coal Yard (see Fig.26), and the concrete surface common across the open space.

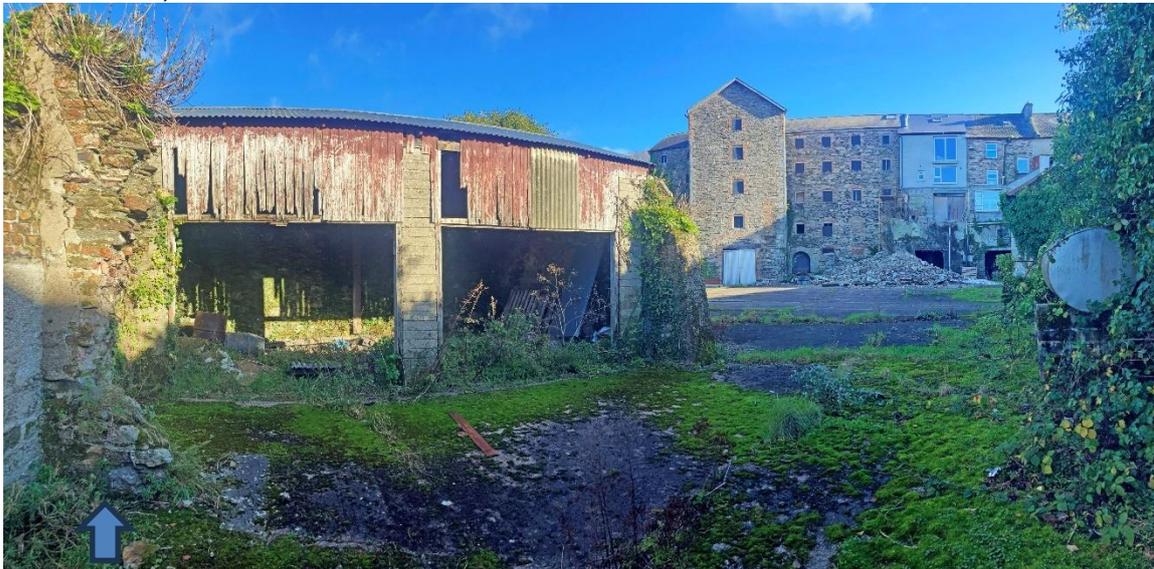
Fig.21: View of the existing corrugated iron structure with the coal yard and John Street grain stores to the west. Note the concrete buttress at the corner. The wall fragment on the left (arrowed) marks the southern end of the former lean-to building (see Fig.20)

The existing corrugated iron roofed structure is a twentieth century intervention to a reduced lean-to building¹⁹ which formerly stood at the site until at least 1951 (Fig.20). The existing structure is a mid- to late-twentieth century storage structure and its loss would not detract from the character of the Protected Structure. The oil tank is supported by concrete blockwork and was a functional intervention to the area, and is also of no special architectural heritage interest.

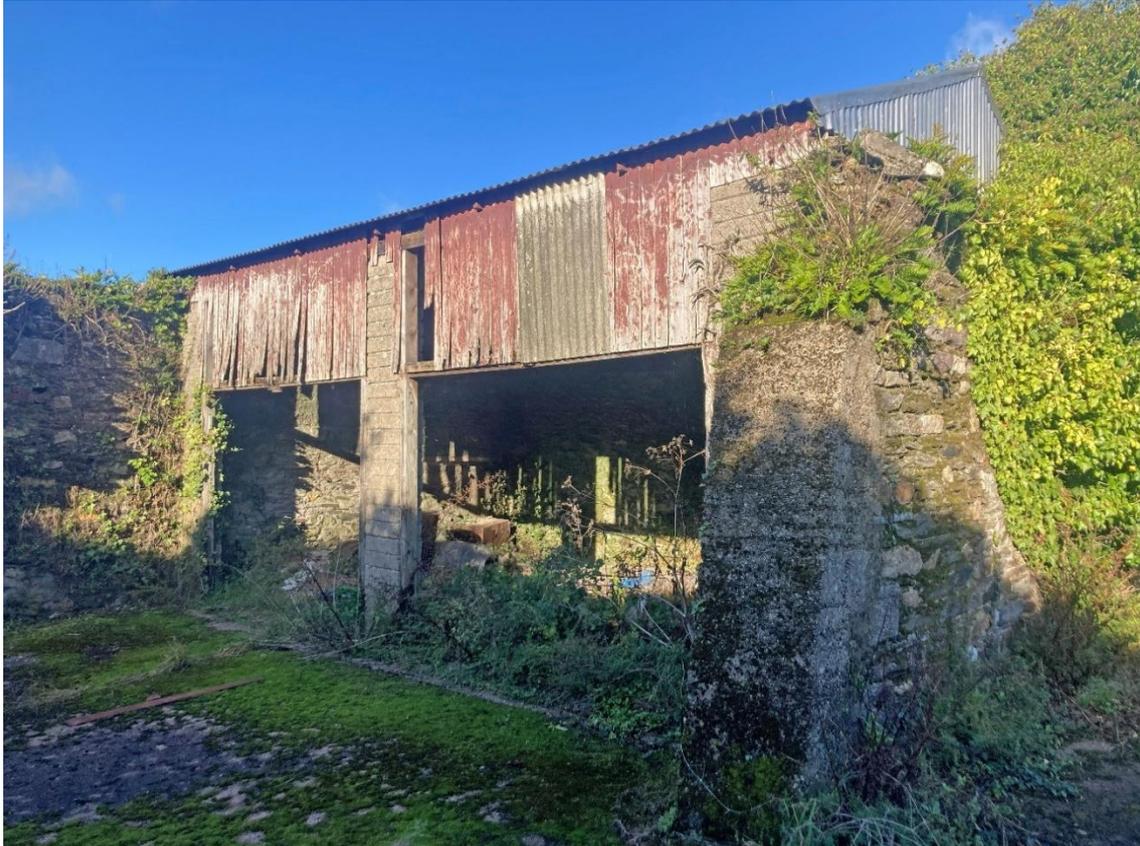
Fig.22: The former lean-to building was reduced and altered, with concrete blockwork piers introduced to support the corrugated iron roof structure on a smaller footprint than the original building. A mass concrete buttress was added at the south-east corner to act as the terminus of the reduced masonry wall.

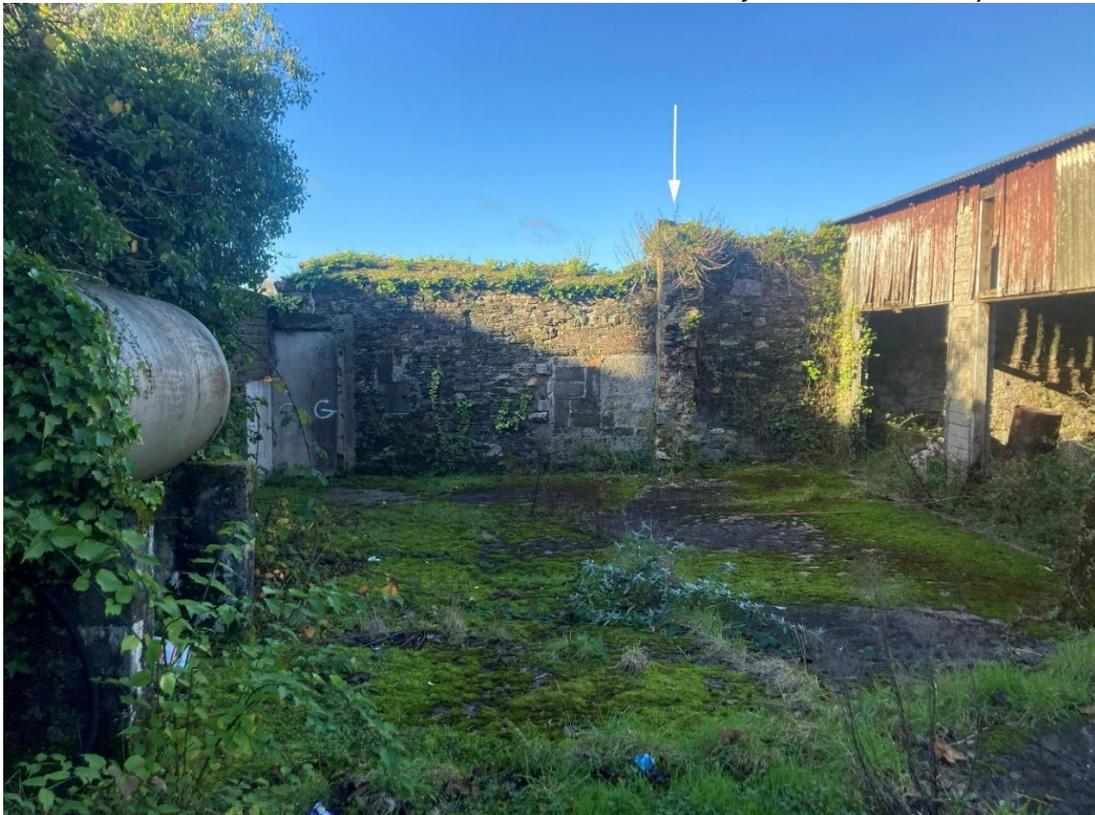
Fig.23: The white arrow indicates the original south wall of the lean-to building (see Fig.20).

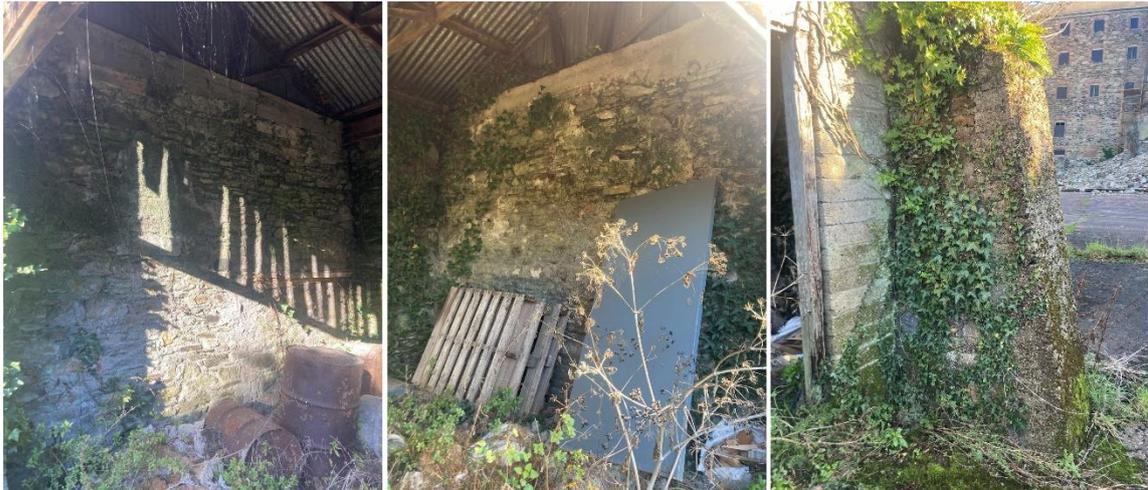
Fig.24: The interior of the corrugated iron roof building retains rubble masonry walls on three sides.

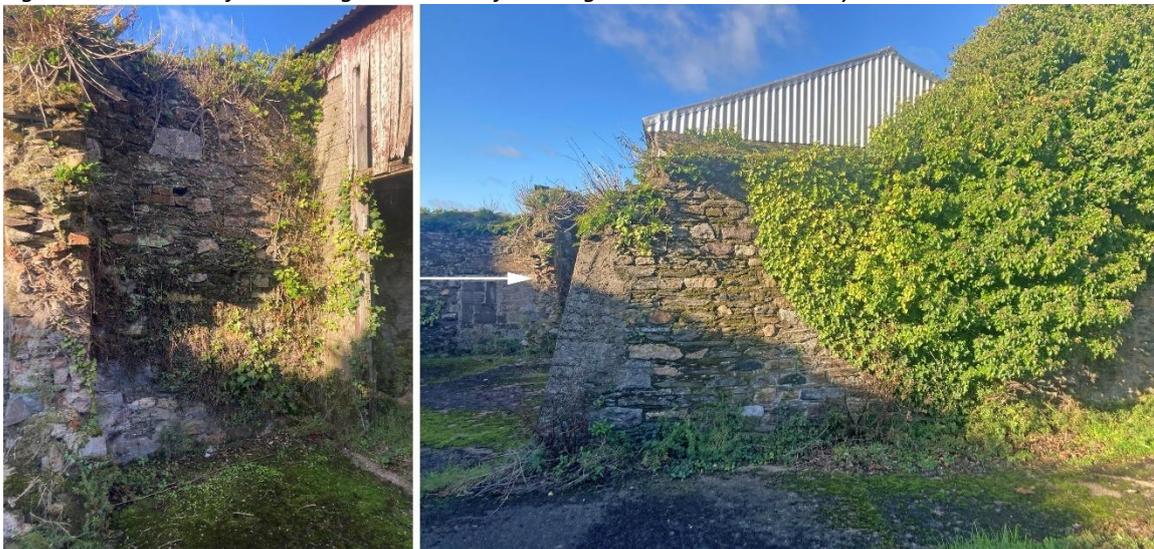
Fig.25: View of the wall fragment from the reduced lean-to (see Figs.20, 23).

Proposed Work	Impact
Remove existing granite steps & Construction of new granite steps in to connect to new access route at upper level.	The existing steps and railings originally provided pedestrian access to the bridge (which was demolished c.1968). The steps have suffered from settlement. Proposed Mitigation: The existing steps should be assessed for potential salvage and re-use in the proposed new steps.
Remove Section of Existing Blockwork Wall	The wall is composed of a plain concrete blockwork wall which is of no architectural heritage interest and does not contribute to the streetscape. There are a number of information plaques mounted on the walls. Consideration should be given to re-mounting these within the new public realm works, or to provide alternative new signage on the significance of the bridge site.
Abutment of Old Bridge (outside of site boundary)	The north curving wing wall is outside the redline boundary of the development. However, this riverside wall has been dislodged and is at risk of collapse and in need of immediate repair (Fig.35). As this wall forms the boundary of the site, immediate repair should be included in the proposed works. The wall fragment should be carefully recorded, and then taken down and rebuilt in the same location.

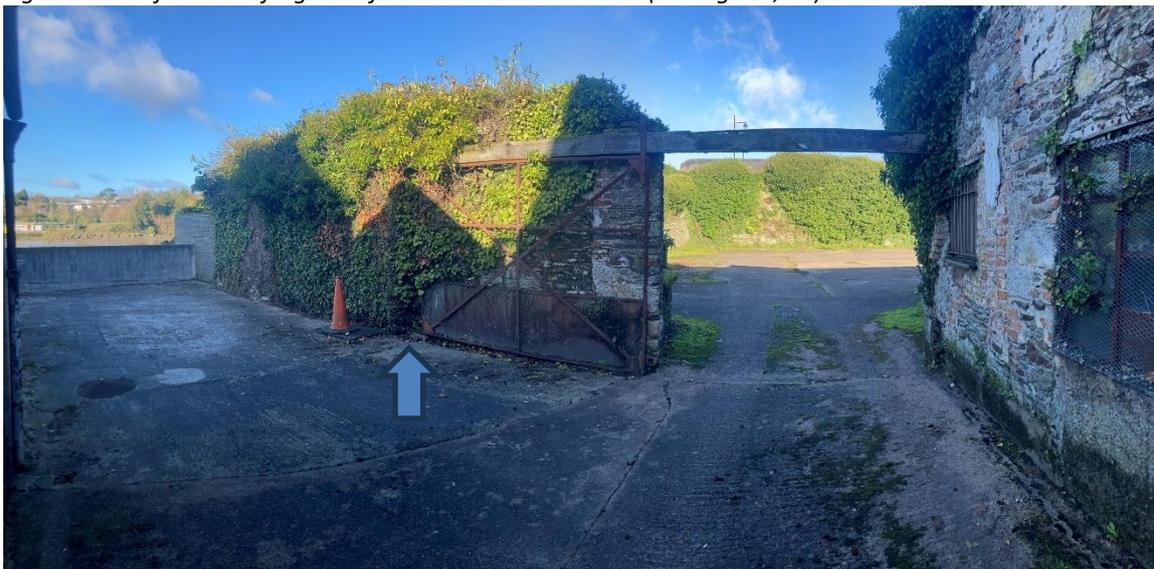
Fig.26: Left-to-Right: The vacant lot of the site of No.1 Bridge Street; The rubble masonry wall forming the south wall facing the corrugated iron roofed structure (see Figs.23,27) and the existing entrance into the Coal Yard. The rubble wall (arrowed) is to be reduced in height to 1100mm to match that of the flood walls and to increase visibility of the site. The north face of this wall is visible in Fig.27 overleaf.

The reduction of the existing riverside masonry walls has a negative impact as it removes historic fabric. Some mitigation is provided by the vistas over the River Barrow which reinforces the historic connection of the space with the river, and the opportunity to carry out necessary repairs and remove past poor quality interventions to the wall. However, the crane loading bay is outside the redline boundary of the proposed works, and the sense of space in this working area will be lost. This area should be carefully recorded prior to commencement.

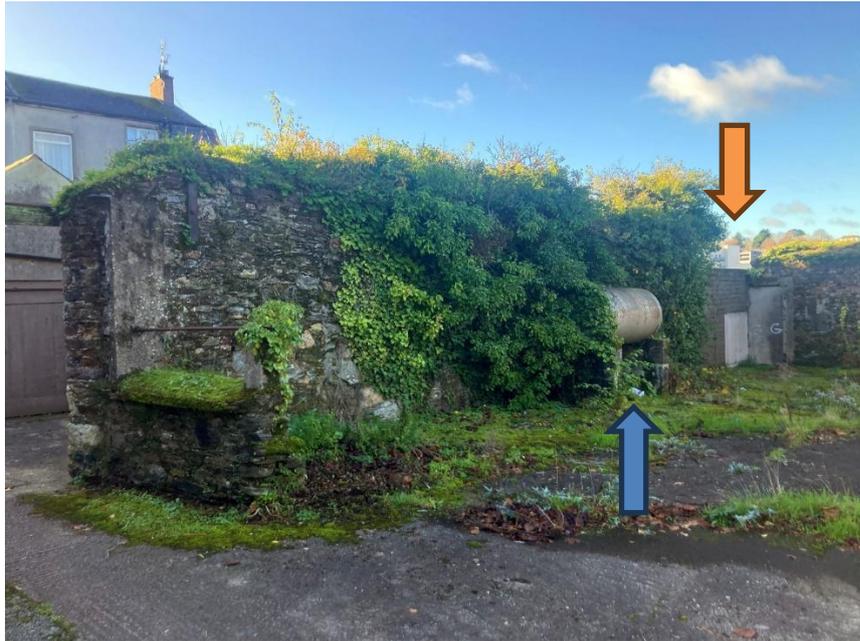
Fig.27: The oil tank (blue arrow) is to be removed, with concrete blockwork at the site of No.1 Bridge St.

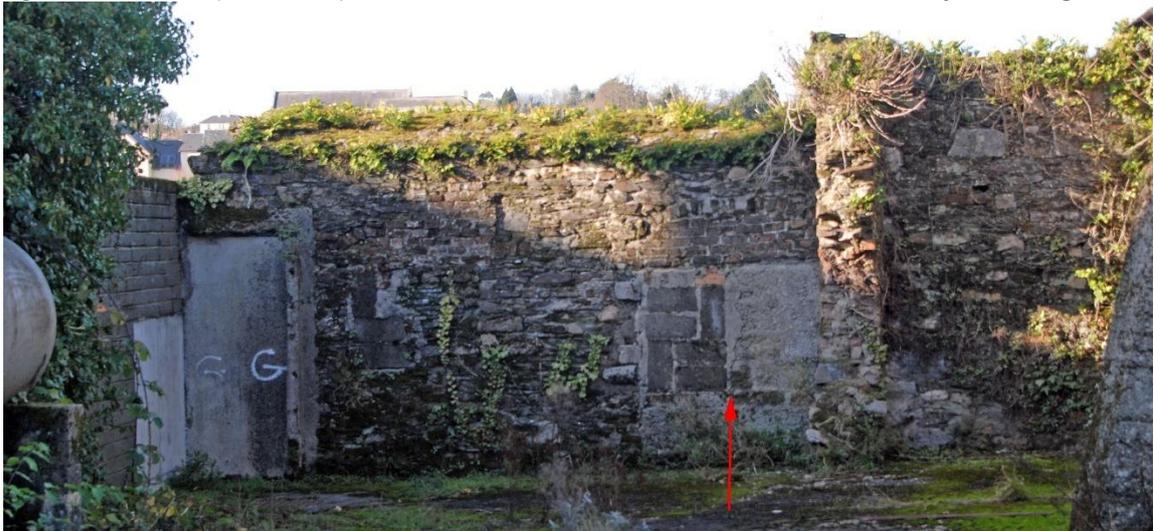
Fig.28: The west wall contains a blocked-up watergate (see Fig.20).

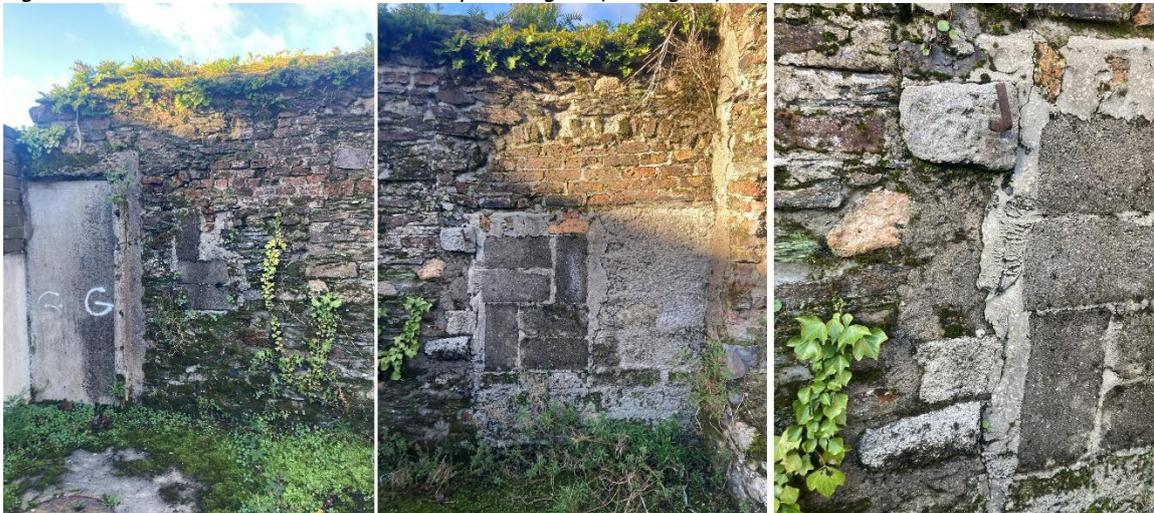
Fig.29: Blocked-up openings on the riverside wall.

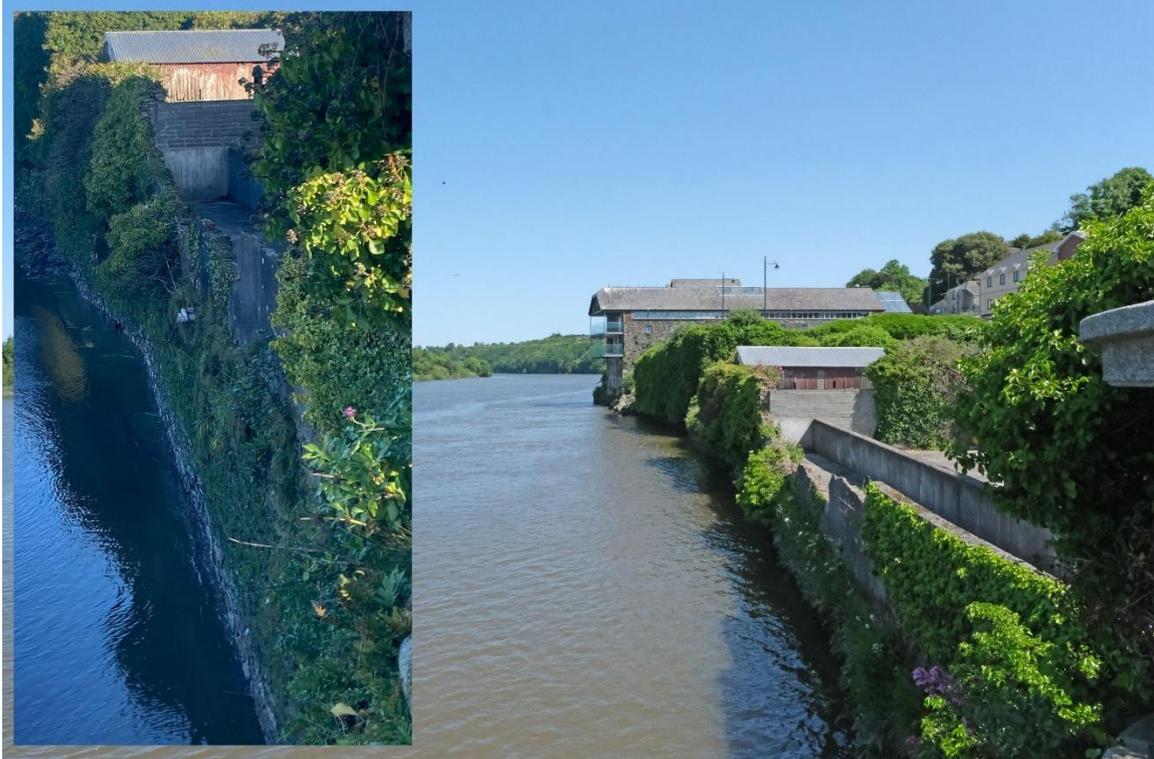
Fig.30: The riverside walls appear to be concrete replacing the former hotel buildings, with overgrown masonry appearing at the corrugated iron roofed structure (see Section 3.3).

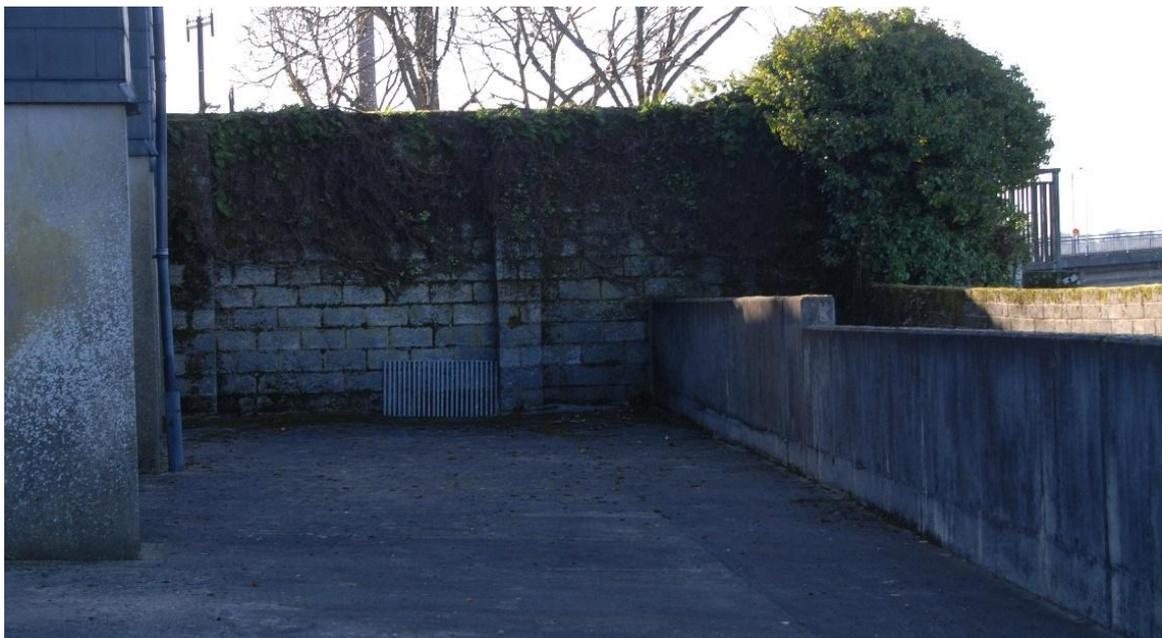
5.4 Site of No.1 Bridge Street: The former hotel (Figs.7-9,20) was entirely removed in the past, and the area largely consists of a twentieth century concrete ground surface (Figs.26), with a cement-rendered concrete wall on the riverside (west), a concrete blockwork wall at the north end (Figs.27), and a concrete blockwork wall at the south end (Fig.) adjacent to the wing walls of New Ross Bridge (Old) (see Section 5.5). **The area retains no features of architectural heritage interest.**

Fig.31: South end of the vacant plot consisting of a concrete blockwork wall, with rendered riverside wall (see Figs.33,38).
