John Street Grain Store Public Realm Project, New Ross, Co. Wexford

Architectural Heritage Impact Assessment

December 2025

Dr Jason Bolton

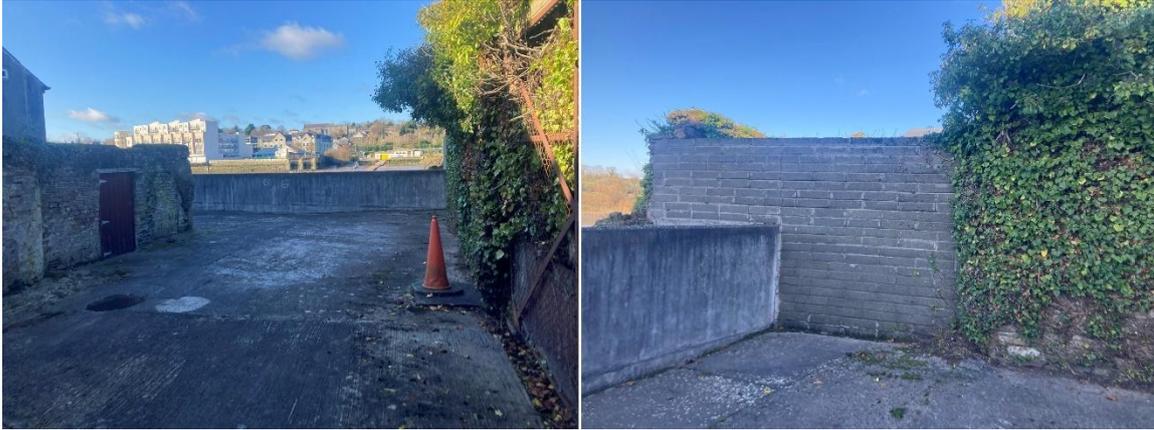
5.4 Site of No.1 Bridge Street: The former hotel (Figs.7-9,20) was entirely removed in the past, and the area largely consists of a twentieth century concrete ground surface (Figs.26), with a cement-rendered concrete wall on the riverside (west), a concrete blockwork wall at the north end (Figs.27), and a concrete blockwork wall at the south end (Fig.) adjacent to the wing walls of New Ross Bridge (Old) (see Section 5.5). **The area retains no features of architectural heritage interest.**

Fig.32: The north end of the vacant plot has a concreted surface, relatively modern cement-rendered concrete river walls, and concrete blockwork separating the site from the former Coal Yard (see Figs.27-28).

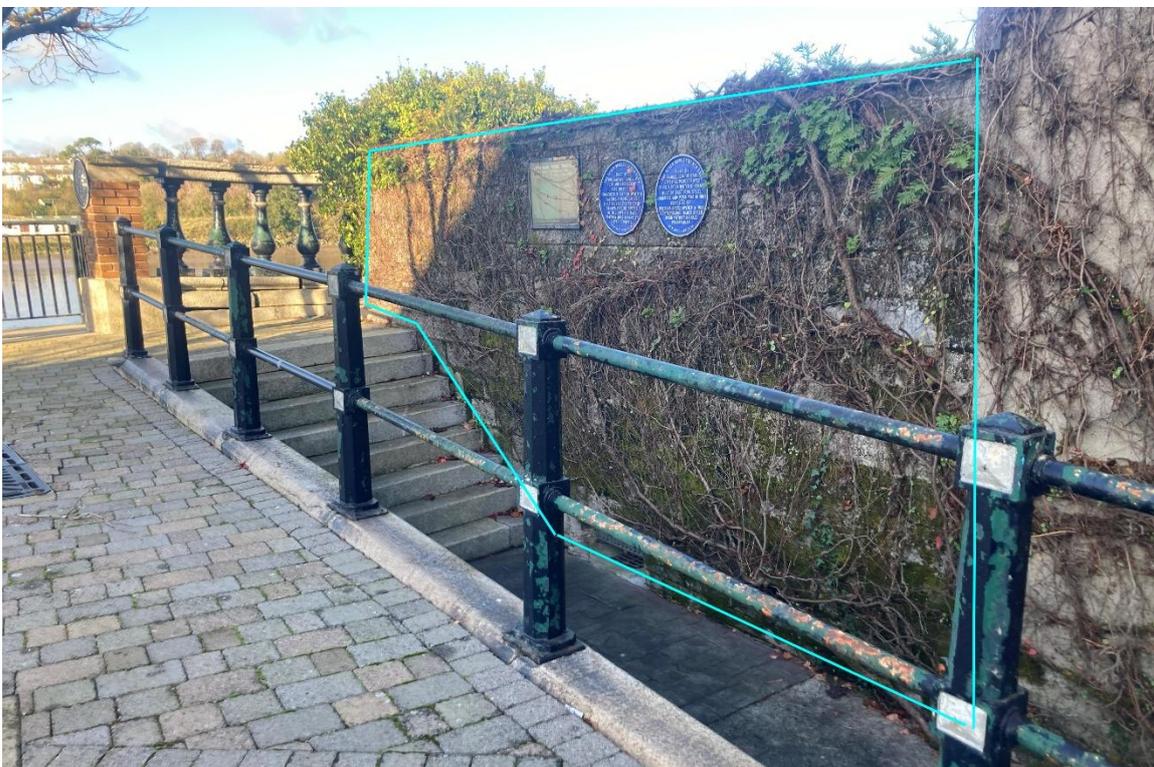
Fig.33: Concrete blockwork at the site of No.1 Bridge Street (proposed as new entrance to the public realm space) See Figs.20 & 34 also. The concrete steps and metal railings in the foreground can be seen in the 1951 aerial photograph. Commemorative plaques of former bridges were erected on the blockwork wall.

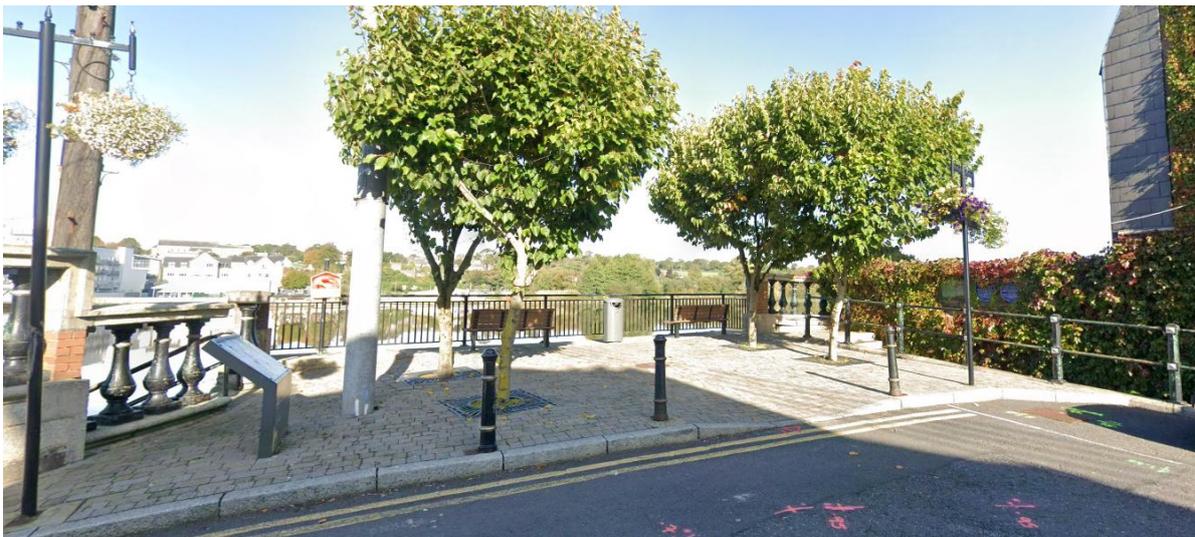
5.5 Wing Walls of New Ross Bridge (Old): The bridge was demolished c.1968¹⁶, and metal railings were set along the river front to span the gap where the road once passed. The curving wing walls were retained but altered and incorporated into the streetscape, with a new machine-cut brick terminus at both north and sides; and with a gap cut into the curving south wing wall and a set of concrete steps provided giving access to the lower quay levels to the south. The metal railings separating the road from the pedestrian areas and the quays were retained, as were the granite steps which rose to the level of the bridge on front of the now-lost No.1 Bridge Street (see Section 5.4). These elements are visible on the 1951 aerial photograph (Fig.34). The area is currently laid out as a public pedestrian area with modern rectangular sets, a bench, small trees, signage,

Fig.35: Current view of the site of the bridge which was removed c.1968.

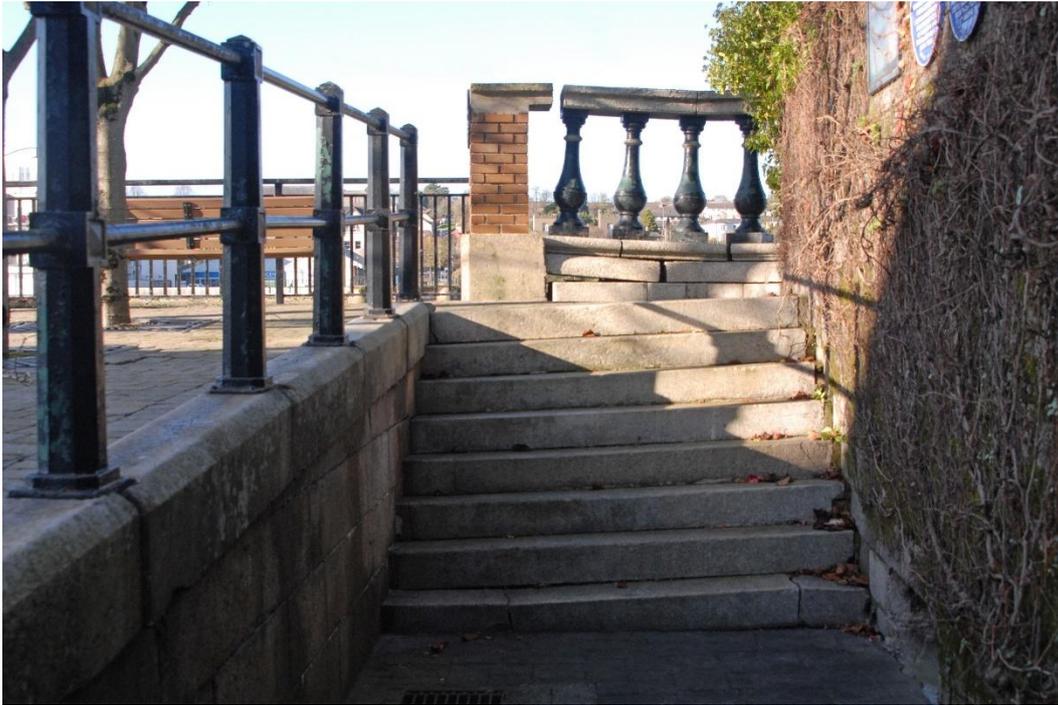
Granite Steps: The **granite steps** are in situ, but have settled to the south resulting in opening of joints and cracking of some stones. The granite wall and metal railings are in situ. The pathway leading to the granite steps are rectangular concrete slabs and the road surface is macadamed.

Bridge Wing Wall: The **northern wing wall is damaged and in very poor condition**. Local subsidence has disturbed the moulded granite plinth and the curving coping stones have lost bond with the c.1960s brick pier (inserted as a new terminus when the bridge was demolished)¹⁸. The roadside metal railings are set onto a low granite plinth. The **southern wing wall was significantly altered c.1968** to accommodate changes in ground level following the demolition of the bridge.

Fig.36: Settlement affecting wing wall and granite steps.

¹⁸ The level of disturbance will require take-down-and-rebuild to prevent collapse of the wing wall.

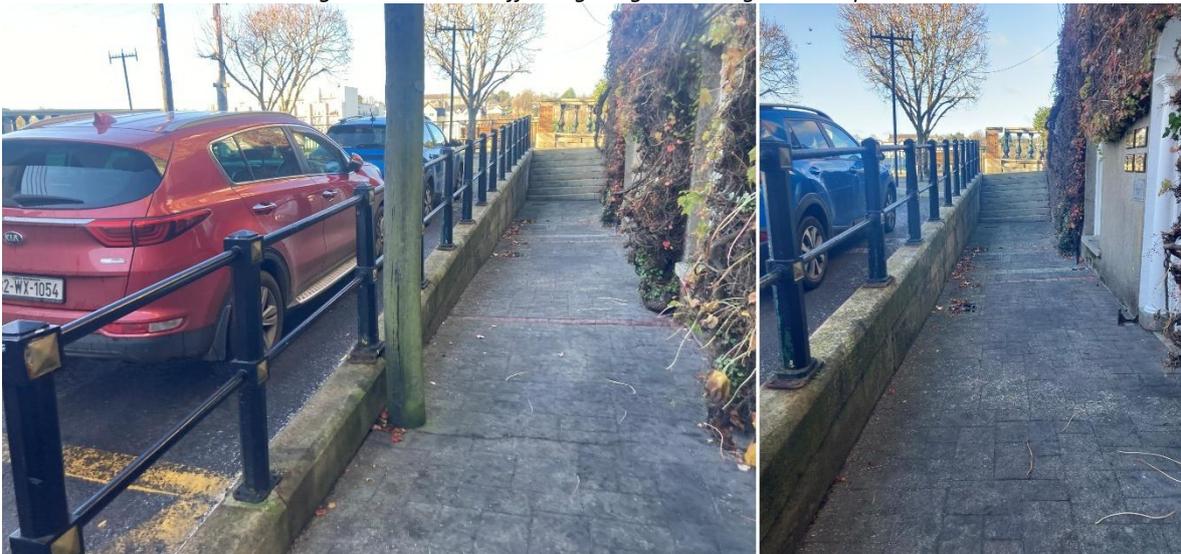
Fig.37: View of metal railings and granite plinth with concrete slab paving leading to the granite steps.

Remove existing metal railing on plinth & replace with new balustrade with integrated seating.	The replacement of the existing metal railings and granite plinth with new integrated seating and planting, c.1100mm above current level as part of a scheme to extend the public pavement into the existing parking bays significant alters the space. The existing concrete ground slabs are not of architectural heritage interest. The metal railings and granite plinth have matching railings on the opposite corner and a section stands beside the southern curving wing wall, and clearly form part of a past public realm scheme. The metal railings are of good quality Proposed Mitigation: The existing metal railings and plinth could be salvaged and considered for re-use elsewhere in New Ross.

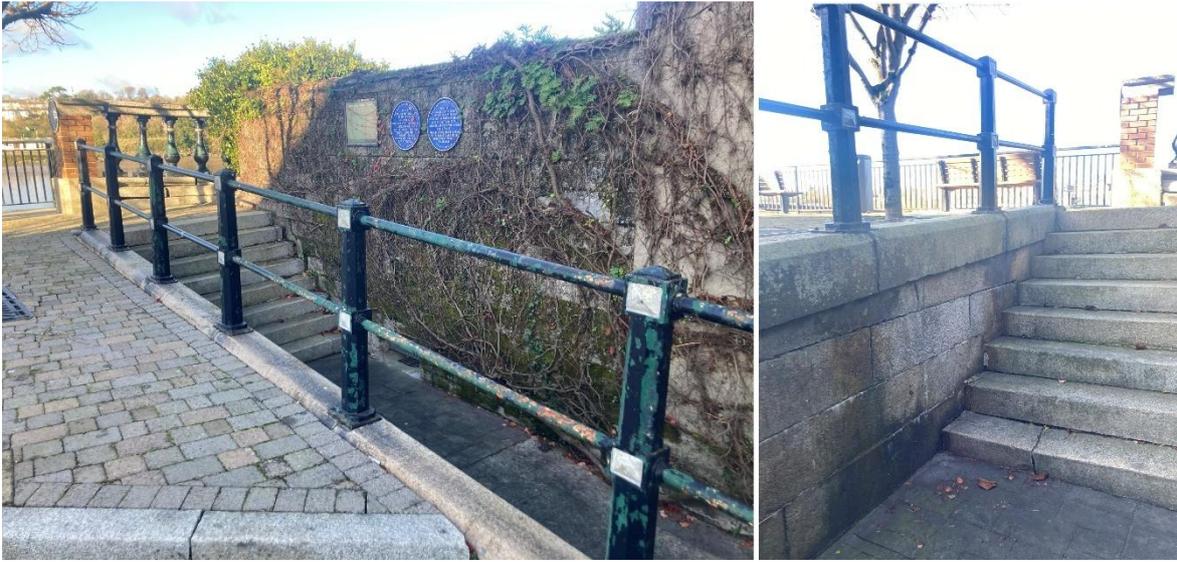
Fig.39: View of the granite steps and walkway fronting the vacant lot of No.1 Bridge Street (see Fig.31).

Proposed Work	Impact
Remove existing granite steps & Construction of new granite steps in to connect to new access route at upper level.	The existing steps and railings originally provided pedestrian access to the bridge (which was demolished c.1968). The steps have suffered from settlement. Proposed Mitigation: The existing steps should be assessed for potential salvage and re-use in the proposed new steps.
Remove Section of Existing Blockwork Wall	The wall is composed of a plain concrete blockwork wall which is of no architectural heritage interest and does not contribute to the streetscape. There are a number of information plaques mounted on the walls. Consideration should be given to re-mounting these within the new public realm works, or to provide alternative new signage on the significance of the bridge site.
Abutment of Old Bridge (outside of site boundary)	The north curving wing wall is outside the redline boundary of the development. However, this riverside wall has been dislodged and is at risk of collapse and in need of immediate repair (Fig.35). As this wall forms the boundary of the site, immediate repair should be included in the proposed works. The wall fragment should be carefully recorded, and then taken down and rebuilt in the same location.

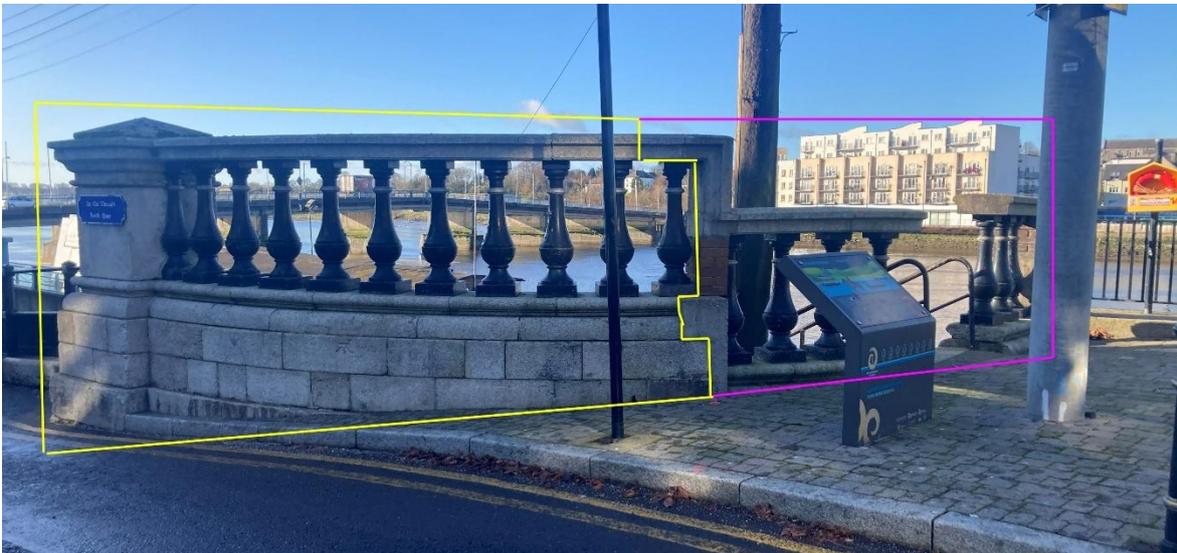
Fig.40: Part of the southern curving wing wall was retained (in yellow) while the rest was dismantled and reused to form a lower railing and entrance to a new set of concrete steps accessing the lower quay to the south.

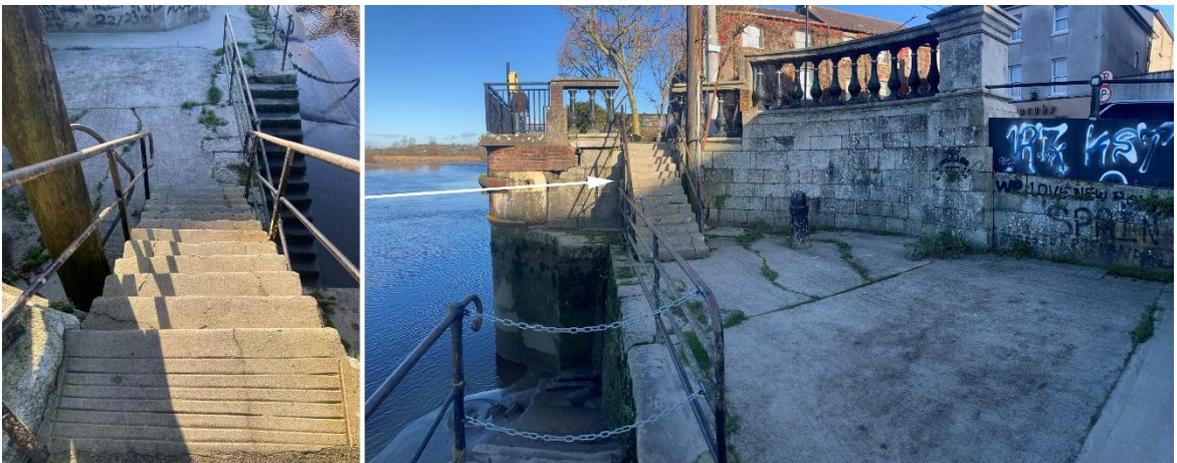
Fig.41: The southern curving wing wall was altered with the addition of concrete steps and lowering of part of the balustrade.

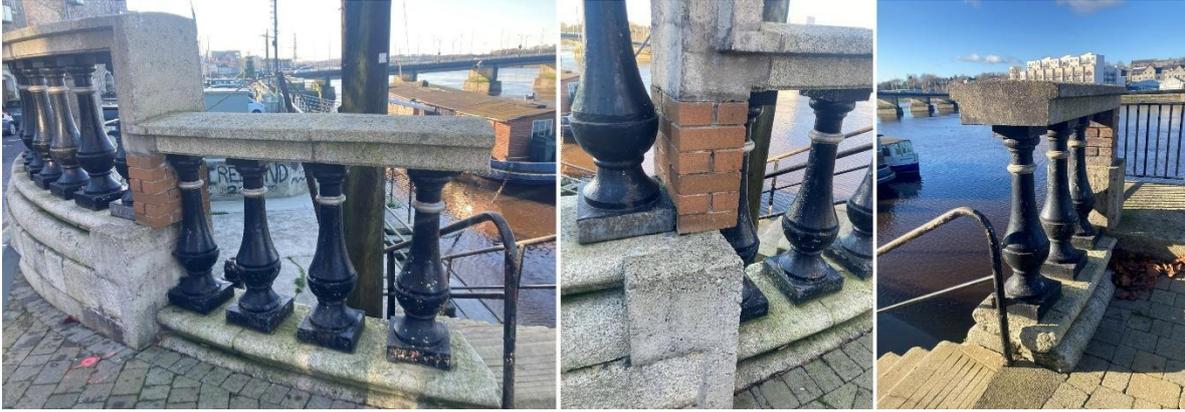
Fig.42: Altered southern curving wing wall.

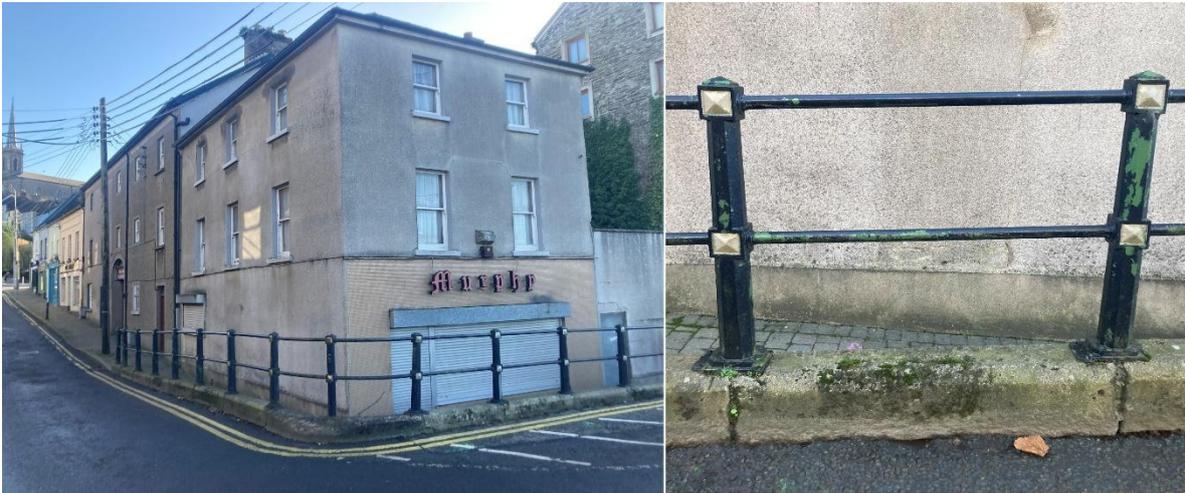
Fig.43: The metal railings are also in situ on the corner of Bridge Street and the along the quay – outside the redline boundary of the public realm improvement works.

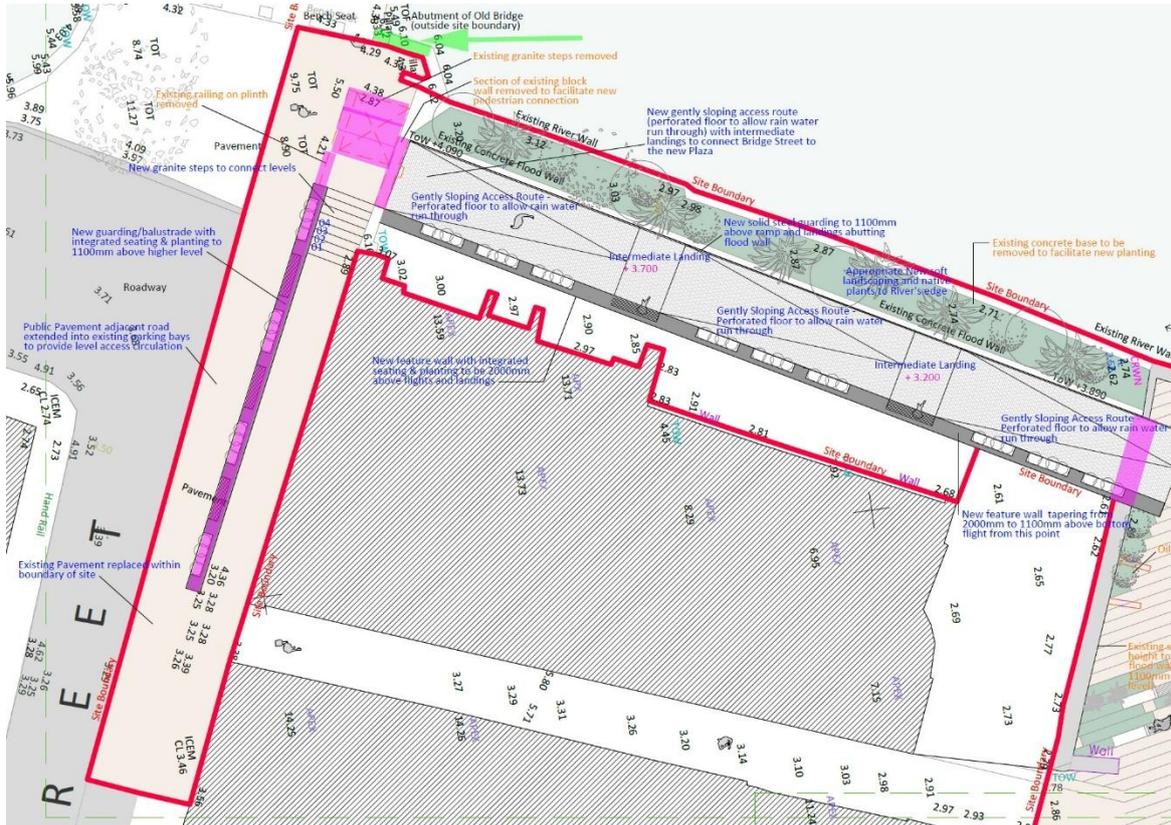
Fig.44: Extract from the ODKM Architects drawings highlighting areas of demolition (in purple) – the granite steps, railing and granite plinth, and blockwork walls at the north and south ends of the vacant riverside plot.

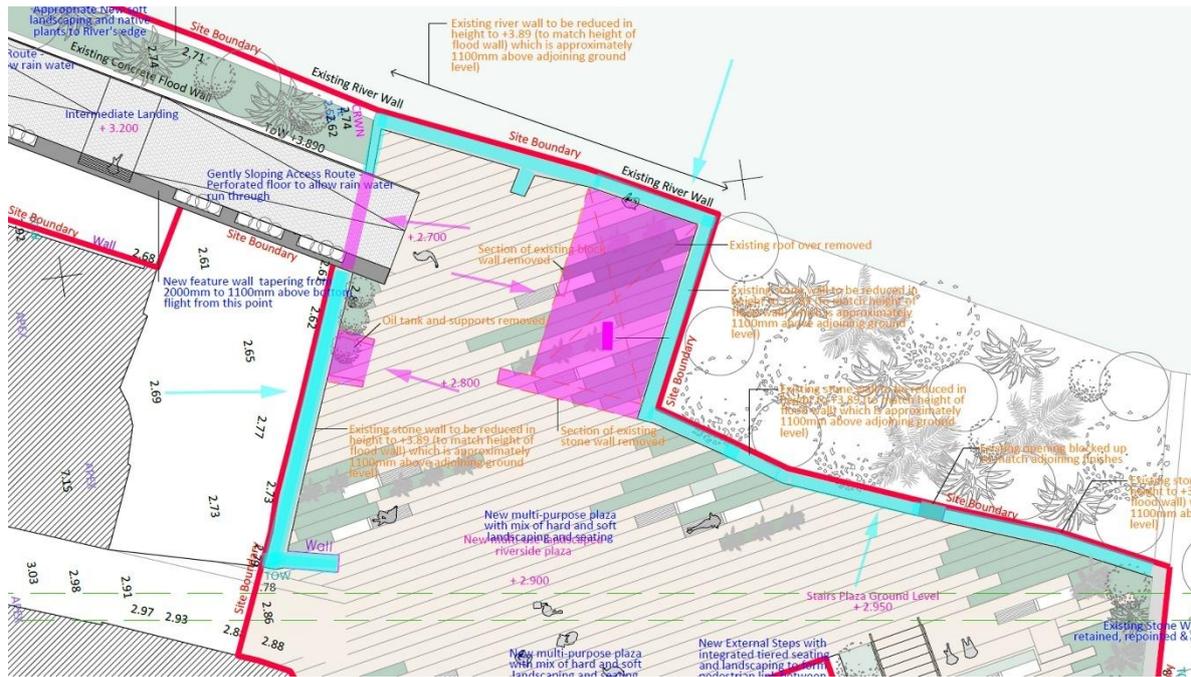
Fig.45: Proposed alterations to the riverside masonry walls (highlighted in blue) and demolition of structures in this area (highlighted in purple).

The reduction of the existing riverside masonry walls has a negative impact as it removes historic fabric. Some mitigation is provided by the vistas over the River Barrow which reinforces the historic connection of the space with the river, and the opportunity to carry out necessary repairs and remove past poor quality interventions to the wall. However, the crane loading bay is outside the redline boundary of the proposed works, and the sense of space in this working area will be lost. This area should be carefully recorded prior to commencement.

Proposed Work	Impact
Existing River Masonry Wall & Existing Stone wall separating coal yard from the former loading bay to be reduced to c.1100mm above current ground level, & existing concrete doorway to be blocked up.	<p>The proposed works have a negative impact as they remove historic fabric. The proposal to remove the concrete doorway and repair the wall with rubble masonry effectively erases a historic brick-arched opening (see Figs.18, 35), and the treatment of the crane loading bay is not addressed in the proposed works.</p> <p>Proposed Mitigation: The existing walls should be carefully recorded prior to the commencement of works, and a copy of that record together with a text interpretation of significance should be deposited in the form of a report (preservation by record) in the local studies section of Wexford Library Service and with the Irish Architectural Archive.</p> <p>A specification should be developed detailing the finish of the wall-top (to prevent water ingress to preserve the wall - either with a new stone coping, or a durable NHL haunching), the mortar to be used for repointing, for rebuilding and for any haunching²⁰).</p> <p>The stone from the upper parts of the wall should be carefully dismantled by hand and stored on pallets on site to allow sorting and re-use for repairs to all historic masonry walls within the project.</p> <p>The landscaping and treatment of the former crane loading bay (which will be visible from the plaza but outside the redline boundary) should be detailed as this area impacts the character of the former coal yard.</p> <p>Prior to the commencement of works, the quay walls (which should not be impacted by the proposed works) should be inspected from the waterside, and assessed for any necessary repairs.</p>

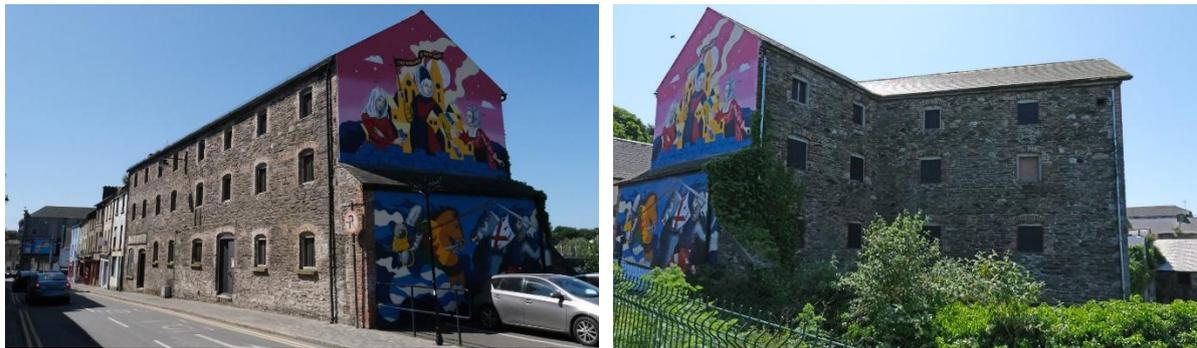
6.4 New Tiered Staircase & Landscaping of Plaza: The new stairs is immediately adjacent to the Grain Store (Protected Structure Ref. No.NR0143), rising from the new plaza to the John Street car park at the gable end of the Grain Store (Figs.46-47,49). The proposed new stairs are to be partly constructed on the single-storey element of the Grain Store extension (previously approved under Ref. No. LAC2401, but not yet constructed) and will not disturb or alter the masonry of the rear of the Grain Store. **The new staircase will obscure views of the lower part of the rear and off-set return of the Grain Store** (Fig.48). However, this is ‘back-of-house’, and this **should not detract from the character of the Protected Structure**. The main features of the rear of the Grain Store are the granite entrance on the south side, pattern of brick openings, and the chute corbels, none of which will be altered as part of the proposed development. Externally, the appearance of the building will remain largely unchanged when viewed from John Street. **The new pedestrian access to the plaza removes three existing car parking bays and should increase public views and appreciation of the Grain Store** (Fig.46) and is a conservation gain for the site.

Fig.46: General view of the façade and north gable of the John Street Grain Store (left), and a view of the off-set return and the overgrown area where the proposed tiered stairs are to be constructed.

Proposed Work	Impact
Construction of New Tiered Staircase	<p>The top Section of Existing Masonry Wall in the North-East corner of the site to be reduced to facilitate the construction of the new tiered stairs. This masonry formed part of an early building and is currently obscured by mature vegetation. The repair of the wall should be considered a conservation gain.</p> <p>Proposed Mitigation: The existing walls should be carefully recorded prior to the commencement of works, and a copy of that record together with a text interpretation of significance should be deposited in the form of a report (preservation by record) in the local studies section of Wexford Library Service and with the Irish Architectural Archive.</p> <p>The stone from the upper parts of the wall should be carefully dismantled by hand and stored on pallets on site to allow sorting and re-use for repairs to all historic masonry walls within the project.</p>

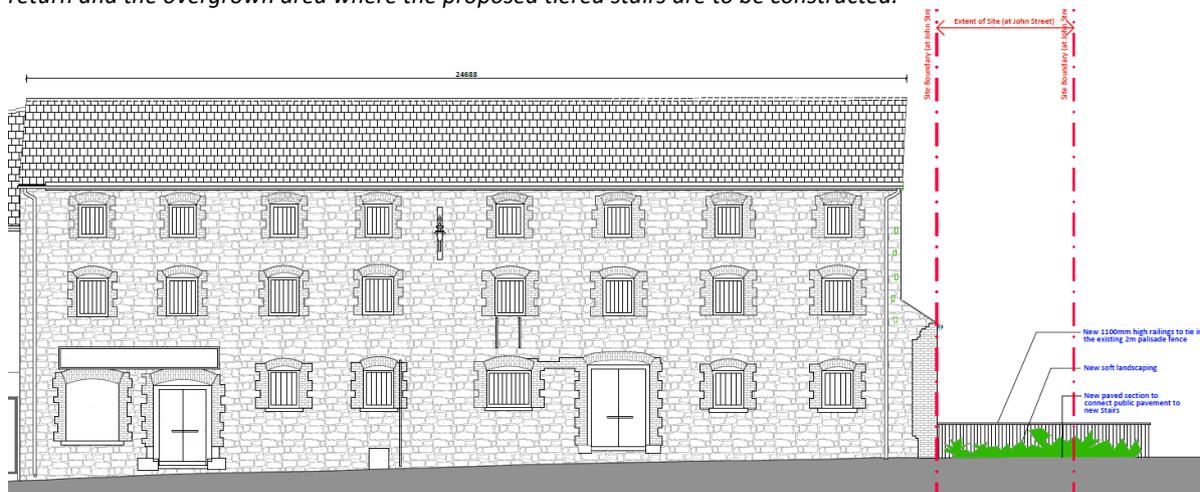
Fig.47: Extract from the ODKM Architects drawings showing the proposed new pedestrian entrance on John Street.

Section of existing palisade fence to be removed and new railings inserted ²²	<p>This is a modern fence bordering the car park, and its alteration with new railings of high quality and craftsmanship should have no impact on the character of the Protected Structure.</p>
New multi-purpose plaza ground surface (hard & soft landscaping with seating.	<p>This replaces a twentieth century concreted ground surface. The replacement of one relatively modern surface with another modern surface of good design should have no impact on the character of the Protected Structure.</p>

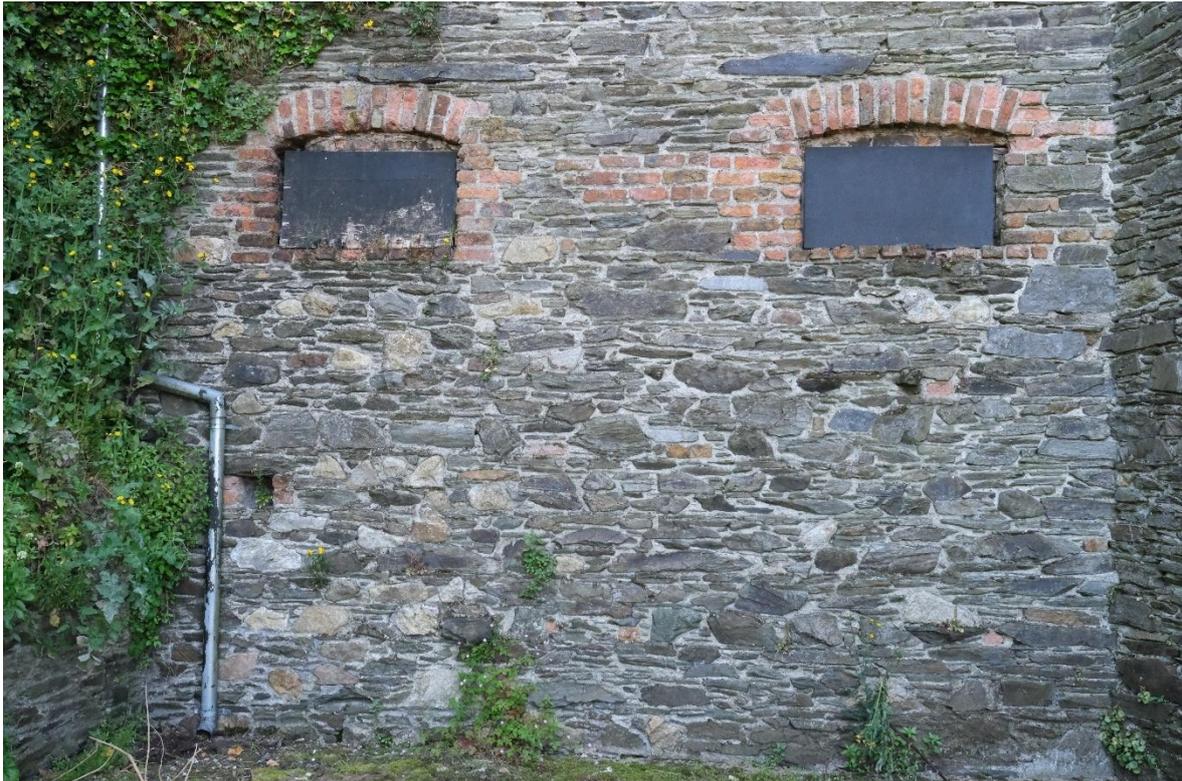
Fig.48: The blocked-up windows and rubble masonry walls of part of the rear of the Grain Store will be obscured by the proposed new tiered staircase.

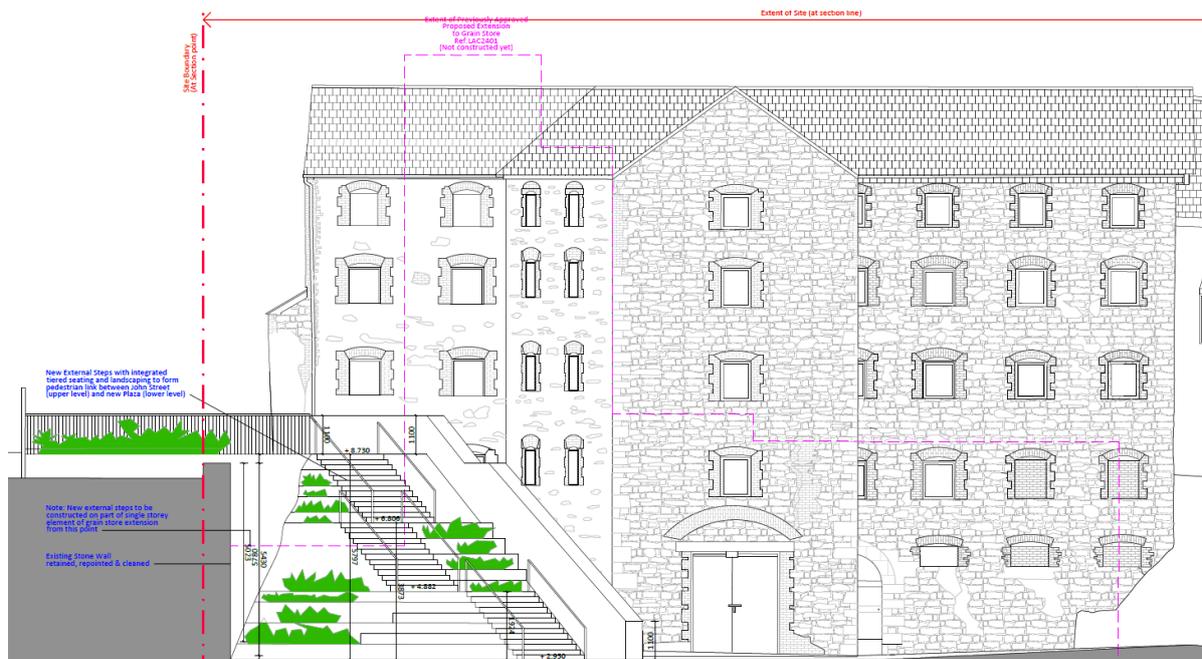
Fig.49: Extract from the ODKM Architects drawings showing the proposed new tiered staircase.
