## **Grain Store, John Street, New Ross, Co. Wexford: Archaeological Assessment**

Improvements to Public Realm to Bridge Street and lands to the rear and side of  
The Grain Store, John's Street, New Ross, Wexford

**November 2025**

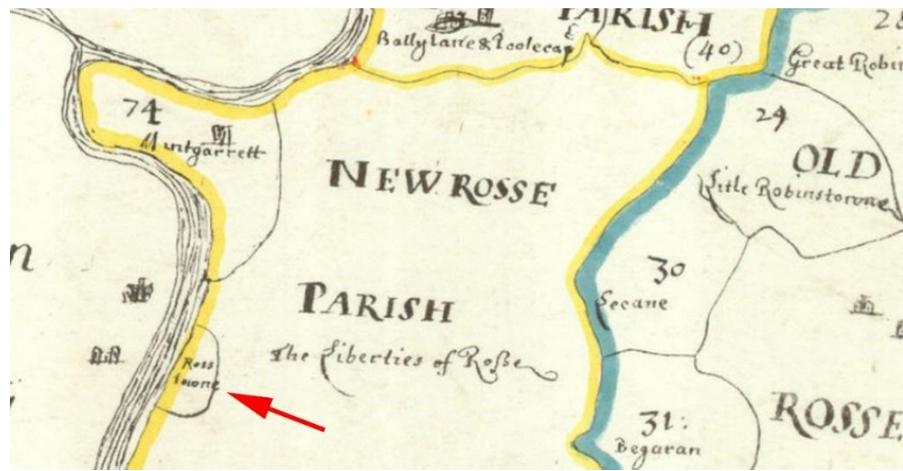
Fig.3: Down Survey barony map of Bantry, Co. Wexford showing the walled town of New Ross. However, the lands were not subject to forfeitures and were not included in more detailed maps or terriers.

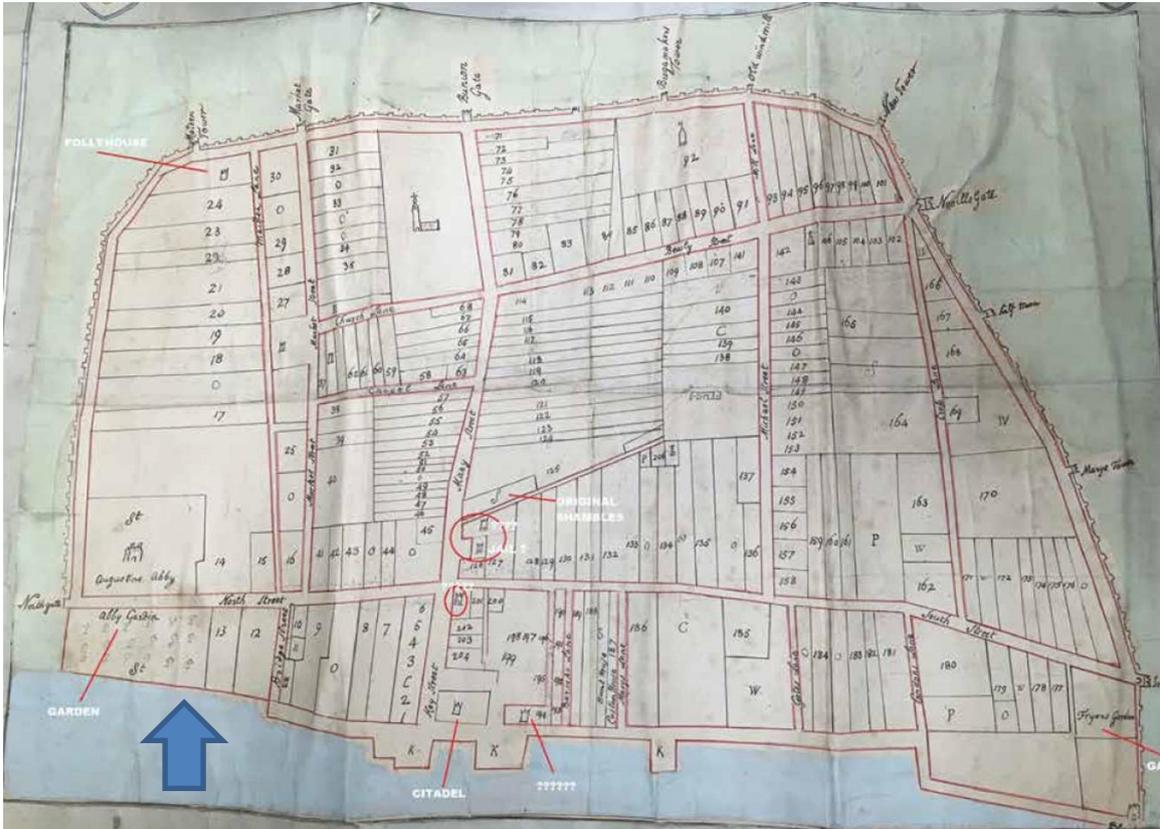
Fig.4: 1687 map of New Ross, at which time the John Street site was set out as a garden. John Street lies on the edge of a rocky slope, and provided access to the North Gate, with a relatively steep drop overlooking the River Barrow.

- The proposed site was named as the abbey garden on the 1687 map (Fig.4) and was not developed until the second half of the nineteenth century (see Section 2.4).

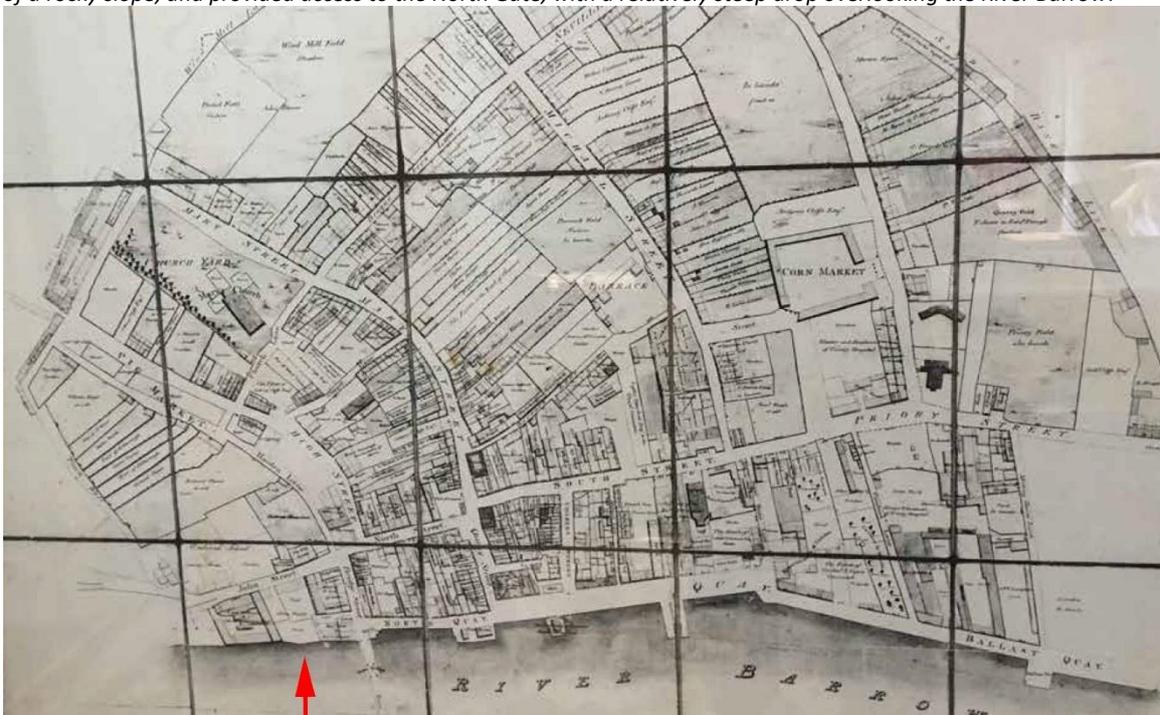
Fig.5: 1827 Tottenham Estate rent-map of New Ross showing the John Street site with a line of buildings on John Street, overlooking an open courtyard and river wall. The map shows quite a number of plots in use as gardens or waste land, with relatively dense settlement in the built-up areas.

- The now-lost hotel on the riverfront was built after 1827 (Fig.5) and before 1837, and it is likely that traces of the foundations of these buildings survive below ground level.

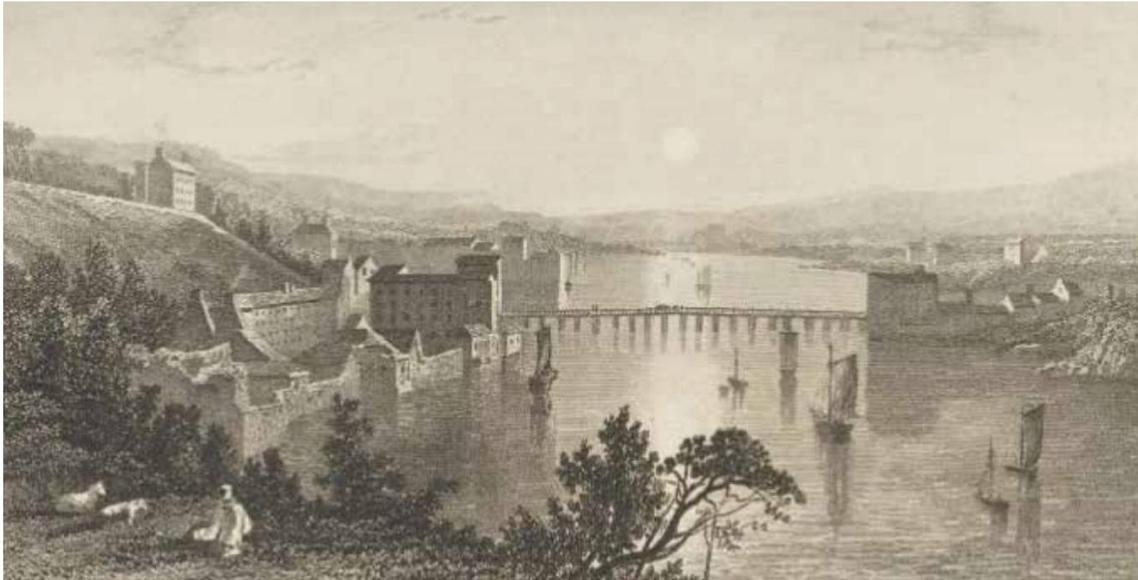
Fig.6: Engraving by William Bartlett c.1830 showing the John Street buildings and river frontage at the site.

postern gate, bridge gate, two Watergates and a flanking tower. The Civil Survey for New Ross of 1654-56 notes "7 gates on the waterside"<sup>12</sup>; while the topographer Samuel Lewis noted in 1837 that the quays were protected by a stone parapet, shown on Bartlett's drawing (Fig.6).

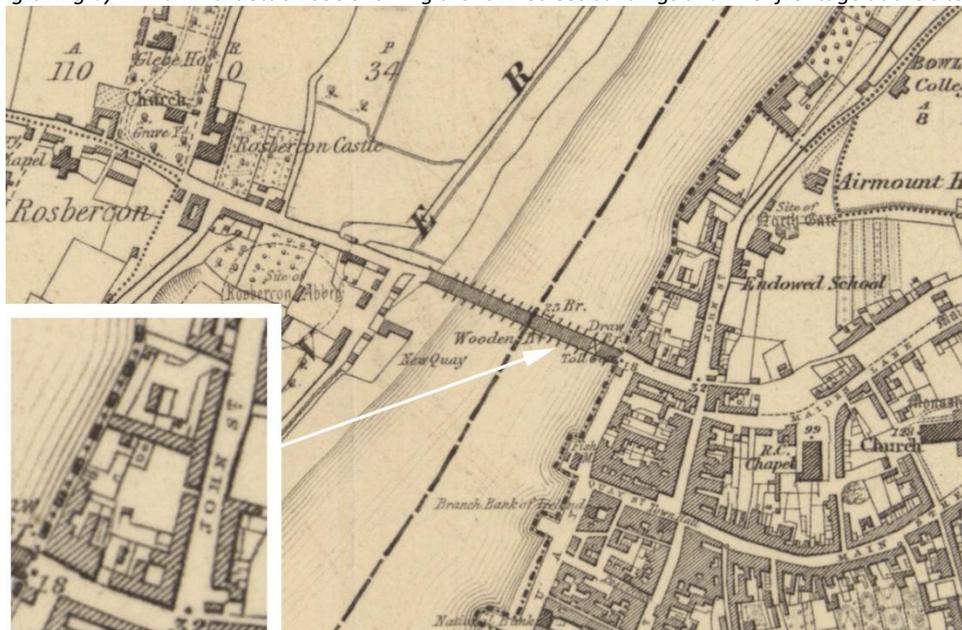
Fig.7: First edition Ordnance Survey map c.1840 showing the layout of the site.

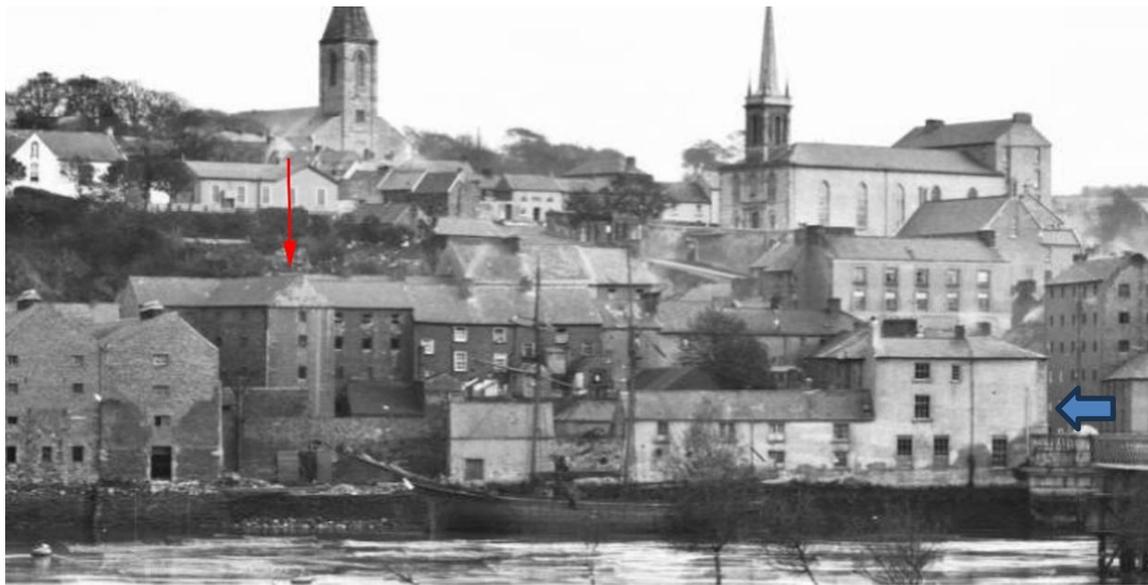
Fig 10: View of the grain store (red arrow) in 1906 by A.H. Poole (National Library of Ireland Ref: POOLEWP 0547). The riverside is dominated by the now-lost hotel (blue arrow) which extended from Bridge Street to the Coal yard (see Fig.9). The quay walls are relatively low (allowing access for off- and on-loading by ship traffic) to an area which formerly held a crane (see Fig.9). The lime kilns are concealed from view by an internal masonry wall.

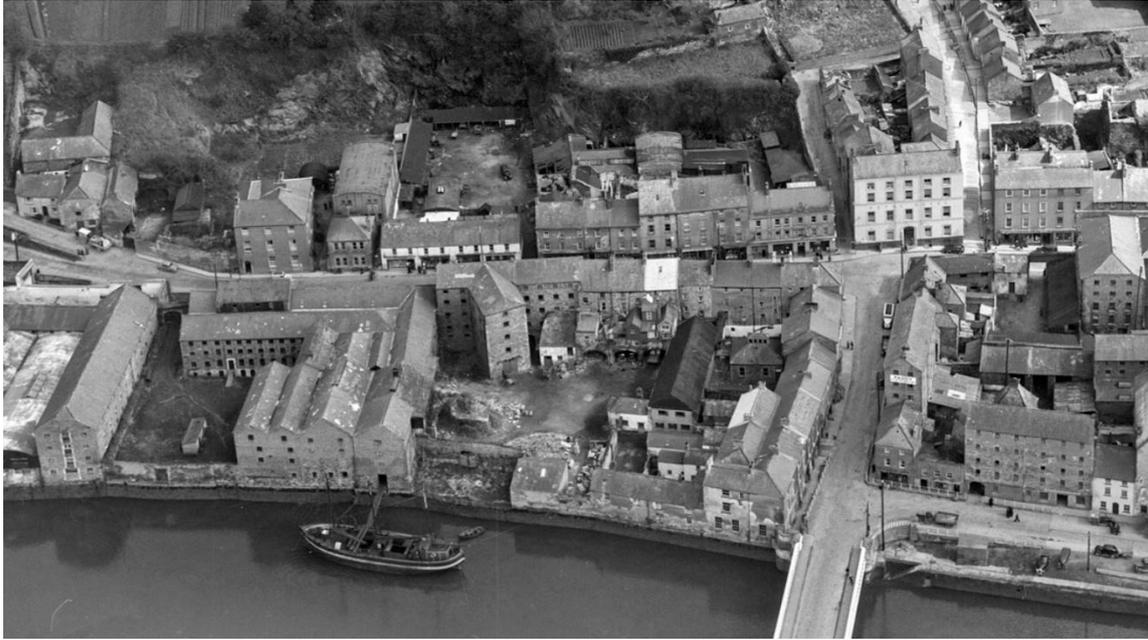
Fig.11: Aerial photograph of the Grain Store site c.1951 by Norman Ashe showing the hotel occupying the south-west corner adjacent to the bridge, and extending along the river frontage to the coal yard. The lime kiln structure is still in situ at this time but appear disused and in poor repair. The quay walls are visible, but rise to form the buildings of the hotel (now-lost and with the walls replaced by concrete walls), with a lean-to structure flanked by yards. The northern yard was noted as having a crane for loading in the nineteenth century (Fig.9). The bridge was still in situ, but was demolished c.1968.

**3.3 Corrugated Iron Roofed Structure:** The 1951 aerial photograph (Figs.11,23) shows a lean-to structure in place in this location. The existing structure consists of masonry walls on the west, north and east sides, with concrete blockwork piers on the south side supporting a corrugated iron roof structure, and with a mass concrete buttress at the south-east corner. The masonry walls appear to be from the earlier structure depicted on nineteenth century maps (Figs.8,9). The southern part of this building appears to have been

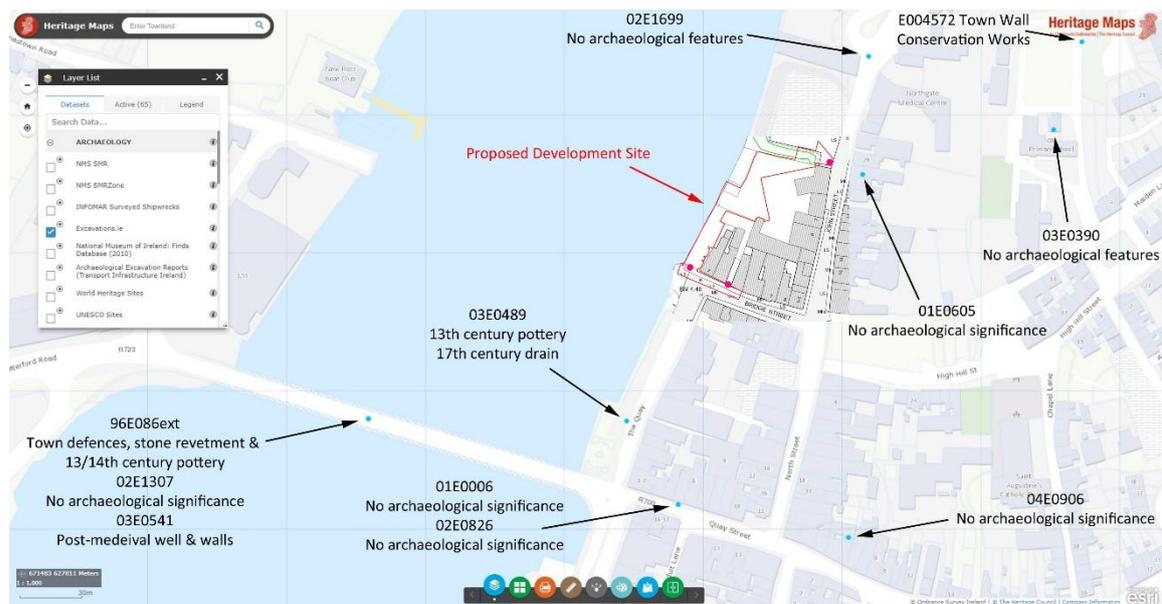
Fig.14: Annotated screengrab of heritagemaps.ie showing archaeological excavations in the vicinity of the proposed development site (see Appendix 2 also).

**Archaeological Excavations** in and around the town (Fig.14 & Appendix 2) have uncovered evidence of medieval settlement activity including thirteenth century pottery and a seventeenth century drain off the quays to the south (03E0489), parts of the town defences (96E86ext.) as well as evidence of post-medieval

<sup>18</sup> Alistair Coey Architects *ibid.* *New Ross Town Walls Conservation Plan*; & see Fig.14 & E004572, Appendix 2.

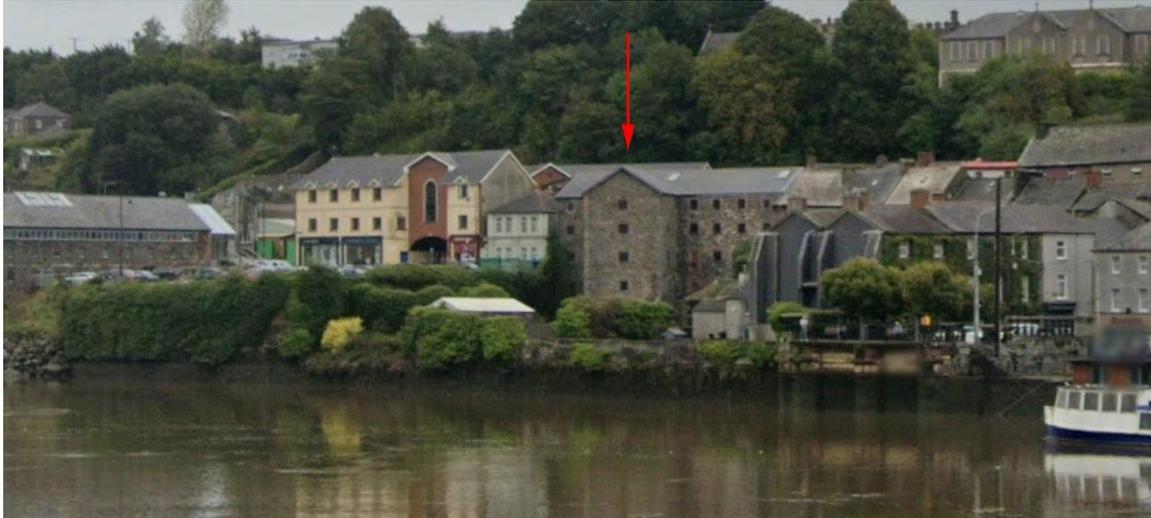
*Fig.15: View of the riverside and west elevation of the John Street grain store site (arrowed) from the west side of the River Barrow at Rosbercon, Co. Kilkenny.*

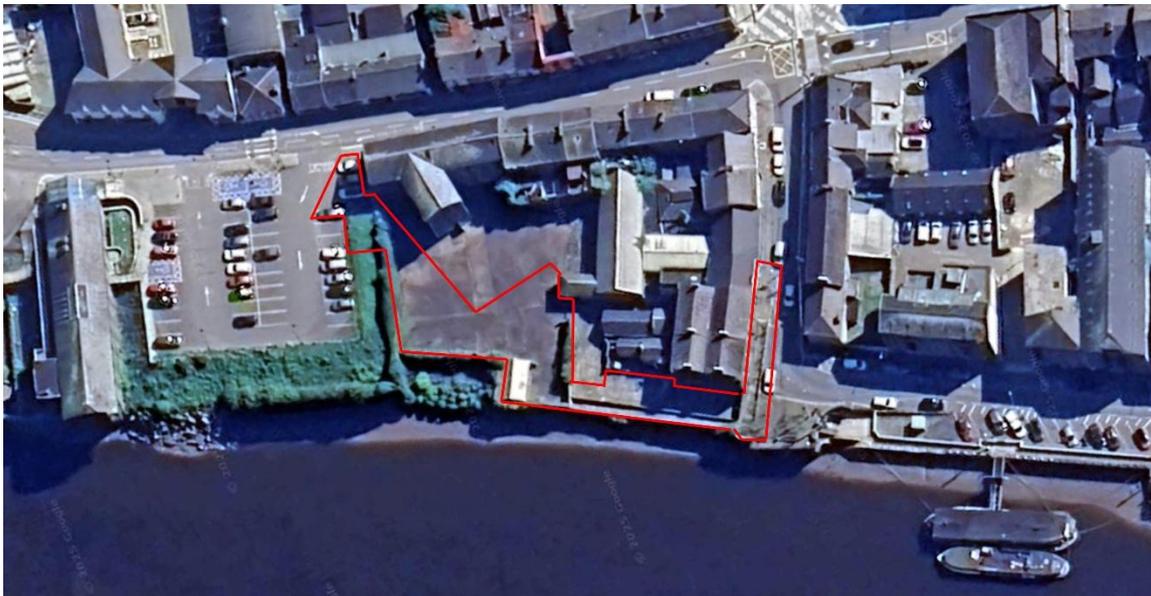
*Fig.16: GoogleMaps view showing the redline boundary of the proposed development.*

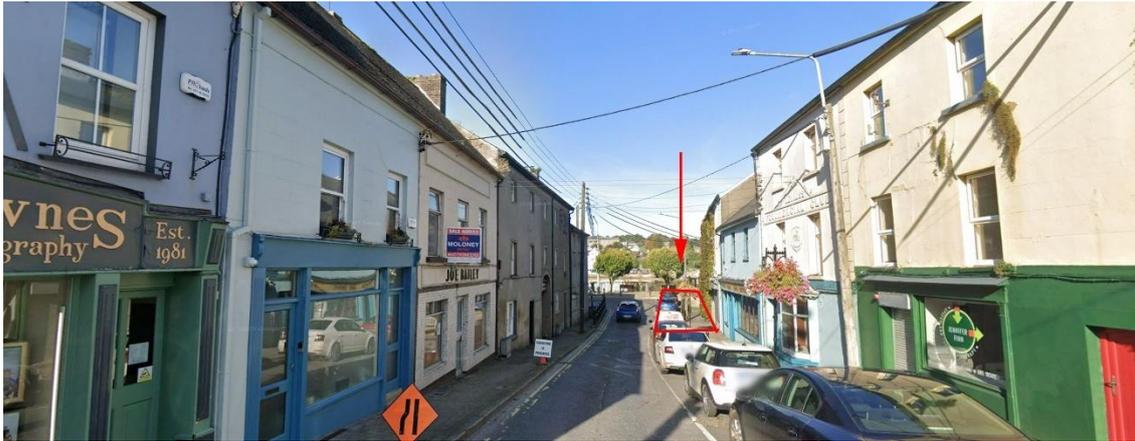
Fig.17: General view of Bridge Street looking west showing the location of the proposed public realm works.

**3.1 Bridge Street:** This part of the public realm is confined to the north-western part of Bridge Street and consists the existing path leading to a flight of granite steps, metal balustrade separating the steps from the road, and a viewing platform at the site of the former bridge with part of a balustrade enclosing the west side. The site consists of twentieth century surfaces and construction, fragments of the balustraded wing walls of the former bridge (demolished c.1968), a flight of granite steps with decorative railings. There were **no indications of any above-ground features of archaeological significance.**

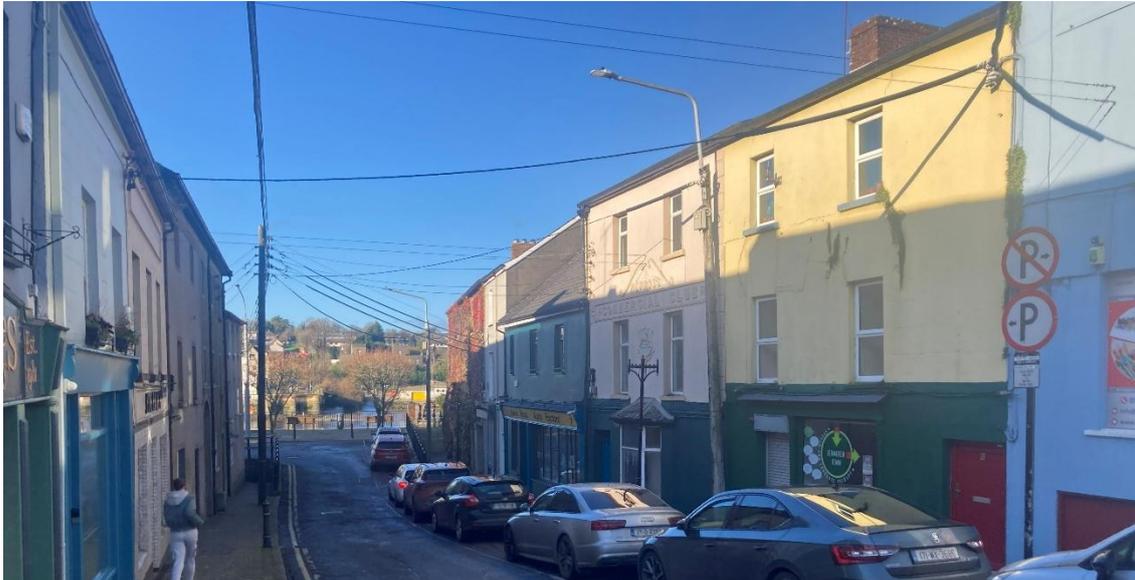
Fig.18: The public realm space shows no above-ground features of archaeological significance.

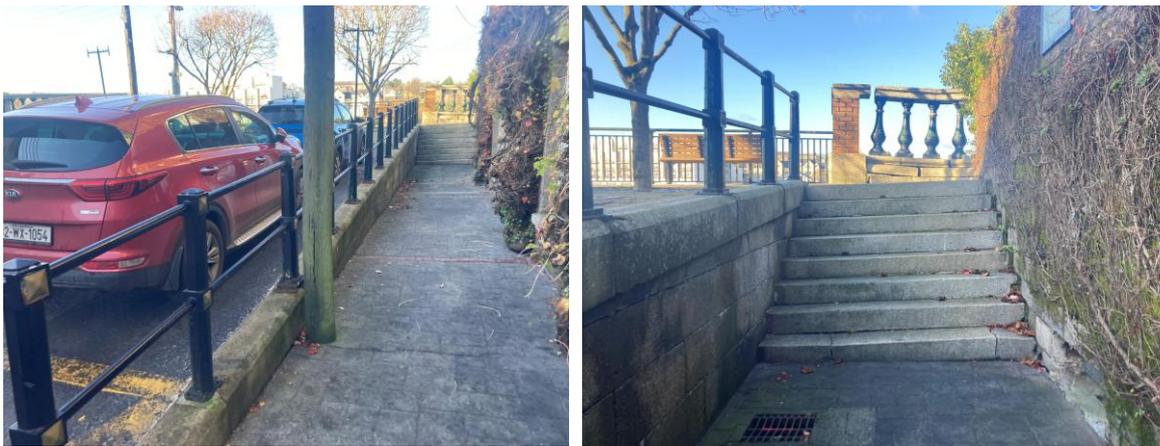
Fig.19: The existing path and flight of granite steps at the north-west of Bridge Street.

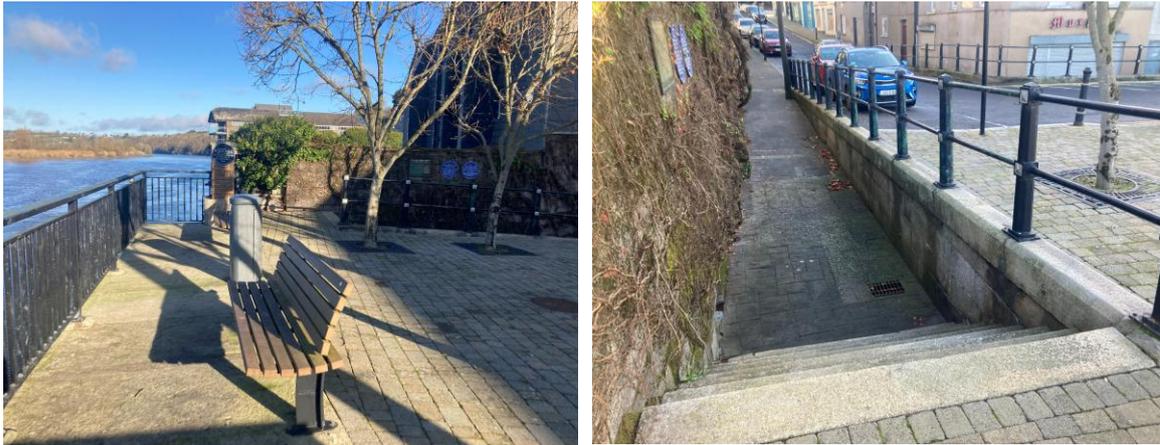
Fig.20: The existing path and flight of steps at the north-west of Bridge Street.

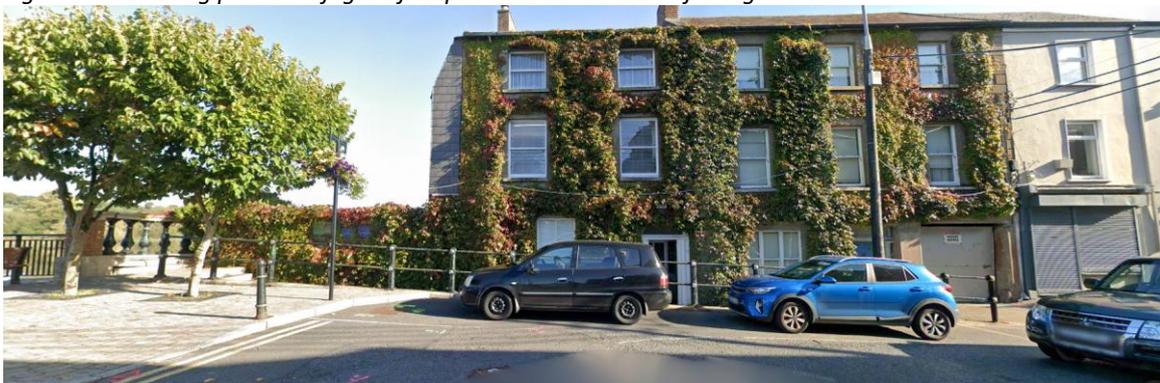
Fig.21: The existing public realm at the north-west of Bridge Street.

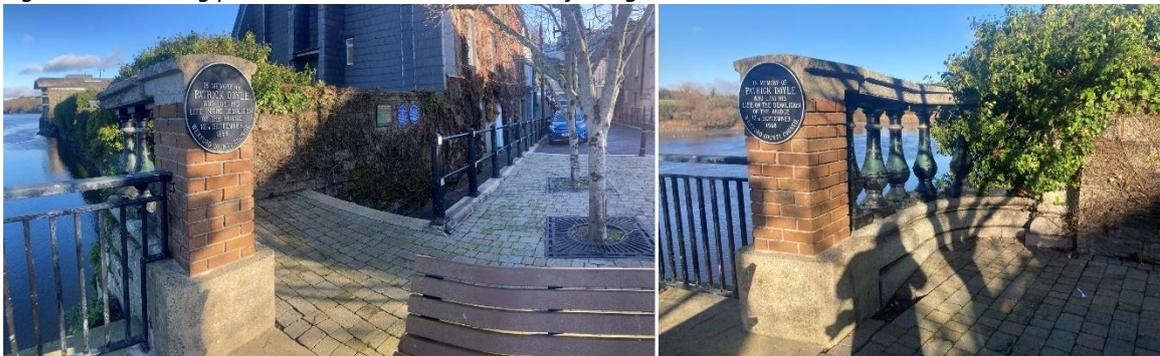
Fig.22: Remnant of the wing wall of the former bridge (demolished c.1968) with modern landscaping and planting in the existing current realm.

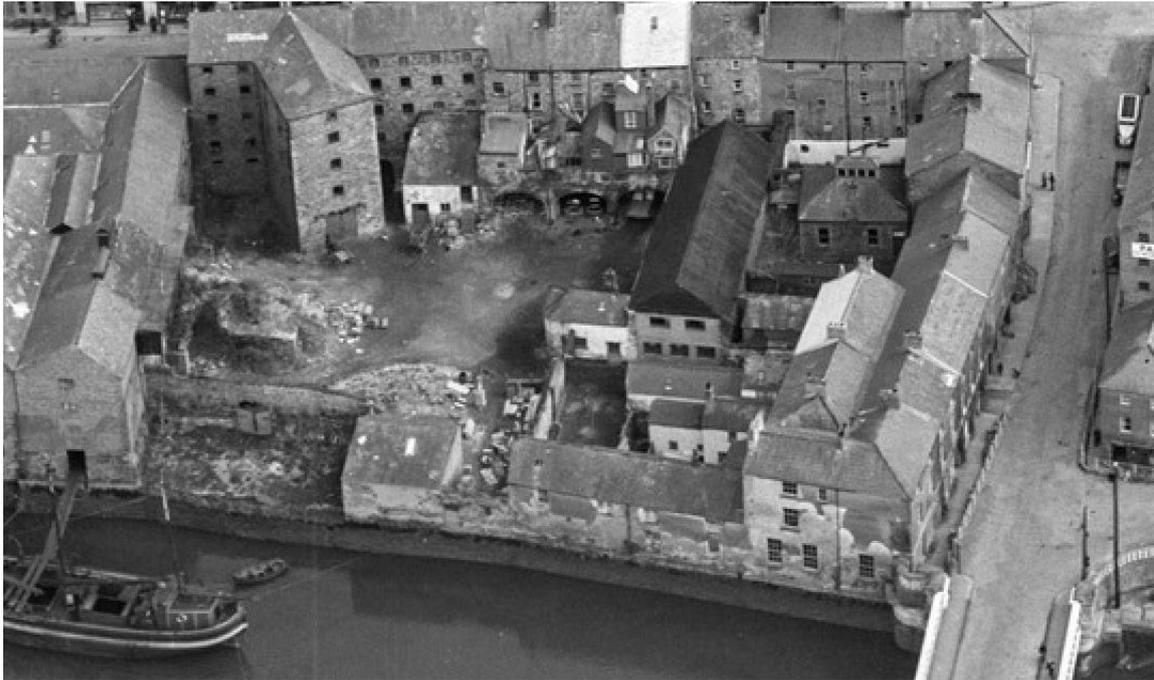
Fig.23: Detail of the 1951 aerial photograph (see Fig.11) showing the three-storey hotel with outbuildings to rear which extended along the riverfront and which were later demolished. The bridge (demolished c.1968), balustraded wing walls and granite steps can be seen on Bridge Street.

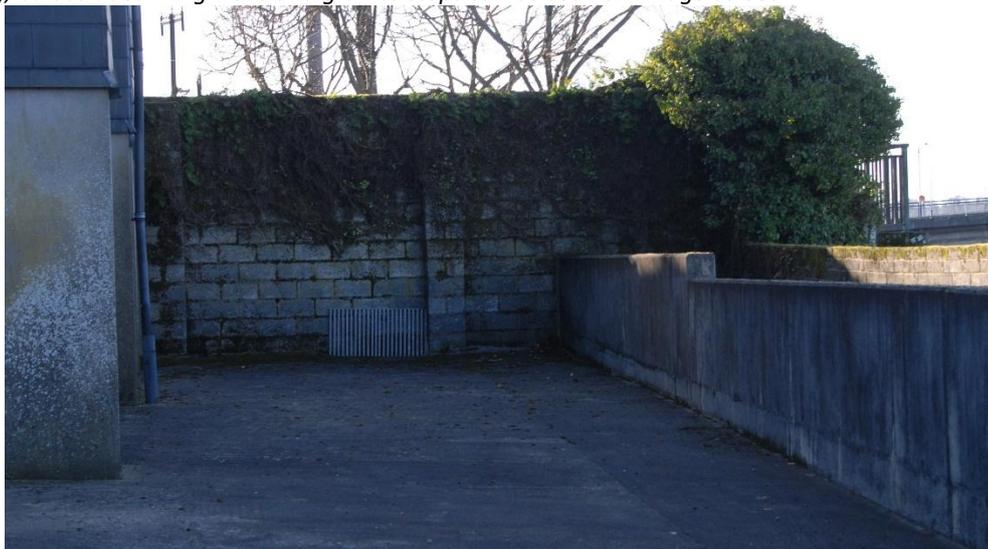
Fig.24: South end of the vacant plot.

**3.2 The Vacant Plot:** The west side of the proposed development consists of a vacant lot which was formerly occupied by a hotel which extended from Bridge Street to the Coal Yard (see Figs.9-11). The area currently consists of relatively modern surfaces and construction throughout, and there were **no indications of any above-ground features of archaeological significance**, and no indications of the former buildings which extended along the riverfront of the site and which appear to have been built above the level of the quay walls (Fig.23). The south (Bridge Street) end is enclosed with a concrete blockwork wall (Figs.22,24), as is the north end of the rectangular plot where it meets the former coal yard. The east side is bounded by the adjacent property, and the west (riverside) is formed by a modern concrete cement-rendered wall, with a concreted ground surface (Figs.24-25).

**The Time Scale** for the construction phase should be made available to the archaeologist, with information on where and when ground disturbances will take place. Given the surface area to be exposed (Fig.24), **it is strongly advised that this element of work be undertaken well in advance of any planned construction to allow for any archaeological issues to be resolved.**

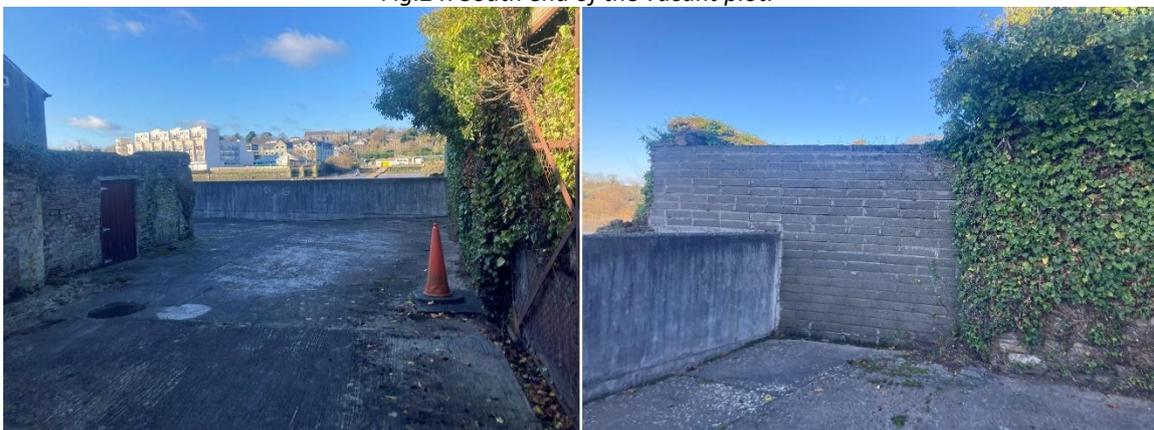
Fig.25: The north end of the vacant plot.

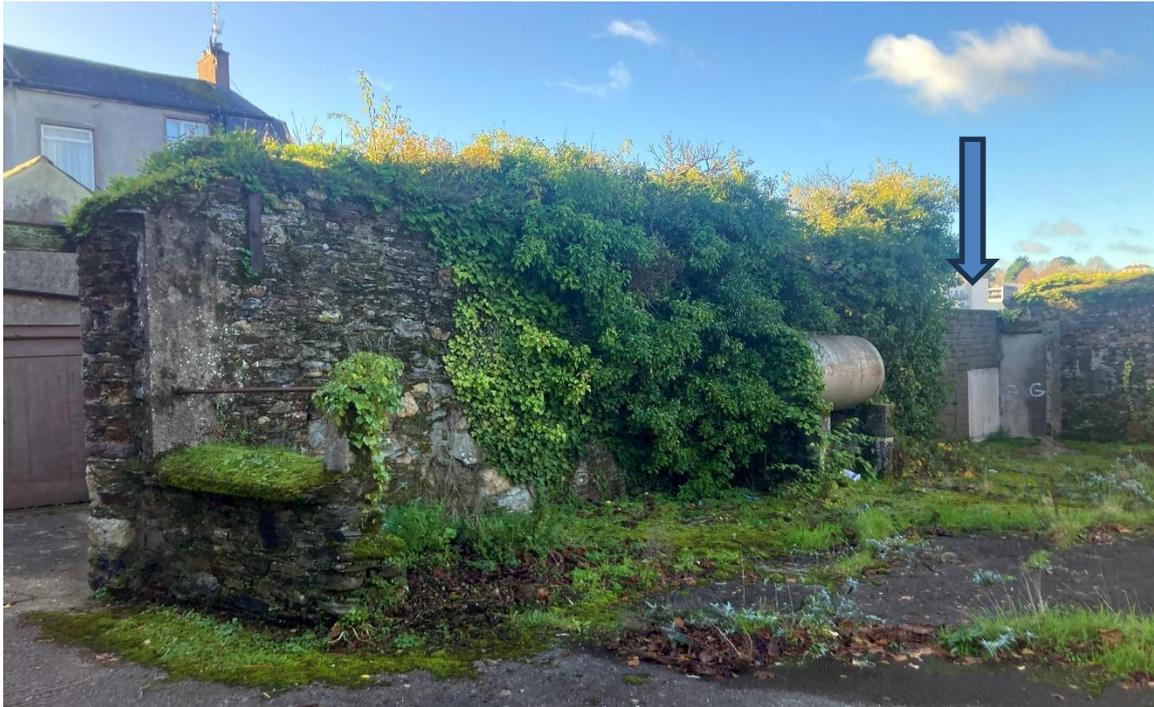
Fig.26: View from within the former coal yard showing the blockwork wall marking the north end of the vacant plot (arrowed).

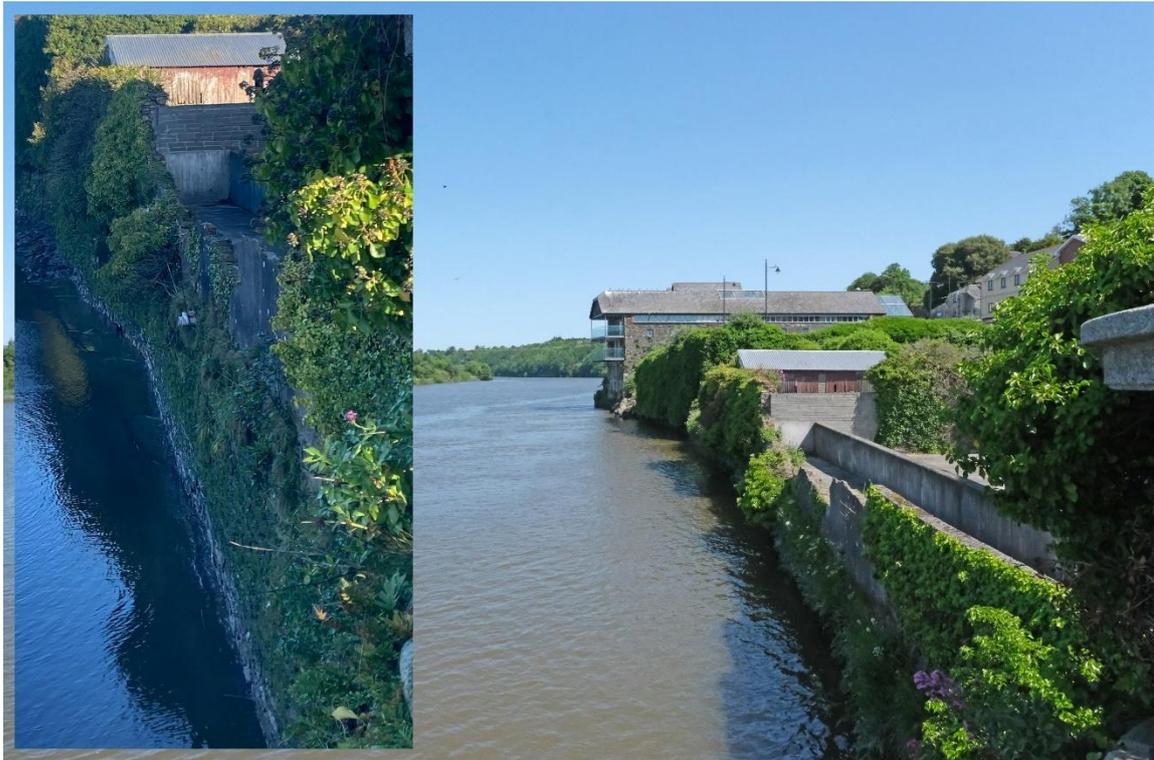
Fig.27: The riverside walls appear to be concrete replacing the former hotel buildings, with overgrown masonry appearing at the corrugated iron roofed structure (see Section 3.3).

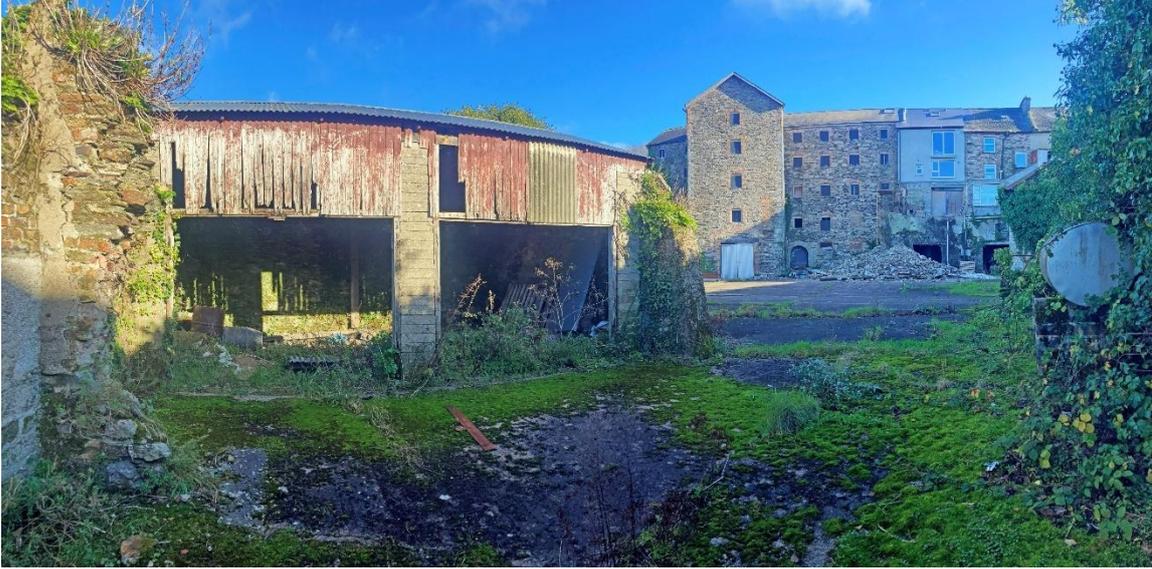
*Fig.28: View of the existing corrugated iron structure with the coal yard and John Street grain stores to the west.*

**Archaeological Monitoring** should be carried out of any ground disturbance works which take place as part of the development, and also recording of the masonry rubble wall of the corrugated iron-roofed structure prior to lowering of the upper parts. It should be borne in mind that if any significant archaeological remains are found during the construction phase, further archaeological mitigation may be required.

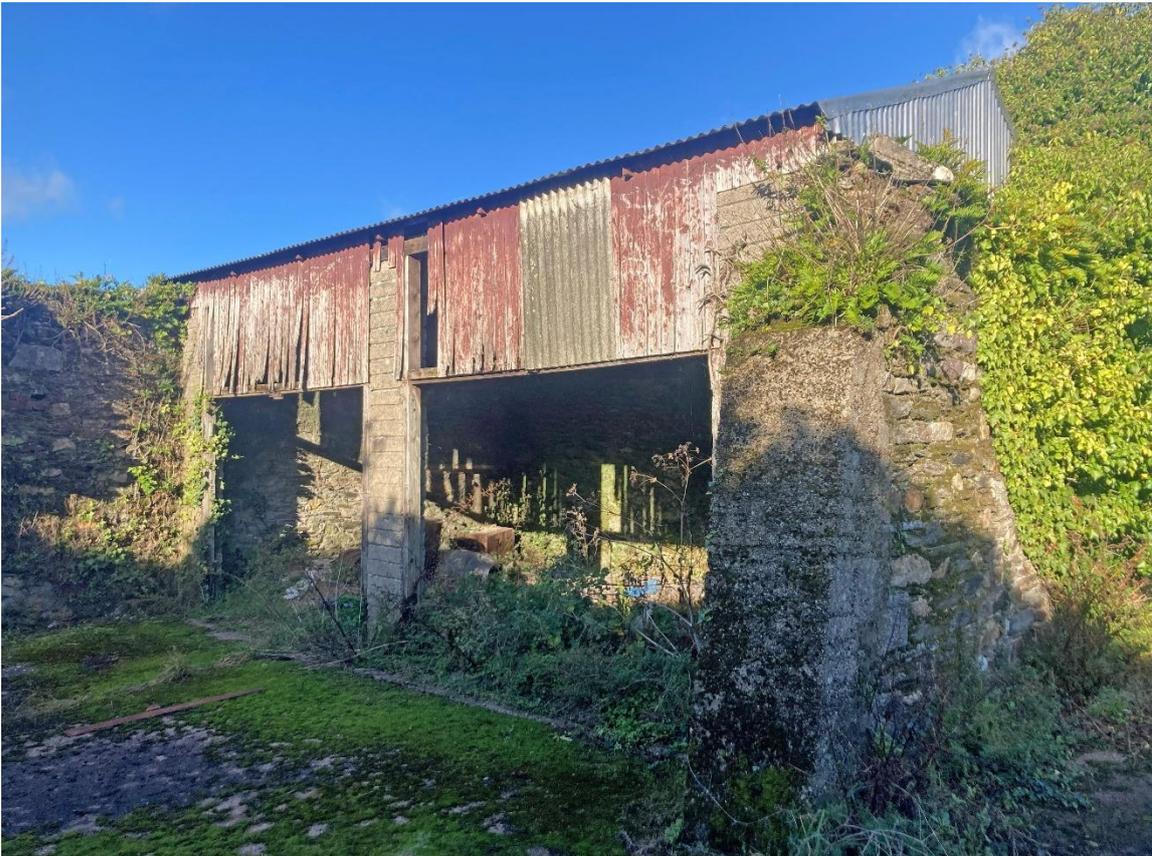
removed (Fig.31) to create a larger courtyard space in this part of the former coal yard, and a new corrugated iron-roofed structure erected. The concrete blockwork and mass concrete buttress indicates this is twentieth century work. There were **no indications of any above-ground features of archaeological significance** in this area.

*Fig.29: The south side was altered, with concrete blockwork piers introduced to support the corrugated iron roof structure, with a mass concrete buttress added at the south-east corner to act as the terminus of the existing masonry wall.*

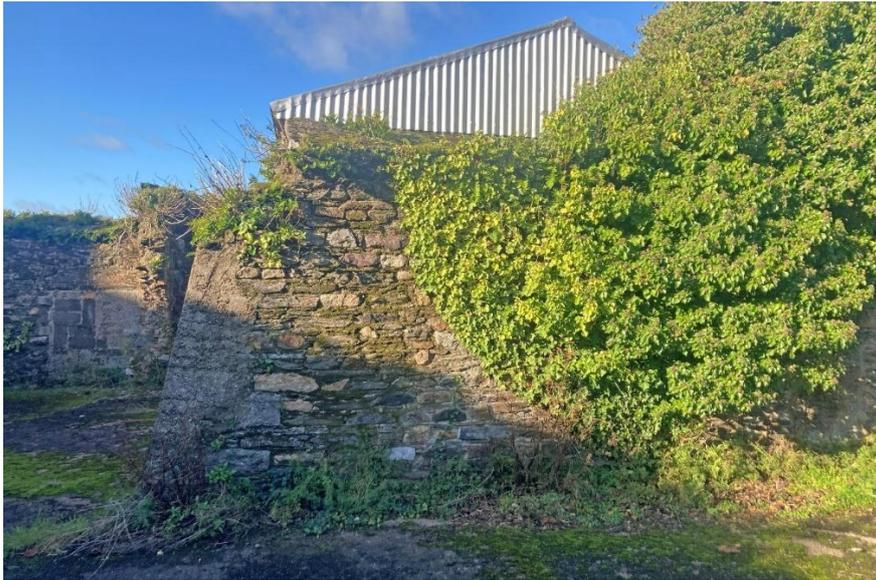
Fig.30: The east side consists of a traditional rubble masonry wall, with a mass concrete buttress at the south end.

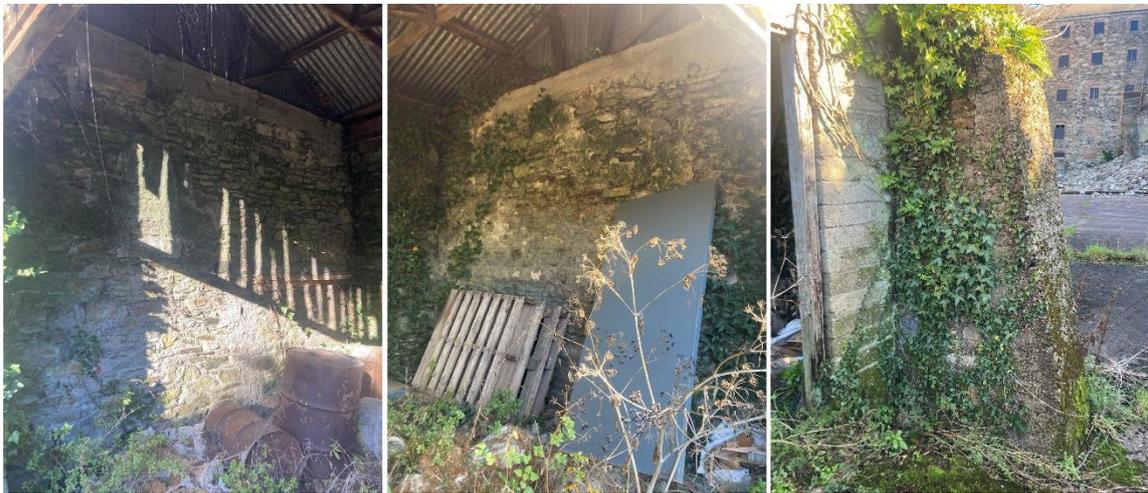
Fig.31: View of the interior of the corrugated iron-roofed structure.

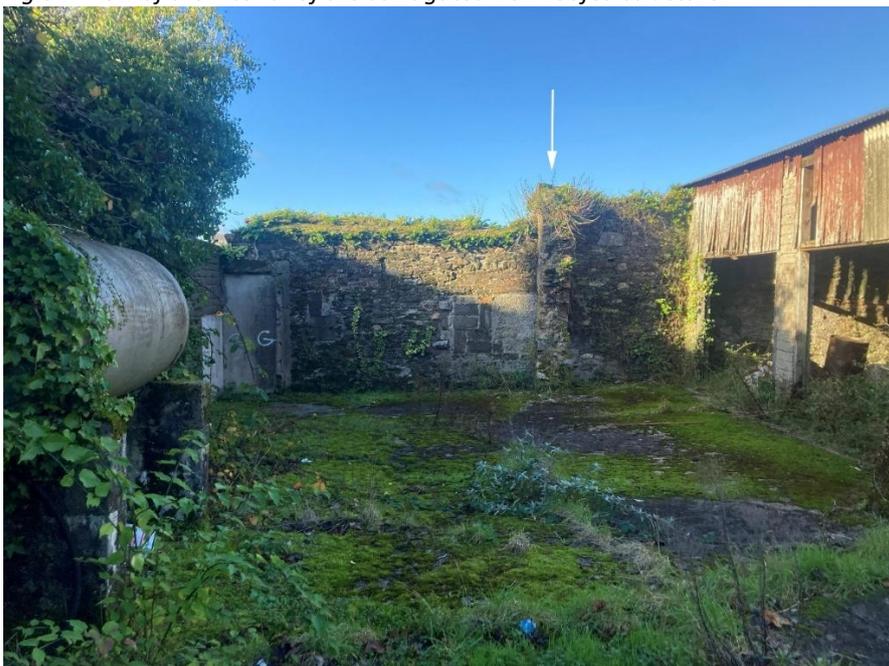
Fig.33: The nineteenth century building (Figs.8-9) was removed, and a smaller corrugated iron-roofed structure inserted into the space.

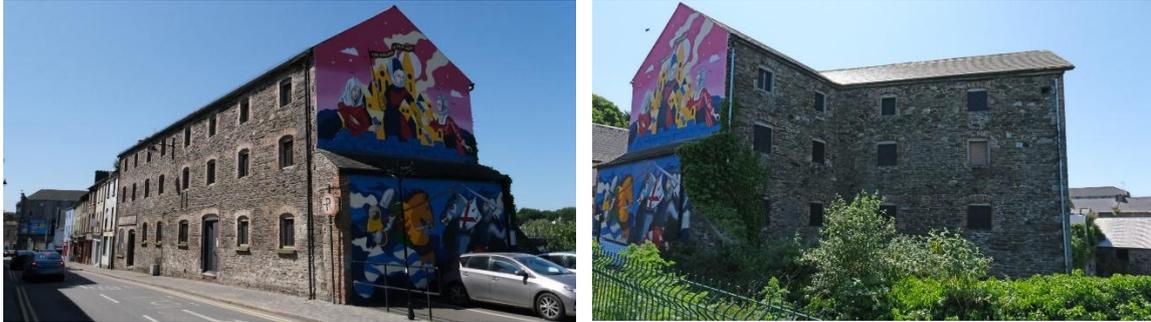
**3.4 Former Coal Yard:** The space consists of a concreted surface bounded by the John Street Grain Stores and the rear of existing buildings along John Street on the east side; masonry walls on the north and west sides; open space and the rear of existing structures to the south (see Planning-P-001 drawing). The existing ground surface consists of concrete, and there are no indications of the former lime kilns at the north end of the yard marked on nineteenth century maps (see Section 2.4). The northern part of the site consists of masonry retaining walls rising to the existing public car park on John Street. There were **no indications of any above-ground features of archaeological significance** in this area.

Fig.32: General view of the John Street Grain Stores and the proposed south-west entrance to the area via a new tiered staircase. The existing ground surface consists of a modern concrete, and the adjacent area is overgrown with vegetation and the ground surface is not visible.

**4.2.1 Ground Disturbance:** All ground surfaces within the public realm development are to be disturbed and renewed as part of the proposed development, as detailed on the accompanying drawings prepared by ODKM Architects. While the site appears to have been undeveloped in the medieval period as it acted as a garden area, there remains potential for medieval finds within the area. In addition, historical mapping (Section 2.4) notes a double lime kiln constructed during the nineteenth century which survived until at least the 1950s (Figs.11,23) and there are likely to be foundations from the now-demolished nineteenth century hotel which occupied the riverside plot. Removal of the existing surfaces on Bridge Street, at the new proposed entrance on John Street, and within the proposed plaza area and along the riverside has the potential to expose previous unsuspected archaeology. This has the potential to reveal previously unknown archaeological finds, features, deposits of structures; and the **all ground disturbance within the site should be archaeologically monitored by an appropriately qualified archaeologist under an excavation license.**

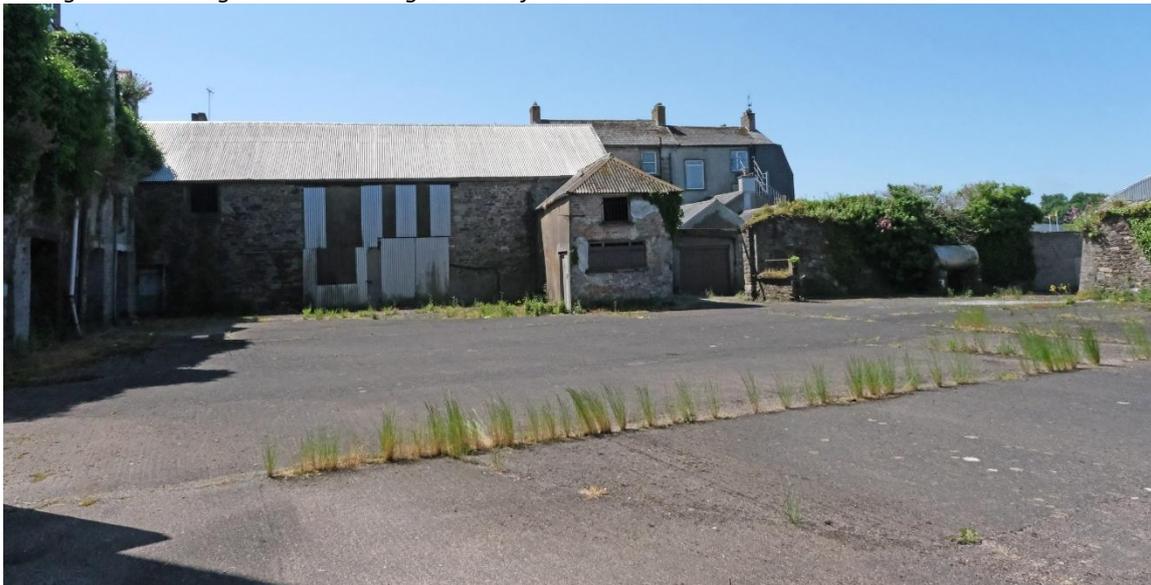
Fig.33: View looking south-west over the former coal yard.

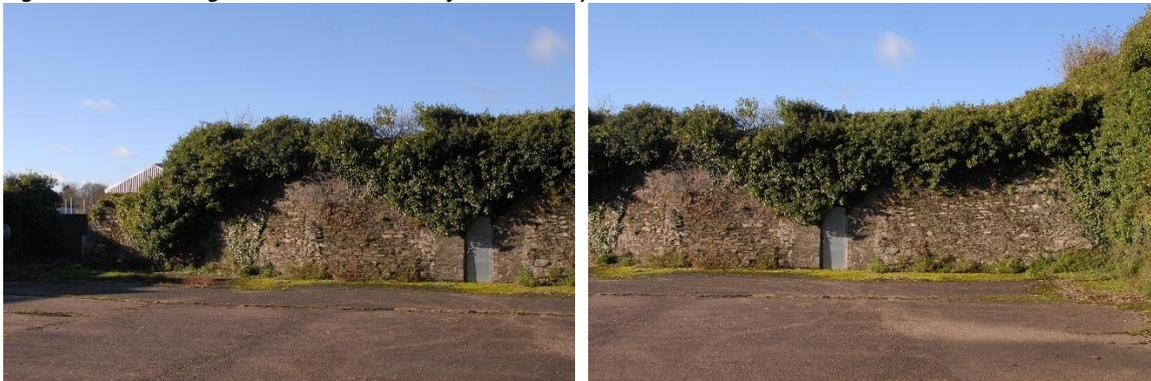
Fig.34: View looking west showing the rubble masonry wall separating the coal yard space from the former loading area (see Section 2.4).

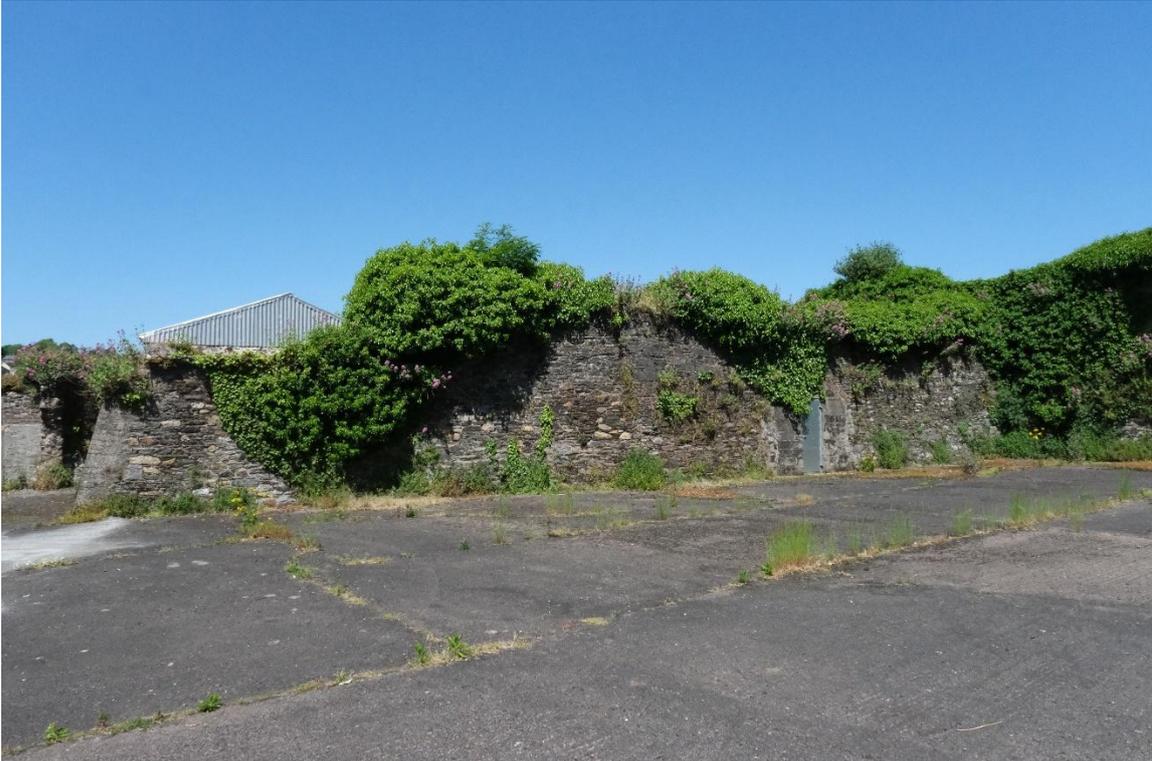
*Fig.35: View looking north-west showing the concreted ground surface with the rubble masonry wall separating the coal yard space from the former loading area (see Section 2.4) which is outside the red line boundary of the proposed public realm works.*
