## **Grain Store, John Street, New Ross, Co. Wexford: Archaeological Assessment**

Improvements to Public Realm to Bridge Street and lands to the rear and side of  
The Grain Store, John's Street, New Ross, Wexford

**November 2025**

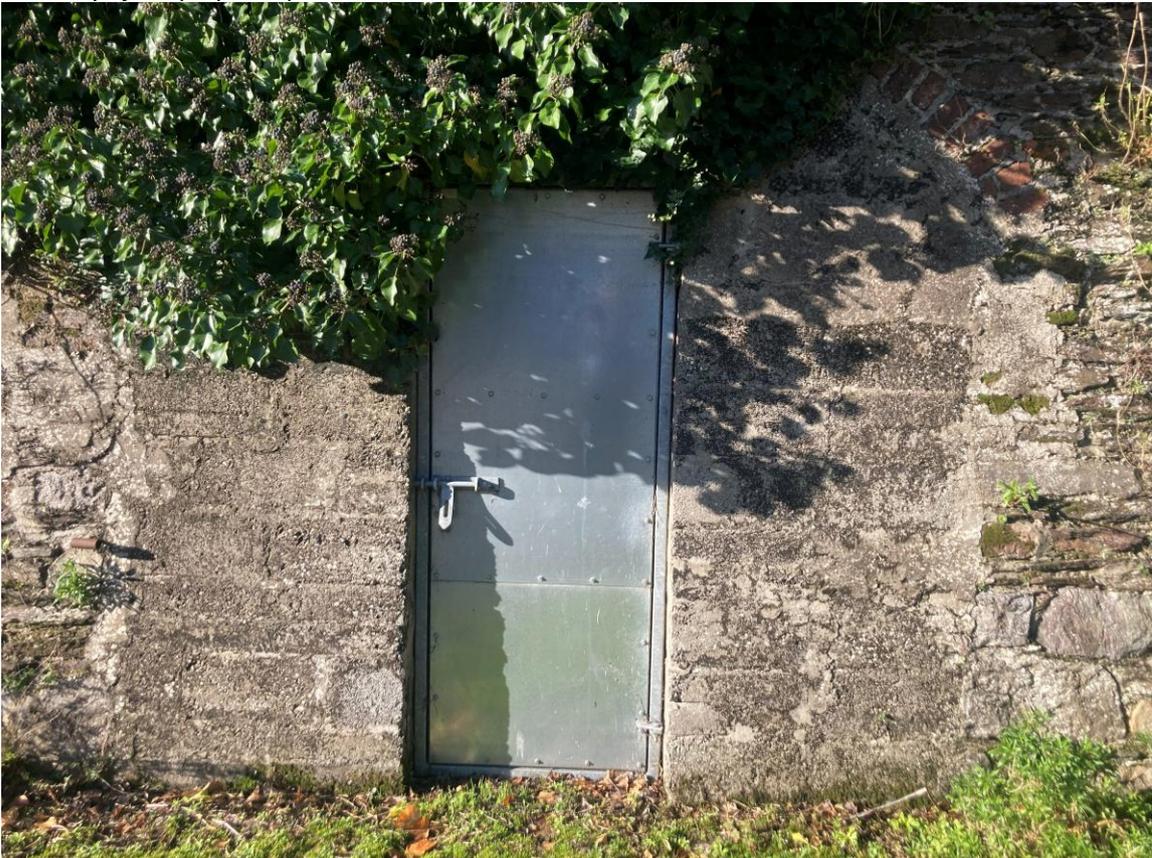
*Fig.36: Detail of Figs.34 & 35 showing concrete doorway in the rubble masonry wall.*

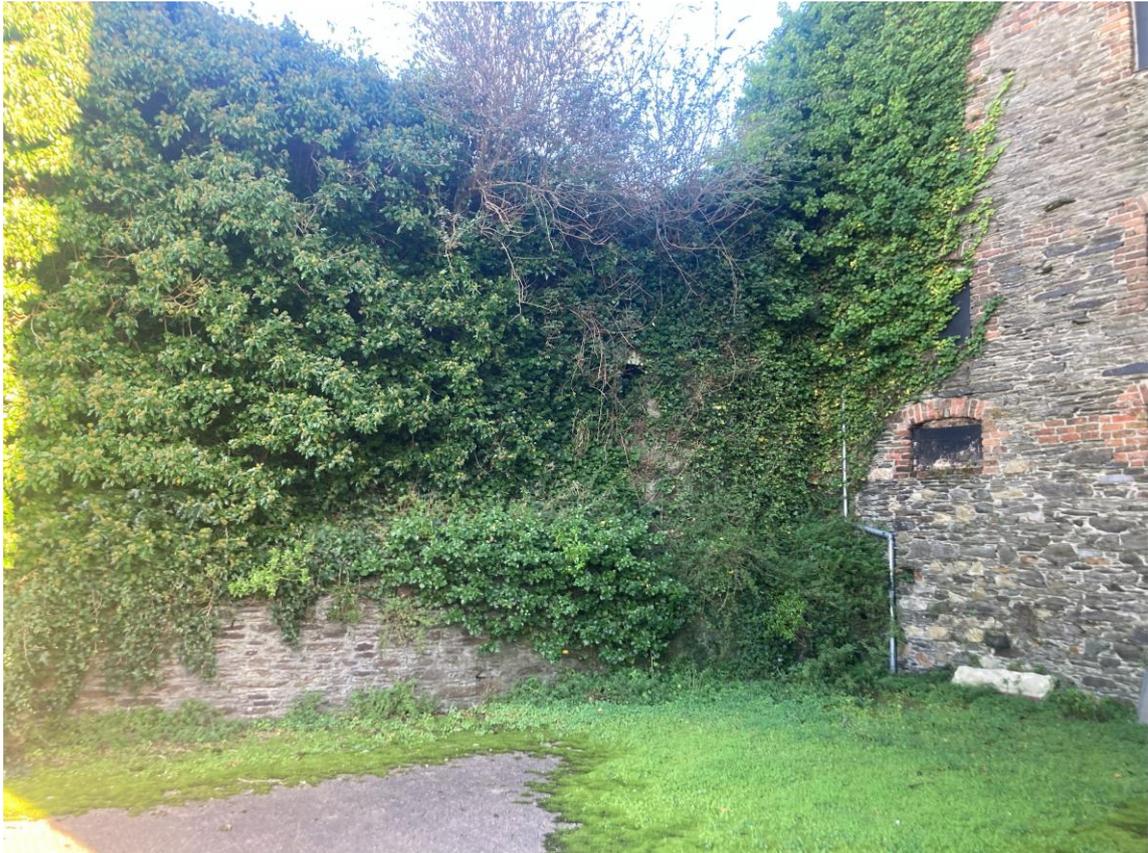
*Fig.37: Proposed location of the tiered steps at the south-east corner of the site rising to John Street.*

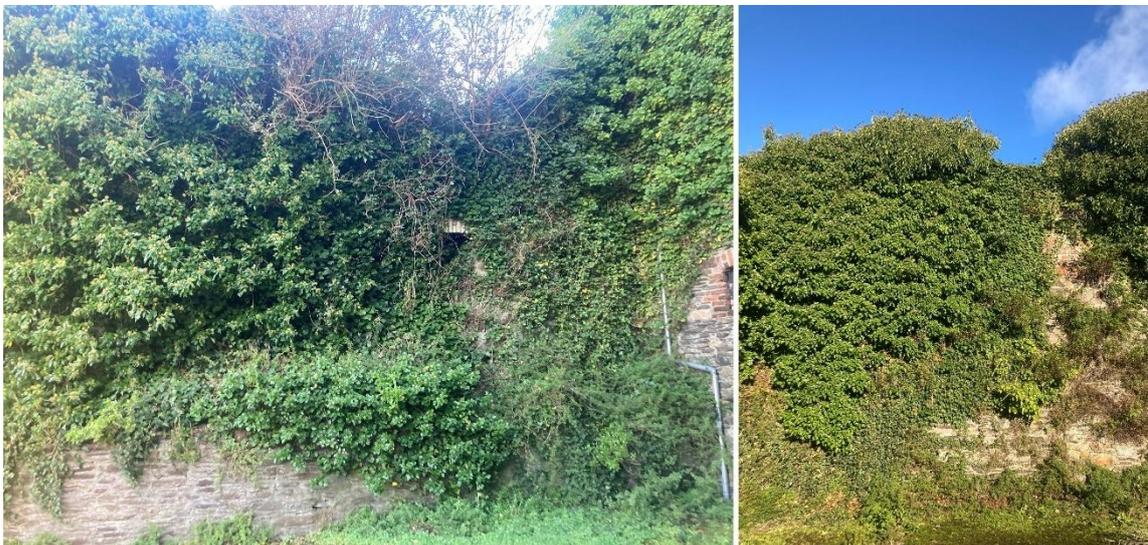
*Fig.38: The north wall of the site consists of a rubble masonry wall. The area is obscured by well-developed mature vegetation.*

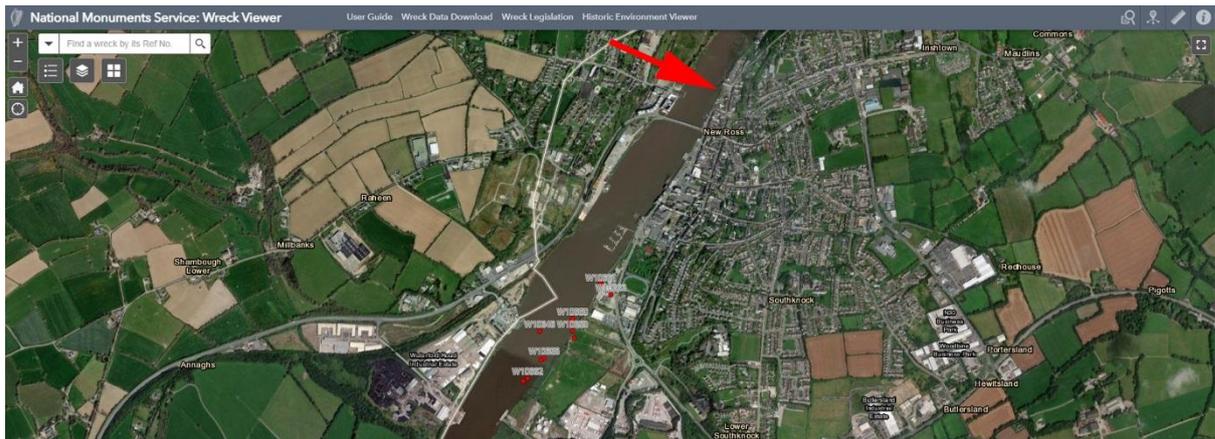
Fig.A1: Screenshot from the National Monuments Service Wreck Viewer showing recorded shipwrecks at New Ross<sup>28</sup> located some distance downstream of the development site.

Wreck Number	Findings
W10643; W10644; W10645; W10646; W10647; W10648; W10658; W10659; W10660; W10661; W10662; W10663	Unknown. No descriptive details available at the National Monuments Service: Wreck Viewer.
