Conservation    Research    Analysis

## Grain Store, John Street, New Ross, Co. Wexford

Architectural Heritage Assessment

January 2024

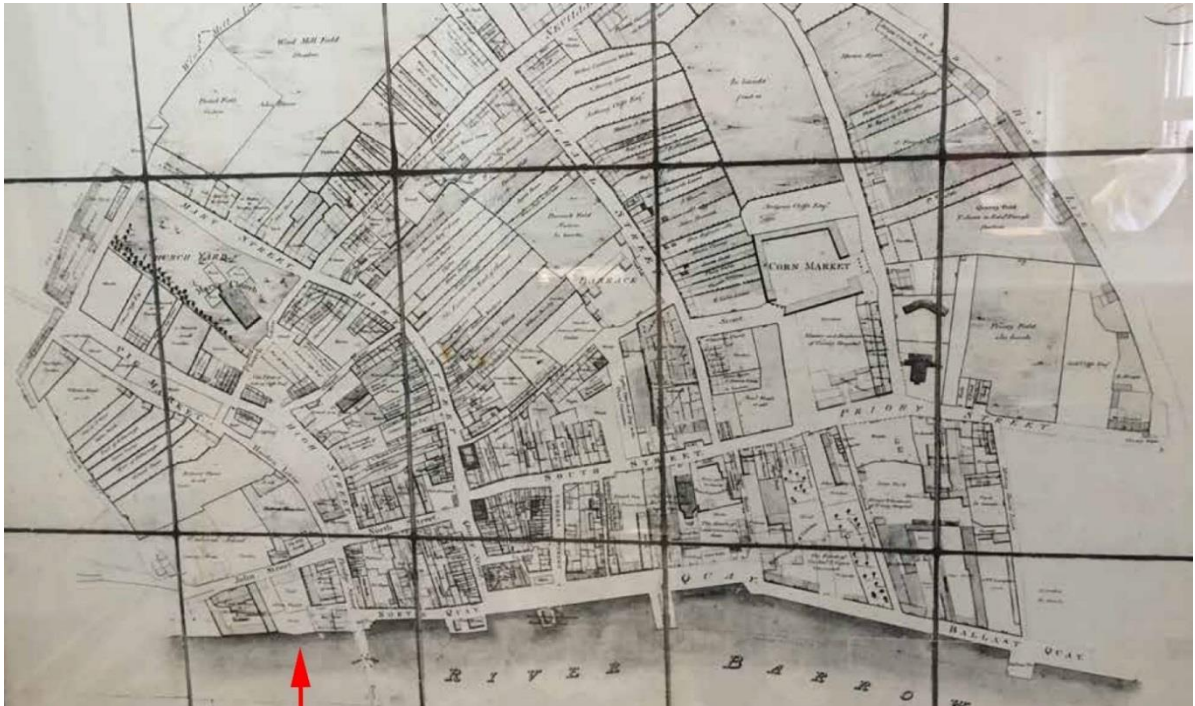
Fig.6: 1827 Tottenham Estate rent-map of New Ross showing the John Street site with a line of buildings on John Street, overlooking an open courtyard and river wall. The map shows quite a number of plots in use as gardens or waste land, with relatively dense settlement in the built-up areas.

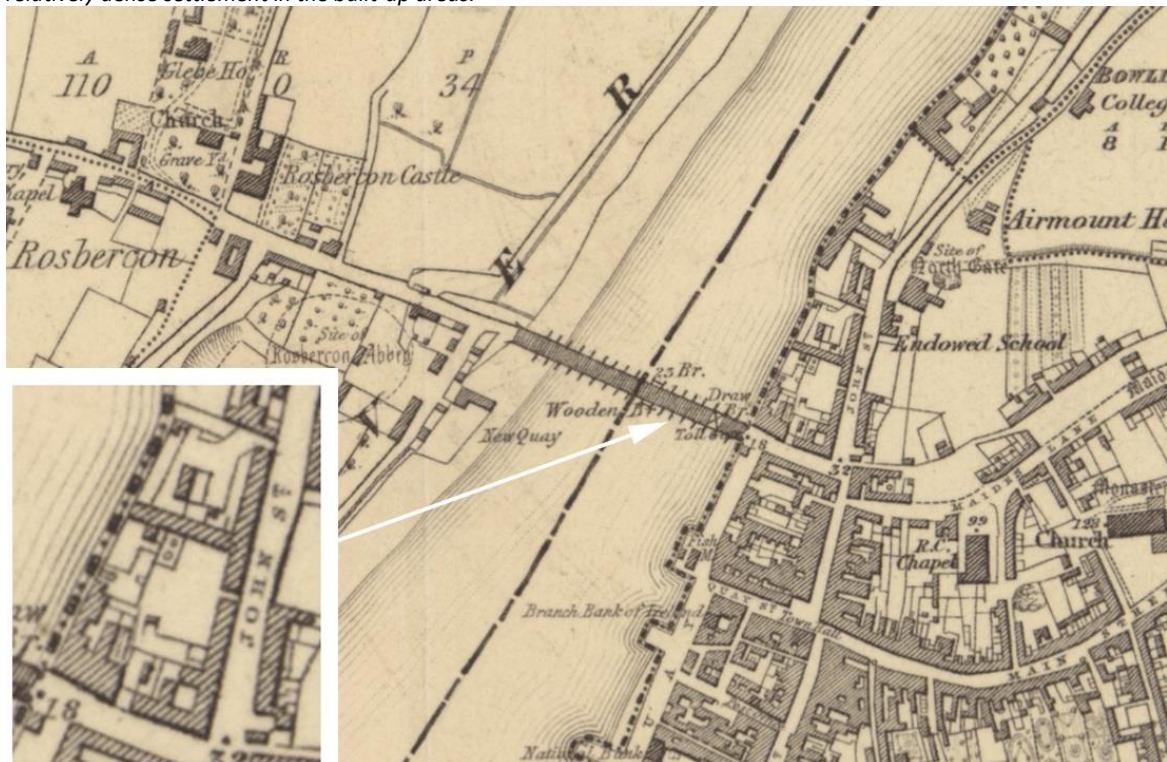
Fig.7: First edition Ordnance Survey map c.1840 showing the layout of the site, with terraced buildings with a passage on John Street, an open courtyard lined by walls and other buildings between the site and the River Barrow; and with a passageway to Bridge Street.

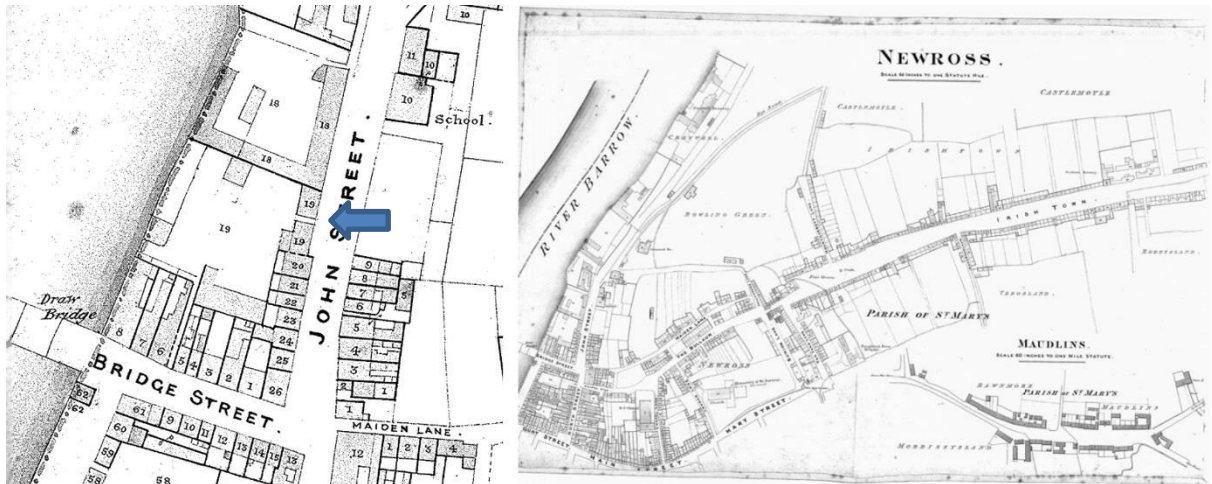
Fig.8: Mid-nineteenth century Griffith's Valuation (1847-64) map of New Ross showing the layout of the site; with two narrow buildings on John Street, overlooking an enclosed courtyard below and the river frontage.

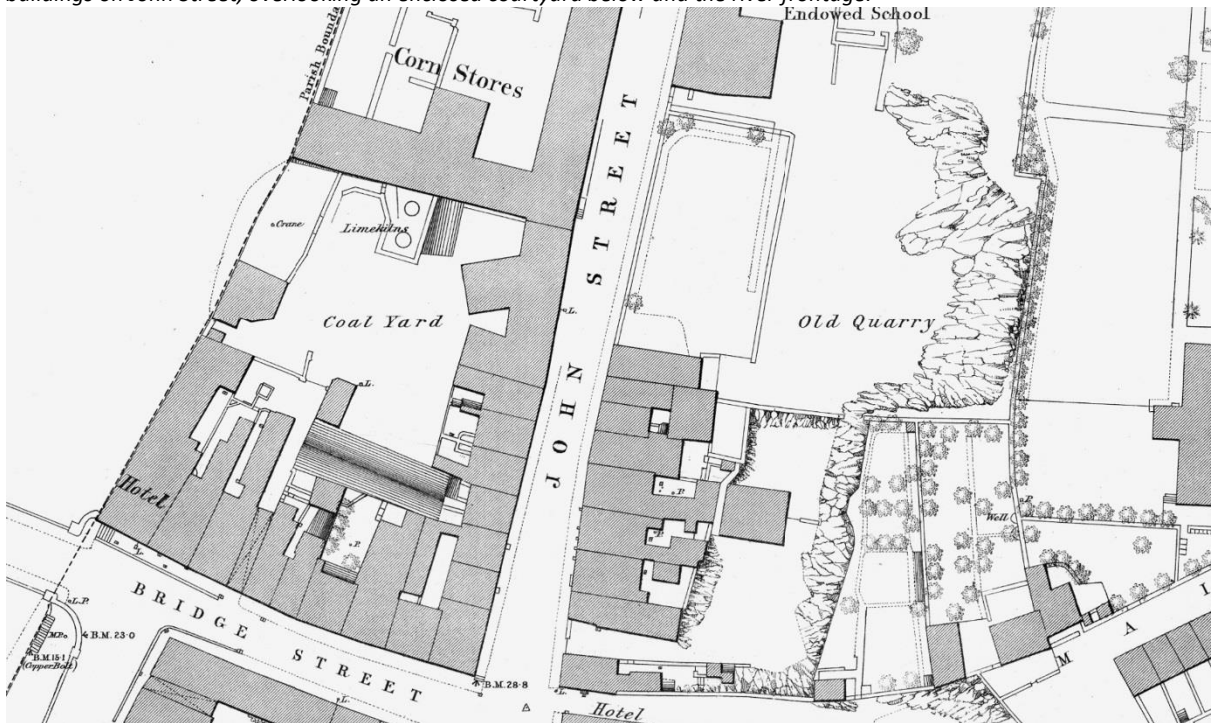
Fig.9: 1881 Ordnance Survey 25-inch map showing redevelopment with a new large grain store with off-set return to rear.

overlooking a coal yard with lime kilns built against the north wall, and with crane in a separate enclosure beside the river, and with a passage to a watergate and a separate passage to Bridge Street (Fig.9). Historic photographs held by the National Library of Ireland (Figs.10-11) show the west (river-facing) elevation of the Grain Store appearing very similar to how it appears today.

**4.3 Summary:** The Grain Store appears to have been built sometime c.1864-1881, replacing two earlier buildings on the site. The grain store was operated by William Howlett, a corn merchant, who also burnt lime as agricultural manure in the courtyard (Fig.9). The Grain Store formed part of a commercial property dedicated to bulk commodities, and the link to the quayside and the River Barrow (Fig.11) was essential for the functioning of the building. The rear elevation of the building appears little changed since the opening decade of the twentieth century, and the site appears to have maintained its overall character as a working element of New Ross’s industrial heritage.

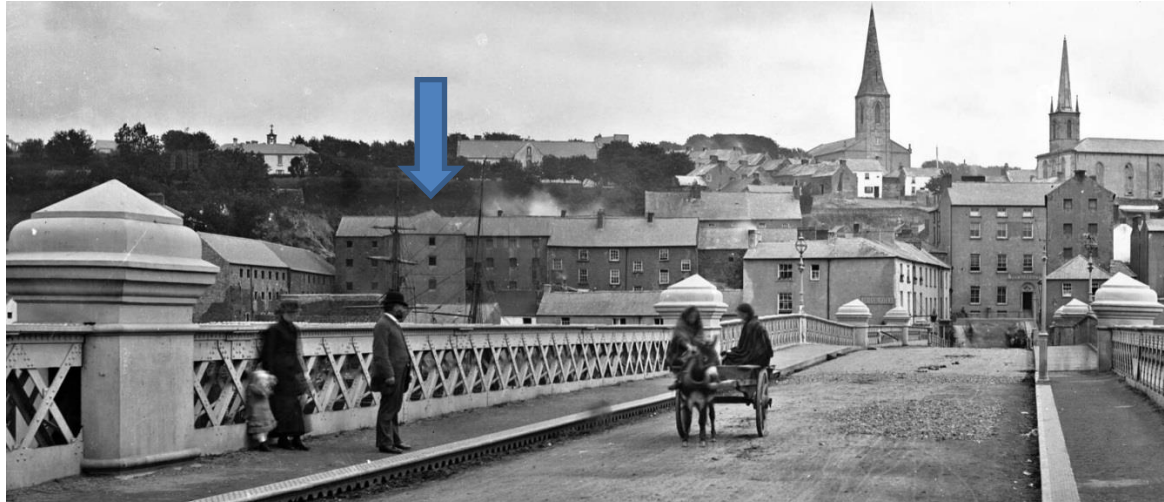
Fig.10: Photograph of New Ross by Robert French, c.1936 showing the Grain Store. Source: National Library of Ireland.

Fig.18: General view of the five-storey rear elevation (three floors at John Street level, and two basement levels) composed of random rubble masonry walls punctuated by camber- and segmental-headed brick windows, with granite used for the quoins of the return and for the arched doorway. The elevation shows a number of small repairs and alterations, but is largely unchanged from its appearance at the beginning of the twentieth century (compare Figs.10 & 11).

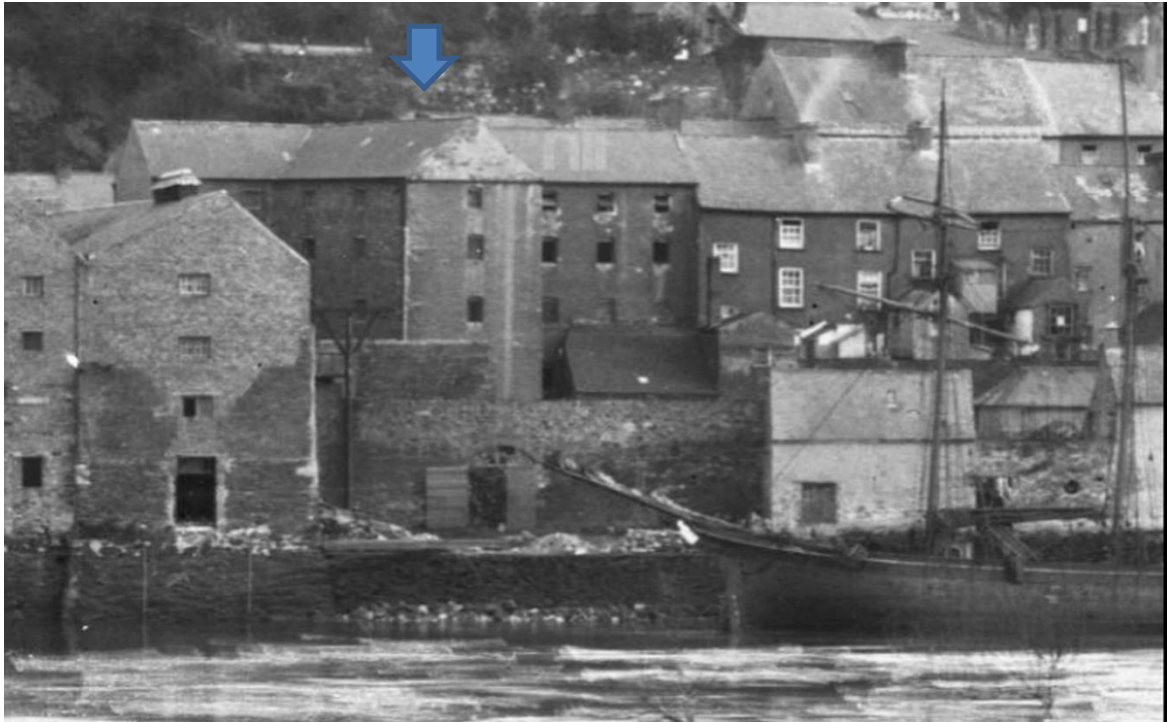
Fig.11: Photograph of the Grain Store by A.H. Poole c.1906. Source: National Library of Ireland.

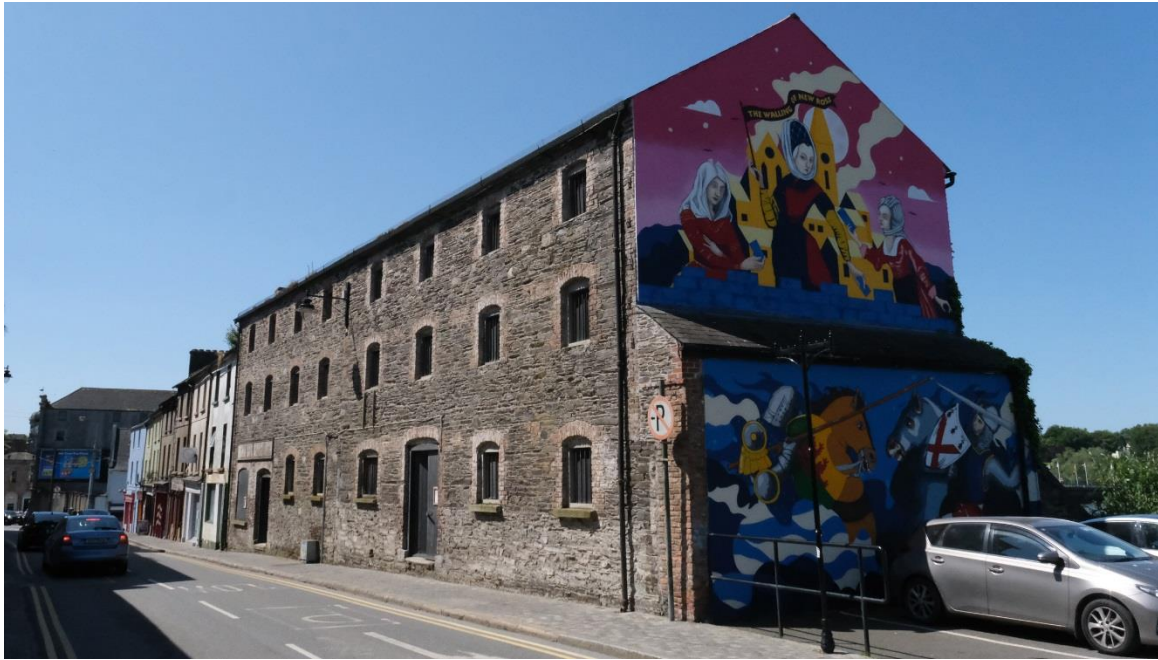
*Fig.12: General view of the façade and north gable of the Grain Store.*

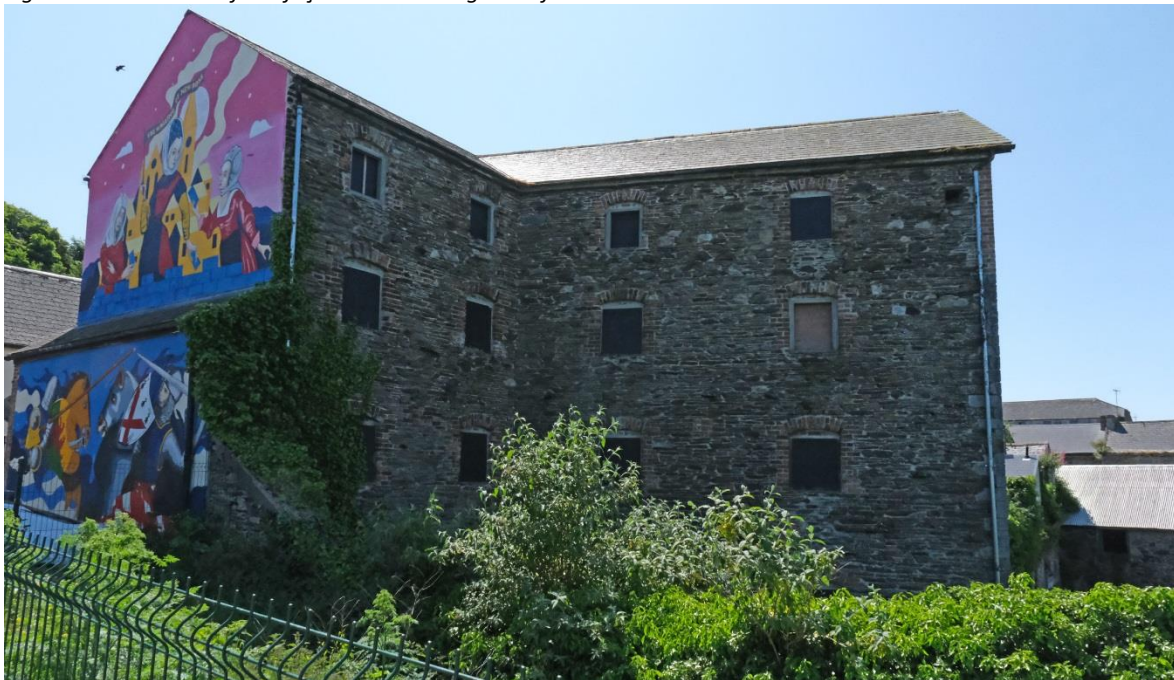
*Fig.13: North elevation showing off-set return, mural on the north gable and slated roof and rainwater goods.*

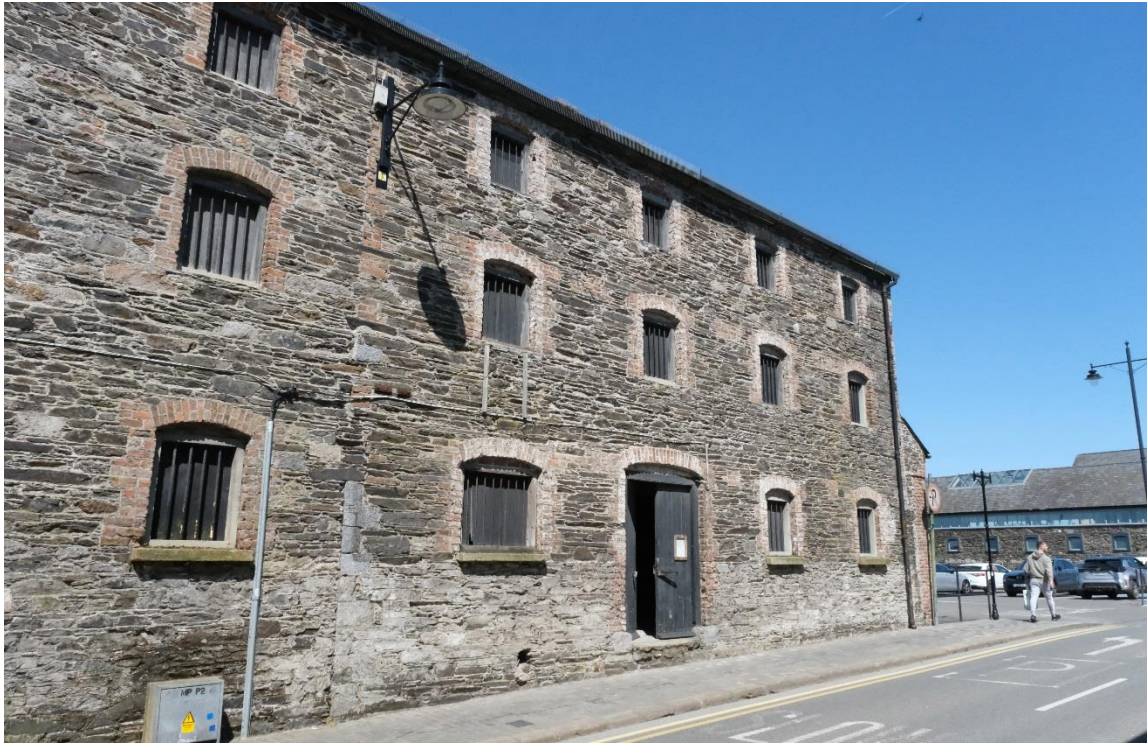
*Fig.14: View of the northern part of the façade showing limestone quoins at ground floor level marking the separation between the two buildings, with matching treatment of masonry and detail in both parts.*

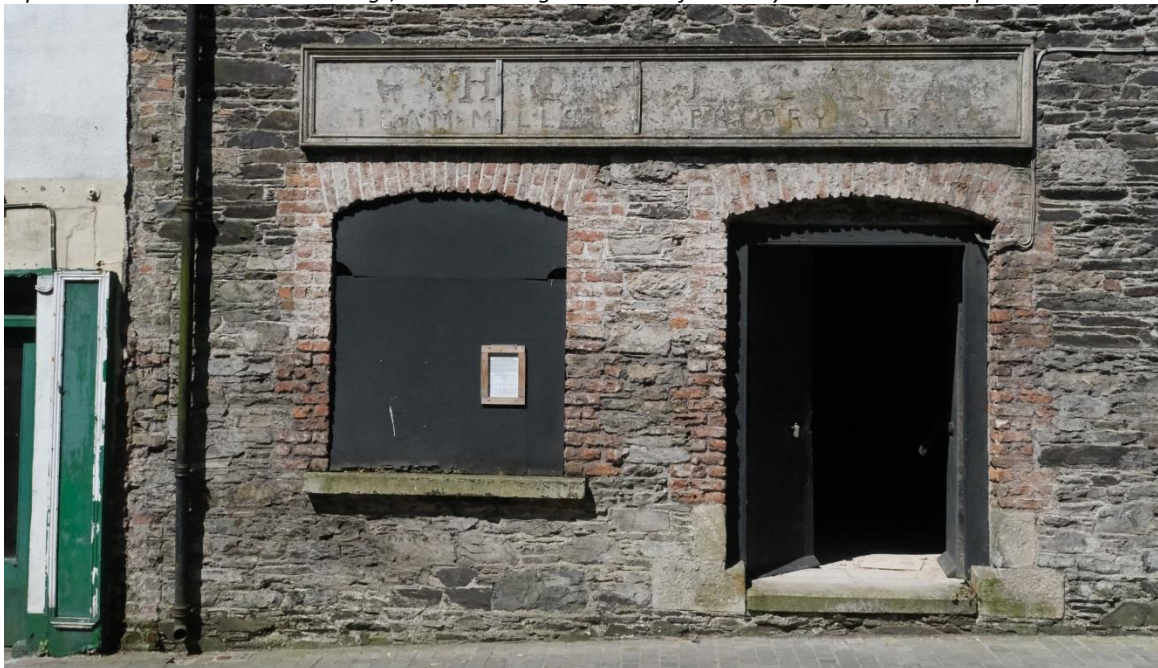
*Fig.15: Ground floor window and doorway at the south end of the façade with signage plate above.*

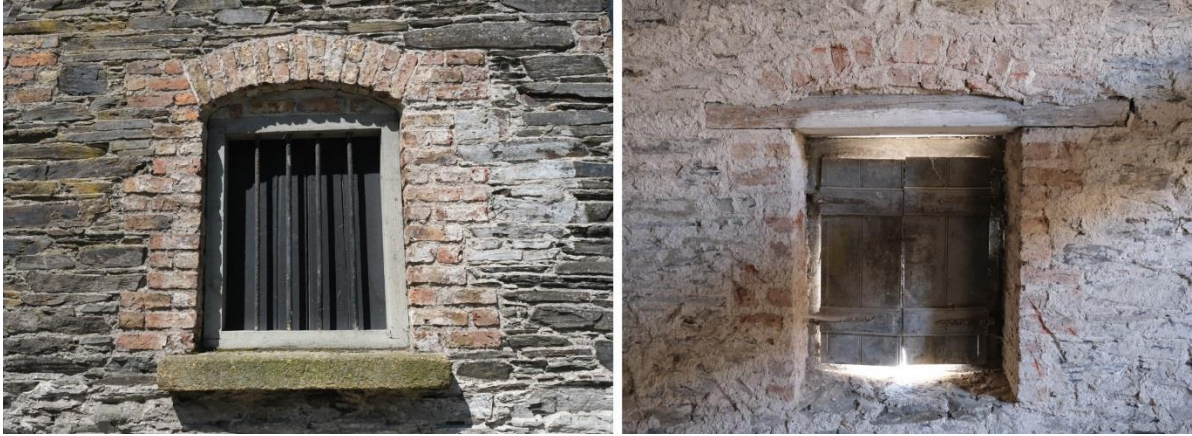
Fig.16: Detail of the external and internal faces of a typical window.

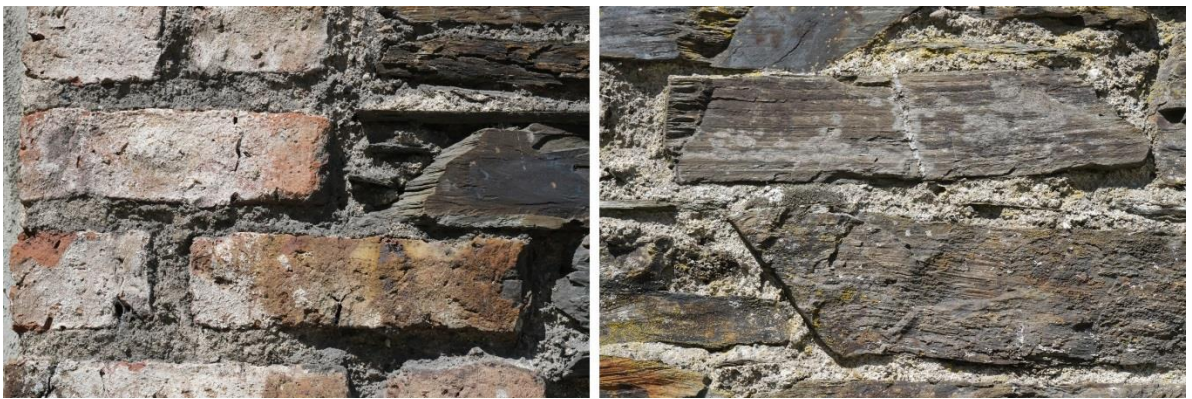
Fig.17: Detail of hand-made clamp-fired brick used to form door and window openings (left) and a detail of the locally obtained rubble stone used for the bulk of the masonry fabric (right) all bedded in a lime-based mortar.

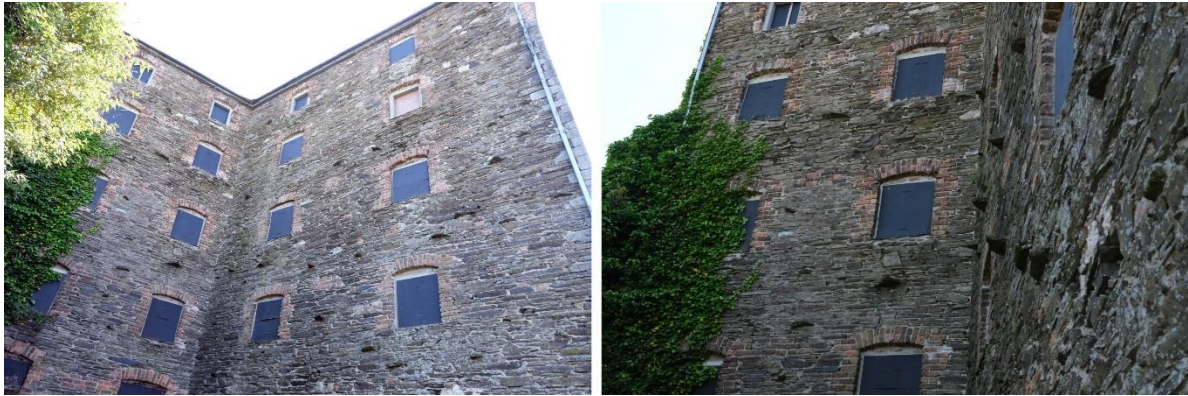
Fig.19: The north elevation of the off-set return and adjacent west elevation of the main building is again composed of random rubble masonry punctuated by brick window openings, but with projecting rough stone corbels arranged in a diagonal pattern (probably to support chutes) which are a distinctive feature of the elevation.

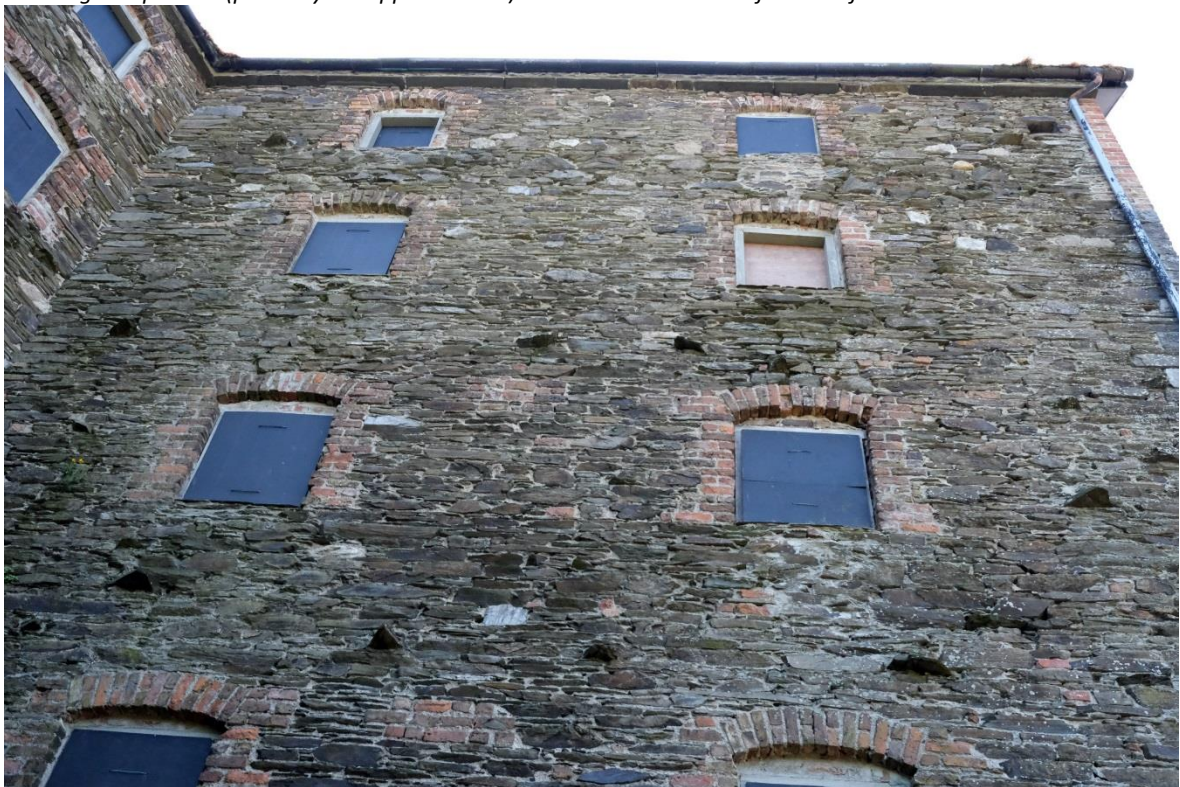
Fig.20: North elevation of the off-set return showing projecting rough corbels.

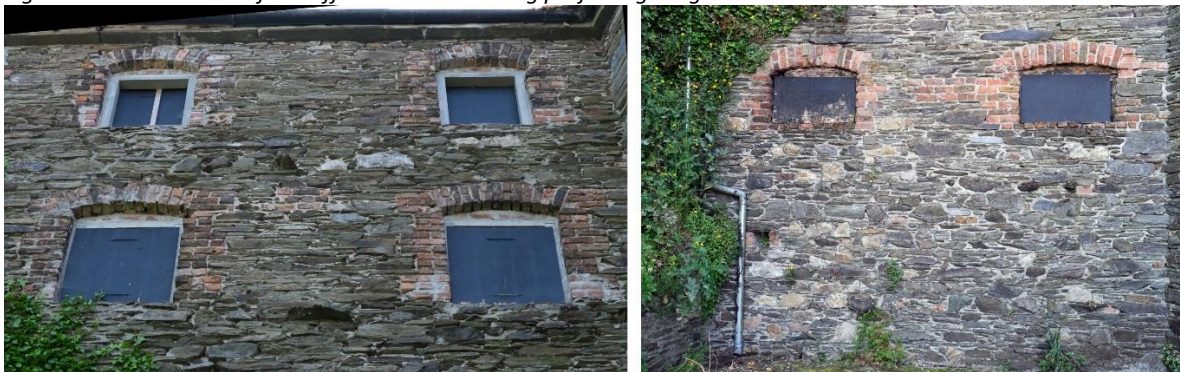
Fig.21: Details of the northern end of the west elevation showing the overhanging eaves course supporting the cast iron rainwater goods, brick window surrounds, and projecting rough corbels from the random rubble masonry walls.

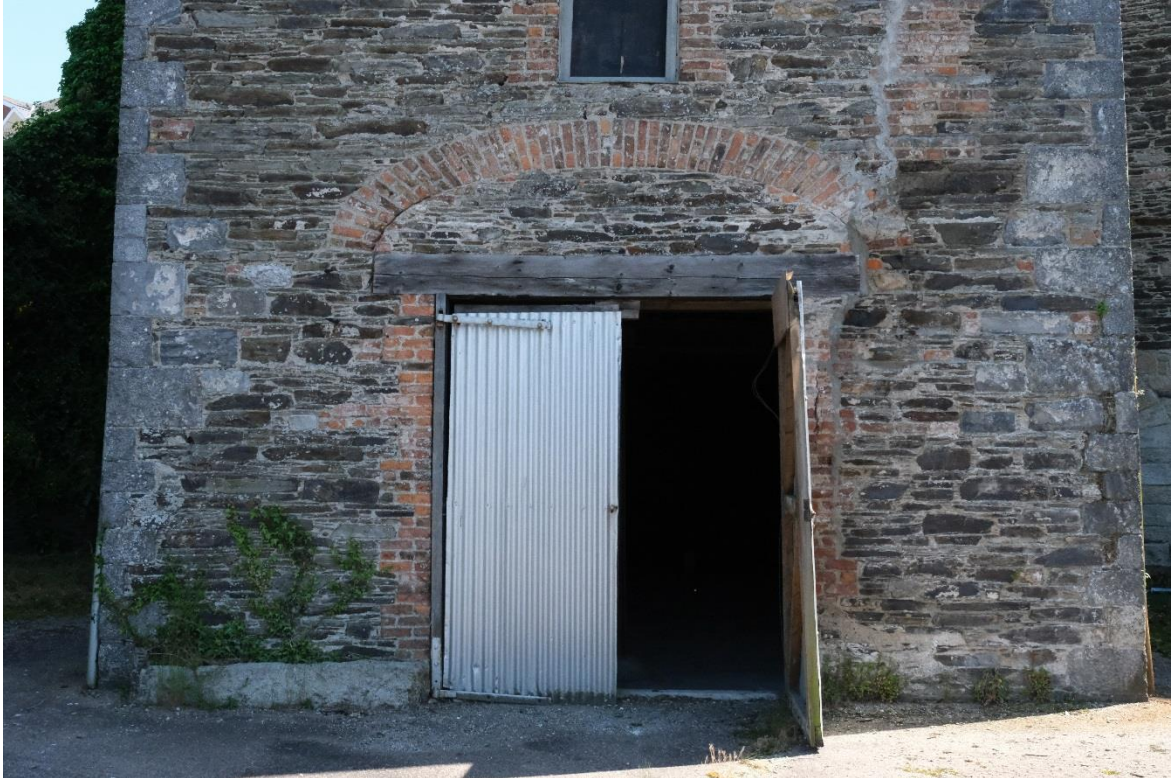
Fig.22: The courtyard level door of the return has a massive timber lintel and rubble masonry infill beneath a brick arch, with brick quoins. The elevation has limestone quoins (see Fig.14 also) and past repairs.

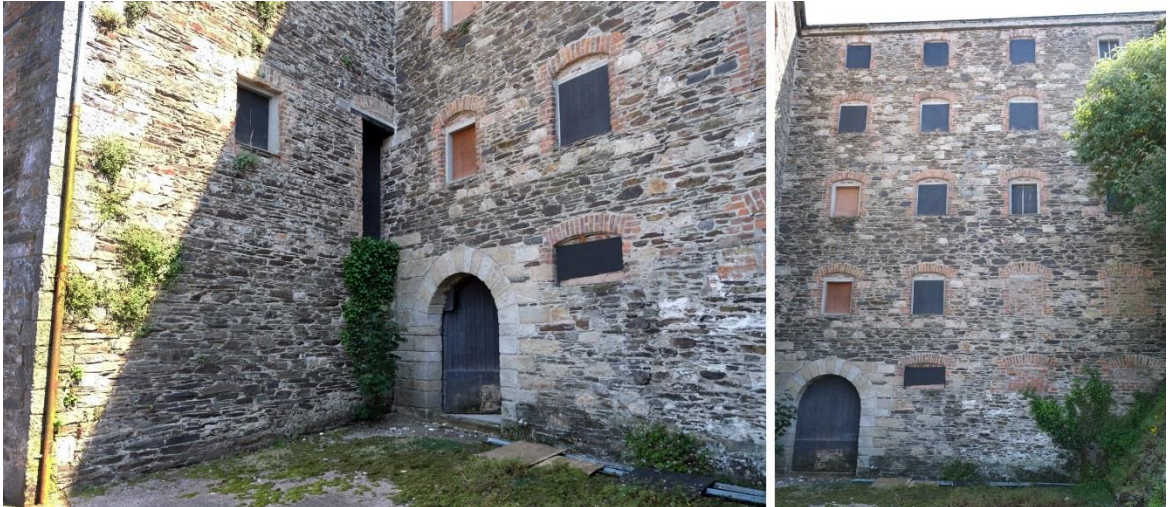
Fig.23: View of the junction between the north elevation and the offset return showing a granite ashlar doorway at ground floor level, with brick windows and rubble masonry mirroring that seen elsewhere on the building.

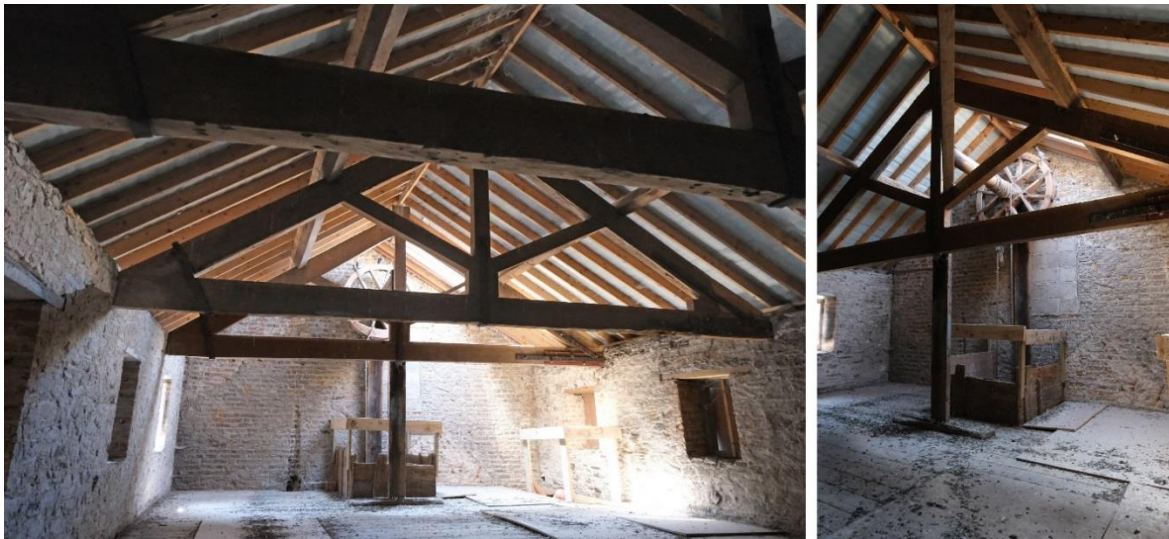
Fig.25: Top floor showing bare rubble masonry walls, roof timbers, and timber floorboards. Note blocked-up south window to rear of the winch. The window reveals have timber lintels, and some internal timber shutters survive.

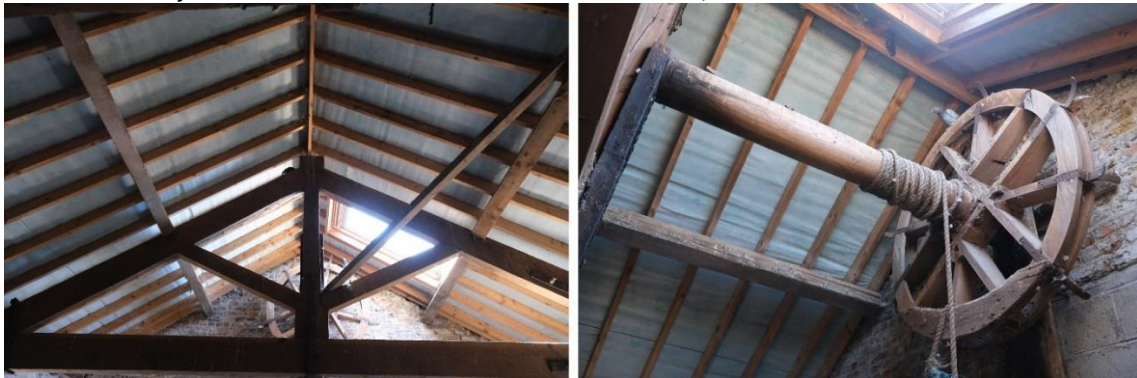
Fig.26: Detail showing replacement roof cover (left) and winch.

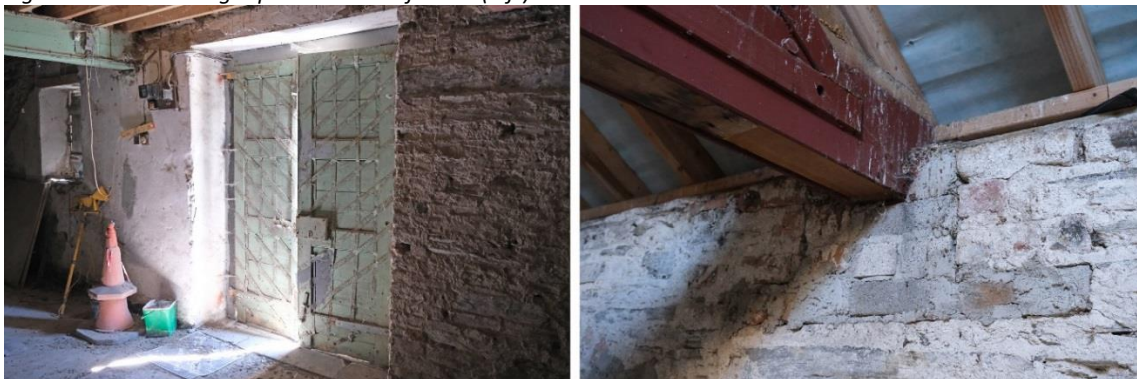
Fig.27: John Street level interior showing the southern doorway (left) which is a plain panelled timber door. The roof has been replaced, including replacement of roof timbers and the addition of bracing to existing timbers (right).

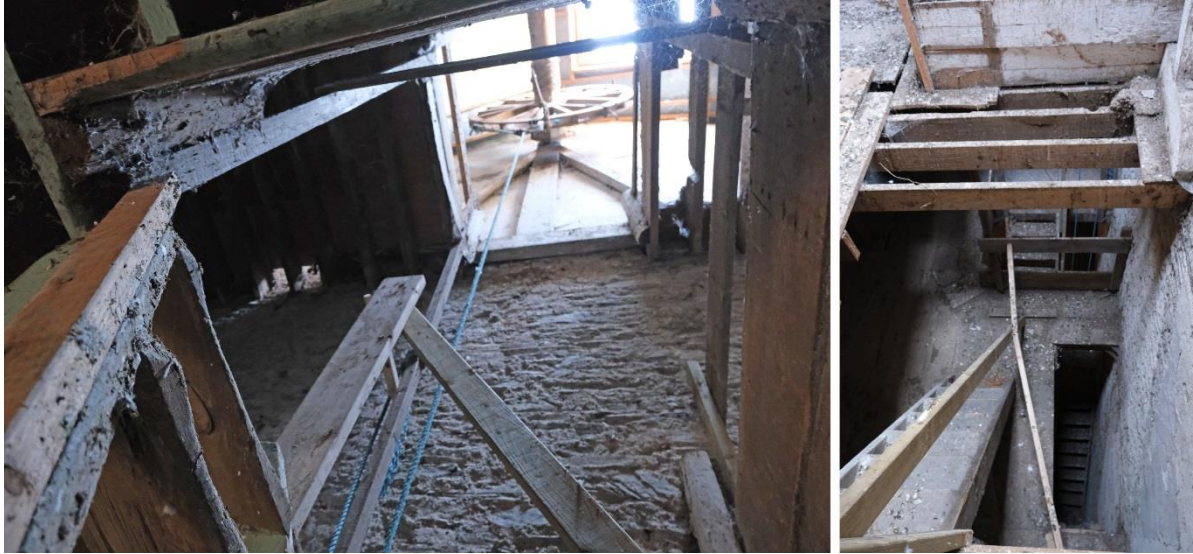
Fig.28: View of the winch shaft (left) and internal staircase (right).

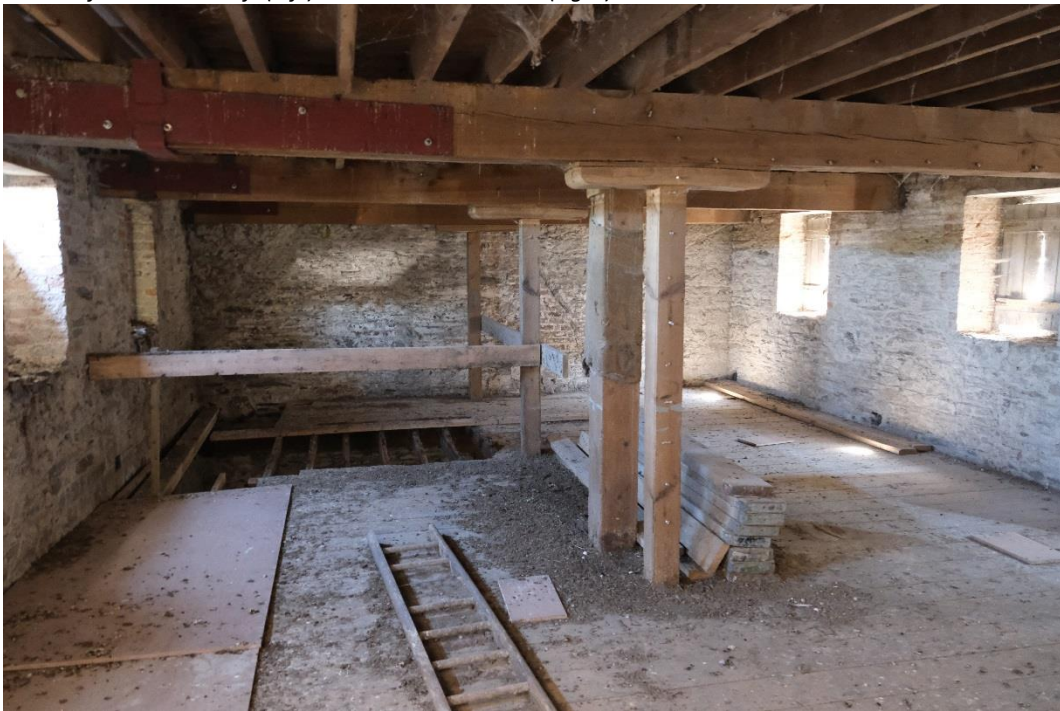
Fig.29: The interior is plain and unfurnished without wall or ceiling finishes, with plain rubble walls and window reveals throughout, sometimes retaining timber shutters.

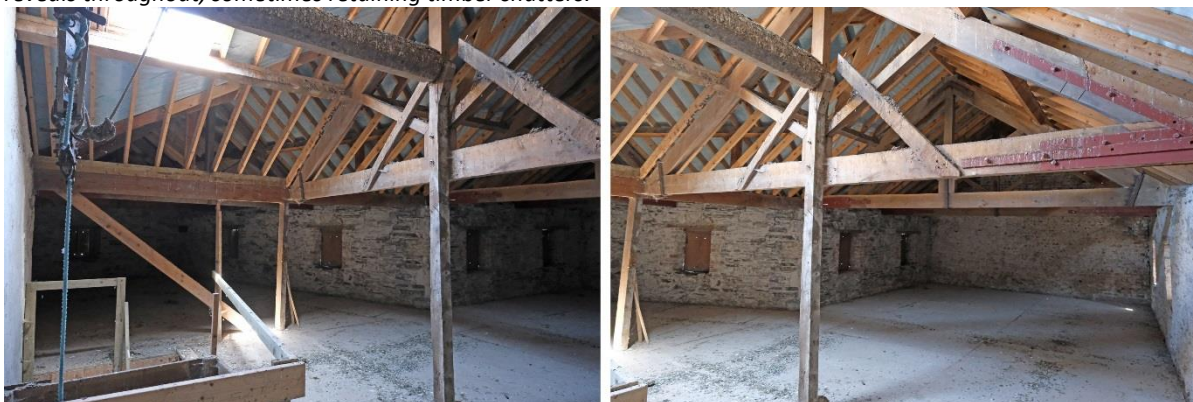
Fig.30: General view of the interior showing floor covering, plain walls and window reveals, and floor joists supported by structural timbers with steel bracing and timber columns.

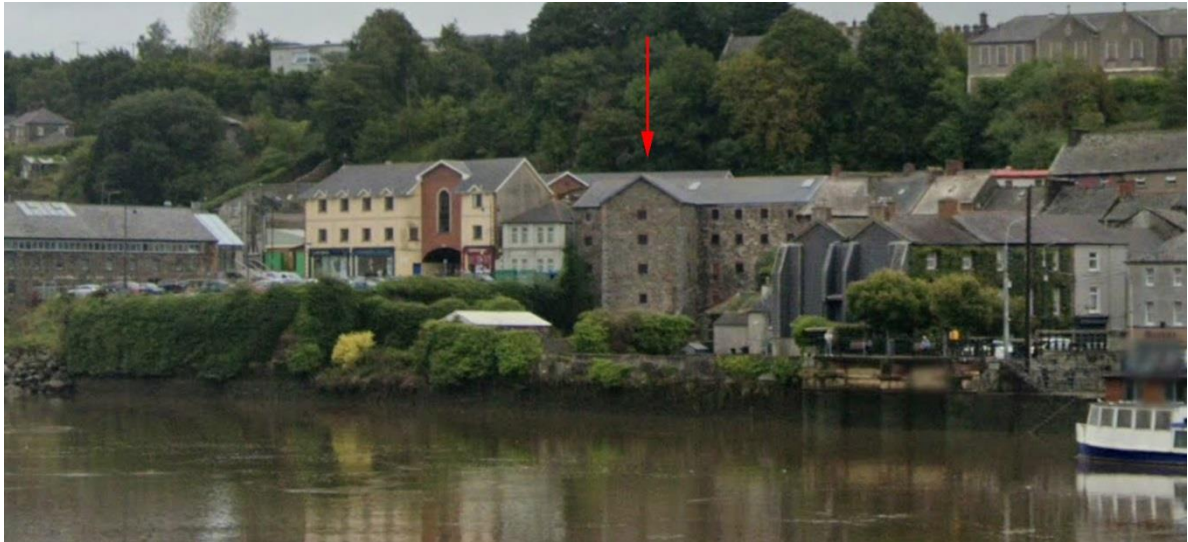
Fig.32: View of the grain store from the bridge. The external lift will be visible. The café/restaurant will be marginally visible.
