**GEOTECHNICAL & PEAT
STABILITY RISK
ASSESSMENT REPORT**

LEMANAGHAN WIND FARM, CO. OFFALY

Geotechnical & Peat Stability Risk Assessment Report

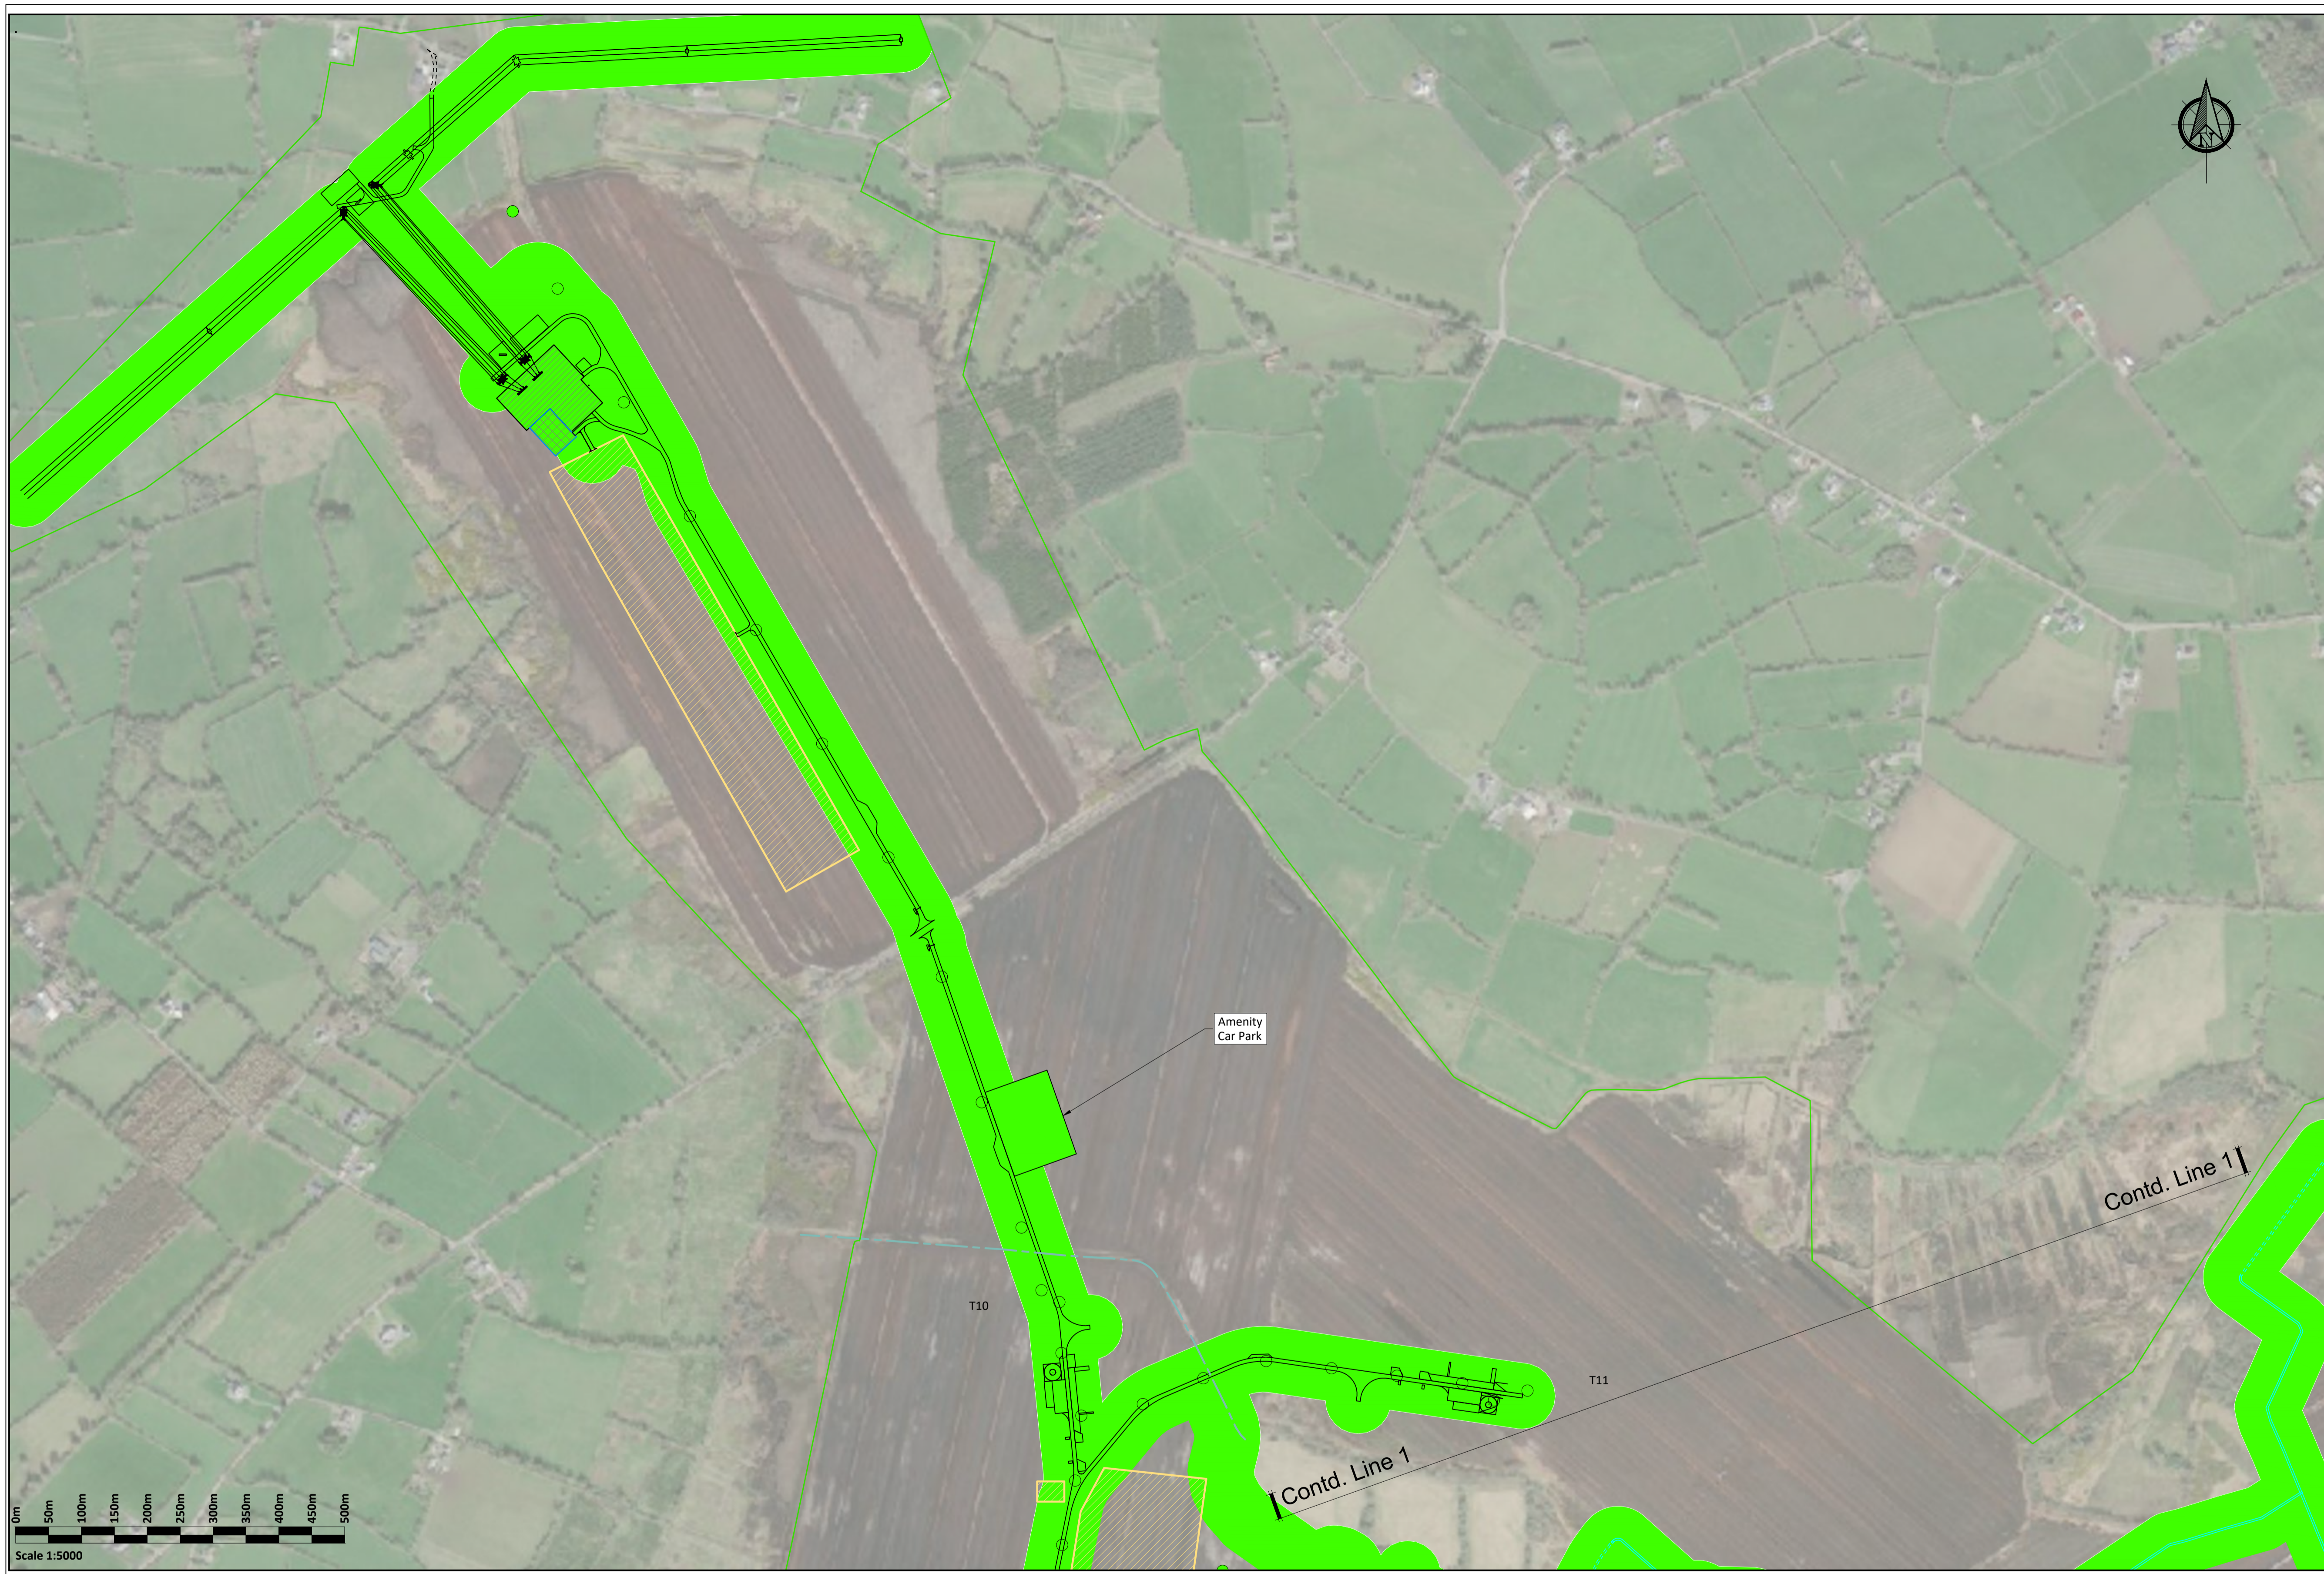
- Factor of Safety Legend:**
- 0 < 1.0 ■
 - ≥ 1.0 < 1.3 ■
 - ≥ 1.3 ■
 - No Peat Recorded At This Location ●
- Increasing Stability ↓

5. Factor of safety plan – compiled for the short-term critical condition (undrained) for 281 no. FoS points analysed along the proposed infrastructure envelope on site.

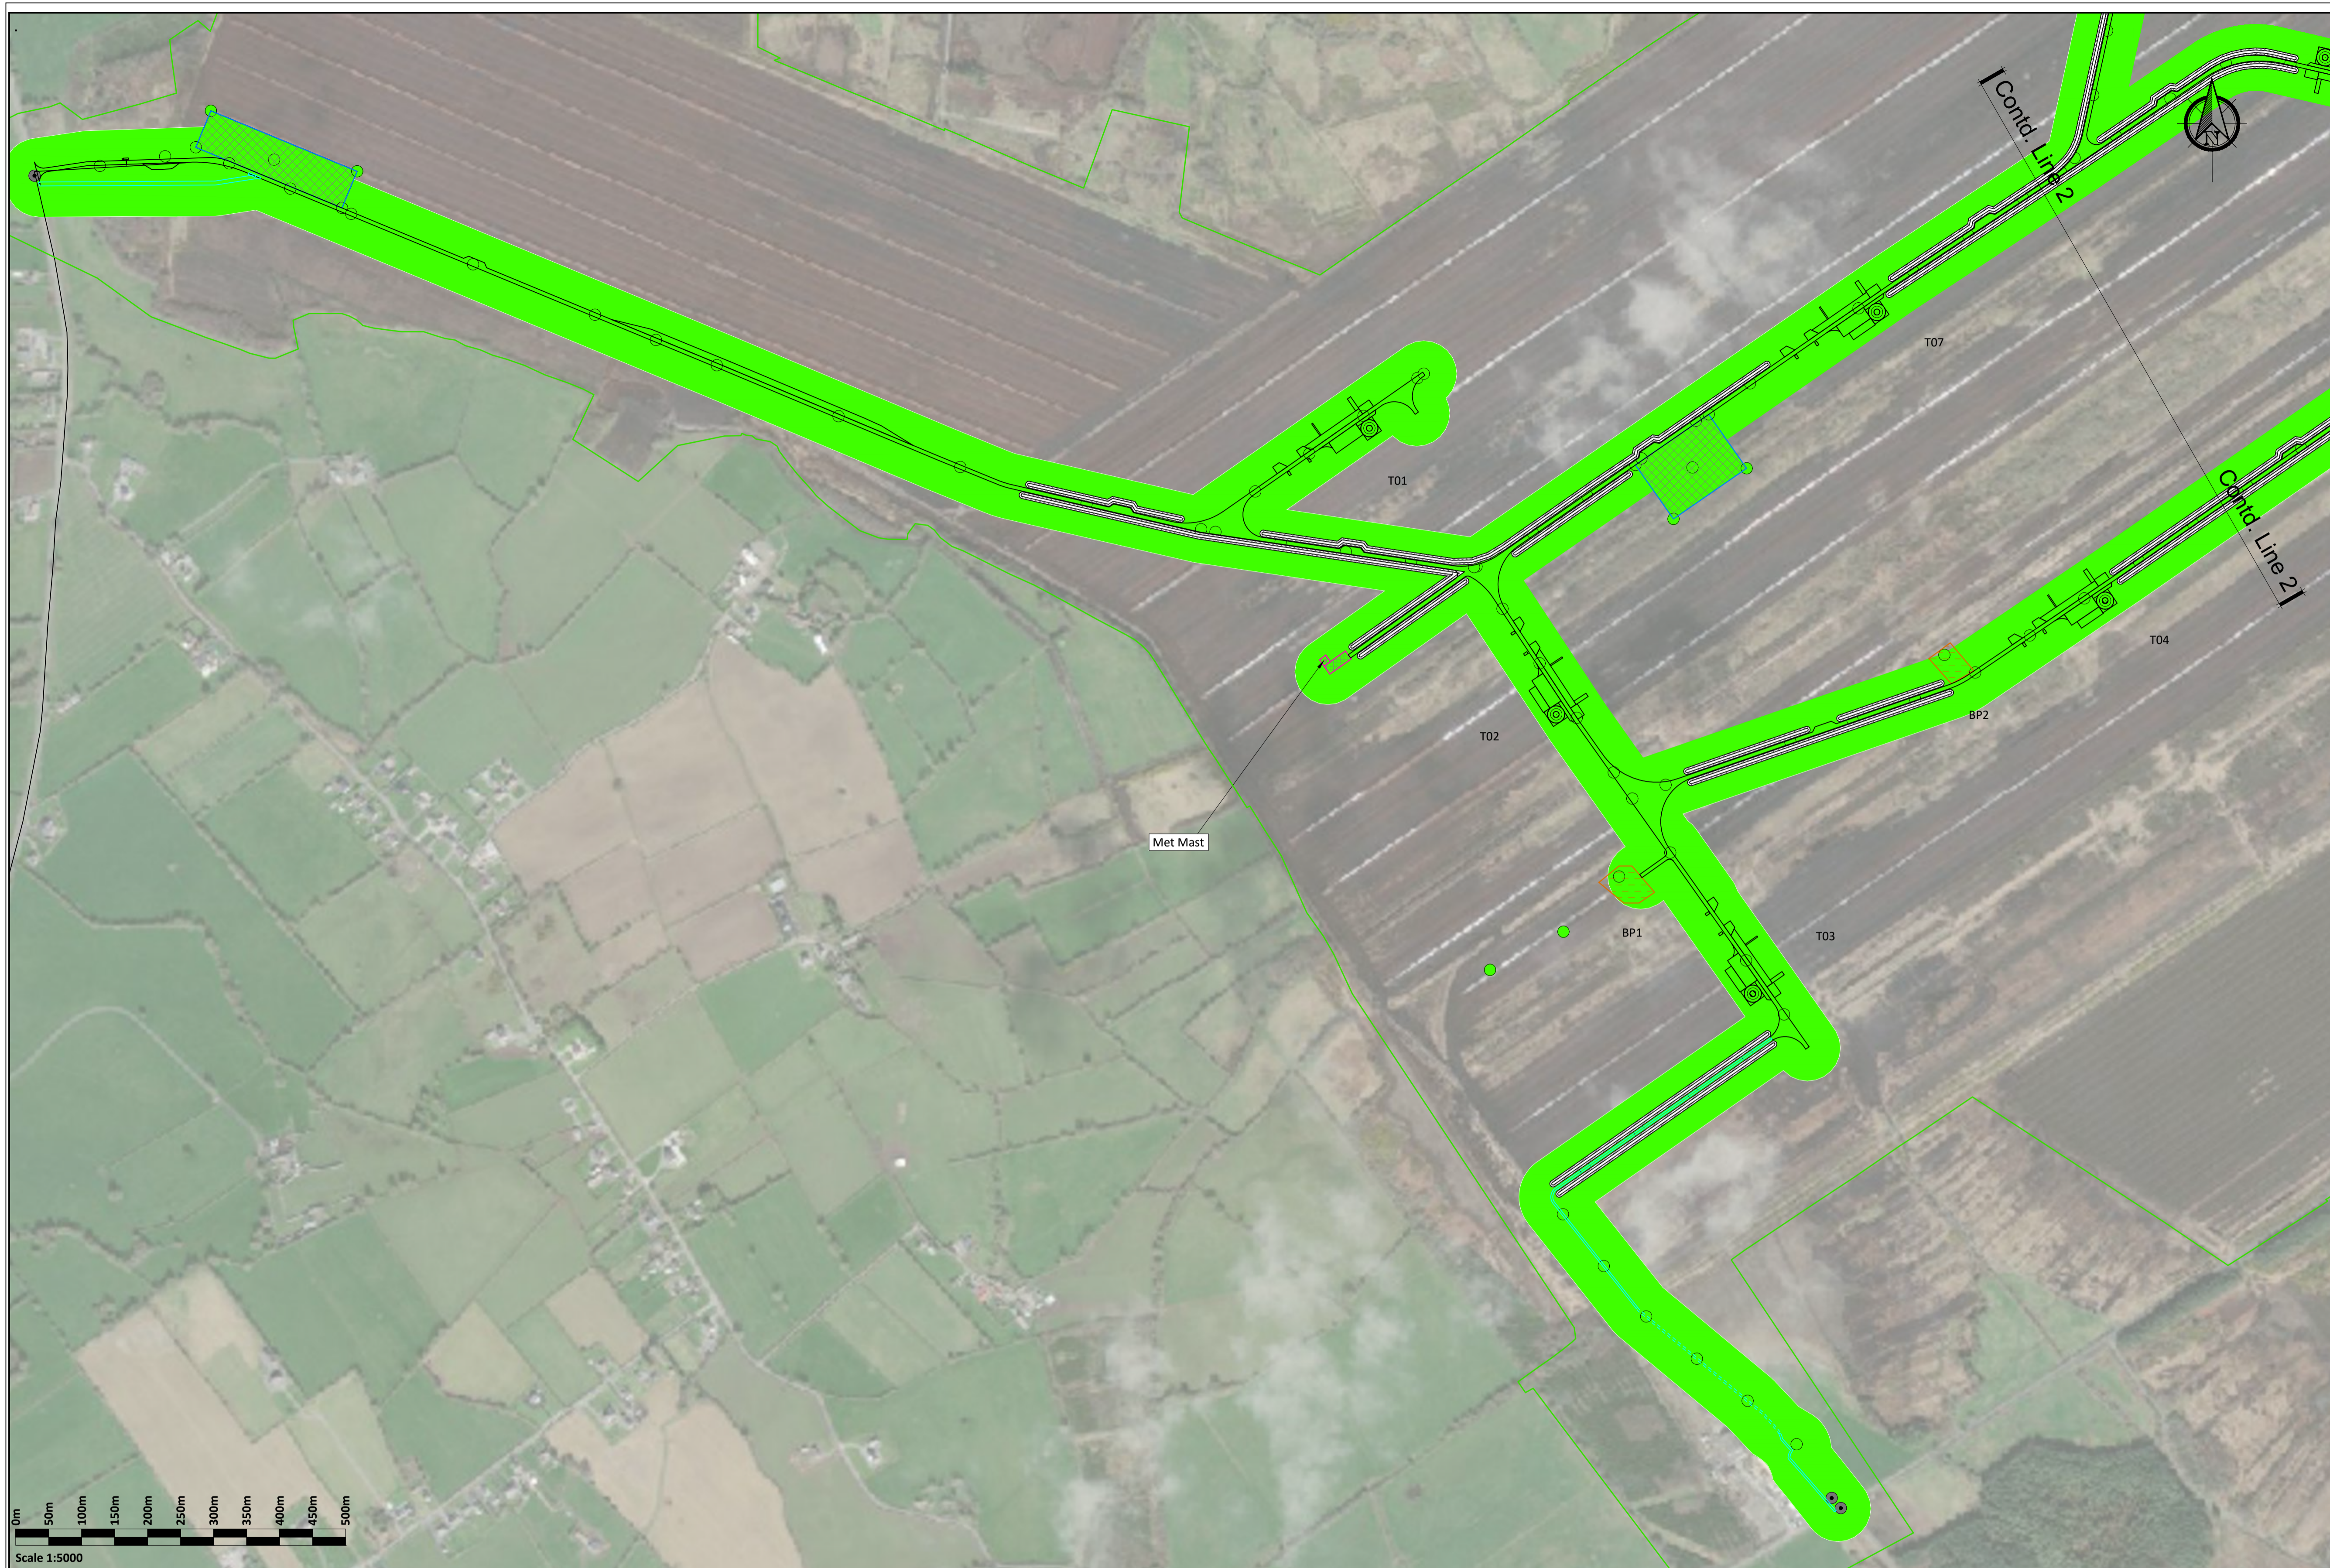
- Factor of Safety Legend:**
- 0 < 1.0
 - ≥ 1.0 < 1.3
 - ≥ 1.3
 - No Peat Recorded At This Location
- Increasing Stability

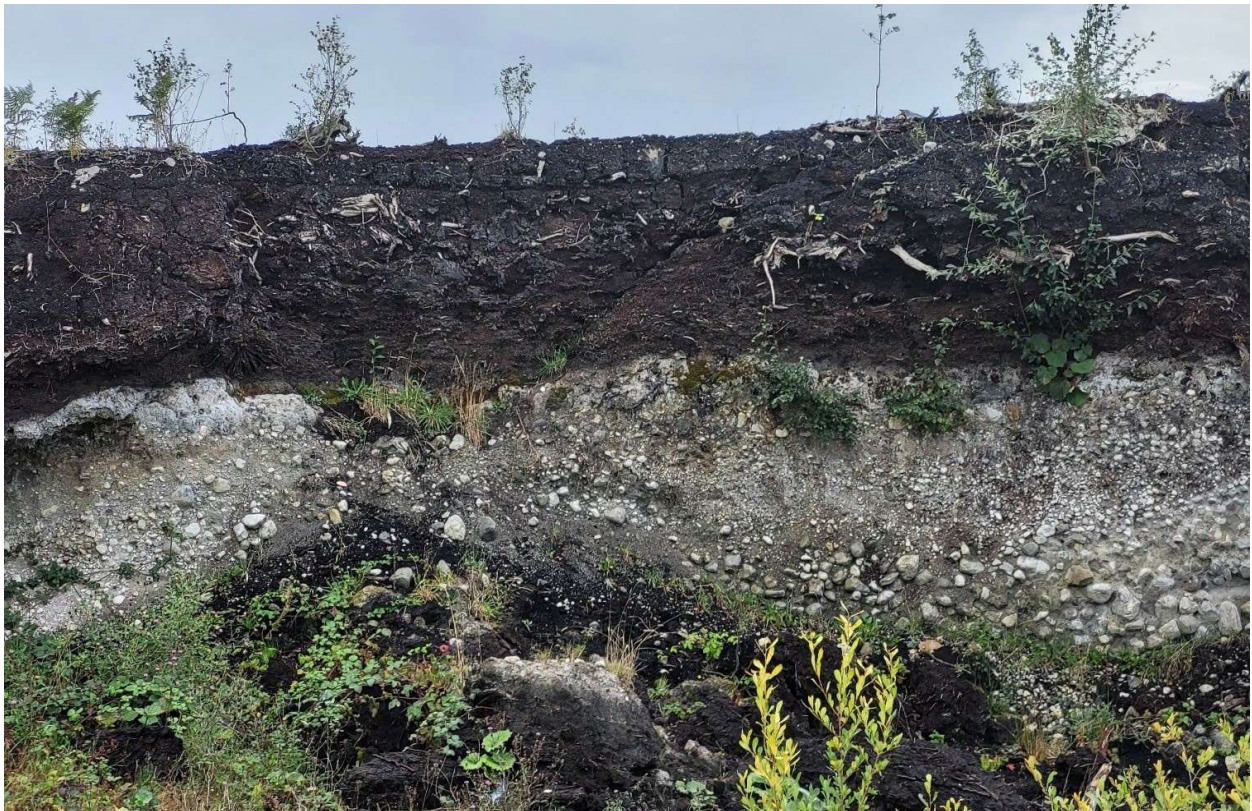
Figure A-4 Soil Profile of Peat overlying Glacial Till.

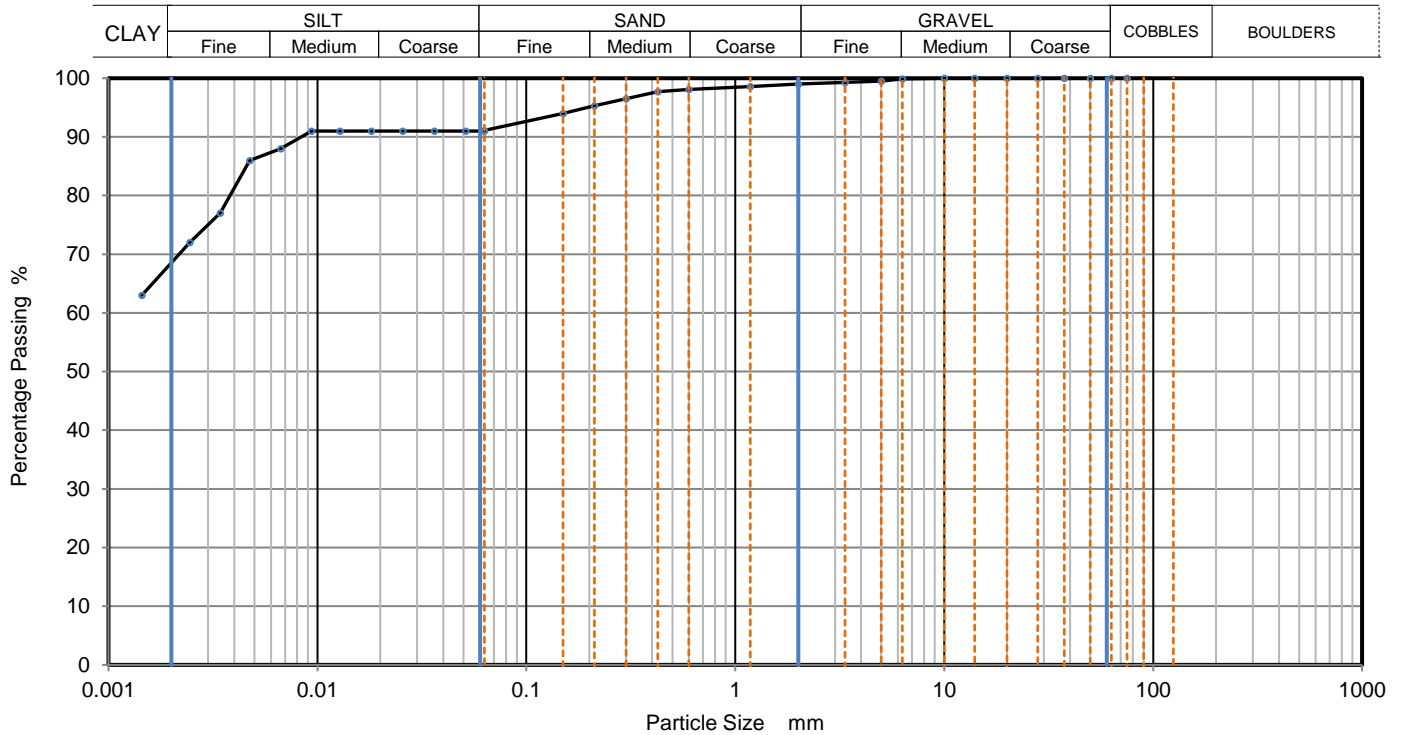
Sieving		Sedimentation	
Particle Size mm	% Passing	Particle Size mm	% Passing
		0.0630	91
		0.0512	91
75	100	0.0362	91
63	100	0.0256	91
50	100	0.0181	91
37.5	100	0.0128	91
28	100	0.0094	91
20	100	0.0067	88
14	100	0.0047	86
10	100	0.0034	77
6.3	100	0.0025	72
5	100	0.0014	63
3.35	99		
2	99		
1.18	99		
0.6	98	Particle density (assumed)	
0.425	98	2.65	Mg/m3
0.3	97		
0.212	95		
0.15	94		
0.063	91

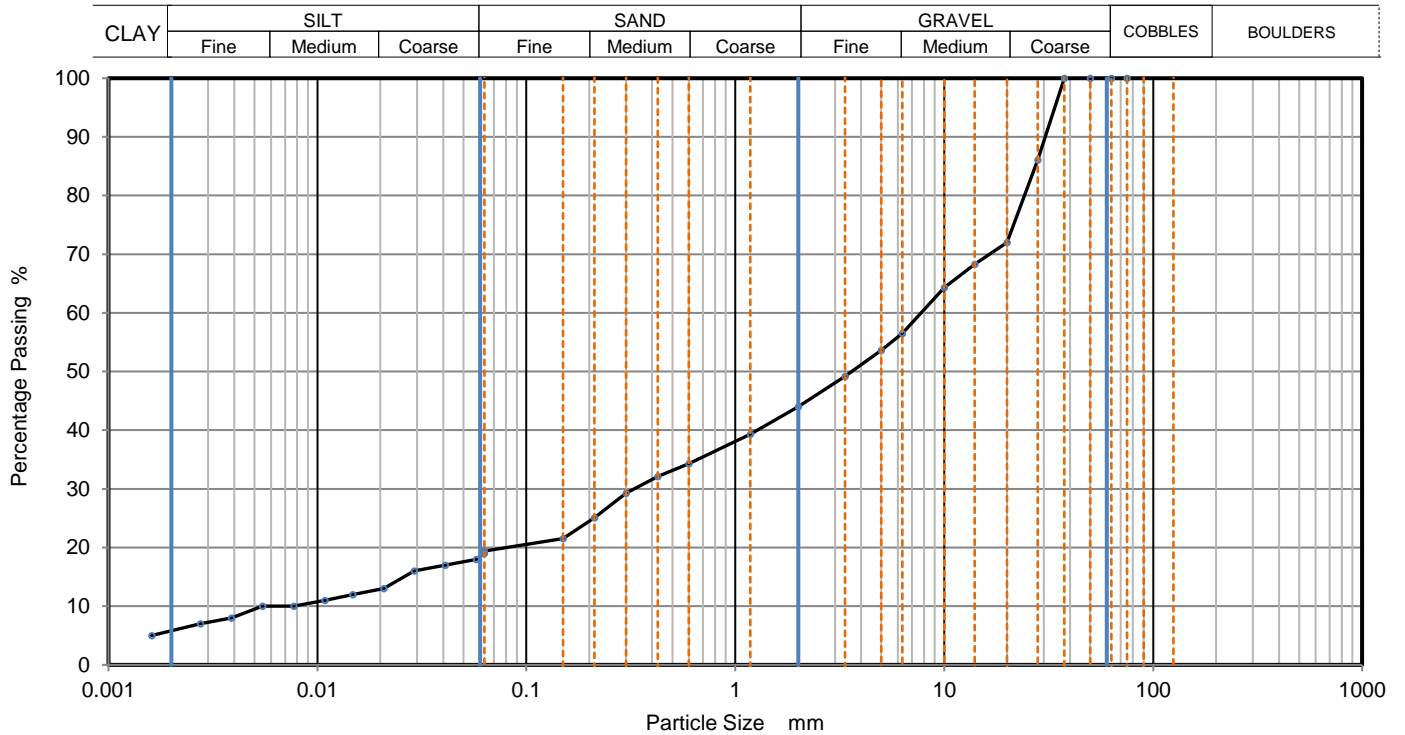
Sieving		Sedimentation	
Particle Size mm	% Passing	Particle Size mm	% Passing
		0.0630	19
		0.0575	18
75	100	0.0409	17
63	100	0.0291	16
50	100	0.0208	13
37.5	100	0.0148	12
28	86	0.0109	11
20	72	0.0077	10
14	68	0.0055	10
10	64	0.0039	8
6.3	57	0.0028	7
5	54	0.0016	5
3.35	49		
2	44		
1.18	39		
0.6	34	Particle density (assumed)	
0.425	32	2.65	Mg/m3
0.3	29		
0.212	25		
0.15	22		
0.063	19

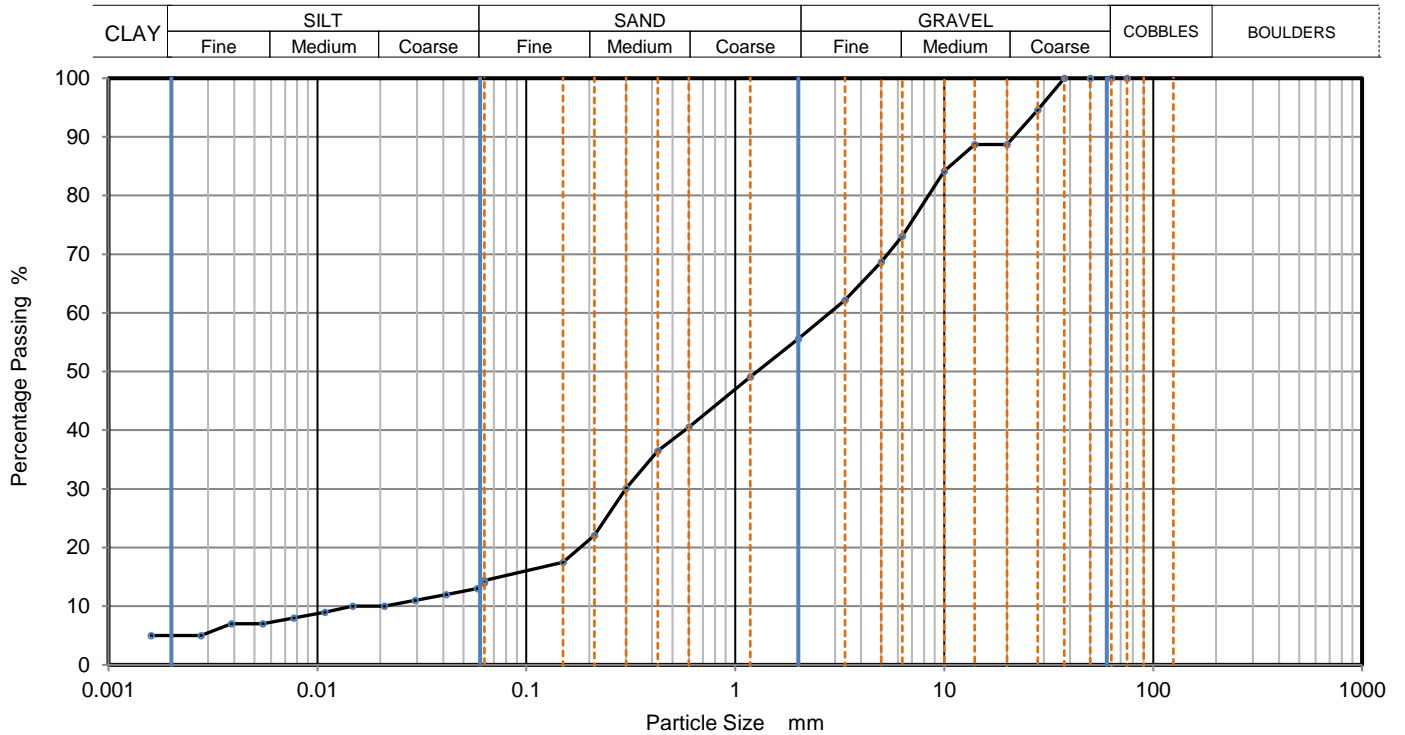
Sieving		Sedimentation	
Particle Size mm	% Passing	Particle Size mm	% Passing
		0.0630	14
		0.0582	13
75	100	0.0414	12
63	100	0.0294	11
50	100	0.0209	10
37.5	100	0.0148	10
28	95	0.0109	9
20	89	0.0077	8
14	89	0.0055	7
10	84	0.0039	7
6.3	73	0.0028	5
5	69	0.0016	5
3.35	62		
2	56		
1.18	49		
0.6	41		
0.425	37	Particle density (assumed)	
0.3	30	2.65	Mg/m ³
0.212	22		
0.15	18		
0.063	14

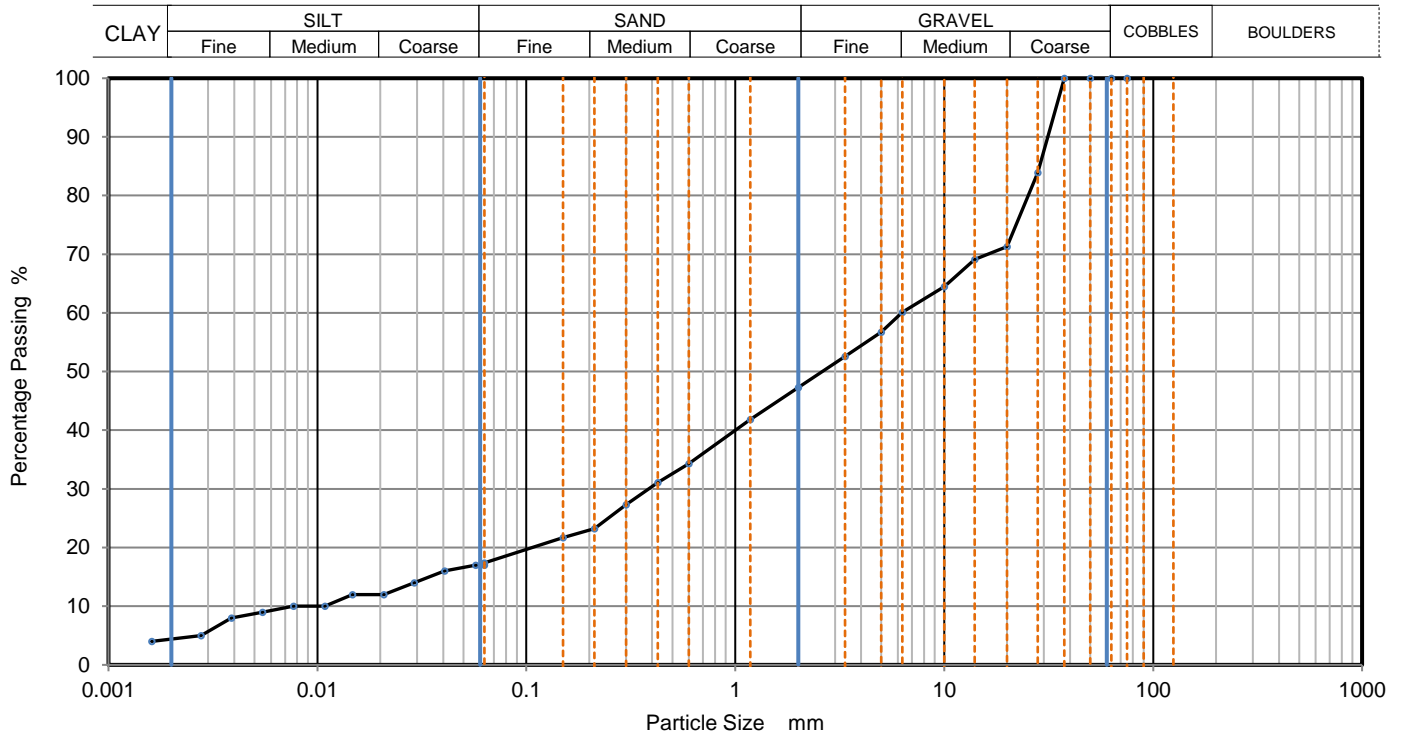
Sieving		Sedimentation	
Particle Size mm	% Passing	Particle Size mm	% Passing
		0.0630	17
		0.0572	17
75	100	0.0407	16
63	100	0.0291	14
50	100	0.0208	12
37.5	100	0.0147	12
28	84	0.0109	10
20	71	0.0077	10
14	69	0.0055	9
10	65	0.0039	8
6.3	60	0.0028	5
5	57	0.0016	4
3.35	53		
2	47		
1.18	42		
0.6	34	Particle density (assumed)	
0.425	31	2.65	Mg/m3
0.3	27		
0.212	23		
0.15	22		
0.063	17

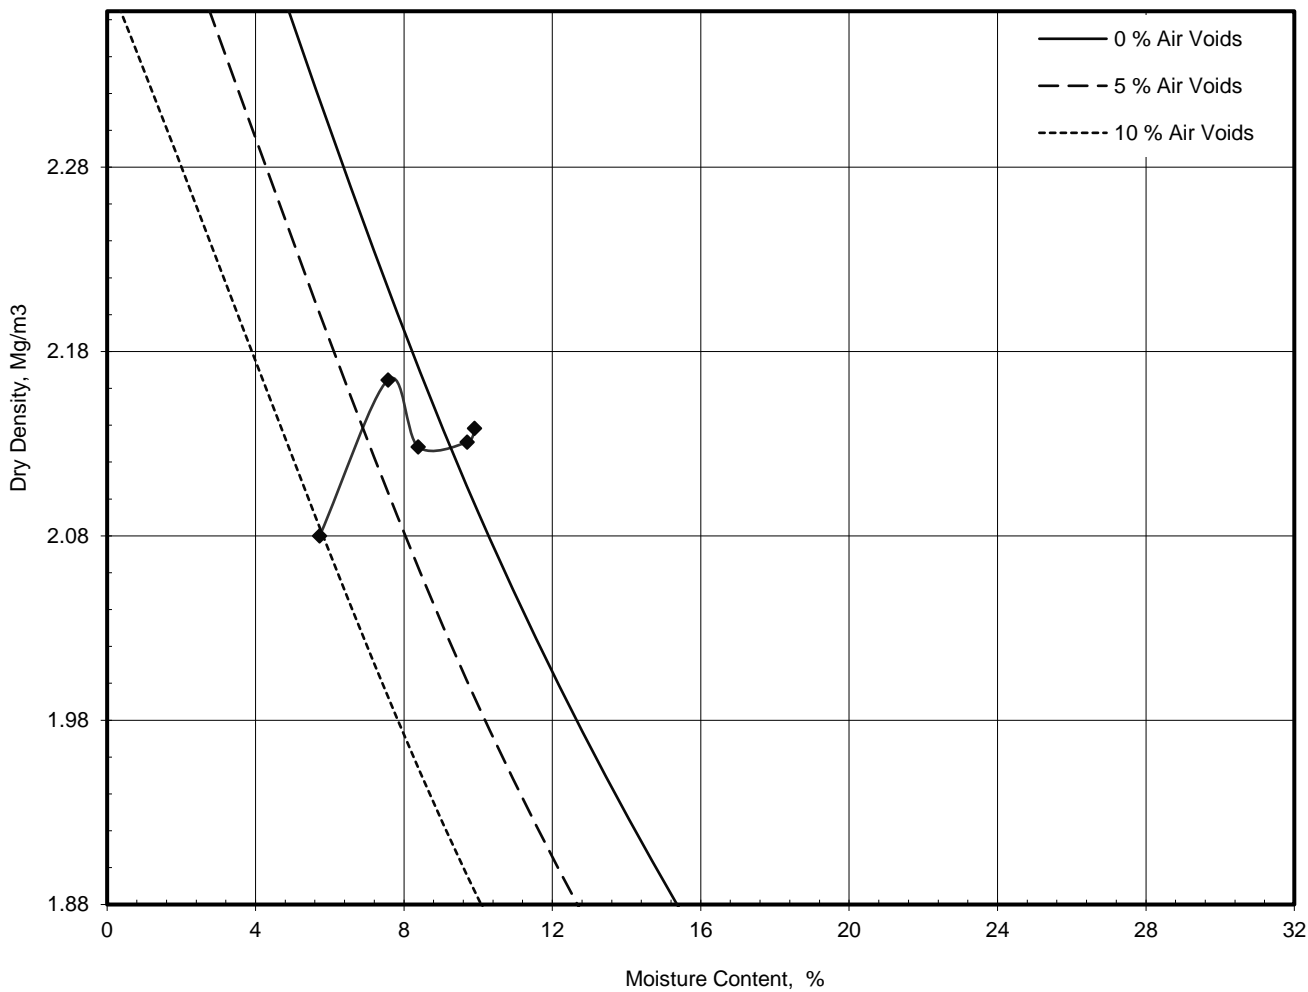
Preparation	Material used was natural and air dried	
Mould Type	CBR	
Samples Used	Composite specimens tested	
Material Retained on 37.5 mm Sieve	%	0
Material Retained on 20.0 mm Sieve	%	30
Particle Density - Assumed	Mg/m ³	2.65

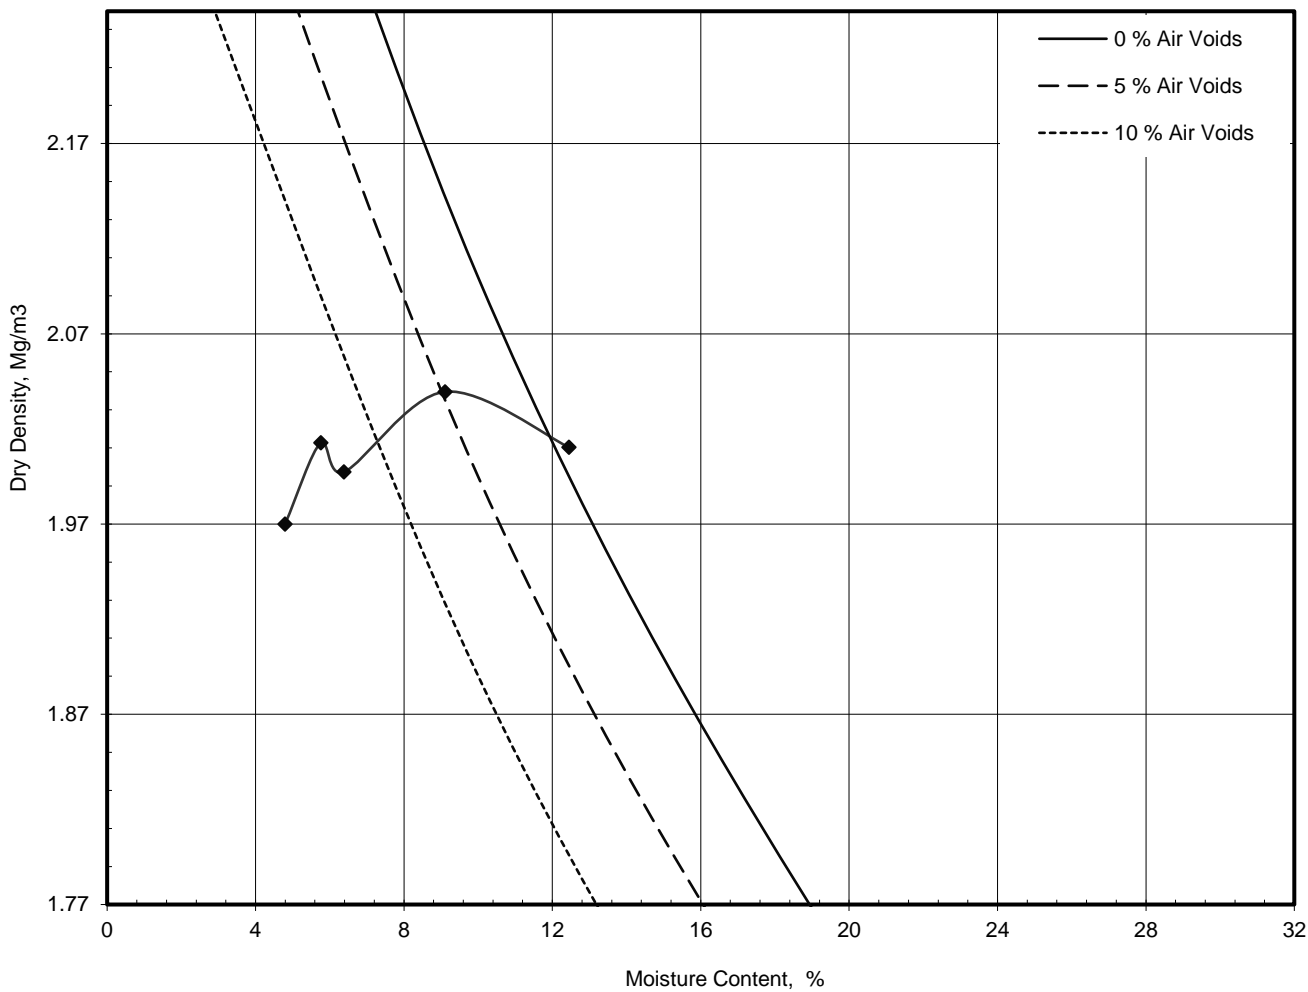
Preparation	Material used was natural and air dried	
Mould Type	CBR	
Samples Used	Composite specimens tested	
Material Retained on 37.5 mm Sieve	%	0
Material Retained on 20.0 mm Sieve	%	19
Particle Density - Assumed	Mg/m ³	2.65
