APPENDIX 6-1
BOTANICAL SURVEY REPORT

Botanical Survey Report - Appendix 6-1

Maughanaclea Renewable
Energy Development, Co,
Cork

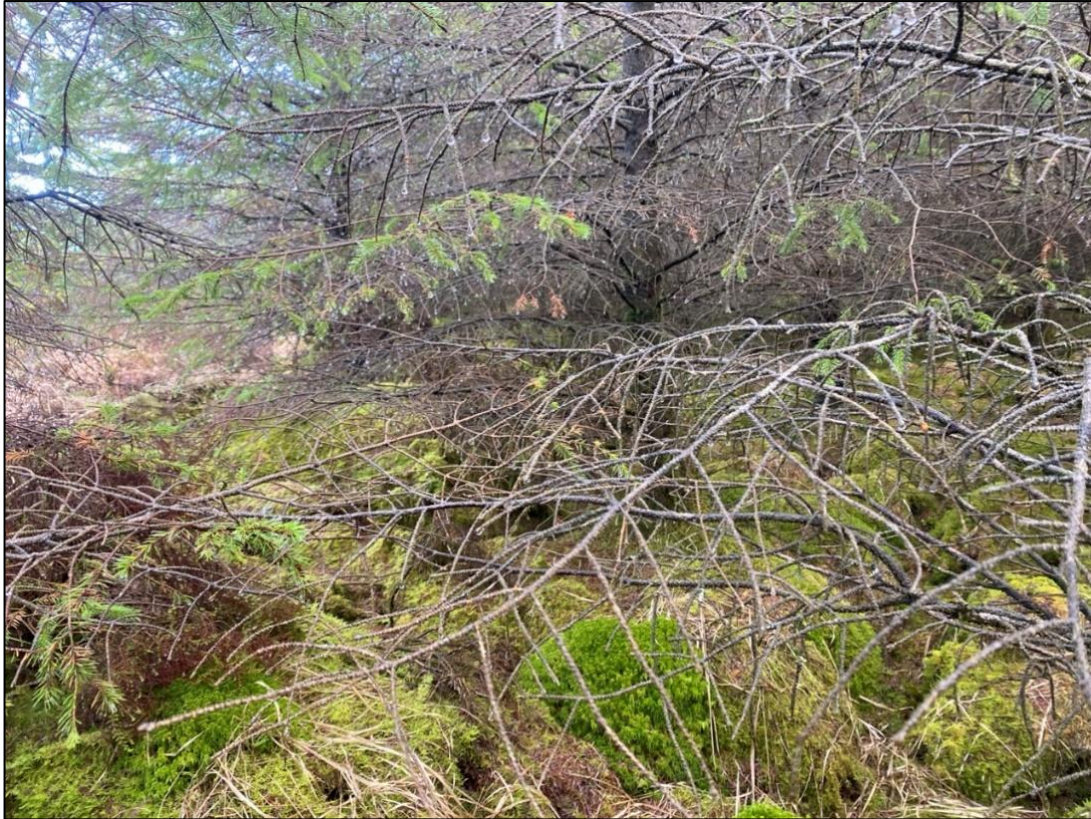
Plate 3-1 Dense Conifer Plantation (WD4) within footprint of proposed Turbine T01/hardstand

Turbine T01 and associated infrastructure (hard stand and access roads) are located within a large, mature, dense Conifer Plantation (WD4) in the northeast of the Proposed Wind Farm site. The Conifer Plantation is located on sloping ground, on peat soils. Ground conditions varied, with drier grounds covered in needles recorded on higher grounds (upper slopes), and wet ground dominated by carpets of bryophytes and sphagnum recorded on lower grounds (base of slopes). This plantation was dominated by dense Sitka Spruce (*Picea sitchensis*).

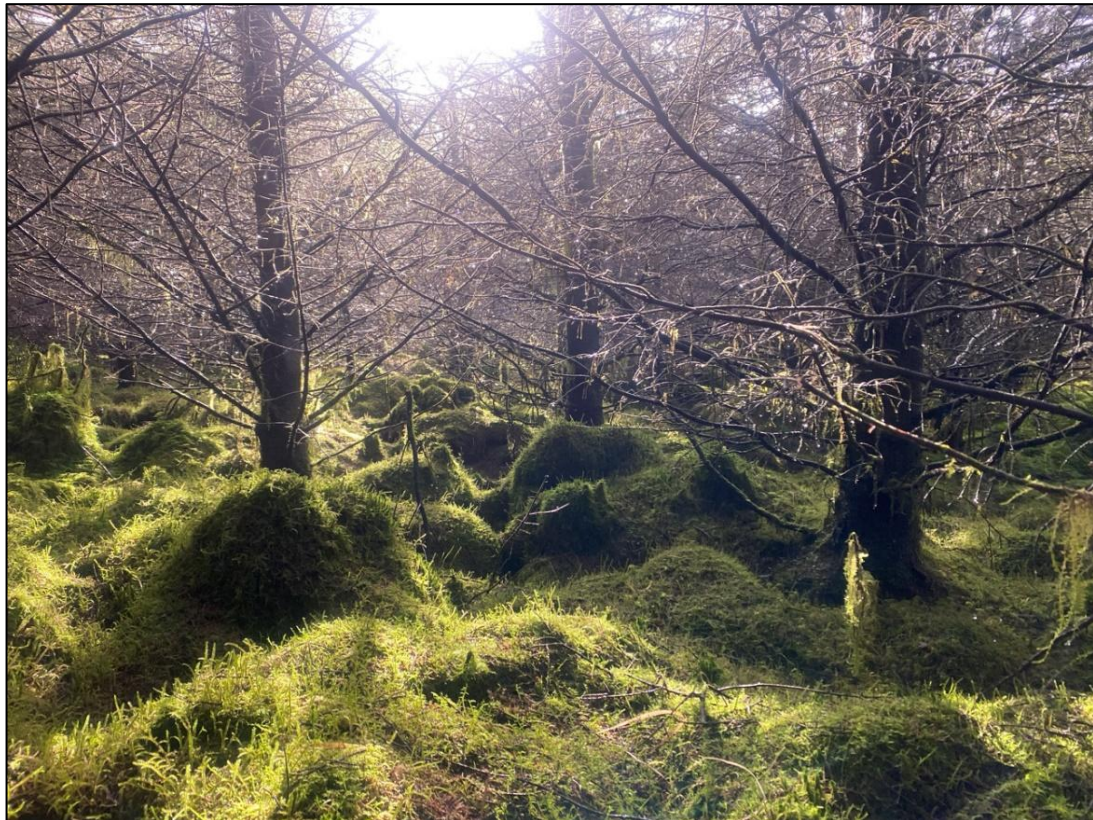
Plate 3-2 Dense Conifer Plantation (WD4) within footprint of proposed Turbine T02/hardstand

Turbine T02 and associated infrastructure (hard stand and access roads) are located within a large, mature, dense Conifer Plantation (WD4) in the northeast of the Proposed Wind Farm site. This Conifer Plantation is located on a steep slope, on peat soils. Ground conditions vary, with drier grounds covered in needles recorded on higher grounds (upper slopes), and wet ground with bryophytes and *Sphagnum* recorded on lower grounds (base of slopes). This plantation is dominated by dense Sitka Spruce (*Picea sitchensis*).

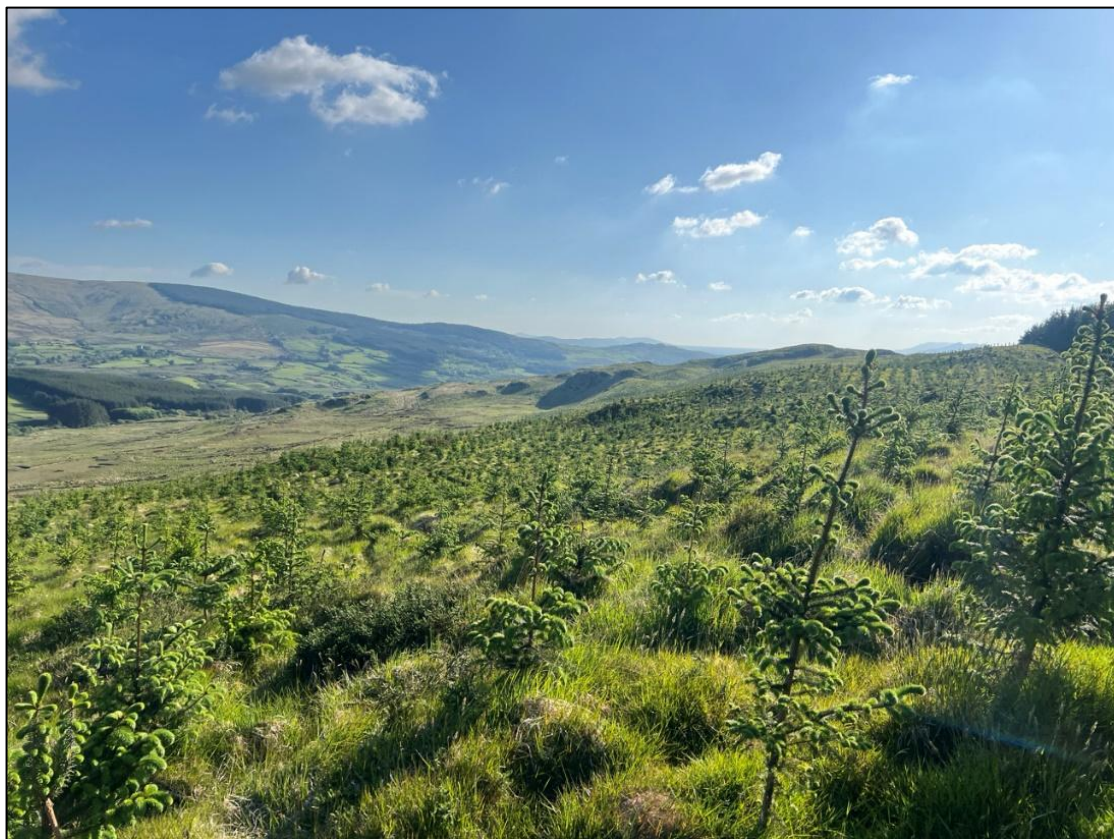
Plate 3-3 Proposed access road from T01/T02 to T03/T05 located on steep sloping ground, on recently planted Conifer Plantation (WD4)

The access road linking T01 and T02, to T03/T05 is located in the northeast of the Proposed Wind Farm site. The access road is located partially within mature Conifer Plantation (WD4) dominated by Sitka spruce (*Picea sitchensis*) linking T01 and T02, and on an area of recently planted Conifer Plantation (WD4) located on steep sloping ground. The ground conditions are dry, with areas of exposed, bare peat present throughout the area. The ground vegetation is comprised of typical heath species, such as purple moor grass, tormentil and ling heather. The access road then runs partially through an area of degraded Dry Humid Acid Grassland/ Wet Grassland (GS3/GS4).

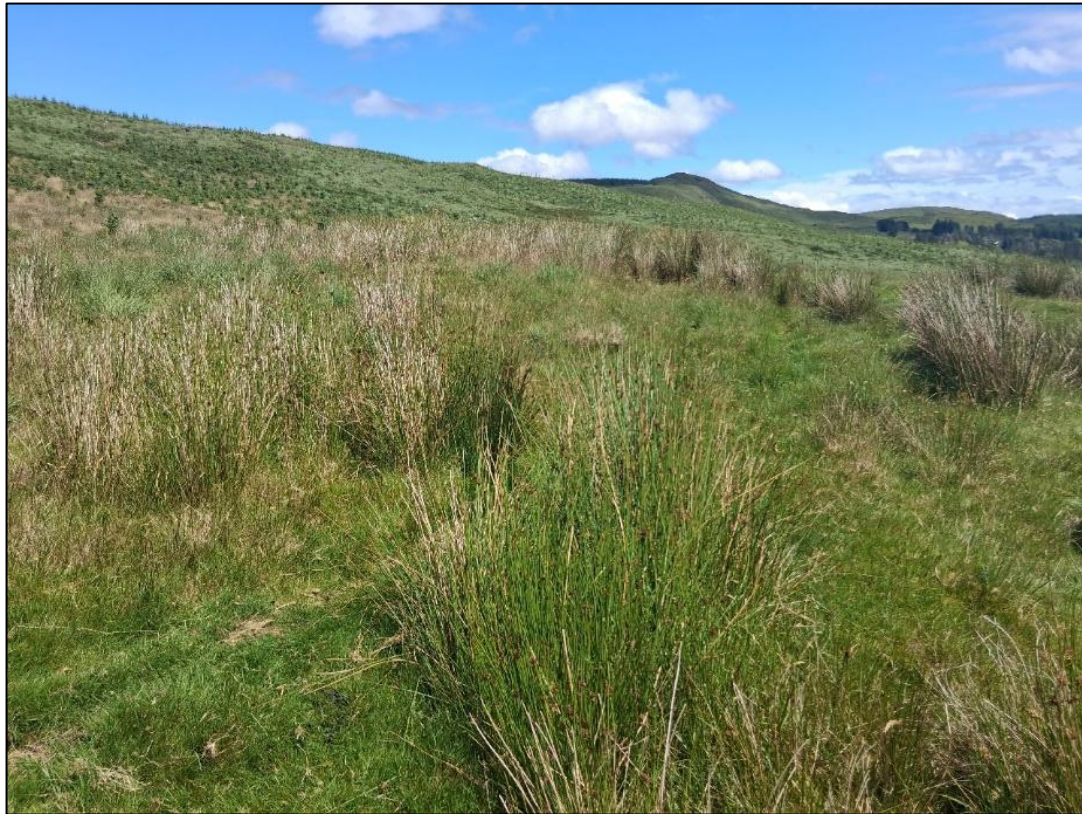
Plate 3-4 Degraded Dry Humid Acid Grassland/ Wet Grassland (GS3/GS4) in the vicinity of T03/hardstand.

Turbine T03 and associated hard stand are located in the northeast of the Proposed Wind Farm site, on an area of degraded Dry Humid Acid Grassland/ Wet Grassland (GS3/GS4). The area is degraded as a result of on-going intensive sheep grazing, creating a short, uniform sward with little species diversity and a dry underfoot. Turbine T03 and hardstand are located on sloping grounds. A large area of recently planted Conifer Plantation (WD4) is located to the north of T03.

The potential for the habitat to have links to the Annex I habitat ‘*species-rich Nardus grasslands on siliceous substrates in mountain areas*’ was considered. However, as stated in Fossitt (2000) ‘*high species diversity is not characteristic but species-poor stands that appear to be the product of overgrazing are excluded*’. As such, due to the degraded nature of this mosaic habitat, Dry Humid Acid Grassland/ Wet Grassland (GS3/GS4), as a result of intensive sheep grazing, this area does not conform to the Annex I habitat

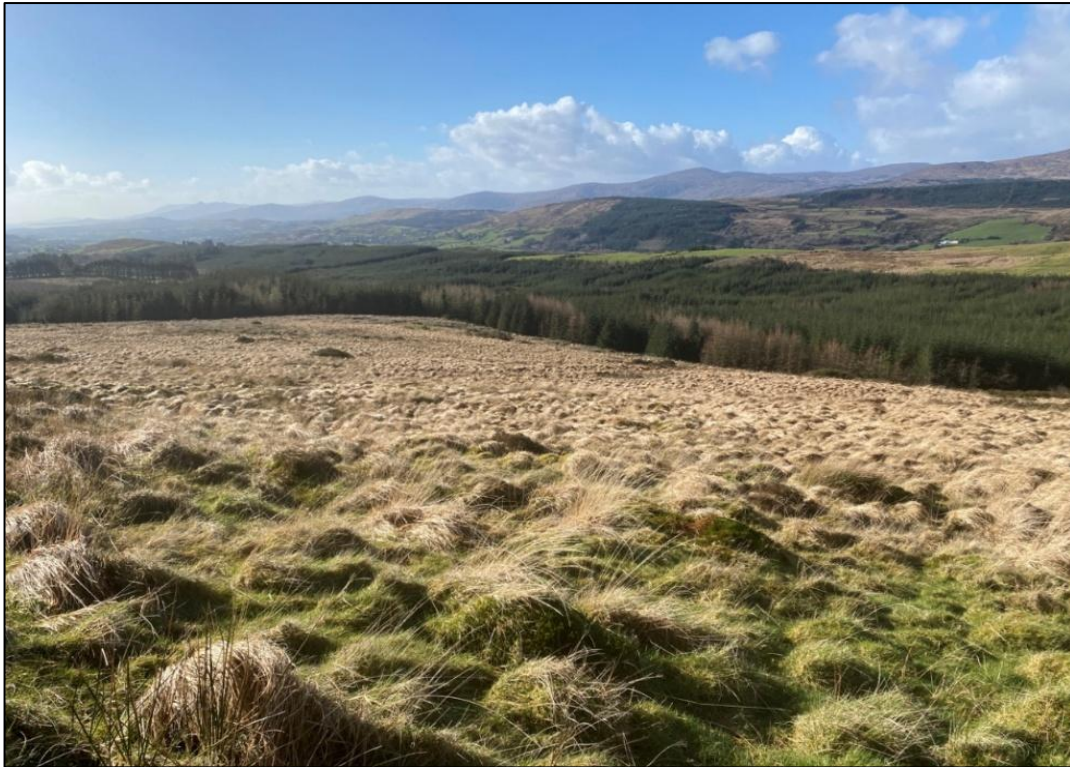
Plate 3-5 Proposed location for T04 and hardstand within degraded Wet Heath (HH3) on a steep slope.

Turbine T04 and associated infrastructure (hardstand and access roads) are located in the north of the Proposed Wind Farm site, on an area of degraded Wet Heath (HH3). The area of wet heath has links to the Annex I habitat ‘Northern Atlantic Wet Heath with *Erica tetralix* (4010).

Extensive on-going sheep grazing was evident in the vicinity of T04 and as a result the wet heath habitat was degraded, and uniform in appearance, with little species diversity. This area was dominated by dense purple moor grass, with a low cover of dwarf shrubs and bryophytes. Cross leaved heath (*Erica tetralix*) and tormentil (*Potentilla erecta*) were recorded. The cover of dwarf shrubs was well below the 25% threshold defined for this habitat by Fossitt (2000). Perrin et al. (2014) states that “dwarf shrub cover as dwarf shrubs may be scarce or absent in degraded examples of wet heath characterised by *Trichophorum germanicum* or *Molinia caerulea*”. Further, the negative indicator species, Yorkshire fog and common bent grass, were recorded in these areas of wet heath (Perrin et al 2014).

As such, the wet heath habitat in the vicinity of T04 is degraded due to intensive sheep grazing, resulting in a low cover of dwarf shrubs, and poor species diversity dominated by purple moor grass.

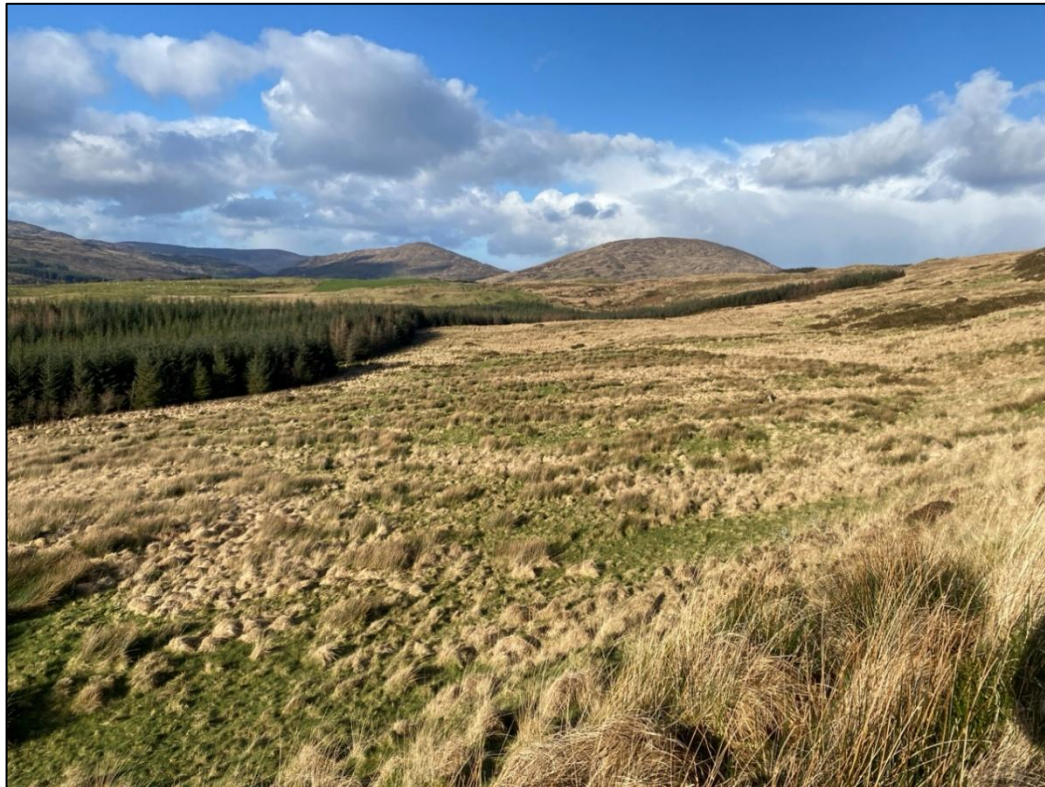
Plate 3-6 A mosaic of degraded Wet Heath (HH3) and degraded Dry Humid Acid Grassland/ Wet Grassland (GS3/ GS4) along the access road to T04.

The proposed access road to T04 is located in the north of the Proposed Wind Farm site on sloping ground. The access road runs predominantly through degraded Wet Heath (HH3) and Dry Humid Acid Grassland/ Wet Grassland (GS3/GS4). The access road to T04 crosses an unmapped watercourse, classified as an Upland/Eroding River (FW1). The area is intensively grazed by sheep.

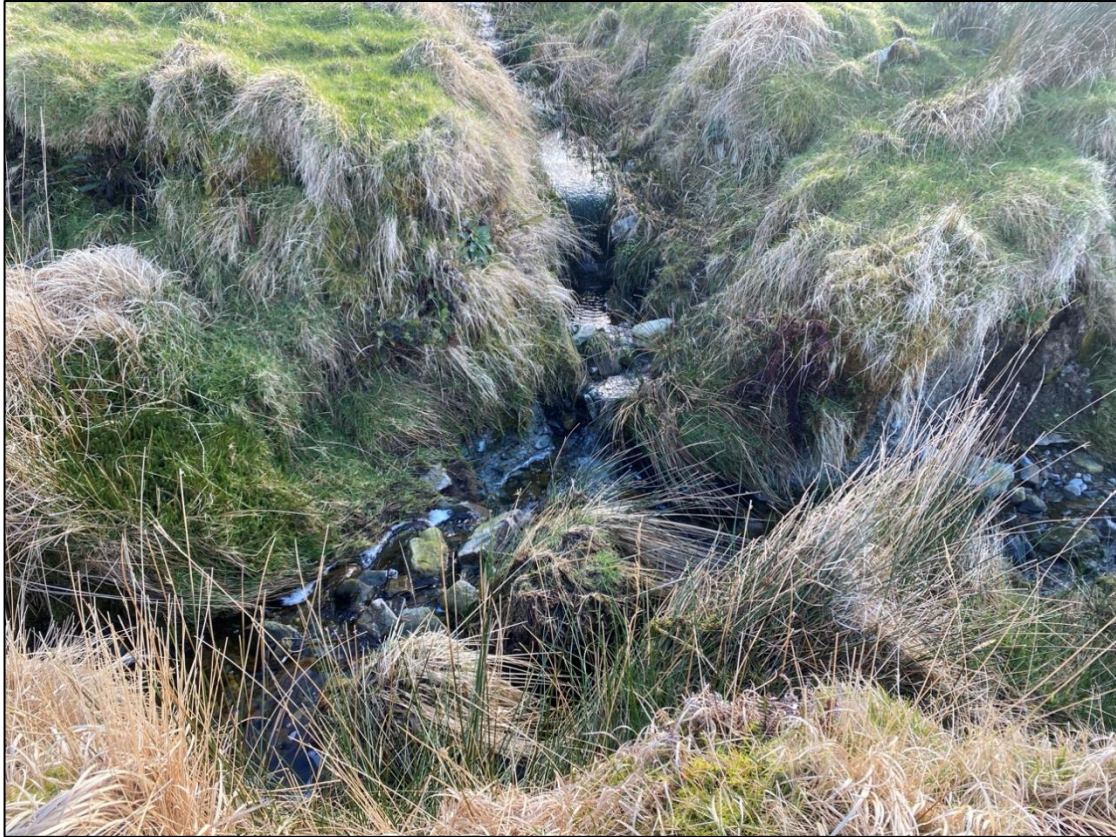
Plate 3-7 Unmapped **Eroding Upland River (FW1)** along the access road to T04.

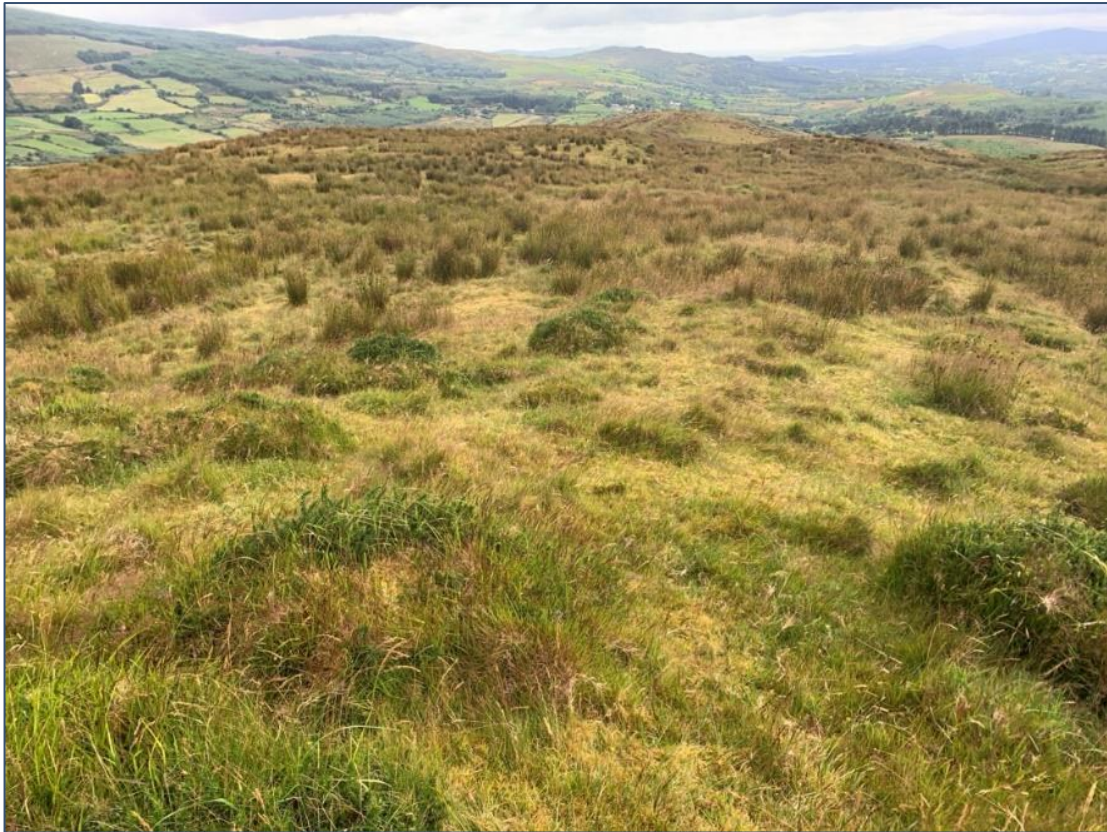
Plate 3-8 Degraded Dry Humid Acid Grassland/ Wet Grassland (GS3/ GS4) at T05/hardstand.

Turbine T05 and associated hard stand and access road are located in the north of the Proposed Wind Farm site, on an area of degraded Dry Humid Acid Grassland/ Wet Grassland (GS3/GS4) on sloping grounds. The area is degraded as a result of on-going intensive sheep grazing, creating a short, uniform sward with little species diversity.

The potential for the habitat to have links to the Annex I habitat ‘*species-rich Nardus grasslands on siliceous substrates in mountain areas*’ was considered. However, as stated in Fossitt (2000) ‘*high species diversity is not characteristic but species-poor stands that appear to be the product of overgrazing are excluded*’. As such, due to the degraded nature of this mosaic habitat Dry Humid Acid Grassland/ Wet Grassland (GS3/GS4) as a result of intensive sheep grazing, this area does not conform to the Annex I habitat.

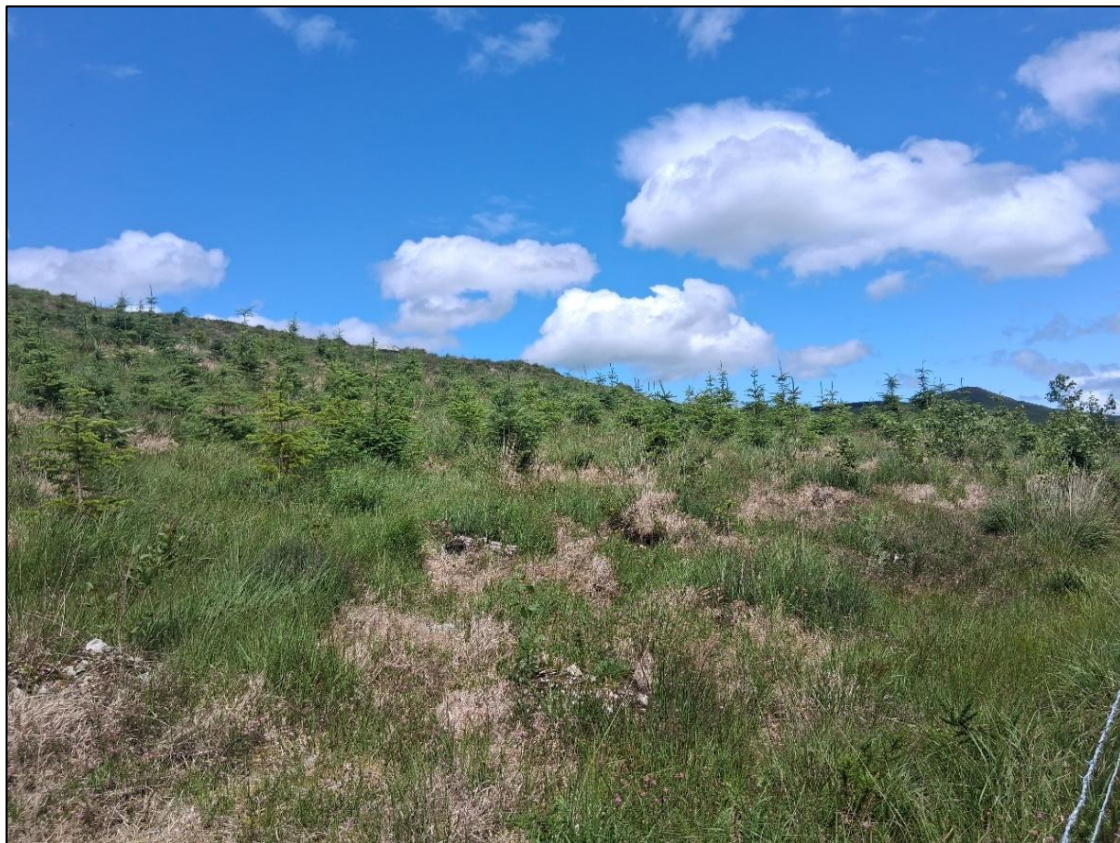
Plate 3-9 T06 and hardstand located within an area of recently planted **Conifer Plantation (WD4)**.

Turbine T06 and associated infrastructure (hard stand and access roads) are located in the north of the Proposed Wind Farm site, in an area of recently planted Conifer Plantation (WD4), located on steep sloping ground. The ground vegetation is comprised of typical heath species, such as purple moor grass, tormentil and ling heather. An area of degraded Dry Humid Acid Grassland/ Wet Grassland (GS3/ GS4) is present to the north of T06.

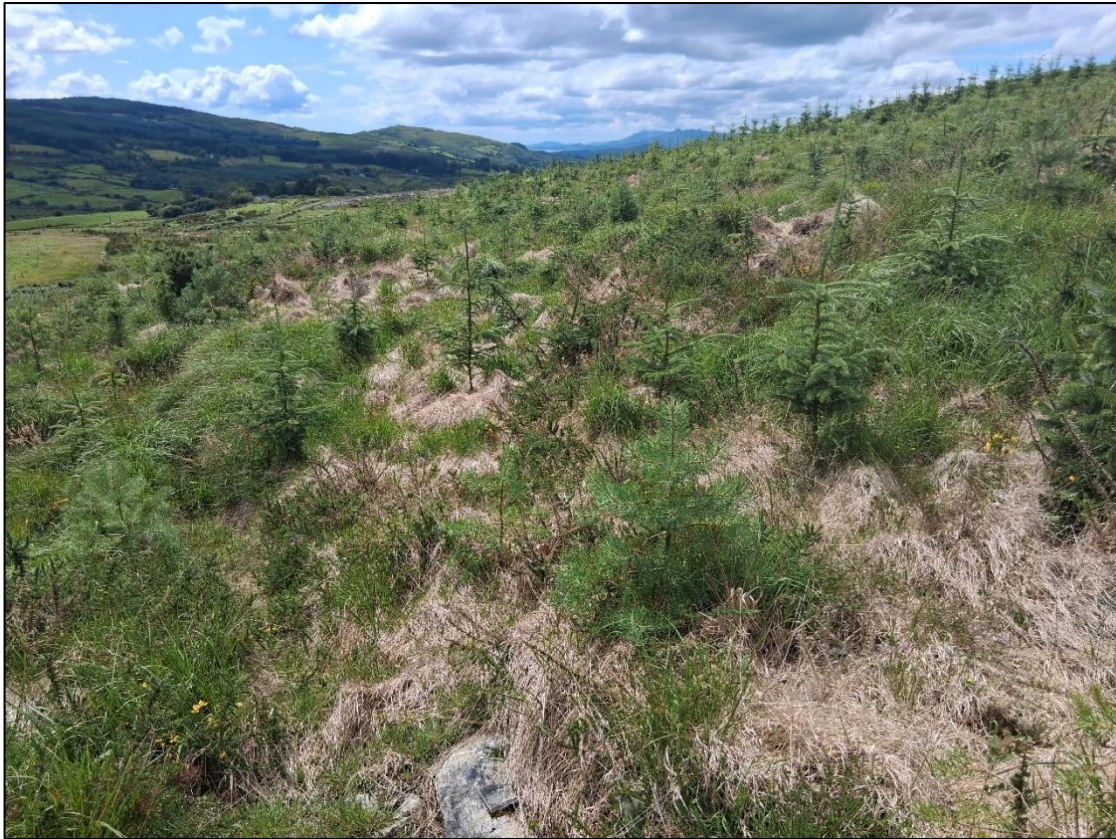
Plate 3-10 Area of proposed access road to T06 located on an area of recently planted **Conifer Plantation (WD4)**

The proposed access road linking T06 to T05 is located in the north of the Proposed Wind Farm site, in an area of recently planted Conifer Plantation (WD4), located on steep sloping ground. The ground vegetation is comprised of typical heath species, such as purple moor grass, tormentil and ling heather. The access road then runs through an area of degraded Dry Humid Acid Grassland/ Wet Grassland (GS3/GS4) as described in Section 2.3.7 above.

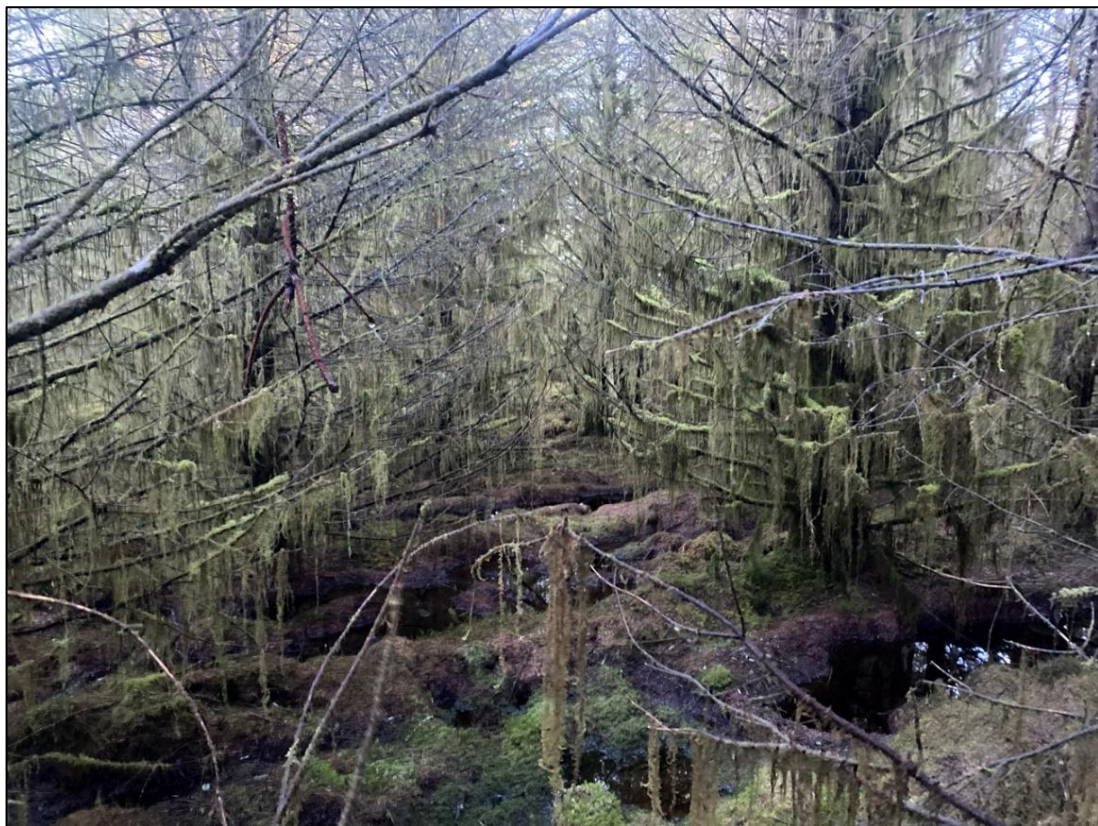
Plate 3-11 Turbine T07 and hardstand located within a wet section of dense, conifer plantation (WD4).

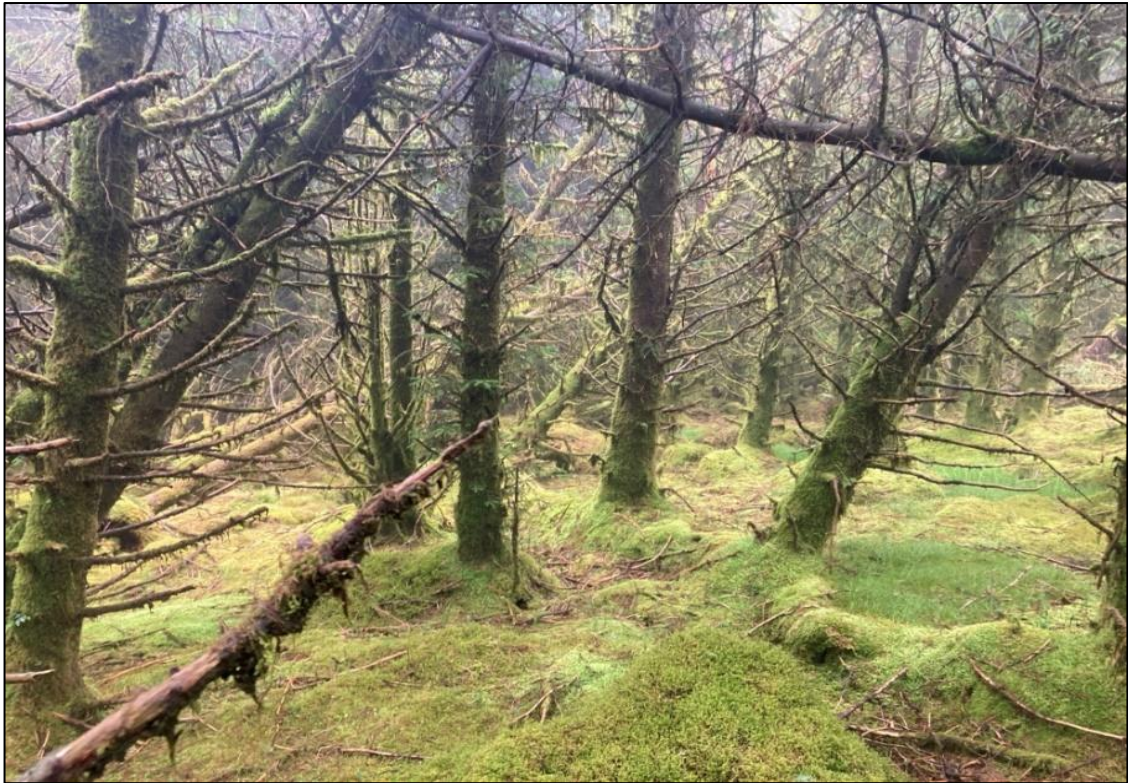
Plate 3-12 Carpets of moss/sphagnum within Conifer Plantation (WD4) in the vicinity of T08/hardstand

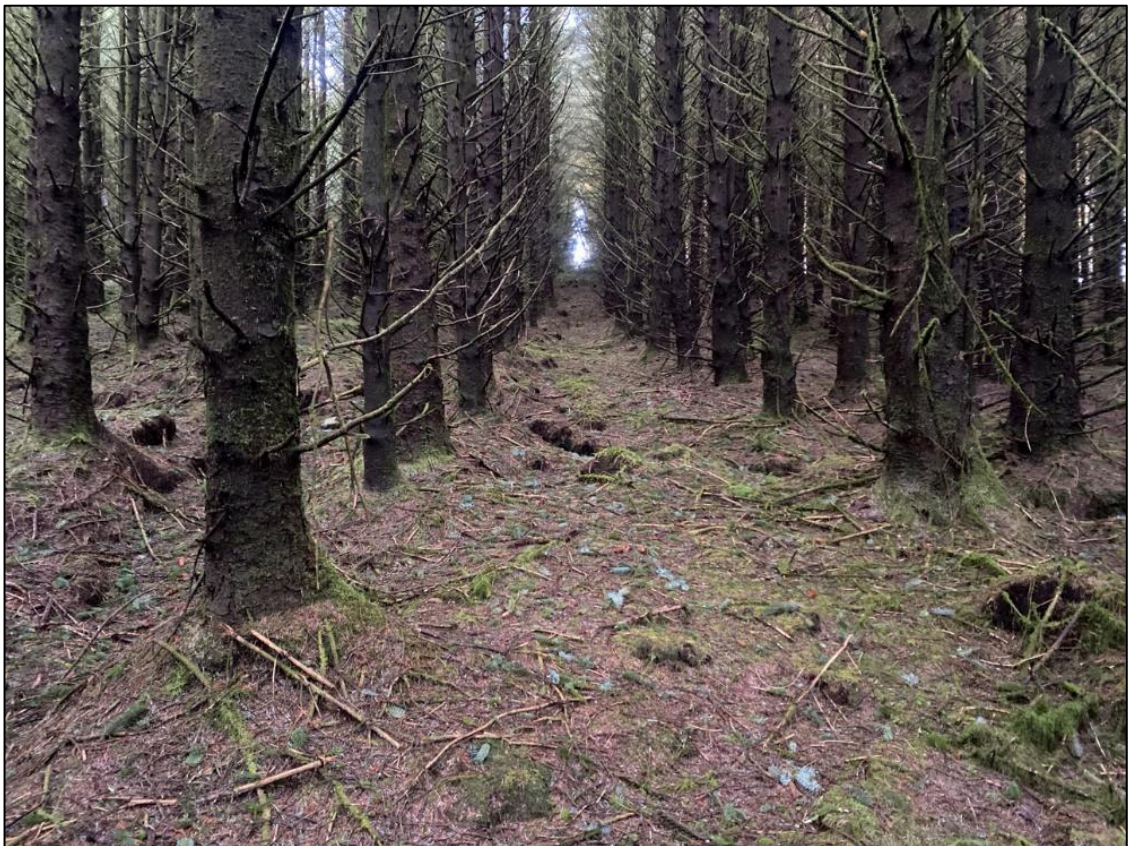
Plate 3-13 Mature Conifer Plantation (WD4) with a dry underfoot in the vicinity of T08/hardstand.

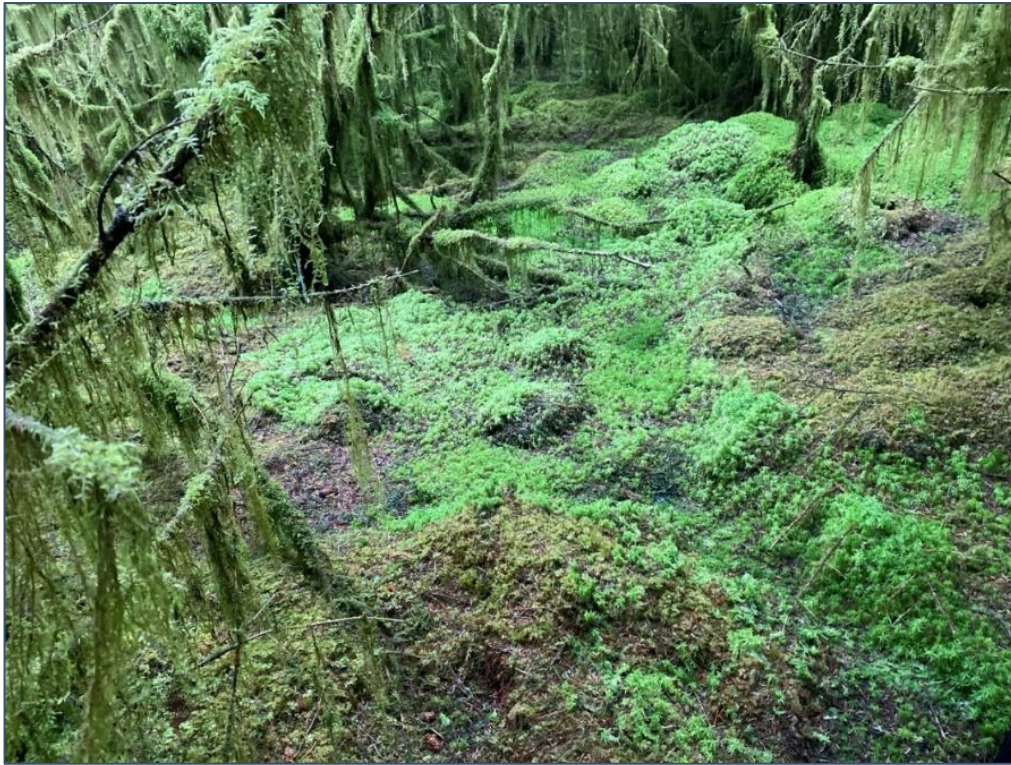
Plate 3-14 Habitat within the vicinity of T09 within Conifer Plantation (WD4).

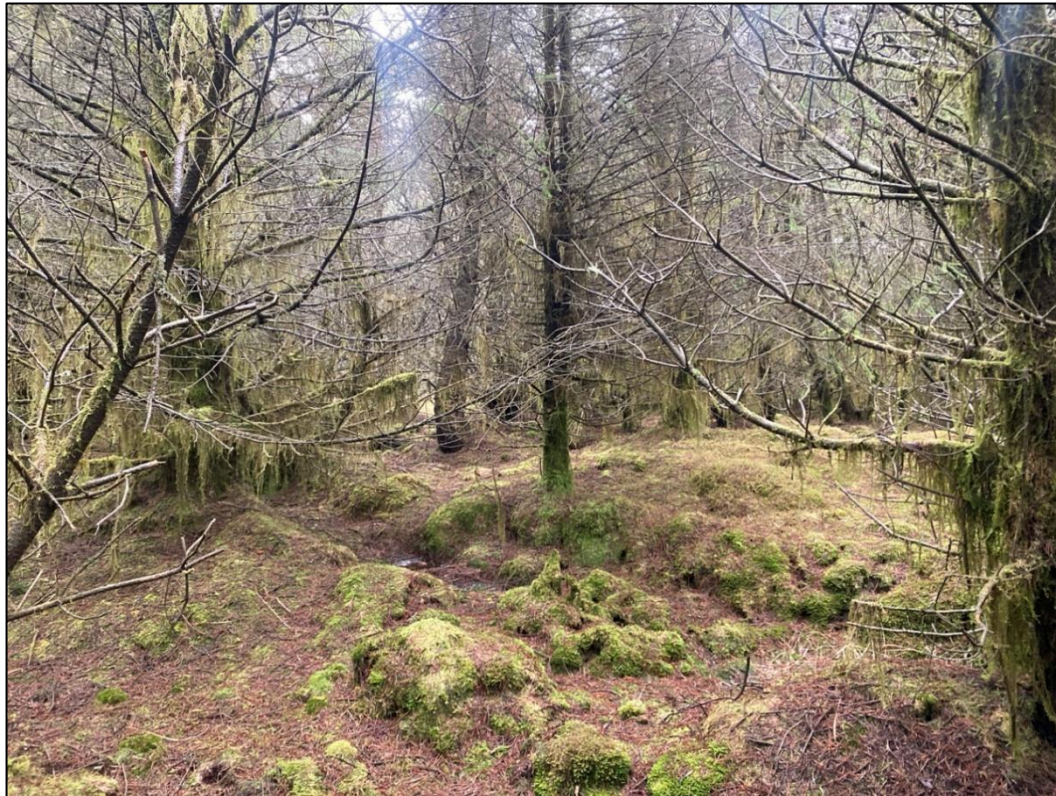
Plate 3-15 Conifer Plantation (WD4) wherein T10 is proposed.

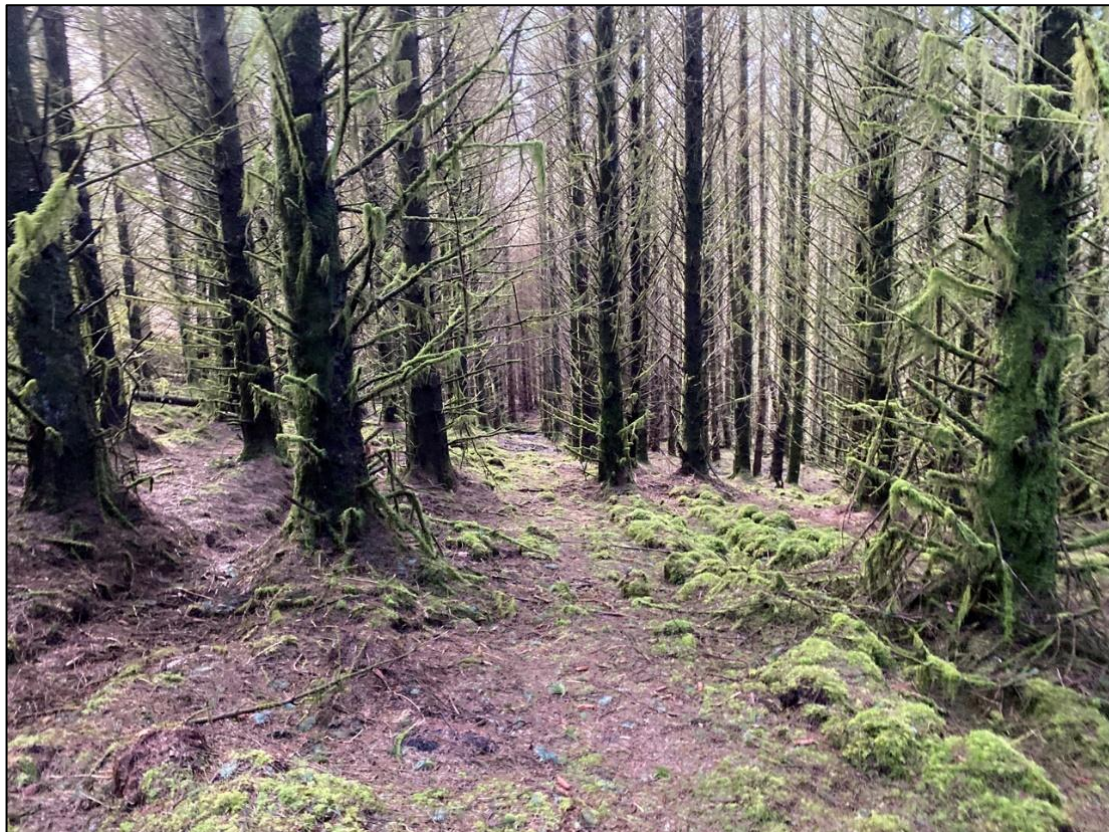
Plate 3-16 Dense, mature Conifer Plantation (WD4) where T11 and hardstand are located.

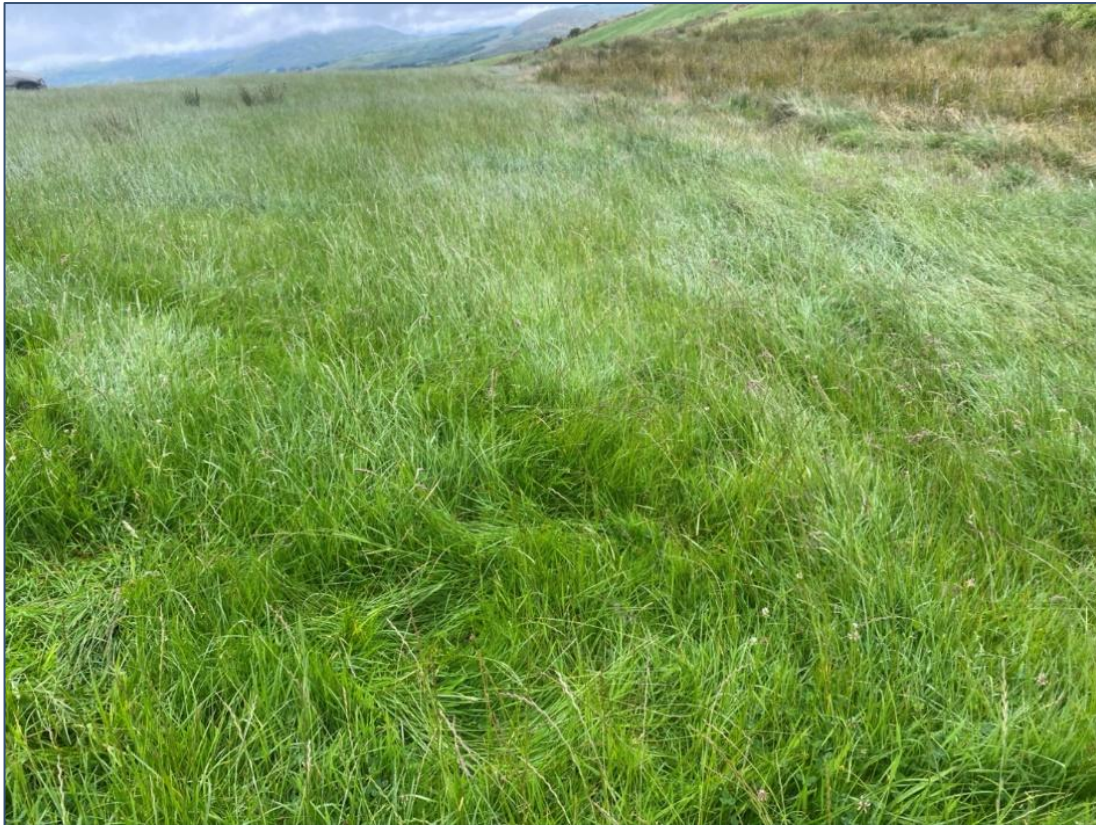
Plate 3-17 Turbine T12 and hardstand located within an area of Improved Agricultural Grassland (GA1).

Turbine T12 and associated infrastructure (hard stand and access roads) is located in the southwest of the Proposed Wind Farm site, predominantly on improved/ reclaimed agricultural lands classified as Improved Agricultural Grassland (GA1). Dominant species recorded within the improved agricultural field include Perennial Rye Grass (*Lolium perenne*), Sweet vernal grass (*Anthoxanthum odoratum*), Common bent (*Agrostis capillaris*), and Yorkshire fog (*Holcus lanatus*). This grassland is intensively managed via grazing/ mowing, creating a short, uniform sward. The ground conditions are dry. An area of degraded Upland Blanket Bog (PB2) was recorded to the south/ southeast of T12 that has not been reclaimed for agricultural purposes/ grazing. This area has been avoided by T12 infrastructure.

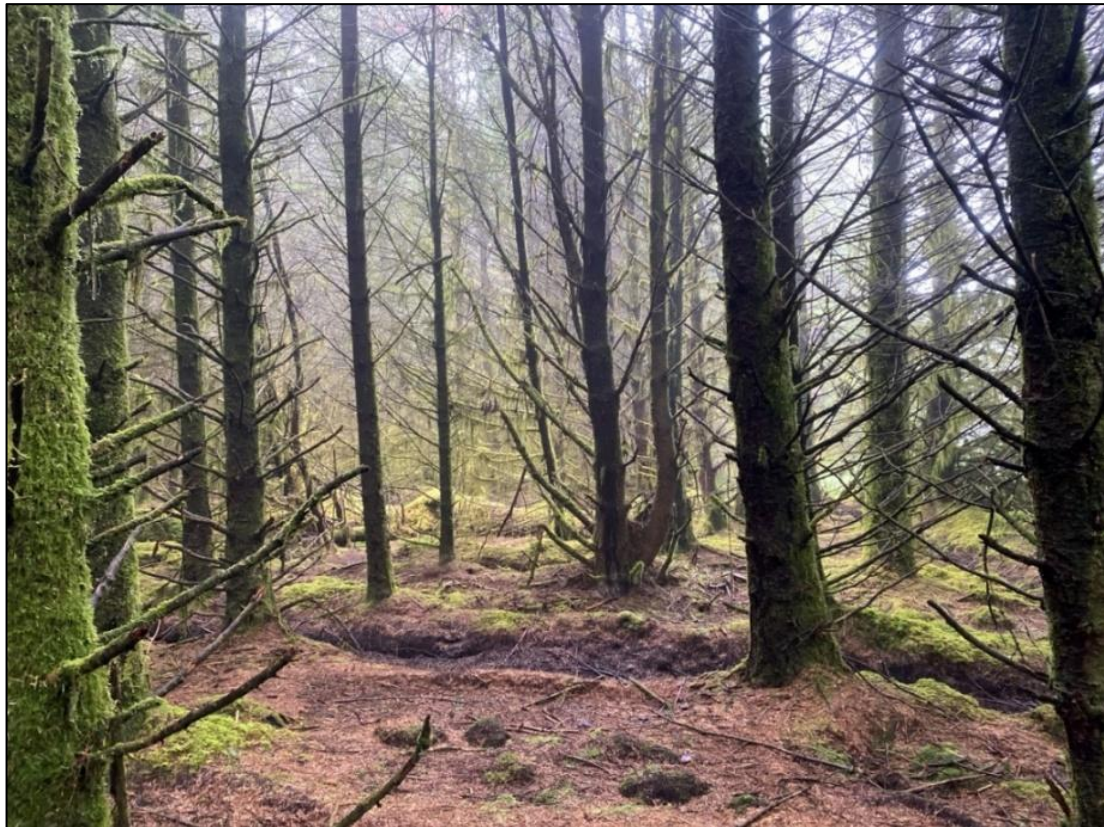
Plate 3-18 Section of the proposed road to T11 through Conifer Plantation (WD4).

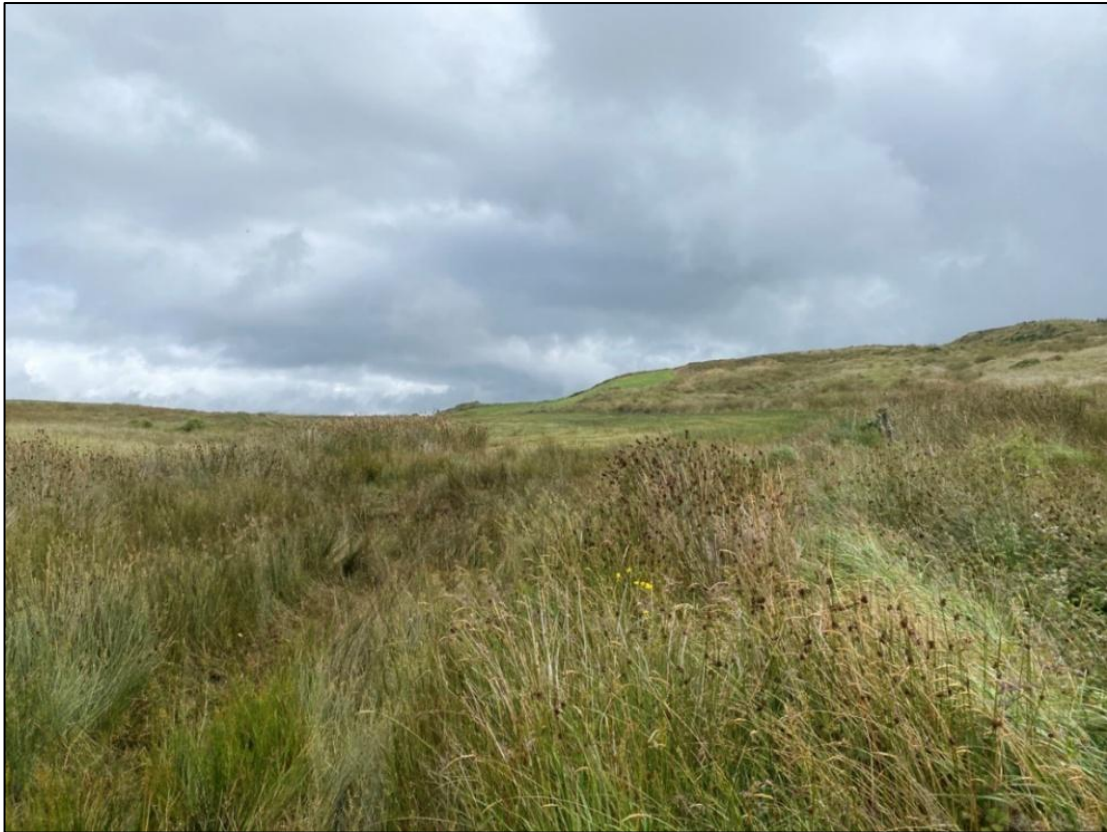
Plate 3-19 Wet Grassland (GS4) along proposed road.

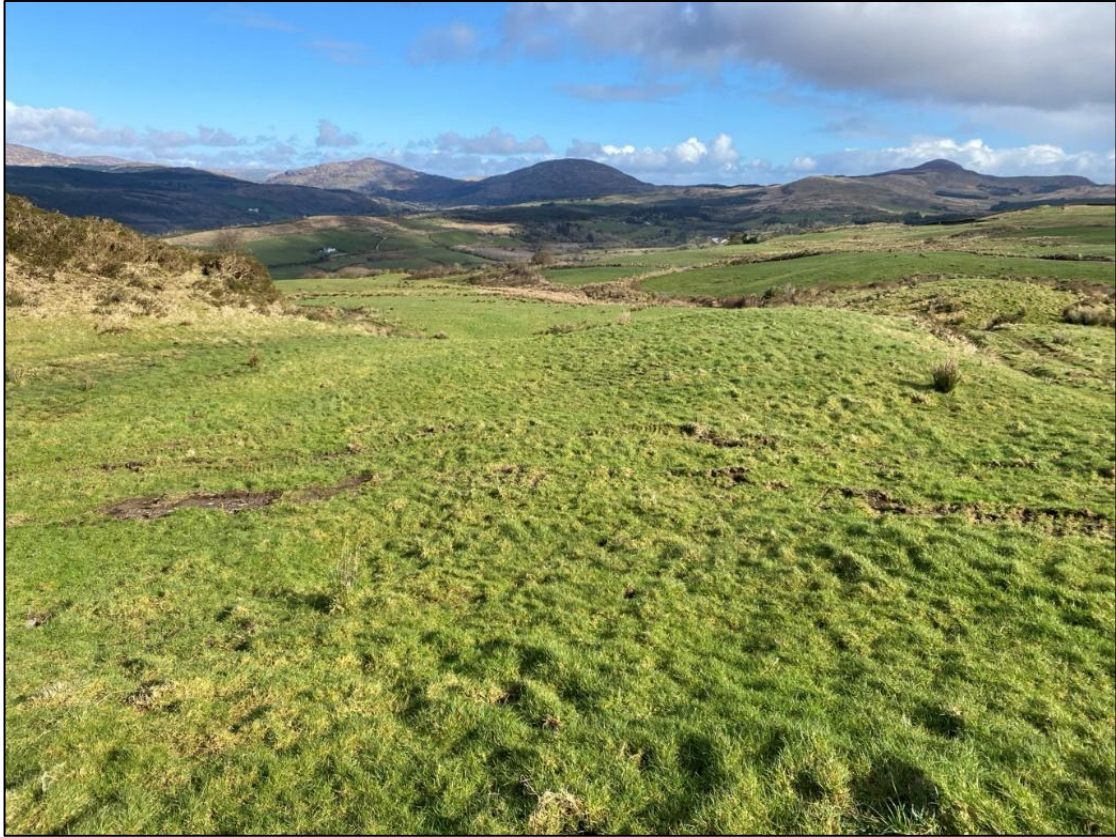
Plate 3-20 Improved Agricultural Grassland (GA1) in the vicinity of T13 and hardstand.

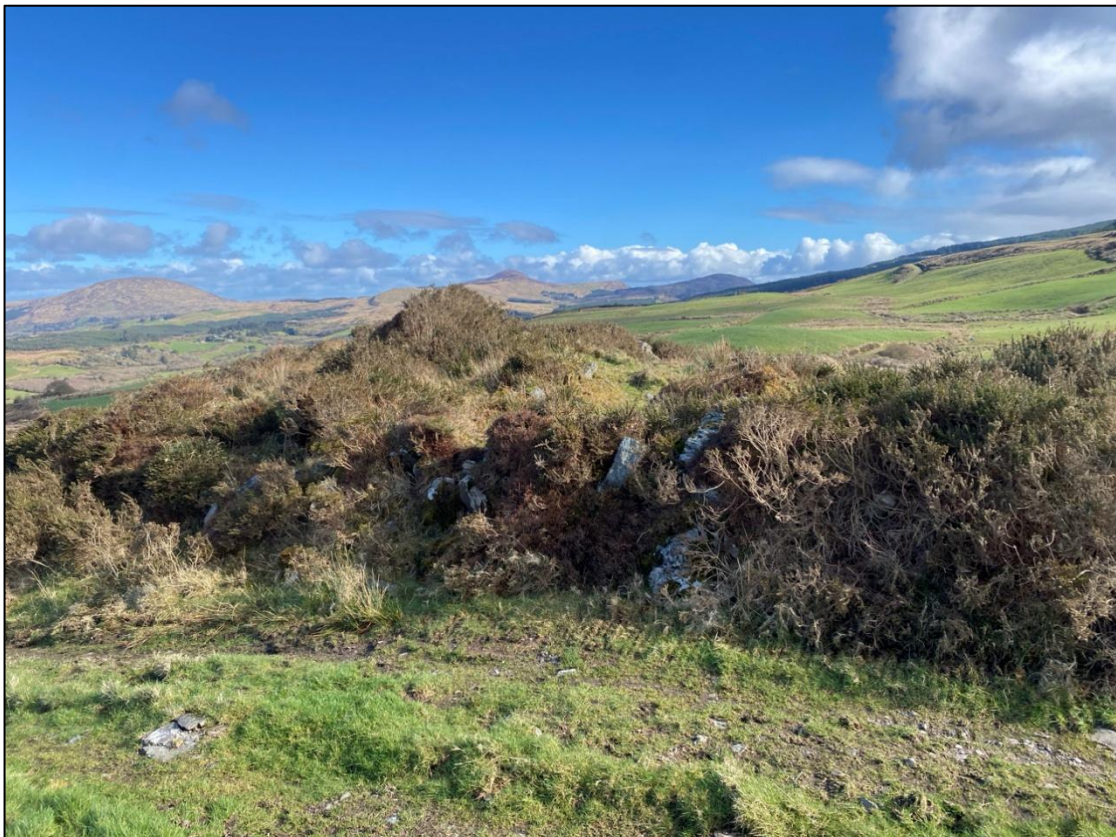
Plate 3-21 Fragmented Dry Siliceous Heath (HH1) to the south of T13/hardstand.

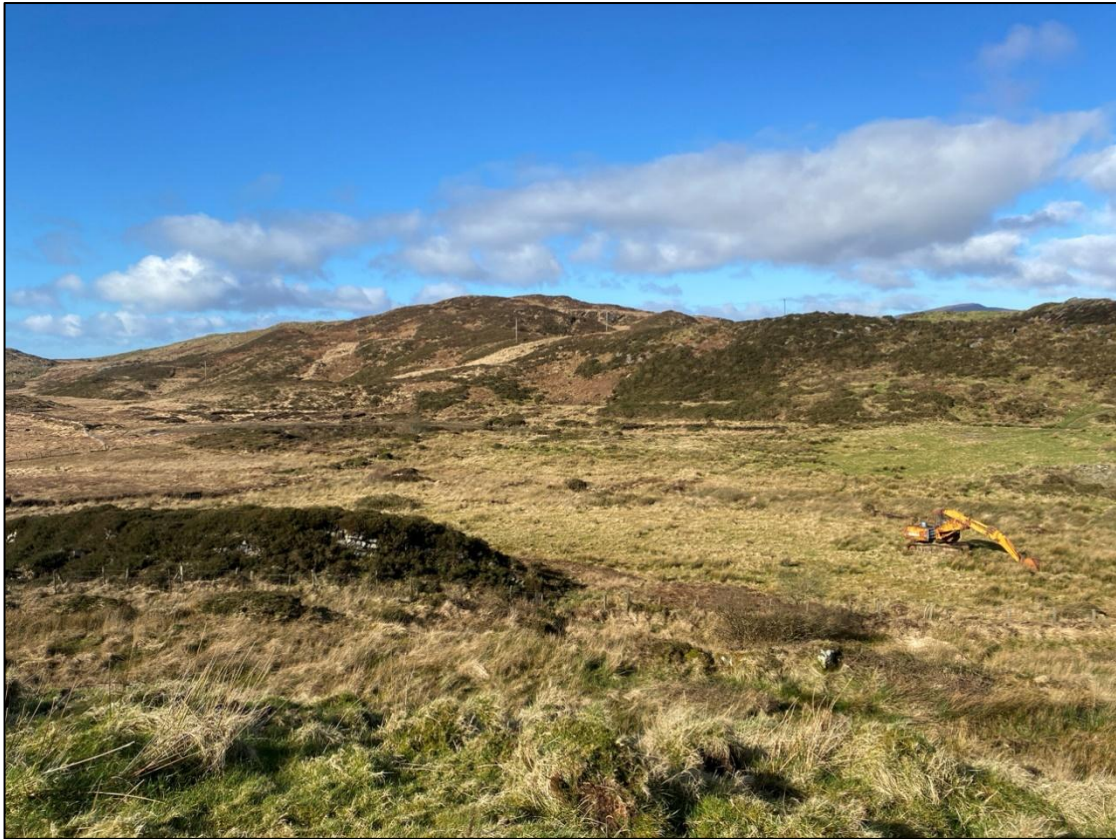
Plate 3-22 Access Road linking T12 to T13, located on undulating Wet Grassland (GS4)/Scrub (WS1) in the west of the Proposed Wind Farm southern turbine cluster.
