APPENDIX 6-1
BOTANICAL SURVEY REPORT

Botanical Survey Report - Appendix 6-1

Maughanaclea Renewable
Energy Development, Co,
Cork

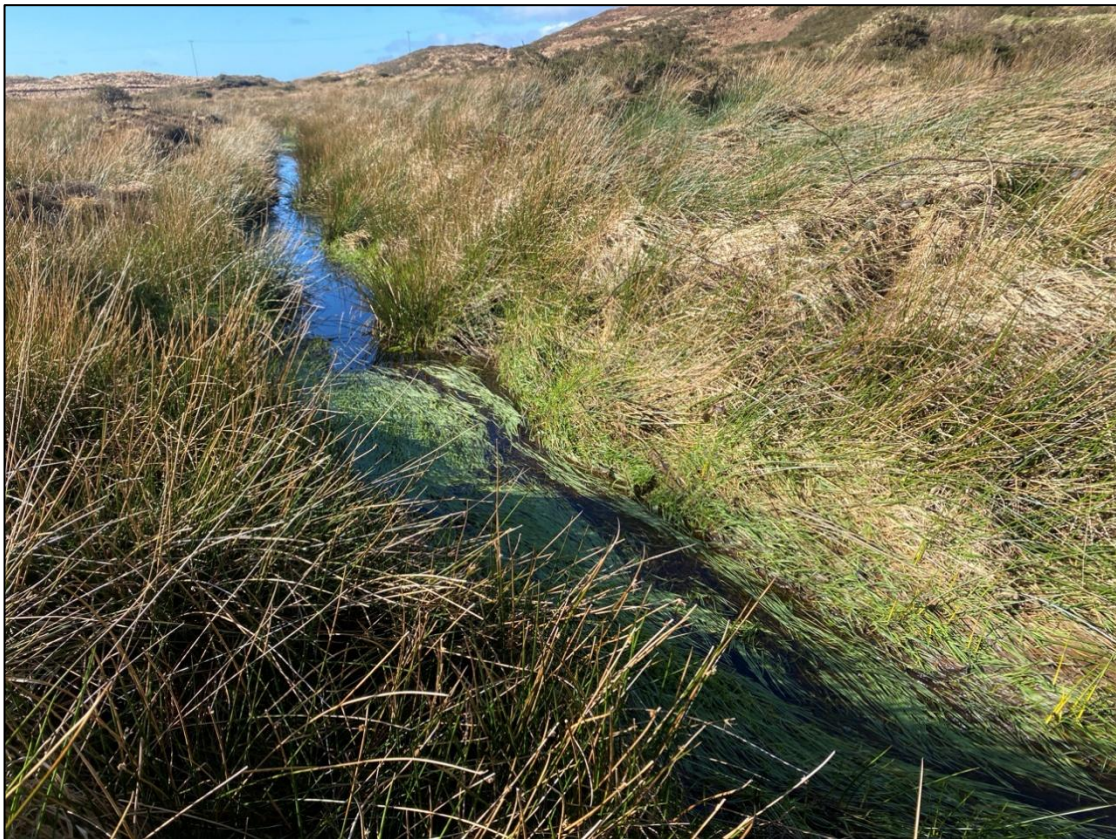
Plate 3-23 Unmapped Eroding/Upland River (FW1) along the access road linking T12 to T13.

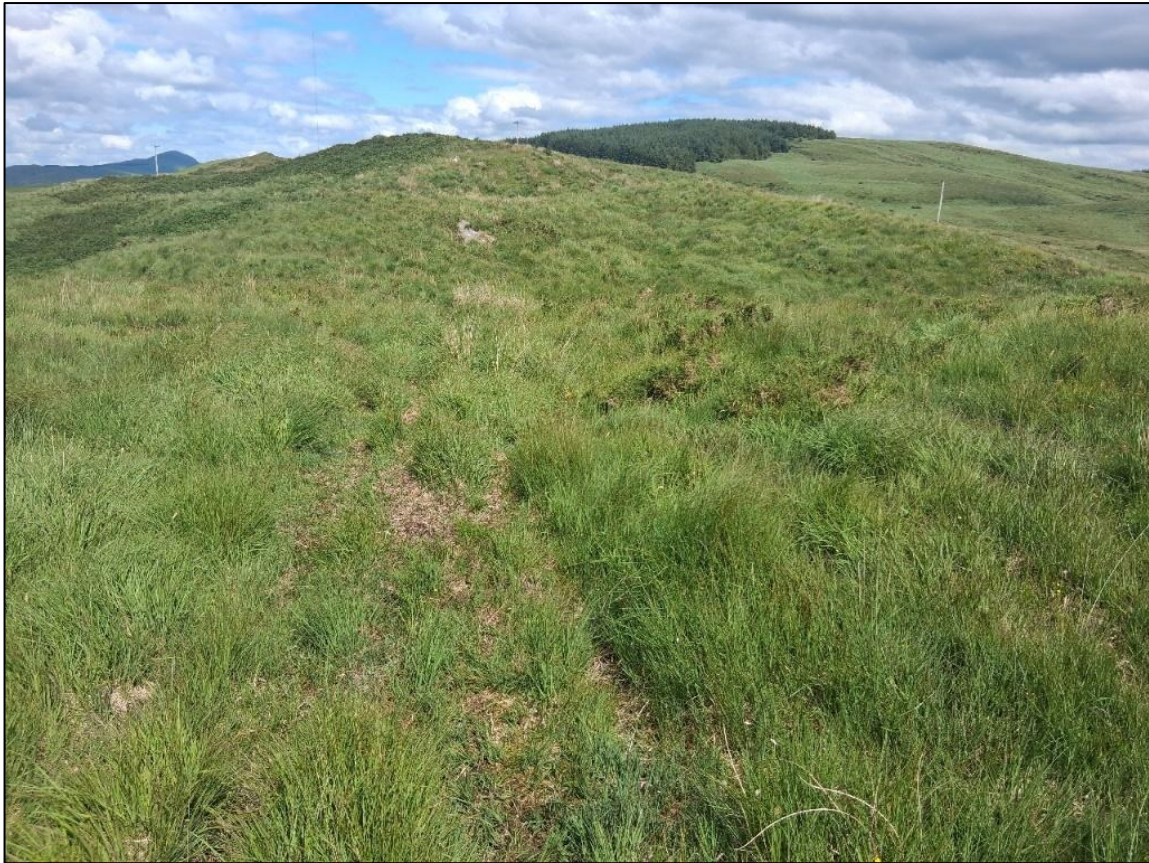
Plate 3-24 Degraded Wet Heath (HH3) at Turbine T14/hardstand.

Turbine T14 and associated infrastructure are located in the southwest of the Proposed Wind Farm site, on an area of degraded Wet Heath (HH3). This habitat has a low cover of dwarf shrubs (under 25%) and bryophytes. Cross leaved heath (*Erica tetralix*) and tormentil (*Potentilla erecta*) were recorded throughout this area. Overall, this area of wet heath contained poor species diversity and had a dry underfoot. Intensive, on-going sheep grazing was evident throughout this area of Wet Heath (HH3). Wet Heath (HH3) in the vicinity of T14 has links to the Annex I Habitat 'Northern Atlantic wet heaths with *Erica tetralix* (4010'.)

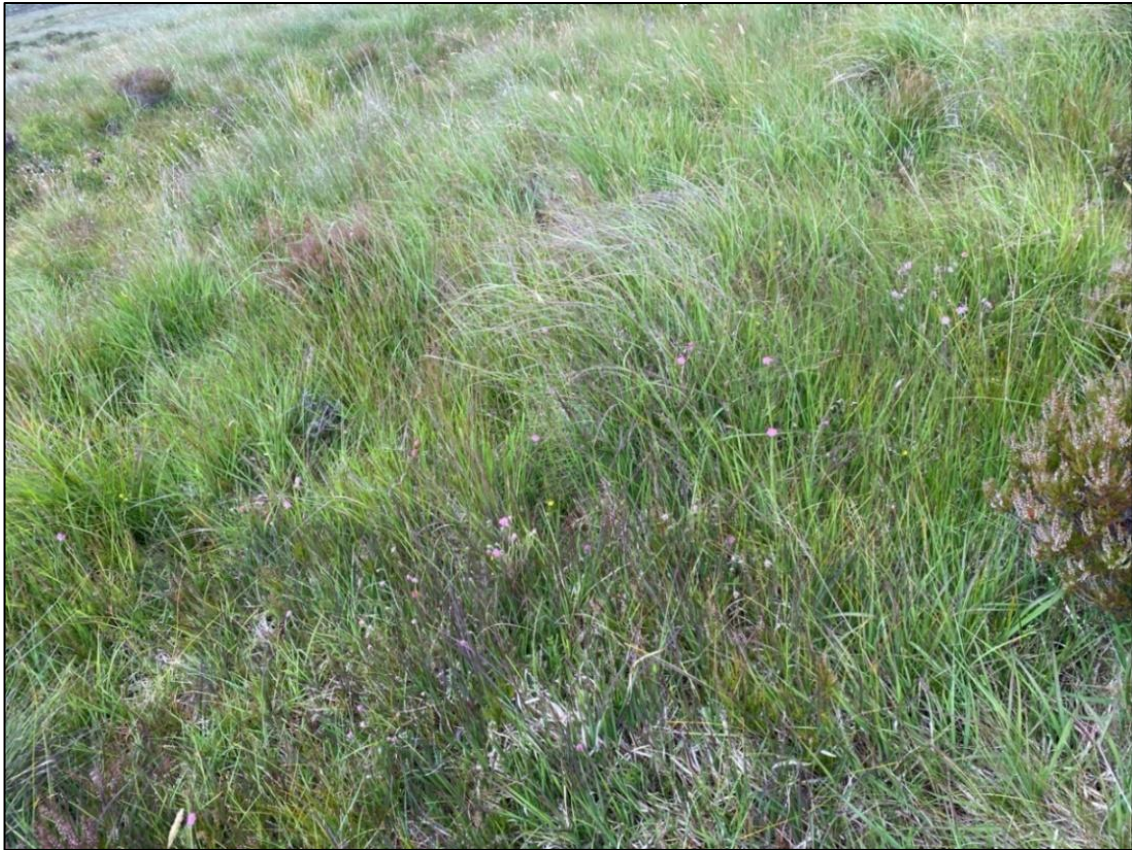
Plate 3-25 Ground conditions of upland blanket bog (PB2) along the proposed access road to T14

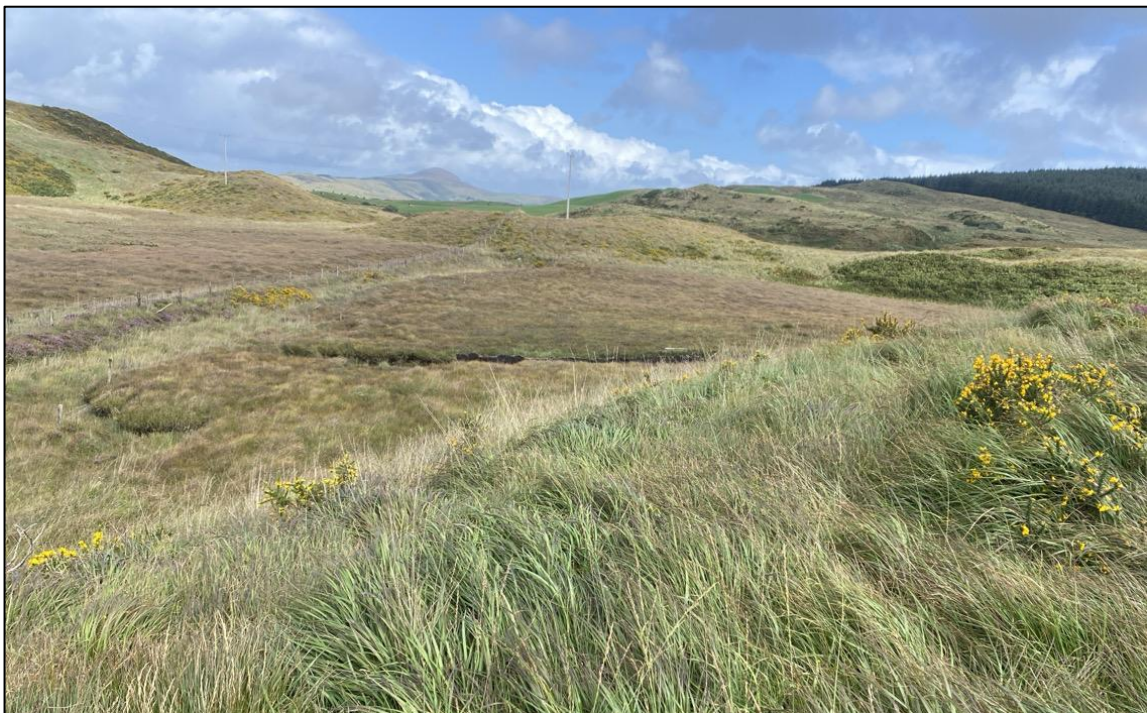
Plate 3-26 Upland Blanket Bog (PB2), Dense Bracken (HD1) and Wet Heath (HH3) recorded along the proposed access road to T14.

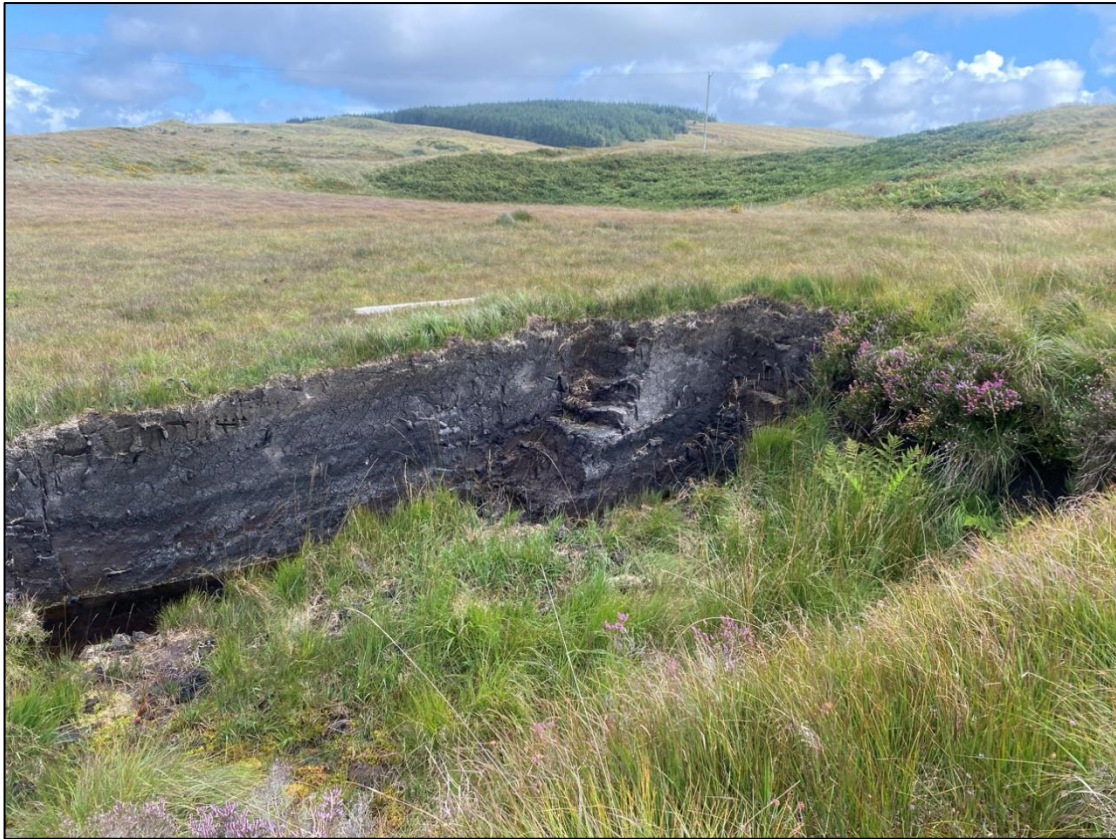
Plate 3-27 Turbary Activity in the vicinity of T14.

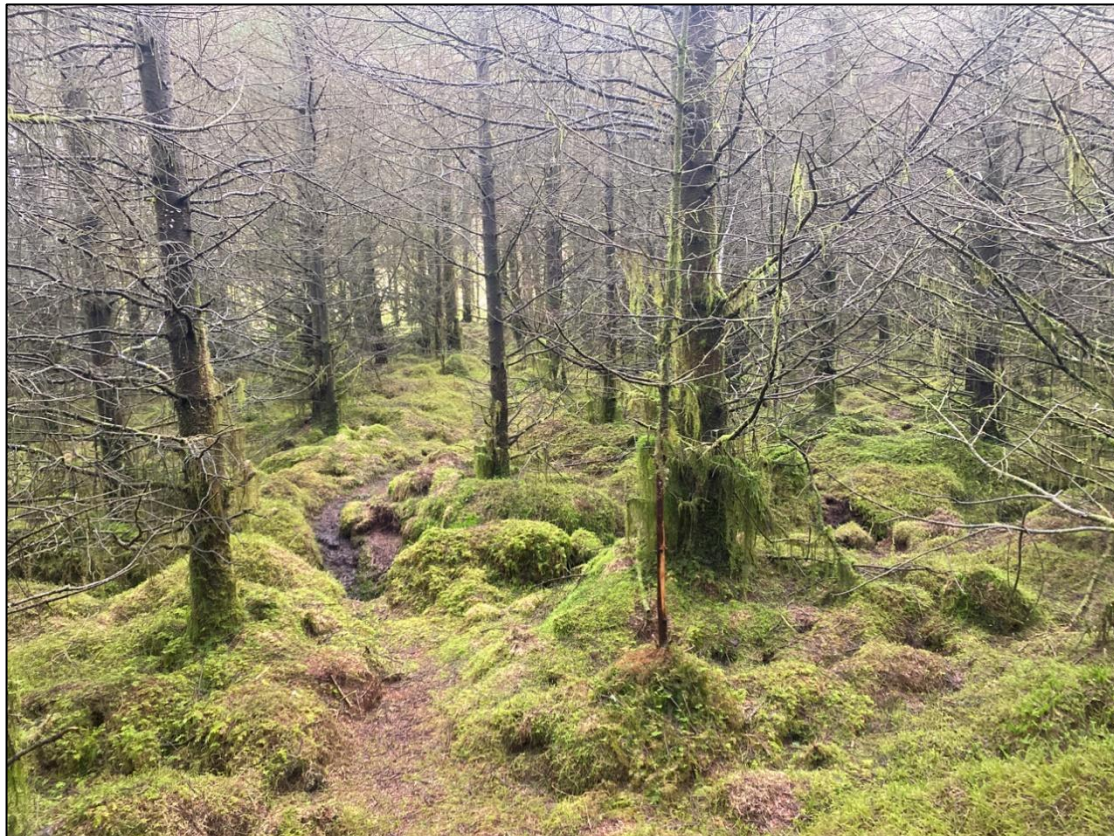
Plate 3-28 Proposed 110kV onsite substation located with Conifer Plantation (WD4), with a wet underfoot.

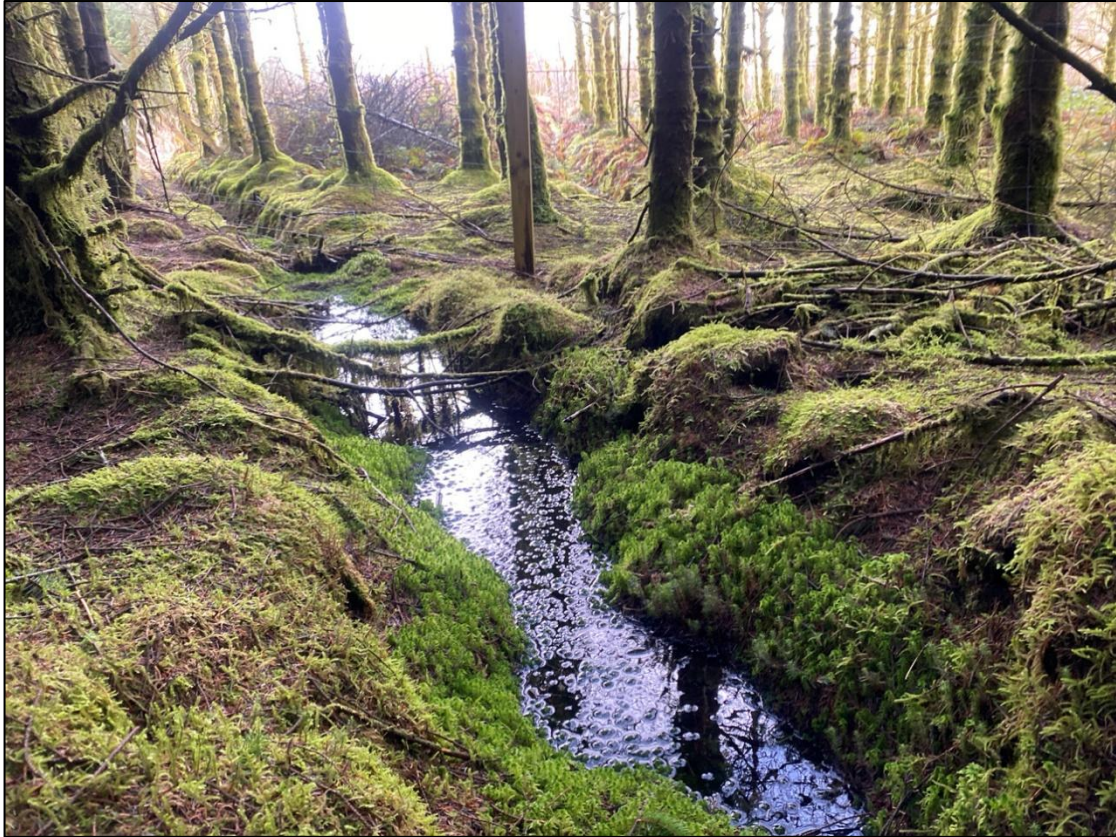
Plate 3-29 Drainage Ditch (FW4) within the vicinity of the proposed 110kV onsite substation.

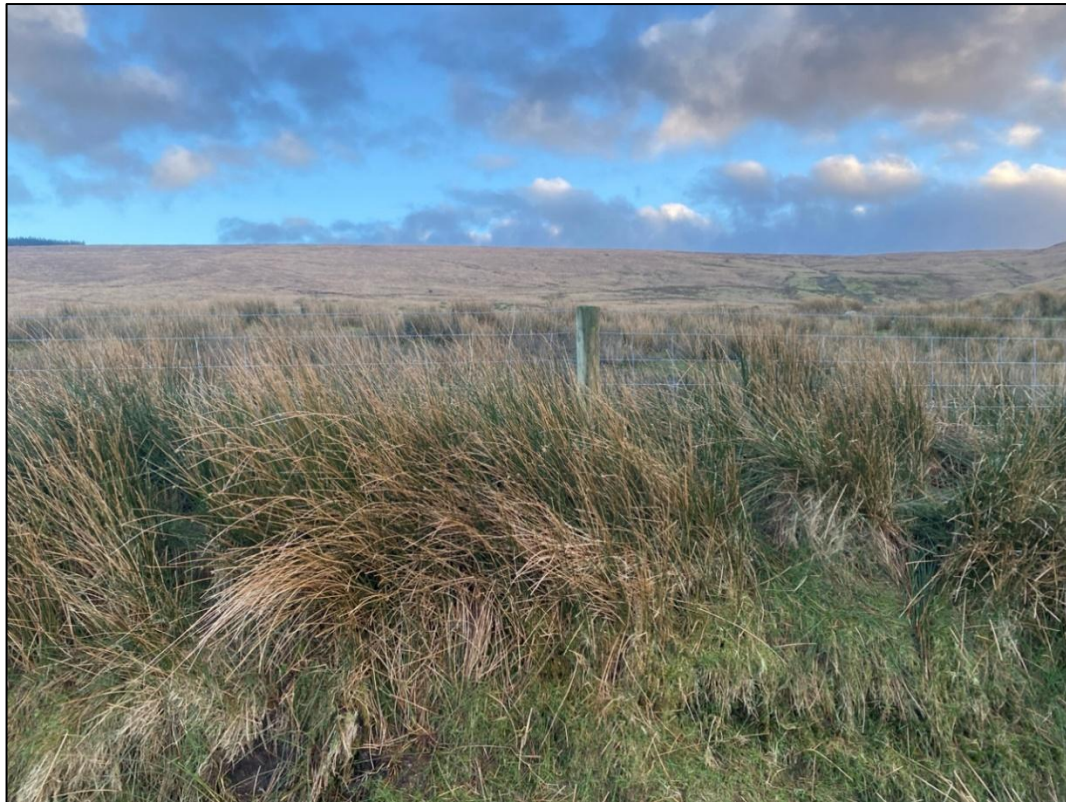
Plate 3-30 Proposed security cabin in the southern turbine cluster of the Proposed Wind Farm site located on an area of Wet Grassland (GS4).

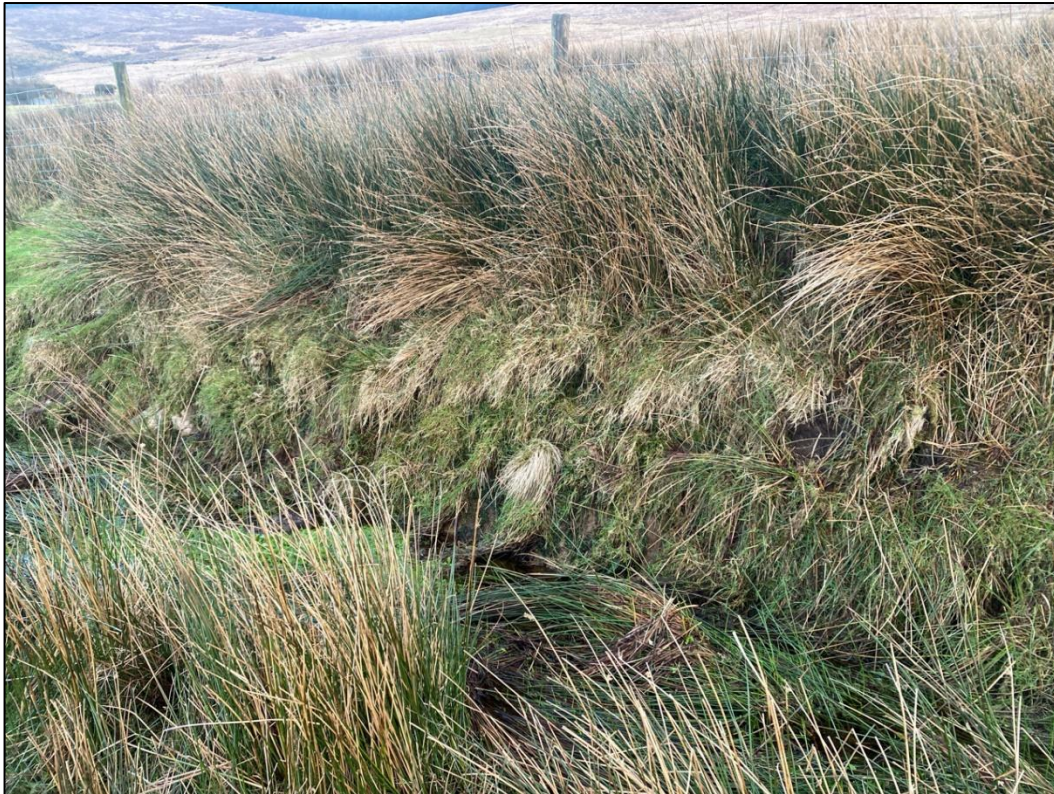
Plate 3-31 Drainage Ditch (FW4) located to the north of the proposed security cabin in the southern turbine cluster of the Proposed Wind Farm.

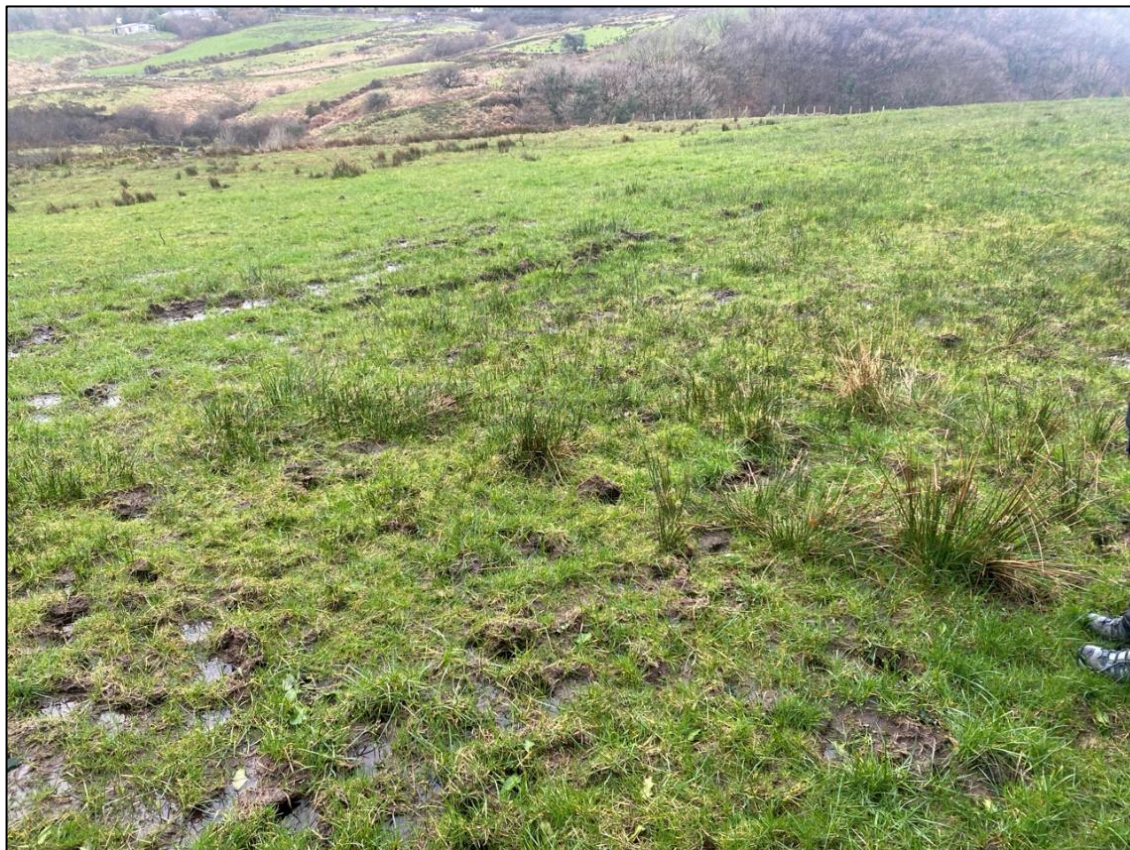
Plate 3-32 Proposed security cabin/proposed access road to the northern turbine cluster of the Proposed Wind Farm located on an area of Wet Grassland (GS4)/ Improved Agricultural Grassland (GA1).

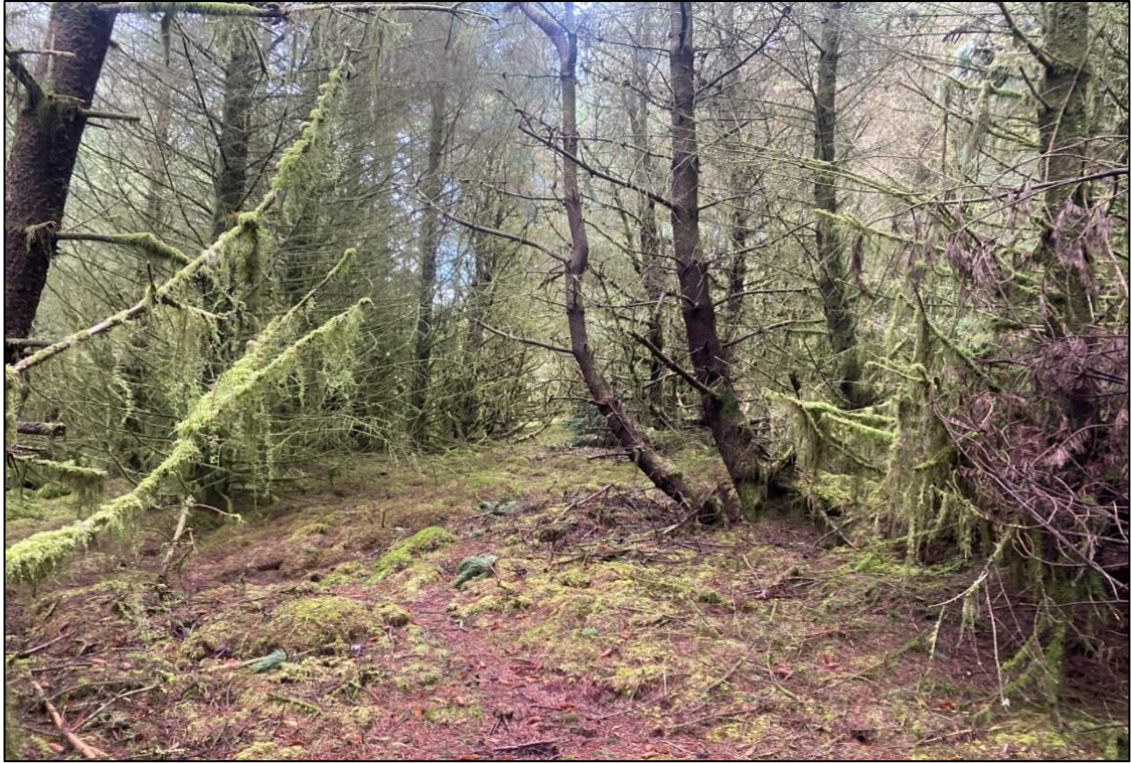
Plate 3-33 Proposed met mast located within the southern Conifer Plantation (WD4) on steep sloping ground.

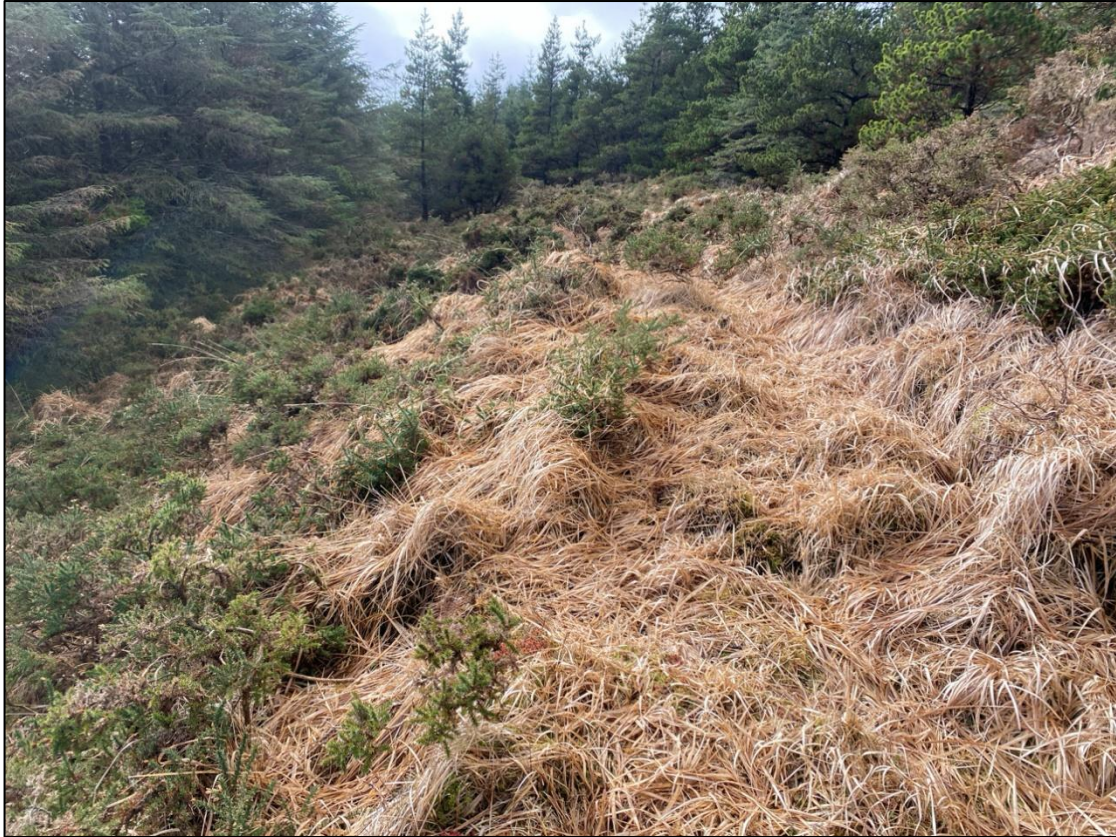
Plate 3-34 Temporary construction compound in the southern turbine cluster of the Proposed Wind Farm partially within Conifer Plantation (WD4) and partially within an opening within the Conifer Plantation.

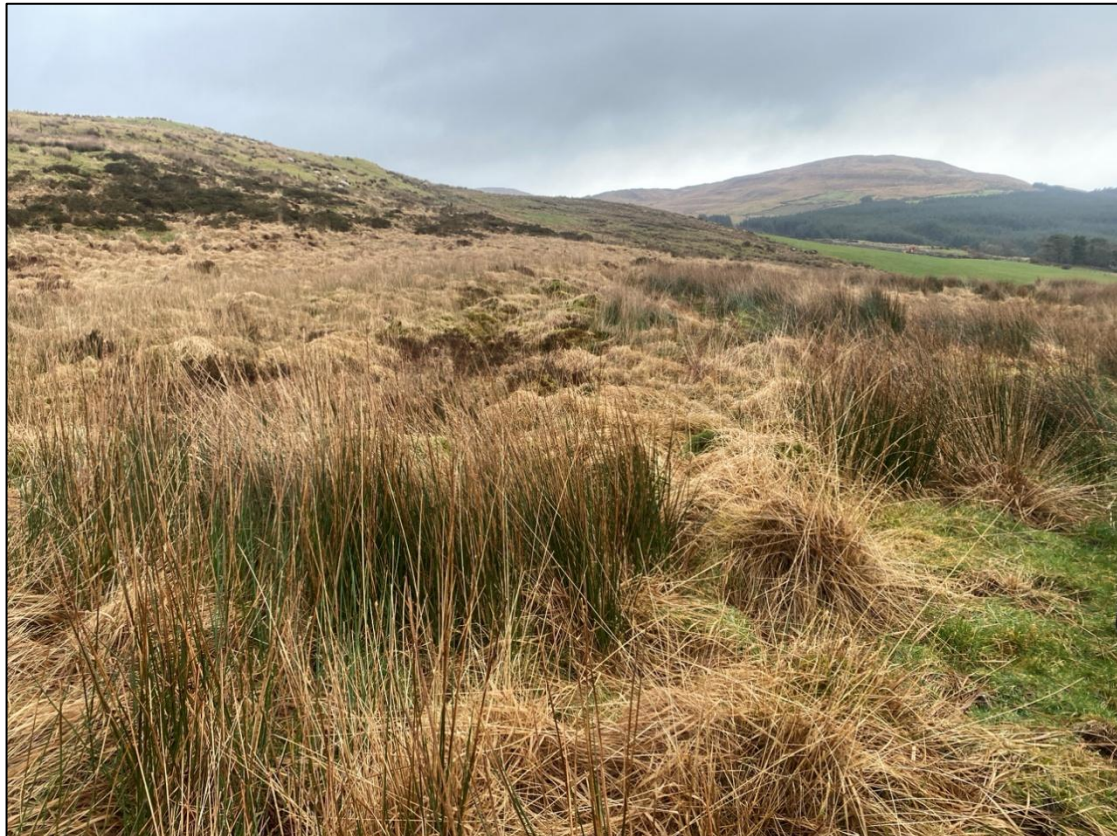
Plate 3-35 Temporary construction compound in the northern turbine cluster of the Proposed Wind Farm located partially on an area of degraded Wet Heath (HH3) and partially on a mosaic of Dry Humid Acid Grassland (GS3)/Wet Grassland (GS4)

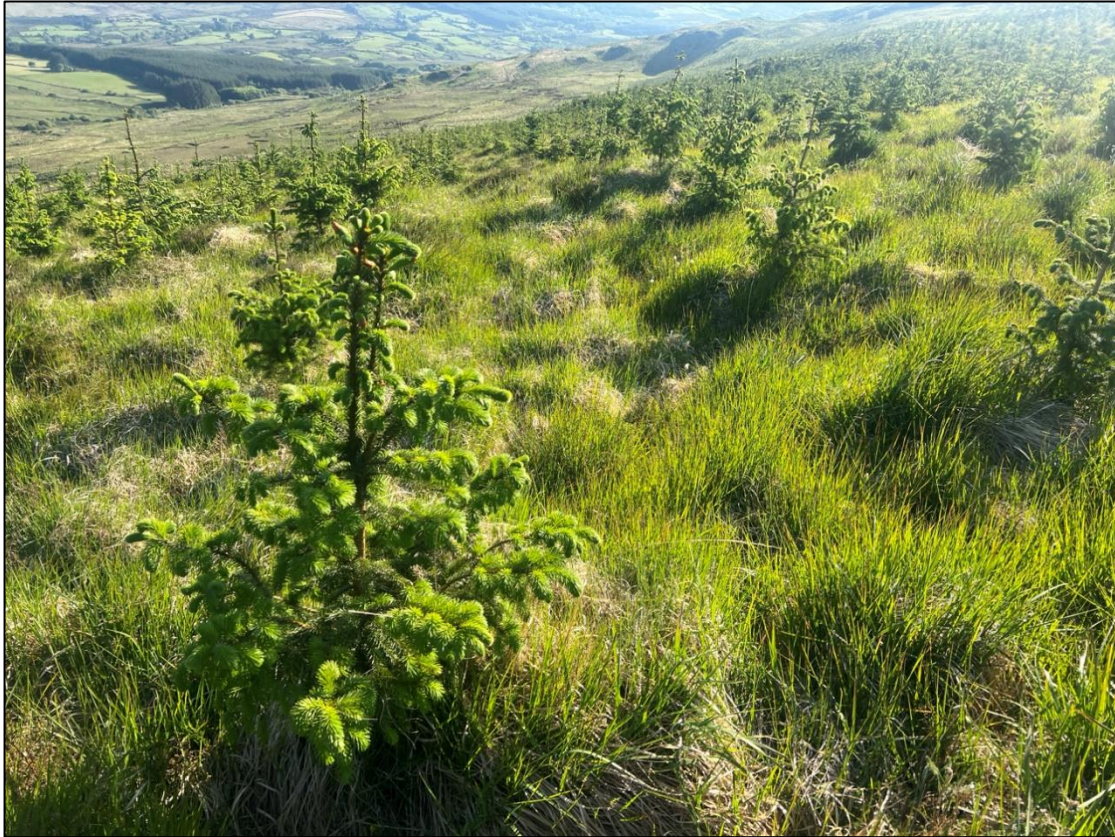
Plate 3-361 BP1 is located in the northern turbine cluster of the Proposed Wind Farm site, on an area of recently planted Conifer Plantation (WD4).

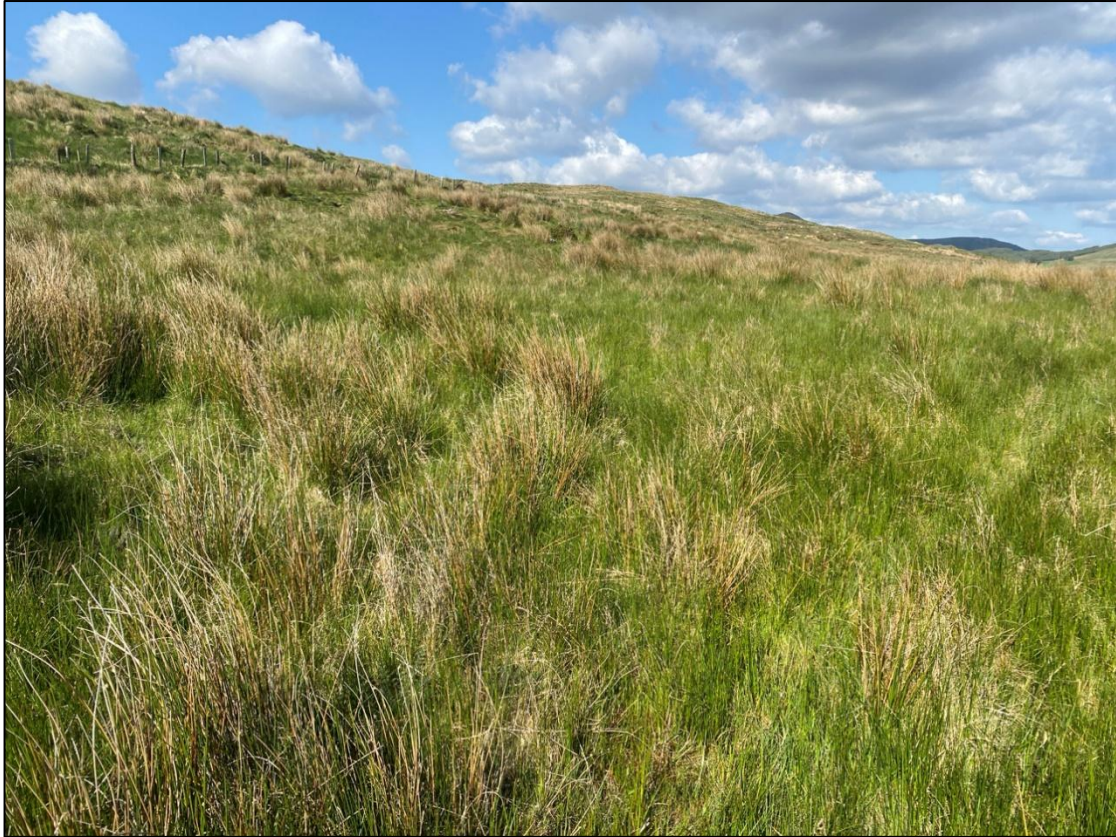
Plate 3-372 The proposed borrow pit southwest of T05 and T06 is located on an area of degraded Dry Humid Acid Grassland (GS3)/ Wet Grassland (GS4).

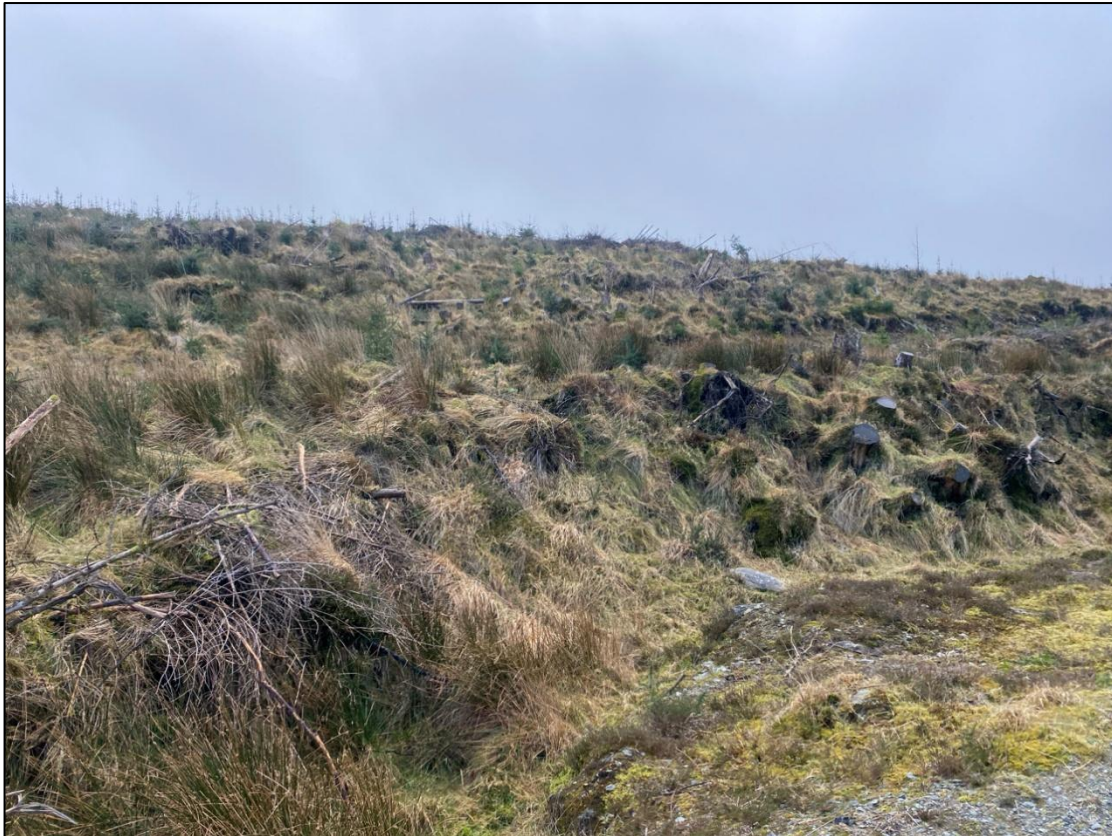
Plate 3-38 BP3 is located on an area of Conifer Plantation (WD4) in the southern turbine cluster of the Proposed Wind Farm.

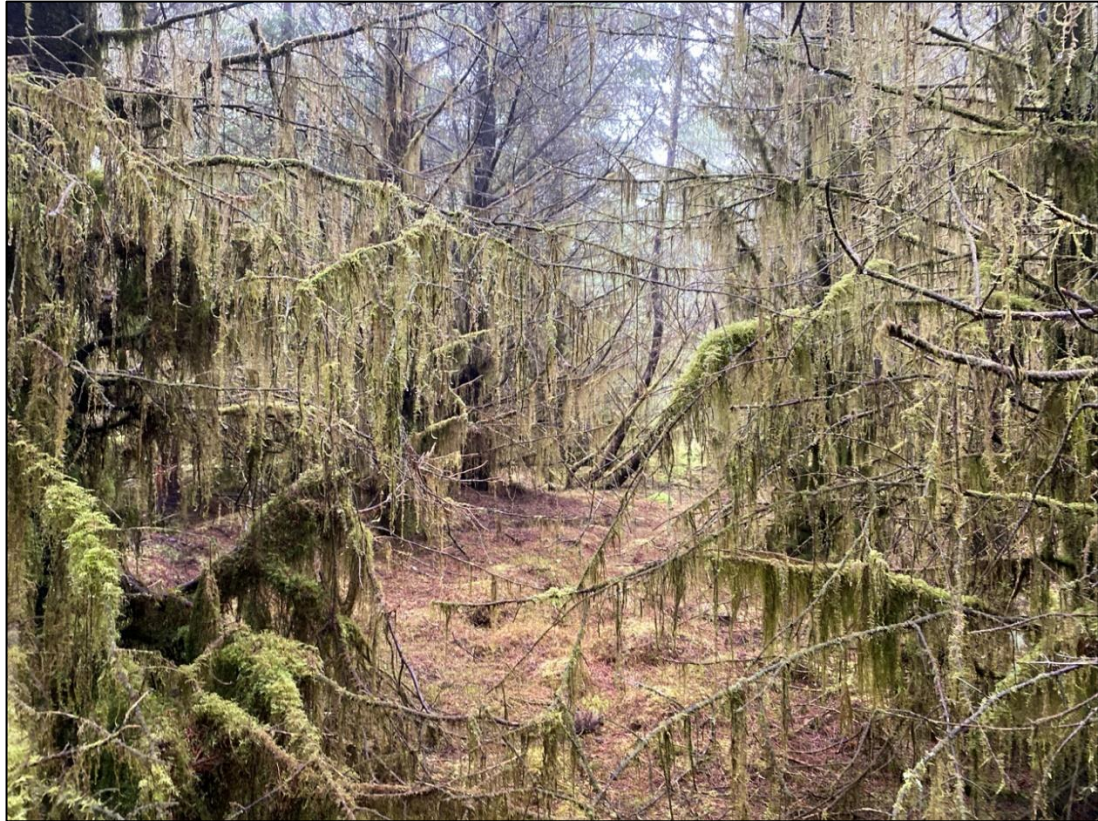
Plate 3-39 BP4 is located within Conifer Plantation (WD4) in the southern turbine cluster of the Proposed Wind Farm.
