## **Appendix 6-3 Aquatic Baseline Report**

Maughanaclea Renewable  
Energy Development

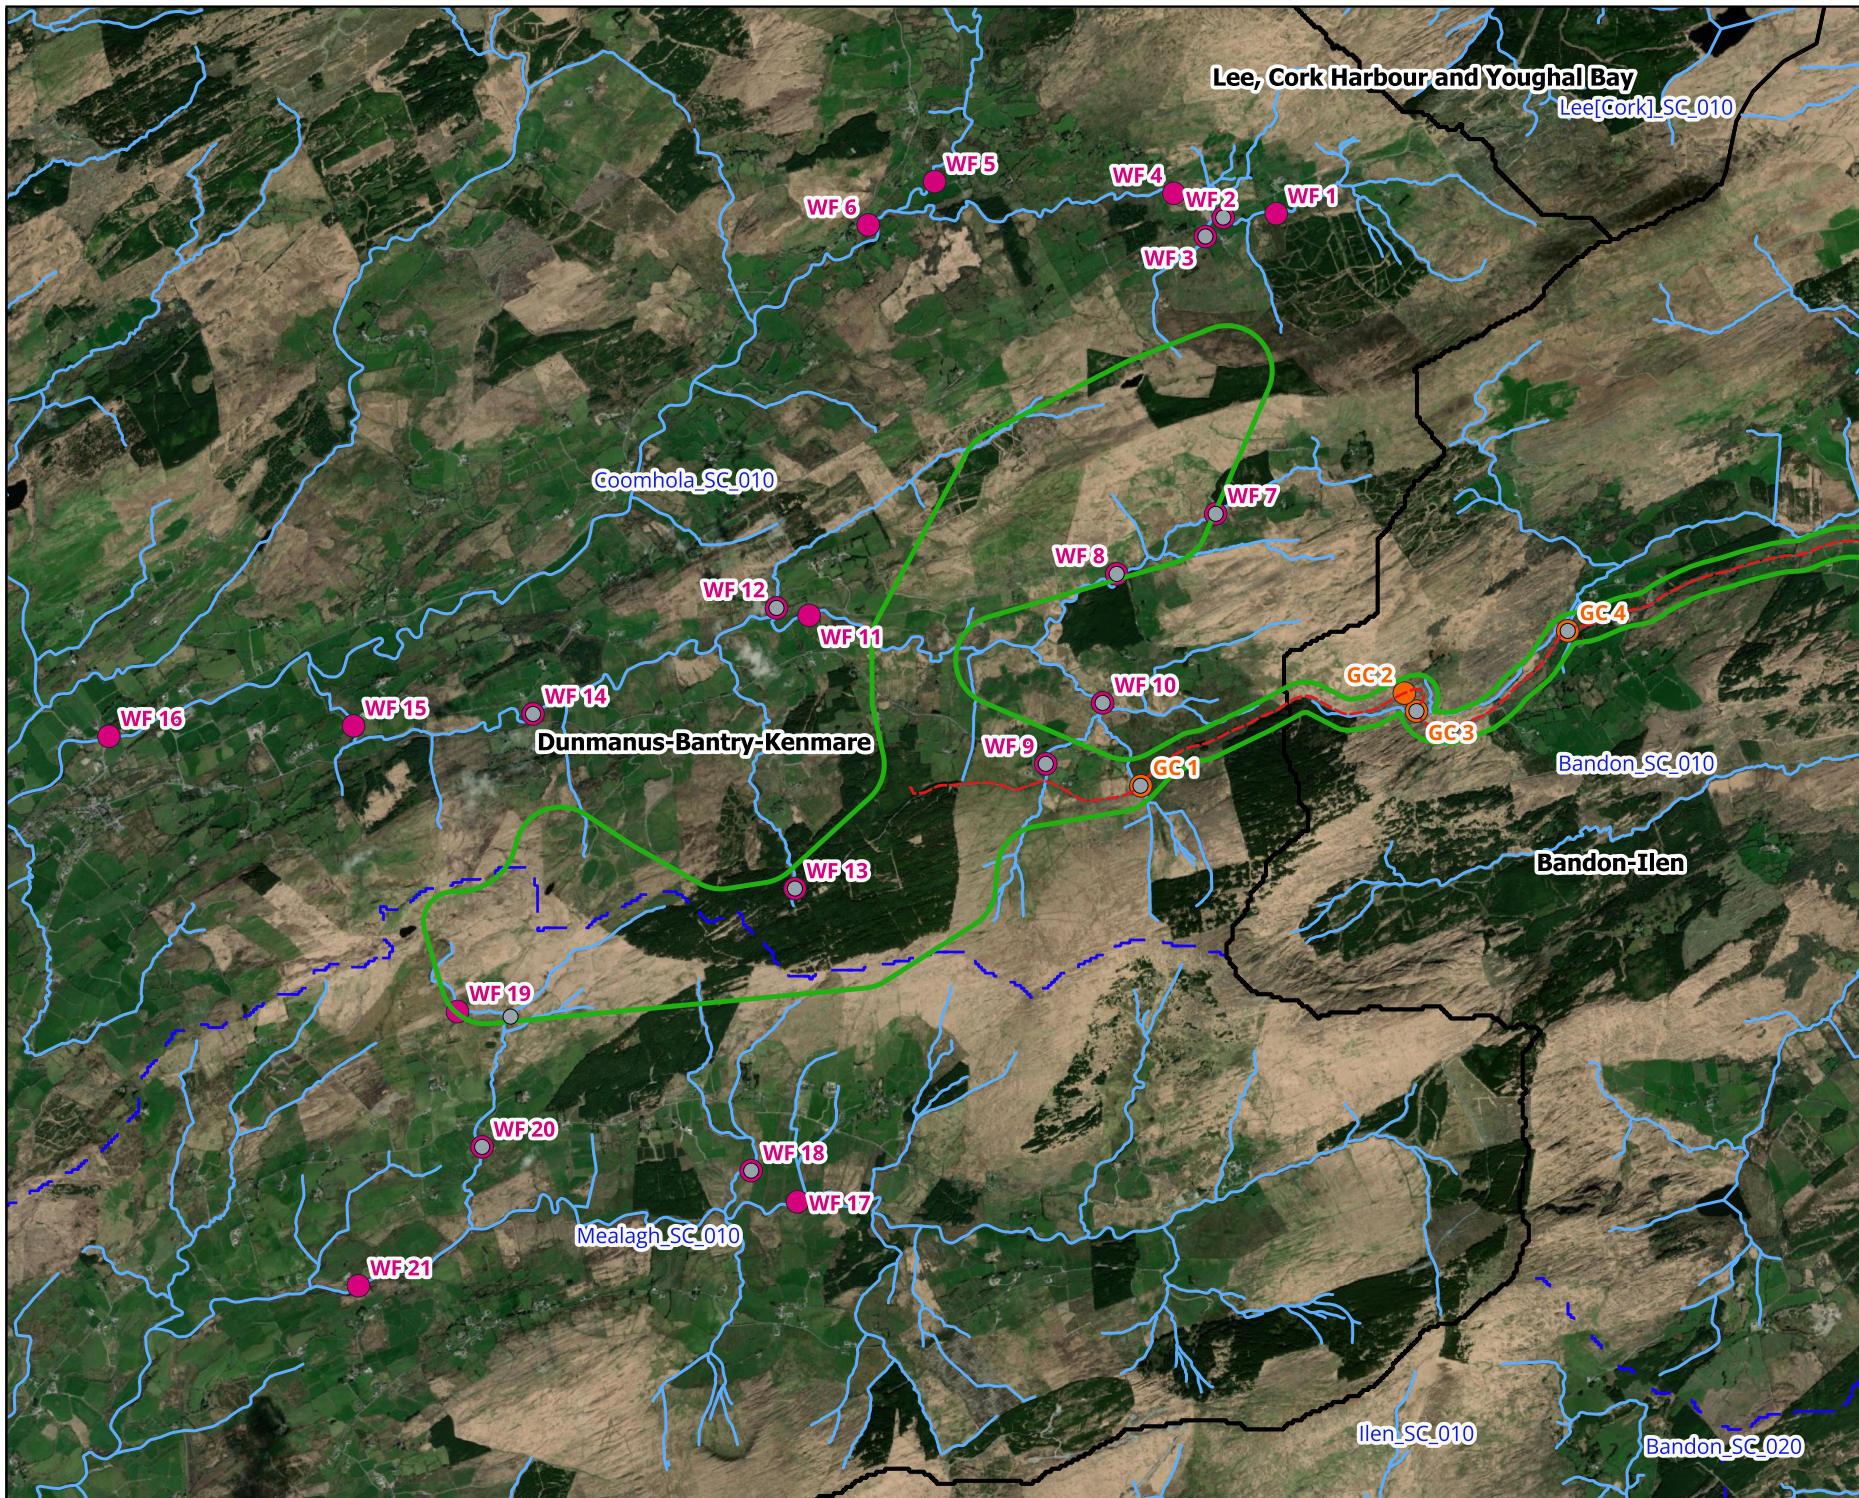
Drawn By <b>NR</b>	Checked By <b>JH</b>
Project No. <b>240225</b>	Drawing No. <b>Figure 1-1</b>
Scale <b>1:50,000</b>	Date <b>26.03.2026</b>

The aquatic baseline surveys for the Proposed Wind Farm and Proposed Grid Connection took place in the vicinity of Kealkill and Dunmanway, Co. Cork. Locations for survey sites in the vicinity of the Proposed Wind Farm are shown in in Figure 1-1, locations for the Proposed Grid Connection survey sites are shown in Figure 1-2.

The 'Proposed Wind Farm study area' refers to the survey sites selected along watercourses upstream, downstream and within the Proposed Wind Farm Site, as shown in Figure 1-1. The 'Proposed Grid Connection study area' refers to the survey sites selected at points which the Proposed Grid Connection crosses watercourses, as shown in Figure 1-2.

A 5- or 10-minute timed electrofishing survey was undertaken at each of the survey sites, to determine the presence/absence of fish species within the Proposed Wind Farm study area while adhering to best practice methodology (Electric Fishing in Wadeable Reaches, Central Fisheries Board (CFB, 2008)), as well as European standards for electrofishing (CEN, 2003). Two suitably qualified ecologists conducted electro-fishing operations at the electro-fishing locations as per Fig 1-1, using an E-fish EF-500B-SYS Electric Fishing Backpack System.

Environmental DNA (eDNA) surveys were undertaken on watercourses at 12 no. Proposed Wind Farm survey sites and 9 no. Proposed Grid Connection survey sites (locations shown in Figure 1-1 and Figure 1-2). Survey sites were chosen to give the best chance of detecting eDNA of target species and to aid in determining approximate area of presence of such species if positive results were garnered.

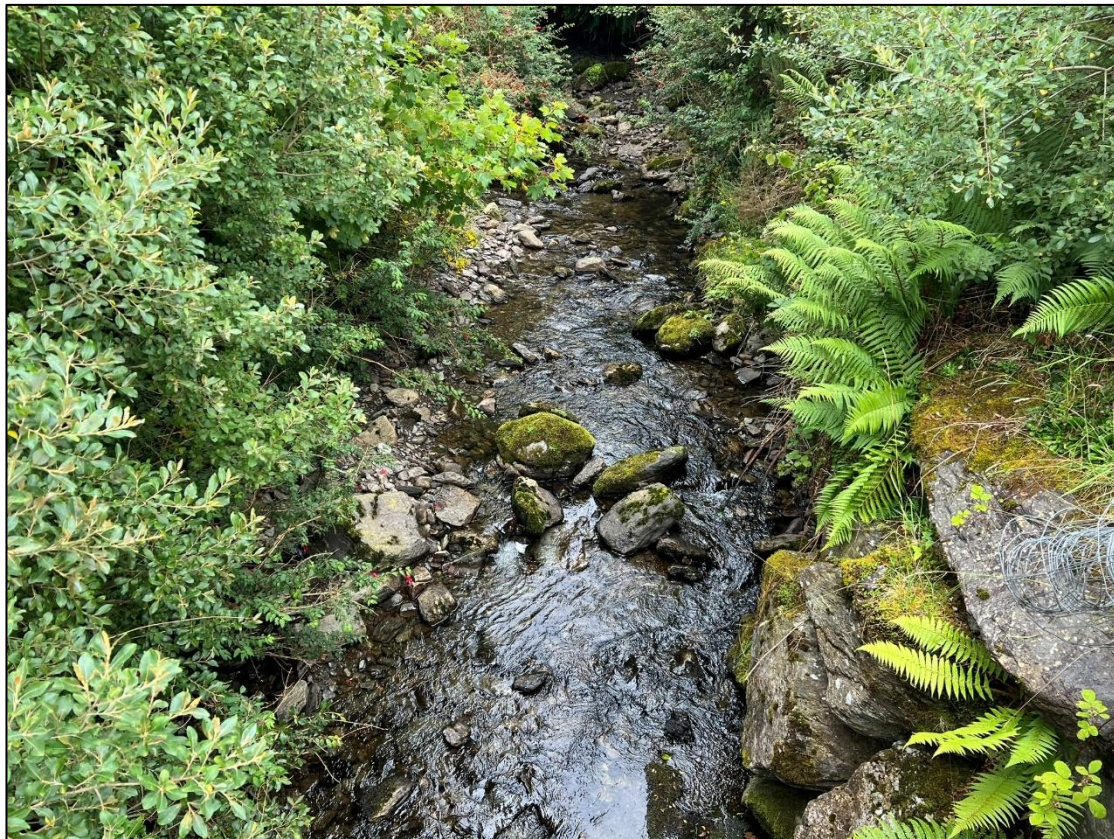
Plate 4-1. A representative photo of survey site WF 1

Properties	Record
Average Depth (m)	0.2
Average Bank Width (m)	4.0
Average Wetted Width (m)	2.5
Flow	Low
Colouration	No distinct coloration
Clarity	Very Clear
Average Bank height (m)	LHB   2.0   RHB   1.8
Dominant Substrates	Boulder (>128mm): 30% Cobble (>32–128mm): 50% Gravel (8-32mm): 20%
Substratum Condition	Compacted

Although the watercourse displayed a varied channel substrate composition, with diverse flow patterns both laterally and longitudinally along the channel, the upgradient, headwater location of this survey site limited its fisheries potential. A mixture of large boulder, cobble and smaller patches of interstitial gravels provided localised juvenile salmonid habitat, which may be inaccessible to fish in the wider landscape of this watercourse. A lack of adequate areas of spawning gravels and overall compacted channel substrate provided negligible spawning habitat for all fish species, and overall shallow depth (with the exception of some deeper pools upstream of the bridge) saw inadequate holding habitat for adult salmonids. Overhanging willow trees and marginal boulder features provided complex marginal habitat suitable for eel but is likely unutilised due to the watercourse's inaccessibility and natural barriers to migration in the form of boulder and bedrock steps and small cascades throughout the wider

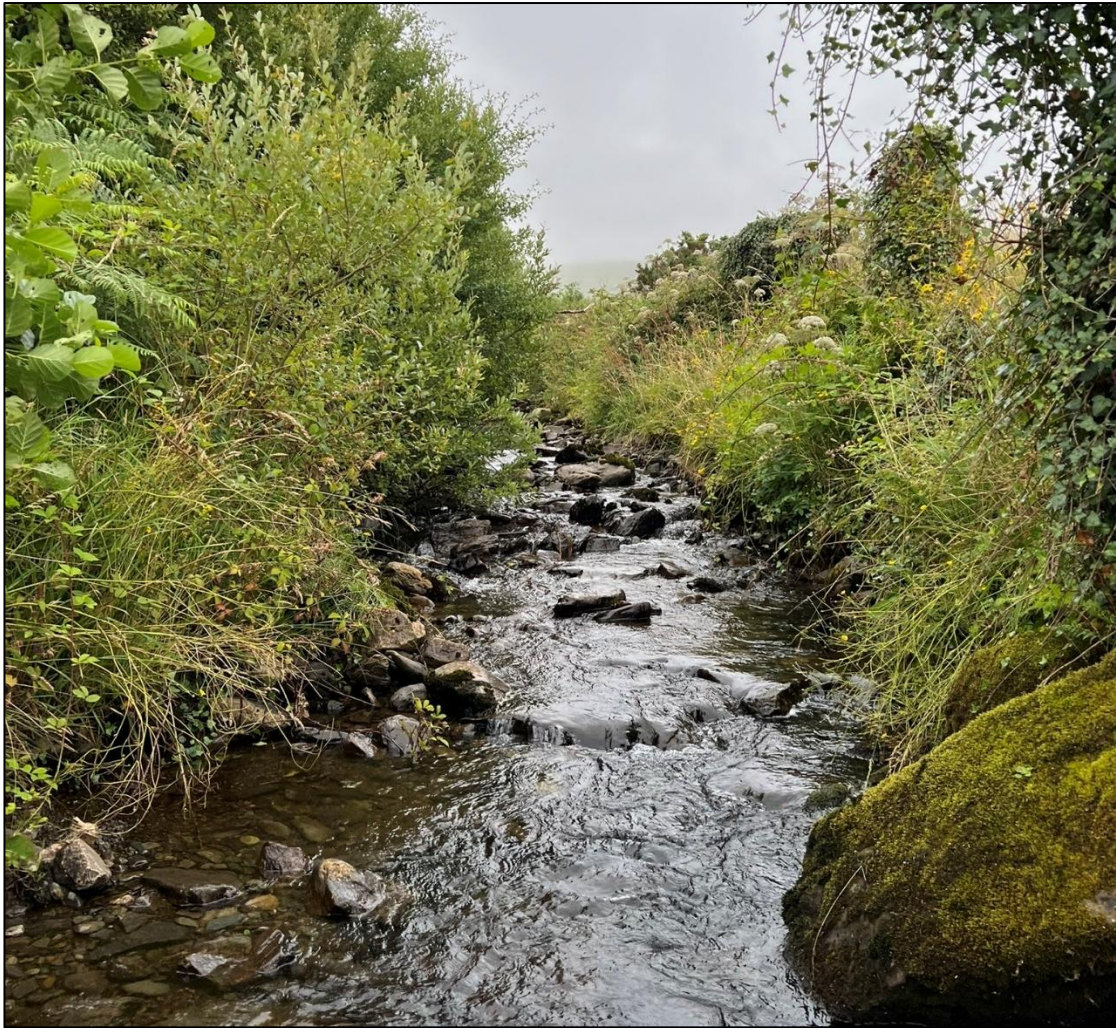
Plate 4-2. A representative photo of survey site WF 2

This stretch of the Inchiroe was of low fisheries value given its headwater profile, upland gradient and bedrock/boulder channel bed with step features throughout, all of which may preclude upward migration of fish. Salmonid or lamprey *sp.* spawning in the way of loose, mobile gravel beds and lamprey *sp.* nursery habitat in the way of fine sediment beds, were absent. Although channel substrate was varied and flow patterns diverse, with instream structural refuge suitable for nursery age salmonids, salmonid nursery classified as locally moderate-good would be largely inaccessible to migratory fish species, reflected in the 5-minute qualitative electrofishing survey results conducted at this survey site Table 4-4.

Properties	Record			
Average Depth (m)	0.2			
Average Bank Width (m)	3.0			
Average Wetted Width (m)	2.0			
Flow	Fast			
Colouration	No distinct coloration			
Clarity	Very clear			
Average Bank height (m)	LHB	1.2	RHB	2.0
Dominant Substrates	Bedrock: 30% Boulder (>128mm): 30% Cobble (>32-128mm): 20% Gravel (8-32mm): 20%			
Substratum Condition	Compacted

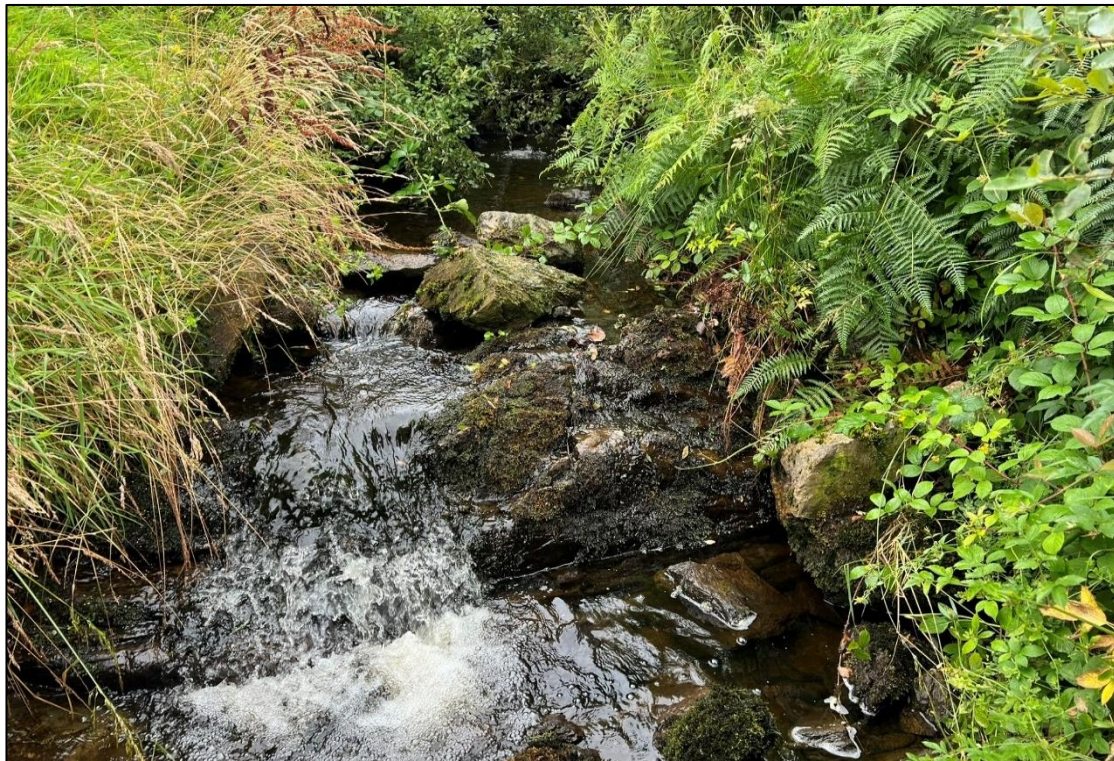
Plate 4-3. A representative photo of survey site WF 3

Properties	Record			
Average Depth (m)	0.2			
Average Bank Width (m)	1.8			
Average Wetted Width (m)	1.4			
Flow	Low			
Colour	No distinct coloration			
Clarity	Very clear			
Average Bank height (m)	LHB	2.0	RHB	0.7
Dominant Substrates	Bedrock: 50% Boulder (>128mm): 25% Cobble (>32–128mm): 15% Gravel (8-32mm): 10%			
Substratum Condition	Compacted

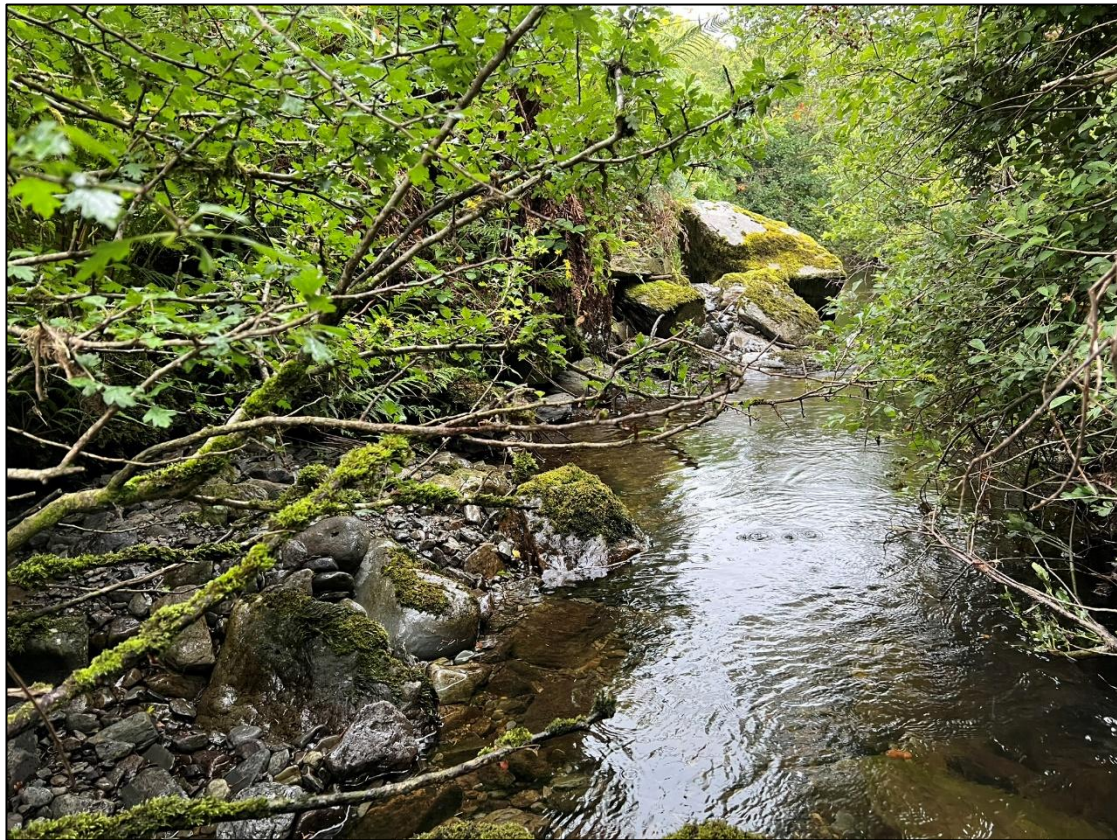
Plate 4-4. A representative photo of survey site WF 4.

Properties	Record
Average Depth (m)	0.2 (with pools of up to 0.6)
Average Bank Width (m)	4.0
Average Wetted Width (m)	2.5
Flow	Low
Colour	No distinct coloration
Clarity	Clear
Average Bank height (m)	LHB 0.3 RHB 0.7
Dominant Substrates	Bedrock: 50% Boulder (>128mm): 20% Cobble (>32-128mm): 20% Gravel (8-32mm): 10%
Substratum Condition	Highly compacted

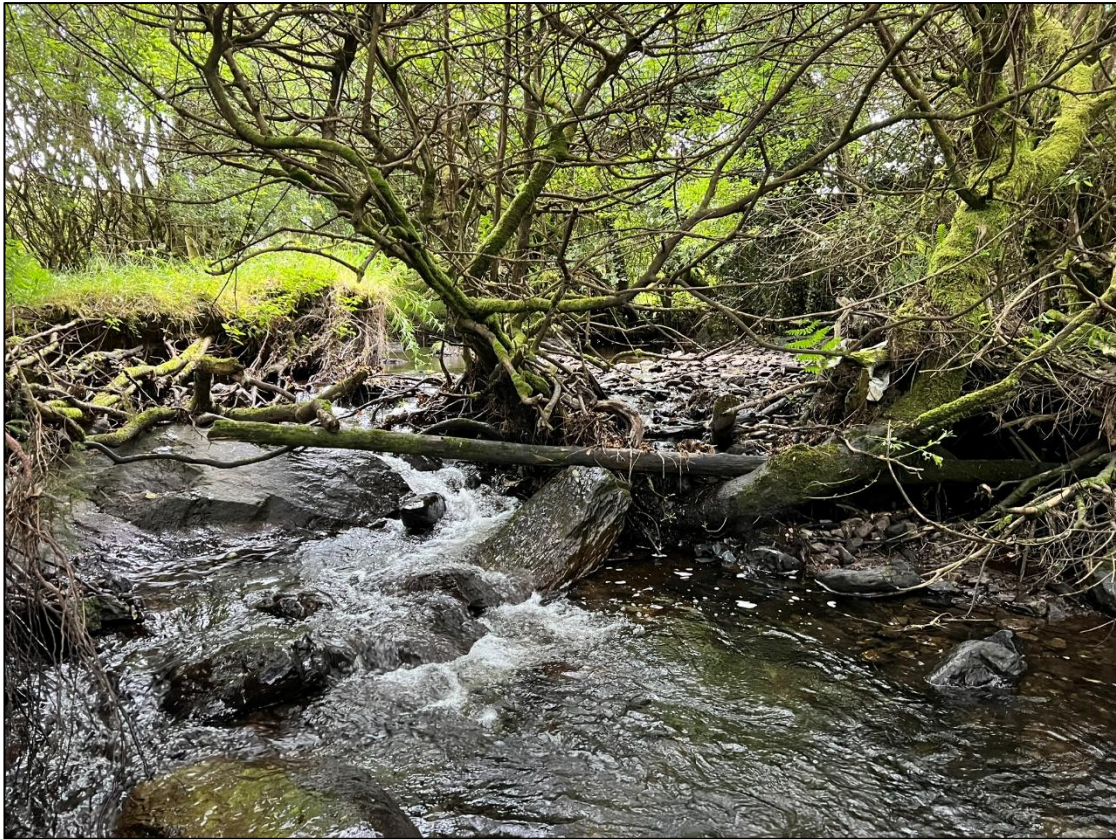
Plate 4-5. A representative photo of bedrock and boulder step features at survey site WF 4.

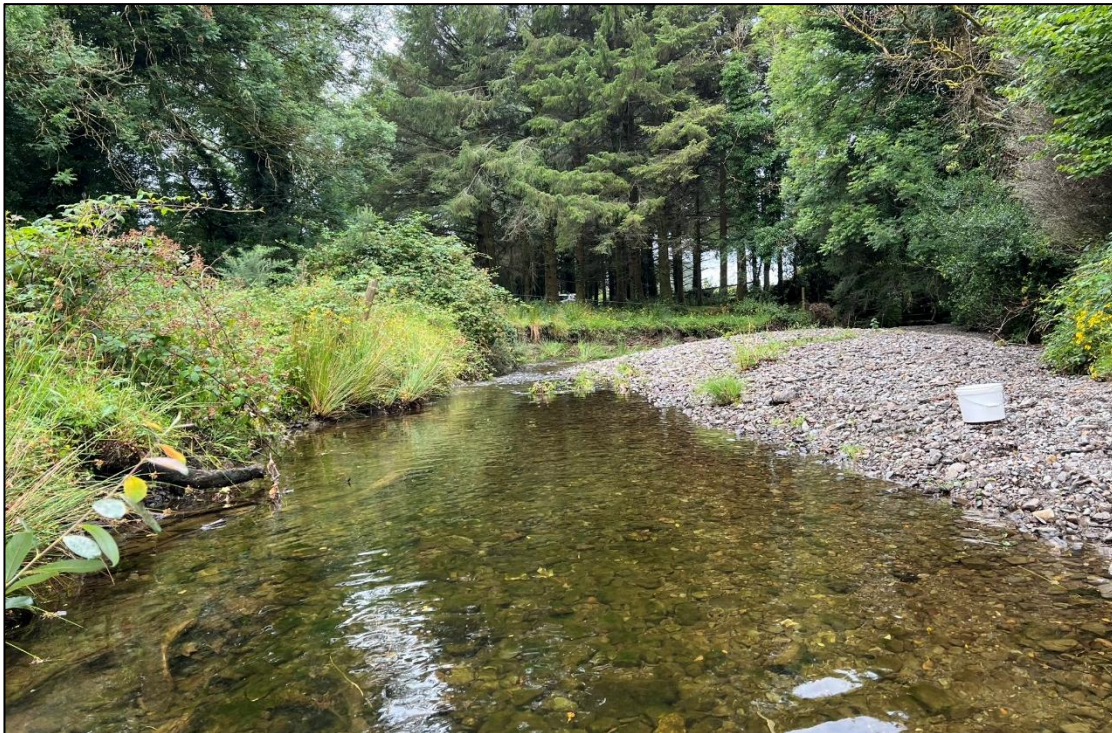
Plate 4-6. A representative photo of survey site WF 5

Loosely compacted and relatively clean gravel beds with a variety of gravel sizes provided good salmonid and lamprey species spawning habitat, respectively. Marginal sheltering features such as overhanging marginal tree limbs, undercut banks and encroaching bankside vegetation created structural complexity and shade at the channel margins, and in conjunction with repeating riffle and glide, created locally good salmonid nursery. Localised patches of structured fine sediment beds provided moderate-good lamprey ammocoete nursery habitat, with no barriers to instream continuity

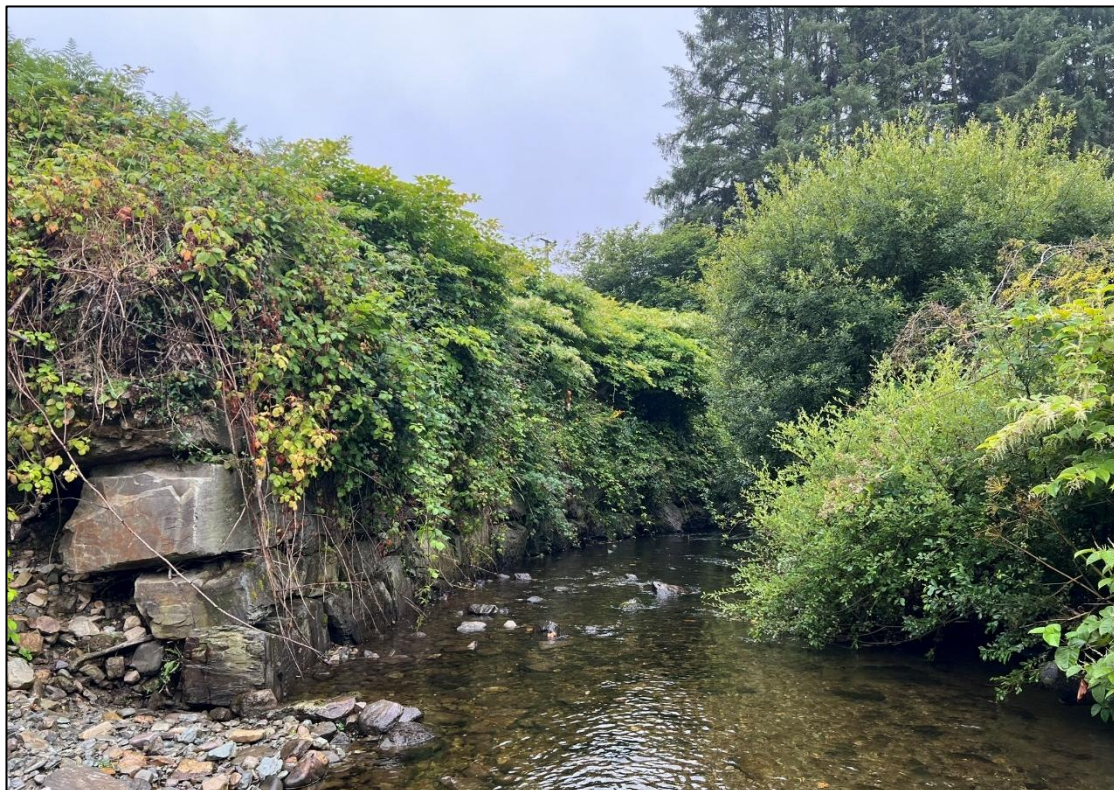
Plate 4-7. A representative picture of survey site WF 6

Properties	Record
Average Depth (m)	0.3 (deeper pools of 0.8 at downstream survey extent)
Average Bank Width (m)	6.0
Average Wetted Width (m)	5.0
Flow	Moderate
Colour	Slightly yellow in colour
Clarity	Clear but plumes of silt when disturbed
Average Bank height (m)	LHB 1.5 RHB 2.0-5.0 (highest point at steep sided clay/exposed rock banks and large rock armour)
Dominant Substrates	Boulder (>128mm): 5% Cobble (>32-128mm): 40% Gravel (8-32mm): 20% Fine gravel (2-8mm): 20% Sand (0.25-2mm): 5% Silt (<0.25mm): 5%
Substratum Condition	Loose

The channel bed itself sloped to the right, with channel substrate consisting of loose gravels with occasional cobbles and marginal boulders along the right-hand bank. Fine sediment beds in shallower water persisted along the left-hand bank for much of the survey stretch. Flow patterns consisted of repeating sequences of pool-riffle-glide, with depth across gravel-cobble riffle approx. 0.3m. Deeper, slower flowing glide and pool reached up to 0.8m in depth along the right side of the channel.

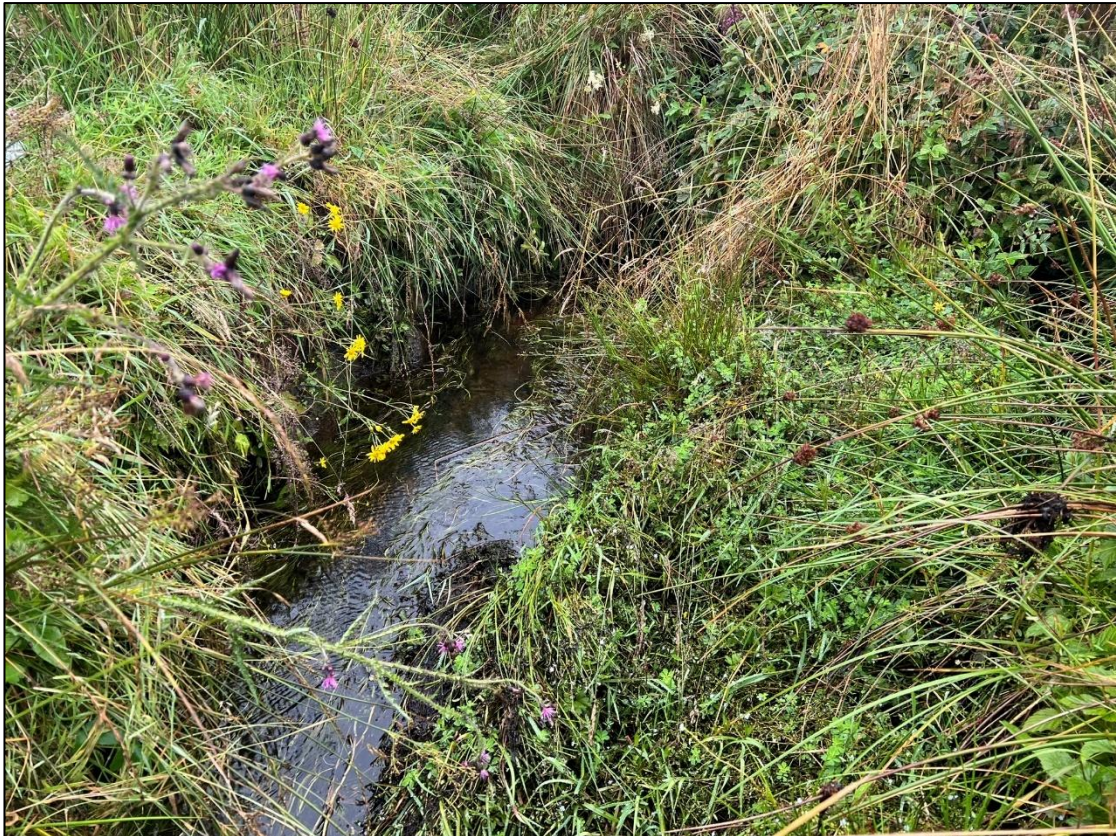
Plate 4-8. A representative picture of survey site WF 7.

The surveyed stretch along survey site WF 7 consisted of a narrow, laterally confined upland peat stream, with highly brown, humic water colouration. Banks were composed of peat, with active erosion at the bank face, with bank top vegetation including with bird’s-foot trefoil, yorkshire fog, meadowsweet (*Filipendula ulmaria*), soft rush, jointed rush (*Juncus articulatus*), gorse, heather (*Calluna vulgaris*), purple moor grass (*Molinia caerulea*), loosewort (*Pedicularis palustris*), marsh thistle (*Cirsium palustre*), marsh ragwort (*Jacobaea aquatica*), marsh bedstraw (*Galium palustre*), and marsh woundwort (*Stachys palustris*). Emergent species included water-speedwell (*Veronica anagallis-aquatica*).

Properties	Record
Average Depth (m)	0.4
Average Bank Width (m)	0.8
Average Wetted Width (m)	0.6
Flow	Slow
Colour	Highly brown, humic colouration- peat stained
Clarity	Turbid
Average Bank height (m)	LHB   Sloping bank ranging from 0.3-2.5   RHB   0.8 (peat)
Dominant Substrates	Bedrock: 20% Boulder (>128mm): 65% Cobble (>32–128mm): 5% Gravel (8–32mm): 10%
Substratum Condition	Compacted

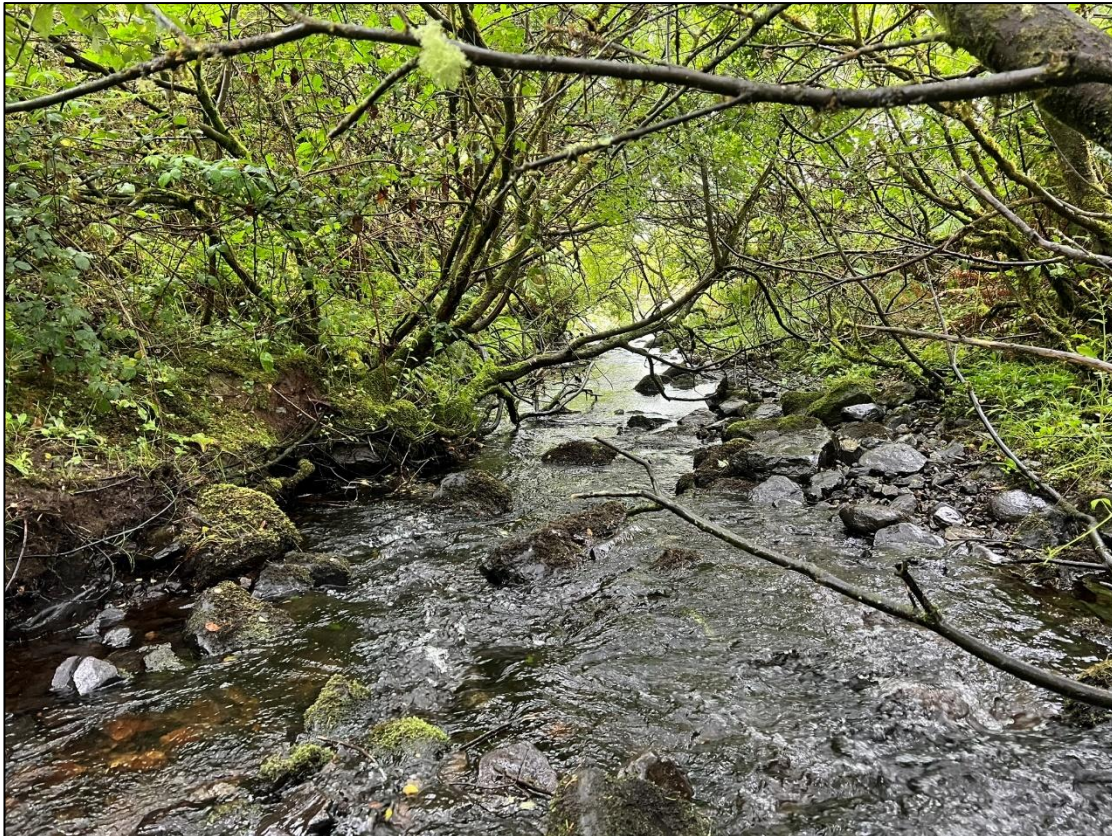
Plate 4-9. A representative picture of survey site WF 8

Survey site WF 8 consisted of a boulder dominant stretch of **Eroding/Upland River (FW1)**, with moderate velocity flow across repeating pool-riffle-glide sequences over a slight upland gradient. Water was slightly humic in colour due to upstream peat streams and peat bank composition. The watercourse was highly shaded by encroaching willow trees (*Salix spp.*), with dense patches of bracken along much of the survey stretch. Bankside vegetation also featured bramble, common bent (*Agrostis capillaris*), common figwort (*Scrophularia nodosa*), creeping buttercup, false oat-grass, male fern (*Dryopteris filix-mas*), marsh horsetail (*Equisetum palustre*), polypody (*Polypodium vulgare*), self-heal, and wild angelica. Bryophyte coverage included abundant common tamarisk-moss (*Thuidium tamariscinum*) on trees, as well as river feather-moss (*Brachythecium rivulare*) and greater water-moss (*Fontinalis antipyretica*) on boulders and submerged instream. Water crow-foot (*Ranunculus sp.*) was present occasionally in patches along the survey stretch.

Properties	Record			
Average Depth (m)	0.3			
Average Bank Width (m)	4.0			
Average Wetted Width (m)	2.5			
Flow	Moderate			
Colour	Slightly brown, humic colouration- peat stained			
Clarity	Clear			
Average Bank height (m)	LHB	Sloping bank ranging from 0.3-0.8	RHB	Sloping bank ranging from 0.2-0.7
Dominant Substrates	Boulder (>128mm): 40% Cobble (>32-128mm): 30% Gravel (8-32mm): 20%			
Substratum Condition	Compacted

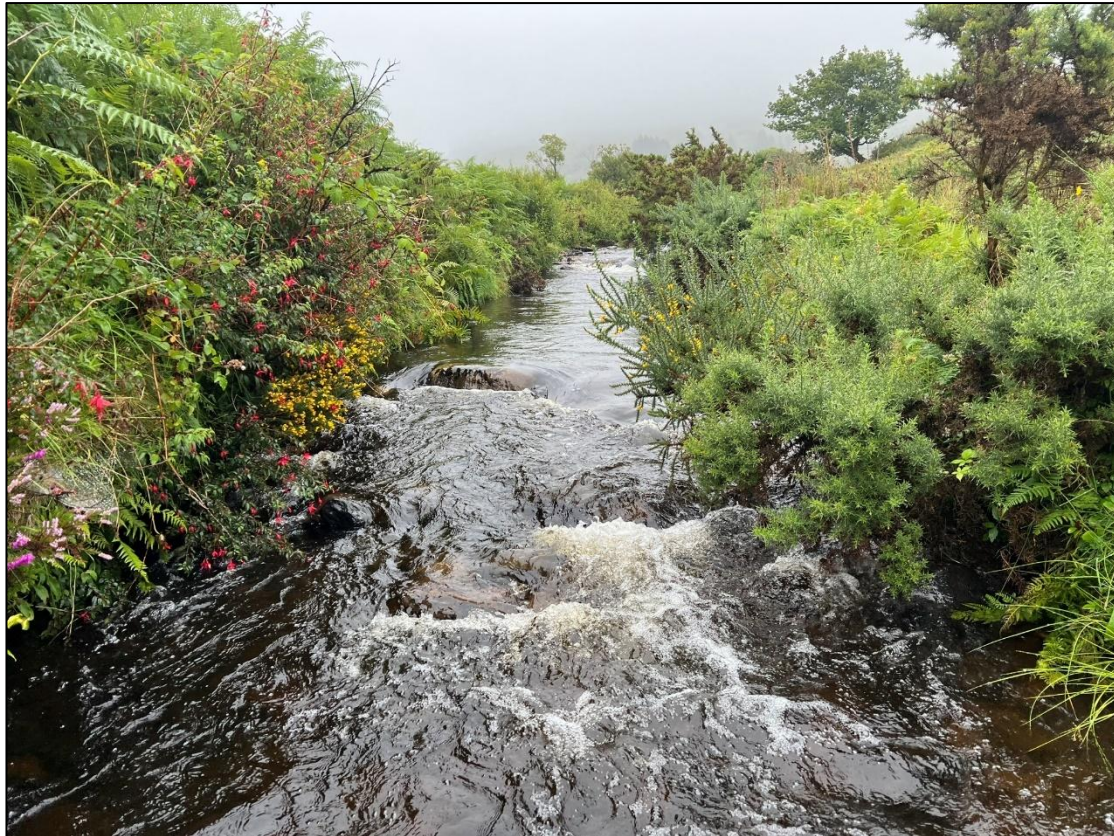
Plate 4-11. A representative picture of survey site WF 10

Properties	Record			
Average Depth (m)	0.4 (deeper pool up to 0.7)			
Average Bank Width (m)	3.5			
Average Wetted Width (m)	3.0			
Flow	Fast			
Colour	Humic colouration as a result of surrounding peat			
Clarity	Slightly turbid			
Average Bank height (m)	LHB	1.2	RHB	1.8
Dominant Substrates	Bedrock: 50% Boulder (>128mm): 20% Cobble (>32-128mm): 15% Gravel (8-32mm): 15%			
Substratum Condition	Compacted

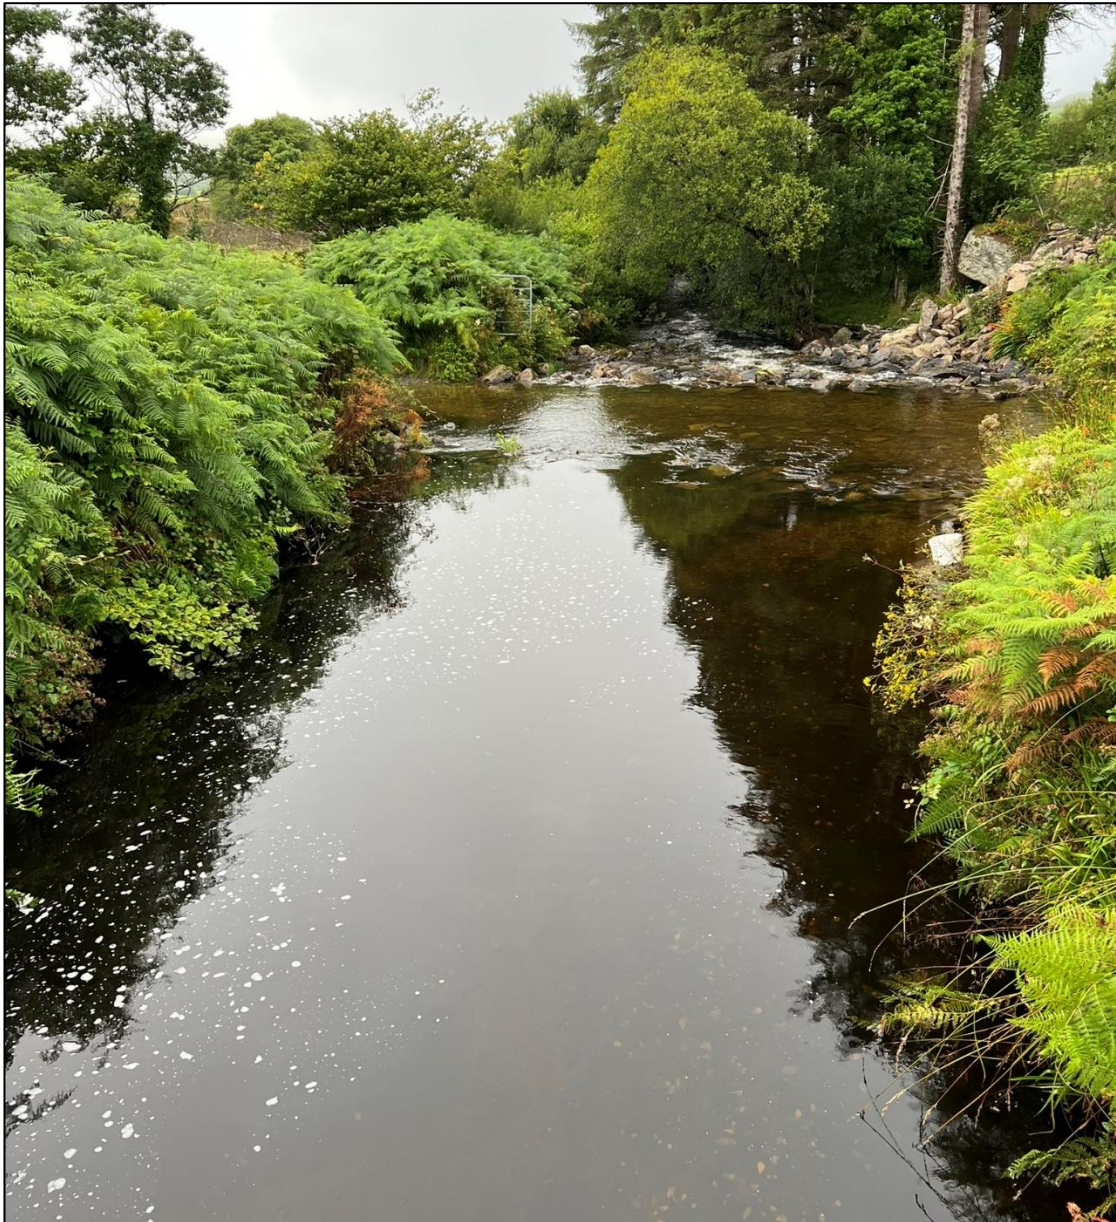
Plate 4-12. A representative picture of survey site WF 11

Properties	Record			
Average Depth (m)	0.4 (deeper pool up to 0.7)			
Average Bank Width (m)	6.0			
Average Wetted Width (m)	6.0			
Flow	Slow upstream of rock ramp, fast downstream of rock ramp			
Colour	Slightly brown			
Clarity	Slightly turbid			
Average Bank height (m)	LHB	0.1 (at ford crossing) sloping to 2.0	RHB	0.1 (at ford crossing) sloping to 2.0
Dominant Substrates	Bedrock: 5% Boulder (>128mm): 10% Cobble (>32–128mm): 25% Gravel (8–32mm): 60%			
Substratum Condition	Loose

Earthen banks were reinforced in sections with rip-rap and large boulders, with evidence of historic embankment. A ford crossing was observed within the survey stretch at survey site WF 11. Bankside vegetation included bracken, bramble, wild angelica, soft rush, meadowsweet, gorse, self-heal and montbretia. Shading was largely absent from the channel with the exception of marginal shading provided by Willow *sp.*, hazel, spruce and ash treelines toward the downstream survey extent. Habitats extending beyond both banks consisted of riparian buffers of **Scrub (WS1)** and agricultural and pastoral land.

Despite the presence of abundant, relatively loose gravel beds, channel substrate displayed a slight degree of siltation and filamentous green algal growth, clogging interstitial spaces between gravels which are essential to optimal spawning grounds. Therefore, spawning habitat for salmonid and lamprey species was assessed as poor. Flow was also slow and impounded in areas of gravel dominant channel bed and thus limiting to optimal spawning habitat. Areas of enhanced diverse flow across gravel and cobble riffle downstream of the rock ramp provided localised moderate salmonid nursery, although gradient features such as steps and cascades throughout the wider watercourse may limit

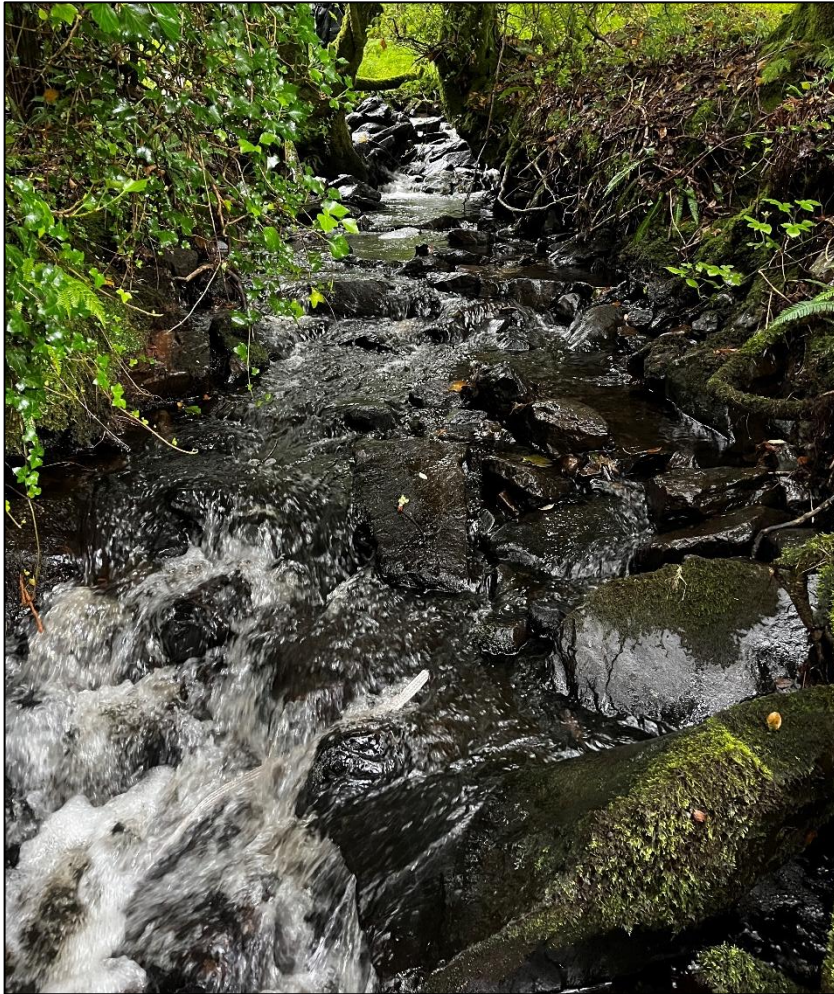
Plate 4-13. A representative picture of survey site WF 12

Dominant Substrates	Bedrock: 40% Boulder (>128mm): 25% Cobble (>32–128mm): 25% Gravel (8–32mm): 10%
Substratum Condition	Semi-compacted

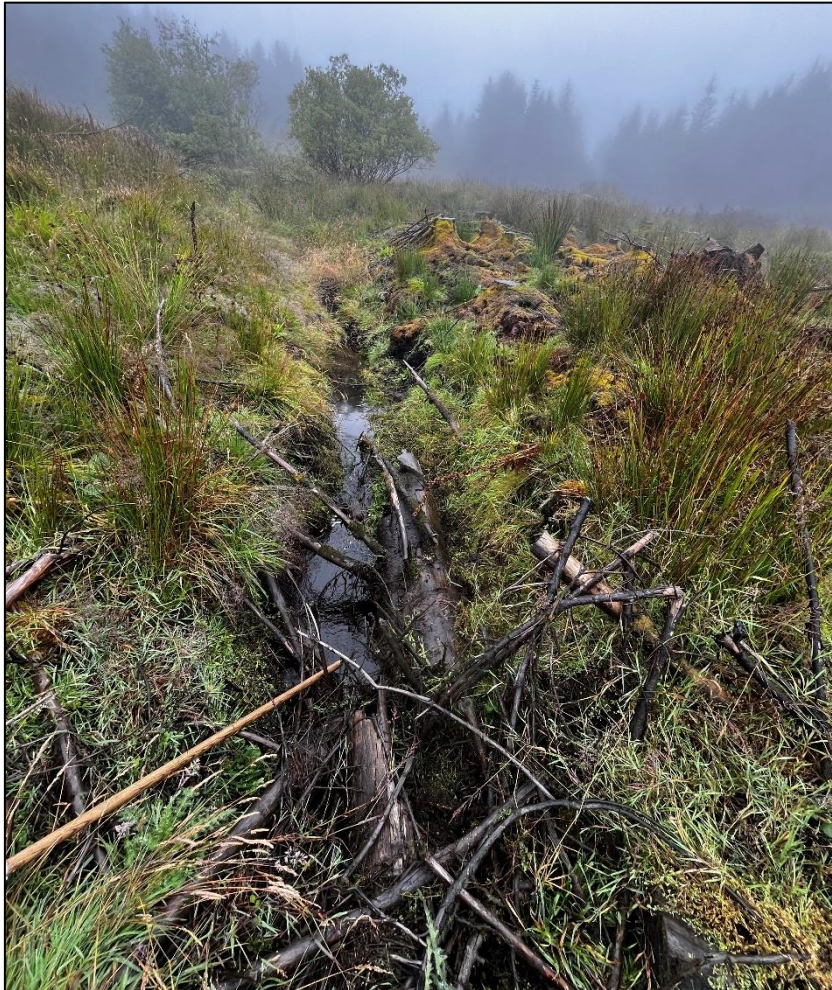
Plate 4-14. A representative picture of survey site WF 13

Properties	Record			
Average Depth (m)	0.3			
Average Bank Width (m)	0.7			
Average Wetted Width (m)	0.6			
Flow	Moderate			
Colour	Highly brown, humic colouration			
Clarity	Slightly turbid			
Average Bank height (m)	LHB	1.0	RHB	1.0
Dominant Substrates	Boulder (>128mm): 10% Cobble (>32-128mm): 20% Peat: 70%			
Substratum Condition	Loose

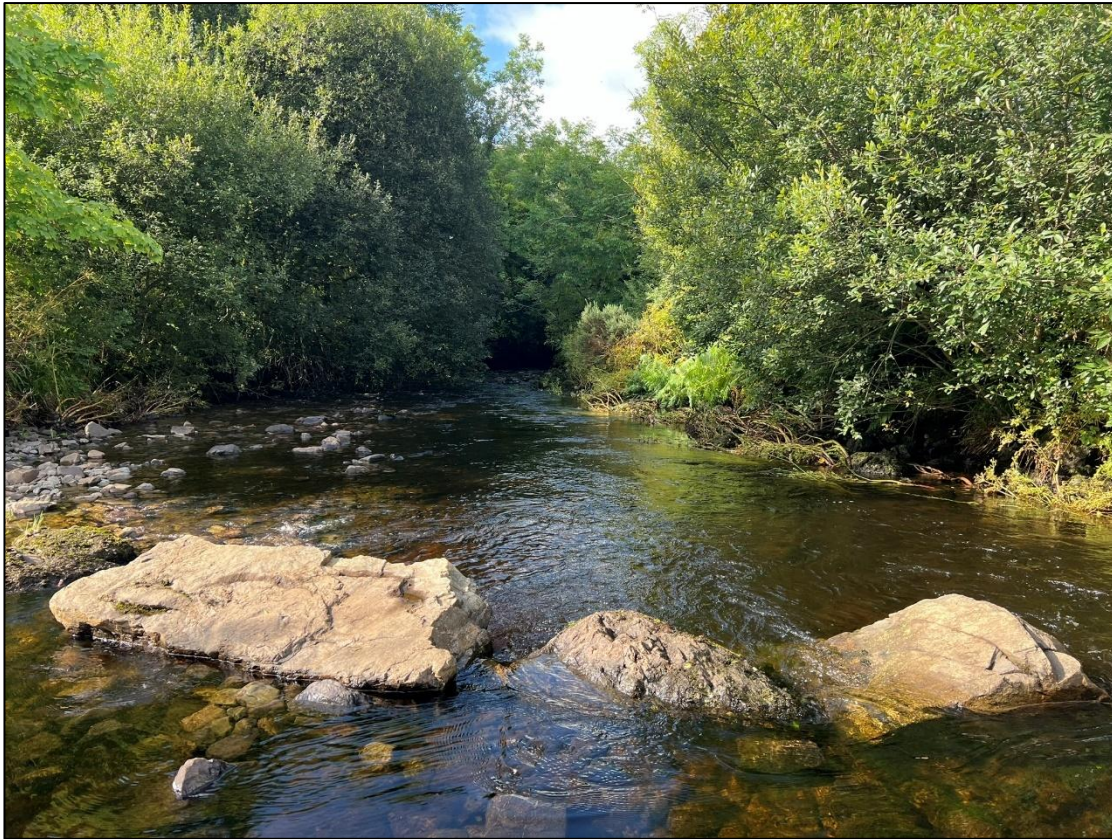
Plate 4-15. A representative picture of survey site WF 14

Isolated areas of loose, mobile, clean gravels limited suitable spawning habitat at this survey site, with sediment often covered in a degree of filamentous green algae, particularly upstream of the rock ramp. Fine sediment beds suitable for lamprey ammocoetes were present occasionally at the channel margins and behind the rock ramp. However, the presence of the rock ramp as a barrier to migration, as well as the downstream gradient may limit access to these suitable areas of slower flow. Areas of deep, slow flow, particularly upstream of the rock ramp, provided good adult salmonid holding habitat. Marginal submerged root structures and encroaching vegetation added instream complexity to areas of backwater, creating good european eel habitat. Two eel were observed but not caught electrofishing. Results for 10-minute qualitative electrofishing survey are shown in Table 4-35.

Properties	Record
Average Depth (m)	0.4 (with deeper glide up to 0.7)
Average Bank Width (m)	7.0
Average Wetted Width (m)	5.5
Flow	Moderate-Fast
Colour	Slightly brown
Clarity	Clear when undisturbed, with a slight degree of siltation underfoot
Average Bank height (m)	LHB   0.5   RHB   1.5
Dominant Substrates	Boulder (>128mm): 30% Cobble (>32–128mm): 35% Gravel (8–32mm): 25% Silt (<0.25mm): 10%
Substratum Condition	Semi-compacted

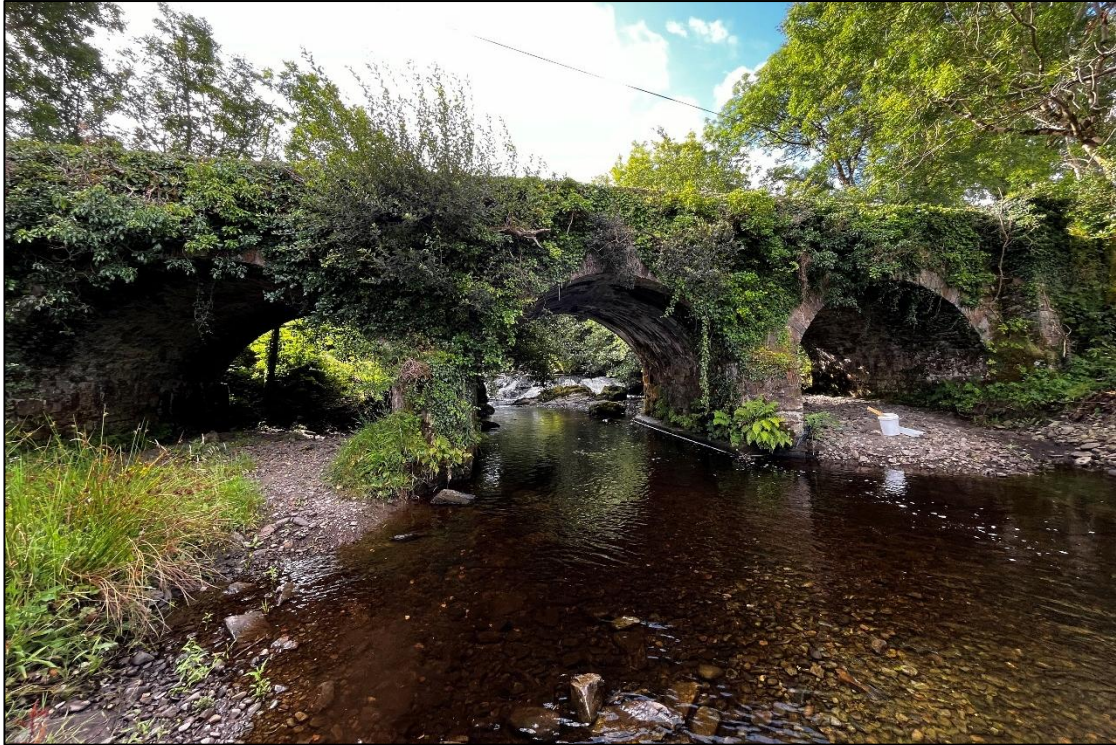
Plate 4-16. A representative picture of survey site WF 15

Properties	Record			
Average Depth (m)	0.3 (pools of 1.0 downstream of waterfall)			
Average Bank Width (m)	8.0			
Average Wetted Width (m)	7.0-8.0			
Flow	Moderate-Fast			
Colour	Slightly brown			
Clarity	Slightly turbid			
Average Bank height (m)	LHB	1.0	RHB	1.0-1.7
Dominant Substrates	Bedrock: 10% Boulder (>128mm): 20% Cobble (>32-128mm): 20% Gravel (8-32mm): 50%			
Substratum Condition	Loose (gravels)

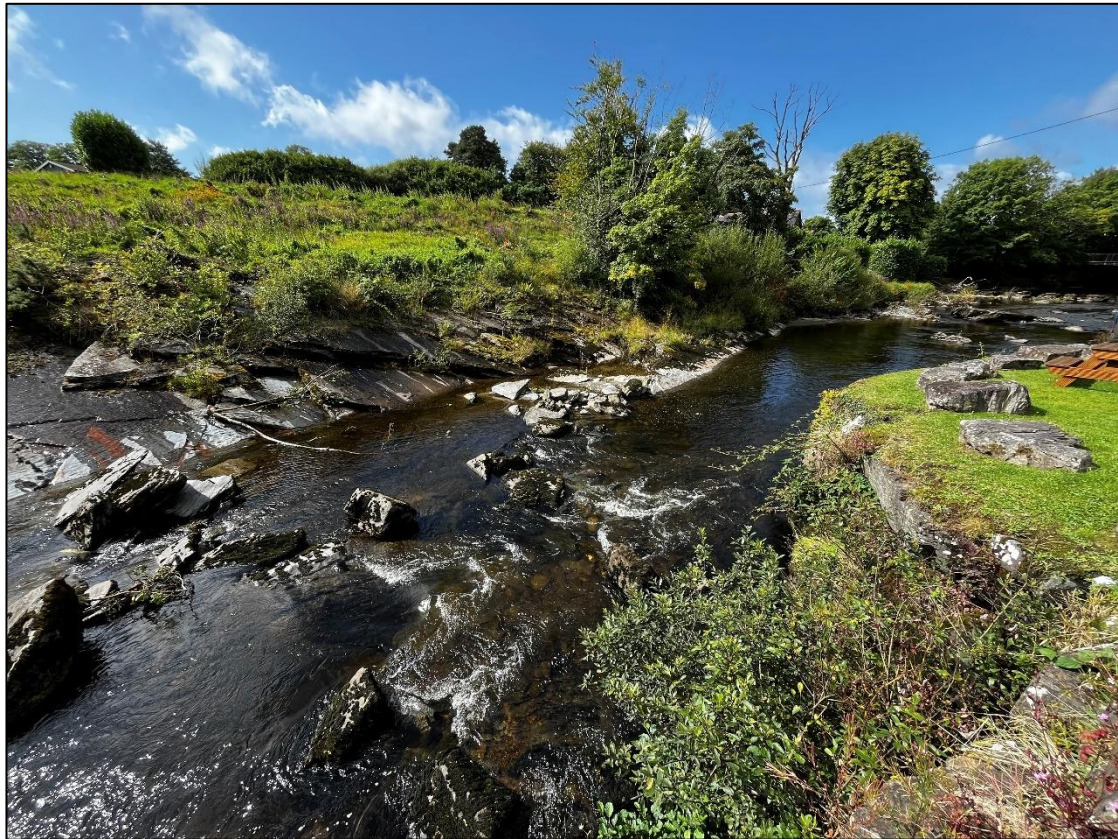
Plate 4-17. A representative picture of survey site WF 16

Substratum Condition	Loose (gravels only), compacted boulders
----------------------	--

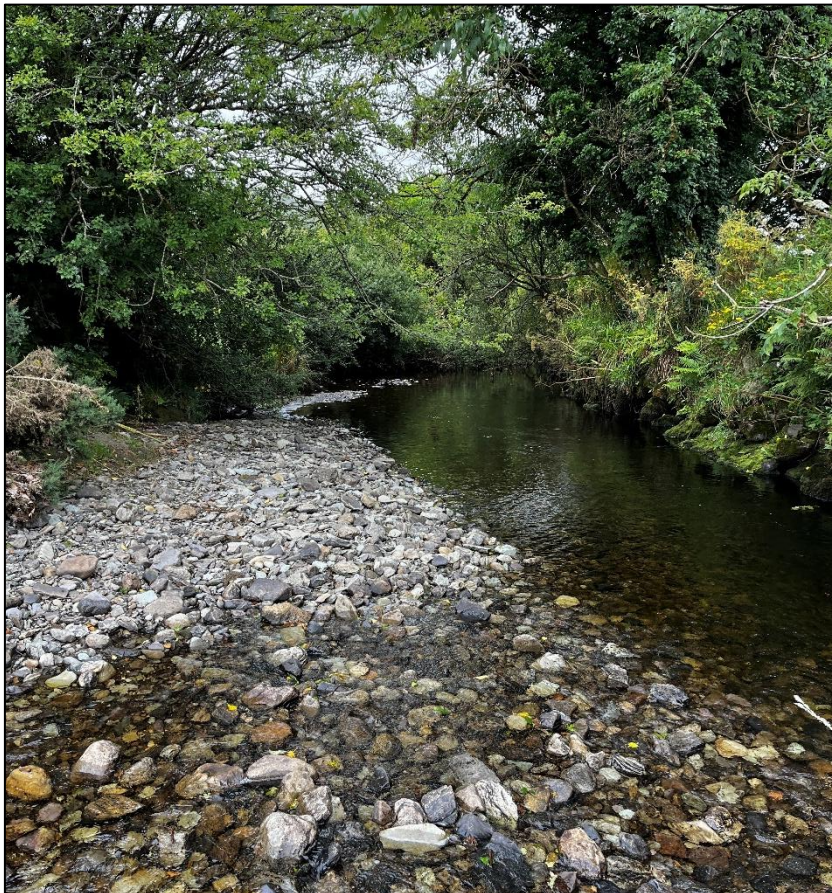
Plate 4-18. A representative picture of survey site WF 17

Properties	Record	
Average Depth (m)	0.3 (pools of 0.8)	
Average Bank Width (m)	5.0	
Average Wetted Width (m)	2.0-4.0	
Flow	Moderate	
Colour	No distinct colouration	
Clarity	Clear when undisturbed	
Average Bank height (m)	LHB 0.2-1.0	RHB 1.2
Dominant Substrates	Bedrock: 5% Boulder (>128mm): 10% Cobble (>32-128mm): 55% Gravel (8-32mm): 30%	
Substratum Condition	Semi-compacted
