## **Appendix 6-3 Aquatic Baseline Report**

Maughanaclea Renewable  
Energy Development

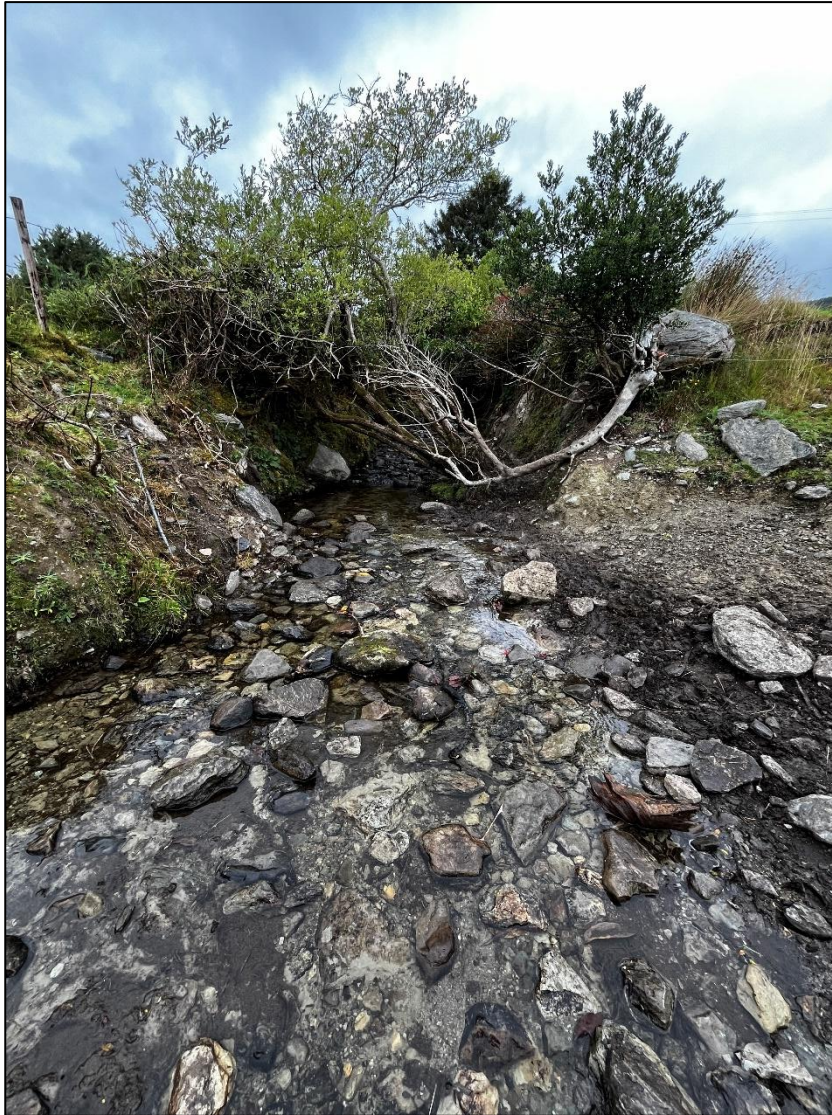
Plate 4-19. A representative picture of survey site WF 18

Properties	Record
Average Depth (m)	0.05
Average Bank Width (m)	2.0 (3.0 at area of livestock crossing/recent bank resectioning)
Average Wetted Width (m)	1.5
Flow	Moderate
Colour	Yellow/brown
Clarity	Slightly turbid
Average Bank height (m)	LHB   0.6-2.5   RHB   1.2-2.5
Dominant Substrates	Bedrock: 30% Boulder (>128mm): 30% Cobble (>32-128mm): 30% Gravel (8-32mm): 10%
Substratum Condition	Semi-compacted

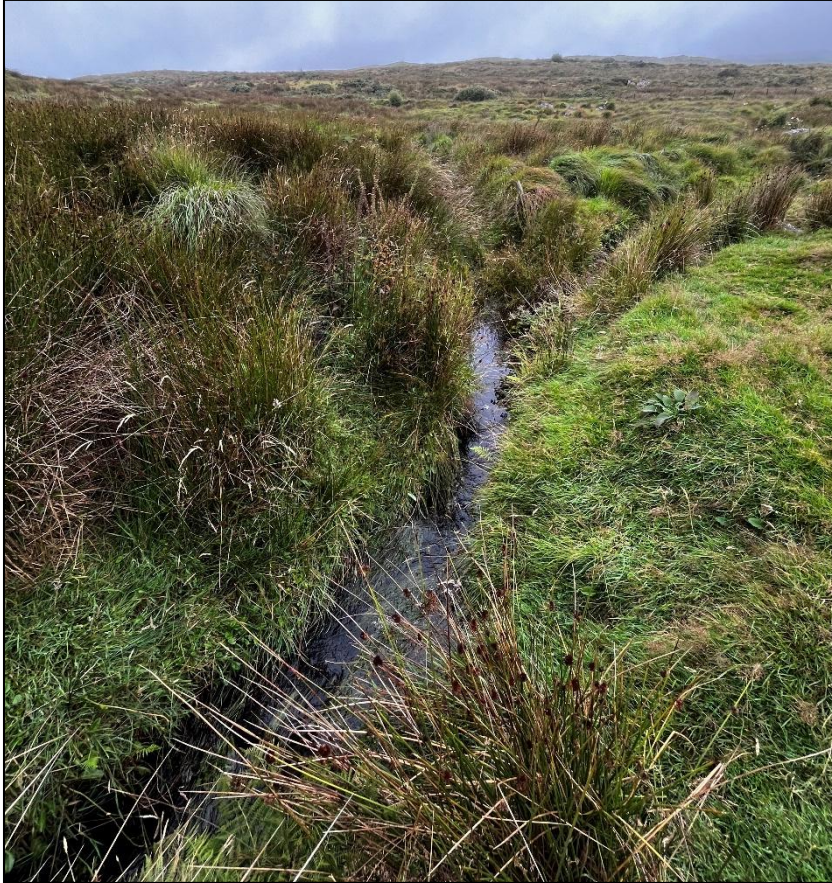
Plate 4-20. A representative picture of survey site WF 19

Survey site WF 19 was located along a stretch of Mealagh River (EPA code: 21M01, IG Ref.: W 07161 54770). Properties of the watercourse at this sample location are provided in Table 4-48 below and a representative photograph of the survey site is shown in Plate 4-20.

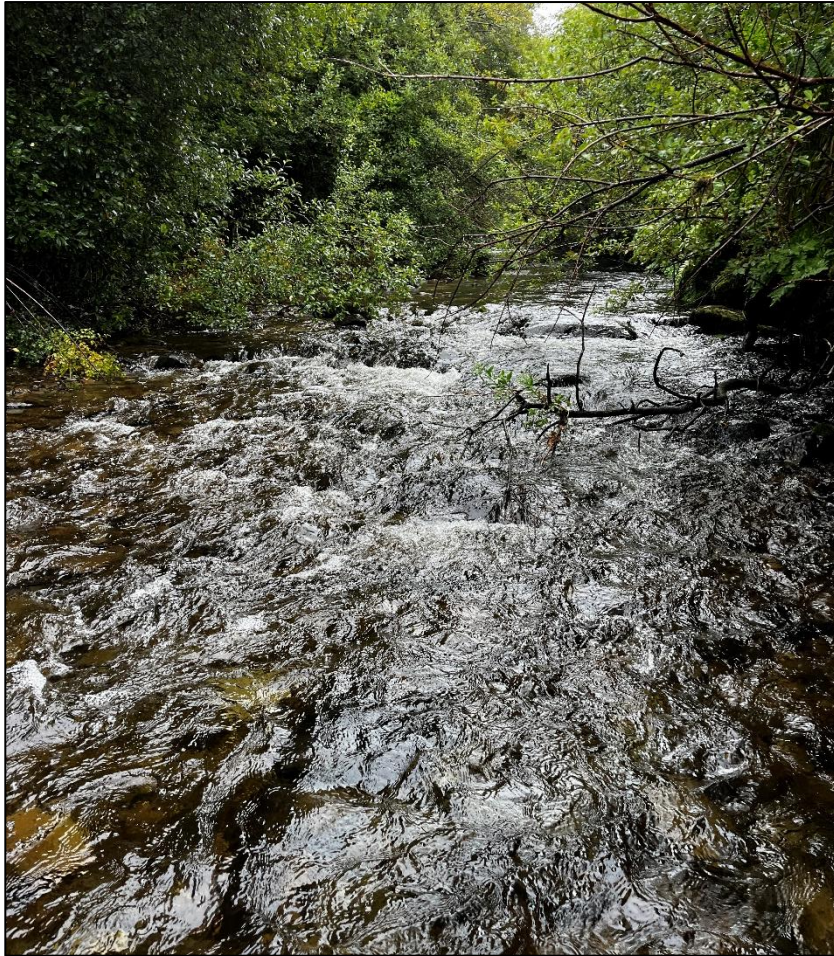
Plate 4-22. A representative picture of survey site WF 21

Properties	Record		
Average Depth (m)	0.5		
Average Bank Width (m)	8.0		
Average Wetted Width (m)	8.0		
Flow	Moderate		
Colour	No distinct colouration		
Clarity	Clear		
Average Bank height (m)	LHB	1.5	RHB 3.0
Dominant Substrates	Bedrock: 5% Boulder (>128mm): 30% Cobble (>32–128mm): 35% Gravel (8–32mm): 30%		
Substratum Condition	Semi-compacted

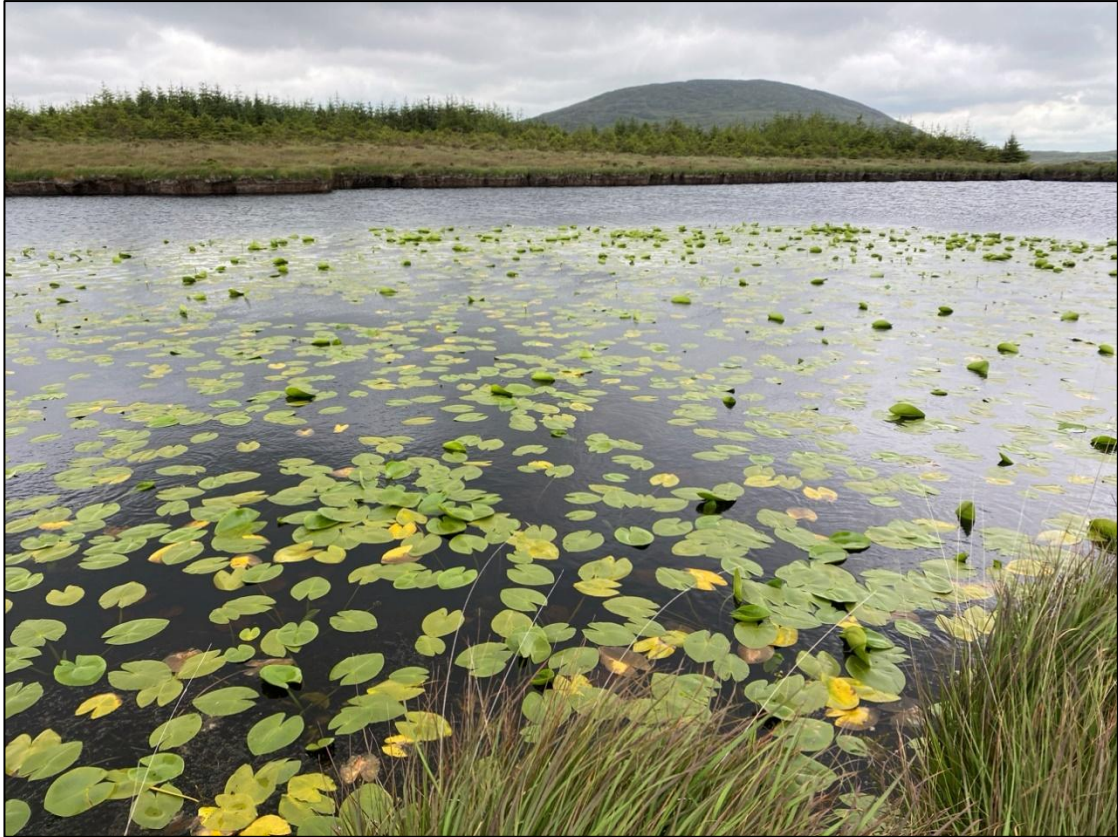
Lake margins were characterised by peaty substrate, with the water humic in colouration due to high levels of peat. Yellow water lily (*Nuphar lutea*) was recorded growing on both lakes. Lake margin species included cuckoo flower (*Cardamine pratensis*), purple moor grass (*Molinia caerulea*), common cottongrass (*Eriophorum angustifolium*), soft rush (*Juncus effusus*), common sedge (*Carex nigra*), bottle sedge (*Carex rostrata*) and marsh lousewort (*Pedicularis palustris*).

Plate 4-23. A representative photo of the **Dystrophic lake (FL1)** north of the proposed turbine 2 (T2)

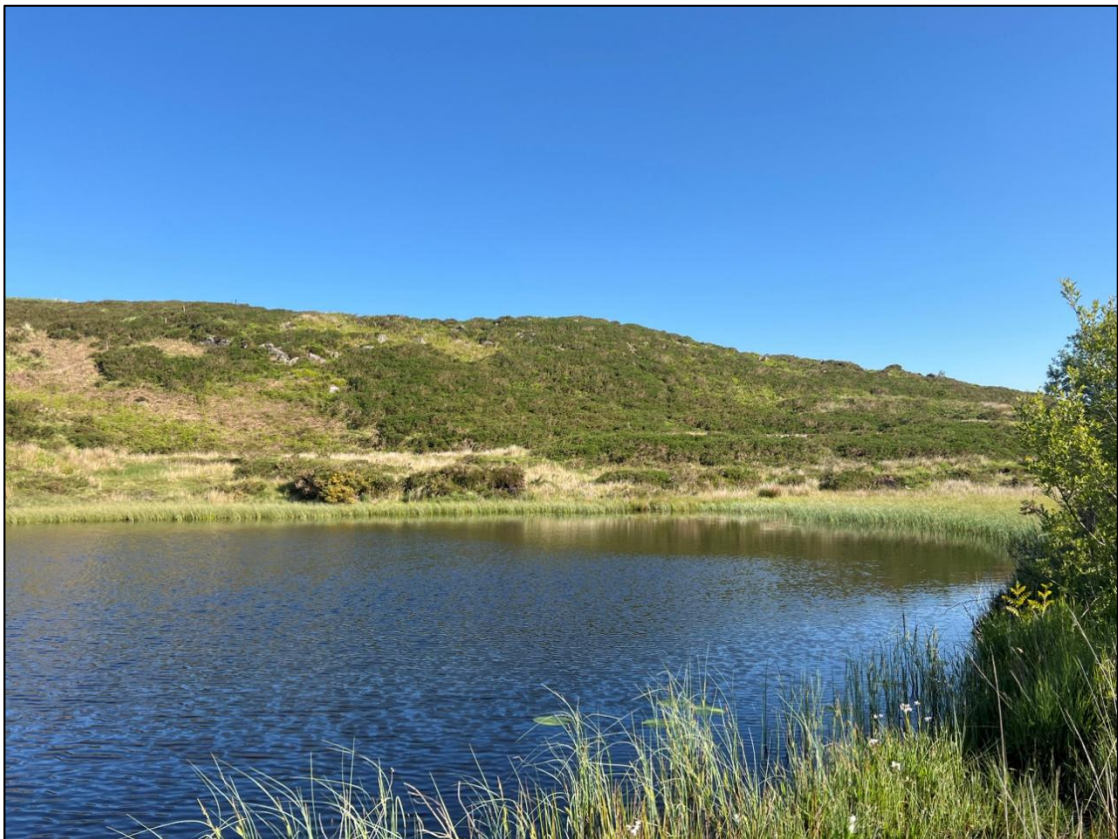
Plate 4-24. A representative photo of the **Dystrophic lake (FL1)** southwest of the proposed turbine 13 (T13)

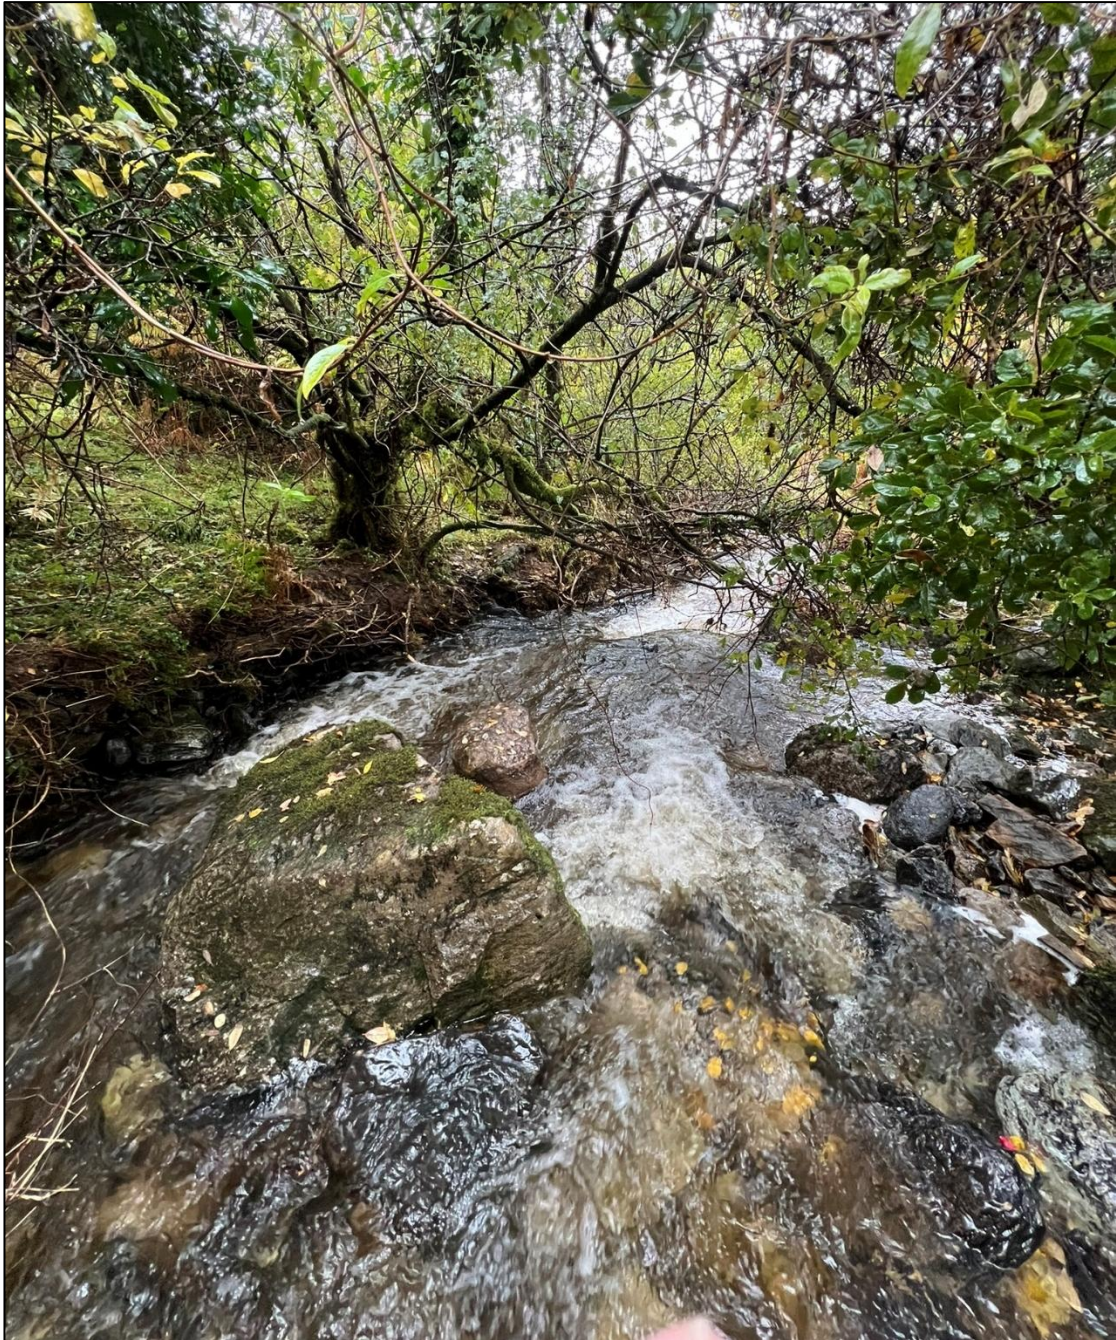
Plate 4-25. A representative photo of survey site GC 1

Properties	Record			
Average Depth (m)	0.4			
Average Bank Width (m)	5.0			
Average Wetted Width (m)	3.0			
Average Bank height (m)	LHB	1.8	RHB	2.5
Flow	Fast			
Colour	No distinct colouration			
Clarity	Very Clear			
Dominant Substrates	Bedrock: 40% Boulder (>128mm): 25% Cobble (>32-128mm): 25% Gravel (8-32mm): 10%			
Substratum Condition	Compacted

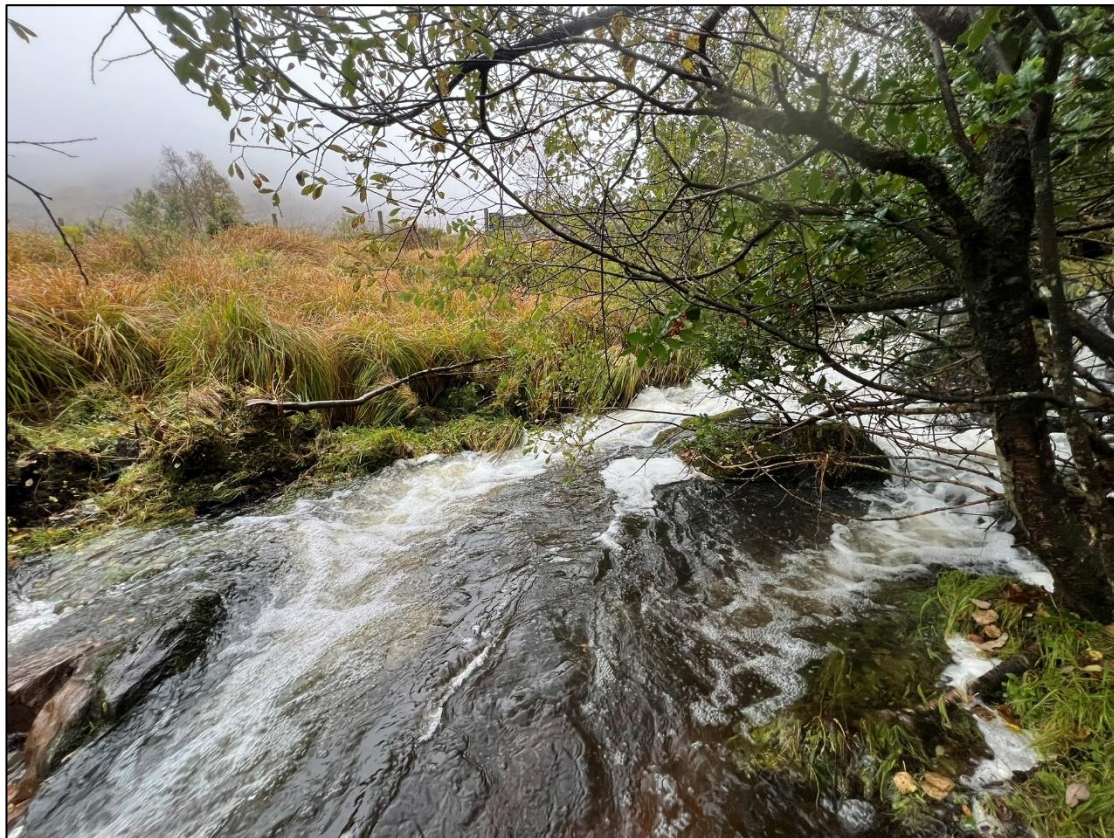
Plate 4-27. A representative picture of survey site GC 3

Properties	Record
Average Depth (m)	0.35
Average Bank Width (m)	4.0
Average Wetted Width (m)	3-3.5
Average Bank height (m)	LHB 0.4-1.0 RHB 0.6-2m
Flow	Fast
Colour	Slightly yellow
Clarity	Very clear
Dominant Substrates	Bedrock: 30% Boulder (> 128mm): 25% Cobble (>32-128mm): 30% Gravel (8-32mm): 10% Silt (<0.25mm): 5%
Substratum Condition	Semi-compacted cobbles, loose gravels

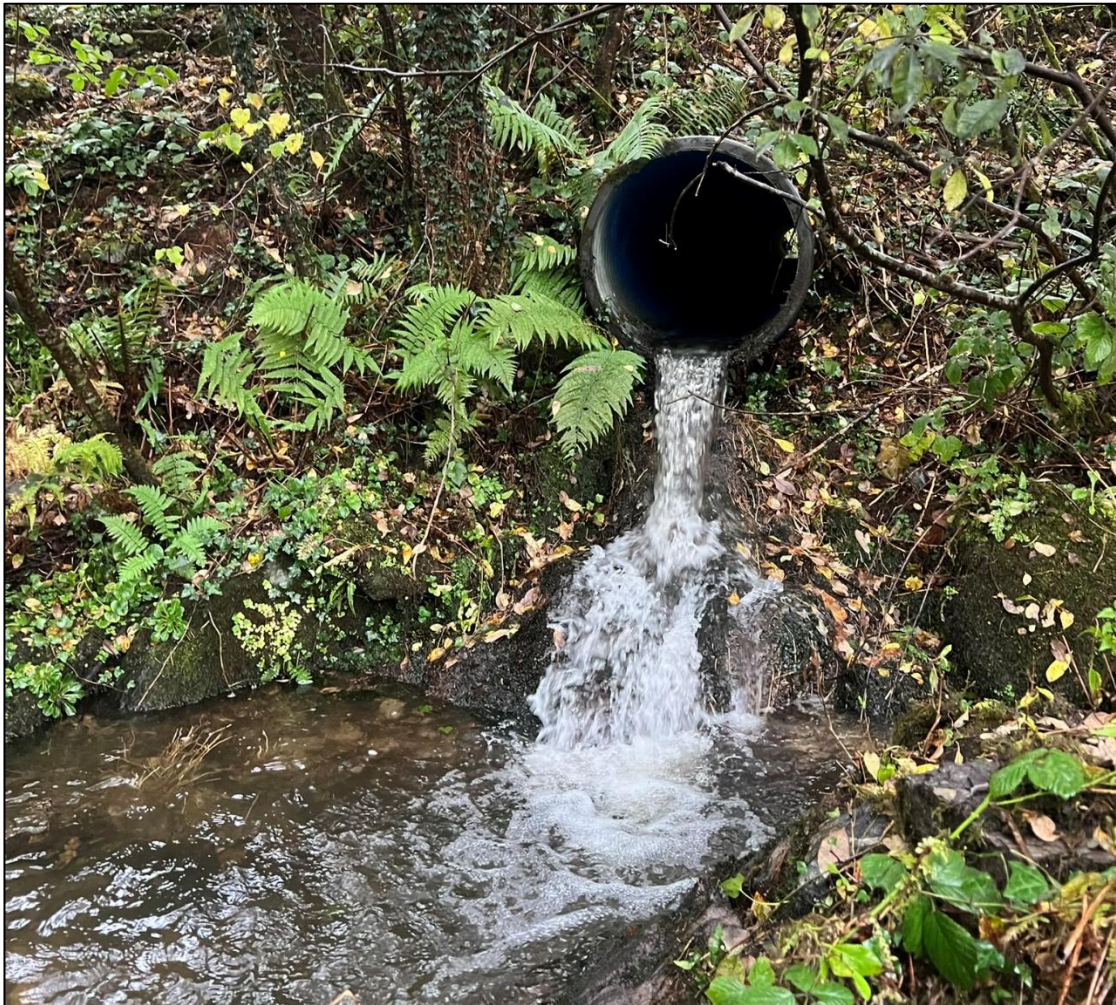
Plate 4-29. A representative picture of the pipe culvert at the upstream survey extent of GC 4

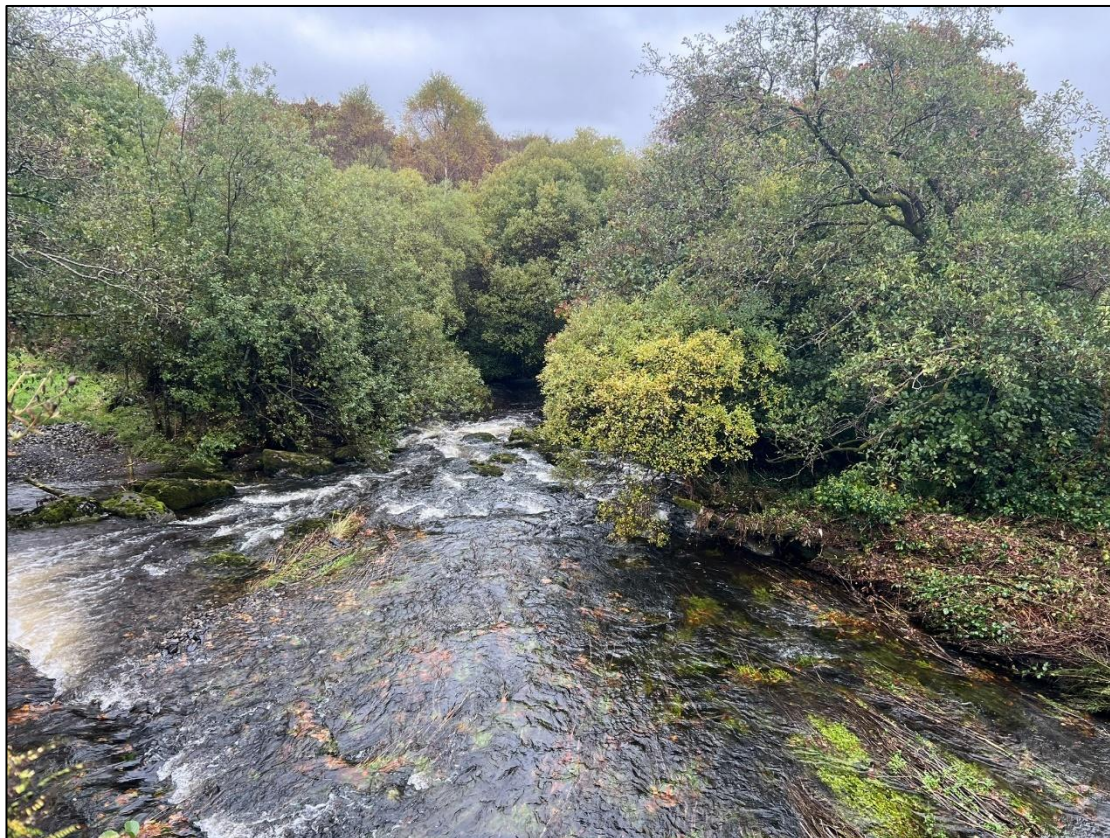
Plate 4-30. A representative picture of survey site GC 5

Average Bank Width (m)	6.0-8.0			
Average Wetted Width (m)	5.0-8.0			
Average Bank Height (m)	LHB	1.0	RHB	1.0
Flow	Torrential			
Colour	Slightly yellow			
Clarity	Very clear			
Dominant Substrates	Bedrock: 20% Boulder (> 128mm): 20% Cobble (>32-128mm): 30% Gravel (8-32mm): 20% Fine gravel (2-8mm): 10%			
Substratum Condition	Compacted cobble and boulder, loose gravels

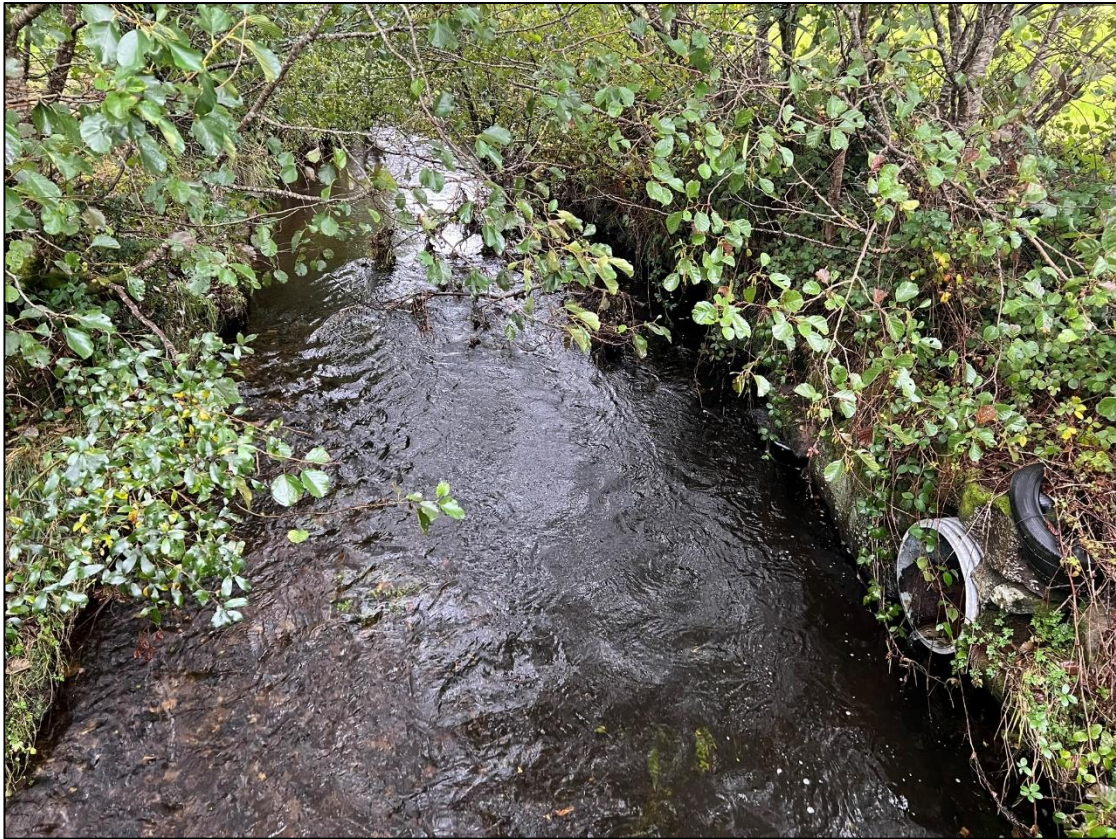
Plate 4-31. A representative picture of survey site GC 6

Properties	Record
Average Depth (m)	0.4
Average Bank Width (m)	3.0
Average Wetted Width (m)	2.8
Average Bank Height (m)	LHB   0.5-2.0   RHB   2.0
Flow	Moderate
Colour	No distinct colouration
Clarity	Very clear when undisturbed
Dominant Substrates	Boulder (> 128mm): 20% Cobble (>32-128mm): 40% Gravel (8-32mm): 15% Fine gravel (2-8mm): 10% Silt (<0.25mm): 15%
Substratum Condition	Compacted

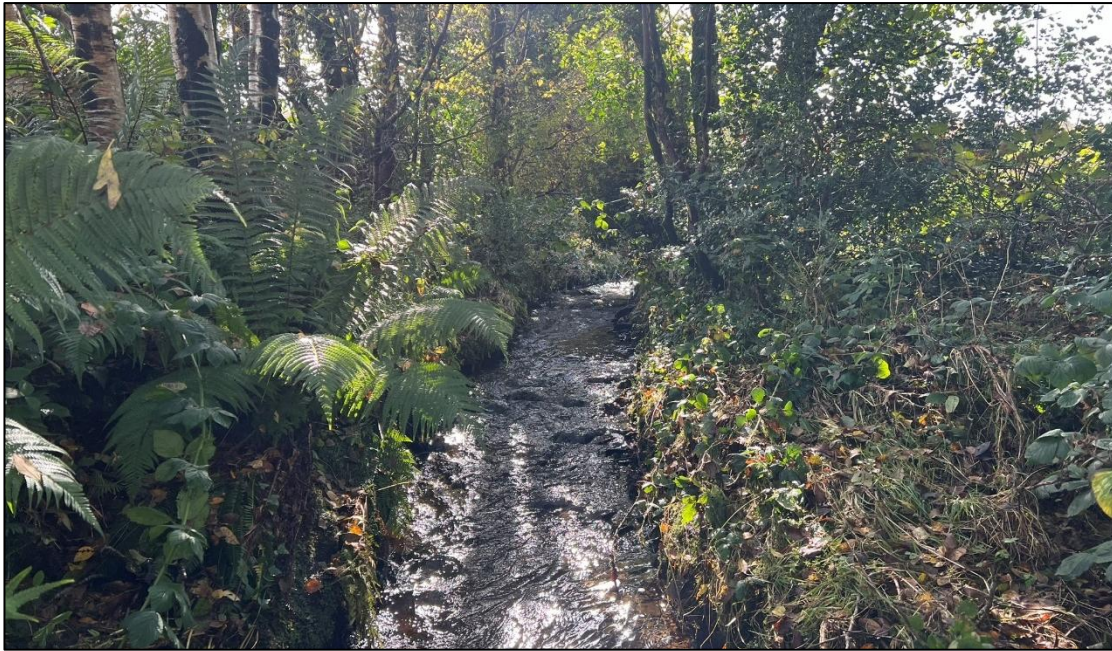
Plate 4-32. A representative picture of survey site GC 7

Properties	Record
Average Depth (m)	0.2
Average Bank Width (m)	1.0
Average Wetted Width (m)	0.8
Average Bank Height (m)	LHB      0.5      RHB      0.5
Flow	Moderate
Colour	Slight yellow colouration
Clarity	Very clear
Dominant Substrates	Boulder (> 128mm): 20% Cobble (>32–128mm): 50% Gravel (8-32mm): 20% Fine gravel (2-8mm): 10%
Substratum Condition	Semi-compacted

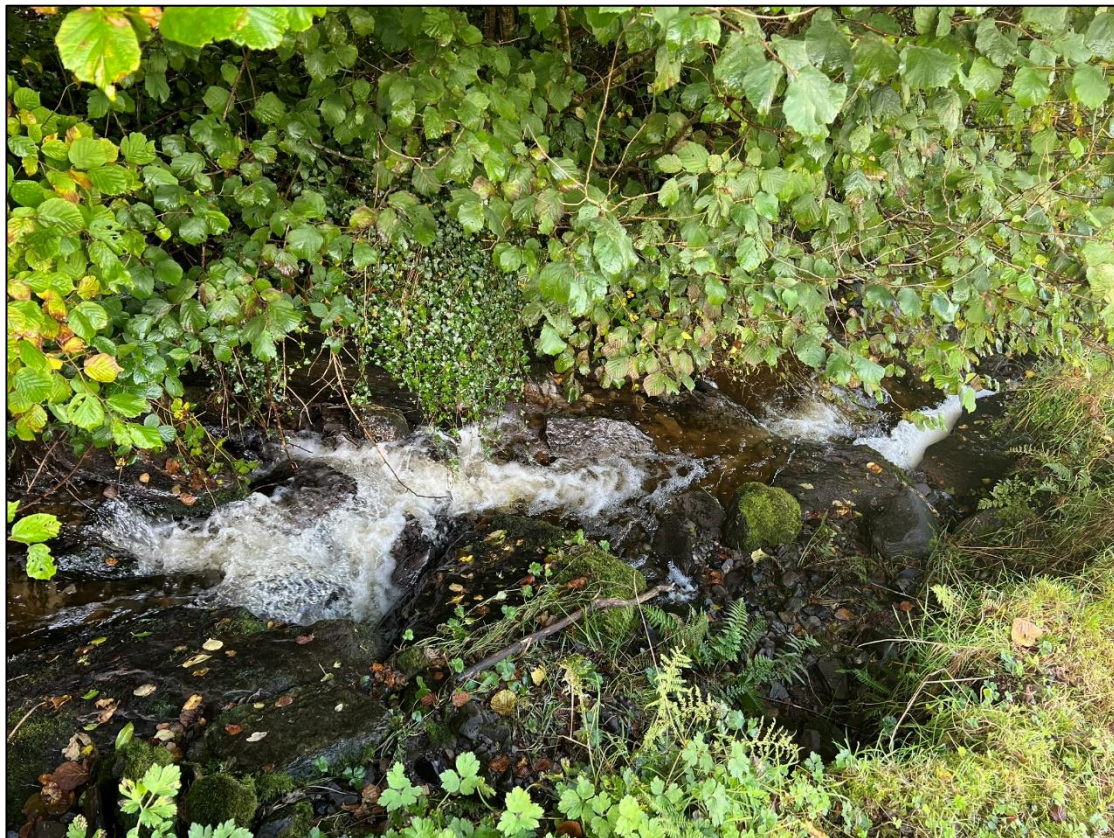
Plate 4-33. A representative image of survey site GC 8

Properties	Record
Average Depth (m)	0.2
Average Bank Width (m)	3.0
Average Wetted Width (m)	1.0
Average Bank Height (m)	LHB 2.0 RHB 1.2
Flow	Fast-Torrential
Colour	Slight yellow colouration
Clarity	Very clear
Dominant Substrates	Bedrock: 45% Boulder (> 128mm): 25% Cobble (>32-128mm): 10% Gravel (8-32mm): 10% Fine gravel (2-8mm): 10%
Substratum Condition	Loose cobble and gravel within bedrock pools

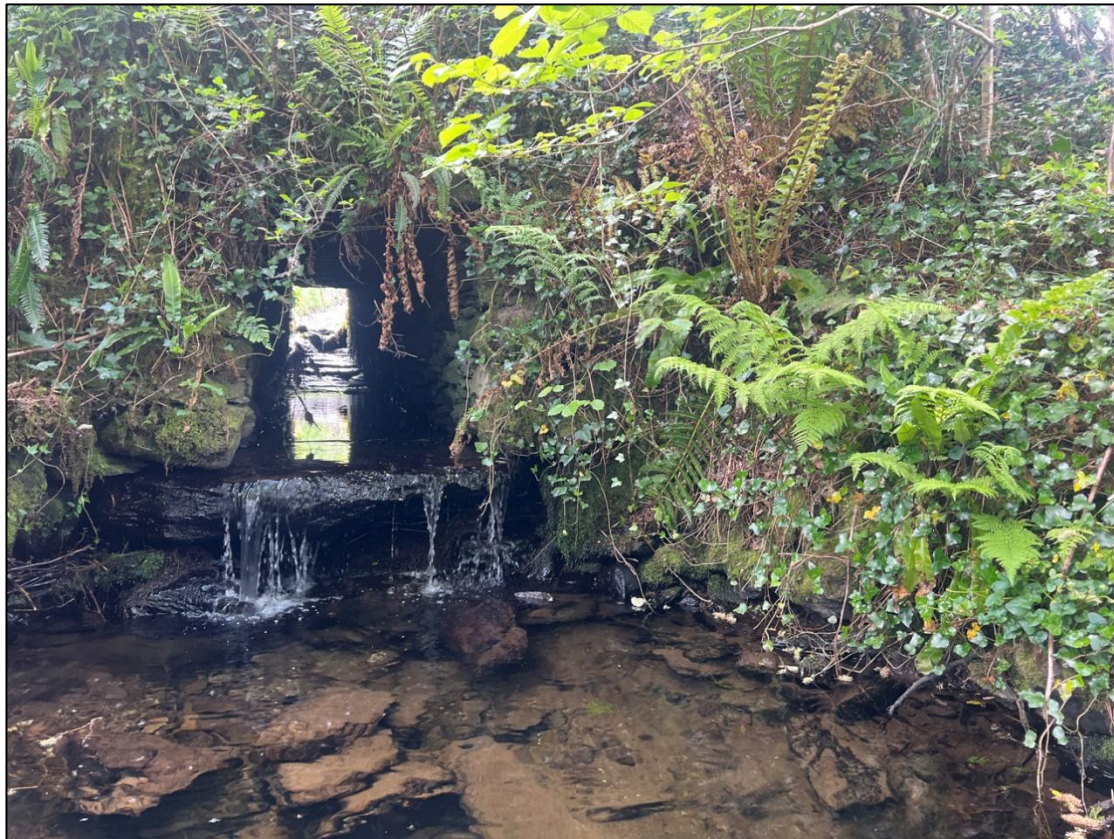
The bedrock-boulder substrate and high-energy flow of the watercourse provided negligible lamprey or salmonid species spawning habitat at this survey site. Although localised slower flow may provide refuge amongst areas of marginal cobble and undercut banks, the step-pool features throughout the watercourse may limit accessibility for juvenile salmonid fish. Pools up to 0.4m within the watercourse (0.6m at the foot of the culvert) provided some localised deeper water for adult salmonids. However, the steep gradient and upland morphology of this channel may again limit access to these habitats by salmonids. Lamprey ammocoete nursery in the form of fine sediment beds in slower flowing areas of water were absent, while areas of limited marginal refuge for eel were also assessed as inaccessible for the species.

Plate 4-34. A representative picture of the under-road box culvert and raised apron at the upstream survey extent of GC 8.

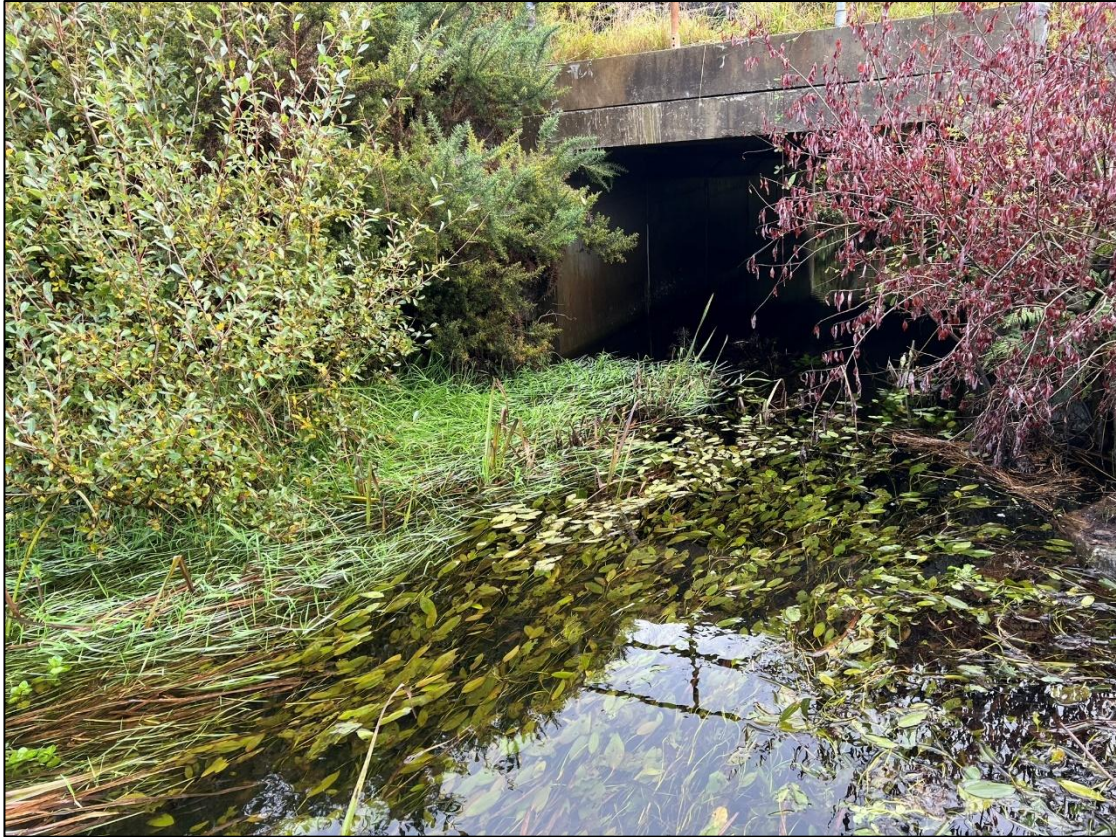
Plate 4-35. A representative picture of survey site GC 9

Properties	Record
Average Depth (m)	1.4
Average Bank Width (m)	4.0
Average Wetted Width (m)	3.5-3.8
Average Bank height (m)	LHB 1.0 RHB 0.8-1.0
Flow	Very slow flow
Colour	Brown
Clarity	Clear when undisturbed
Dominant Substrates	Cobble (>32-128mm): 20% Gravel (8-32mm): 20% Fine gravel (2-8mm): 20% Silt/Clay (<0.25mm): 60%
Substratum Condition	Loose

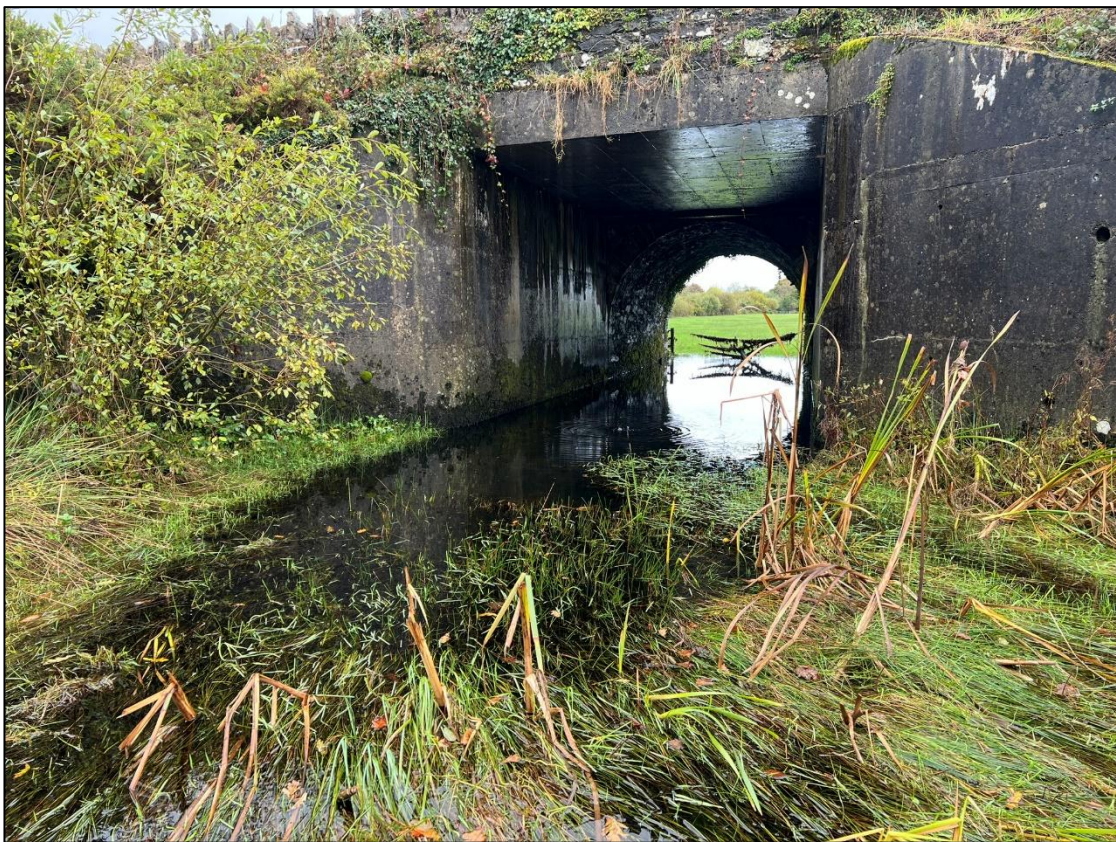
Plate 4-36. A representative picture of survey site GC 10

Overall, the highly modified nature of this watercourse, with uncontained channel margins provided poor fisheries habitat. A lack of any gravel substrate or suitable flow, and the presence of excessive mats of instream vegetation precluded any significant suitable spawning habitat for salmonid or lamprey species. Additionally, salmonid and lamprey nursery habitat were absent due to a lack of any coarse substrate refugia, diverse flow patterns or well-structured fine sediment beds, respectively. Adult salmonid holding habitat and European eel habitat was absent as a result of lack of adequate deep water and flows. This watercourse likely only provided suitable habitat for minnow and three-spined stickleback.

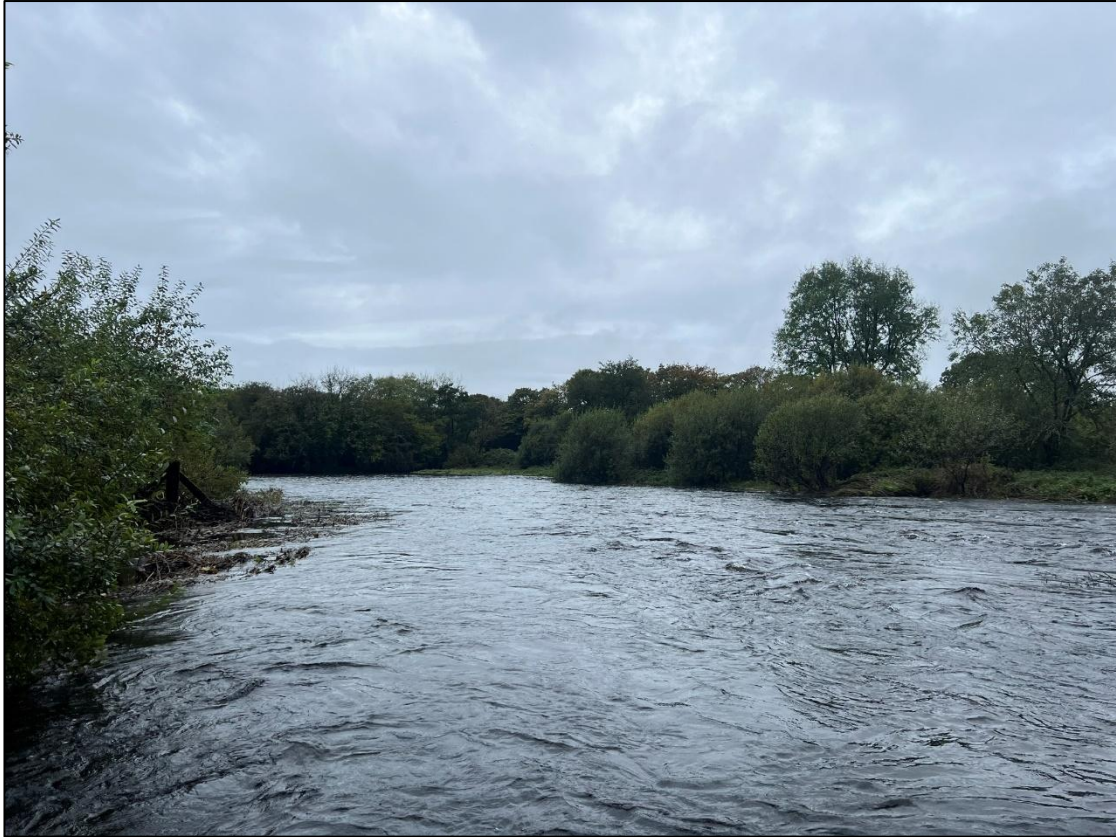
Plate 4-37. A representative picture of survey site GC 11

No otter signs were identified at survey site GC 11, although the mainstem Bandon provides excellent potential commuting and foraging habitat for these species. Earthen banks were either low and undercut or heavily vegetated, with no significant suitable kingfisher burrow habitat at GC 11. However, similar to otter, this uninterrupted stretch of **Depositing/Lowland River (FW2)** provided excellent potential foraging and commuting habitat for kingfisher, with perches available for fishing both upstream and downstream of the bridge. No kingfisher burrows were identified at survey site GC 11 at the time of survey and no kingfisher were observed at the time of survey.
