### **GEOTECHNICAL AND PEAT STABILITY ASSESSMENT REPORT**

# GEOTECHNICAL & PEAT STABILITY REPORT

## MAUGHANACLEA RENEWABLE ENERGY DEVELOPMENT

**Keywords:** Geotechnical, Peat Stability, Peat Failure, Risk Assessment

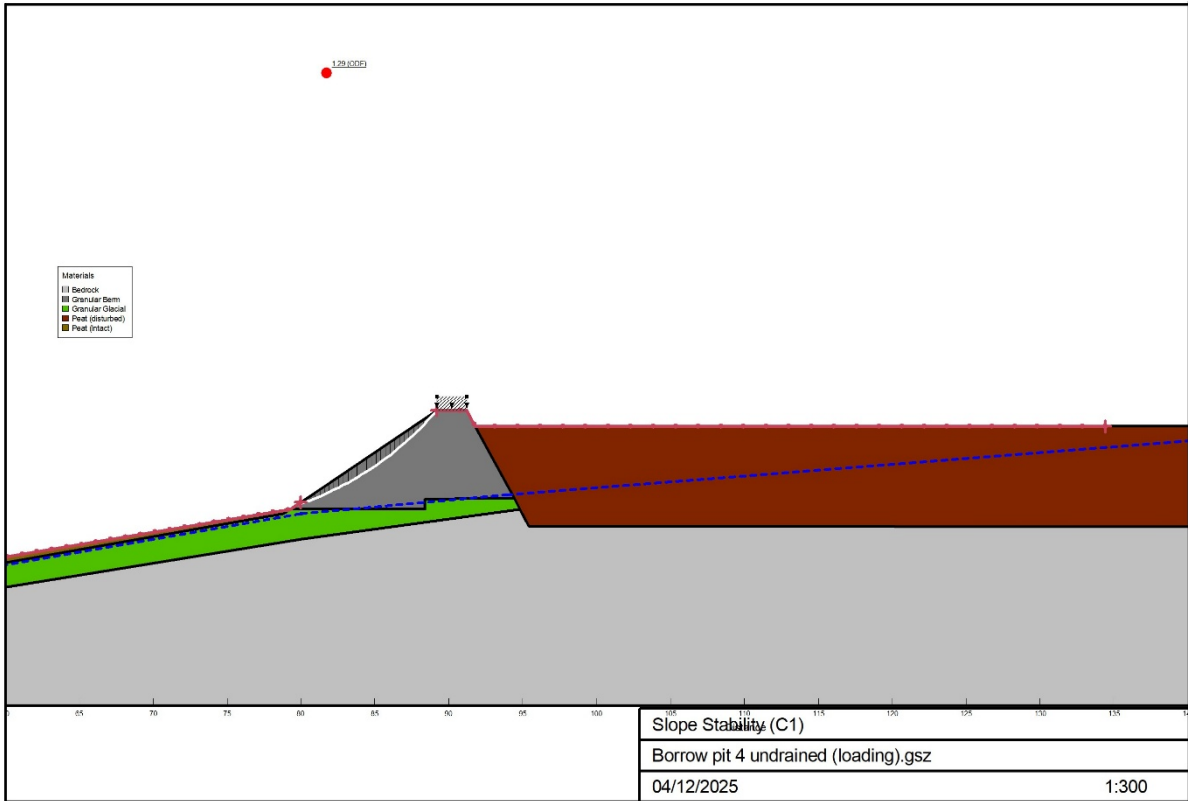
**Figure 7.1: Borrow Pit Stability Check, Undrained DA1C1**

Borrow Pit	Over Design Ratio (ODR)	
	DA1C1	DA1C2
Undrained Analysis	1.29	1.03
Drained Analysis	1.29	1.03

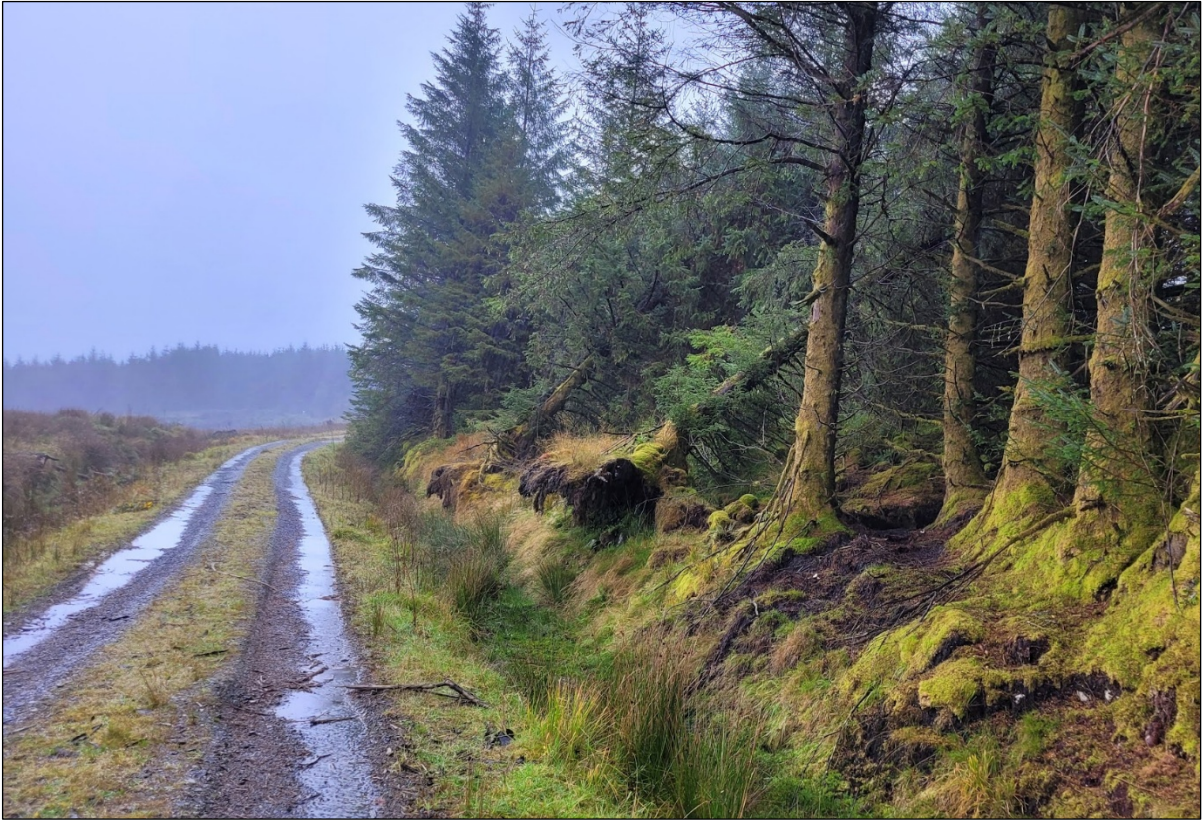
**Photo 1:** Existing section of access road

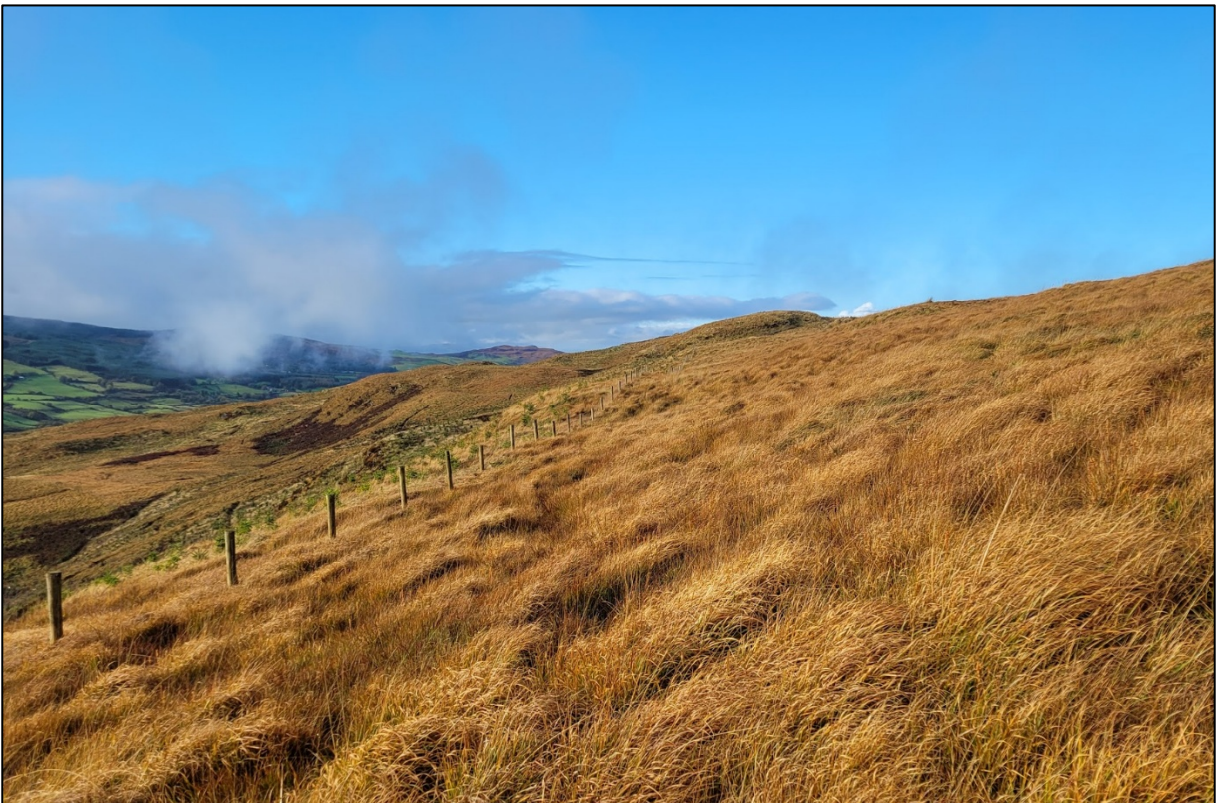
**Photo 2:** Open hillside close to T03

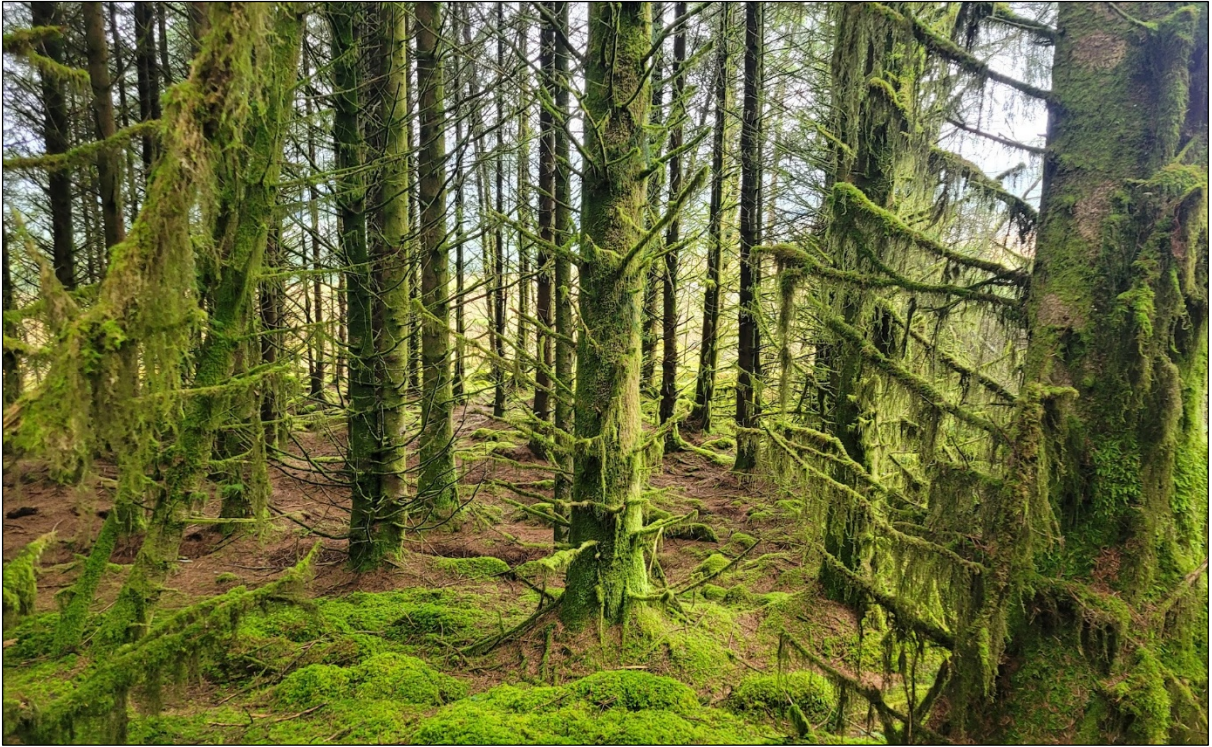
**Photo 3:** Forestry in southern portion of site

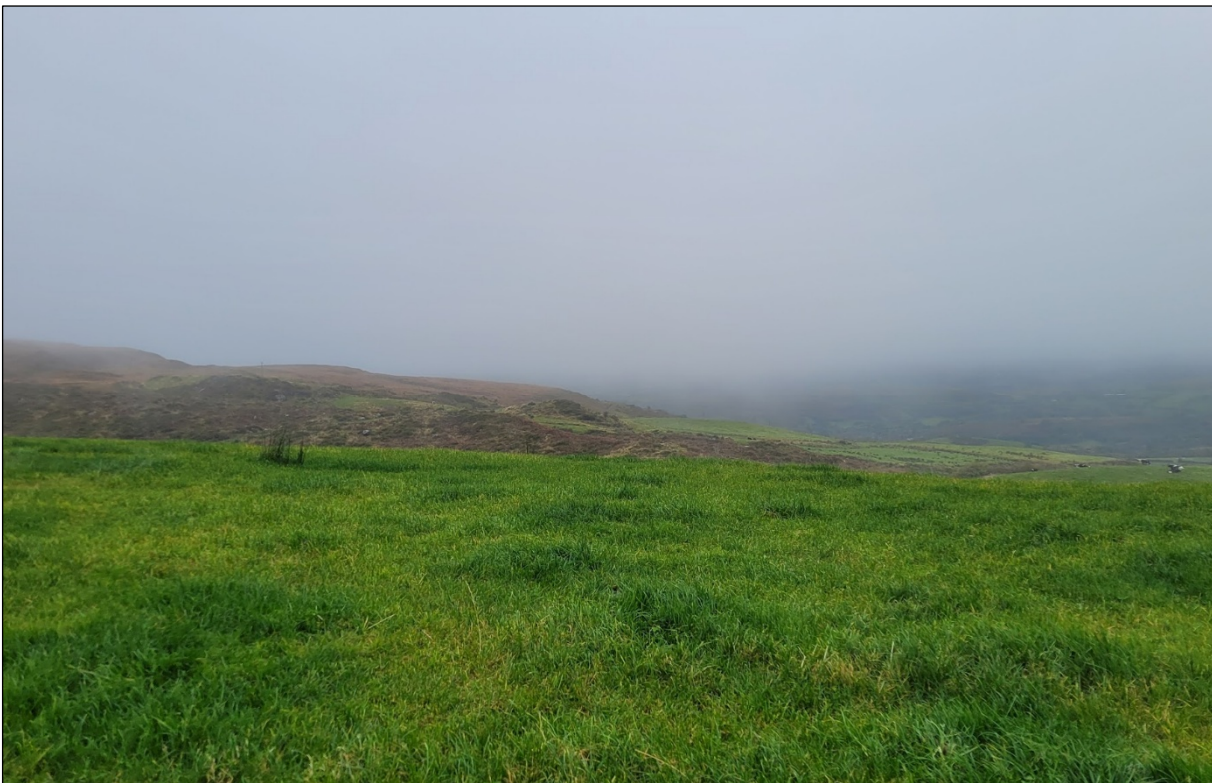
**Photo 4:** Open hillside near T12
