Carrigeen Renewable Energy Development

Figure 6.8a

Western Wind Farm Parcel Habitat Map

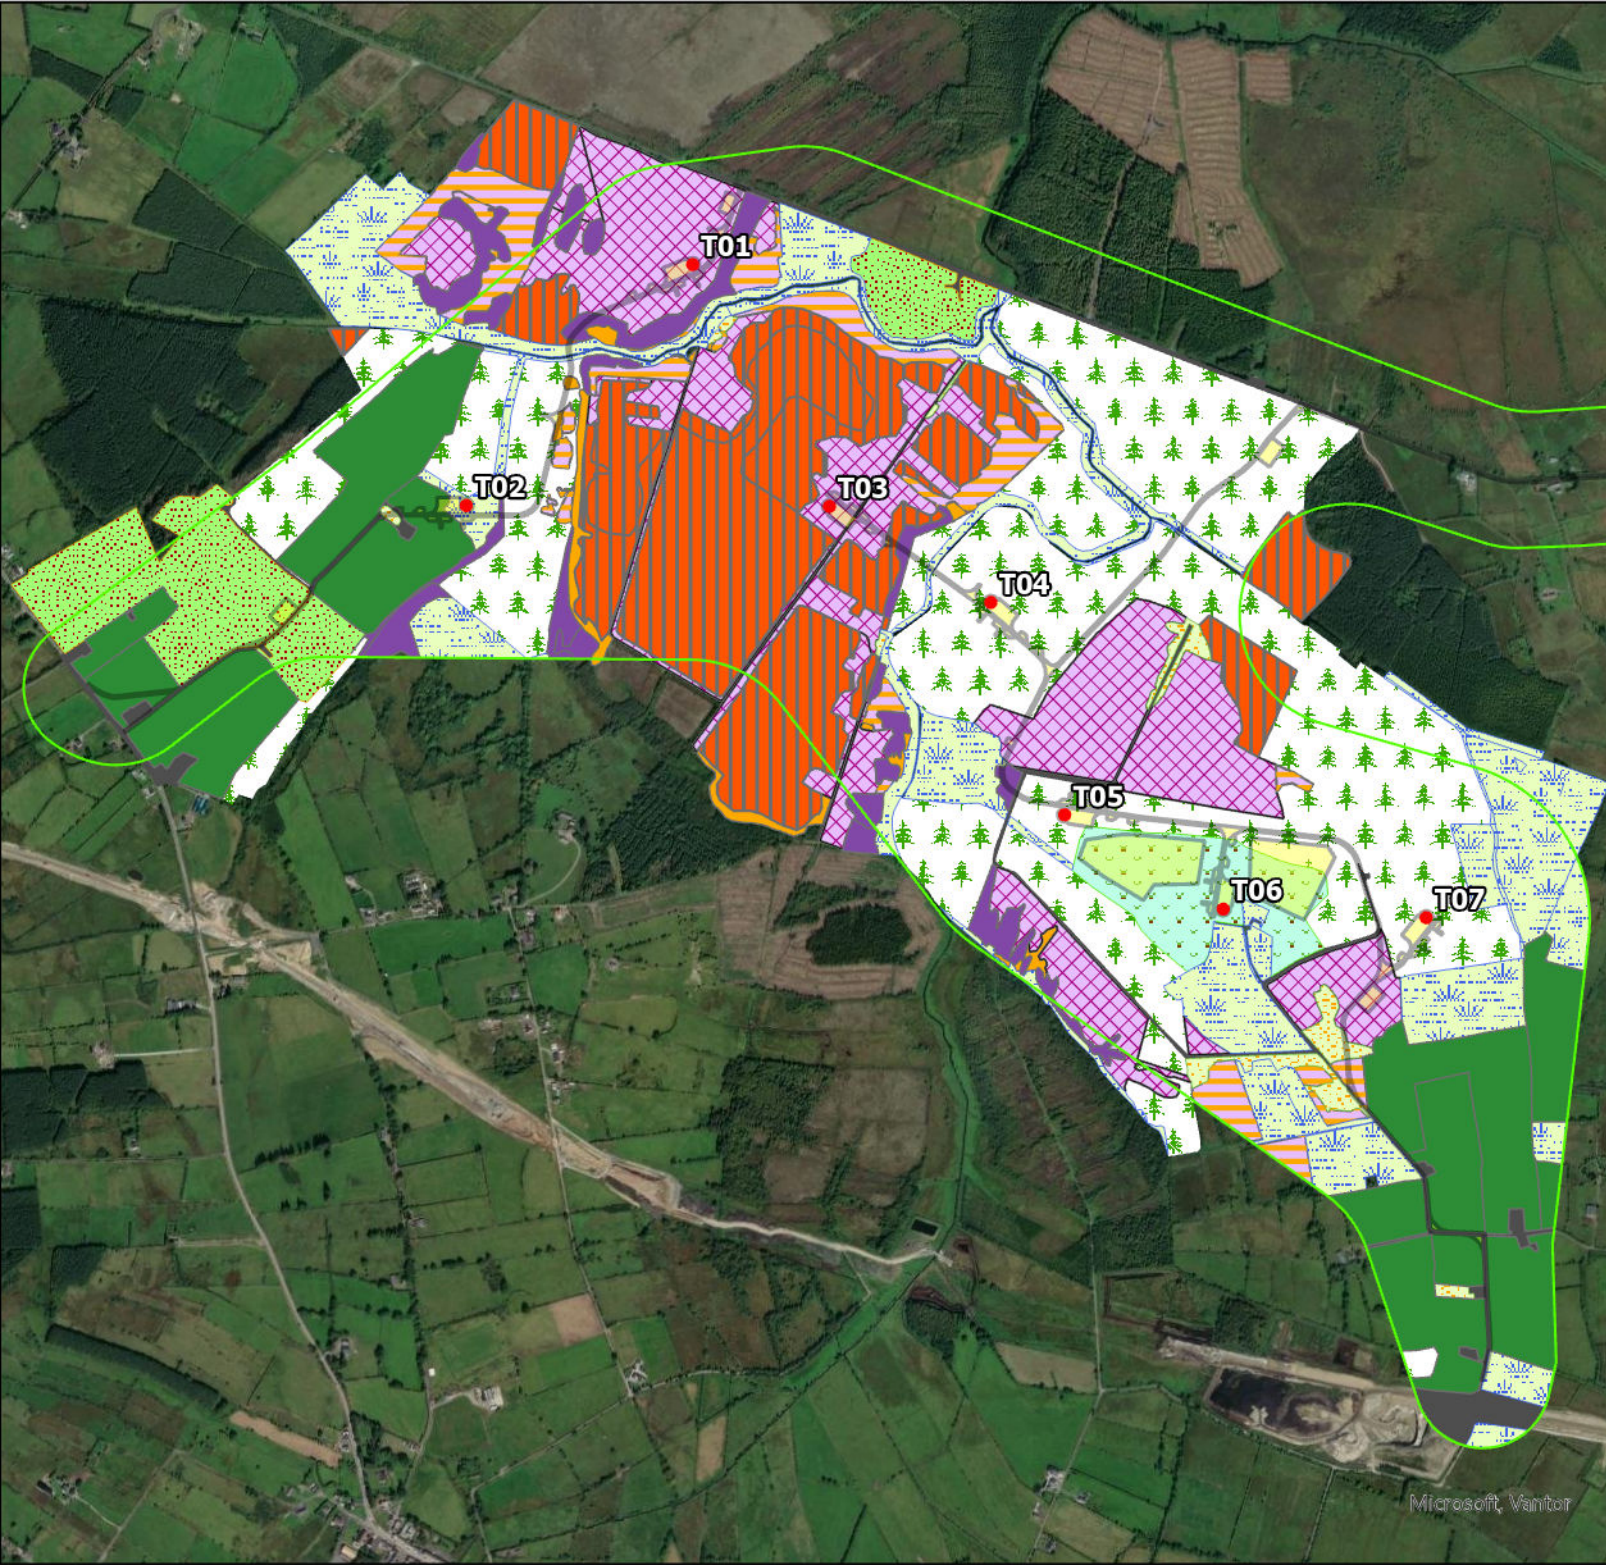
- Improved Agricultural Grassland GA1
- Wet Grassland GS4
- Dense Bracken HD1
- Degraded Raised Bog PB1
- Degraded Raised Bog PB1
- Raised Bog Degraded PB1- Molinia Dominated
- Cutover Raised Bog PB4
- Wet Willow Alder Ash Woodland WN6
- Scrub WS1
- Immature Plantation WS2
- Recently Felled Plantation WS5
- Conifer Plantation WD4
- Buildings Artificial Surfaces BL3
- Carrigeen WF Layout
- EIAR Boundary
