# Borrow Pit Assessment for Carrigeen Renewable Energy Development, Co. Roscommon, Ireland

## Supplementary Ground Investigation

Report No: 2278-24 BP Rev1

# [SOILS AND GEOLOGY STUDY – BORROW PIT ASSESSMENT]

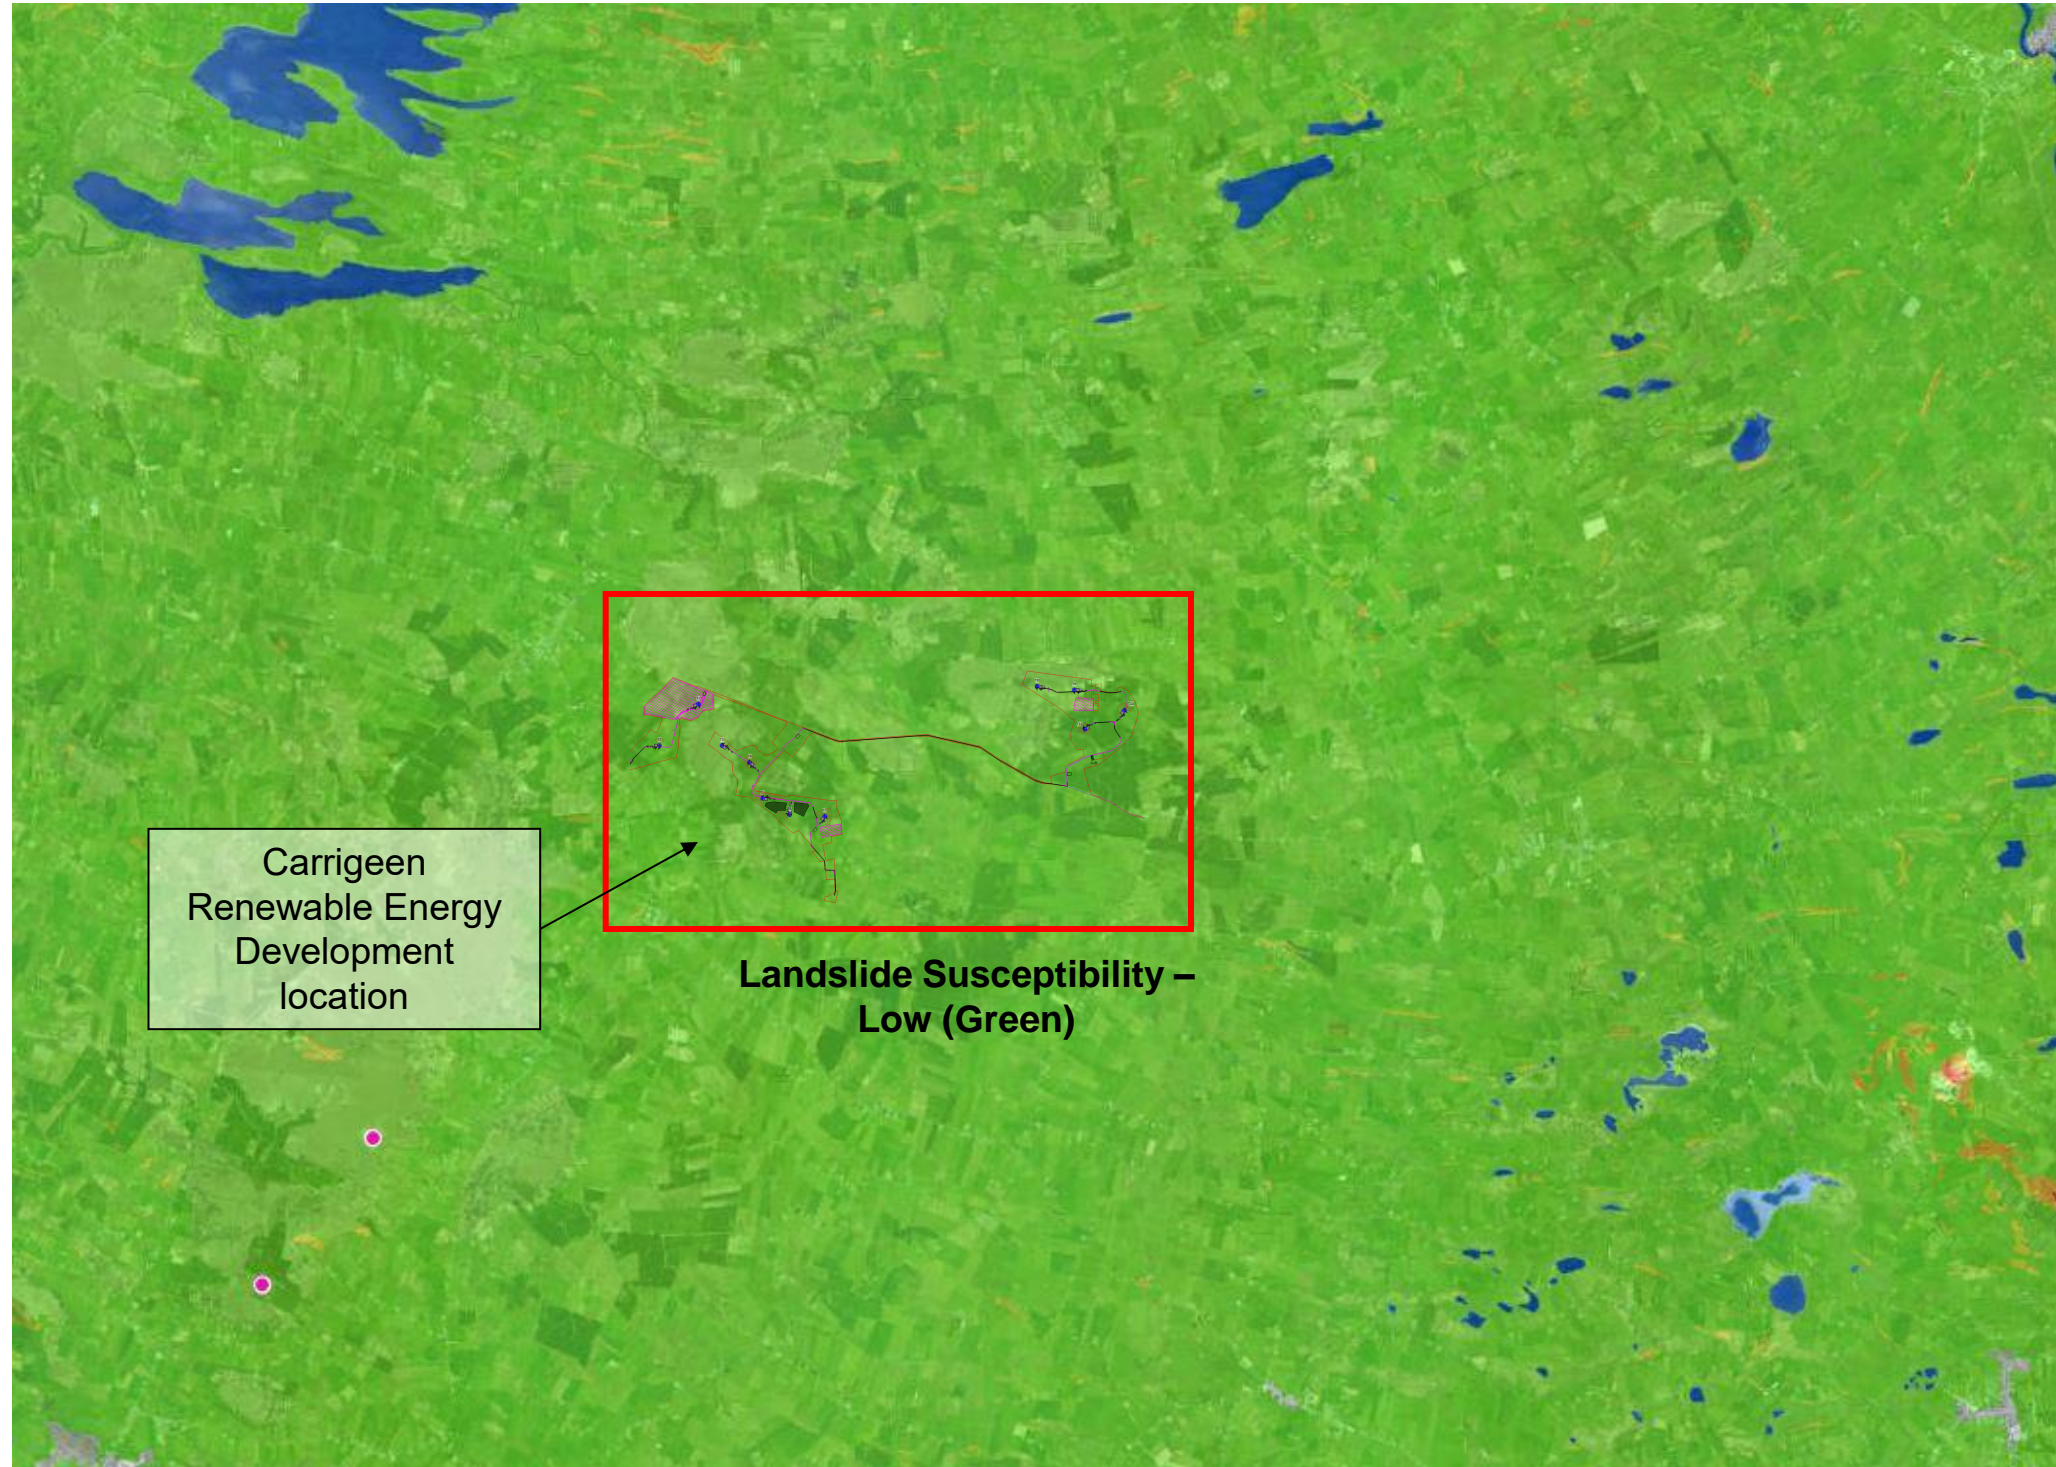
GSI – Landslide Susceptibility

Landslide Susceptibility –  
Low (Green)

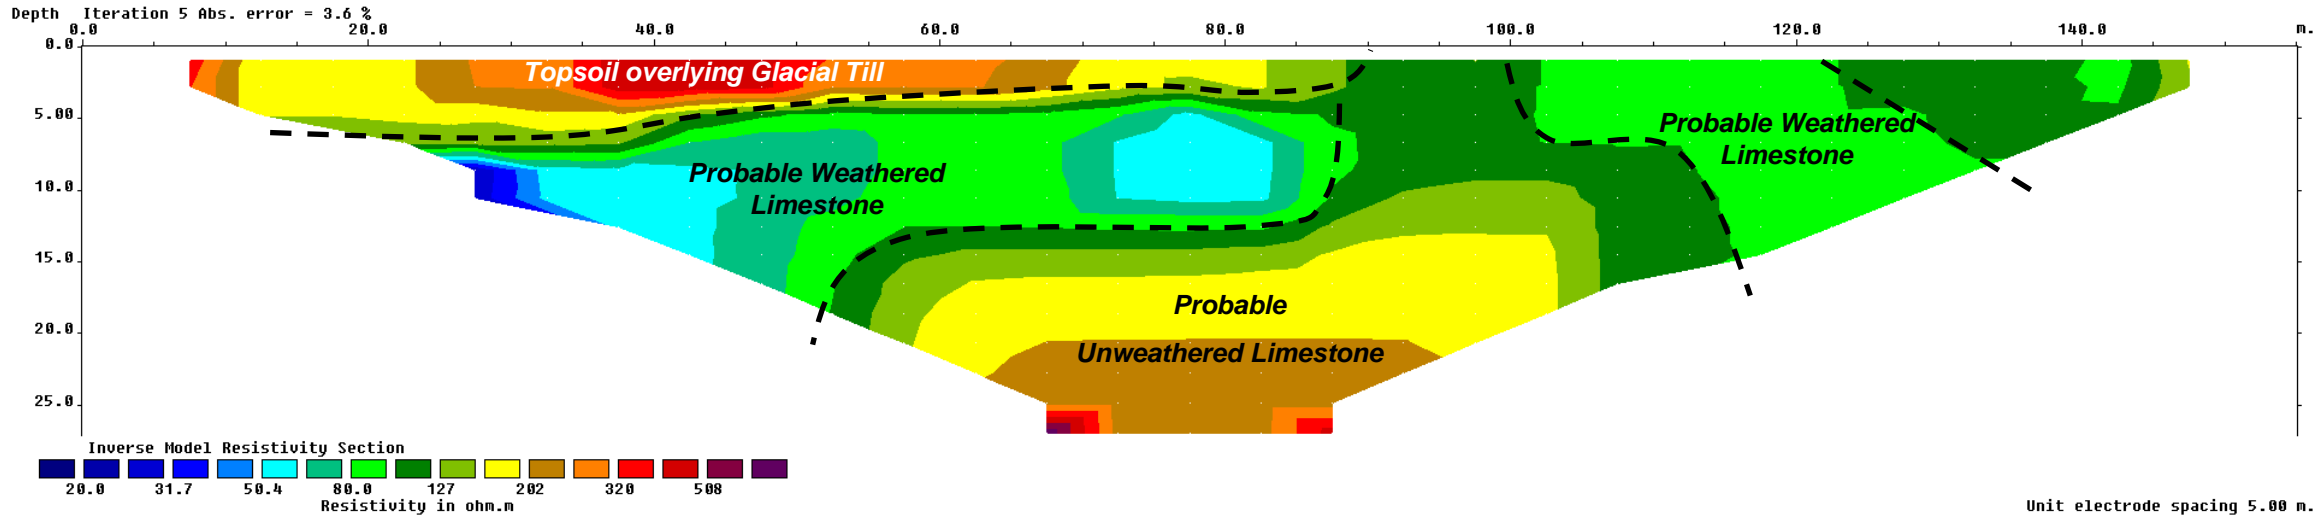
### BP East, Profile L3 (E-W) (Up to 6m overburden over rock)

Borrow Pit Area (TP Refs)	Geophysical Profile Nr	Depth of Rock Layer (m)	Resistivity ( $\Omega$ m)	Predicted Rock Type
East (TP-BP1, 3 & 5)	L3	4.0 – 7.0	100 - 600	LIMESTONE (Weathered to 15m)
East (TP-BP2, 4 & 5)	L4	3.0 – 8.0	100 - 600	LIMESTONE (Weathered to 12m)
West (TP-BP6 & 7)	L5	3.0 – 8.0	100 - 600	LIMESTONE (Intermittently weathered from 7m)
West (TP-BP7)	L26	3.0 – 5.0	100 - 600	LIMESTONE (Weathered to 12m)
West (TP-BP9 & 10)	L7	4.0 – 7.0	100 - 600	LIMESTONE (Intermittently weathered from 7m)
West (TP-BP6, 8 & 10)	L25	5.0 – 8.0	100 - 600	LIMESTONE

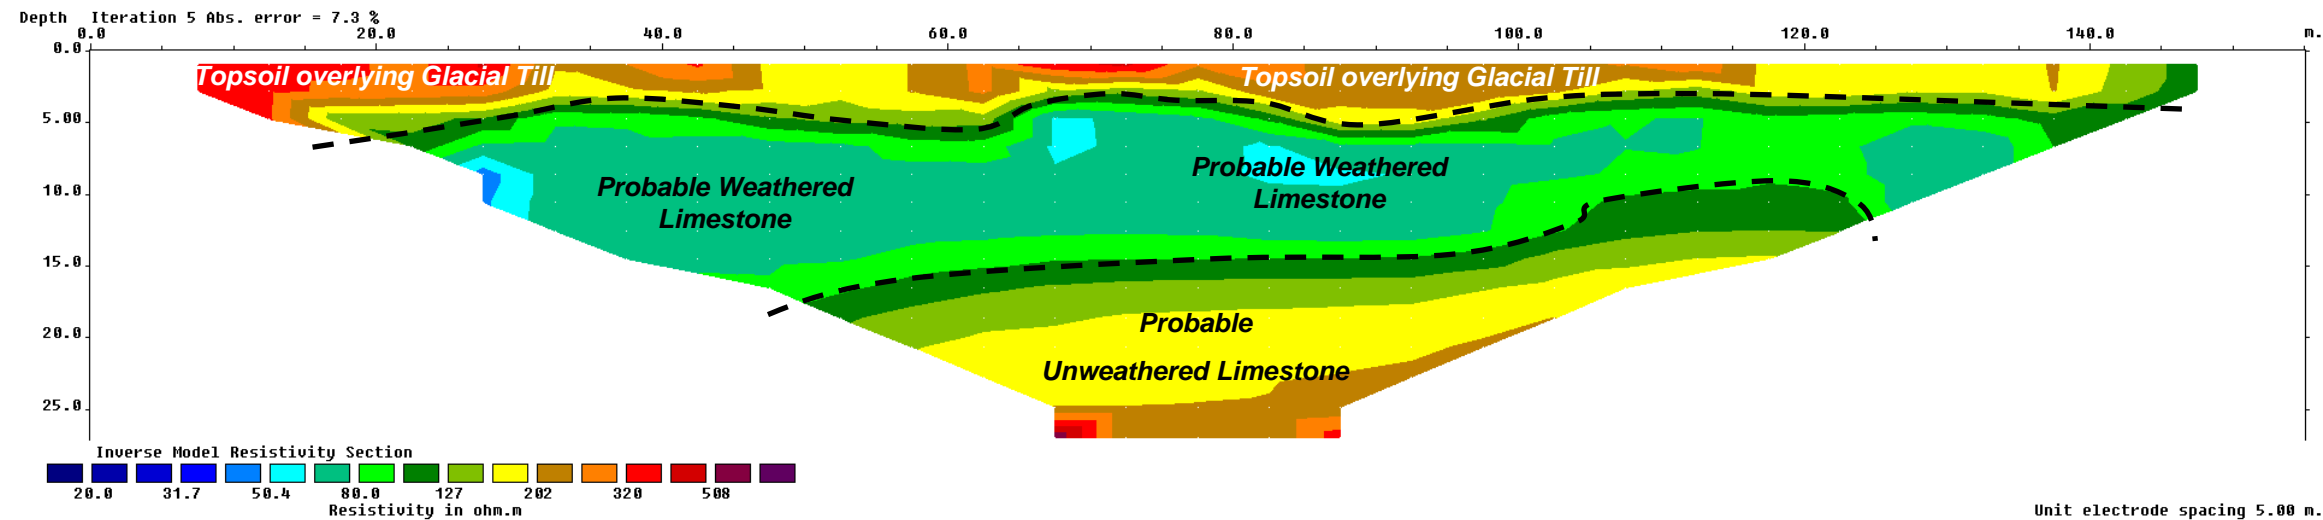
### BP East, Profile L4 (S-N) (5 - 8m overburden over rock)

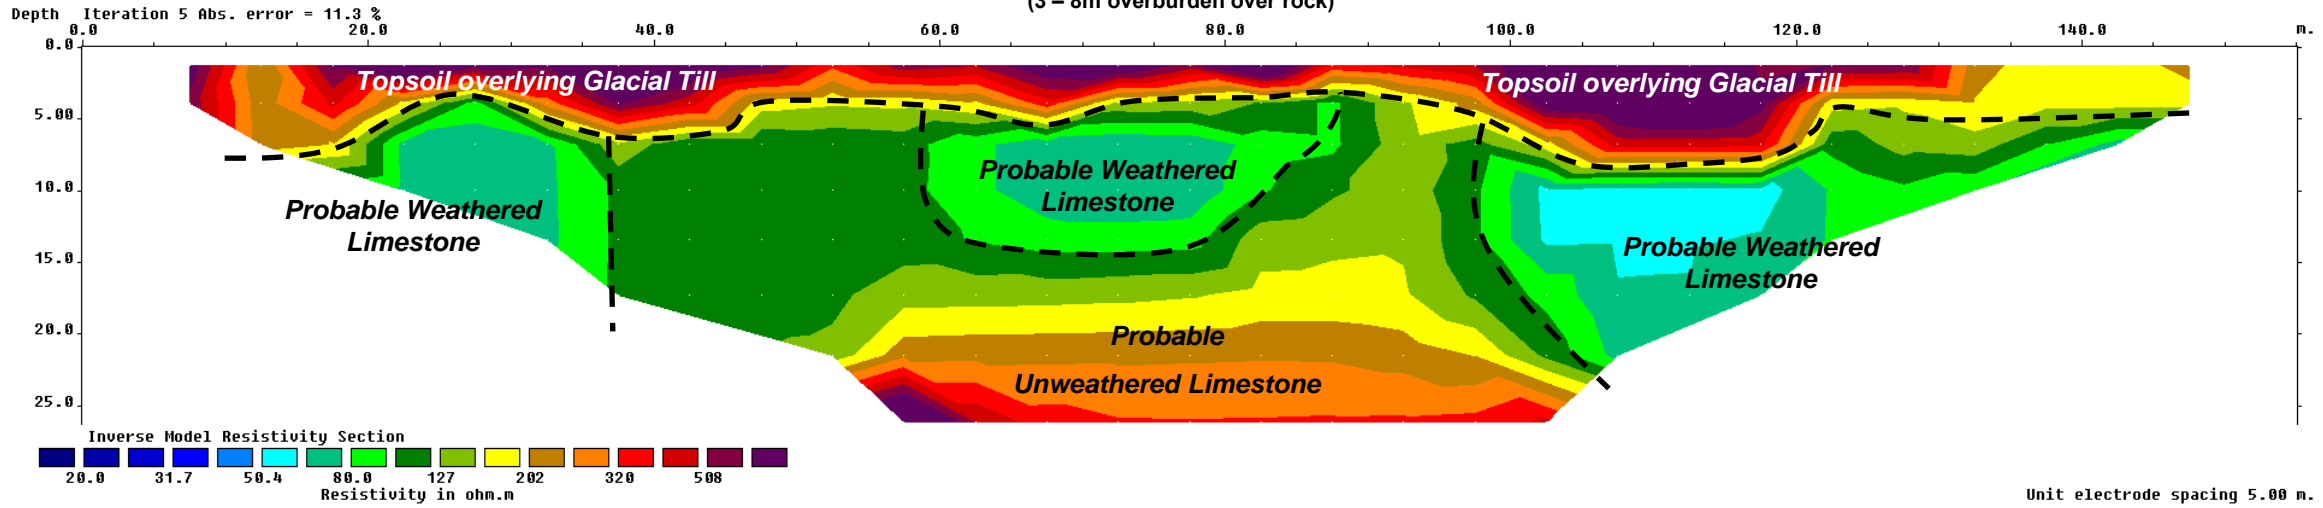
### BP West, Profile L5 (W-E)

(3 – 8m overburden over rock)

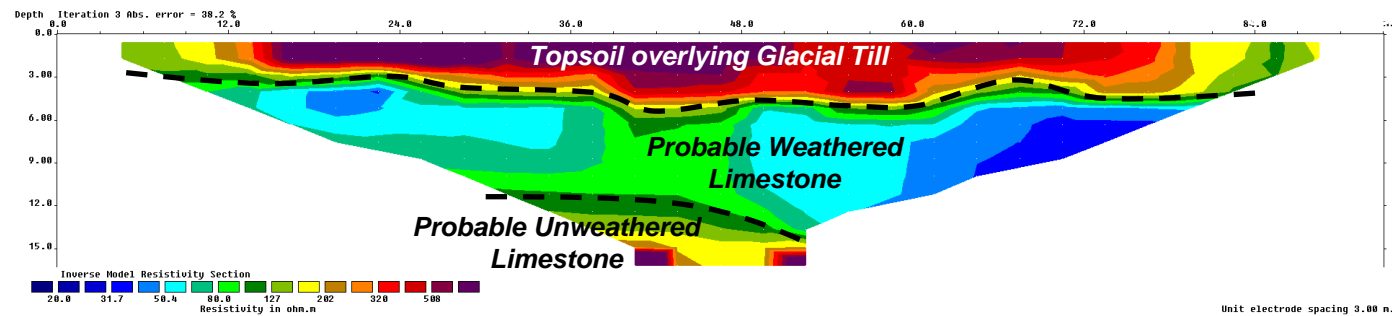
### BP West, Profile L26 (S-N)

(3 – 5m overburden over rock)

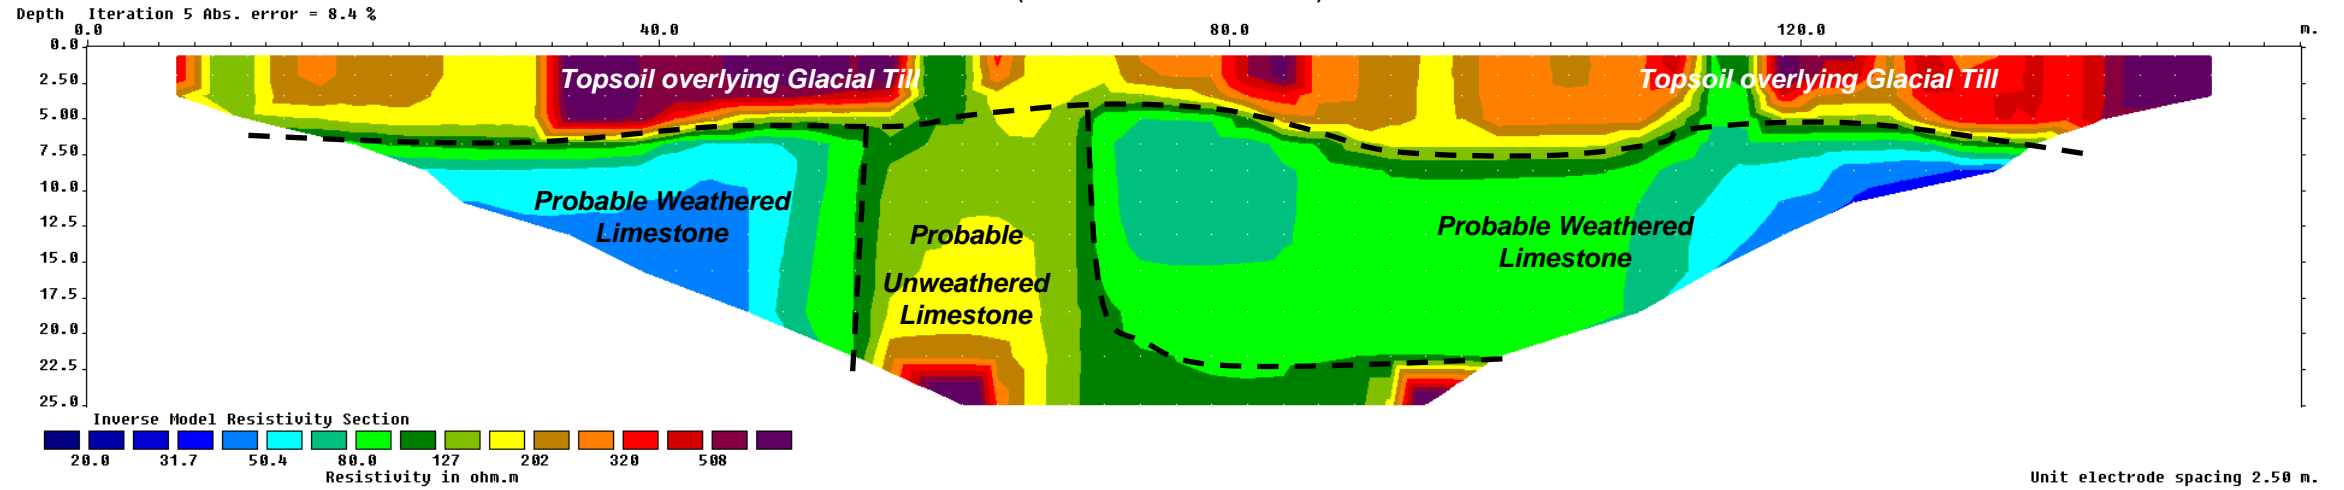
### BP West, Profile L7 (E-W)

(4 – 7m overburden over rock)

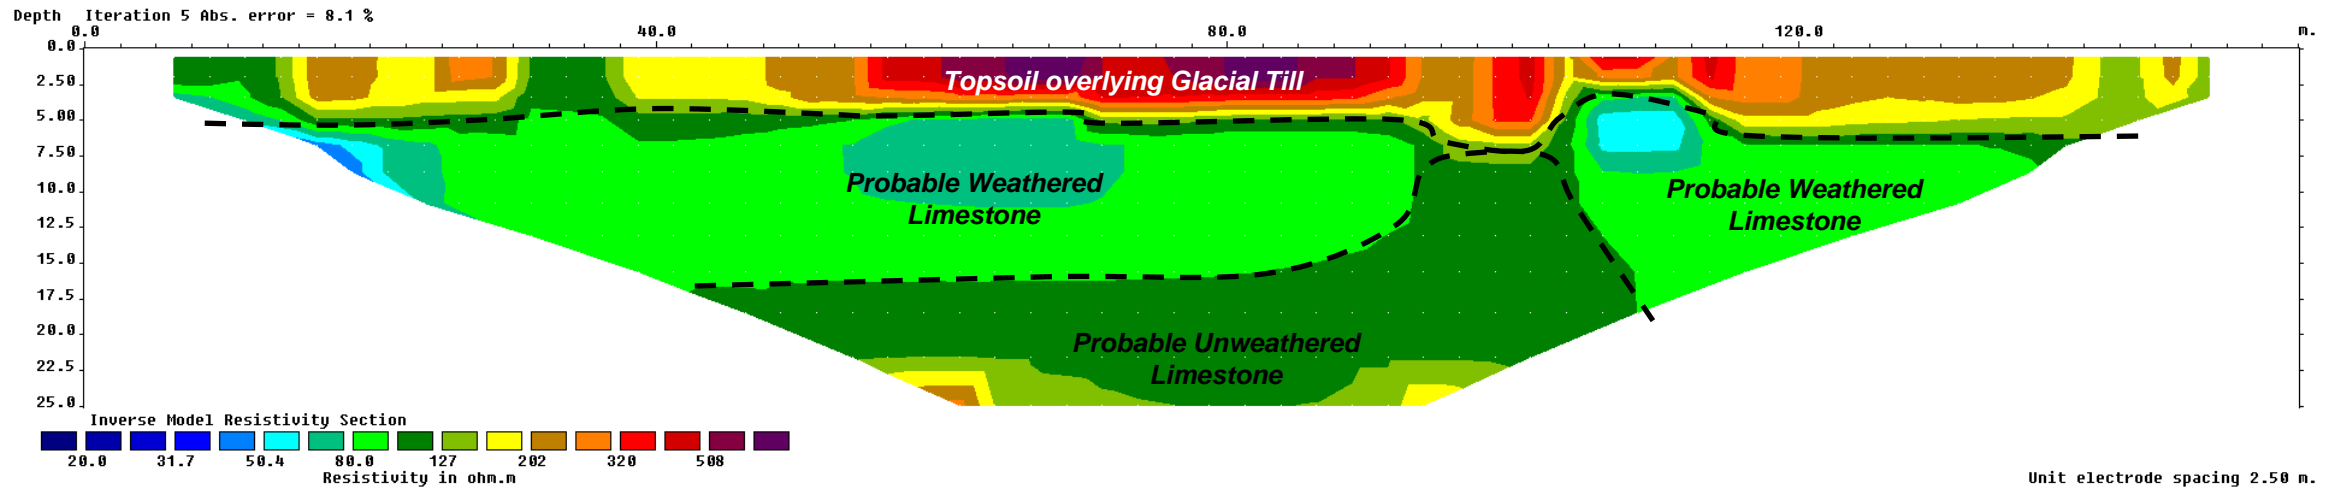
(5 – 7m overburden over rock)
