Residential Development on Rathmullan Road, Drogheda		Rev: 0	Target Direction 705848, 775063, 27.9	
Recommended viewing distance with both eyes is 500mm.

Photomontage Methodology / Method Statement

Appendix 12.2 Plates

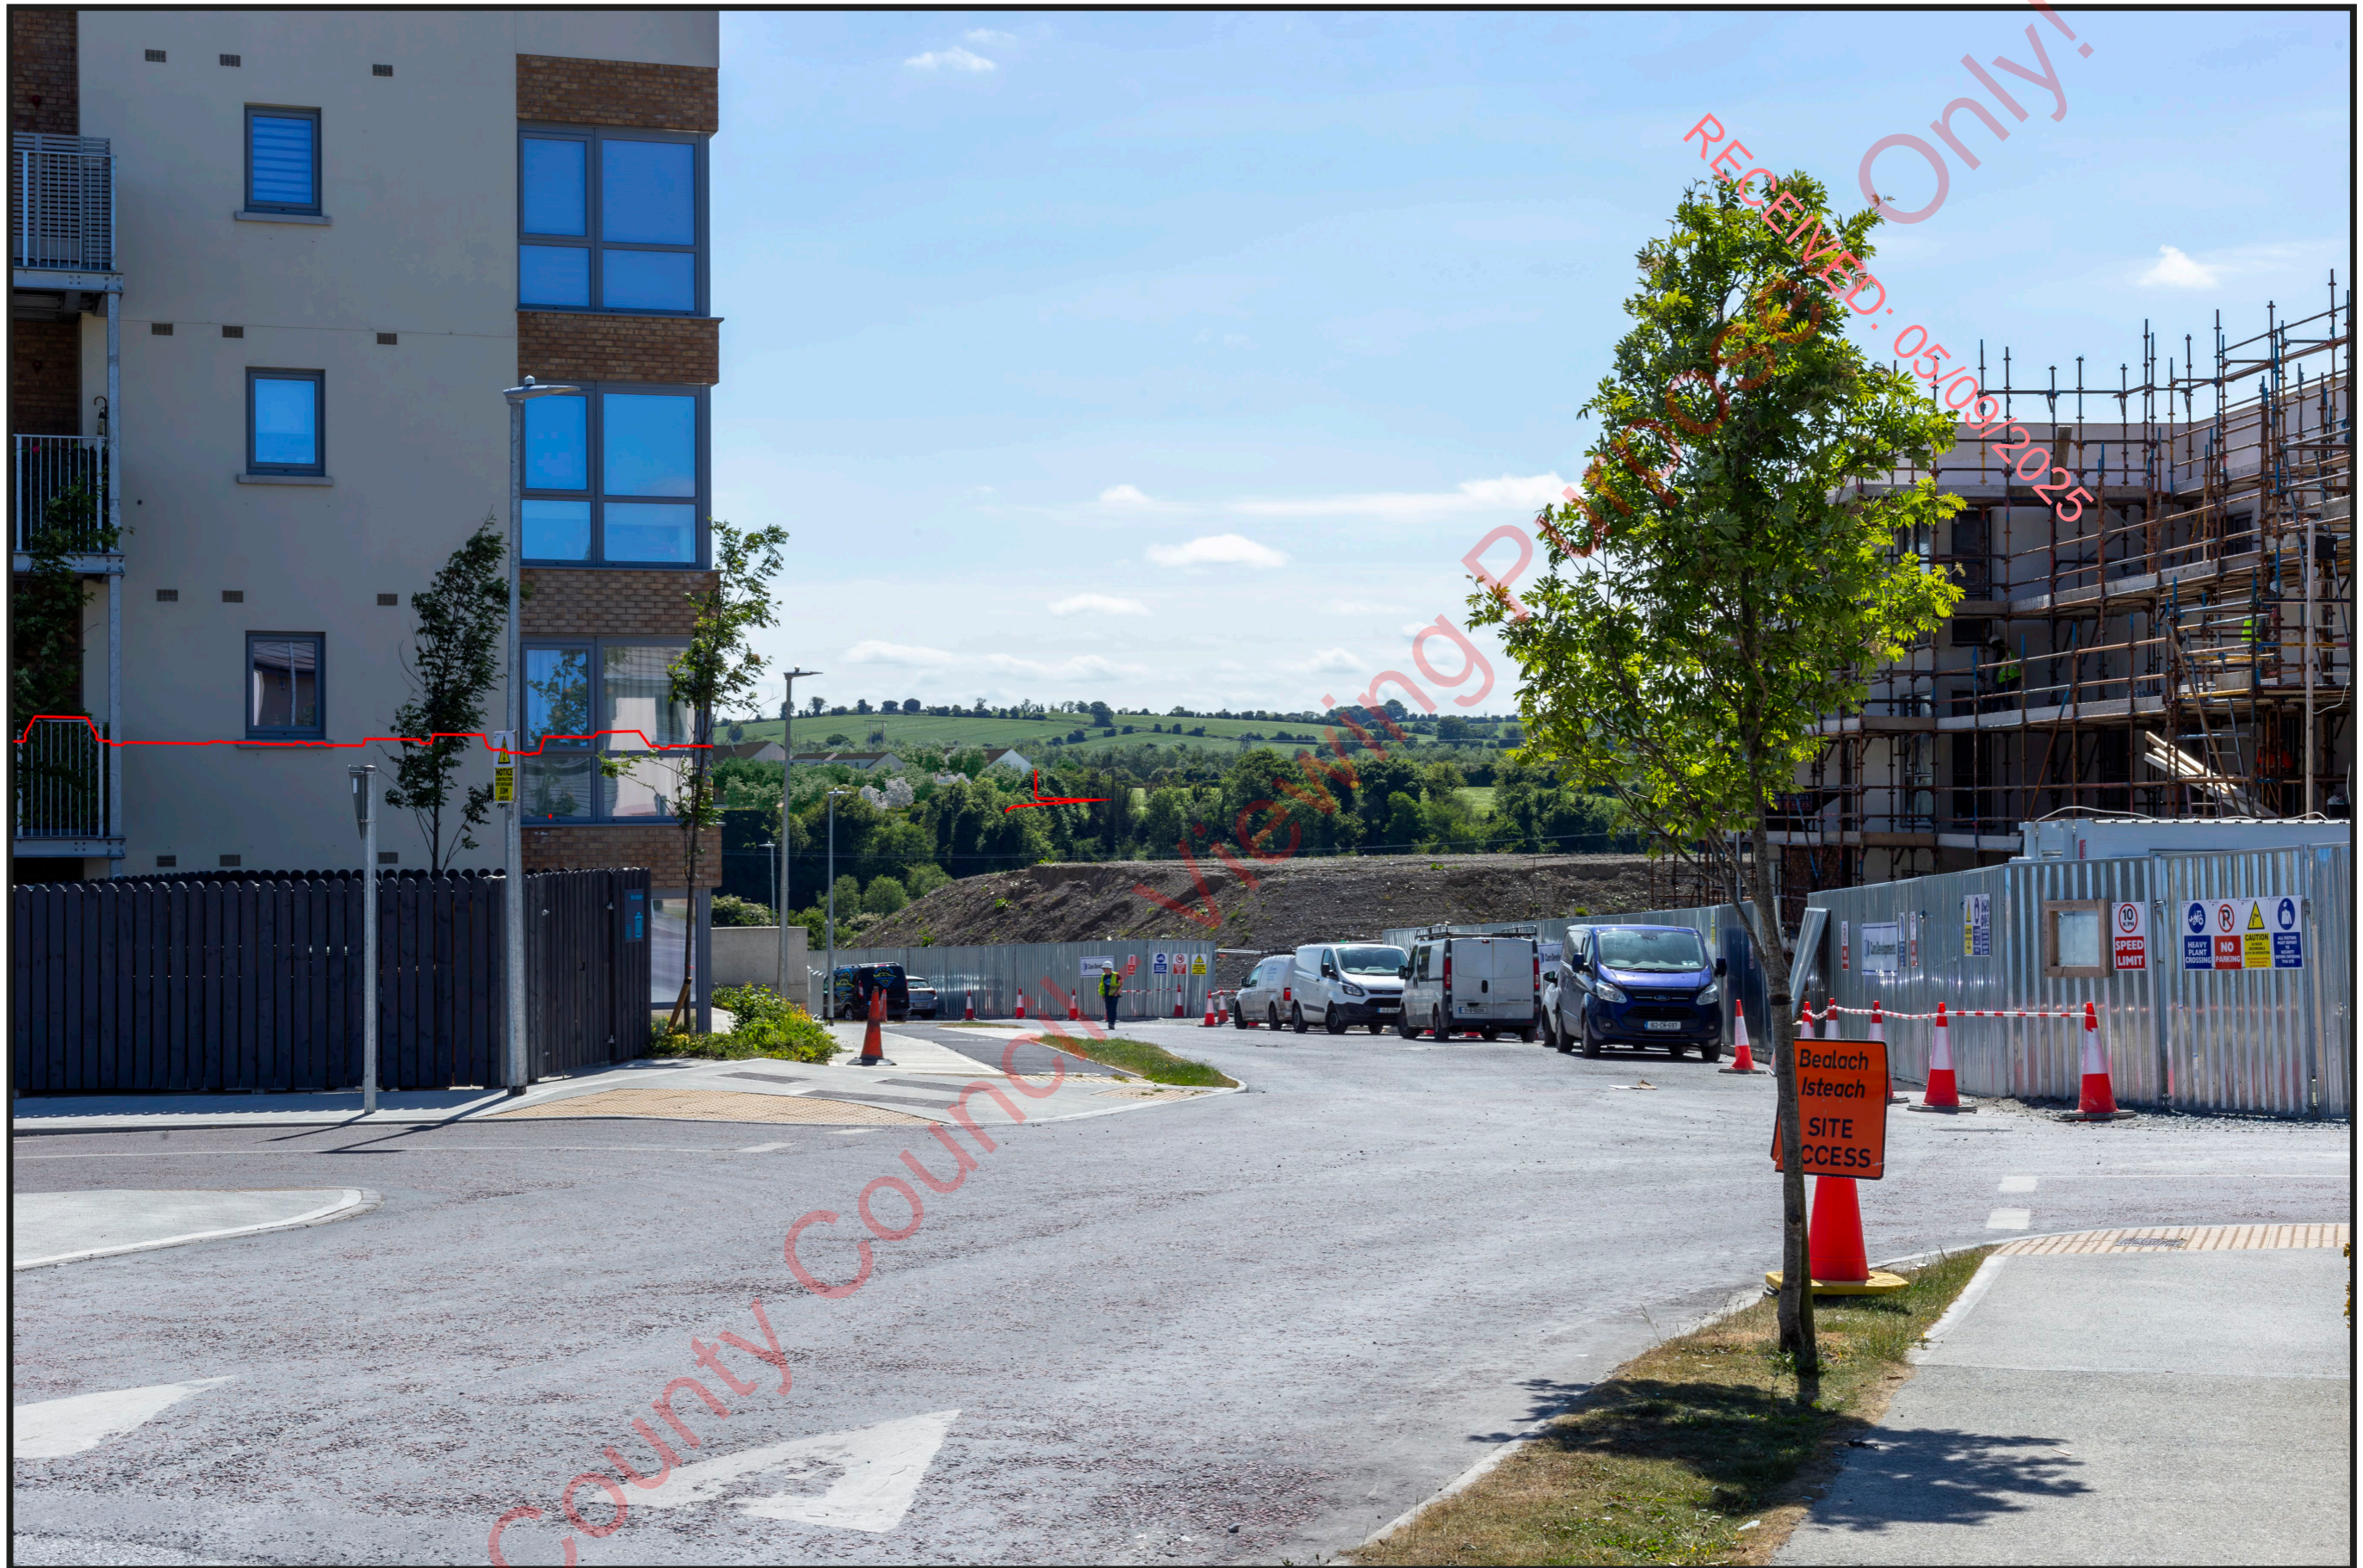
Name PM12 Status Proposed Reference: Tullybrook Housing looking SSW	Earlsfort Developments Drogheda Limited	Camera location 706340, 775954, 21.8	Camera Canon 6D Mk 2 Lens Canon EF 50mm HView Angle Nominal 40 degrees

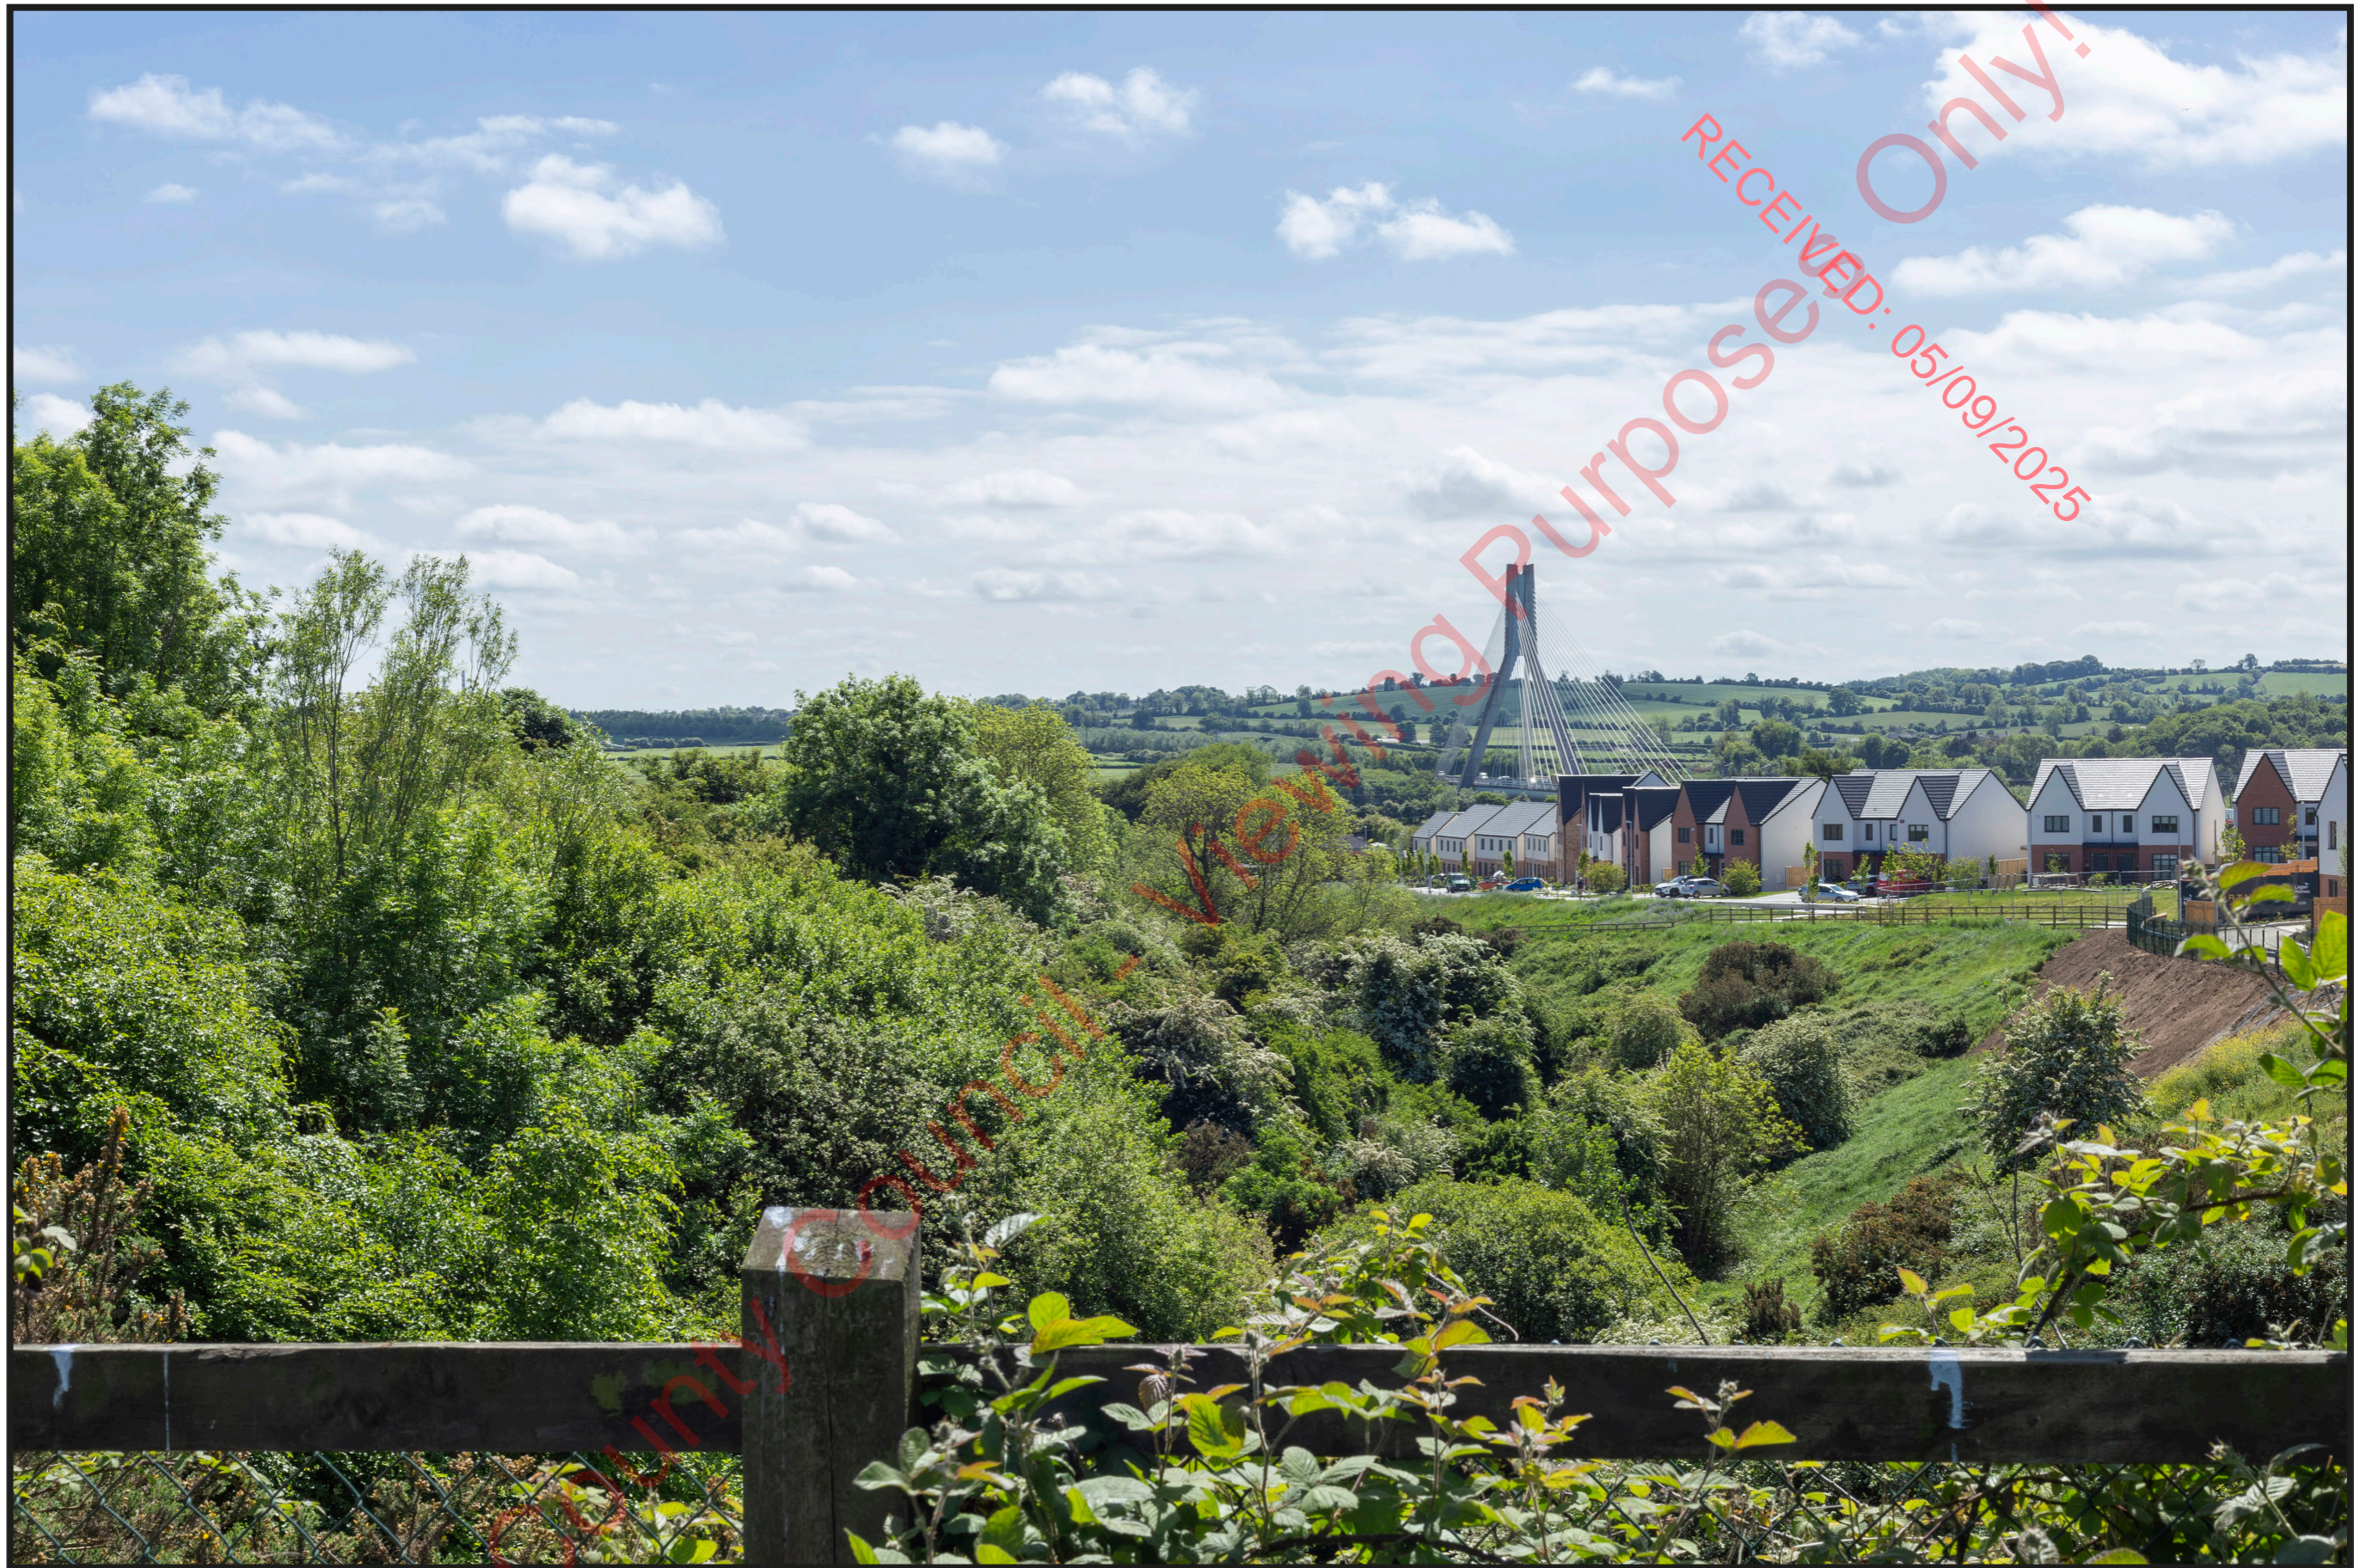
Name PM13 Status Existing Reference: N51 at Mell looking S	Earlsfort Developments Drogheda Limited	Camera location 706083, 776552, 34.2	Camera Canon 6D Mk 2 Lens Canon EF 50mm HView Angle Nominal 40 degrees

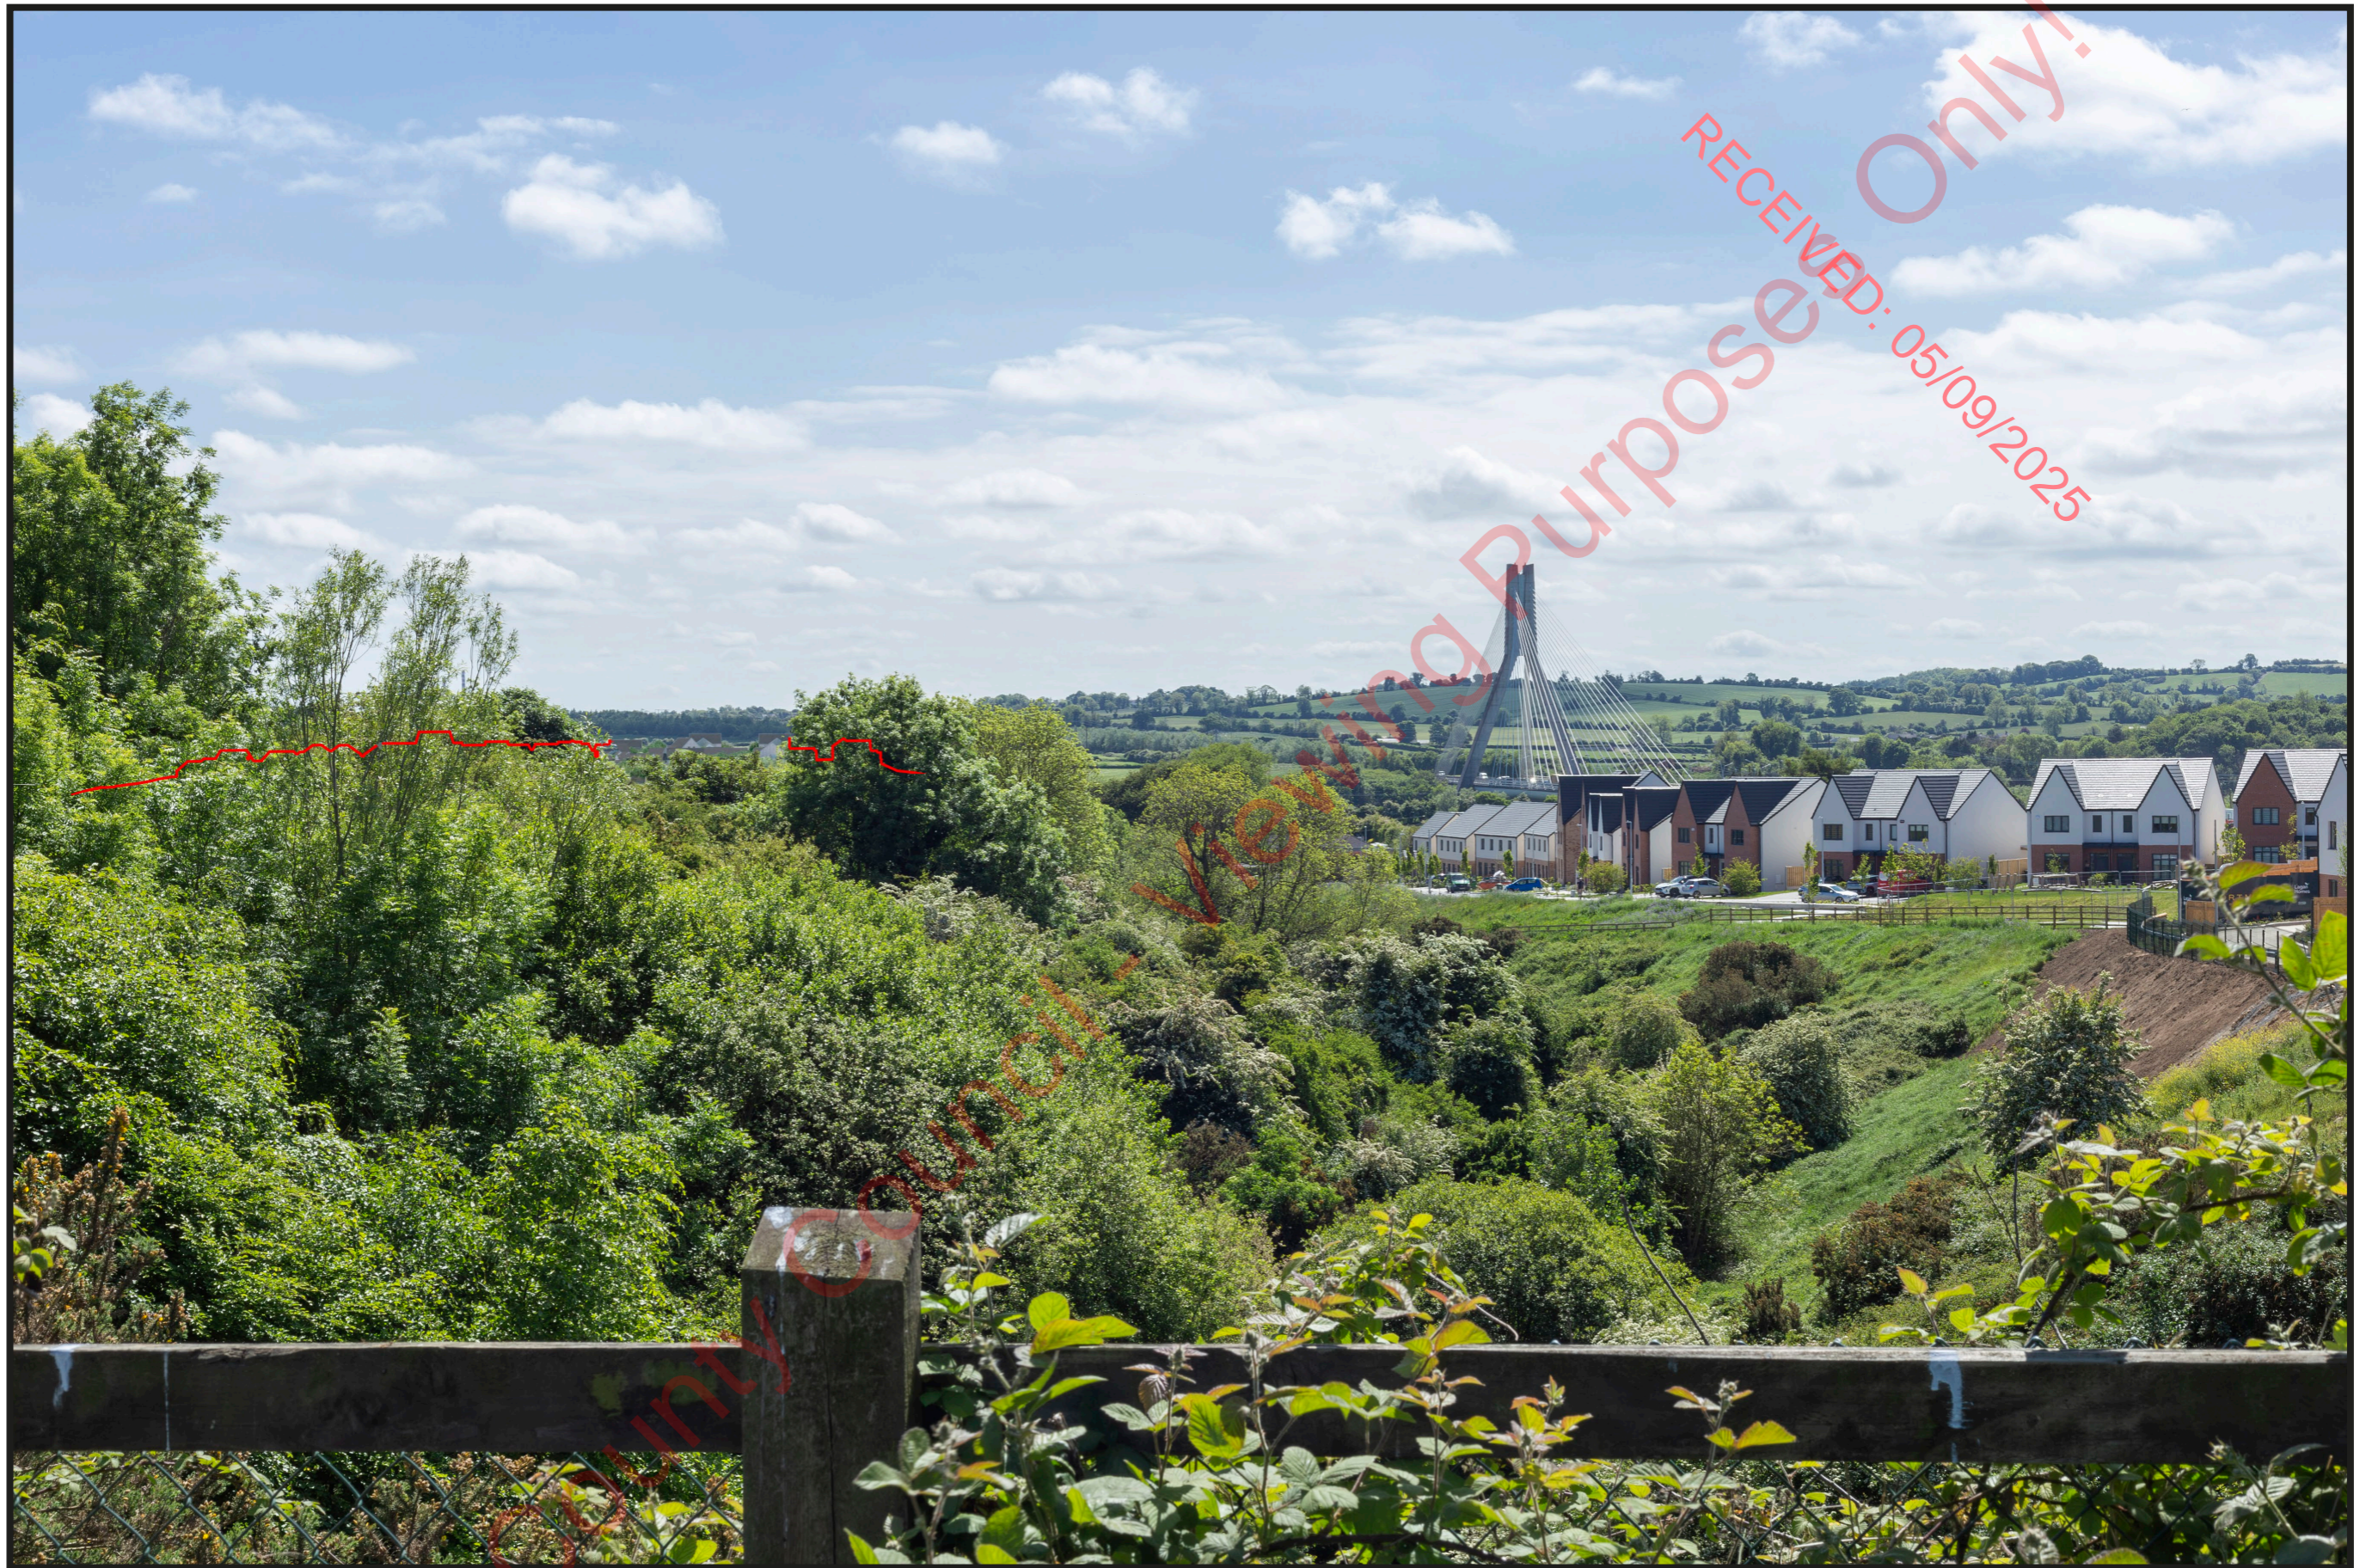
Name PM13 Status Proposed Reference: N51 at Mell looking S	Earlsfort Developments Drogheda Limited	Camera location 706083, 776552, 34.2	Camera Canon 6D Mk 2 Lens Canon EF 50mm HView Angle Nominal 40 degrees

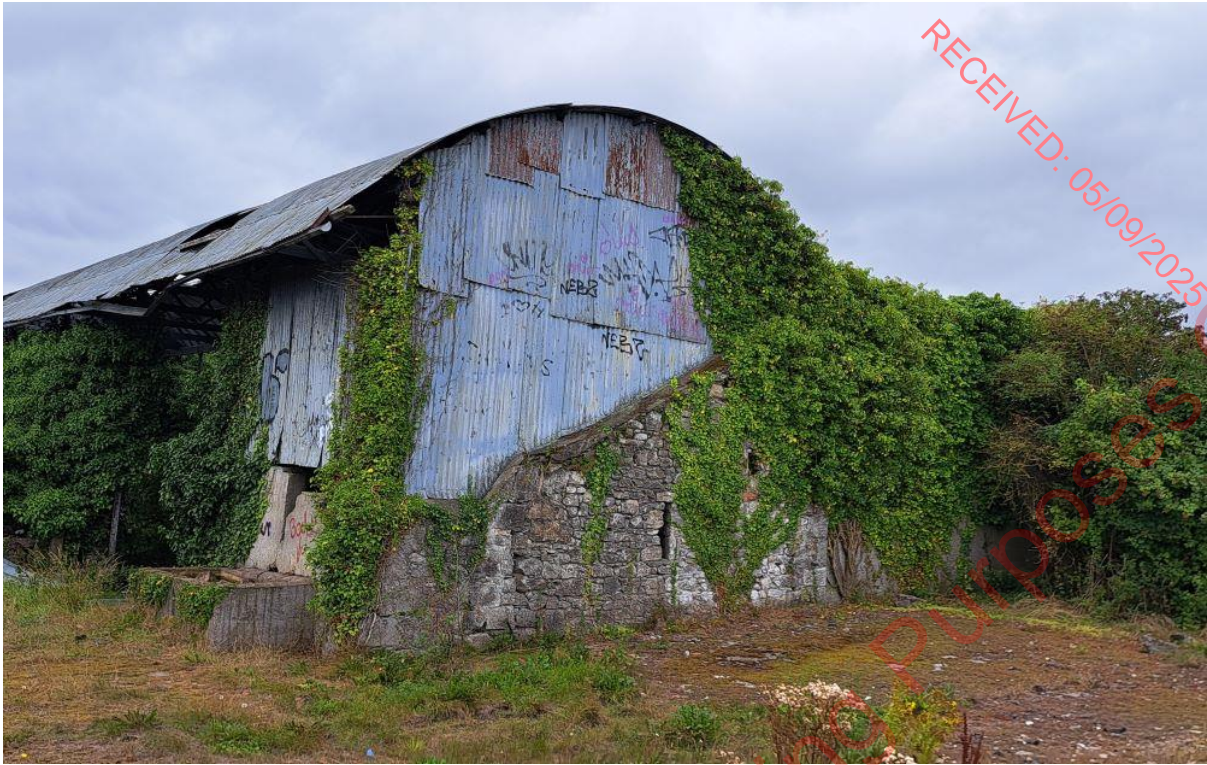
Plate 12.7 Remains of older farm buildings under modern developments

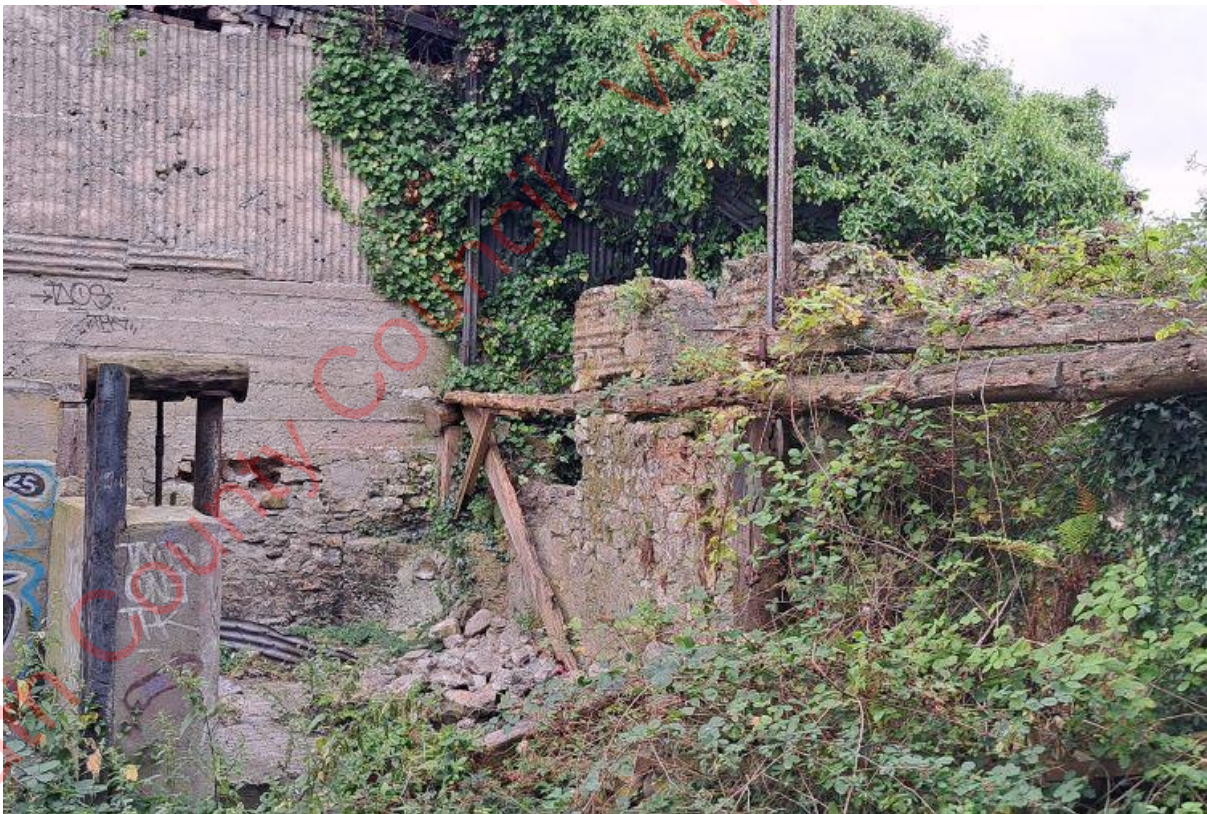
Plate 12.8 Additional remains of older farm buildings surrounded by 20th century modifications.

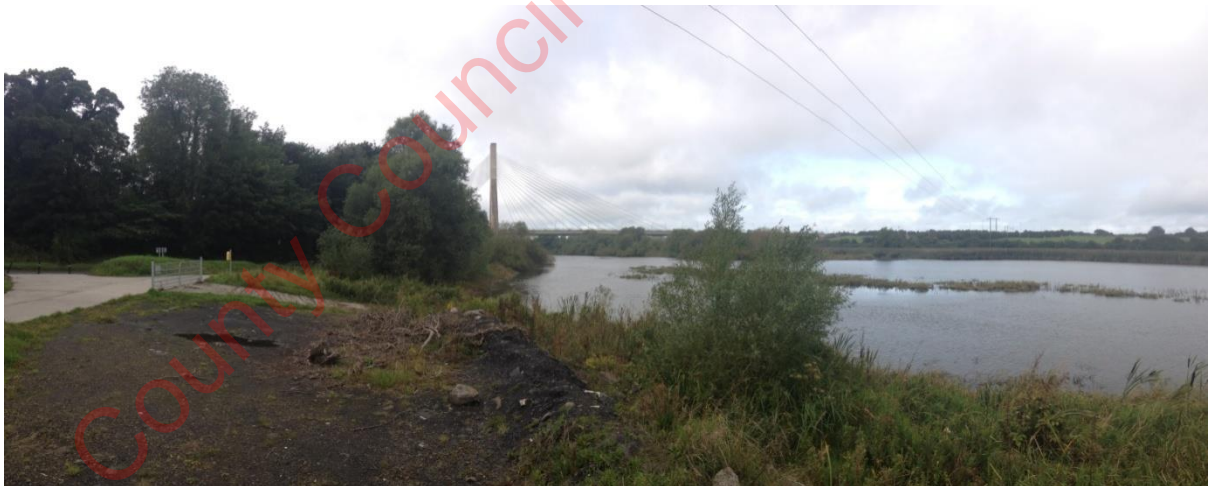
Plate 12.12 The location of Mill Ford, the point where William crossed the Boyne. Note the steeply rising ground to the left, on top of which is the Proposed Development site.

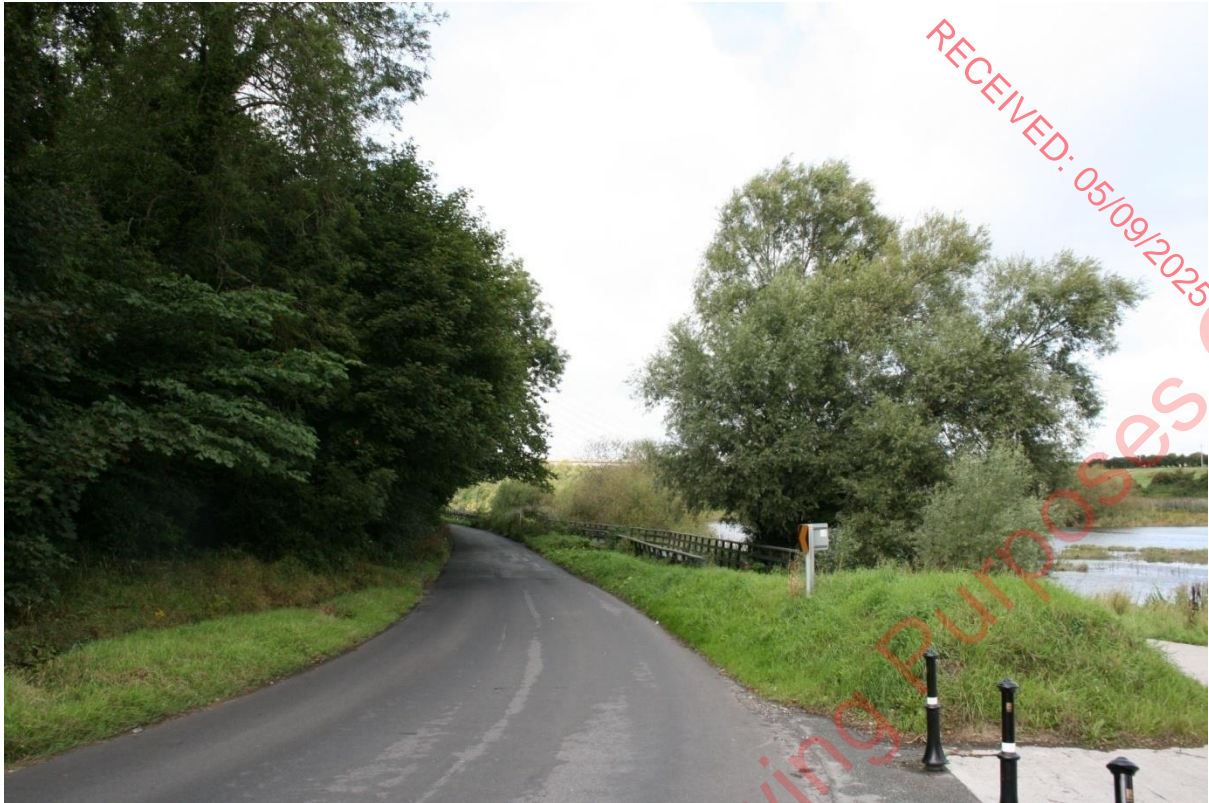
Plate 12.13 Detail of the steeply rising ground to the left which forms the southern bank of the Boyne at Mill Ford
