## **Stage 1/2 Road Safety Audit**

**Ballincor Wind Farm**

**On behalf of RWE Renewables Ireland Limited**

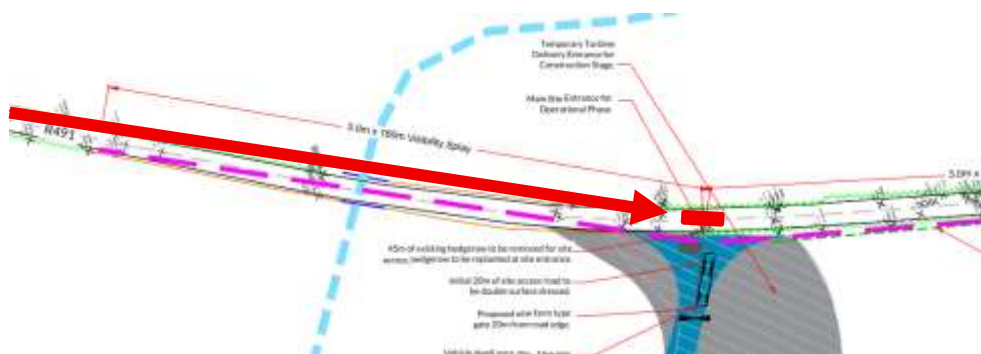
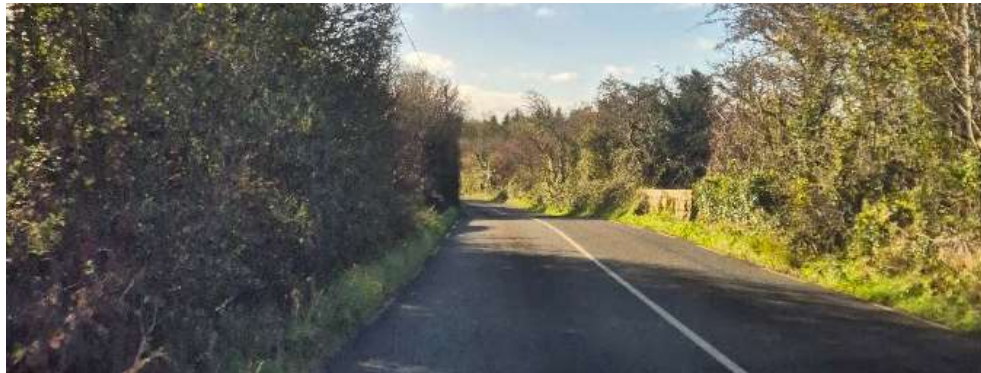
**Problem:** Forward visibility for R491 southbound drivers to a vehicle waiting to turn right into the development junction may be restricted by roadside hedging.

**Hazard:** Rear end shunts may result.

**Recommendation:** The Design Team should ensure adequate forward visibility is provided.

4.1.2	Yes	Yes		
4.1.3	Yes	Yes		
4.2.1	Yes	Yes		
4.2.2	Yes	Yes

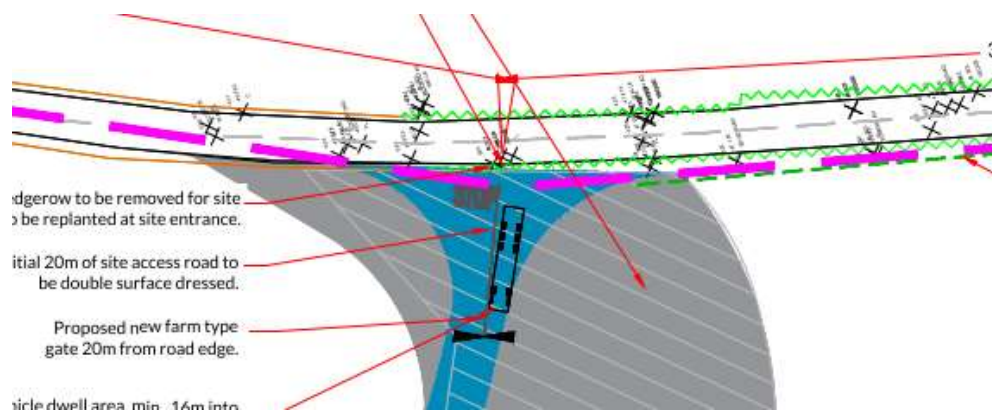
**Problem:** The R491 junction radii for the operational phase of the development appears large. There is risk development traffic may exit left off the R491 at high speeds and lose vehicle control. Additionally, development traffic waiting to enter the R491 by turning left may align their vehicle at an acute angle, thereby the driver being required to look over their right shoulder to view approaching traffic. The driver may not see smaller vehicles approaching i.e. two-wheeled vehicles.

**Hazard:** Development traffic may impact with other road users or roadside hazards.

**Recommendation:** The Design Team should undertake vehicle swept path analysis and reduce the junction radii accordingly.

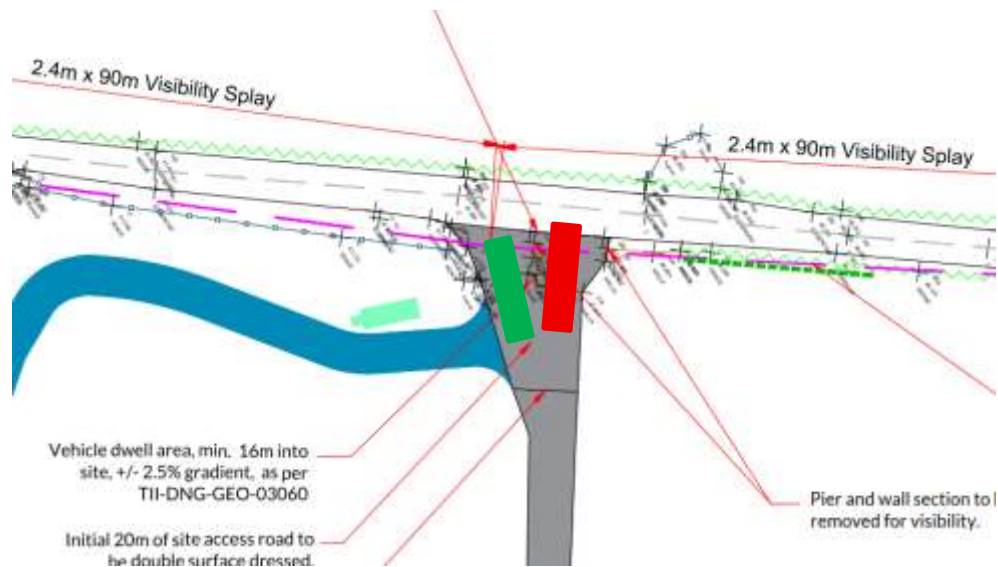
**Problem:** The development site access forms a junction with the farm access in close proximity to the L1071 carriageway. Development traffic may turn off the L1071 but may not be able to fully clear the junction due to farm traffic waiting to join the L1071.

**Hazard:** Rear end shunts may result.

**Recommendation:** The Design Team should amend the junction arrangement to ensure vehicles do not become stranded with the rear end protruding into the L1071 carriageway.
