St Edmundsbury Hospital, Lucan

Architectural Heritage Impact Assessment

This Architectural Heritage Impact Assessment (AHIA) has been prepared to assess the impact of the proposed partial demolition and reconstruction of a section of the southern boundary wall at St. Edmundsbury Hospital, Lucan Road, Dublin.

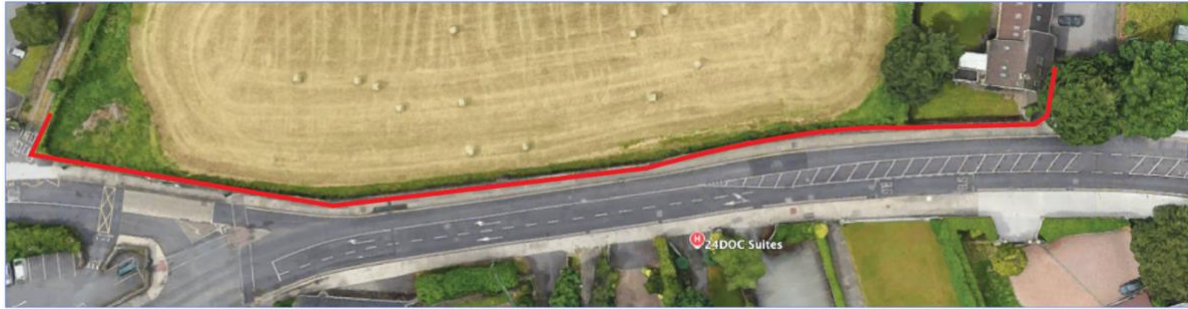
Figure 3 Line showing the extents of the Southern Boundary Wall along the Lucan Road R835

The southern boundary wall runs along the Lucan Road and defines the primary interface between the public realm and the historic institutional landscape.

The section subject to proposed works comprises approximately **180m**

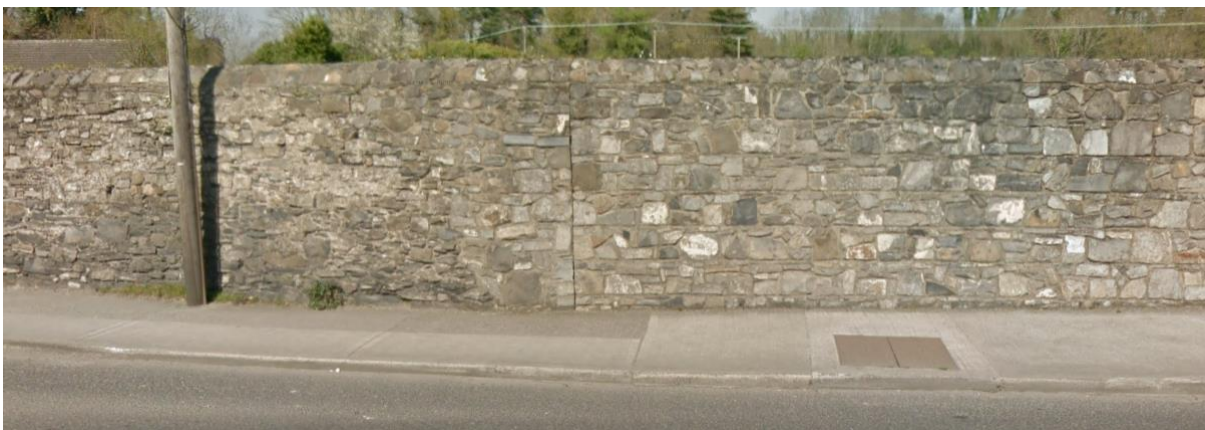
Figure 4 Elevation to Lucan Rd. Showing clear distinction in building methods.

The southern boundary wall is of masonry construction; however, close inspection indicates that it is not a uniform or wholly original structure.

The wall exhibits clear evidence of phased construction and later intervention, including:

- Sections of coursed rubble masonry, distinct from more irregular earlier construction
- The use of cementitious materials, particularly in upper sections
- Defined junctions and vertical breaks, suggesting rebuilding in discrete sections
- Apparent construction joints, indicating interfaces between original and later fabric

These characteristics indicate that substantial portions of the wall have been reconstructed or repaired, likely at different stages during the evolution of the site.

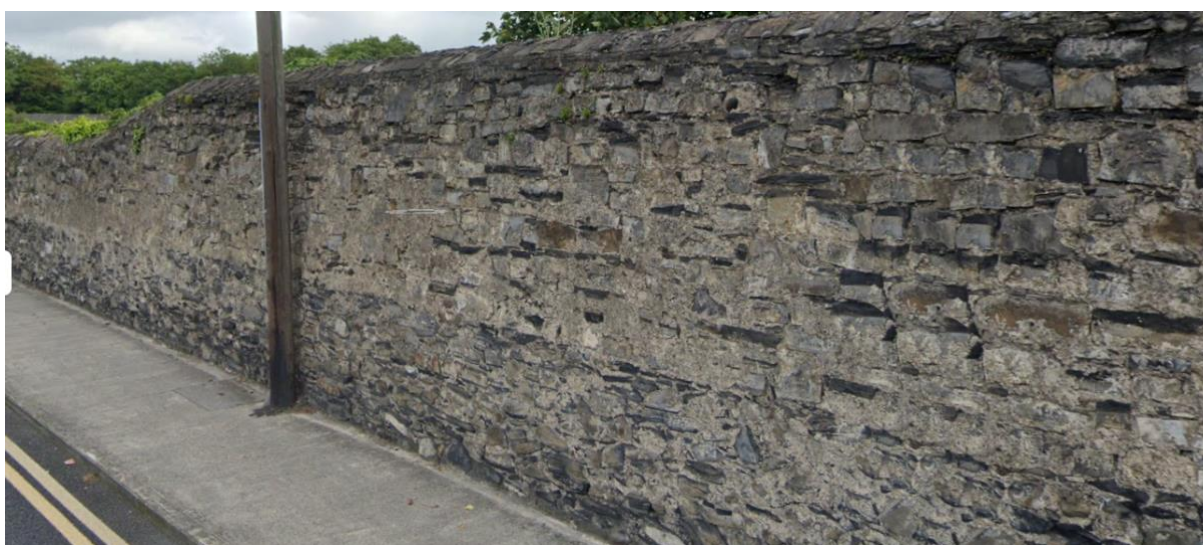
Figure 5 Clear distinction in stonework between upper and lower sections indicated by a datum which is consistent along the eastern and western sections of original wall.

A consistent horizontal line visible across sections of the wall suggests that the wall may have originally been constructed at a lower height and subsequently raised.

This is likely to correspond with the transition of the site from a private demesne to an institutional healthcare setting following its acquisition by St. Patrick's Hospital in the late 19th century, when increased enclosure and privacy would have been required.

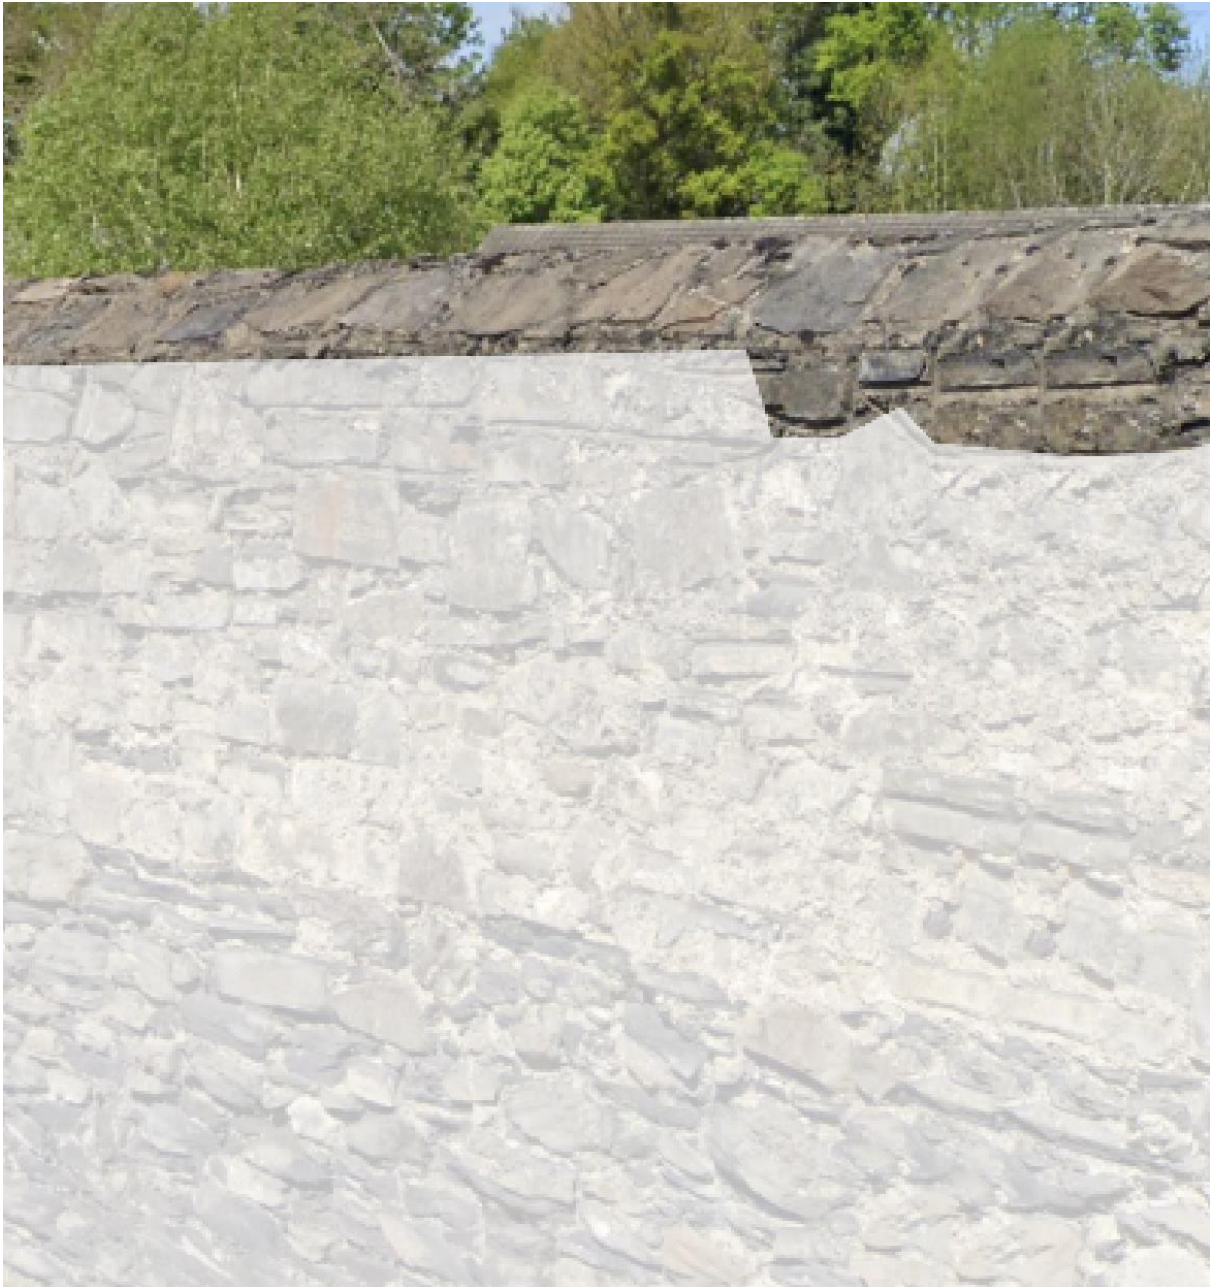
Figure 6 Upper section of wall which is consistent in profile along its entirety and shows a clear distinction in materiality between the lower sections suggesting modern addition

The upper portion of the wall appears to be a later intervention, characterised by:

- The use of concrete and cementitious material
- A more uniform and consistent finish across the Lucan Road elevation
- A clear distinction between the lower lime-based masonry and the upper cement-based construction

This suggests that the wall has been raised and/or capped in more recent history, and that this element does not form part of the original historic construction.

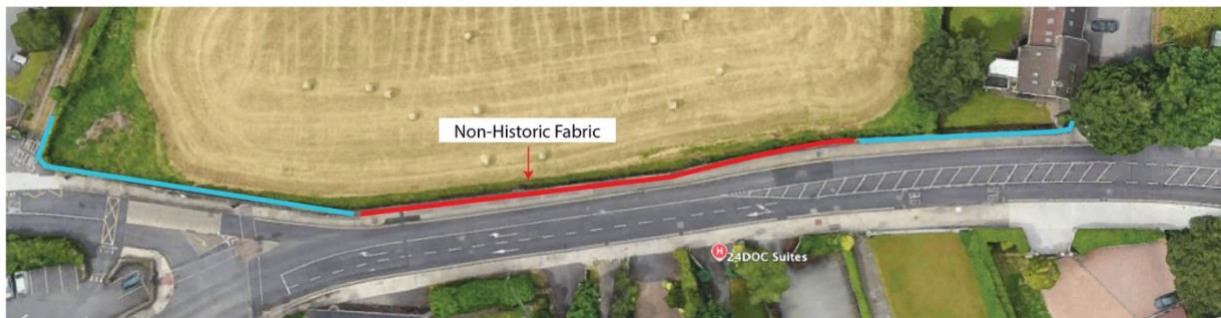
Figure 7 Indication of Non-historic Fabric of wall which has been re-built

While the wall retains elements of historic fabric, it is evident that:

- The structure has undergone substantial alteration and partial reconstruction
- The upper sections are not original – though it is assumed that the line of the wall is largely intact this cannot be confirmed across its entirety
- The wall represents a composite structure of varying dates and materials
