APPENDIX 6-1

BAT SURVEY REPORT

Project Title
**Slieveacurry Wind Farm,
 Co. Clare**

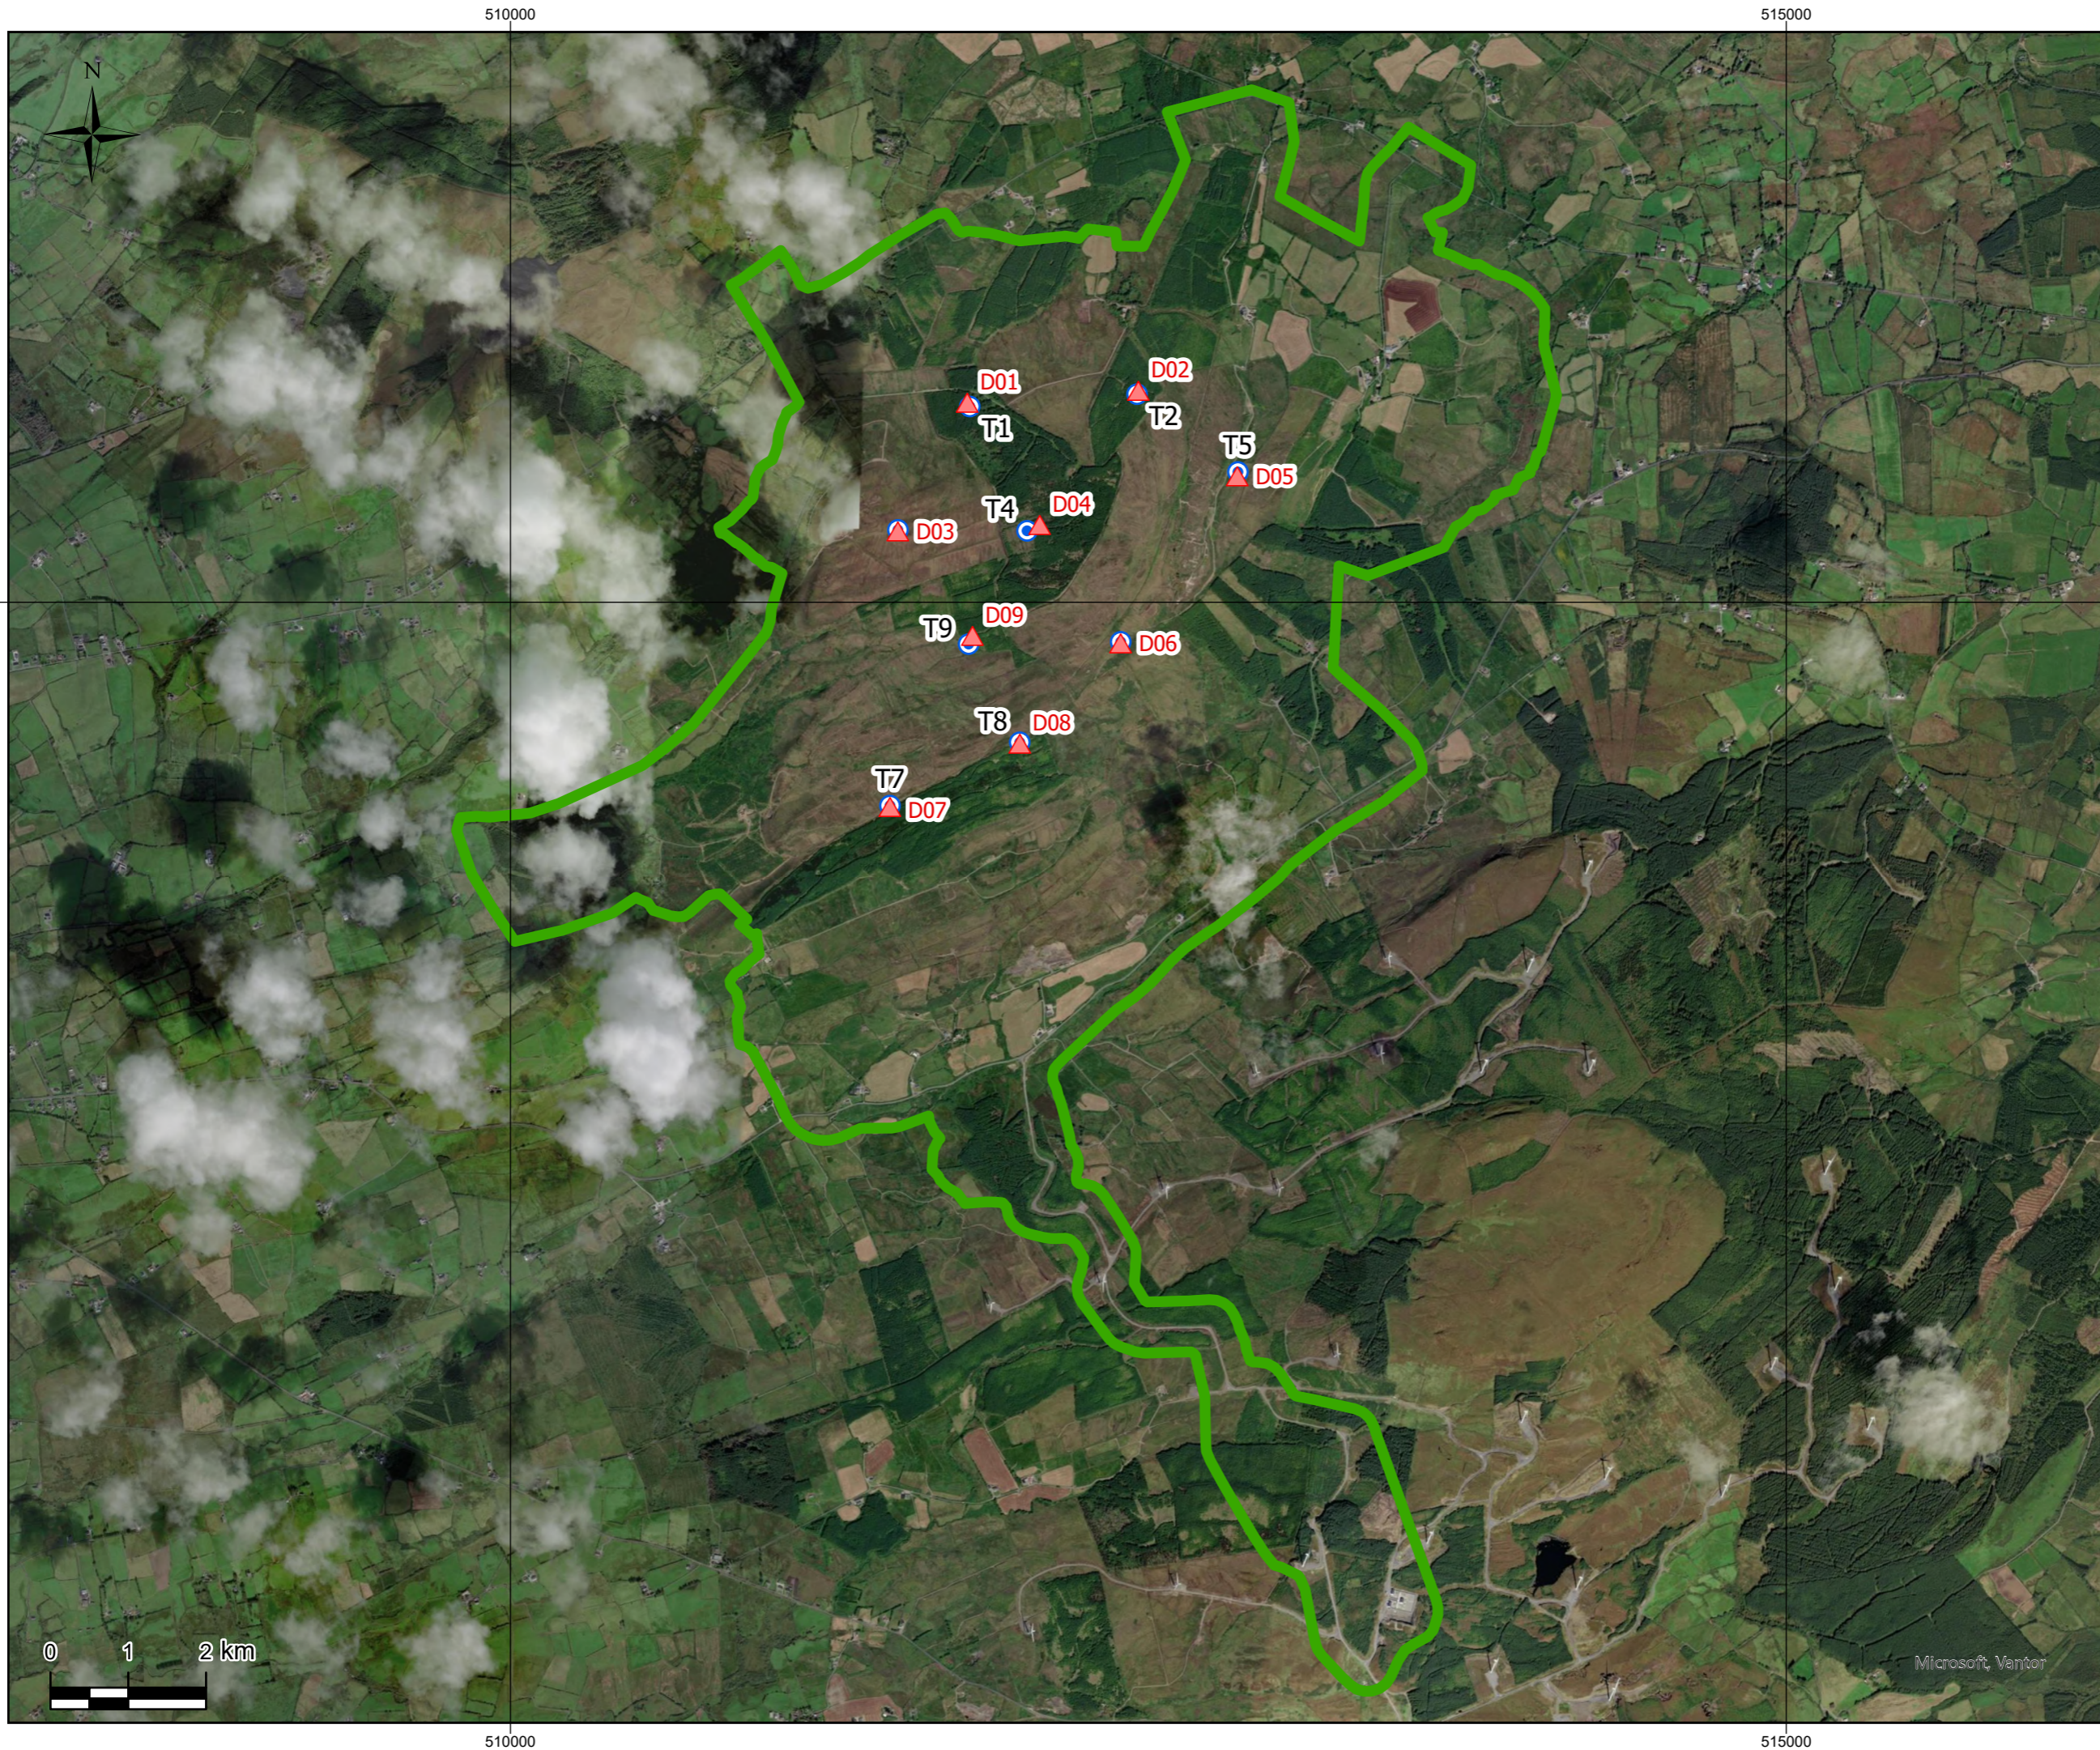
- ▲ 2024 Spring Detector Locations
- Proposed Turbine Layout
- EIA Site Boundary

Season	Survey Period	Total Survey Nights per Detector Location	Nights with Appropriate Weather
Spring 2024	28 th May – 11 th June 2024	15	13
Summer 2024	4 th July – 28 th July 2024	25	25
Autumn 2024	4 th September – 26 th September 2024	22	22
Total Survey Effort		62	60

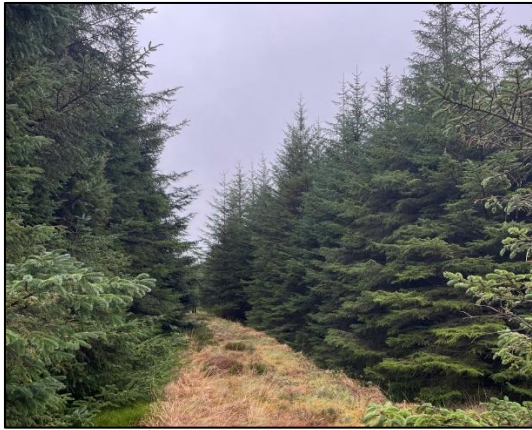
Plate 4-1 Example of mature Conifer plantation (WD4) within the Proposed Wind Farm site.

Tree cover within the Proposed Wind Farm Site is dominated by commercial conifer plantation (Plate 4-1). Small areas of wet willow alder ash woodland are also present, comprising of willow (*Salix* spp.), with frequent to occasional recordings of alder (*Alnus glutinosa*), hawthorn (*Crataegus monogyna*), blackthorn, and Birch (*Betula pubescens*), with an understory of encroaching bramble. No trees with bat roosting potential were identified within the bat felling buffer or other infrastructure footprint.

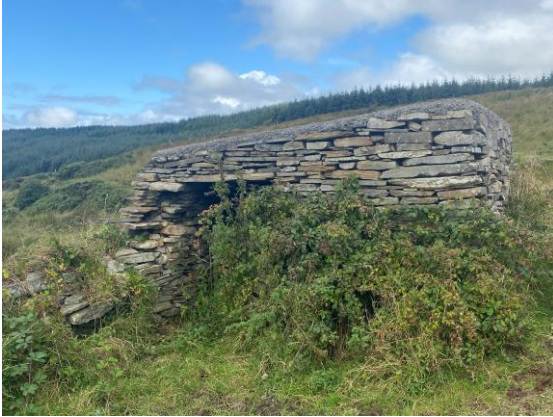
The structure is constructed of stone with a corrugated metal roof. Potential access into the building is provided via an open doorway. Several gaps were also noted within the stonework; however, these features are limited in extent and offer only low suitability for use by roosting bats.

Plate 4-1 Stone structure exterior

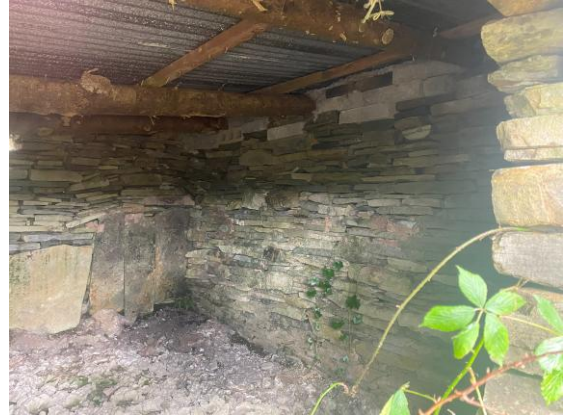
Plate 4-2 Stone structure interior

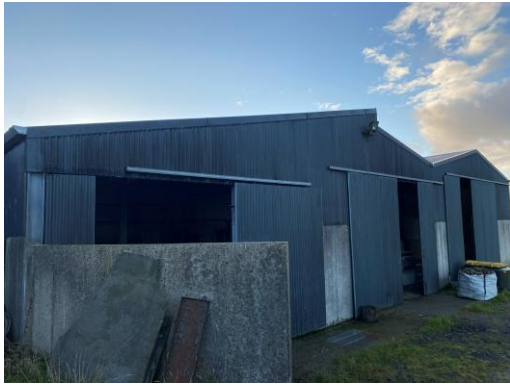
The modern brick and corrugated iron shed appears in regular use, alongside an older stone-built shed structure with a tile roof. Visual inspections revealed several cracks in the stone walls and roof that may offer limited roosting opportunities for crevice-dwelling bat species. Open doorways/shed entrances were noted in the outbuildings, providing potential access to the building interiors. No potential access points were identified in the single-storey dwelling.

Plate 4-3 Eastern elevation of farm shed with open doors

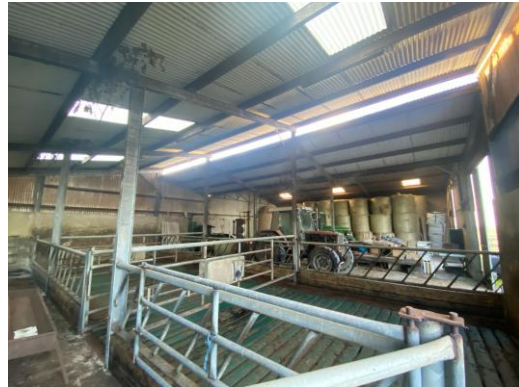
Plate 4-5 Interior of farm shed

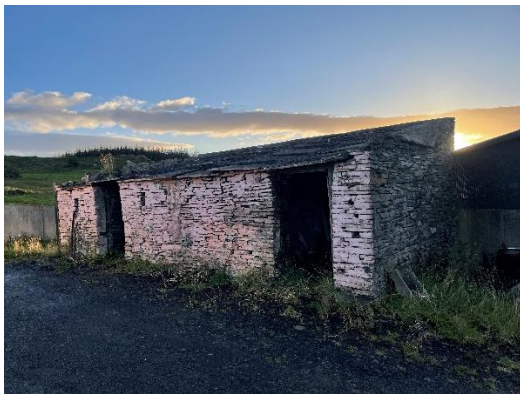
The surrounding habitat comprises open grasslands with small areas of managed hedgerows and plantation forestry connected to field boundaries, offering some connectivity to the wider landscape. Due to the limited number and quality of roosting features, these structures were assessed as having *Low* bat roost potential in accordance with Collins (2023). No evidence of roosting bats were identified during the 2024 inspections. However, it is noted that an individual bat was identified resting within the stone shed during a survey in 2019.

Plate 4-4 Stone shed exterior – adjoining farm shed

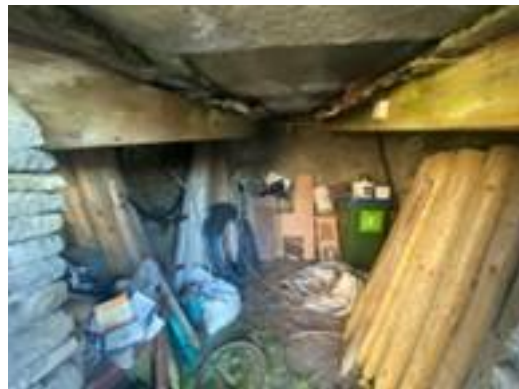
Plate 4-6 Stone shed interior

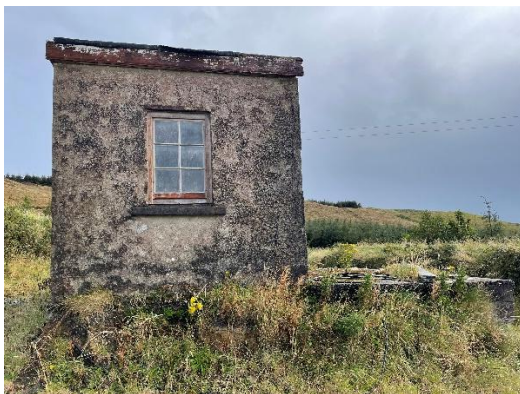
This concrete block structure is located approximately 560 m west of Turbine 7. While the doorway remains continuously open, providing potential access into the building, the structure itself was assessed as not providing significant suitable roosting potential for bats. Following a thorough inspection, the structure was assessed as having *Negligible* roosting potential i.e. No obvious habitat features on site likely to be used by roosting bats; however, a small element of uncertainty remains as bats can use small and apparently unsuitable features on occasion (Collins, 2023). Additionally, no evidence of bat use was recorded during the inspections.

Plate 4-7 Brick building

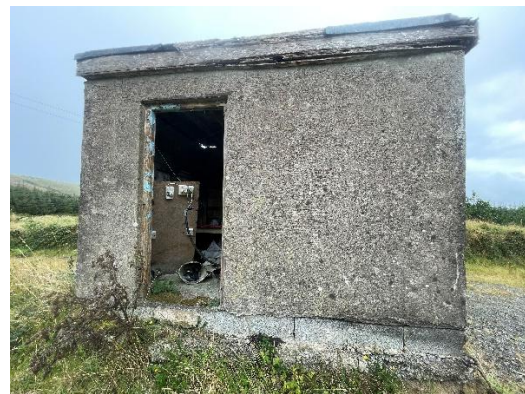
Plate 4-8 Brick building access.

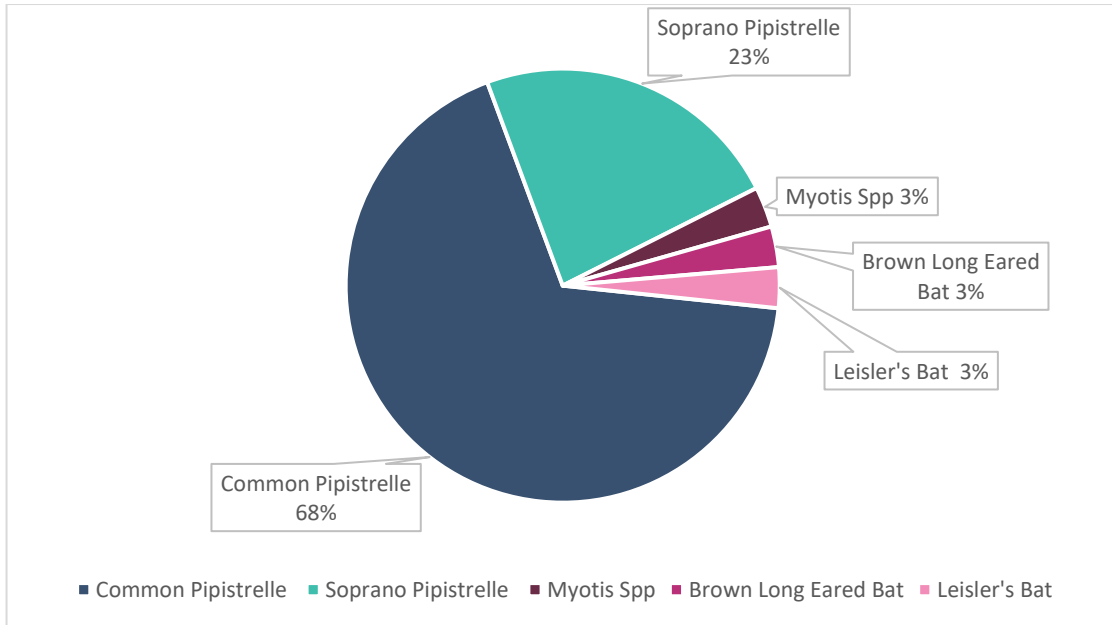
Manual transects were undertaken in spring, summer and autumn 2024. Bat activity was recorded in all seasons. A total of 149 bat passes were recorded. In general, Common pipistrelle (n=100) was recorded most frequently, followed by Soprano pipistrelle (n=34). *Myotis spp* (n=5), Leisler's bat (n=5) and Brown long-eared (n=5) were less frequent (Plate 4-9).

Plate 4-9 2024 Manual Activity Surveys (Total Species Composition)

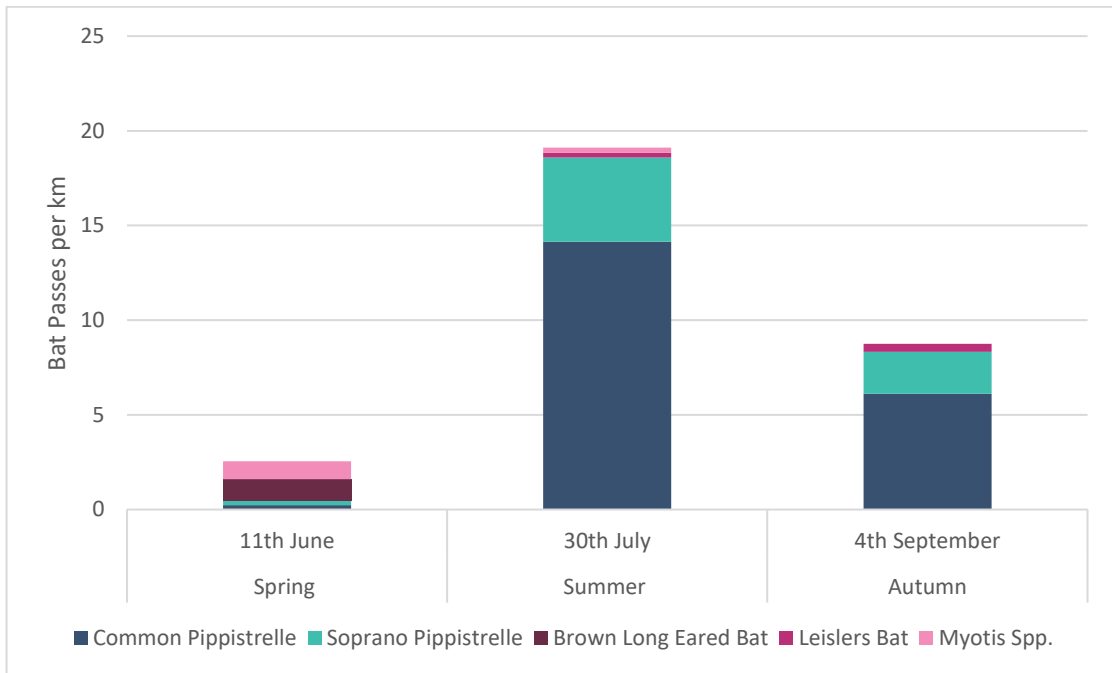
Species composition and activity levels varied across the survey periods. Transect survey results were calculated as bat passes per km surveyed (to account for differences in survey effort). Plate 4-10 presents the results for individual species per survey period. Figures 4-1 – 4-3 present the spatial distribution of bat activity across surveys. Common and Soprano pipistrelle were most frequently recorded in summer and autumn 2024, whereas Brown long-eared bat and *Myotis spp.* bat were mainly detected during spring. Leisler's bat was recorded only in summer and autumn, and brown long-eared bat was recorded only during the spring.

Plate 4-10 2024 Transect Results – Species Composition Per Survey Period

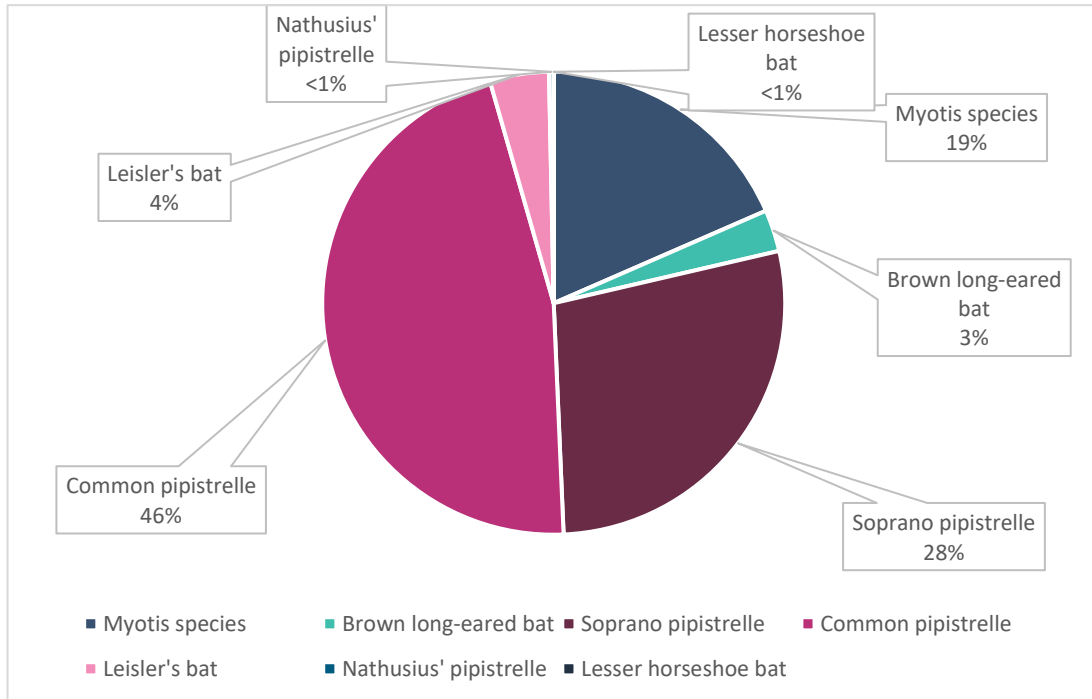
In total, 37,852 bat passes were recorded across all deployments. In general, Common pipistrelle (n=17,499) occurred most frequently, followed by Soprano pipistrelle (n=10,579) and *Myotis spp.* (n=6,987). Instances of Leisler’s bat (n=1,562), Brown long-eared bat (n=1,102) and Nathusius’ pipistrelle (n=121) were recorded less frequently while only two Lesser horseshoe bat passes were recorded in autumn. Plate 4-11 presents relative species composition across all ground-level static detector surveys.

Plate 4-11 2024 Static Detector Surveys: Species Composition Across All Deployments (Total Bat Passes)

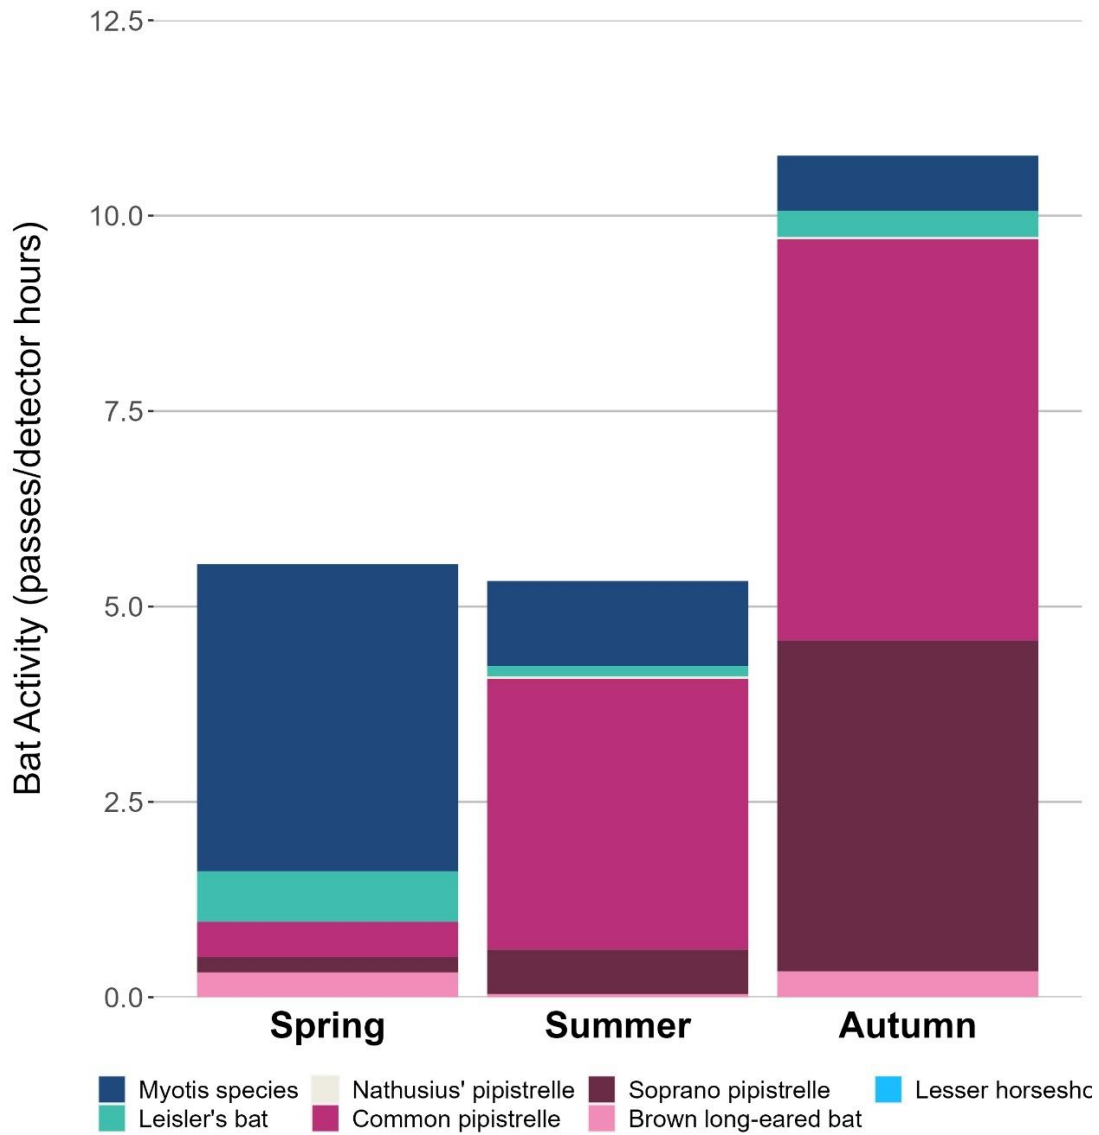
Bat activity was calculated as total bat passes per hour (bph) per season to account for any bias in survey effort, resulting from varying night lengths between seasons. Plates 4-12 and Table 4-7 presents these results for each species per season. Spring activity was dominated by *Myotis spp.* with contributions from Common and Soprano pipistrelle. Summer activity saw a significant increase in Common pipistrelle activity, with *Myotis spp.* the second most recorded species. Soprano pipistrelle activity also increased. During the autumn, activity was more evenly distributed between common and soprano pipistrelle, which both experienced activity increases. *Myotis spp.* activity remained similar to that of the summer survey. Leisler’s bat activity was highest in Spring, and low across all other seasons. Instances of brown long-eared bat and Nathusius’ pipistrelle were relatively rare throughout the survey periods. Lesser horseshoe bats were recorded only during the autumn season with two bat passes in total.

Plate 4-12 2024 Static Detector Surveys: Species Composition Across All Deployments (Total Bat Passes Per Hour, All Nights)

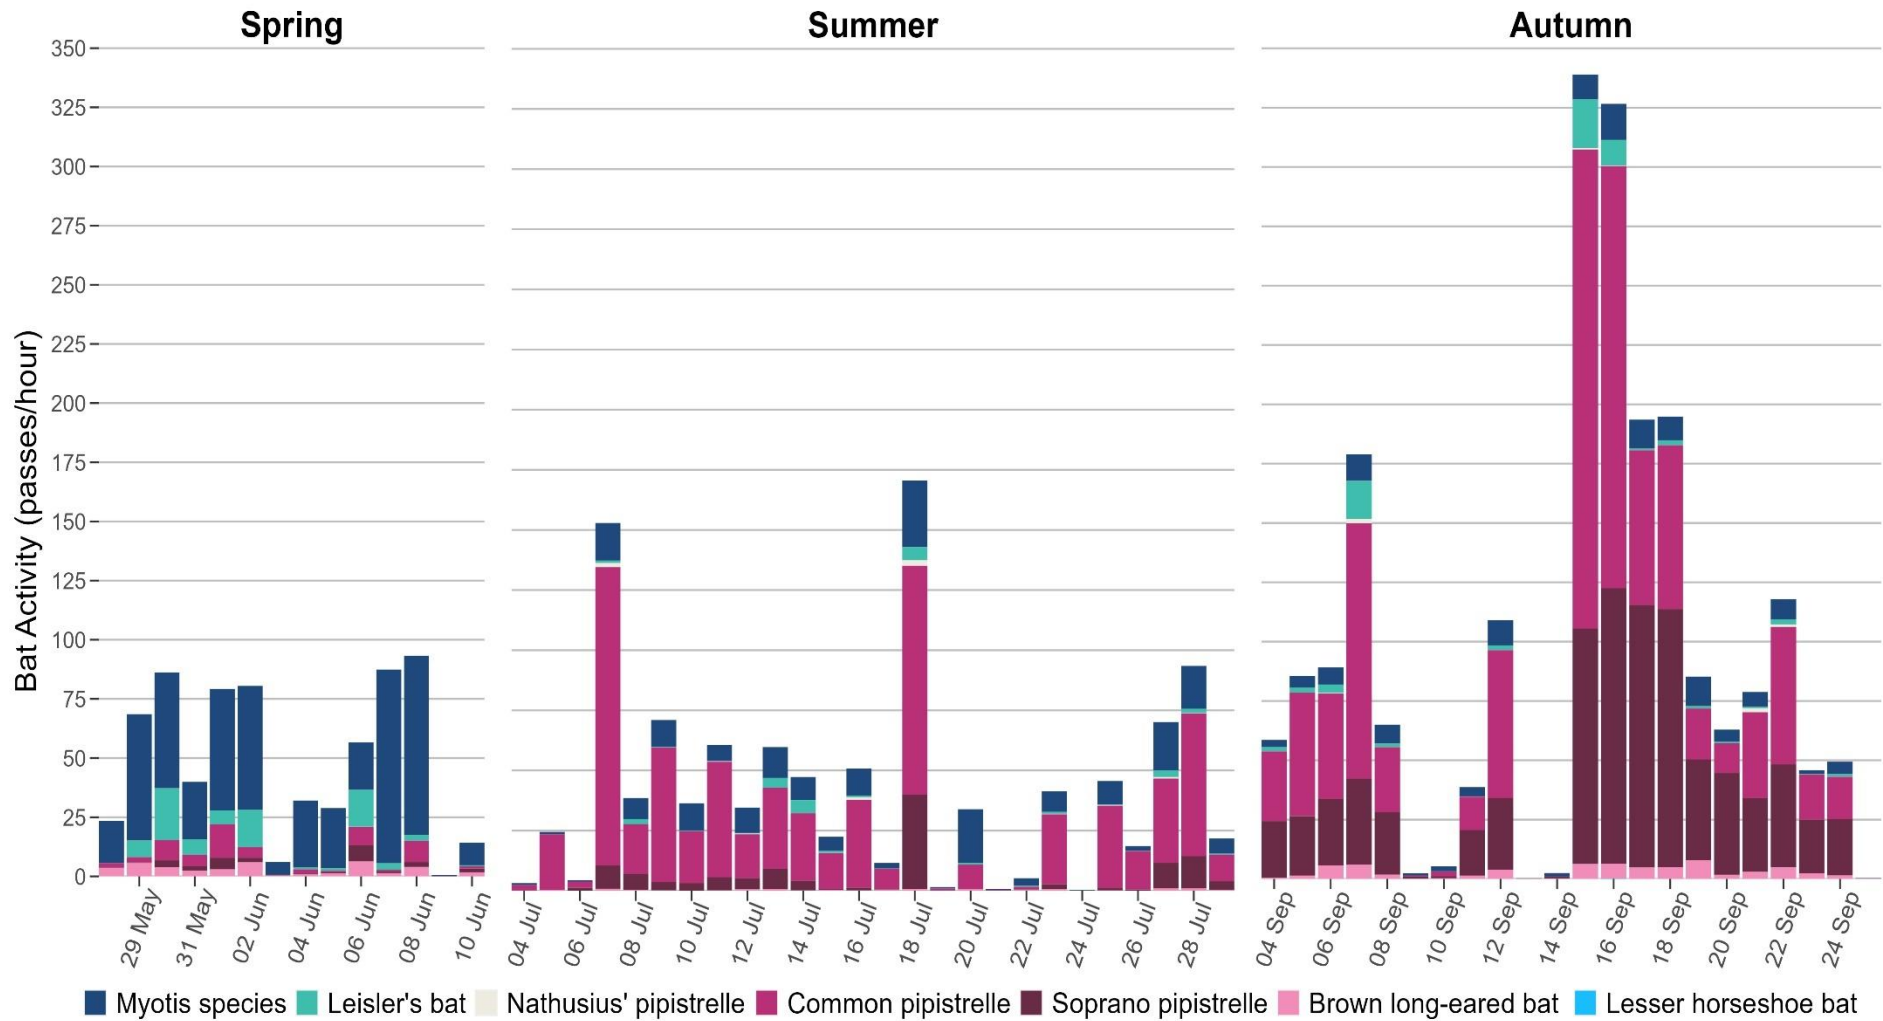
The median nightly pass rate (i.e. median total bat passes per hour per night) was used as a robust measure of typical bat activity at the Proposed Wind Farm Site, as shown in Plate 4-15. This metric reduces the influence of occasional high-activity nights on overall results and is recommended to account for nightly variability caused by weather, seasonal changes and other environmental factors (Lintott & Mathews, 2018). Zero values, representing nights when a given species was not detected, were retained in the dataset to avoid overestimating activity levels.

Plate 4-15 Static Detector Surveys: Median Bat Pass Rate (bph) Including Absences, Per Season Per Night
