Appraisal Of Architectural Significance

ATTACHED TO EIAR CHAPTER 7.0 ARCHITECTURAL HERITAGE

MILLTOWN PARK, SANDFORD ROAD, DUBLIN 6

July 2025

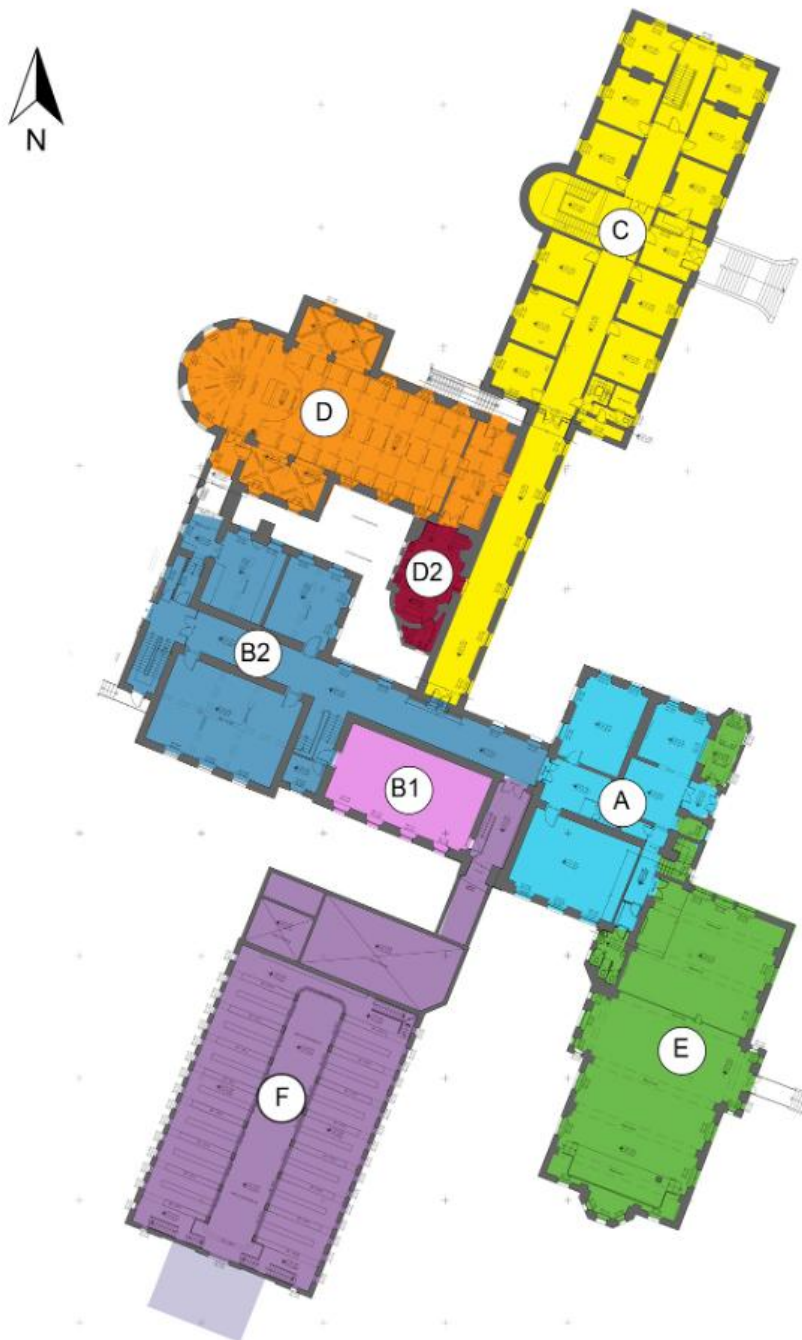
- A Milltown Park House
- B Rear Extension
- C Tabor House
- D Chapel
- E Finlay Wing
- F Archive

Fig. 1 Outline of building range- identifying each building element

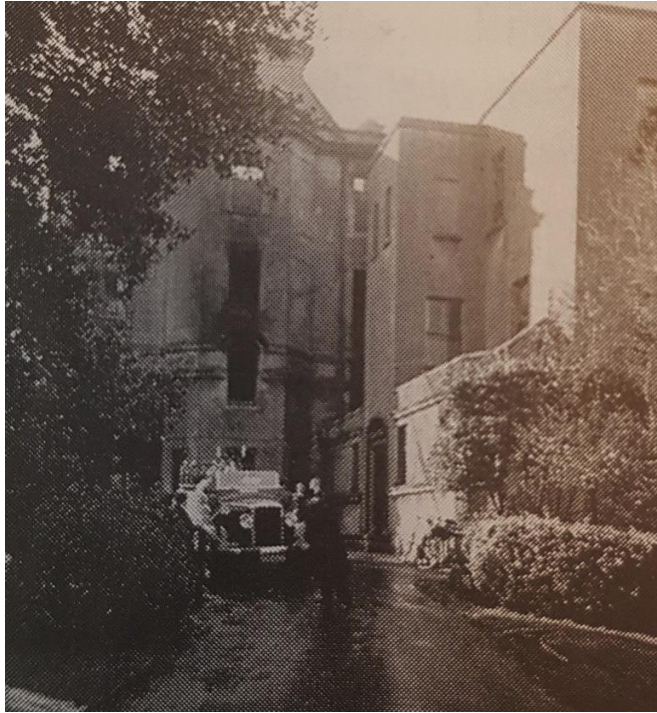
Fig. 16 *The fire damaged exterior of the Finlay Wing, indicating its original height of three storey over basement with pitched roof over.*

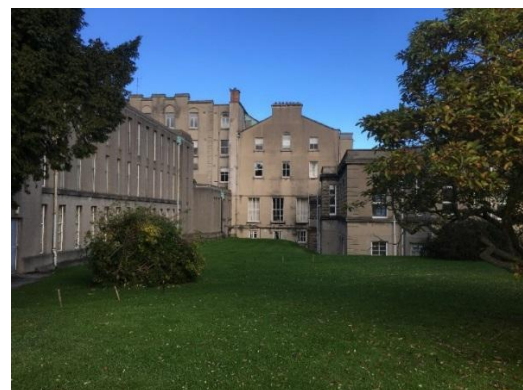
Fig. 24 Southern elevation, comprising an extension, with its expressed gable. Note the uncomfortable connection with its rear, later, extension, at a storey higher.

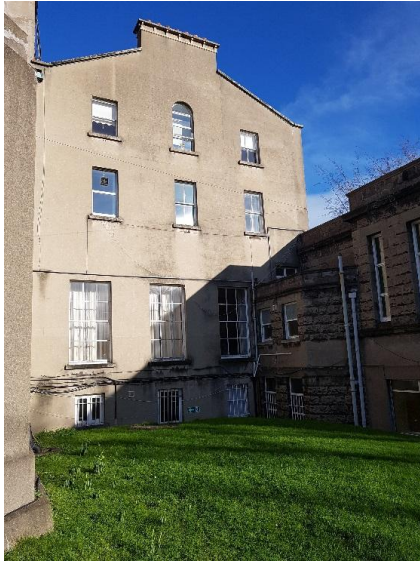
Fig. 25 Southern elevation, comprising an extension, with its expressed gable in context with the Finlay Wing and Archive (corner visible). Lower windows are early in origin, with the 6/6 windows attached to a former orangerie, which was vertically extended in the 20th century.

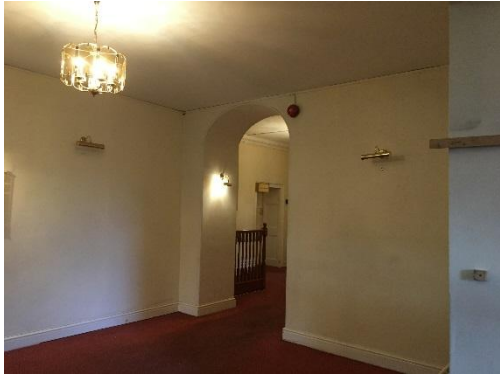
The most significant alteration internally is the removal of the central staircase and infilling of what would have originally comprised a grand double height entrance hall.

Fig. 29 *Infilled entrance hall at entry level with modest access to rear inner hall, leading to the late 19th century extension block. Stair visible through the arch accessing upper floors.*

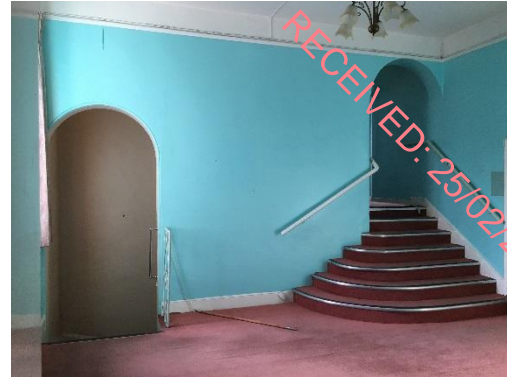
Fig. 30 *First floor level infilled entrance hall with later wall painted blue. Curved stair leads to vertical extension wing above a former orangerie.*

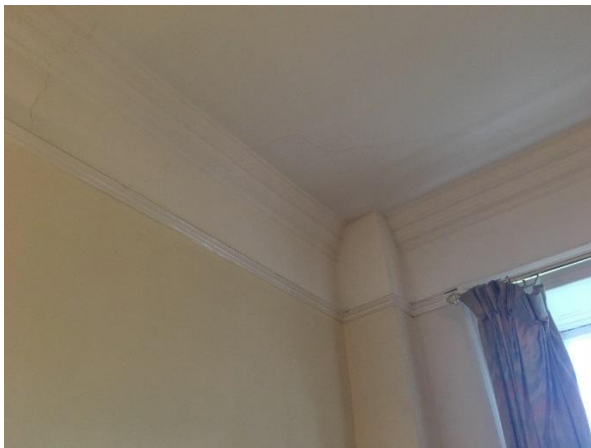
Much of the plasterwork and joinery throughout the house has been replaced, with a single original, excessively overpainted stucco cornice surviving at entrance level in the former reception room to the northeast. Surviving chimney pieces originate from the late 19th century, and may comprise relocated original pieces, given the later origin of some tiled insets.

Fig. 31 *Overpainted stucco cornice, with services riser in corner.*

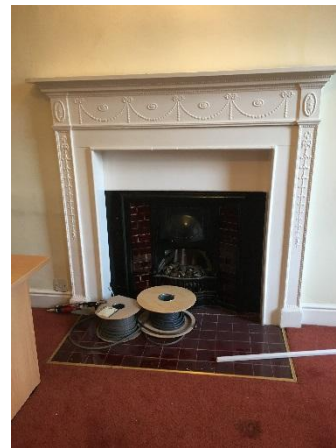
Fig. 32 *Early chimney piece with later tiled inset and hearth, in same room.*

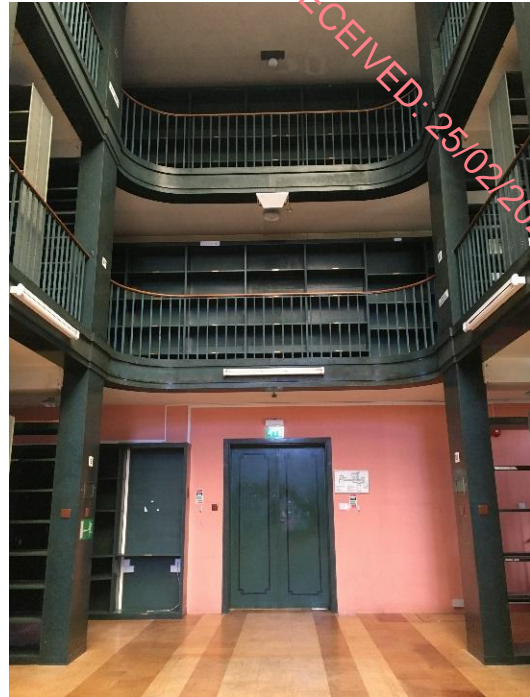
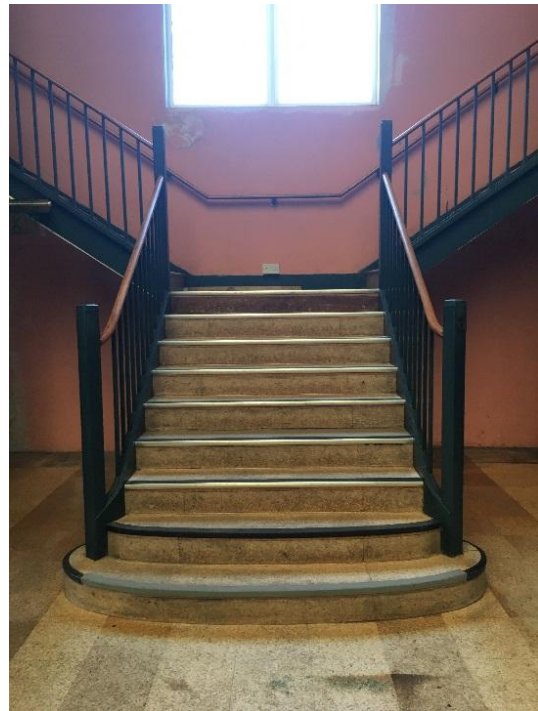
The building's interior reflects its function as an archive. A quadrangle generated by a pressed copper-clad structure encircling at three levels an apse ended lantern roof light, comprises book shelving aligned with the structure to create bays each having their own window. Guarding in steel uprights with polished oak handrail encloses the bow ended void.

Fig. 59 Interior view, due south

Fig. 60 View, due north

Fig. 61 Structure/ bookshelf bay composition

Fig. 62 Stair composition

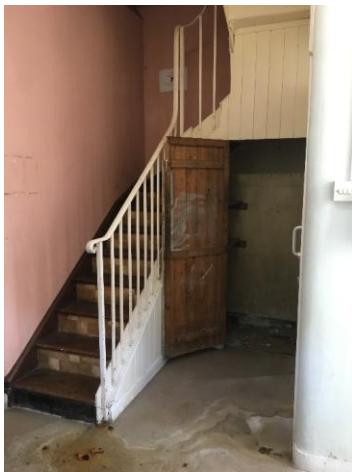
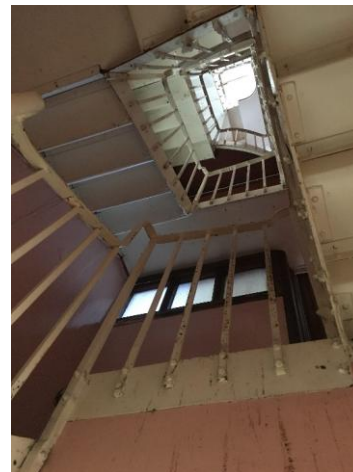
Fig. 70 Secondary steel stair of interest

Fig. 71 As above

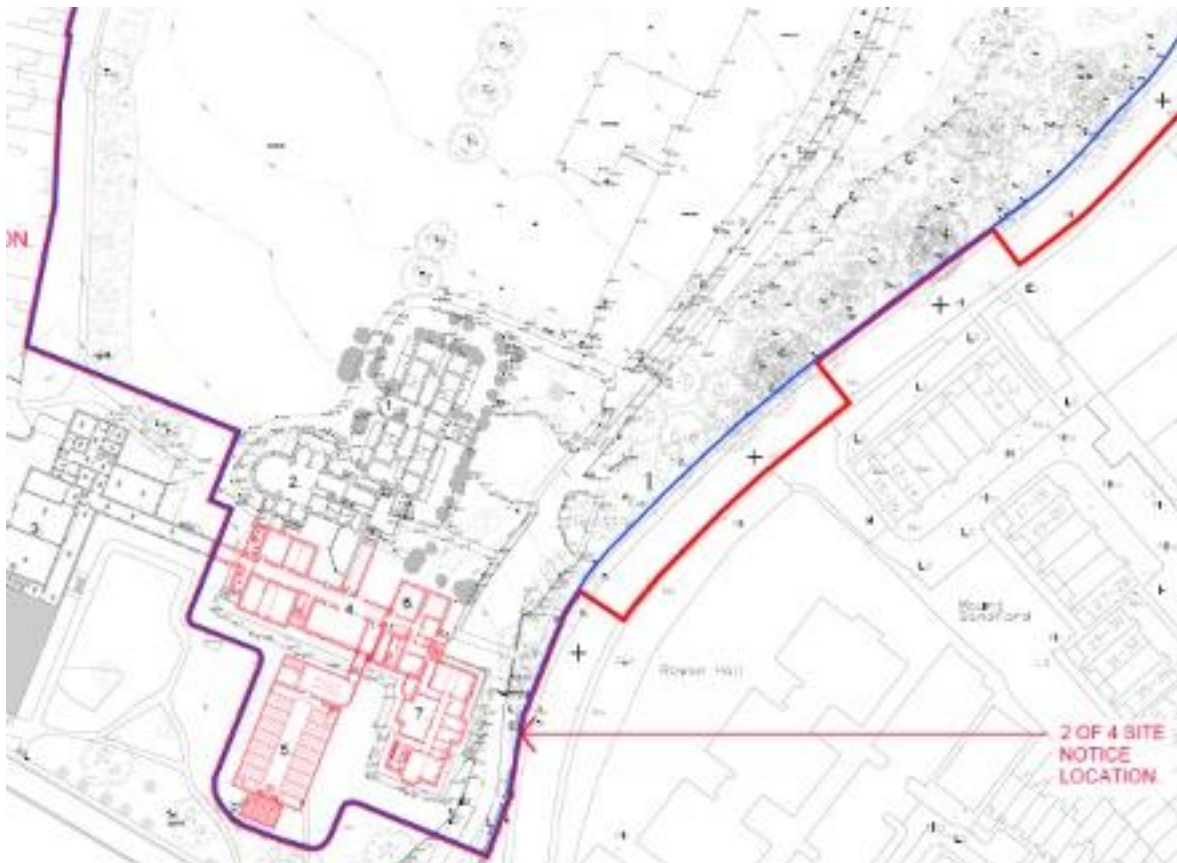
Fig. 72 Proposed identification of building retention and demolition
