ARDCAHAN QUARRY SECTION 37L  
ENVIRONMENTAL IMPACT ASSESSMENT  
REPORT (EIAR)

**VOLUME III**  
APPENDICES

April 2026

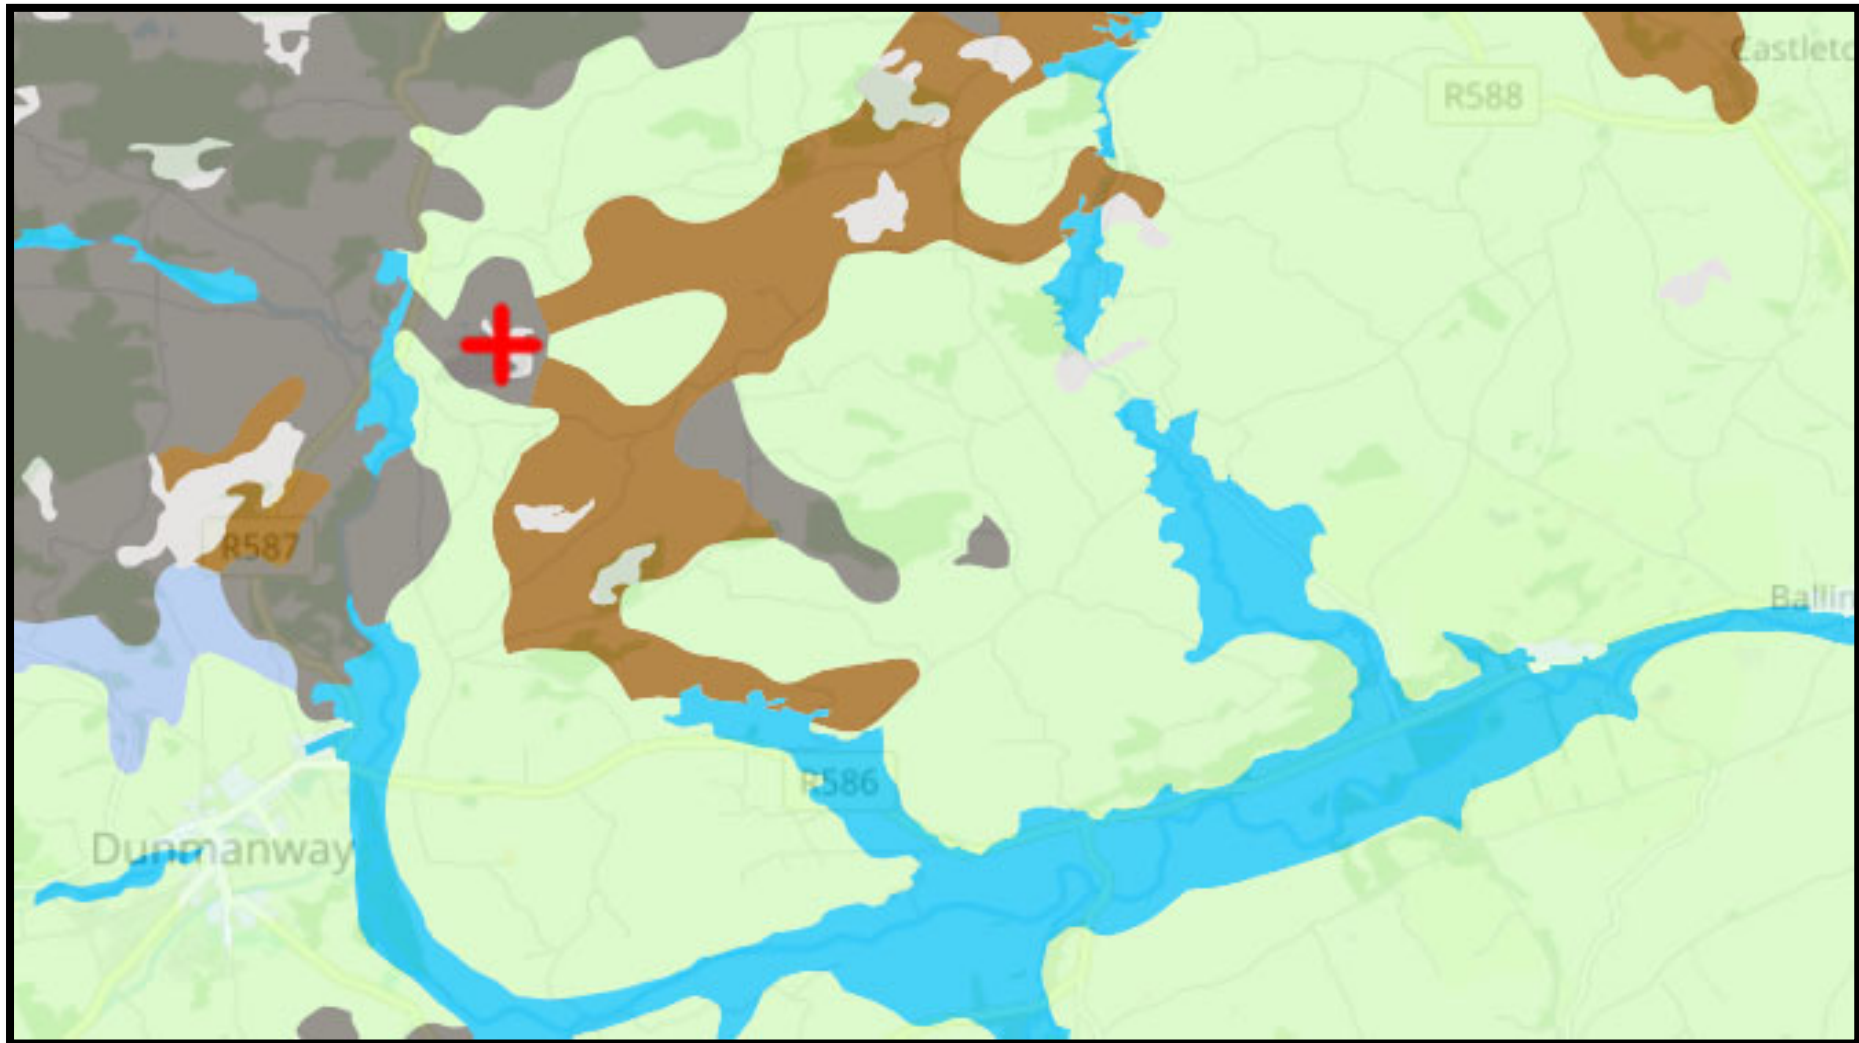
**Appendix 6.2.3 – Map 3 Teagasc/Cranfield Soil Map with rock (light grey) & peaty soil (dark grey) in the site area with Carbury Soil Association (light green) to Southwest and south of site. (Site location shown by red cross). Source [www.GSI.ie](http://www.GSI.ie).**

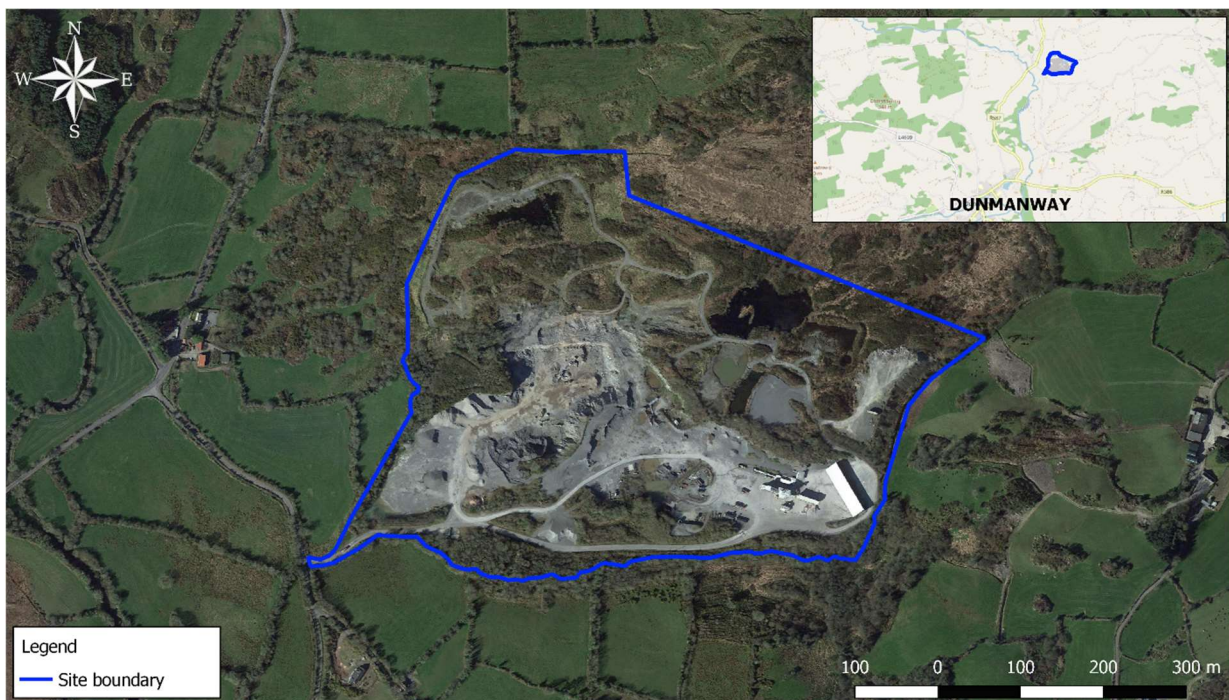
Figure 2.1A. Site location with boundary in blue.

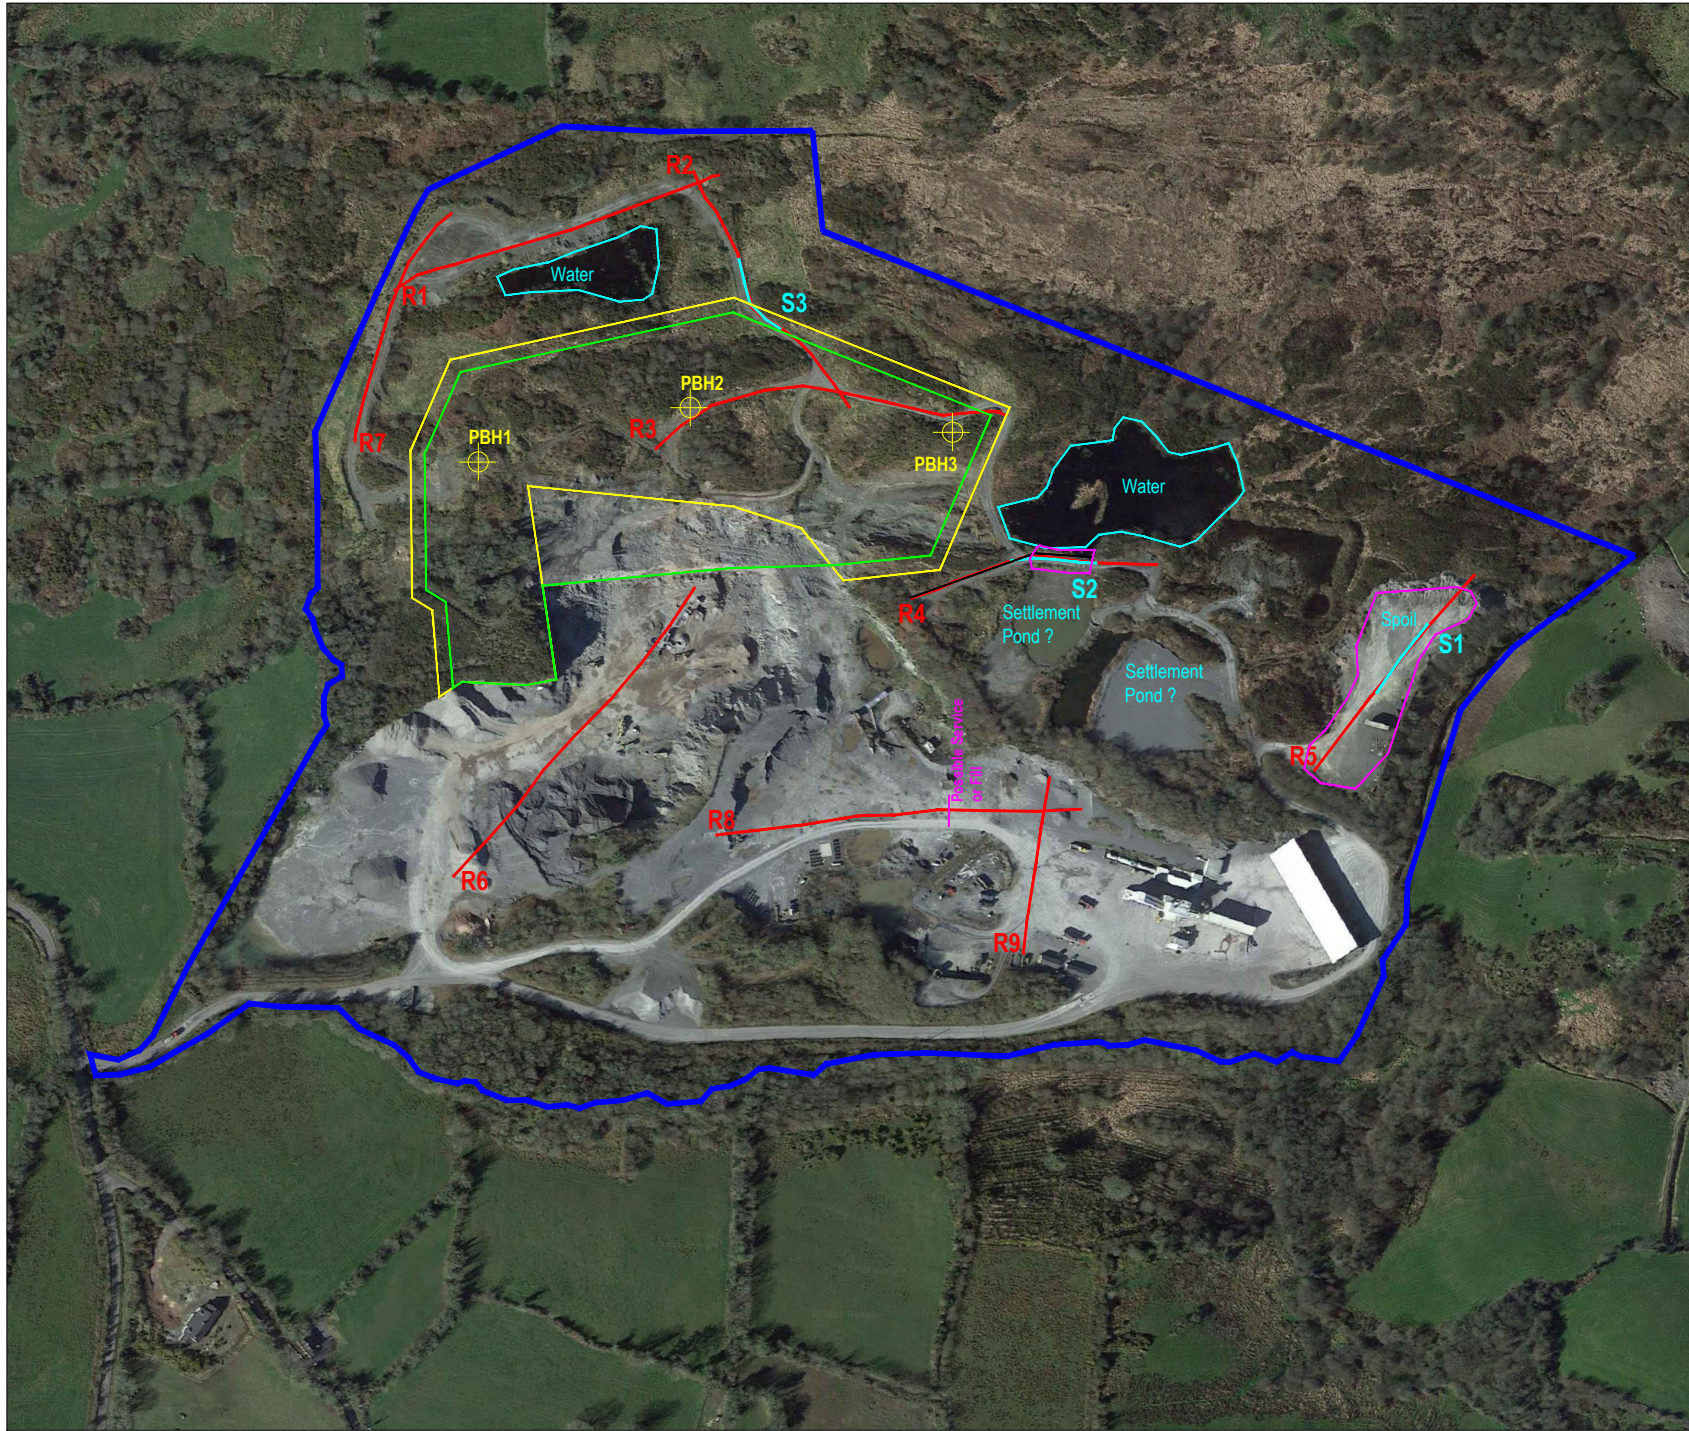
PROJECT:	ARDCAHAN QUARRY GEOPHYSICAL SURVEY		
CLIENT:	MURRAY BROTHERS TARMACADAM LIMITED		
DRAWING NO:	AGP22197_02		
SCALE:	AS INDICATED @ A4		
DATE:	17-01-2023		
Version:	Date:	Drawn By:	Checked:
01	17-01-2023	MN	POC

- LEGEND:
- Site boundary
  - 2D resistivity profile
  - Seismic refraction profile
  - Thick soil/spoil/fill
  - Proposed Benches
  - Possible Service or Fill
  - Proposed Borehole

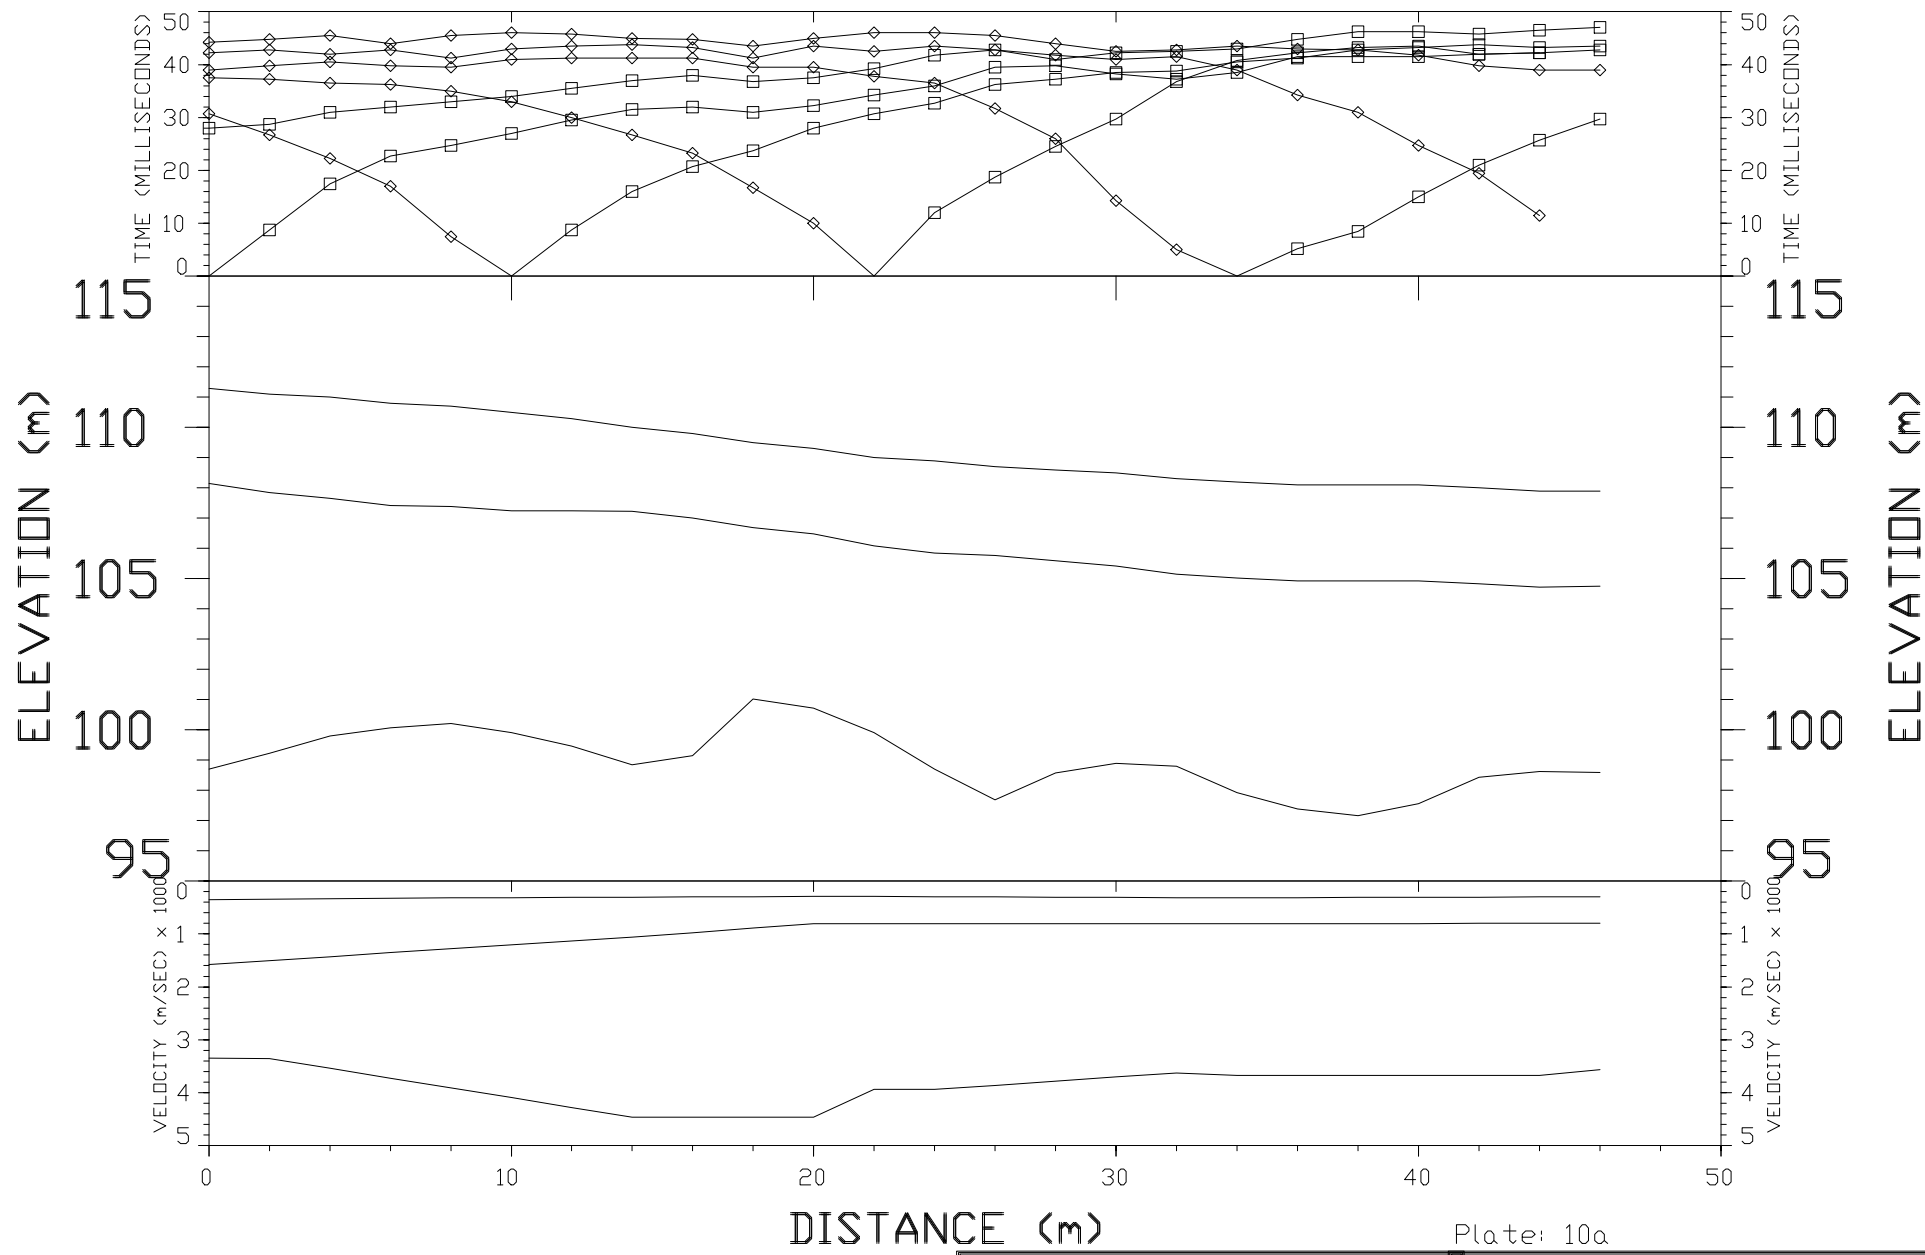
for: Ardcahan Quarry		AGP22197	
by: APEX Geophysics Ltd.		Ardcahan Cork	
Data Set: S1	Date: 13/01/23		
Equipment: Geode	Spread: S1	Azimuth:

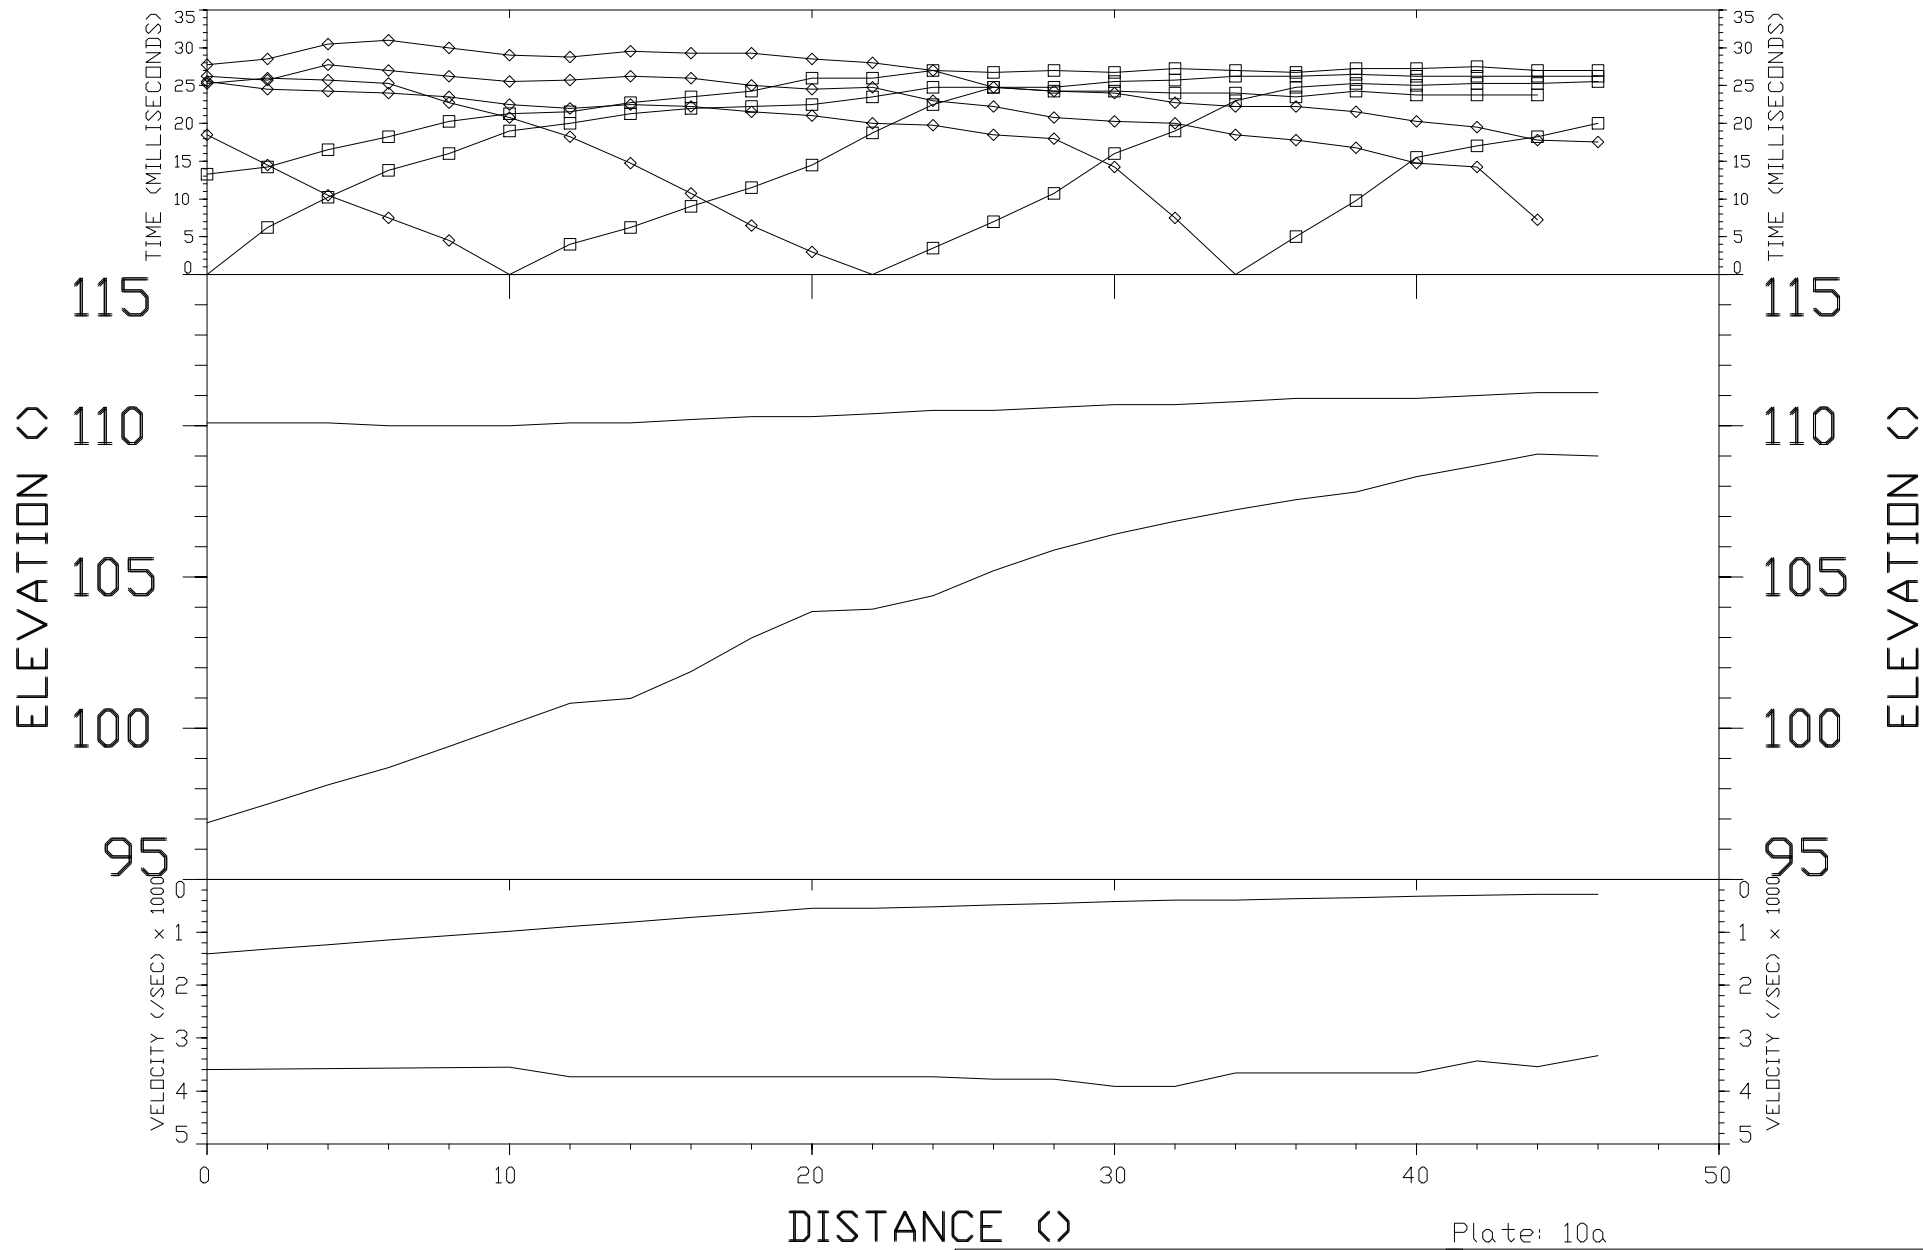
for: Ardcahan Quarry		AGP22197	
by: APEX Geophysics Ltd.		Ardcahan Cork	
Data Set: S2	Date: 13/01/23	Azimuth:	
Equipment: Geode	Spread: S2

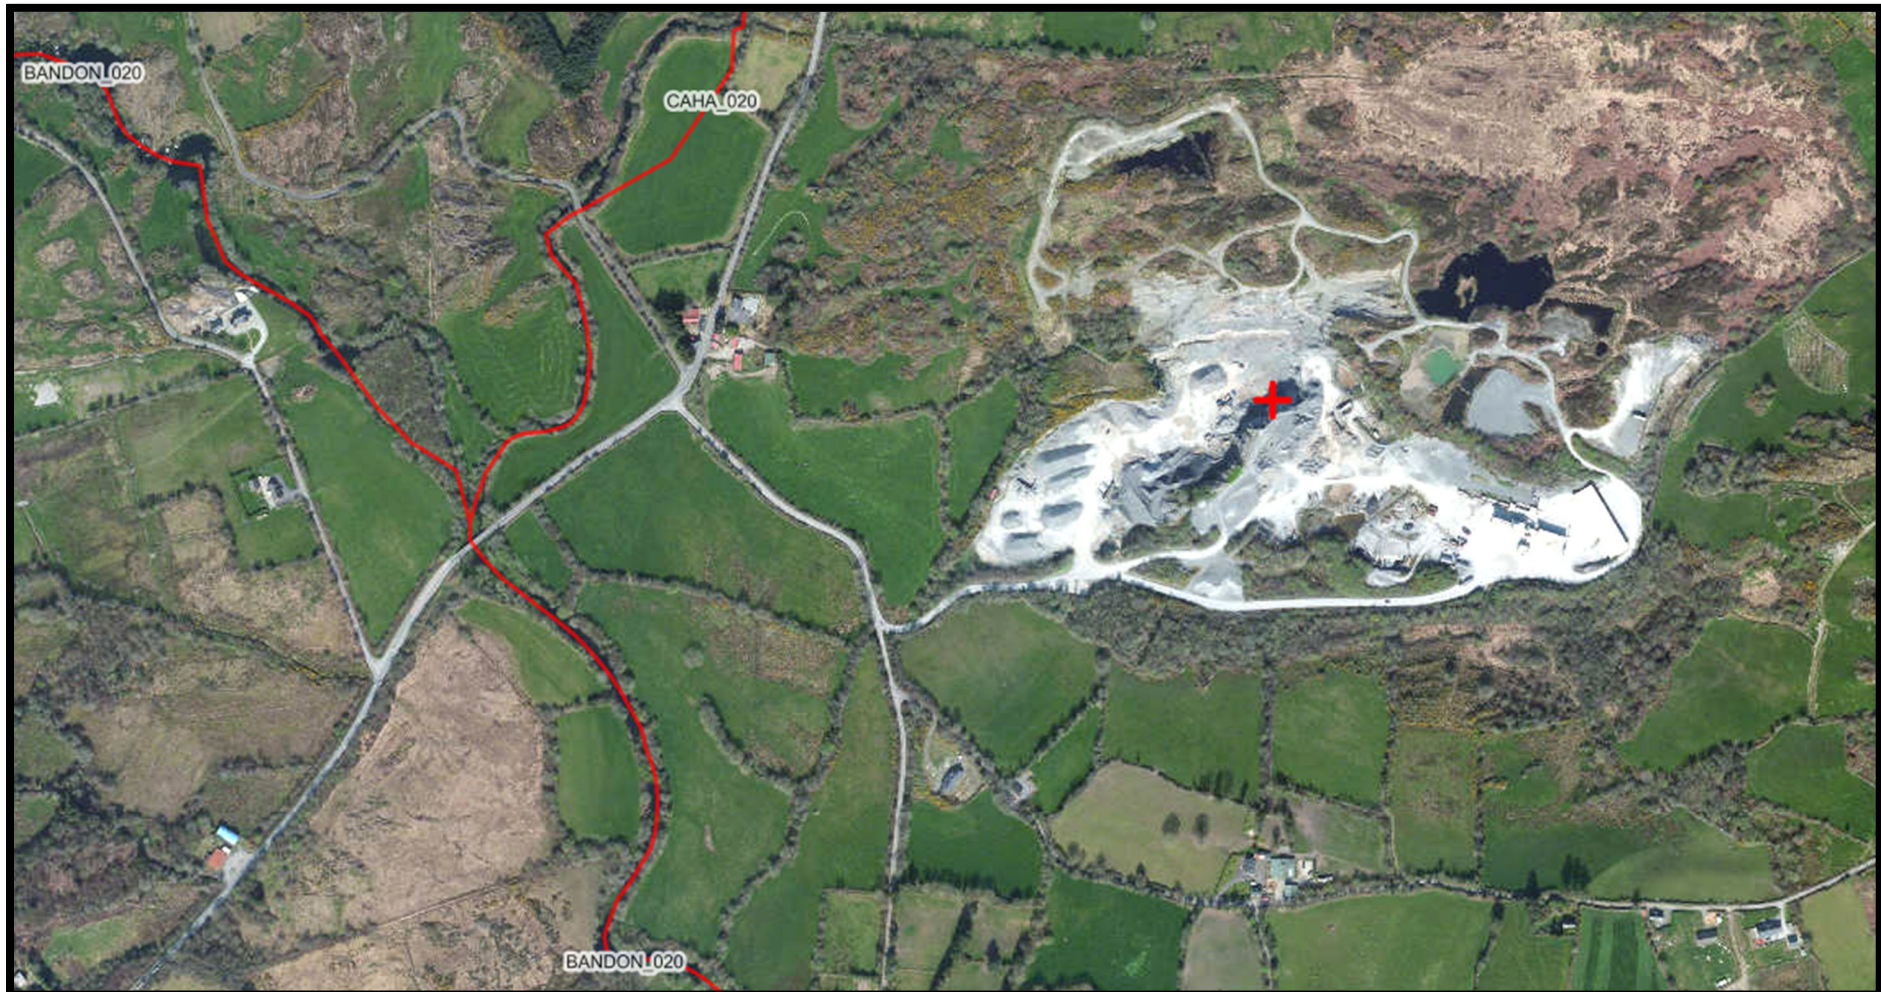
**Appendix 7.1.4 – EPA Hydrology Mapping showing the Bandon\_020 and Caha\_020 rivers both having High Risk Status. (EPA River Future Risk Quality Status Mapping 2019 to 2024 from <https://gis.epa.ie/EPAMaps/Water>.)**

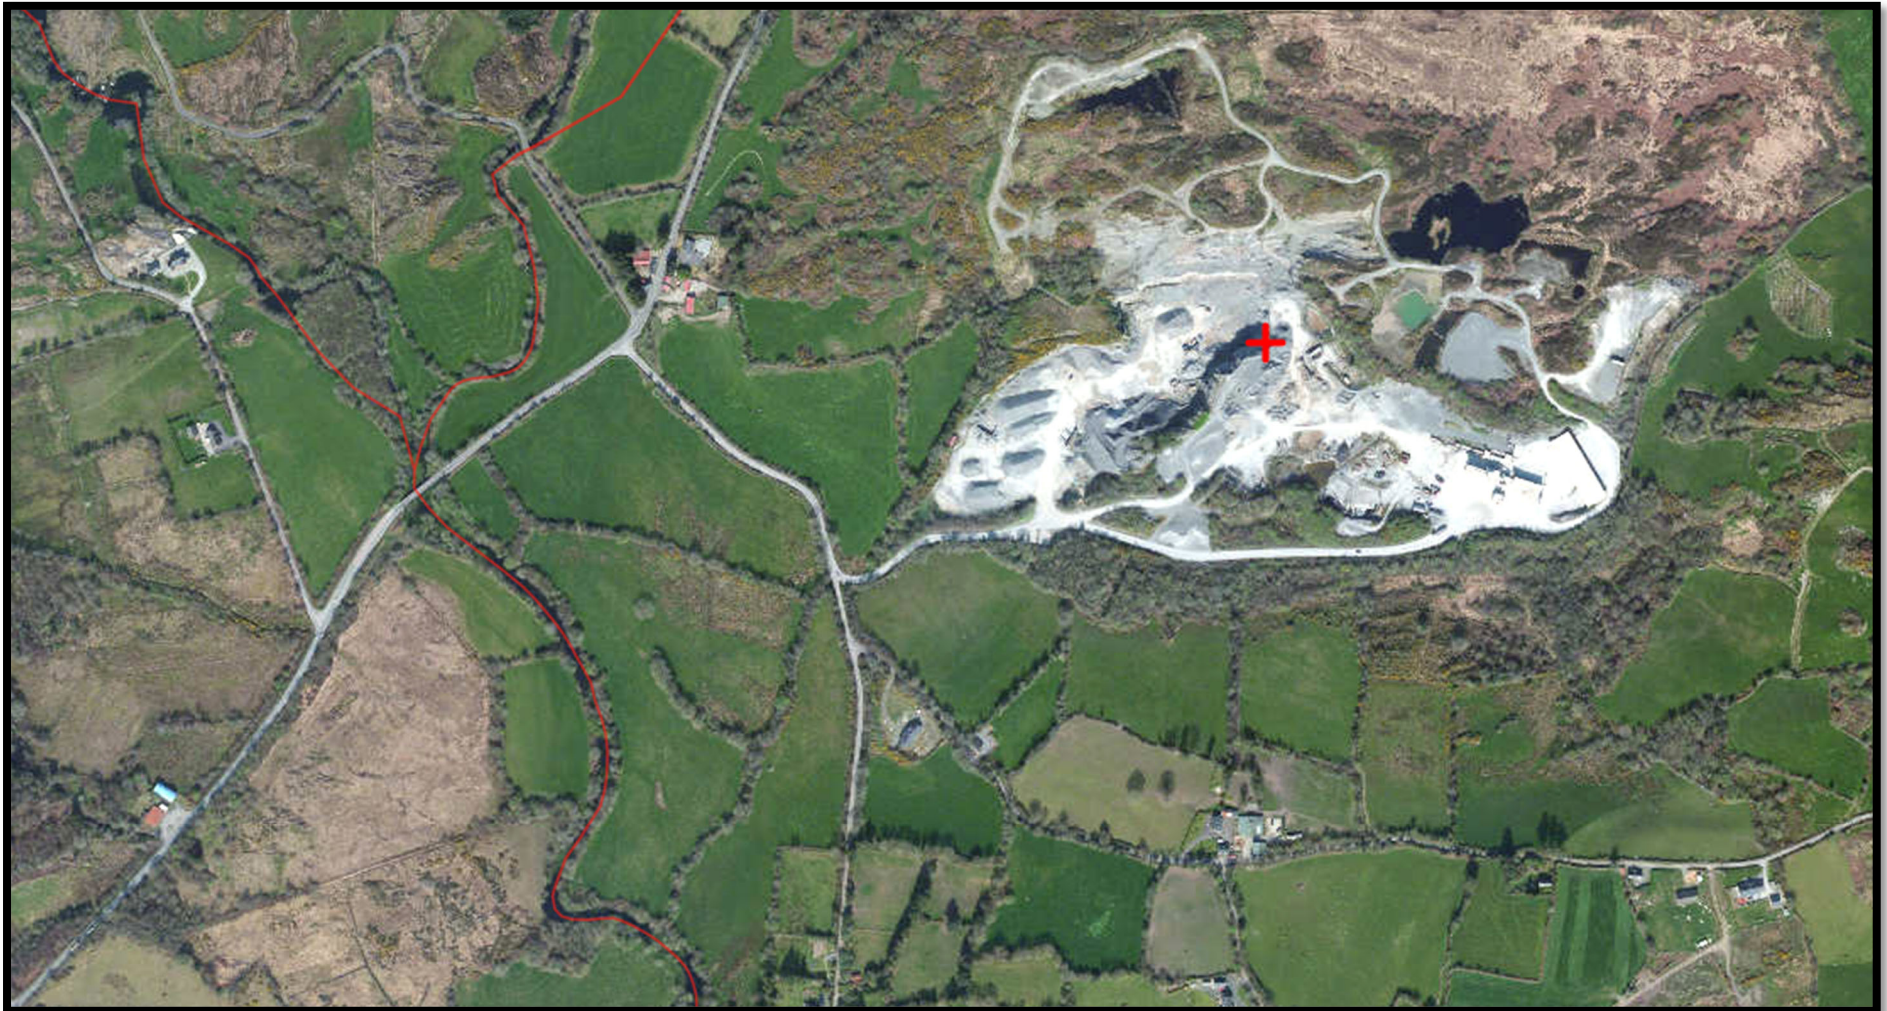
**Appendix 7.1.5 – EPA Hydrology Mapping showing the Bandon\_020 & Caha\_020 rivers both under Agricultural Risk Pressures. (EPA River Future Risk Quality Status Mapping 2019 to 2024 from <https://gis.epa.ie/EPAMaps/Water>.)**

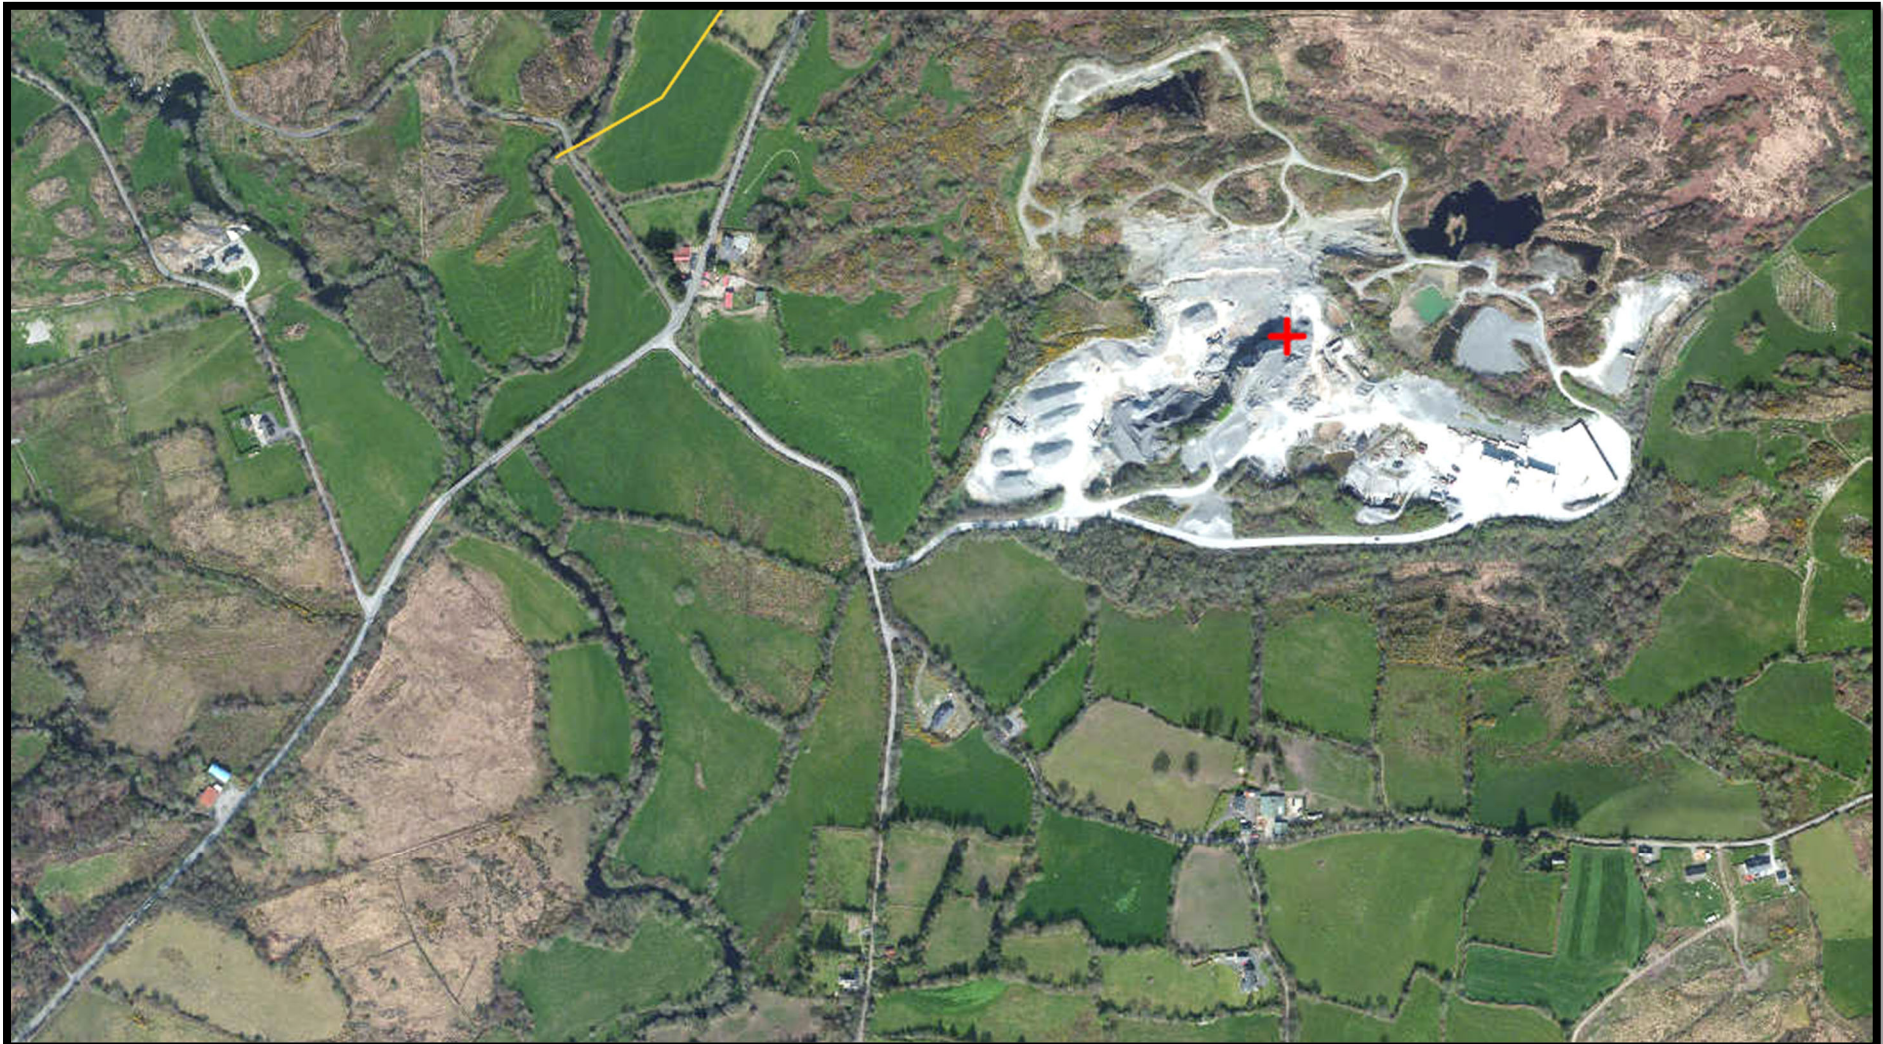
**Appendix 7.1.5 – EPA Hydrology Map showing the Caha\_020 river under Extractive Industry & Anthropogenic Risk Pressures. (EPA River Future Risk Quality Status Mapping 2019 to 2024 from <https://gis.epa.ie/EPAMaps/Water>.)**

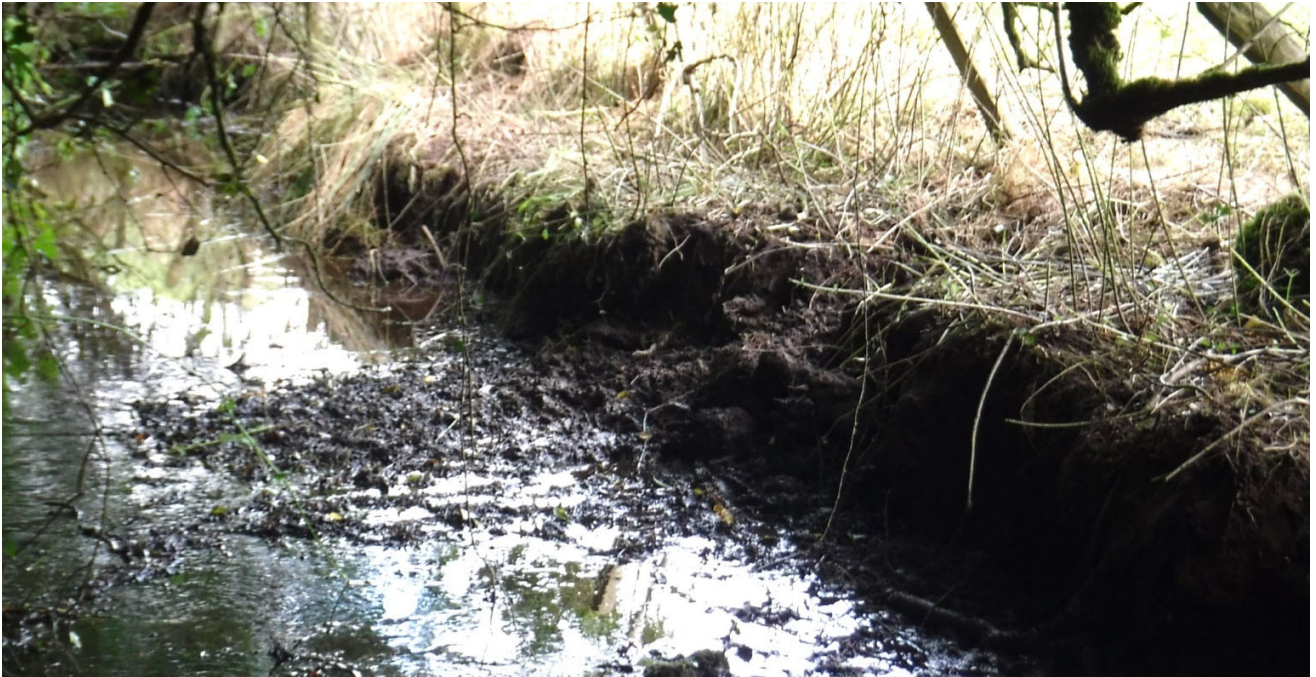
**Photo 7.13.26: View of local stream down gradient of the Quarry main gate. Cattle allowed access the stream for drinking water creates very dirty, muddy and silty water conditions.**

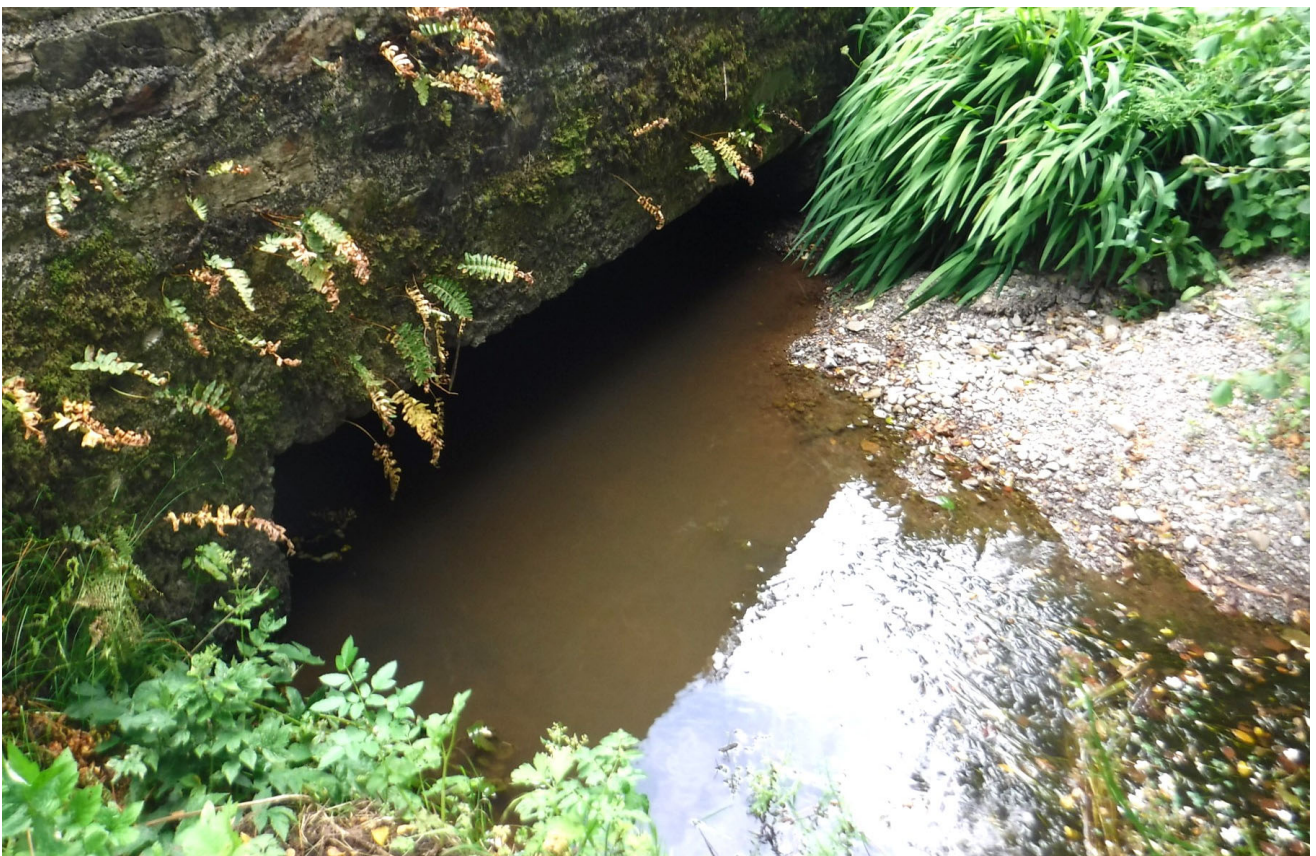
**Photo 7.3.27: Down stream sampling point by road bridge – impacted by local agricultural activity.**

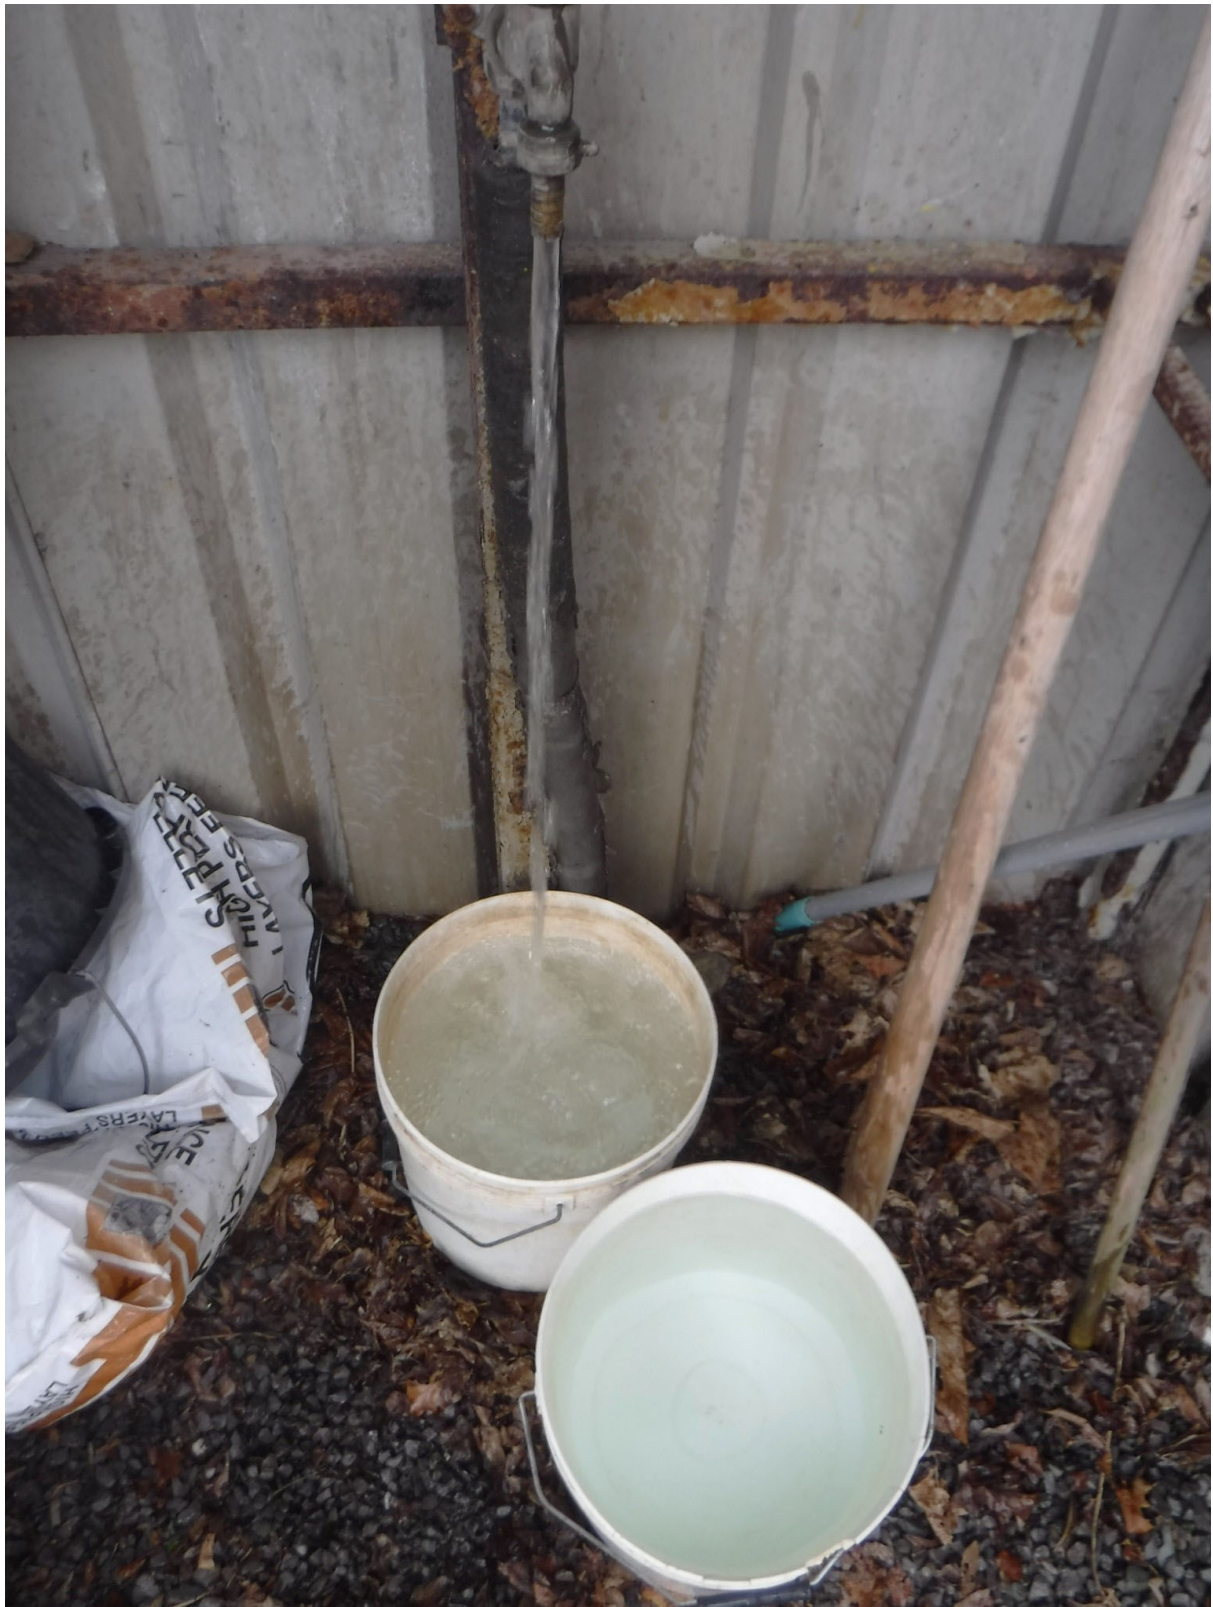
Photo 20: View of water sample being acquired from Tarmac Well outside tap, (4<sup>th</sup> July 2023).

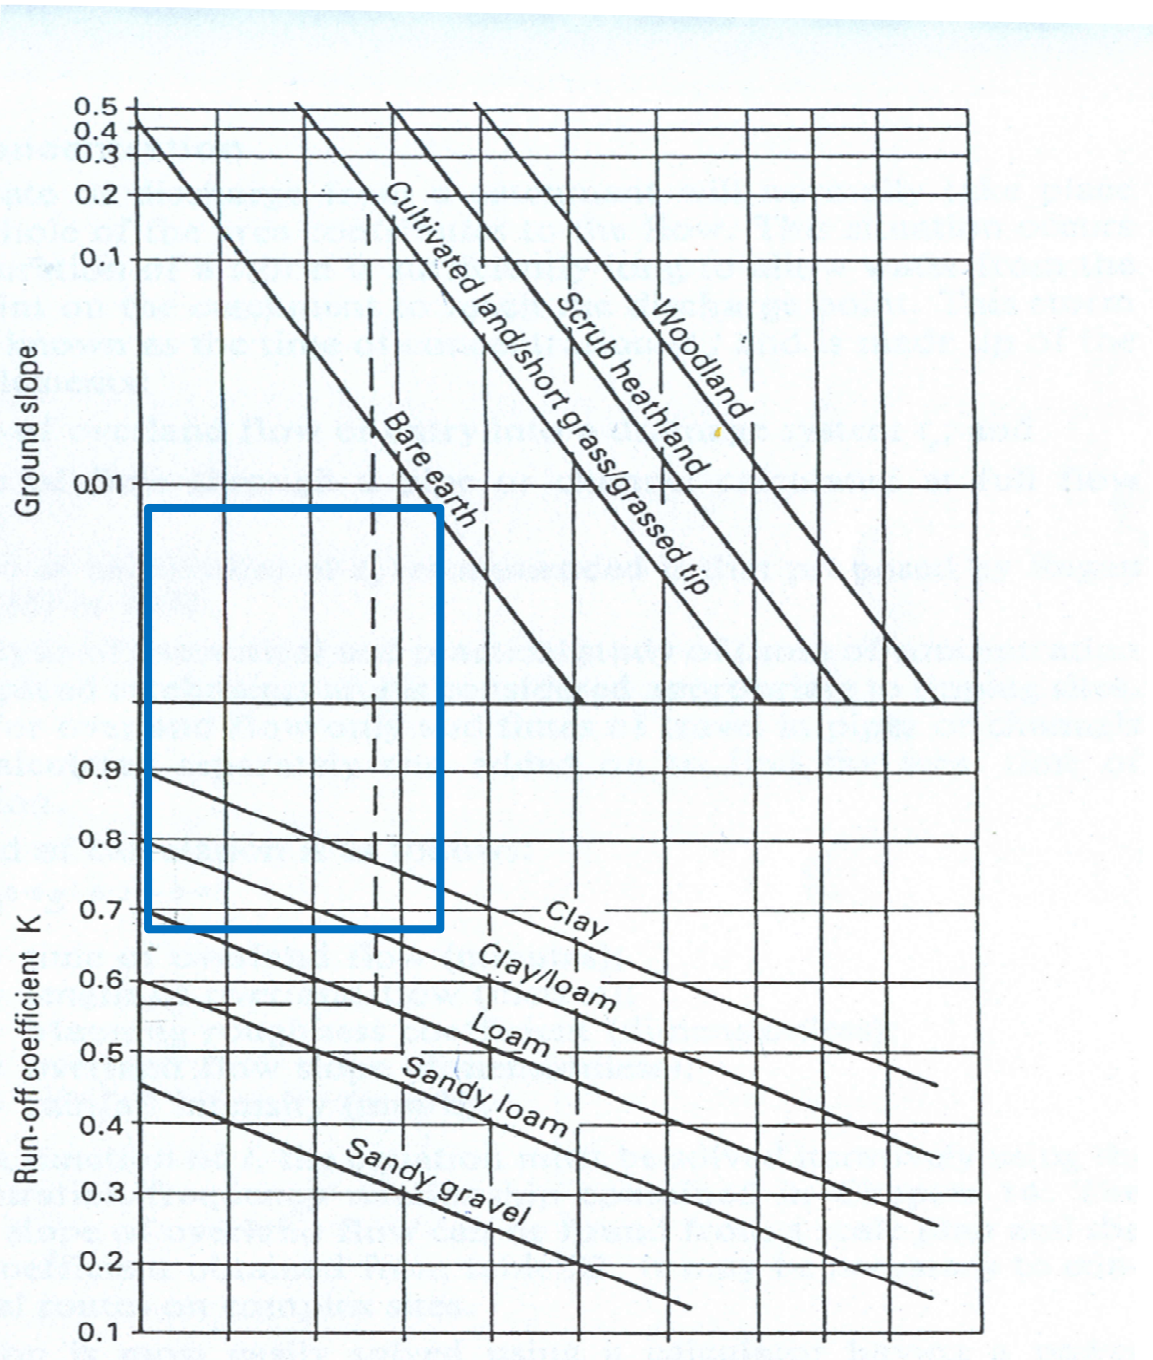
Figure 3 Nomogram to determine the run-off coefficient
