ARDCAHAN QUARRY SECTION 37L  
ENVIRONMENTAL IMPACT ASSESSMENT  
REPORT (EIAR)

**VOLUME III**  
APPENDICES

April 2026

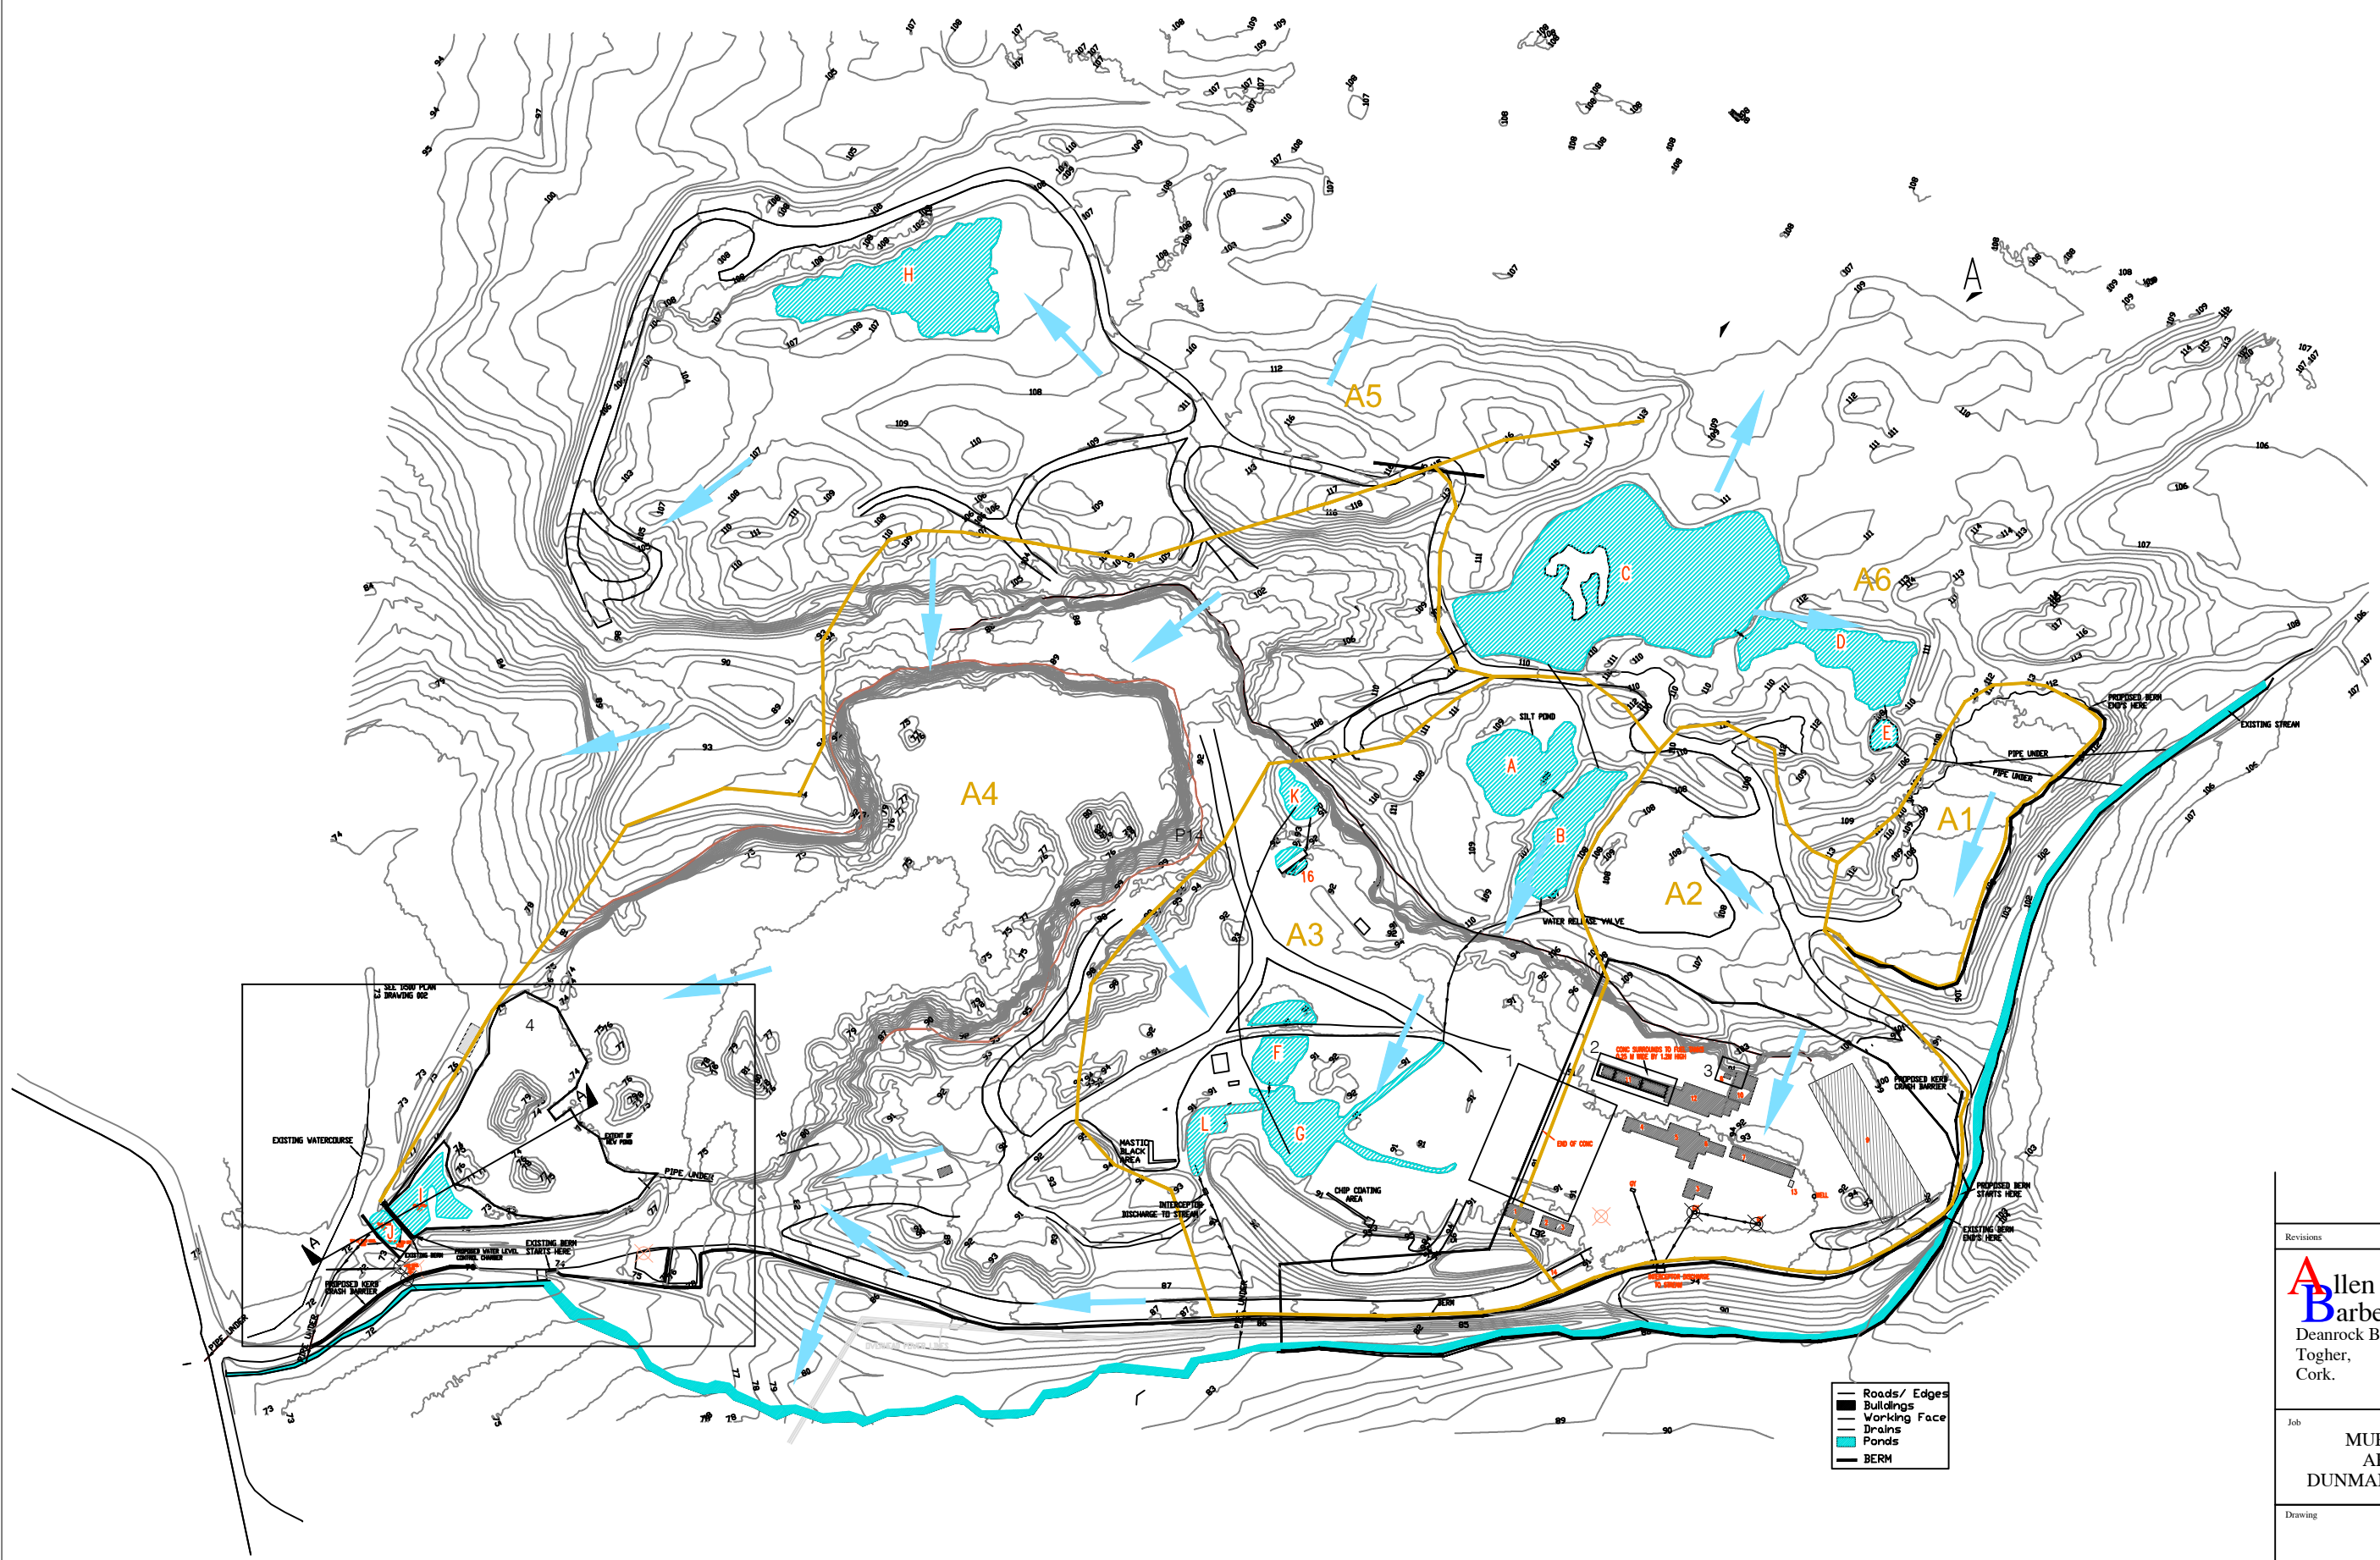
**Appendix 7.11 – Main Attenuation Pond & Discharge Design**

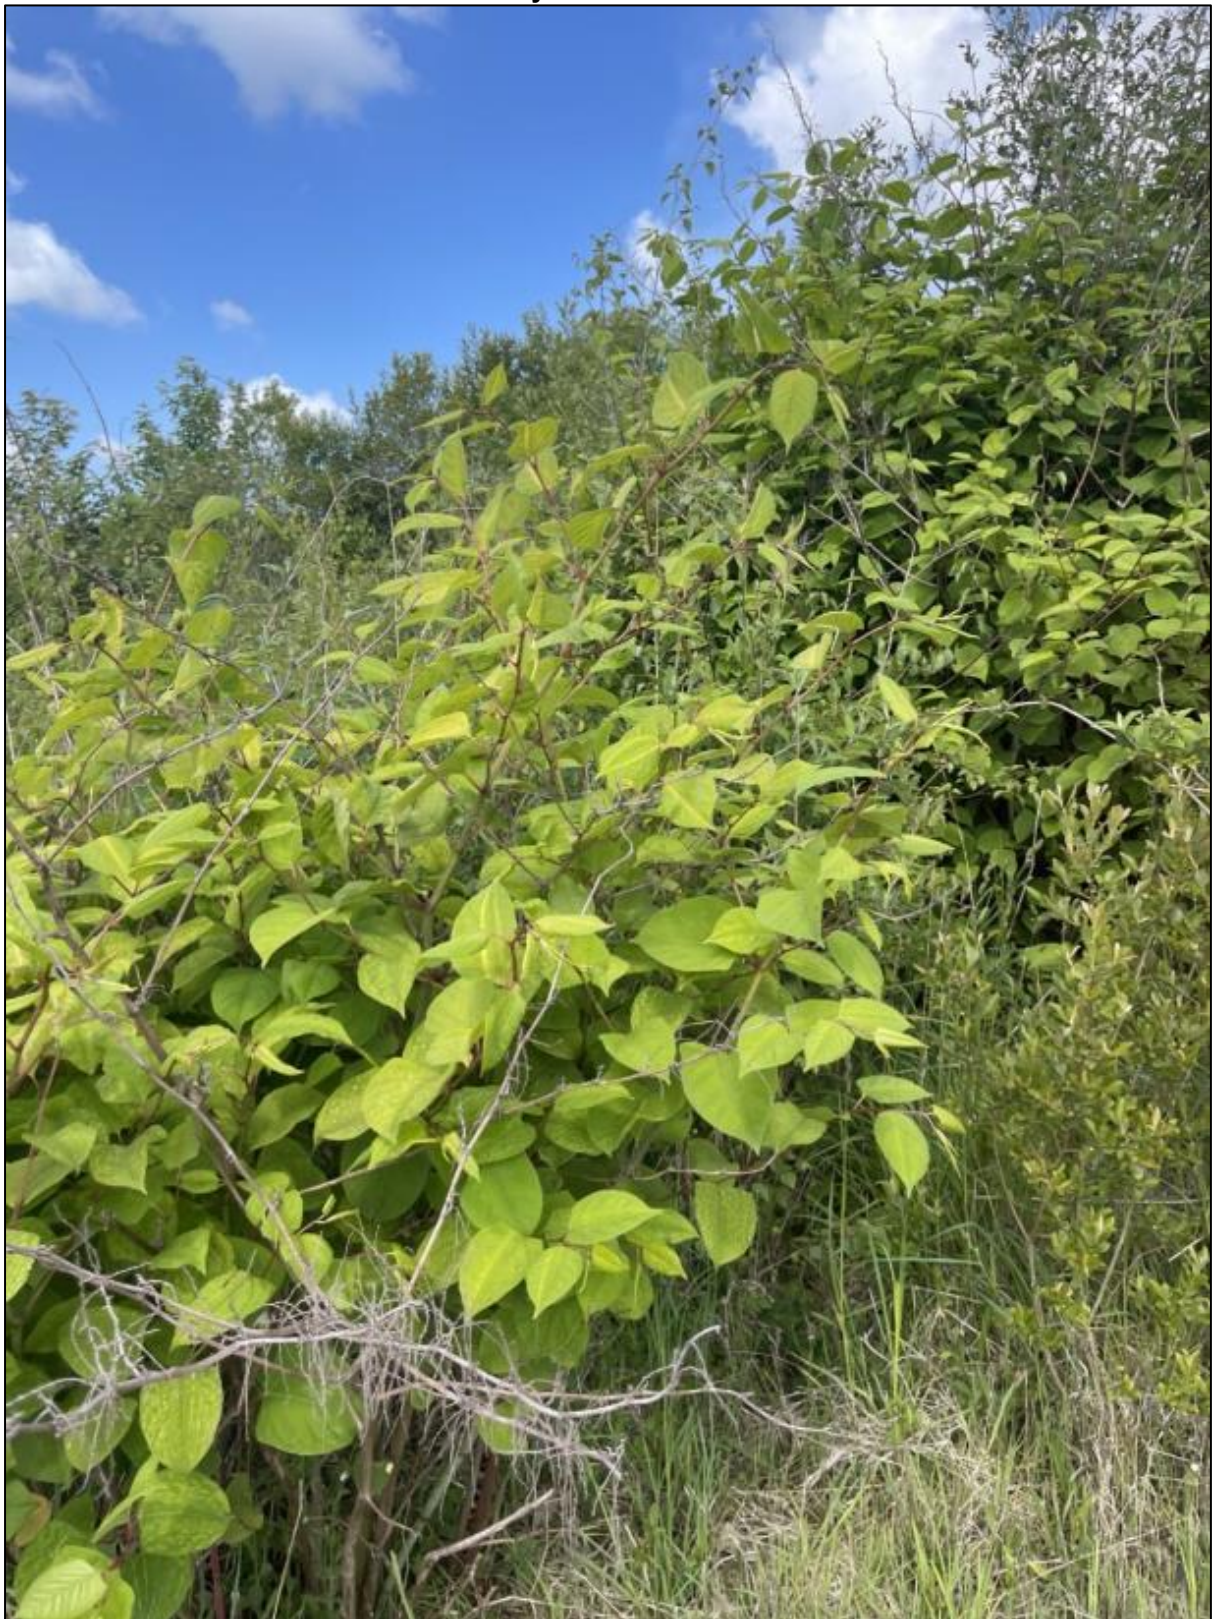
**Plate 3-2: JK in the southwest of the Site**
