Kilshane Energy Phase 2

Environmental Impact Assessment Report

Volume 3 – Appendices

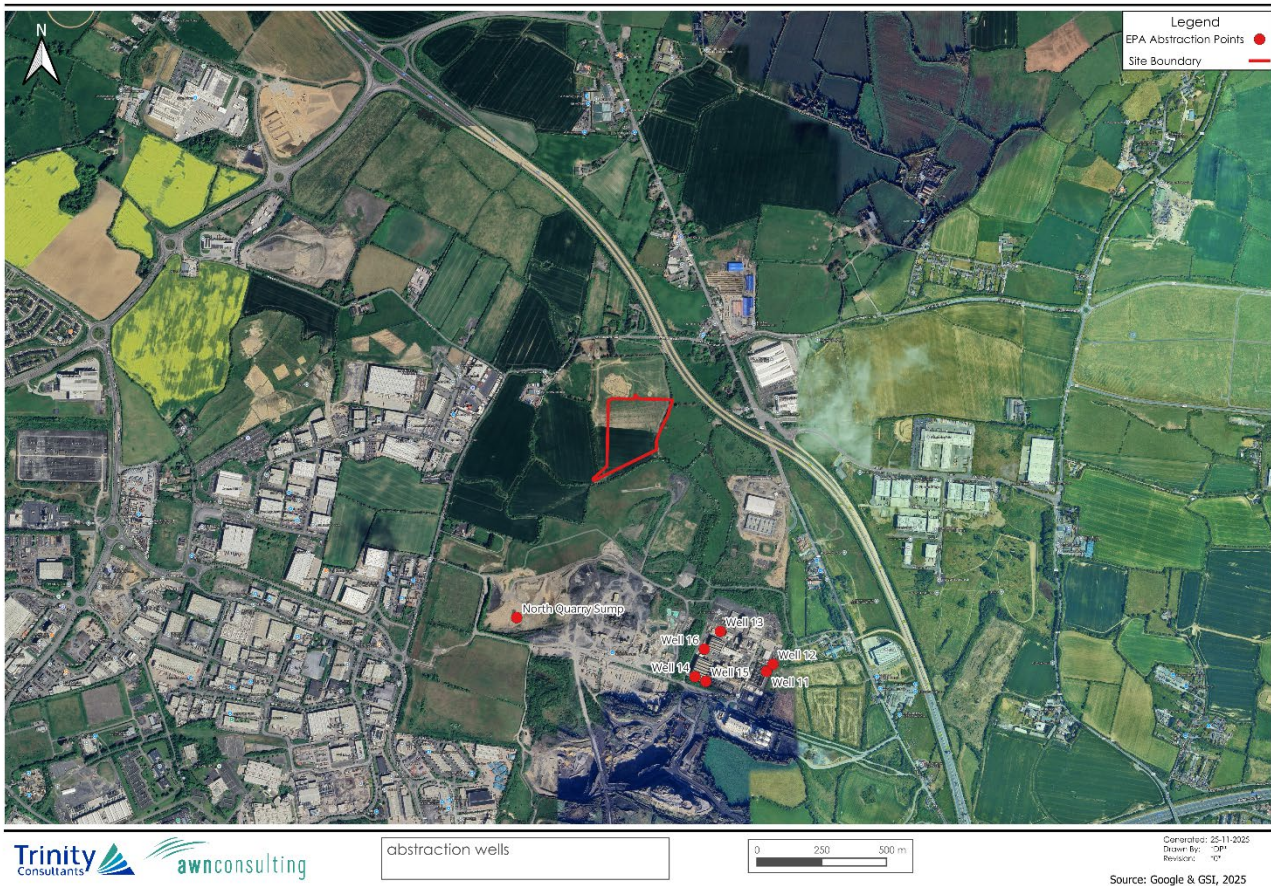
Figure 2-3 Abstraction well locations

In terms of water abstraction, there are no registered water abstraction sites located within the site boundaries. The nearest water abstraction pumps are located on the site of the Huntstown quarry. Please see Figure 2-3 below.

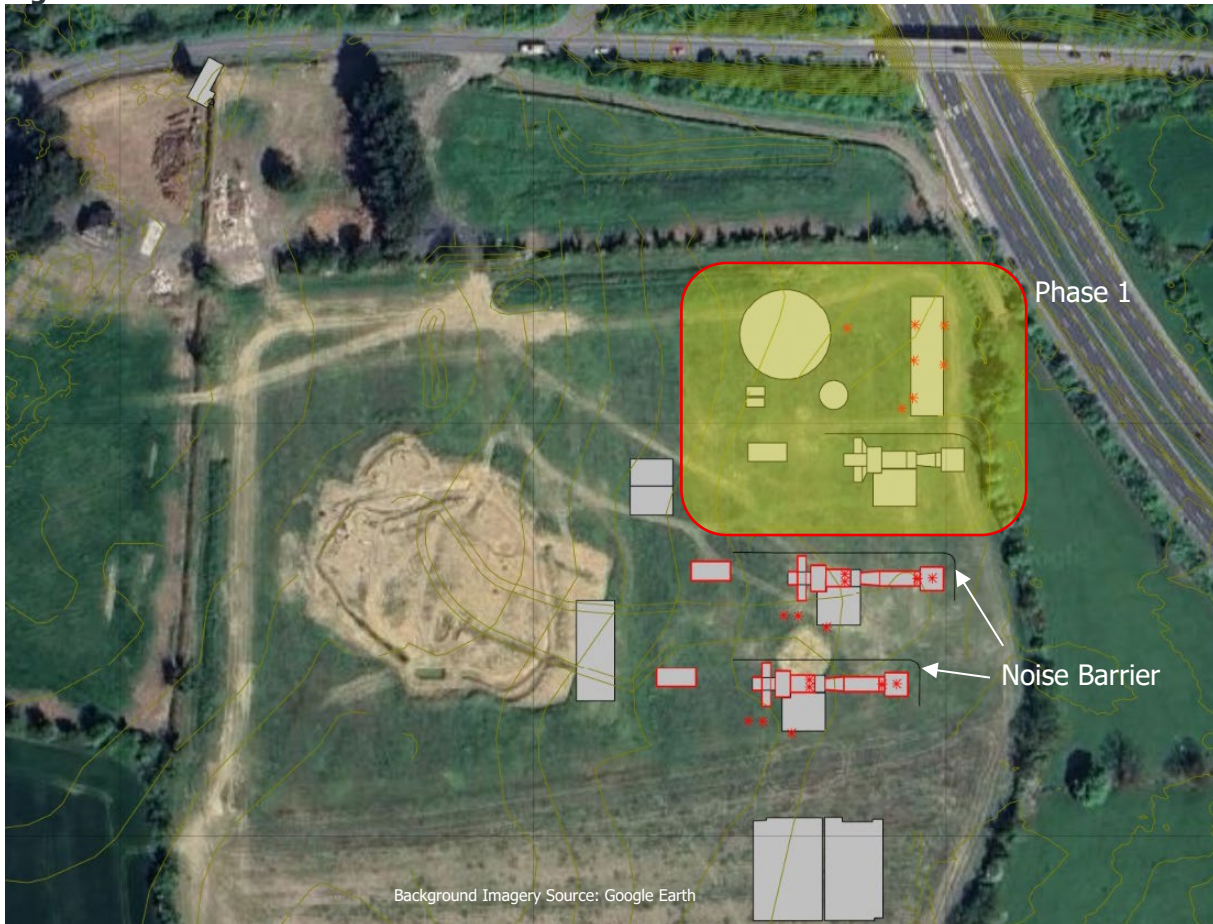
Figure 10.A2.1 Noise Barrier

The design incorporates a noise barrier of 12 m height at the north east part of the main gas turbine area, as in the figure below:

The noise barrier has the following acoustic properties:

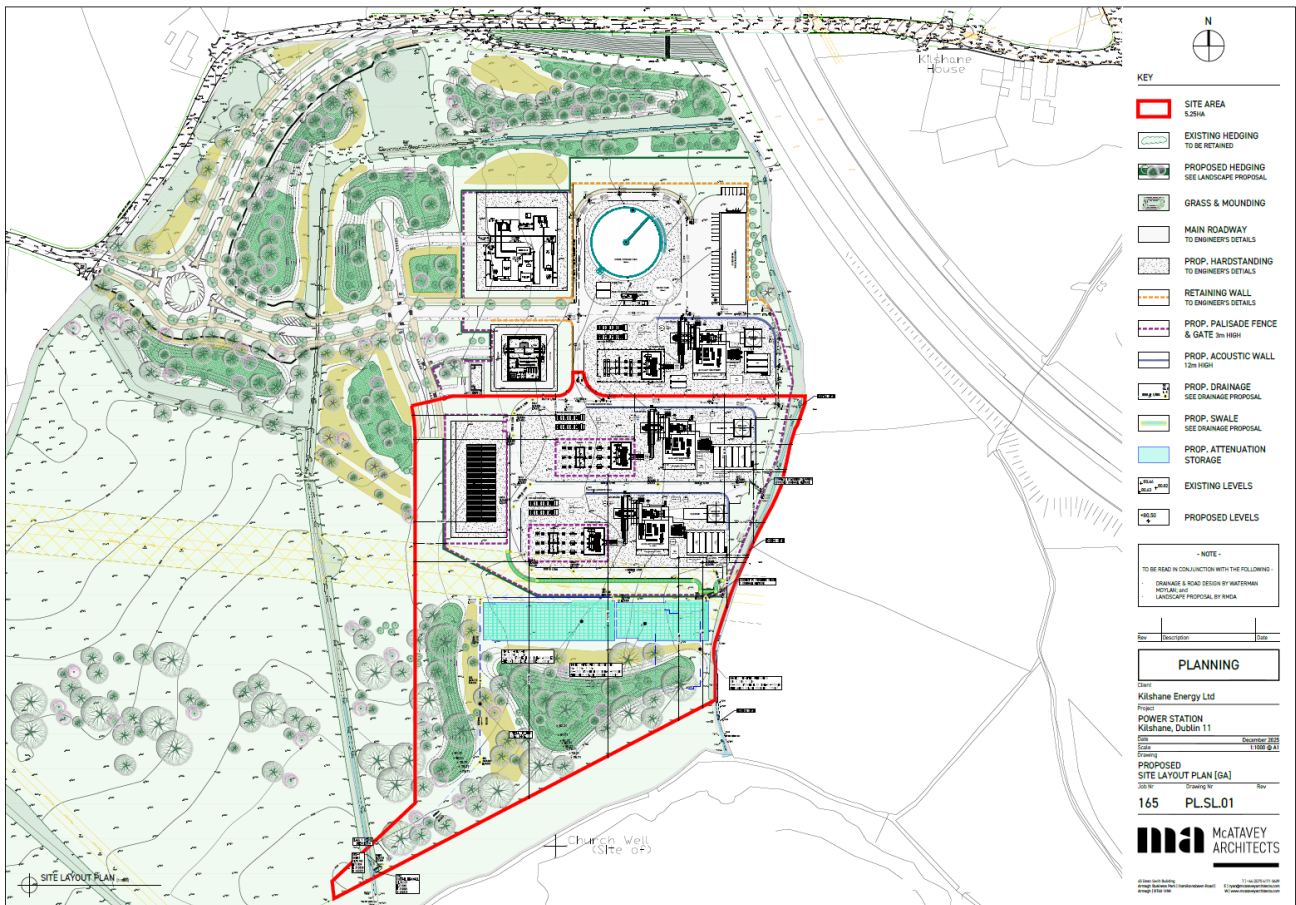
Figure 4.2 Proposed Development Site Layout

- ▶ The proposed development will be bound to its northern and part of its eastern boundary by acoustic fencing.
- ▶ Construction of a 400kV GIS building and associated electrical equipment located to the northwest of the site, within a fenced compound.

- ▶ Provision of hard and soft landscaping works, tree planting and boundary treatments.
- ▶ Attenuation storage will be located to the southeast of the site, alongside the existing permitted attenuation storage.
