# Technical Appendix 6-1 GI Factual Report

**Muingmore Wind Farm**

## MUINGMORE WIND FARM

### GROUND INVESTIGATION FACTUAL REPORT

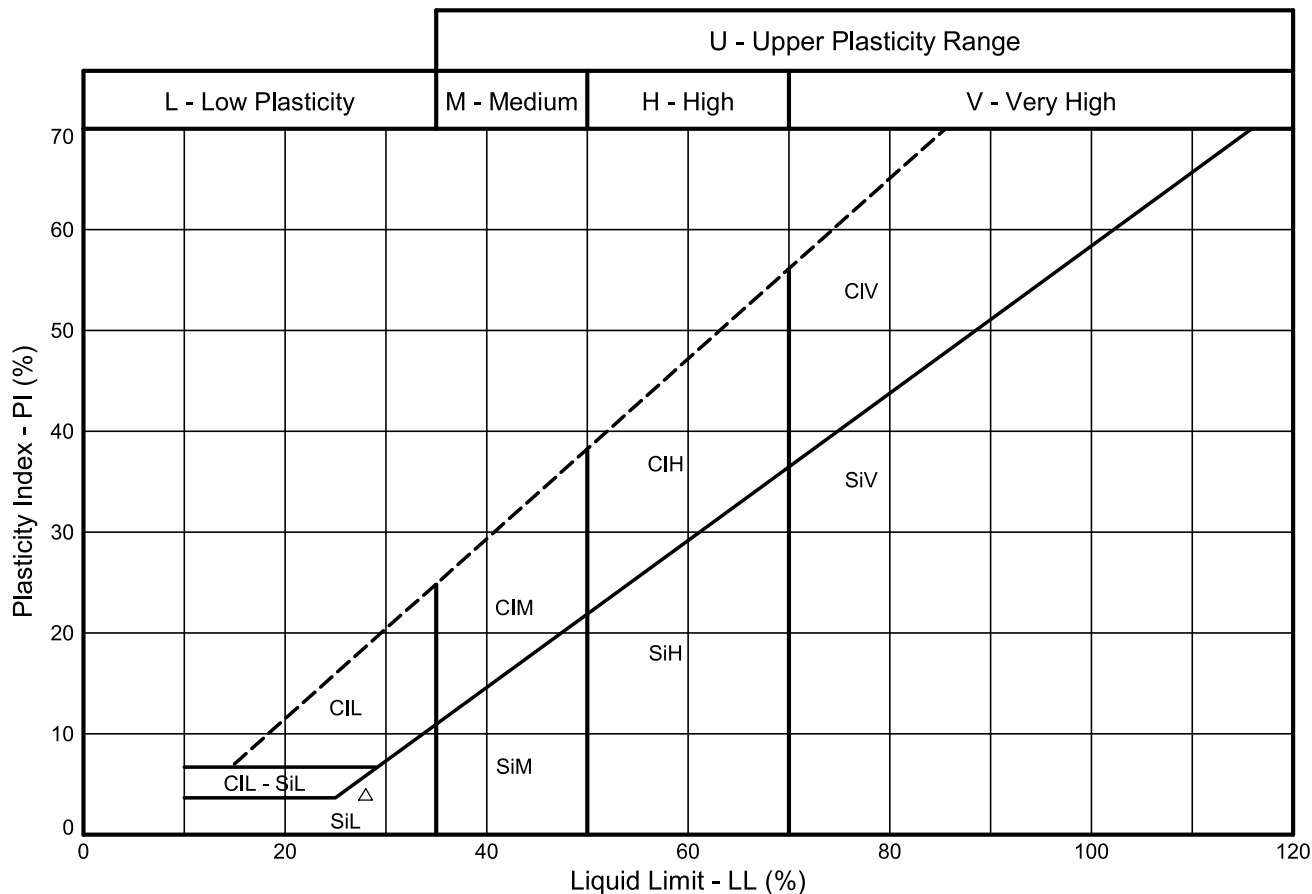
# PI vs LL CHART

Sample Identification			Test Method #	Preparation Method +	WC %	LL %	PL %	PI %	<425µm %	Lab location	Notes
Exploratory Position ID	Sample	Depth (m)									
TP-03	4D	3.00	5.3/5.5/6.5	5.2.7	15.8	NP	NP	NP	65	T	
TP-10	4D	3.00	5.3/5.5/6.5	5.2.7	10.3	NP	NP	NP	64	T	
TP-13	4D	3.00	5.3/5.5/6.5	5.2.7	15.2	NP	NP	NP	62	T	
TP-15	AMAL	3.50	5.3/5.5/6.5	5.2.7	16.3	NP	NP	NP	62	B	
TP-21	4D	3.60	5.3/5.5/6.5	5.2.7	11.9	NP	NP	NP	42	T	
TP-28	1B	1.50	5.3/5.5/6.5	5.2.7	11.1	NP	NP	NP	62	B	
TP-30	AMAL	3.00	5.3/5.5/6.5	5.2.7	12.3	NP	NP	NP	38	B	
Δ TP-CC	3B	2.50	5.3/5.5/6.5	5.2.7	11.2	28	24	4	55	B I

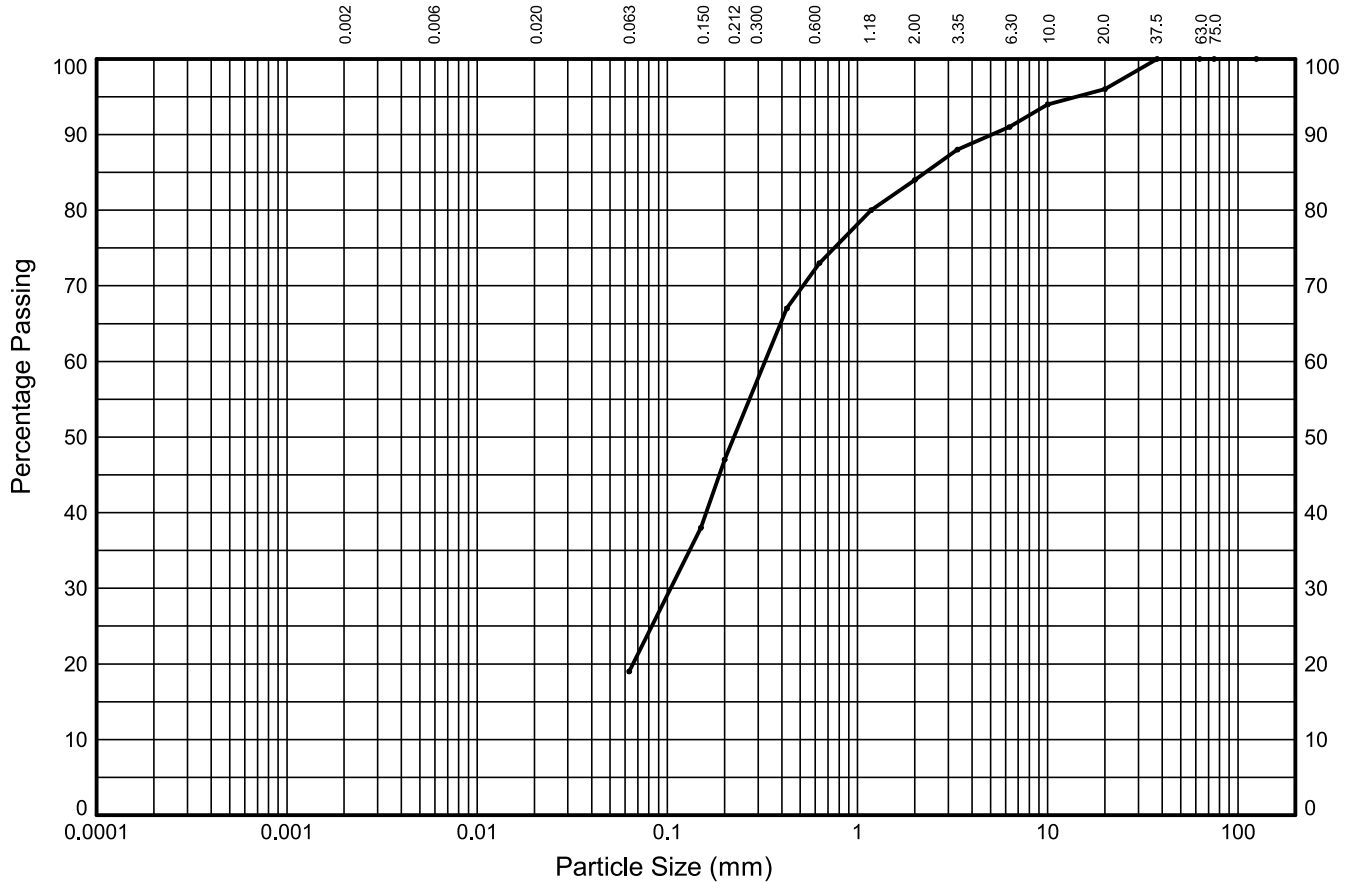
Trial Pit: **TP-03**    Sample Ref: **4**    Sample Type: **D**    Depth (m): **3.00**

CLAY	fine	medium	coarse	fine	medium	coarse	fine	medium	coarse	COBBLES
	-	-	-	28%	26%	11%	7%	5%	4%	
SILT			SAND			GRAVEL				
19%			65%			16%			0%

Test Sieve (mm)	Percent Passing (%)	Particle Diameter (mm)	Percent Passing (%)	Coefficients	
125.0	100			D <sub>10</sub> (mm)	NA
75.0	100			D <sub>15</sub> (mm)	NA
63.0	100			D <sub>30</sub> (mm)	0.104
37.5	100			D <sub>50</sub> (mm)	0.224
20.0	96			D <sub>60</sub> (mm)	0.326
10.0	94			D <sub>85</sub> (mm)	2.275
6.30	91			D <sub>90</sub> (mm)	5.104
3.35	88			C <sub>u</sub>	NA
2.00	84			C <sub>c</sub>	NA
1.18	80			Sedimentation sample was not pre-treated	
0.630	73				
0.425	67				
0.200	47				
0.150	38				
0.063	19				
Soil Description: <b>Greyish brown gravelly silty SAND</b>

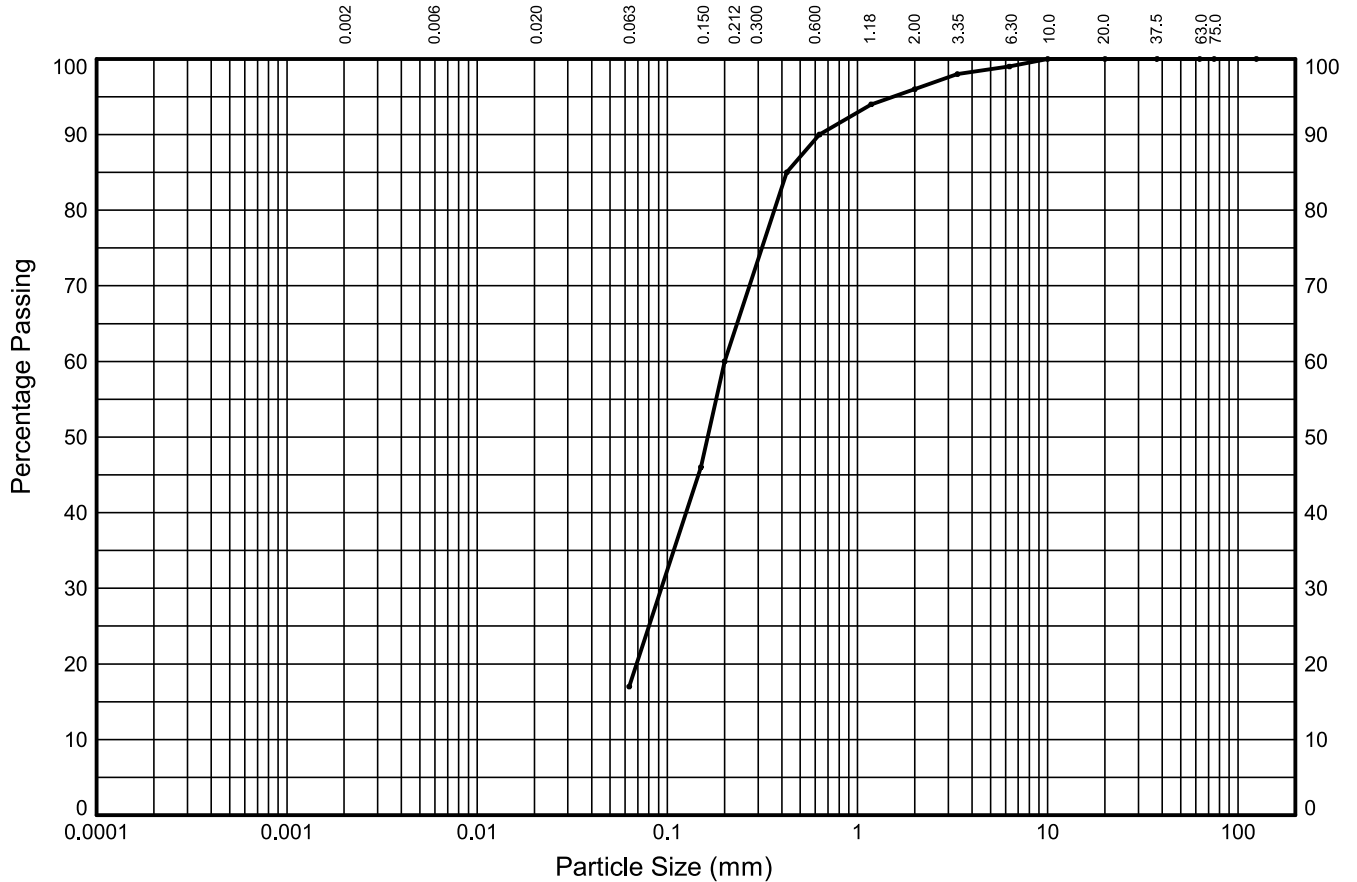
Trial Pit: **TP-07**    Sample Ref: **4**    Sample Type: **D**    Depth (m): **4.00**

CLAY	fine	medium	coarse	fine	medium	coarse	fine	medium	coarse	COBBLES
	-	-	-	43%	30%	6%	3%	1%	0%	
SILT			SAND			GRAVEL				
17%			79%			4%			0%

Test Sieve (mm)	Percent Passing (%)	Particle Diameter (mm)	Percent Passing (%)	Coefficients	
125.0	100			D <sub>10</sub> (mm)	NA
75.0	100			D <sub>15</sub> (mm)	NA
63.0	100			D <sub>30</sub> (mm)	0.093
37.5	100			D <sub>50</sub> (mm)	0.163
20.0	100			D <sub>60</sub> (mm)	0.200
10.0	100			D <sub>85</sub> (mm)	0.425
6.30	99			D <sub>90</sub> (mm)	0.630
3.35	98			C <sub>u</sub>	NA
2.00	96			C <sub>c</sub>	NA
1.18	94			Sedimentation sample was not pre-treated	
0.630	90				
0.425	85				
0.200	60				
0.150	46				
0.063	17				
Soil Description: <b>Light greyish brown slightly gravelly silty SAND</b>

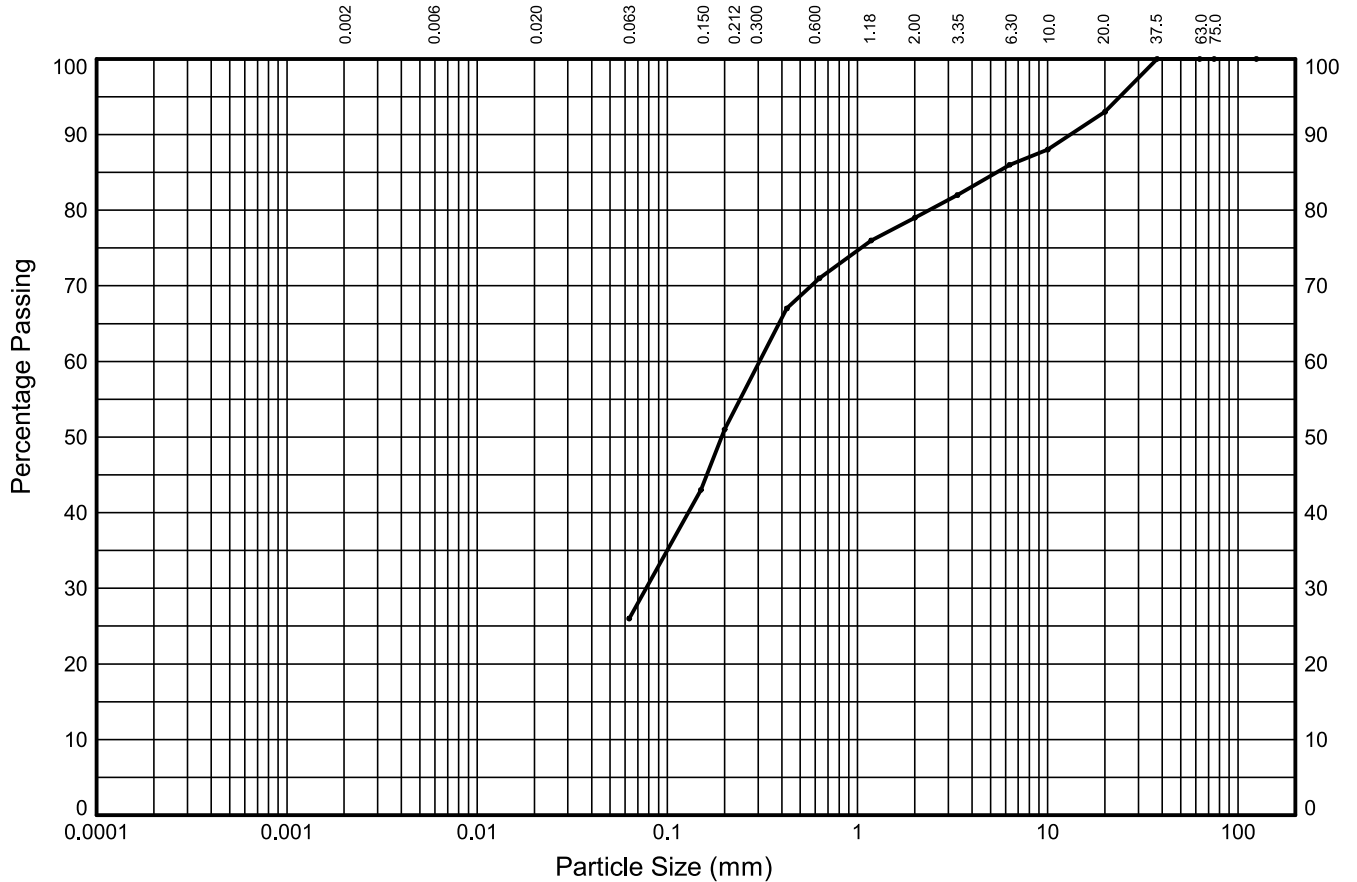
Trial Pit: **TP-09**    Sample Ref: **4**    Sample Type: **D**    Depth (m): **3.60**

CLAY	fine	medium	coarse	fine	medium	coarse	fine	medium	coarse	COBBLES
	-	-	-	25%	20%	8%	7%	7%	7%	
SILT			SAND			GRAVEL				
26%			53%			21%			0%

Test Sieve (mm)	Percent Passing (%)
125.0	100
75.0	100
63.0	100
37.5	100
20.0	93
10.0	88
6.30	86
3.35	82
2.00	79
1.18	76
0.630	71
0.425	67
0.200	51
0.150	43
0.063	26

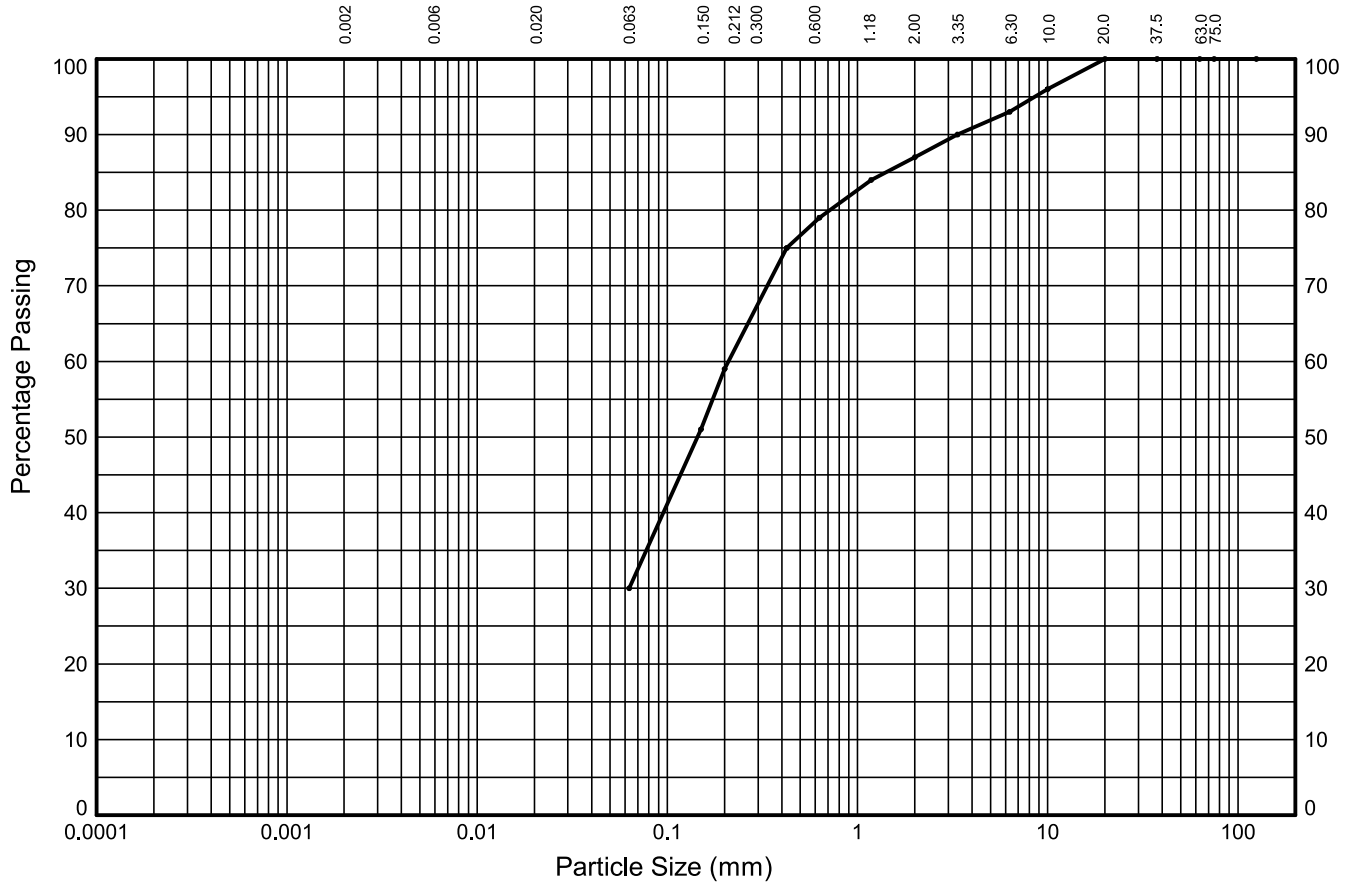
Trial Pit: **TP-11**    Sample Ref: **4**    Sample Type: **D**    Depth (m): **3.30**

CLAY	fine	medium	coarse	fine	medium	coarse	fine	medium	coarse	COBBLES
	-	-	-	29%	20%	8%	6%	7%	0%	
SILT			SAND			GRAVEL				
30%			57%			13%			0%

Test Sieve (mm)	Percent Passing (%)
125.0	100
75.0	100
63.0	100
37.5	100
20.0	100
10.0	96
6.30	93
3.35	90
2.00	87
1.18	84
0.630	79
0.425	75
0.200	59
0.150	51
0.063	30

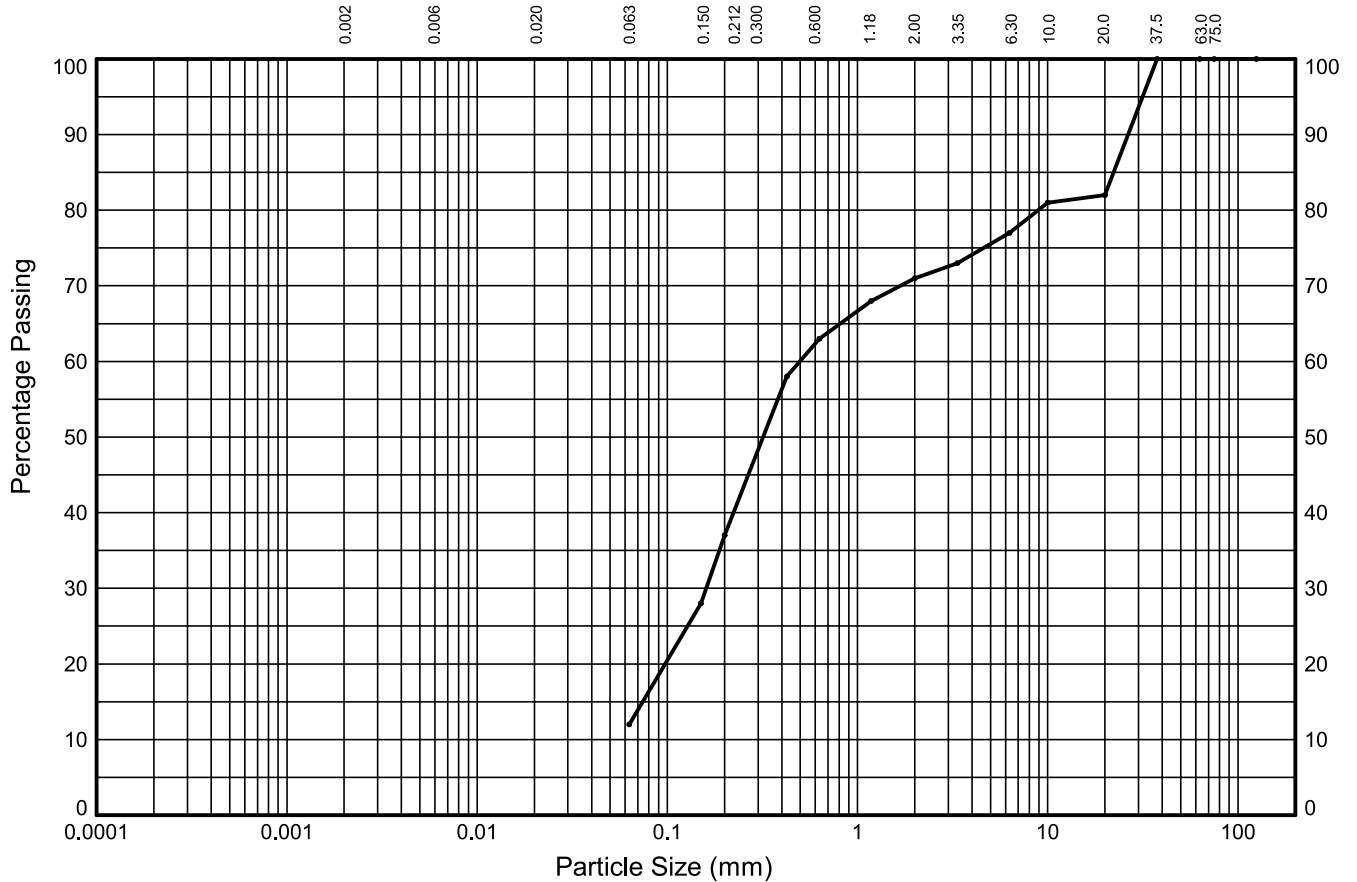
Trial Pit: **TP-12**    Sample Ref: **4**    Sample Type: **D**    Depth (m): **4.10**

CLAY	fine	medium	coarse	fine	medium	coarse	fine	medium	coarse	COBBLES
	-	-	-	25%	26%	8%	6%	5%	18%	
SILT			SAND			GRAVEL				
12%			59%			29%			0%

Test Sieve (mm)	Percent Passing (%)
125.0	100
75.0	100
63.0	100
37.5	100
20.0	82
10.0	81
6.30	77
3.35	73
2.00	71
1.18	68
0.630	63
0.425	58
0.200	37
0.150	28
0.063	12

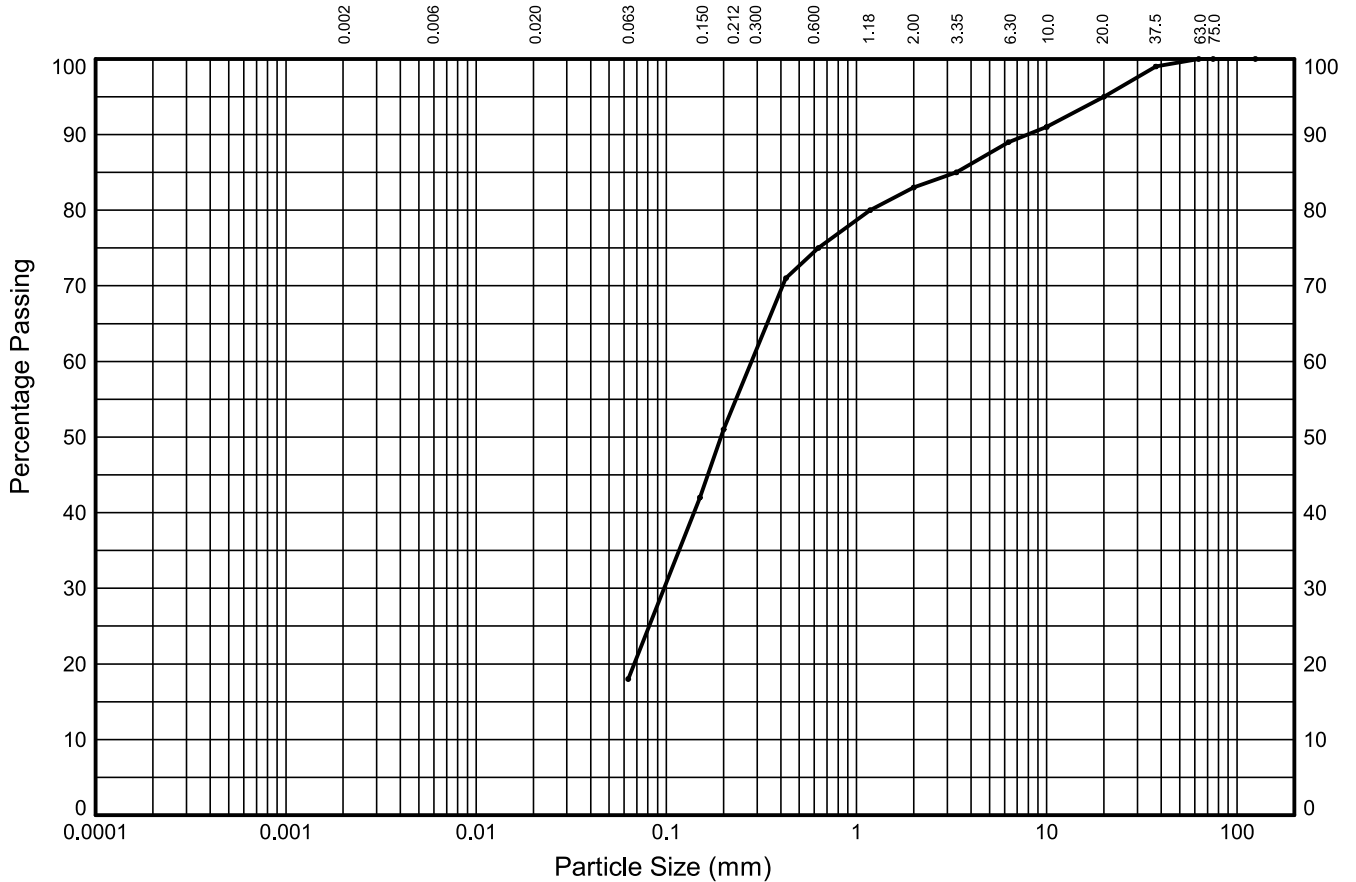
Trial Pit: **TP-15**    Sample Ref:    Sample Type: **AMAL**    Depth (m): **3.50**  
 Amalgamation comprises: TP-15, Depth:3.50, Ref:4, Type:D + TP-15, Depth:3.50, Ref:3, Type:B

CLAY	fine	medium	coarse	fine	medium	coarse	fine	medium	coarse	COBBLES
	-	-	-	33%	24%	8%	6%	6%	5%	
SILT			SAND			GRAVEL				
18%			65%			17%			0%

Test Sieve (mm)	Percent Passing (%)	Particle Diameter (mm)	Percent Passing (%)	Coefficients	
125.0	100			D <sub>10</sub> (mm)	NA
75.0	100			D <sub>15</sub> (mm)	NA
63.0	100			D <sub>30</sub> (mm)	0.097
37.5	99			D <sub>50</sub> (mm)	0.194
20.0	95			D <sub>60</sub> (mm)	0.281
10.0	91			D <sub>85</sub> (mm)	3.350
6.30	89			D <sub>90</sub> (mm)	7.937
3.35	85			C <sub>u</sub>	NA
2.00	83			C <sub>c</sub>	NA
1.18	80			Sedimentation sample was not pre-treated	
0.630	75				
0.425	71				
0.200	51				
0.150	42				
0.063	18				
Soil Description: <b>Brown very gravelly silty SAND</b>

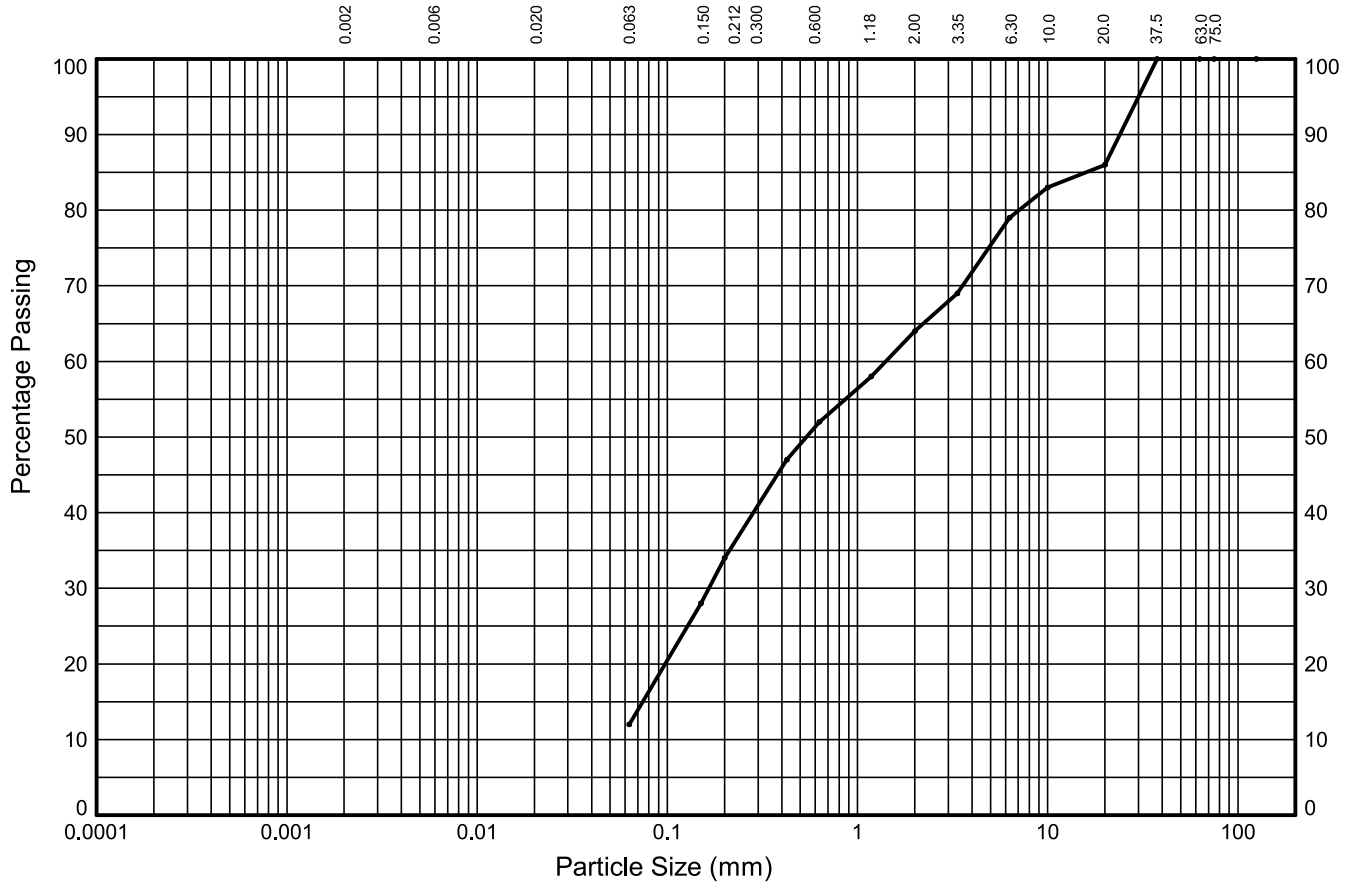
Trial Pit: **TP-15**    Sample Ref: **4**    Sample Type: **D**    Depth (m): **3.50**

CLAY	fine	medium	coarse	fine	medium	coarse	fine	medium	coarse	COBBLES
	-	-	-	22%	18%	12%	15%	7%	14%	
SILT			SAND			GRAVEL				
12%			52%			36%			0%

Test Sieve (mm)	Percent Passing (%)
125.0	100
75.0	100
63.0	100
37.5	100
20.0	86
10.0	83
6.30	79
3.35	69
2.00	64
1.18	58
0.630	52
0.425	47
0.200	34
0.150	28
0.063	12

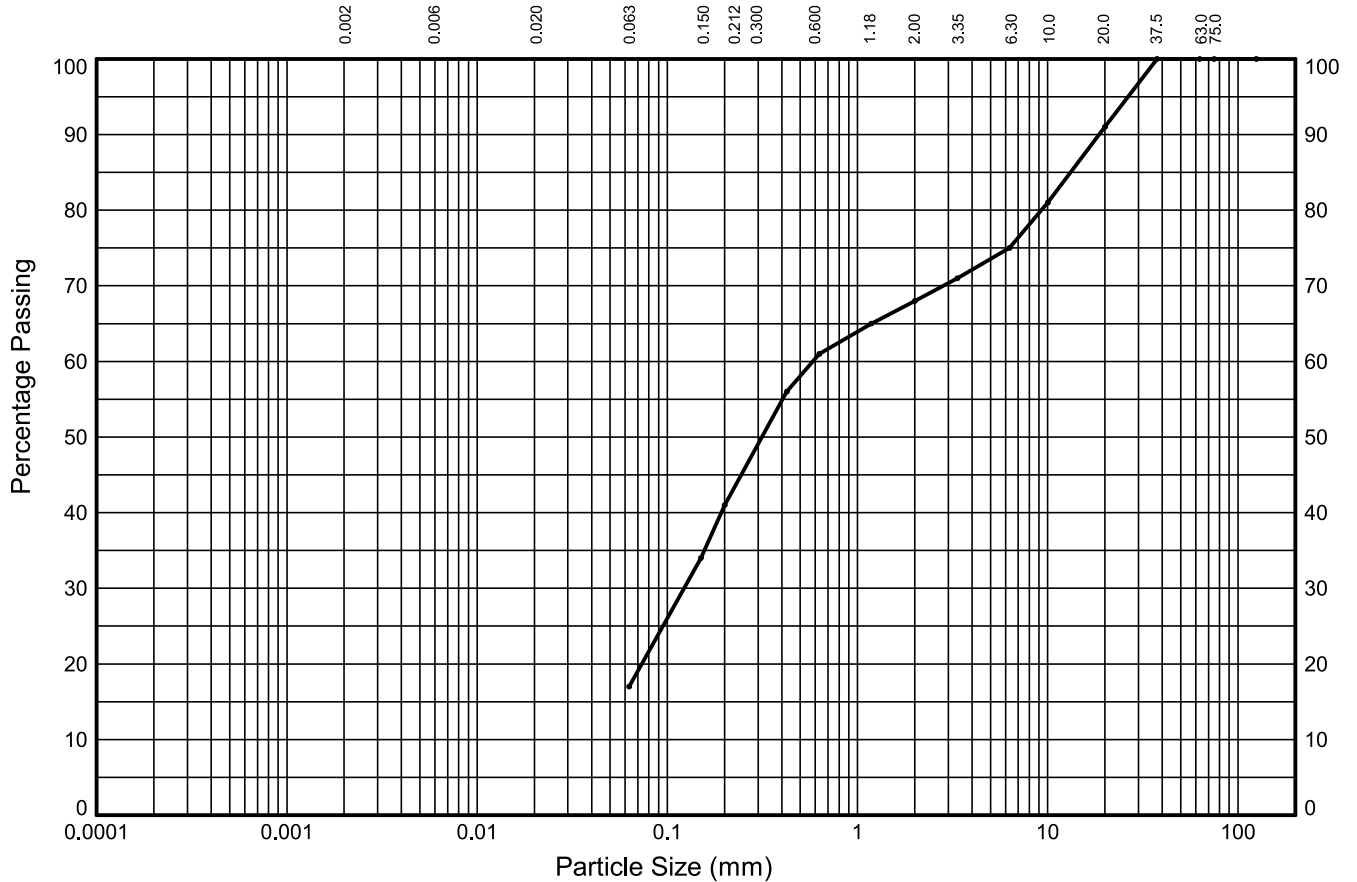
Trial Pit: **TP-24**    Sample Ref: **4**    Sample Type: **D**    Depth (m): **2.50**

CLAY	fine	medium	coarse	fine	medium	coarse	fine	medium	coarse	COBBLES
	-	-	-	24%	20%	7%	7%	16%	9%	
SILT			SAND			GRAVEL				
17%			51%			32%			0%

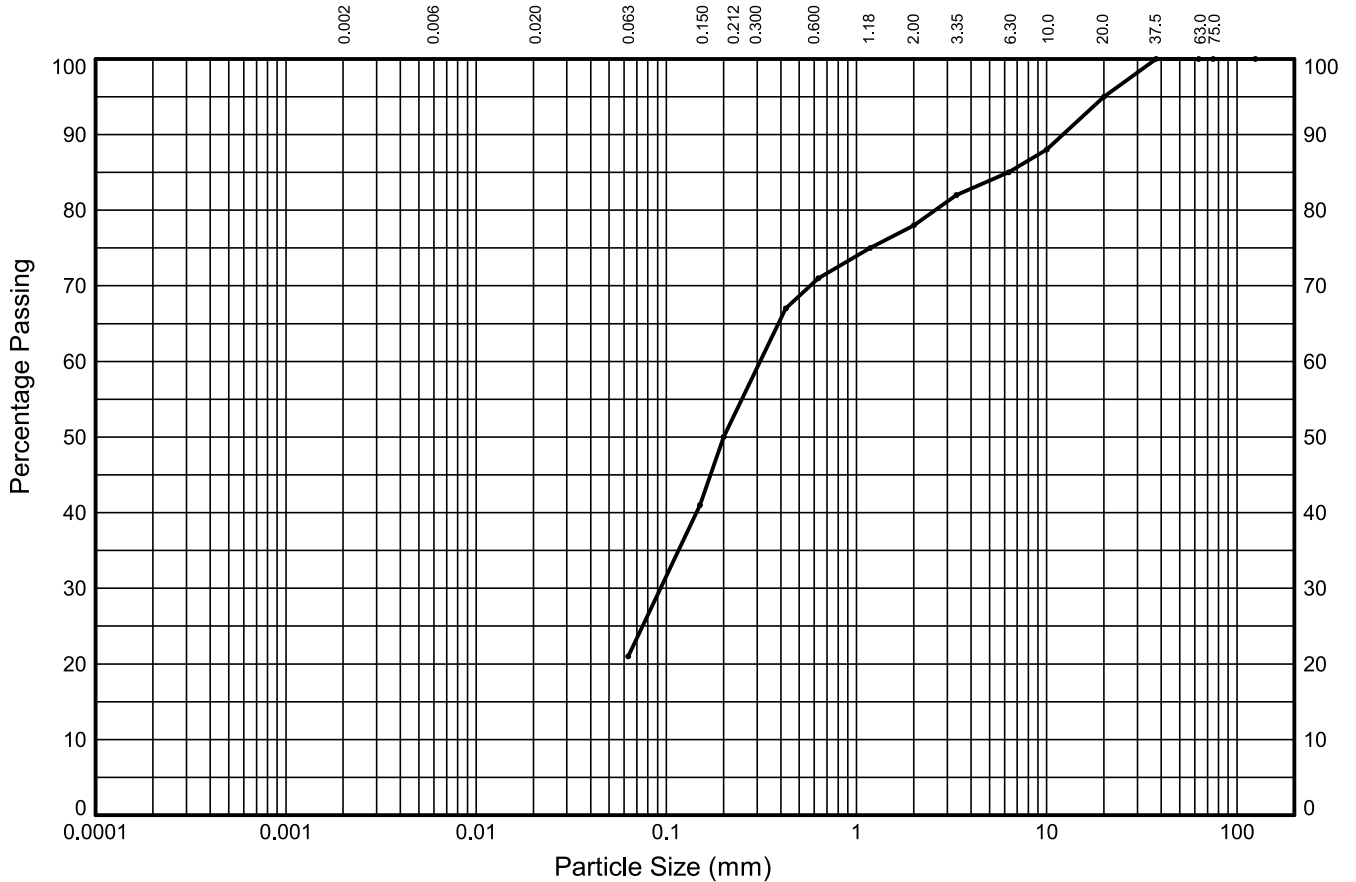
Trial Pit: **TP-30**    Sample Ref:    Sample Type: **AMAL**    Depth (m): **3.00**  
 Amalgamation comprises: TP-30, Depth:3.00, Ref:4, Type:D + TP-30, Depth:3.00, Ref:3, Type:B

CLAY	fine	medium	coarse	fine	medium	coarse	fine	medium	coarse	COBBLES
	-	-	-	29%	21%	7%	7%	10%	5%	
SILT			SAND			GRAVEL				
21%			57%			22%			0%
