Water Status Impact Assessment

WATER STATUS IMPACT ASSESSMENT (WSIA) BURNFOOT FLOOD RELIEF SCHEME

IBE1898

F01

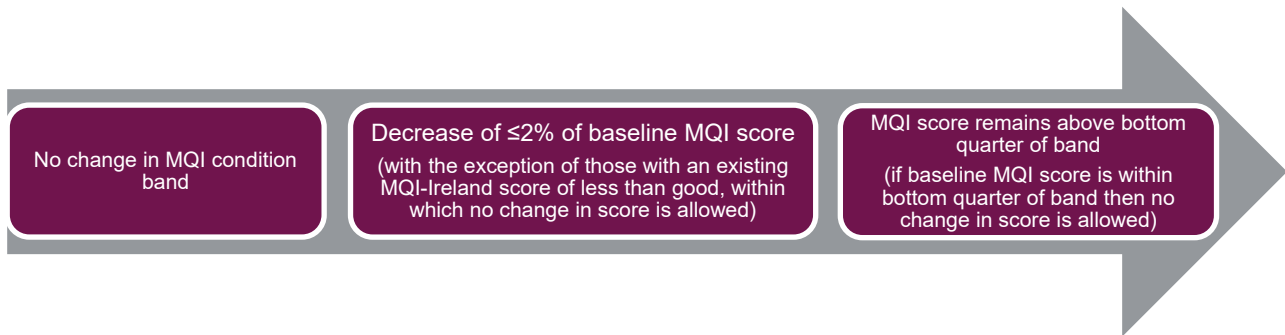
Figure 1.2: Stage 2 Acceptance Criteria

The above acceptance criteria are specific to MQI scoring at the reach level. Through adhering to this acceptance criteria would ensure a precautionary approach to negating any impacts at the waterbody level. Where the scenario based assessment has determined that there is no morphological risk of non-compliance with WFD objectives, the application may proceed, following General Binding Rules (GBR) to Stage 4, without the need for Stage 3 Detailed Assessment. However if Stage 2 Morphological Risk Assessment has determined that the deviation in MQI-Ireland score is unacceptable under the Acceptance Criteria, or there is uncertainty with regards to the extent of morphological risk, the assessment should move to a Stage 3 Detailed Assessment.
