# Appendix 15

## Appendix 15.1

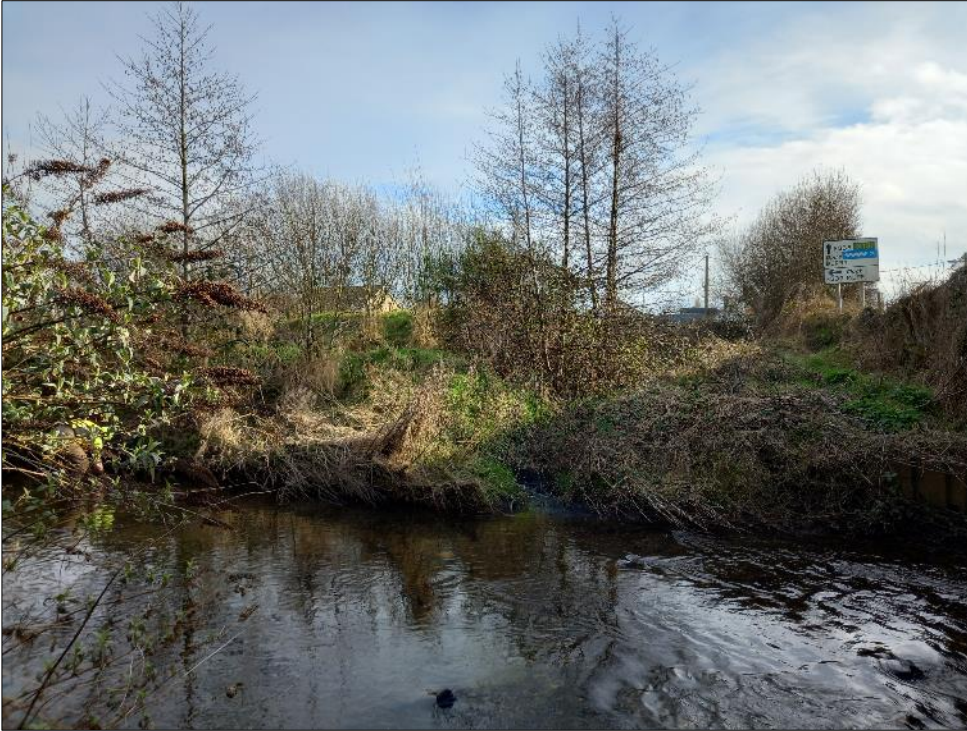
**Plate 15.1: View towards southern riverbank at east side of Burnfoot bridge. Note disturbed ground and heavy vegetation**

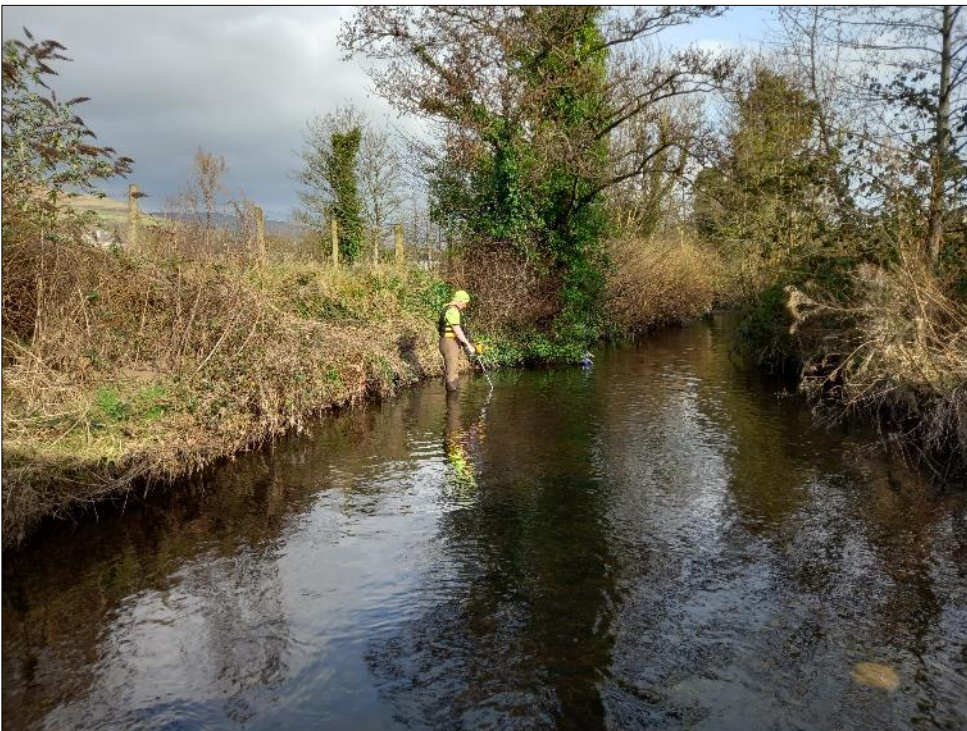
**Plate 15.2: View towards northern riverbank and higher ground in fields adjacent (behind fence-line)**

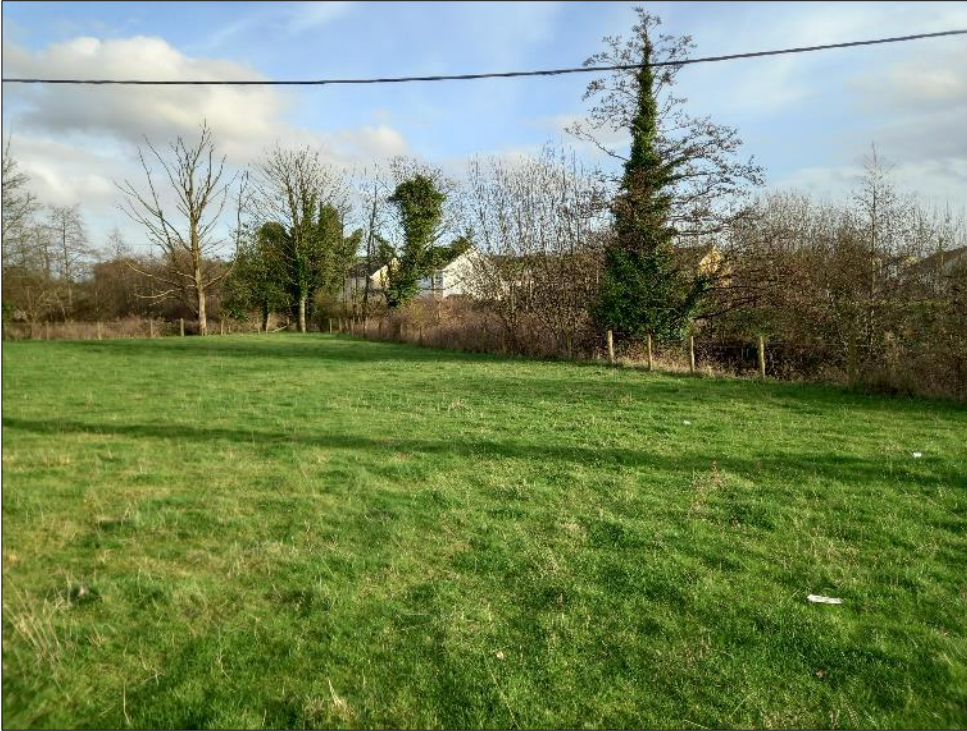
**Plate 15.3: View towards south and level area of pasture adjacent northern riverbank of Burnfoot River**

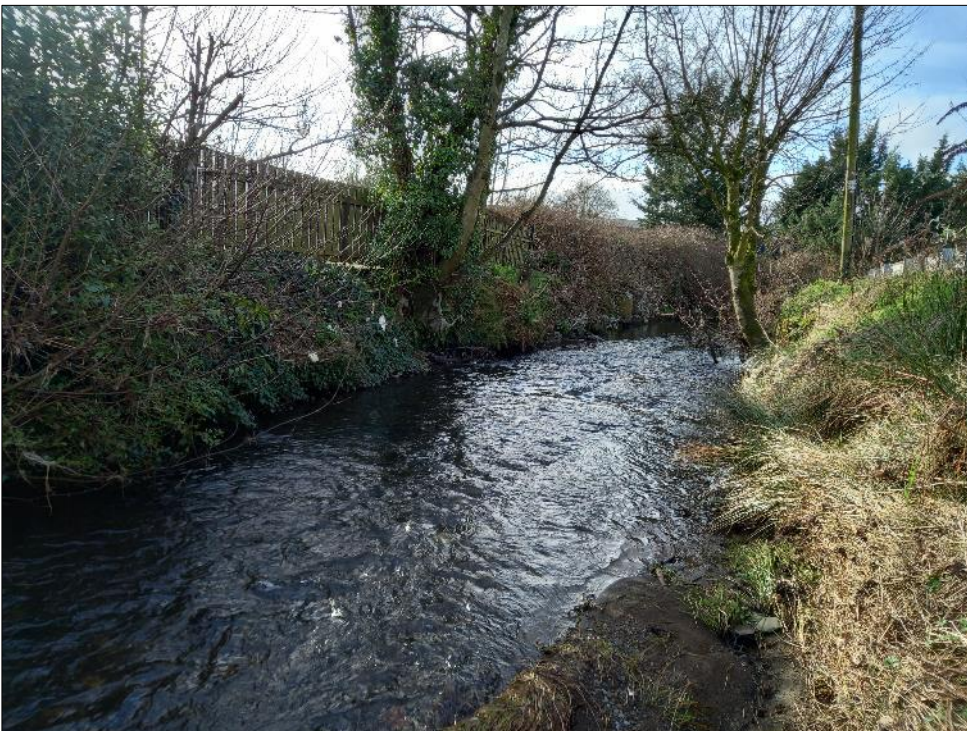
**Plate 15.4: View towards southern riverbank area to west side of Burnfoot Bridge. Note residential fencing to private properties**

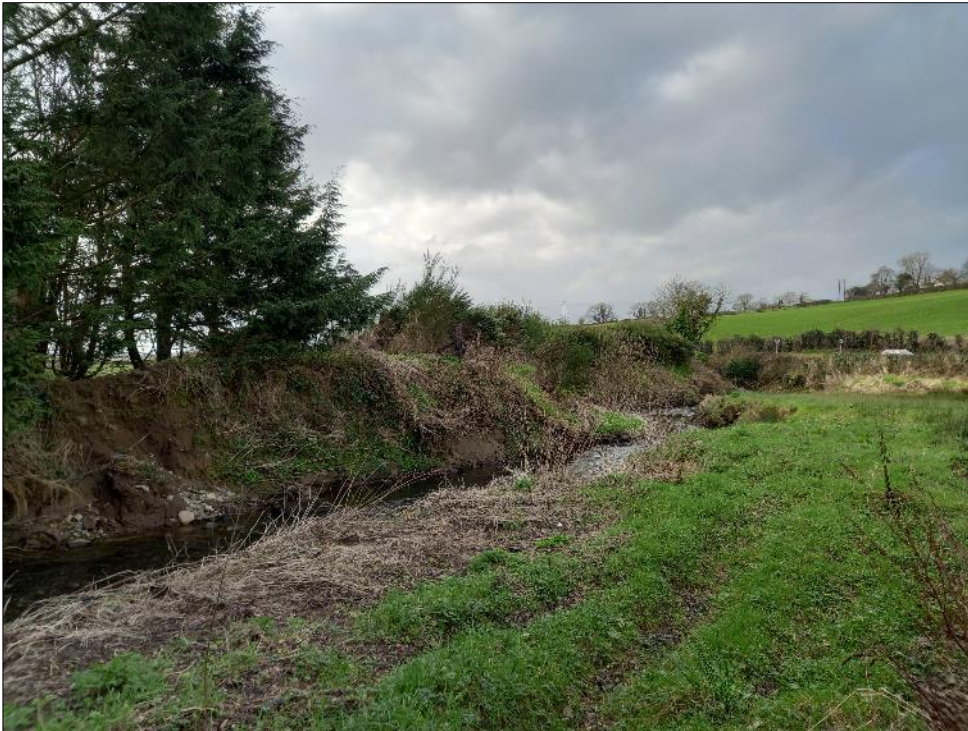
**Plate 15.5: View to west along southern riverbank and existing earthen embankment area**

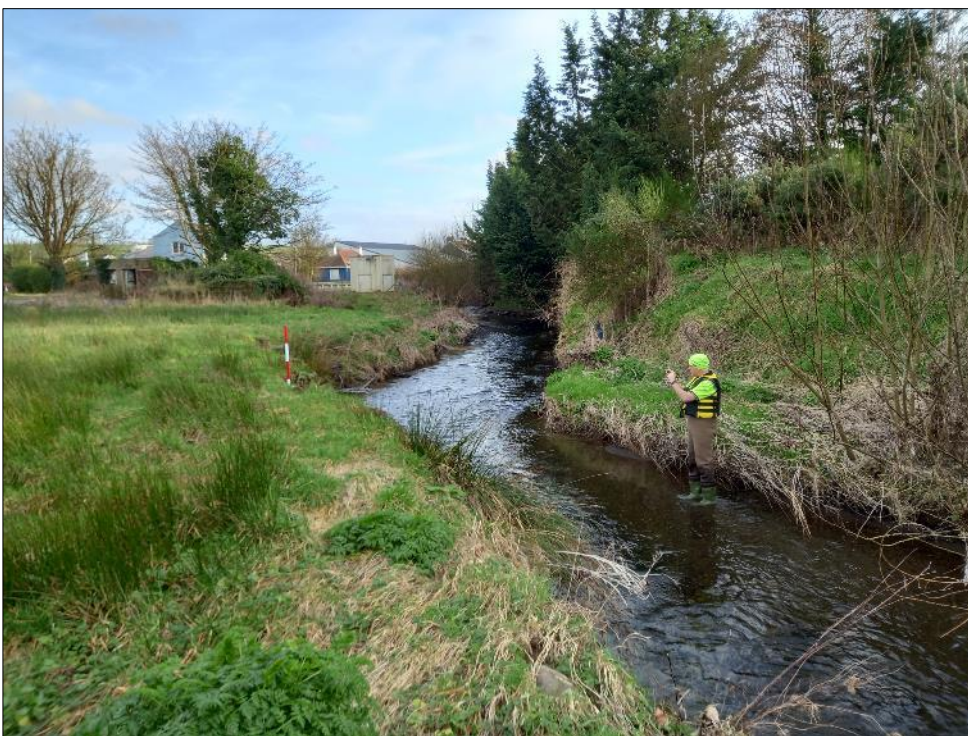
**Plate 15.6: View to east and bridge location beyond, along northern riverbank. Note location of burnt spread noted within exposed riverbank section (ranging rod).**

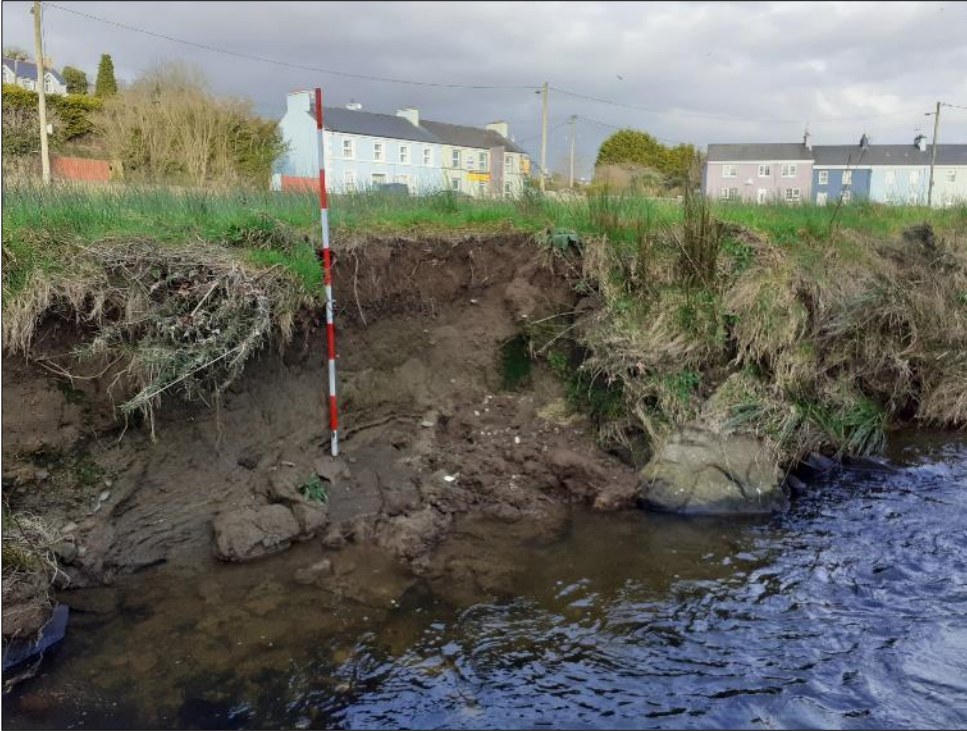
Plate 15.7: View to northeast of exposed section of burnt spread along northern riverbank edge

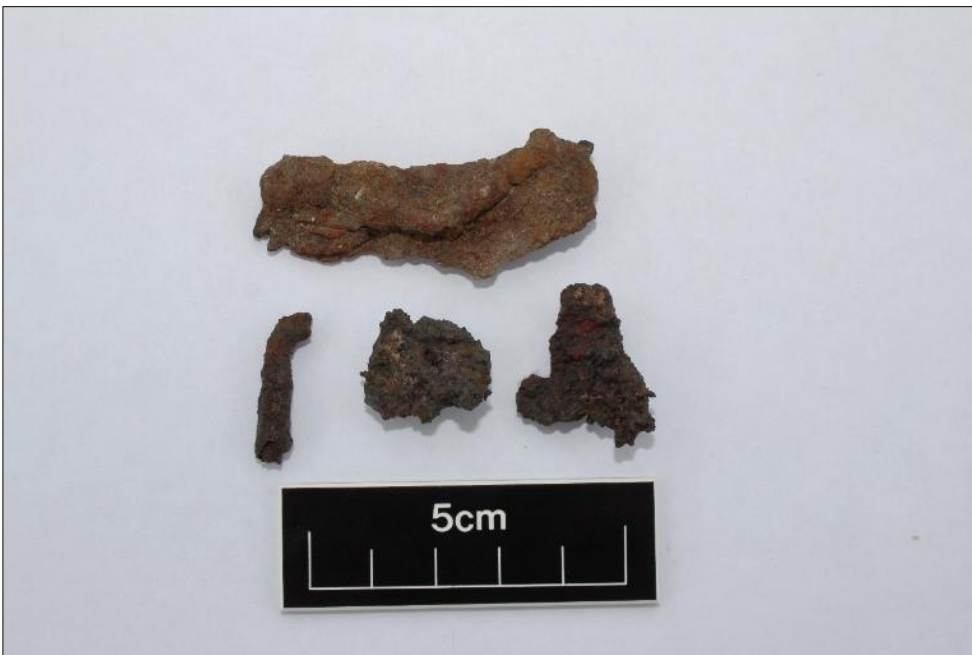
Plate 15.8: Detail of metal find and slag material retrieved from exposed soil at burnt spread material

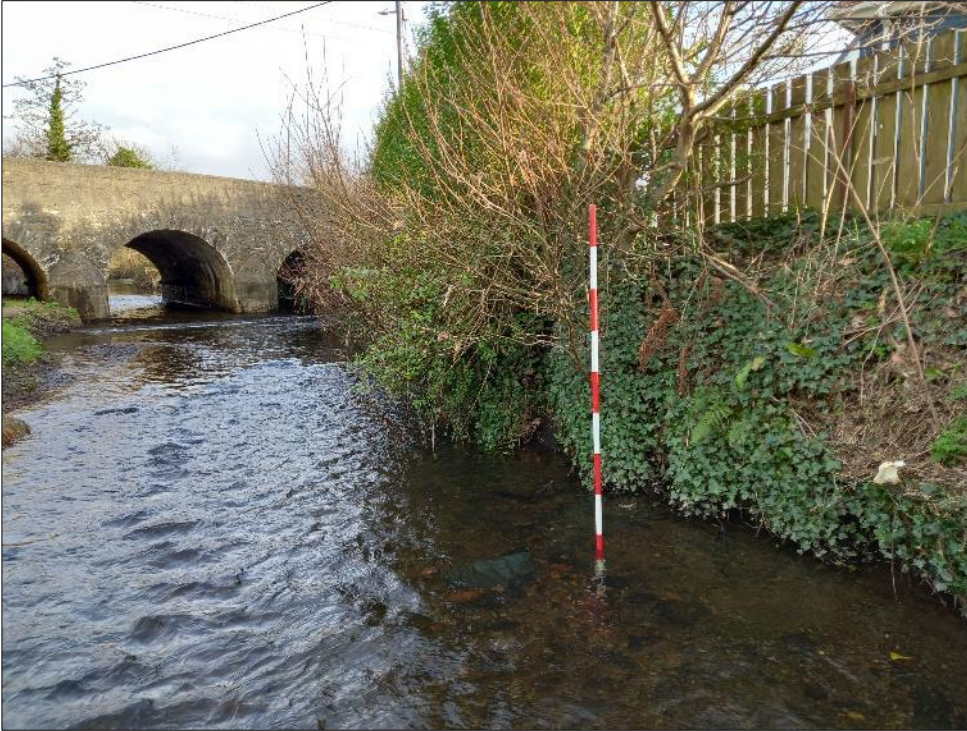
**Plate 15.9: View towards east of location of cylindrical metal object set within riverbed (west of bridge)**

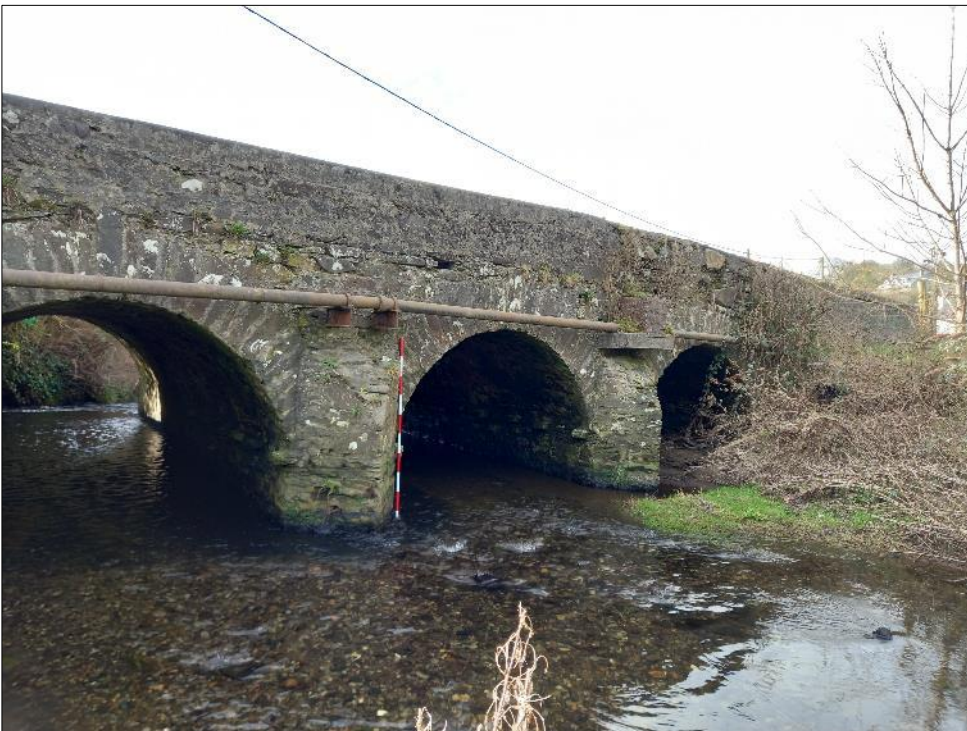
**Plate 15.10: View towards northwest of eastern elevation of Burnfoot Bridge**

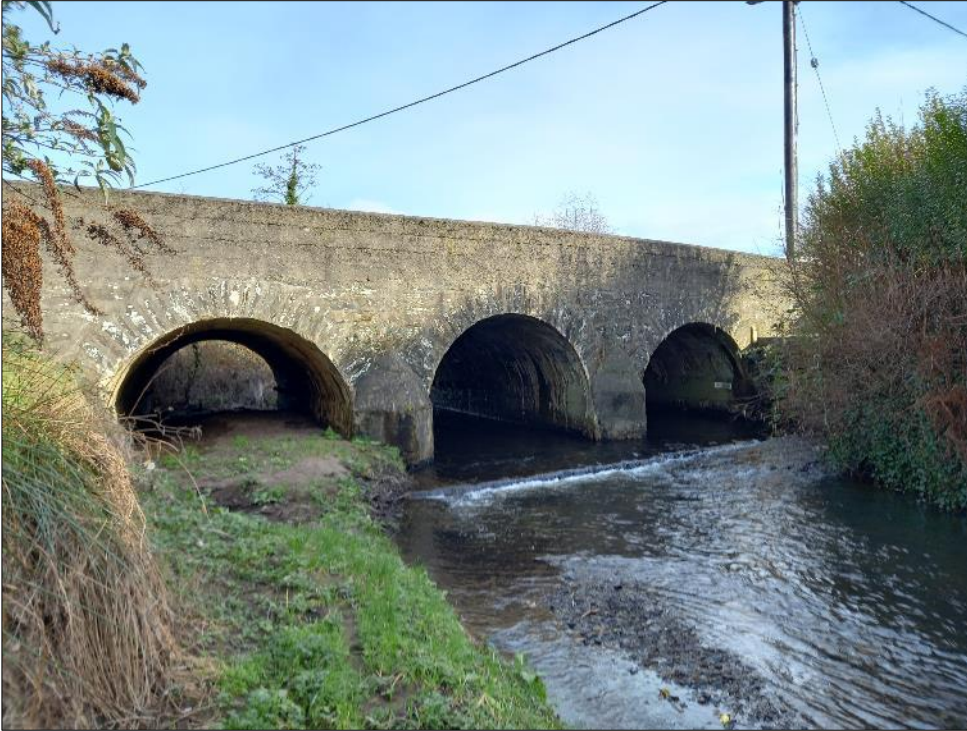
**Plate 15.11: View towards east of western elevation of Burnfoot Bridge**

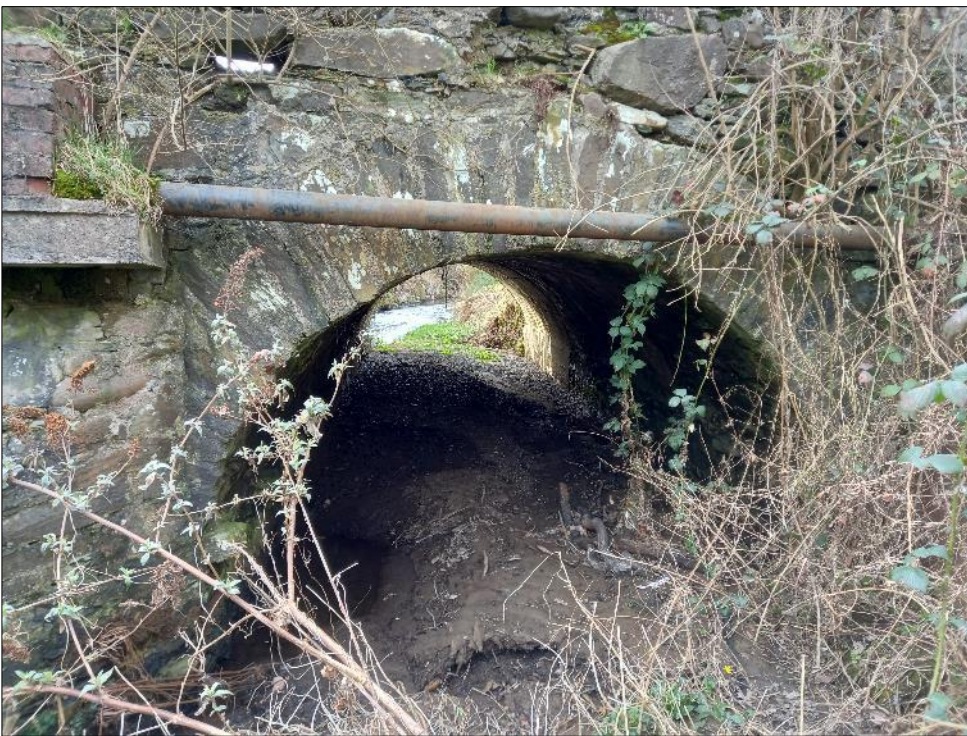
**Plate 15.12: View towards west of northern silted bridge arch on eastern bridge elevation**

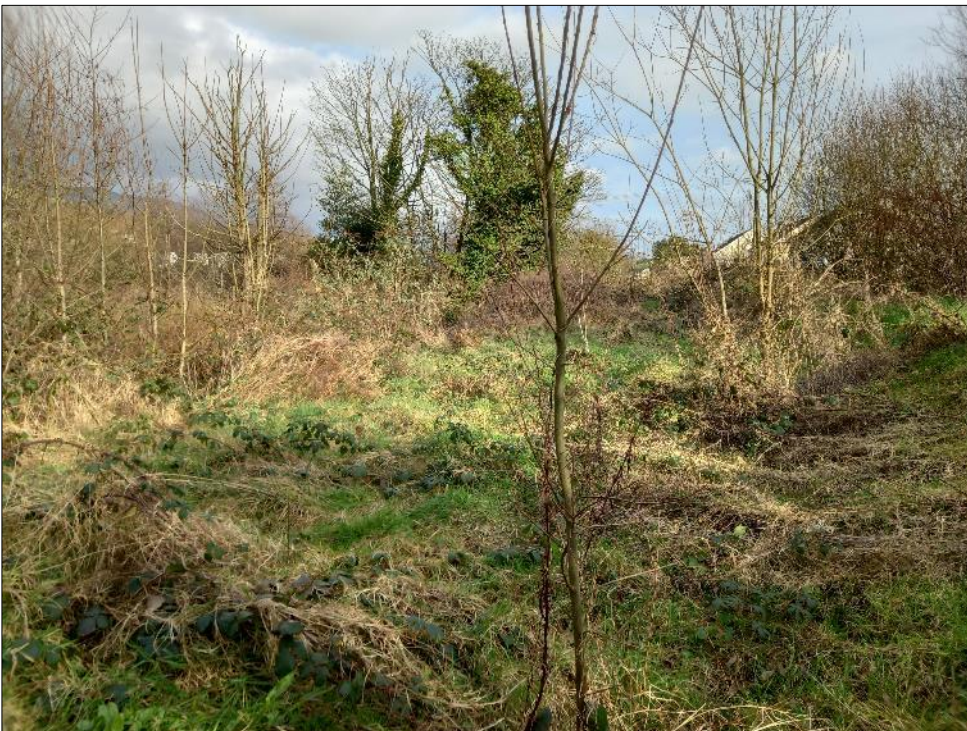
**Plate 15.18: View towards east (downstream) to rear of Lios na Gréine, along Burnfoot River bank**

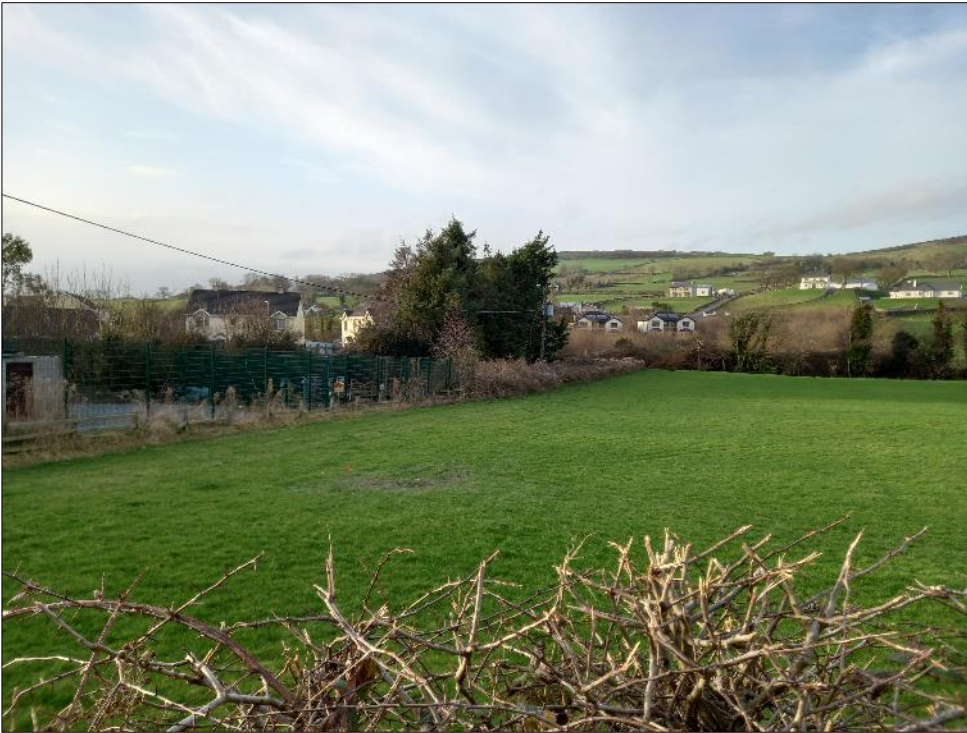
**Plate 15.19: View towards north and gently sloping pastureland flanking the Burnfoot River. This is the location of proposed embankment and temporary site compound/storage area (AAP02). Note existing Burnfoot WWTP to left of image**

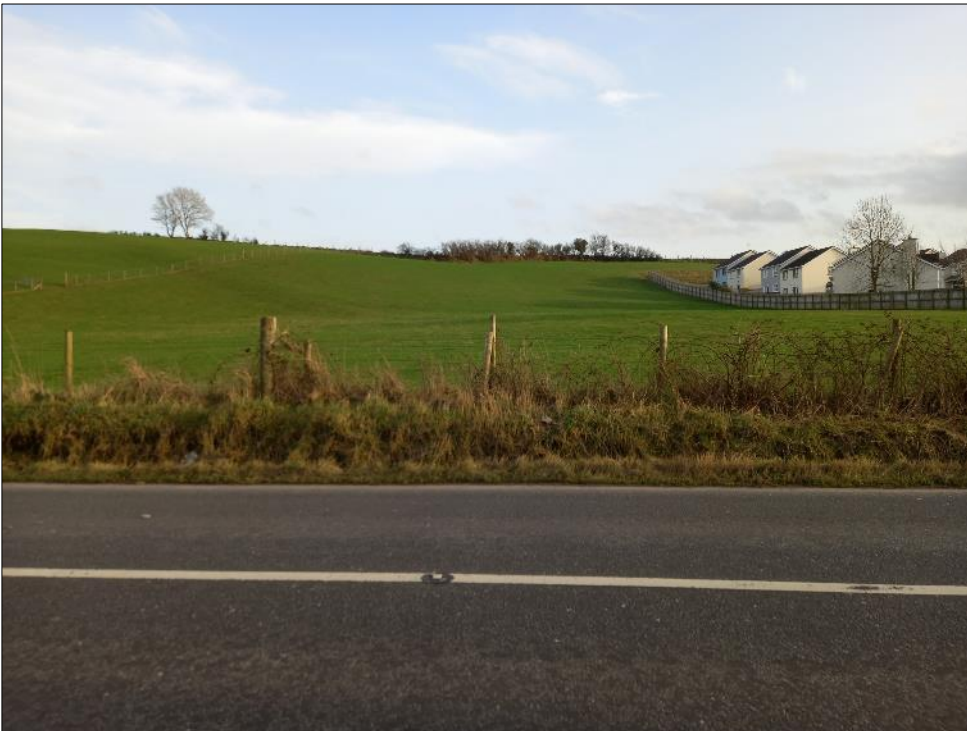
**Plate 15.20: View towards south and higher good quality pasture opposite Páirc and Grianán area**

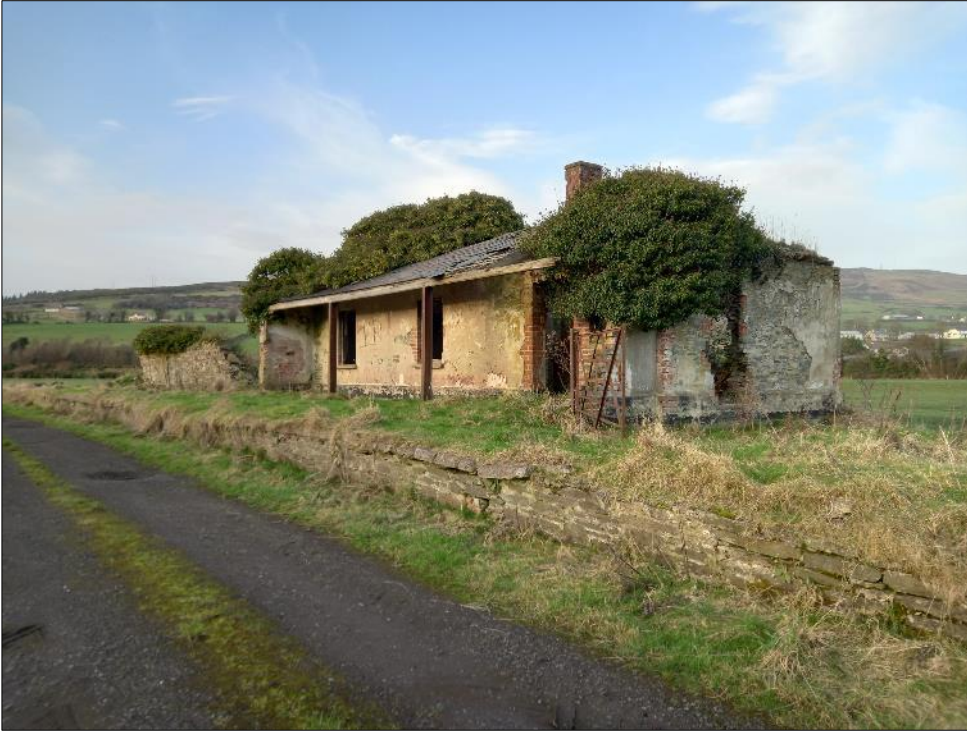
**Plate 15.21: View towards north and former Burnfoot Railway Station and Londonderry & Lough Swilly Railway line (now an access track) located southwest and outside of the proposed works area**

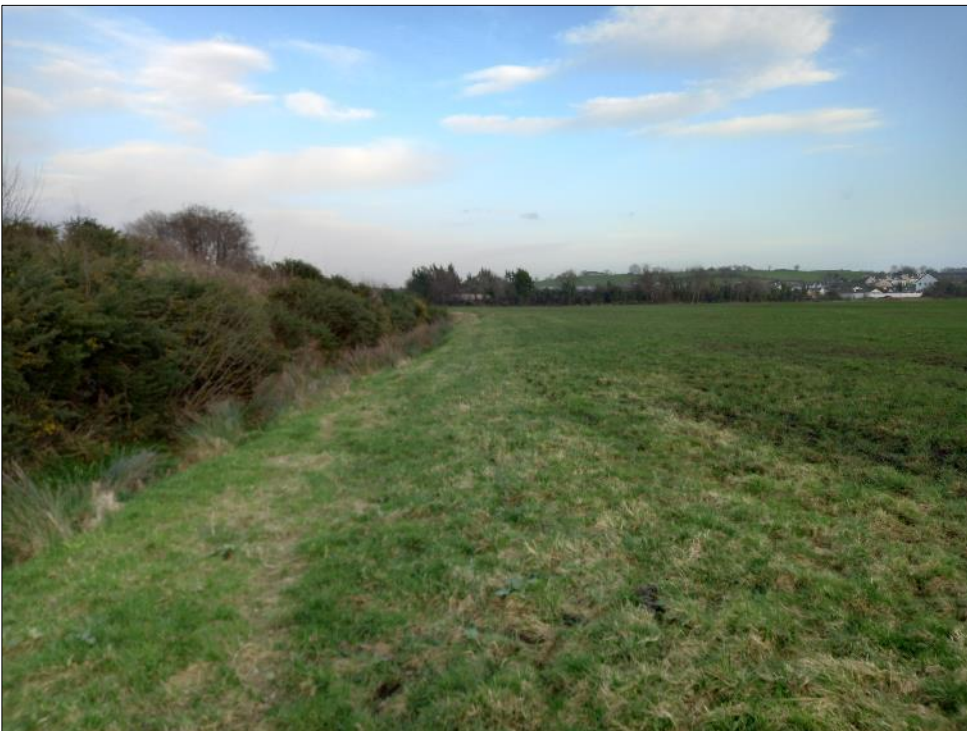
**Plate 15.22: View towards east along existing embankment (left of image) proposed for removal**

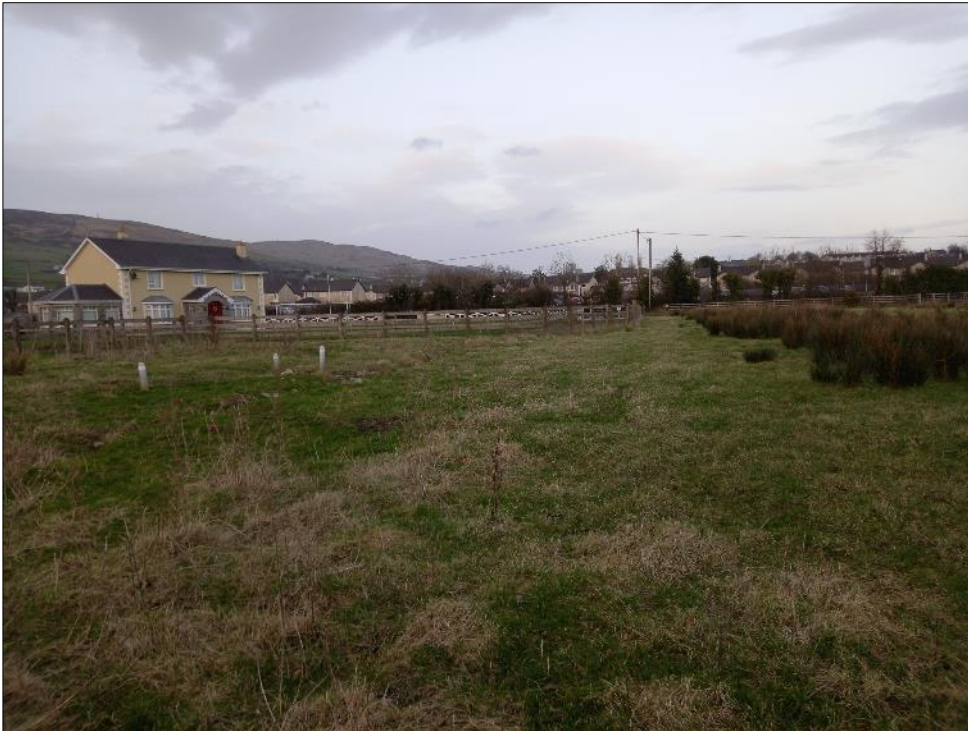
**Plate 15.27: View towards northeast and location of former Burnfoot Brick Works**

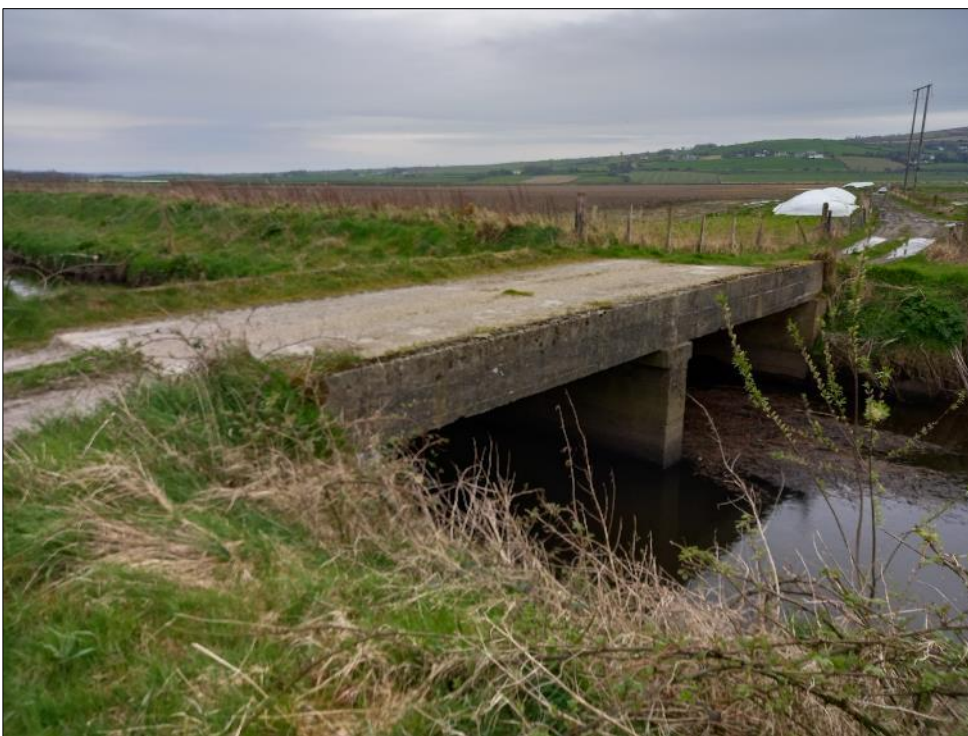
**Plate 15.28: View towards southwest of concrete vehicular bridge crossing the Skeoge River**

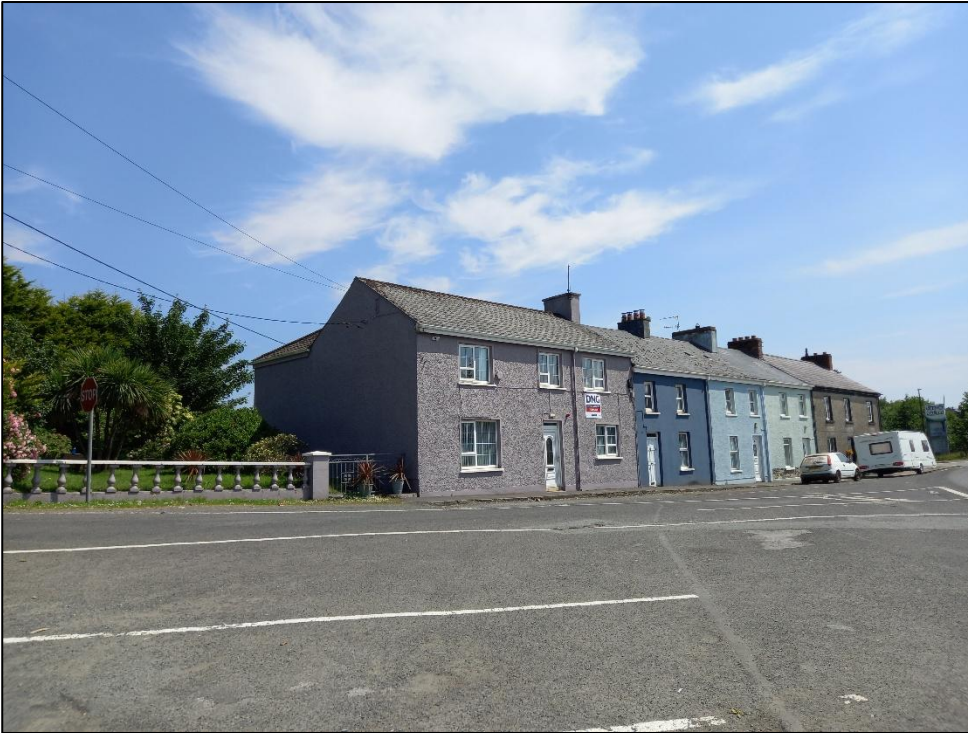
**Plate 15.33: View towards the southeast of former site of RIC Constabulary Barracks (gable end house and adjacent greenfield site) that was attacked and burned with the use of explosives in August 1920**

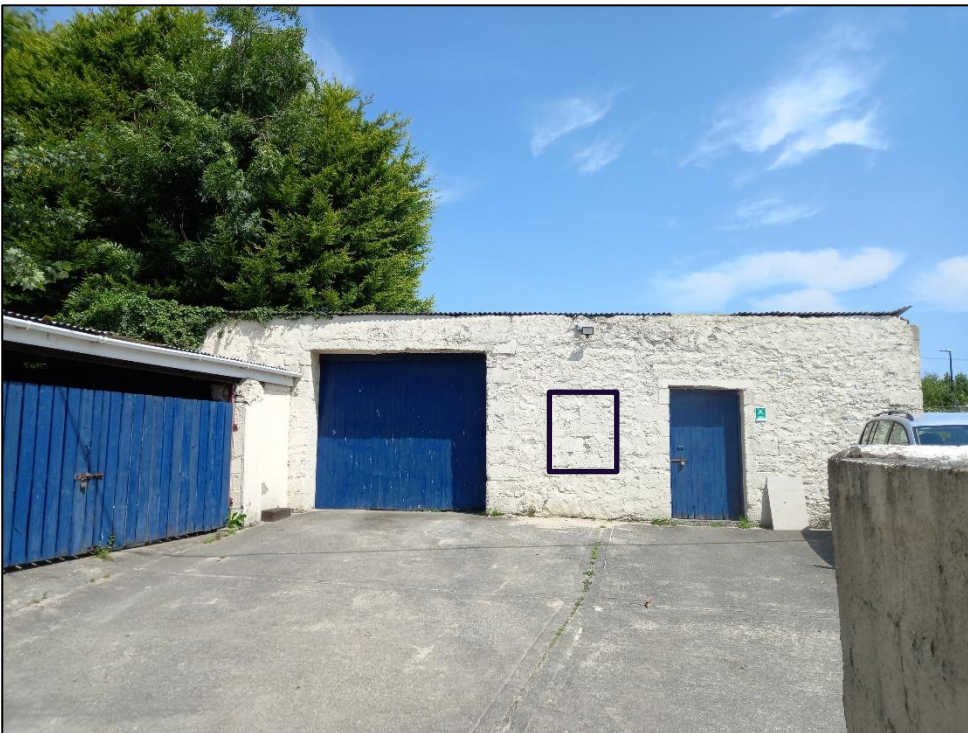
**Plate 15.34: View towards east elevation of rear outbuilding within former RIC barracks complex. Note blocked up opening (black line) and breeze blocks with concrete lintels to existing opening surrounds. Note also attached modern built shed to northwest**

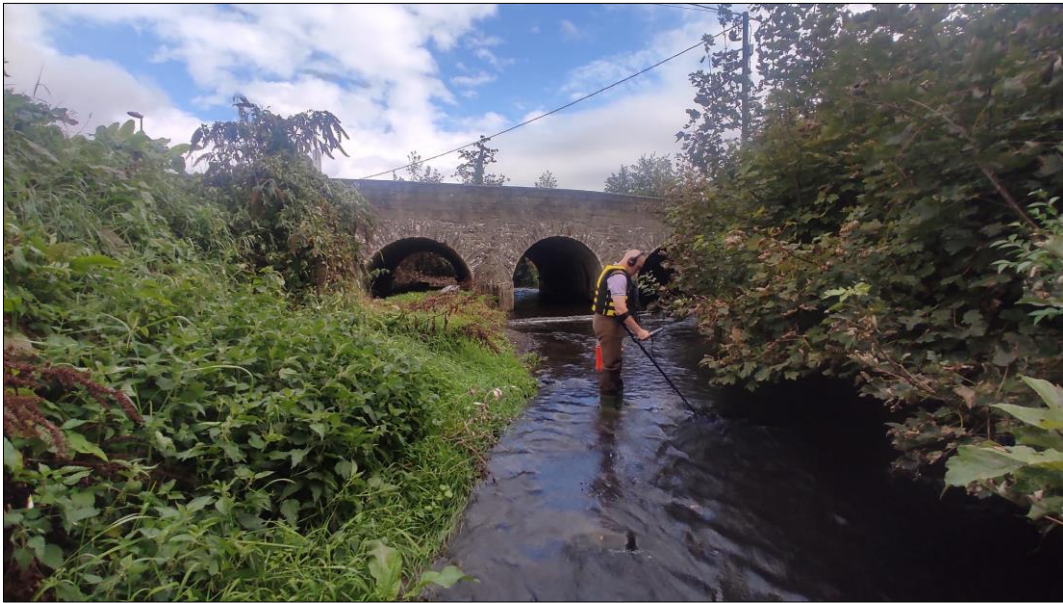
**Dive/Survey Licence 23D0073 & Detection Device Consent 23R0067ext.**

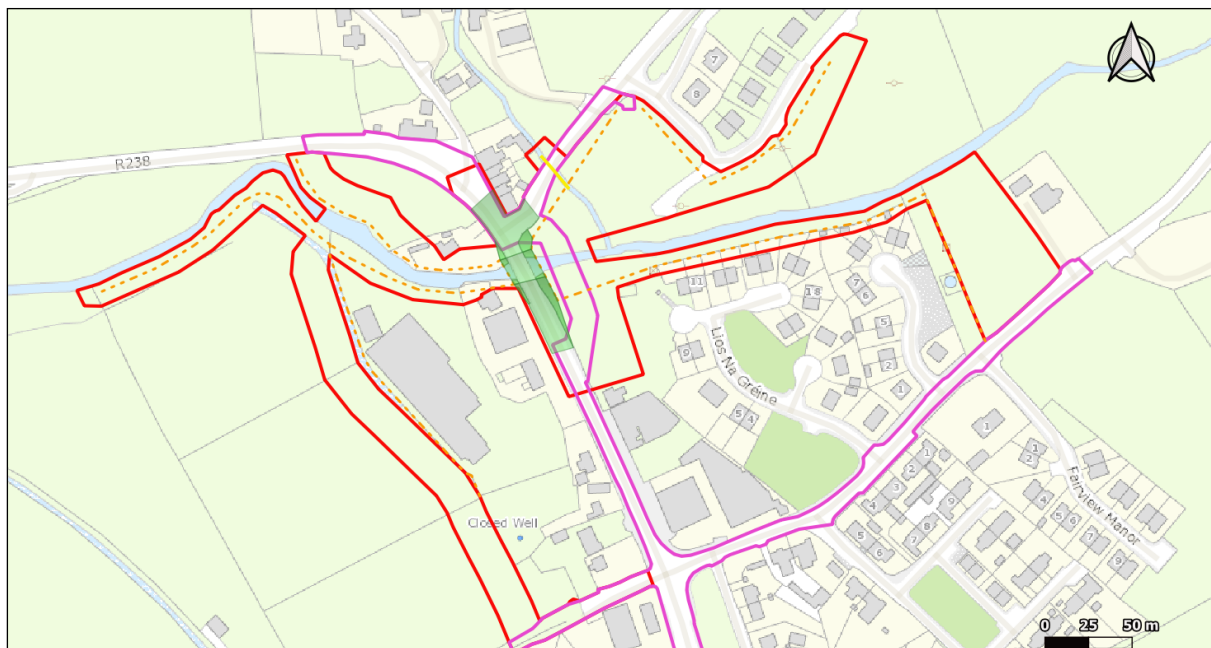
**Figure 1** Proposed Scheme Area and Redline Boundary (red) extent adjacent Burnfoot River (access roads in purple)

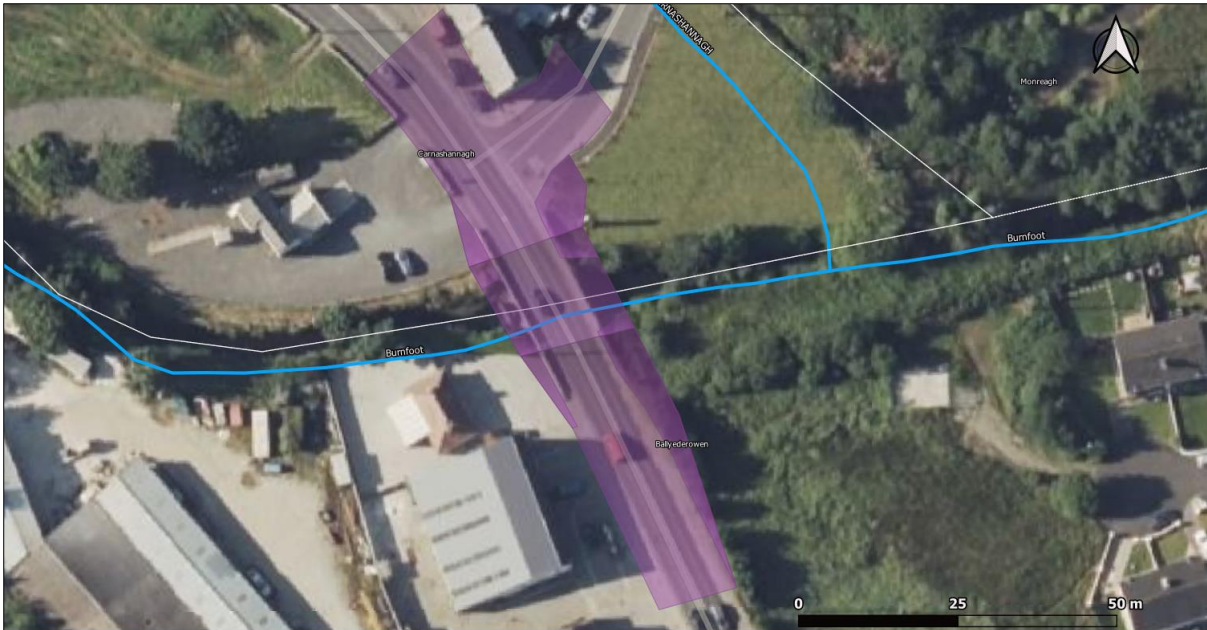
**Figure 2** Proposed replacement bridge location and works areas, Burnfoot Flood Relief Scheme, Co. Donegal

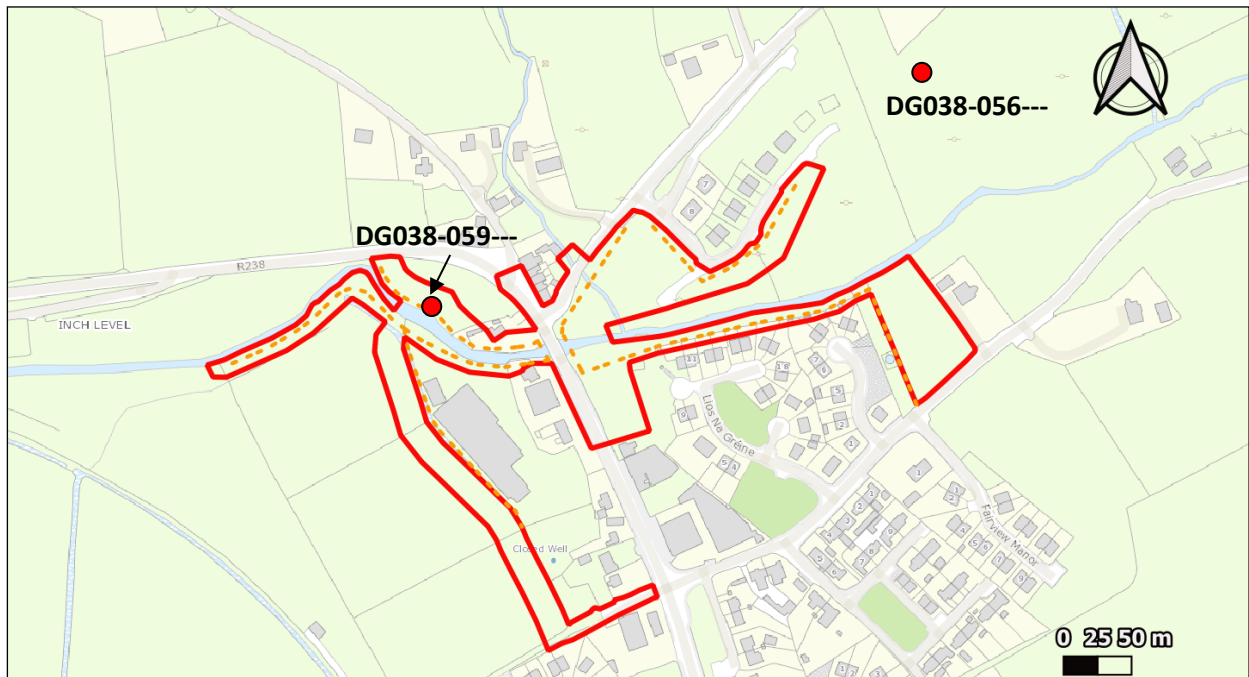
Figure 3: Recorded Archaeological sites within 500m of subject site.

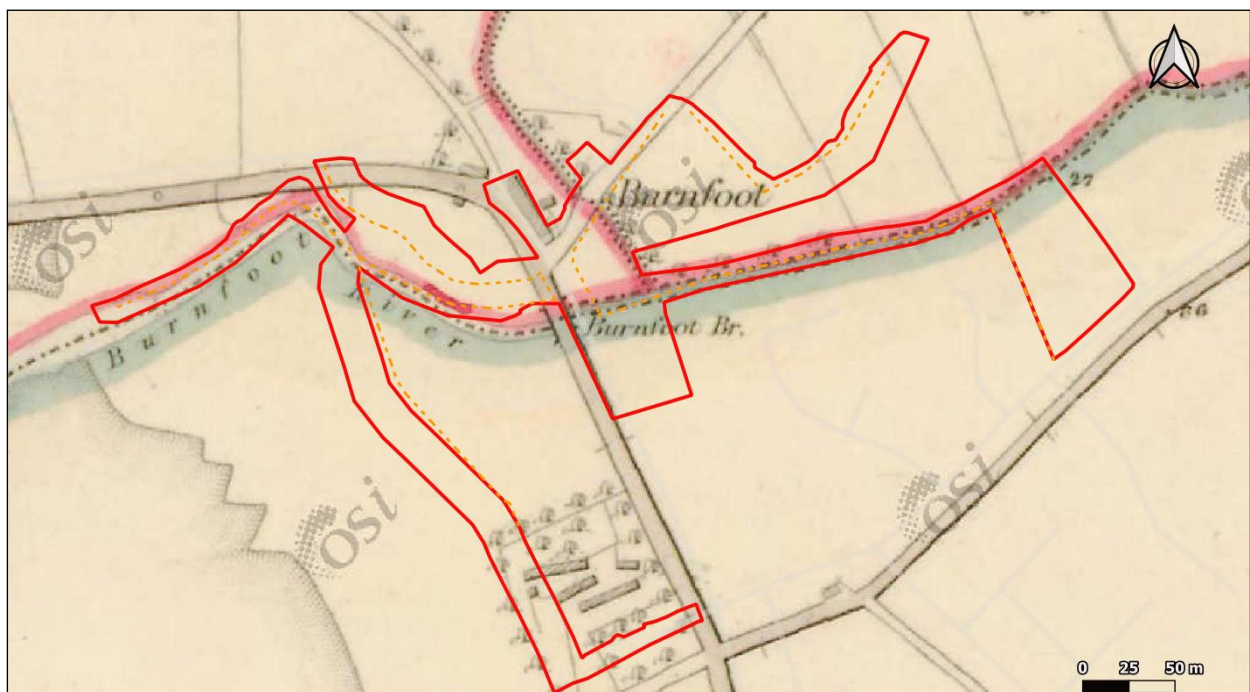
**Figure 4:** First edition OS map extract showing Burnfoot River relative to the proposed Burnfoot FRS

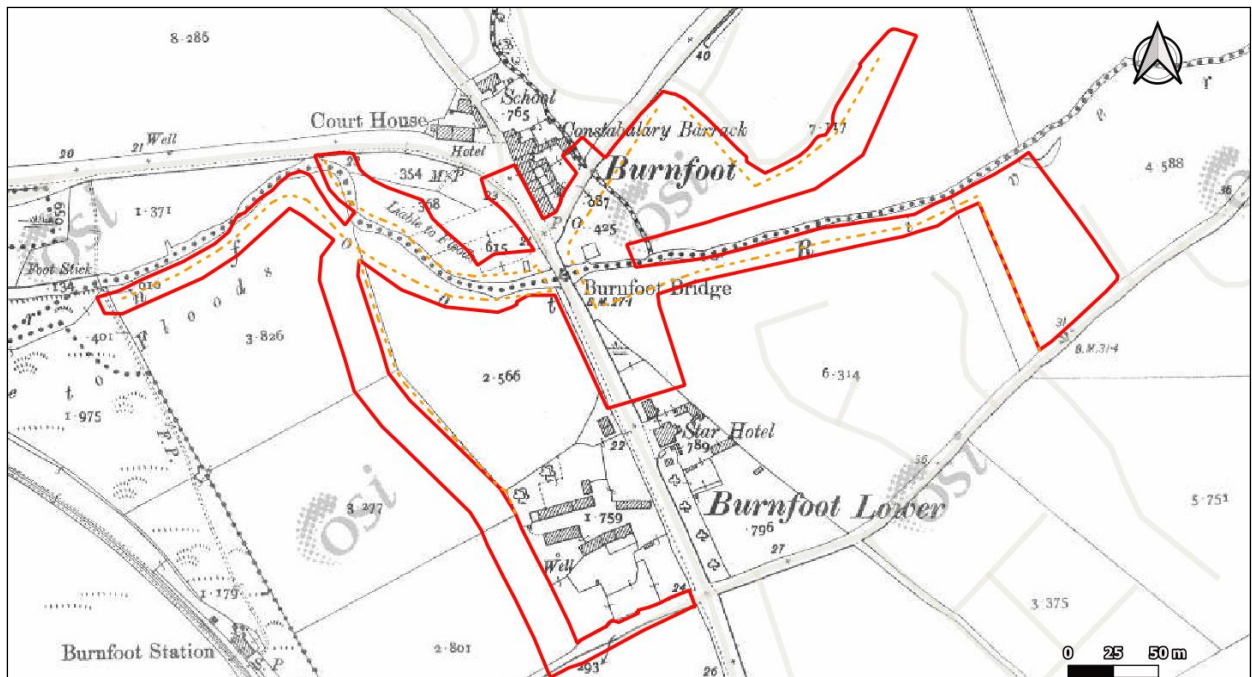
**Figure 5:** 25-inch edition OS map extract showing Burnfoot River relative to the proposed Burnfoot FRS

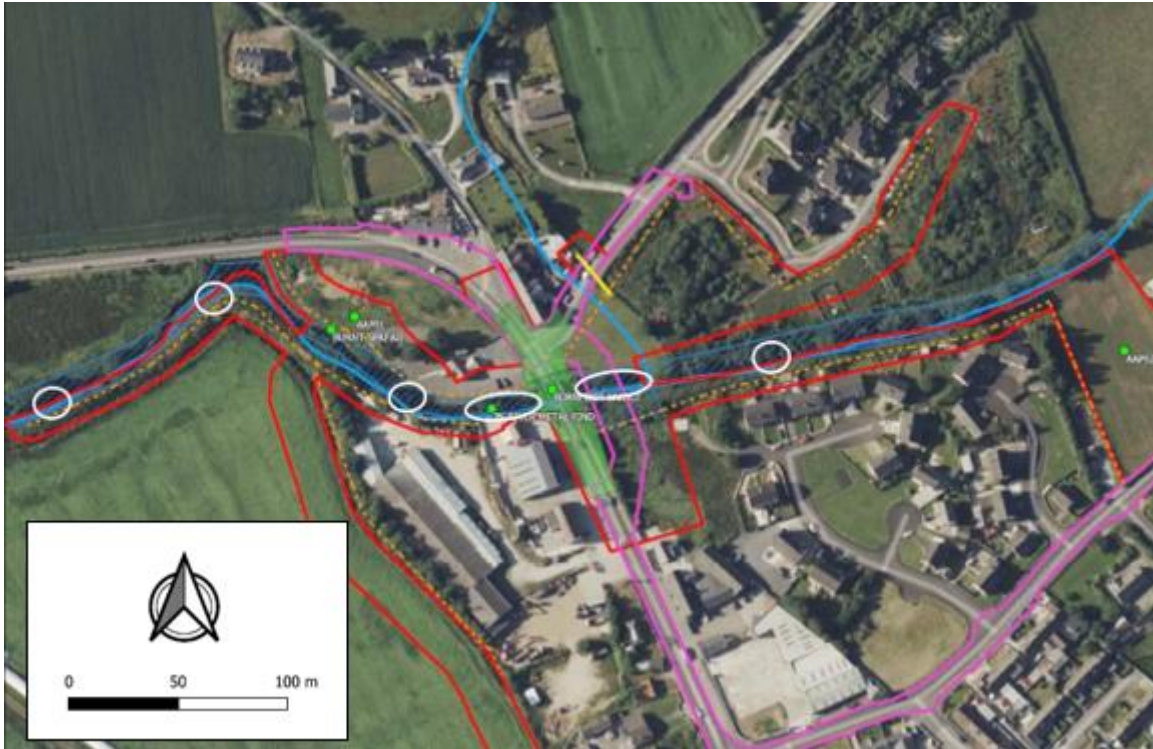
**Figure 3:** *Approximate locations of ceramic finds encountered during survey (non-archaeological)*

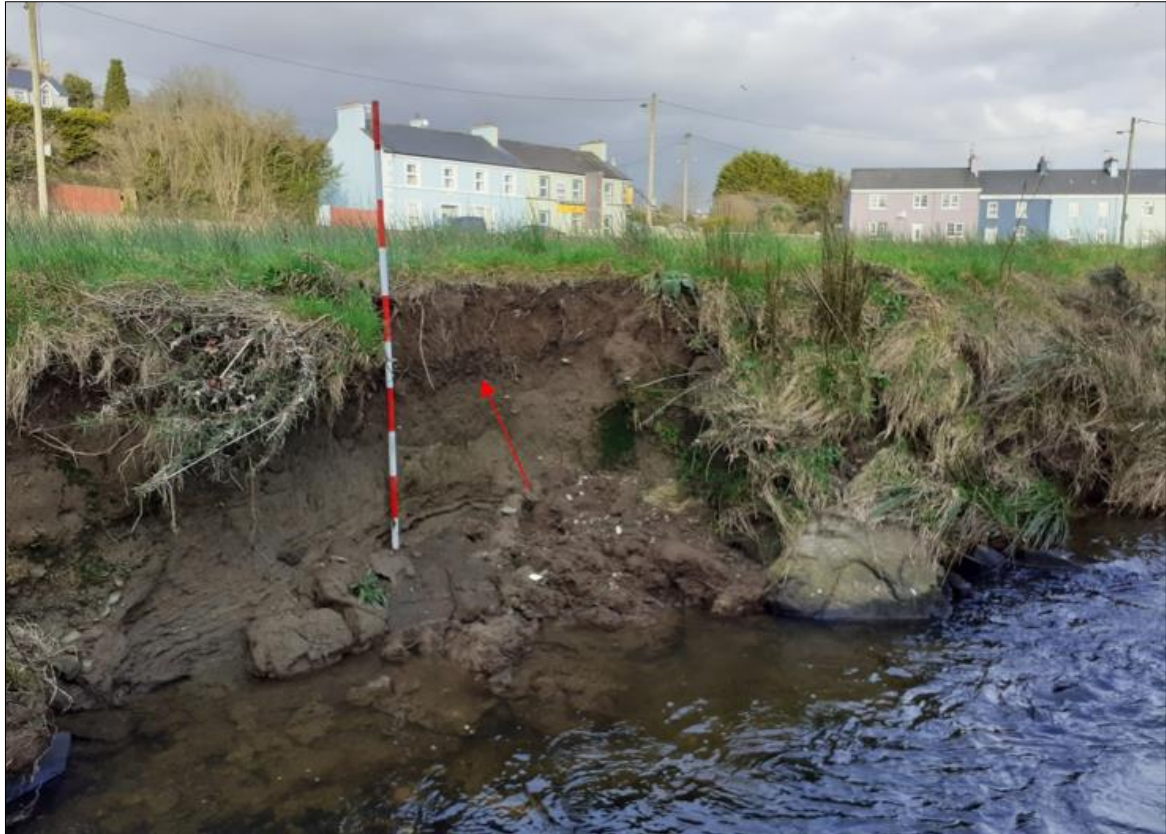
*Figure 5: Location of exposed section of riverbank c. 105m downstream from proposed replacement bridge location*

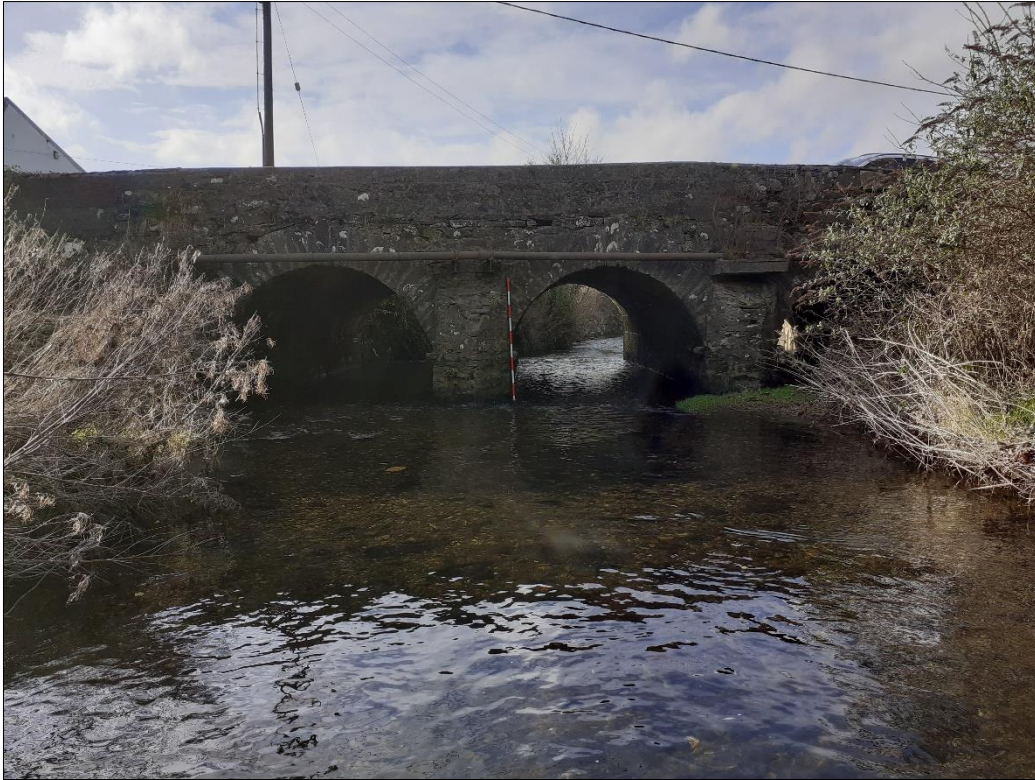
*Plate 1: East (upstream) elevation of Burnfoot Bridge, facing west*
