# Appendix 15

## Appendix 15.1

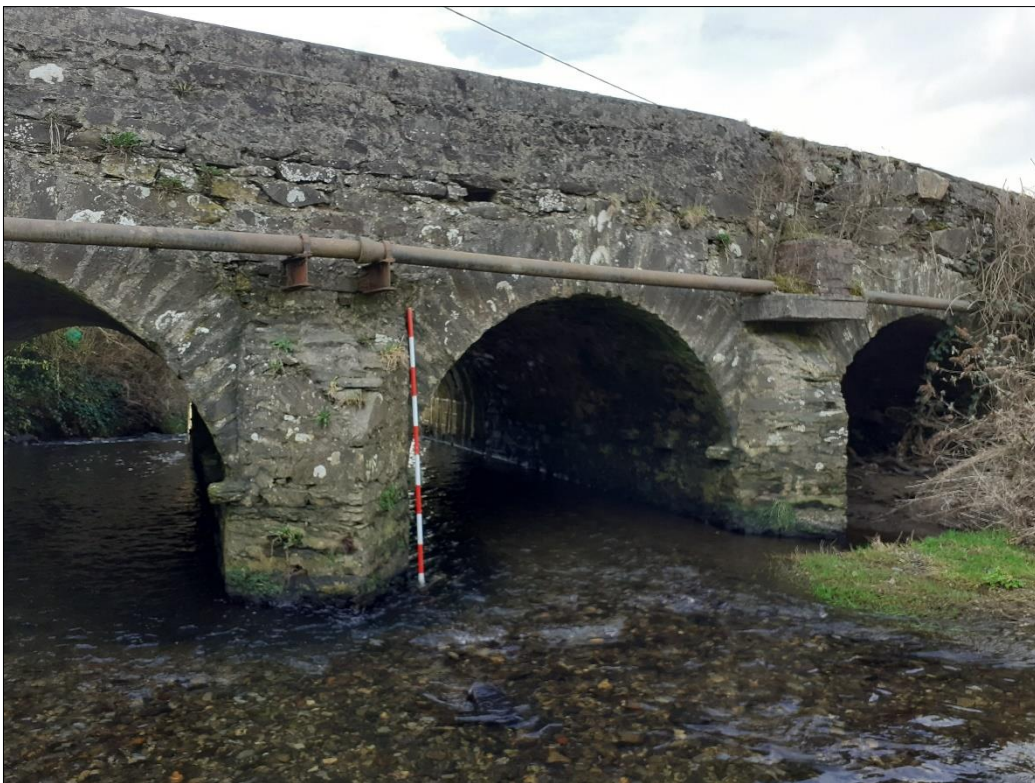
*Plate 2: East (upstream) elevation of Burnfoot Bridge showing cutwaters, and parapet detail, facing west*

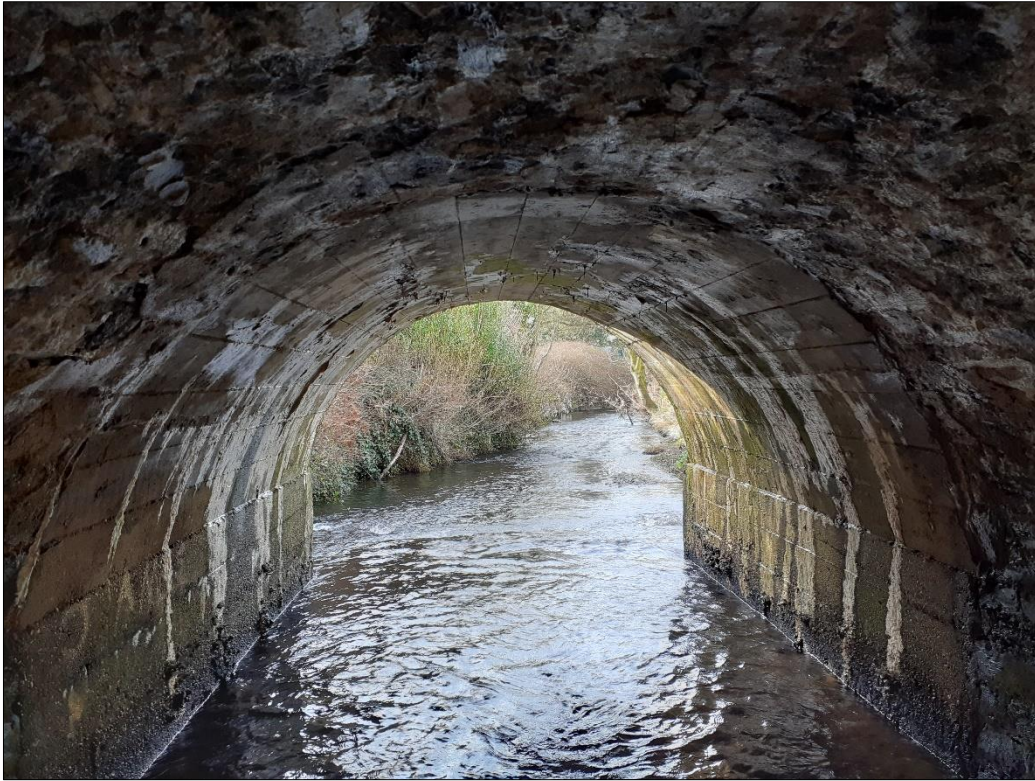
*Plate 3: Bridge soffit, showing the composite construction of the widened bridge, facing west*

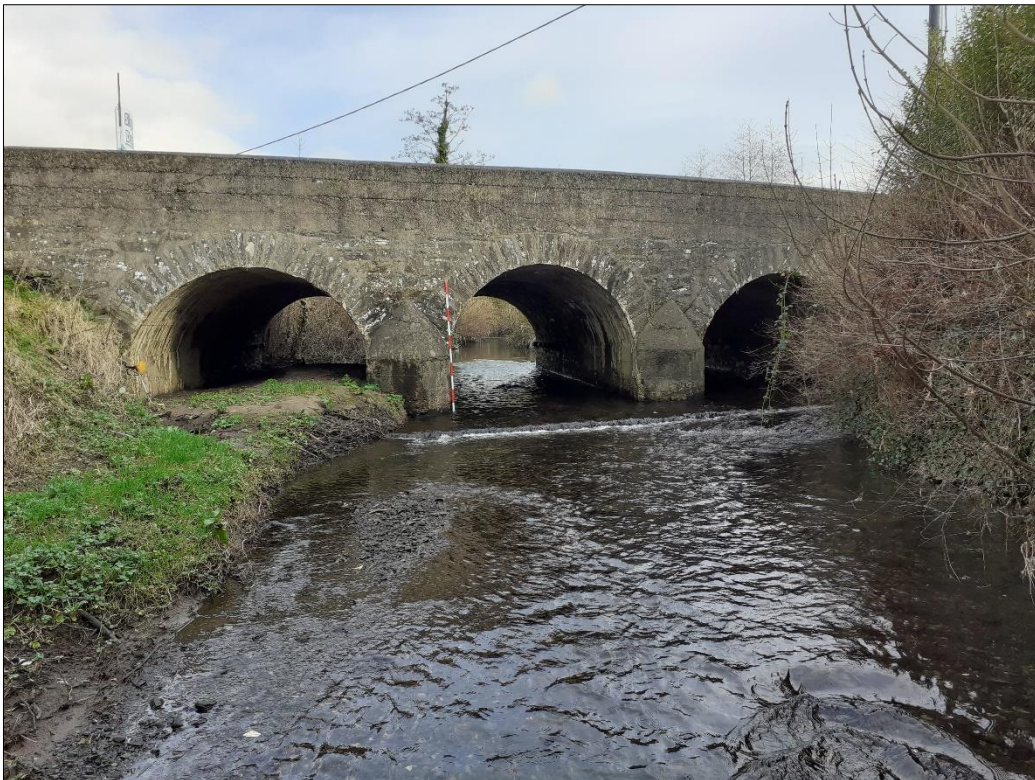
*Plate 4: West (downstream) elevation of Burnfoot Bridge, facing east*

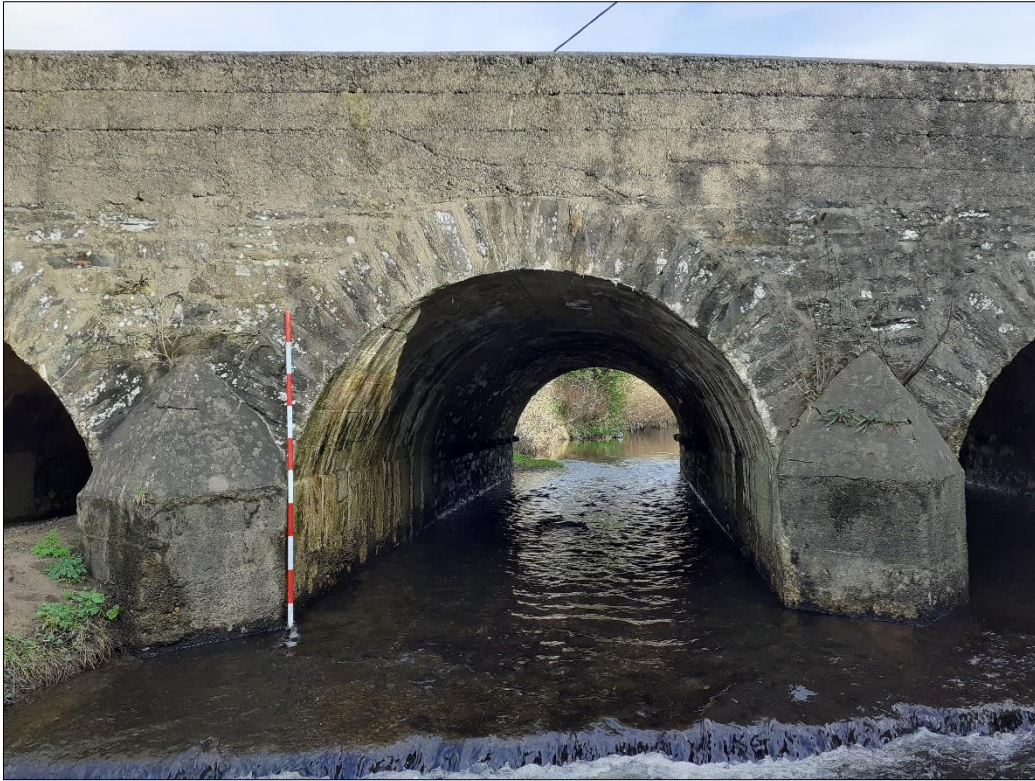
*Plate 5: West (downstream) elevation of Burnfoot Bridge showing concrete plinth, cutwaters and parapet, and cut stone voussoirs, facing east*

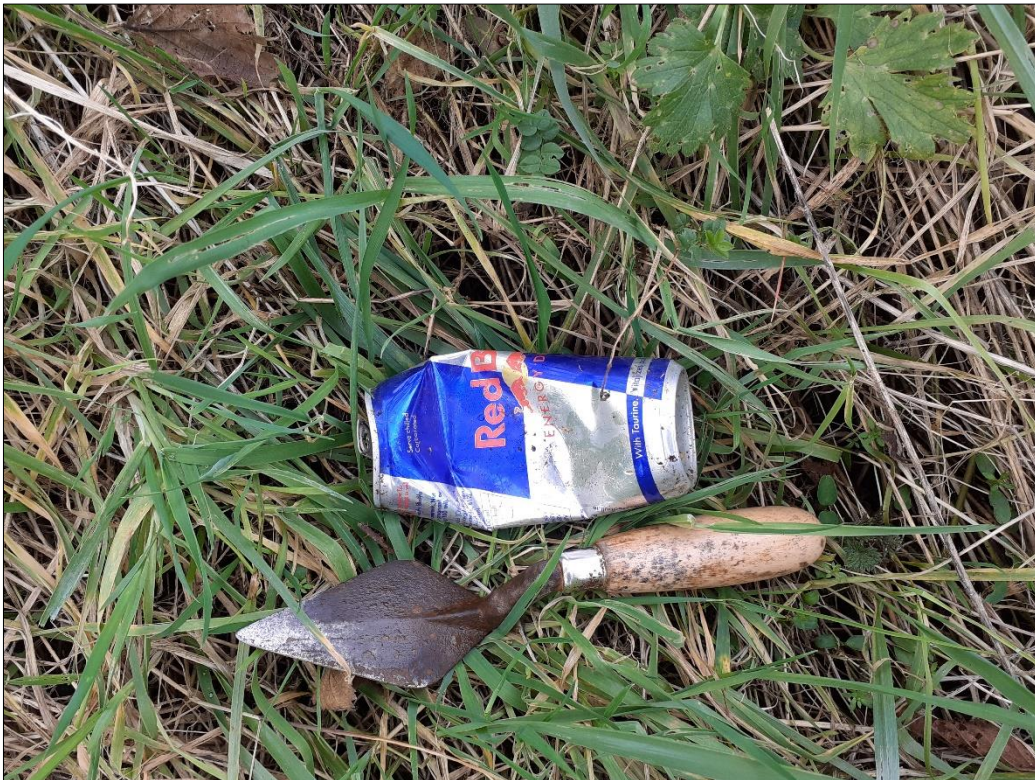
*Plate 6: Typical metal find on south bank, upstream side of Burnfoot Bridge*

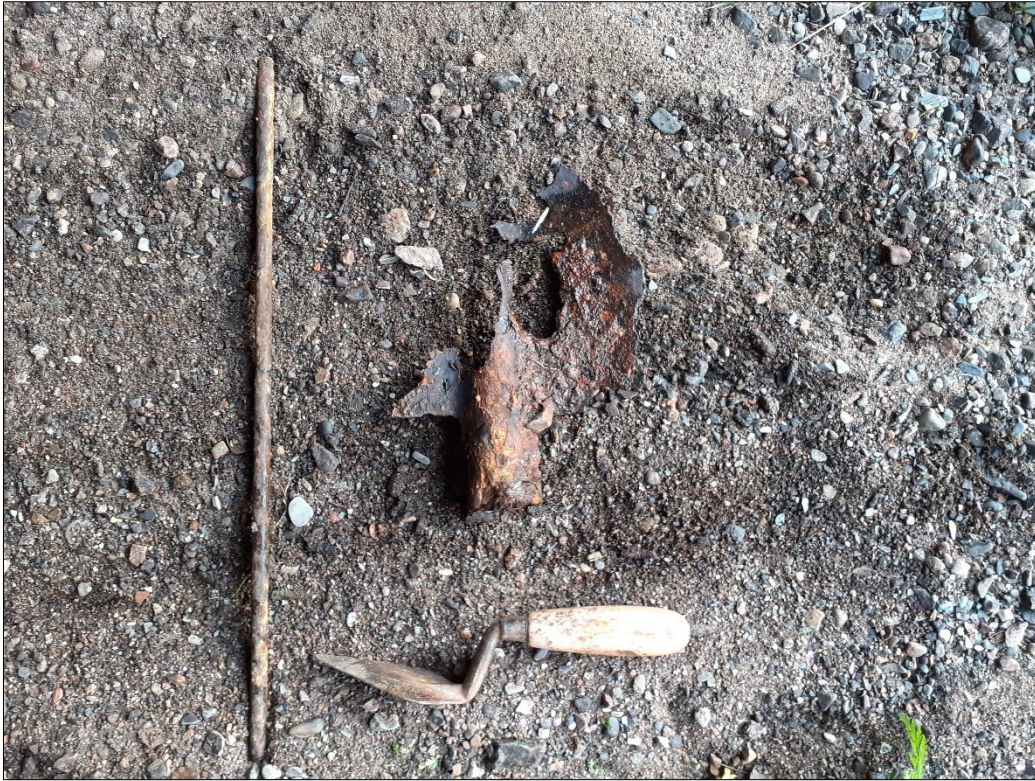
*Plate 7: In-river metal finds from east (up to 10m upstream) of Burnfoot Bridge*

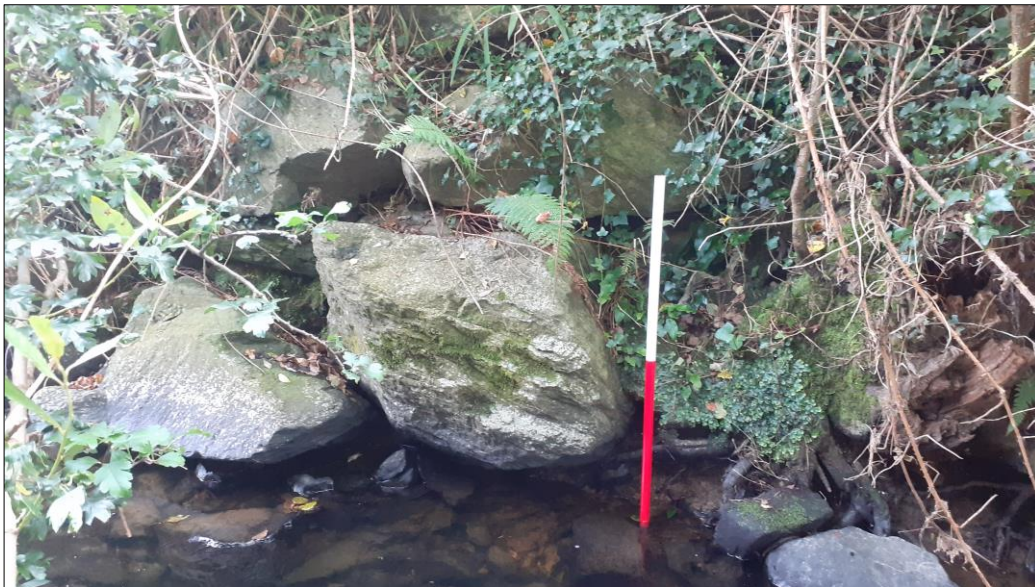
*Plate 8: View of boulders along south bank of river at approximately 60m upstream. This was likely a flood protection measure for the Lios na Greine housing development to the south*

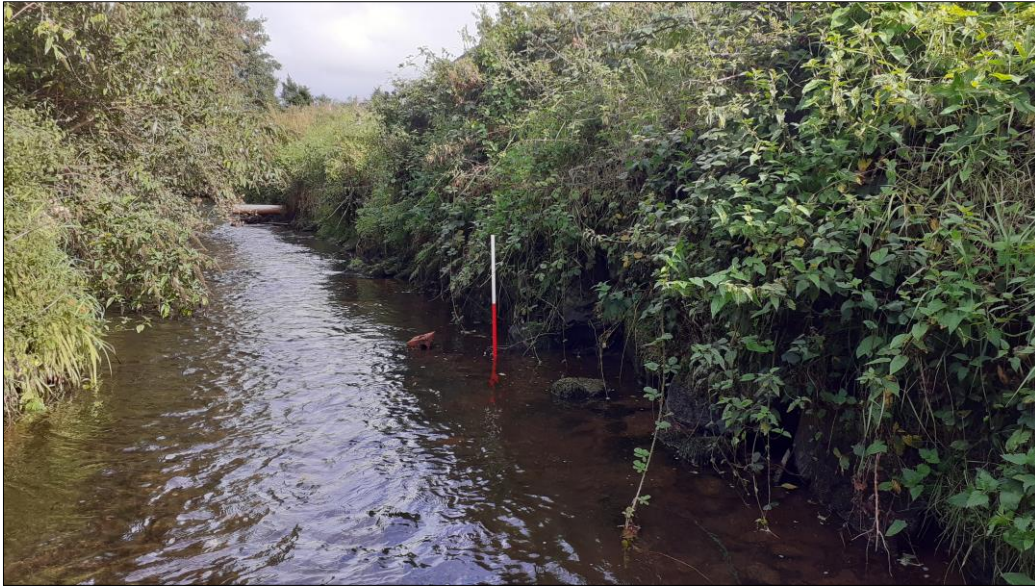
**Plate 9:** View of river channel facing east-northeast (approximately 100m upstream of Burnfoot Bridge). Note continued flood protection boulders and outflow pipe associated with Lios na Greine housing development

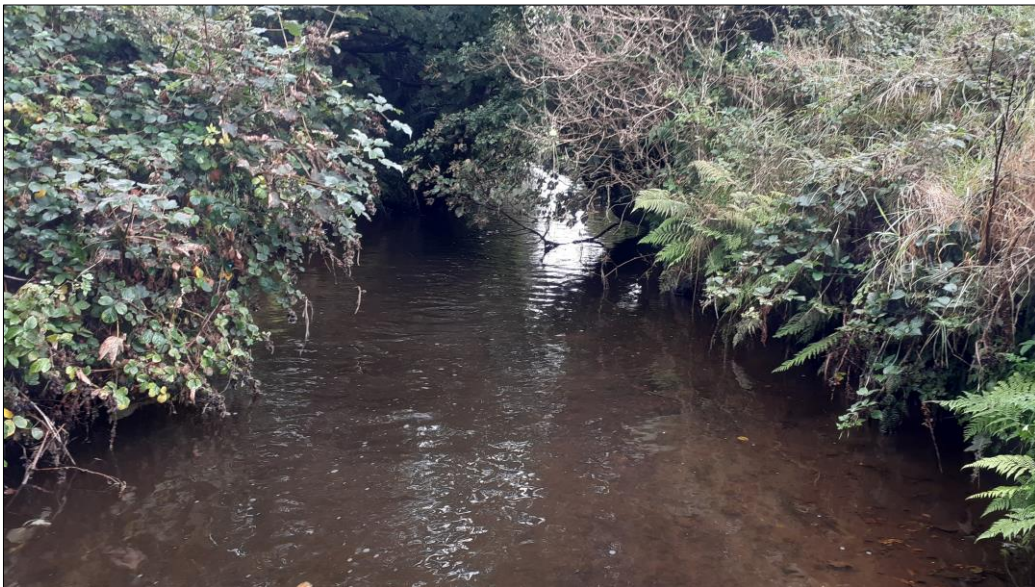
**Plate 10:** In-channel view from the eastern end of the survey area, facing west-southwest

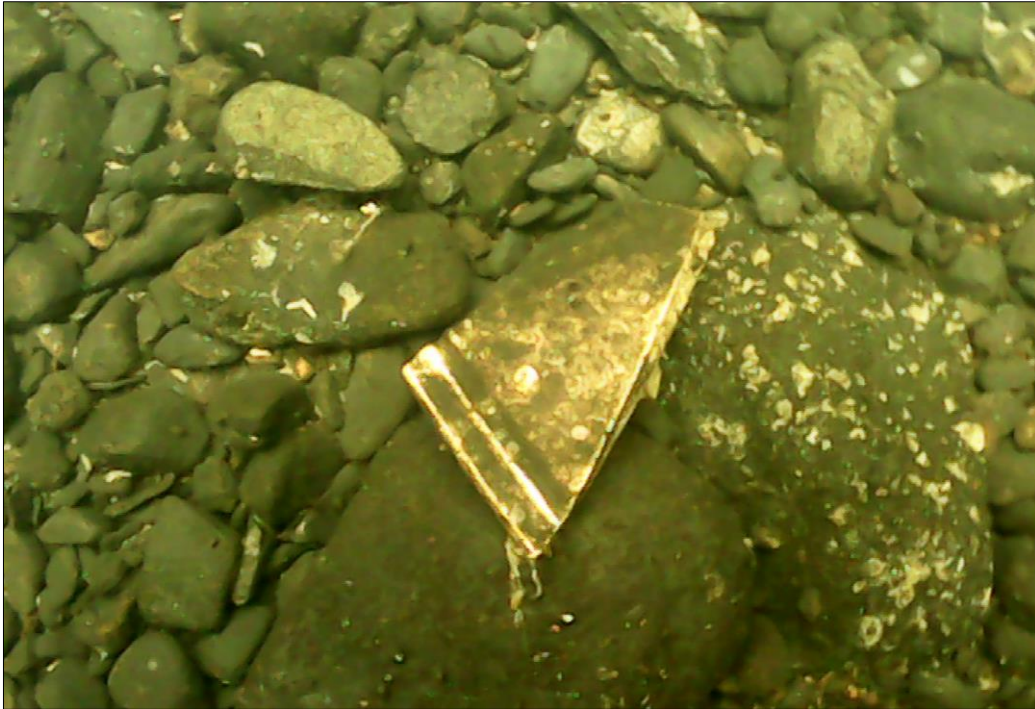
*Plate 13: Underwater image showing the riverbed composition and modern ceramic sherd from immediately east (upstream) of Burnfoot bridge*

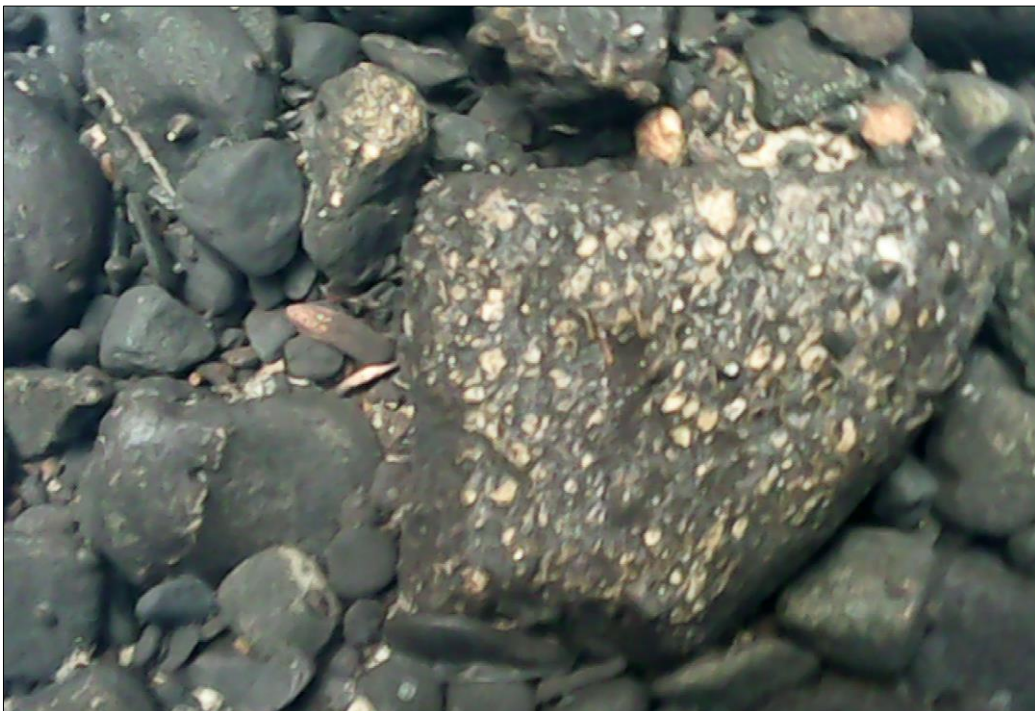
*Plate 14: Underwater image showing the riverbed composition at approximately 100m east (upstream) of Burnfoot bridge*

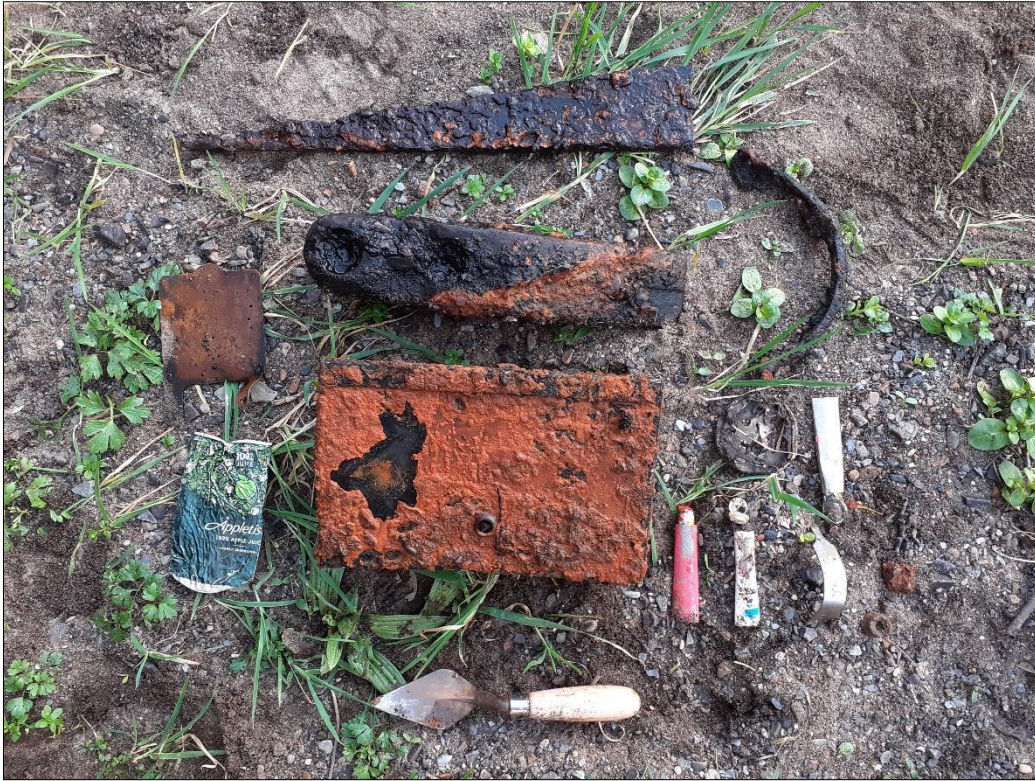
*Plate 15: In-river metal finds from west (up to 10m downstream) of Burnfoot Bridge*

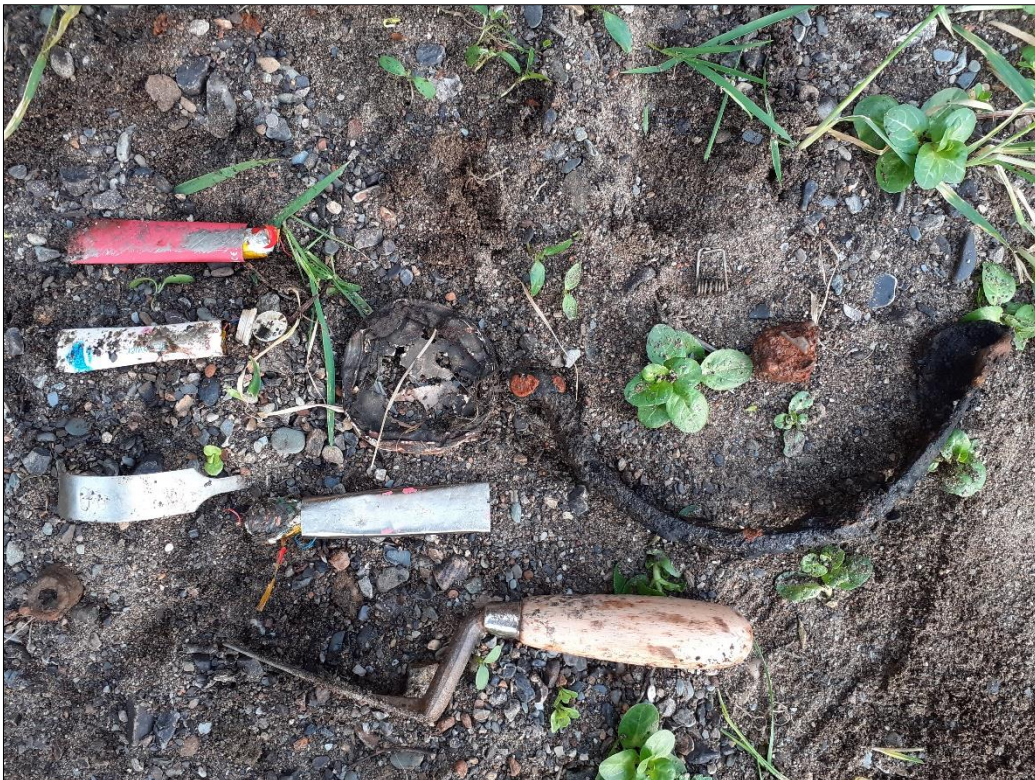
*Plate 16: Close up of some of the in-river metal finds from west (up to 10m downstream) of Burnfoot Bridge*

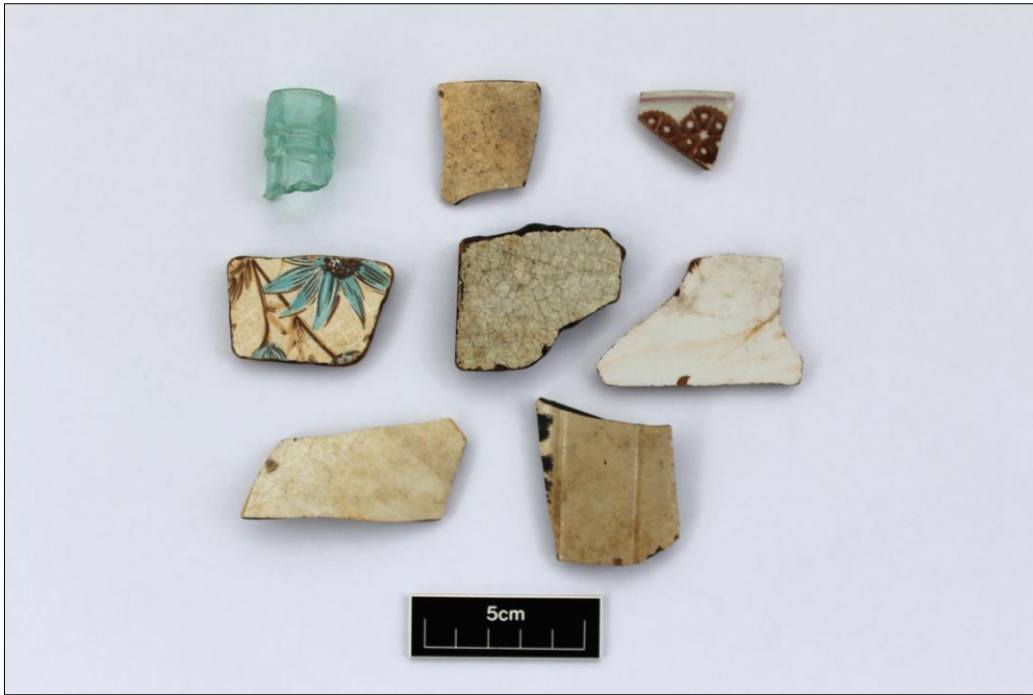
**Plate 17:** *In-river ceramic and glass fragments from west (up to 10m downstream) of Burnfoot Bridge*

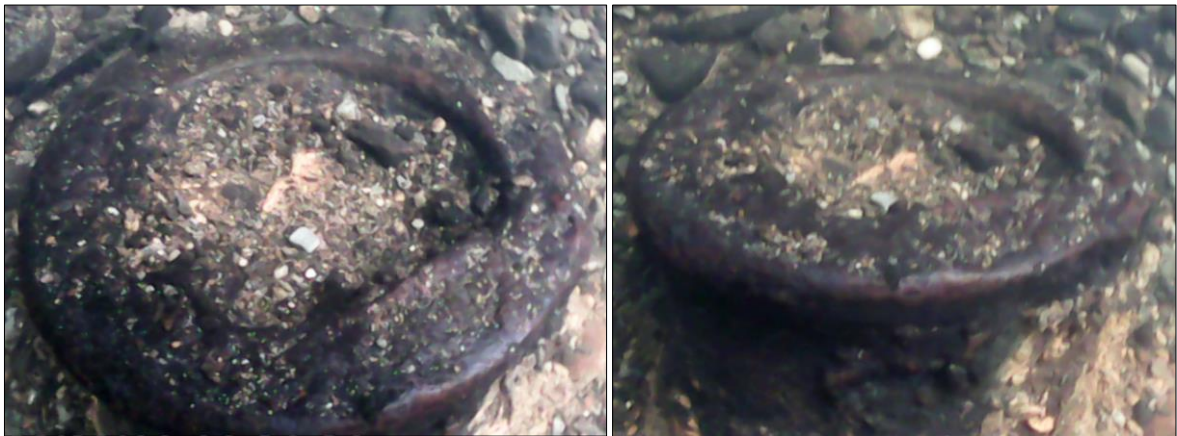
**Plate 18:** *Underwater image of ferrous metal pipe located approximately 15m west of Burnfoot bridge. This object is similar in shape and composition to the flange of a pipe that is appended to the eastern side of the bridge (see **Plate 2**)*

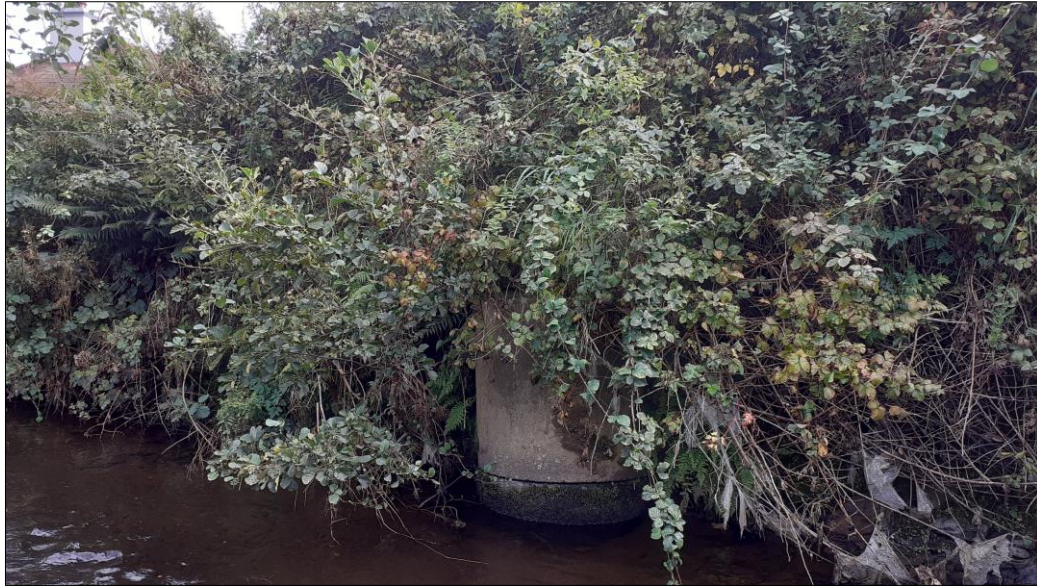
**Plate 19:** View of south bank of river and cylindrical concrete pipe approximately 30m west (downstream) of Burnfoot Bridge

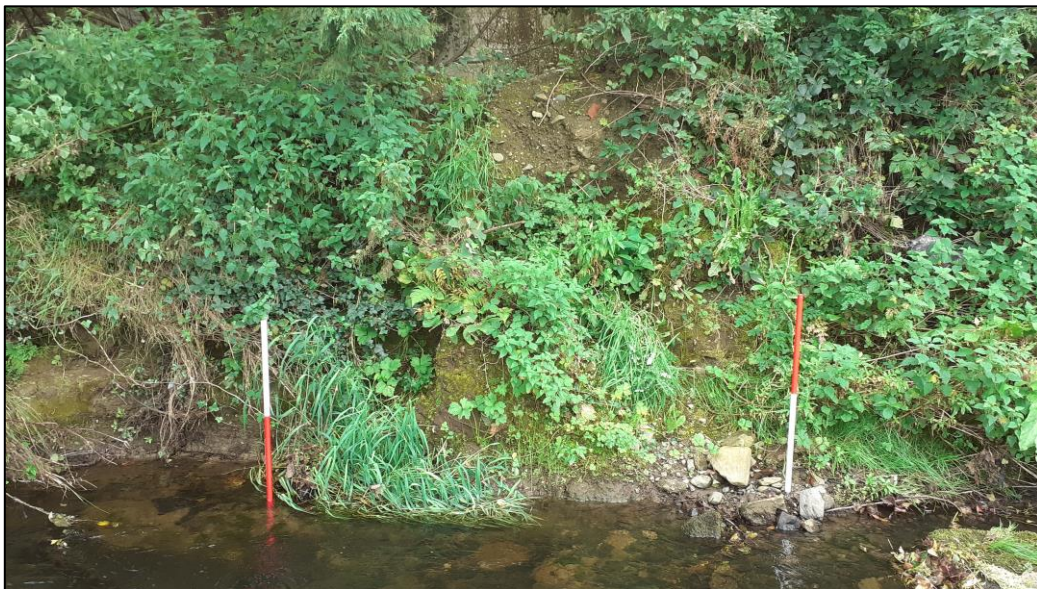
**Plate 20:** View of south bank of river approximately 70m west (downstream) of Burnfoot Bridge. Modern redbrick and metal debris was visible in unvegetated areas

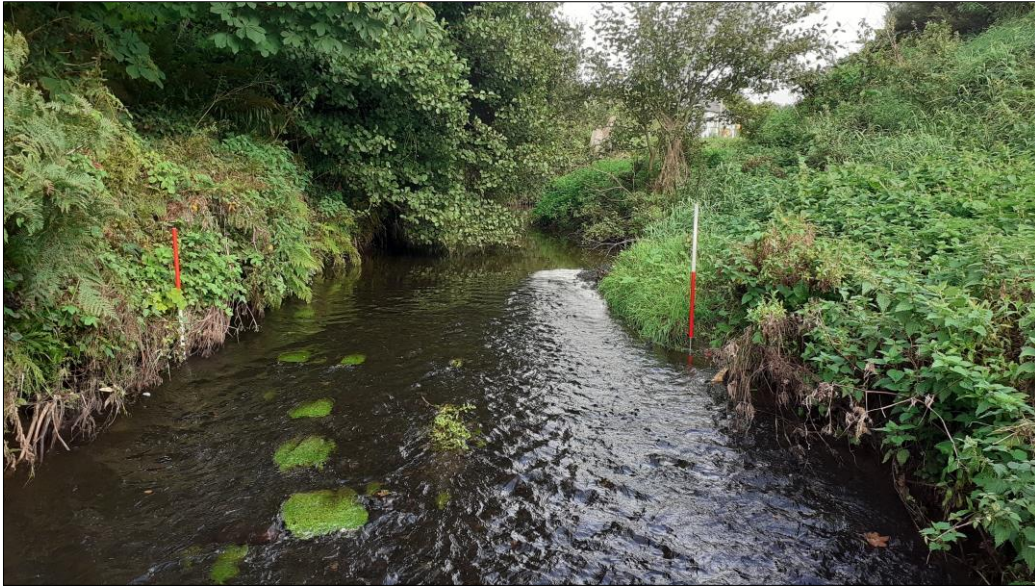
*Plate 21: In-channel view from western end of the survey area facing northeast showing current river banks*

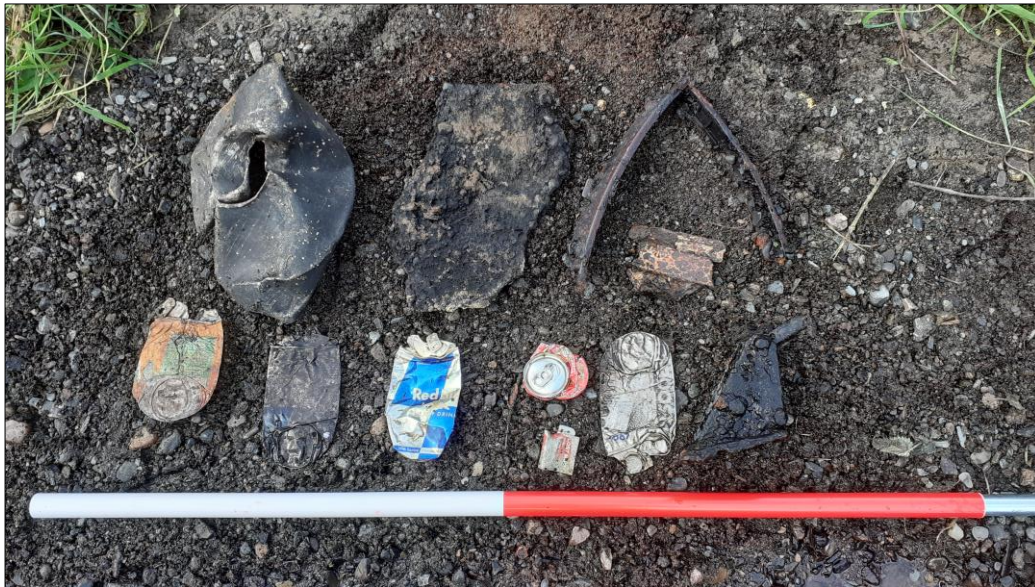
*Plate 22: Selection of metal objects from beyond 10m downstream (west) of Burnfoot Bridge*

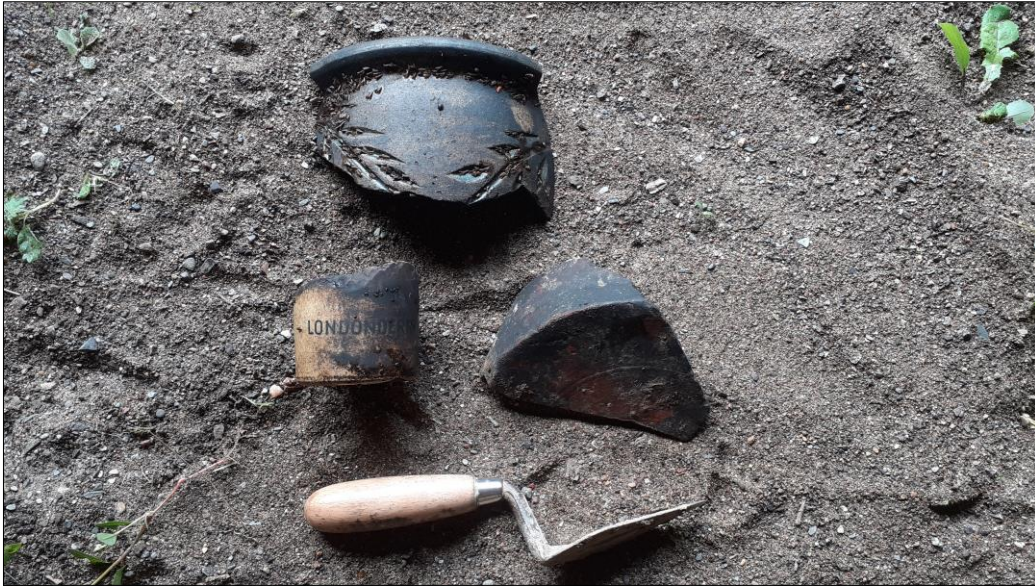
**Plate 23:** Selection of ceramics retrieved from the streambed downstream (west) of Burnfoot Bridge. These include a 20<sup>th</sup> century chamber pot rim sherd, 19<sup>th</sup> / 20<sup>th</sup> century imported Scottish Stoneware bottle, and 19<sup>th</sup> / 20<sup>th</sup> century crock pot base sherd

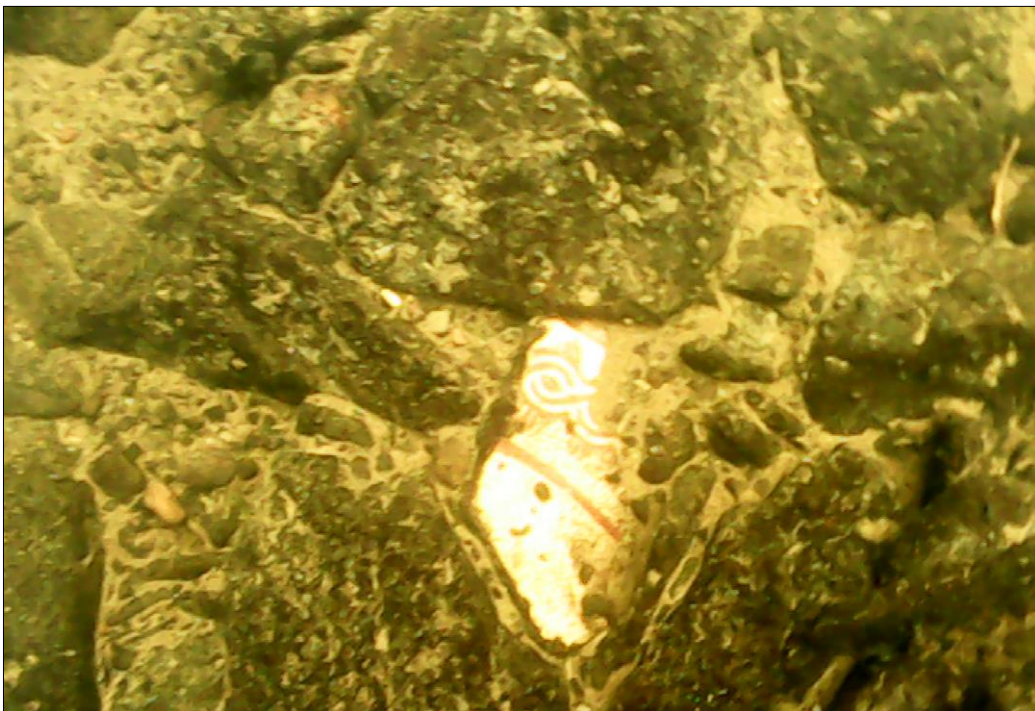
**Plate 24:** Underwater view of the riverbed downstream (west) of Burnfoot Bridge, showing glazed ceramic sherd in situ

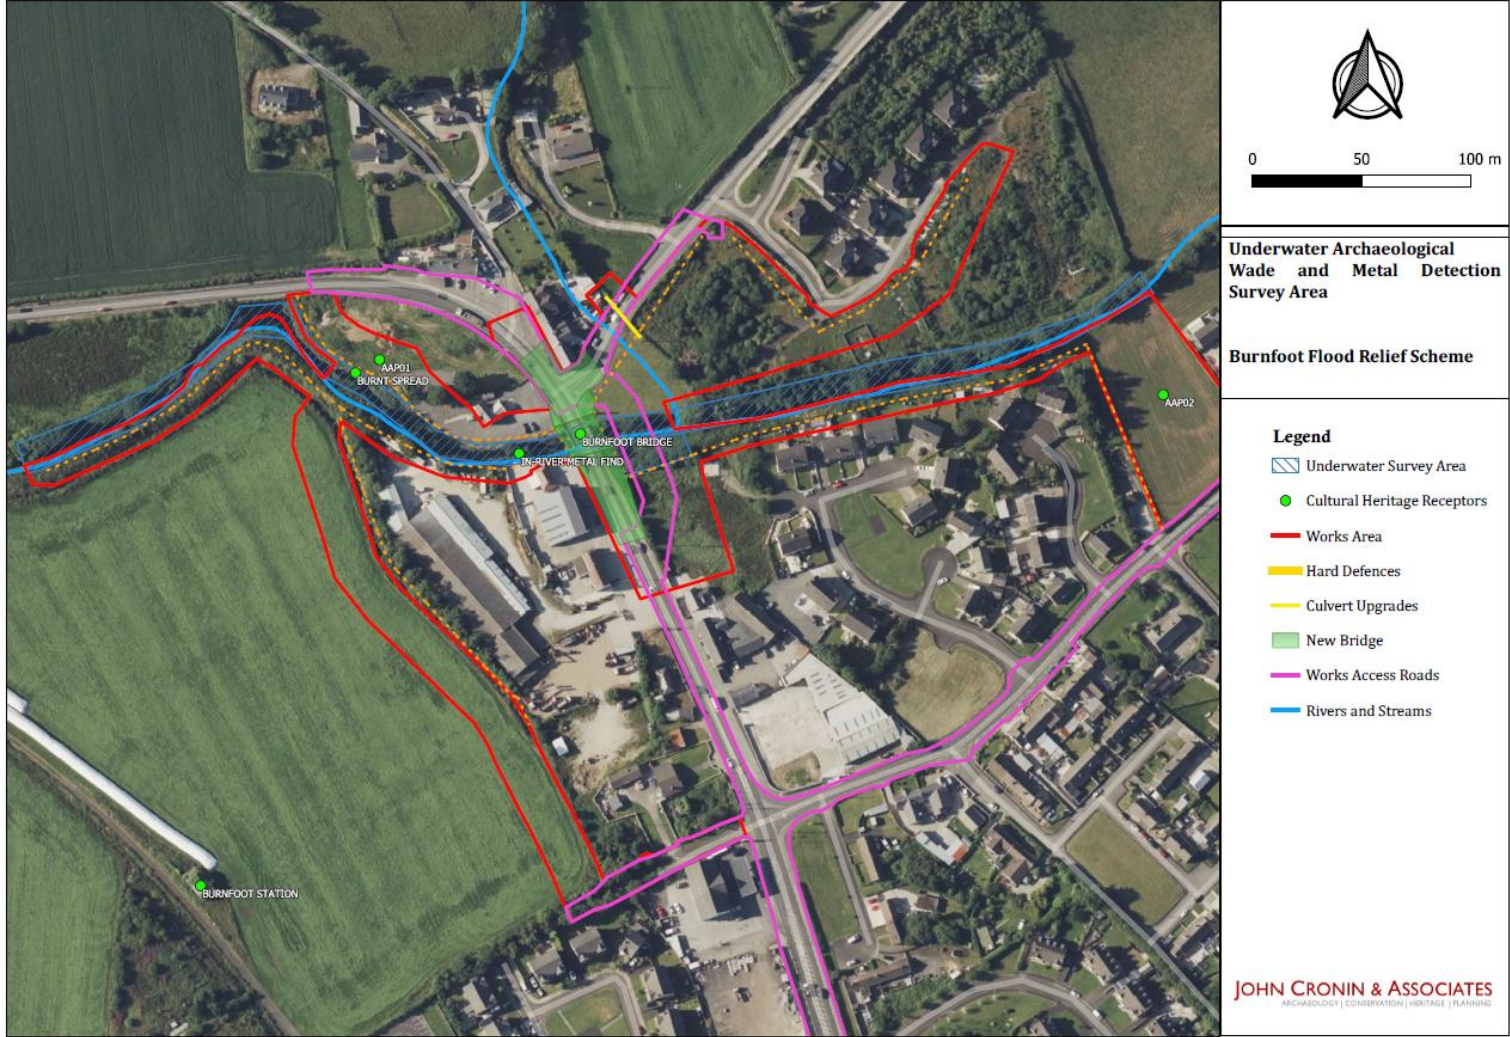
## **Appendix 15.4**

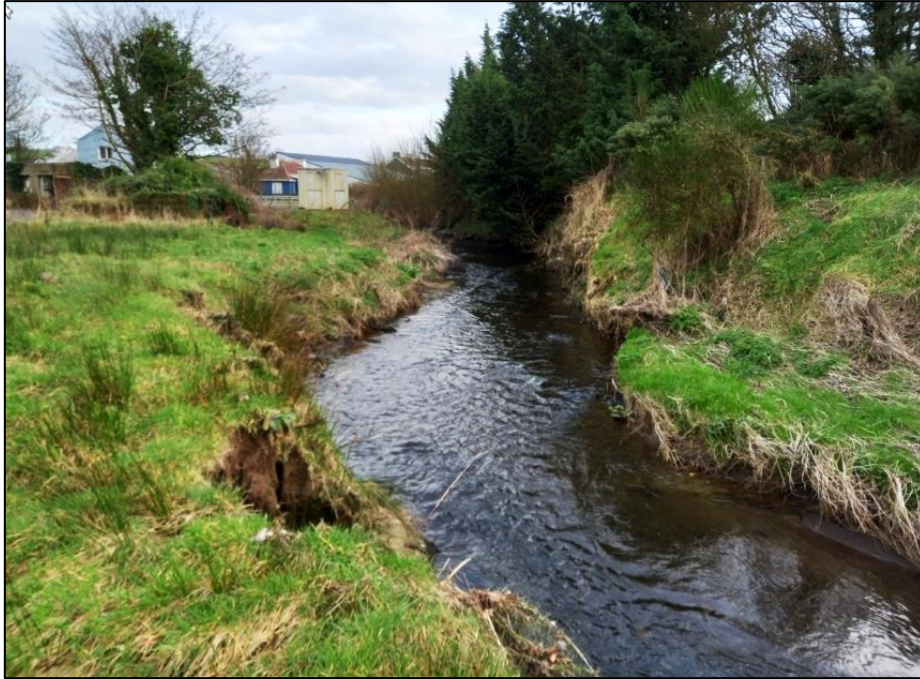
**Excavation Licence No. 23E0821**

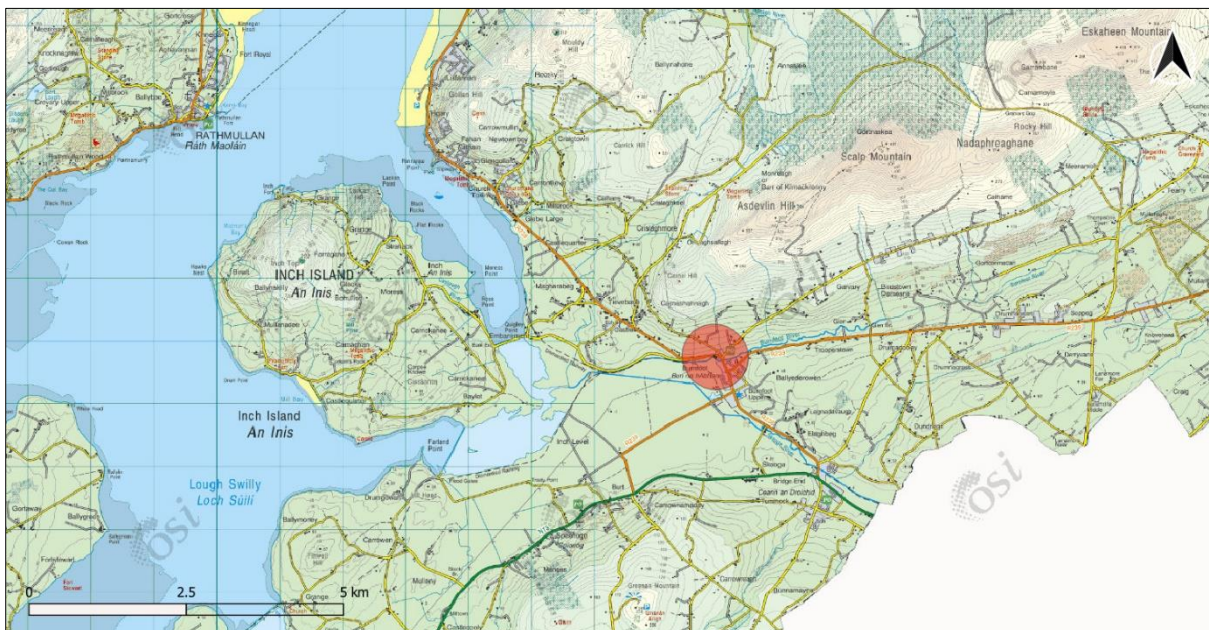
Figure 1: General location of proposed development (red circle)

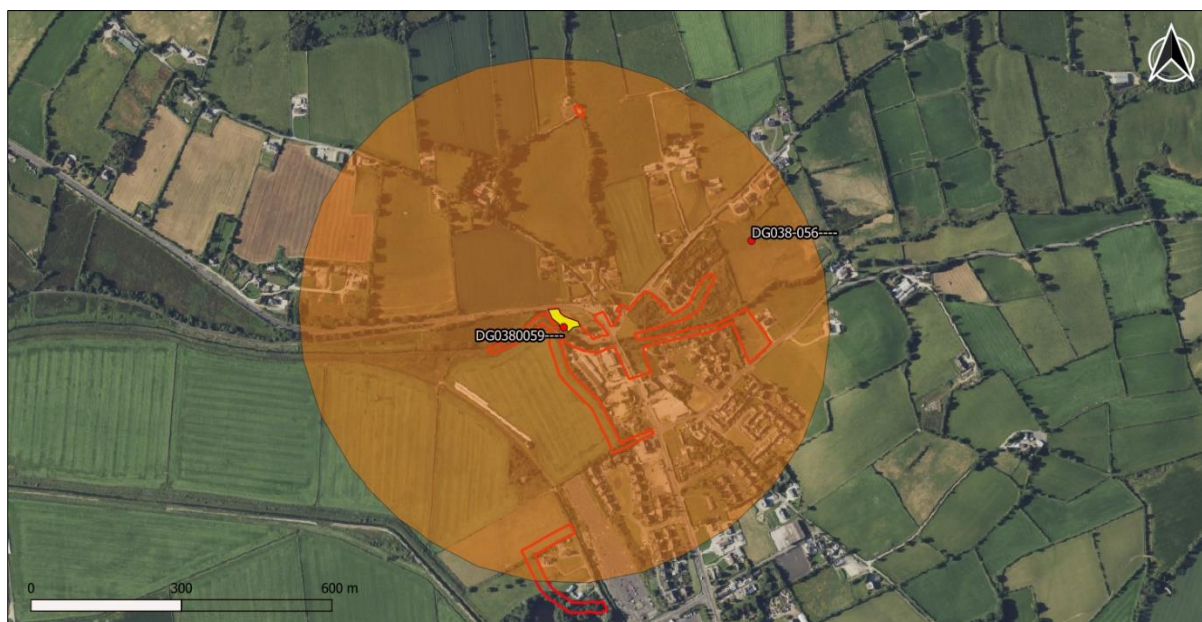
**Figure 3:** Recorded Archaeological sites within 500m of subject site

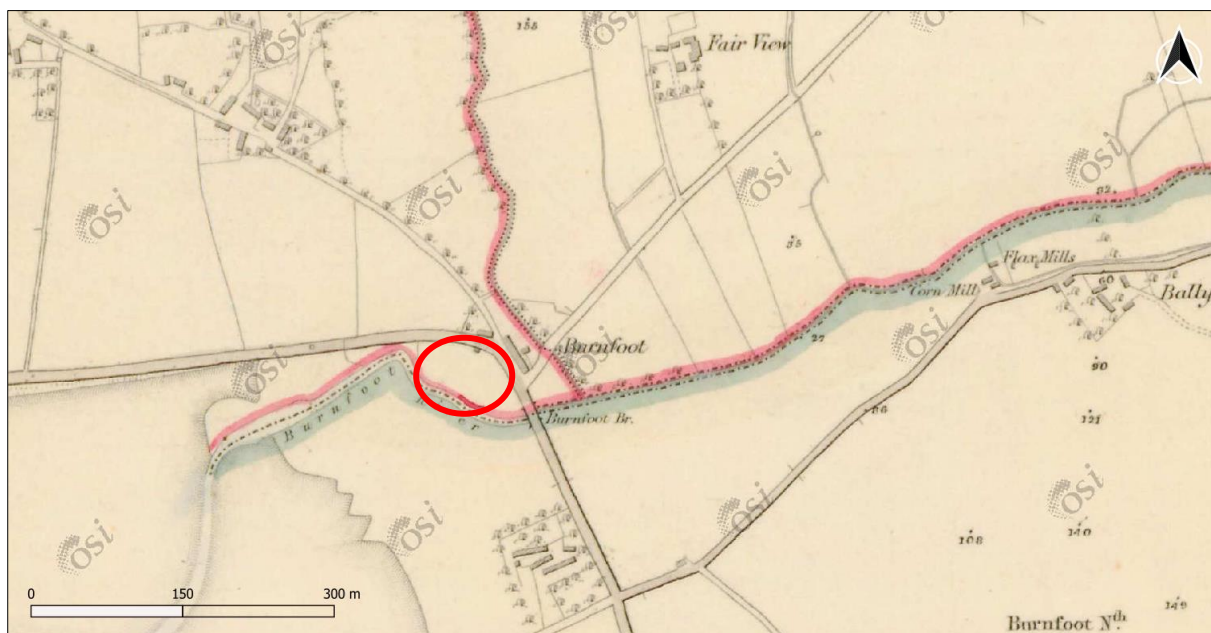
**Figure 4:** First edition OS map with subject area location circled in red

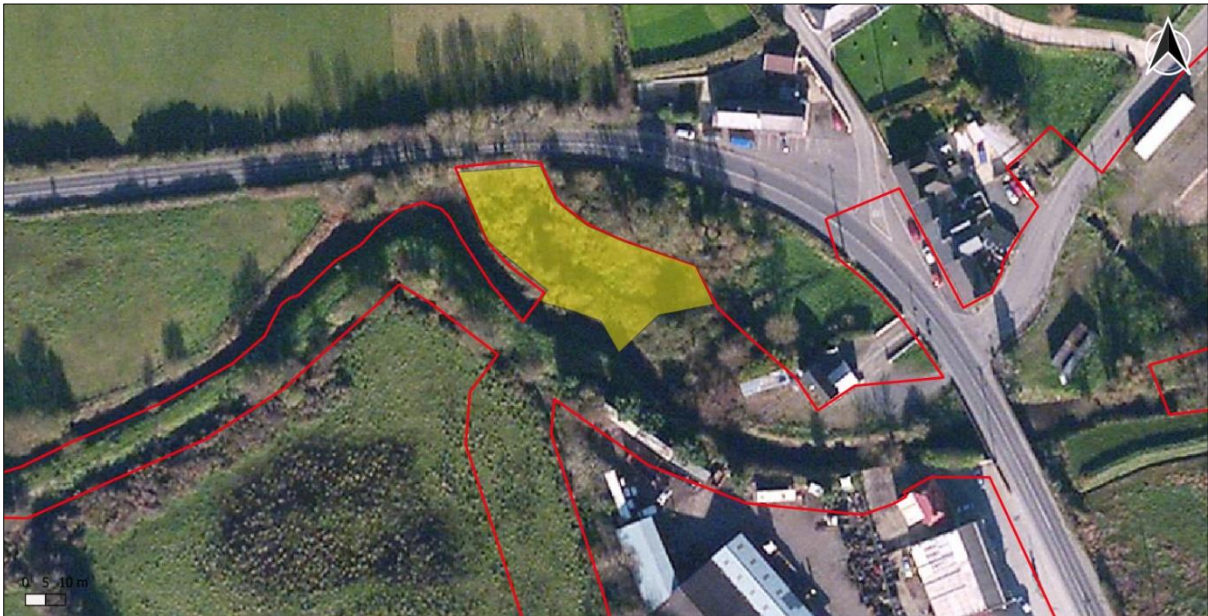
**Figure 6:** Digital Globe Satellite imagery of the subject site testing area (yellow) within Burnfoot FRS working area boundary (red)

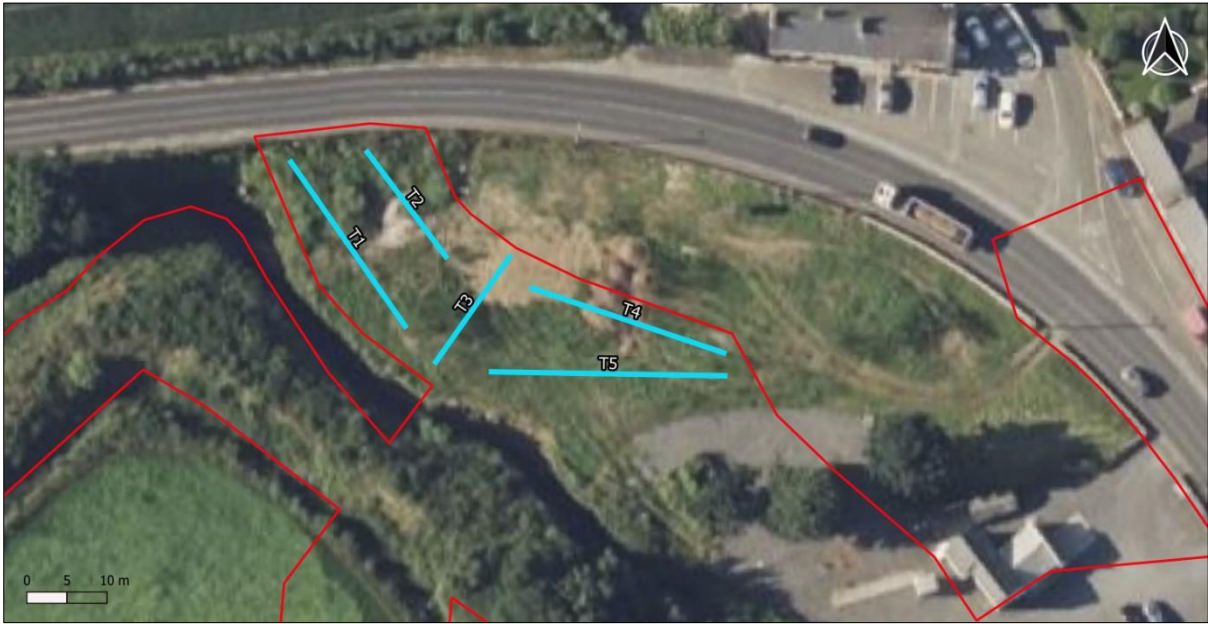
**Figure 7:** Plan showing test trench layout T1-T5, Carnashannagh, Burnfoot, Co. Donegal

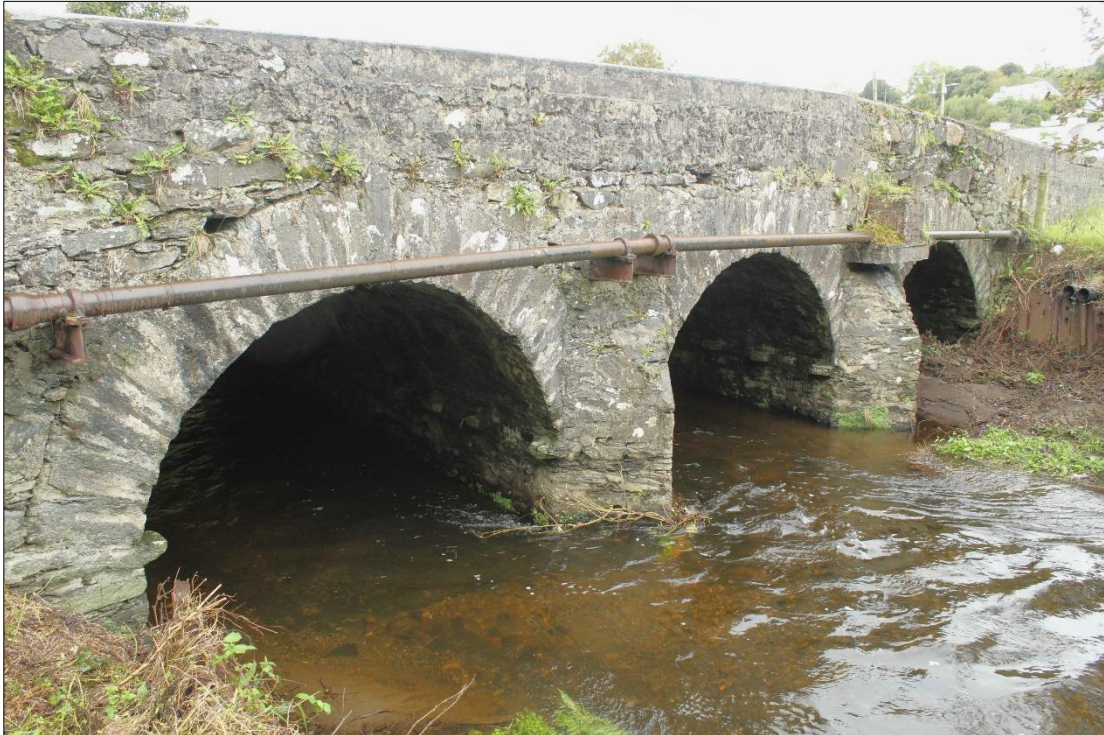
### Burnfoot Bridge, Burnfoot, Lifford, County Donegal
