# Appendix 15

## Appendix 15.1

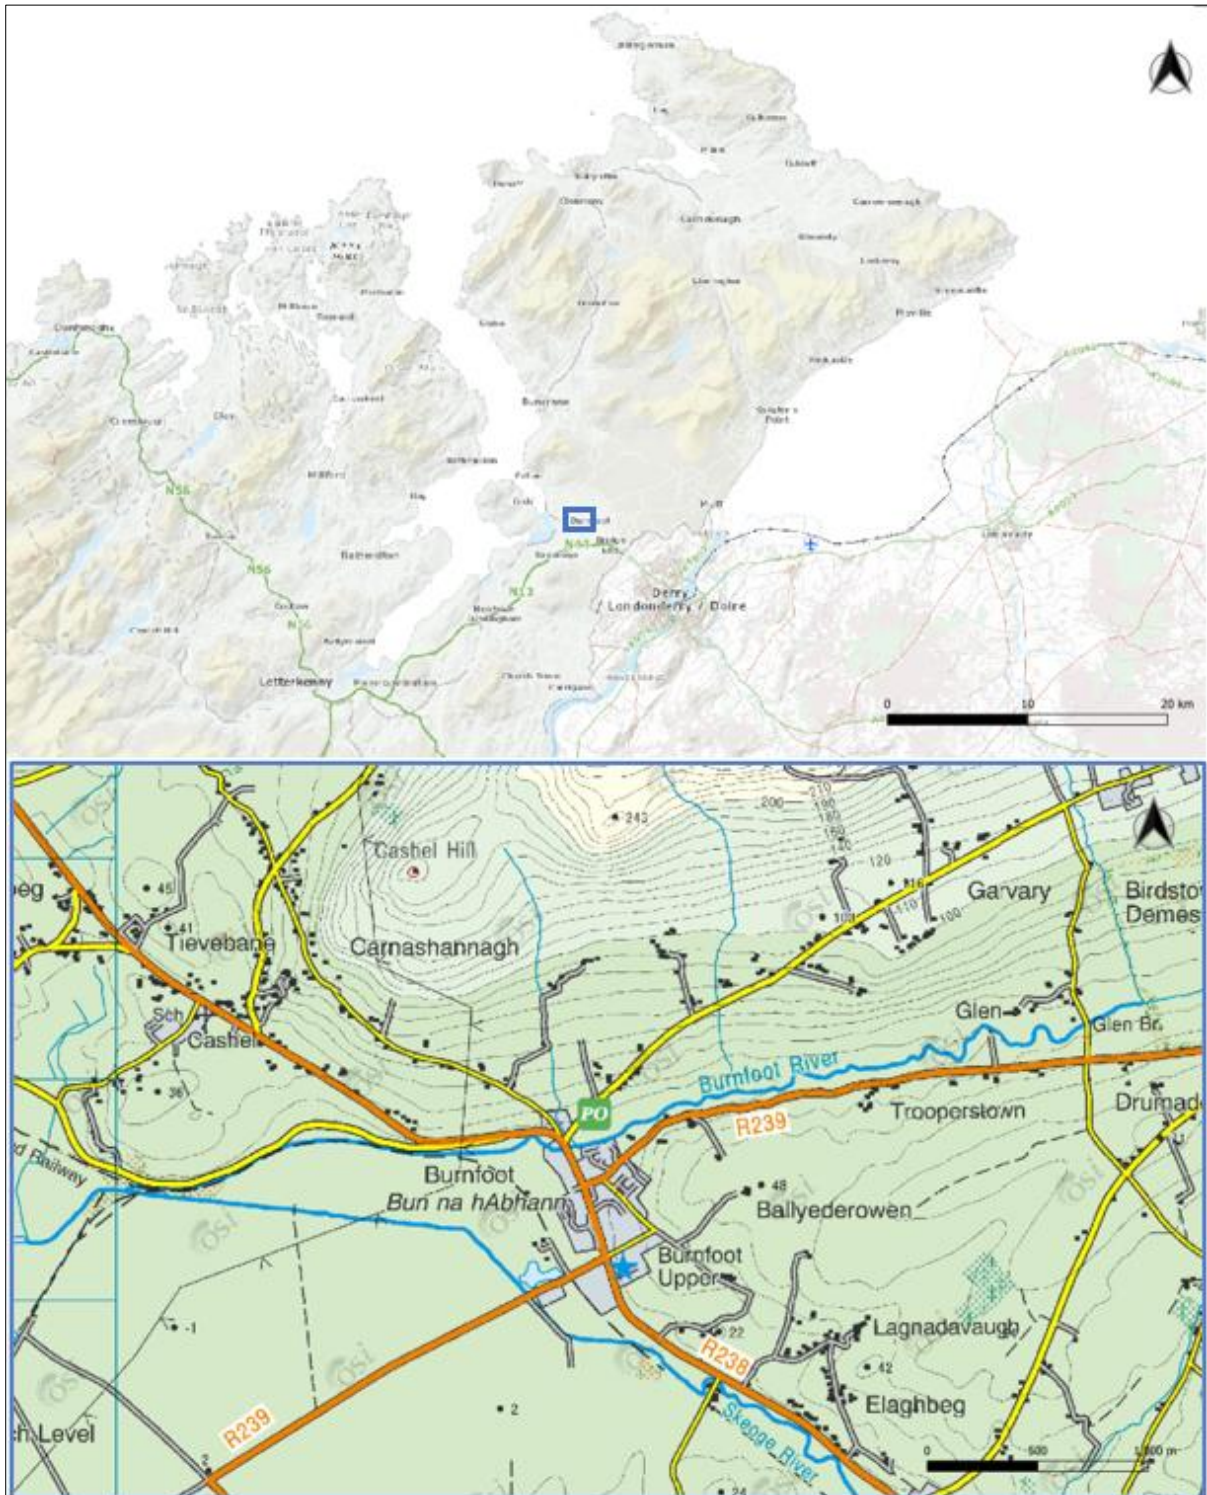
**Figure 1:** Location of Burnfoot Bridge, Burnfoot, Co. Donegal (ITM 637976, 923680)

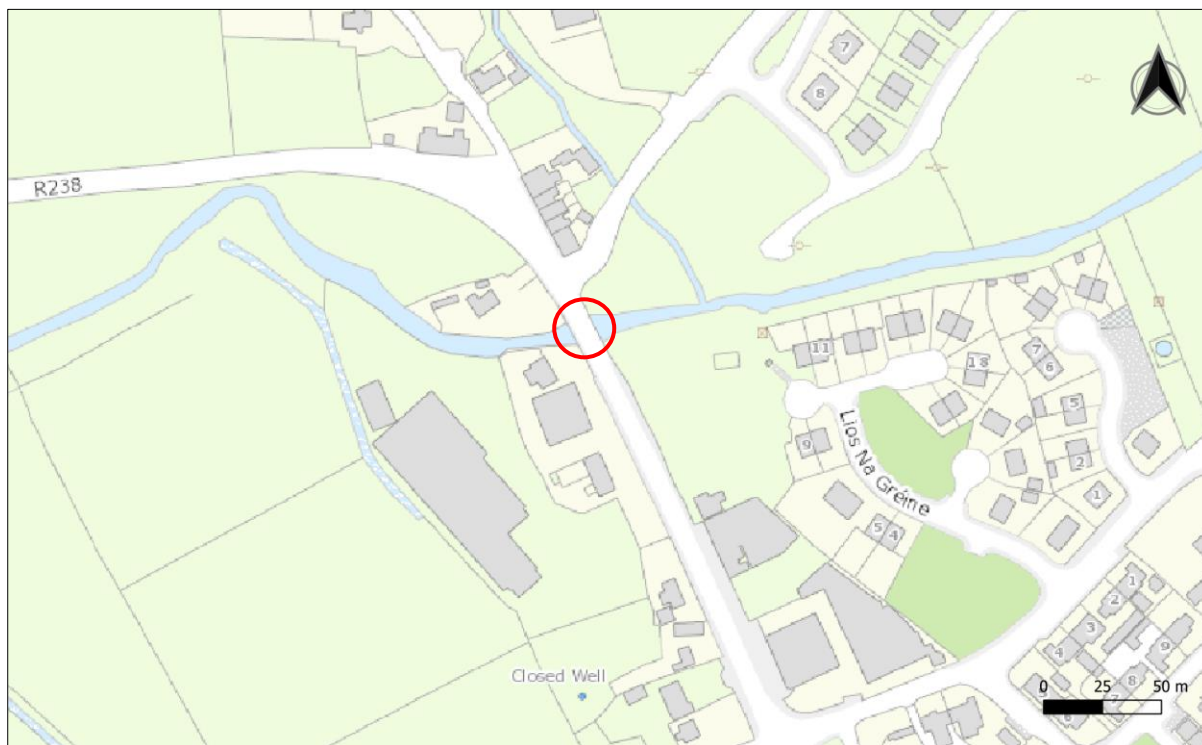
**Figure 2:** Basemap location of Burnfoot Bridge, Burnfoot village, Co. Donegal, along the R238 road network

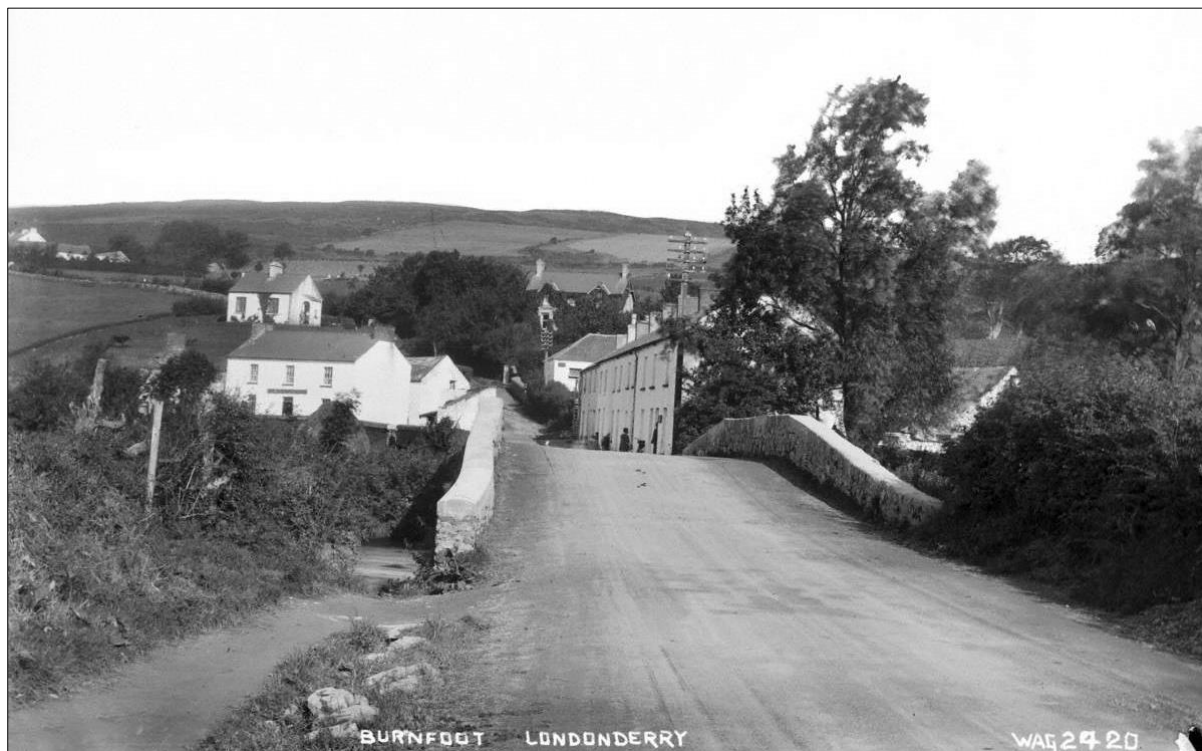
**Figure 3:** Historic photograph of Burnfoot Bridge c.1900; compare with **Plate 1** in appended photographic record. (Source: National Museum of Northern Ireland)

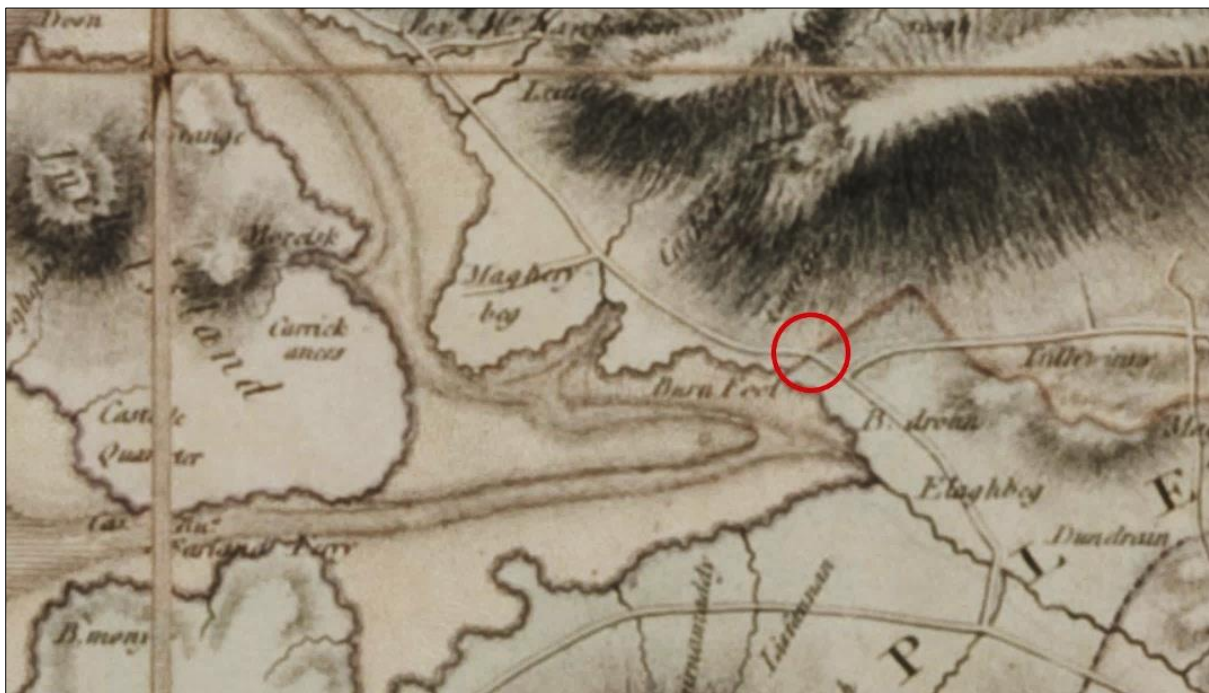
**Figure 4:** Extract from Grand Jury map of 1796 with subject site circled in red (Source: [www.logainm.ie](http://www.logainm.ie))

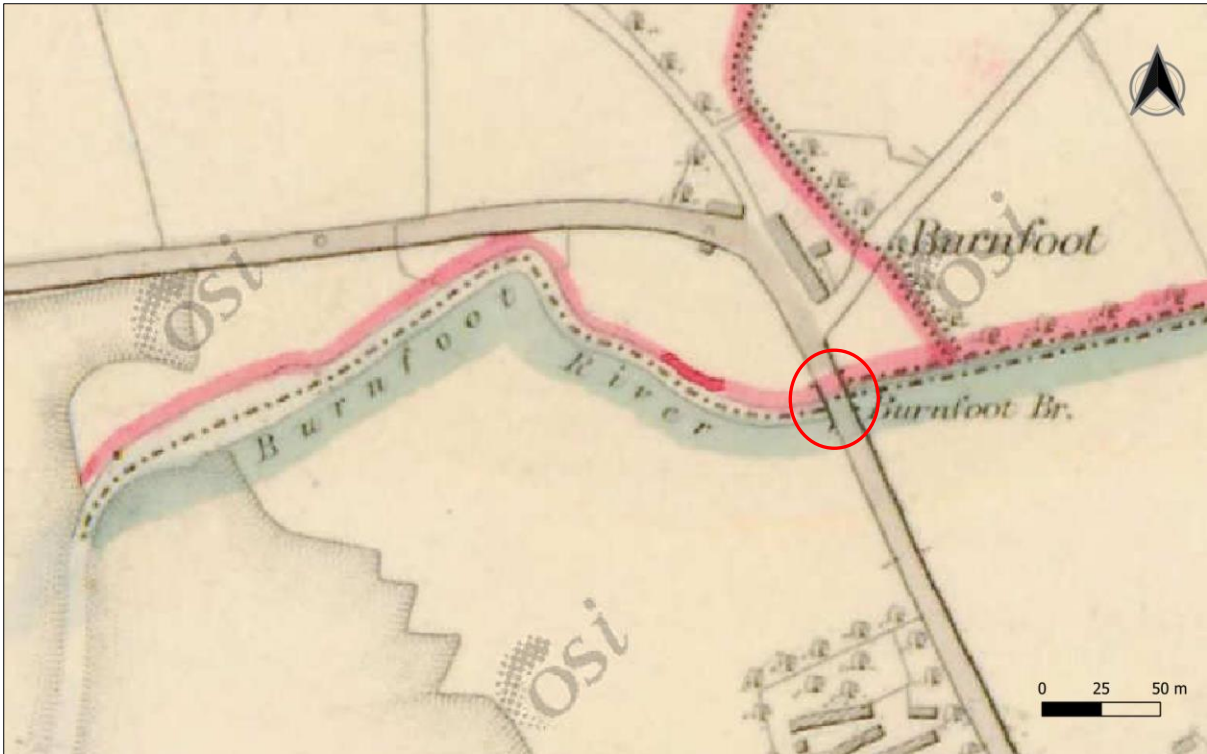
**Figure 5:** Extract from First Edition 1:10,560 Ordnance Survey map (Surveyed 1832, published 1836)

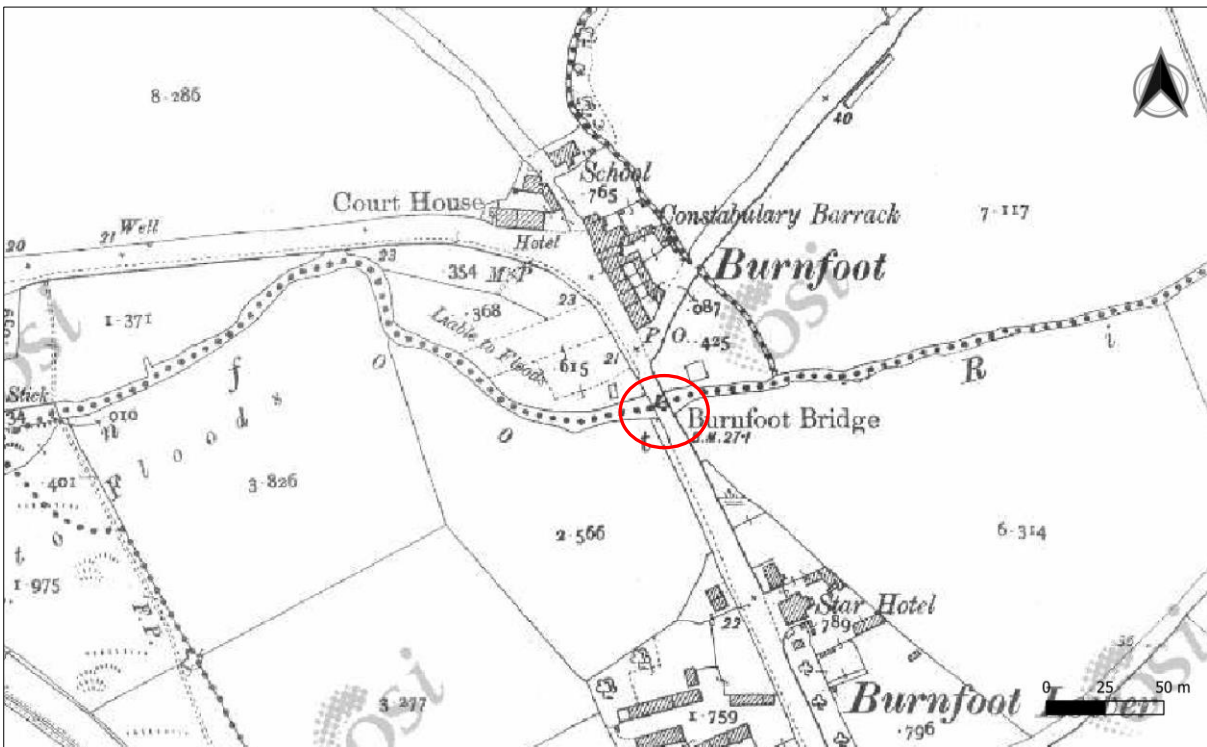
**Figure 6:** Extract from Second Edition 1:2500 Ordnance Survey map (Surveyed 1903, published 1904)

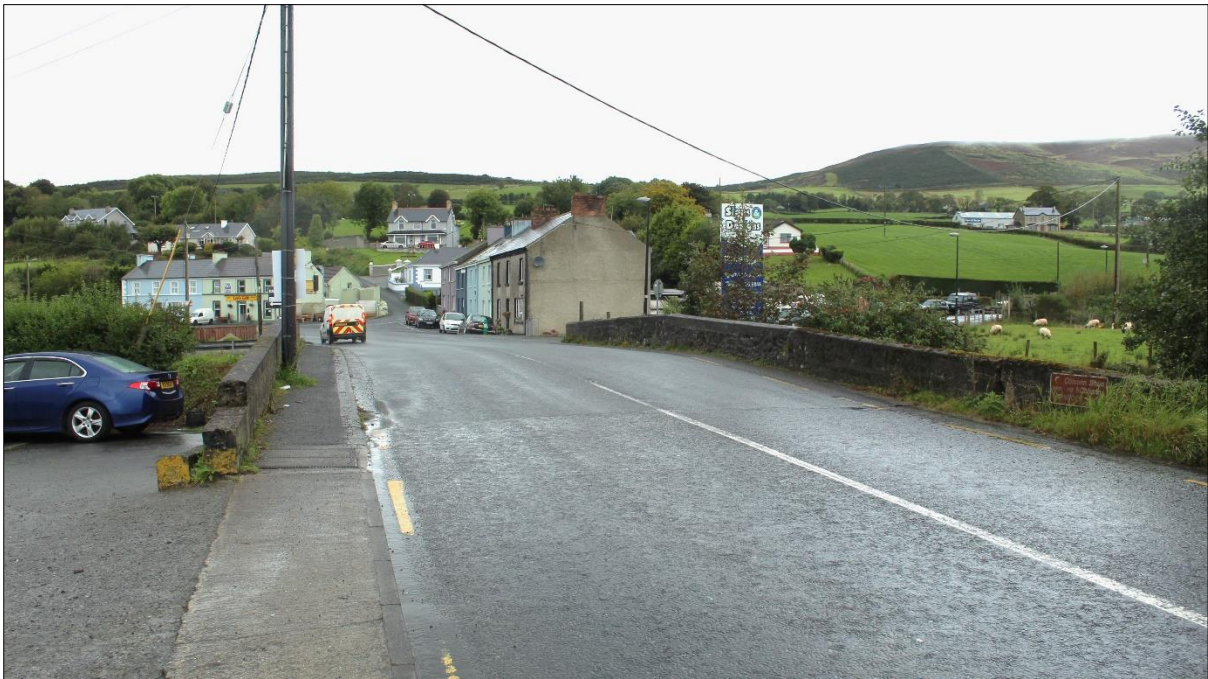
*Plate 1: View to north over Burnfoot Bridge which carries R238 over Burnfoot River. Compare with historic photograph in Figure 3 (main text) which shows similar view prior to mid twentieth-century widening of bridge to west (left side of photograph) and levelling of roadway to reduce hump-back nature of crossing.*

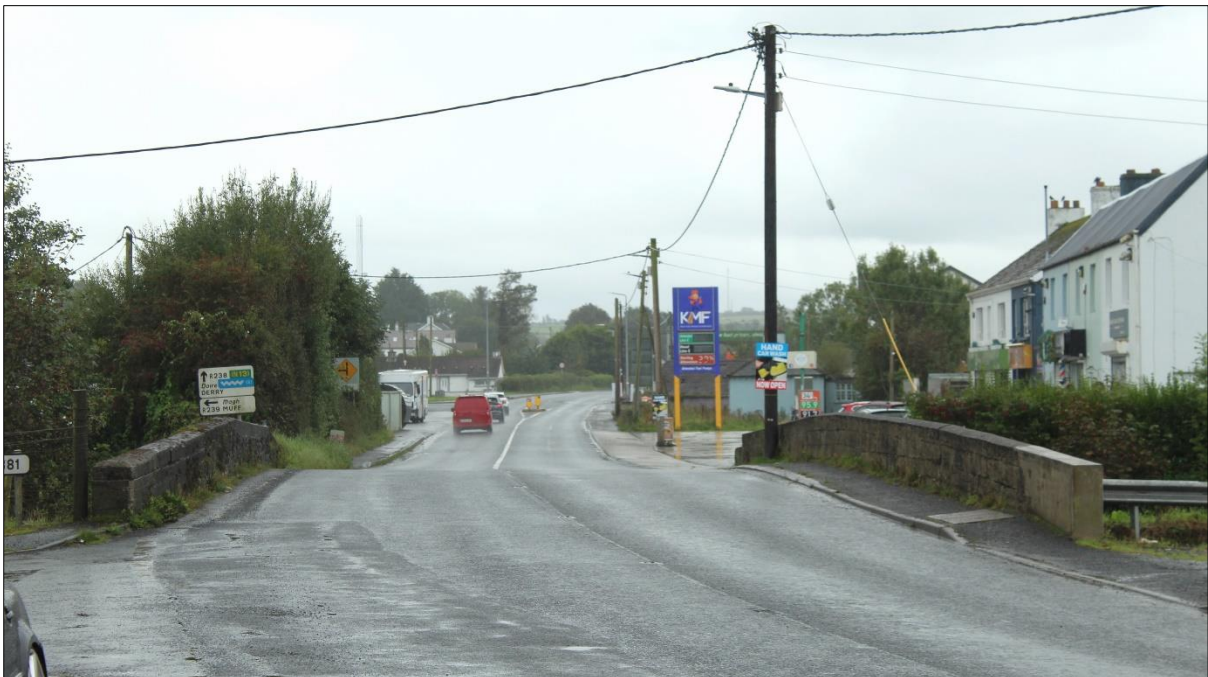
*Plate 2: View to south over Burnfoot Bridge*

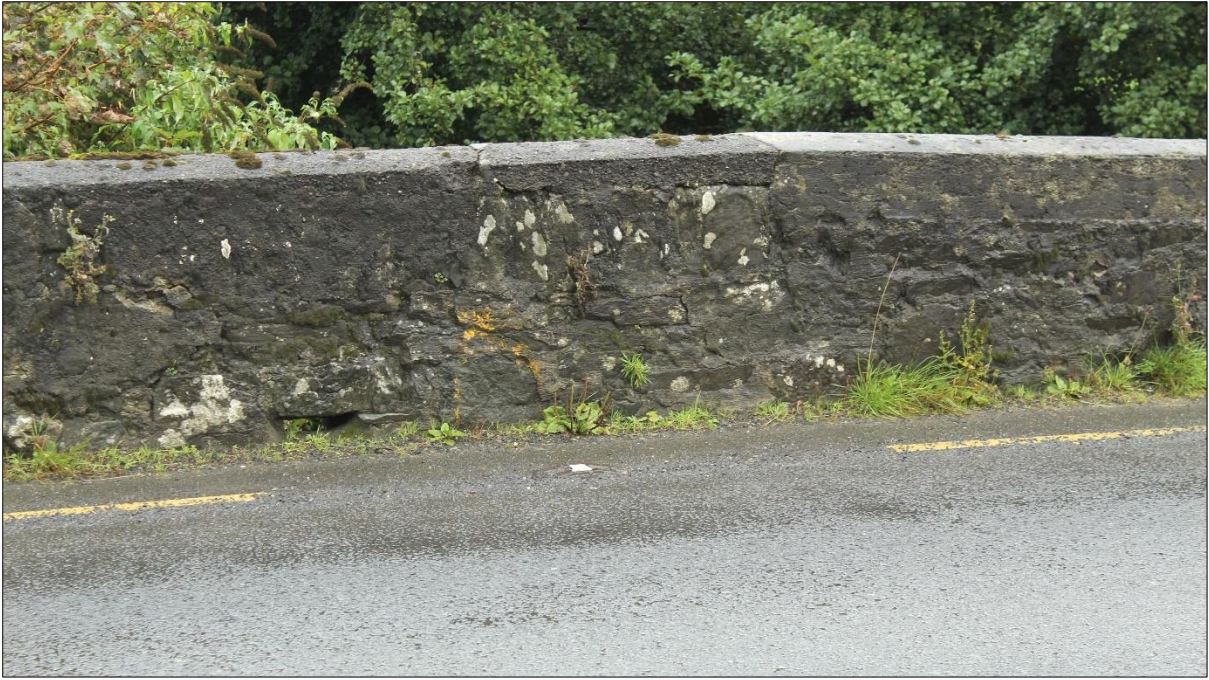
**Plate 3:** Road-side detail of original, eastern parapet masonry to crown of bridge. Note drainage hole from bridge deck to left of centre of photograph and original vertical coping stones beneath, or replaced by cast-concrete capping.

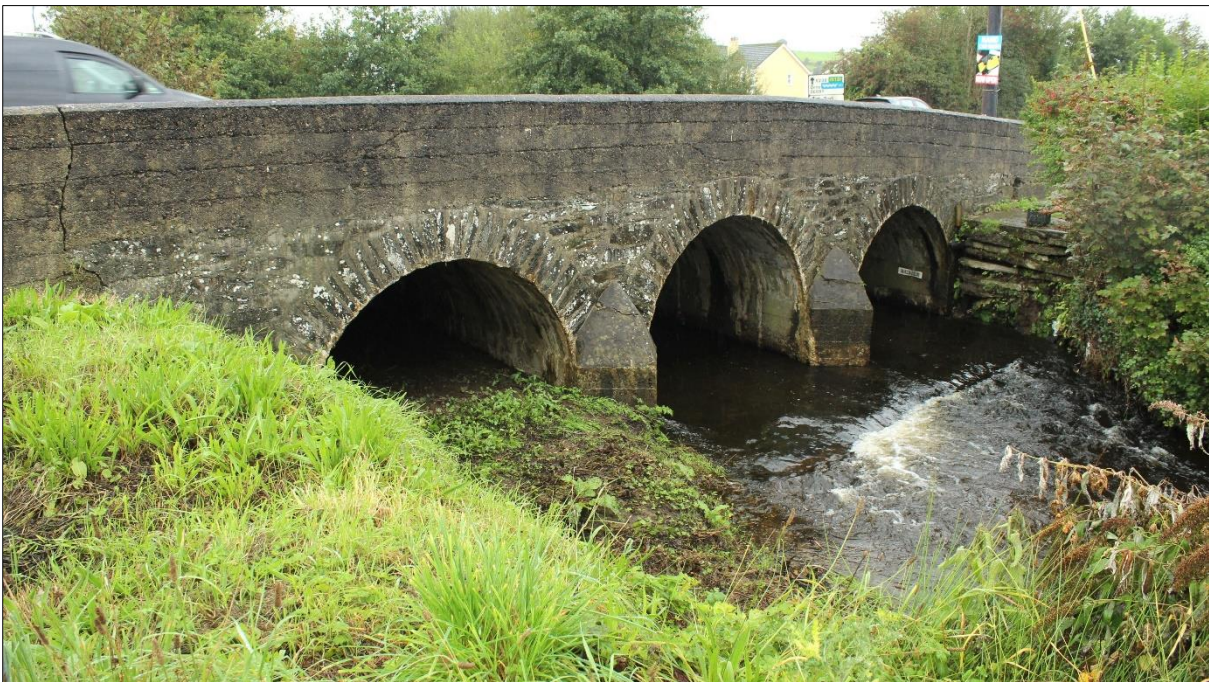
**Plate 4:** West elevation from north with stone arch and spandrel masonry over mid twentieth-century cast-concrete arch extensions. Parapet, cutwaters and paved river bed are also all of cast-concrete.
