## APPENDIX 14-2

**DELANY (2023)  
ARCHAEOLOGICAL MONITORING  
REPORT**

**ARCHAEOLOGICAL MONITORING OF A WINDFARM DEVELOPMENT  
AT MEENBOG, COUNTY DONEGAL**

*Excavation Licence Number: 19E0739*

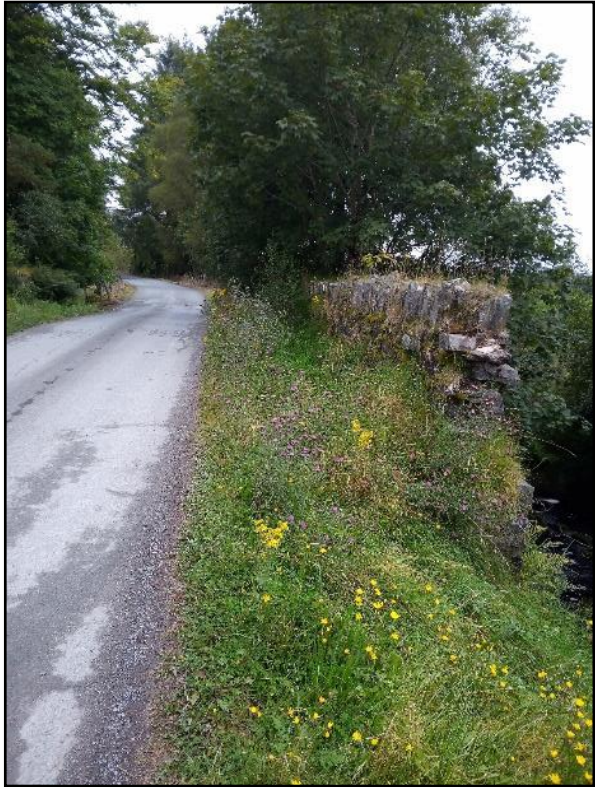
**Plate 1** Roadbridge across Bunadowen River built *circa* 1860

There are no items of architectural heritage interest on the site of the development. There are two bridges listed by the National Inventory of Architectural Heritage (NIAH) on the Castlederg Road to the north of the site. One of these bridges is associated with the construction of the West Donegal Railway in 1882. The other is thought to have been built by Lord Henry the Fourth of Lifford at the time of construction of Meenglass Castle to the northeast between 1840 and 1860. The parapet wall on this bridge is in quite poor repair and appears to have been breached at the eastern end (plate 1). There is an upstanding cottage (plate 2) on the west bank of the river south of this bridge and there are the remains of an earlier house (plate 3) across the road to the northwest. Neither of these structures appear on the 1<sup>st</sup> edition ordnance survey map and are likely to date from the late 19<sup>th</sup> or early 20<sup>th</sup> century.

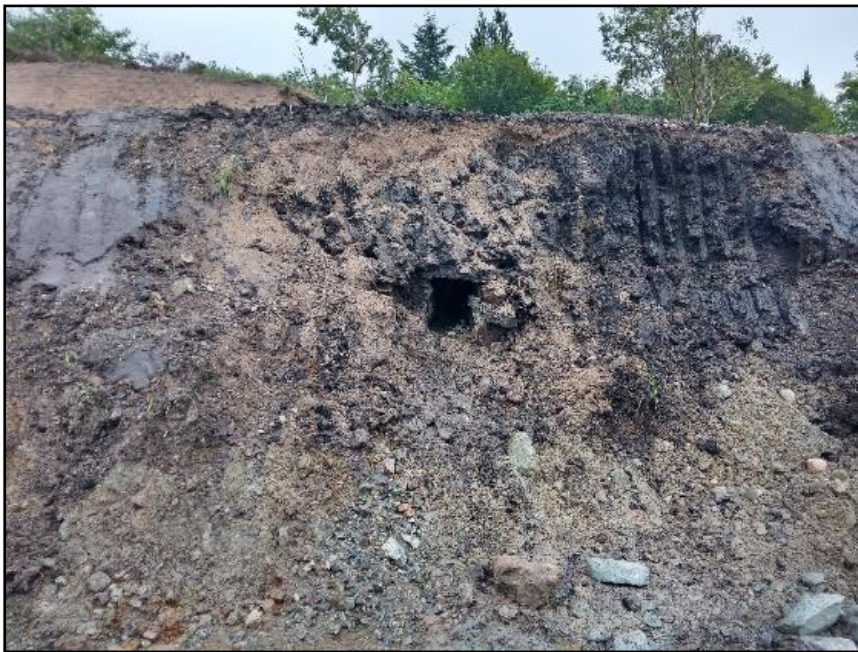
There are no architectural or vernacular features on the site. There are two 19<sup>th</sup> century road bridges on the Castlederg Road on the northern boundary of the site. Two cottages, one of which is ruined, are located on this same road. None of these features was impacted by the development. The wall of the railway bridge was rebuilt during the construction phase but not as part of the development. A culvert associated with the railway dating from 1882 was exposed north of the site entrance (plate 4). It was constructed of stone lintels and is typical of road culverts of the time (plate 5). The culvert was preserved *in situ*.

**Plate 4** Exposed culvert in section face to north of site entrance

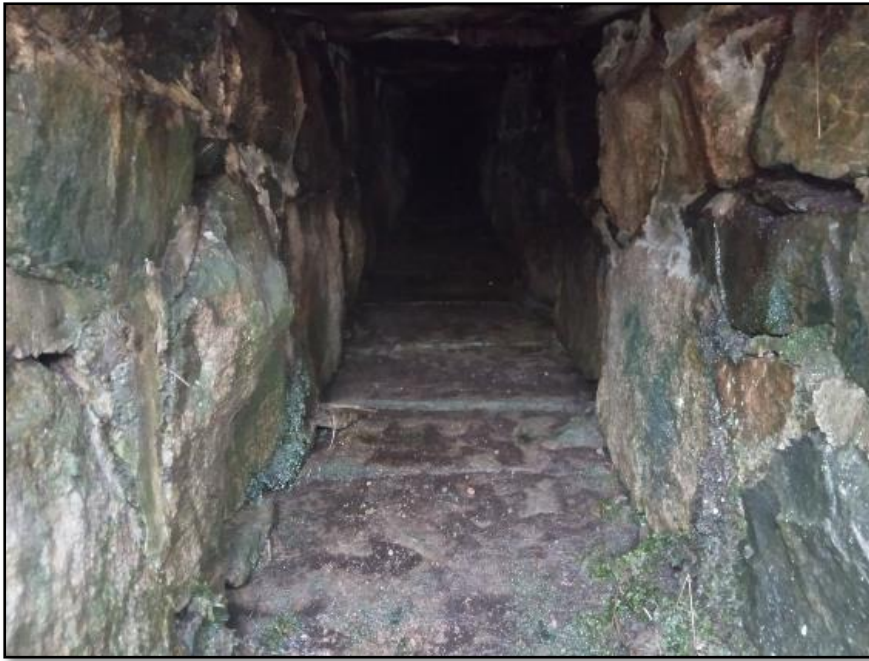
**Plate 5** Interior of culvert showing flagstone flooring and mortared wall

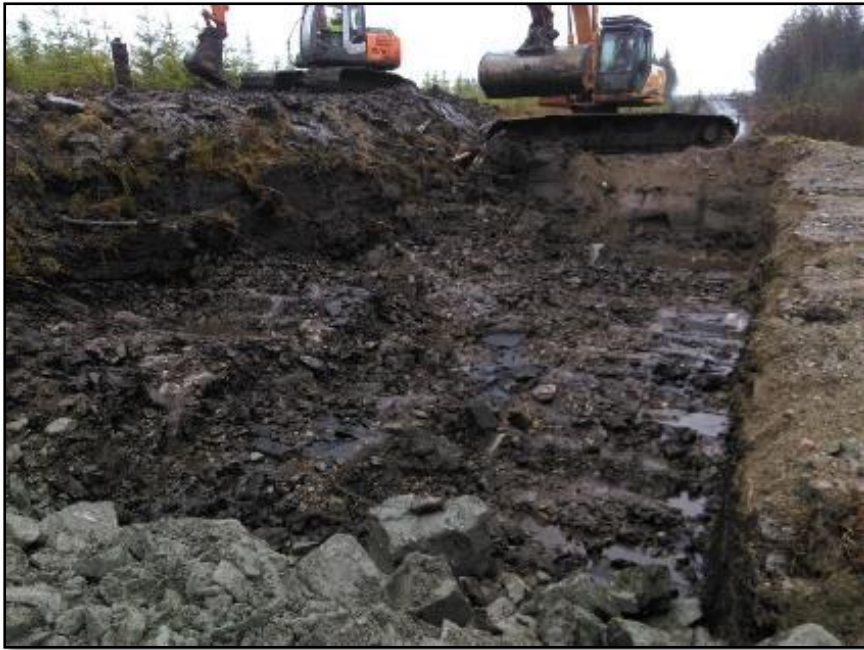
**Plate 6** Road between first borrow pit and temporary compound

Construction of the road network on the site of the windfarm involved temporary widening of the existing forestry roads for the purposes of a construction traffic haul road followed by permanent upgrading for transport of turbines. The forestry roads generally had sandy stone fill over brash laid directly over peat. The peat depths varied from 1m to 3m. The peat usually overlay silty clay and sandy clay over gravel and rock. This stratigraphy was occasionally interrupted by upcast from drainage or road works. There was some variation in the construction of the forestry roads with frequent instances of fishing net and plastic flotation drums fulfilling the roll of geogrid in floating roads. Nothing of archaeological interest was uncovered in the monitoring of road excavations.

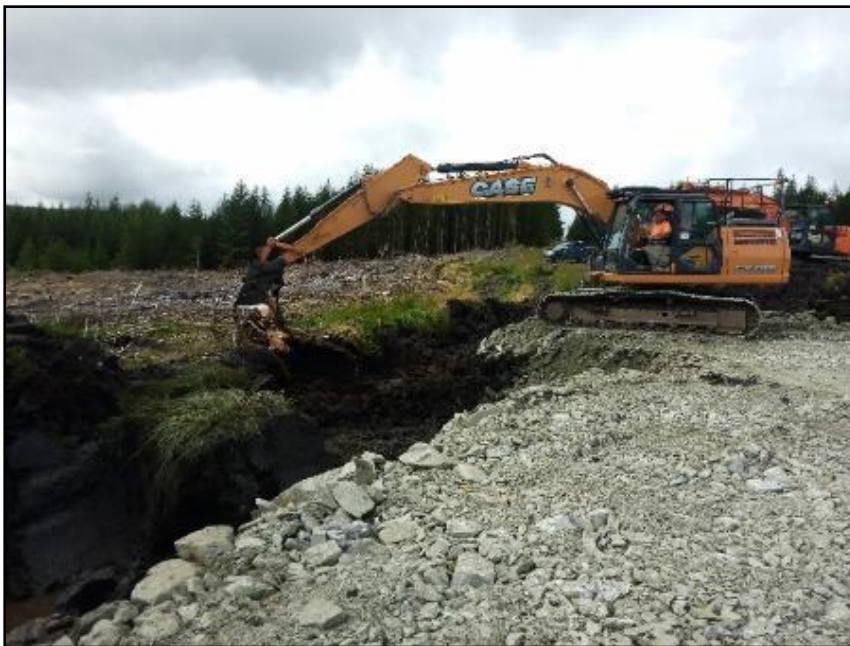
T1 is located in the very south of the site in felled forestry to the east of Carrickaduff Hill, at a height of 290m O.D. The ground falls away steeply to the south of the turbine base area. Excavations began in late August 2020. The peat was quite stable but the excavation was quickly stoned-up on account of the water ingress. Peat depths averaged about 1.5m in the south of the site but the peat was shallower on the footprint of the base, generally comprising 0.4m to 0.5m of peat under matted moss, very occasional grass, tree stumps and brash. The ground falls away sharply here. The underlying stratigraphy consists of broken rock in a sandy clay matrix over rock.

**Plate 8** Looking southwest at peat excavations at T1

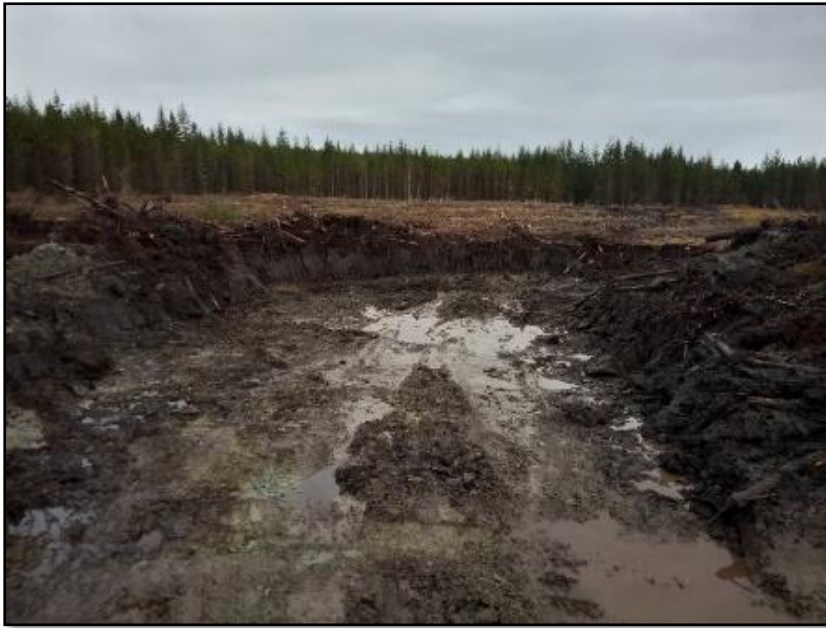
T2 is located in the south of the site in felled forestry at 270m O.D. Excavation of the hardstand began on 29<sup>th</sup> September. There was 2m of peat in the east reducing to 1m in the west with rising bedrock between. The peat dried out as excavations proceeded to the southwest with firm well humified peat of between 2m and 2.5m under grass, moss and heather and over broken stone and rock in a silty clay matrix with occasional rising bedrock. Excavation of the turbine base began on 6<sup>th</sup> October. The ground here was wet with up to 1m of grassy mossy sod peat over very soft humified peat.

**Plate 9** Looking east at excavations of hardstand at T2

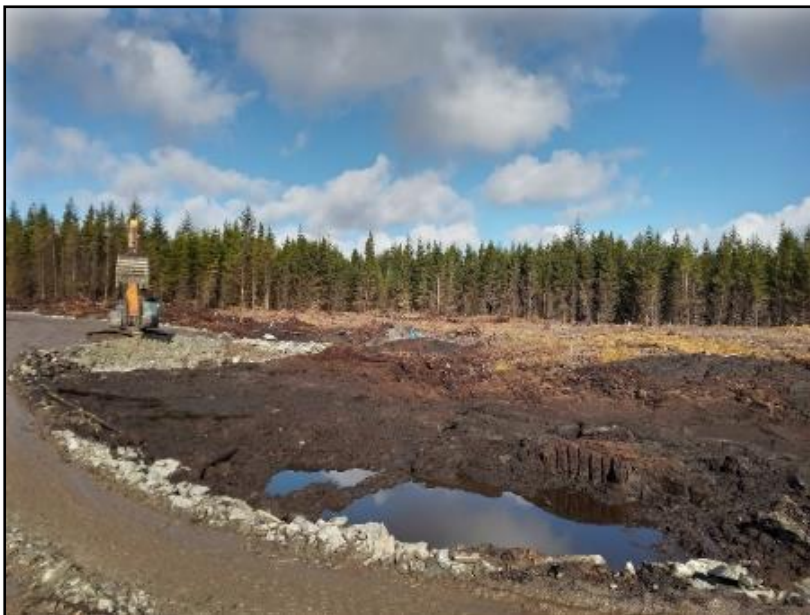
**Plate 10** Looking northwest at excavation of turbine base at T2

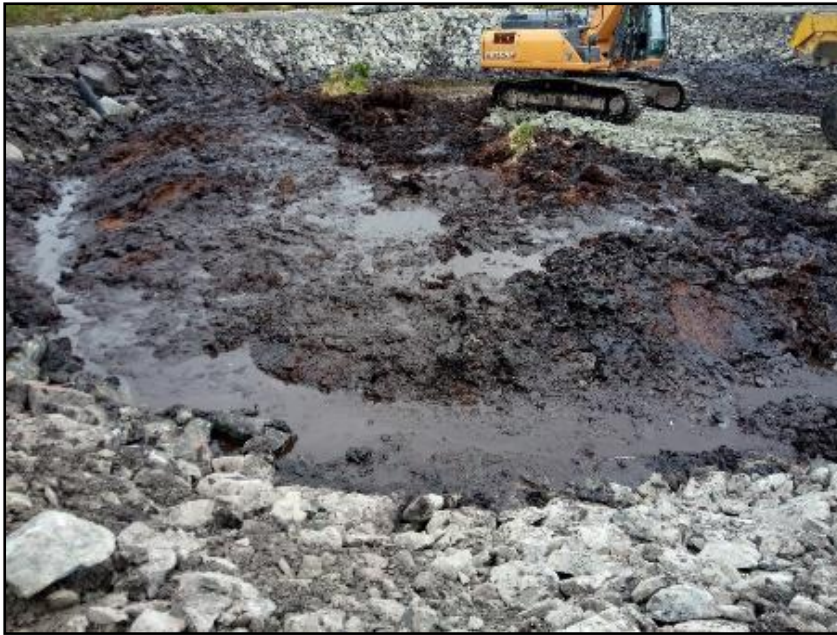
Excavations at T3 began at the beginning of August 2020. Peat here is generally shallower and drier than elsewhere in the south of the site. This is high ground near the summit of Carrickaduff Hill at a height of 315m O.D. Peat deposits deepened to the west. There was up to 3m of peat in the west of the turbine base and 2m in the east of the base while the hardstand to the east again generally had about 1m of peat. Excavation of peat continued into late August when the north east edge of the hardstand was completed. Peat here measured 1.5m and was stable with a mature profile.

**Plate 11** Looking south at turbine base during peat excavations at T3

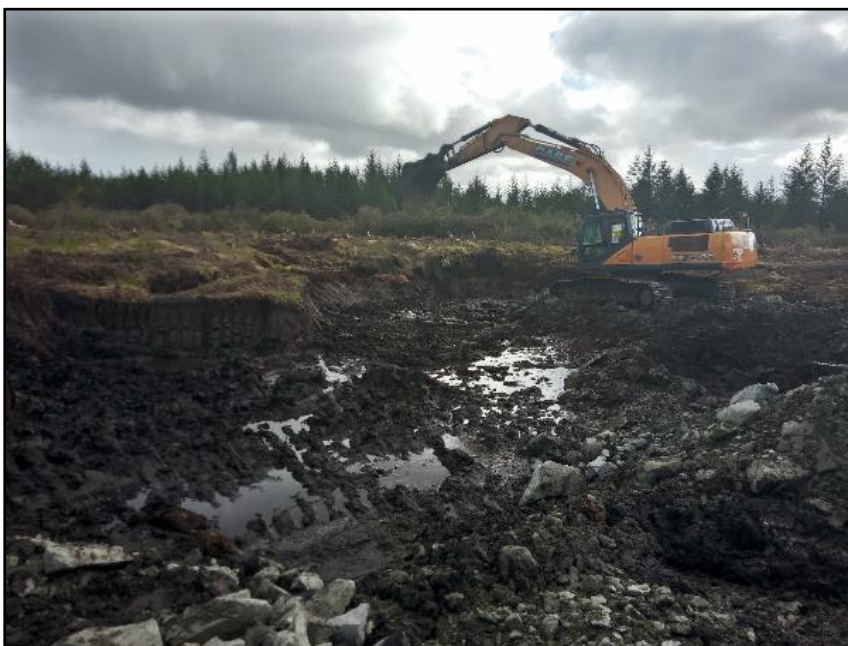
Excavation of T4 took place in October 2020. The site of the turbine and hardstand was on high level ground c. 300m O.D. The area excavated was in felled forestry. There were deep deposits of peat with occasional rising bedrock and substantial deposits of soft gravels and clay. There was significant water ingress from the surrounding bog and mitigation measures included construction of causeways and infill and pumping of water from excavated areas.

**Plate 12** Looking east at T4 during peat excavation

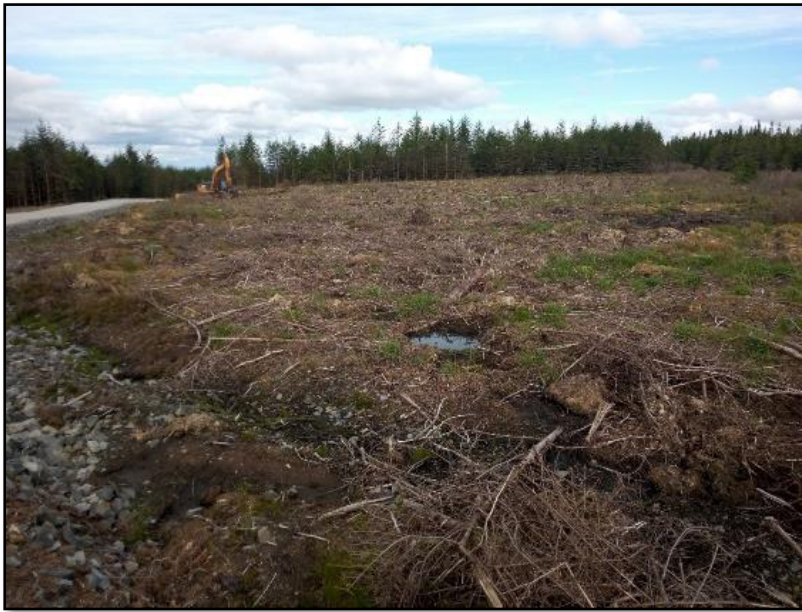
**Plate 13** Looking northeast at site of T5 pre peat excavation

T5 is centrally-located in the southern part of the windfarm. This is high ground west of Carrickaduff lough at just over 300m O.D. The site of the turbine and hardstand is in felled forestry with the ground consisting of tree stumps in grass and moss over peat. Excavations began at the end of August 2020 and continued throughout September. The ground here was wet and excavated areas were immediately stoned up, with a bulwark placed against the *in-situ* peat and the space between quickly filled with rock. There were deep deposits of up to of 4m peat here ranging from scraw and spongey top layers to well humified peat in the lower levels.

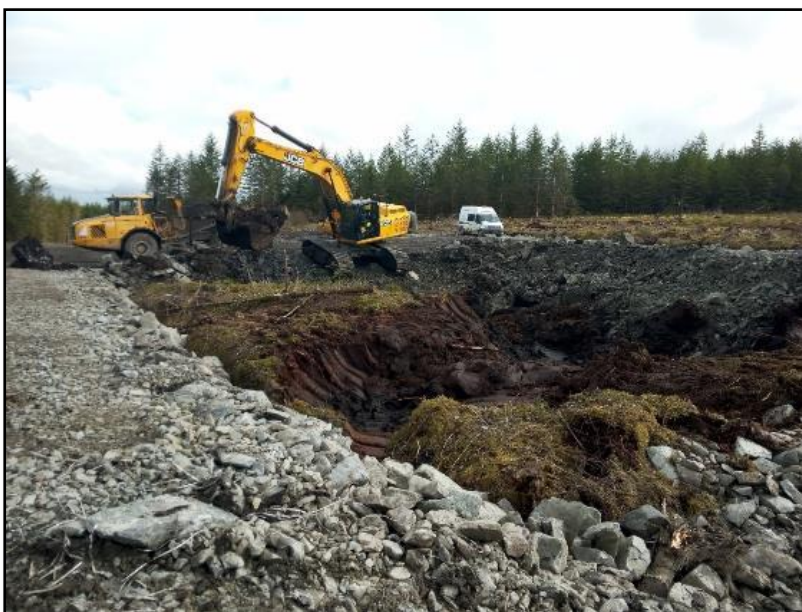
**Plate 14** Looking northeast at T5 during peat excavation

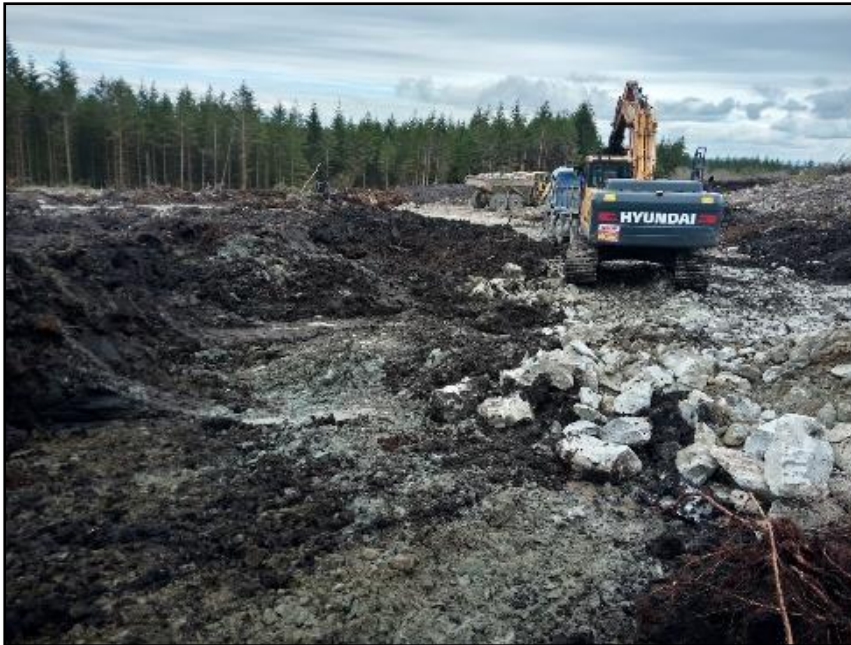
T6 was located on high rocky ground in the centre of the site at over 300m O.D. There was relatively little peat here with shallow deposits generally less than 1m in depth. The ground rose to the east and rising bedrock had to be broken following peat stripping.

**Plate 15** Looking west during excavations at T6

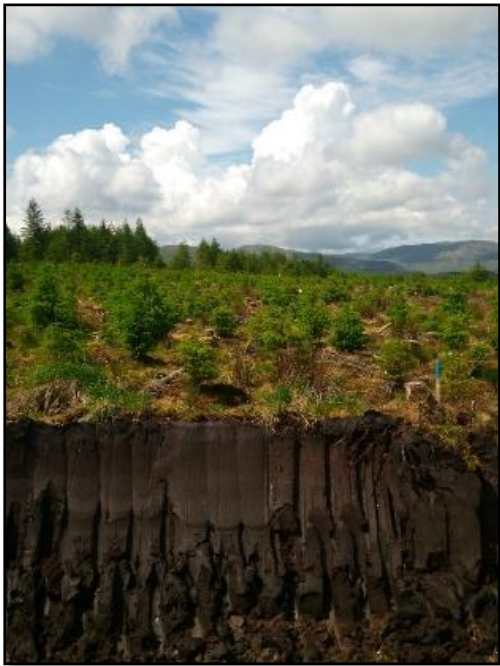
T8 is located in the centre of the site in mature forestry at a height of 250m O.D. Peat along the road to the turbine was firm and well humified with deposits of between 1m and 2m. Peat deposits on the site of the turbine were generally shallower but there were deep deposits of soft gravel and sandy clay.

**Plate 17** East-facing section of peat during excavation of road to T8

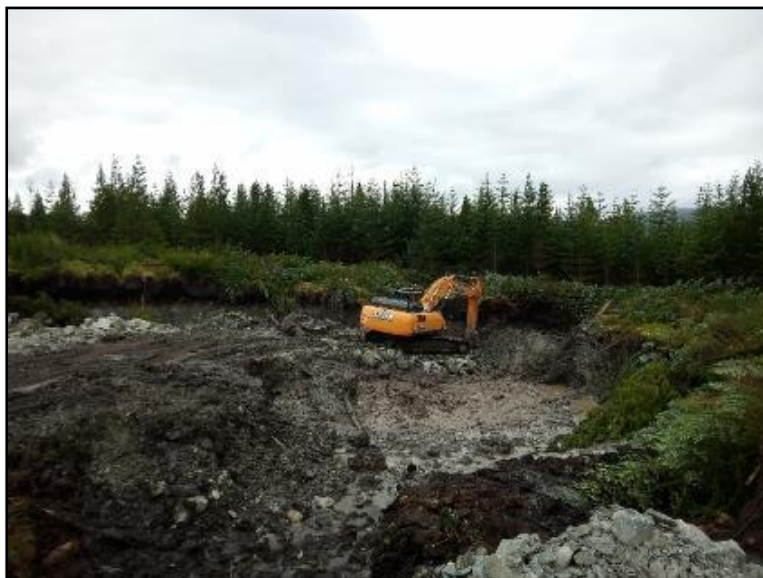
**Plate 18** Looking north at excavation of turbine base at T8

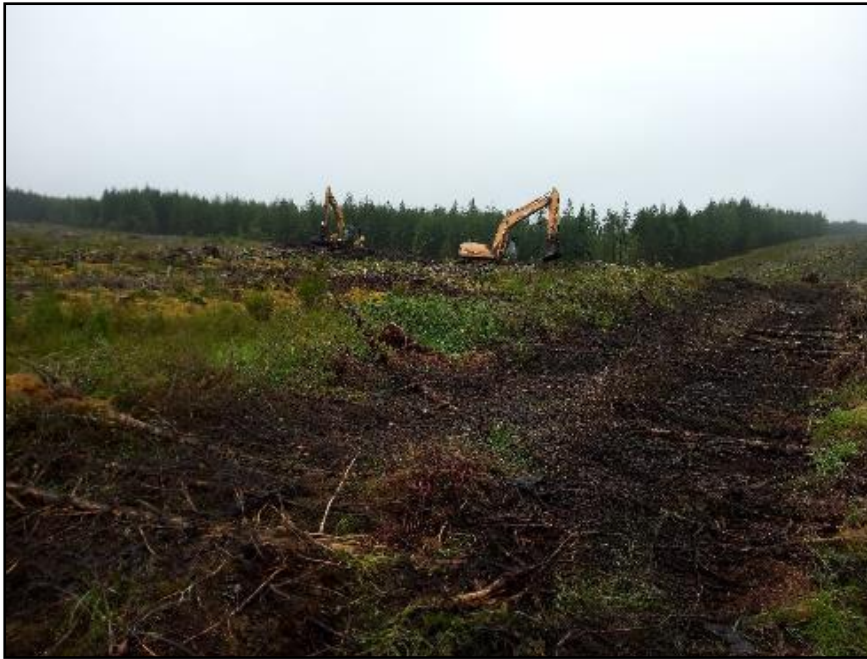
Plate 19 Looking west at site of T9 pre-excitation

T9 is located in the east of the site close to the Tyrone border. It is in felled forestry and rises gradually from west to east. There is an average of 1m of peat over broken stone in sandy grey to green clay. The ground undulates somewhat with up to 1.5m of peat in low lying spots.

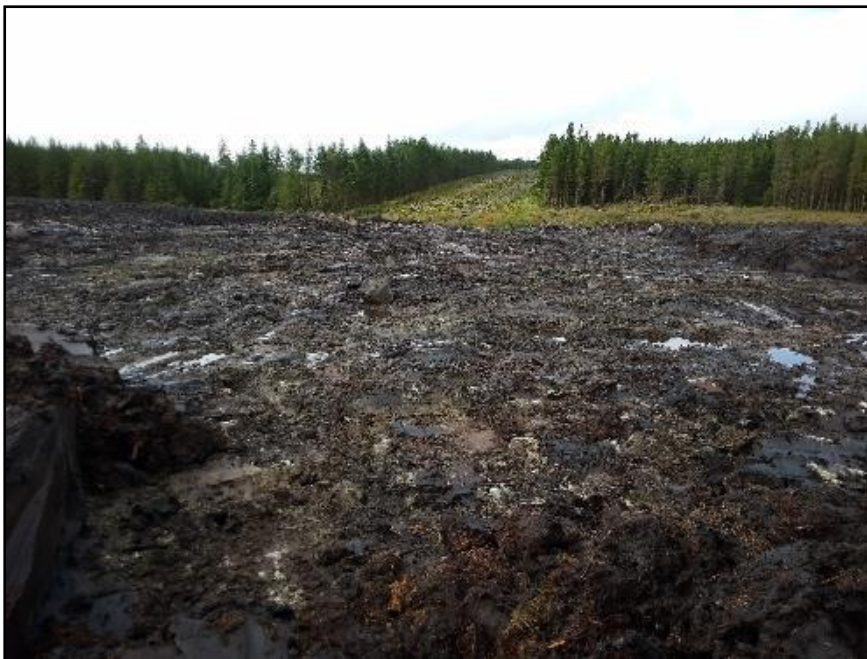
Plate 20 Looking west at T9 post peat excavation

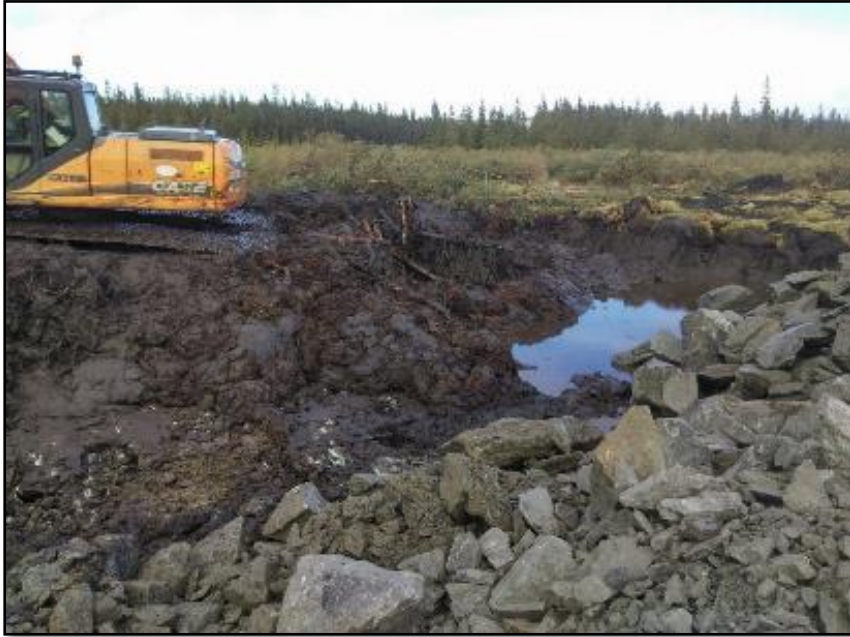
T10 was located in relatively low ground which is starting to rise out of the Bunadower River valley at a height of 215m O.D. The peat was wet and the base and hardstand were excavated using causeways and cell walls to separate and contain an area of bog. The peat was then be excavated in orderly fashion.

**Plate 21** Looking north at peat excavations at T10

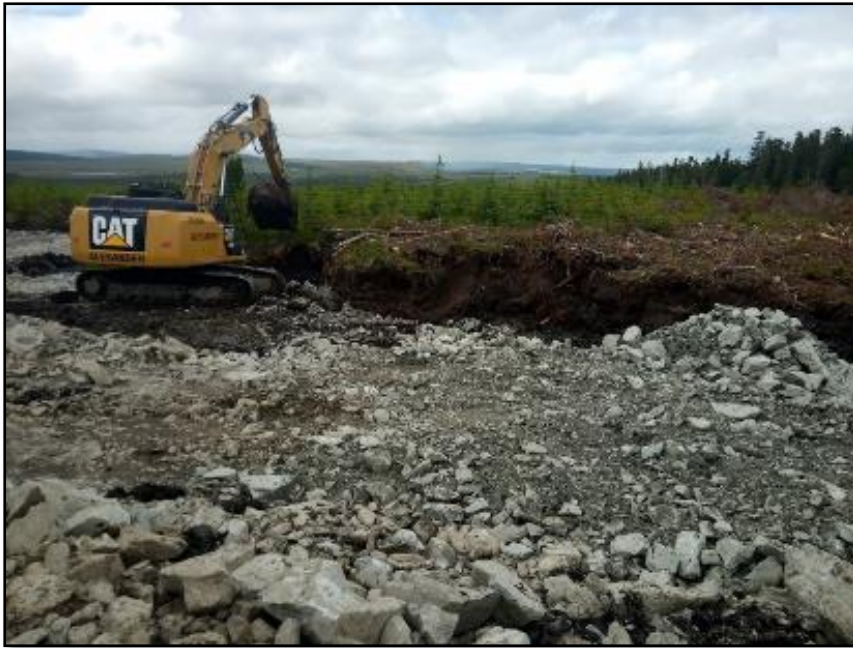
T11 was located on high ground towards the east of the site with commanding views over the surrounding countryside. The site was in felled forestry at a height of 255m O.D. The peat was quite wet here, particularly the ground at the hardstand on the west of the site. This area was excavated piecemeal and stoned up immediately. The ground rose to the east and there was some rising bedrock with shallower firmer peat here.

**Plate 22** Looking north at hardstand excavation and fill at T11

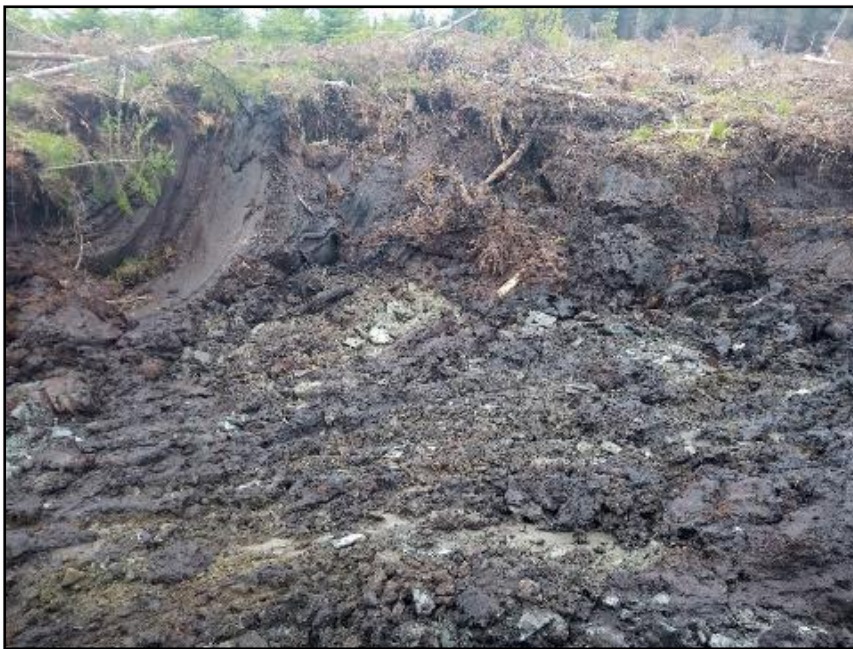
**Plate 23** West facing section in east of hardstand area at T11

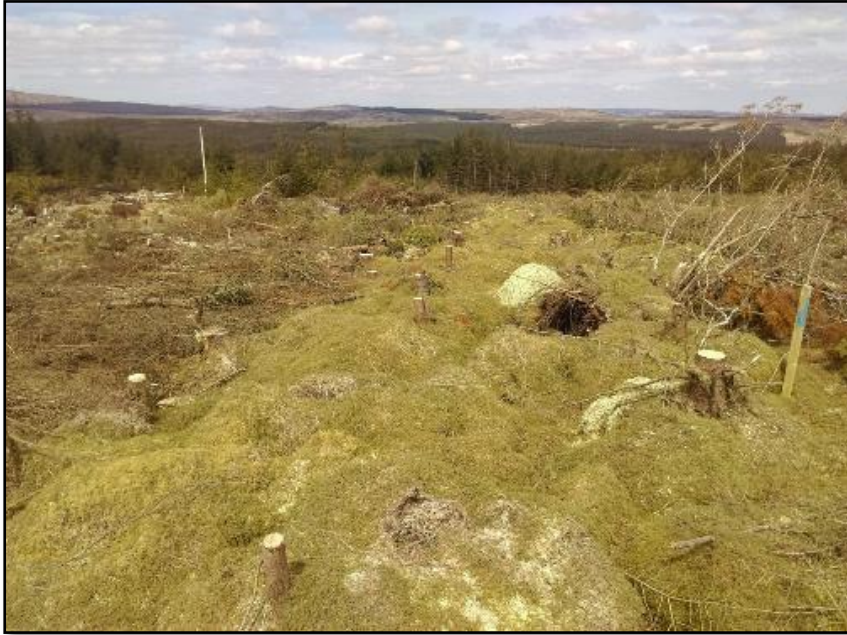
**Plate 24** Looking north at site of T12 pre-excitation

T12 is located in the centre of the site on rising ground at 230m O.D. The site falls away severely to the north and west and large amounts of stone were required to level it out. The peat was wet in the west and north on the site of the turbine but was drier and firmer over rising bedrock in the east and south on the site of the hardstand. The site was under immature plantation and felled trees with brash.

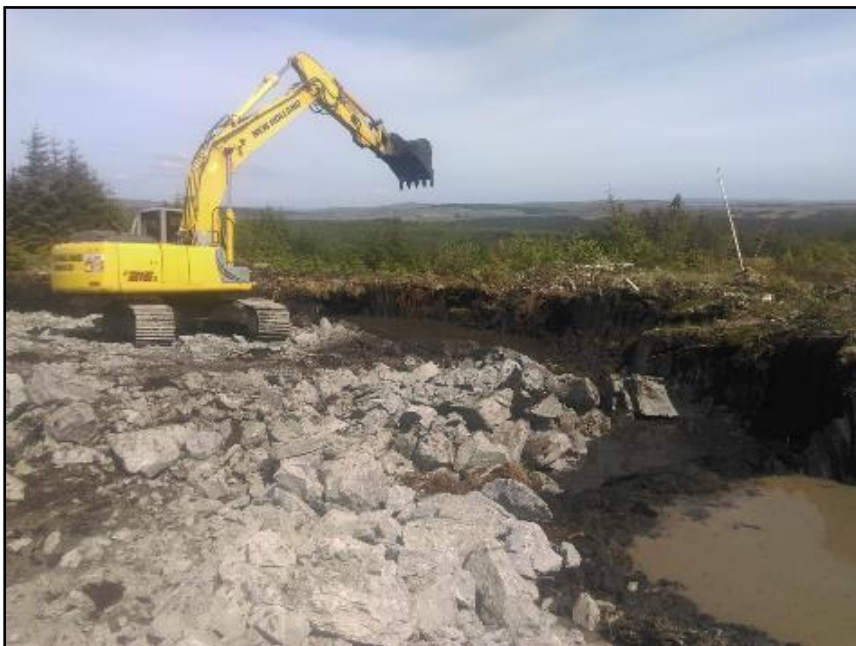
**Plate 25** Looking north at peat excavations for turbine base at T12

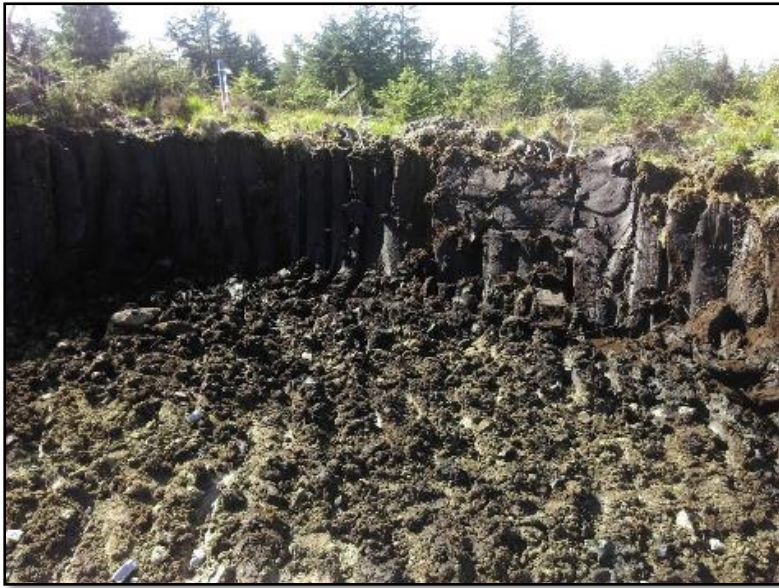
**Plate 26** Southeast-facing peat section at hardstand for T12

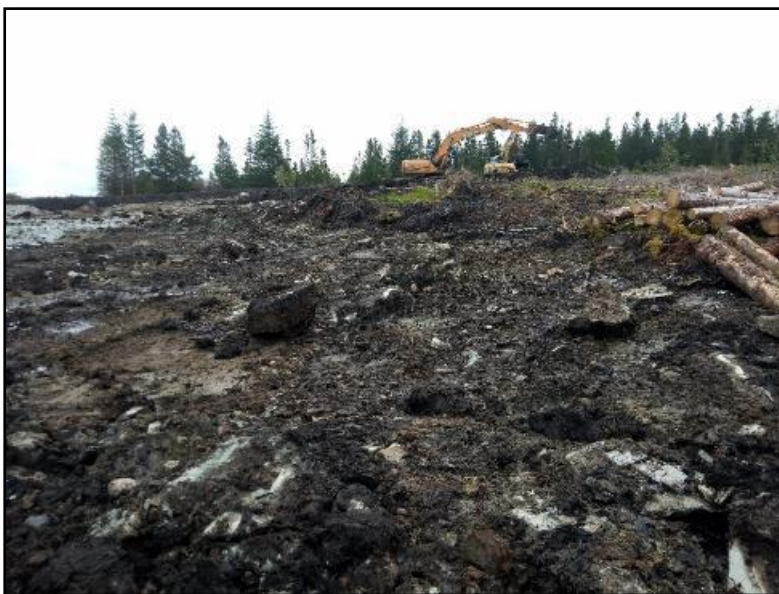
T13 is located on rising ground towards the northeast of the site at 220m O.D. It is in felled forestry with birch regrowth. Excavation of the turning area at the entrance to the turbine began on 5<sup>th</sup> August 2020. There is rising bedrock throughout with shallow peat less than 1m deep. Grass and moss cover 0.5m of mossy scraw over better peat which comes down onto sandy clay and green mica sand on broken rock. There are preserved grasses, *calluna* root and moss on rock under the basal sand and very occasional roots in the basal peat layers. Rising bedrock with ridges of outcrop to the west with no more than 0.5m of peat over silty sand and broken rock onto the bedrock.

**Plate 27** Looking west at T13 hardstand

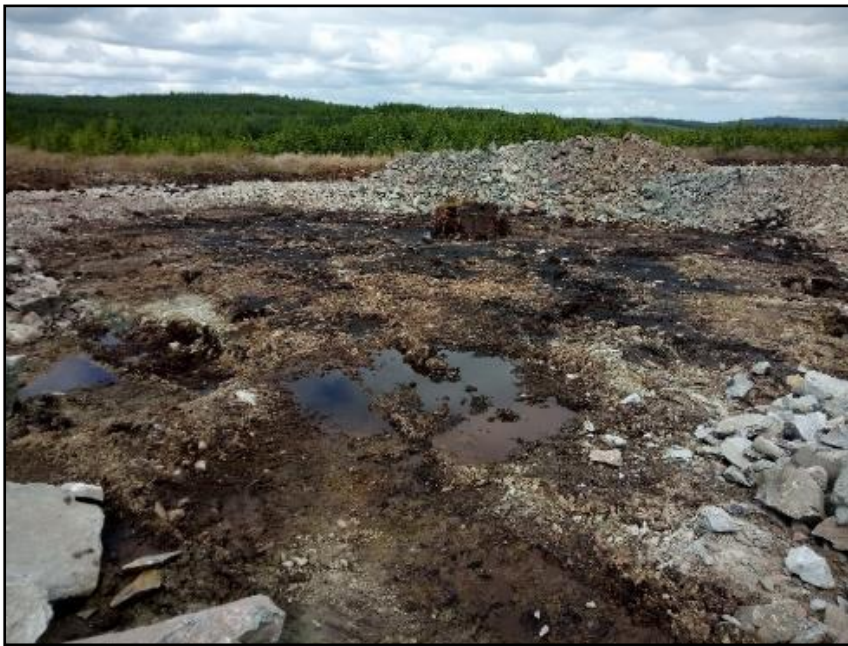
T14 was located in relatively low ground of 185m O.D., south of the Bunadownen River in an area known as 'The Leap'. The road and turbine base were excavated intermittently throughout the summer of 2020. The road to the turbine falls sharply through felled forestry and some deep peat was excavated on the lower reaches in the north as it approached the river valley. The ground in the south was covered in shallower peat and had underlying rock. The bog on the site of the hardstand was deep and required the wide pad machine to excavate up to 4m of well humified peat.

**Plate 28** Looking northwest at T14 base

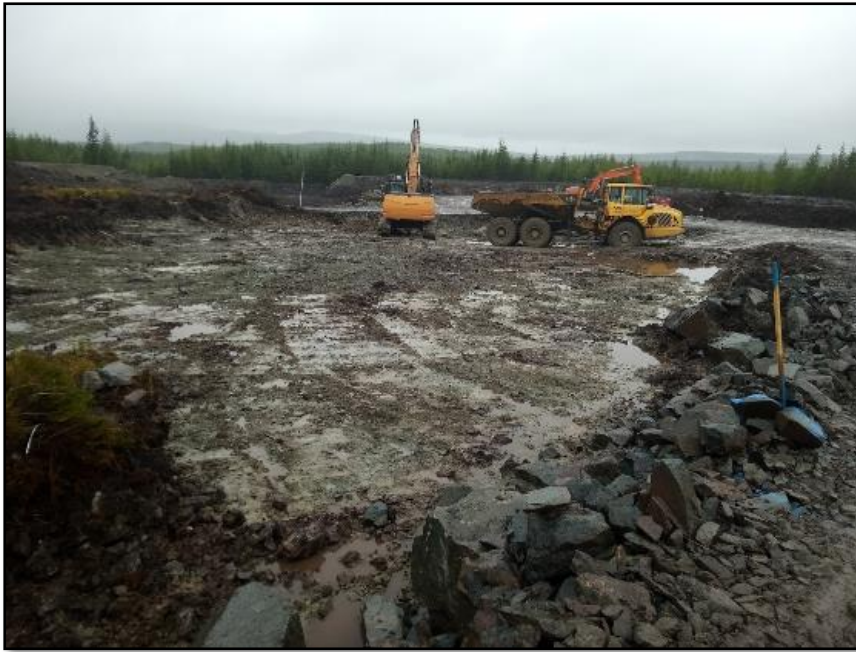
T15 was located in the north of the site in an area of felled forestry with young regrowth. Excavations began in July 2020. Digging in the west showed 1m of peat under felled forestry. This overlay gravelly clay with large cobbles. There was very little wood in the peat. Excavations in the east showed less than 1m of peat, usually between 0.5m and 0.7m over gravelly clay.

**Plate 29** Looking northwest at T15 hardstand

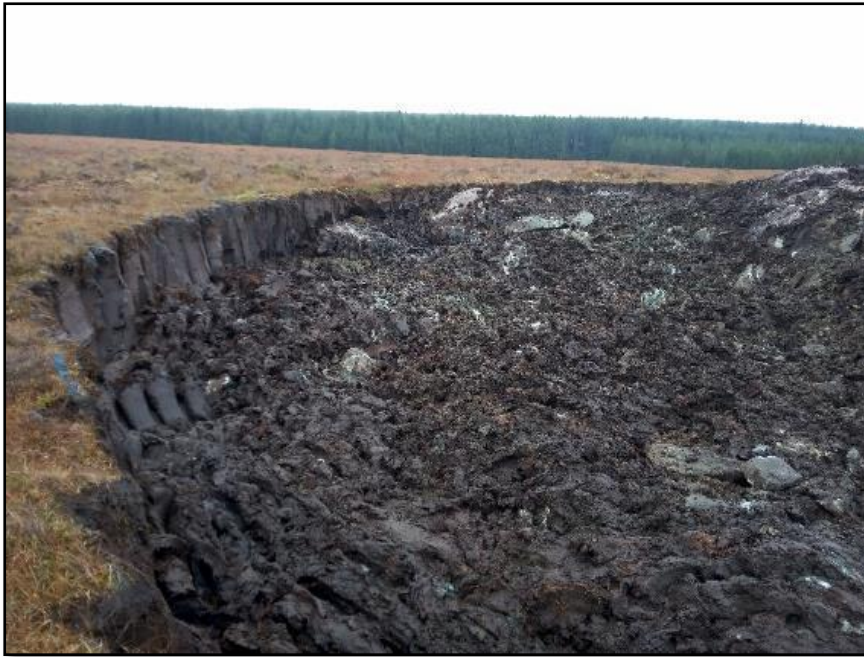
Excavation of the road to T16 began in October 2020. The ground rose steeply initially with shallow peat over rock and gravel. It then fell into a valley with wet peat 2m to 3m in depth. There was a bank of rock on the west as the road nears the hardstand on high open ground. Digging of the hardstand began on 22<sup>nd</sup> October. There was a short break in excavations with work resuming on 6<sup>th</sup> November when the turbine base was excavated. This area is characterized by rising bedrock with less than 1m of peat over rock in the centre of the base. There were pockets of deeper peat on all sides as the rock fell away to a maximum depth of 2m on the eastern edge of the base. The peat was very grassy all the way to the basal levels with heather, grass and sphagnum on top.

**Plate 30** T16 base looking south

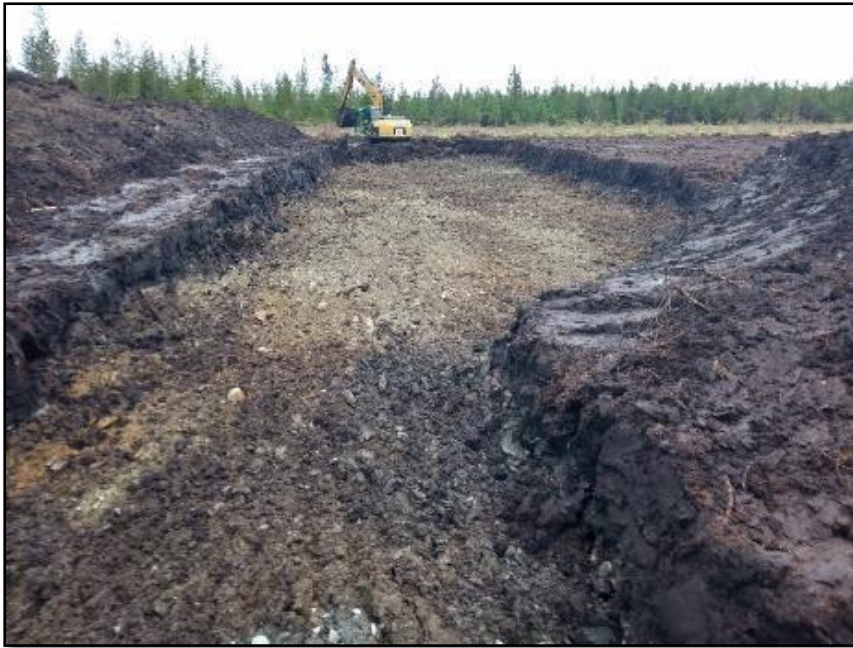
T17 is located in the northeast of the site in felled forestry with peat under grass and moss. Excavations began in July. The hardstand area sloped from east to west with less than 1m of peat in the east and up to 2.5m in the west next to the road. Generally there was about 1m of peat over stone and rising bedrock in clay. The turbine base was to the west of the hardstand and had slightly deeper peat with depths of 1.5m in the west of the base. The peat overlay boulders in sandy light brown clay. The entrance was widened on 30<sup>th</sup> July. There is a 2m fall in the west of the hardstand between the rear (east) and front (west). There were occasional roots in the basal layers but there is no ancient wood in the peat only stumps and roots from the recently felled plantation.

**Plate 31** Looking east at excavation of T17 Hardstand

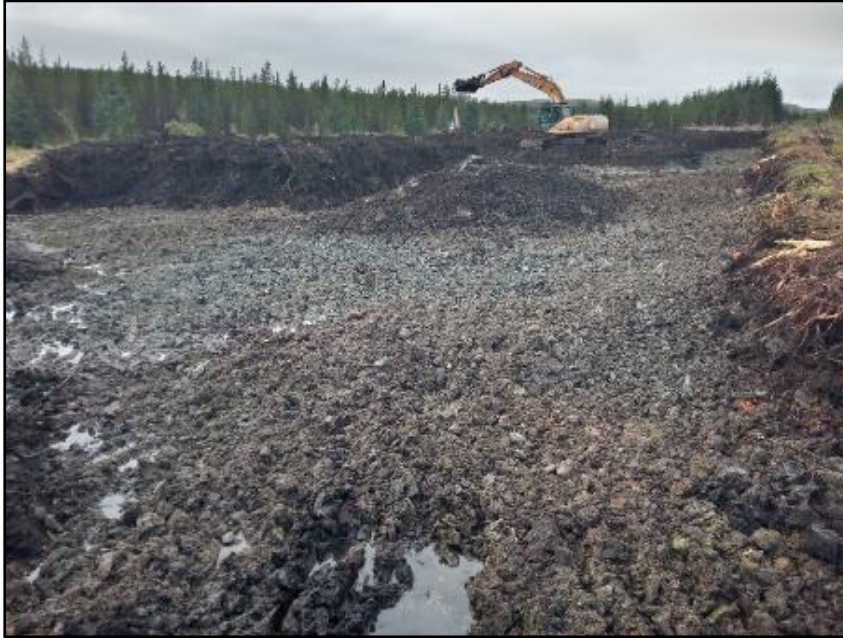
Topsoil stripping began on the Peat Storage Area opposite T18 on Friday 25<sup>th</sup> September. The turbine and Peat Storage Area are located in felled forestry sloping down west to east towards the existing forestry road. There was rock outcrop in the west just outside the footprint of the hardstand. Shallow relatively dry peat of 1m or less overlay grey and brown sandy clay over grey dry sandy clay onto rock. Excavation of the hardstand began on 13<sup>th</sup> October 2020. There was rising bedrock in the northeast

with peat of less than 1m under felled forestry. Peat deepens to 1.75m to 2m further south towards the base and overlies sandy gravel and clay with frequent cobble sized stone. Excavation of the turbine base began on 4<sup>th</sup> November with 1.5m of overburden over 2m of peat onto gravel and clay.

**Plate 33** Looking southwest at T18 hardstand excavation

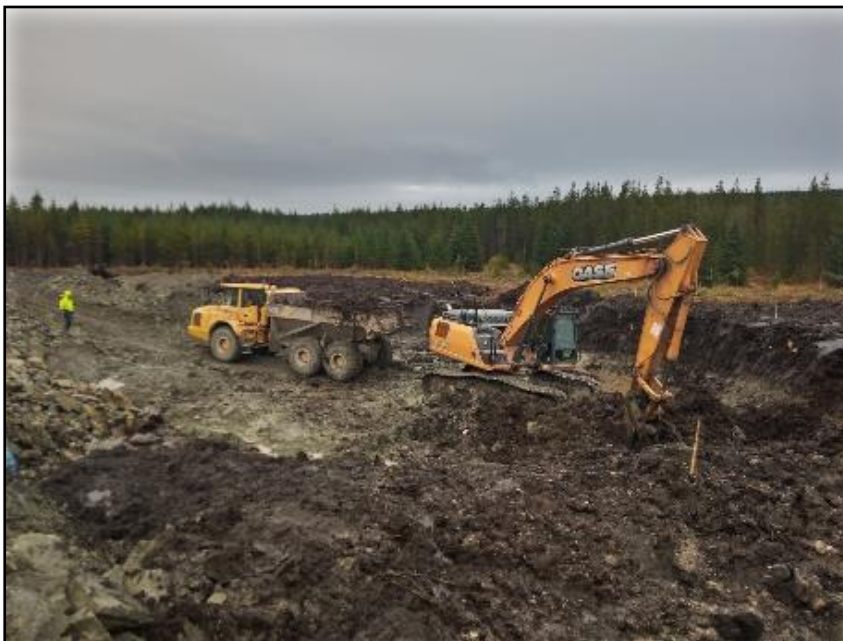
**Plate 34** Looking east at T18 base excavation

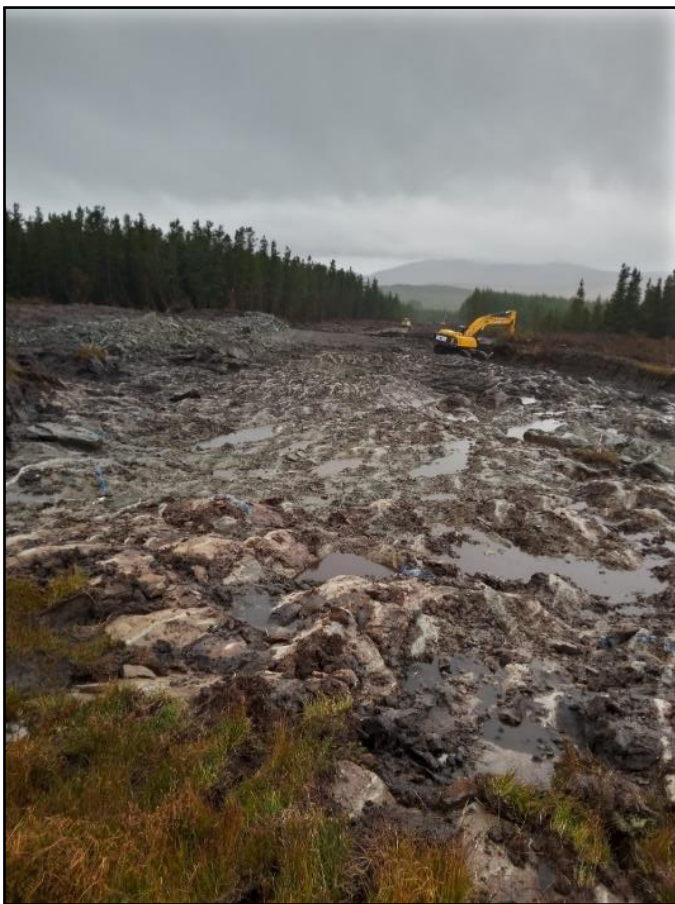
T19 is located on a relatively level plateau in the northeast of the site at about 200m O.D. Excavation of the road into the turbine began on 20<sup>th</sup> August 2020. The initial stages of the road climbed through plantation. The stratigraphy here consisted of up to 2m of firm peat onto rock with no excessive water. The road levels out at the summit where the turbine and hardstand are located and peat here is shallow but wet. There was a maximum of 1.5m of peat onto rising bedrock here. The ground is level and plantation free with grass and heather on relatively flat moorland falling away to the northeast and south. There were deeper peat deposits in the north and west of the hardstand with depths of 2.5m onto gravel over rock. There was rising bedrock in the east and south.

**Plate 35** Looking west across T19 hardstand post topsoil stripping

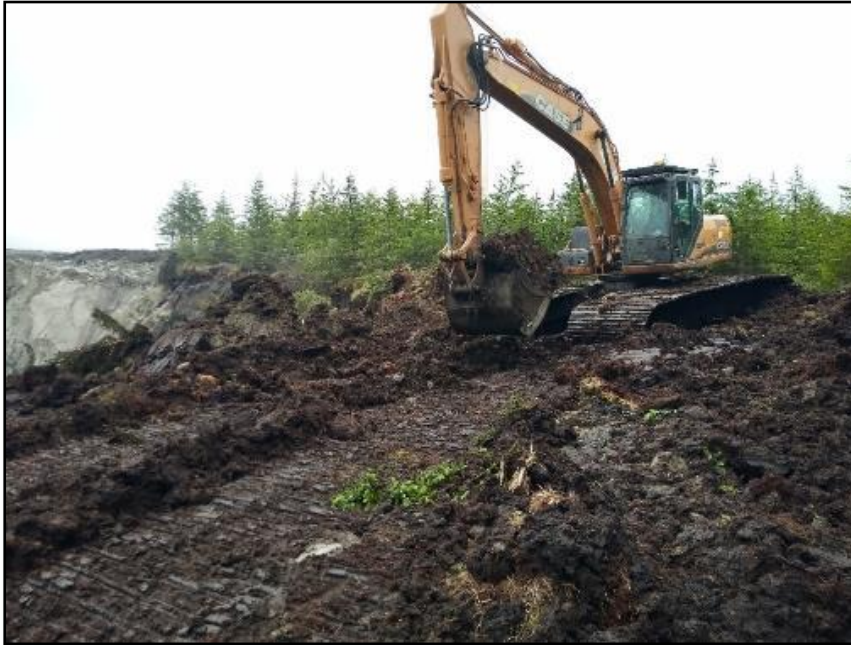
**Plate 36** Borrow pit 1 was located at the road junction west of T12

Borrow pits were stripped of topsoil or peat before extraction began. As these were areas of rising bedrock or outcrop the topsoil or peat cover was generally shallow. Nothing of archaeological interest was found in these areas.

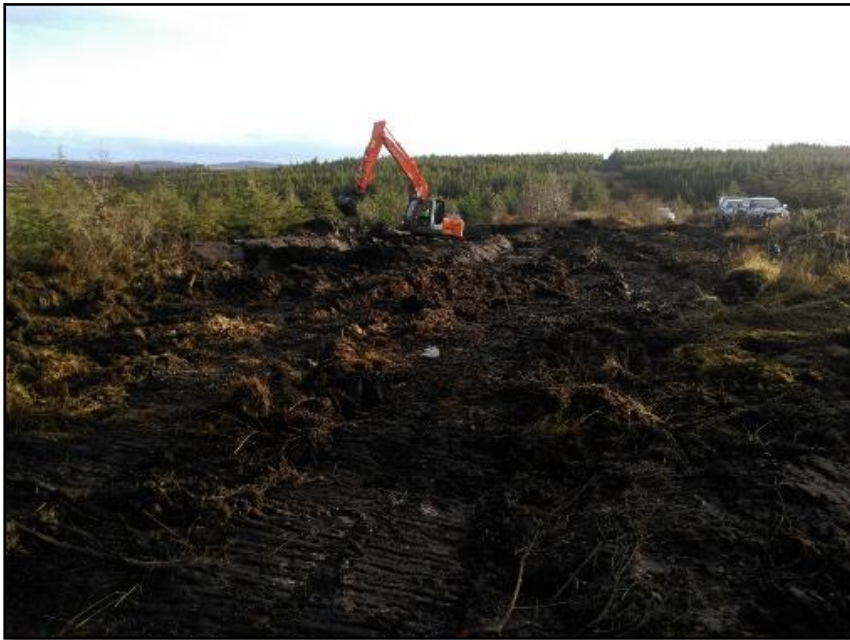
**Plate 44** Peat excavations at site of substation

The substation and compound were located in the northwest of the site and were quite separate from the turbines which are almost all on higher ground east of the Bunadower River. The substation was excavated periodically starting in November 2019 with the final peat removal taking place in June 2020. The bulk of the excavation work took place in Spring 2020.

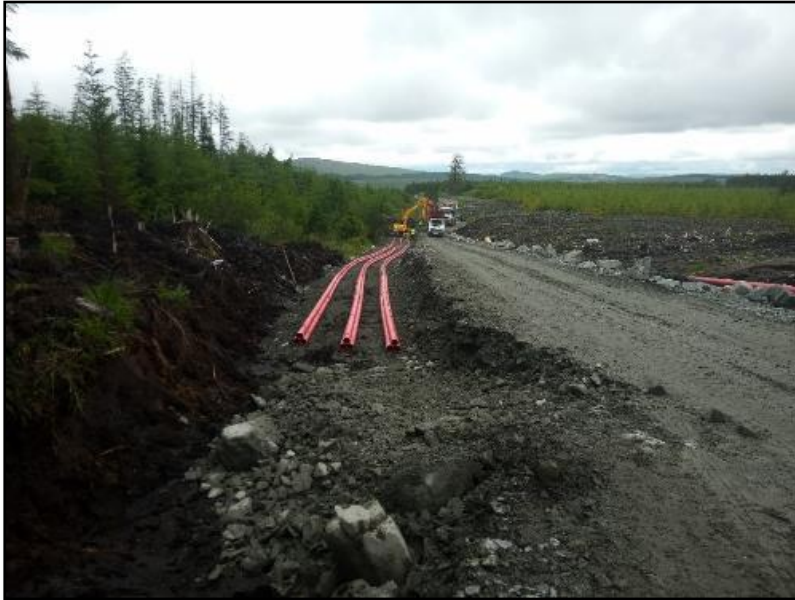
**Plate 46** Looking northwest along ducting route between compound and substation

Ducting on site took place in the side of roads which had been upgraded during the initial phase of construction. As such the removal of peat had already been monitored and the ducting work was subject to intermittent monitoring only.

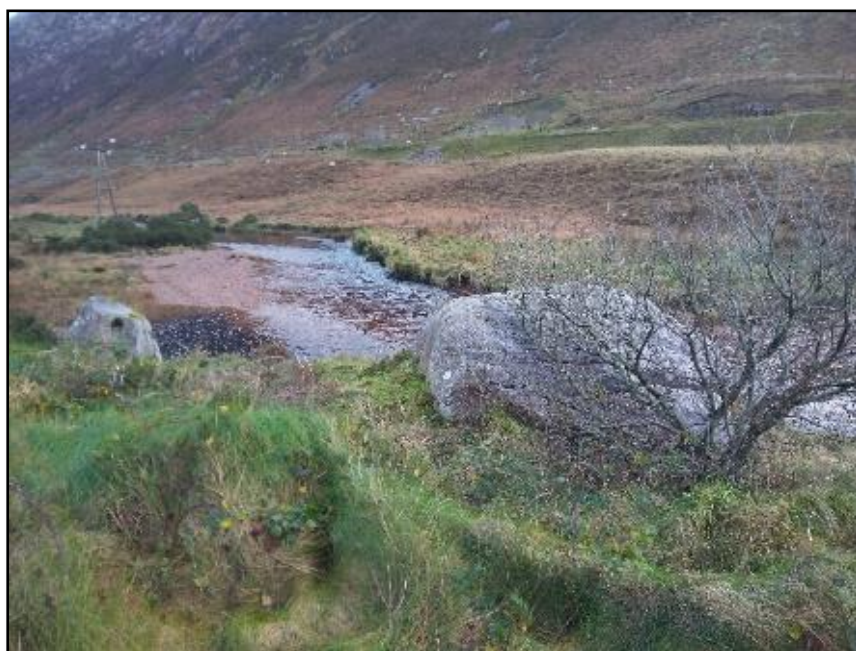
Plate 48 Looking north at DG005-085

This site has been designated a redundant record since the compilation of the EIAR cultural heritage chapter. It is located on the river bank several metres from the hard shoulder where it is proposed to lay ducting. The site is as described in the inventory as consisting of a number of large boulders. The bank has recently been planted with willows. No archaeology was found during monitoring.

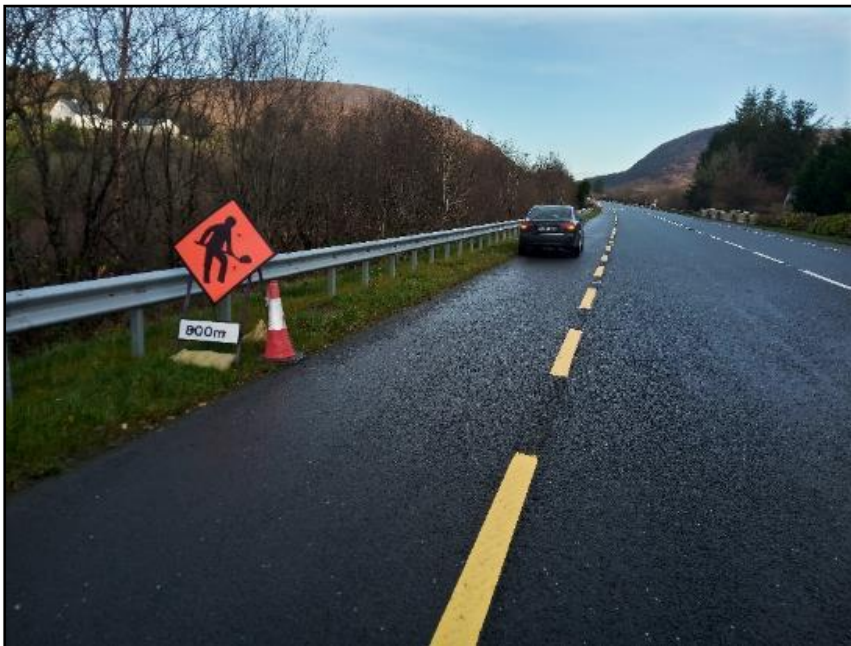
**Plate 50** Looking north at site of DG094-026

This site was fully excavated as mitigation of the N15 re-alignment. No archaeology was found during monitoring.
