## APPENDIX 14-2

**DELANY (2023)  
ARCHAEOLOGICAL MONITORING  
REPORT**

**ARCHAEOLOGICAL MONITORING OF A WINDFARM DEVELOPMENT  
AT MEENBOG, COUNTY DONEGAL**

*Excavation Licence Number: 19E0739*

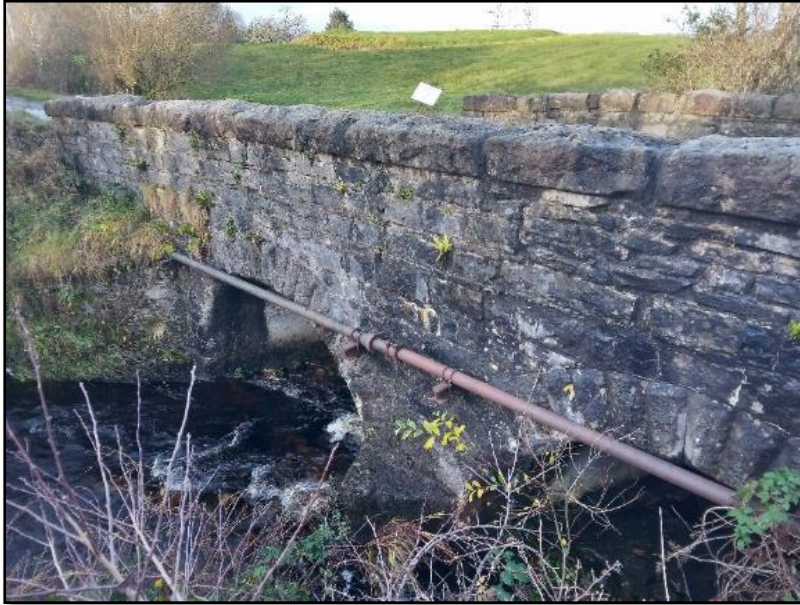
**Plate 51** Looking west at road bridge NIAH Ref. 40909424

Ducting was installed under the bridge using directional drilling.

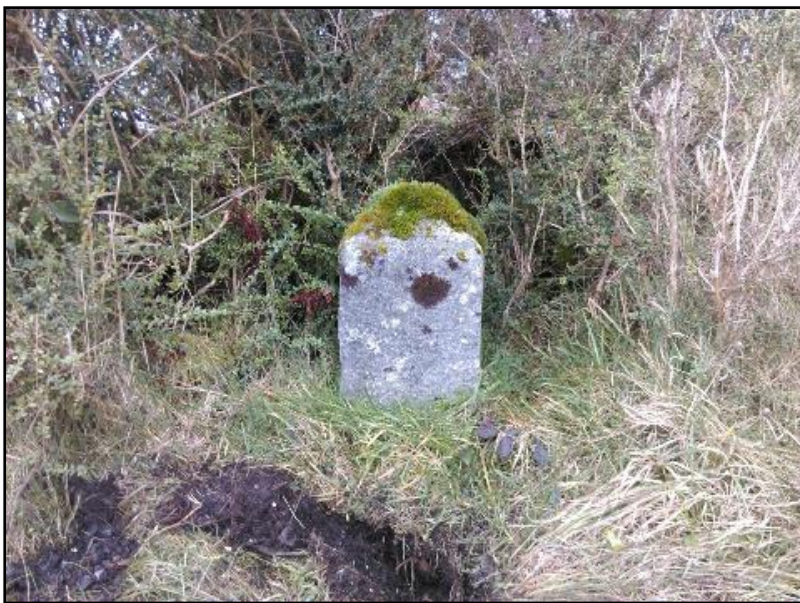
**Plate 52** Looking west at milestone NIAH Reg. No. 40909423

A milestone which is included in the National Inventory Architectural Heritage (Reg No 40909423) is located in the vicinity of the works. The milestone dates from 1775 and is assessed as being of social and historical interest and is of regional importance. It was on the opposite road carriage at the junction of local road leading to the Clogher substation and the old Barnes road. There was no impact on the milestone and no archaeology was found during monitoring.

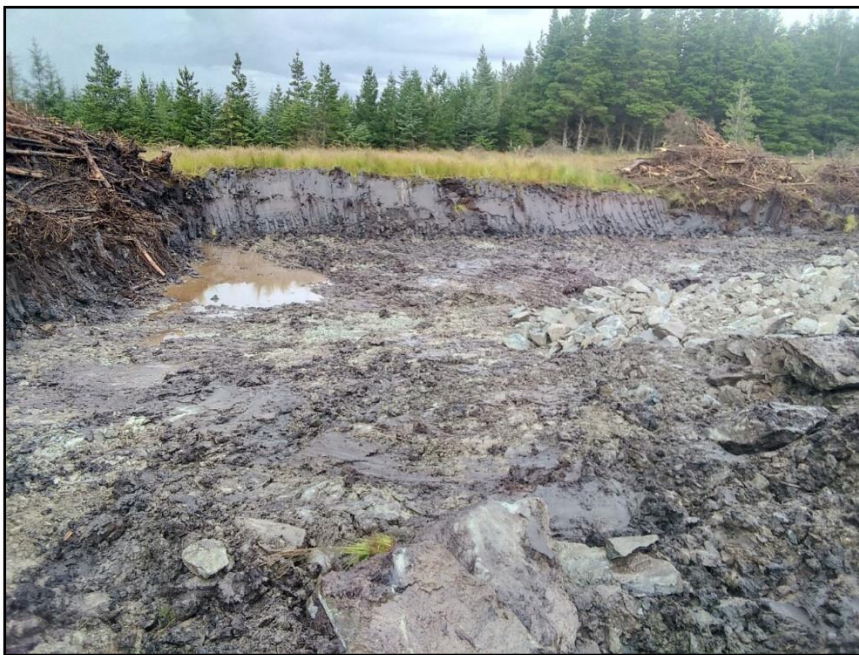
Excavation works began in earnest on Wednesday 7<sup>th</sup> September with stripping of the borrow pit SW of T16. Excavations here continued intermittently until 5<sup>th</sup> October. The site of the borrow pit slopes from the peat cell in front of the base down towards the road. Stratigraphy was composed of 1.2m overburden of previously excavated peat over 1.5m of peat near the road. There was less than 1m of overburden on the higher ground, and the *in situ* peat depth varies with some rising bedrock with boulders. There was generally sandy clay under the peat with some soft shaley rock. Stratigraphy remained consistent across the borrow pit but was slightly deeper in the SW corner where there was 1.5m of overburden peat over 1m of *in situ* peat onto rock in grey clay.

**Plate 54** Looking west at Borrow Pit post peat excavations

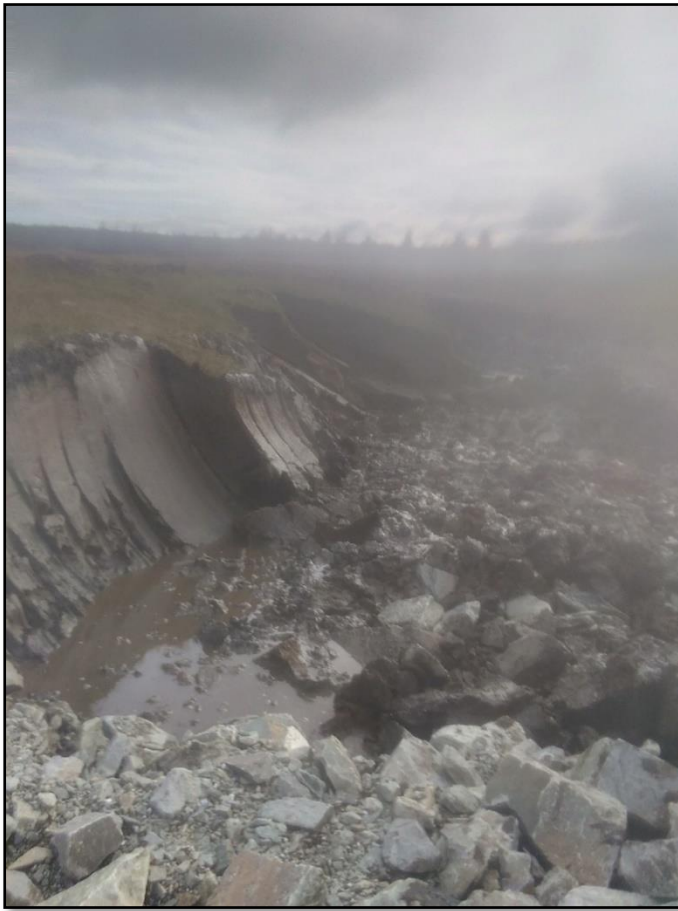
Work began at T16 on Thursday 22<sup>nd</sup> September with the widening of the entrance. There was 1.5m to 2m of peat with 1m of very hairy spongy scraw and peat over more developed peat down onto stony grey clay. Stratigraphy here generally consisted of 2m of fibrous moderately humified peat over brown clay. Water ingress made the peat very wet. There were some large stumps and roots in the basal layer. On the north side of the hardstand the peat was shallower reaching depths of no more than 1.5m but was equally wet. There was occasional branch wood in the basal layer in this area but

none showed signs of having been worked. Work on the hardstand was completed on 3<sup>rd</sup> October. Nothing of archaeological interest was found.

**Plate 55** Peat section face in T16 hardstand extension

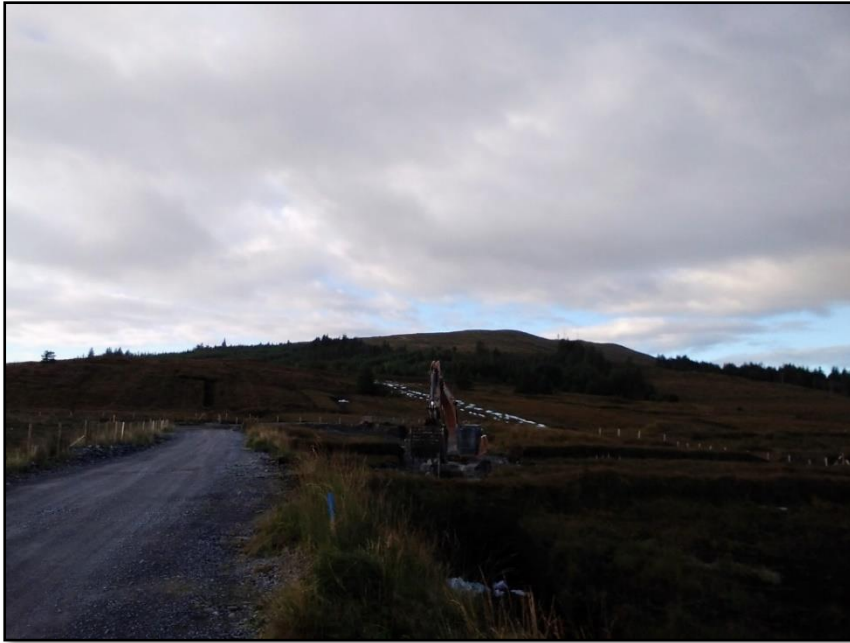
Between Thursday 15<sup>th</sup> September and Thursday 22<sup>nd</sup> September excavation works involved the realignment of the access road from the N15 up to the substation. Work began in the west and progressed east taking out each of the sharp bends in the upgraded existing forestry road. Excavations took place largely in cutaway bog. At the first bend peat depths averaged 2m in cutaway and 3m on the ridges. There were large amounts of wood at the base of peat including roots, stumps and branches. These occurred at a depth of 2.5m.

Excavations began on the second corner on Wednesday 21<sup>st</sup> September. There was generally stable peat under overburden of spread excavated peat to a depth of 2.5m on the south side. The north side consisted of overburden with mixed grey clay over 0.2m of a stone and sand old forestry track over stable peat.

**Plate 56** Looking east at Site Access Road Realignment

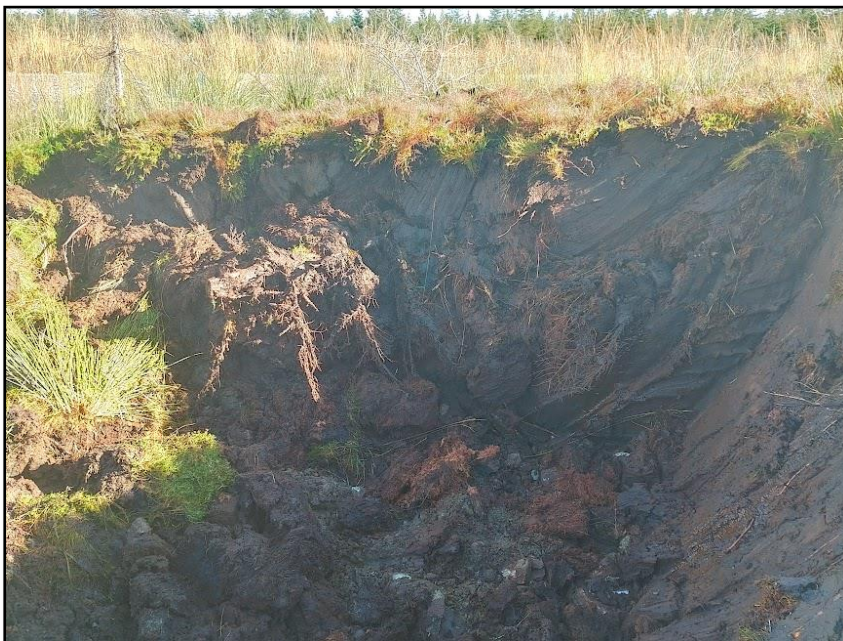
On Tuesday 4<sup>th</sup> October work began on excavating a new road to T9. Stratigraphy consisted of 1.5m of fibrous peat under brash and felled tree stumps in an area otherwise covered in reed.

**Plate 57** Looking west at peat section in new road to T9

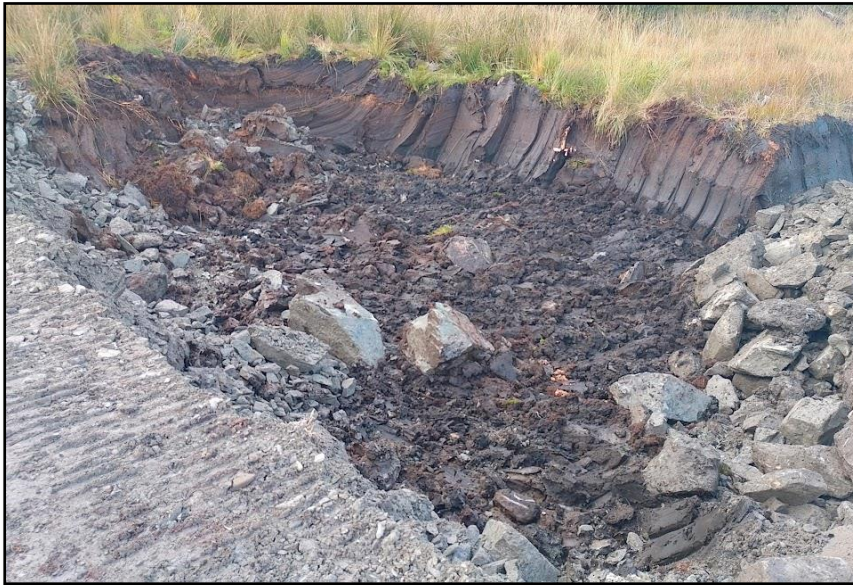
There is a major road junction in the NE of the site where roads to T19, T17 and beyond, and T15 and beyond meet the forestry access road from the Dearg Line. Excavation of the southern end of this junction took place from 5<sup>th</sup> October to 7<sup>th</sup> October. There was some overburden at the southern end of excavations but generally there was between 1.5m and 2m of peat under reed cover overlying 0.2m of sticky, sandy clay with frequent rock.

**Plate 58** Looking south at extension of NE junction
