# MEENBOG WIND FARM (PROSPECTIVE DEVELOPMENT)

## PEAT STABILITY ASSESSMENT REPORT

**Document No:**  
**P24234-FT-EGT-XX-RP-GE-0002**

**Abstract:** Fehily Timoney and Company (FT) were engaged by MKO Ltd to undertake a geotechnical assessment of the Meenbog Wind Farm site with respect to peat stability, to cover the works required to complete the Prospective Development.

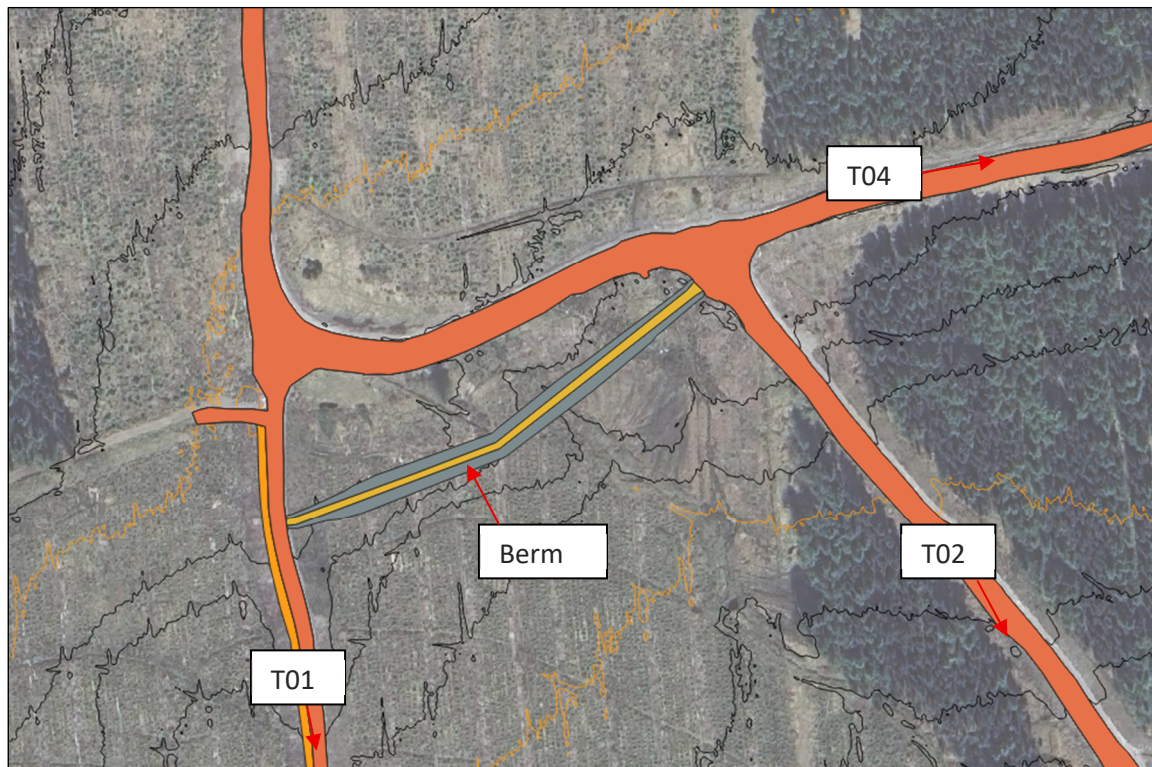
Figure 6.1: Berm Location, South of T01/T04 Junction

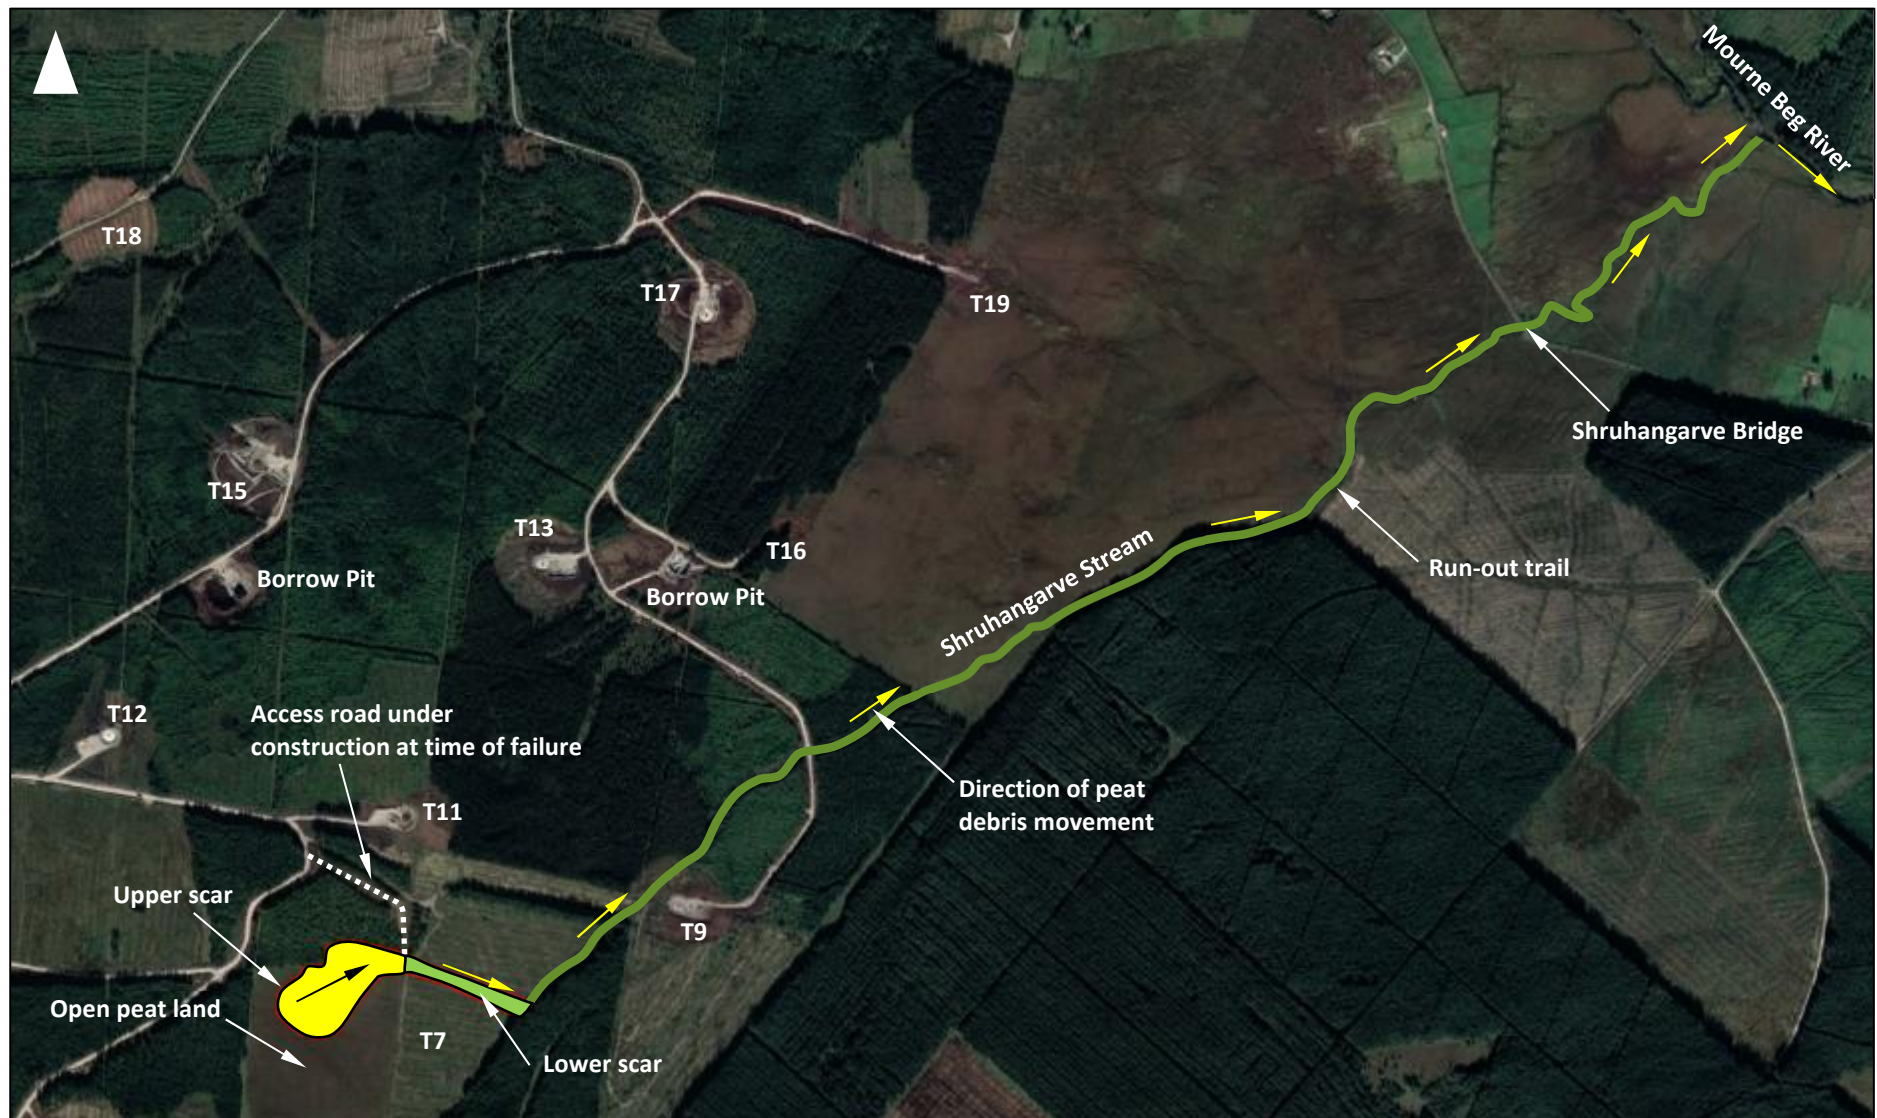
Figure 5-2: Aerial image of upper and lower scars

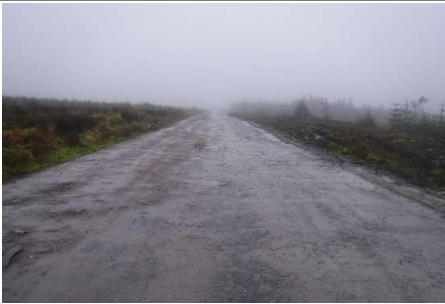
| Track near T12 | 6 degree slope. Minor area of side casting downslope. No evidence of stability issues. | | | |

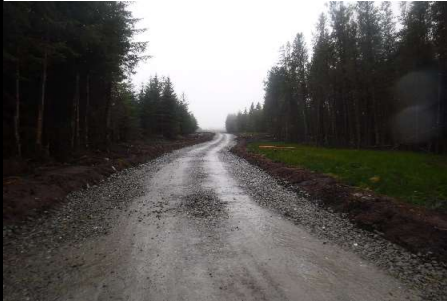
| T14 access track | Side casting both sides, 6 degree slope, <1m side cast. No evidence of stability issues. | | | |

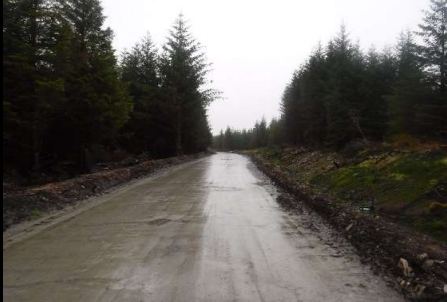
| T15-T19 | Founded section of track, rock visible in drain on upslope side. No evidence of stability issues. | | | |

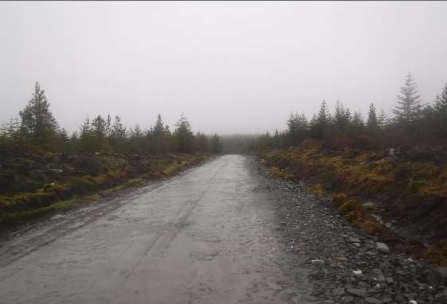
| T16-T17 | View towards T17, no evidence of stability issues. | | | |

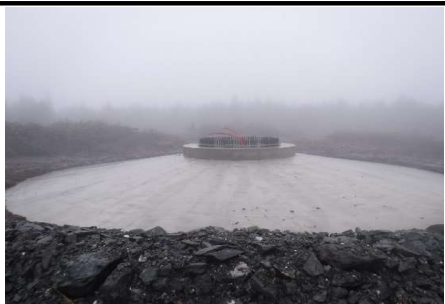
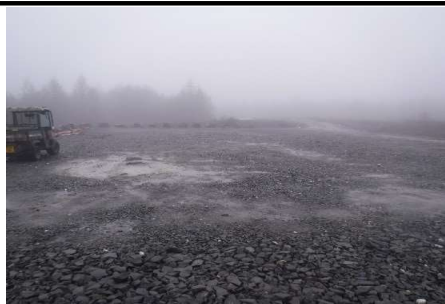
| T4 | Relatively flat, 1-2 degree slopes around hardstand. Peat 1-2m in thickness. No evidence of stability issues. | | | |

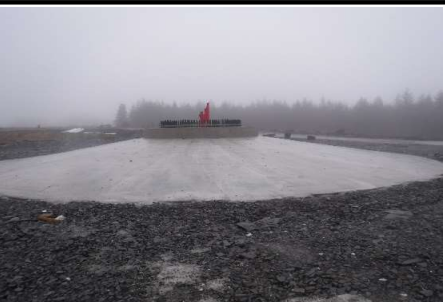
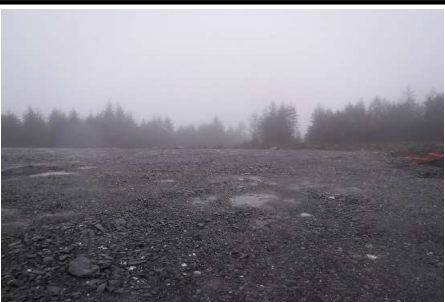
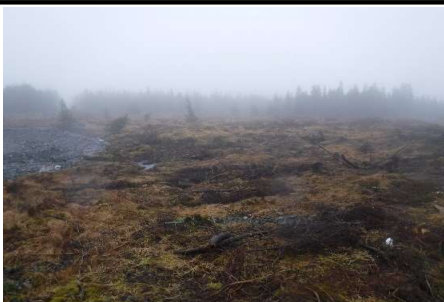
| T5 | 3 degree slope around hardstand. Evidence of instability around hardstand - tension cracks visible to 25-30m away from hardstand. | | | |
| | | T5 Turbine | T5 Hardstand | Tension cracks around hardstand |

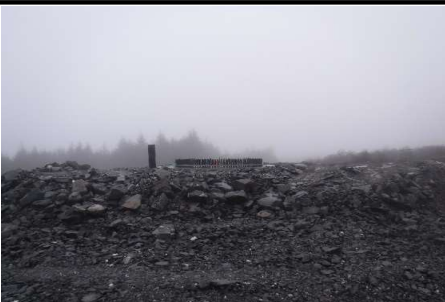
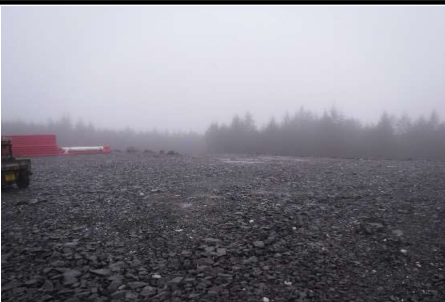
| T6 | 5 degree slope around hardstand. Minor side casting of peat (<0.5m). No evidence of stability issues. | | | |

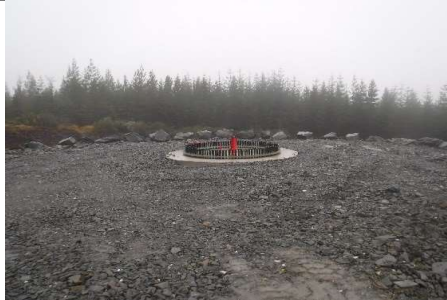
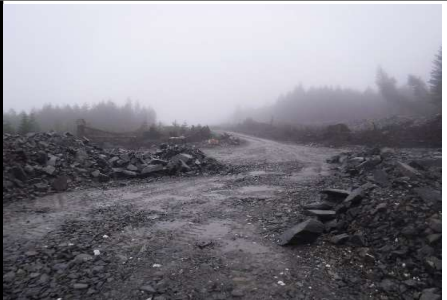
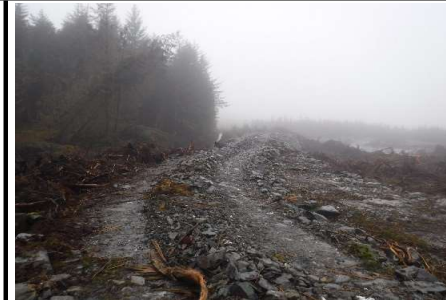
| T8 | 5 degree slope upslope for hardstand. Minor side casting around hardstand. Barrage close to hardstand to retain material that failed upslope. | | | |
| | | T8 Turbine | T8 hardstand | Barrage |

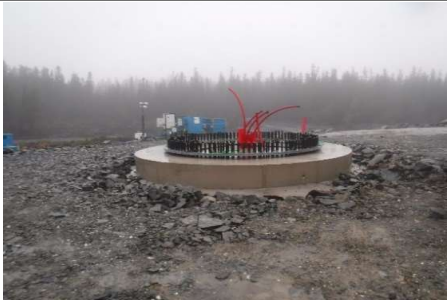
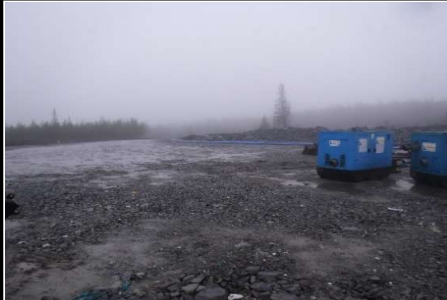
| T9 | 2 degree slope around hardstand. Peat side cast upslope of hardstand, <1m thick. No evidence of stability issues. | | | |

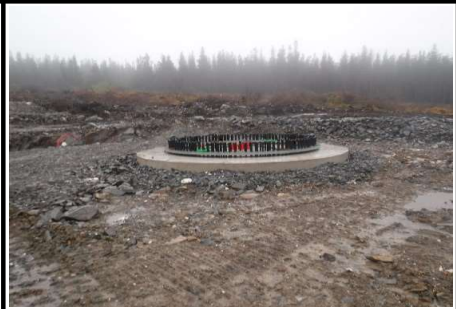
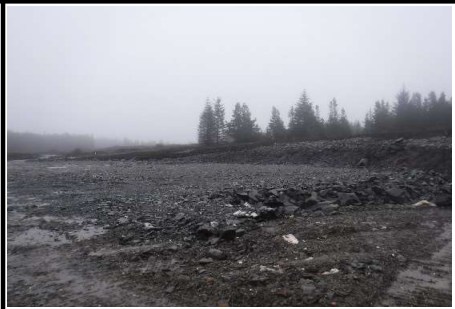
| T13 | 3-4 degree slopes around hardstand. Small area of side casting upslope from hardstand. No evidence of stability issues. | | | |

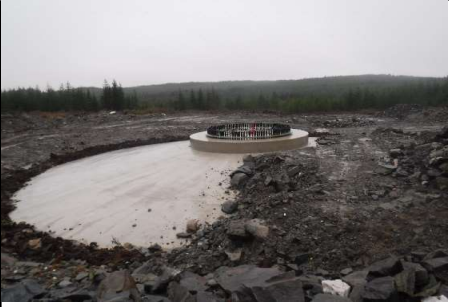
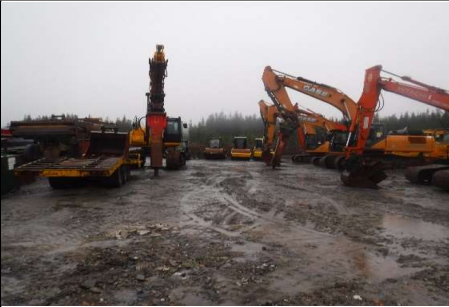
| T14 | 2-3 degree slope around hardstand. Peat side cast around hardstand and access track. No evidence of stability issues. | A circular concrete structure, likely a turbine foundation, is surrounded by a wide, flat area of dark, wet peat and gravel. The background shows a line of trees under an overcast sky. | A large, flat, muddy area with several orange excavators and other heavy machinery parked on it. The ground is wet and reflective. | |

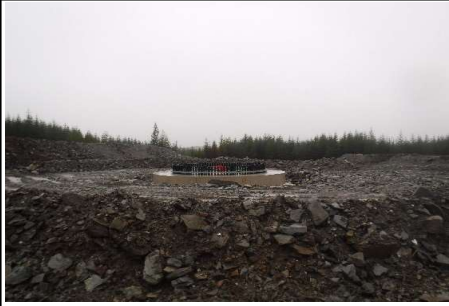
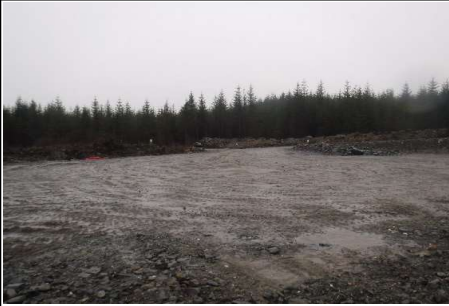
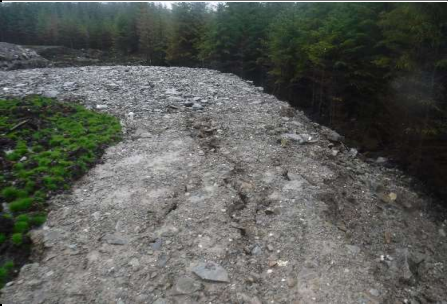
| T15 | 2-4 degree slope around hardstand. Peat stored both north and west of the hardstand. Area to the north shows signs of movement in perimeter berm. | A circular concrete structure, likely a turbine foundation, is surrounded by a wide, flat area of dark, wet peat and gravel. The background shows a line of trees under an overcast sky. | A large, flat, muddy area with several orange excavators and other heavy machinery parked on it. The ground is wet and reflective. | A close-up view of a peat repository, showing a large pile of dark, wet peat and gravel. The peat is piled up in a way that suggests it has been recently deposited or moved. |
| | | Turbine T15 | T15 Hardstand | Peat Repository |

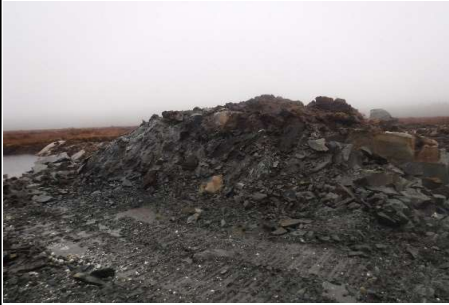
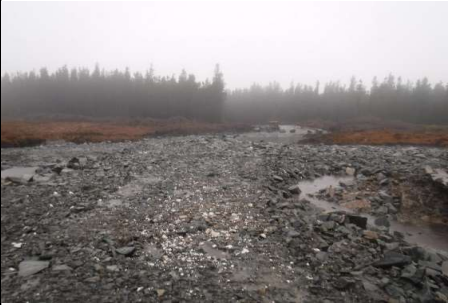
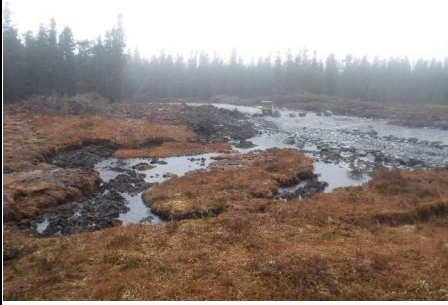
| T16 | 3 degree slope around hardstand. Small failure between cut-off drain and hardstand in peat. Water from drain now draining into hardstand. | A large, flat, muddy area with several orange excavators and other heavy machinery parked on it. The ground is wet and reflective. | A large, flat, muddy area with several orange excavators and other heavy machinery parked on it. The ground is wet and reflective. | A close-up view of a peat repository, showing a large pile of dark, wet peat and gravel. The peat is piled up in a way that suggests it has been recently deposited or moved. |
| | | Turbine T16 | T16 Hardstand | Failure between drain and hardstand |

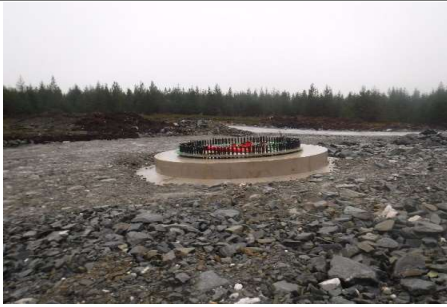
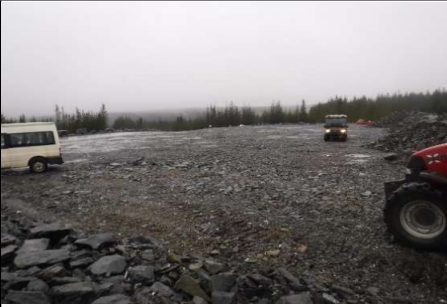
| T17 | 3 degree slope around turbine and hardstand. Peat side cast upslope and hardstand. Peat storage area downslope, berm shows evidence of minor movement. | | | |

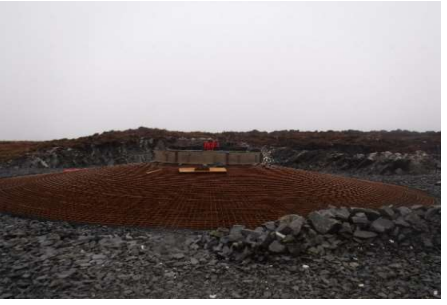
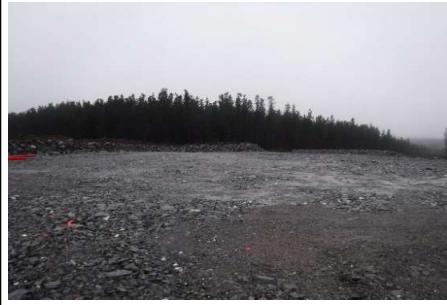
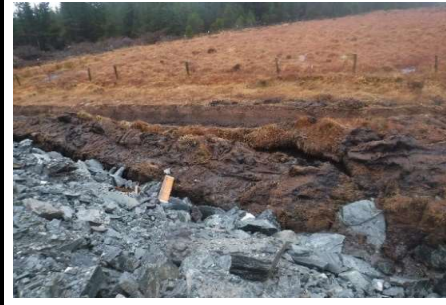
| T19 | 2-3 degree slope around hardstand. Rock at surface at turbine location, 1.5-2m of peat adjacent to hardstand. Minor slump between cut-off drain and hardstand. | | | |
| | | T19 Turbine | T19 Hardstand | Minor failure along edge of drain |

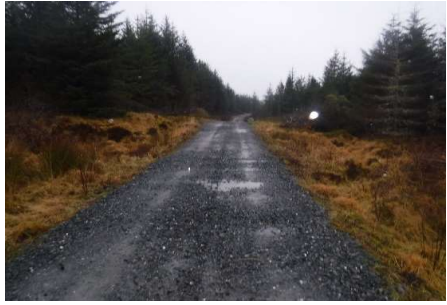
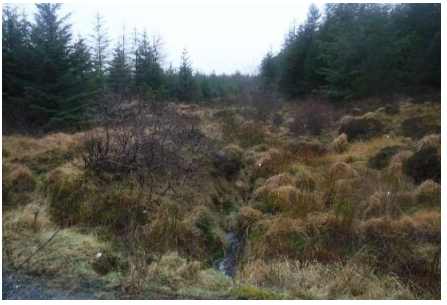
| Drain crossing<br>of track to T18 | Narrow drain crossed by existing track.<br>Shallow (<0.5m) peat. | | | |

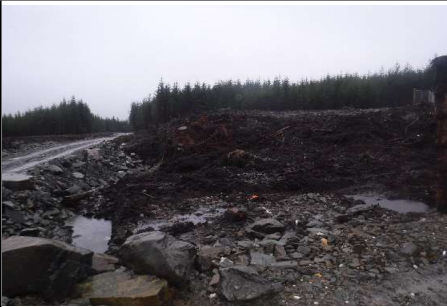
| Side casting upslope of track close to T18 | General view | | | |

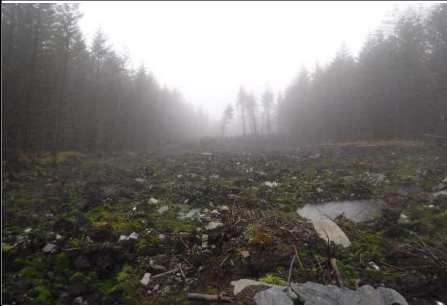
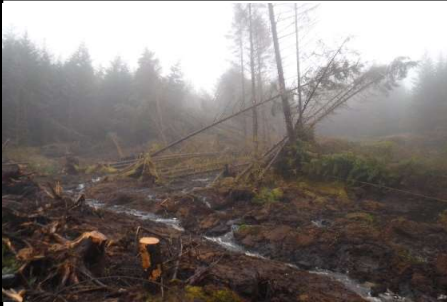
| Failure T6-T8 | General views of peat failures - see report text for details | <br>Downslope at head of failure | <br>View close to T8 | |

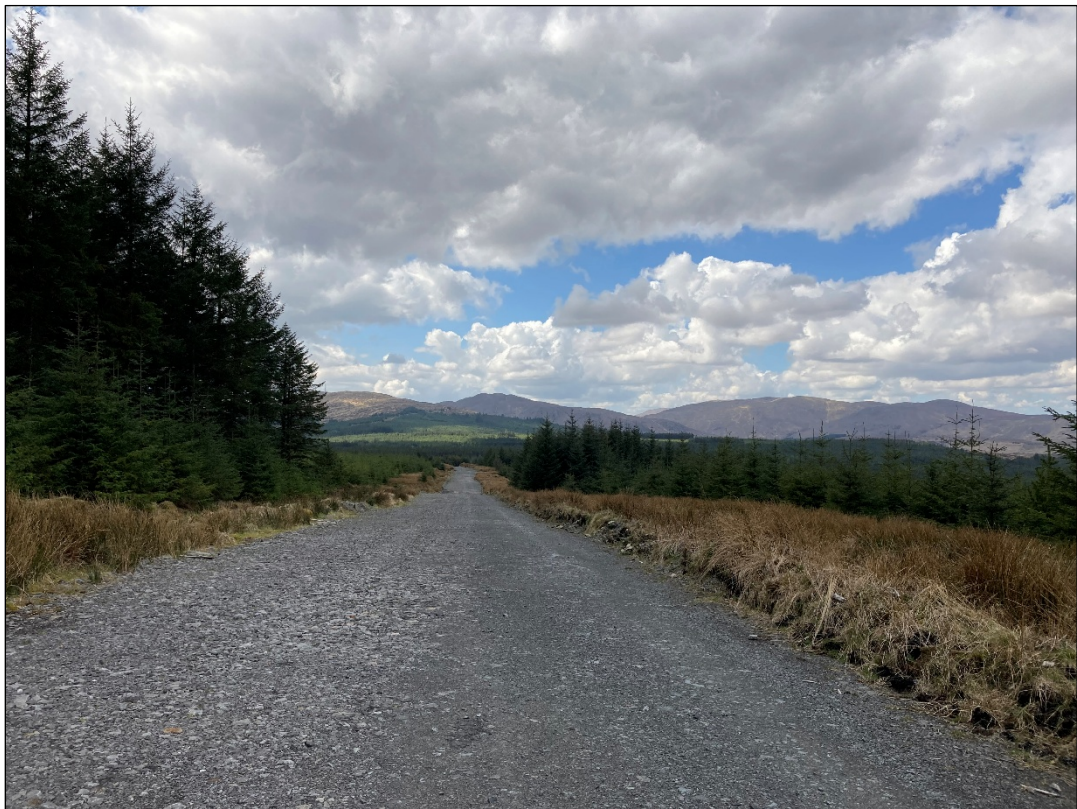
View West along founded access road between T11 and T12

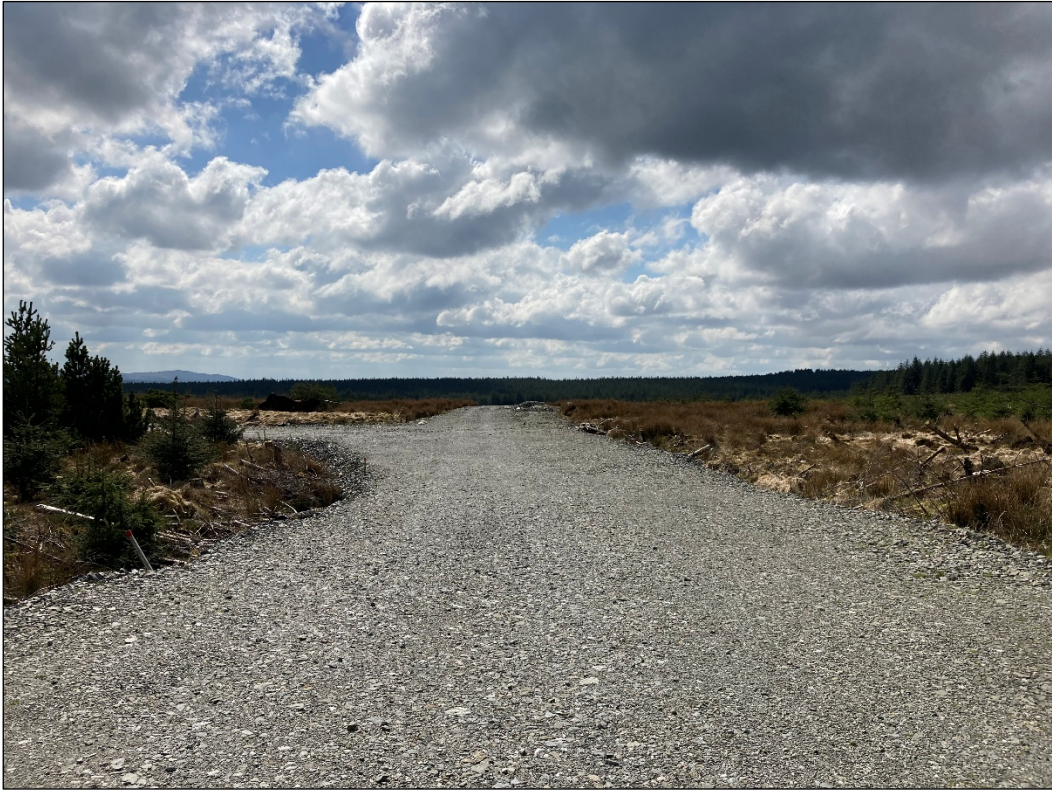
Looking south at section of floating road at Junction to T01 and T04

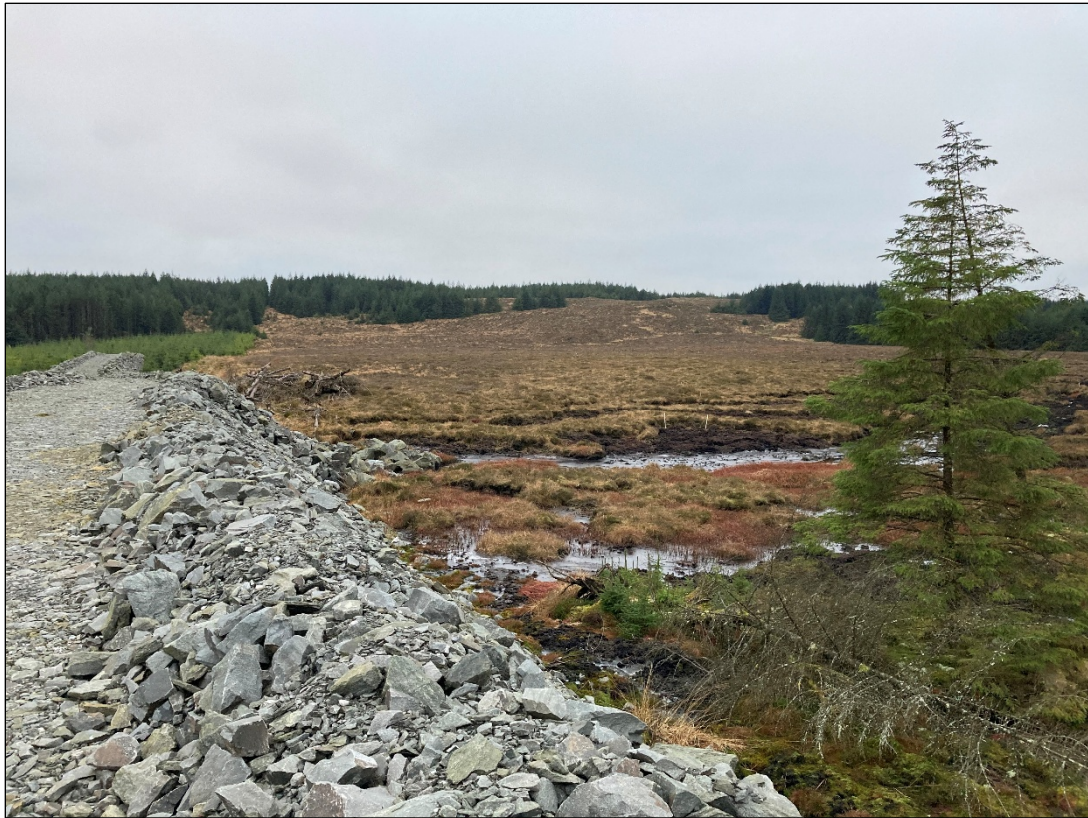
View of head of peat failure along access road to T7 and stabilising berm
