## Appendix 5 – Material Deviations from Permitted Plans

*Table 1 Deviations between the Existing Development and the Permitted Development*

# MEENBOG WINDFARM

## Ecological Assessment of Planning Deviations

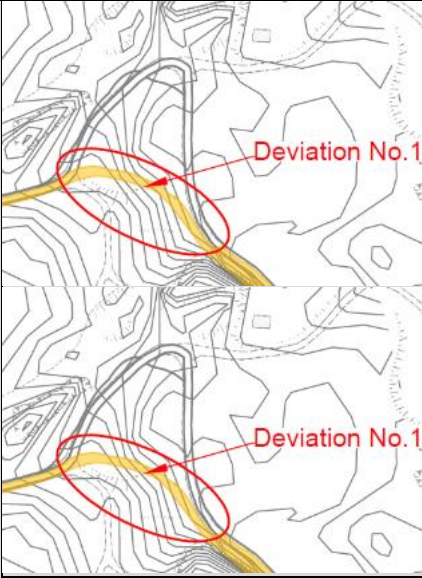
| No. | Deviation Description | Location of Deviation | Reason for Deviation |
|---|---|---|---|
| 1 | Entrance road off N15<br>(the hairpin bend) | | <p>The existing hairpin bend was unsafe as it did not provide adequate line of sight for vehicles using the road. This was a safety concern that only came to light prior to construction and after it was established that the as-built route was feasible from a geotechnical perspective with the benefit of site investigations. Furthermore, the longer blades authorised by the S.146B process in June 2019 can be more easily accommodated on the as-built road by eliminating the need to traverse the hairpin bend.</p> <p>The as-built alignment also required a reduced construction footprint compared to the permitted alignment.</p> |

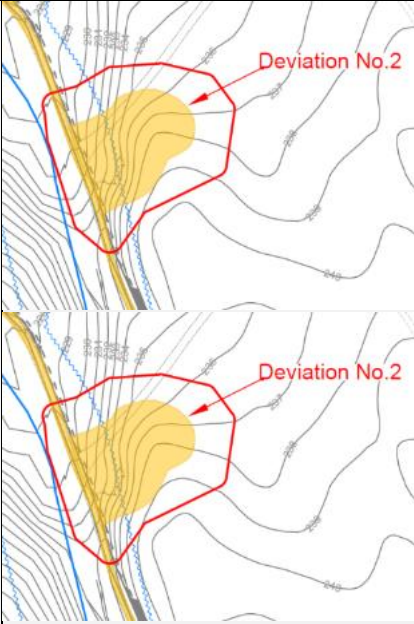
| 2 | Peat cell southeast of substation | | Peat cells were created as part of the engineering plans for excess peat that was generated during the course of construction and required management, greater than the volumes estimated pre-construction. |

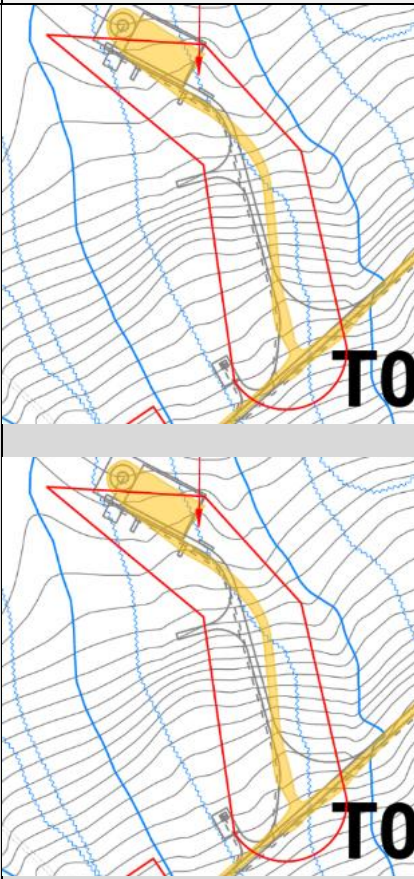
| 3 | T10 access road: | | Realigned road was adjusted to follow more favourable ground conditions and topography. |

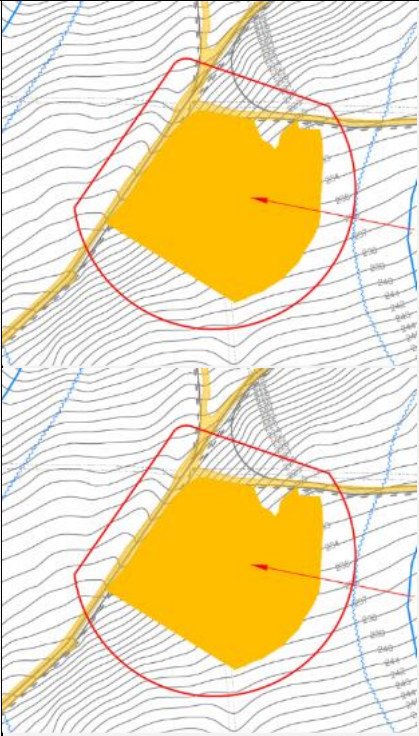
| 4 | Borrow Pit southwest of T12 | | <p>Existing forestry borrow pit was expanded to win stone on-site ahead of gaining access to the wind farm borrow pits.</p> <p>Excavation of the existing forestry borrow pit continued in lieu of excavation at the permitted BP1 borrow pit.</p> |

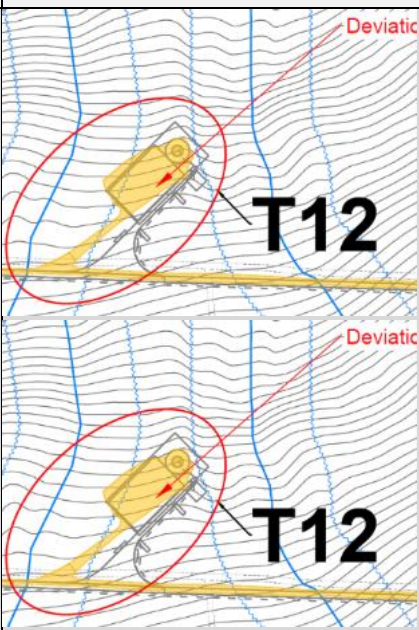
| 5 | T12 access road | | <p>The natural topography on site required a slight realignment of the approach to T12 due to rising ground to the east of the planned road. Moving the road approximately 30 metres to the west negated the need for excessive cut at this location.</p> |

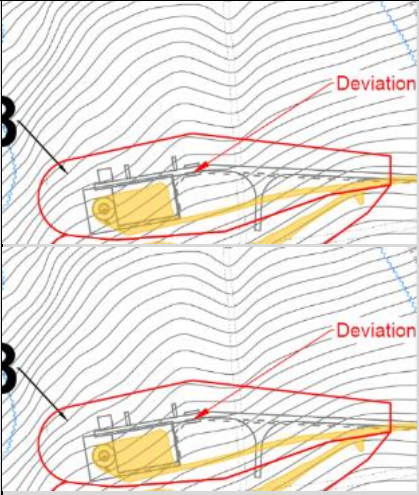
| 7 | T8 access road<br>(see 6 further above for peat containment berm) | | The access road to T8 was amended to approach the southern side of the turbine and align with the berm. |

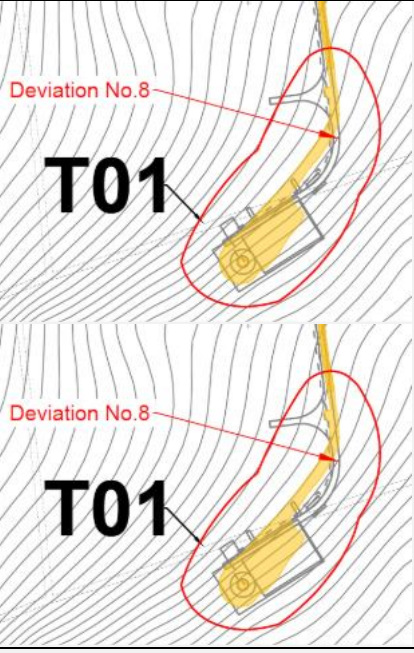
| 8 | T1 access road | | <p>The approach to T1 was slightly amended to provide a more effective alignment for delivery vehicles based on detailed design of road alignment pre-construction, resulting in a slight reduction in road length.</p> |

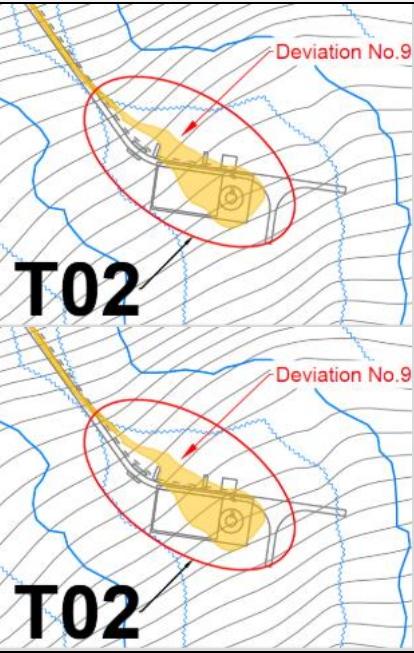
| 9 | T2 access road | | <p>The approach to T2 was slightly amended to provide a more effective alignment for delivery vehicles based on detailed design of road alignment pre-construction.</p> |

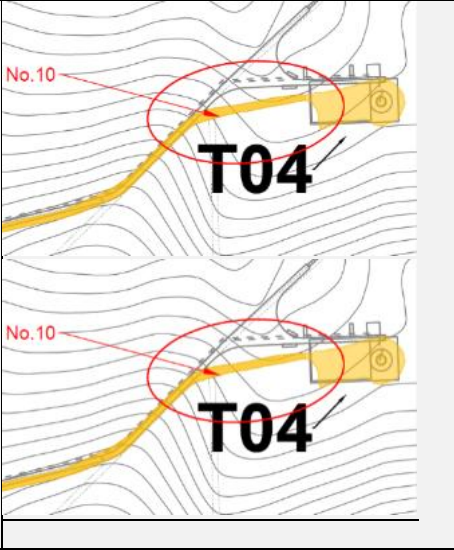
| 10 | T4 access road | | <p>The approach to T4 was slightly amended to provide a more effective alignment for delivery vehicles based on detailed design of road alignment pre-construction.</p> |

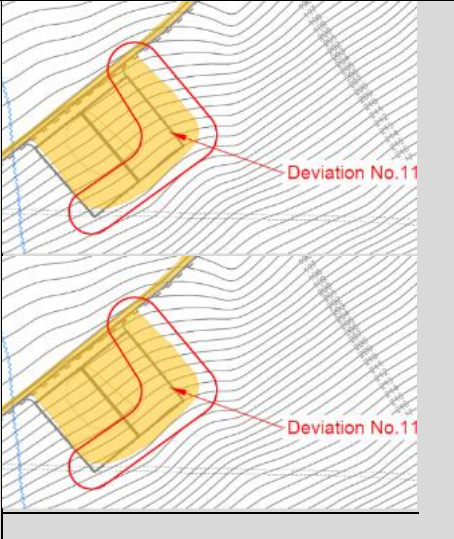
| 11 | Borrow pit (BP2) south of T15 | | <p>Permitted borrow pit was expanded slightly to win more rock on-site and avoid the importation of additional volumes from off-site.</p> |

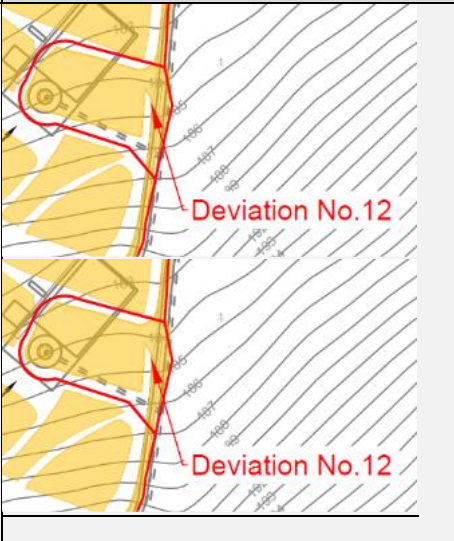
| 12 | T15 hardstand and access road | | <p>The natural topography on site facilitated direct access to T15 off the main spine road at this location which negated the need for the proposed road to T15. This was achieved by rotating the hardstand by 90 degrees.</p> |

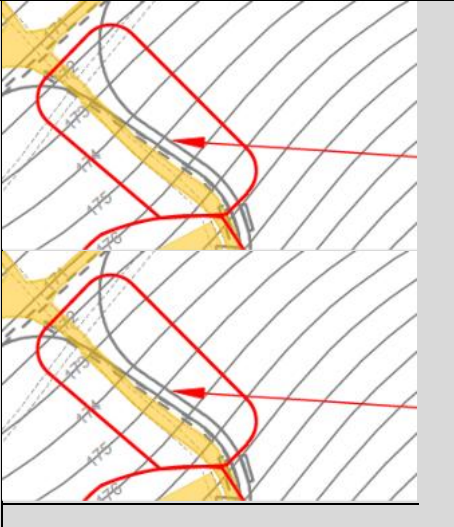
| 13 | T17 access road | | <p>The permitted road followed the route of a pre-existing forestry firebreak, and the as-built road was constructed as intended, along that firebreak. The intent was clear, but a minor difference in alignment arose between the permitted road and as-built road.</p> |

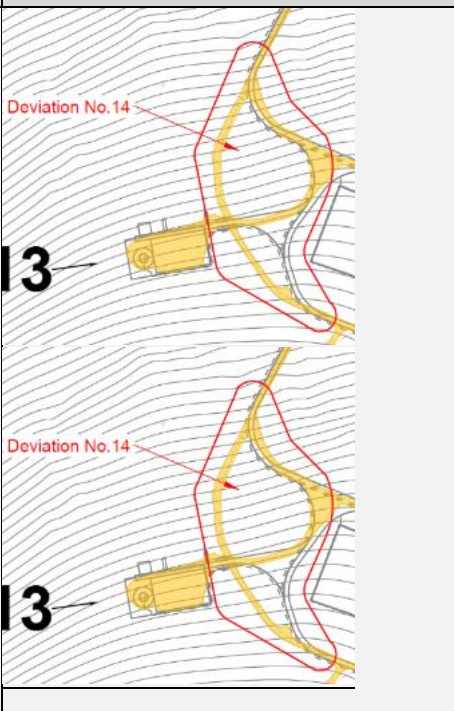
| 14 | T13 road alignment (upgrade of existing forestry track) | | <p>An existing forestry road was upgraded and used, thus preventing the need for the construction of the section of new permitted road based on detailed design of road alignment pre-construction.</p> |

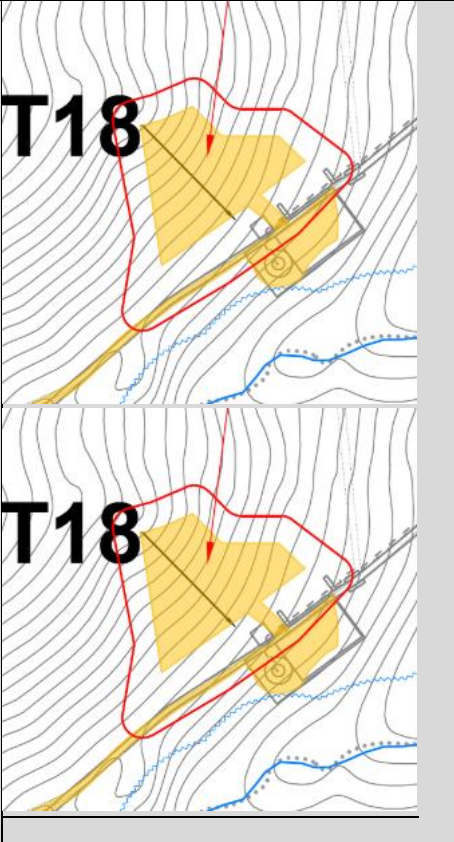
| 15 | Peat cells NW of T18 | | <p>Peat cells were created as part of the engineering plans for excess peat that was generated during the course of construction and required management, greater than the volumes estimated pre-construction.</p> |

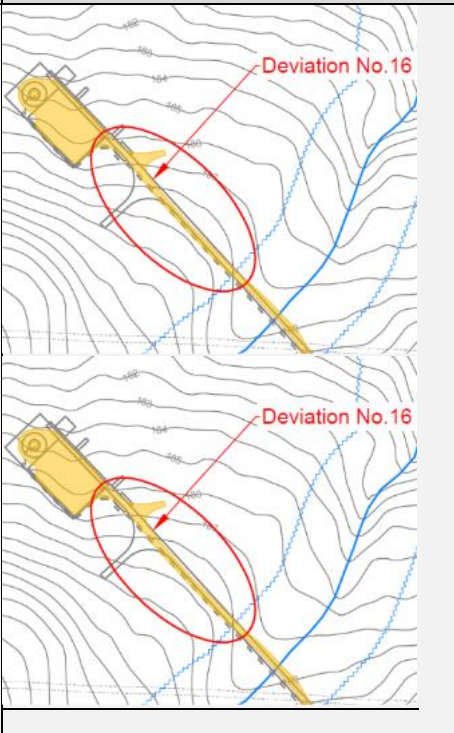
| 16 | T14 turning head | | <p>Position of turning head altered to suit the natural topography on the ground.</p> |

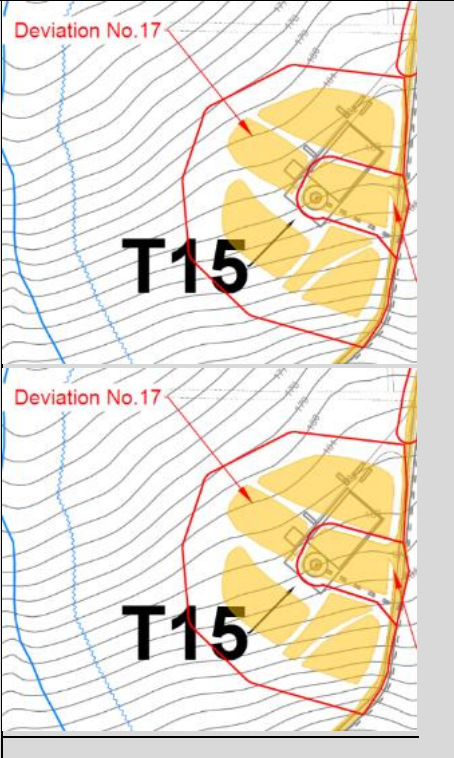
| 17 | Peat cells near T15 | | <p>Peat cells were created as part of the engineering plans for excess peat that was generated during the course of construction and required management, greater than the volumes estimated pre-construction.</p> |

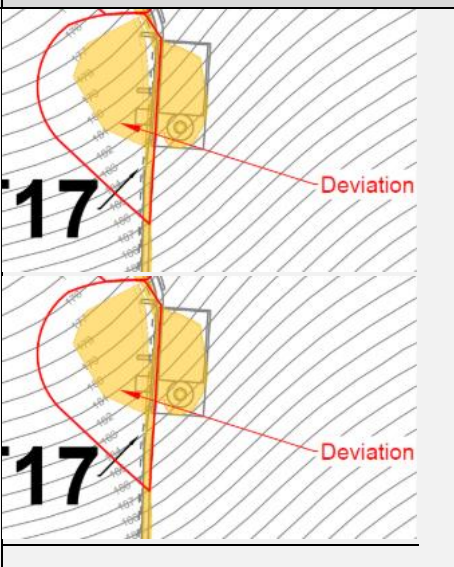
| 18 | Peat cells near T17 | | <p>Peat cell was created as part of the engineering plans for excess peat that was generated during the course of construction and required management, greater than the volumes estimated pre-construction.</p> |

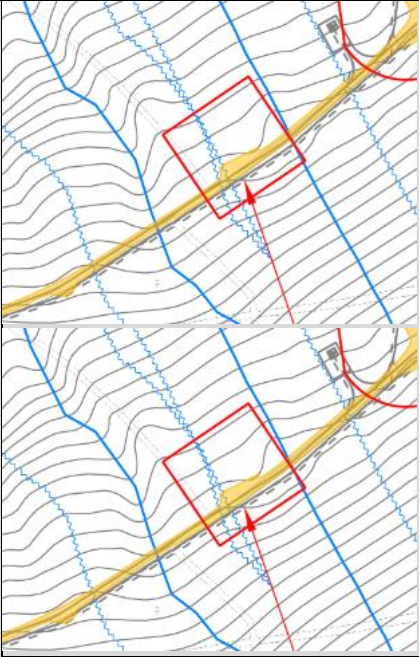
| 19 | Layby south of T10 with welfare facilities | | <p>This was an existing forestry access for harvesting, which was repurposed for locating site office and welfare facilities, which will be removed upon completion of construction.</p> |

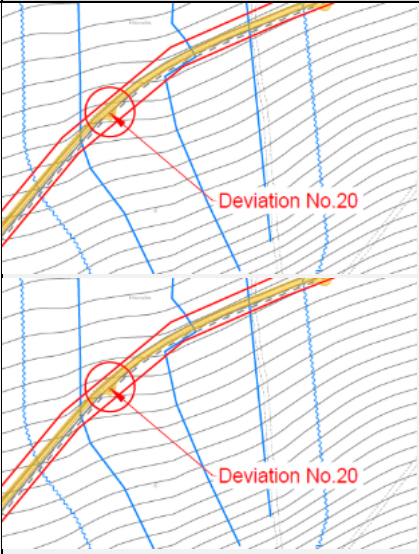
| 20 | Layby northeast of T15 | | <p>Layby in this area installed as a safety measure to allow construction traffic to pass. It is along the original permitted road alignment to T15. Passing bays were included in the planning drawings though actual location on the ground may have varied as dictated by ground conditions.</p> |

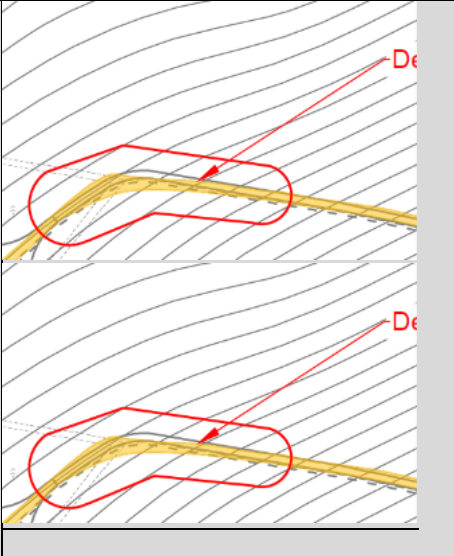
| 21 | T19 access road | | Slight widening and curve realignment to increase horizontal bend radius for turbine blade delivery. |

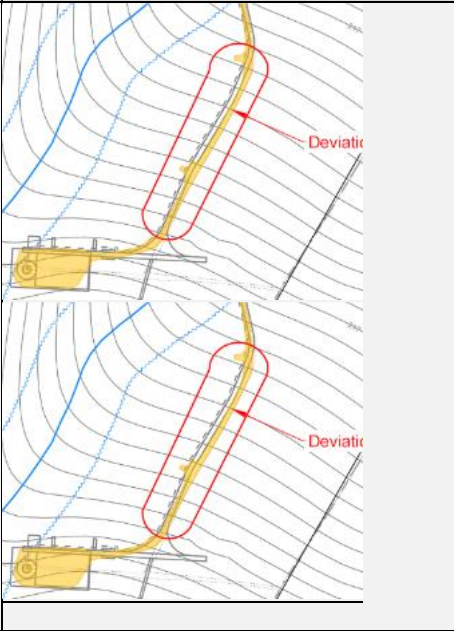
| 22 | T9 access road | | The permitted road followed the route of a pre-existing forestry track, and the as-built road was constructed as intended, along that forestry track. The intent was clear, but a minor difference in alignment arose between the permitted road and as-built road. |

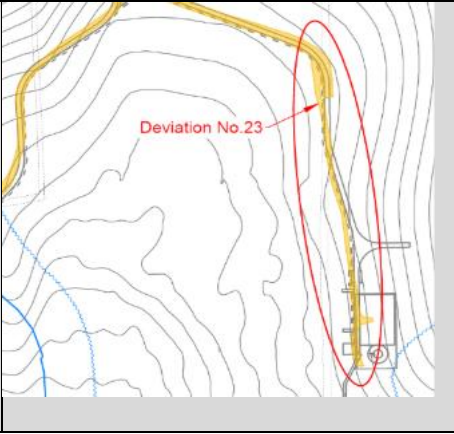
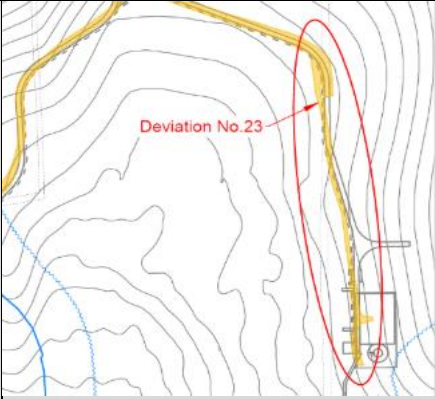
| 23 | Additional storage area and access road to T7 | | The slightly realigned road served the dual purpose of acting as a peat containment berm following the November 2020 peat failure. |

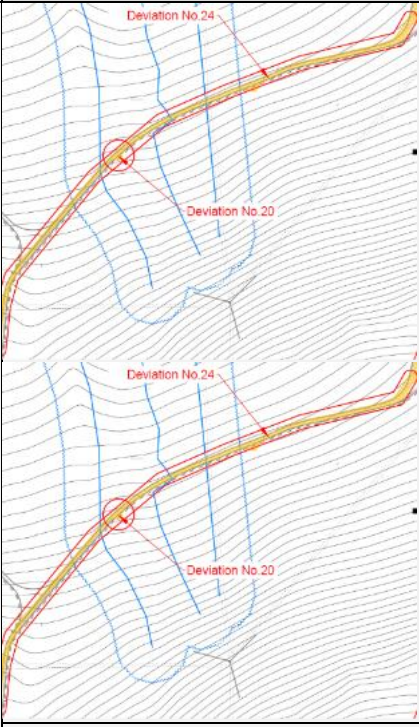
| 24 | Roadside berms and settlement ponds | | <p>Small, low-level roadside berms were used to contain mud within the road corridor surface and prevent run-off into the wind farm drainage system or settlement ponds, check dams and silt fences.</p> <p>Settlement ponds are entirely consistent with the permitted wind farm's drainage design, but would not have been shown on planning drawings and therefore may appear to have been outside the Permitted Development footprint.</p> |

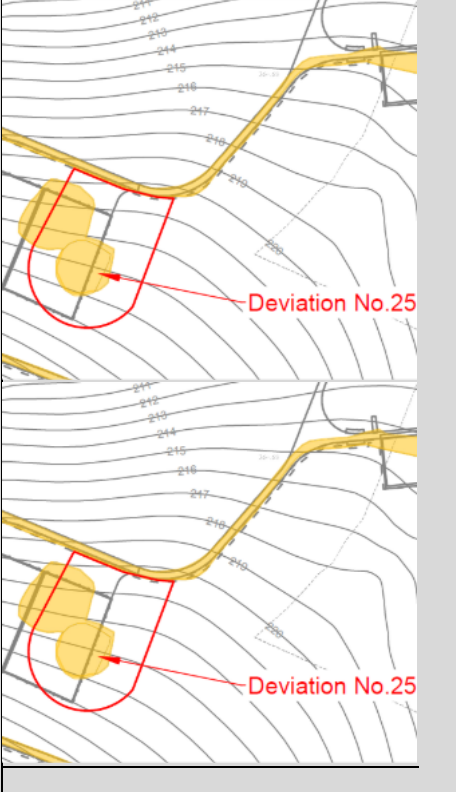
| 25 | Assessment of additional excavated borrow pit and peat storage cell at T-13 | A topographic map showing contour lines with elevations ranging from 212 to 219. Two yellow circular areas are highlighted on the map, each with a red line pointing to it from the label 'Deviation No.25'. The map also shows a yellow line representing a road or path and some black lines representing boundaries or structures. | Position of permitted borrow pit was repositioned to suit local topography. |

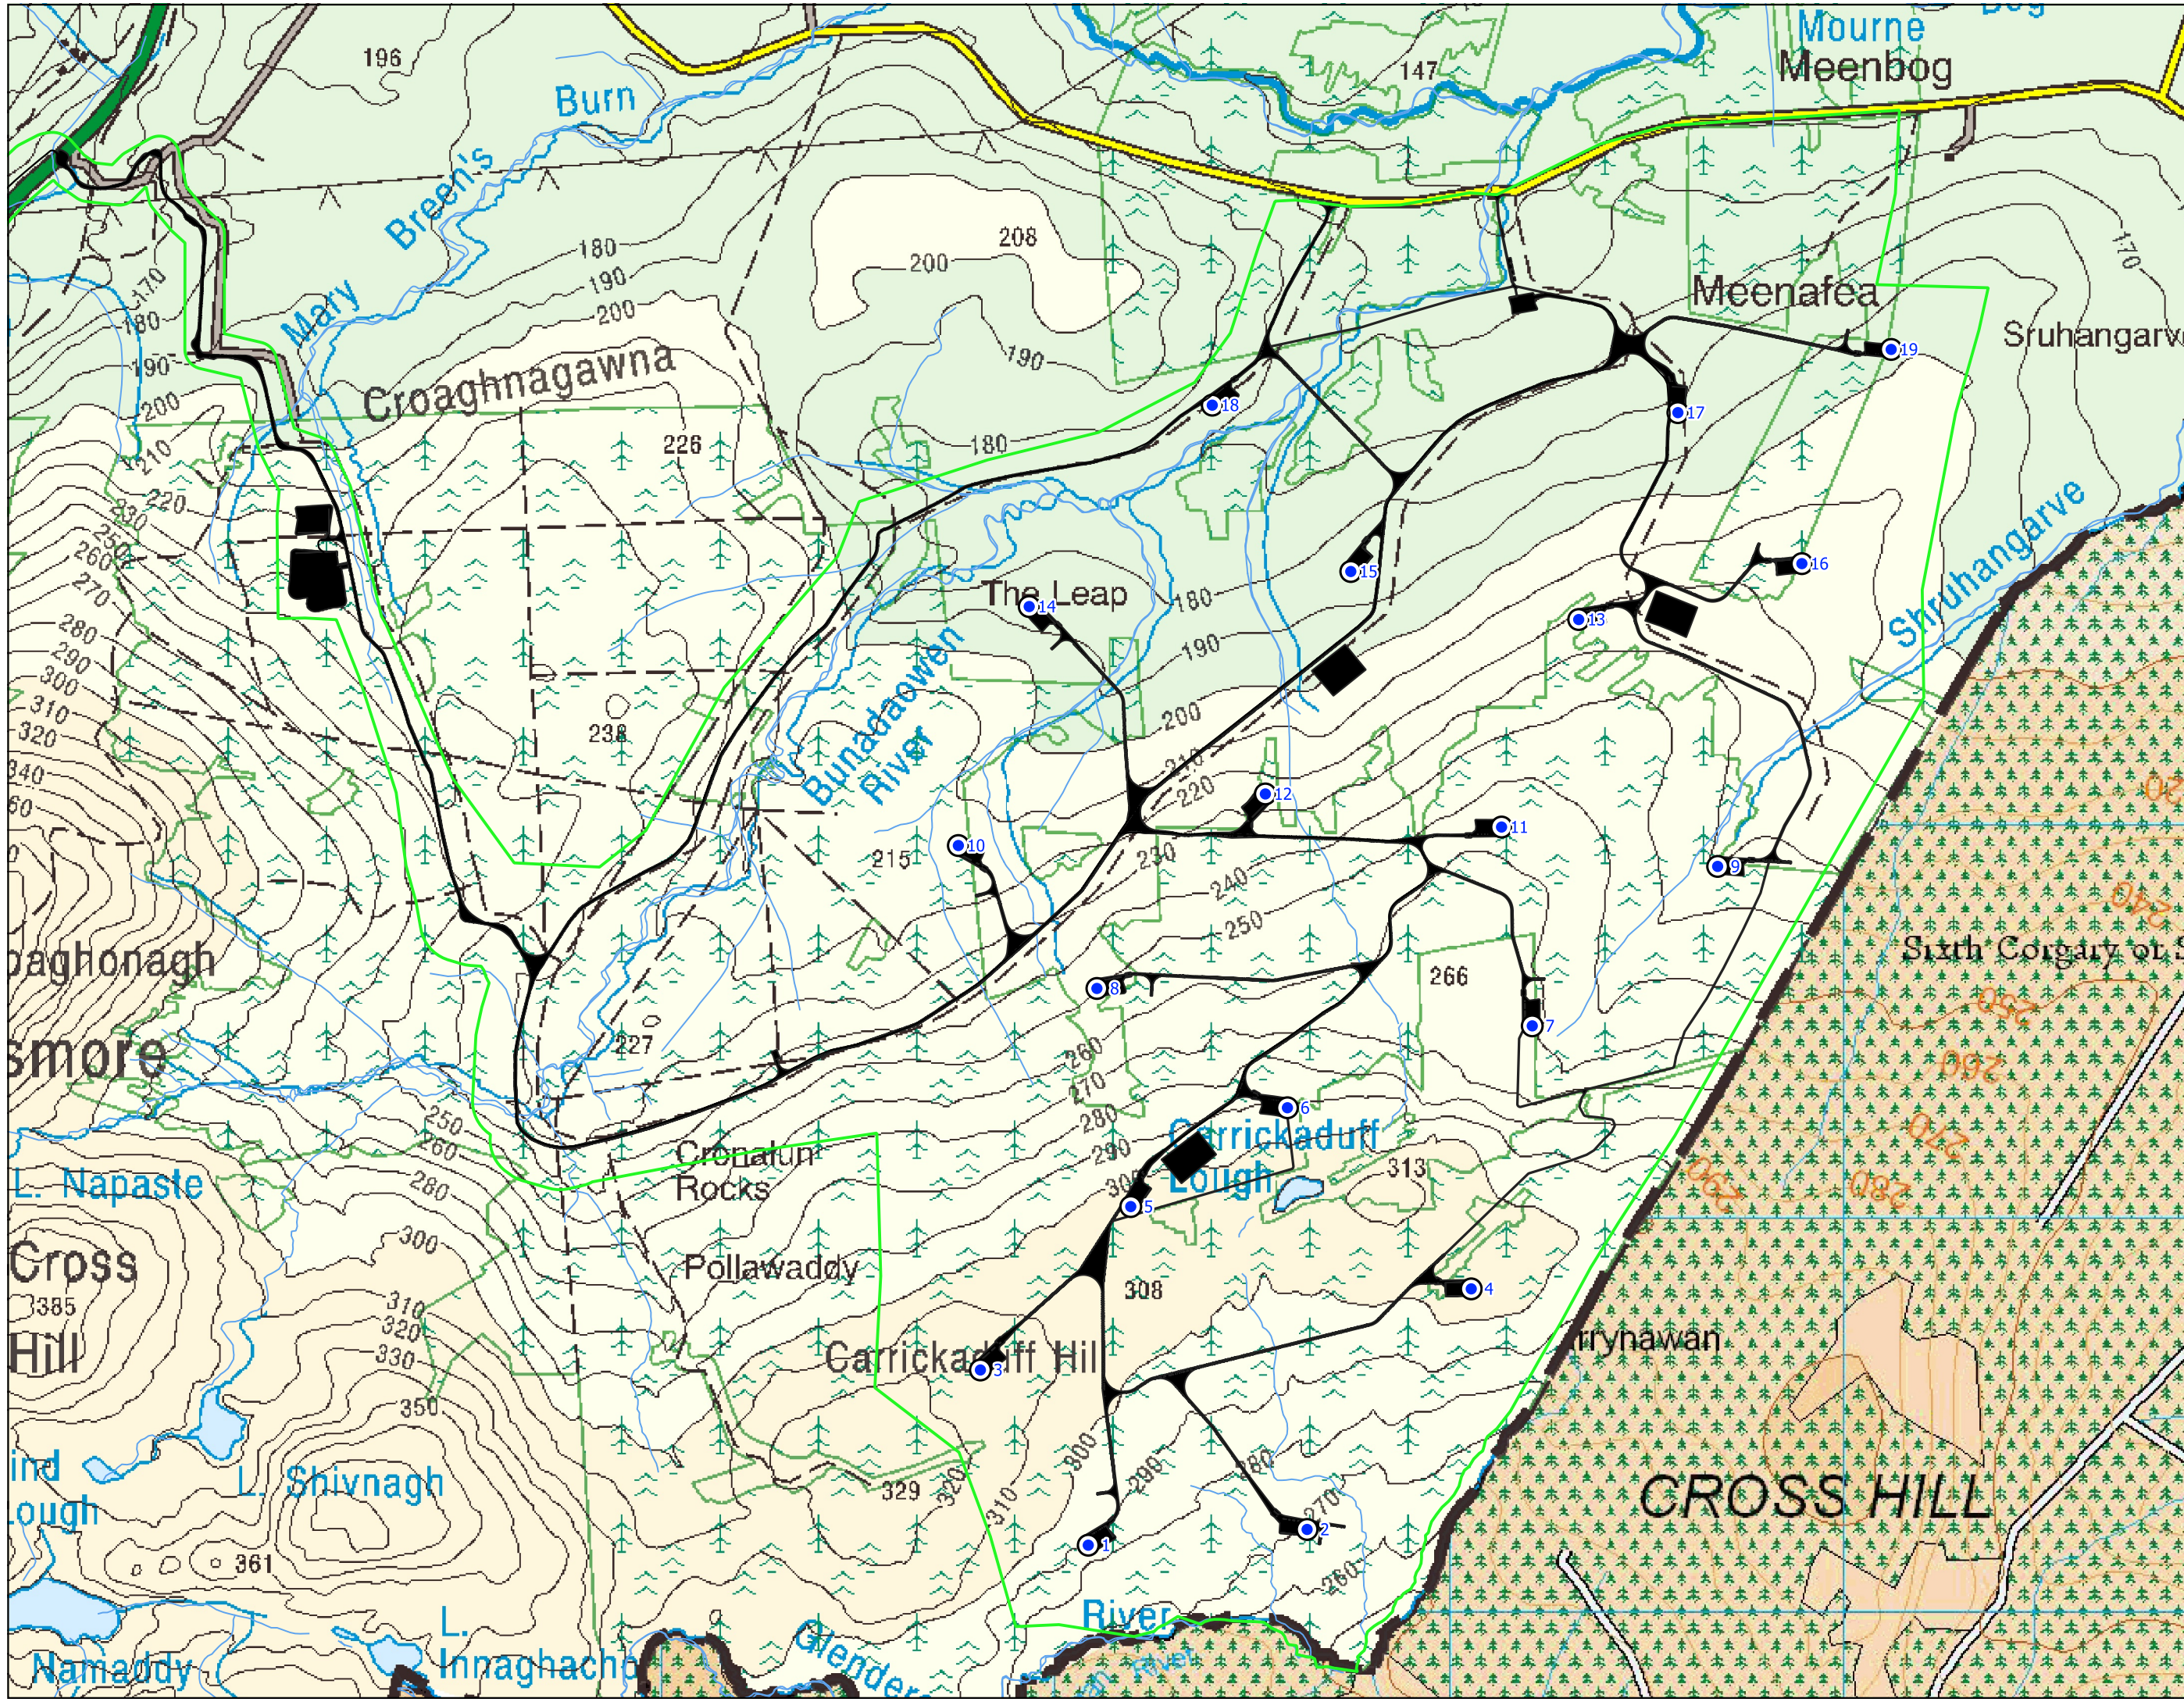
## FIGURE 1

Wind Farm Layout, map extracted from MKO response of 1/03/2020, 'Required Actions List and associated actions map'

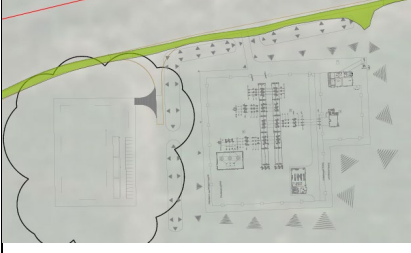
| Ref | Brief Description<br>(from MKO) | Location/Habitat | Description and notes | Ecological Risks of<br>Deviation | Map Extract | Photo |
|---|---|---|---|---|---|---|
| 2 | Construction Compound opposite Substation: Compound not constructed and a smaller compound was established within the footprint of the Substation construction area | Mapped as forestry in EIAR for both compound and substation, confirmed by aerial imagery. However compound area is now mainly <i>Molinia</i> with scattered conifer trees presumably following earlier removal of trees. 250m from Croaghonagh Bog SAC. | Reduced development footprint as the compound was not built. All ground works and surfacing of the substation are now complete., and the construction compound within the footprint of the substation has been removed. | No material change in ecological risk. Some benefit to biodiversity as the conifer trees have largely been replaced by a wet heath type habitat at the original location of the proposed compound. | | |

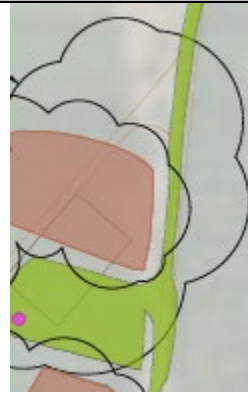
| Ref | Brief Description (from MKO) | Location/Habitat | Description and notes | Ecological Risks of Deviation | Map Extract | Photo |
|---|---|---|---|---|---|---|
| 12 | T15: The natural topography on site facilitated direct access to T15 off the main spine road at this location which negated the need for the proposed road to T15. This was achieved by rotating the hardstand by 90 degrees. | Forestry plantation, mid-aged conifers which have now been cleared for bat mitigation. Bunadaowen catchment. | Approximately 140m of access road not constructed leading to a potential reduction of the development footprint, however much of this area has now been developed as peat cells see Ref 18. | Reduced risk as slightly less vegetation clearance required. | | |
