***RETROSPECTIVE PEAT AND SPOIL  
MANAGEMENT PLAN (EXISTING  
DEVELOPMENT) (FT, 2026) (RPSMP  
(FT,2026)***

# MEENBOG WIND FARM (EXISTING DEVELOPMENT)

## PEAT AND SPOIL MANAGEMENT PLAN

**Document No:**  
**P24234-FT-EGT-XX-RP-GT-0004**

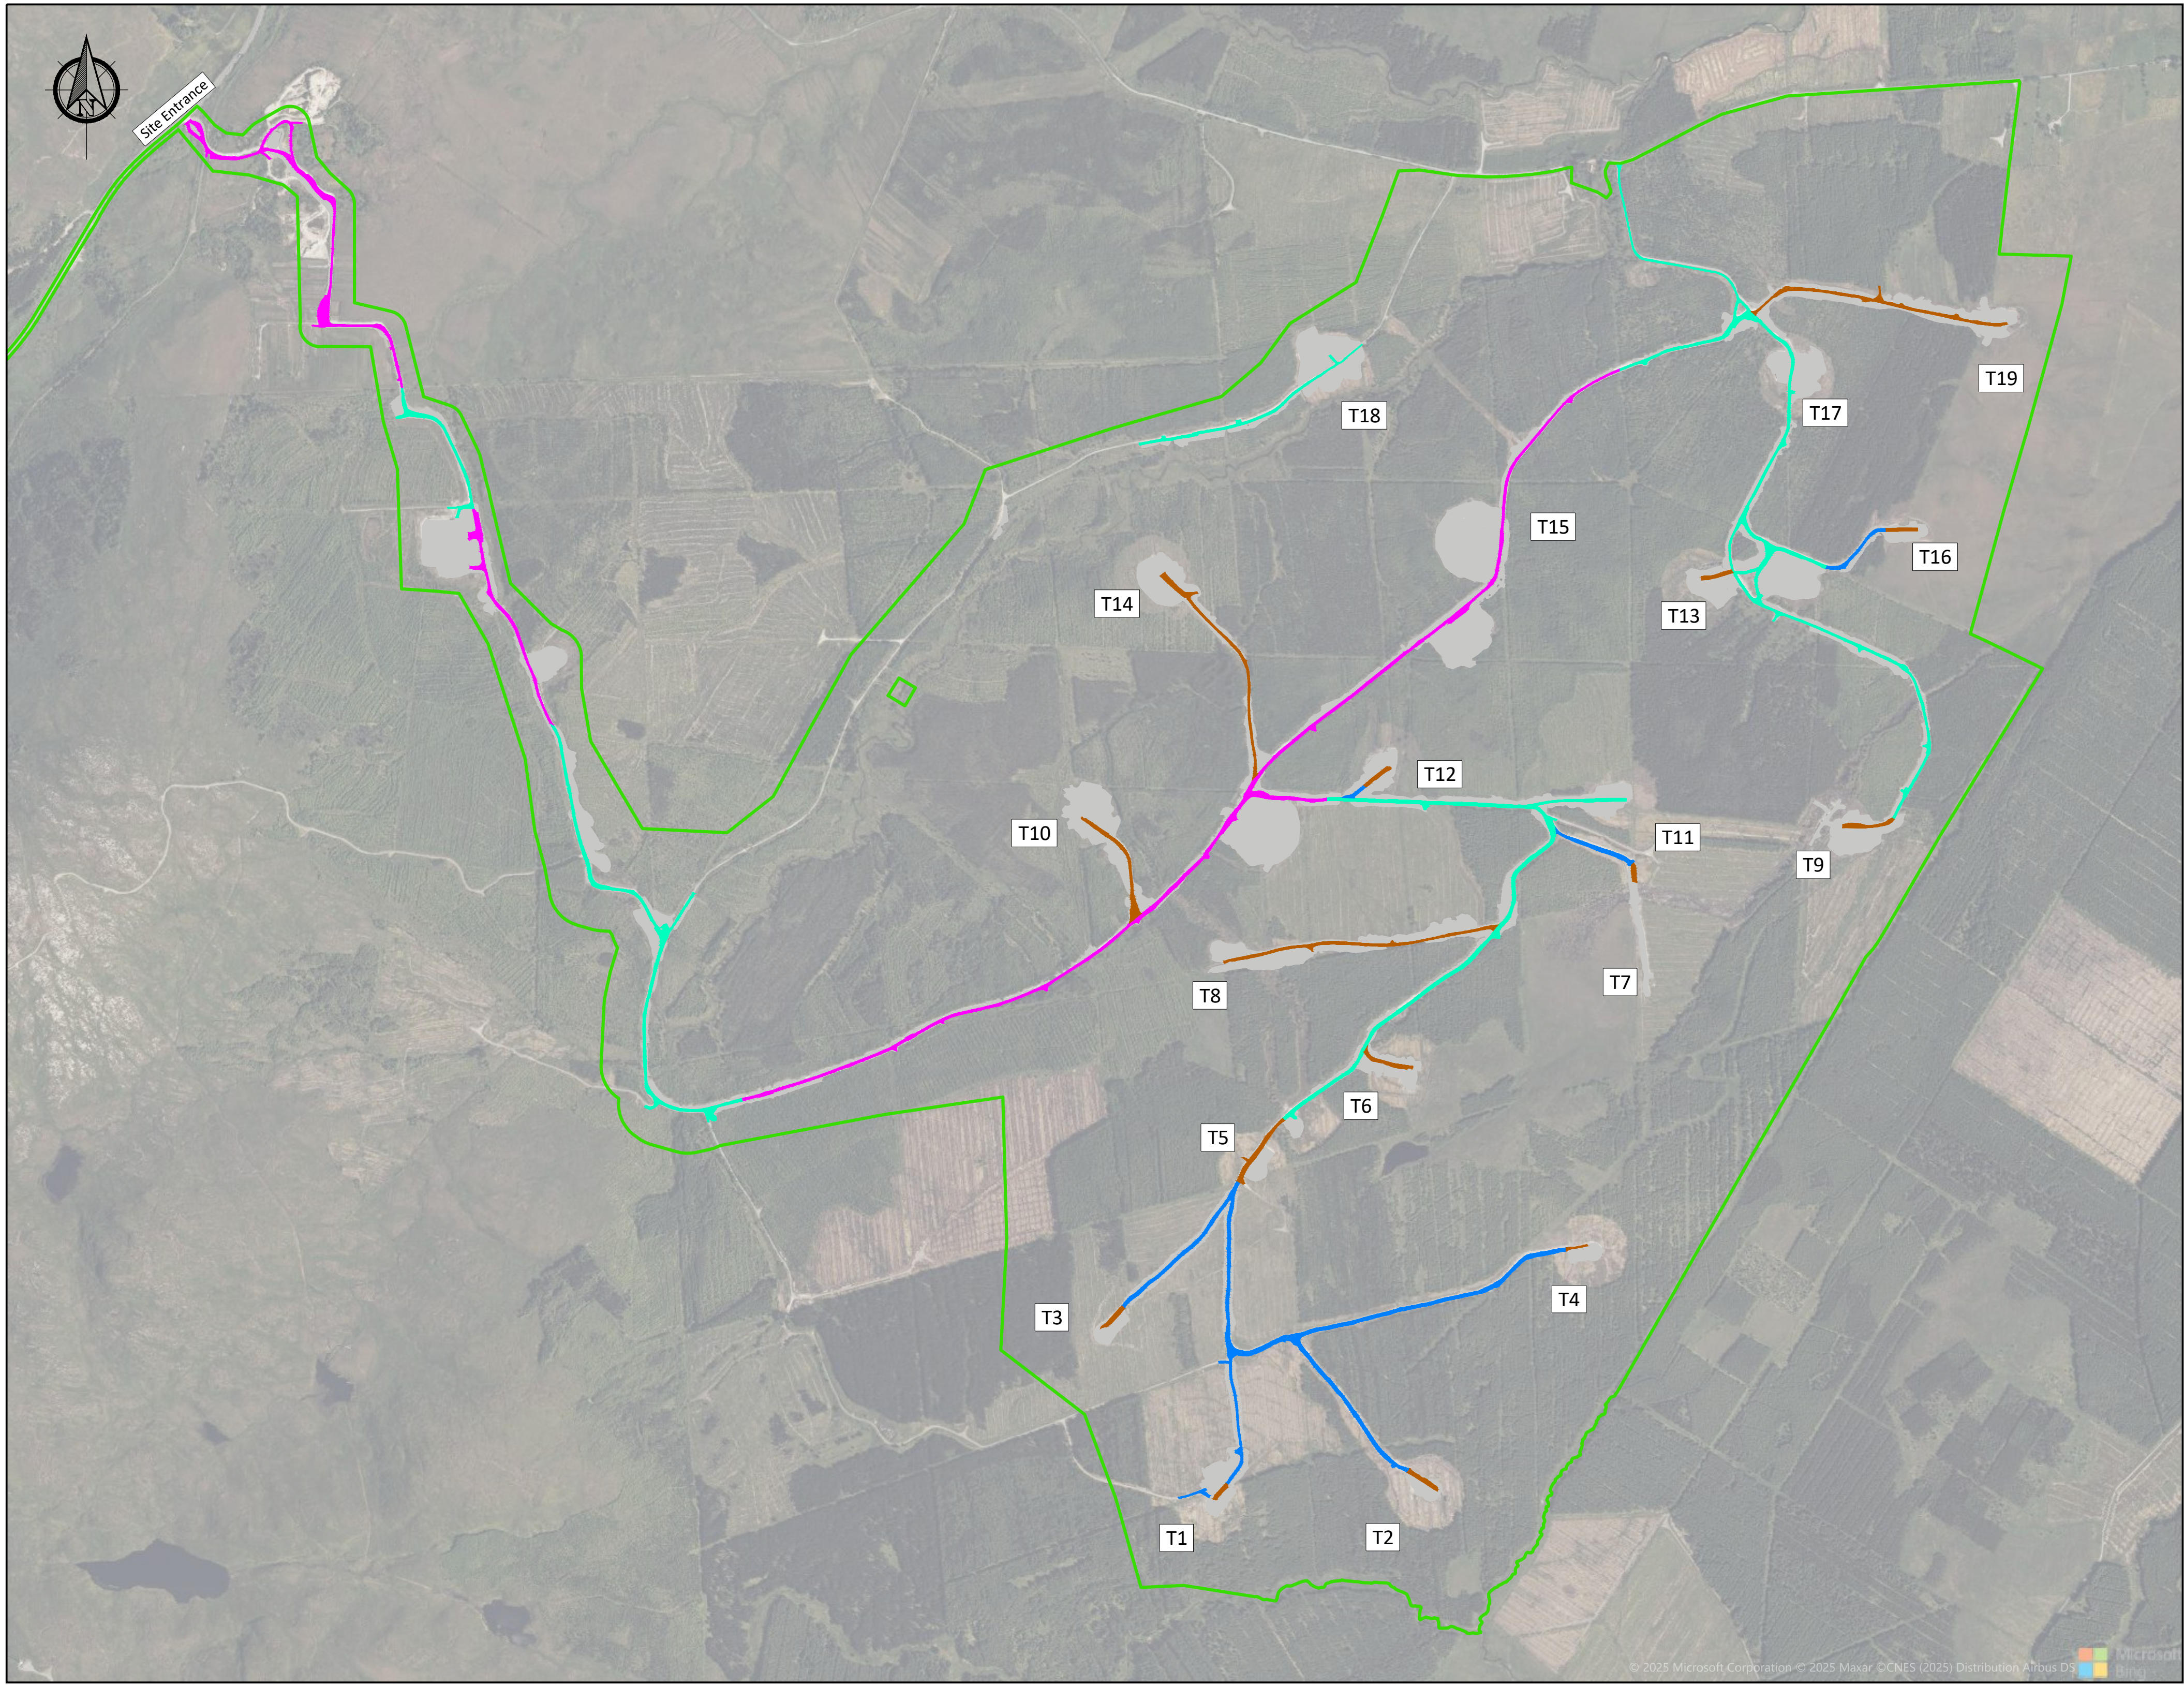
Type B - Upgrade of Existing Floated Access Road to Founded Access Road

Type C - New Excavate & Replace Access Road

| Construction Method | Typical Site Conditions | | | Comment |
|---|---|---|---|---|
| New founded access road | Type C | Typically, less than 1.5m | <5 degrees | Locations shown on drawing P24-234-0603-0001 and details on drawing P24-234-0603-0004. |

Approximately 13.7km of existing access roads were present across the Wind Farm Site and had been in operation for a number of years prior to the construction of the Existing Development. The existing access roads were constructed using both a founded and floating construction techniques. Upgrade works involved the widening of the existing access roads. The locations where upgrade of the existing access roads was undertaken on the Wind Farm Site are shown in Drawing P24-234-0603-0001 and details are shown in Drawing P24-234-0603-0002 to 0004.

The excavation of peat and spoil and founding of access roads on competent stratum (below the peat) for new access roads was carried out at various locations across the Wind Farm Site. Locations for new excavated access roads on site are shown in Drawing P24-234-0603-0001 and details are shown in Drawing P24-234-0603-0004.

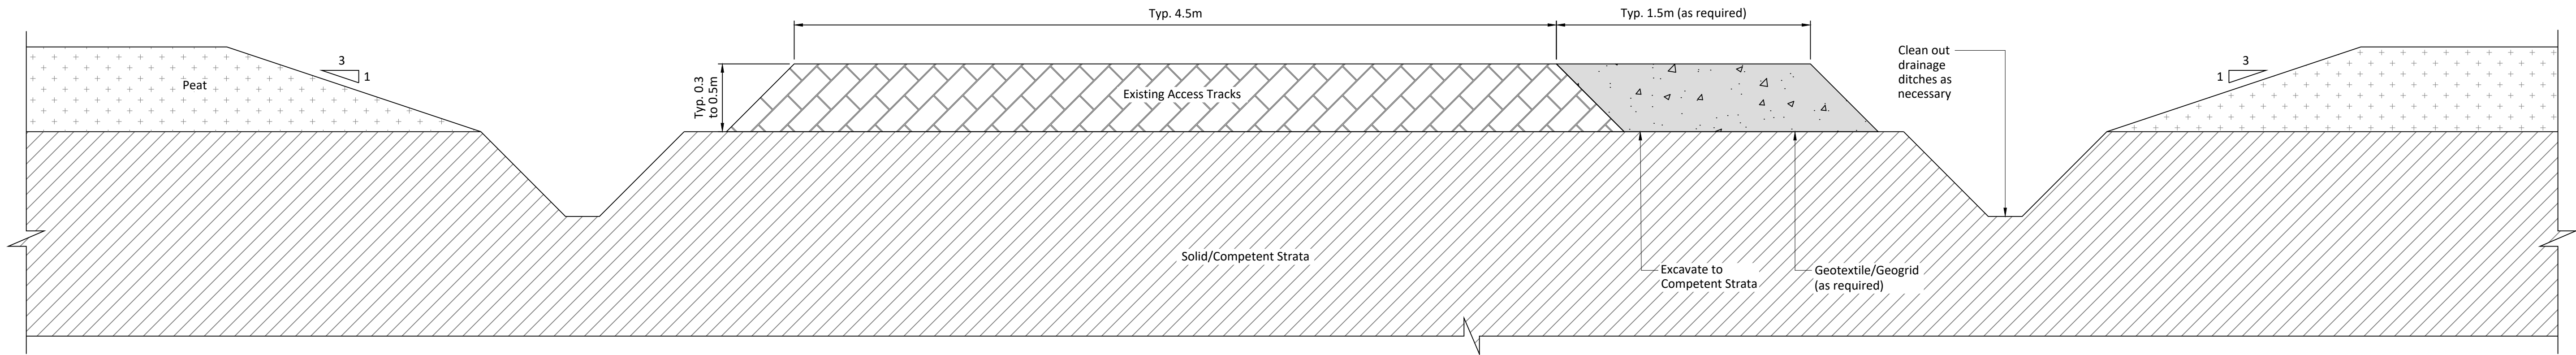
DETAIL  
1:20

| PROJECT | CLIENT | | | |
|---|---|---|---|---|
| TYPE A - UPGRADE OF EXISTING FOUNDED ACCESS ROAD | Drawn by<br>POR | Drawing Number<br>P24-234-0603-0002 | | P02 |

| Construction Method | Typical Site Conditions | | | Comment |
|---|---|---|---|---|
| Upgrade of existing founded access roads | Type A | <1.5m | Varies | Upgrade existing excavated access roads to the required width and finished with a layer of selected granular fill – Drawing P24-234-0603-0002. |

- (1) For upgrading of all existing founded access roads (Type A – Drawing P24-234-0603-0002) the following applied:
  - (a) Excavation of the widened section of the access road took place to a competent stratum beneath the peat, removing all peat and soft clay and backfilling with suitable granular fill.
  - (b) Benching of the excavation was undertaken between the existing section of access road and the widened section of access road where the depth of excavation exceeds 500mm.
  - (c) Access roads were finished with a layer of capping/surfacing material across the full width of the road.
  - (d) For excavations in peat, side slopes were not greater than 1 (v): 3 (h). This slope inclination was reviewed during construction. Where areas of weaker peat were encountered then slacker slopes were formed to ensure stability, or the sides of the excavation were supported with rock fill.

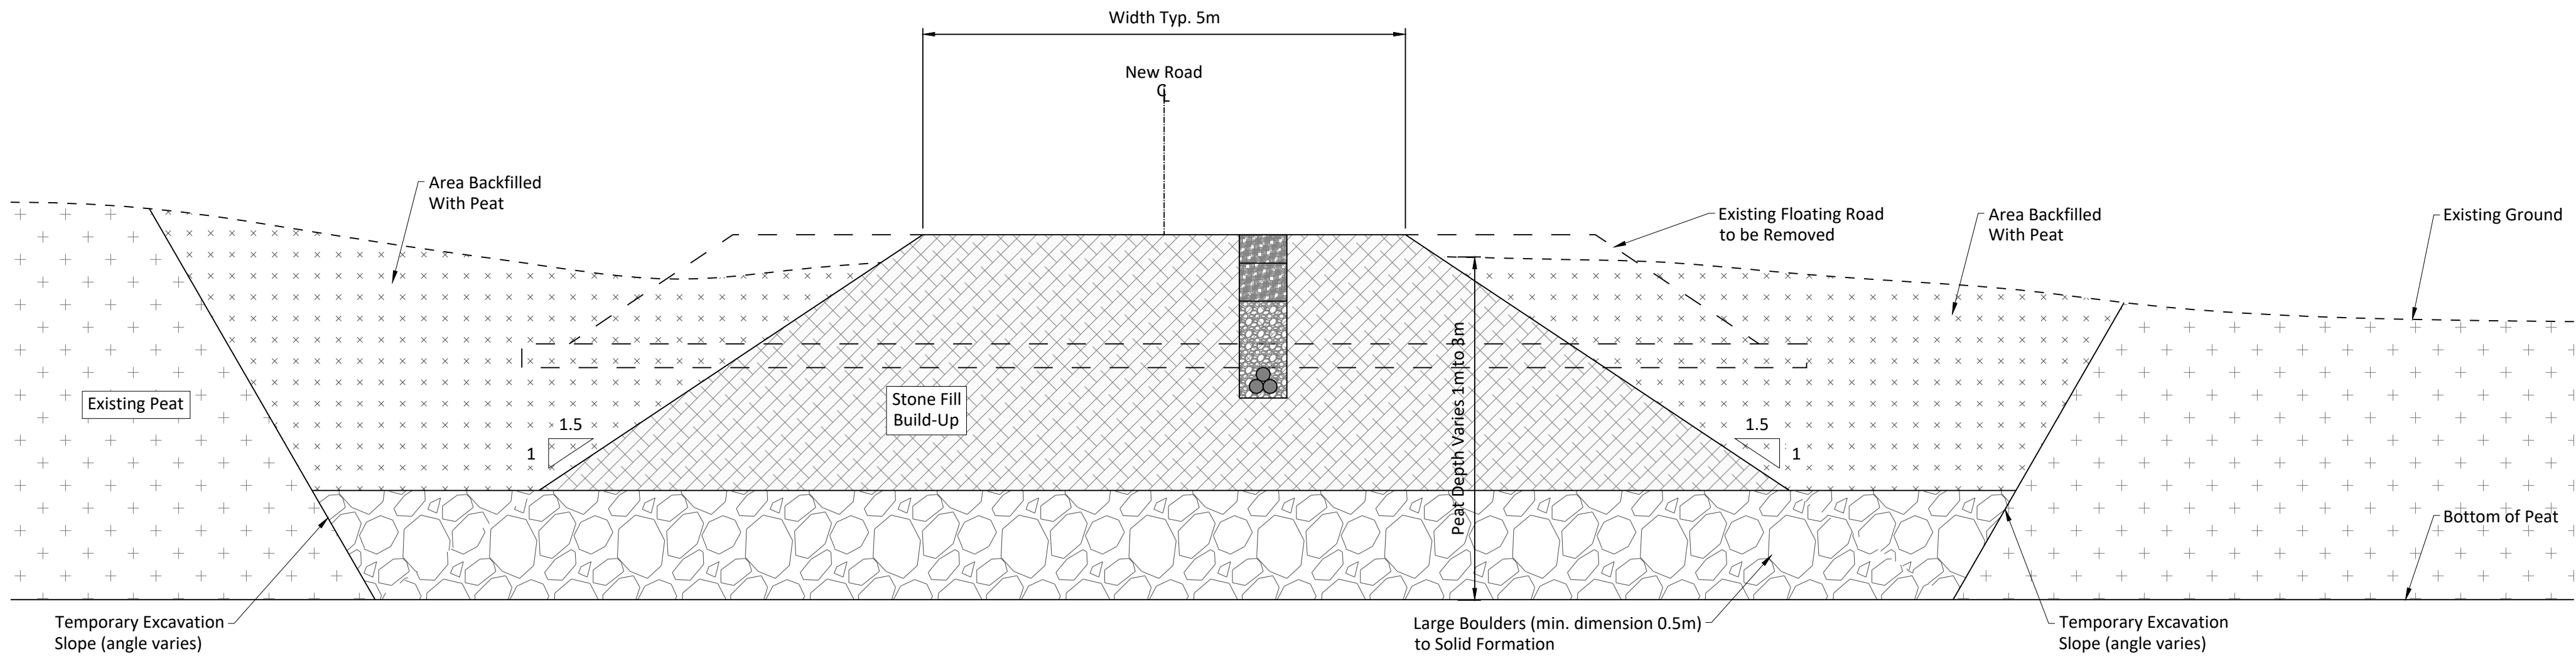
DETAIL  
1:50

| SHEET | TYPE B - UPGRADE OF EXISTING FLOATING TO<br>FOUNDED ACCESS ROAD | Date | 19.06.26 | Project number | P24-234 | Scale (@ A1 ) | As Shown |

| Construction Method | Typical Site Conditions | | | Comment |
|---|---|---|---|---|
| Upgrade of existing floated access road to founded road | Type B | Typically, less than 1.5m, locally up to 3.0m | Varies | Upgrade existing floated access road to a founded construction the required width and finished with a layer of selected granular fill – Drawing P24-234-0603-0003. |

- (1) For upgrading of existing access roads previously constructed using a floated construction technique (Type B1 – Drawing P24-234-0603-0003) the following applied:
  - (a) The existing floating road was incrementally removed by pulling back the engineering fill material and existing base layer, before constructing the new road using the excavate and replace/partial displacement method (as described in Section 4.1).
  - (b) The road was built incrementally, with peat removed before being backfilled with coarse rock sourced from the borrow pit where the peat is relatively shallow (<3m). The excavator worked from the founded section of road at all times.

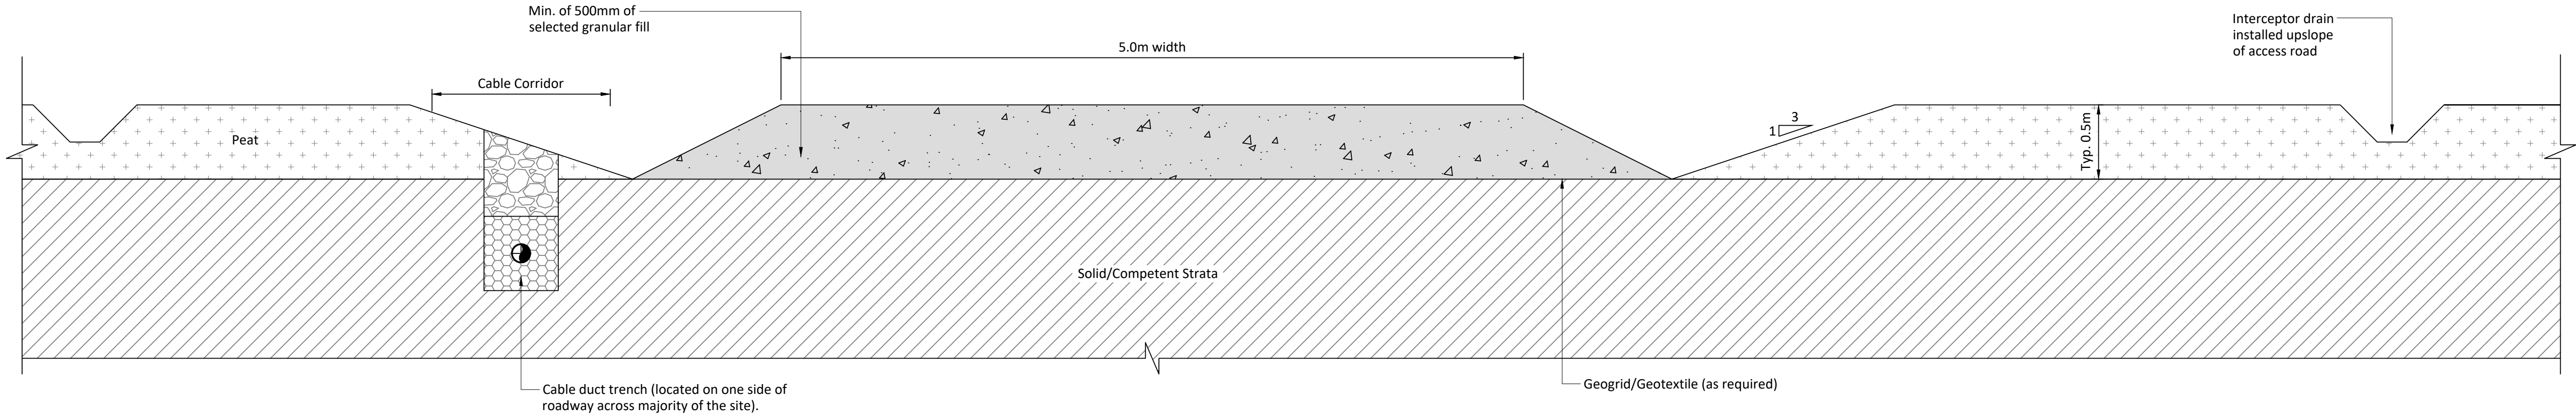
DETAIL  
1:25

| SHEET | TYPE C - NEW FOUNDED ACCESS ROAD | | | Date | 27.05.26 | Project number | P24-234 | | Scale (@ A1 )<br>As Shown | |

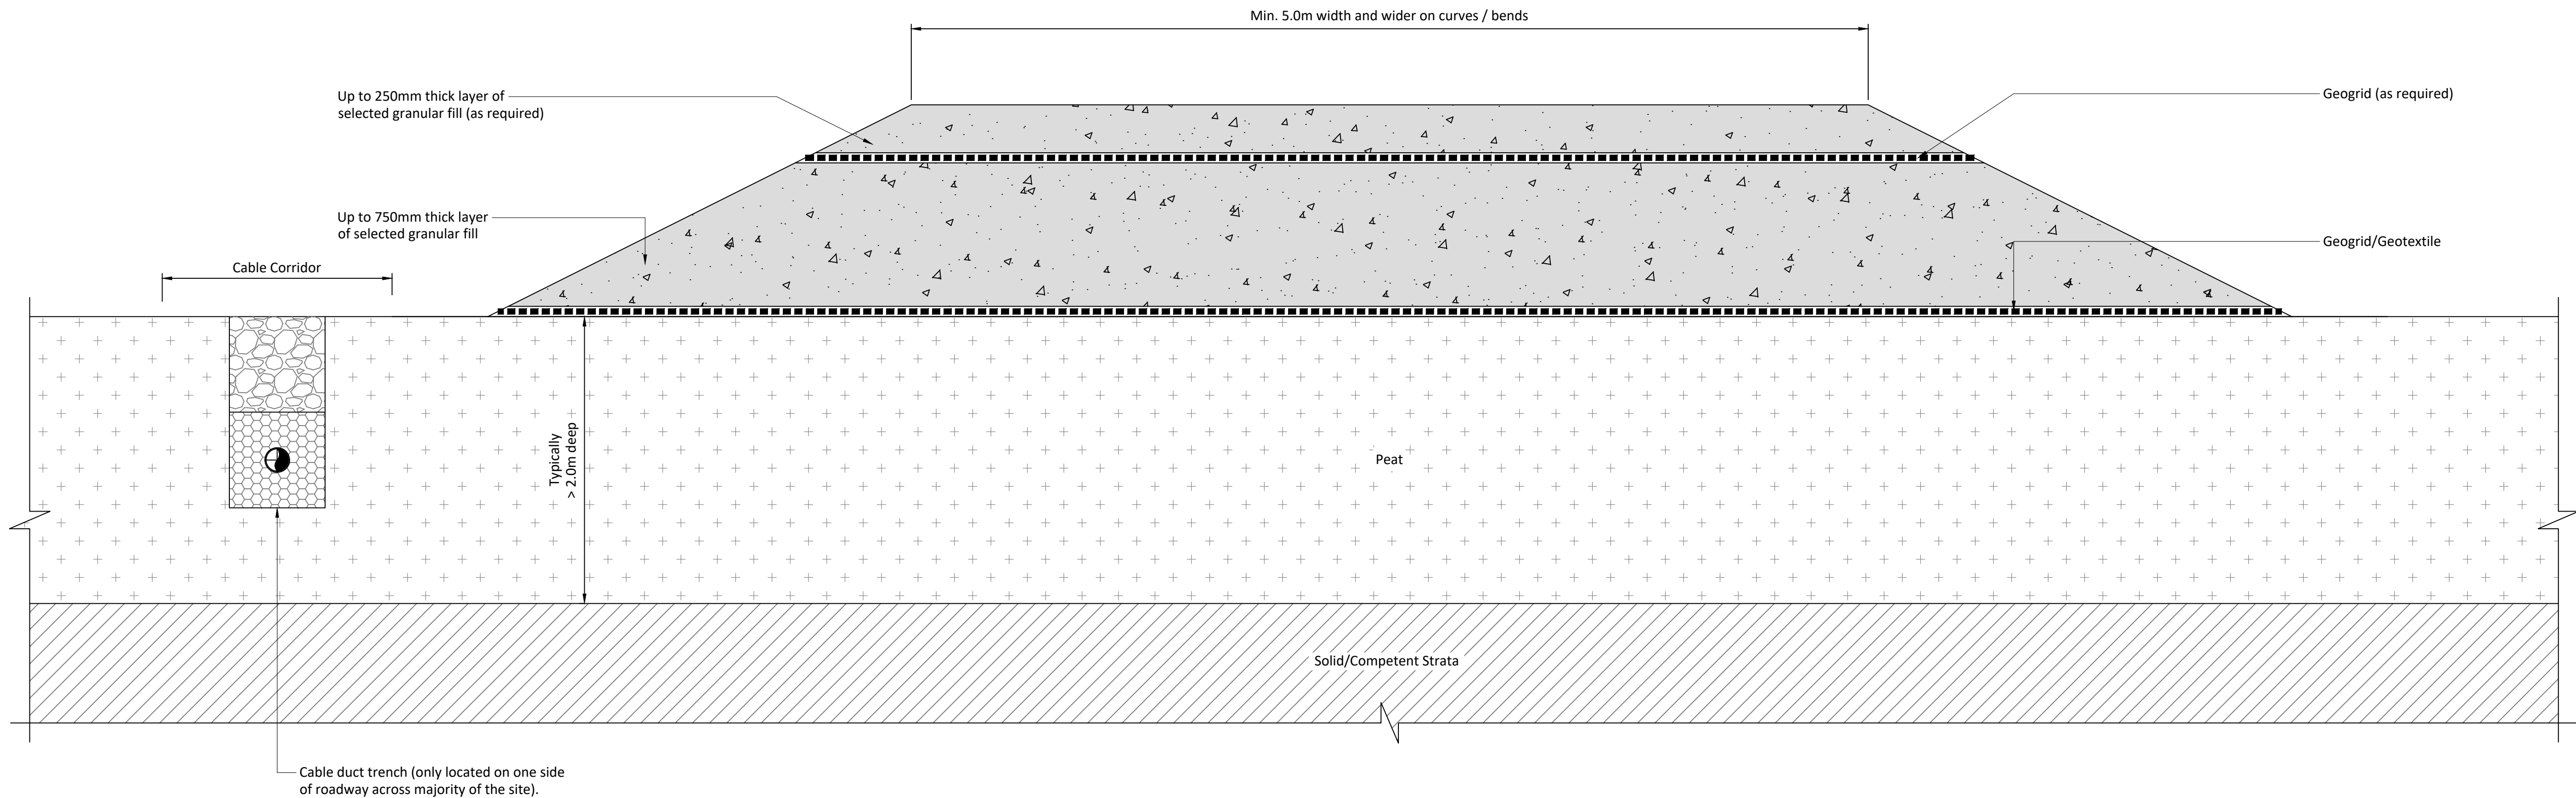
DETAIL  
1:20  
TYPE D

| TYPE D - NEW FLOATED ACCESS ROAD | Checked by | (Sheet not subject PDSMP Existing) | | |

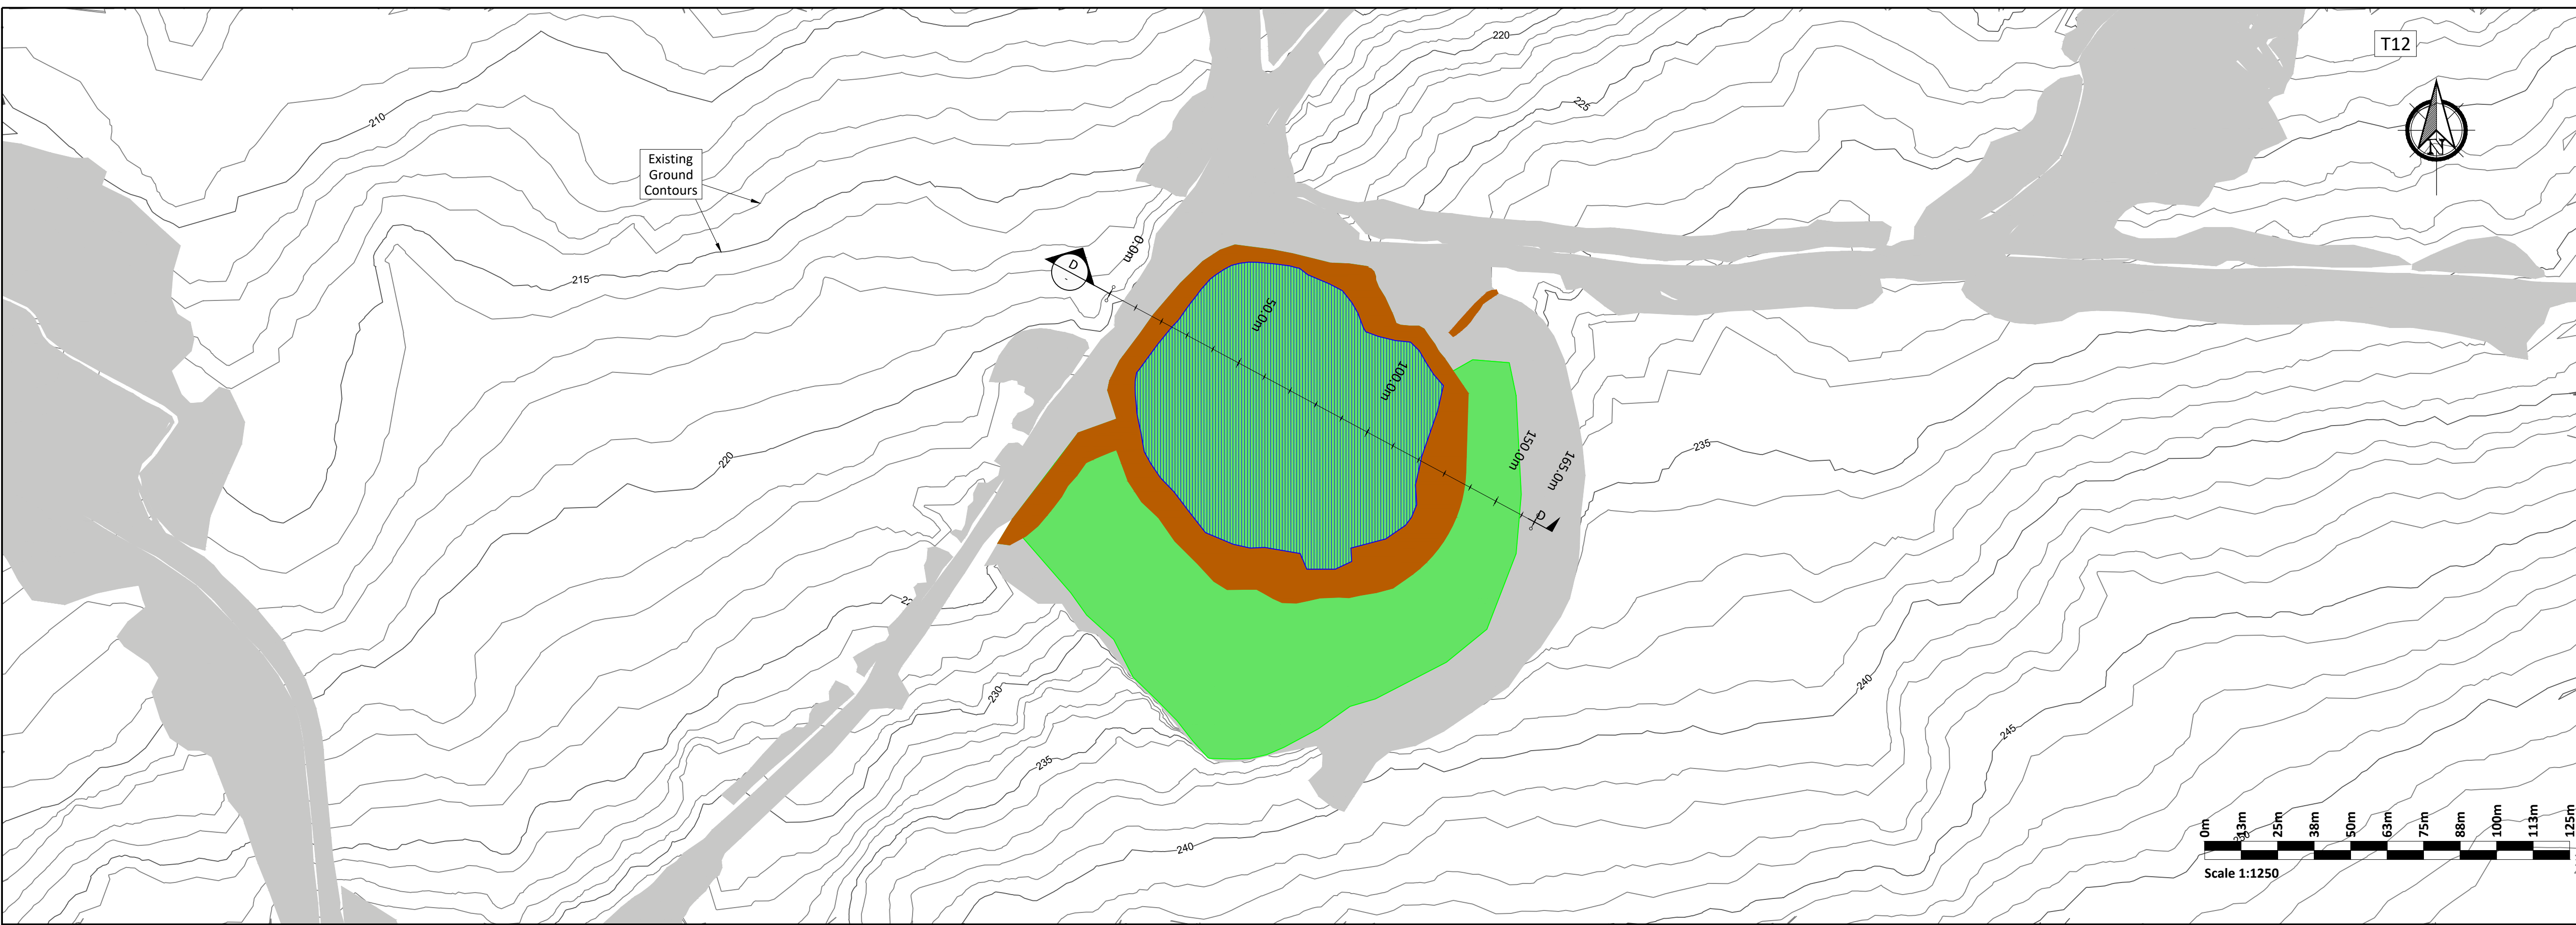
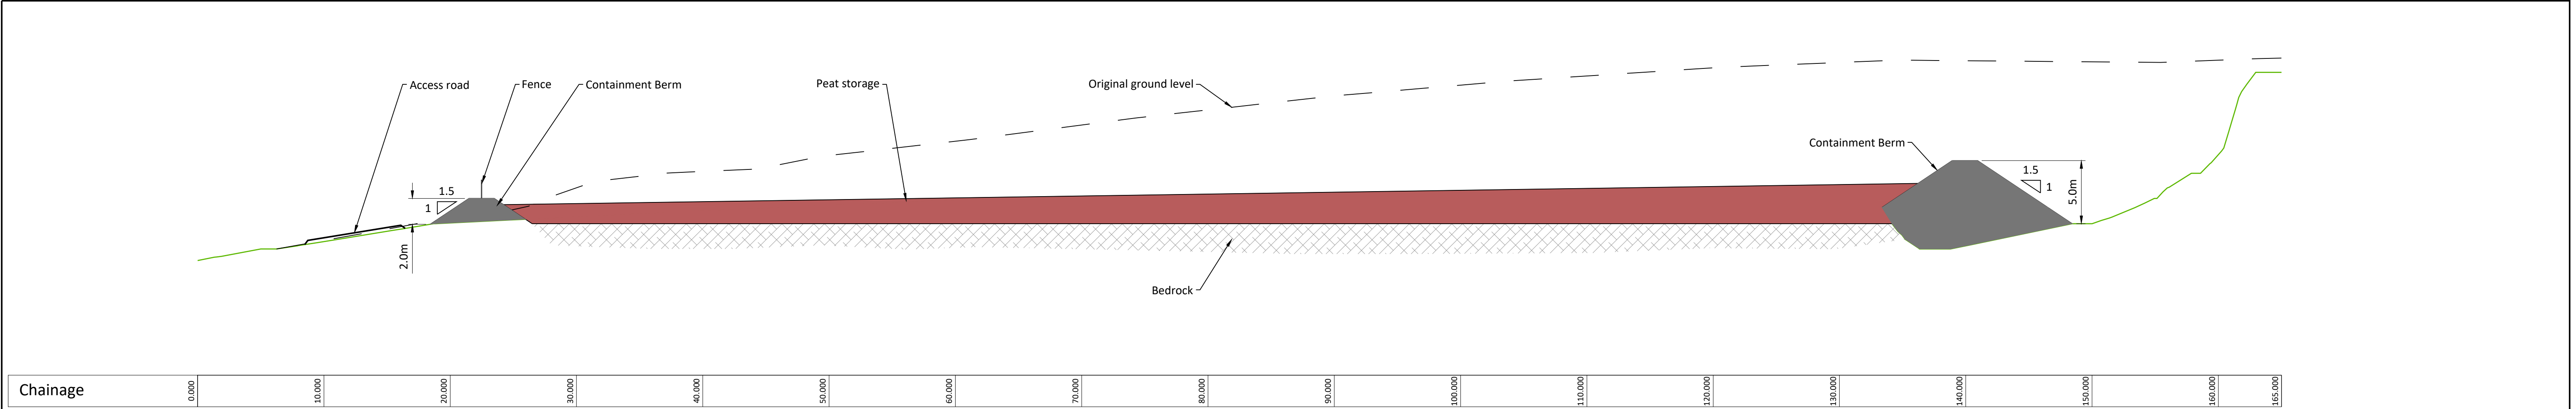
PLAN  
1:1250  
BP1

- (1) The base of the borrow pit is below the level of the adjacent section of access road.
- (2) Slopes within the excavated rock formed around the perimeter of the borrow pit have been formed at stable inclinations to suit local in-situ rock conditions.
- (3) Infilling of the peat & spoil commenced at the back edge of the borrow pit and progressed towards the borrow pit entrance. An internal buttress was constructed to allow the borrow pit to be developed and infilled in cells.
- (4) The surface of the placed peat & spoil was shaped to allow efficient run-off of surface water from the placed arising's.
- (5) Further guidelines on the construction of the borrow pit are included within Section 7.5 of the Peat & Spoil Management Plan

| PROJECT | CLIENT | | |
|---|---|---|---|
| BORROW PIT 1 | Drawn by<br>POR | Drawing Number<br>P24-234-0603-0006 | Rev<br>P02 |

- (3) Slopes within the excavated rock formed around the perimeter of the borrow pit were formed at stable inclinations to suit local in-situ rock conditions. Exposed sections of the rock slopes were left with irregular faces and declivities to promote re-vegetation and provide a naturalistic appearance.

- (8) As the borrow pit excavations progressed, surface water and groundwater ingress was removed via pumping to settlement ponds, and re-distribution locally across natural vegetated areas. Where required additional specialist treatment, including sediment bags and silt fences, was employed to ensure no deterioration in downstream water quality occurred.
- (9) The perimeter rock berm and internal berm were inspected and signed off by competent personnel.

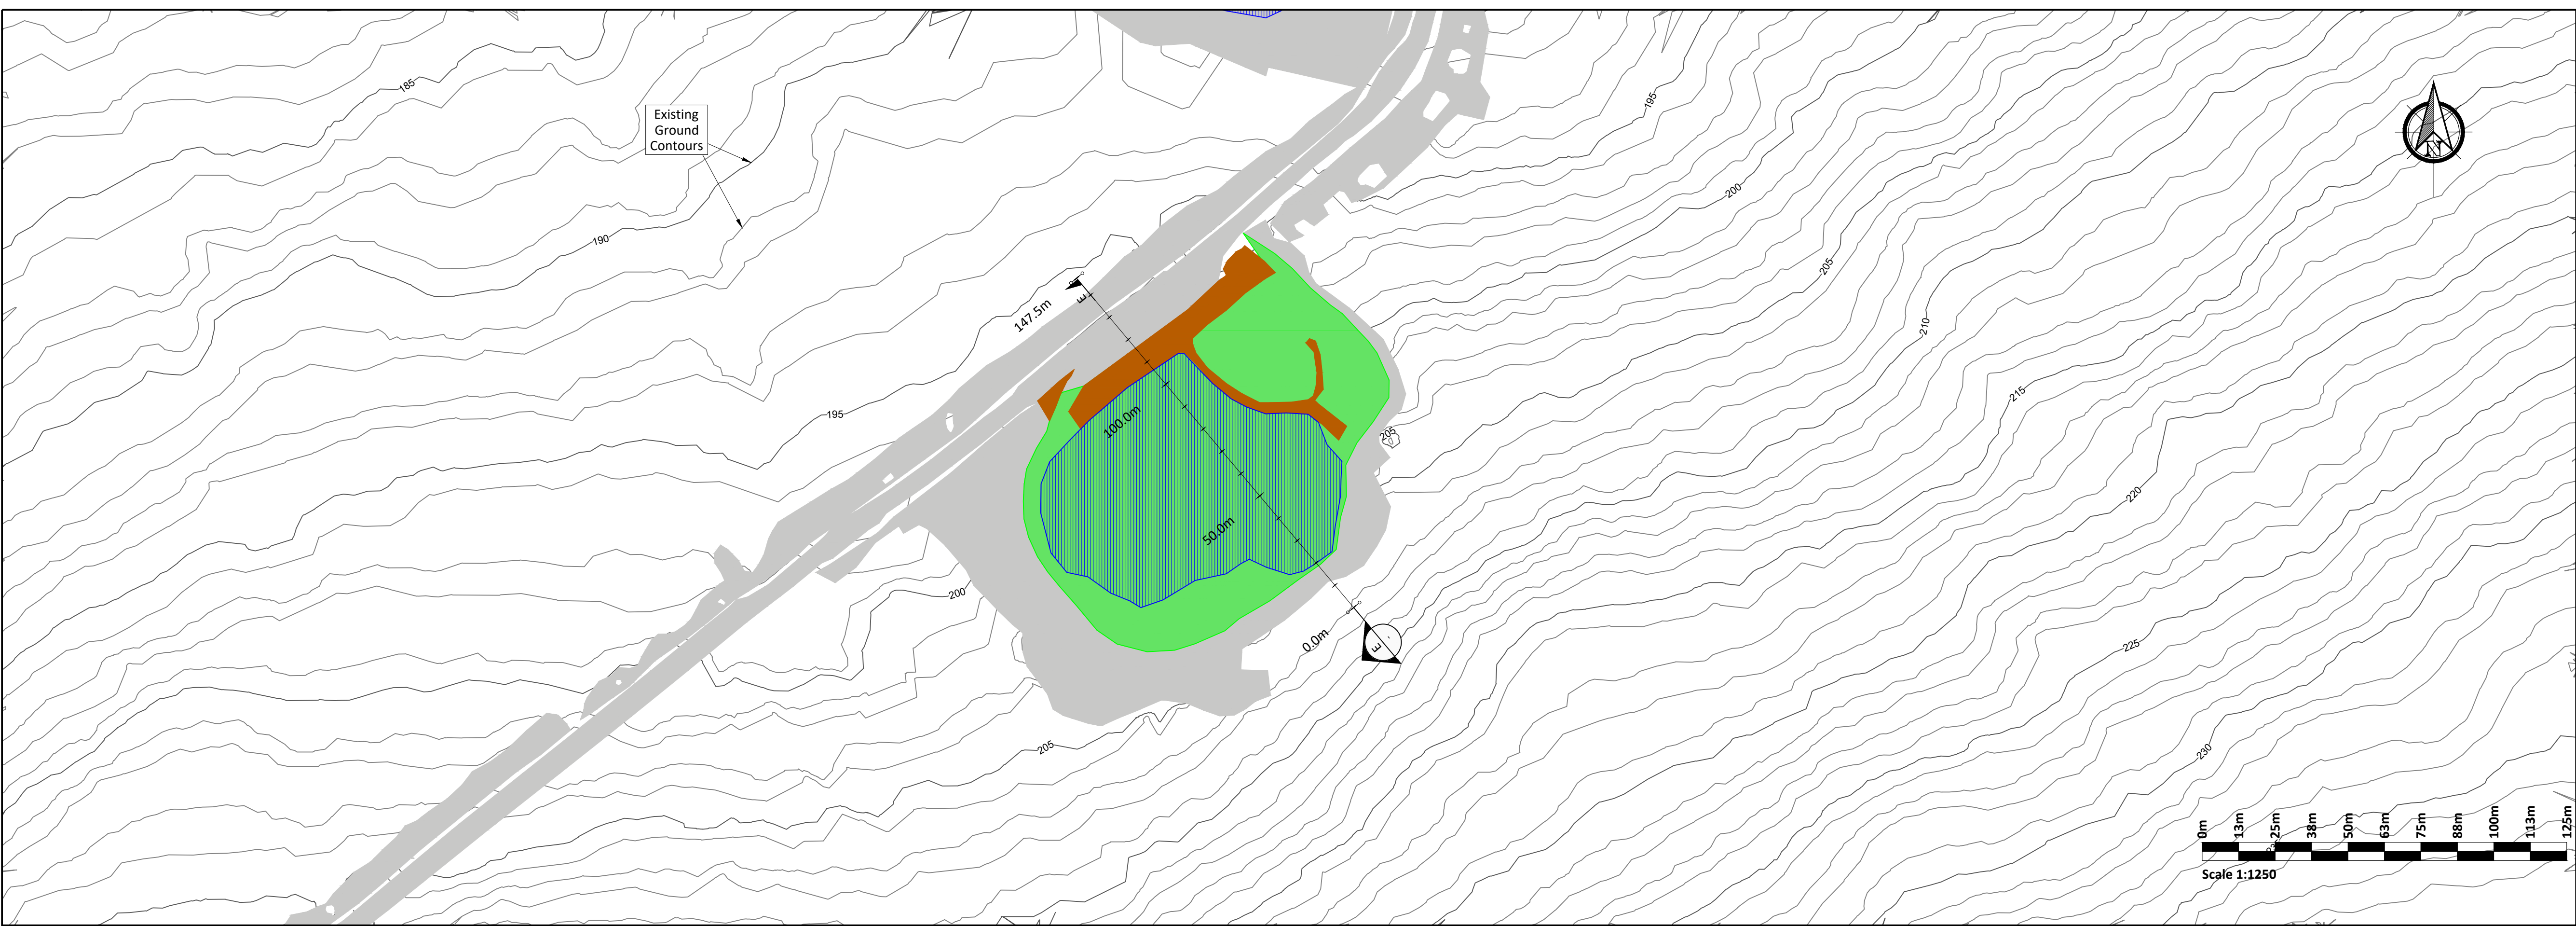
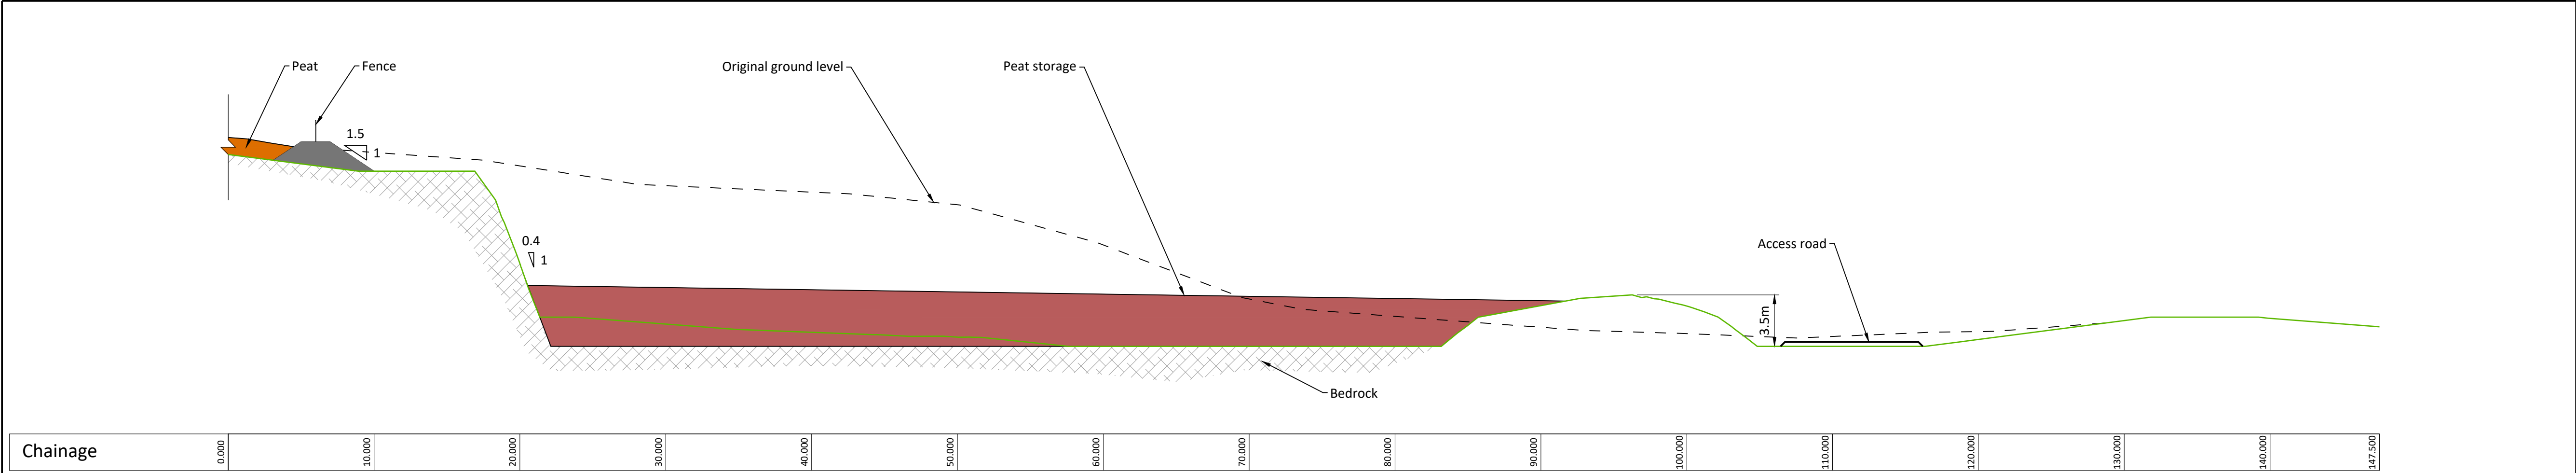
PLAN  
1:1250

- (1) The base of the borrow pit is below the level of the adjacent section of access road.
- (2) Slopes within the excavated rock formed around the perimeter of the borrow pit have been formed at stable inclinations to suit local in-situ rock conditions.
- (3) Infilling of the peat & spoil commenced at the back edge of the borrow pit and progressed towards the borrow pit entrance. An internal buttress was constructed to allow the borrow pit to be developed and infilled in cells.
- (4) The surface of the placed peat & spoil was shaped to allow efficient run-off of surface water from the placed arising's.
- (5) Further guidelines on the construction of the borrow pit are included within Section 7.5 of the Peat & Spoil Management Plan

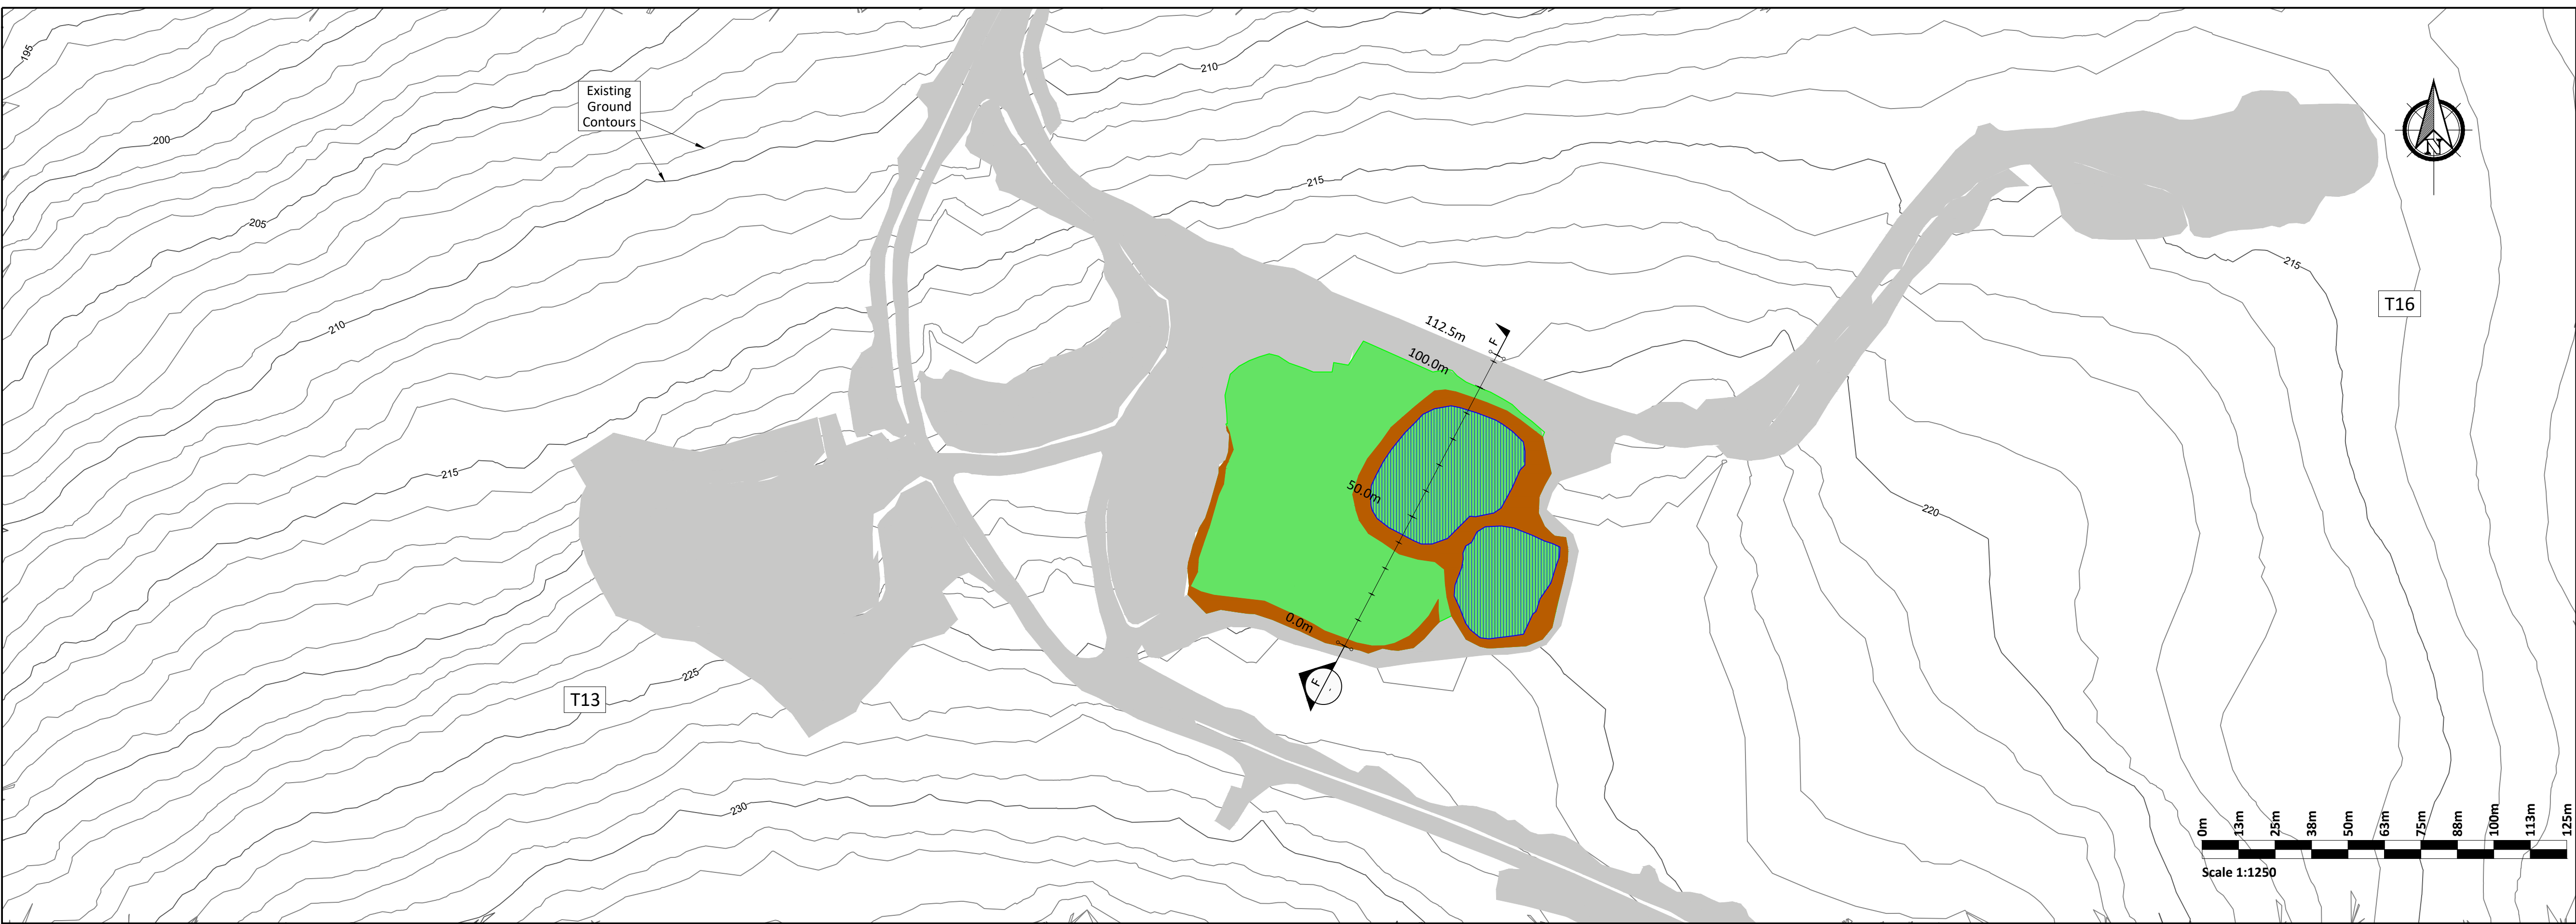
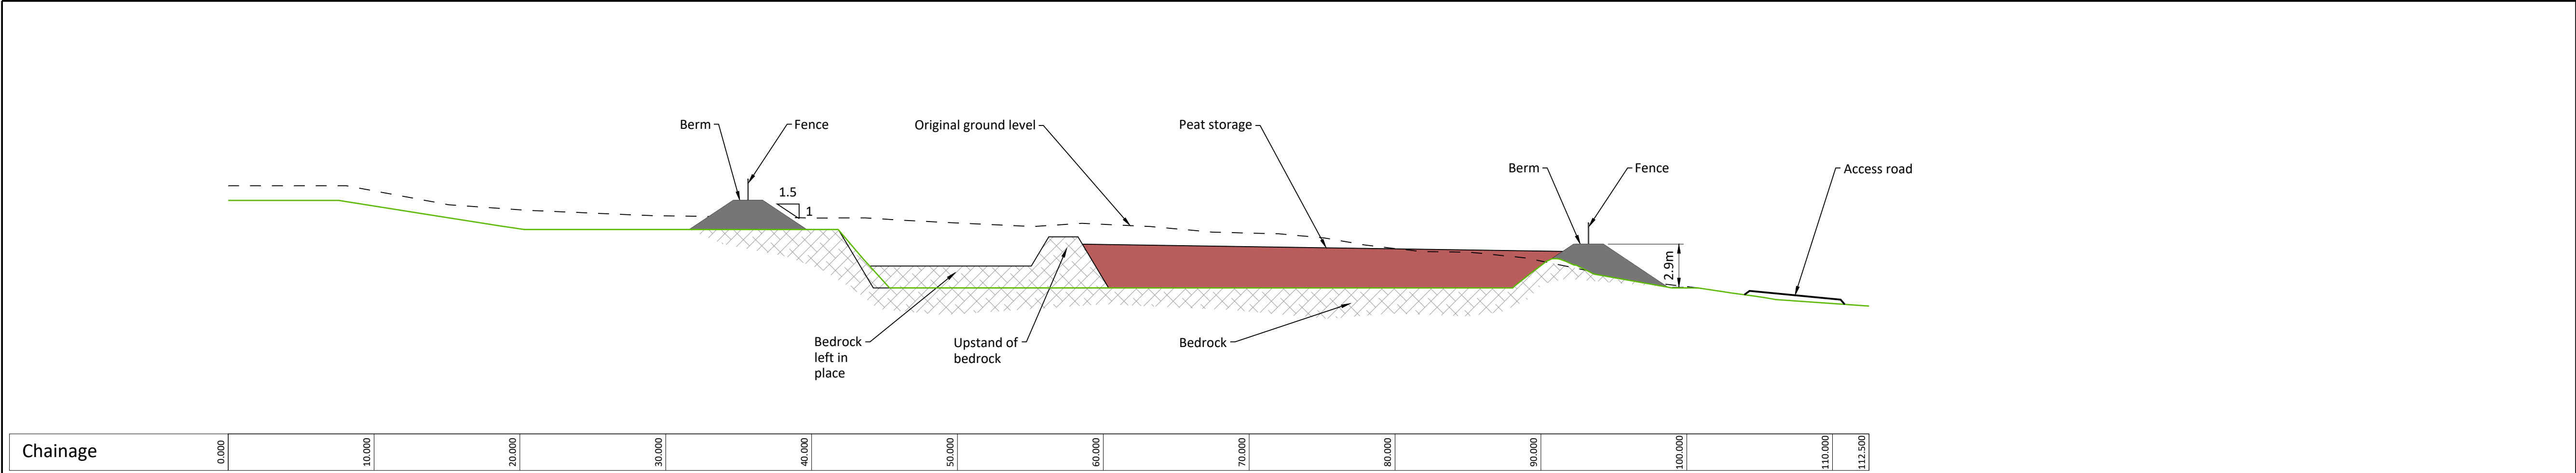
PLAN  
1:1250  
BP3

- (1) The base of the borrow pit is below the level of the adjacent section of access road.
- (2) Slopes within the excavated rock formed around the perimeter of the borrow pit have been formed at stable inclinations to suit local in-situ rock conditions.
- (3) Infilling of the peat & spoil commenced at the back edge of the borrow pit and progressed towards the borrow pit entrance. An internal buttress was constructed to allow the borrow pit to be developed and infilled in cells.
- (4) The surface of the placed peat & spoil was shaped to allow efficient run-off of surface water from the placed arising's.
- (5) Further guidelines on the construction of the borrow pit are included within Section 7.5 of the Peat & Spoil Management Plan

| PROJECT | CLIENT | | |
|---|---|---|---|
| BORROW PIT 3 | Drawn by<br>POR | Drawing Number<br>P24-234-0603-0008 | Rev<br>P02 |
