***RETROSPECTIVE PEAT AND SPOIL  
MANAGEMENT PLAN (EXISTING  
DEVELOPMENT) (FT, 2026) (RPSMP  
(FT,2026)***

# MEENBOG WIND FARM (EXISTING DEVELOPMENT)

## PEAT AND SPOIL MANAGEMENT PLAN

**Document No:**  
**P24234-FT-EGT-XX-RP-GT-0004**

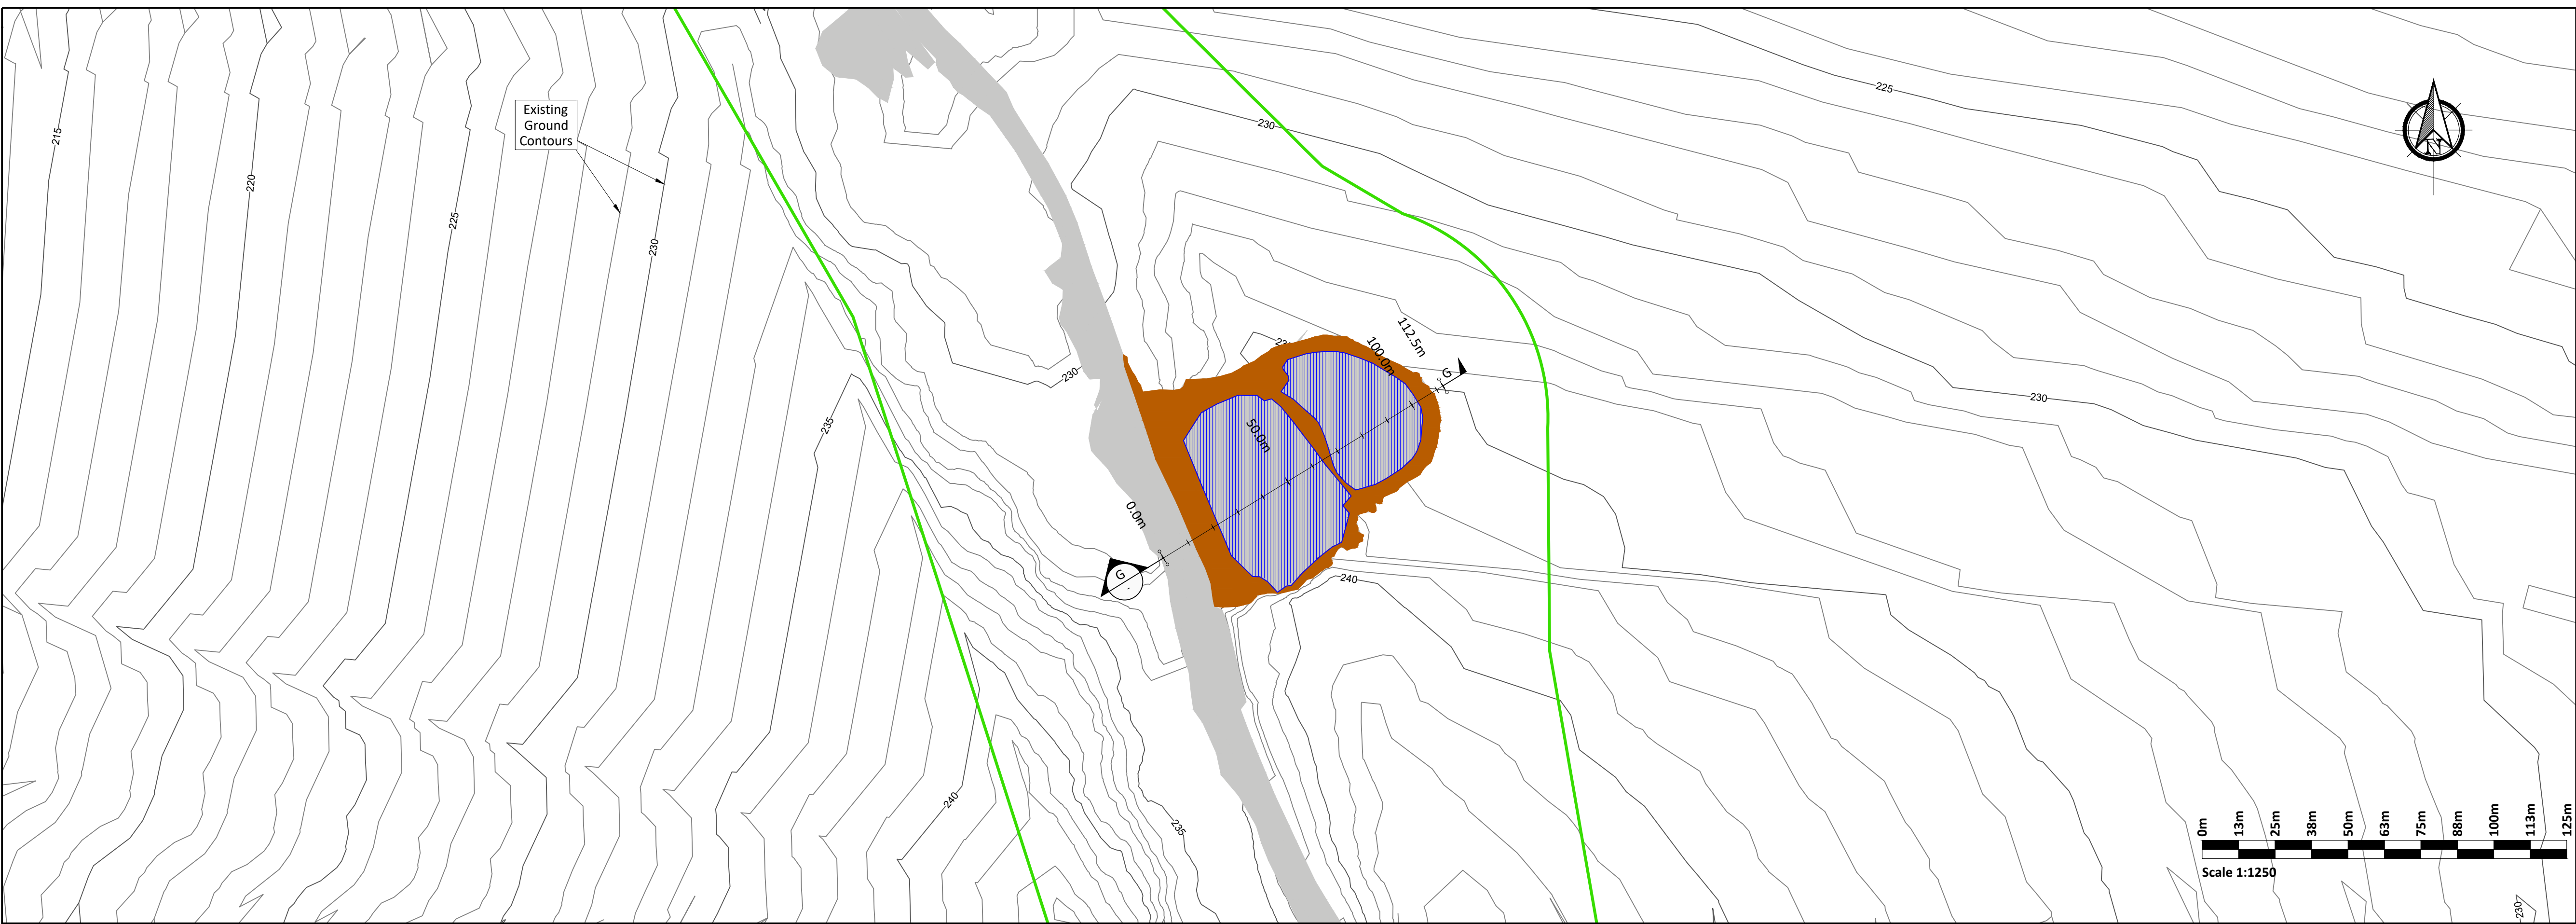
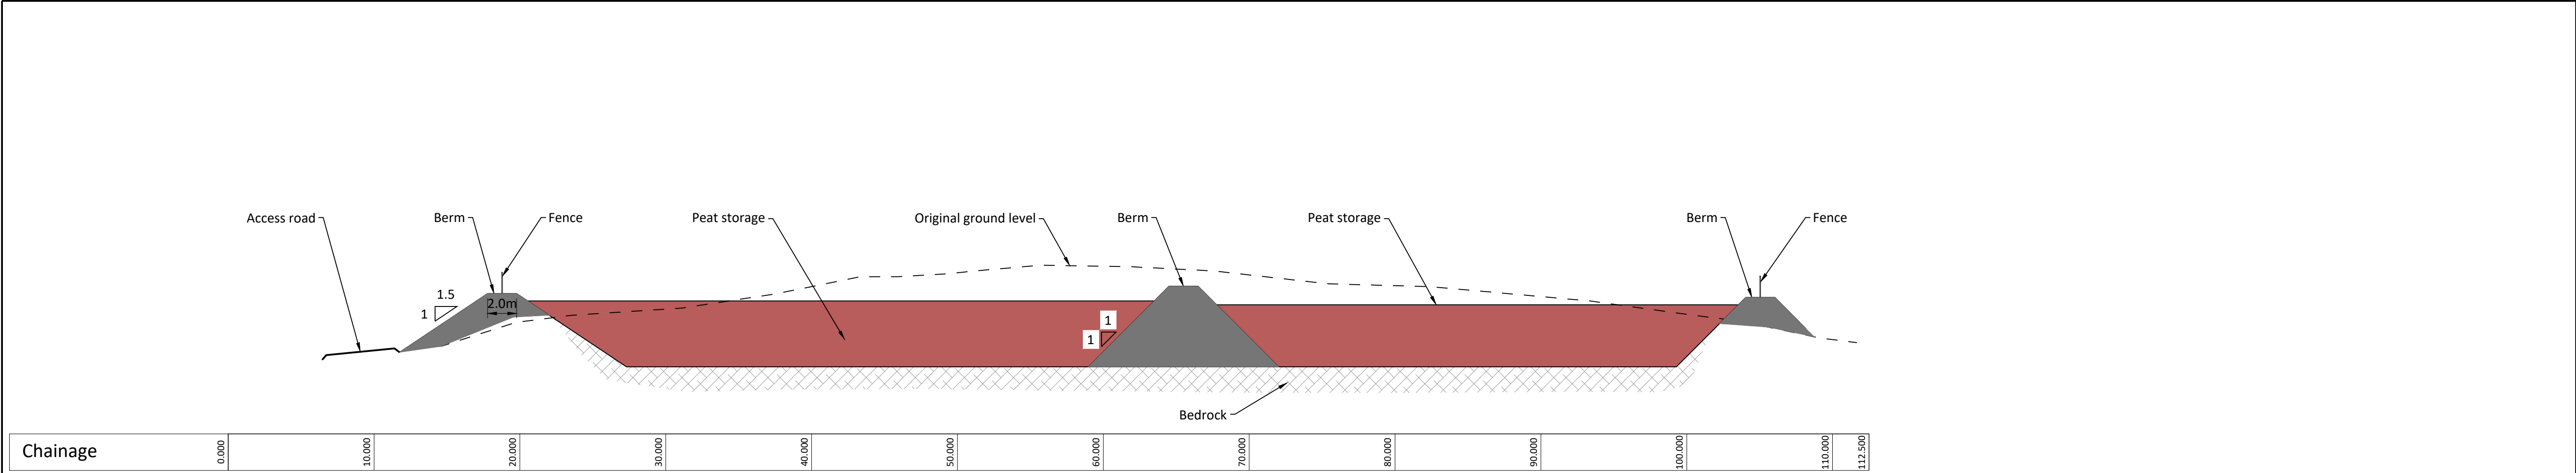
PLAN  
1:1250

- All peat and soft clay was removed from below the base of the perimeter berms prior to construction of the berms.
- Coarse rock fill was placed and compacted in layers to create the perimeter berms.
- The surface of the placed peat was shaped to allow run-off of surface water towards the perimeter berms.
- Drains/channels have been cut into the crest of the perimeter berms to prevent water buildup on the surface of the stored peat.

- (6) The berm was constructed in a manner which prevented water retention within the storage area. This was in order to prevent a build-up of hydrostatic pressure at the base of the berm at a varying rate across the footprint which could have effectively placed a point load at a specific location.

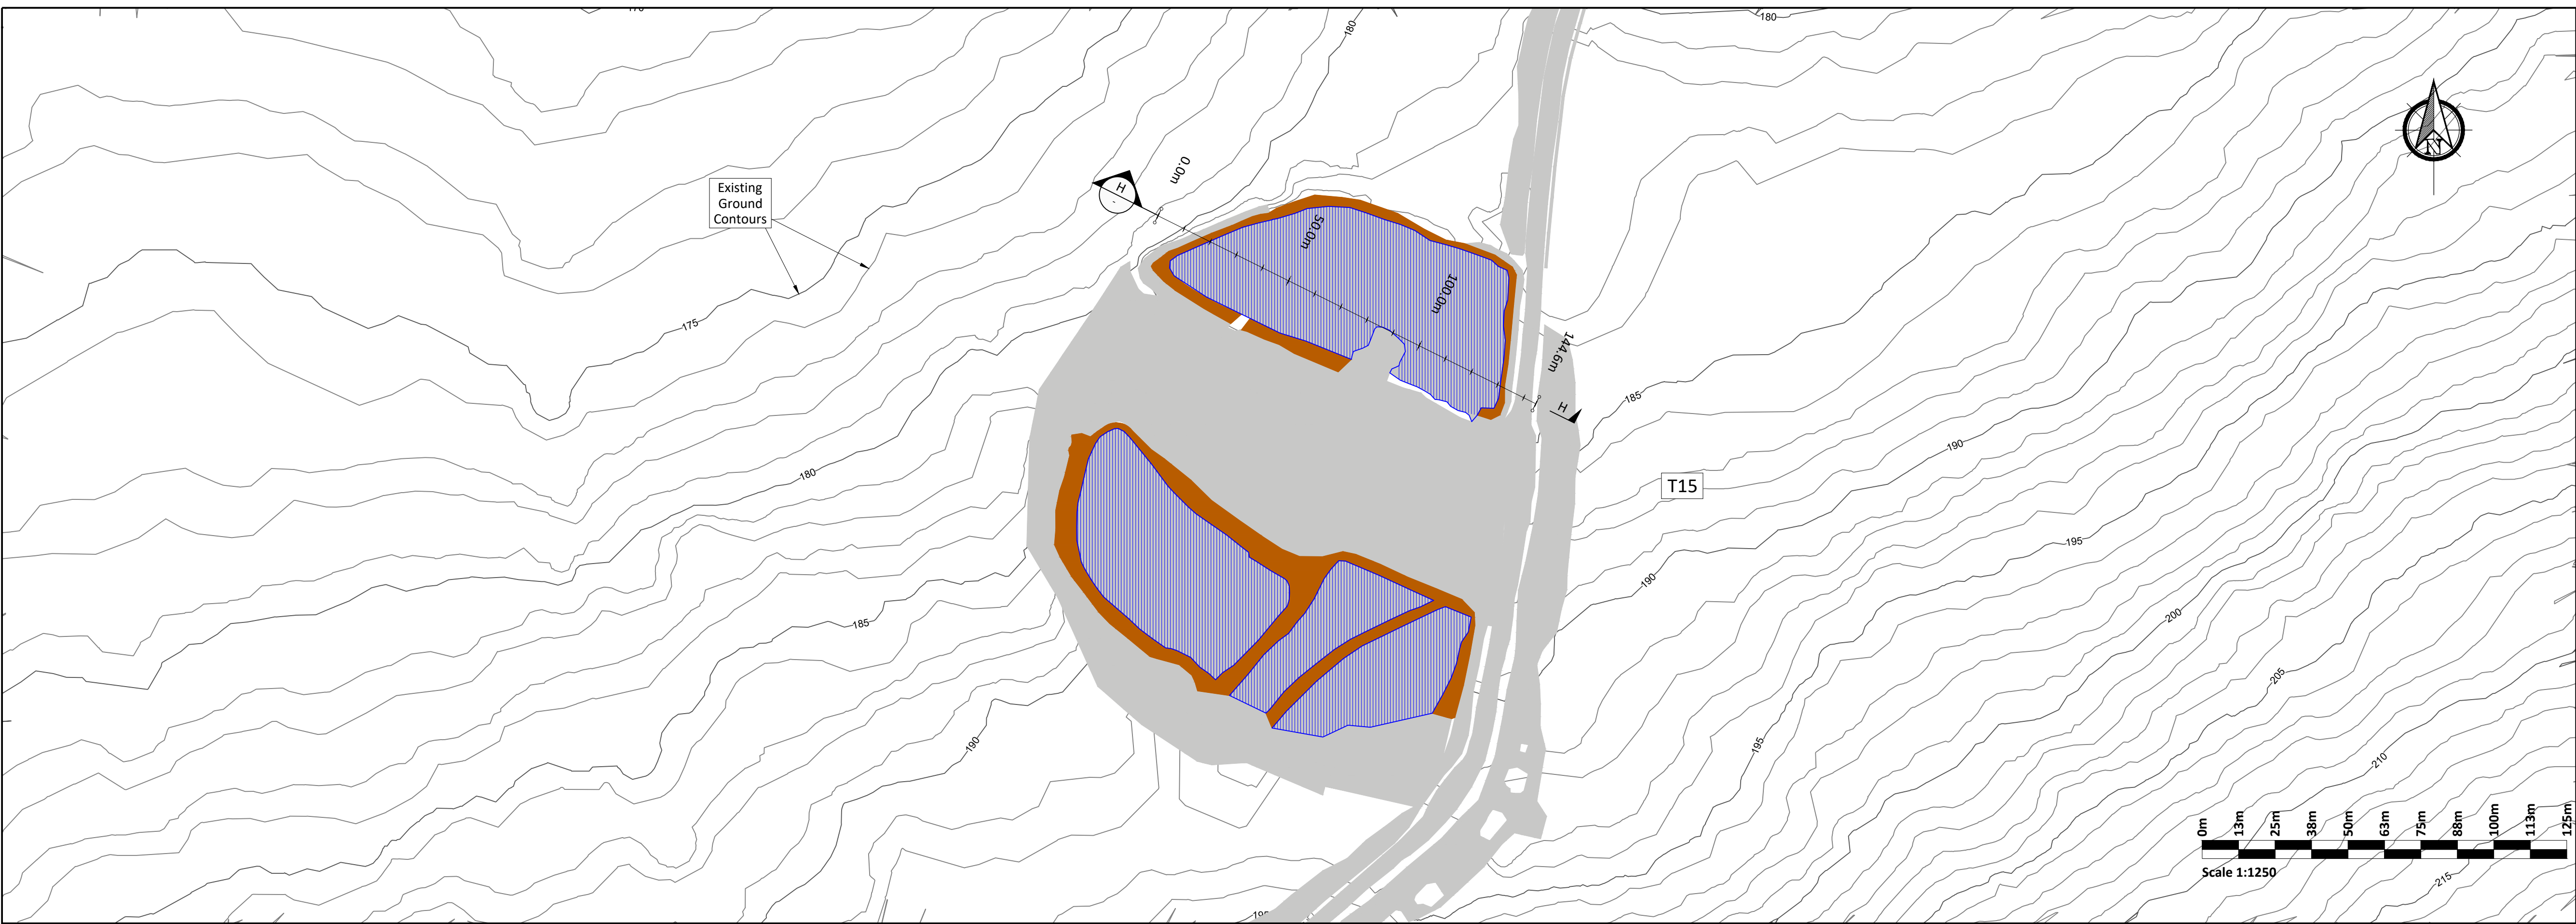
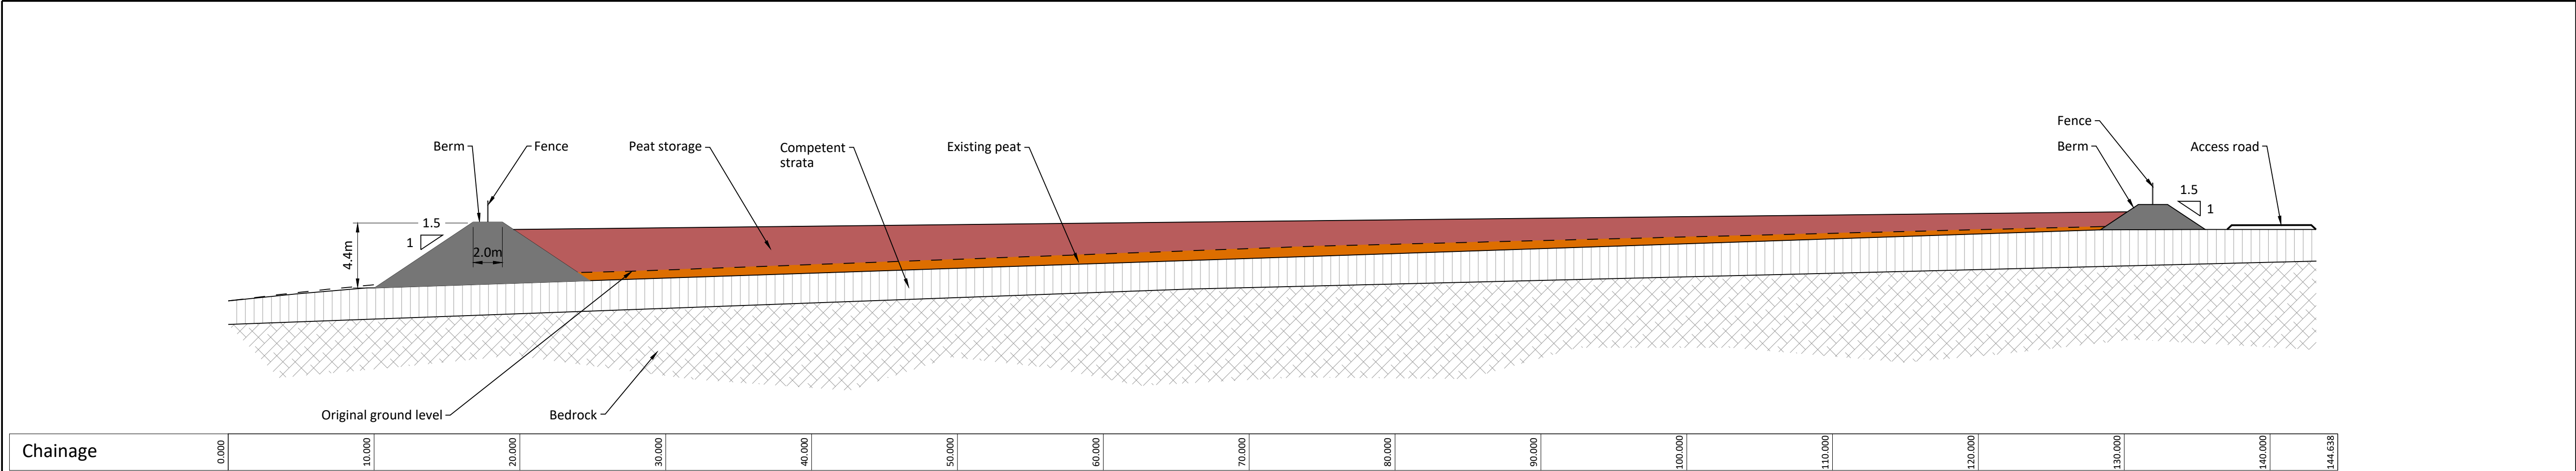
- Construction Notes Peat Cells:
- (1) All peat and soft clay was removed from below the base of the perimeter berms prior to construction of the berms.
  - (2) Coarse rock fill was placed and compacted in layers to create the perimeter berms.
  - (3) The surface of the placed peat was shaped to allow run-off of surface water towards the perimeter berms.
  - (4) Drains/channels have been cut into the crest of the perimeter berms to prevent water buildup on the surface of the stored peat.

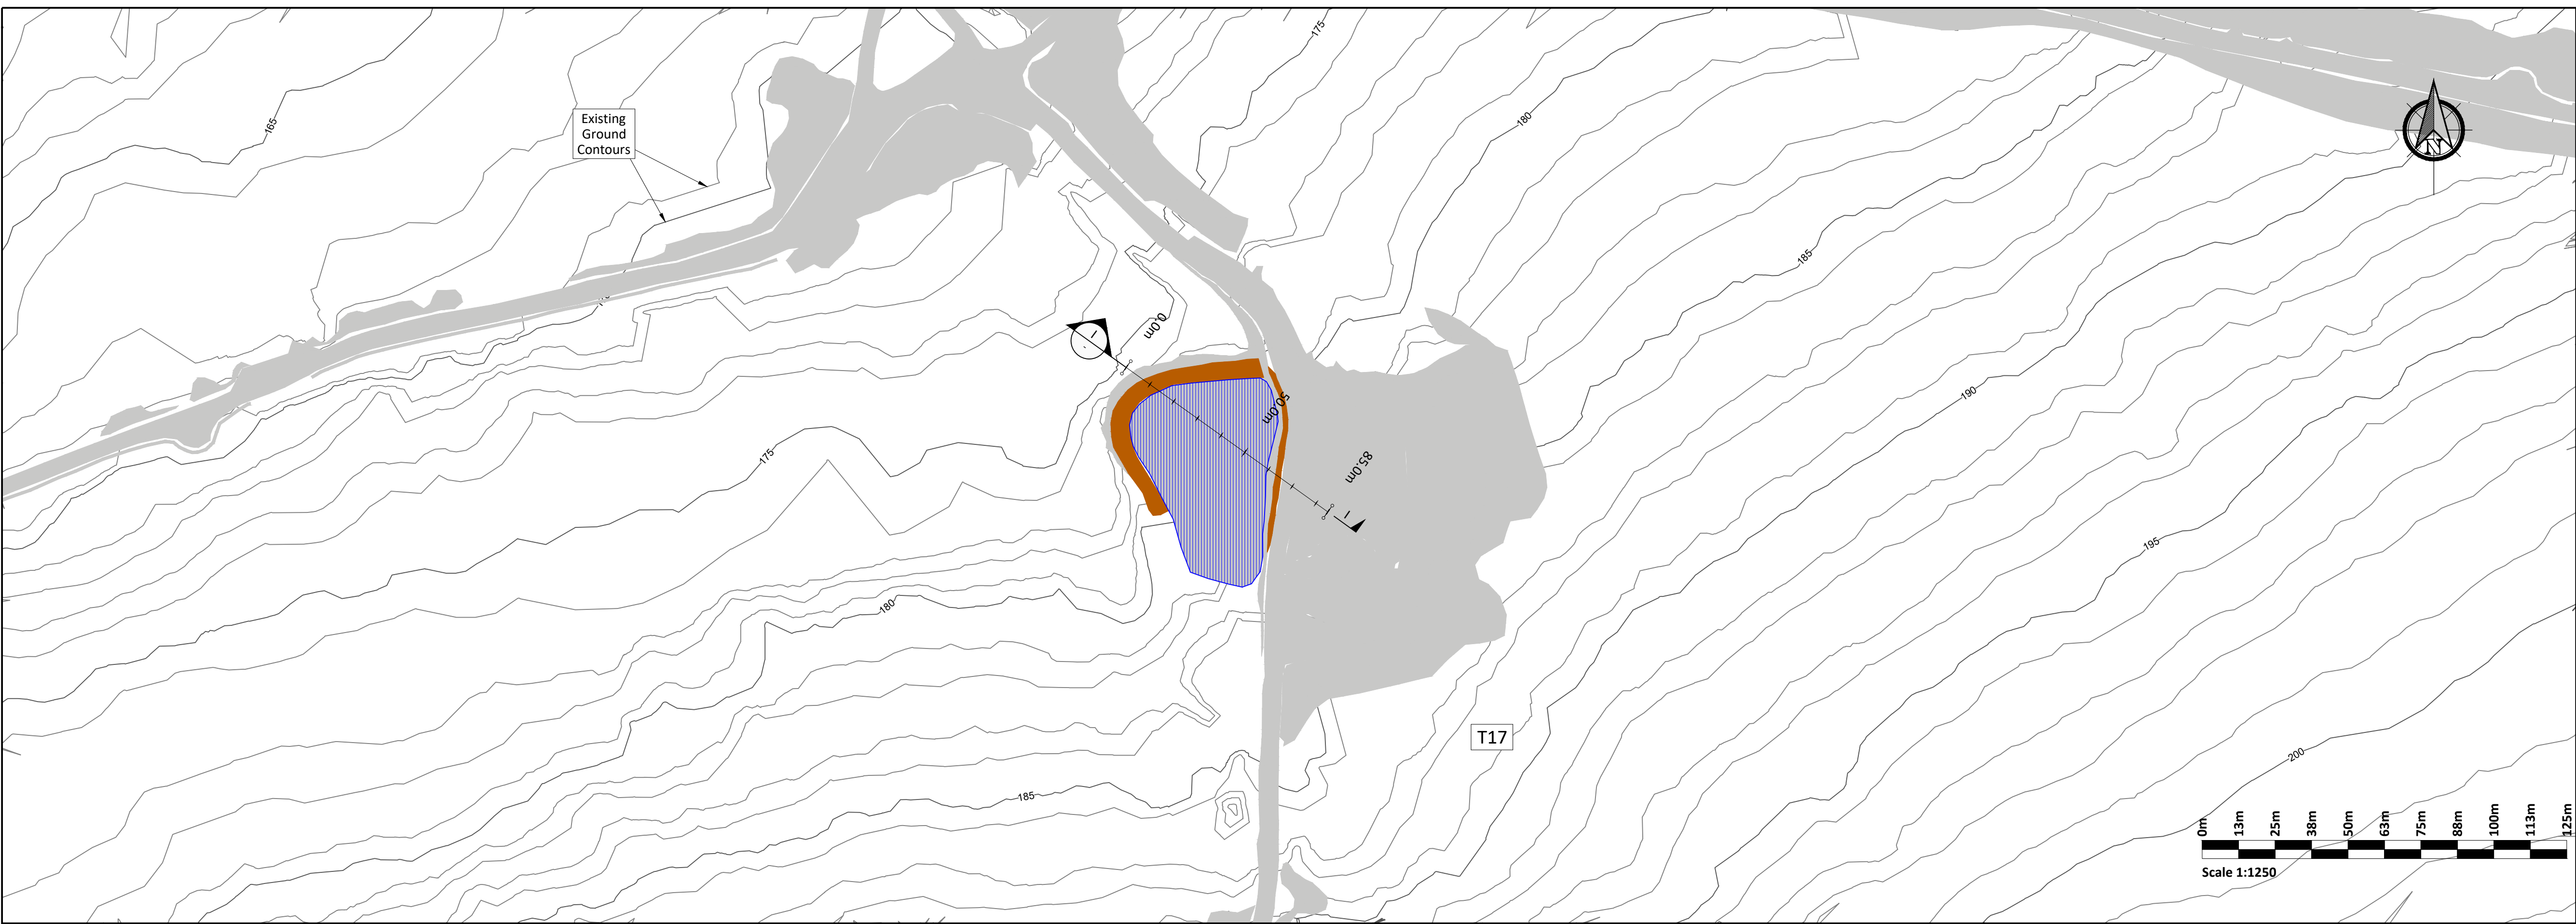
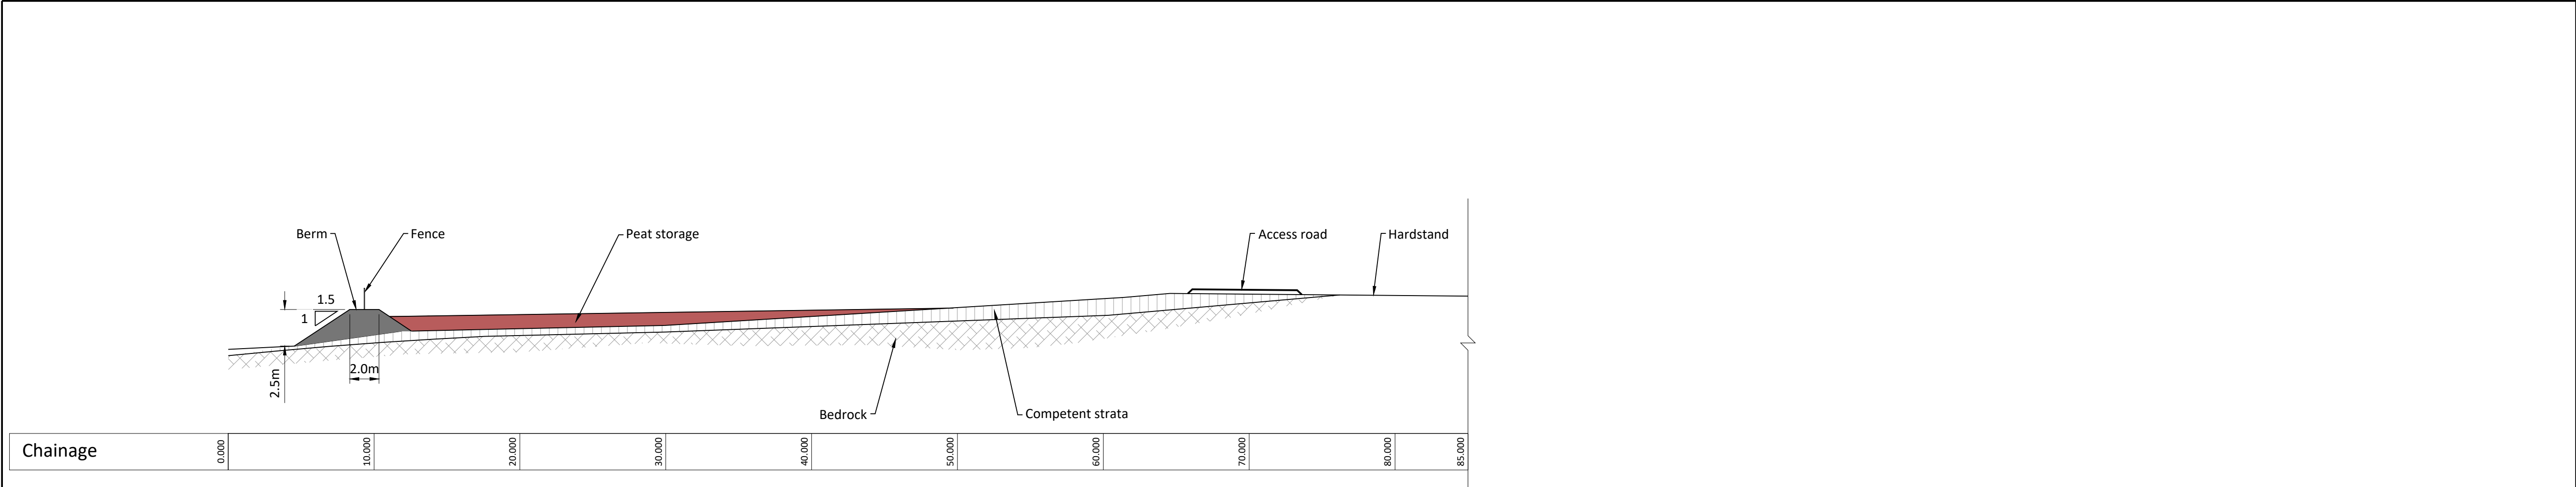
PLAN  
1:1250  
T17

- Construction Notes Peat Cells:
- (1) All peat and soft clay was removed from below the base of the perimeter berms prior to construction of the berms.
  - (2) Coarse rock fill was placed and compacted in layers to create the perimeter berms.
  - (3) The surface of the placed peat was shaped to allow run-off of surface water towards the perimeter berms.
  - (4) Drains/channels have been cut into the crest of the perimeter berms to prevent water buildup on the surface of the stored peat.

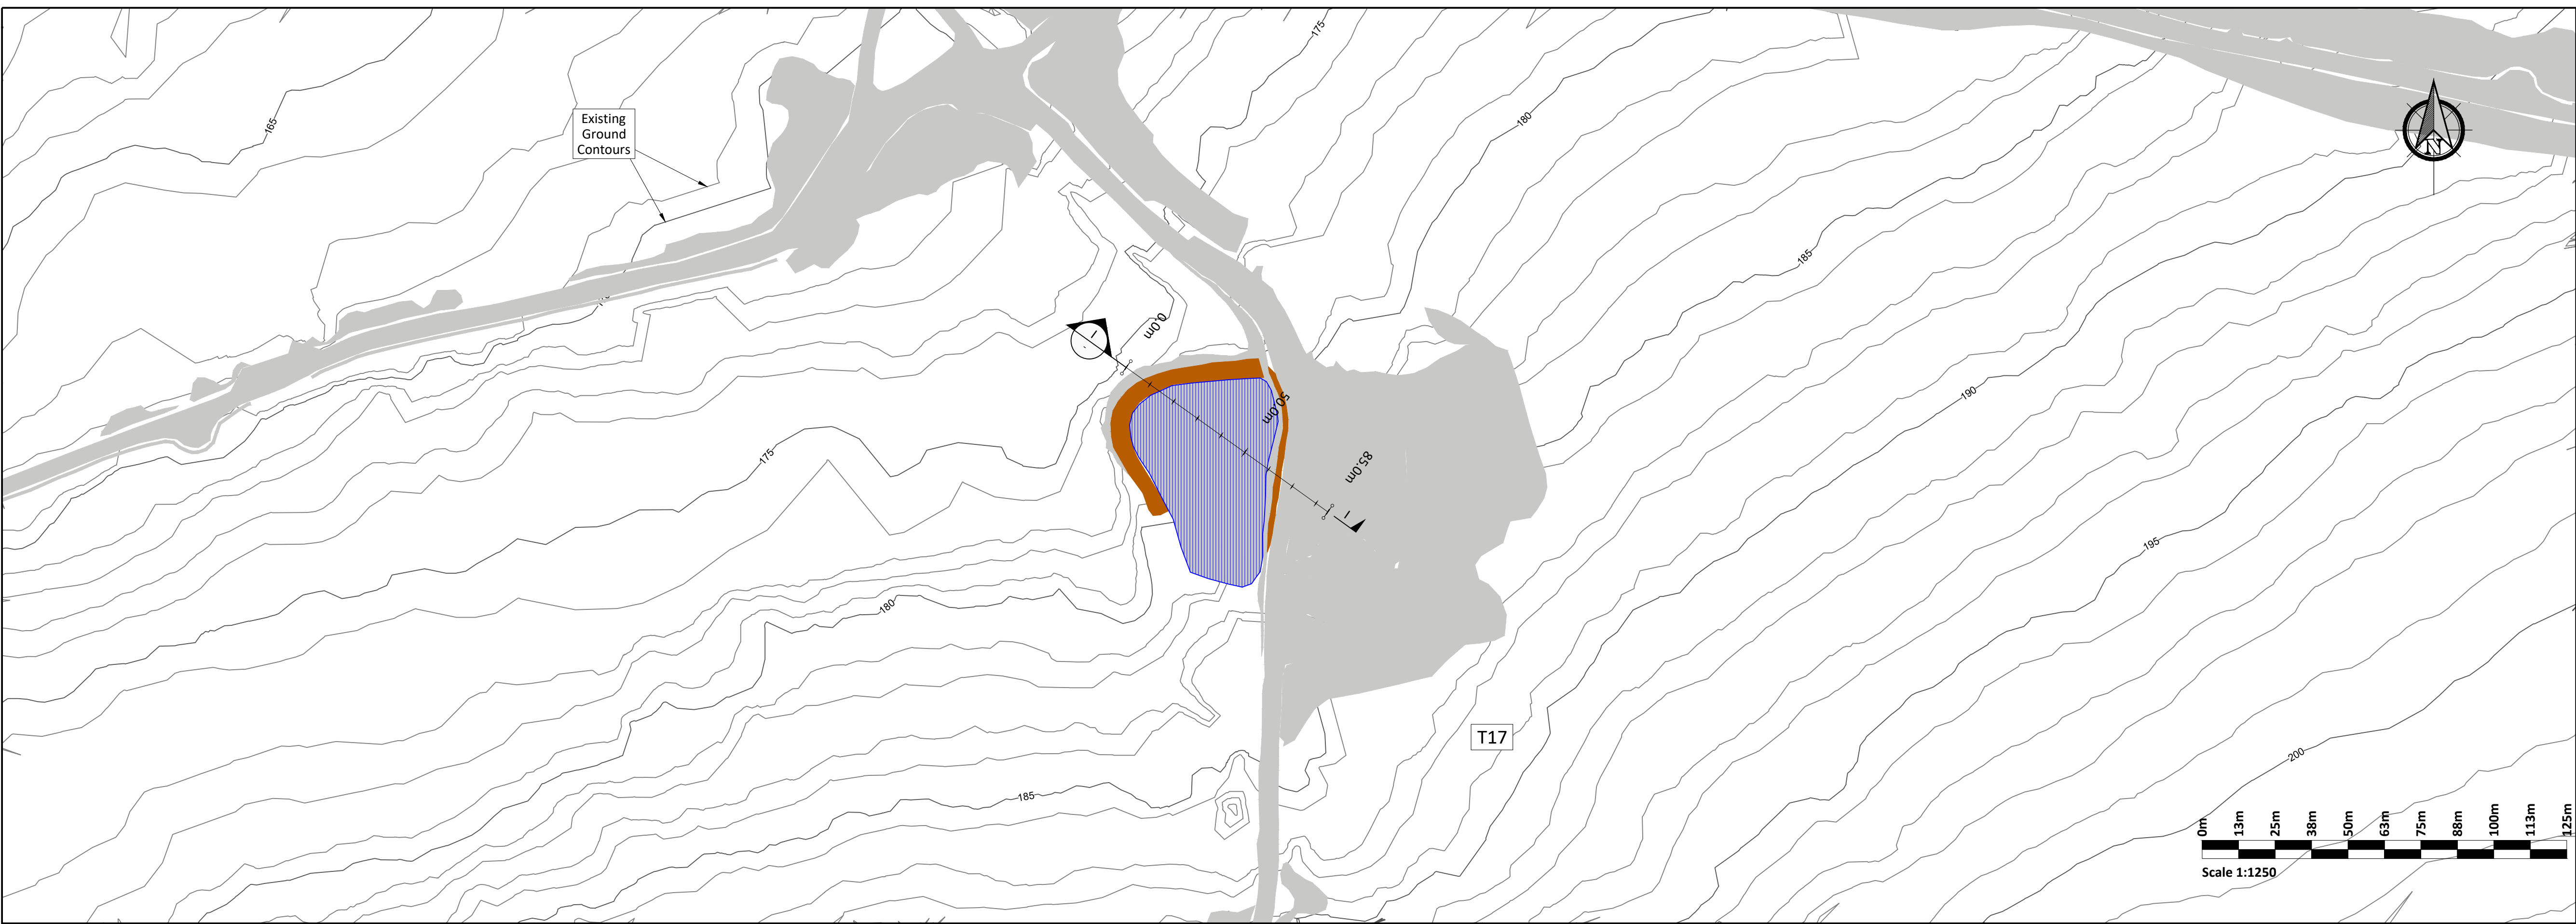
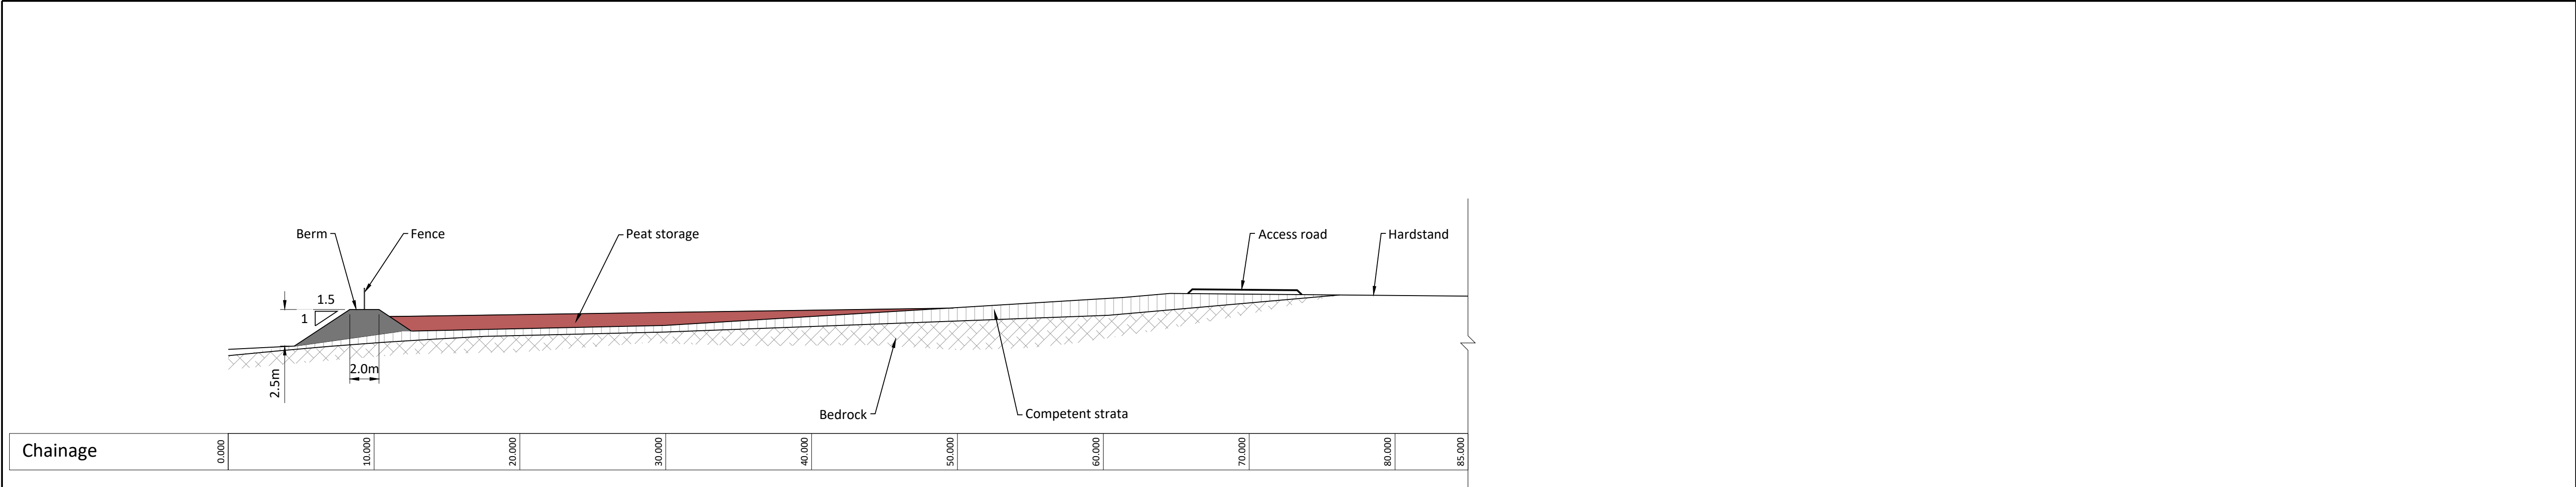
- Construction Notes Peat Cells:**
- (1) All peat and soft clay was removed from below the base of the perimeter berms prior to construction of the berms.
  - (2) Coarse rock fill was placed and compacted in layers to create the perimeter berms.
  - (3) The surface of the placed peat was shaped to allow run-off of surface water towards the perimeter berms.
  - (4) Drains/channels have been cut into the crest of the perimeter berms to prevent water buildup on the surface of the stored peat.
