## **Appendix 5.4. Bat Surveys Report, 2020**

# **BAT SURVEYS CONDUCTED AT MORTARSTOWN WASTE WATER TREATMENT PLANT AND PUMPING STATION, CARLOW**

**Report Prepared for**  
Atkins Global,  
150 Airside Business park,  
Swords,  
Co. Dublin

**September/November 2020**

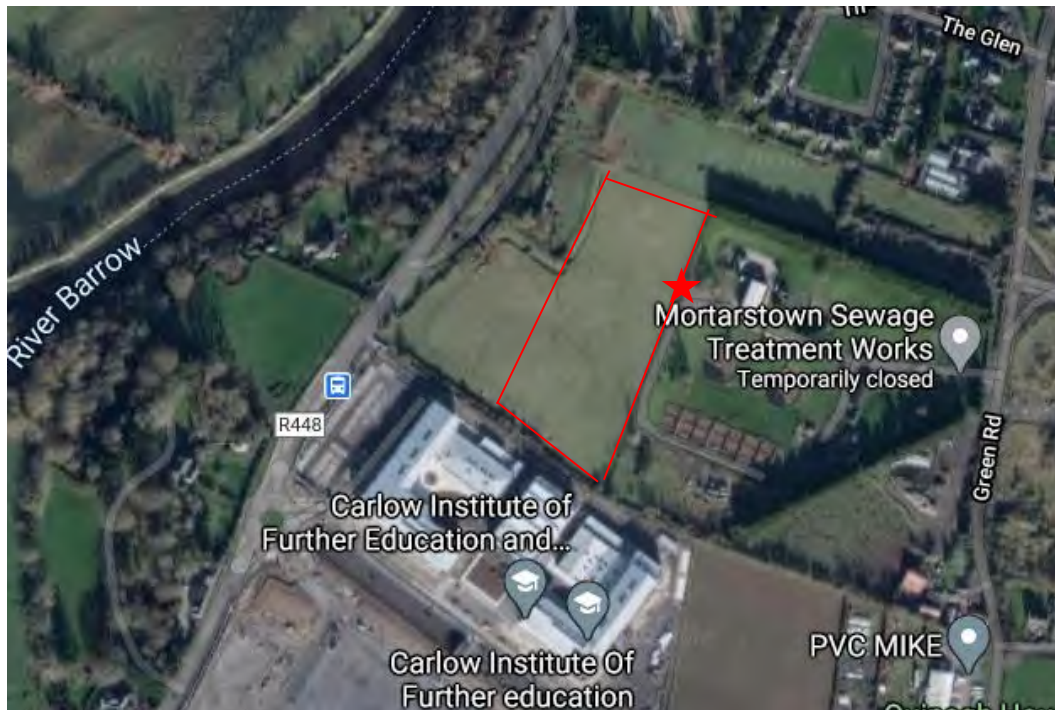
**Figure 3** - Mortarstown Waste Water Treatment Plant – position of remote detector indicated (star). The location of the proposed extension is indicated within the red lines

At Mortarstown Waste Water Treatment Plant the Songmeter detector was placed on the security fence on the eastern side of the proposed extension area (Figure 3). The microphone was positioned to face towards the extension area.

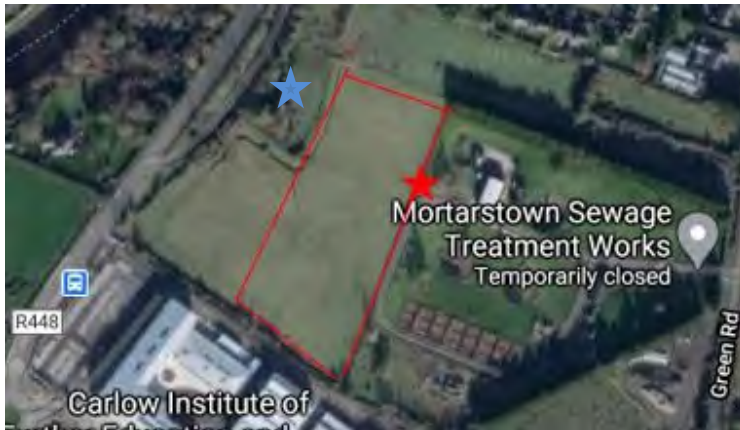
**Figure 4** – showing position of single storey dwelling house backing onto site (blue star)

A single storey dwelling house backs onto the north western portion of the site as shown by blue star in Figure 4. There is a row of very mature Horse chestnut trees to the front of this house. These trees have ideal crevices for bats and were assessed as having high potential for roosting bats. There are also potential roost sites in the dwelling house roof and sheds. However, the tenant reported no sightings of bats in the internal roof space of the dwelling house. He reported seeing a lot of bat activity in summer months on the slip-road in front of the house and in the garden.

A bat detector survey should be conducted during 2021 on the premises to establish if bats are roosting on site.

If timing allows, additional hand-held bat detector surveys should be conducted in the vicinity of the dwelling house on the slip-road off the R448 and at the site of the pumping station.

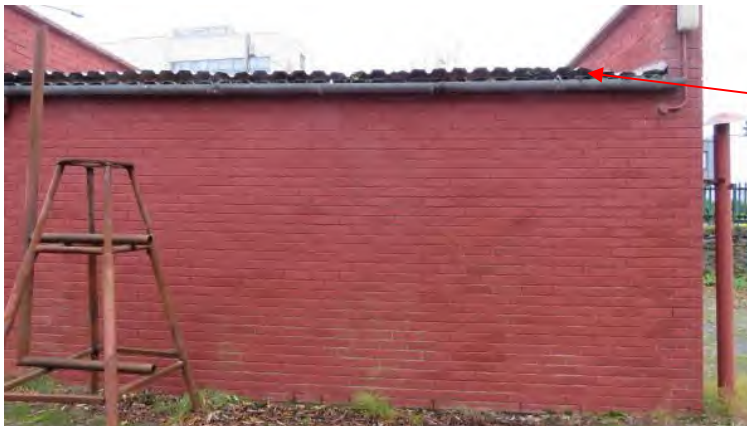
**Photo 27** – potential roosting sites under roof

Kilkenny road pumping station was also resurveyed on 5th Nov to examine the two small buildings for roosting potential for bats. The red brick building was considered to have medium potential for bats under the roof. The cement building was assessed as having low potential for roosting bats.

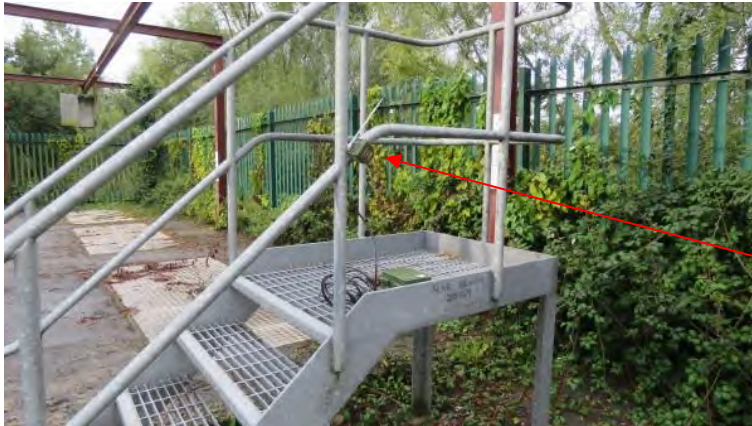
**Photo 28** – showing Songmeter detector in position on steps

At the Pumping Station the Songmeter detector was placed on steps between the two buildings in the centre of the site (Figure 2).

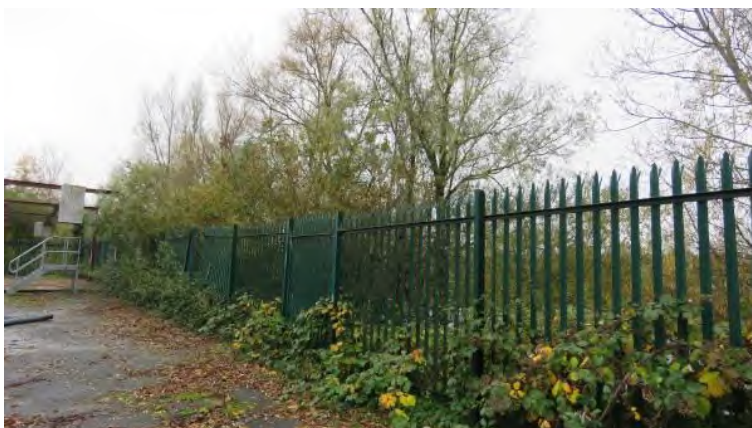
**Photo 32** – Western boundary fence along River Barrow with semi mature willow along river banks

The pumping station is located immediately beside the River Barrow and has a shelter belt of semi-mature willow along the river bank. The presence of the river and semi-mature trees represent ideal foraging conditions for bats.
