## **Appendix 5.6. Bat Surveys Report, 2021b**

**BAT SURVEYS CONDUCTED ALONG POTENTIAL  
NEW ROUTES OF RISING MAIN PIPE AND IN  
GREEN AREA TO NORTH OF PLANT AT  
MORTARSTOWN WASTE WATER TREATMENT  
PLANT IN CARLOW**

**October 2021**

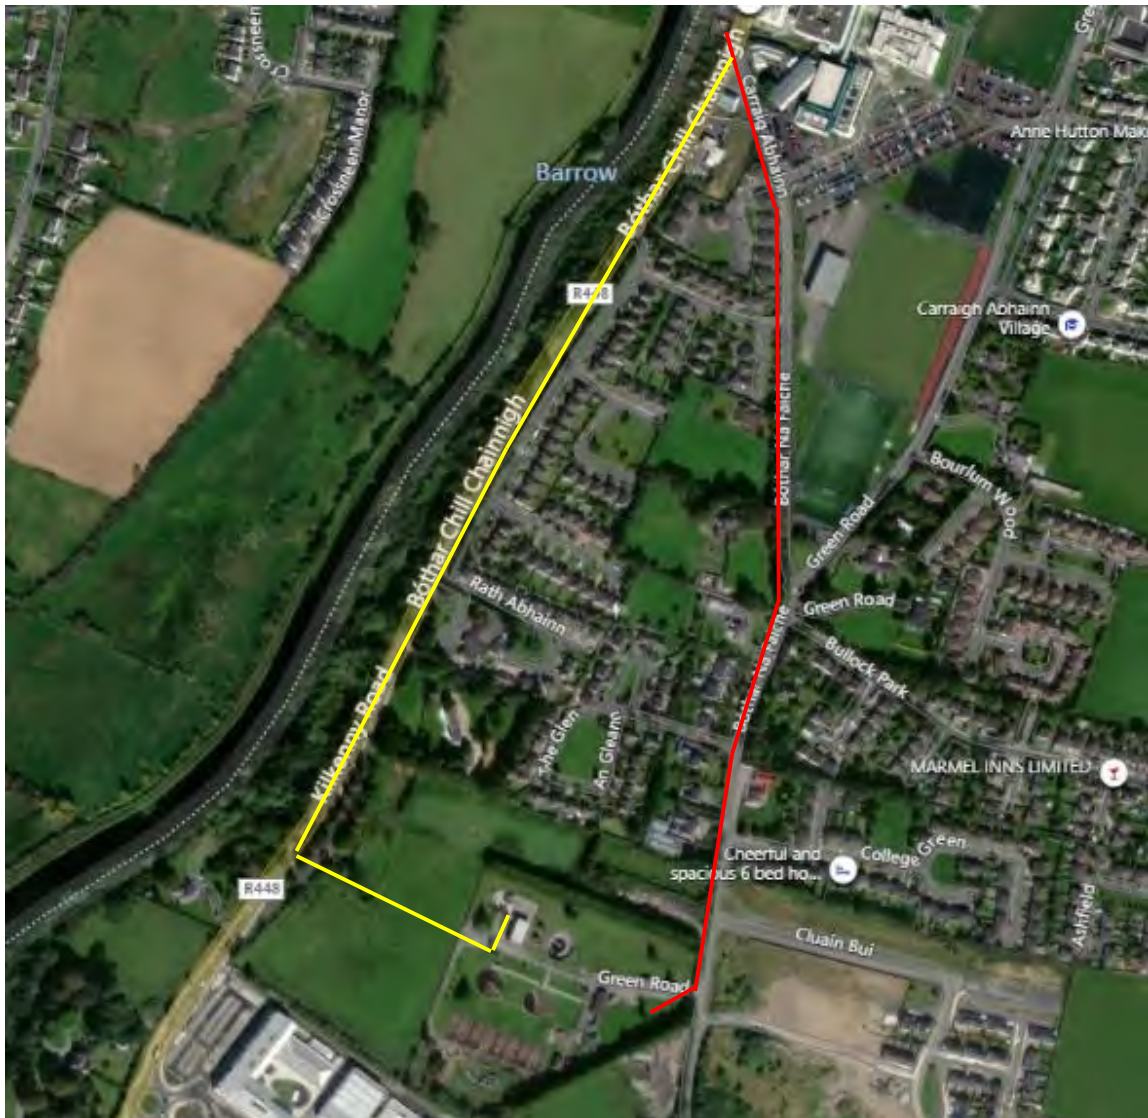
Figure 1 shows the two options for the route of the rising main pipe between Mortarstown Waste Water Treatment Plant and Kilkenny Road Pumping Station. Option 1 is shown in red and runs from the treatment plant, north along the western side of the Green Road, past Carlow Institute of Technology, and crosses under the R448 Kilkenny Road into the pumping station. This option is 950m in length.

Option 2 is for the outfall pipe to run north-west from Mortarstown Waste Water Treatment Plant, then north along the eastern side of the R448, then crossing under the R448 road into the pumping station. This option is 1,023m in length.

**Figure 1** - aerial view of Mortarstown Waste Water Treatment Plant showing two options for route of Rising Main Pipe  
Option 1 in Red (950m), Option 2 in Yellow (1023m)

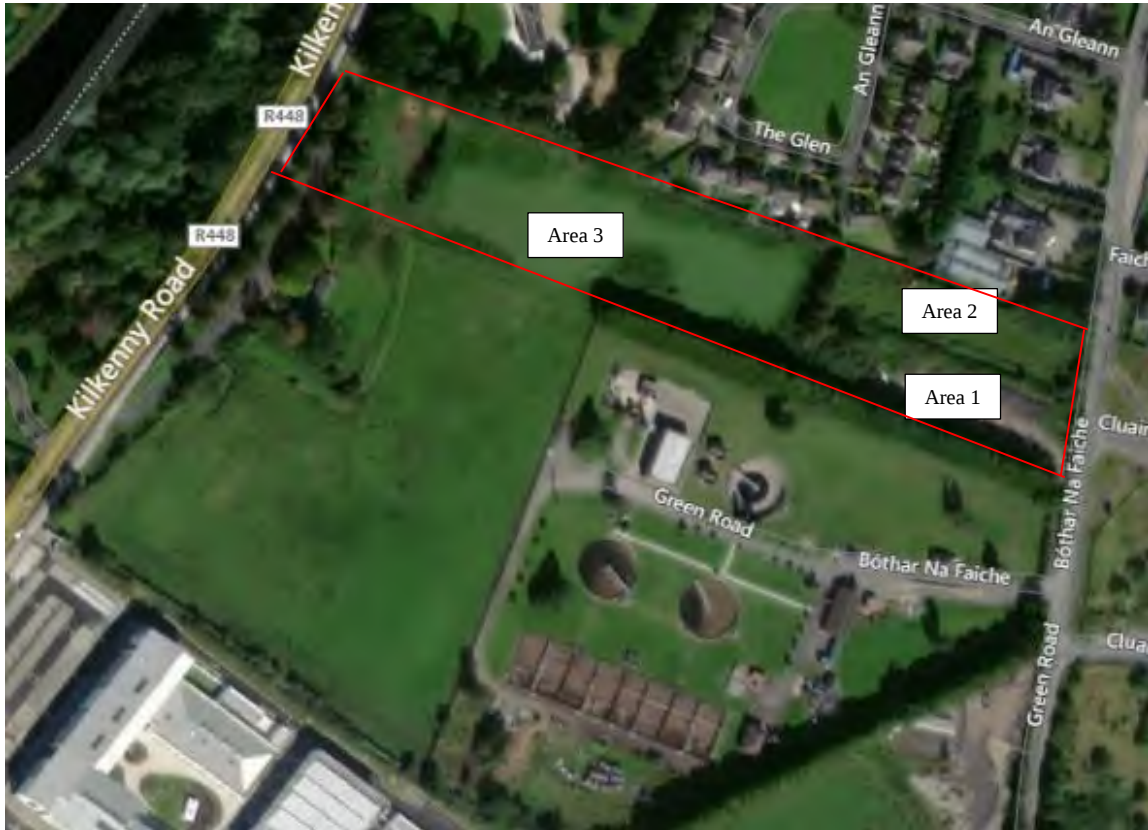
**Figure 2** – Green area to north of Mortarstown Waste Water Treatment Plant (outlined in red).

The green area to the north of the treatment plant is situated between the R448 regional road to the west and the Green Road to the east. The green area was subdivided into 3 separate areas. Each area was accessed via a different route. Currently there is no access points between the three areas.

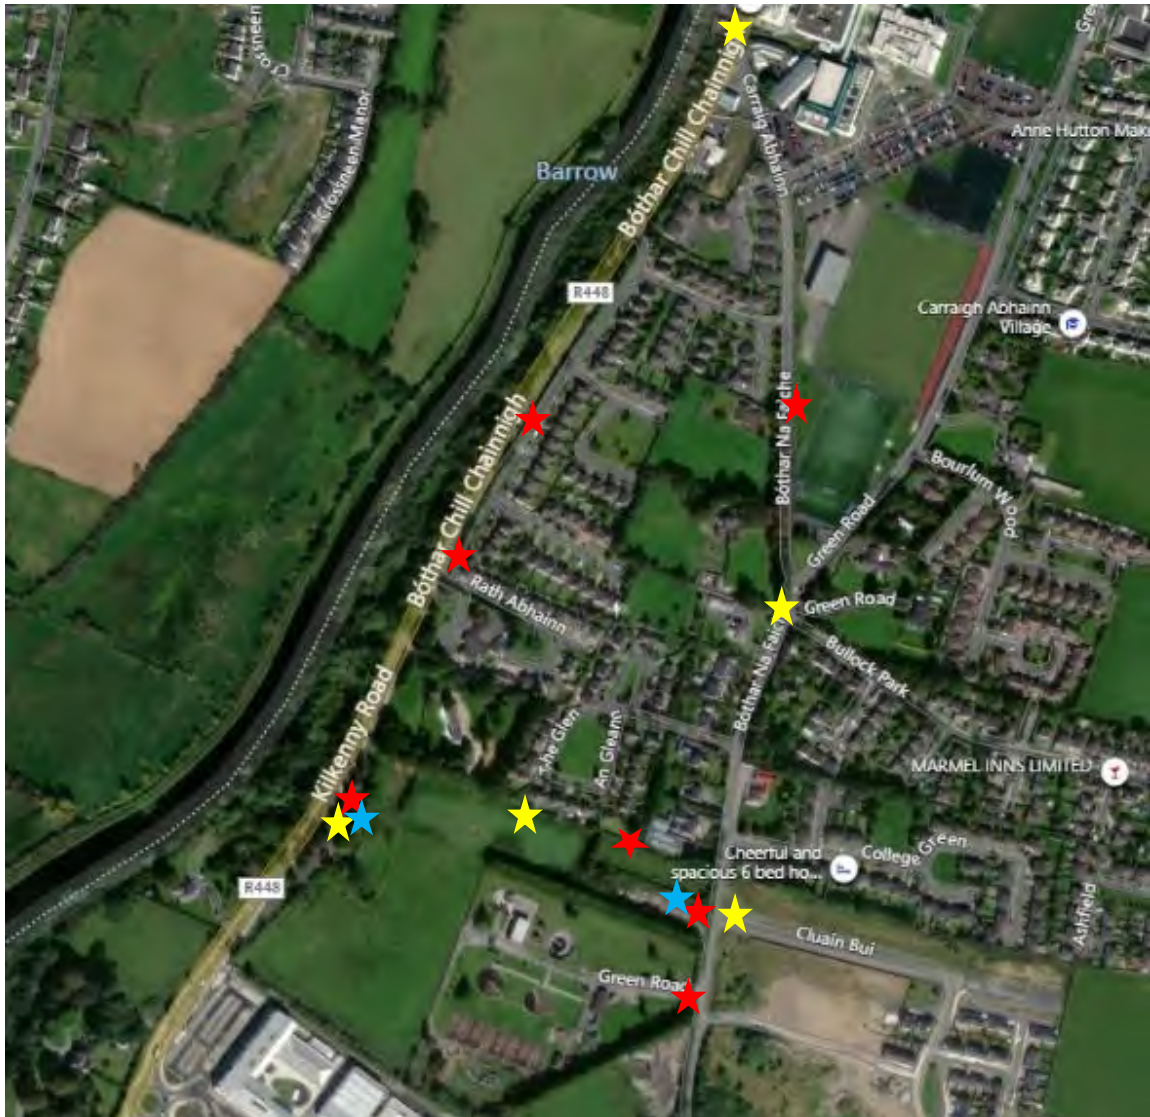
Option 2 - Individual Soprano pipistrelles were recorded foraging around two streetlights on the eastern side of the R448 between the slip lane and the Pumping station. A single Common pipistrelle was recorded foraging around trees at the entrance to the pumping station.

Option 1 – two Soprano pipistrelles were recorded foraging below floodlights at playing pitches at Carlow Institute of Technology. A single Common pipistrelle was recorded foraging at the roundabout to the east of the college. A single Common pipistrelle was recorded at the entrance to a new housing estate on the Green Road.

Two Soprano pipistrelles and two Brown long-eared bats were recorded foraging on the entrance lane to Area 1 which opens off the Green Road just north of the entrance to the treatment plant. Several Soprano pipistrelles were recorded foraging along the length of the northern treeline in Area 2.

Both Common and Soprano pipistrelles were recorded foraging along the slip lane off the R448. The entrance to Area 3 is situated on this slip lane. A single Brown long-eared bat was recorded foraging at the entrance gate. Two Common pipistrelles were recorded foraging along the northern treeline in Area 1.

**Figure 3** – showing areas where bats were detected during bat detector surveys  
 Red Star = Soprano pipistrelle, Yellow star = Common pipistrelle, Blue = Brown Long-eared

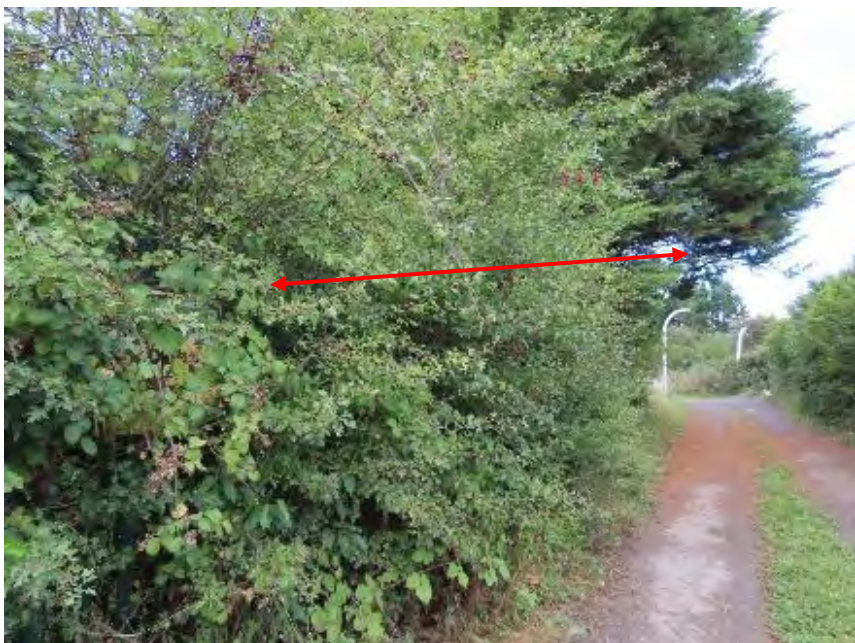
**Photo 2** – showing location on entrance to Area 1 where Brown long-eared bats and Soprano pipistrelles were recorded foraging

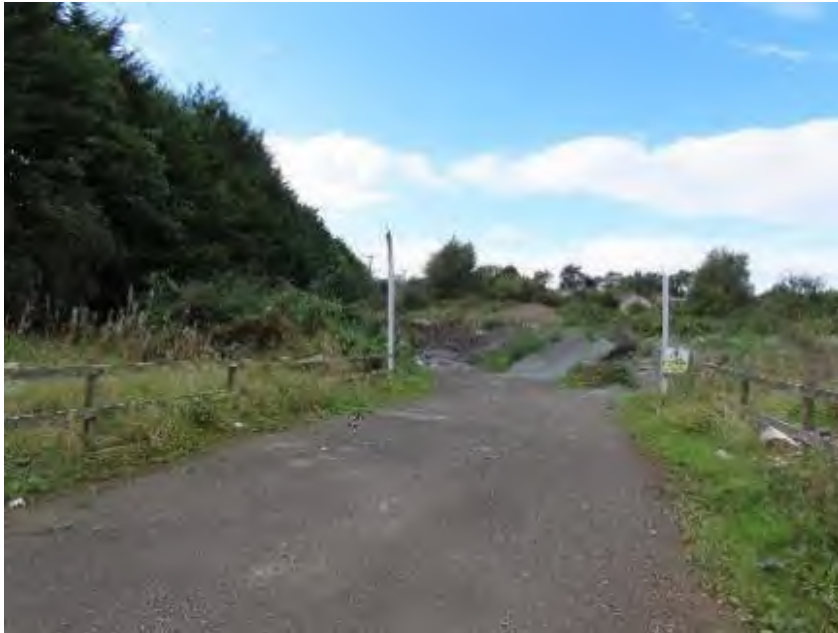
Area 1 is used by Carlow County Council to dump rubble and waste tarmac. Access to this area is via a laneway opening from the Green Road to the north of the entrance to the treatment plant. This area is very overgrown. The only invasive species present is Buddleia. There are 4 small Buddleia plants present in this area. No Japanese knotweed was recorded.

**Photo 3** - Area 1 used by Carlow County Council to dump rubble and fill

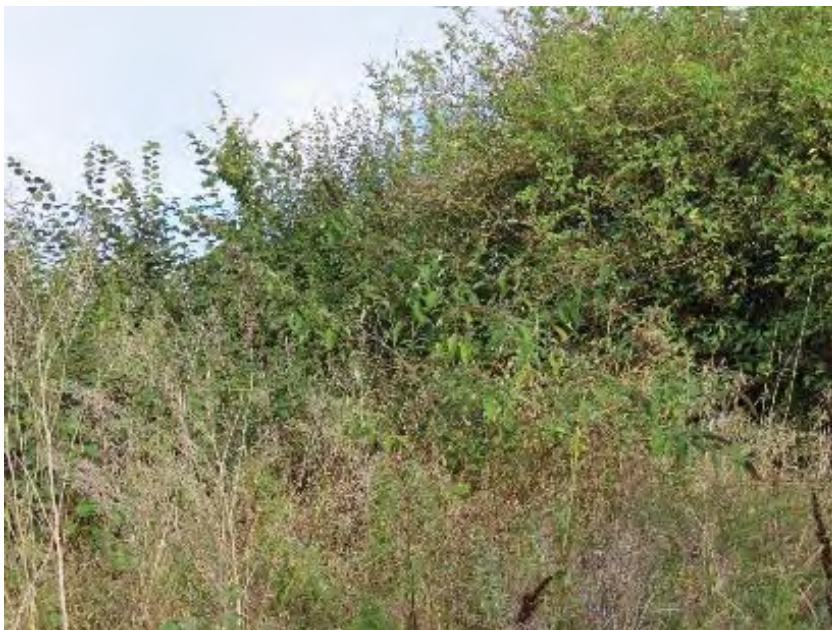
**Photo 8** – buddleia plants growing in Area 1

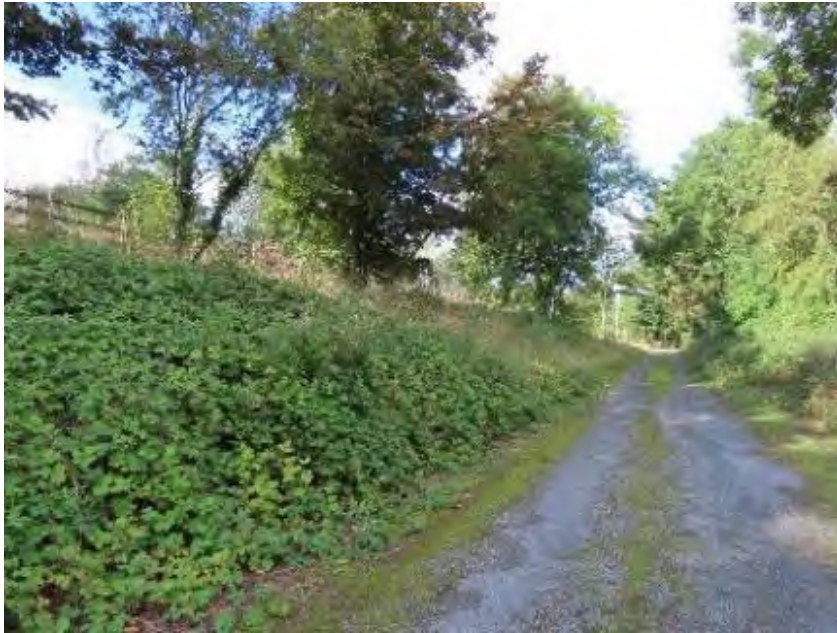
Area 3 was accessed via a gate on the slip road off the R448. There is a large area of winter heliotrope on the western side of the slip road on the bank sloping down from the R448. This area measures c. 20 x 15m. There is also numerous plants of Old man's beard growing on the hedgerow on the eastern side of the slip lane. There are no invasive species within Area 3. This section is currently being grazed by travellers' horses.

**Photo 9** – large area of Winter heliotrope on western side of sliplane opposite entrance to Area 3

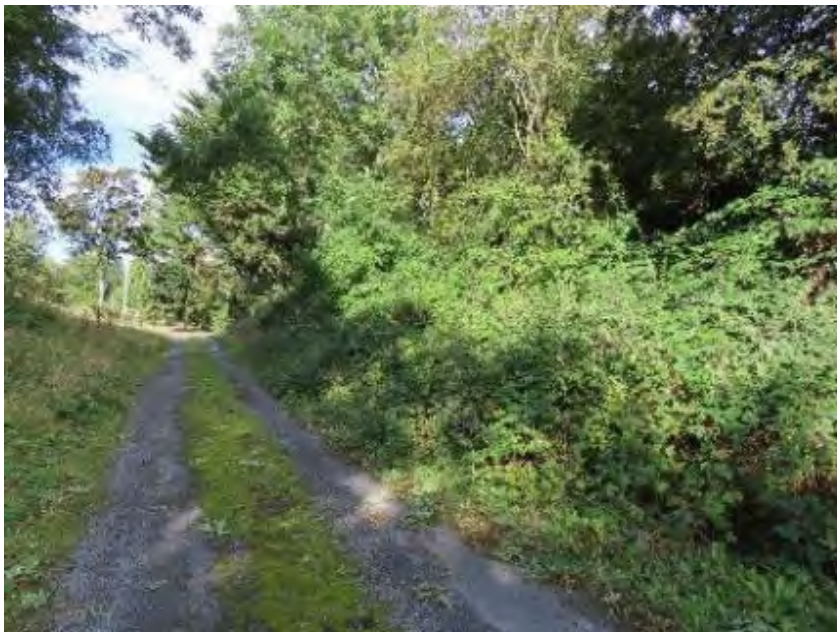
**Photo 10** – Old Mans' beard growing in hedgerow on eastern side of slip lane

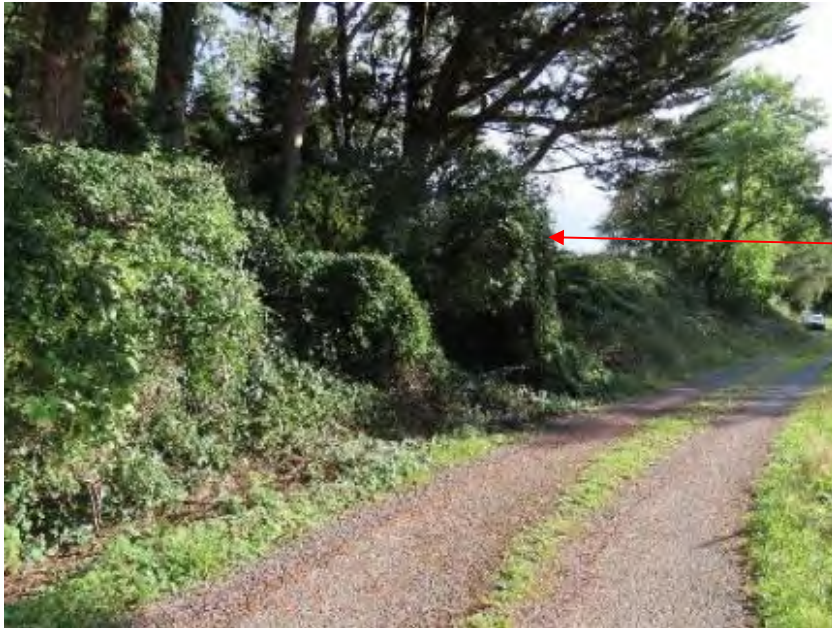
**Photo 11**– Old Mans’ beard growing in hedgerow on eastern side of slip lane

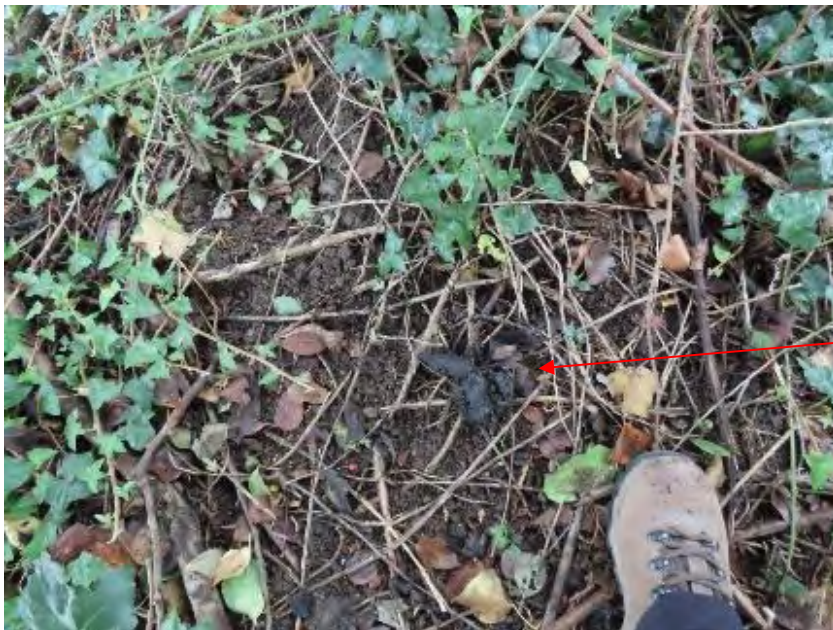
A lot of badger activity in the form of trails and latrines was recorded crossing the mature hedgerow between Area 3 and Area 2. Area 2 was accessed through the mature hedgerow between Area 2 and Area 3. There is a high wooden gateway on the northern side of Area 2 but this was locked. Numerous badger trails were recorded throughout Area 2, with several trails leading into an area on dense brambles on the southern side of Area 2.

**Photo 22** – badger latrine on hedgerow bank

Further surveys should be conducted during the winter months of 2021/2022 in Area 2 to establish if there is a badger sett in the area under brambles.

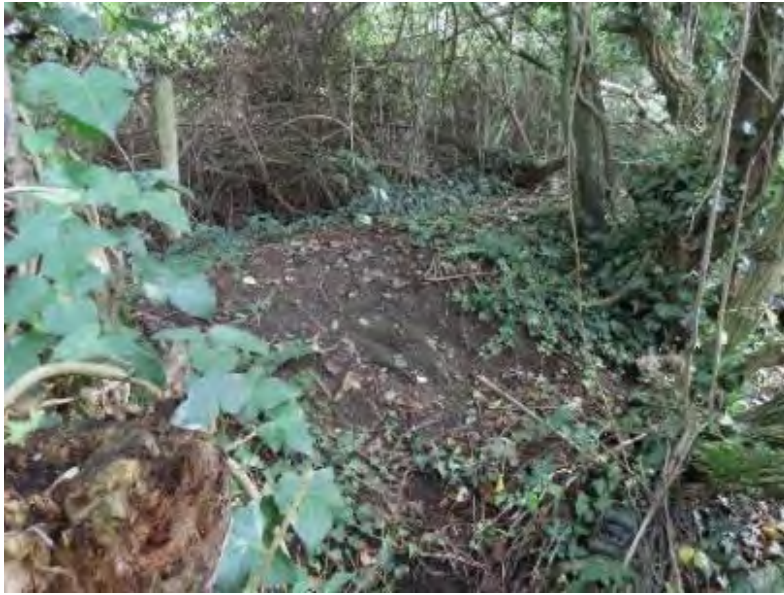
**Photo 23** – badger track over earthen bank of hedgerow

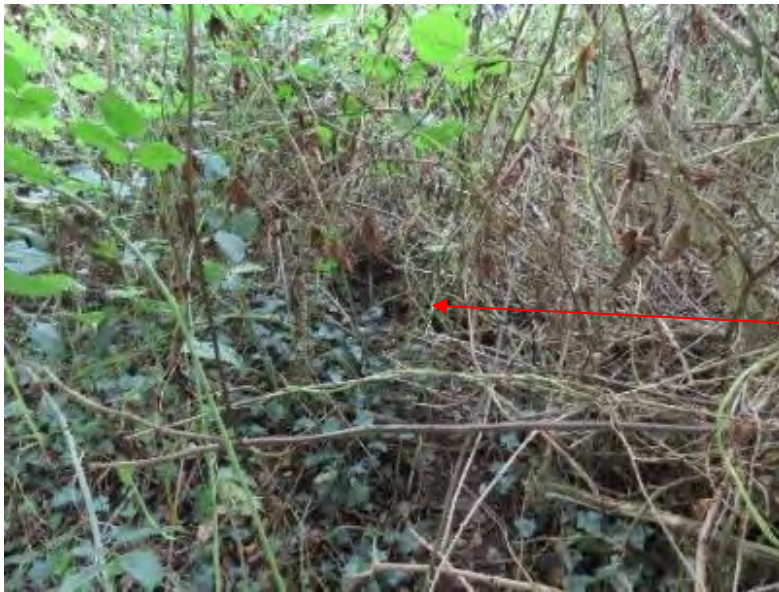
**Photo 24** – badger trail through brambles leading into Area 2

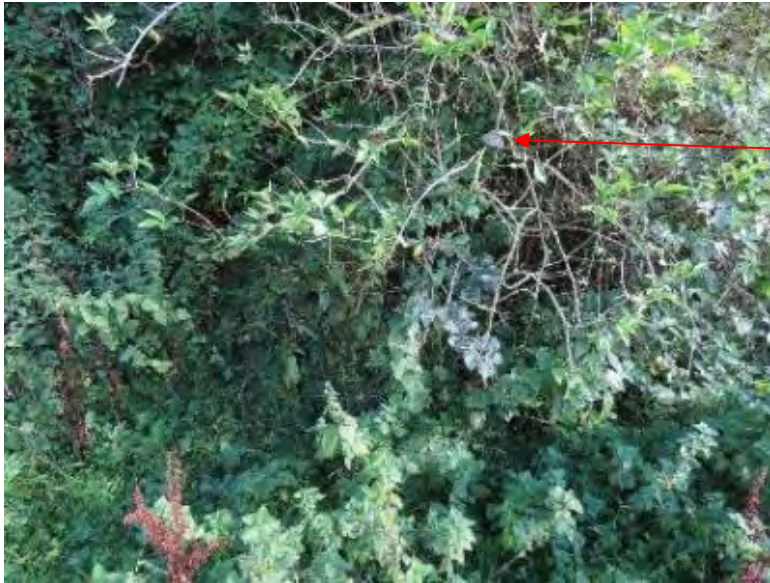
**Photo 27** – Microphone of Songmeter detector on branch of elder tree

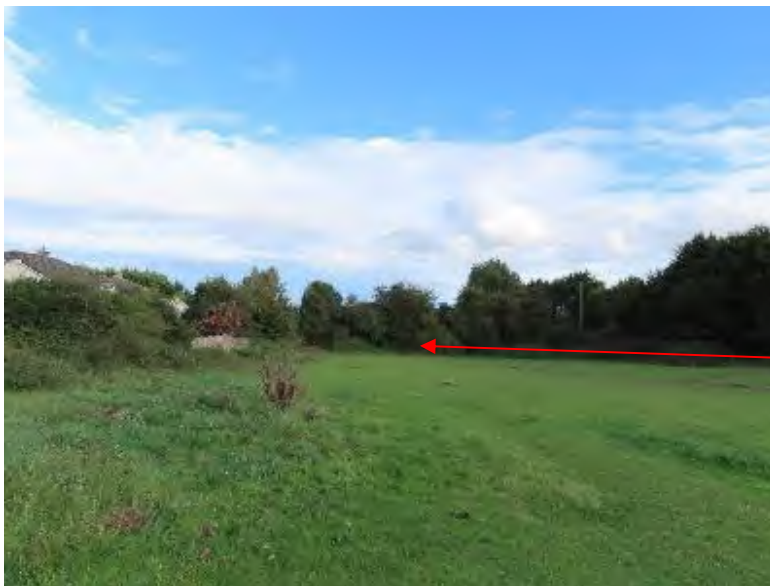
**Photo 28** – showing position of Songmeter on mature hedgerow between Area 3 and Area 2

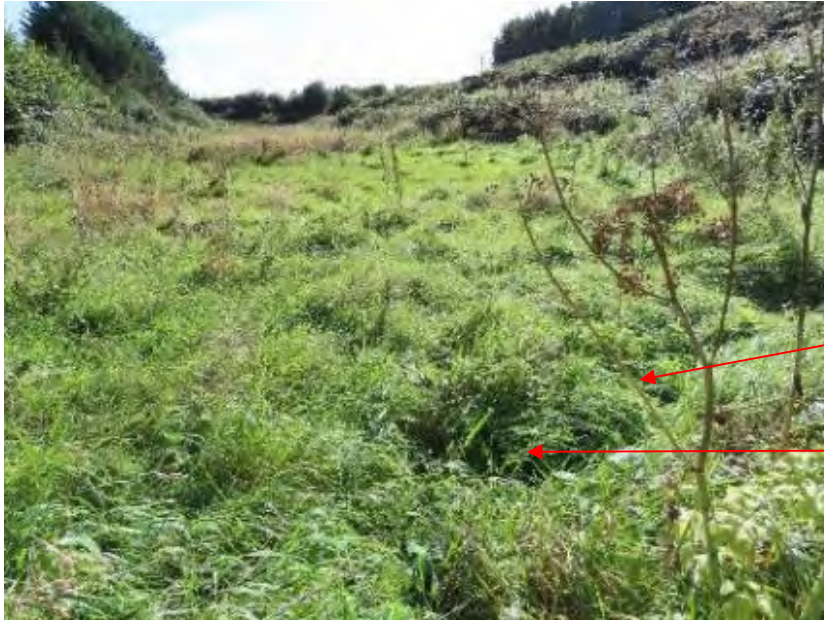
**Photo 29** – Area 2 is largely overgrown with rank grassland and brambles encroaching from all boundaries. Badger trail in grass indicated

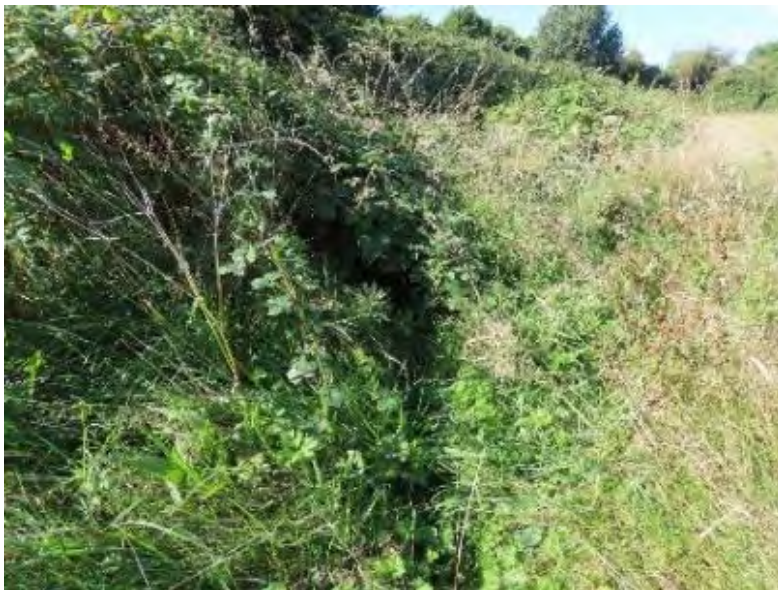
**Photo 36** – badger trails into brambles on southern boundary

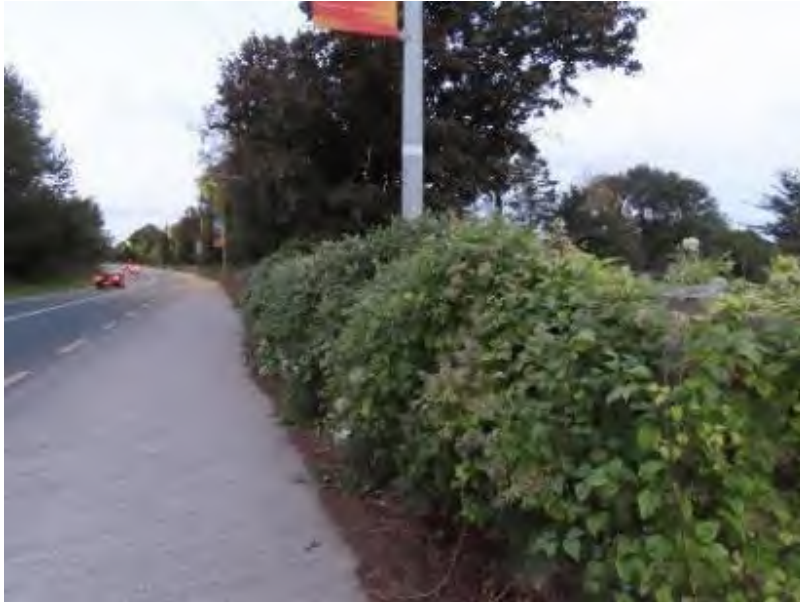
**Photo 37** – point where rising main will enter on eastern side of R448 Kilkenny Road. Old man's beard growing on wooden fence

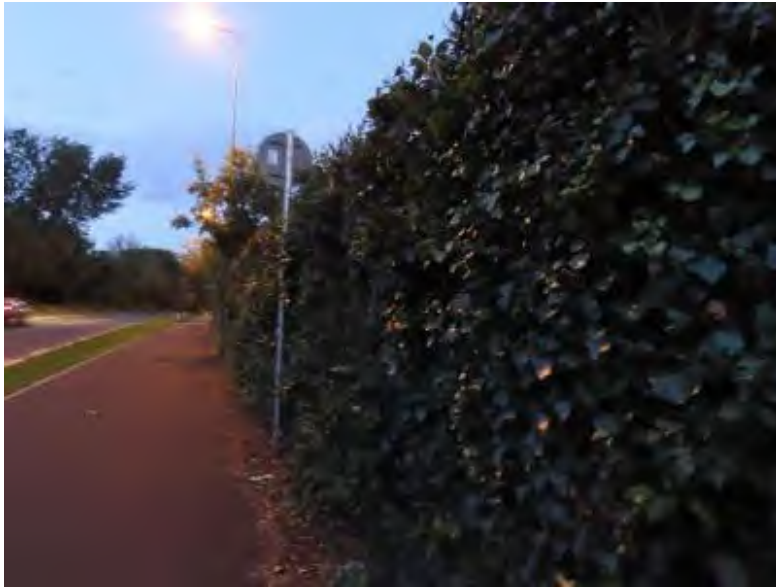
**Photo 39** – Streetlight on eastern side of R448 where Soprano pipistrlle bats were recorded foraging

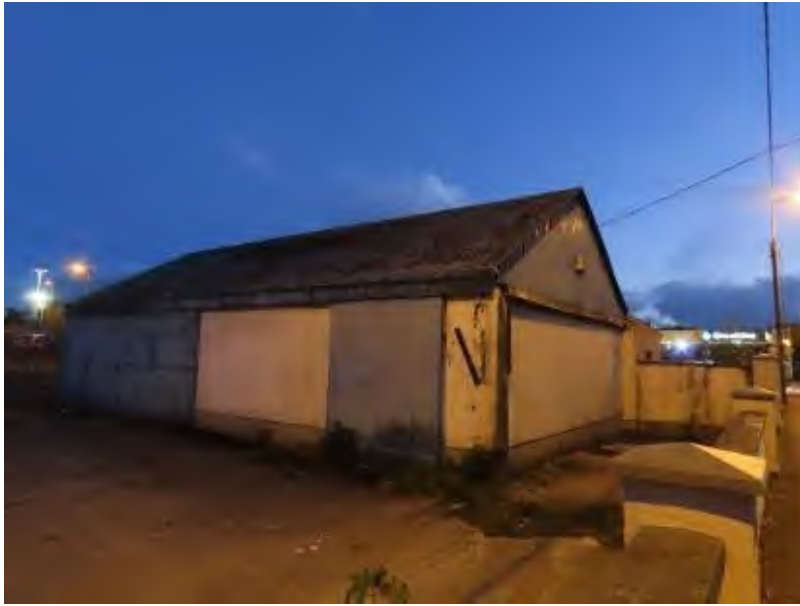
**Photo 41** – potential bat roost on eastern side of R448 at roundabout. No bats were recorded emerging from shed

Construction work for the proposed routes of the rising mains pipe does not require a derogation licence from the National Parks and Wildlife Service. No bat roosts were recorded on site or adjacent to the site.

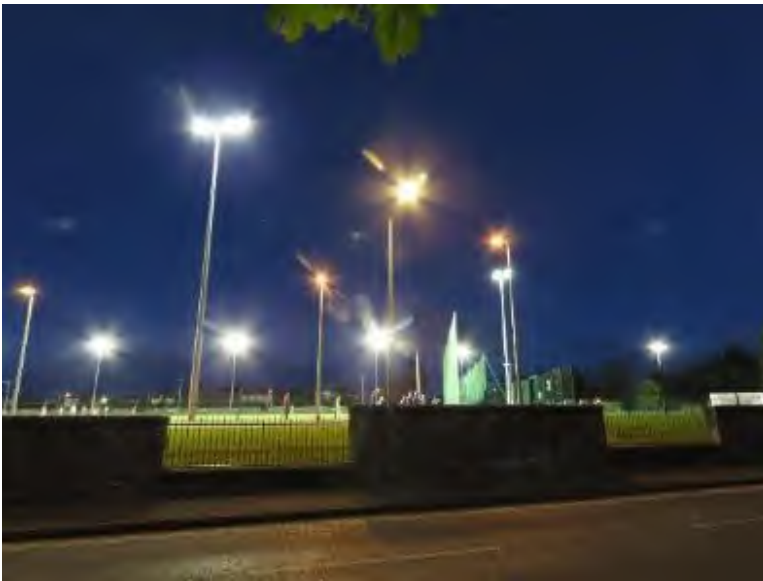
**Photo 44** – floodlights at Carlow IT playing fields . Soprano pipistrelle recorded foraging under floodlights

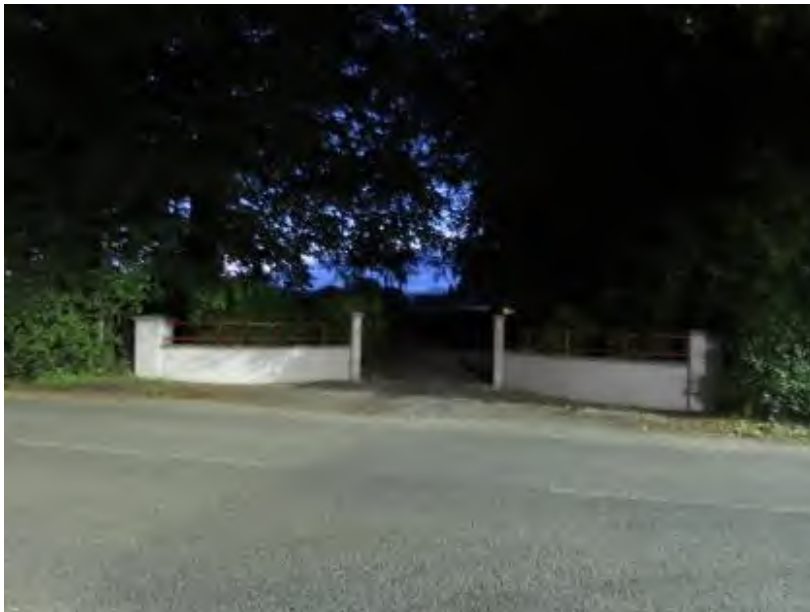
**Photo 46** – Dark entrance on western side of green road. Common pipistrelle recorded foraging here. There is a stand of winter heliotrope on both sides of entrance gates

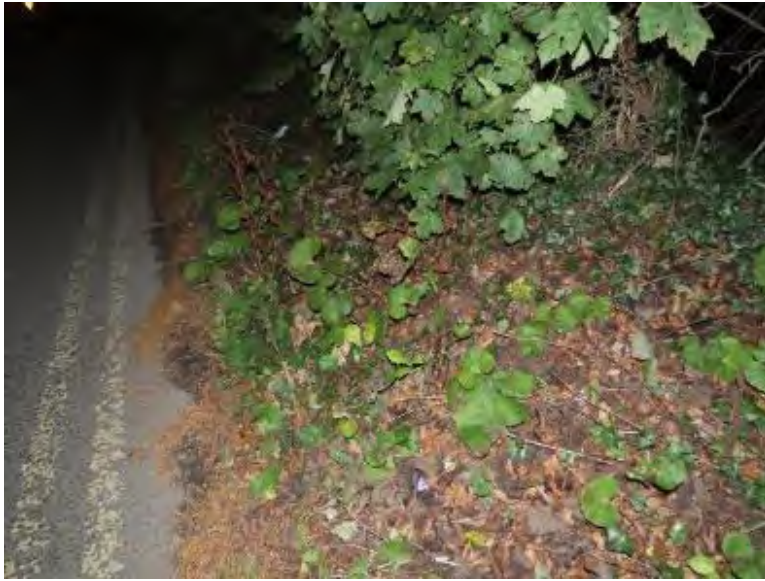
No obvious potential roosts were noted along the routes of the rising main. Winter heliotrope was recorded at the entrance to a house opposite the playing pitches at Carlow IT.

**Photo 47** – winter heliotrope at entrance gates
