## **Appendix 5.9. Bat Surveys Report, 2025b**

**BAT SURVEYS OF BUILDINGS AND TREES WITH  
POTENTIAL ROOST FEATURES ON SITE OF  
PROPOSED EXTENSION AREA AND ALONG  
ROUTE OF PIPELINE AT MORTARSTOWN WASTE  
WATER TREATMENT PLANT IN CARLOW**

**July 2025**

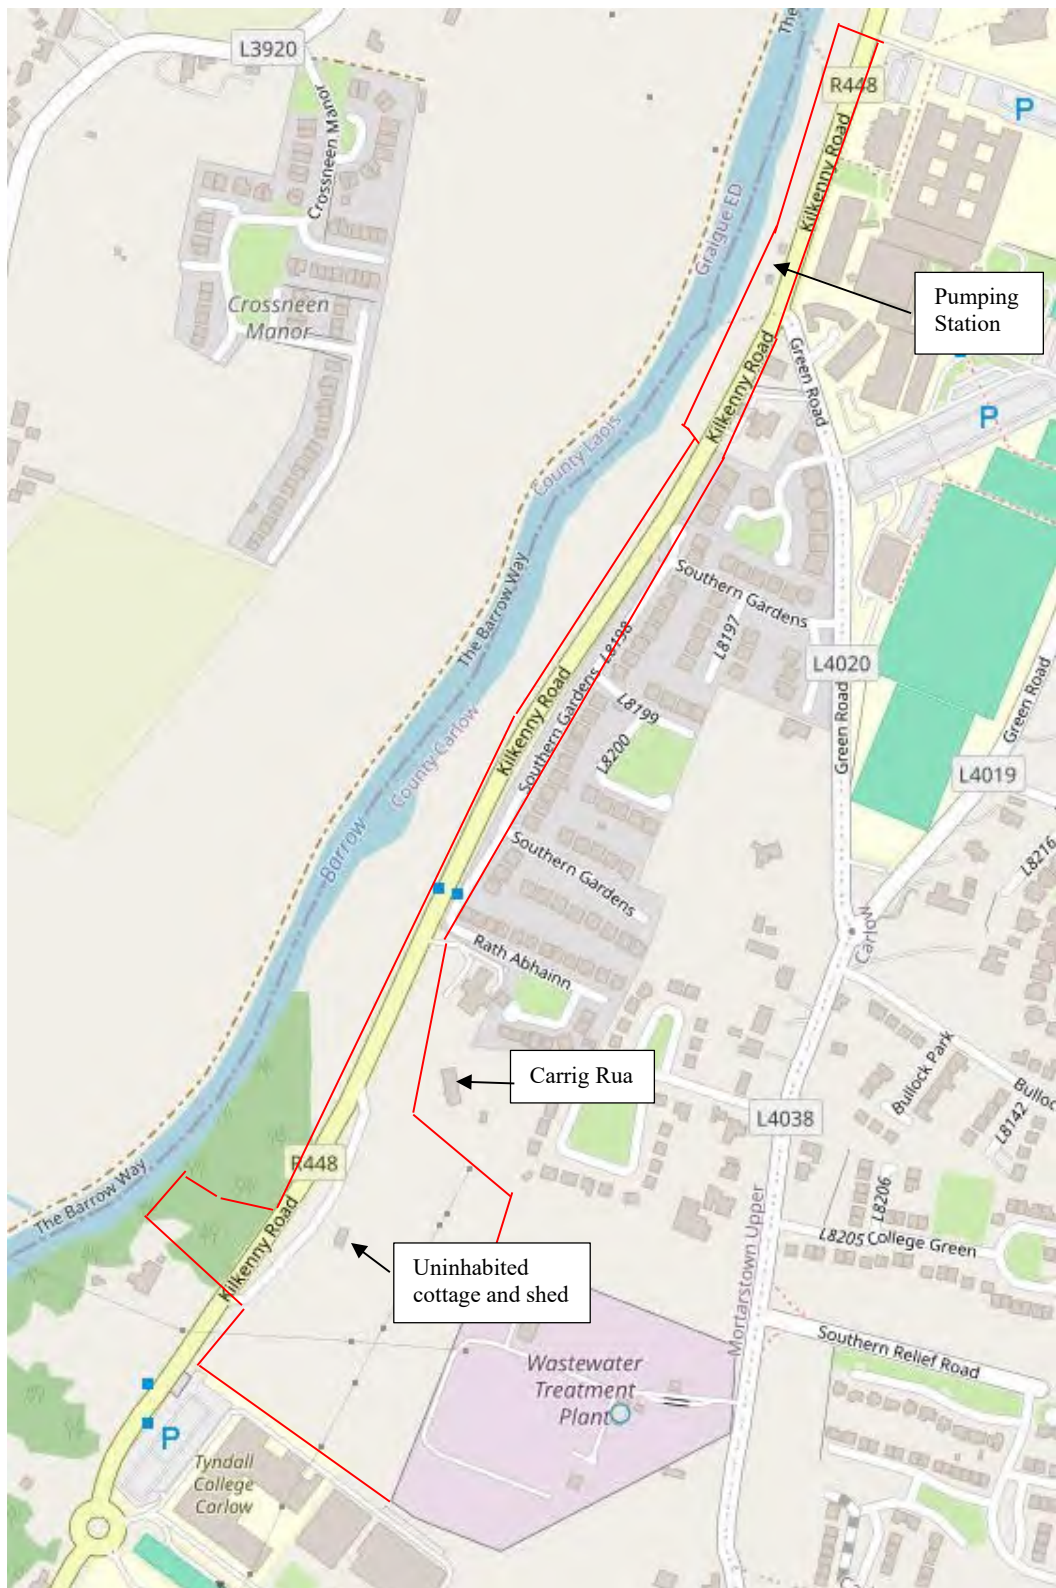
**Figure 1** – showing red line boundary of proposed extension area and pipe line

Figure 1 shows the approximate red line boundary of the extension to the waste water treatment plant and the route of the proposed pipe line along the R448 regional road.

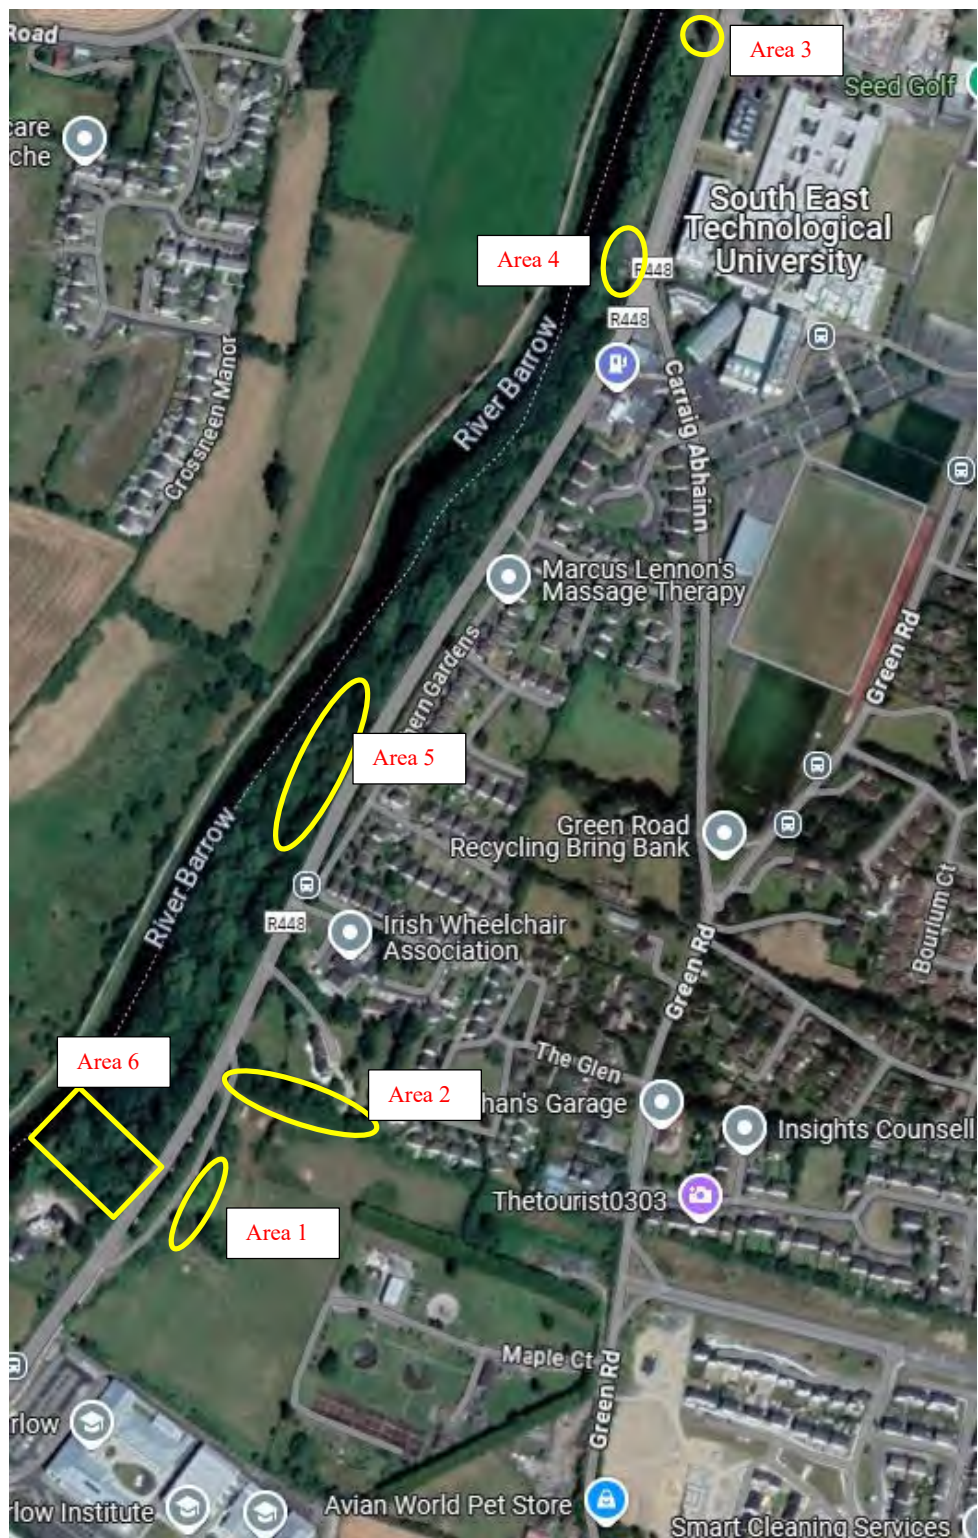
**Figure 2** – indicating areas requiring bat detector surveys

The existing outfall pipe runs from the Mortarstown plant in a north westerly direction under the R448 regional road and under a wooded area to reach the eastern bank of the River Barrow Figure 2 – Area 6.

Figure 2 is an aerial photo of the site illustrating areas where bat detector surveys were recommended.

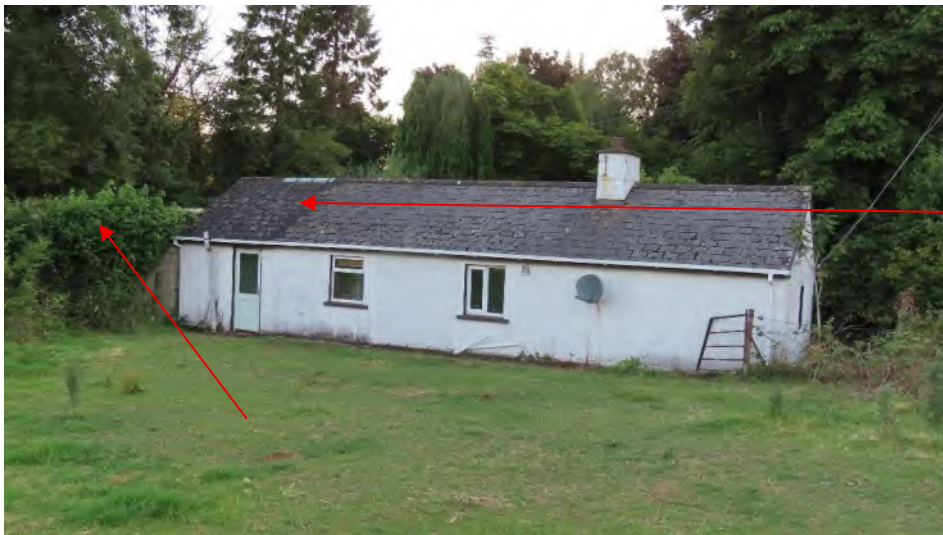
At 21.41 a single Soprano pipistrelle emerged from the rear of the shed adjoining the cottage.

At 21.49 a single Soprano pipistrelle was recorded emerging from the rear roof of the cottage.

Photo 2 – rear elevation of cottage showing approximate location of exit point from rear roof. A single Soprano pipistrelle also emerged from the rear of the adjoining shed

The cottage has been confirmed as a roost site for at least one Soprano pipistrelle bat. The slates should be removed carefully by hand. The adjoining shed is also a roost site for at least one Soprano pipistrelle bat. The roof should be removed carefully by hand. Demolition of these structures should be supervised by an ecologist

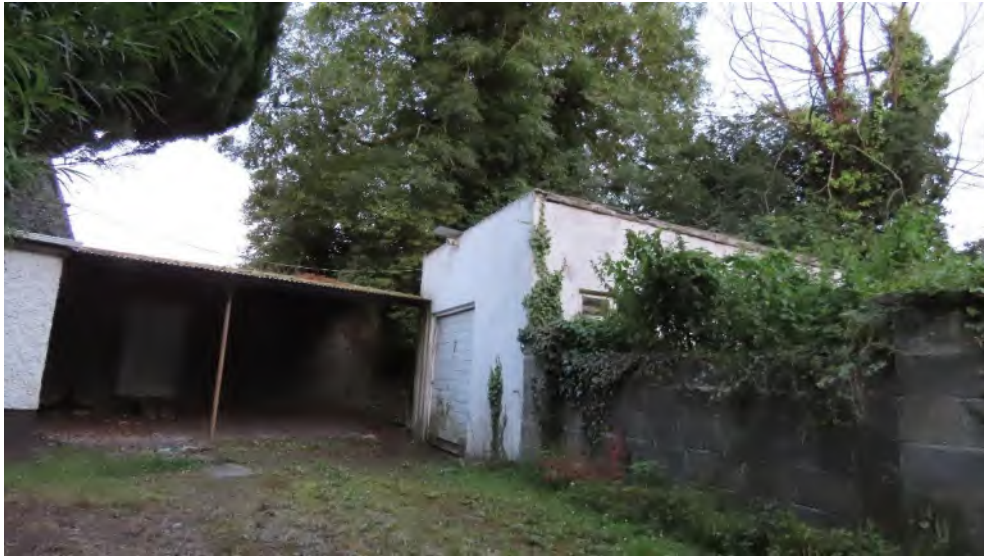
The exterior of the cottage was examined for signs of bats in the form of droppings or staining on walls, window cills and window panes. No signs of bats were recorded. There are two sheds to the south of the cottage – one attached to the southern gable of the house and the second is a free standing garage. The sheds were also surveyed internally for signs of bats. No signs of bats were recorded in either shed.

Photo 3 – shed attached to southern gable of cottage and garage to right hand side

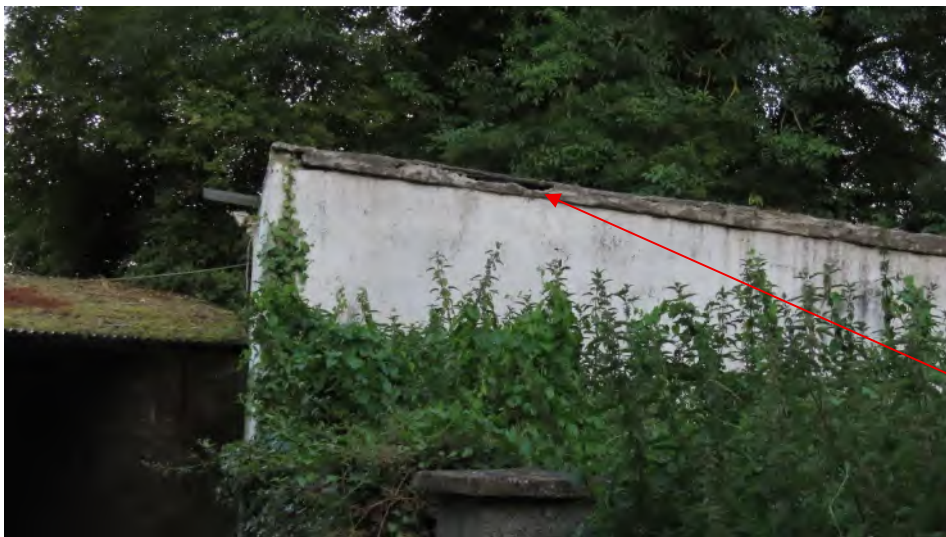
Photo 4 – showing potential roost feature at roof level on garage

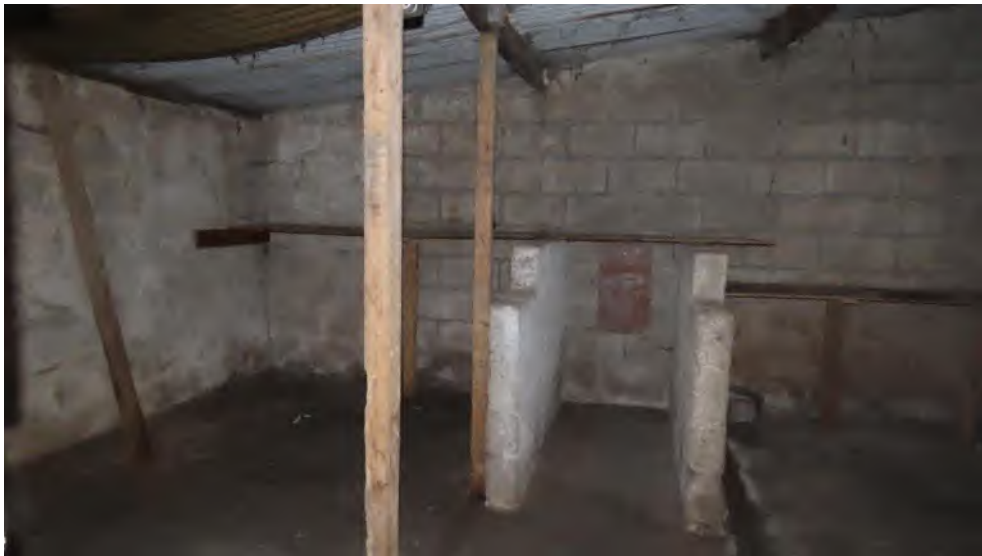
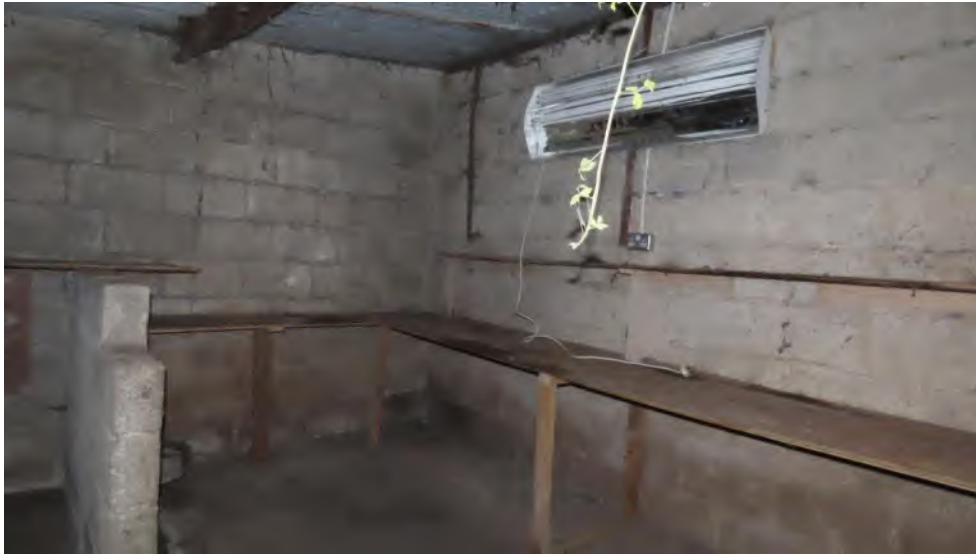
The sheds were checked intermittently for bat activity inside the sheds. No bats were recorded foraging in either of the sheds.

Photo 8 – interior of shed attached to cottage

Photo 9 – interior of shed attached to cottage

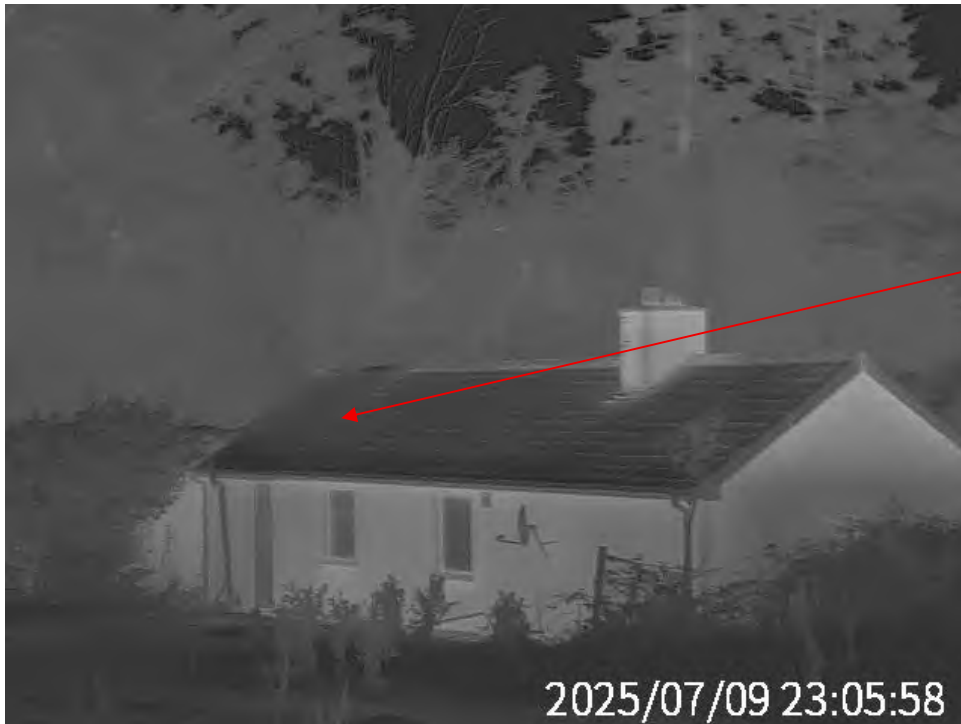
Photo 11 – thermal photo of rear of cottage. The point where single Soprano pipistrelle emerged from rear roof is indicated

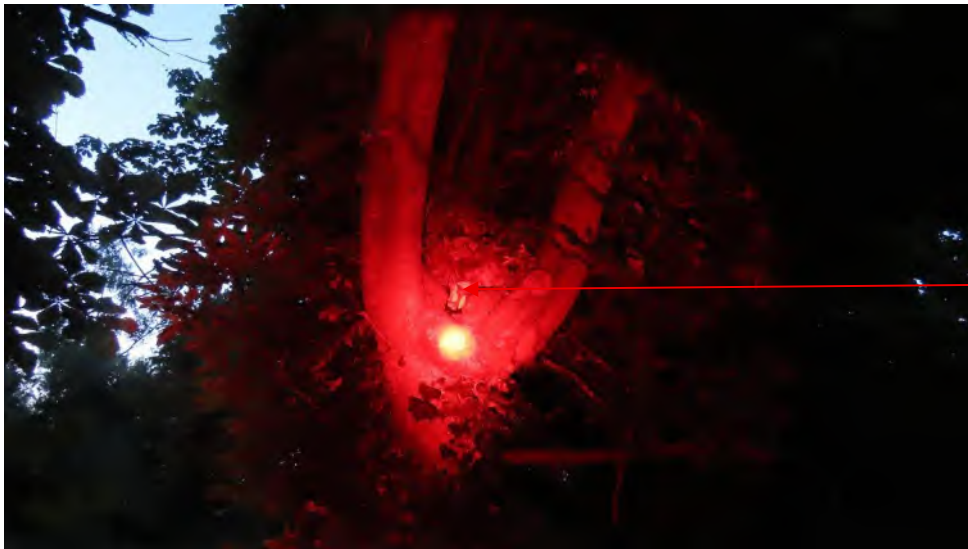
At 22.41 2 Brown long-eared bats emerged from one of the Horsechestnut trees at the front of the cottage and remained foraging in the vicinity of the trees and along the tree-lined lane to the front of the cottage.

Photo 12 – crevice in Horsechestnut tree adjacent to front gate from which 2 Brown long eared bats likely emerged

At least one of the mature Horse chesnut trees at the front of the cottage is highly likely to be a roost site for Brown long-eared bats. It was difficult to pin point the exact location of the roost feature due to heavy foliage.

Felling of these trees should be sectional and supervised by an ecologist.

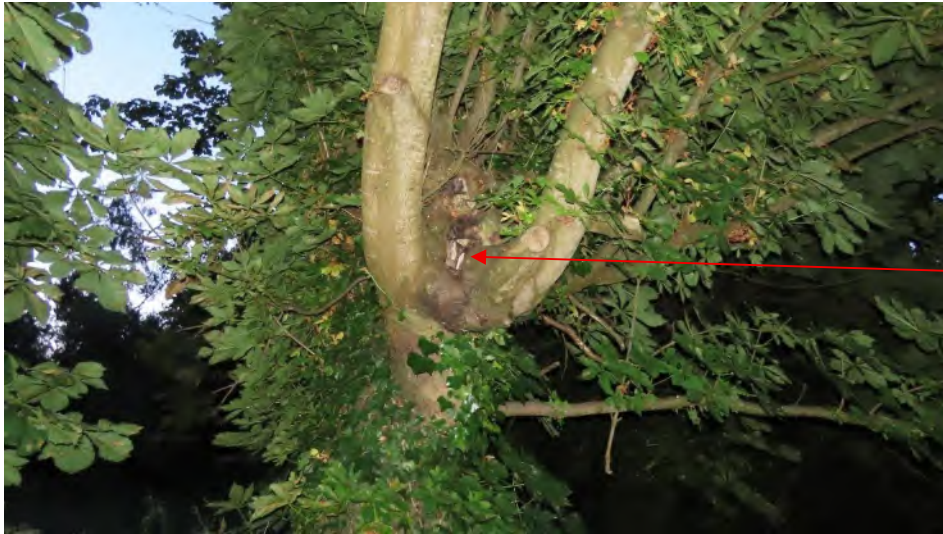
Photo 13 – crevice in Horsechestnut tree adjacent to front gate from which 2 Brown long eared bats likely emerged

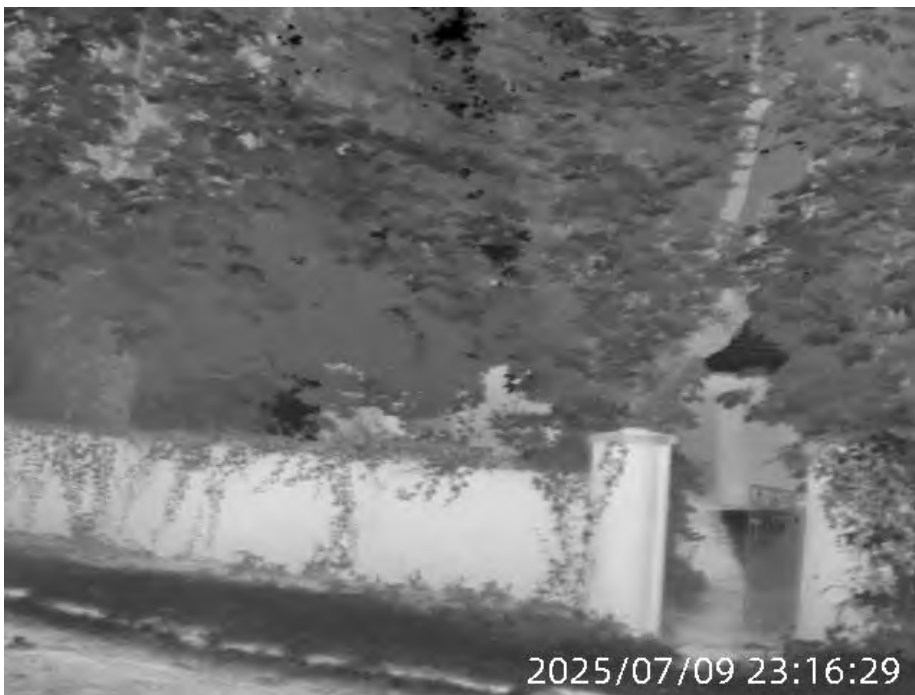
Soprano pipistrelles were recorded intermittently in the garden of the cottage for the duration of the survey. Brown long-eared bats were also recorded intermittently in the vicinity of the Horse chestnut trees.

Photo 14 – thermal photo of Horsechestnut trees at gateway to cottage. Brown long-eared bats recorded foraging in the vicinity of these trees

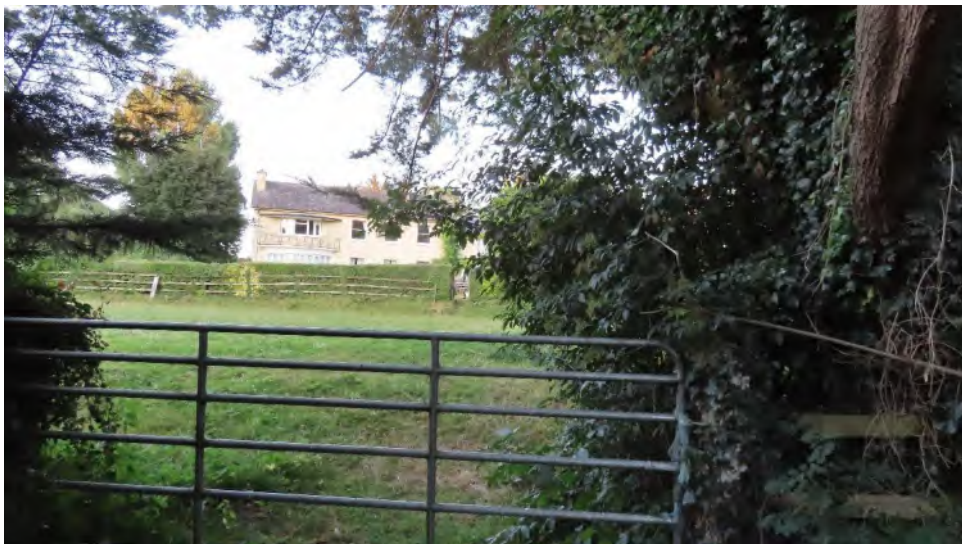
No bats were recorded emerging from any of the trees in the treeline. However, 6-8 soprano pipistrelles were recorded foraging over the paddock to the front of *Carrig Rua* shortly after sunset. A smaller number of Soprano pipistrelles were also recorded foraging in this position at dawn. These bats may have emerged from Carrig Rua house.

Photo 25 – paddock to front of *Carrig Rua* where 6-8 Soprano pipistrelles were recorded foraging

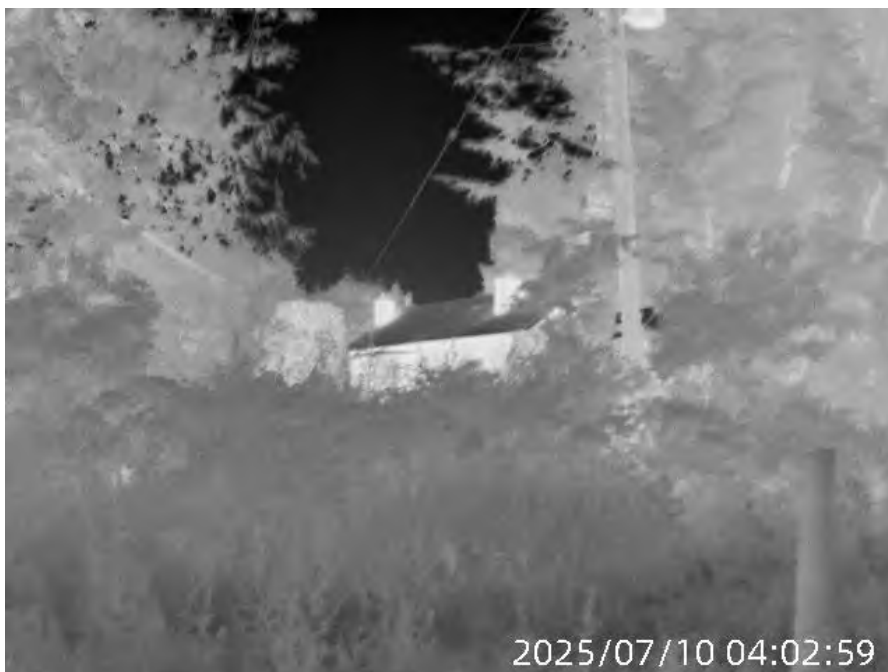
Photo 28 – *Carrig Rua* house through treeline. Several Soprano pipistrelles were recorded foraging on northern side of treeline at dawn

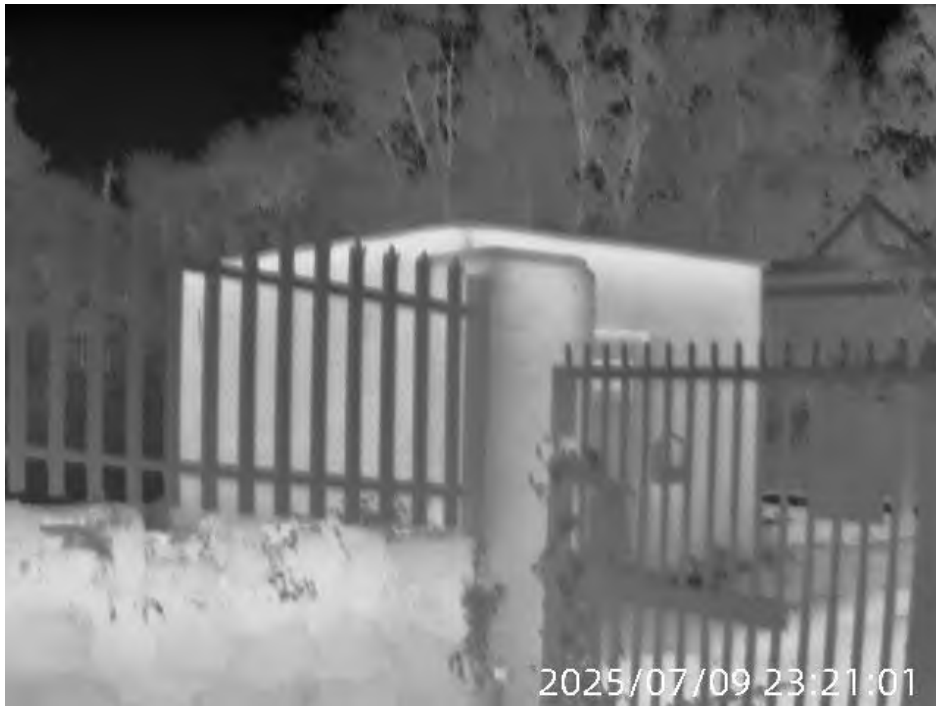
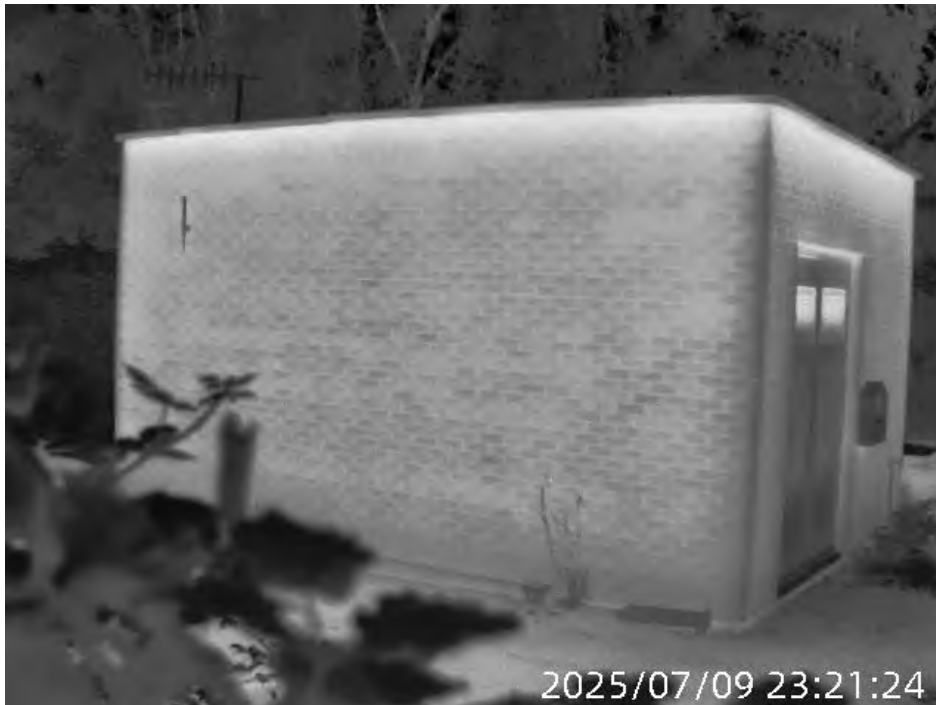
No bats were recorded returning to either of the buildings at dawn.

Photo 31 – thermal image of southernmost building at pumping station

Photo 32 – thermal image of southernmost building at pumping station

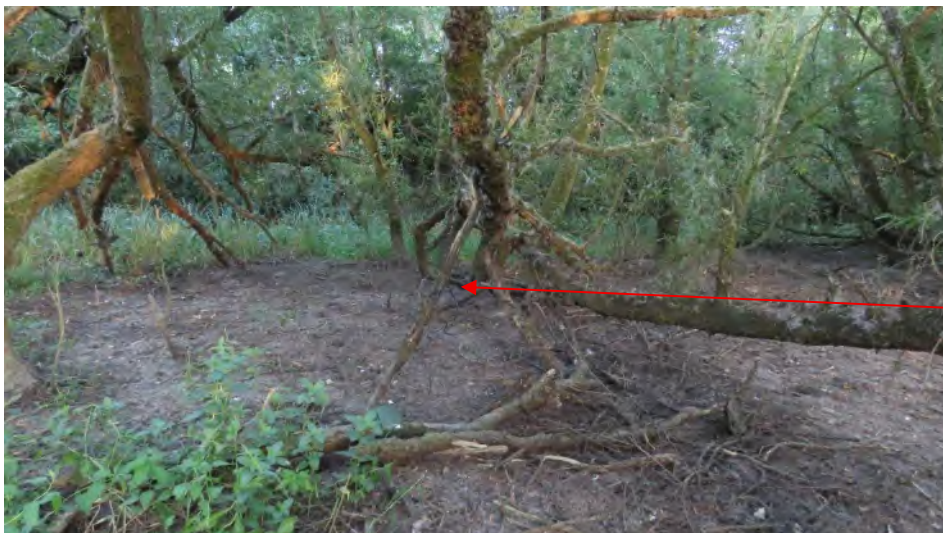
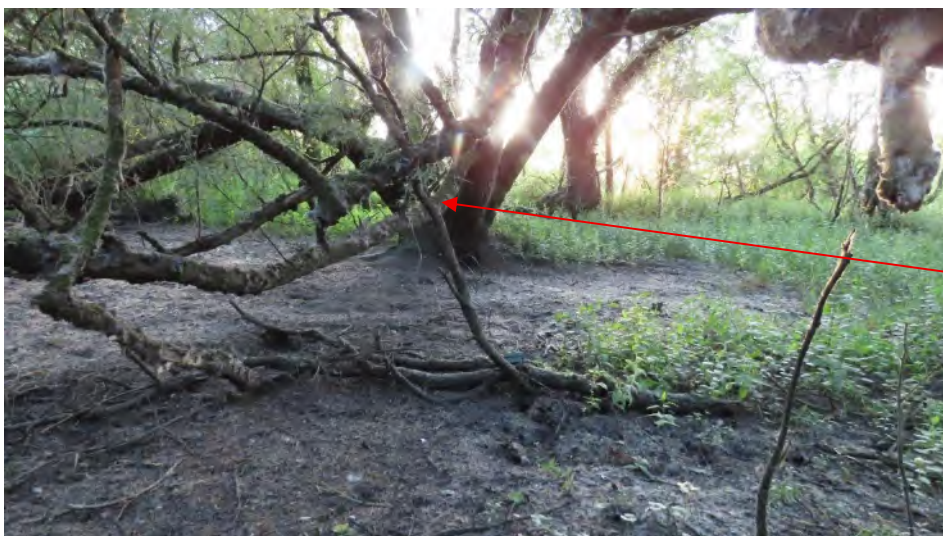
A Songmeter 4 bat detector was deployed overnight on 9<sup>th</sup>/10<sup>th</sup> July on a large willow tree in this area.

This floodplain area is an important foraging area for bats.

Photo 34 – Songmeter 4 placed overnight on willow tree in floodplain area

Photo 35 – Songmeter 4 placed overnight on willow tree in floodplain area
