**Underwater Archaeological Impact Assessment (UAIA)  
Proposed Outfall  
Mortarstown WWTP  
River Barrow, Mortarstown Upper  
Carlow Town**

**22D0069, 22R0225**

**Report Update  
March 2025**

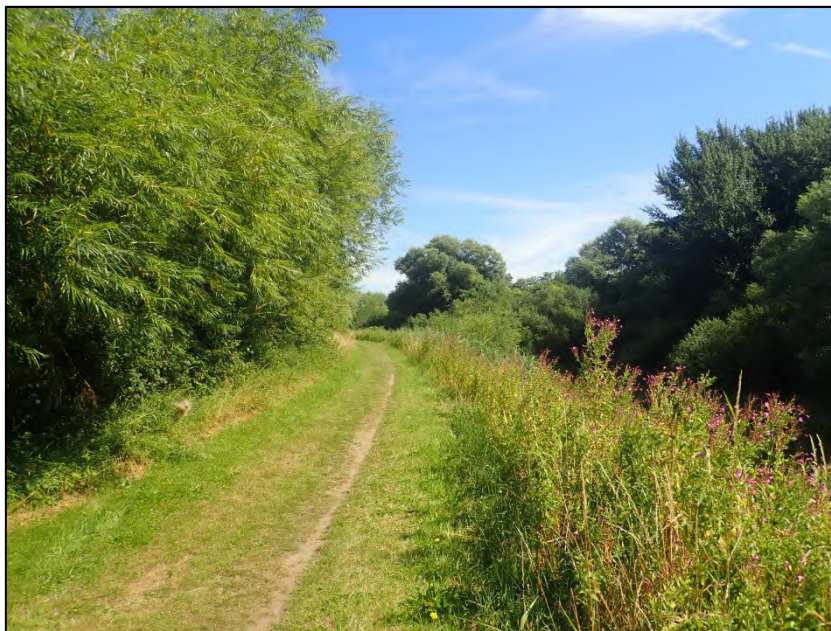
**Plate 2:** Northeast-facing (upstream) view of former tow-path located on the west side of the assessment area.

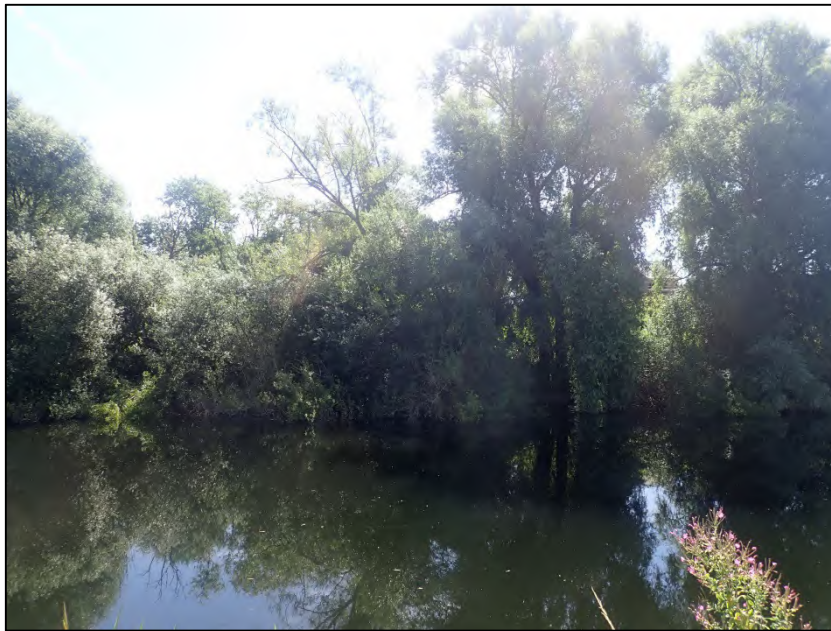
**Plate 3:** East-facing view of river assement area, showing the overgrown nature of the east bank.

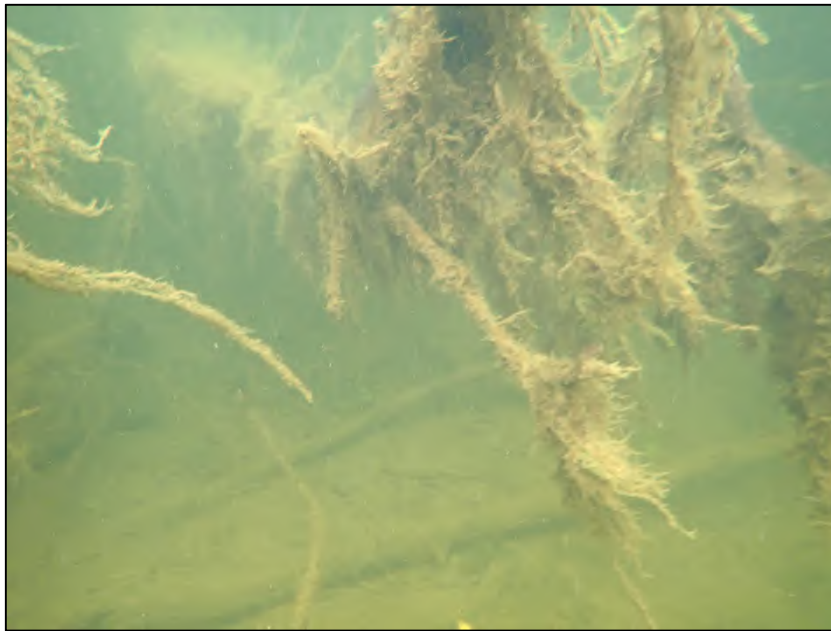
The riverbed itself is composed, in the most part, of a compact deposit rounded to sub-rounded pebbles (<40mm) with occasional small cobbles (<100mm), overlying a substratum of coarse-sand and gravel (Plates 4-5). However, the riverbed becomes less uniform in nature along the west side of the channel; where larger cobbles and small boulders are also present (Plate 6). In addition, a degree of sedimentation is also taking place, river-flow evidently being slower along this side of the waterway (Plate 7). It was also noted that discharge from the

**Plate 7:** Example shot showing degree of sedimentation present along the base of the east bank; shot taken at point close to proposed outfall location.

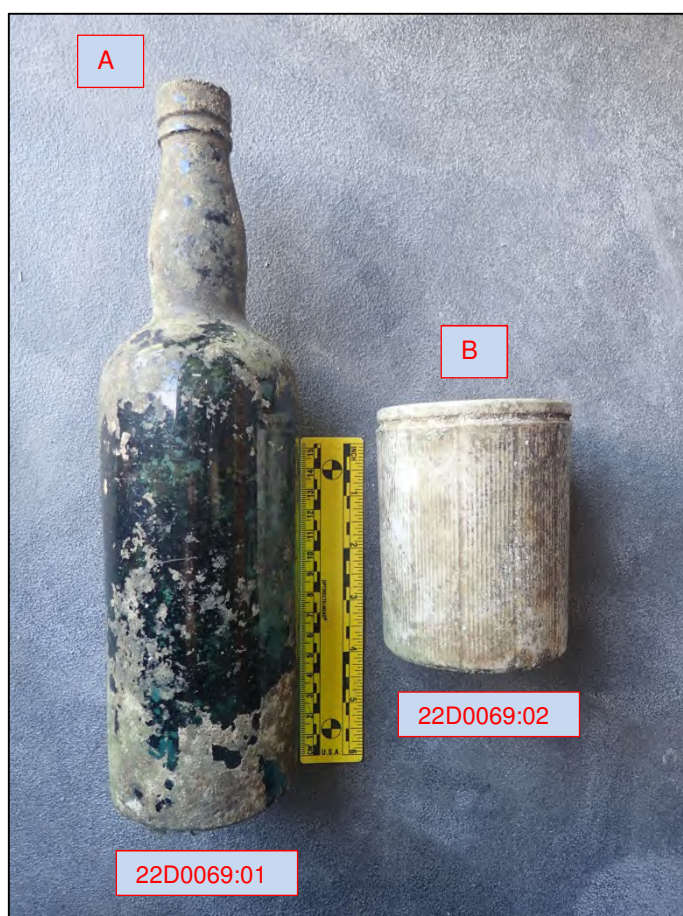
**Plate 9:** [A] Early-twentieth century (spirit) bottle and [B] Victorian stoneware preserve jar recovered as part of the underwater survey (150mm scale)
