## **APPENDIX 6-2**

## **Appendix 6-2 – Bat Survey Report**

Crumhach Wind Farm, Co.  
Sligo

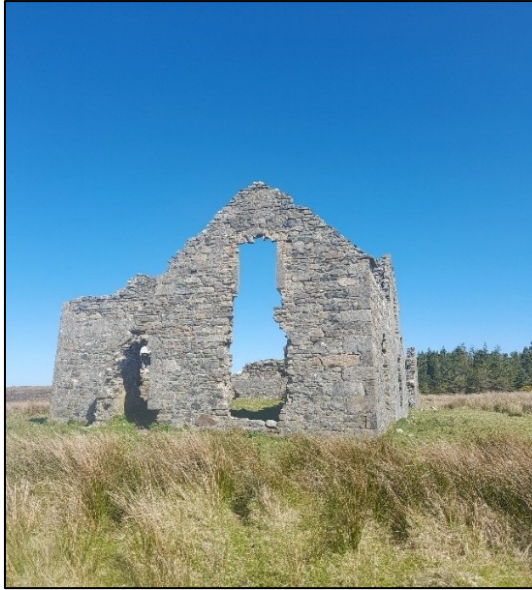
No evidence of bat use was recorded. The structure was assessed as having *Low* bat roost potential in accordance with Collins (2023).

Plate 4-17 old Stone Ruin to the east of T4.

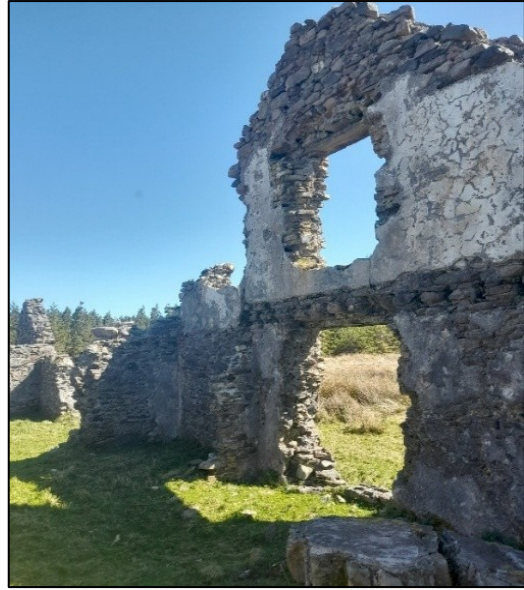
Plate 4-18 Second angle of Old stone ruin - gaps in stonework visible

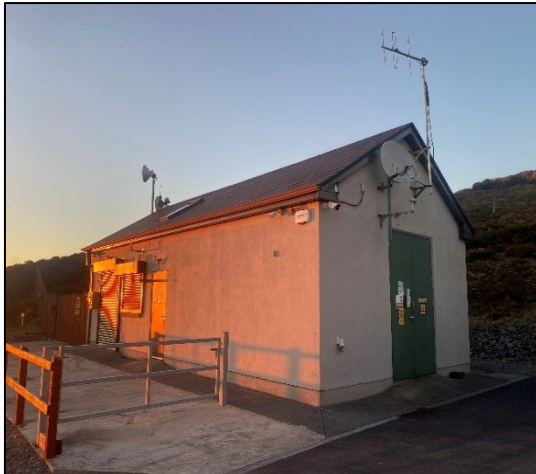
Minor features such as lifting fascia and gaps at the roof interface were noted; however, these are limited and do not provide suitable roosting conditions. The building was inspected internally and externally using a torch and endoscope. No evidence of bat use was recorded. The structure was assessed as having *Low* bat roost potential.

Plate 4-19 Exterior of Kingsmountain control building.

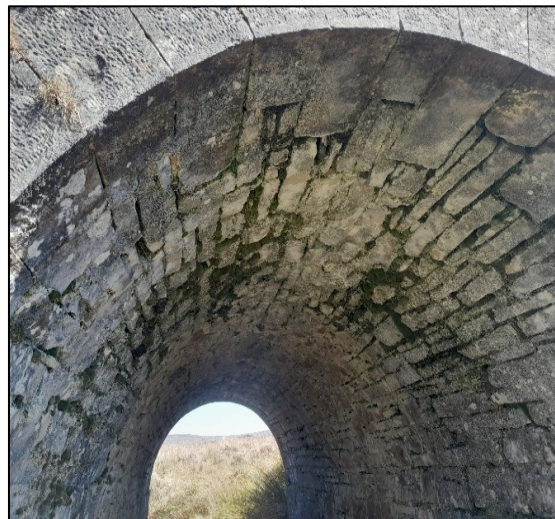
Plate 4-24 Gaps visible between the stones of Bridge 1

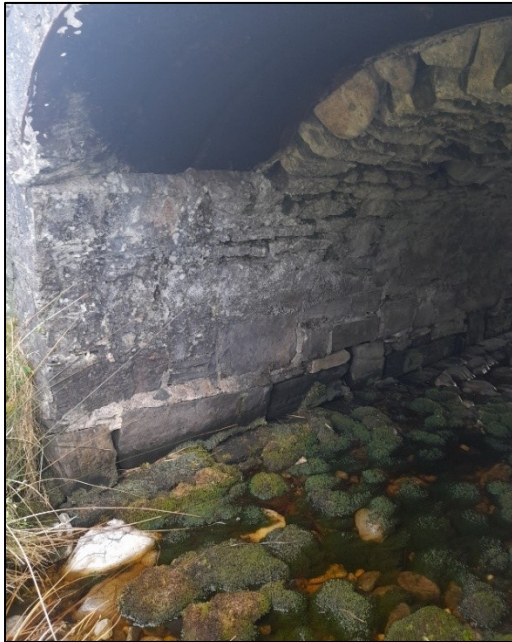
Plate 4-25 Bridge 2 with crevices visible in between the stones

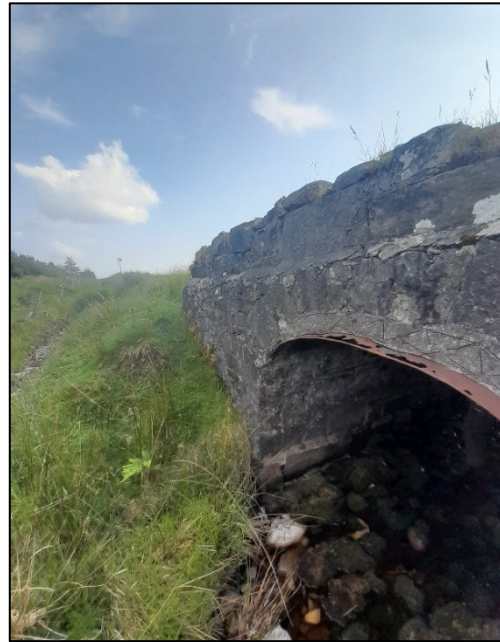
Plate 4-26 Face of Bridge 2 – stone arch bridge.

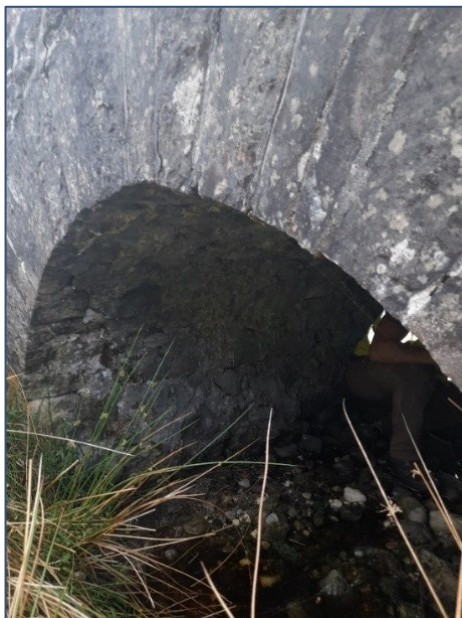
The structure was inspected using a torch and endoscope and no evidence of bat use was recorded. The structure was assessed as having *Low* bat roost potential.

Plate 4-27 Stone arch Bridge 3 located near T5.

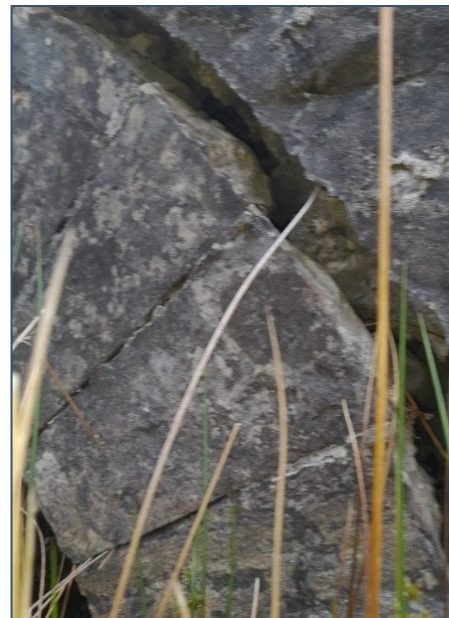
Plate 4-28 Gap in the stonework of the bridge providing roost potential for bats.

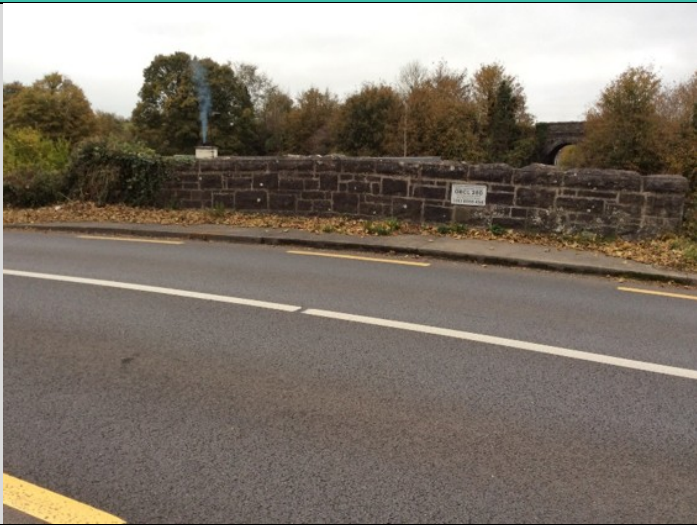
| Crossing | Grid Reference | Bridge/Culvert type | Photo | Bat Roost Potential | Extent of Works |
|---|---|---|---|---|---|
| WC1<br>(36 (in reference to numbering in Table 4-7 of Chapter 4 of the main EIAR. Applicable to all crossings)) | G 67868<br>26836 | Service Crossing | | | Horizontal<br>Directional<br>Drilling (HDD) |

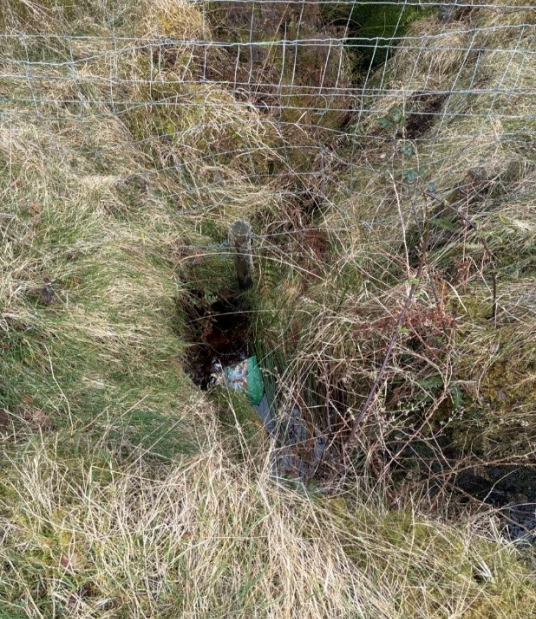
| WC2<br>(34) | G 43881<br>29178 | Concrete Pipe | | | | Concrete pipe not visible,<br>vegetation overgrown.<br>No ( <i>None</i> ) roosting potential<br>for bats | Standard<br>Formation<br>Crossing under<br>Culvert |

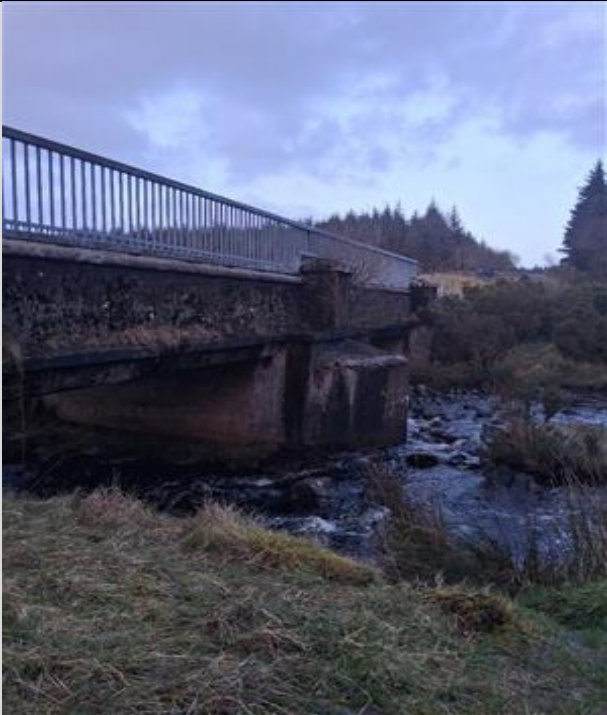
| WC3<br>(33) | G 44508<br>29221 | Stone Arch<br>Bridge | | | Double arch smooth concrete bridge with no gaps, cracks or crevices that provide roosting potential.<br>Overall, no ( <i>None</i> ) roosting potential. | Horizontal Directional Drilling (HDD) |

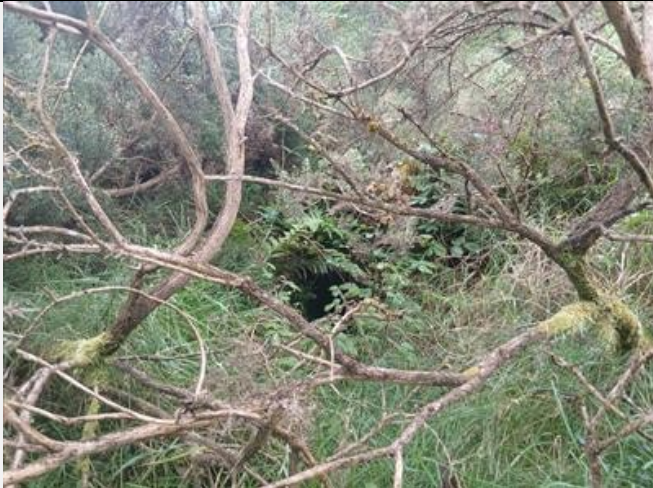
| WC4<br>(32) | G 45025<br>29368 | Concrete Pipe | | Too heavily vegetated to see nature of bridge.<br>Concrete pipes provide no PRF's for roosting bats.<br>Overall, no ( <i>None</i> ) roosting potential. | Standard Formation<br>Crossing under Culvert |

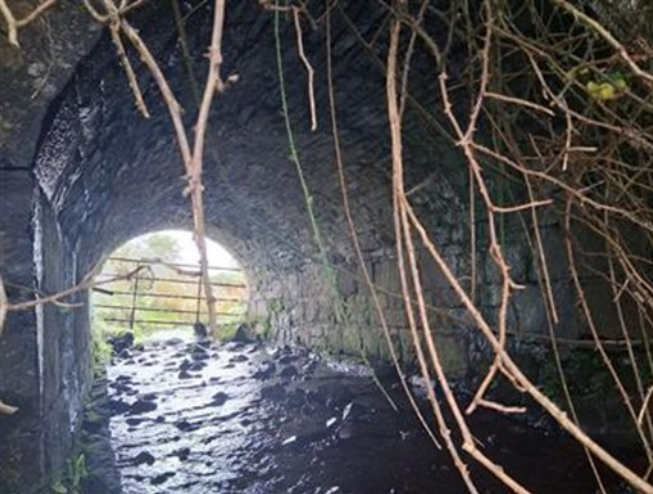
| WC5<br>(31) | G 45994<br>29627 | Stone Arch Bridge | | Heavily vegetated stone bridge, well pointed bridge face and roof, heavily vegetated- soft rush, ivy, bramble, nettle- <i>Negligible</i> roosting potential. | Horizontal Directional Drilling (HDD) |

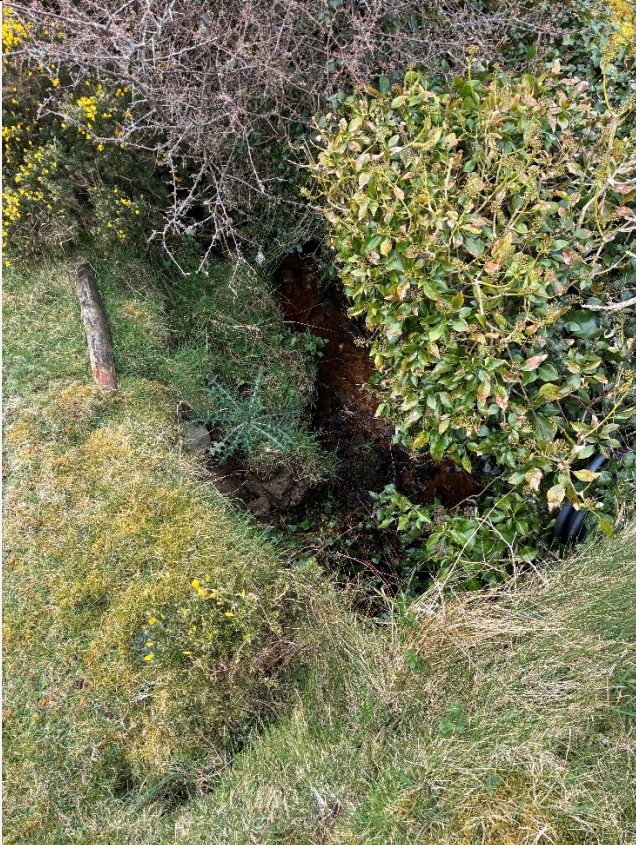
| WC6<br>(30) | G 45864<br>30490 | Stone Culvert | | Plastic pipe culvert,<br>overgrown vegetation in front<br>of it.<br>No ( <i>None</i> ) roosting potential. | Standard<br>Formation<br>Crossing under<br>Culvert |

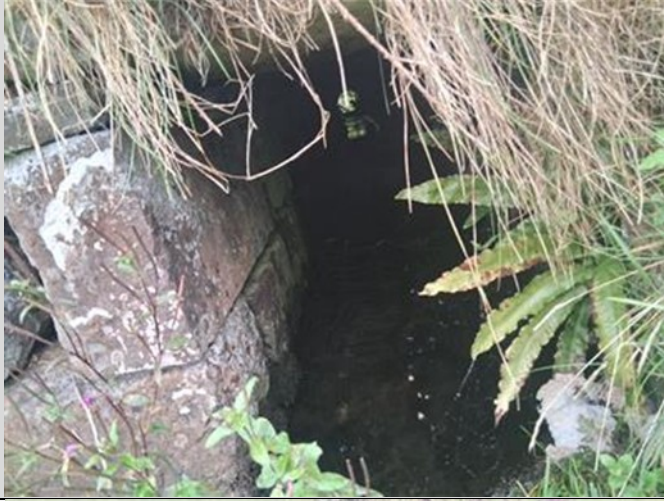
| WC7<br>(29) | G 45761<br>31093 | Stone Culvert | | Stone structure, dark long tunnel, holes/ crevices in stone work, vegetated, bramble- <i>Low</i> roosting potential | Standard Formation Crossing under Culvert |

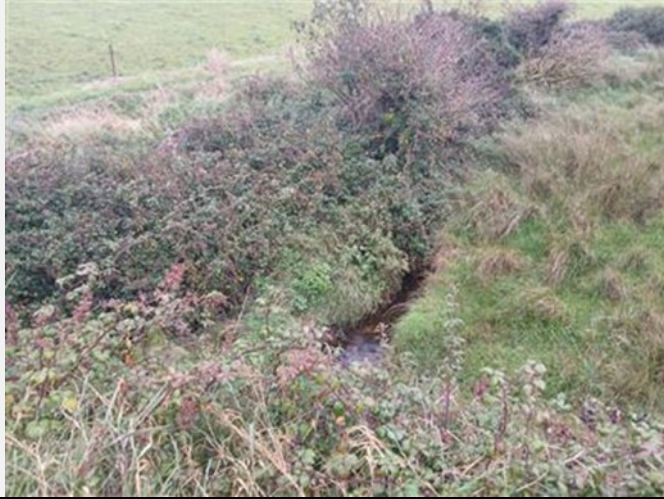
| WC8<br>(28) | G 45743<br>31515 | Stone Arch bridge | | Too heavily vegetated (bramble) to see nature of bridge.<br>No access for bats due to dense vegetation overgrowth blocking the bridge structure -<br>No ( <i>None</i> ) roosting potential. | Horizontal Directional Drilling (HDD) |

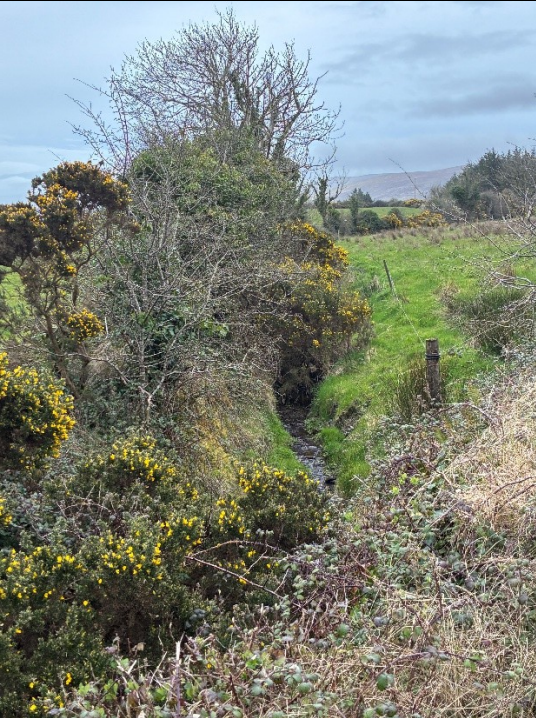
| WC9<br>(27) | G 45914<br>31981 | Concrete Pipe | | | Too heavily vegetated with gorse bramble ash. No access for bats due to dense vegetation overgrowth blocking the bridge structure. No ( <i>None</i> ) roosting potential. | Standard Formation<br>Crossing under Culvert |

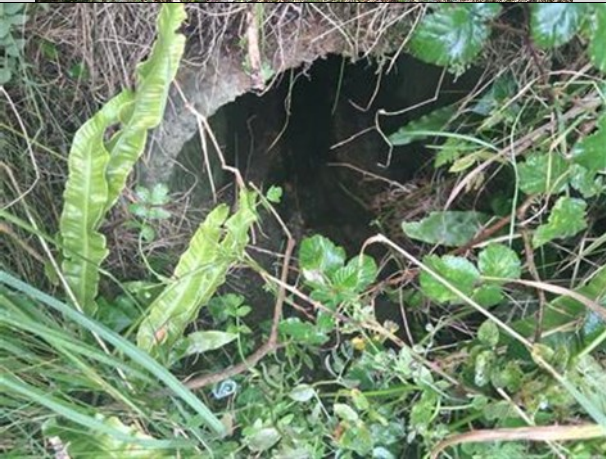
| WC10<br>(26) | G 45943<br>32321 | Stone Culvert | | | No gaps, cracks or crevices, heavily vegetated with ivy, bramble, harts tongue fern cleavers- No ( <i>None</i> ) roosting potential. | Standard Formation<br>Crossing under Culvert |

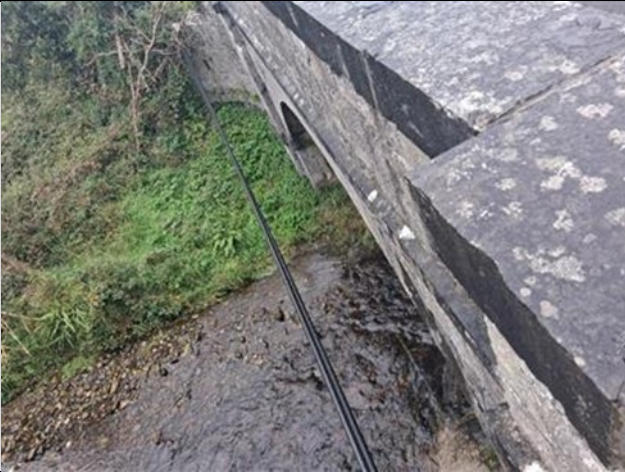
| WC11<br>(25) | G 46358<br>33097 | Stone Arch<br>Bridge | | Well pointed concrete bridge,<br>no gaps, cracks or crevices,<br>no vegetation cover - No<br>(None) roosting potential. | Horizontal<br>Directional<br>Drilling (HDD) |

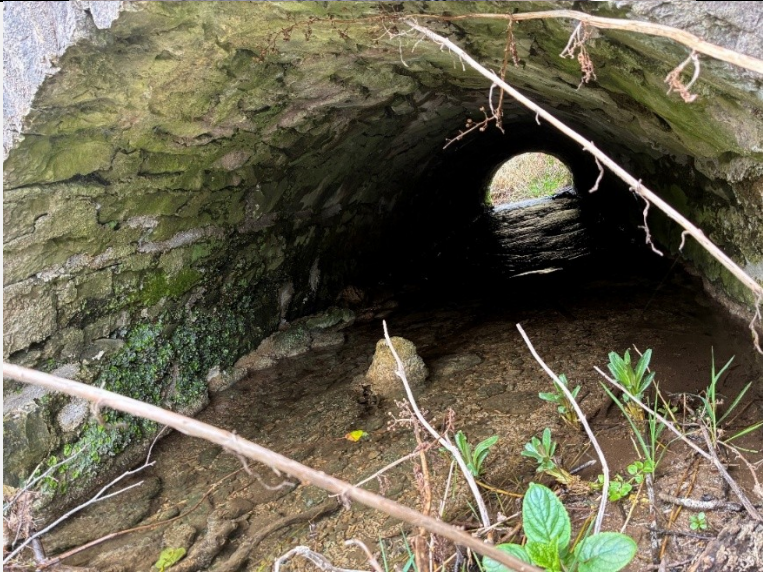
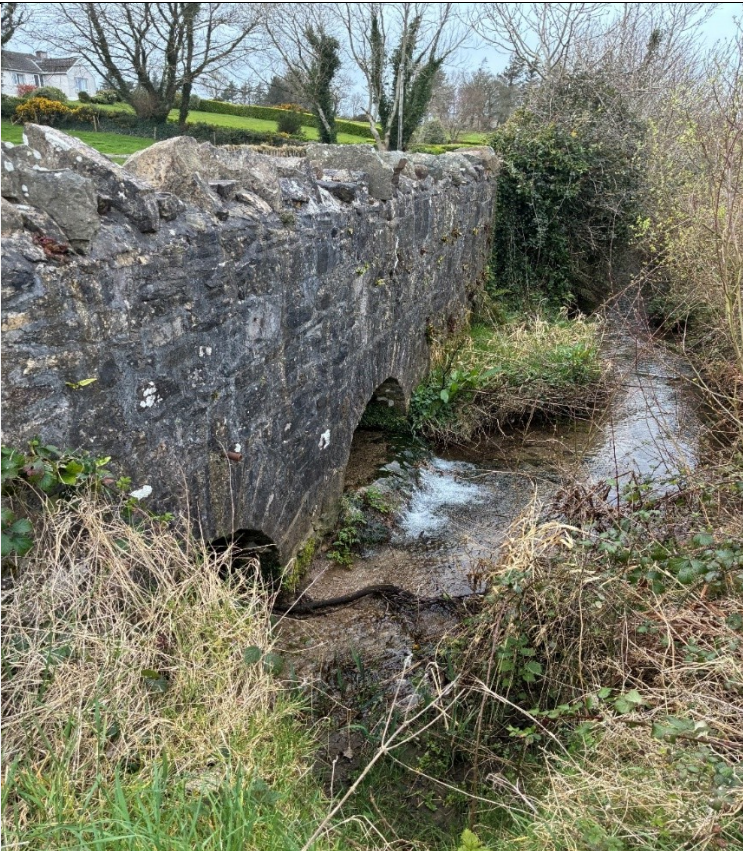
| WC12<br>(24) | G 48732<br>32607 | Stone Arch<br>bridge | | Well pointed bridge face with<br>no visible cracks or crevices.<br>Some well pointed stonework<br>in the barrel of the bridge,<br>with a small number of holes,<br>cracks and crevices present.<br>Overall, <i>Low</i> roosting<br>potential. | Standard<br>Formation<br>Crossing under<br>Culvert |

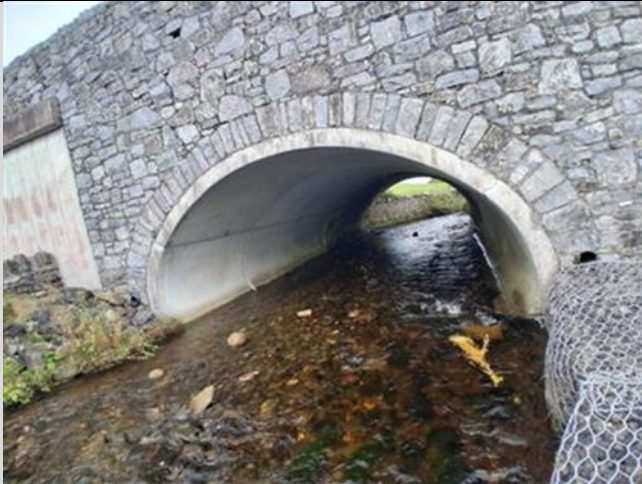
| WC13<br>(23) | G 50809<br>32478 | Stone Arch<br>Bridge | | Well pointed concrete/ brick structure, no gaps, cracks or crevices in roof or bridge face, no vegetation- No ( <i>None</i> ) roosting potential. | Horizontal Directional Drilling (HDD) |

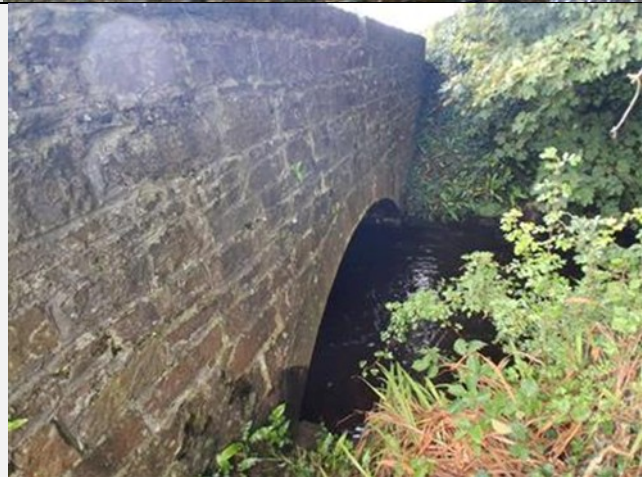
| WC14<br>(22) | G 53762<br>33102 | Stone Arch<br>Bridge | | Well pointed bridge, no gaps, cracks or crevices for bats, vegetation cover - No ( <i>None</i> ) roosting potential. | Horizontal Directional Drilling (HDD) |

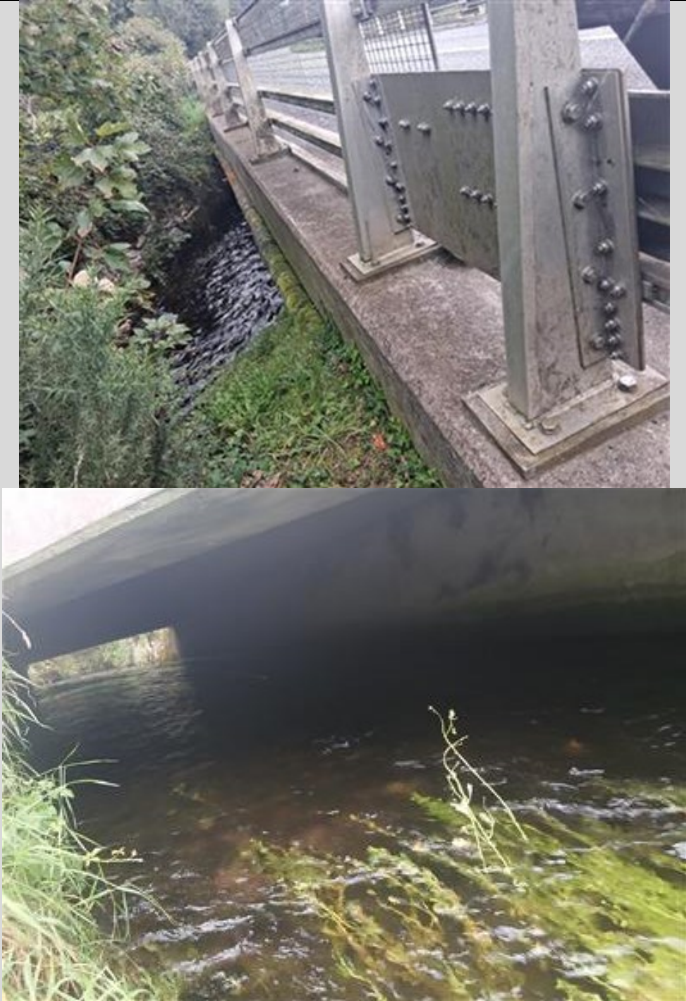
| WC15<br>(20) | G 54338<br>32978 | Stone Arch<br>bridge | | Metal fencing, smooth concrete well pointed face, concrete box culvert, no vegetation, no gaps, cracks or crevices – No ( <i>None</i> ) roosting potential. | Horizontal Directional Drilling (HDD) |

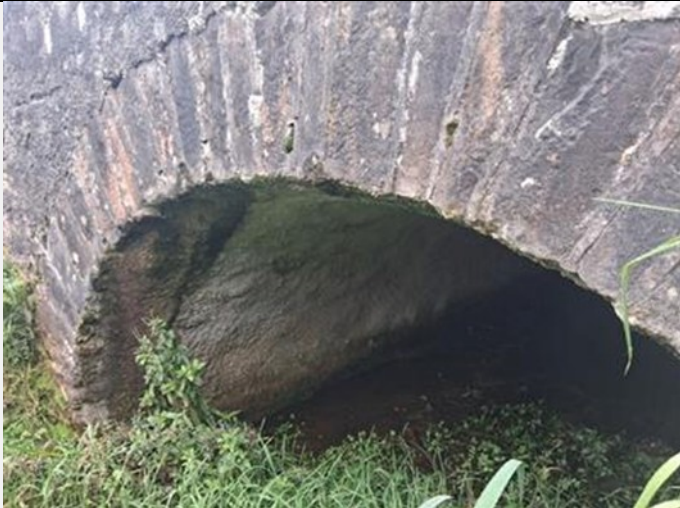
| WC16<br>(21) | G 56092<br>32256 | Stone Arch<br>bridge | | Well pointed concrete structure, no gaps, cracks or crevices, no vegetation cover. The structures roof has a smooth, solid concrete surface with no gaps, cracks or crevices. - overall No ( <i>None</i> ) roosting potential. | Horizontal Directional Drilling (HDD) |

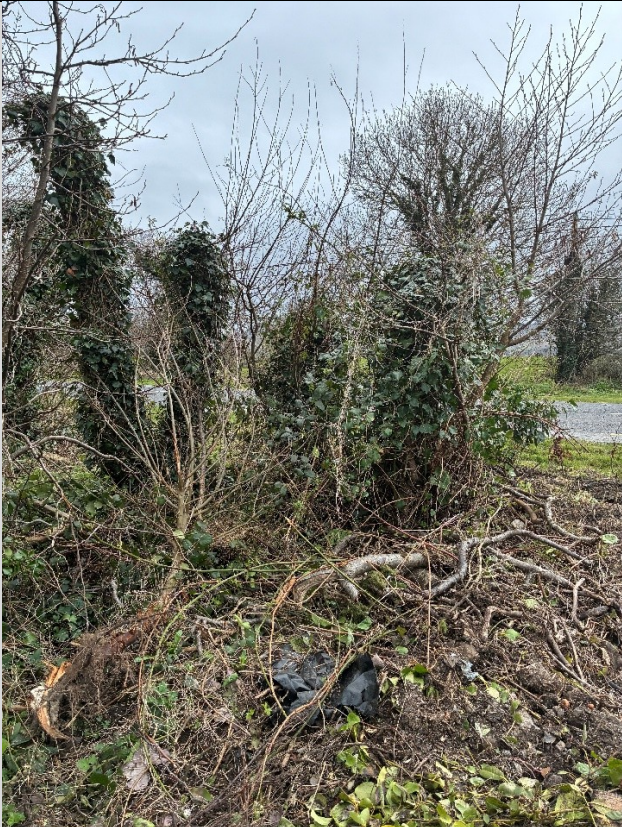
| WC17<br>(19) | G 57153<br>31697 | Stone Culvert | | | | Stone culvert not visible – possibly goes under road.<br>No access for bats.<br>No ( <i>None</i> ) roosting potential. | Standard<br>Formation<br>Crossing under<br>Culvert |

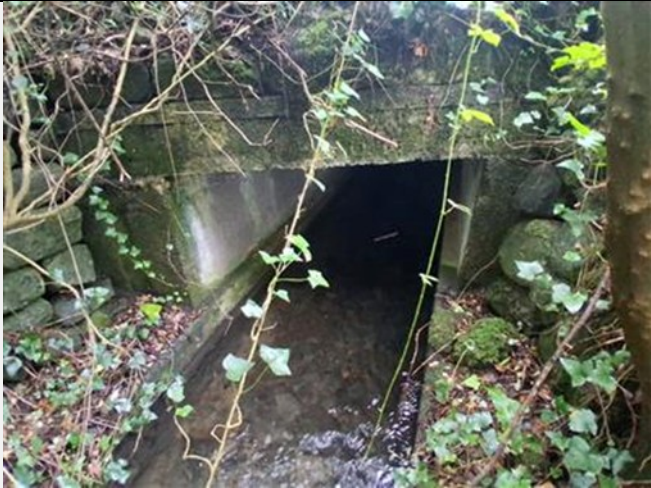
| WC18<br>(18) | G 57810<br>31360 | Concrete Pipe<br>- Concrete<br>box culvert | | Well pointed flat roof, some stone work around bridge with holes/ crevices, long dark tunnel, some ivy cover - overall <i>Low</i> roosting potential. | Standard Formation<br>Crossing under Culvert |

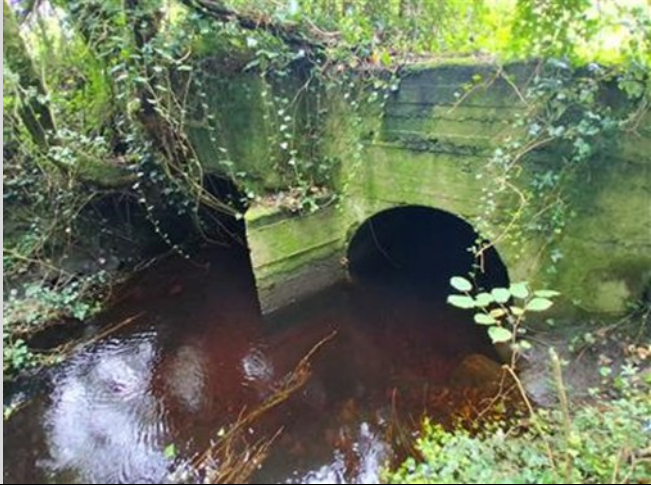
| WC19<br>(17) | G 59785<br>29997 | Concrete Bridge – plastic pipe culvert | | Pipe culvert under road, and well pointed, smooth concrete bridge face, two arches, little vegetation, some ivy, old bridge with stone roof and walls, not well pointed with some holes and crevices and ivy cover. Overall, no ( <i>None</i> ) roosting potential | Standard Formation<br>Crossing over Culvert |

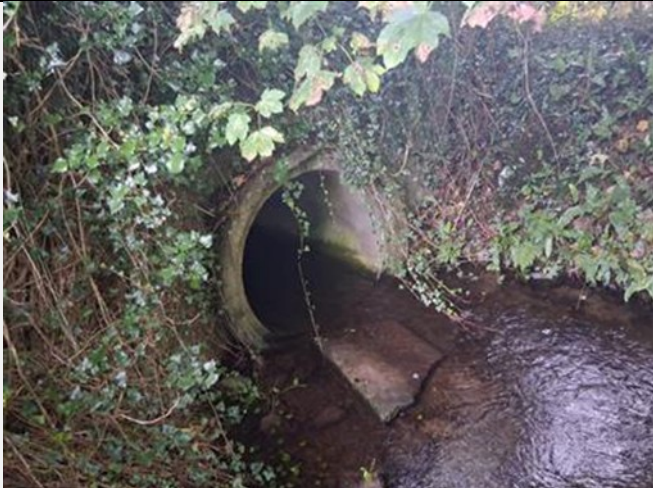
| WC20<br>(16) | G 60458<br>29482 | Stone Culvert | | Well pointed bridge face, concrete bricks and concrete pipe culvert, heavily vegetated with ivy, bramble, no holes or crevices – No ( <i>None</i> ) roosting potential. | Standard Formation<br>Crossing under Culvert |

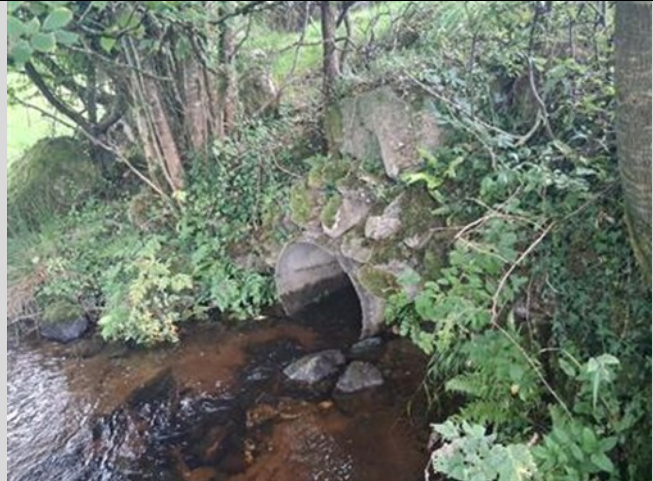
| WC21<br>(15) | G 61089<br>28892 | Concrete Pipe | | Heavily vegetated stone bridge at one side, water crossing culverted under road, concrete culvert, some stone work, not well pointed with holes and crevices, some vegetation cover – Overall, <i>Low</i> roosting potential | Standard Formation<br>Crossing under Culvert |

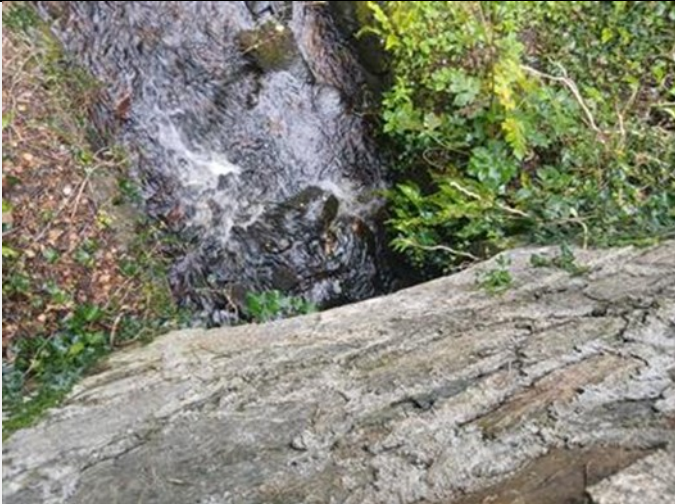
| WC22<br>(14) | G 61818<br>28302 | Stone Arch<br>Bridge | | | Well pointed stone structure at bridge face and roof, some shallow holes and crevices, no vegetation cover, no linear treeline/ riparian vegetation for commuting or foraging - Overall <i>Low</i> roosting potential | Standard Formation Crossing under Culvert |

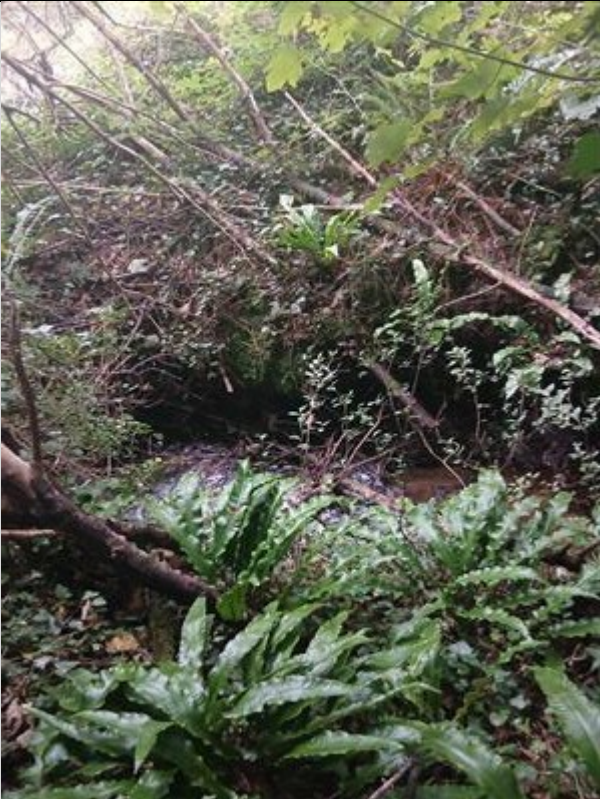
| WC23<br>(13) | G 62281<br>28193 | Concrete Pipe | | | | <p>No clear bridge or crossing under road recorded in the area, heavily vegetated watercourse inaccessible to walk upstream.</p> <p>Concrete pipes provide no potential roosting features–</p> <p>Overall, no (<i>None</i>) roosting potential</p> | <p>Standard Formation</p> <p>Crossing under Culvert</p> |

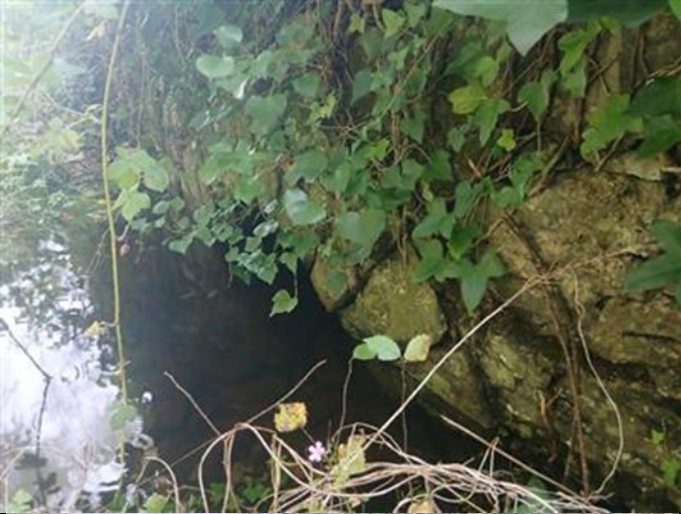
| WC24<br>(12) | G 63016<br>28368 | Plastic Pipe -<br>Stone Arch<br>Bridge | | Stone bridge face and roof, some small shallow crevices, extensively ivy covered and bramble, water levels up to roof top, watercourse heavily vegetated with bramble, ash, alder – Overall, <i>Low</i> roosting suitability | Horizontal<br>Directional<br>Drilling (HDD) |

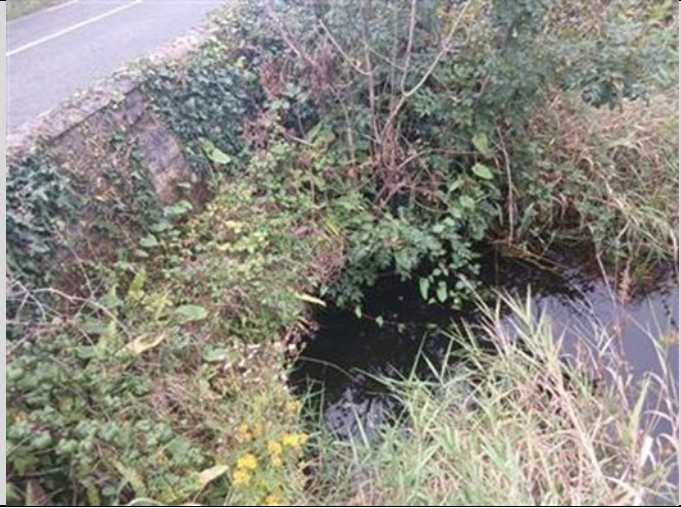
| WC25<br>(11) | G 67174<br>28585 | Stone Arch<br>Bridge | | Well pointed stone face bridge, stone roof, heavily vegetated, very high-water levels up to the roof of the bridge, overall <i>Negligible</i> roosting potential. | Horizontal<br>Directional<br>Drilling (HDD) |

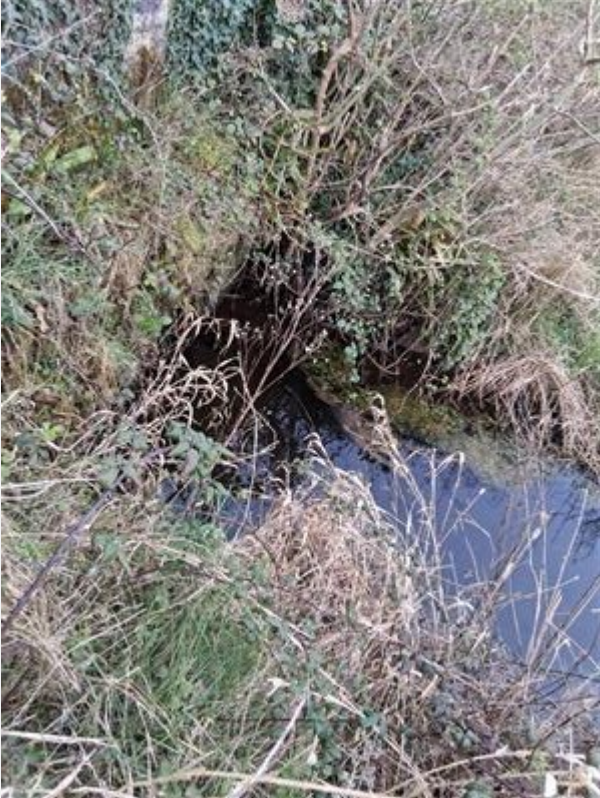
| WC26<br>(10) | G 67251<br>28465 | Stone Culvert | | | Heavily vegetated stone culvert. No crevices gaps, cracks or crevices visible, overall <i>Negligible</i> roosting potential. | Standard Formation Crossing under Culvert |

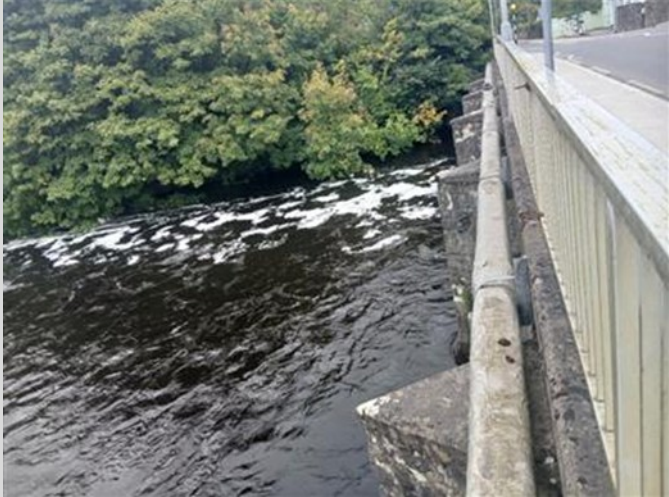
| WC27<br>(9) | G 67967<br>26536 | Stone Arch<br>Bridge | | Seven well pointed stone arches, no gaps, cracks or crevices, no vegetation cover, metal railing - no ( <i>None</i> ) roosting potential | Horizontal Directional Drilling (HDD) |

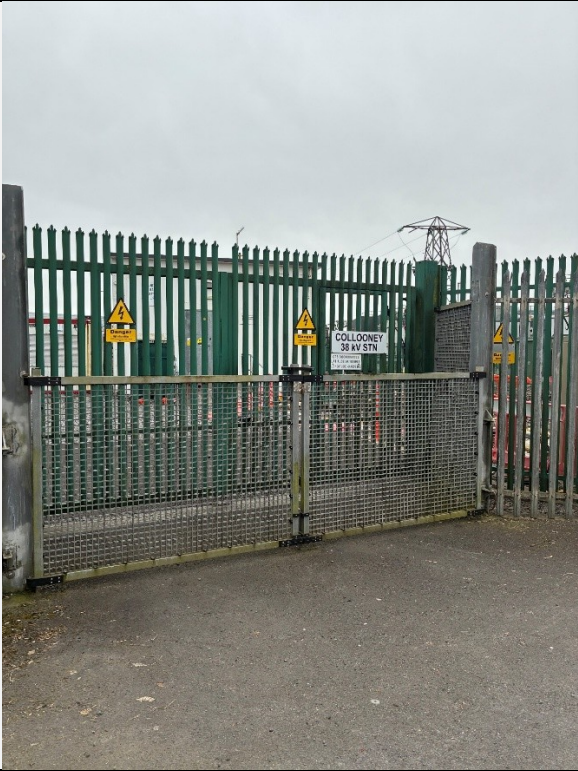
| WC28<br>(35) | G 68473<br>26063 | Service<br>Crossing | | | No structure present here. | Horizontal<br>Directional<br>Drilling (HDD) |

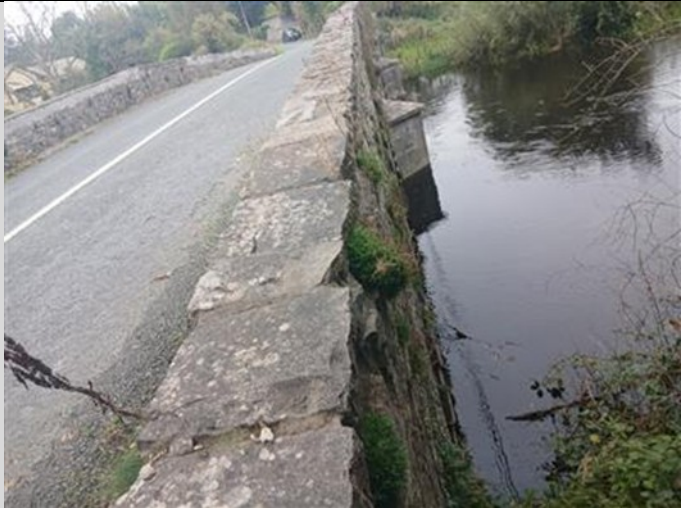
| WC29<br>(8) | G 69481<br>25931 | Stone Arch<br>Bridge | | Well pointed stone bridge, 3 arches, no gaps, cracks or crevices, little vegetation cover - overall <i>Low</i> roosting potential | Horizontal Directional Drilling (HDD) |

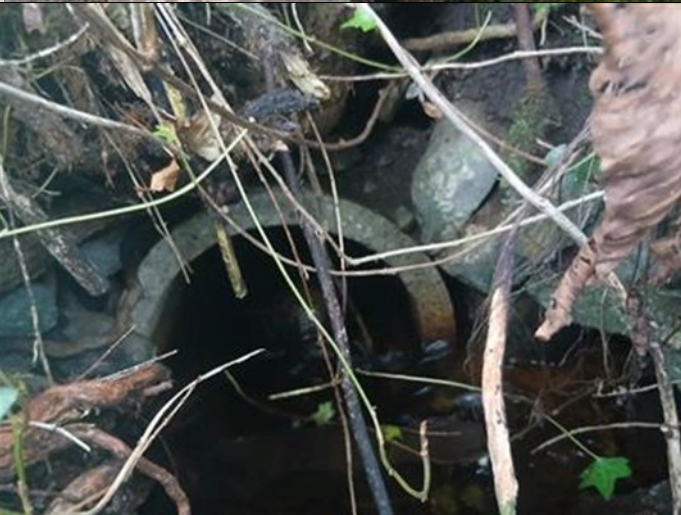
| WC30<br>(7) | G 69977<br>26449 | Concrete pipe | | Watercourse pipe culverted under road, very heavily vegetated, some stone work covered in dense vegetation - overall, no ( <i>None</i> ) roosting potential. | Standard Formation Crossing under Culvert |

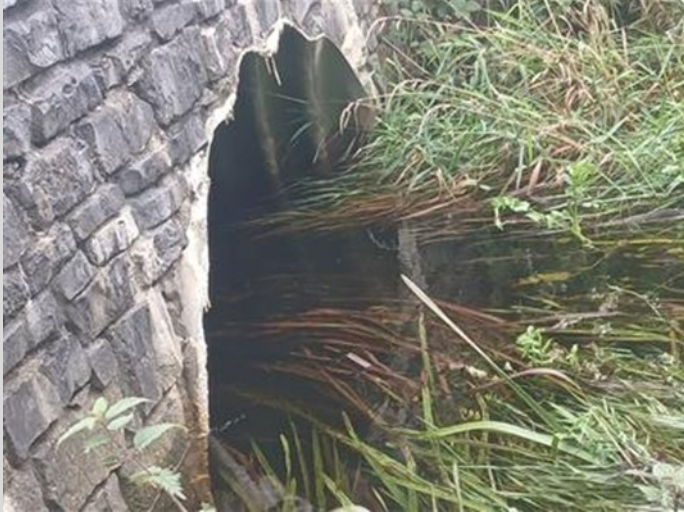
| WC31<br>(6) | G 70862<br>26867 | Stone Arch<br>Bridge | | Well pointed stone bridge, flat, smooth concrete culvert structure- no gaps, cracks or crevices, no vegetation cover- Overall, No ( <i>None</i> ) roosting and commuting/ foraging potential | Horizontal Directional Drilling (HDD) |

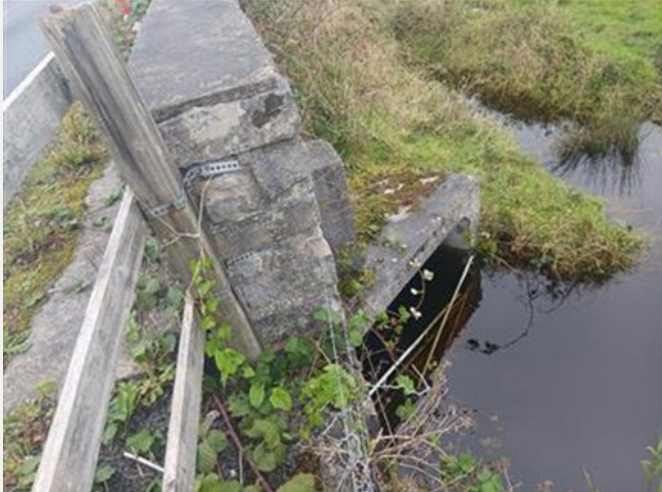
| WC32<br>(5) | G 71020<br>26770 | Stone bridge – concrete box culvert | | Well pointed stone bridge structure, no gaps, cracks or crevices, no vegetation cover. Large concrete box culvert, no cracks or crevices, ivy cover. Overall, no ( <i>None</i> ) roosting potential | Horizontal Directional Drilling (HDD) |

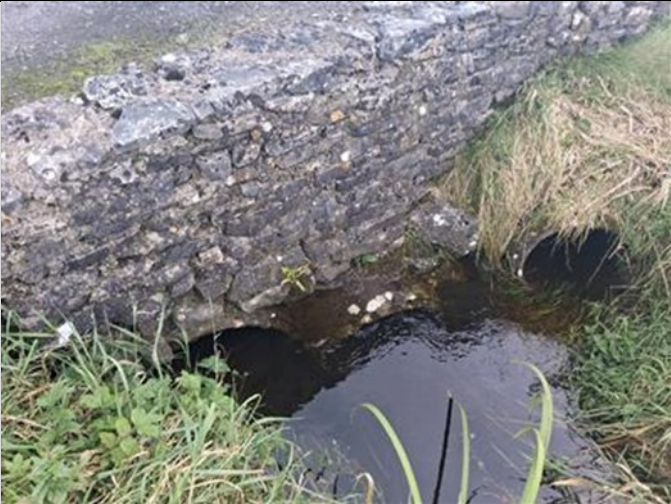
| WC33<br>(4) | G 71089<br>26686 | Stone Arch<br>Bridge –<br>Concrete pipe | | Well pointed bridge structure, no gaps, cracks or crevices in roof or bridge face, three concrete culverts under road, no vegetation cover, no linear or riparian vegetation on either side of watercourse- Overall, no ( <i>None</i> ) roosting potential. | Standard<br>Formation<br>Crossing under<br>Culvert |

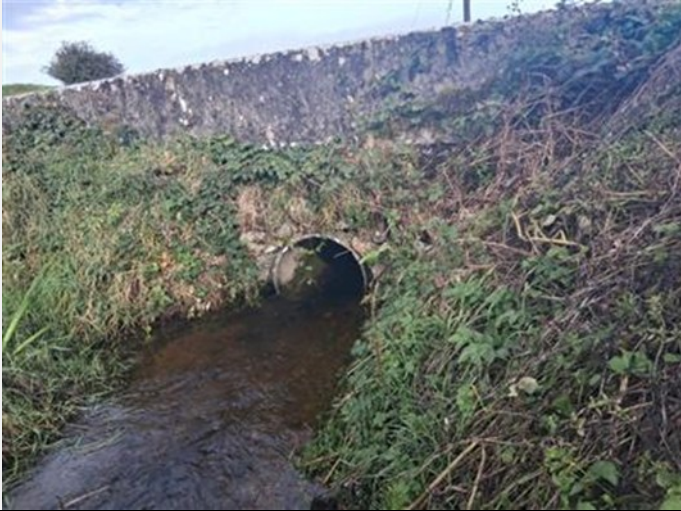
| WC34<br>(3) | G 71258<br>26488 | Plastic Pipe | | Concrete culvert providing no roosting potential, bridge face half well pointed concrete, other half stone work with some gaps and crevices, some vegetation cover - Overall <i>Low</i> roosting potential. | Standard<br>Formation<br>Crossing under<br>Culvert |

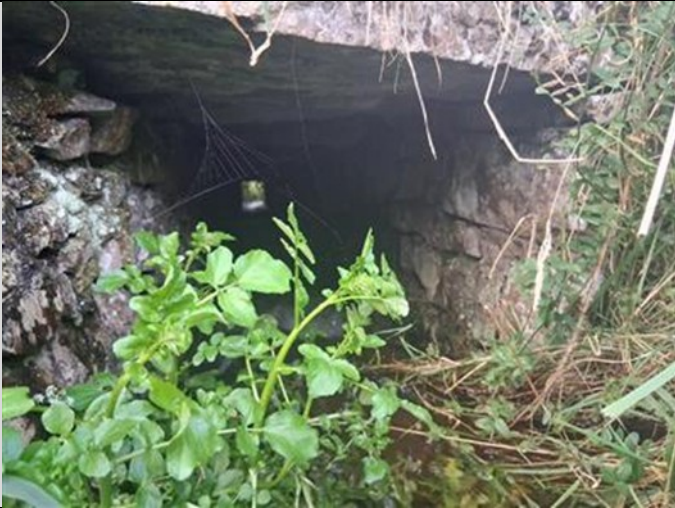
| WC35<br>(2) | G 71358<br>26406 | Stone Culvert | | Stone bridge, stone work has some gaps, cracks and crevices in roof and stone walls, two arches, bridge face heavily vegetated, no evidence of bats found – Overall, <i>Moderate</i> suitability for roosting bats | Standard Formation Crossing under Culvert |

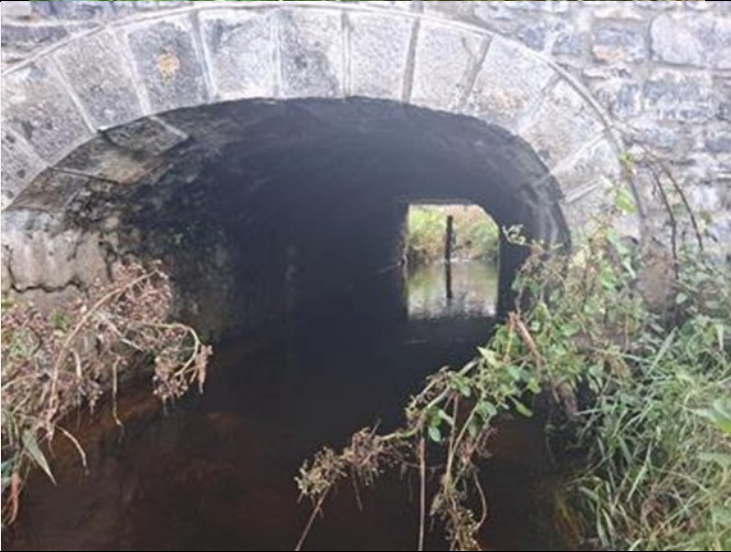
| WC36<br>(1) | G 72404<br>25613 | Stone Arch Bridge | | Well pointed bridge structure, no gaps, cracks or crevices visible on bridge face or roof, no evidence of bats found, concrete pillar on top of bridge wall face, no vegetation cover – Overall, no ( <i>None</i> ) roosting potential. | Horizontal Directional Drilling (HDD) |
