# Aquatic baseline report for the proposed Crumhach Wind Farm, Co. Sligo

Prepared by Triturus Environmental Ltd. for MKO

**February 2025**

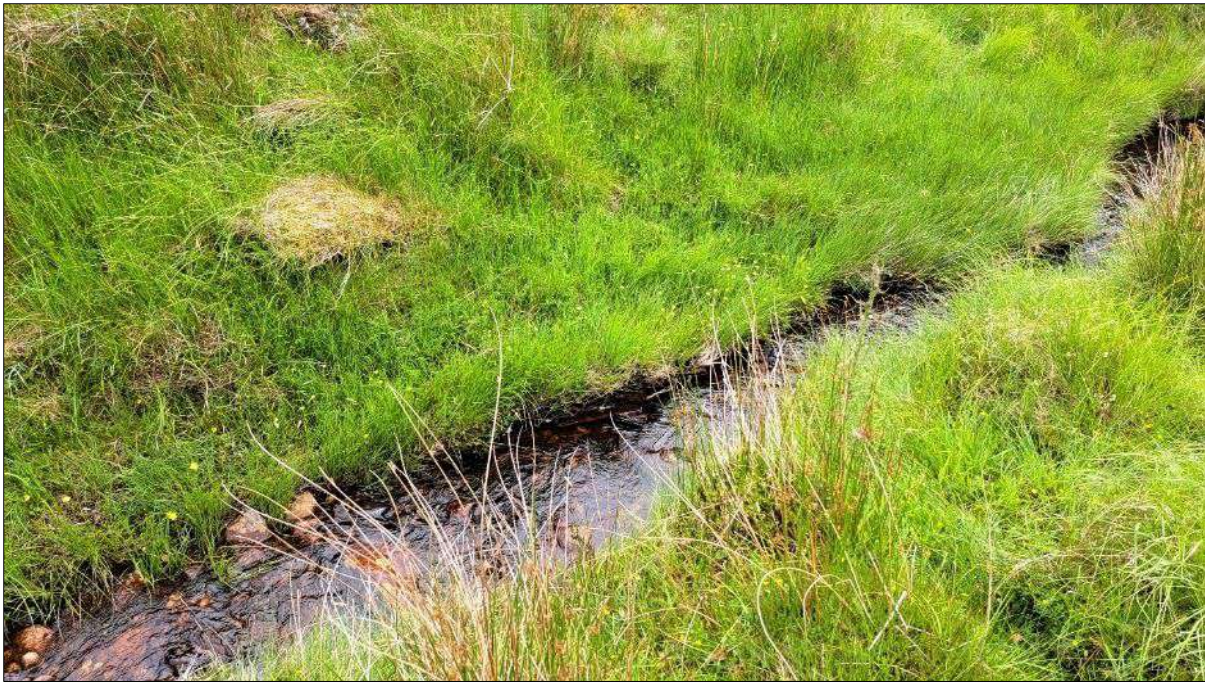
Biological water quality, based on Q-sampling, was calculated as **Q3-4 (moderate status) (Appendix C)**. No macro-invertebrate species of conservation value greater than 'least concern', according to national red lists, were recorded via Q-sampling.

Given the location of the site within the Ox Mountains Bogs SAC (002006), the aquatic ecological evaluation of site A1 was of **international importance (Table 4.3)**.

**Plate 7.1.1** Representative image of site A1 on an unnamed Easky River tributary, July 2024

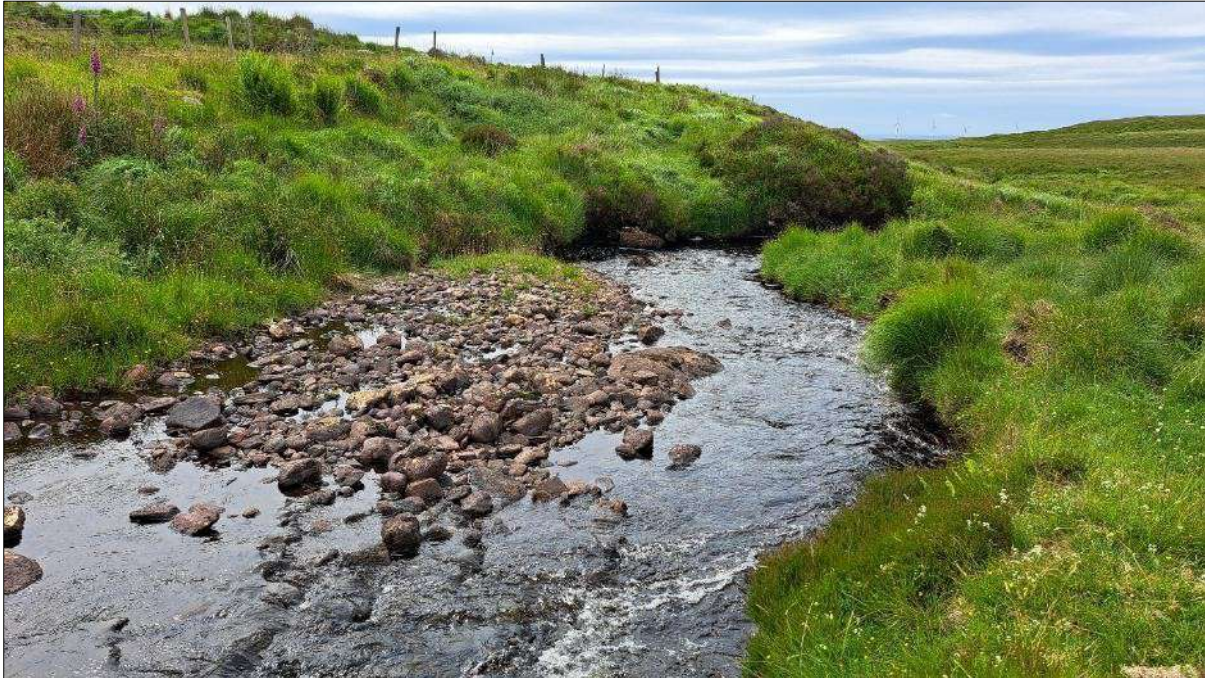
Given the location of the site within the Ox Mountains Bogs SAC (002006), the aquatic ecological evaluation of site A2 was of **international importance** (Table 4.3).

**Plate 7.1.2** Representative image of site A2 on the Easky River, July 2024

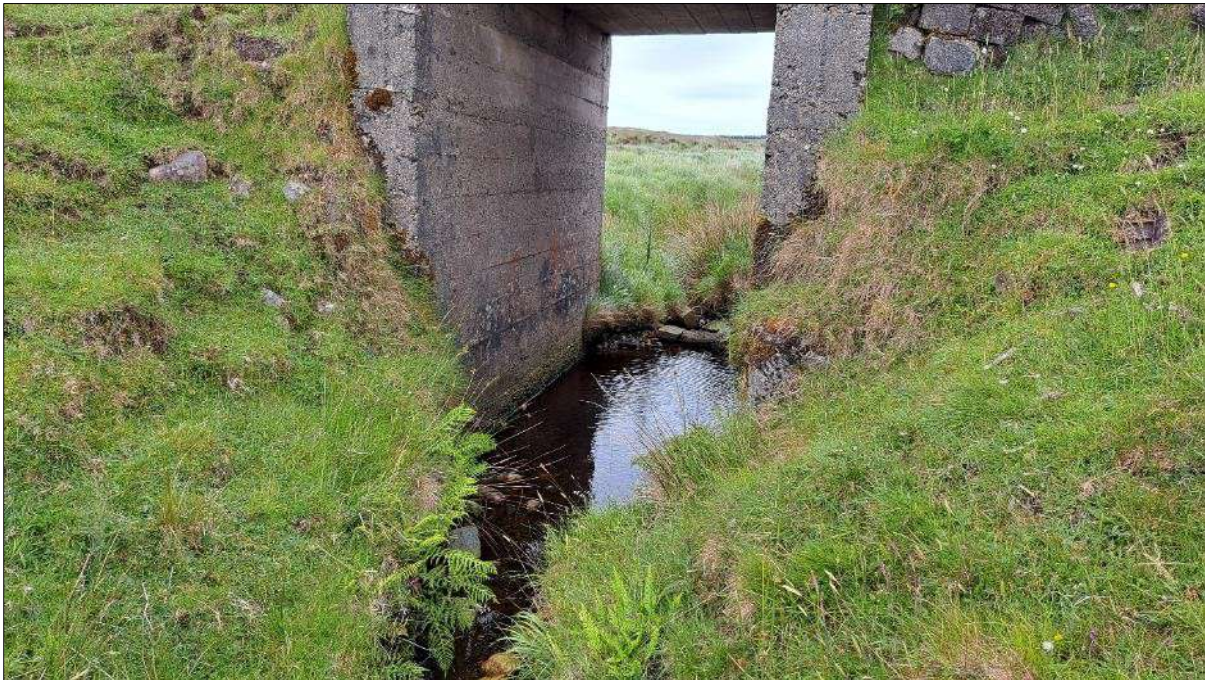
Site A3 was located on the upper reaches of the Letterunshin River (35L56) at a bog access track crossing. The small upland eroding stream (FW1) flowed in a very narrow, deeply incised channel through blanket bog and was often <1m in width and <0.2m in depth. The profile comprised riffle and deep glide between natural cascades and peat impoundments. This resulted in localised pooling of near stagnant water. The substrata were dominated by cobble and mixed gravels with localised sands and scattered small boulder. These were heavily silted. The bridge apron was rendered but degrading and not a barrier to fish at low flows (inherently low summer flows more of an issue than apron). Cover of floc and filamentous algae were locally high in rare open areas of channel. Macrophytes were absent with occasional lesser spearwort along peaty margins. *Scapania undulata* and *Pellia* sp. were occasional instream. The channel was heavily shaded by purple moor grass, soft rush and ferns. The site was bordered by cutover bog (PB4) and degraded blanket bog (PB2).

Biological water quality, based on Q-sampling, was calculated as **Q3 (poor status) (Appendix C)**. No macro-invertebrate species of conservation value greater than 'least concern', according to national red lists, were recorded via Q-sampling.

Given the location of the site within the Ox Mountains Bogs SAC (002006), the aquatic ecological evaluation of site A3 was of **international importance (Table 4.3)**.

**Plate 7.1.3** Representative image of site A3 on the Letterunshin River, September 2024

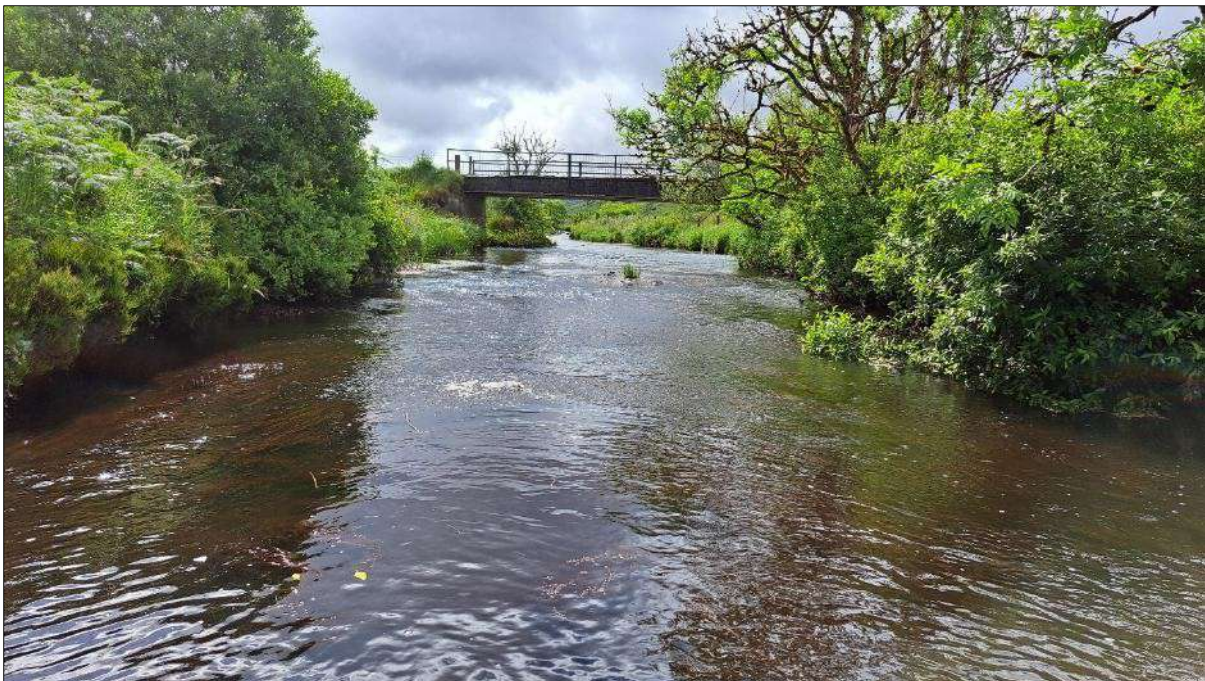
Site A4 was located on the upper reaches of the Easky River (35E01) at a local road crossing. The large upland eroding spate channel was 6-8m wide and 0.1-0.3m deep with a profile comprising riffle, shallow glide and frequent pool. Peat staining was moderate at the time of survey. The substrata of the high energy site were dominated by small mostly mobile cobble and mixed gravels with scattered boulder (mostly upstream). Sand was abundant along depositing margins with soft sediment accumulations (humic) also present. The site was heavily vegetated with abundant alternate leaved milfoil and frequent bog pondweed (*Potamogeton polygonifolius*). Bulbous rush was also present but sparse. Aquatic bryophyte coverage was moderate with *Sciuro-hypnum plumosum* in addition to *Batrachospermum* sp. A stand of invasive Japanese knotweed (*Reynoutria japonica*) adjoined the bridge abutment (downstream, west bank). Whilst historically modified, the banks supported intermittent treelines of ash (*Fraxinus excelsior*), hawthorn (*Crataegus monogyna*), hazel (*Corylus avellana*) and willow species (*Salix* spp.) with bramble scrub. The site was bordered by rough low intensity pasture (GS2) with areas of wet grassland (GS4).

Biological water quality, based on Q-sampling, was calculated as **Q4 (good status)** (**Appendix C**). No macro-invertebrate species of conservation value greater than 'least concern', according to national red lists, were recorded via Q-sampling.

Given the presence of freshwater pearl mussel, the aquatic ecological evaluation of site A4 was of **national importance** (**Table 4.3**).

**Plate 7.1.4** Representative image of site A4 on the Easky River, July 2024

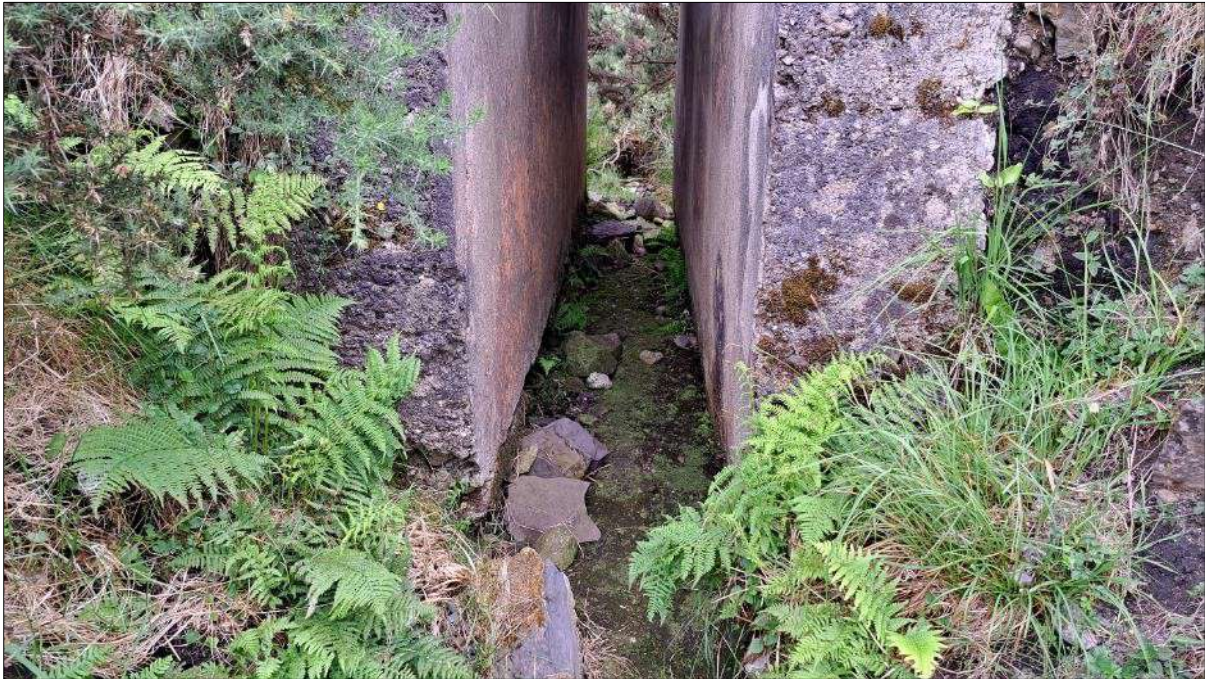
Site A5 was located on the uppermost reaches of an unnamed Easky River tributary at a bog access track crossing adjacent to the EIAR site boundary. The channel had been historically straightened and deepened as part of land drainage resulting in a deep U-shaped channel with slumping, peaty banks. The stream was dry at this location at the time of survey with an absence of aquatic habitats. Some bog pondweed grew on damp muddy areas of the bed, implying occasional water flows. The site was bordered by cutover bog (PB4) and degraded blanket bog (PB2).

It was not possible to collect a biological water quality sample given the dry nature of the stream at this location.

Given the absence of aquatic species or habitats of higher conservation value, the aquatic ecological evaluation of site A5 was of **local importance (lower value)** (Table 4.3).

**Plate 7.1.5** Representative image of site B5 on an unnamed Easky River tributary, July 2024 (dry, ephemeral channel)

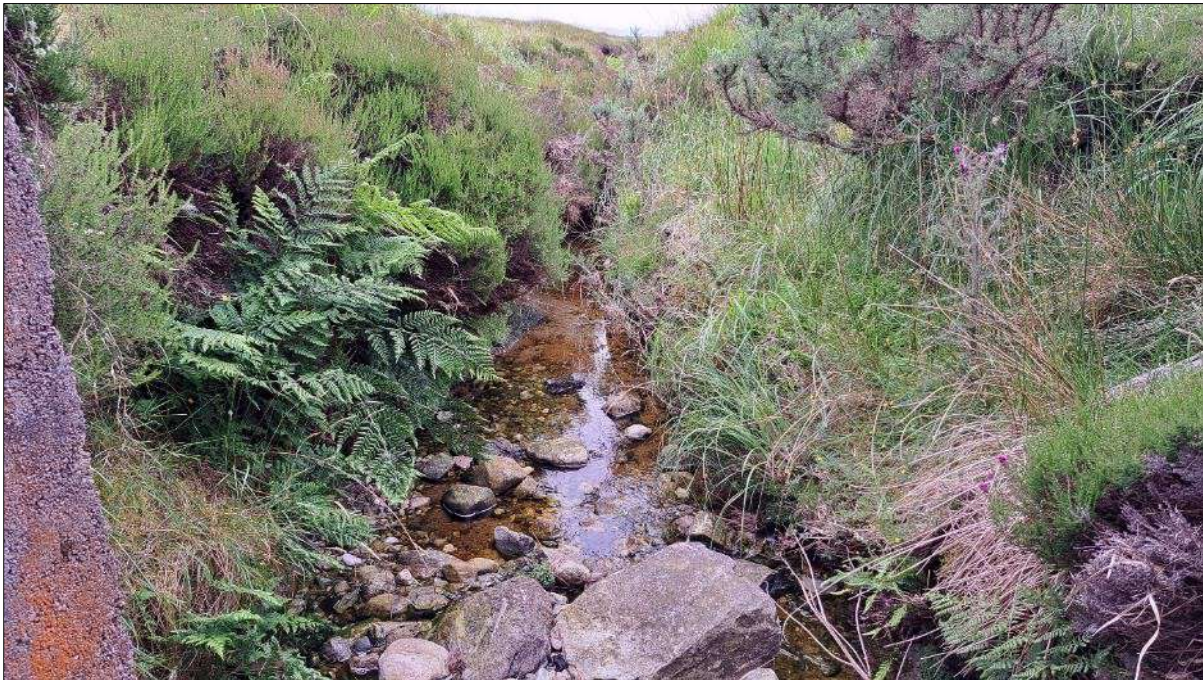
Biological water quality, based on Q-sampling, was calculated as **Q3 (poor status) (Appendix C)**. No macro-invertebrate species of conservation value greater than 'least concern', according to national red lists, were recorded via Q-sampling.

Given the absence of aquatic species or habitats of higher conservation value, the aquatic ecological evaluation of site A6 was of **local importance (lower value) (Table 4.3)**.

**Plate 7.1.6** Representative image of site A6 on an unnamed stream, July 2024

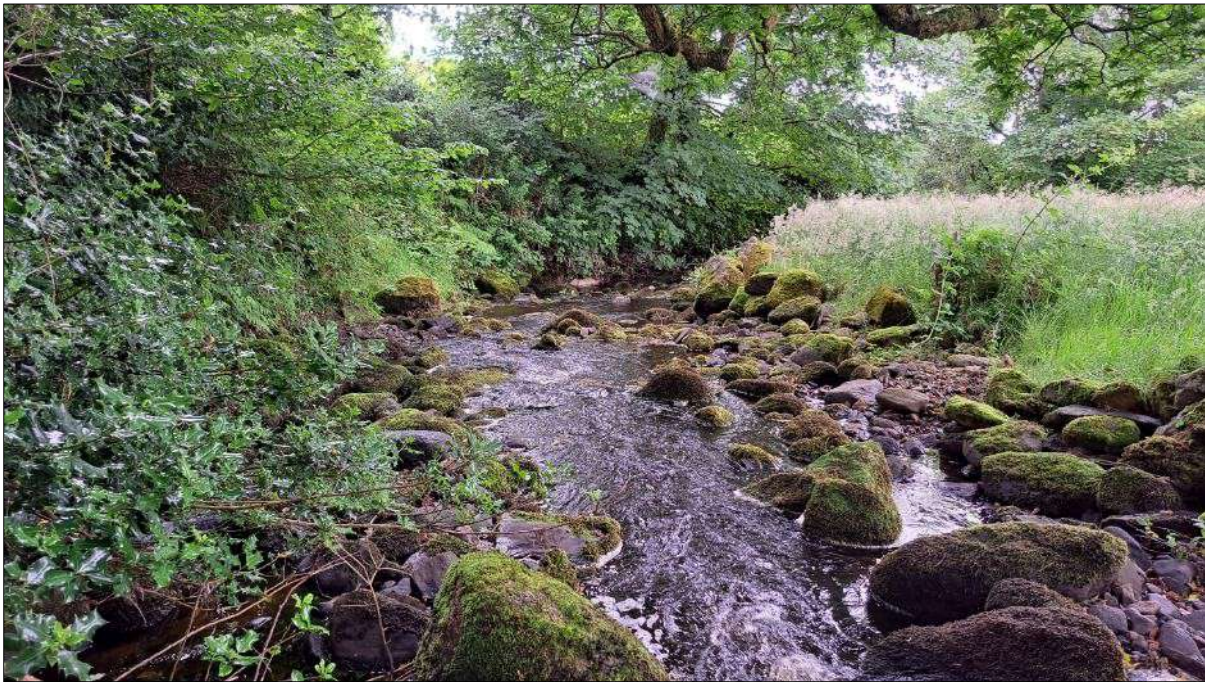
provided some good quality holding areas for migratory adults. The site was of high suitability for European eel although only a low density were recorded. The site was unsuitable for lamprey or white-clawed crayfish. A single old otter spraint was recorded on the broken apron under the bridge (ITM 539665, 828009).

Biological water quality, based on Q-sampling, was calculated as **Q3-4 (moderate status) (Appendix C)**. No macro-invertebrate species of conservation value greater than 'least concern', according to national red lists, were recorded via Q-sampling.

Given the presence of salmonids (including Atlantic salmon) and Red-listed European eel, the aquatic ecological evaluation of site A7 was of **local importance (higher value) (Table 4.3)**.

**Plate 7.1.7** Representative image of site A7 on an unnamed Easky River tributary, July 2024

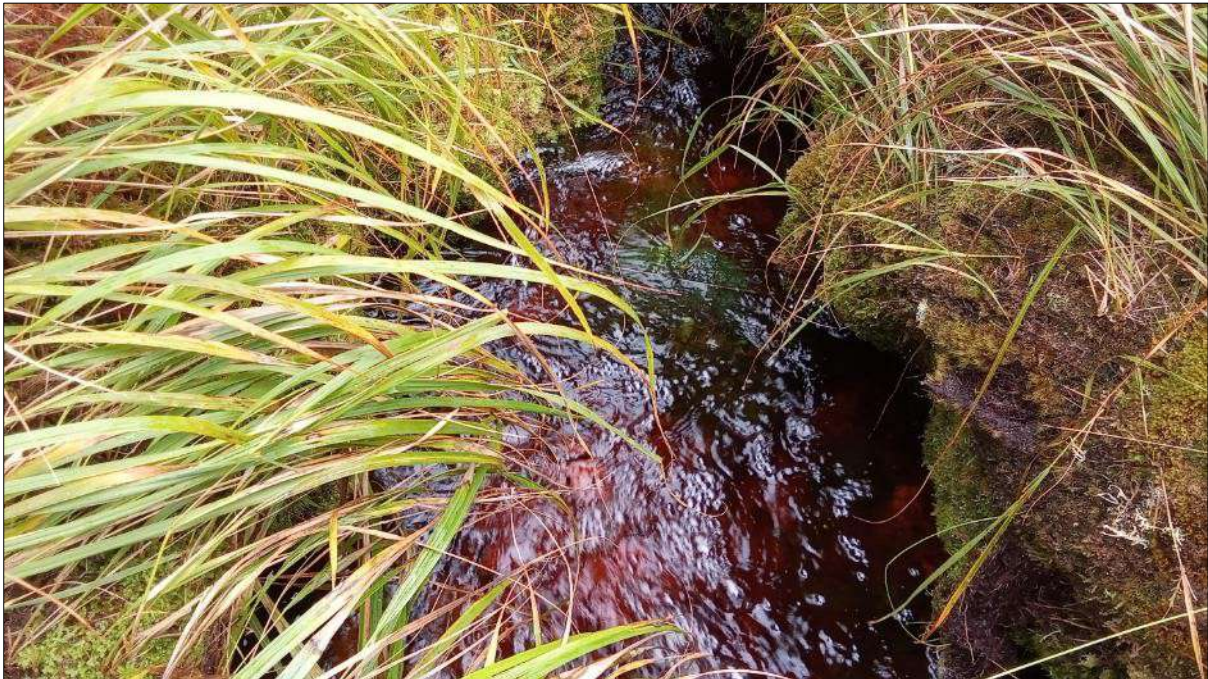
No fish were recorded via electro-fishing at site A8 (**Appendix B**). The channel was considered a poor quality salmonid nursery given an absence of riparian buffers from the adjoining conifer plantations. These evidently caused acidification of the stream with very high pine needle deposition on the bed. The small size of the stream (0.5m width), acidification pressures and the location in the uppermost

reaches of the catchment created conditions inimical for salmonids, European eel or lamprey. There was no suitability for white-clawed crayfish. No otter signs were recorded in vicinity of the site.

Biological water quality, based on Q-sampling, was calculated as **Q3 (poor status) (Appendix C)**. No macro-invertebrate species of conservation value greater than 'least concern', according to national red lists, were recorded via Q-sampling.

Given the absence of aquatic species or habitats of higher conservation value, the aquatic ecological evaluation of site A8 was of **local importance (lower value) (Table 4.3)**.

**Plate 7.1.8** Representative image of site A8 on the upper reaches of the Owenminna River, September 2024

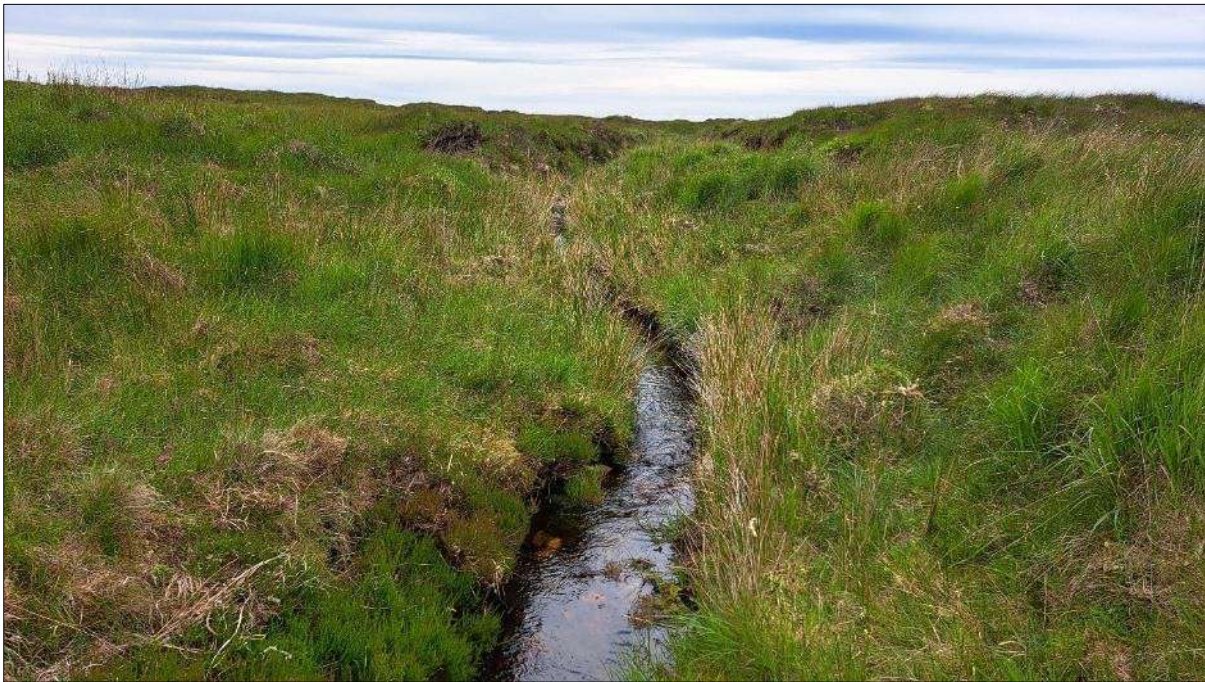
Biological water quality, based on Q-sampling, was calculated as **Q3 (poor status) (Appendix C)**. No macro-invertebrate species of conservation value greater than 'least concern', according to national red lists, were recorded via Q-sampling.

Given the absence of aquatic species or habitats of higher conservation value, the aquatic ecological evaluation of site A9 was of **local importance (lower value) (Table 4.3)**.

**Plate 7.1.9** Representative image site A9 on the Owenminna River, July 2024

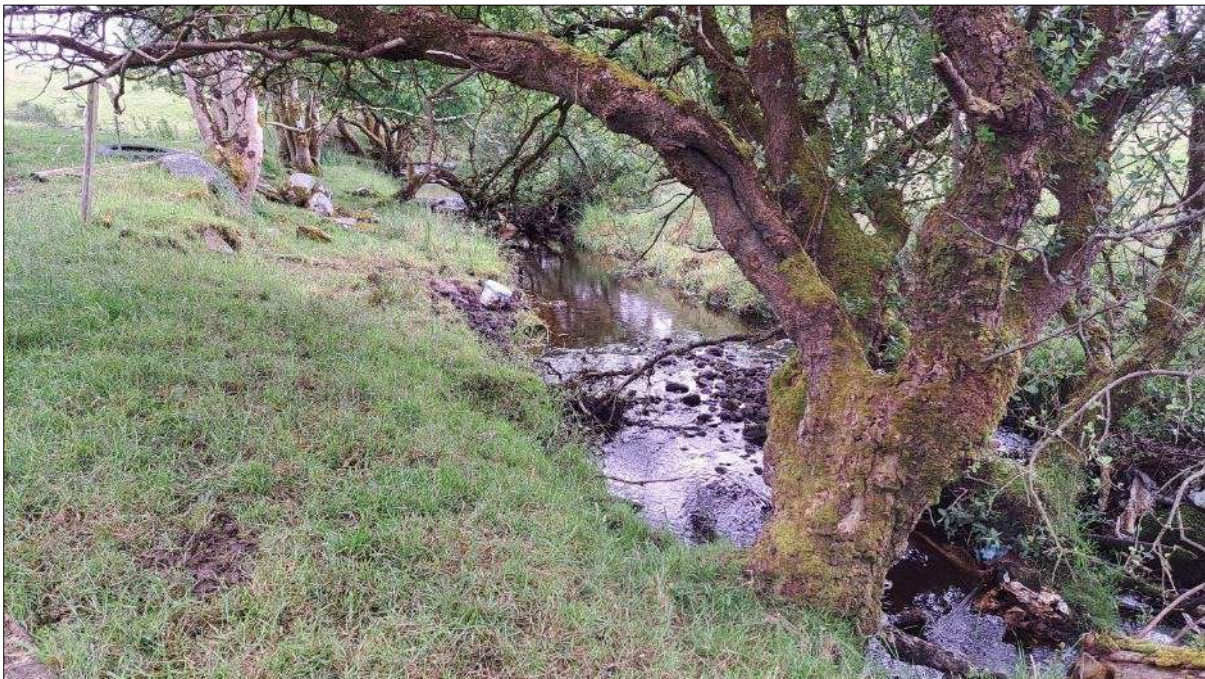
Biological water quality, based on Q-sampling, was calculated as **Q4 (good status) (Appendix C)**. No macro-invertebrate species of conservation value greater than 'least concern', according to national red lists, were recorded via Q-sampling.

Given the presence of salmonids (including Atlantic salmon), the aquatic ecological evaluation of site A10 was of **local importance (higher value) (Table 4.3)**.

**Plate 7.1.10** Representative image site A10 on the Owenminna River, July 2024

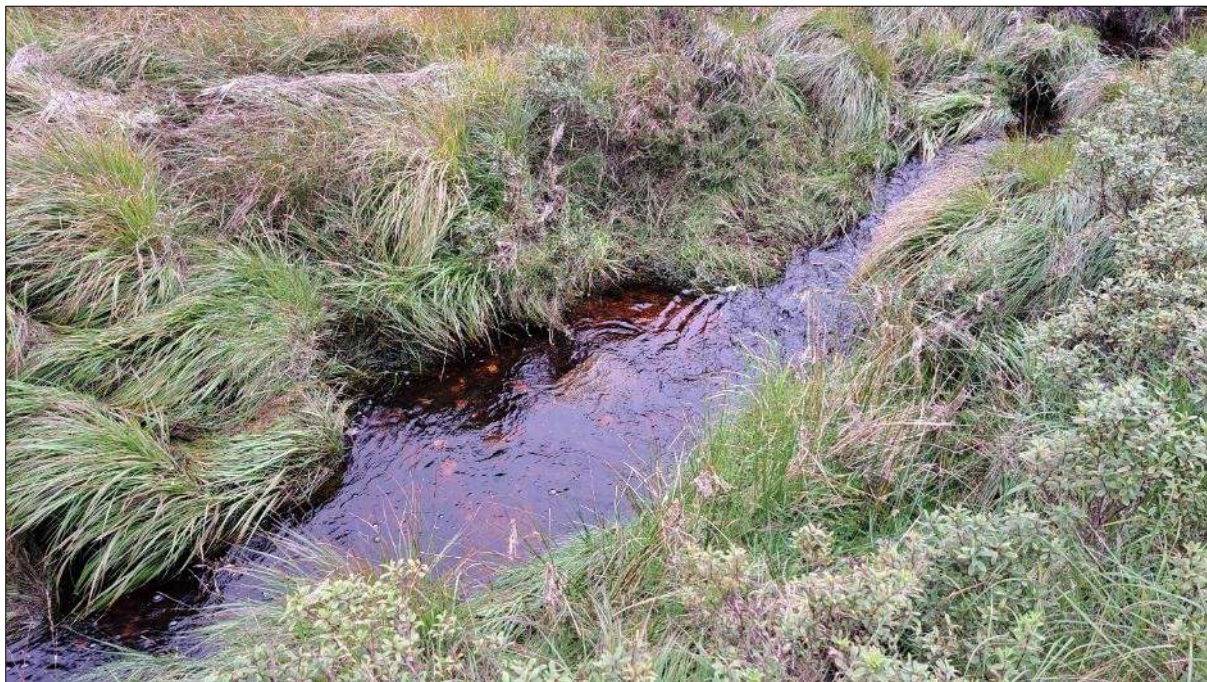
**Plate 7.1.11** Representative image of site A11 on an unnamed Buncrowey River tributary, September 2024

Brown trout was the only fish species recorded via electro-fishing at site A11 (**Appendix B**). The site was of good suitability for salmonids, with abundant spawning habitat present. However, nursery conditions were suboptimal and the poor invertebrate prey resource restricted the trout population - only a low density were recorded. Despite some suitability for European eel, none were recorded and this reflected the location of the site in the upper reaches of the watercourse. There was no suitability for lamprey or white-clawed crayfish. No otter signs were recorded in vicinity of the site.

Given the location of the site within the Ox Mountains Bogs SAC (002006), the aquatic ecological evaluation of site A11 was of **international importance** (**Table 4.3**).

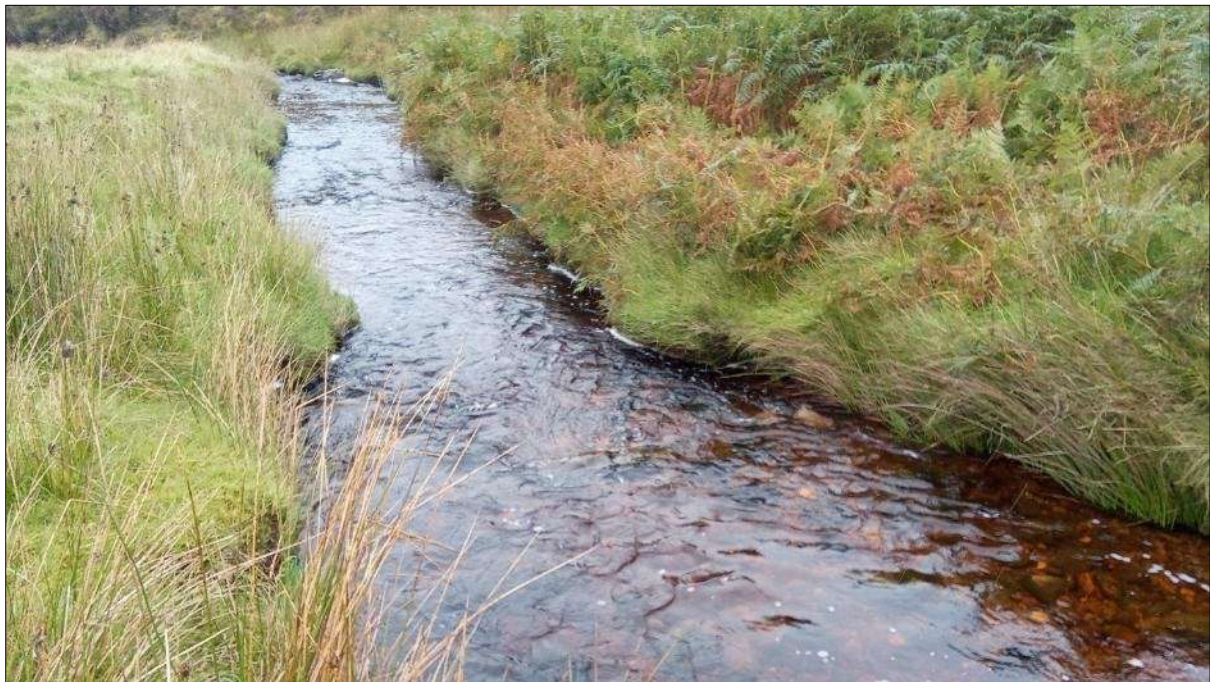
absent given the high energy conditions. However, instream boulders supported the liverwort *Marsupella emarginata* with *Pellia* sp. on incised peaty sandy banks. The largely open banks supported scattered areas of bracken (*Pteridium aquilinum*) scrub (HD1) and wet grassland (GS4) habitat.

Biological water quality, based on Q-sampling, was calculated as **Q4 (good status) (Appendix C)**. No macro-invertebrate species of conservation value greater than 'least concern', according to national red lists, were recorded via Q-sampling.

Given the presence of salmonids, the aquatic ecological evaluation of site A12 was of **local importance (higher value) (Table 4.3)**.

**Plate 7.1.12** Representative image of site A12 on the upper reaches of the Buncrowey River, September 2024

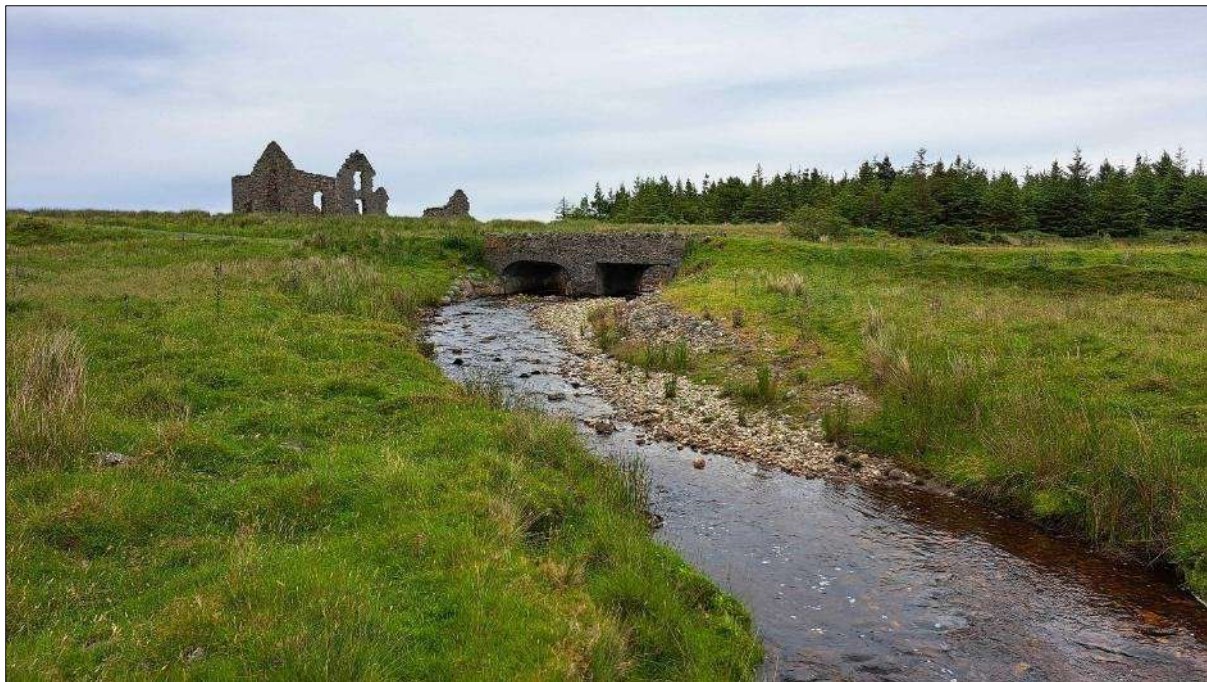
Biological water quality, based on Q-sampling, was calculated as **Q3 (poor status) (Appendix C)**. No macro-invertebrate species of conservation value greater than 'least concern', according to national red lists, were recorded via Q-sampling.

Given the presence of salmonids and Red-listed European eel, the aquatic ecological evaluation of site A13 was of **local importance (higher value) (Table 4.3)**.

**Plate 7.1.13** Representative image of site A13 on the Buncrowey River at Cooper's Lodge, July 2024

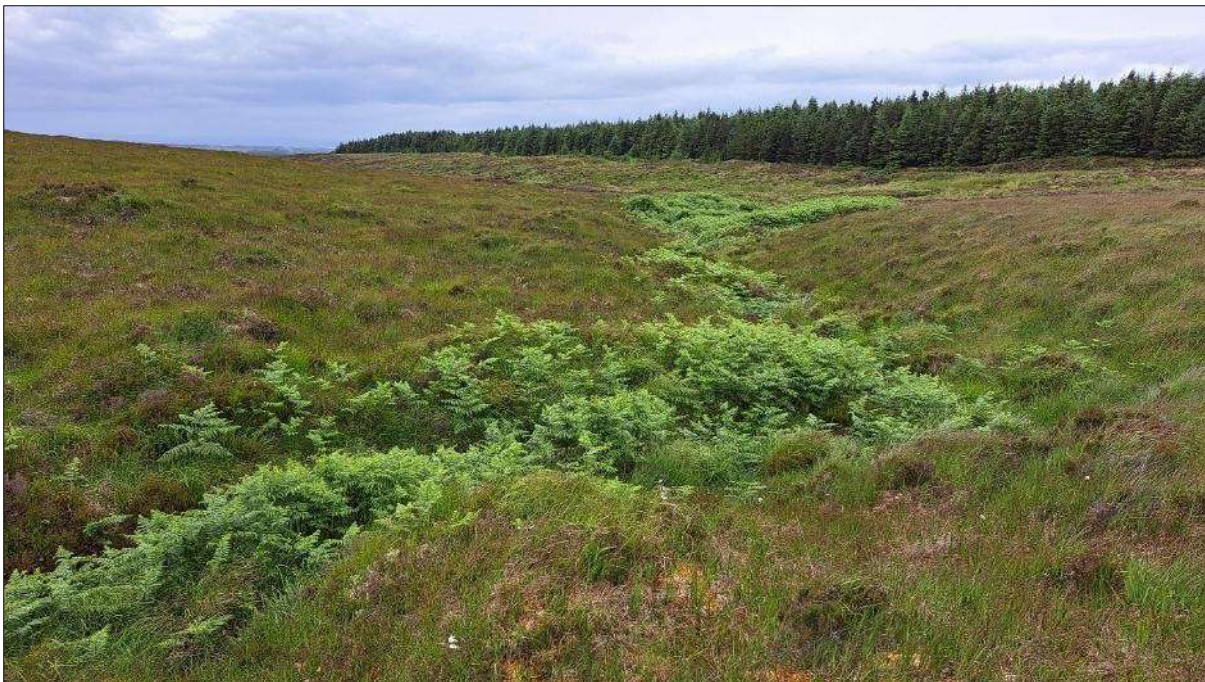
Biological water quality, based on Q-sampling, was calculated as **Q4 (good status)** (**Appendix C**). No macro-invertebrate species of conservation value greater than 'least concern', according to national red lists, were recorded via Q-sampling.

Given the location of the site within the Ox Mountains Bogs SAC (002006), the aquatic ecological evaluation of site A14 was of **international importance** (**Table 4.3**).

**Plate 7.1.14** Representative image of site A14 on the upper reaches of an unnamed Buncrowey River tributary, September 2024

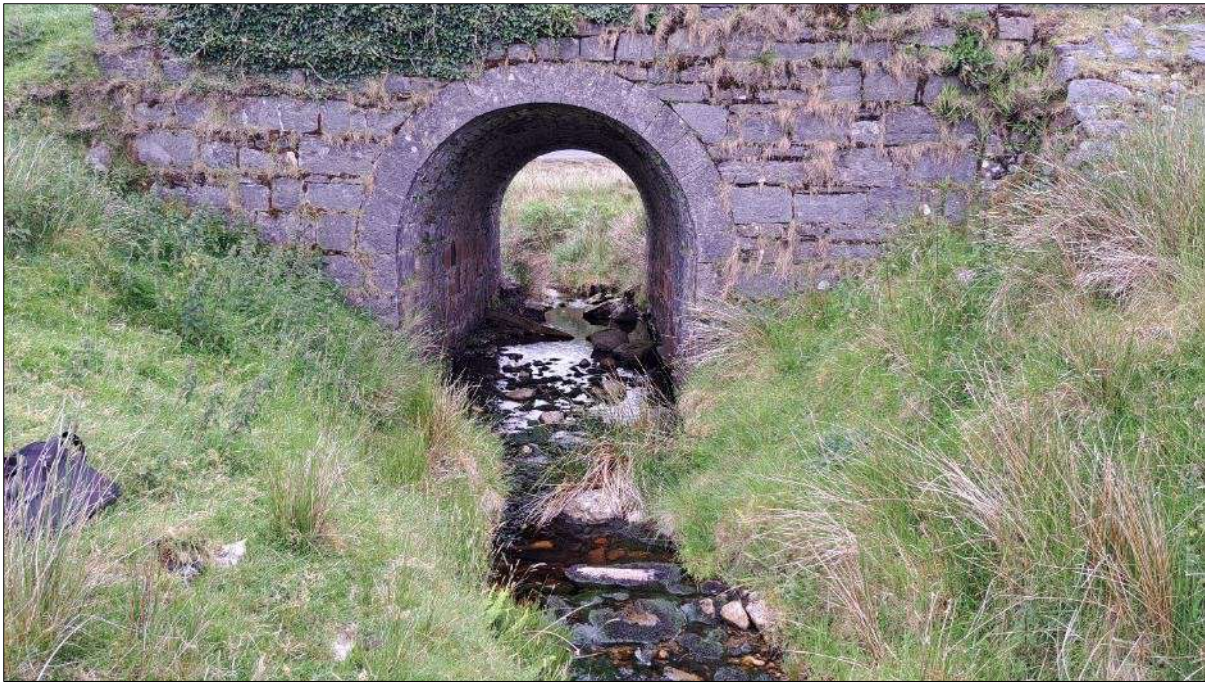
Biological water quality, based on Q-sampling, was calculated as **Q3-4 (moderate status) (Appendix C)**. No macro-invertebrate species of conservation value greater than 'least concern', according to national red lists, were recorded via Q-sampling.

Given the location of the site within the Ox Mountains Bogs SAC (002006), the aquatic ecological evaluation of site A15 was of **international importance (Table 4.3)**.

**Plate 7.1.15** Representative image of site A15 on the lower reaches of an unnamed Buncrowey River tributary, July 2024

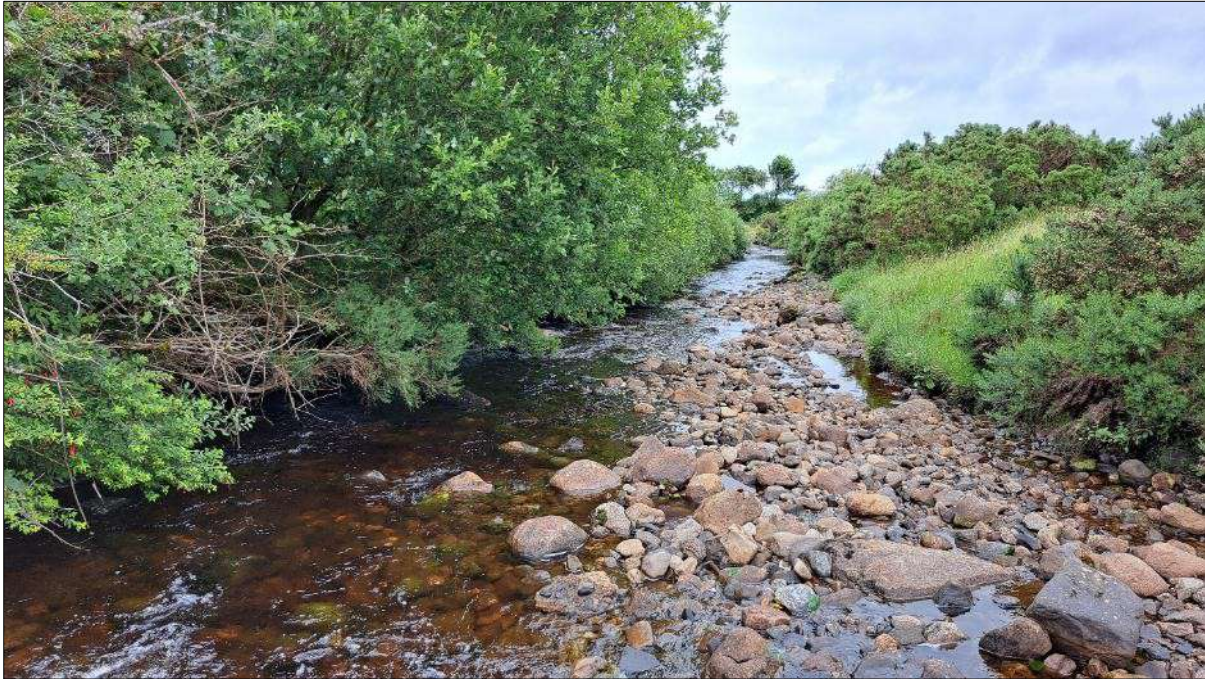
Biological water quality, based on Q-sampling, was calculated as **Q3-4 (moderate status) (Appendix C)**. No macro-invertebrate species of conservation value greater than 'least concern', according to national red lists, were recorded via Q-sampling.

Given the presence of salmonids (including Atlantic salmon), the aquatic ecological evaluation of site A16 was of **local importance (higher value)** (Table 4.3).

**Plate 7.1.16** Representative image of site A16 on the Buncrowey River, July 2024

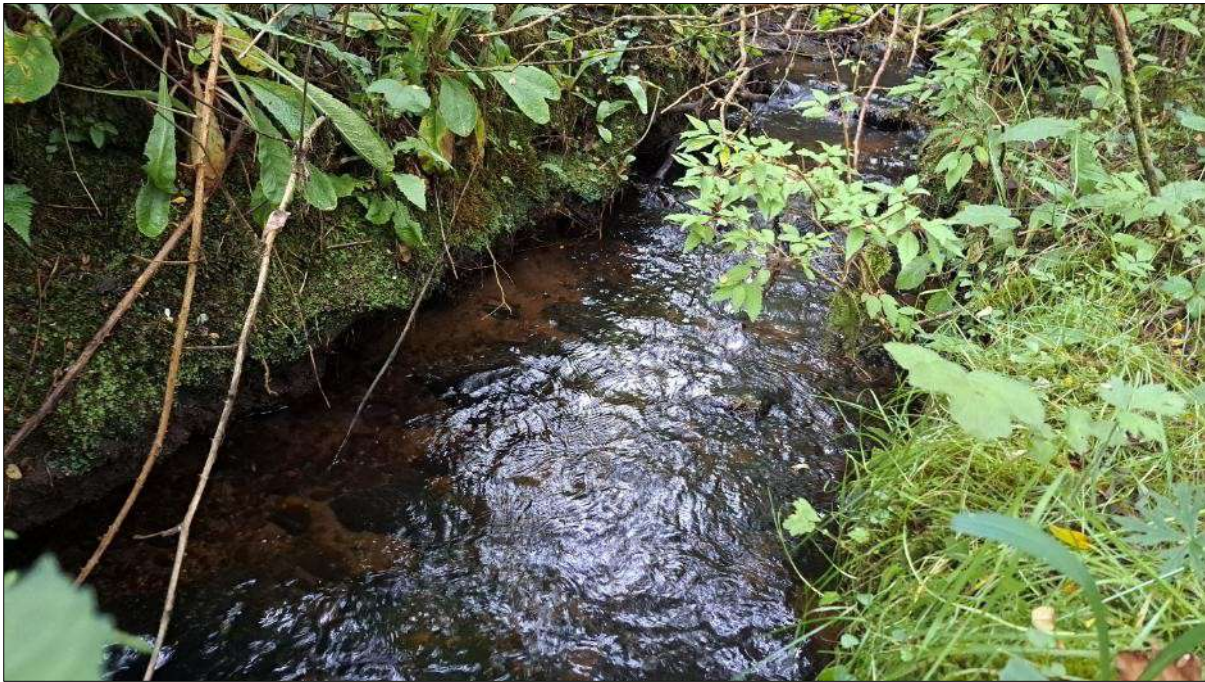
Biological water quality, based on Q-sampling, was calculated as **Q3-4 (moderate status) (Appendix C)**. No macro-invertebrate species of conservation value greater than 'least concern', according to national red lists, were recorded via Q-sampling.

Given the presence of salmonids, the aquatic ecological evaluation of site A17 was of **local importance (higher value) (Table 4.3)**.

**Plate 7.1.17** Representative image of site A17 on the Rathgoonaun River, July 2024

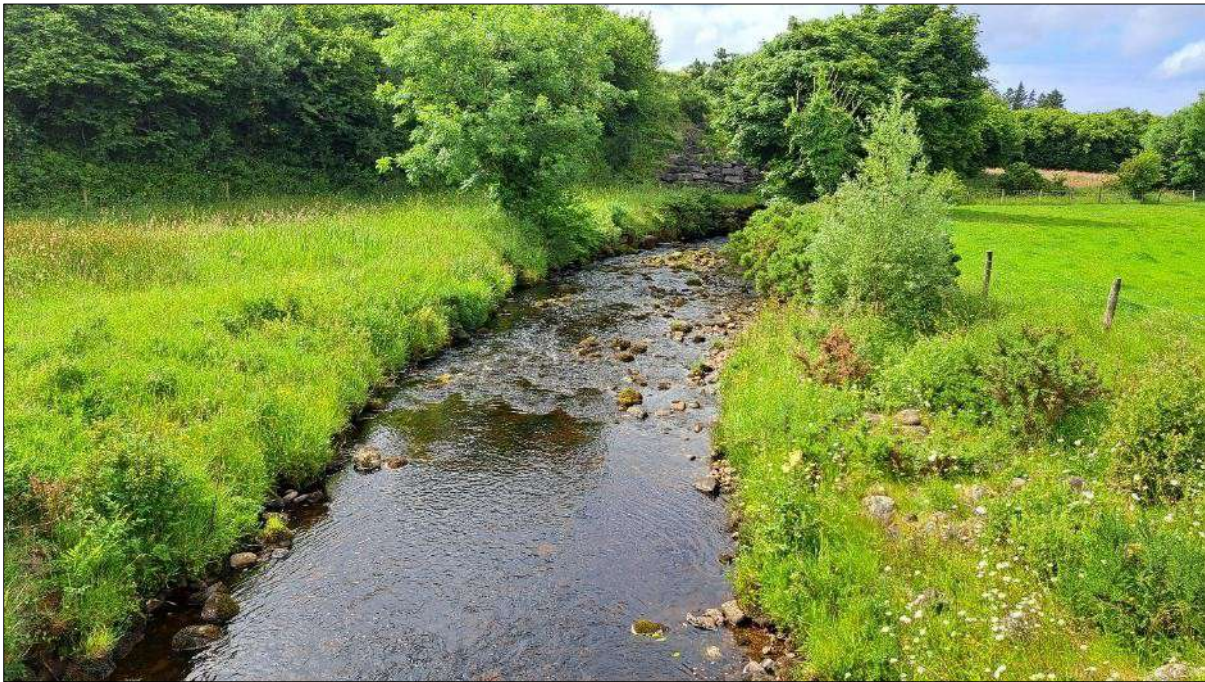
Biological water quality, based on Q-sampling, was calculated as **Q4 (good status) (Appendix C)**. No macro-invertebrate species of conservation value greater than 'least concern', according to national red lists, were recorded via Q-sampling.

Given the presence of salmonids (including Atlantic salmon) and Red-listed European eel, the aquatic ecological evaluation of site A18 was of **local importance (higher value) (Table 4.3)**.

**Plate 7.1.18** Representative image of site A18 on the Buncrowey River, July 2024

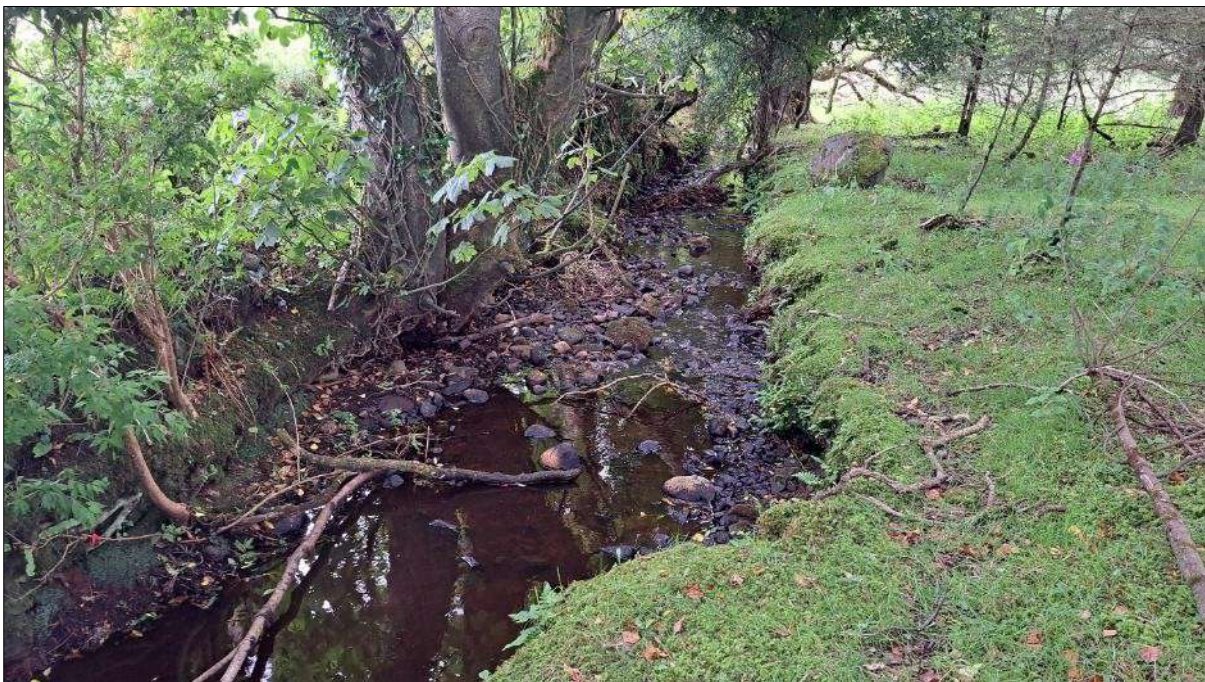
Biological water quality, based on Q-sampling, was calculated as **Q3 (poor status) (Appendix C)**. No macro-invertebrate species of conservation value greater than 'least concern', according to national red lists, were recorded via Q-sampling.

Given the absence of aquatic species or habitats of higher conservation value, the aquatic ecological evaluation of site A20 was of **local importance (lower value) (Table 4.3)**.

**Plate 7.1.20** Representative image of site A20 on the Carrownrush River, July 2024

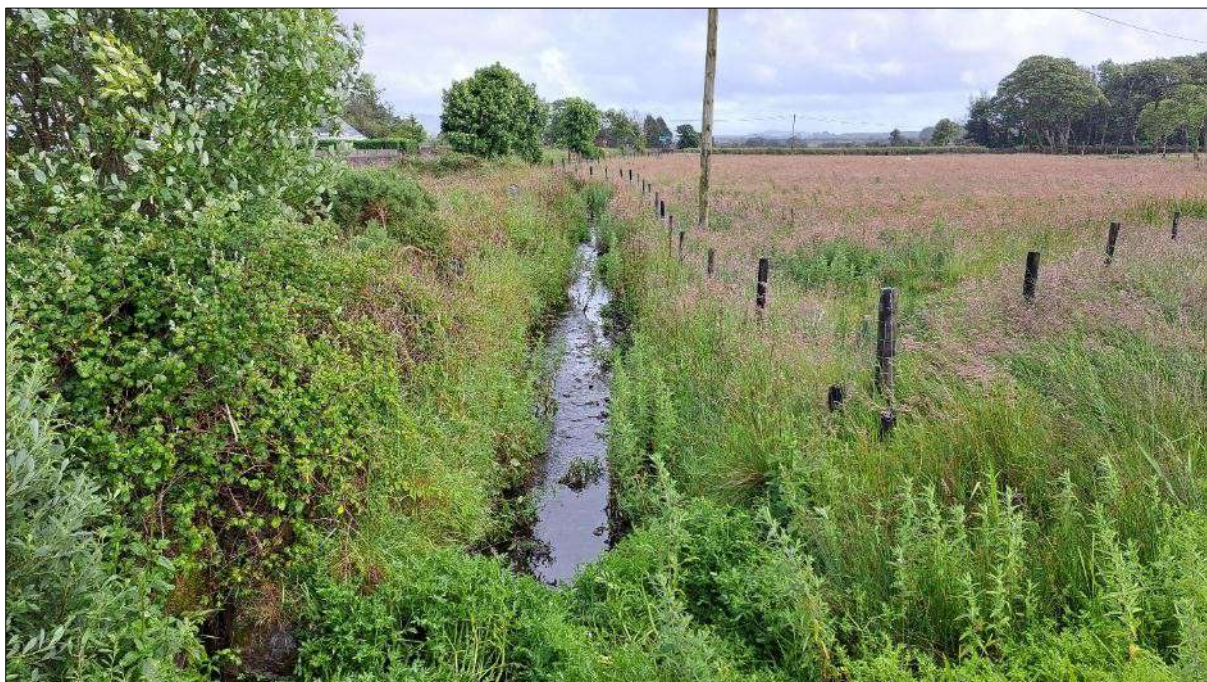
Biological water quality, based on Q-sampling, was calculated as **Q4 (good status) (Appendix C)**. No macro-invertebrate species of conservation value greater than 'least concern', according to national red lists, were recorded via Q-sampling.

Given the absence of aquatic species or habitats of higher conservation value, the aquatic ecological evaluation of site A21 was of **local importance (lower value) (Table 4.3)**.

**Plate 7.1.21** Representative image of site A21 on the Carrownrush River, July 2024

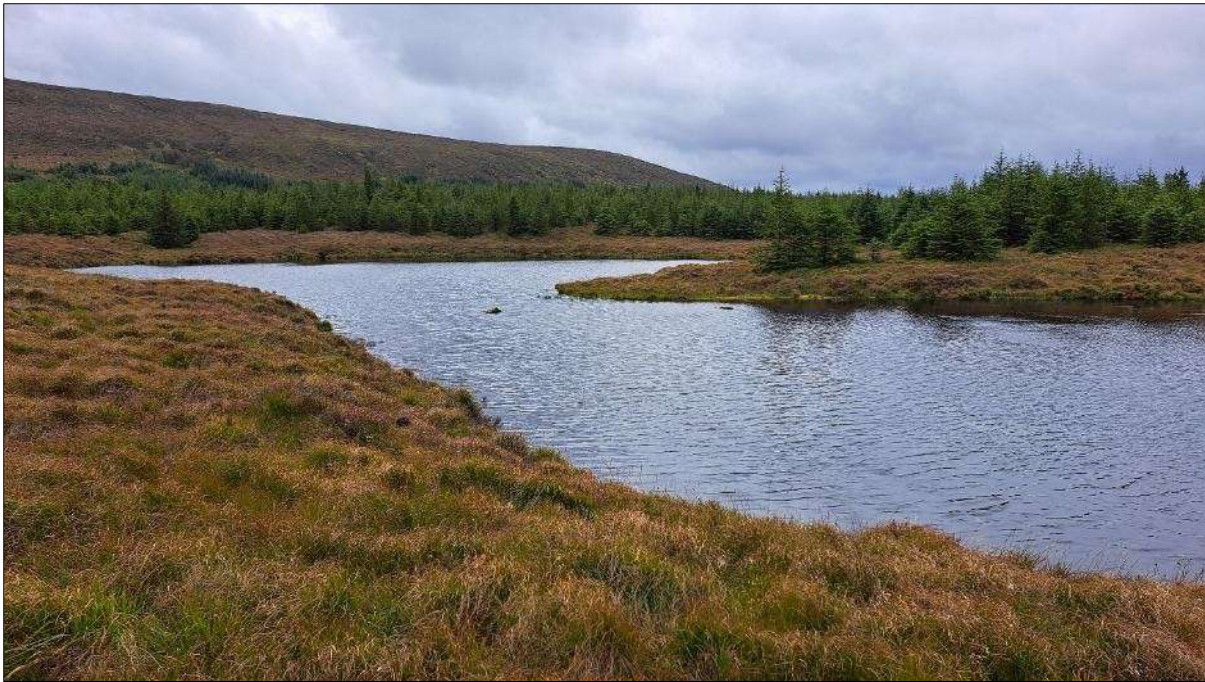
Site L1 was located at Lough Croane, a twin basin lake of c.1ha situated within the vicinity of the Proposed Wind Farm. The lake featured deep margins of >1m and quickly shelved to 1.5->2m depth although shallower areas were present along the western shore. The bed was dominated by boulder and cobble with localised gravels and sands along windward margins. Peat staining was high with abundant flocculent peat on the substrata. In light of this, macrophyte growth was sparse with occasional bottle sedge (*Carex rostrata*), floating bur-reed (*Sparganium angustifolium*), bulbous rush and rare bladderwort (*Utricularia* sp.) along the margins. However, the moss *Sphagnum cuspidatum* was abundant around the margins and littoral areas. The filamentous rhodophyte *Batrachospermum* sp. was frequent. Filamentous algae were also abundant. The lake was representative of natural dystrophic lake Annex I habitat (3160). The open banks were dominated by rushes, sedges, purple moor grass, bilberry (*Vaccinium myrtillus*), cross-leaved heath (*Erica tetralix*) and heather with scattered bog myrtle. The lake was surrounded by pre-thicket sitka spruce (WD4) with localised lodgepole pine in a wider landscape of blanket bog (PB2).

The lake had good potential for brown trout (observed surface feeding during the site visit) with some limited littoral spawning habitat present along windward shores. Likewise, there was also suitability for European eel although the location in the upper reaches of the catchment and poor fluvial connectivity with downstream habitats reduced the likelihood of their presence. There was some suitability for smooth newt (none recorded via sweep sampling). No otter signs were recorded in vicinity of the site.

No macro-invertebrate species of conservation value greater than 'least concern', according to national red lists, were recorded via sweep sampling (**Appendix C**). The sample was dominated by Dipteran larvae, Corixidae and damselfly larvae (Coenagrionidae).

Given the presence of Annex I natural dystrophic lake habitat (3160), the aquatic ecological evaluation of site L1 was of **county importance** (**Table 4.3**).

**Plate 7.1.22** Representative image of site L1 at Lough Croane, September 2024
