# Aquatic baseline report for the proposed Crumhach Wind Farm, Co. Sligo

Prepared by Triturus Environmental Ltd. for MKO

**February 2025**

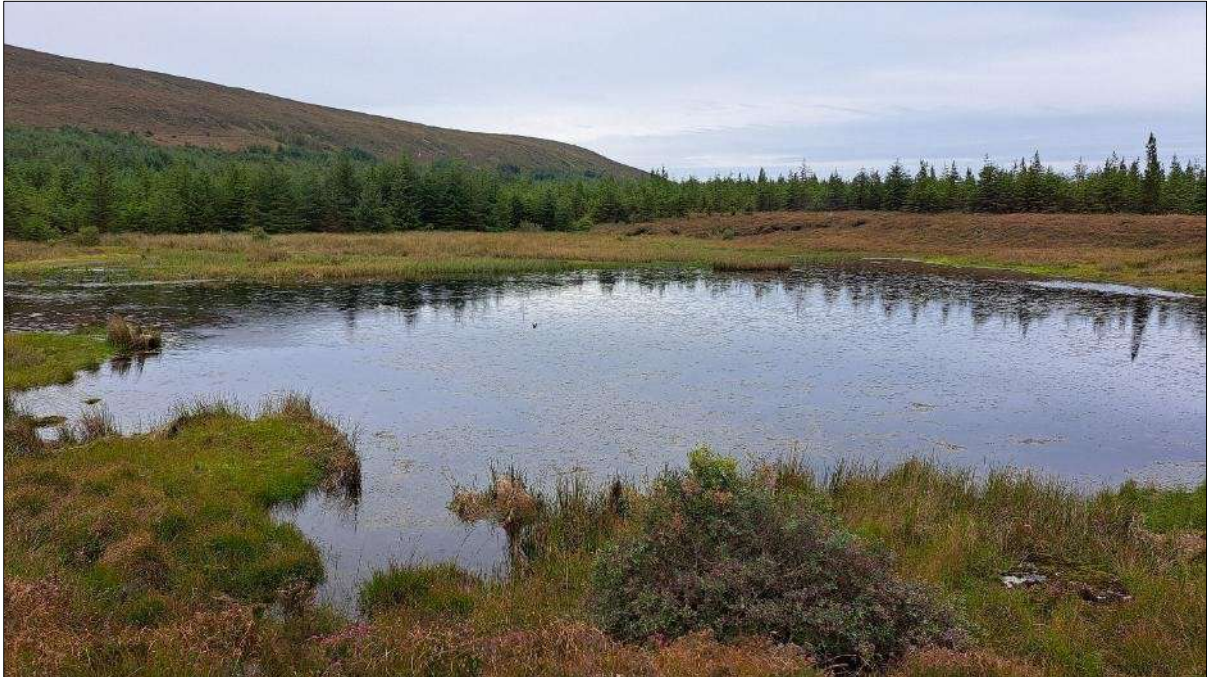
Site L2 was located at Lough Anlaba within the vicinity of the Proposed Wind Farm. Lough Anlaba was a loosely triangular shaped upland lake covering 0.5ha surface area. The very shallow (<0.5m) and homogenous lake featured a bed of compacted gravel and cobble with frequent boulder. There was a high cover of floc and flocculant peat throughout, with areas along the southern shore featuring deep soft sediment accumulations (>0.3m in depth). The lake was heavily vegetated with dominant bulbous rush, frequent bladderwort (*Utricularia* sp.) and occasional bog pondweed. The moss *Sphagnum cuspidatum* was abundant in littoral areas with some bottle sedge locally along SW margins adjoining quaking margins (PF3). Floating bur-reed was present but rare. The lake was representative of natural dystrophic lake Annex I habitat (3160). Lake margins also supported abundant purple moor grass, compact rush (*Juncus conglomeratus*) and sedges. The site was bordered by areas of wet heath (HH3) and coniferous afforestation (WD4) in a landscape of upland blanket bog (PB2).

Lough Anlaba was of relatively low value for salmonids (none observed) with the heavily vegetated, silted lake providing poor fisheries habitat. Some salmonid spawning habitat was present at the lake outflow and also along windward shores given the dominance of hard substrata, locally. Brown trout were recorded from the outflow channel via electro-fishing at site A11, downstream of the lake, in July 2024 (**Appendix B**). The lake was of some suitability for European eel although the likelihood of their presence would be reduced given the location of the lake in the upper reaches of the catchment. There was no suitability for white-clawed crayfish. No otter signs were recorded in vicinity of the site.

No macro-invertebrate species of conservation value greater than 'least concern', according to national red lists, were recorded via sweep sampling (**Appendix C**). The sample was dominated by Dipteran larvae and damselfly larvae (Coenagrionidae).

Given the presence of Annex I natural dystrophic lake habitat (3160), the aquatic ecological evaluation of site L2 was of **county importance** (Table 4.3).

**Plate 7.1.23** Representative image of site L2 at Lough Anlaba, September 2024

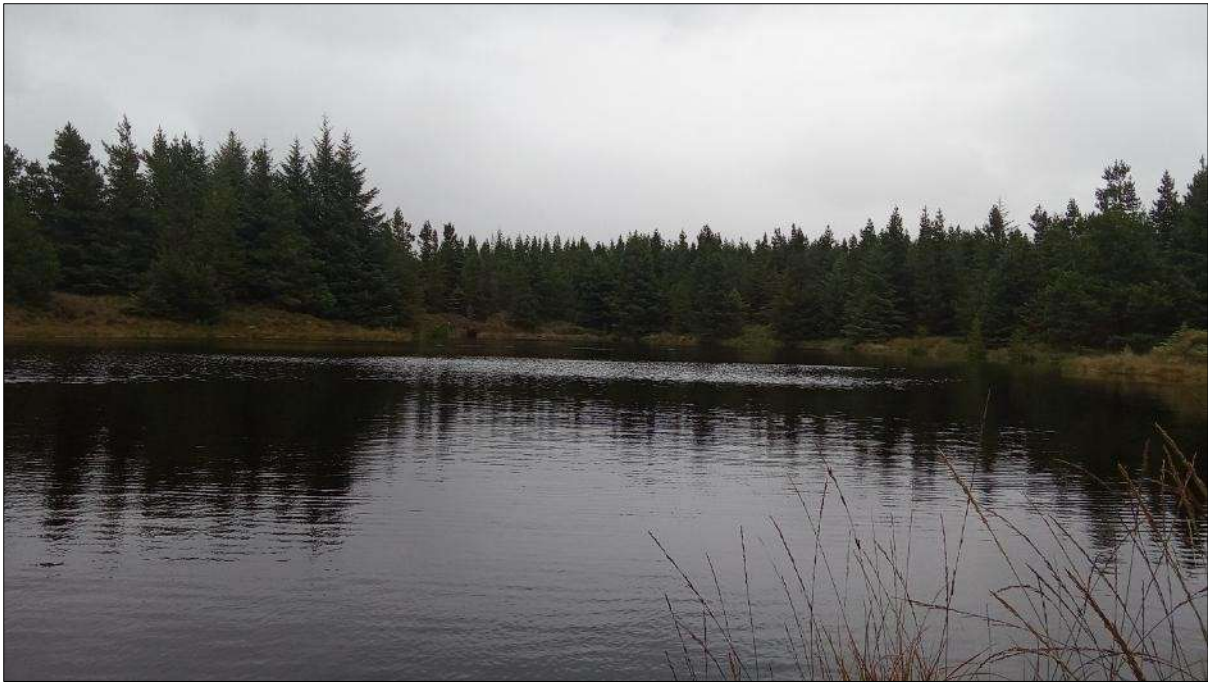
**Plate 7.1.24** Representative image of site L3 at Lough Nacrowagh, September 2024

Site L3 was located at Lough Nacrowagh within the vicinity of the Proposed Wind Farm. The small, sheltered upland lake covered 0.5ha and was 1-4m deep with a bed of humic soft sediment. Peat staining as high and macrophyte growth was resultingly low, although bulbous rush was frequent locally. *Sphagnum* spp. mosses were abundant in littoral areas. The lake was representative of natural dystrophic lake Annex I habitat (3160). The outflow, leading to the Owenminna River, had been modified historically and represented a drainage channel. The lake was bordered by extensive areas of coniferous afforestation (WD4).

Given the presence of Annex I natural dystrophic lake habitat (3160), the aquatic ecological evaluation of site L3 was of **county importance** (Table 4.3).

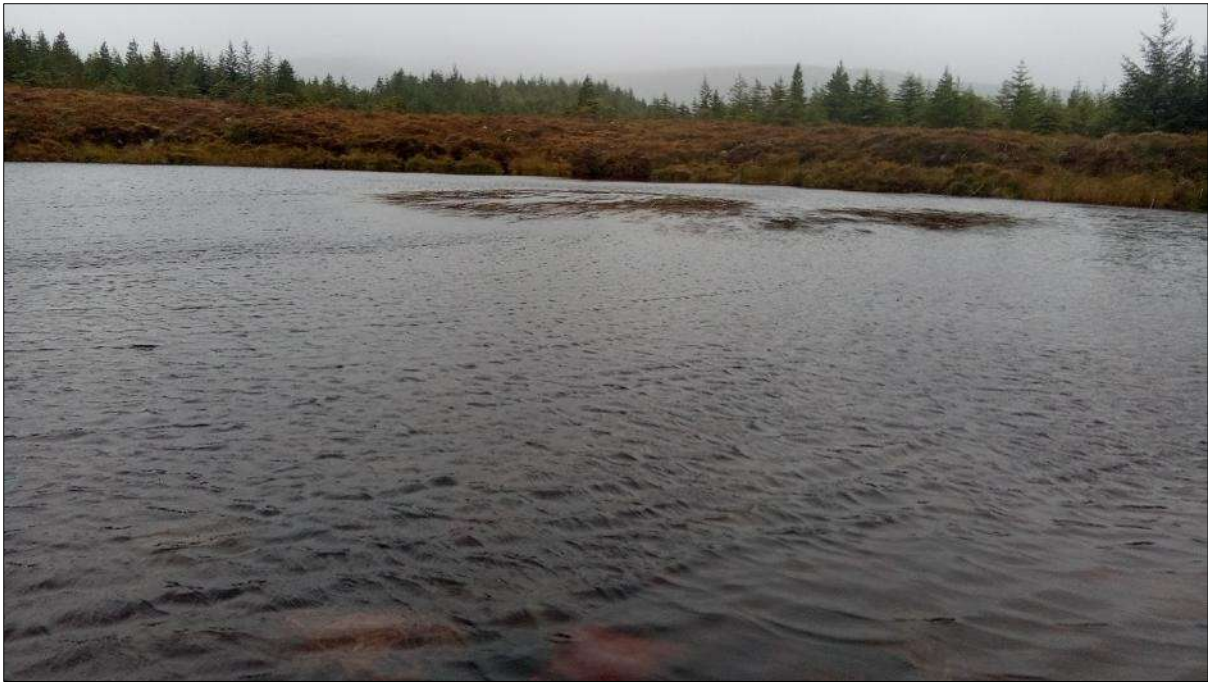
**Plate 7.1.25** Representative image of site L4 at Lough Brickeagh, September 2024

Site L4 was located at Lough Brickeagh within the vicinity of the Proposed Wind Farm. The small, sheltered upland oligotrophic lake of 0.4ha was typically 1-2m deep with low water turbidity and low levels of peat staining. The bed comprised areas of cobble, gravels and sands with scattered bedded boulder and areas of humic soft sediment. The oligotrophic lake supported a low diversity of macrophyte plants. These included frequent submerged bulbous rush and floating bur-reed. *Sphagnum cuspidatum* was frequent in the littorals. The lake was representative of natural dystrophic lake Annex I habitat (3160). The site was bordered by upland blanket bog (PB2) and extensive areas of coniferous afforestation (WD4).

The lake was of some value for salmonids, with brown trout observed (feeding) during the site visit. Littoral areas of hard substrata provided some suitability for lacustrine spawning salmonids. The lake was of some value for European eel although the likelihood of their presence would be reduced given the location of the lake in the upper reaches of the catchment and limited connectivity with the adjacent Buncrowey River. There was no suitability for white-clawed crayfish. No otter signs were recorded in vicinity of the site.

Given the presence of Annex I natural dystrophic lake habitat (3160), the aquatic ecological evaluation of site L4 was of **county importance** (**Table 4.3**).

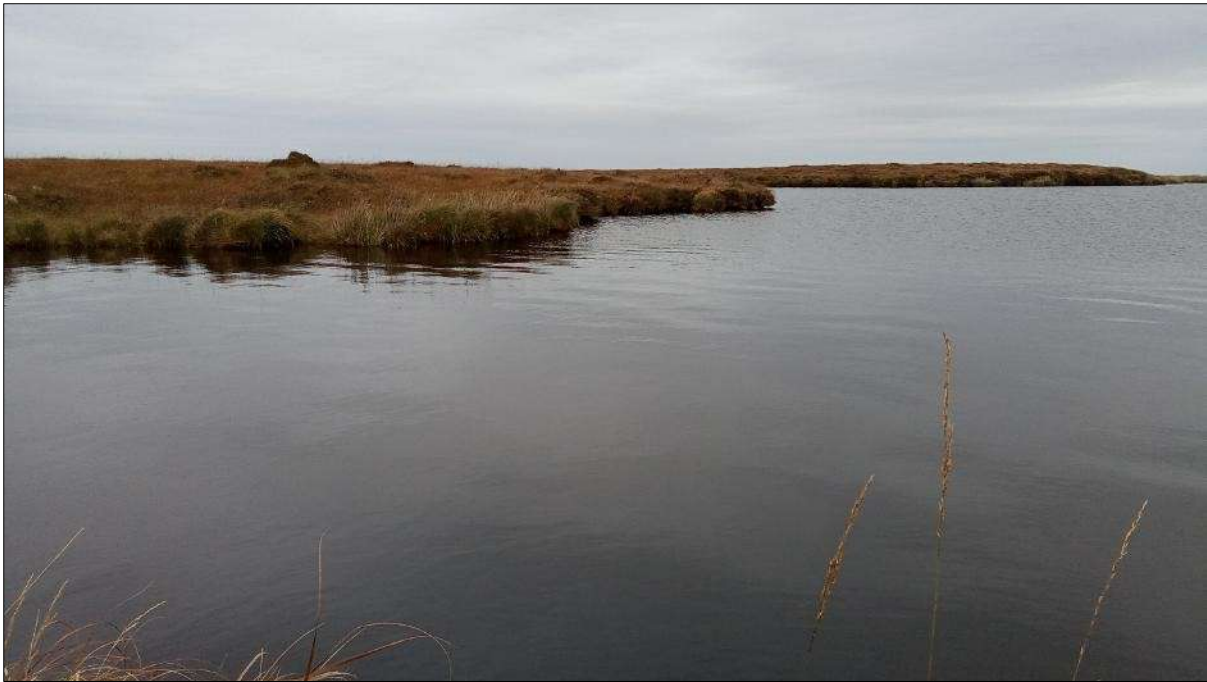
**Plate 7.1.26** Representative image of site L5 at Lough Nafullow, September 2024

Site L5 was located at Lough Nafullow within the vicinity of the Proposed Wind Farm. The 4ha upland oligotrophic lake was 1-4m deep with a bed of humic soft sediment and high levels of peat staining. The lake had eroded peat margins that graded into the adjoining peatland and numerous small peninsulas and bays with an outflowing river in the northwestern corner. The oligotrophic lake supported a low diversity of macrophytes. These included beds of floating bur-reed and frequent submerged bulbous rush. Bog bean (*Menyanthes trifoliata*) and bladderwort (*Utricularia* agg.) were recorded as rare. *Sphagnum cuspidatum* was present very locally in the littorals. The lake was representative of natural dystrophic lake Annex I habitat (3160). The adjoining blanket bog habitat supported cross-leaved heath, purple moor grass, bog asphodel (*Narthecium ossifragum*) and *Cladonia* lichen. The site was bordered by upland blanket bog (PB2) and extensive areas of coniferous afforestation (WD4) to the south.

The site was of some moderate suitability for salmonids, with brown trout observed feeding during the site visit. The lake was also of moderate suitability for European eel with good connectivity to the downstream Easky River. There was no suitability for white-clawed crayfish. No otter signs were recorded in vicinity of the site.

Given the location of the site within the Ox Mountains Bogs SAC (002006), the aquatic ecological evaluation of site L5 was of **international importance** (**Table 4.3**).

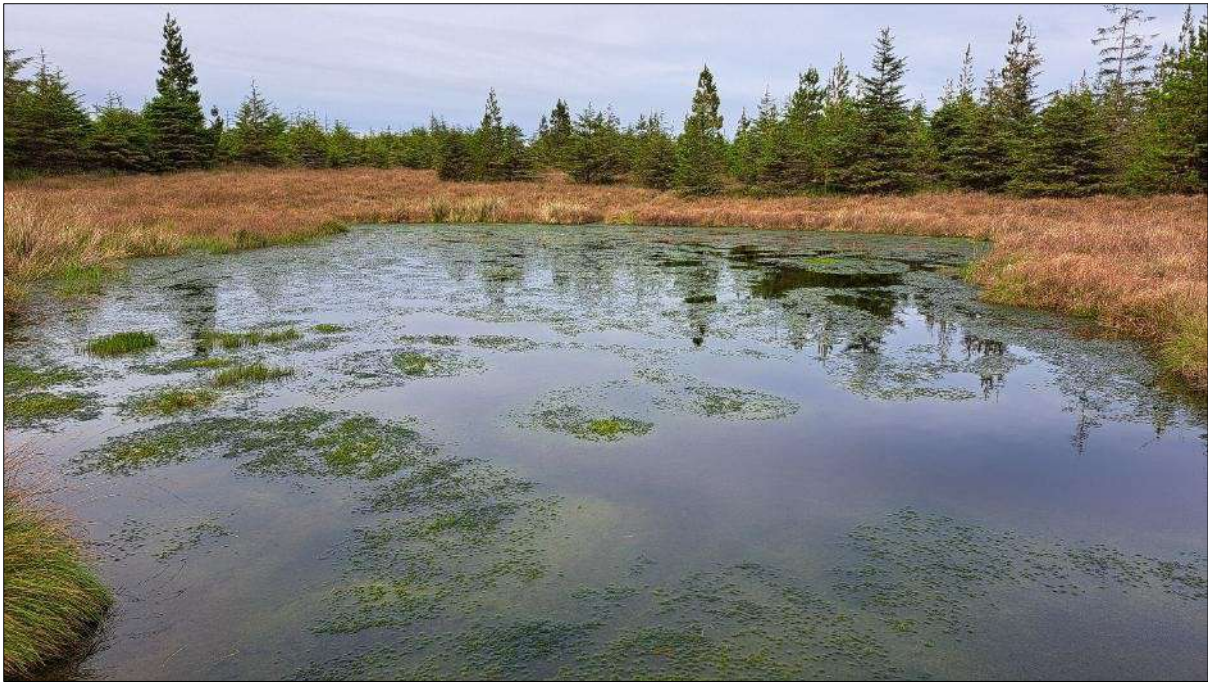
No macro-invertebrate species of conservation value greater than 'least concern', according to national red lists, were recorded via sweep sampling (**Appendix C**). The poorly developed macroinvertebrate community comprised low numbers of Dytiscidae, dragonfly and damselfly larvae.

Given the presence of Annex I natural dystrophic pond habitat (3160), the aquatic ecological evaluation of site P1 was of **county importance** (Table 4.3).

**Plate 7.1.27** Representative image of site P1, September 2024

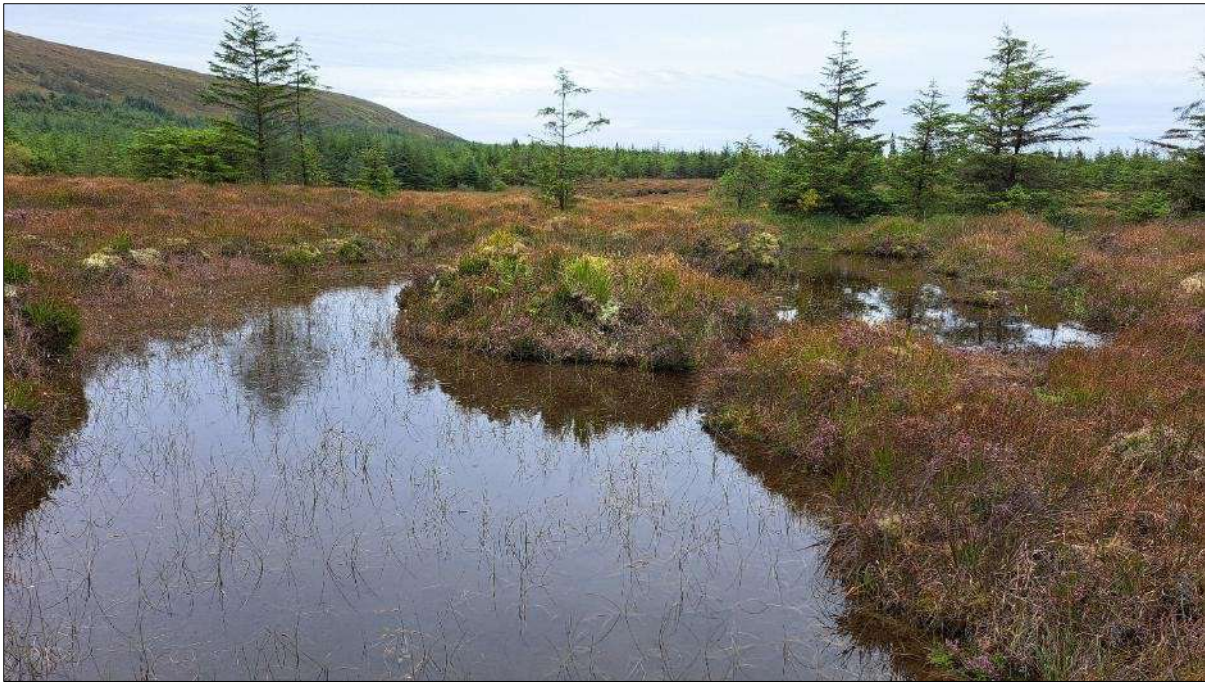
**Plate 7.1.28** Representative image of site P2, September 2024

No macro-invertebrate species of conservation value greater than 'least concern', according to national red lists, were recorded via sweep sampling (**Appendix C**). The poorly developed macroinvertebrate community was dominated by Corixidae and damselfly larvae (Coenagrionidae).

Given the presence of Annex I natural dystrophic pond habitat (3160), the aquatic ecological evaluation of site P2 was of **county importance** (**Table 4.3**).

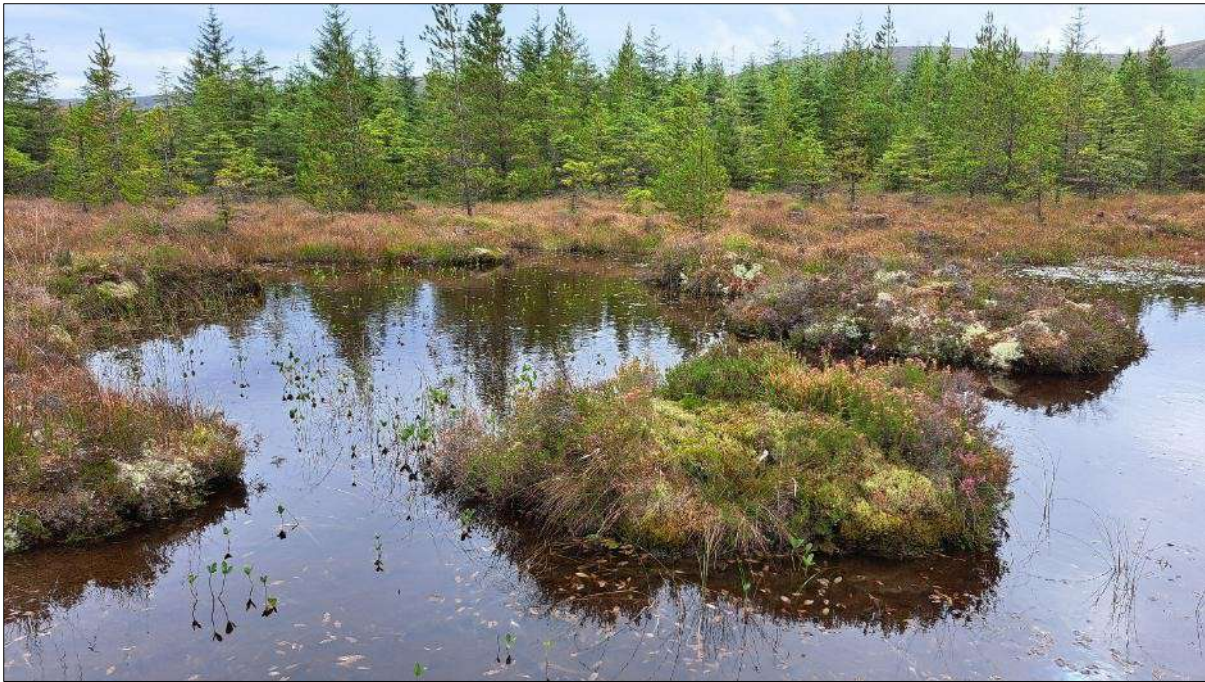
**Plate 7.1.29** Representative image of site P3, September 2024

No macro-invertebrate species of conservation value greater than 'least concern', according to national red lists, were recorded via sweep sampling (**Appendix C**). The poorly developed macroinvertebrate community was dominated by Corixidae and damselfly larvae (Coenagrionidae).

Given the presence of Annex I natural dystrophic pond habitat (3160), the aquatic ecological evaluation of site P3 was of **county importance** (Table 4.3).

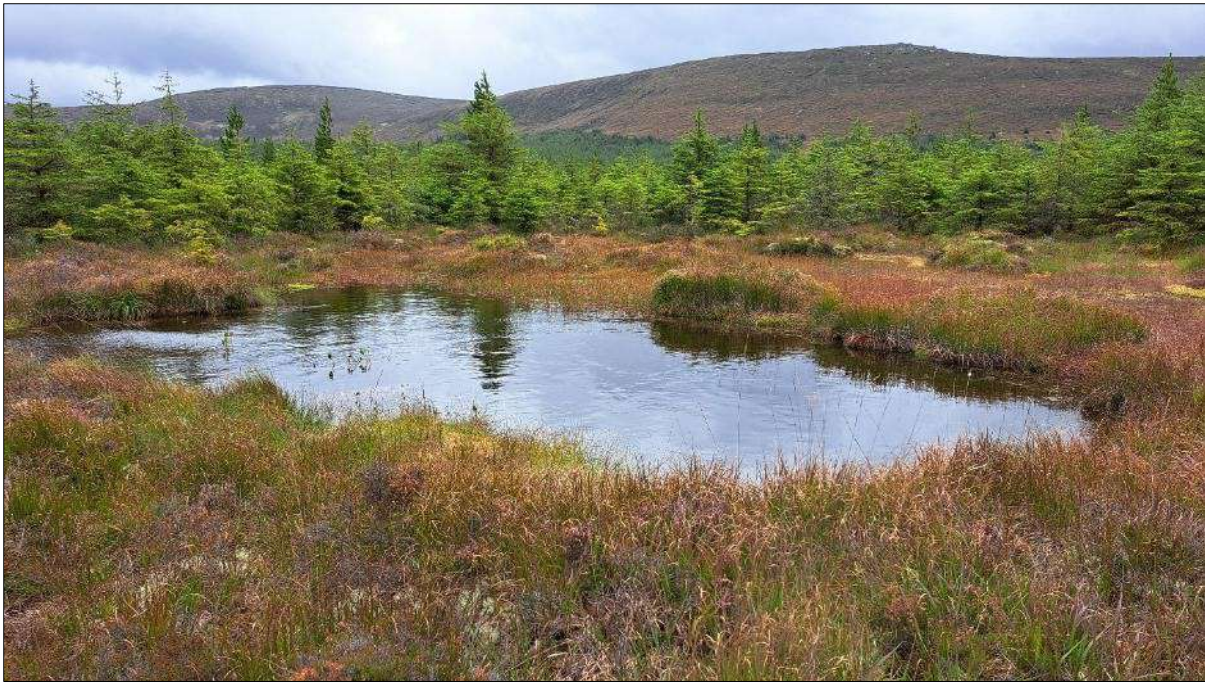
**Plate 7.1.30** Representative image of site P4, September 2024

No macro-invertebrate species of conservation value greater than 'least concern', according to national red lists, were recorded via sweep sampling (**Appendix C**). The poorly developed macroinvertebrate community was dominated by Corixidae and damselfly larvae (Coenagrionidae).

Given the presence of Annex I natural dystrophic pond habitat (3160), the aquatic ecological evaluation of site P4 was of **county importance** (Table 4.3).

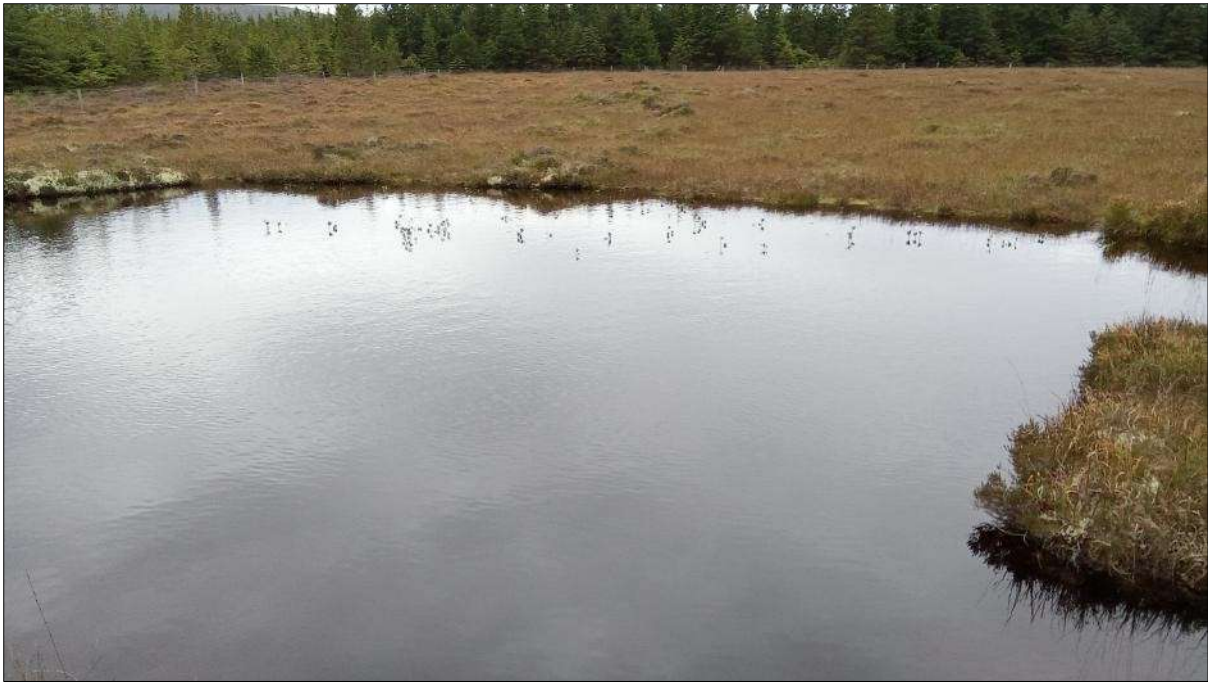
**Plate 7.1.31** Representative image of site P5, September 2024

Site P5 was of poor fisheries value given its small size, siltation and isolation from superior fisheries habitats. The site was a poor quality salmonid habitat (none observed). However, given the close proximity to Lough Nafullow, there was some suitability for European eel. There was no suitability for white-clawed crayfish. No otter signs were recorded in vicinity of the site.

No macro-invertebrate species of conservation value greater than 'least concern', according to national red lists, were recorded via sweep sampling (**Appendix C**). The poorly developed macroinvertebrate community was dominated by damselfly larvae (Coenagrionidae).

Given the location of the site within the Ox Mountains Bogs SAC (002006), the aquatic ecological evaluation of site P5 was of **international importance** (Table 4.3).

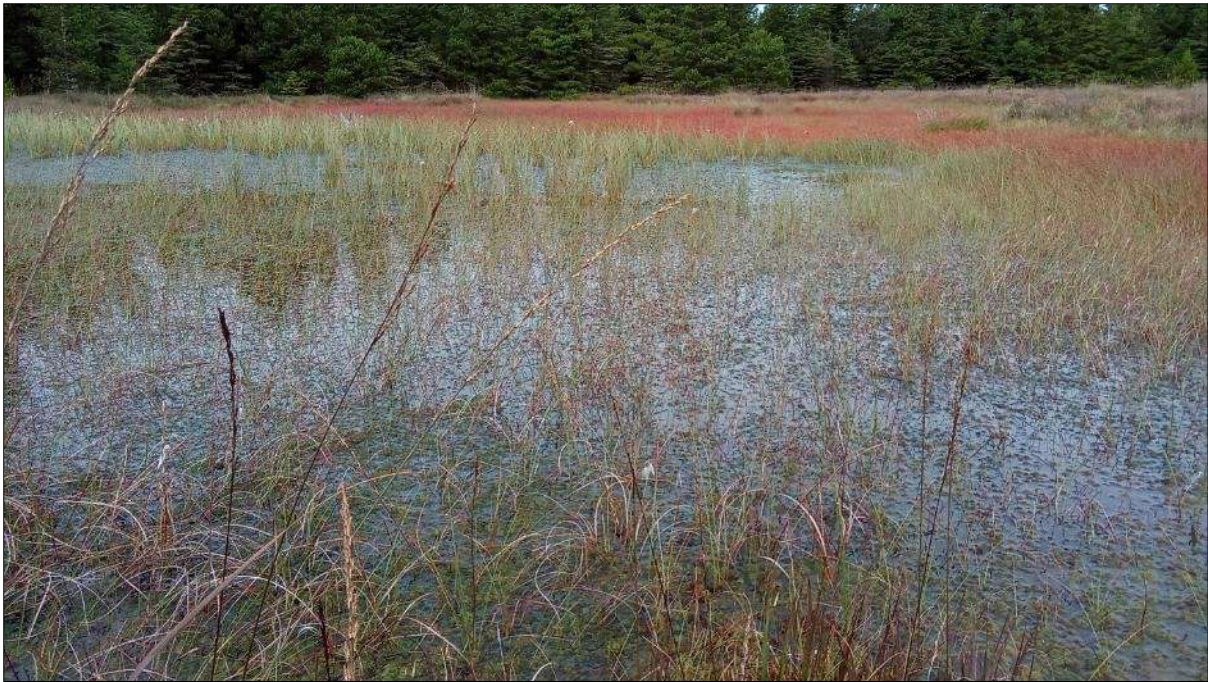
**Plate 7.1.32** Representative image of site P6, September 2024

No macro-invertebrate species of conservation value greater than 'least concern', according to national red lists, were recorded via sweep sampling (**Appendix C**). The poorly developed macroinvertebrate community supported low numbers of Dytiscidae and Corixidae.

Given the presence of Annex I natural dystrophic pond habitat (3160), the aquatic ecological evaluation of site P6 was of **county importance** (**Table 4.3**).

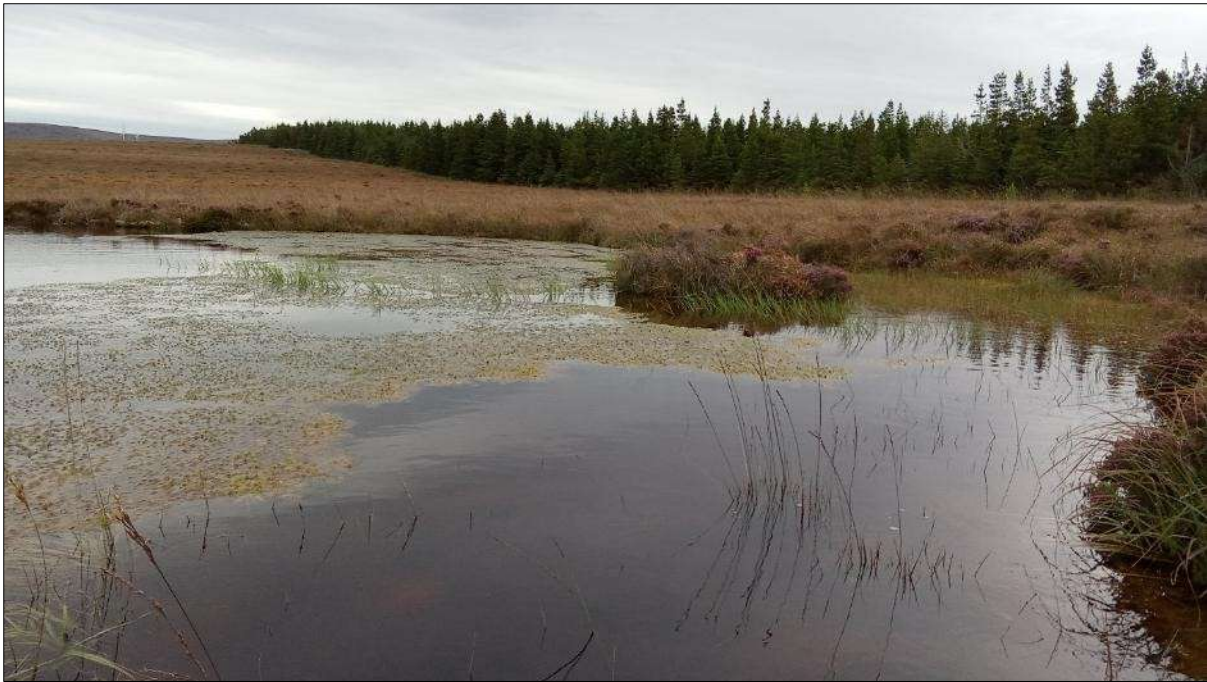
**Plate 7.1.33** Representative image of site P7, September 2024

No macro-invertebrate species of conservation value greater than 'least concern', according to national red lists, were recorded via sweep sampling (**Appendix C**). The poorly developed macroinvertebrate community was dominated by Corixidae and damselfly larvae (Coenagrionidae).

Given the location of the site within the Ox Mountains Bogs SAC (002006), the aquatic ecological evaluation of site P7 was of **international importance** (Table 4.3).

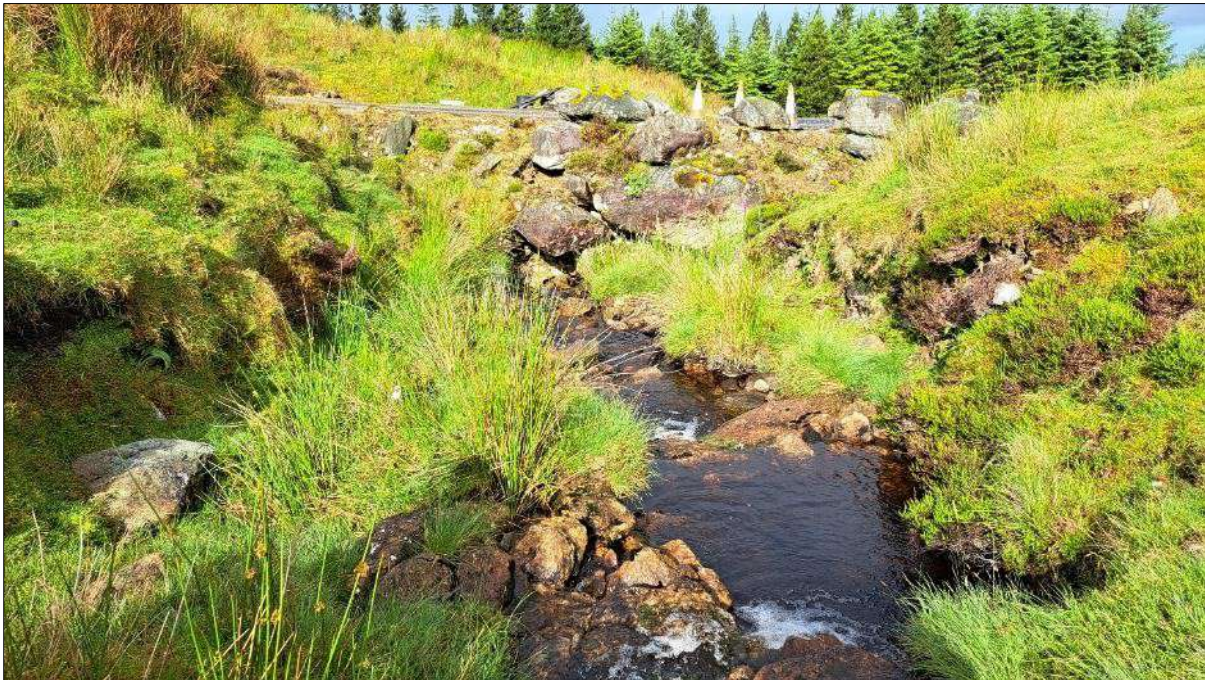
**Plate 7.1.34** Representative image of site B1 on the upper reaches of the Grangebeg Barr River, July 2024

Site B1 was located on the uppermost reaches of the Grangebeg Barr River (35G64) at an access track crossing with the existing Kingsmountain wind farm. The small upland eroding channel (FW1) flowed over a steep gradient and under the access track via a corrugated pipe culvert. The high energy river was characterised by boulder cascades with associated plunge pools. The substrata were dominated by angular mobile cobble and boulder with localised coarse gravels. The river was heavily peat stained with abundant flocculent peat deposits instream. The high energy site was unsuitable for macrophytes. However, larger boulder and cobble supported frequent *Scapania undulata*. Filamentous algal cover was present but low. The river drained upland blanket bog (PB2) and wet heath (HH3) with the riparian zones supporting typical vegetation dominated by heather, soft rush and *Sphagnum* sp. mosses. The site was bordered downstream by coniferous afforestation (WD4).

Biological water quality, based on Q-sampling, was calculated as **Q3-4 (moderate status) (Appendix C)**. No macro-invertebrate species of conservation value greater than 'least concern', according to national red lists, were recorded via Q-sampling.

Given the presence of salmonids, the aquatic ecological evaluation of site B1 was of **local importance (higher value) (Table 4.3)**.

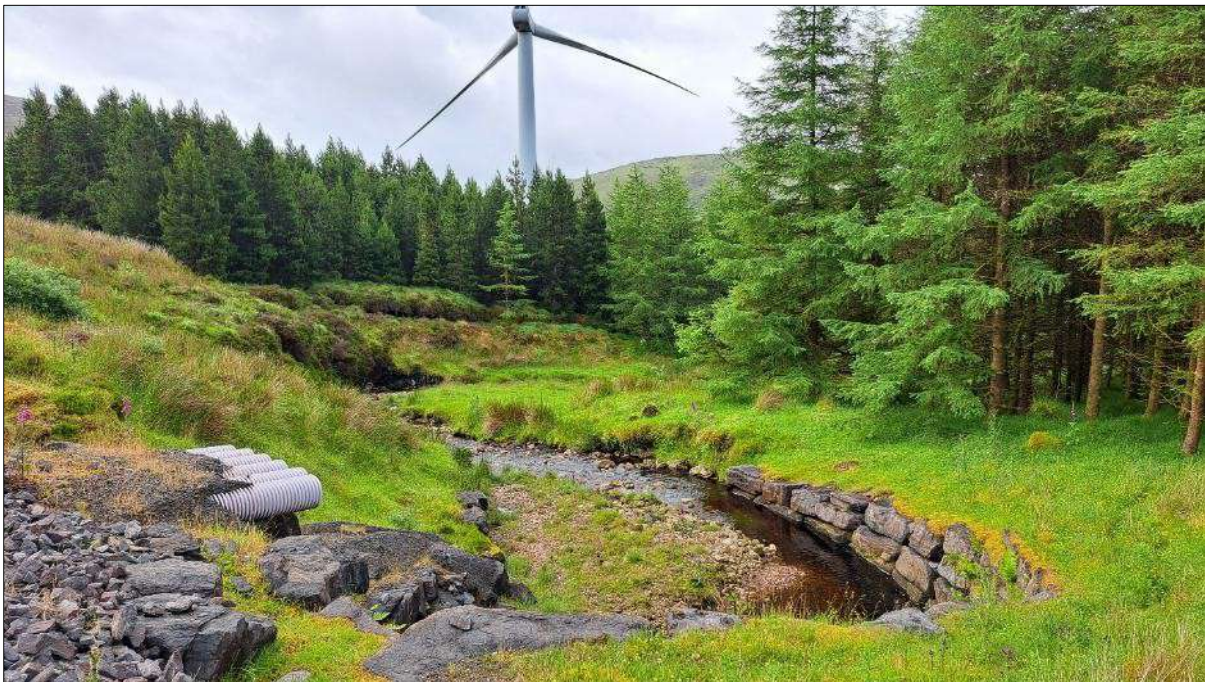
**Plate 7.1.35** Representative image of site B2 on the on the upper reaches of the Ballygreighan Barr River, July 2024

Biological water quality, based on Q-sampling, was calculated as **Q3 (poor status) (Appendix C)**. No macro-invertebrate species of conservation value greater than 'least concern', according to national red lists, were recorded via Q-sampling.

Given the presence of salmonids, the aquatic ecological evaluation of site B2 was of **local importance (higher value) (Table 4.3)**.

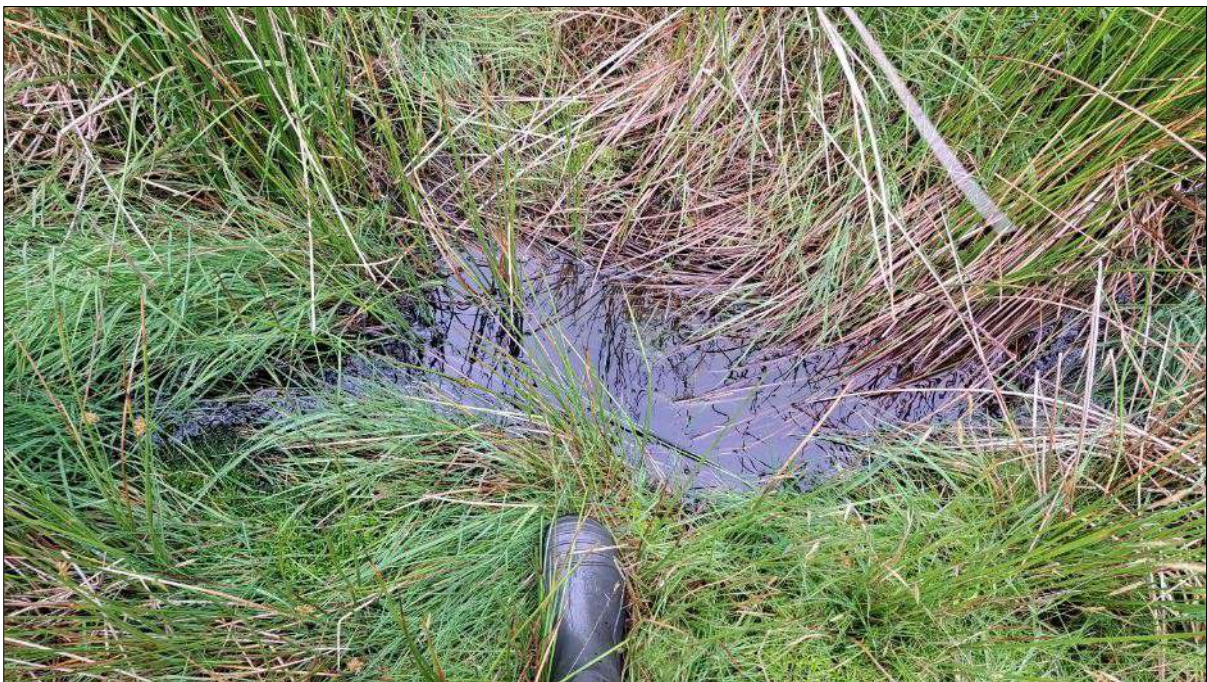
**Plate 7.1.37** Representative image of site B4 on an unnamed Ballygreighan Barr River tributary, July 2024

staining and ponding of stagnant water between peat dams. The substrata comprised humic soft sediment with no hard substrata. Poaching from sheep grazing was also evident. Macrophytes were absent. The channel was heavily encroached by *Sphagnum* sp. mosses and other typical wet heath and wet grassland vegetation such as rushes, purple moor grass, heather and bilberry. The site was bordered by upland blanket bog (PB2) and coniferous afforestation (WD4).

No fish were recorded via electro-fishing at site B4 (**Appendix B**). The narrow peat-stained channel conveyed minimal, intermittent water flows and was more of a seepage area through blanket bog rather than a flowing watercourse. The channel was not of fisheries value given high rates of siltation, shallow depths, narrow widths, poor flows and poor connectivity with downstream habitats. However, the adjoining Ballygreighan Barr River was of high value for salmonids with abundant spawning, nursery and holding habitat in the meandering channel. There was no suitability for white-clawed crayfish. No otter signs were recorded in vicinity of the site.

Biological water quality, based on Q-sampling, was calculated as **Q3 (poor status) (Appendix C)**. However, it should be noted that this was a tentative rating given poor flows and an absence of suitable riffle areas for sampling (Toner et al., 2005). No macro-invertebrate species of conservation value greater than 'least concern', according to national red lists, were recorded via Q-sampling.

Given the absence of aquatic species or habitats of higher conservation value, the aquatic ecological evaluation of site B3 was of **local importance (lower value) (Table 4.3)**.

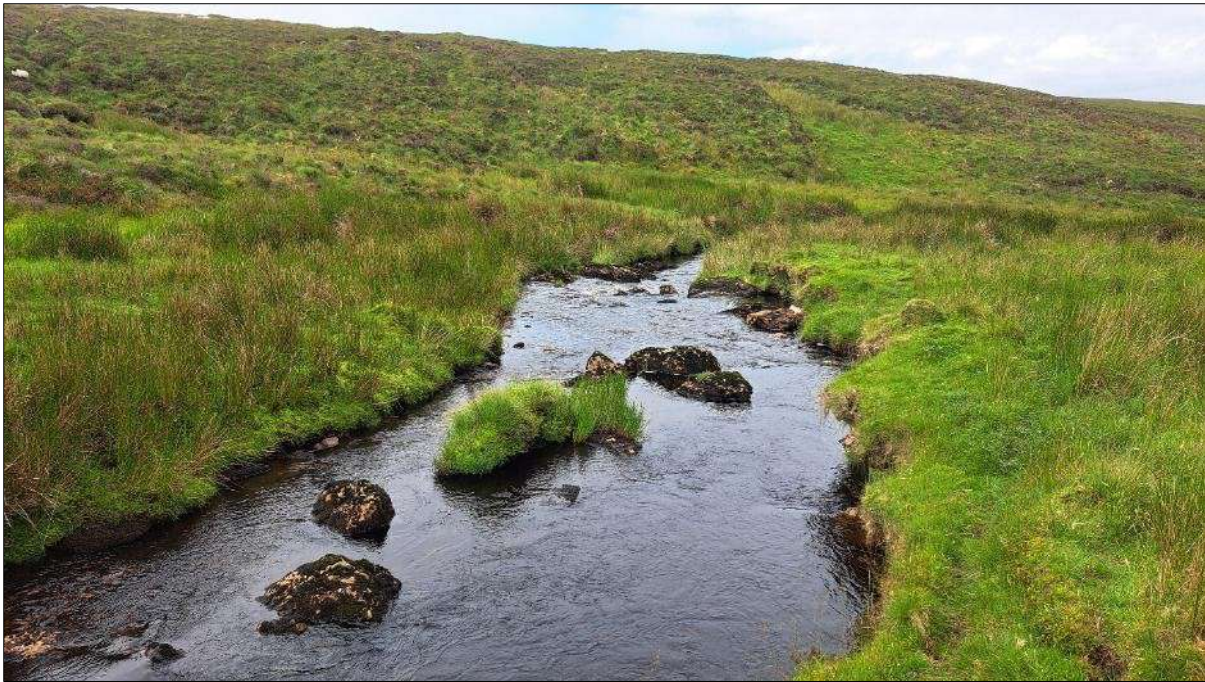
**Plate 7.1.38** Representative image of site B5 on the Ballygreighan Barr River, July 2024

Biological water quality, based on Q-sampling, was calculated as **Q4 (good status) (Appendix C)**. No macro-invertebrate species of conservation value greater than 'least concern', according to national red lists, were recorded via Q-sampling.

Given the river formed a boundary with the Ox Mountains Bogs SAC (002006), the aquatic ecological evaluation of site B5 was of **international importance (Table 4.3)**.

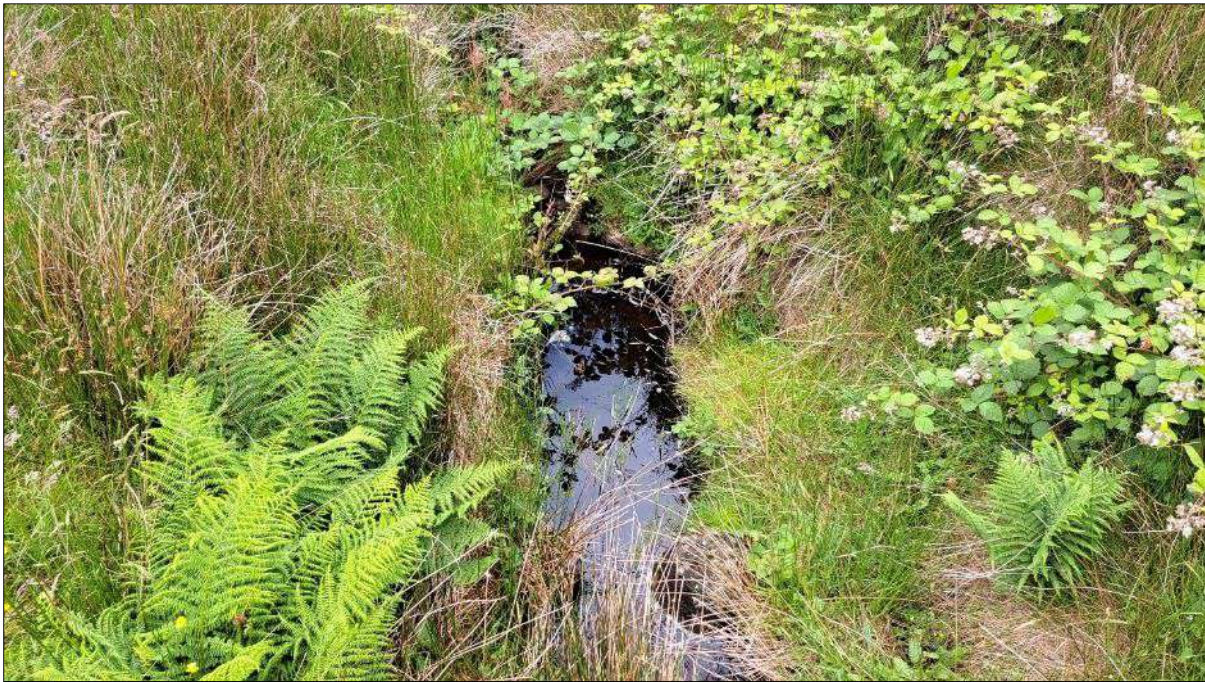
**Plate 7.1.39** Representative image of site B6 on an unnamed Dunneill River tributary, July 2024

Biological water quality, based on Q-sampling, was calculated as **Q4 (good status)** (**Appendix C**). No macro-invertebrate species of conservation value greater than 'least concern', according to national red lists, were recorded via Q-sampling.

Given the absence of aquatic species or habitats of higher conservation value, the aquatic ecological evaluation of site B6 was of **local importance (lower value)** (Table 4.3).

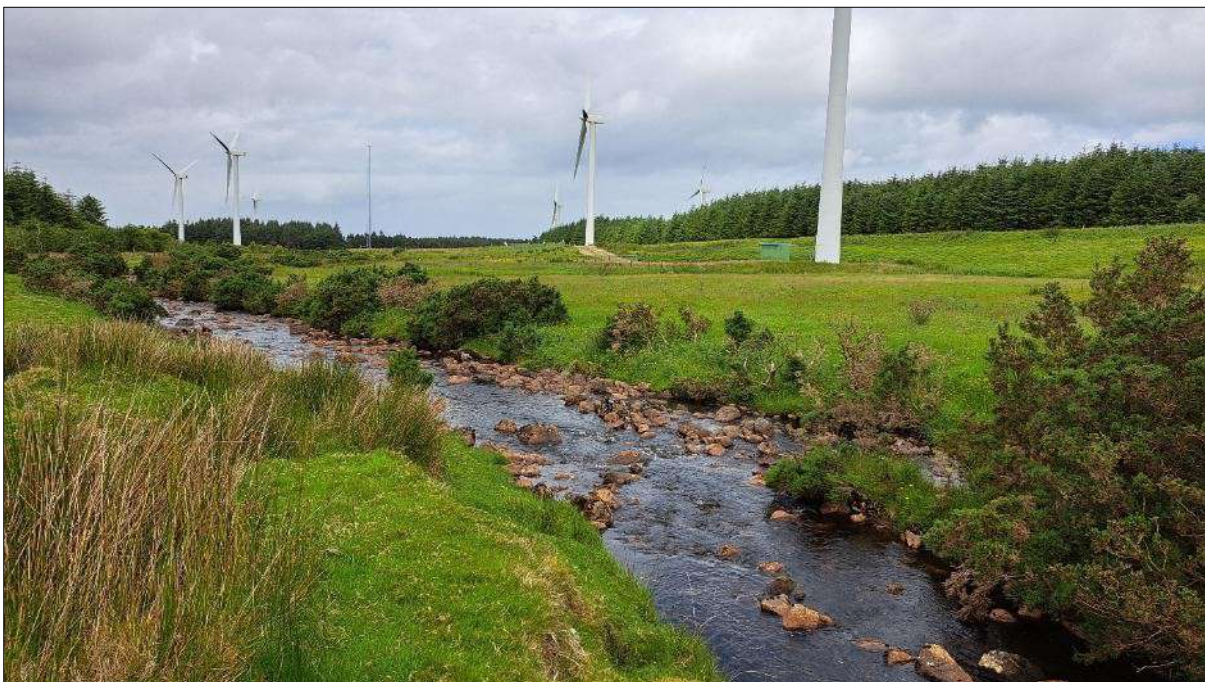
**Plate 7.1.40** Representative image of site B7 on the Dunneill River, July 2024

Biological water quality, based on Q-sampling, was calculated as **Q4 (good status) (Appendix C)**. No macro-invertebrate species of conservation value greater than 'least concern', according to national red lists, were recorded via Q-sampling.

Given the presence of salmonids, the aquatic ecological evaluation of site B7 was of **local importance (higher value) (Table 4.3)**.

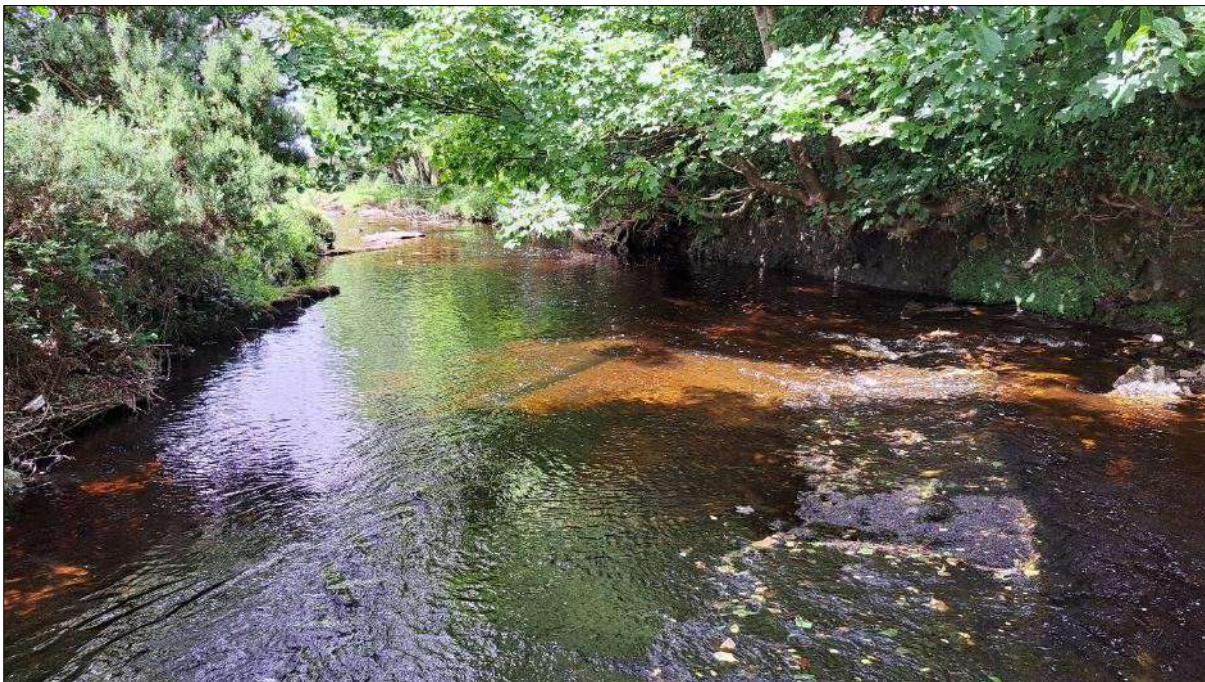
**Plate 7.1.41** Representative image of site B8 on the Dunneill River, July 2024

Biological water quality, based on Q-sampling, was calculated as **Q4 (good status)** (**Appendix C**). No macro-invertebrate species of conservation value greater than 'least concern', according to national red lists, were recorded via Q-sampling.

Given the presence of salmonids and Red-listed European eel, the aquatic ecological evaluation of site B8 was of **local importance (higher value)** (**Table 4.3**).

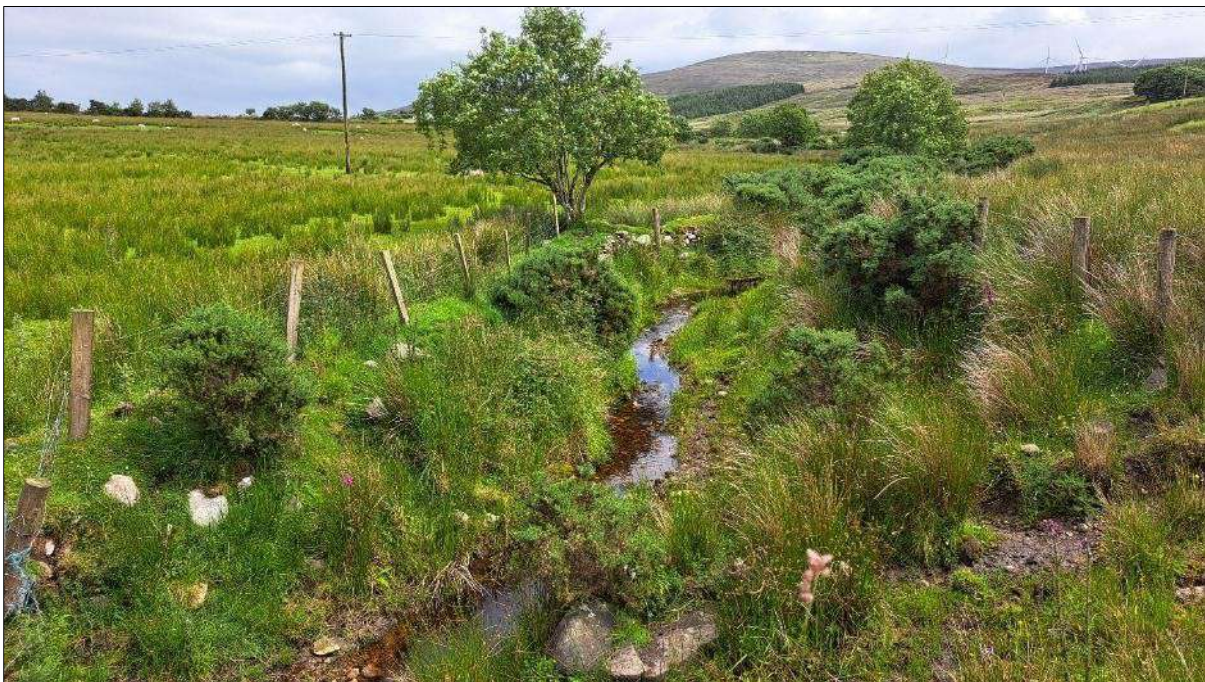
**Plate 7.1.42** Representative image of site B9 on the Doonbeakin River, July 2024

Biological water quality, based on Q-sampling, was calculated as **Q3-4 (moderate status) (Appendix C)**. No macro-invertebrate species of conservation value greater than 'least concern', according to national red lists, were recorded via Q-sampling.

Given the absence of aquatic species or habitats of higher conservation value, the aquatic ecological evaluation of site B9 was of **local importance (lower value) (Table 4.3)**.

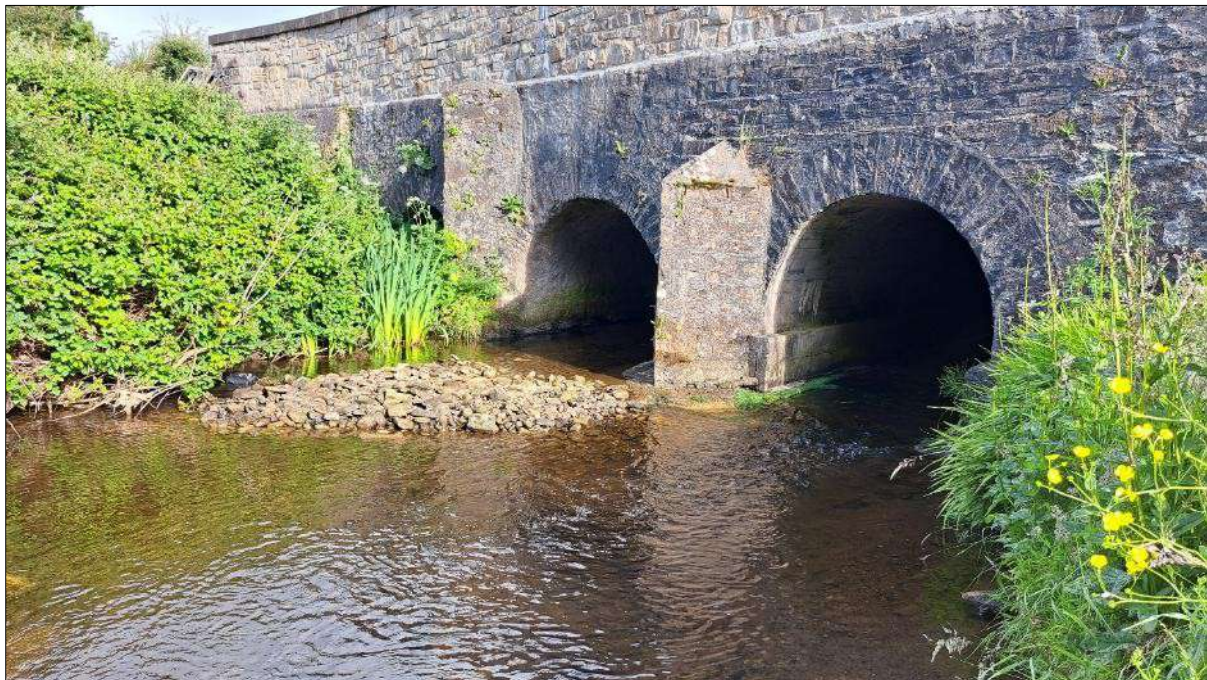
**Plate 7.1.43** Representative image of site B10 on the Doonbeakin River, July 2024

Biological water quality, based on Q-sampling, was calculated as **Q4 (good status) (Appendix C)**. No macro-invertebrate species of conservation value greater than 'least concern', according to national red lists, were recorded via Q-sampling.

Given the presence of salmonids and Red-listed European eel, the aquatic ecological evaluation of site B10 was of **local importance (higher value) (Table 4.3)**.

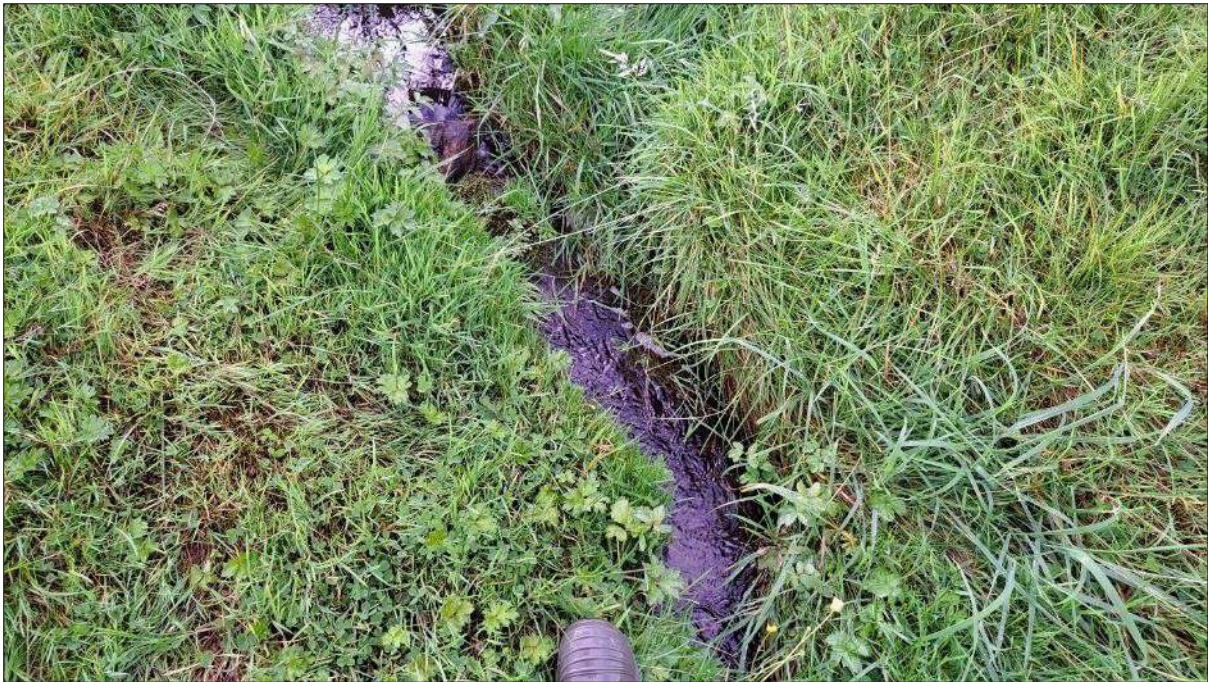
**Plate 7.1.44** Representative image of site B11 on the Cashelboy River, July 2024

Biological water quality, based on Q-sampling, was calculated as **Q4 (good status) (Appendix C)**. No macro-invertebrate species of conservation value greater than 'least concern', according to national red lists, were recorded via Q-sampling.

Given the presence of salmonids, the aquatic ecological evaluation of site B11 was of **local importance (higher value) (Table 4.3)**.
