# Aquatic baseline report for the proposed Crumhach Wind Farm, Co. Sligo

Prepared by Triturus Environmental Ltd. for MKO

**February 2025**

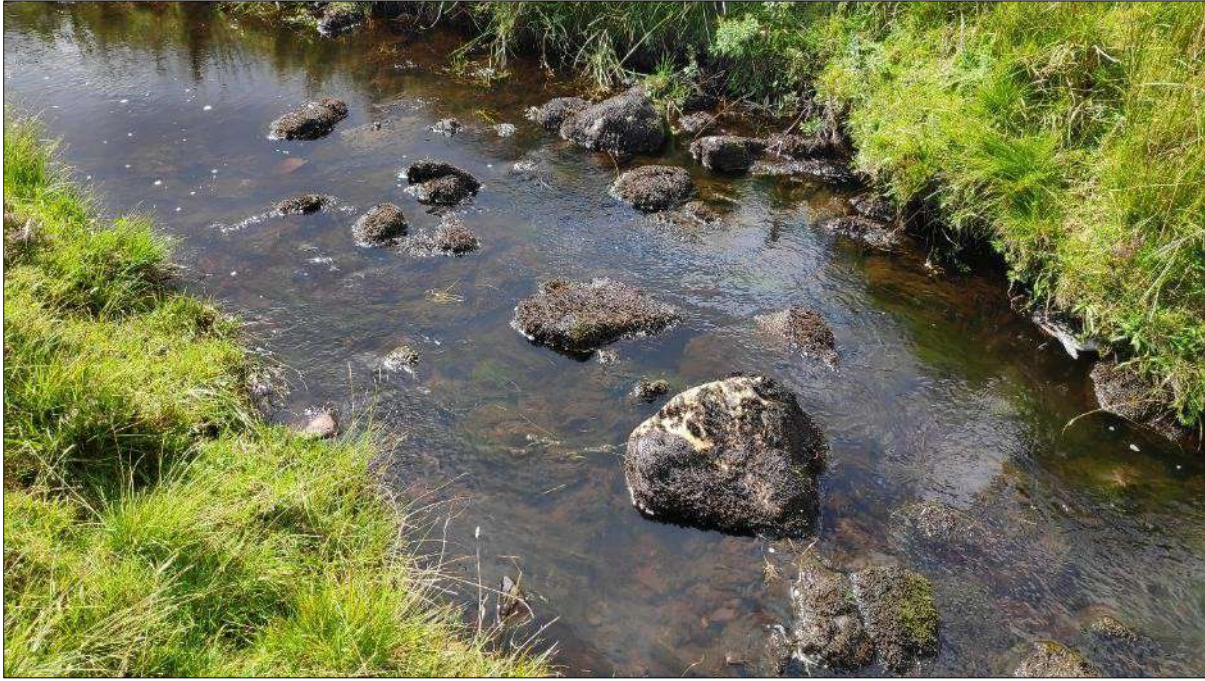
**Plate 7.1.45** Representative image of site B12 on the Lugdoon River, July 2024

macro-invertebrate species of conservation value greater than 'least concern', according to national red lists, were recorded via Q-sampling.

Given the presence of salmonids, the aquatic ecological evaluation of site B11 was of **local importance (higher value)** (Table 4.3).

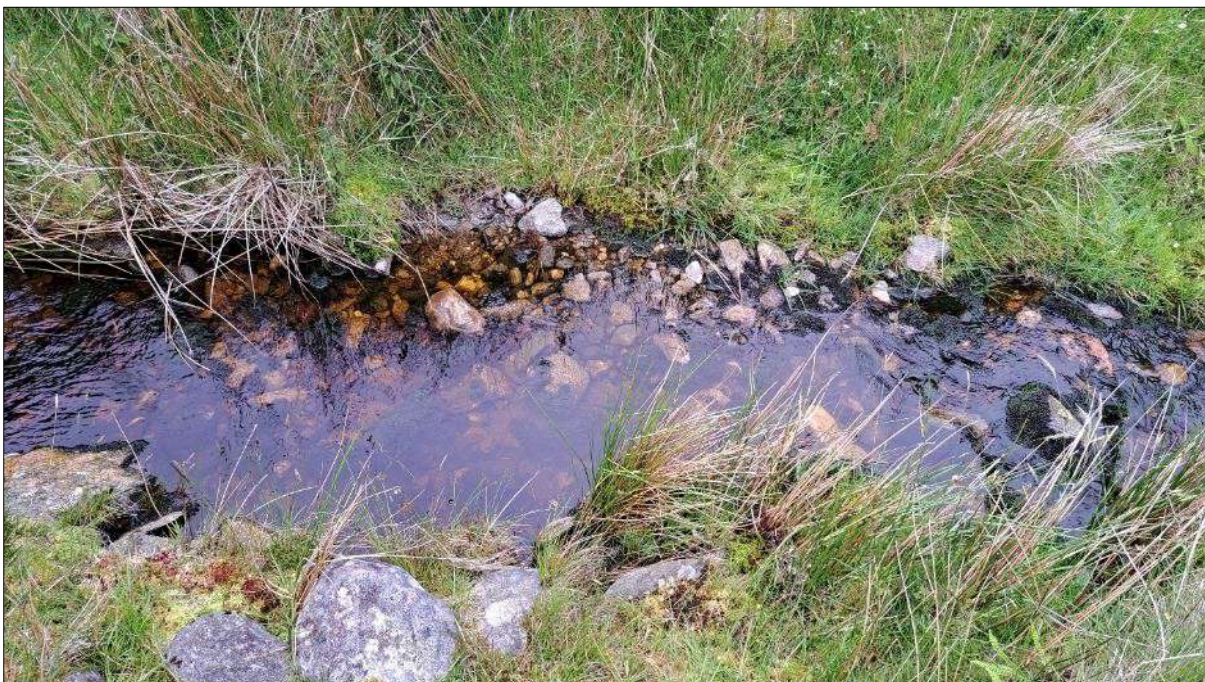
**Plate 7.1.46** Representative image of site B13 on the Grange More River, July 2024

Biological water quality, based on Q-sampling, was calculated as **Q4 (good status) (Appendix C)**. No macro-invertebrate species of conservation value greater than 'least concern', according to national red lists, were recorded via Q-sampling.

Given the presence of salmonids, the aquatic ecological evaluation of site B13 was of **local importance (higher value) (Table 4.3)**.

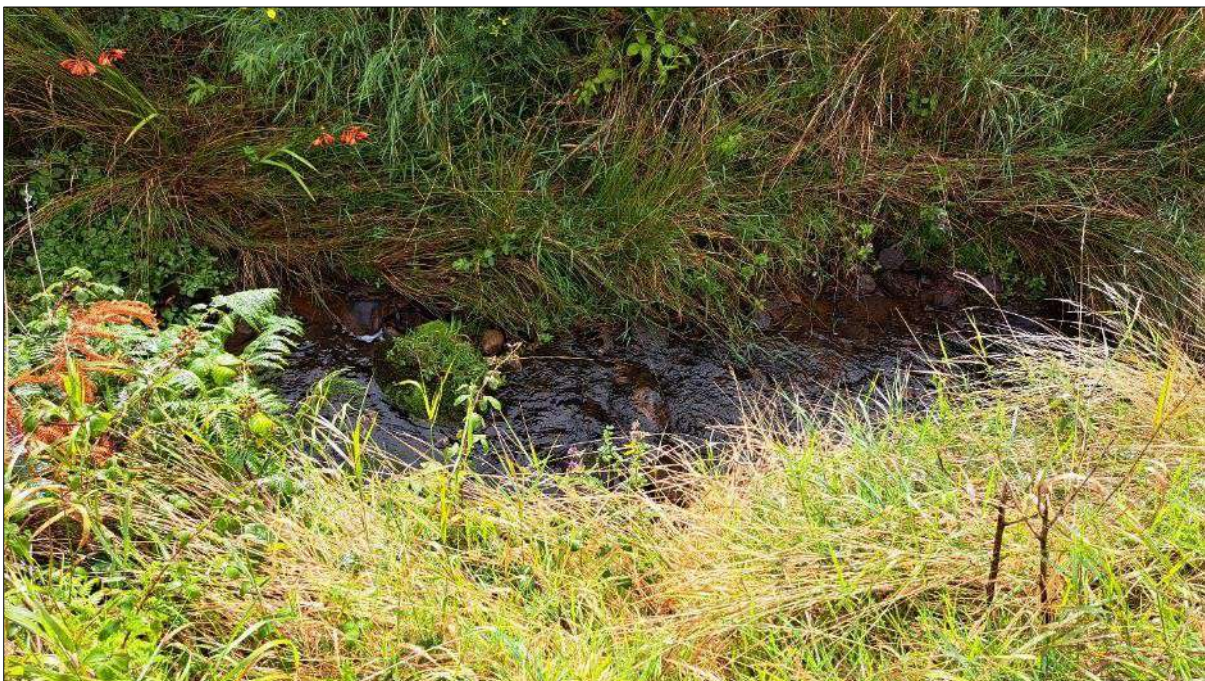
**Plate 7.1.47** Representative image of site B14 on an unnamed Lugdoon Stream tributary, July 2024

Biological water quality, based on Q-sampling, was calculated as **Q3-4 (moderate status) (Appendix C)**. No macro-invertebrate species of conservation value greater than 'least concern', according to national red lists, were recorded via Q-sampling.

Given the presence of salmonids, the aquatic ecological evaluation of site B14 was of **local importance (higher value) (Table 4.3)**.

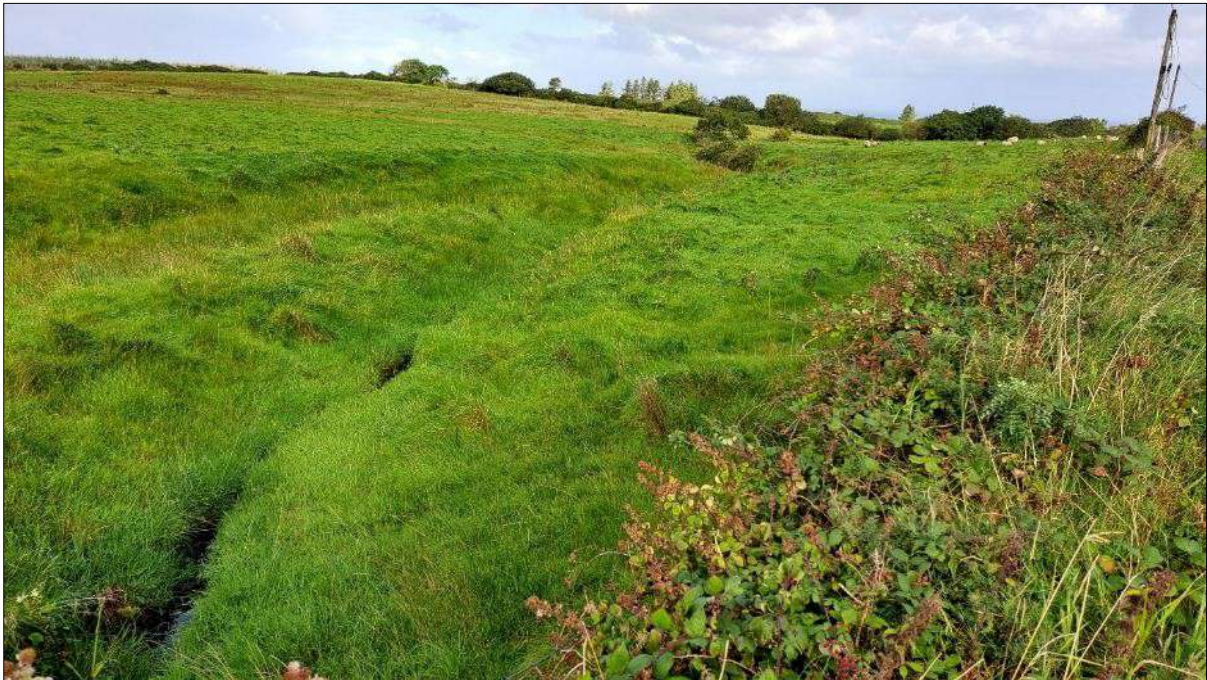
**Plate 7.2.1** Representative image of site C1 on the Altans Stream, September 2024

Three-spined stickleback (*Gasterosteus aculeatus*) was the only fish species recorded via electro-fishing at site C1 (**Appendix B**). With the exception of low densities of this species, the site was not of fisheries value given its very small size, location in the upper reaches of the watercourse and poor fluvial connectivity with downstream habitats. There was no suitability for white-clawed crayfish. No otter signs were recorded in vicinity of the site.

Biological water quality, based on Q-sampling, was calculated as **Q4 (good status)** (**Appendix C**). No macro-invertebrate species of conservation value greater than 'least concern', according to national red lists, were recorded via Q-sampling.

Given the absence of aquatic species or habitats of higher conservation value, the aquatic ecological evaluation of site C1 was of **local importance (lower value)** (Table 4.3).

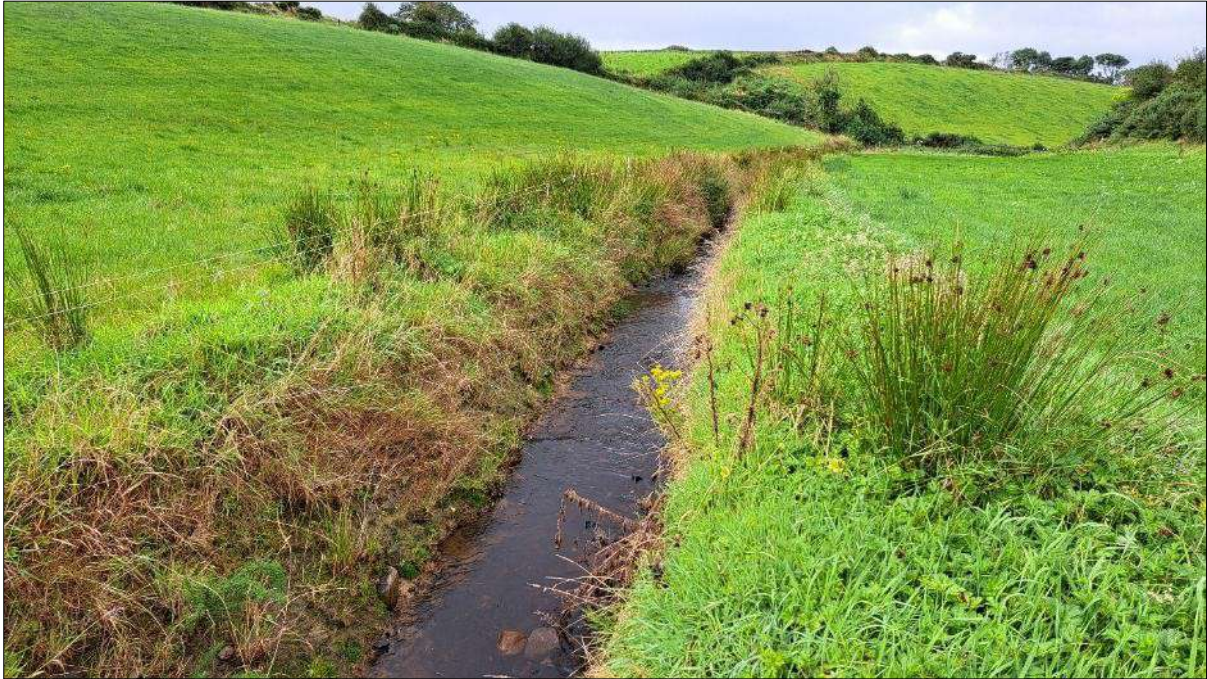
**Plate 7.2.2** Representative image of site C2 on an unmapped Altans Stream tributary, September 2024

Biological water quality, based on Q-sampling, was calculated as **Q4 (good status) (Appendix C)**. No macro-invertebrate species of conservation value greater than 'least concern', according to national red lists, were recorded via Q-sampling.

Given the presence of salmonids and Red-listed European eel, the aquatic ecological evaluation of site was of **local importance (higher value) (Table 4.3)**.

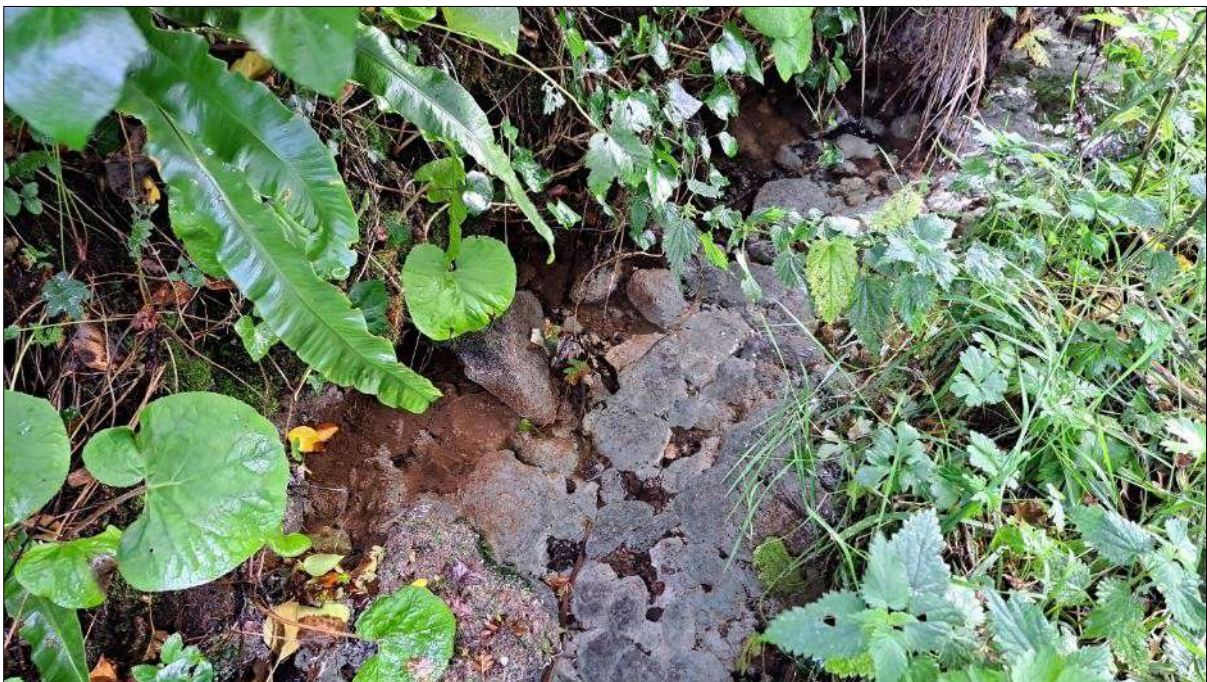
**Plate 7.2.3** Representative image of site C3 on the Ballyeeskeen River, September 2024

Biological water quality, based on Q-sampling, was calculated as **Q3 (poor status) (Appendix C)**. No macro-invertebrate species of conservation value greater than 'least concern', according to national red lists, were recorded via Q-sampling.

Given the absence of aquatic species or habitats of higher conservation value, the aquatic ecological evaluation of site C3 was of **local importance (lower value) (Table 4.3)**.

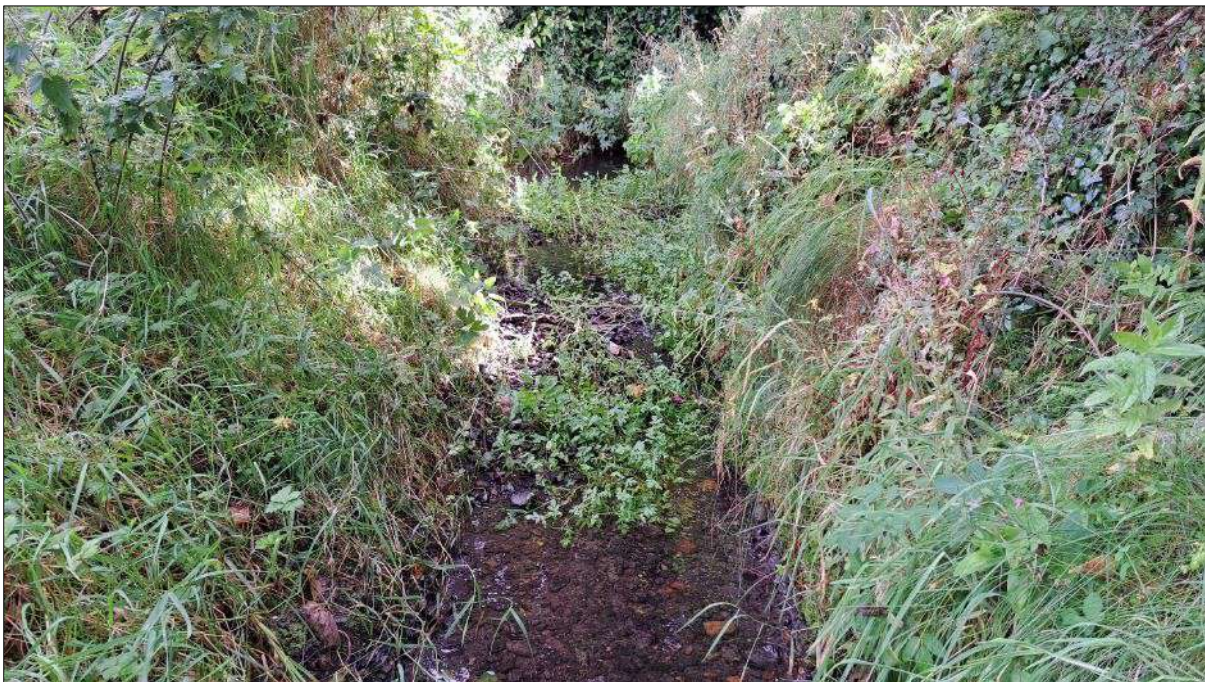
**Plate 7.2.4** Representative image of site C4 on the Ardkill Stream, September 2024

Biological water quality, based on Q-sampling, was calculated as **Q3-4 (moderate status)** (**Appendix C**). No macro-invertebrate species of conservation value greater than 'least concern', according to national red lists, were recorded via Q-sampling.

Given the presence of salmonids, the aquatic ecological evaluation of site C4 was of **local importance (higher value)** (**Table 4.3**).

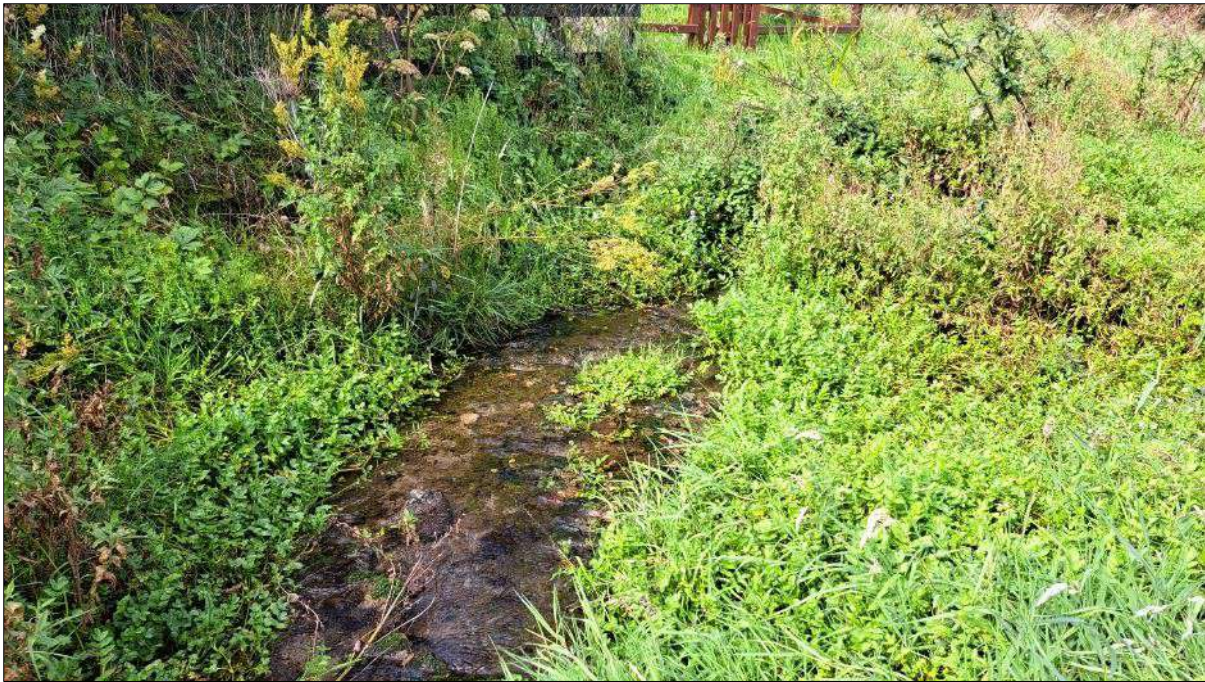
**Plate 7.2.5** Representative image of site C5 on the Kilrusheighter River, September 2024

Biological water quality, based on Q-sampling, was calculated as **Q3 (poor status) (Appendix C)**. No macro-invertebrate species of conservation value greater than 'least concern', according to national red lists, were recorded via Q-sampling.

Given the absence of aquatic species or habitats of higher conservation value, the aquatic ecological evaluation of site C5 was of **local importance (lower value) (Table 4.3)**.

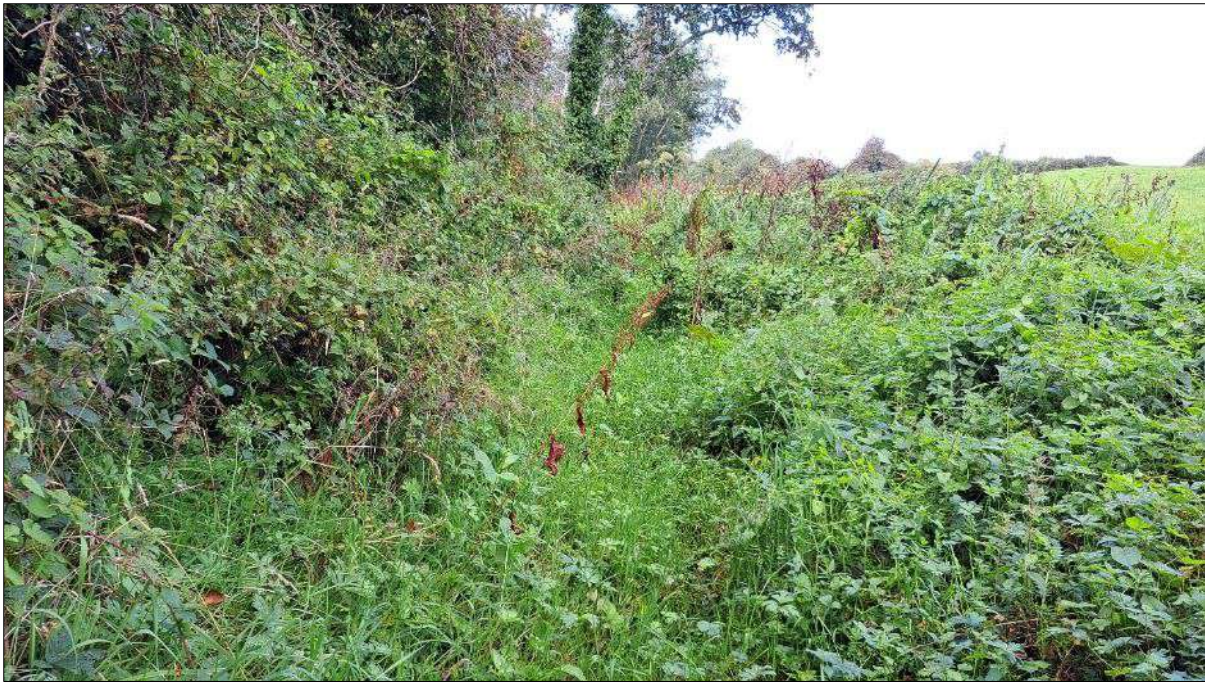
It was not possible to collect a biological water quality sample given the dry nature of the river at this location.

Given the absence of aquatic species or habitats of higher conservation value, the aquatic ecological evaluation of site C6 was of **local importance (lower value)** (Table 4.3).

**Plate 7.2.6** Representative image of site C6 on the Portavaud River, September 2024 (dry, ephemeral channel)

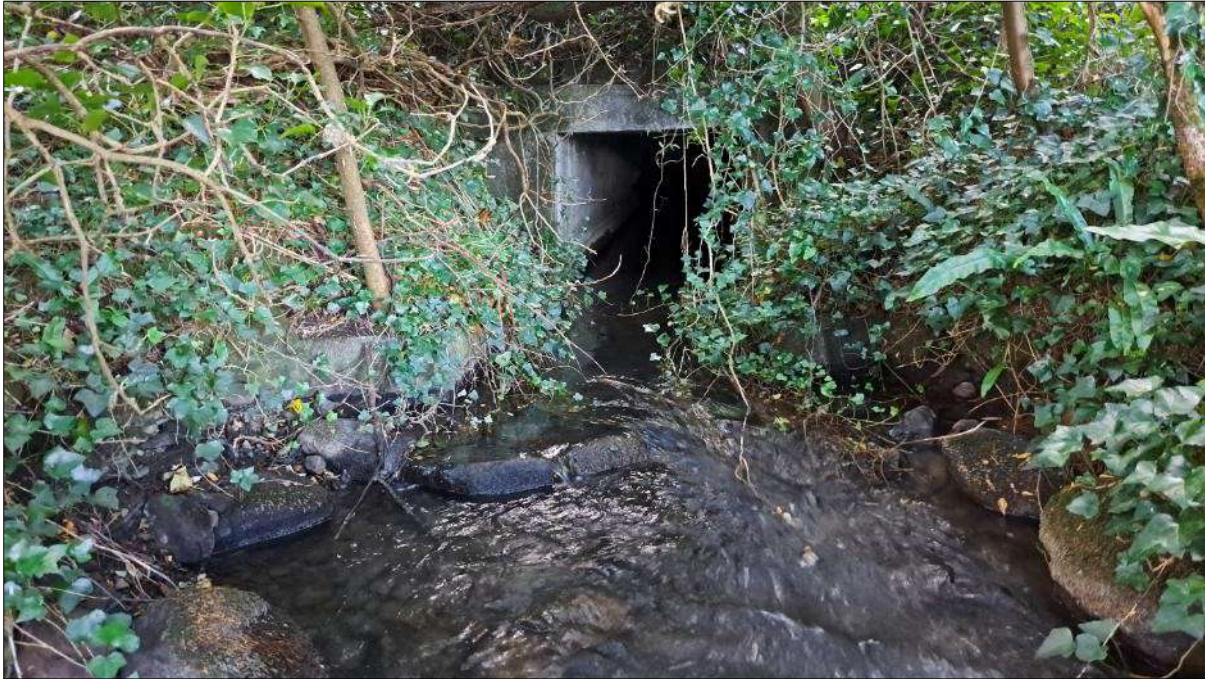
Biological water quality, based on Q-sampling, was calculated as **Q3-4 (moderate status) (Appendix C)**. No macro-invertebrate species of conservation value greater than 'least concern', according to national red lists, were recorded via Q-sampling.

Given the presence of salmonids and Red-listed European eel, the aquatic ecological evaluation of site C7 was of **local importance (higher value) (Table 4.3)**.

**Plate 7.2.7** Representative image of site C7 on the Ballinlig River, September 2024

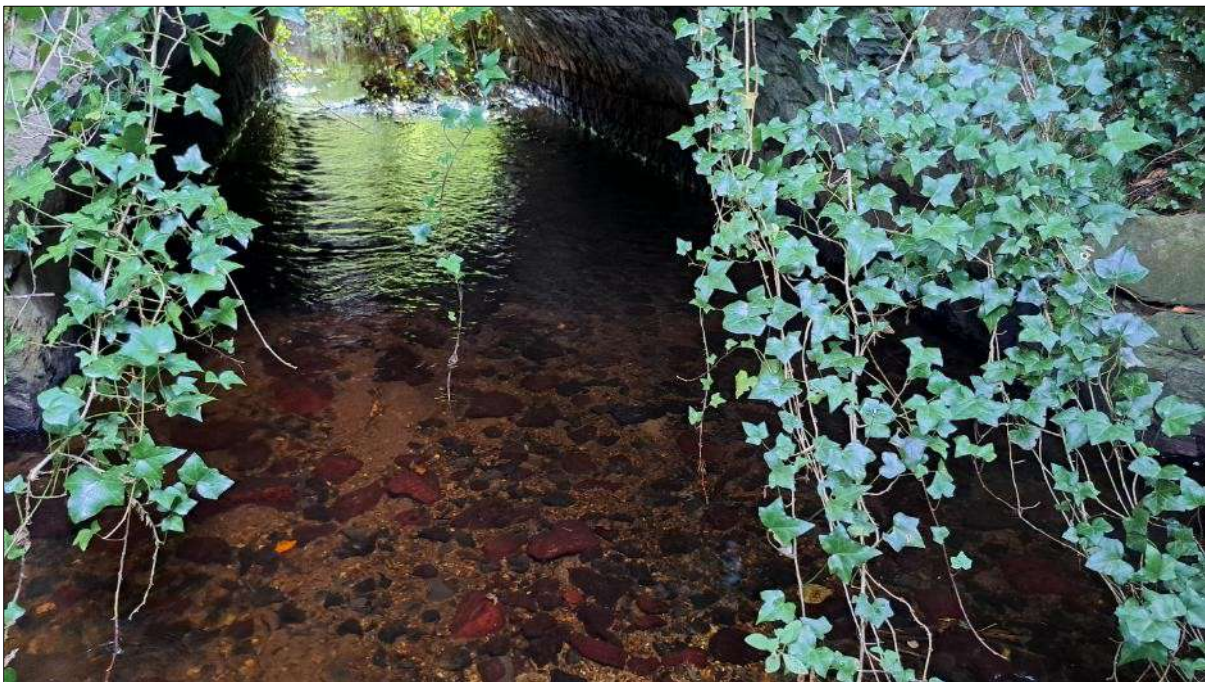
Biological water quality, based on Q-sampling, was calculated as **Q3 (poor status)** (**Appendix C**). No macro-invertebrate species of conservation value greater than 'least concern', according to national red lists, were recorded via Q-sampling.

**Plate 7.2.8** Representative image of site C8 on the Barnabrack River, September 2024

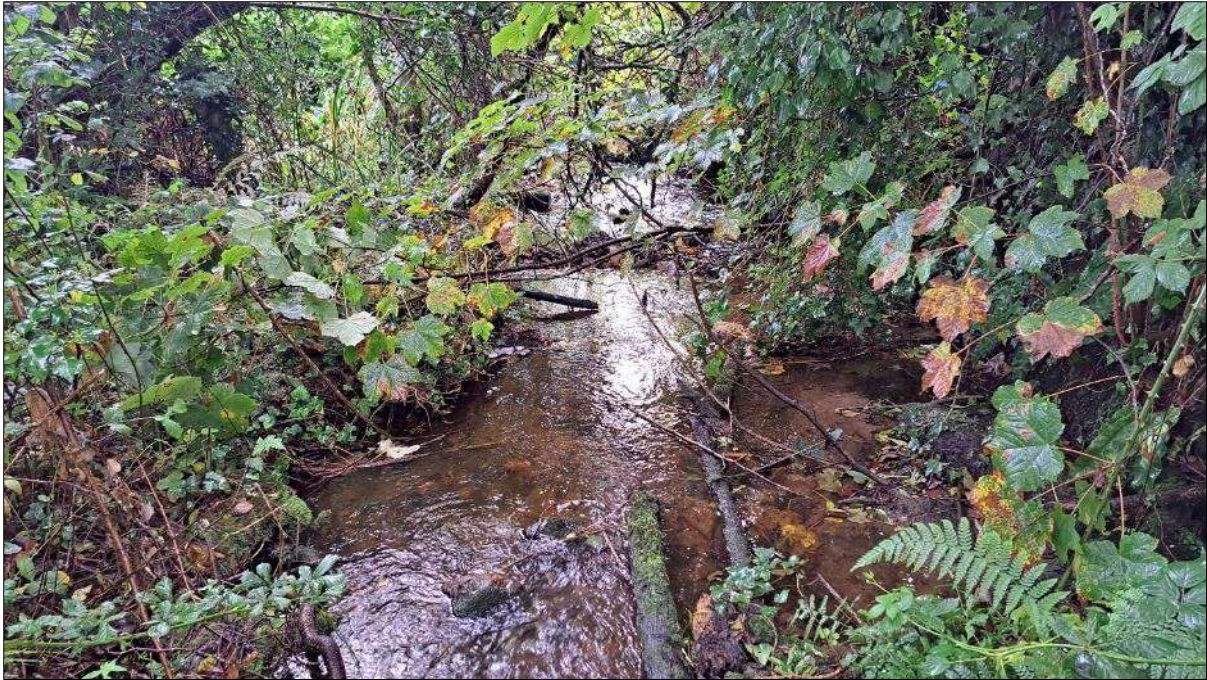
Biological water quality, based on Q-sampling, was calculated as **Q4 (good status) (Appendix C)**. No macro-invertebrate species of conservation value greater than 'least concern', according to national red lists, were recorded via Q-sampling.

Given the presence of salmonids and Red-listed European eel, the aquatic ecological evaluation of site C10 was of **local importance (higher value) (Table 4.3)**.

**Plate 7.2.10** Representative image of site C10 on the Lugnadeffa River, September 2024

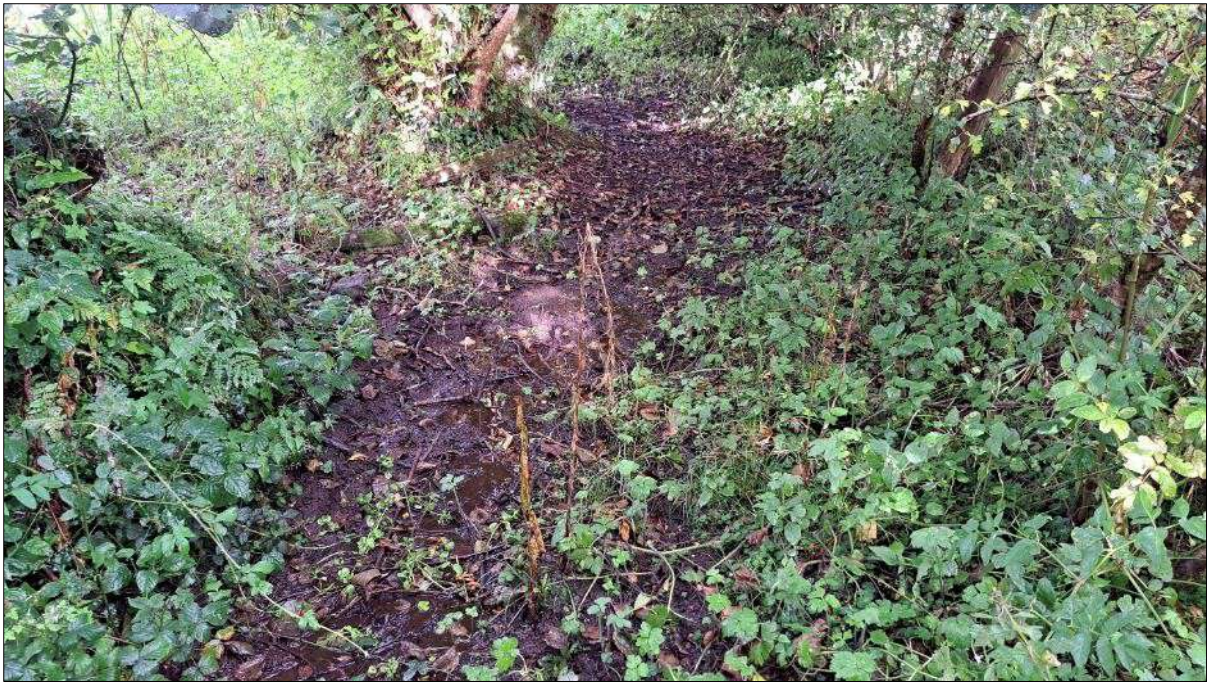
It was not possible to collect a biological water quality sample given the dry nature of the river at this location.

Given the absence of aquatic species or habitats of higher conservation value, the aquatic ecological evaluation of site C11 was of **local importance (lower value)** (Table 4.3).

**Plate 7.2.11** Representative image of site C11 on the Lugawarry River, September 2024 (dry, ephemeral channel)

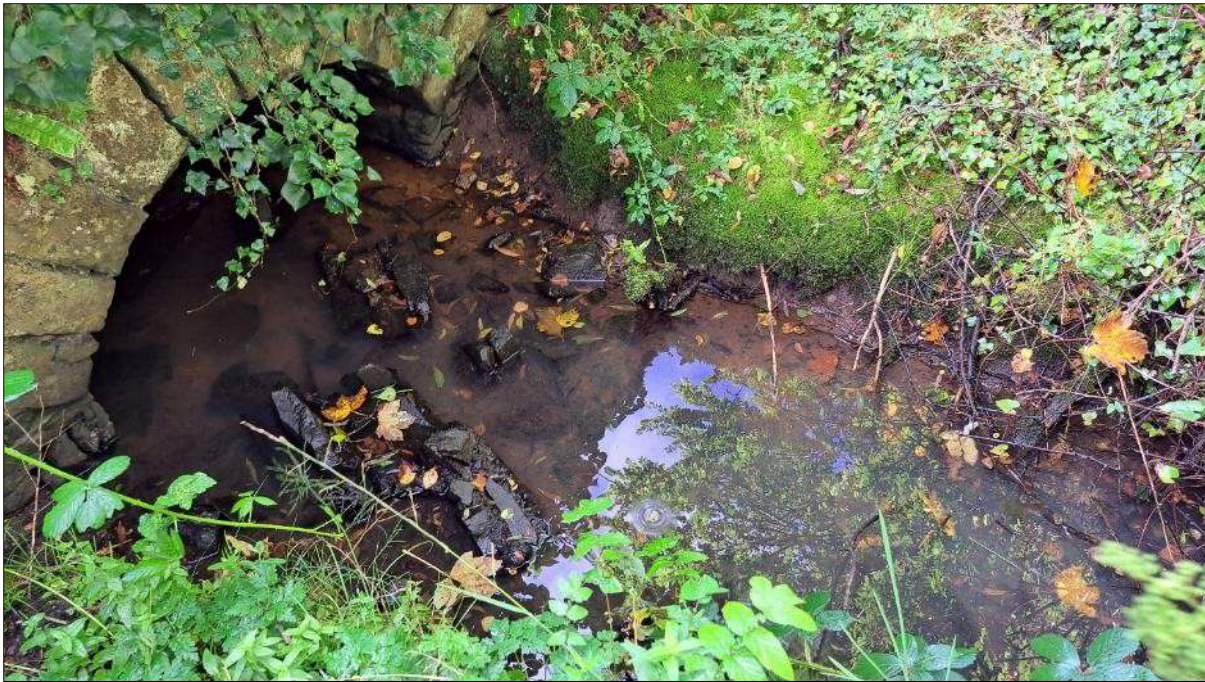
Biological water quality, based on Q-sampling, was calculated as **Q2-3 (poor status) (Appendix C)**. However, it should be noted that this was a tentative rating given poor flows and an absence of suitable riffle areas for sampling (Toner et al., 2005). No macro-invertebrate species of conservation value greater than 'least concern', according to national red lists, were recorded via Q-sampling.

Given the absence of aquatic species or habitats of higher conservation value, the aquatic ecological evaluation of site C12 was of **local importance (lower value) (Table 4.3)**.

**Plate 7.2.12** Representative image of site C12 on the Stonehall River, September 2024

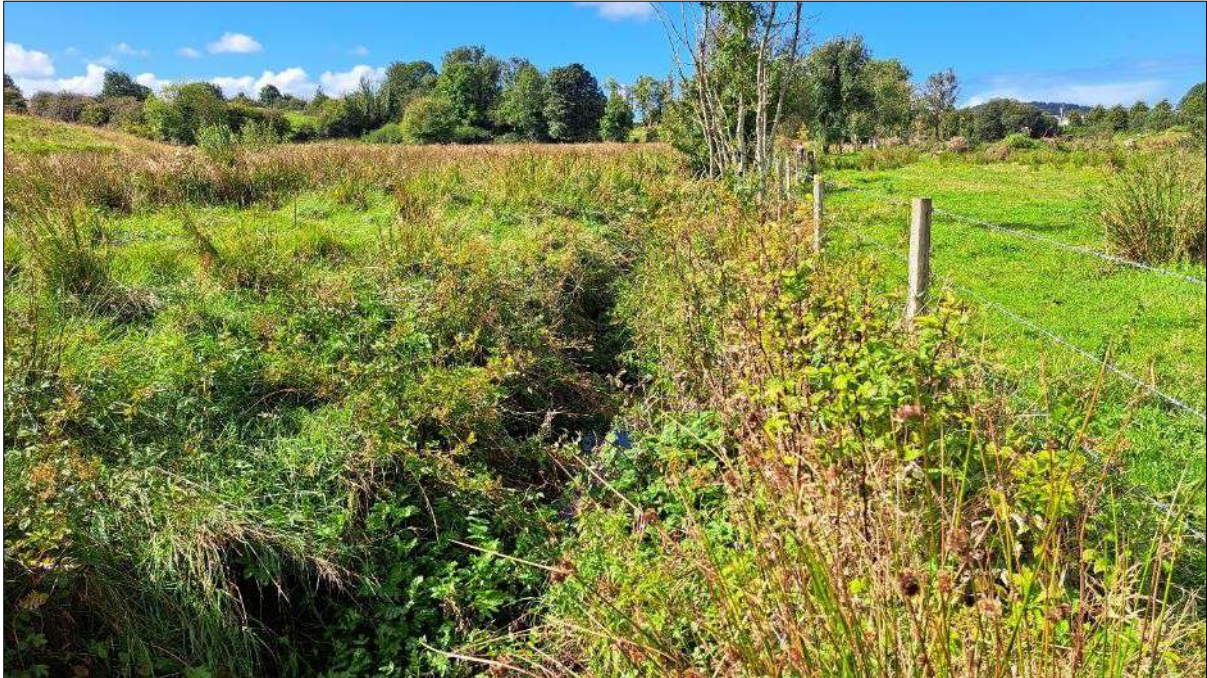
Biological water quality, based on Q-sampling, was calculated as **Q3 (poor status)** (**Appendix C**). However, it should be noted that this was a tentative rating given poor flows and an absence of suitable riffle areas for sampling (Toner et al., 2005). No macro-invertebrate species of conservation

Given the absence of aquatic species or habitats of higher conservation value, the aquatic ecological evaluation of site C13 was of **local importance (lower value)** (Table 4.3).

**Plate 7.2.13** Representative image of site C13 on the Carrigeenboy River, September 2024

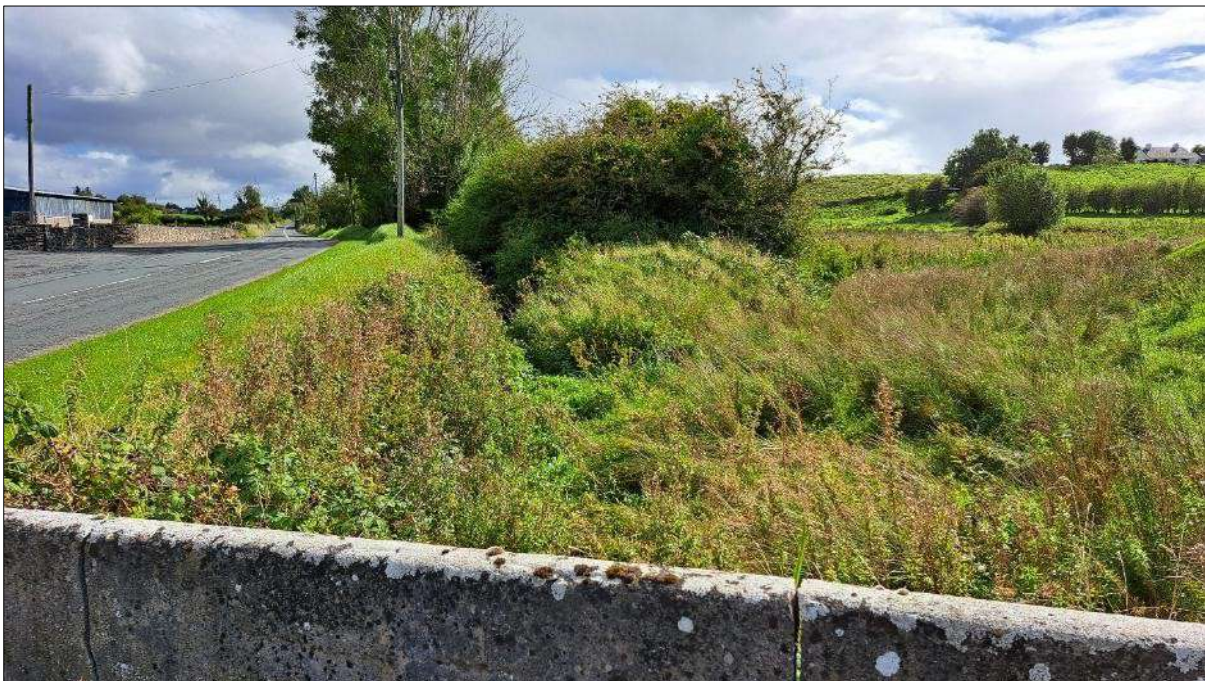
Biological water quality, based on Q-sampling, was calculated as **Q3 (poor status) (Appendix C)**. No macro-invertebrate species of conservation value greater than 'least concern', according to national red lists, were recorded via Q-sampling.

Given the presence of salmonids, the aquatic ecological evaluation of site C14 was of **local importance (higher value) (Table 4.3)**.

**Plate 7.2.14** Representative image of site C14 on the Doonamurray Stream, September 2024

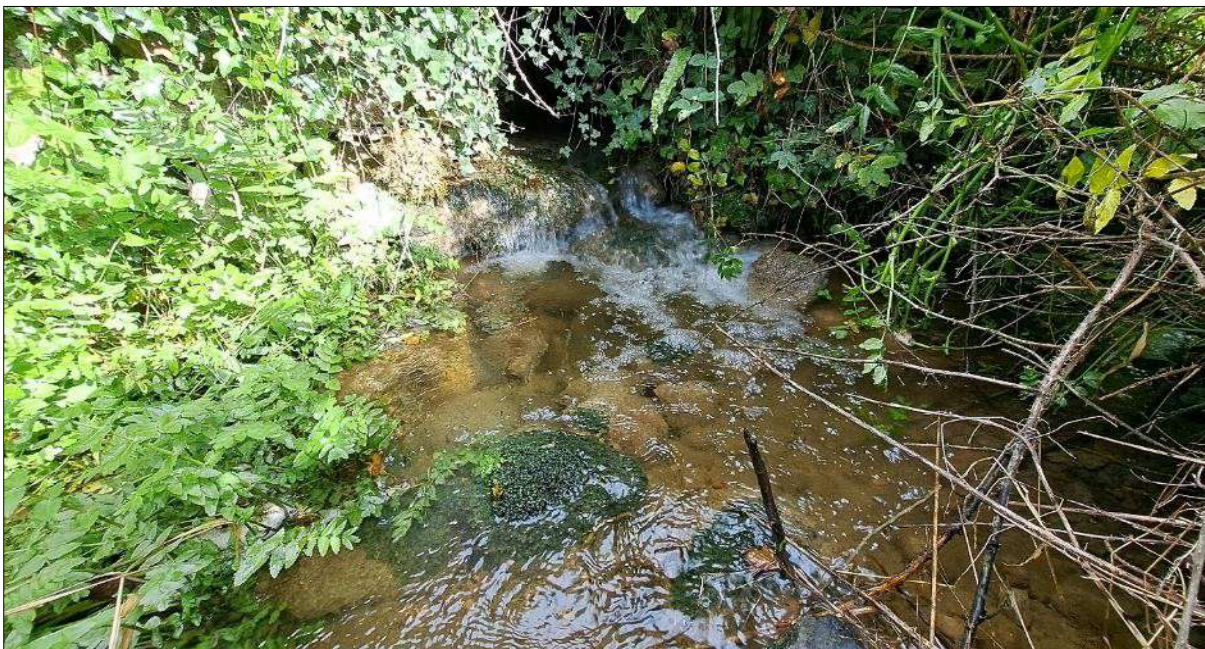
Biological water quality, based on Q-sampling, was calculated as **Q3 (poor status)** (**Appendix C**). No macro-invertebrate species of conservation value greater than 'least concern', according to national red lists, were recorded via Q-sampling.

Given the presence of salmonids, the aquatic ecological evaluation of site C15 was of **local importance (higher value)** (**Table 4.3**).

**Plate 7.2.15** Representative image of site C15 on the Doonamurray River, September 2024

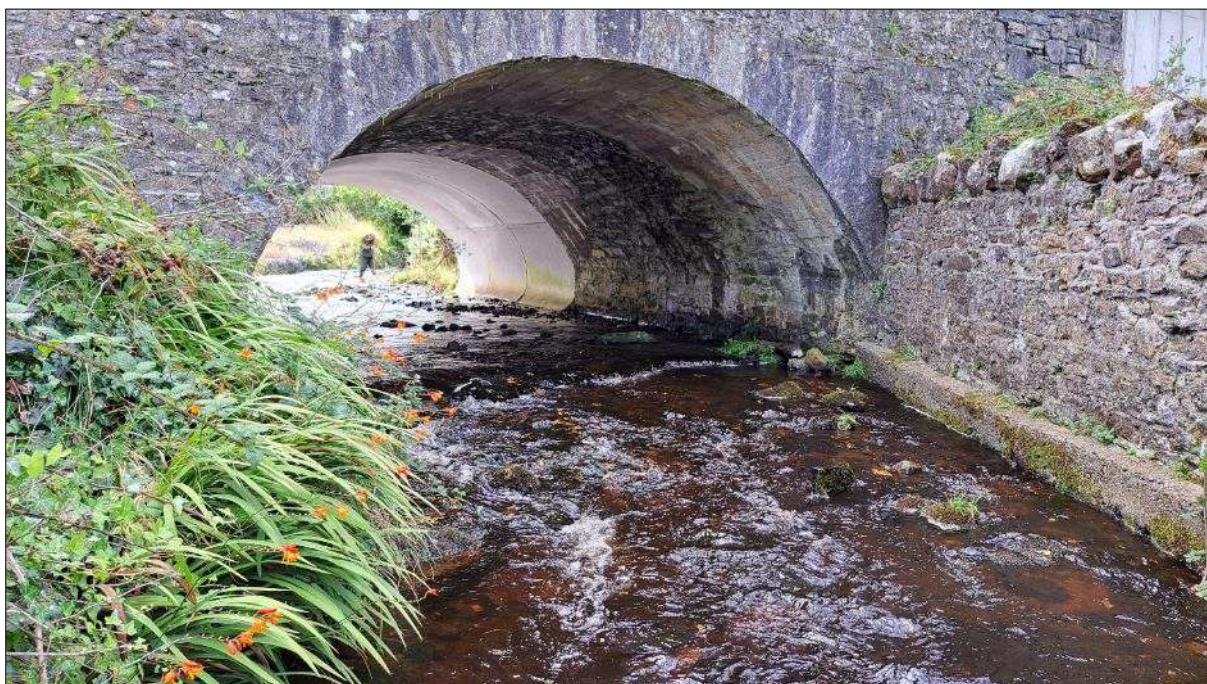
Biological water quality, based on Q-sampling, was calculated as **Q4 (good status)** (**Appendix C**). No macro-invertebrate species of conservation value greater than 'least concern', according to national red lists, were recorded via Q-sampling.

Given the high suitability for salmonids and Red-listed European eel, the aquatic ecological evaluation of site D1 was of **local importance (higher value)** (**Table 4.3**).

**Plate 7.2.16** Representative image of site D1 on the Doonflin River, September 2024

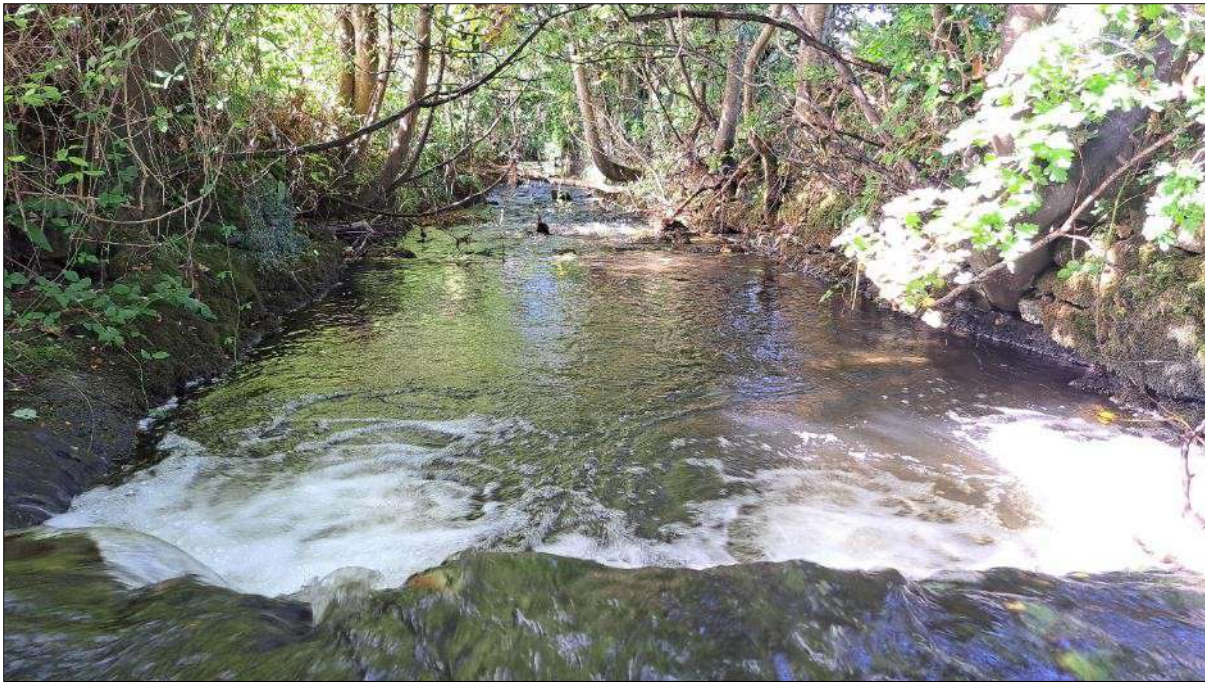
Biological water quality, based on Q-sampling, was calculated as **Q3-4 (moderate status) (Appendix C)**. No macro-invertebrate species of conservation value greater than 'least concern', according to national red lists, were recorded via Q-sampling.

Given the good suitability for salmonids and Red-listed European eel, the aquatic ecological evaluation of site D3 was of **local importance (higher value) (Table 4.3)**.

**Plate 7.2.18** Representative image of site D3 on the Dunmoran River, September 2024

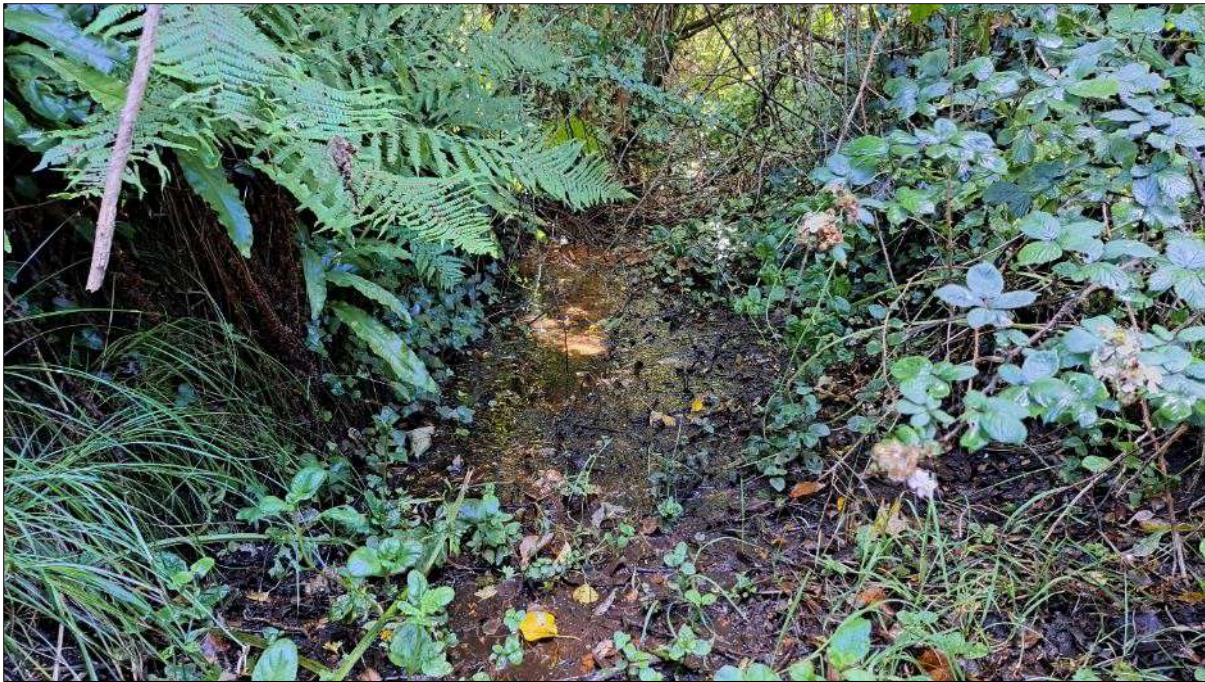
Biological water quality, based on Q-sampling, was calculated as **Q3 (poor status) (Appendix C)**. However, it should be noted that this was a tentative rating given poor flows and an absence of suitable riffle areas for sampling (Toner et al., 2005). No macro-invertebrate species of conservation value greater than 'least concern', according to national red lists, were recorded via Q-sampling.

Given the absence of aquatic species or habitats of higher conservation value and poor suitability for same, the aquatic ecological evaluation of site D4 was of **local importance (lower value) (Table 4.3)**.

**Plate 7.2.19** Representative image of site D4 on an unmapped stream, September 2024

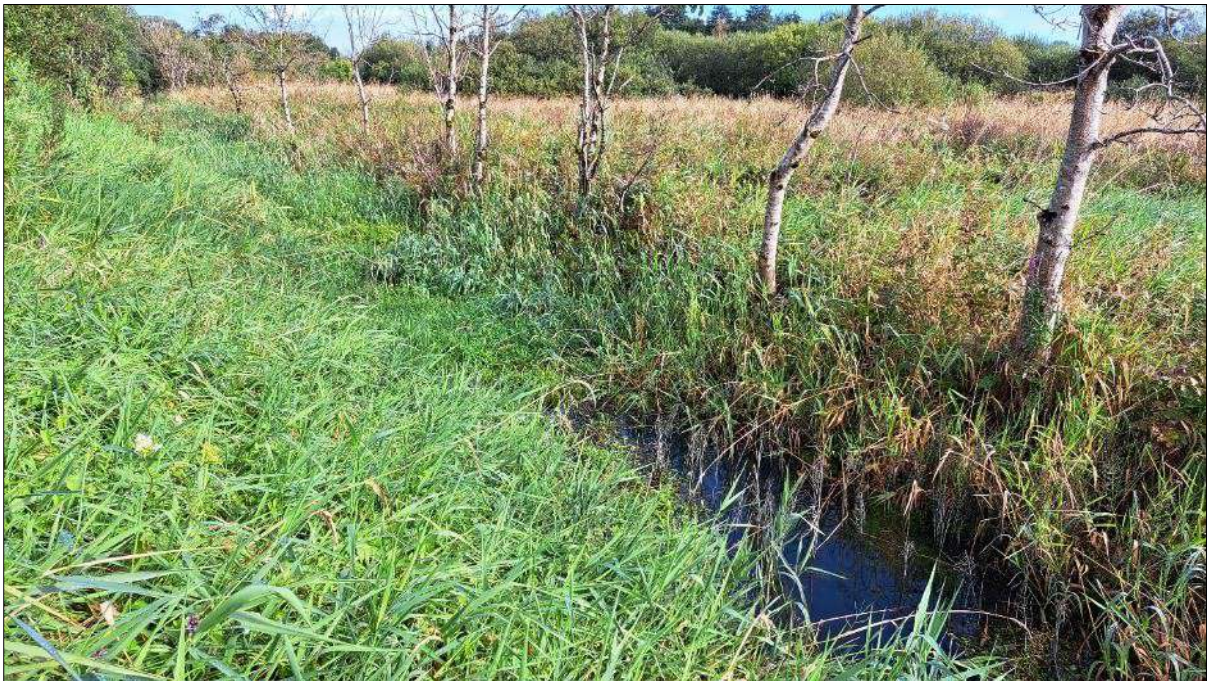
Biological water quality, based on Q-sampling, was calculated as **Q3 (poor status)** (**Appendix C**). However, it should be noted that this was a tentative rating given poor flows and an absence of suitable riffle areas for sampling (Toner et al., 2005). No macro-invertebrate species of conservation value greater than 'least concern', according to national red lists, were recorded via Q-sampling.

Given the absence of aquatic species or habitats of higher conservation value and poor suitability for same, the aquatic ecological evaluation of site D5 was of **local importance (lower value)** (Table 4.3).

**Plate 7.2.20** Representative image of site D5 on the Knoxspark River, September 2024

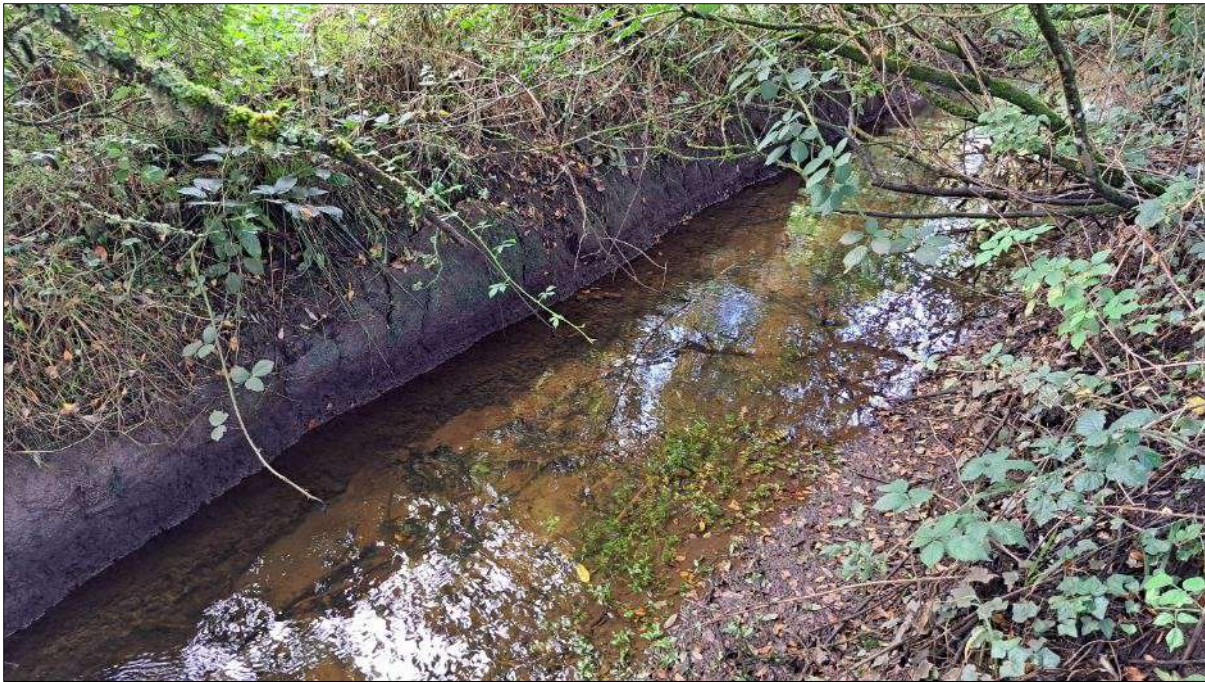
Biological water quality, based on Q-sampling, was calculated as **Q3 (poor status) (Appendix C)**. However, it should be noted that this was a tentative rating given poor flows and an absence of suitable riffle areas for sampling (Toner et al., 2005). No macro-invertebrate species of conservation value greater than 'least concern', according to national red lists, were recorded via Q-sampling.

Given the suitability for salmonids, lamprey and European eel (albeit low), the aquatic ecological evaluation of site D8 was of **local importance (higher value) (Table 4.3)**.

**Plate 7.2.23** Representative image of site D8 on the Carrigeenboy River, September 2024

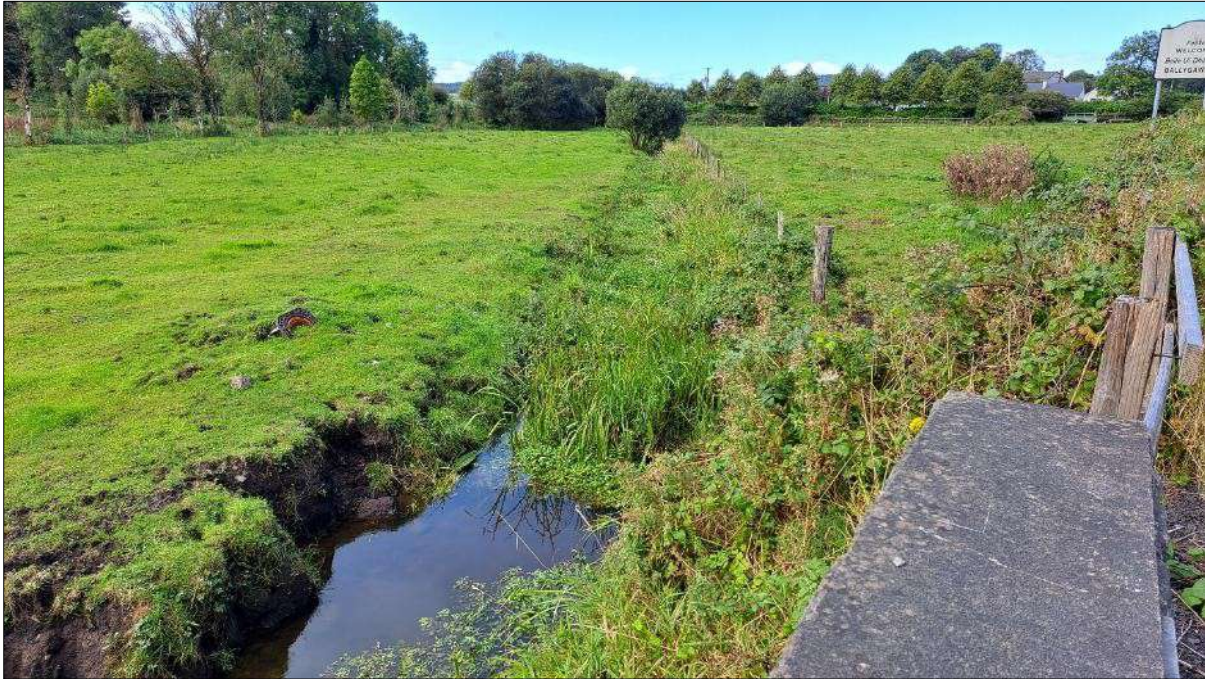
Biological water quality, based on Q-sampling, was calculated as **Q2-3 (poor status)** (**Appendix C**). However, it should be noted that this was a tentative rating given poor flows and an absence of suitable riffle areas for sampling (Toner et al., 2005). No macro-invertebrate species of conservation value greater than 'least concern', according to national red lists, were recorded via Q-sampling.

**Plate 7.2.24** Representative image of site D9 on an unmapped Carrigeenboy River tributary, September 2024
